PHASE I ENVIRONMENTAL SITE ASSESSMENT

*Kimberly-Clark Worldwide, Inc.
Riverside Woodyard
Everett, Washington*

28 December 2005

Delta Project No. 0510545P

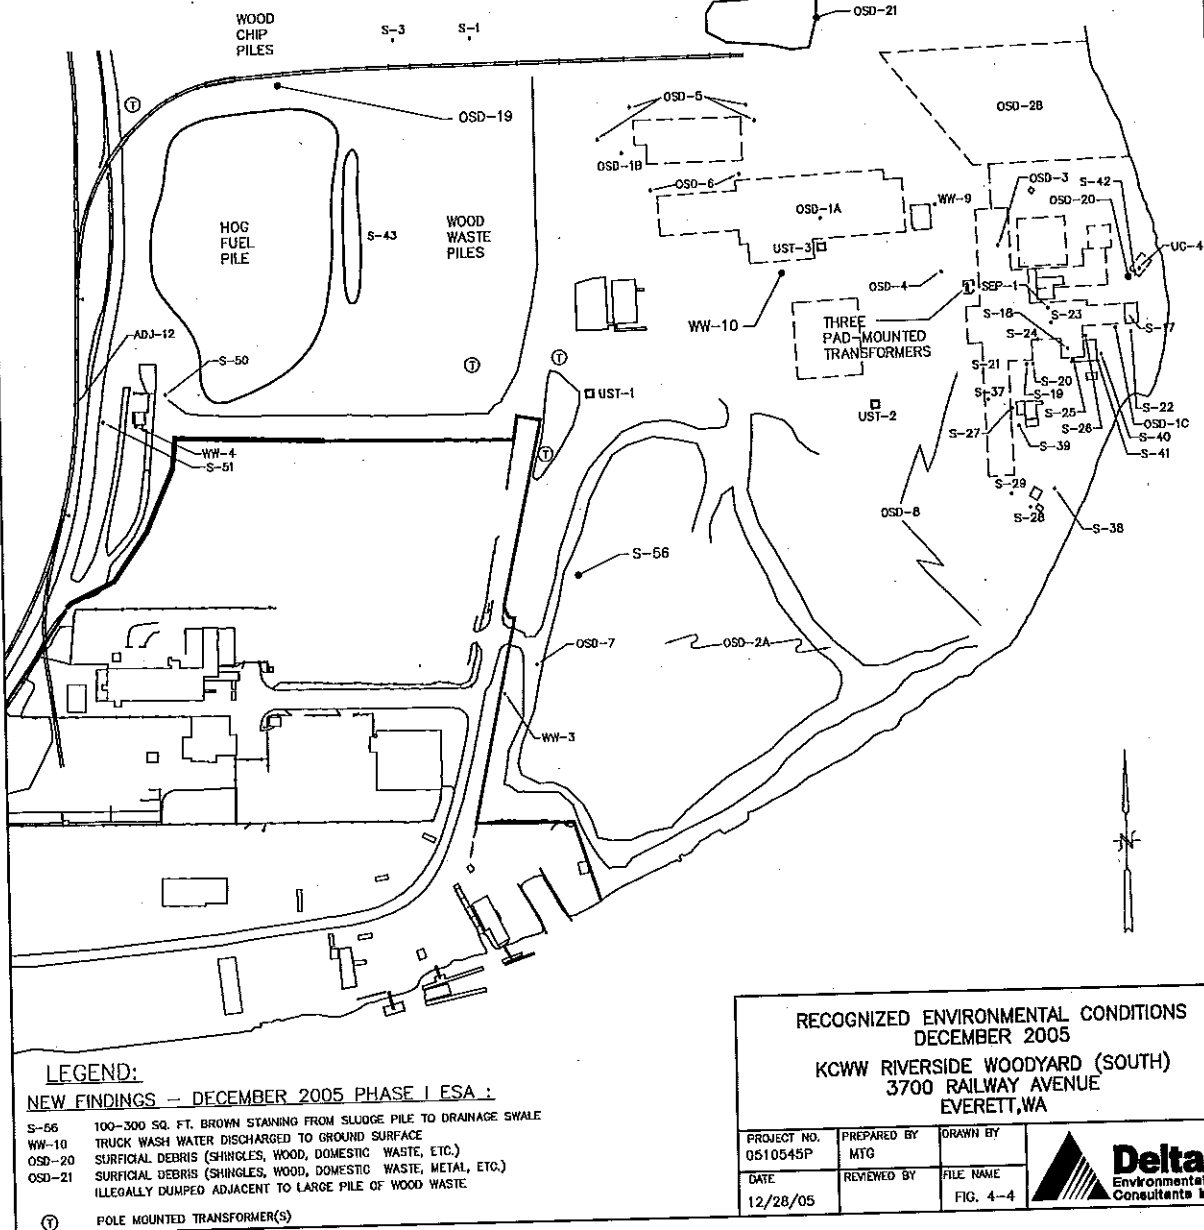
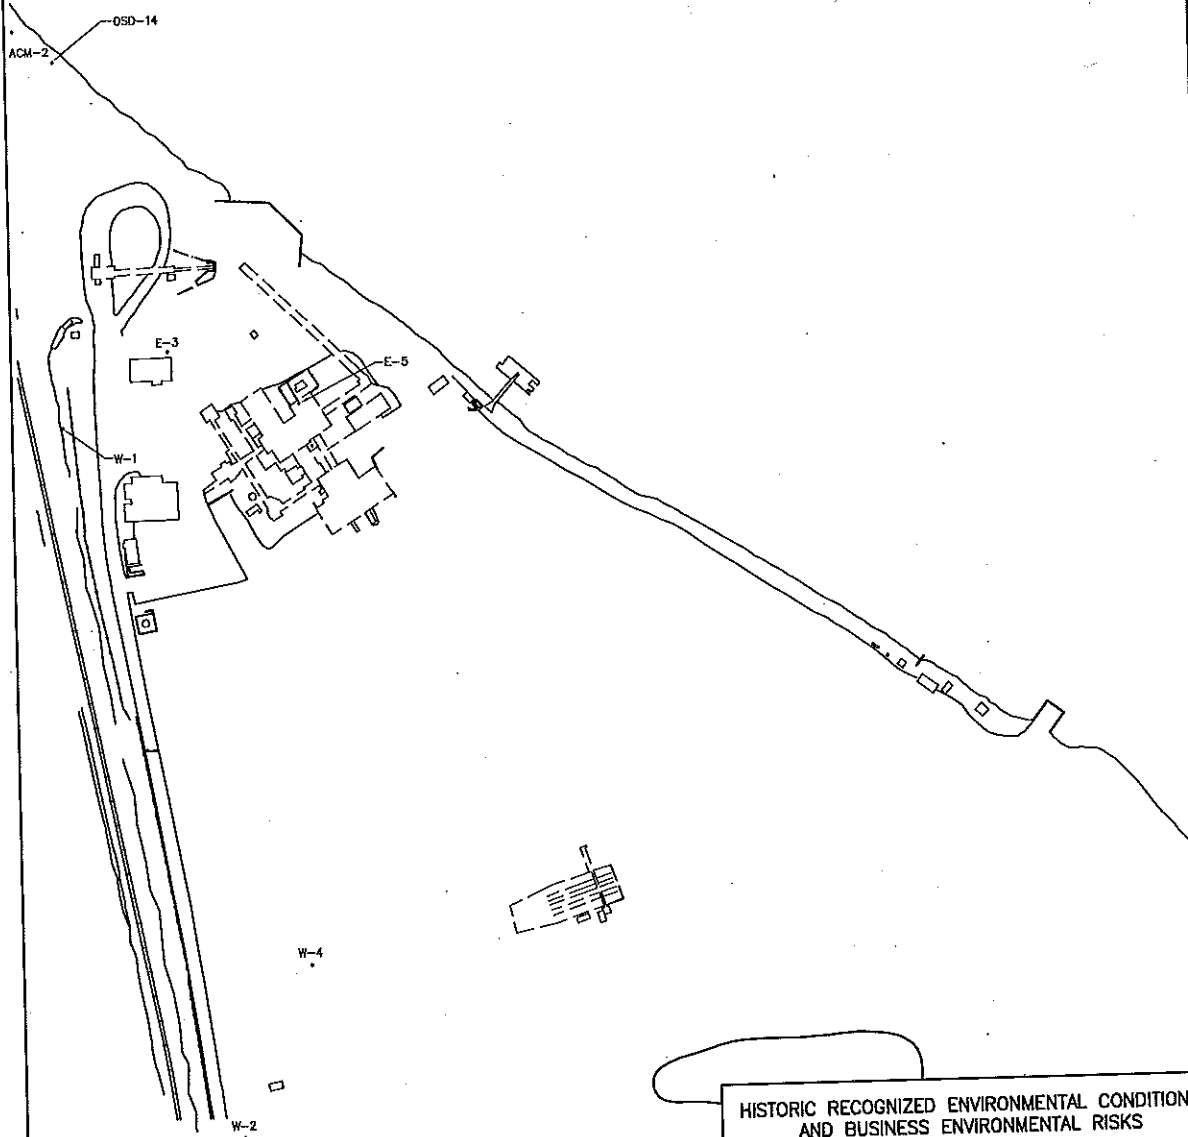
HISTORIC RECOGNIZED ENVIRONMENTAL CONDITIONS
 AND BUSINESS ENVIRONMENTAL RISKS
 KCWW RIVERSIDE WOODYARD (NORTH)
 3700 RAILWAY AVENUE
 EVERETT, WA

ACM-2 ACM ON PIPING (NOT OBSERVED DURING DECEMBER 2005 PHASE I ESA)
 E-3 STAINS, POLE TRANSFORMER, RIVERSIDE MILL OFFICE
 (NOT OBSERVED DURING DECEMBER 2005 PHASE I ESA)
 E-5 2 SQ. FT. STAIN BELOW TRANSFORMER, CHIP MILL MGC ROOM
 (NOT OBSERVED DURING DECEMBER 2005 PHASE I ESA)
 W-1 MONITORING WELL (NOT OBSERVED DURING DECEMBER 2005 PHASE I ESA)
 W-2 MONITORING WELL (NOT OBSERVED DURING DECEMBER 2005 PHASE I ESA)
 W-4 GROUNDWATER MONITORING WELL (OBSERVED DURING DECEMBER 2005 PHASE I ESA)
 OSD-14 MISCELLANEOUS SURFICIAL DEBRIS NORTHERN PORTION OF PROPERTY (NOT OBSERVED DURING DECEMBER 2005 PHASE I ESA)

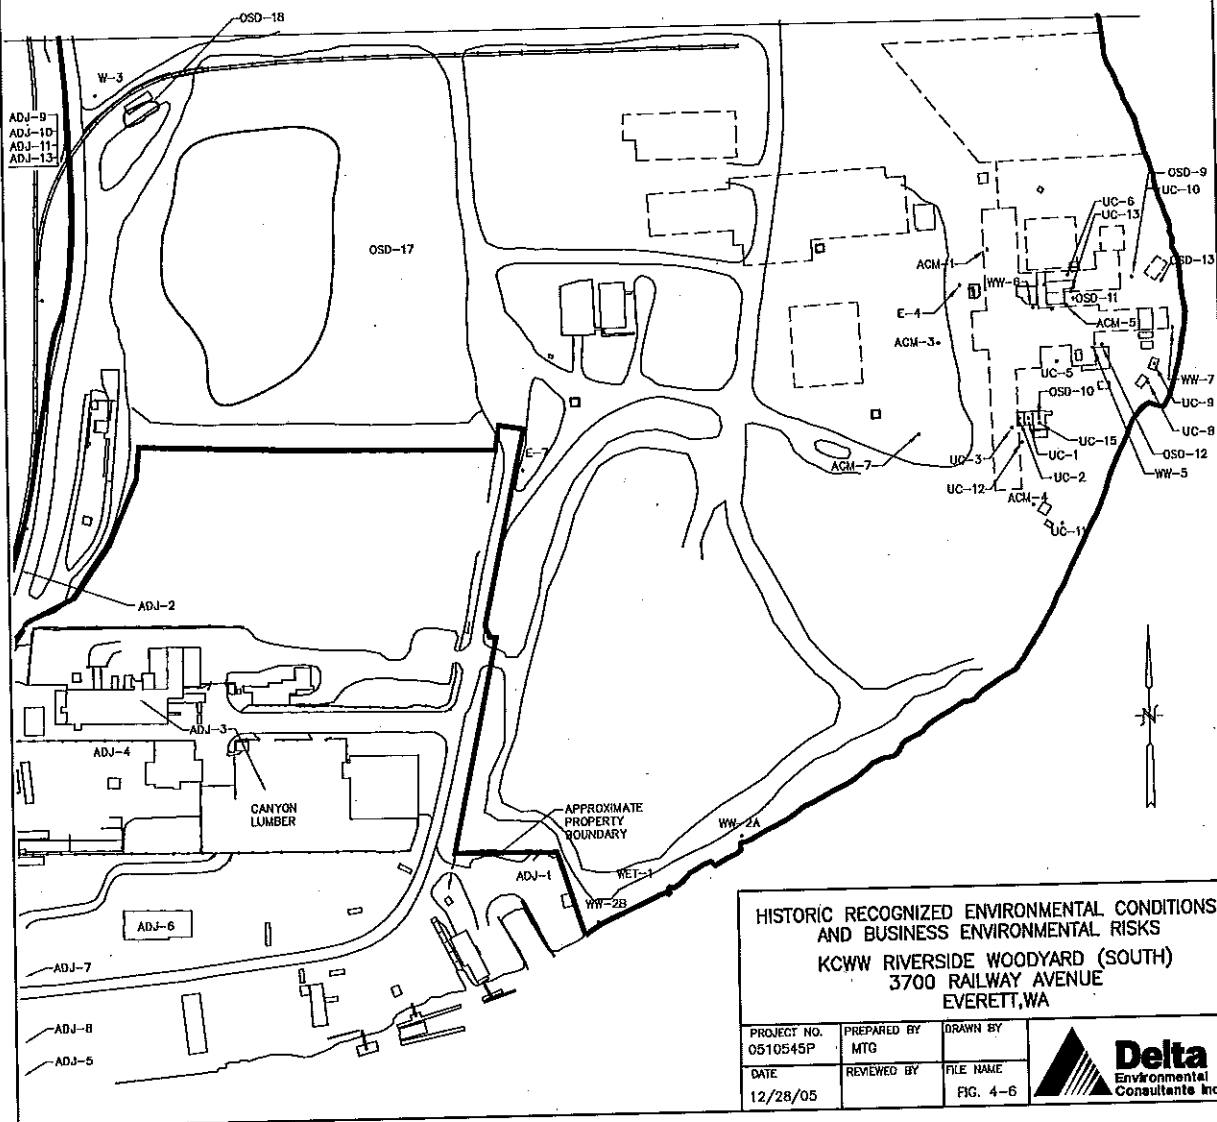
HISTORIC RECOGNIZED ENVIRONMENTAL CONDITIONS
AND BUSINESS ENVIRONMENTAL RISKS
KCWW RIVERSIDE WOODYARD (SOUTH)
3700 RAILWAY AVENUE
EVERETT, WA

OSD-9 DRUMS OF BILGE SCRAPINGS/USED SAND BLAST MATERIAL
(NO LONGER PRESENT)
OSD-10 USED SAND BLAST MATERIAL (NO LONGER PRESENT)
OSD-11 USED SAND BLAST MATERIAL (NO LONGER PRESENT)
OSD-12 GRINDING WASTE (NO LONGER PRESENT)
OSD-13 SURTICAL SCRAP METAL, PIPING, WOOD AND OTHER DEBRIS (NO LONGER PRESENT)
OSD-17 MULTIPLE PILES OF SOLID WASTE (FORMER PILES REMOVED OR GROUND FOR
HOG FUEL, SOME WOOD WASTE PILES PRESENT)
OSD-18 TEMPORARY SLUDGE STAGING AREA (NO LONGER PRESENT)
ADJ-1 ADJACENT MARINE FACILITY (STILL PRESENT, MOST DEBRIS REMOVED)
ADJ-2 METAL STAND PIPE, B-W RIGHT OF WAY (STILL PRESENT, NO LONGER
POTENTIAL/RECOGNIZED ENVIRONMENTAL CONDITION)
ADJ-3 CANYON LUMBER MILL (NO NEW INFORMATION AVAILABLE)
ADJ-4 SHAFER EQUIPMENT (NO NEW INFORMATION AVAILABLE)
ADJ-5 PUGET SOUND ENERGY, 1/5 MILE SOUTHWEST OF SITE (STILL PRESENT)
ADJ-6 CHAPMAN TRUCK SALES (STILL PRESENT, LISTED AS
CHAPMAN TRUCK DITCH IN DECEMBER 2005 DATABASE)

ADJ-7 RUBATINOS REFUSE, 1/5 MILE SOUTHEAST OF SITE (STILL PRESENT)
ADJ-8 NELSON DISTRIBUTING 1/2 MILE SOUTHEAST OF SITE (STILL PRESENT)
ADJ-9 PRIME EQUIPMENT, 3/10 MILE SOUTHEAST OF SITE (STILL PRESENT)
ADJ-10 EXCOM, 1/2 MILE SOUTHWEST OF SITE (STILL PRESENT, CLOSED)
ADJ-11 WESTERN POWER AND EQUIPMENT, 1/2 MILE SOUTHWEST OF SITE
(STILL PRESENT, NOW McEVROY OIL)
ADJ-13 SECOND PRIME EQUIPMENT FACILITY, ONE-QUARTER MILE SOUTHWEST (STILL PRESENT)
E-4 TRANS. IN DEBRIS PILE, LEASED AREA (REMOVED FROM SITE)
E-7 POLE-MOUNTED TRANSFORMER (STILL PRESENT, NO STAINING)
W-3 MONITORING WELL (REPORTEDLY HIT BY TRUCK AND DESTROYED)
