**SITE CHARACTERIZATION
REPORT
FOR
CITY OF CLARKSTON**

**BRIDGE STREET SHOP SITE
1455 BRIDGE STREET
CLARKSTON, WASHINGTON**

**WDOE INCIDENT NO. 3666
WDOE SITE NO. 100255**

FEBRUARY 1993

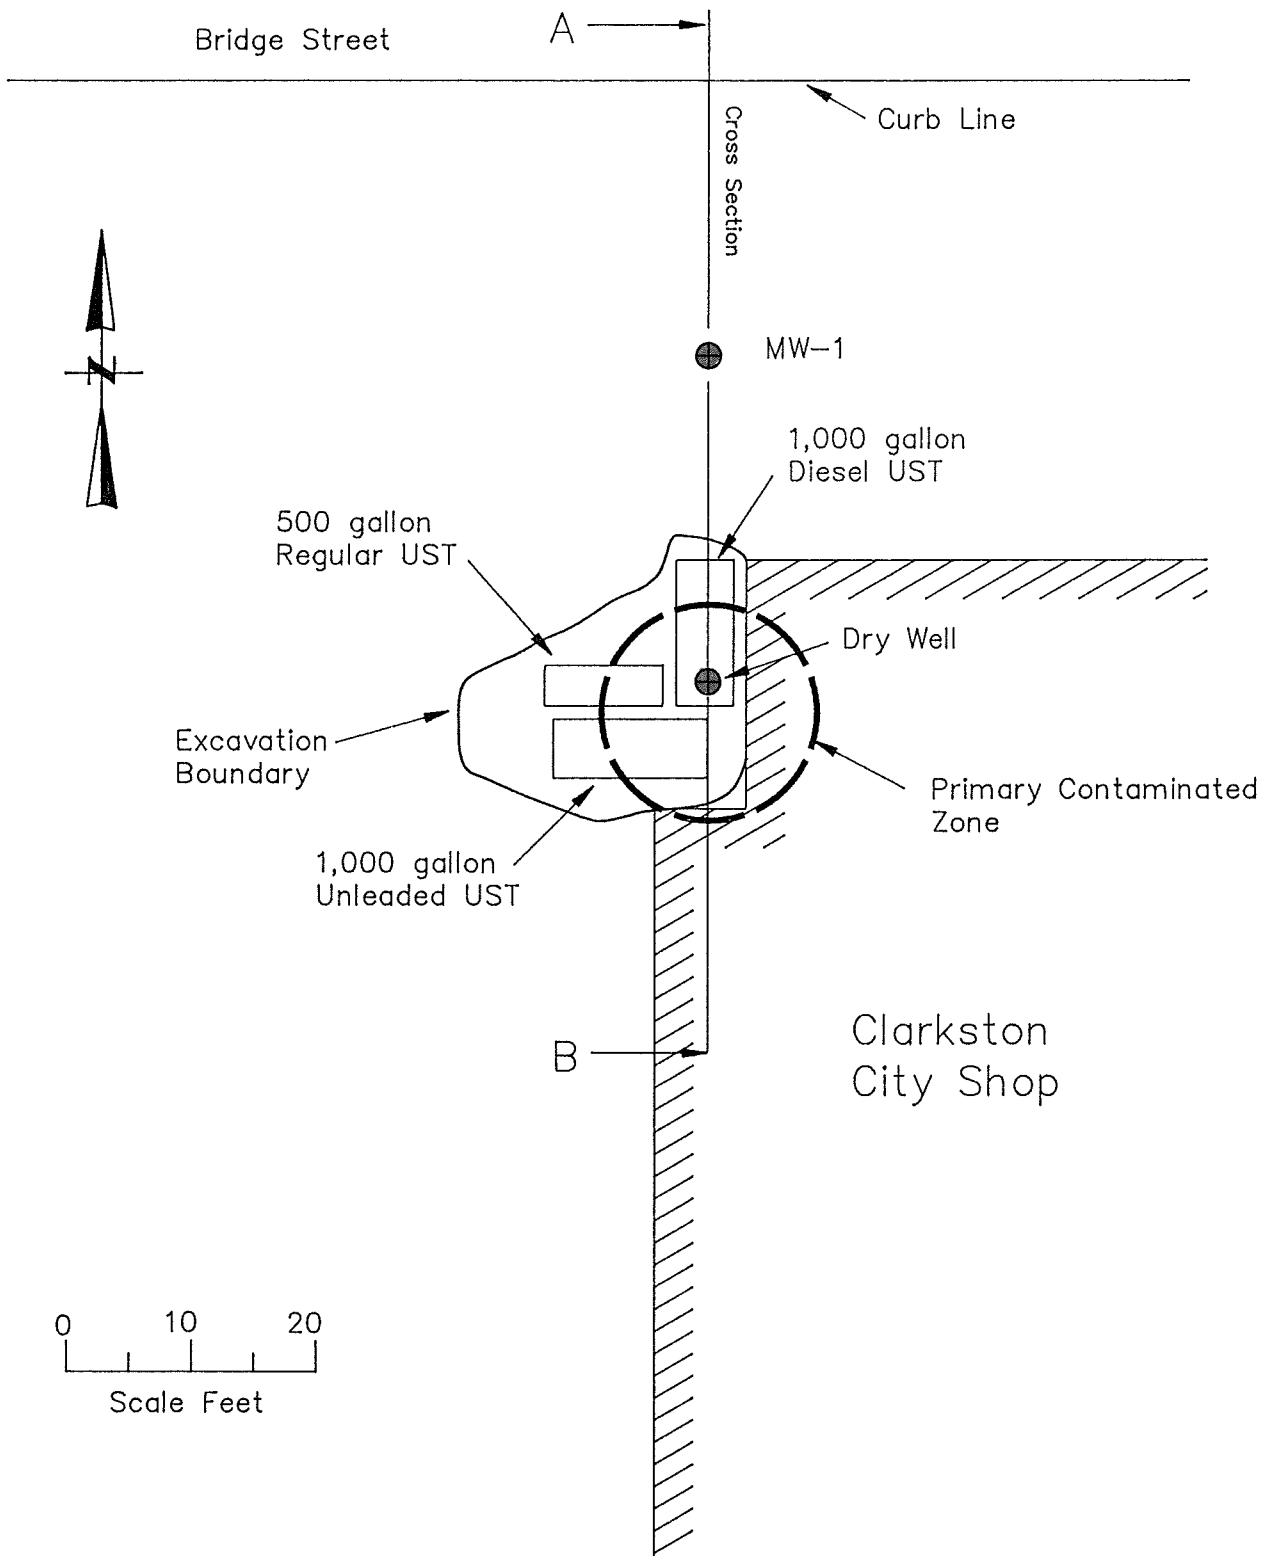
FIGURE # 2

The site had three USTs, as shown in Figure 2. These tanks and the associated dispensing systems were located at the northwest corner of the shop building. The area north and west of the shop building and south of Bridge Street is mostly asphalt covered. The area west of the shop including the excavated area is graveled.

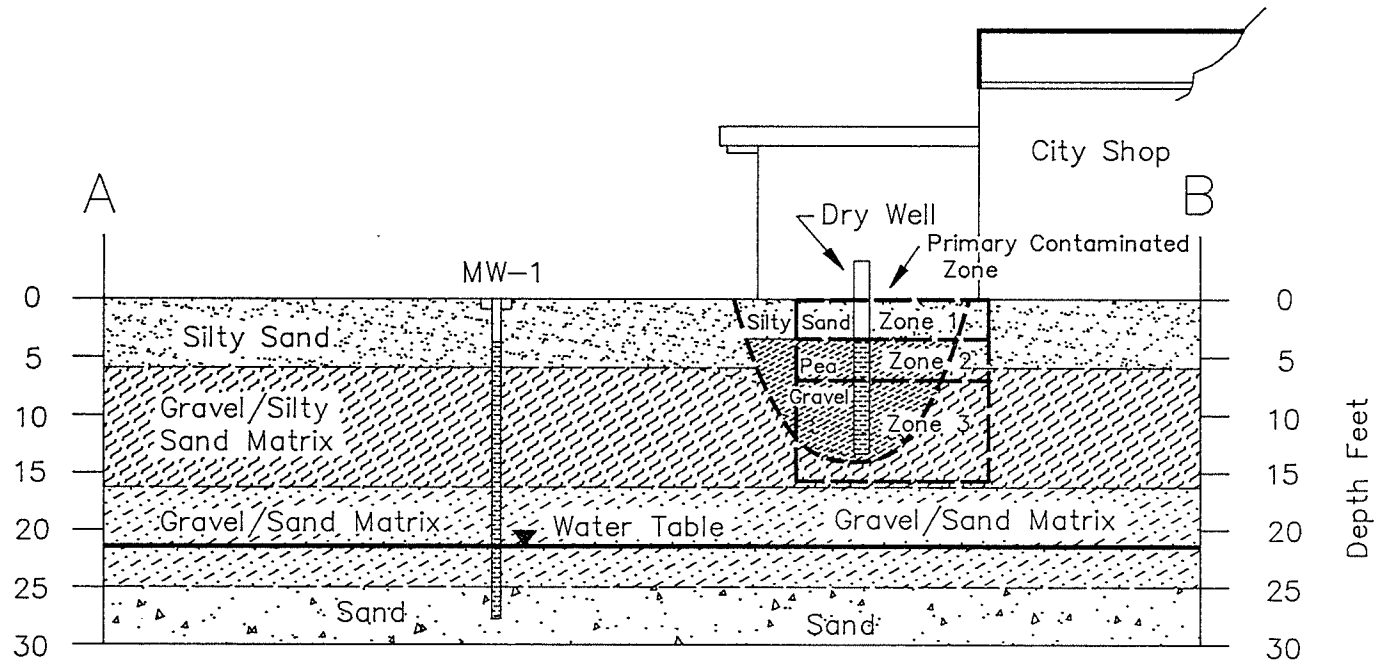
FIGURE #5

throughout most of the vadose zone below the near-surface silt and sand zone. This will allow the well to be used for monitoring gasoline, oxygen, and carbon dioxide levels in the vadose zone air as well as the ground water. The dry well installed in the excavated area will also allow levels of gasoline, oxygen, and carbon dioxide to be monitored in the vadose zone air. Figure 5 is an undistorted cross-section of the site that shows the relative location of the monitoring well, dry well, excavated area, and the primary contaminated zone.
