February 17, 2015

Subject: Conceptual Cleanup Action and Request for NFA-Likely Opinion Letter
Seattle Marriott AC
739 9th Avenue North
Seattle, Washington
GeoEngineers File No. 20776-003-00

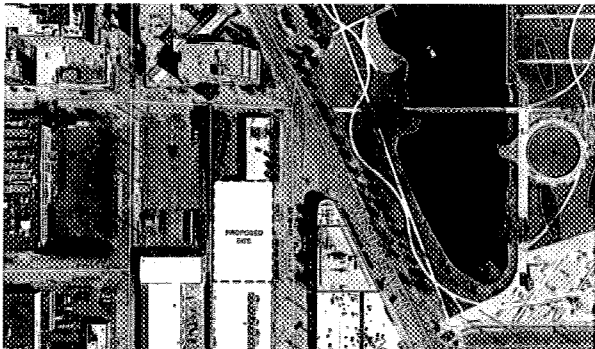
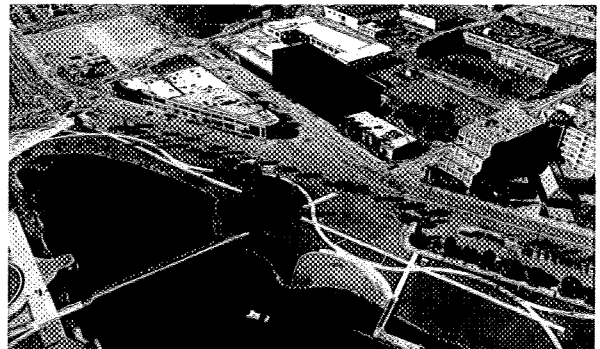
Photo 2 and 3: Proposed redevelopment relative to surrounding properties.
