**2022 ANNUAL PROGRESS REPORT  
SWMU 1 – OILY WATER SEWER  
HF SINCLAIR PUGET SOUND REFINING LLC**

HF Sinclair Puget Sound Refining LLC  
8505 South Texas Road  
Anacortes, WA 98221

February 27, 2023

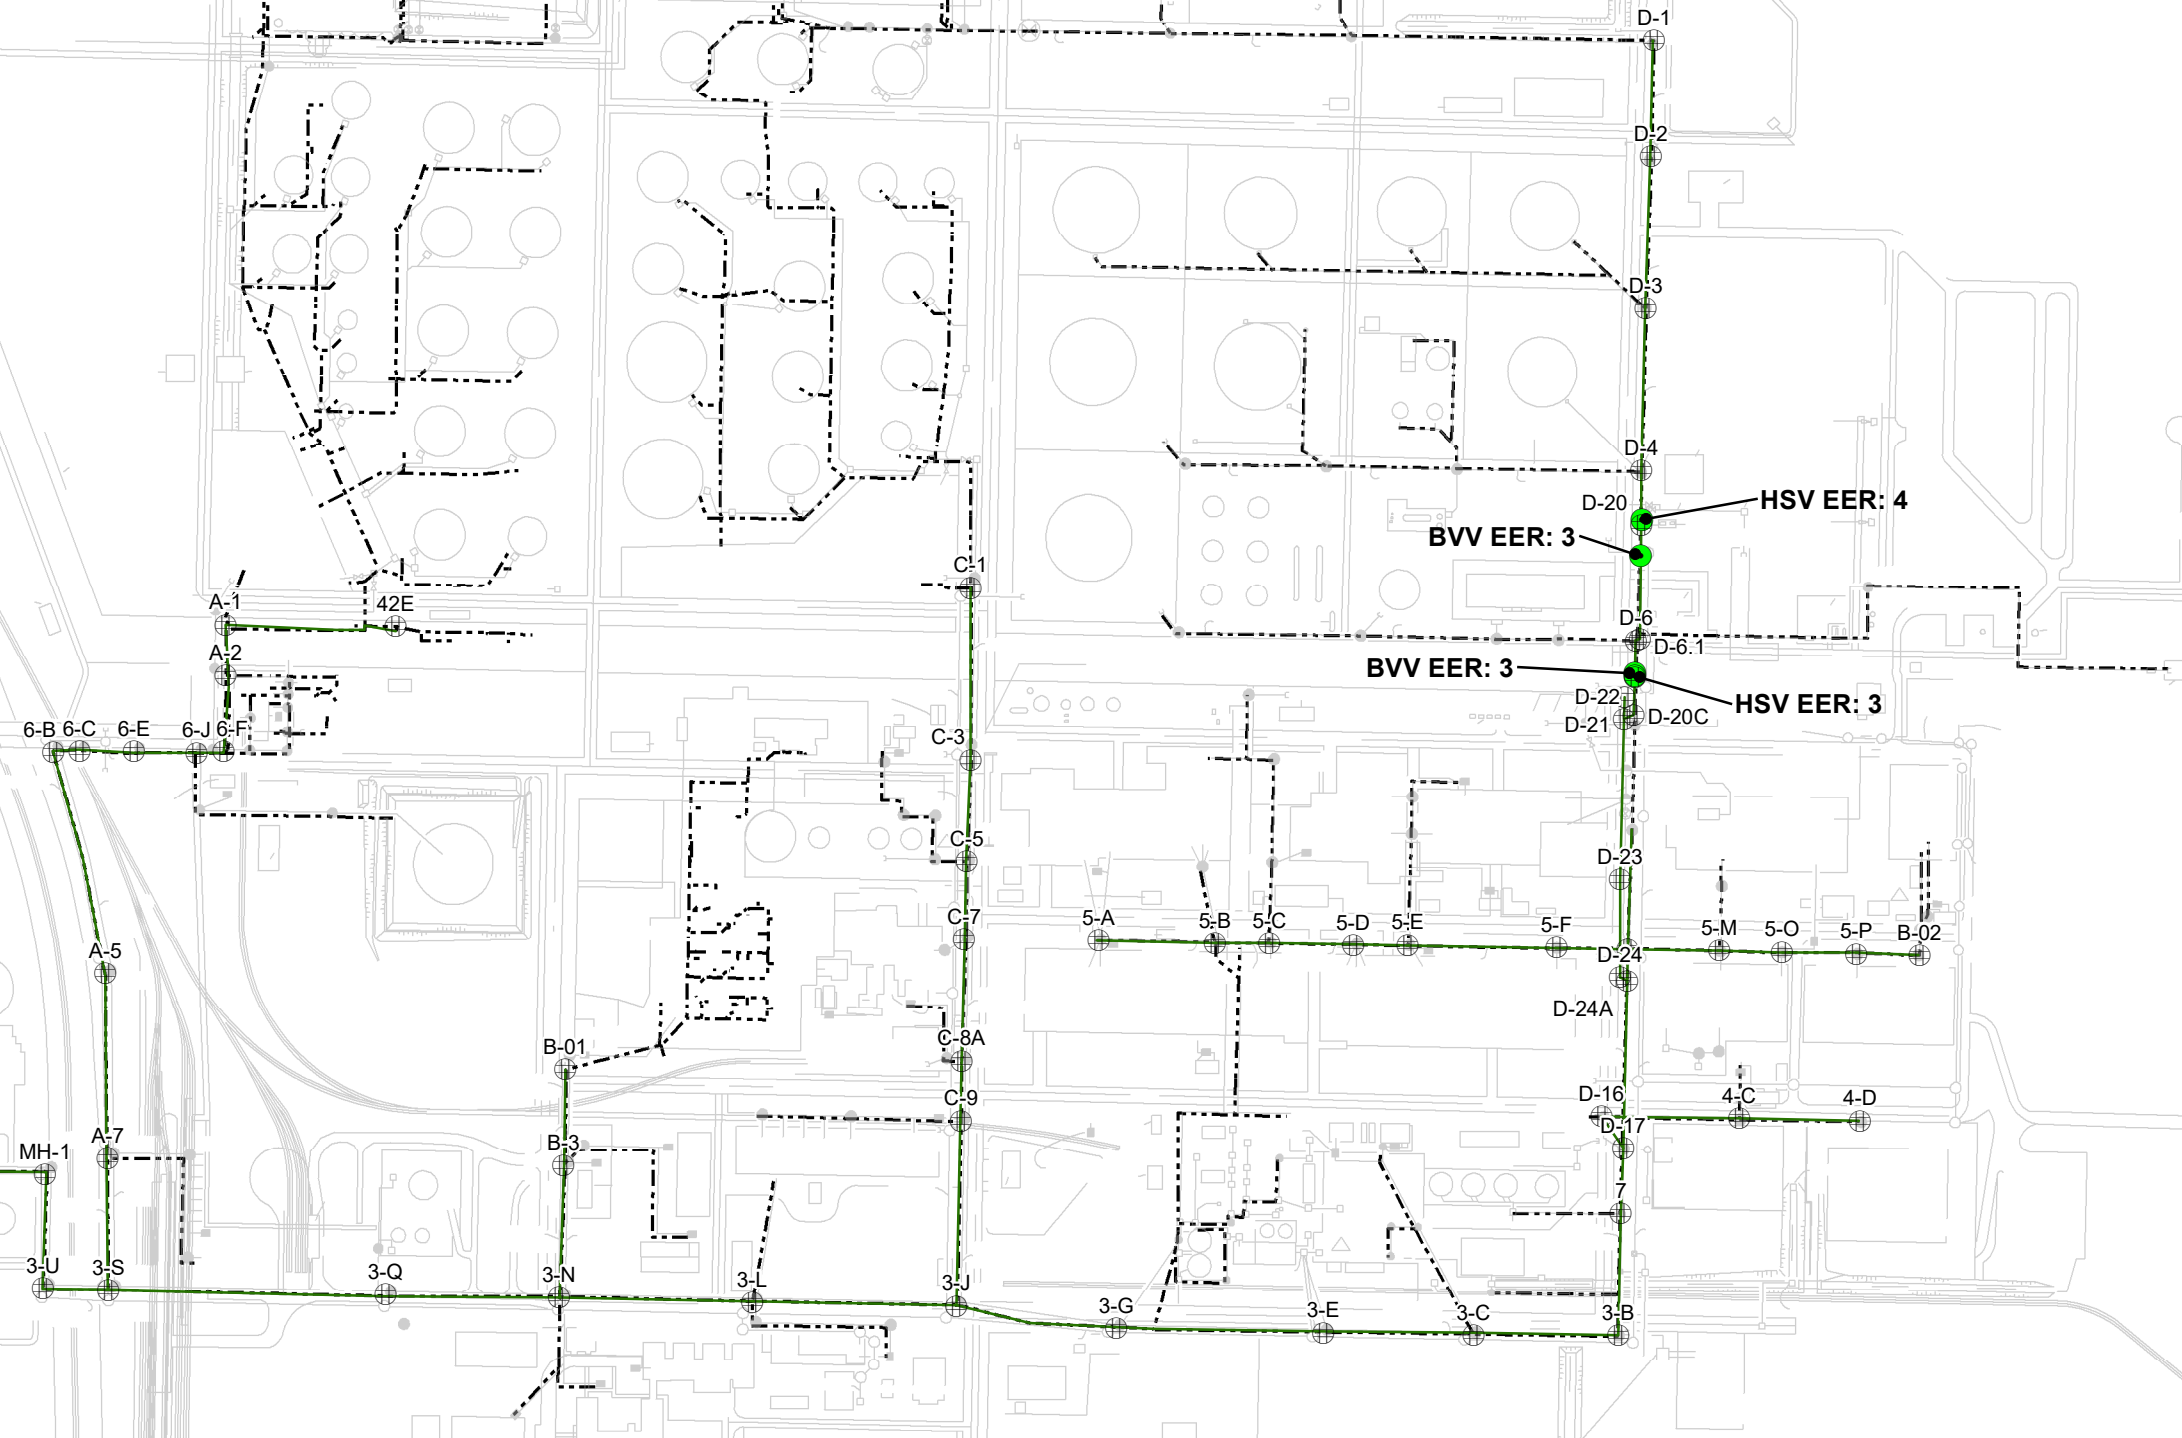
Environmental Evaluation  
Rankings 3 & 4  
Prepared on:  
11/30/22  
**Figure 2**

There were a total of 4 NASSCO codes that were rated at an EER of either 3 or 4. A list and description for each is provided in Table 2 and shown on Figure 2.

Per the IRP, the defects which were identified as EER 3 or EER 4 (as shown on Table 2) are considered potential releases. Site investigation activities should be initiated in these areas to determine if a release has occurred. In addition, pursuant to the IRP, these areas should be prioritized for sewer repairs as needed.

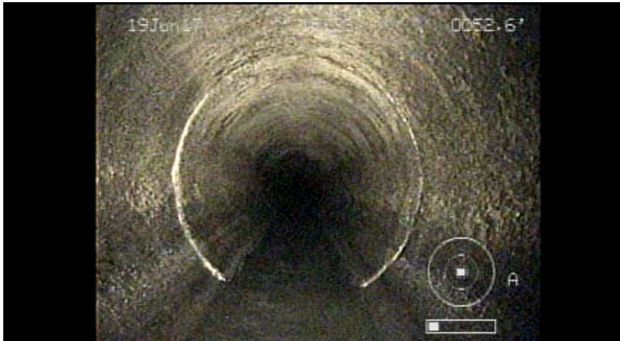
0.0\_SRI\_From-02\_To-05.jpg

**Date:** 6/19/2017  
**Distance:** 0 ft  
**Obs:**  
SRI - Surface Damage  
Roughness Increased  
**Comments:**  
EER: 1

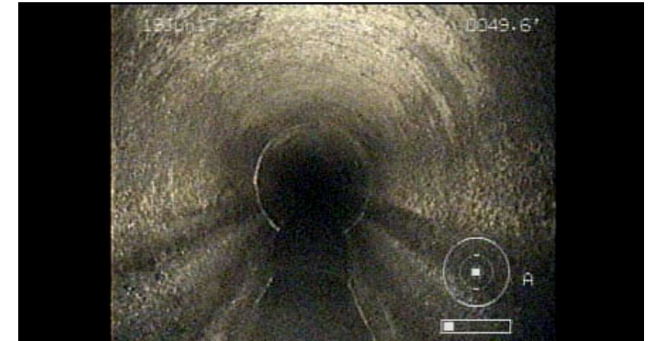
0.0\_SRI\_From-07\_To-10.jpg

**Date:** 6/19/2017  
**Distance:** 0 ft  
**Obs:**  
SRI - Surface Damage  
Roughness Increased  
**Comments:**  
EER: 1

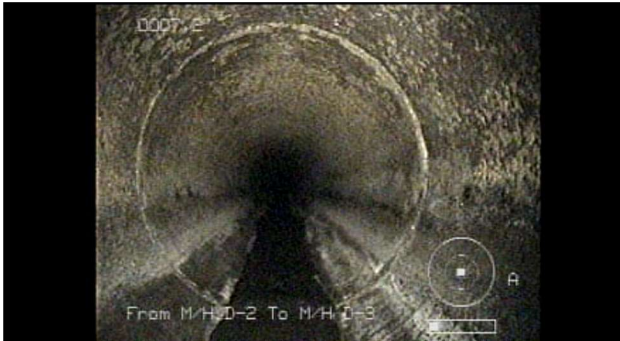
0.0\_SRI\_From-07\_To-05-D.jpg

**Obs:**  
SRI - Surface Damage  
Roughness Increased

EER: 1

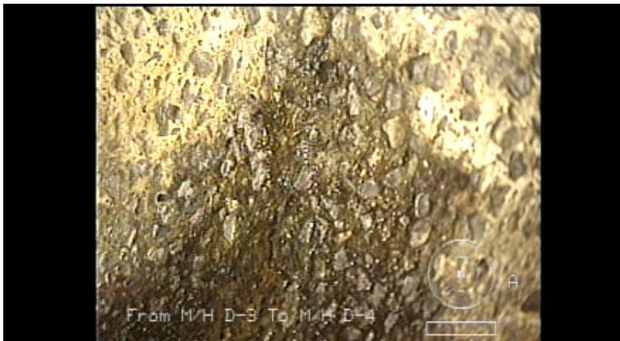
247.0\_SAV\_From-04\_To-05.jpg

**Date:** 6/21/2017  
**Distance:** 247 ft  
**Obs:**  
SAV - Surface  
Aggregate Visible  
**Comments:**  
EER: 1

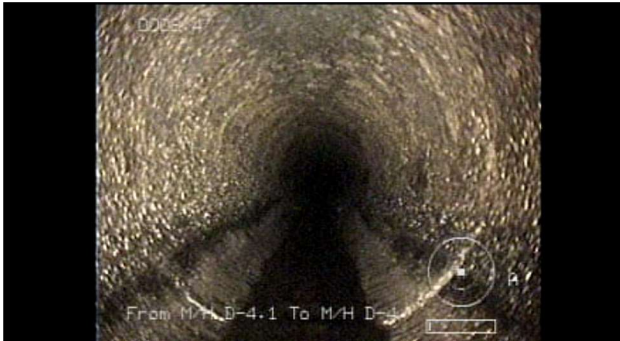
0.0\_SRI\_From-07\_To-05-E.jpg

**Date:** 6/23/2017  
**Distance:** 0 ft  
**Obs:**  
SRI - Surface Damage  
Roughness Increased  
**Comments:**  
EER: 1

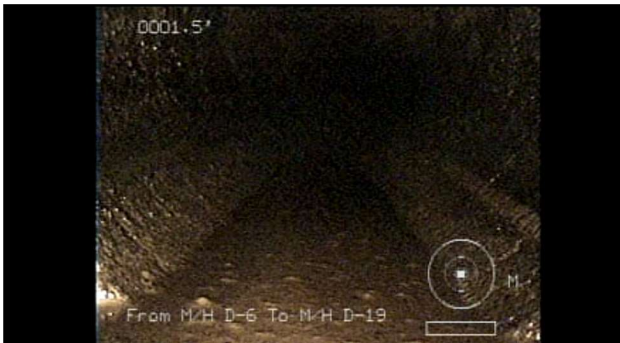
0.0\_MWL\_From\_-To-.jpg

**Date:** 7/10/2017  
**Distance:** 0 ft  
**Obs:**  
 MWL - Miscellaneous  
 Water Level  
**Comments:**

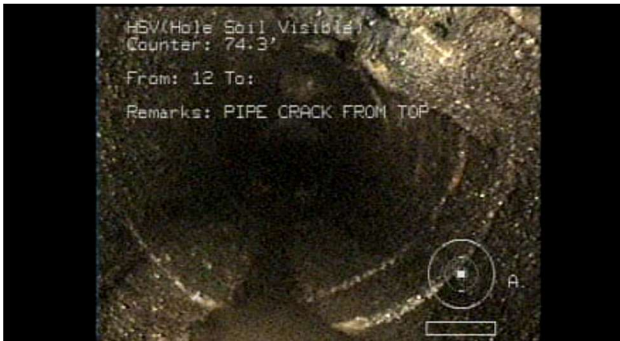
74.0\_HSV\_From-12\_To-.jpg

Sewer Trunk Segment (MH to MH)	NASSCO Code	EER	Location (Length (ft.)/Clock position)	Comments
MH D-4 to MH D-20 & MH D-6.1 to MH D-20	Hole Soil Visible	4	85.5' / 12 to 5 o'clock & 233.8' / 7 to 12 o'clock	Hole created to access Manhole D-20. Infiltration Runner Connection (IRC) from hole. The same code is in both sewer segments because both inspections end at MH D-20.
MH D-6.1 to MH D-20	Broken Void Visible	3	172.6' / 11 o'clock	Noticeably displaced pieces moved from their original position above the flow line.
MH D-6 to MH D-19	Broken Void Visible	3	69.0' / 12 o'clock	Noticeably displaced pieced moved from their original position above the flow line.
MH D-6 to MH D-19	Hole Soil Visible	3	74.0' / 12 o'clock	4 inch hole above flow line.

**Date:** 7/10/2017  
**Distance:** 74 ft  
**Obs:**  
 HSV - Hole Soil Visible  
**Comments:**  
 EER: 3

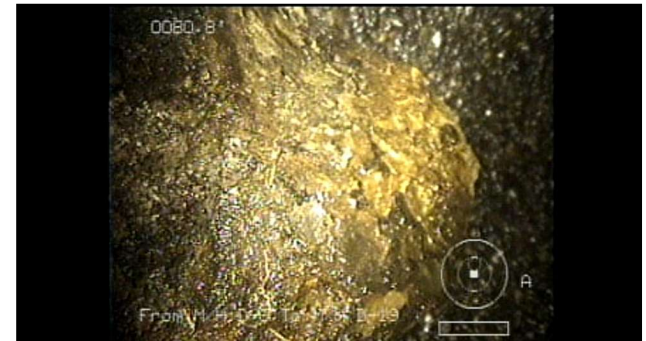
80.0\_DAE\_From-12\_To-.jpg

**Date:** 7/10/2017  
**Distance:** 80 ft  
**Obs:**  
 DAE - Deposits Attached  
 Encrustation  
**Comments:**  
 EER: 1. Calcium Built  
 in Joint

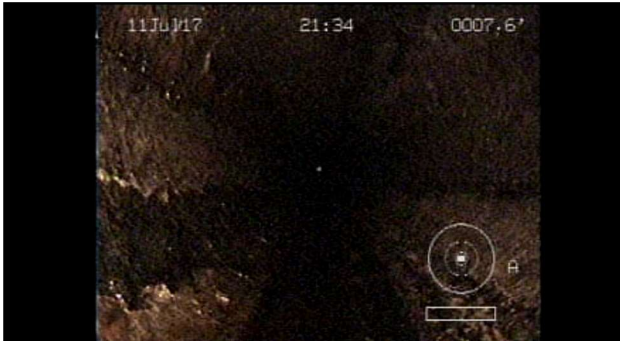
0.0\_SRI\_From-07\_To-09.jpg

**Date:** 7/12/2017  
**Distance:** 0 ft  
**Obs:**  
SRI - Surface Damage  
Roughness Increased  
**Comments:**  
EER: 1

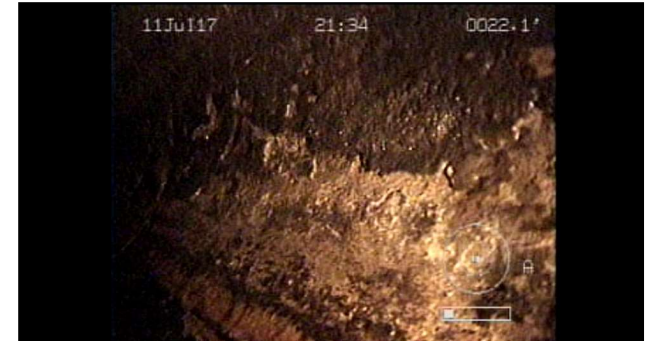
0.0\_SRI\_From-03\_To-05.jpg

**Date:** 7/12/2017  
**Distance:** 0 ft  
**Obs:**  
SRI - Surface Damage  
Roughness Increased  
**Comments:**  
EER: 1

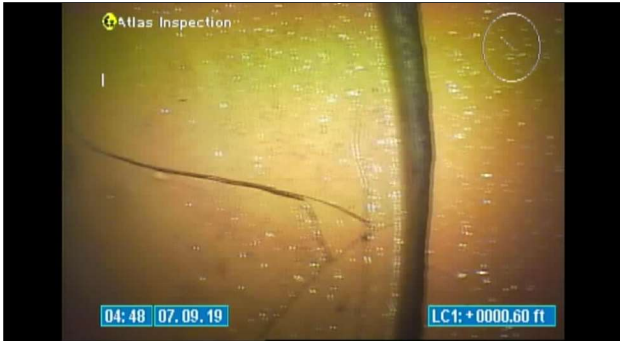
0.6\_CM\_From-11\_To-01.jpg

**Date:** 7/09/2019  
**Distance:** 0.6 ft  
**Obs:**  
 CM - Crack Multiple  
**Comments:**  
 EER: 1

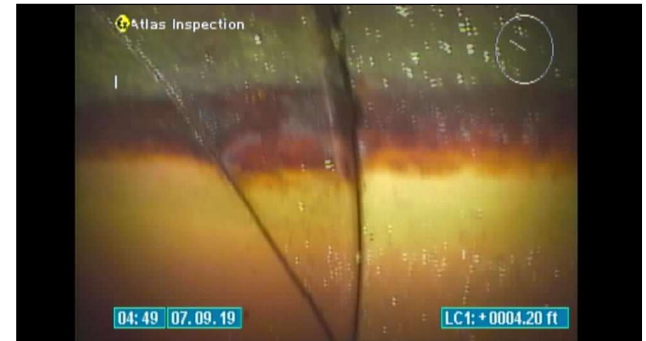
4.2\_CS\_From-08\_To-10.jpg

**Date:** 7/09/2019  
**Distance:** 4.2 ft  
**Obs:**  
 CS - Crack Spiral  
**Comments:**  
 EER: 1

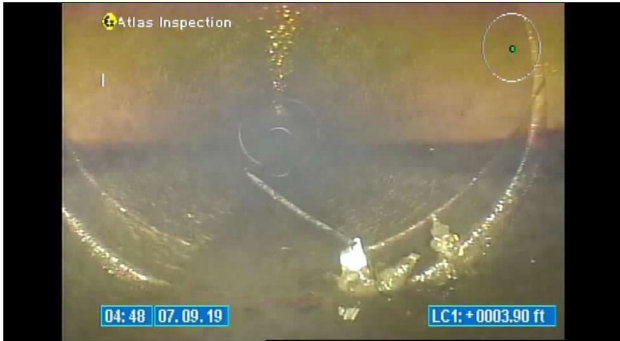
4.2\_OBJ\_From-03\_To-06.jpg

**Date:** 7/09/2019  
**Distance:** 4.2 ft  
**Obs:**  
 OBJ - Obstruction  
 Wedged In The Joint  
**Comments:**  
 EER: 1. Zip ties and possibly a dead vermin. Unclear.

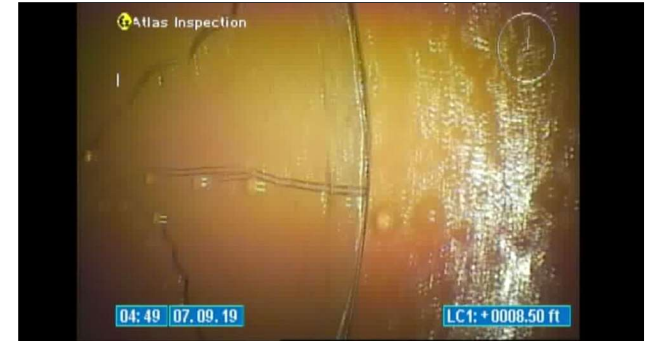
8.5\_CM\_From-10\_To-03.jpg

**Date:** 7/09/2019  
**Distance:** 8.5 ft  
**Obs:**  
 CM - Crack Multiple  
**Comments:**  
 EER: 1

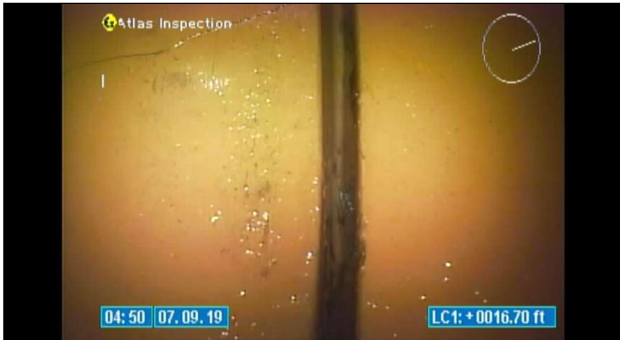
16.7\_CL\_From-02\_To-.jpg

**Date:** 7/09/2019  
**Distance:** 16.7 ft  
**Obs:**  
 CL - Crack Longitudinal  
**Comments:**  
 EER: 1

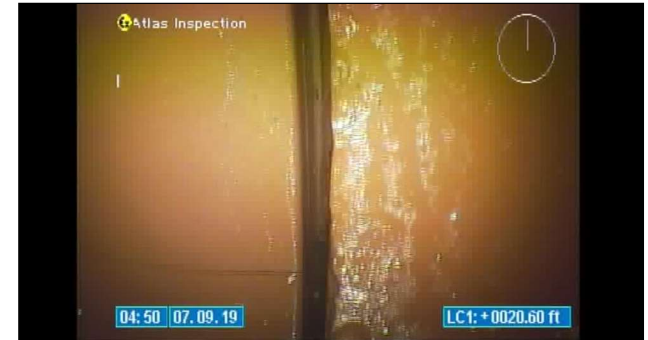
20.6\_CL\_From-12\_To-.jpg

**Date:** 7/09/2019  
**Distance:** 20.6 ft  
**Obs:**  
 CL - Crack Longitudinal  
**Comments:**  
 EER: 1

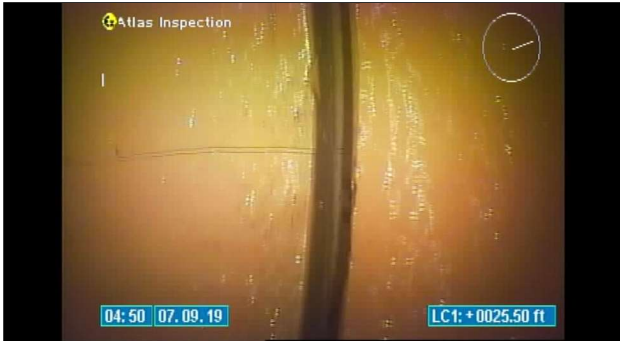
25.5\_CL\_From-02\_To-.jpg

**Date:** 7/09/2019  
**Distance:** 25.5 ft  
**Obs:**  
 CL - Crack Longitudinal  
**Comments:**  
 EER: 1

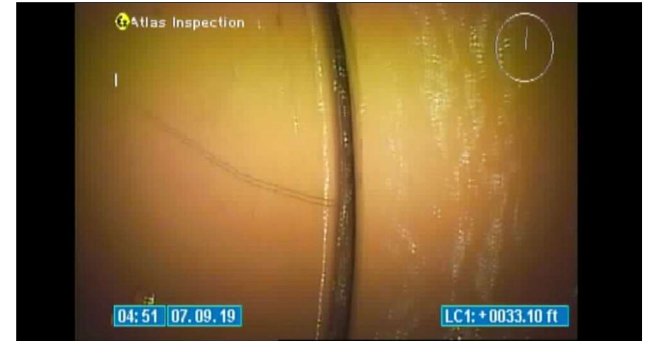
33.1\_CS\_From-11\_To-12.jpg

**Date:** 7/09/2019  
**Distance:** 33.1 ft  
**Obs:**  
 CS - Crack Spiral  
**Comments:**  
 EER: 1

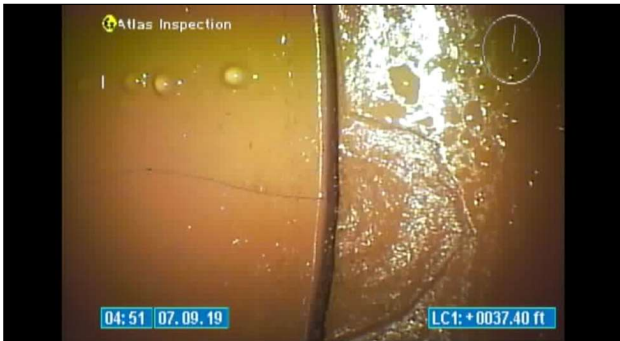
37.4\_CL\_From-12\_To-.jpg

**Date:** 7/09/2019  
**Distance:** 37.4 ft  
**Obs:**  
 CL - Crack Longitudinal  
**Comments:**  
 EER: 1

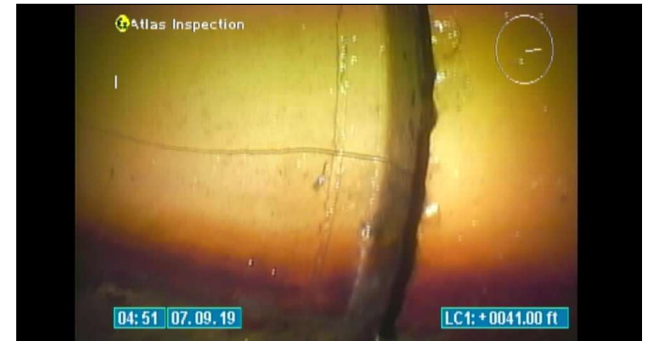
41.0\_CL\_From-03\_To--A.jpg

**Date:** 7/09/2019  
**Distance:** 41 ft  
**Obs:**  
 CL - Crack Longitudinal  
**Comments:**  
 EER: 1

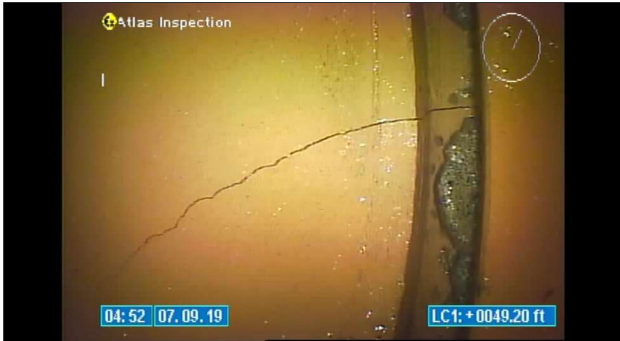
49.2\_CS\_From-01\_To-03.jpg

**Date:** 7/09/2019  
**Distance:** 49.2 ft  
**Obs:**  
 CS - Crack Spiral  
**Comments:**  
 EER: 1

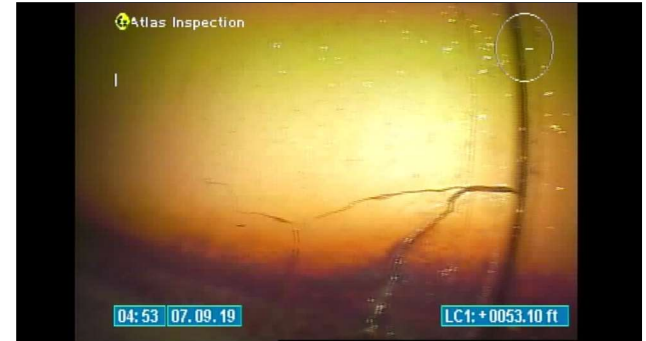
53.1\_CM\_From-03\_To-04.jpg

**Date:** 7/09/2019  
**Distance:** 53.1 ft  
**Obs:**  
 CM - Crack Multiple  
**Comments:**  
 EER: 1

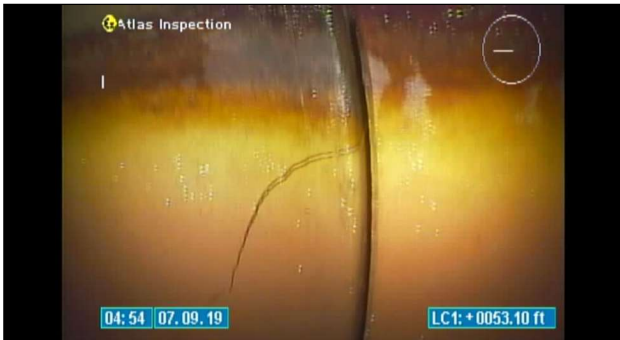
53.1\_CS\_From-09\_To-12.jpg

**Date:** 7/09/2019  
**Distance:** 53.1 ft  
**Obs:**  
 CS - Crack Spiral  
**Comments:**  
 EER: 1

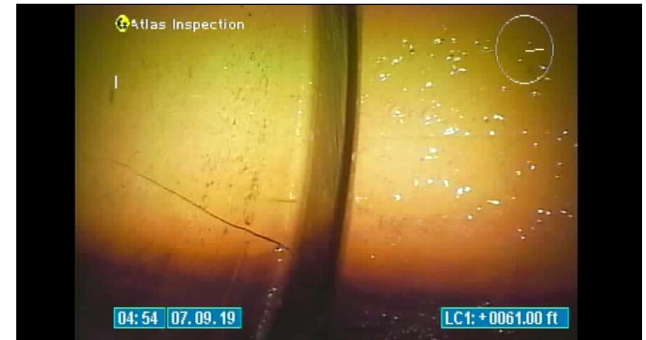
61.0\_CL\_From-03\_To-.jpg

**Date:** 7/09/2019  
**Distance:** 61 ft  
**Obs:**  
 CL - Crack Longitudinal  
**Comments:**  
 EER: 1

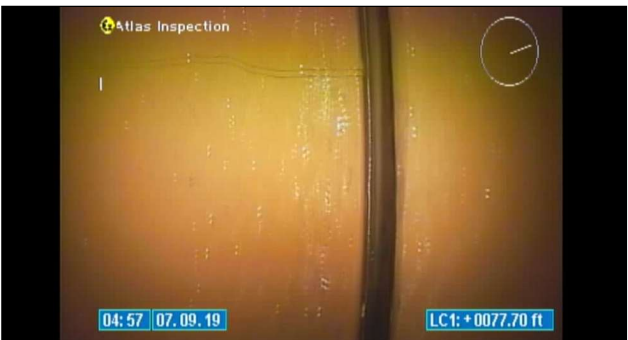
**Obs:**  
CL - Crack Longitudinal

EER: 1

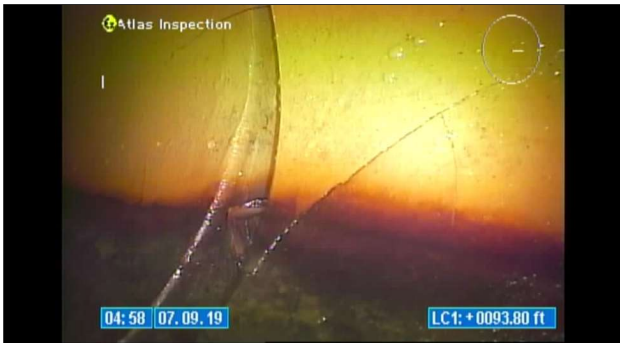
82.3\_CS\_From-03\_To-05.jpg

**Date:** 7/09/2019  
**Distance:** 93.8 ft  
**Obs:**  
 CS - Crack Spiral  
**Comments:**  
 EER: 1

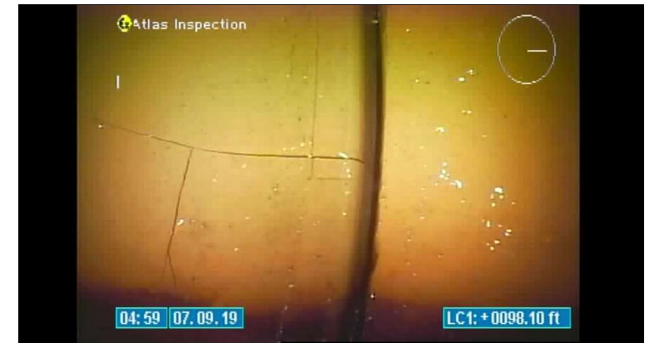
98.1\_CM\_From-03\_To-05.jpg

**Date:** 7/09/2019  
**Distance:** 98.1 ft  
**Obs:**  
 CM - Crack Multiple  
**Comments:**  
 EER: 1

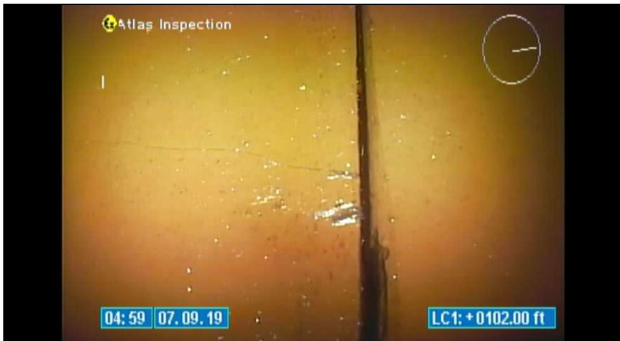
102.0\_CL\_From-03\_To-.jpg

**Date:** 7/09/2019  
**Distance:** 102 ft  
**Obs:**  
 CL - Crack Longitudinal  
**Comments:**  
 EER: 1

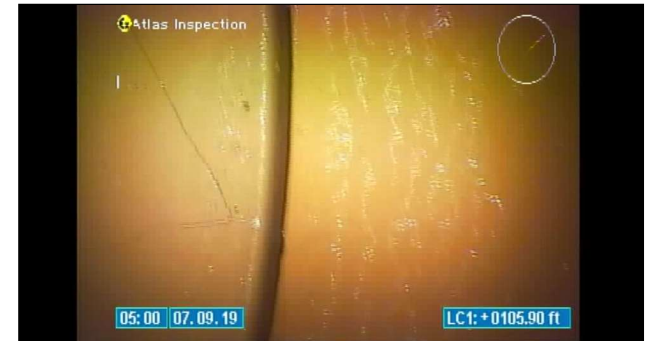
105.9\_CM\_From-12\_To-03.jpg

**Date:** 7/09/2019  
**Distance:** 105.9 ft  
**Obs:**  
 CM - Crack Multiple  
**Comments:**  
 EER: 1

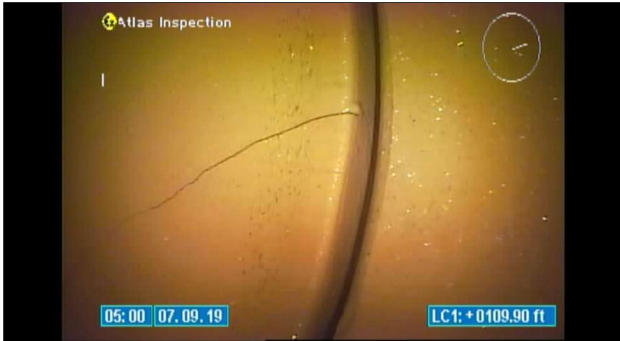
109.9\_CS\_From-02\_To-04.jpg

**Date:** 7/09/2019  
**Distance:** 109.9 ft  
**Obs:** CS - Crack Spiral  
**Comments:**  
EER: 1

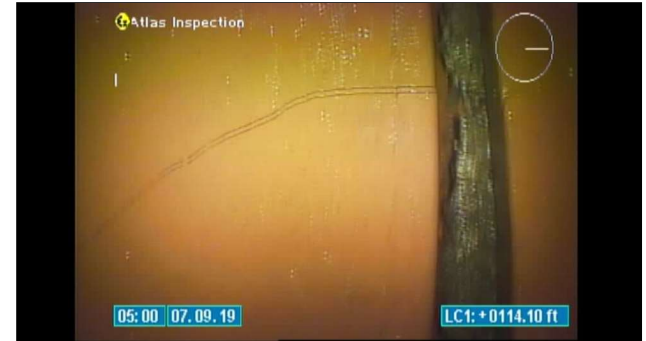
114.1\_CS\_From-03\_To-05.jpg

**Date:** 7/09/2019  
**Distance:** 114.1 ft  
**Obs:** CS - Crack Spiral  
**Comments:**  
EER: 1

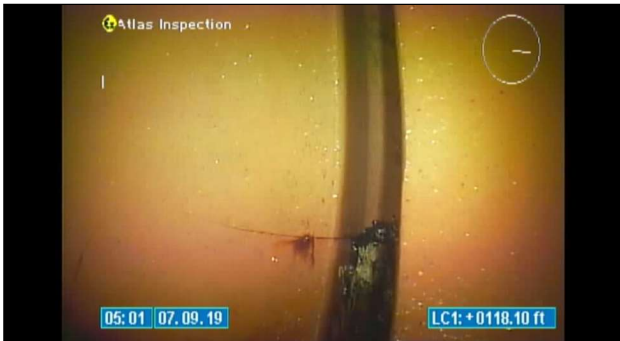
118.1\_CL\_From-03\_To-.jpg

**Date:** 7/09/2019  
**Distance:** 118.1 ft  
**Obs:** CL - Crack Longitudinal  
**Comments:**  
EER: 1

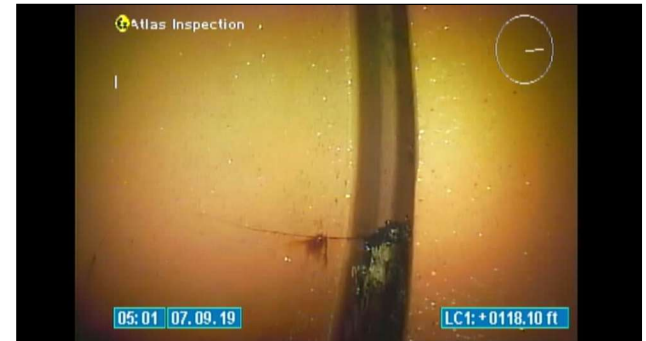
118.1\_ISB\_From-03\_To-.jpg

**Date:** 7/09/2019  
**Distance:** 118.1 ft  
**Obs:** ISB - Infil Stain Barrel  
**Comments:**  
EER: 1

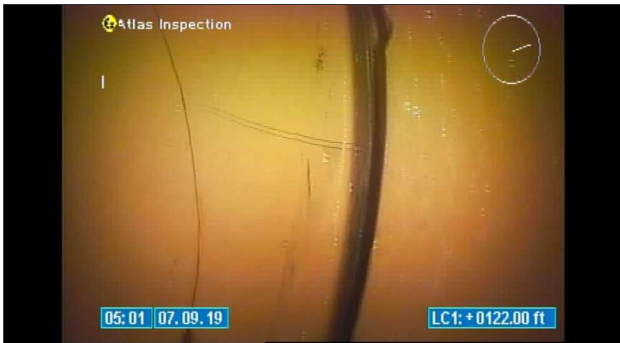
122.0\_CM\_From-07\_To-05.jpg

**Date:** 7/09/2019  
**Distance:** 122 ft  
**Obs:**  
 CM - Crack Multiple  
**Comments:**  
 EER: 1

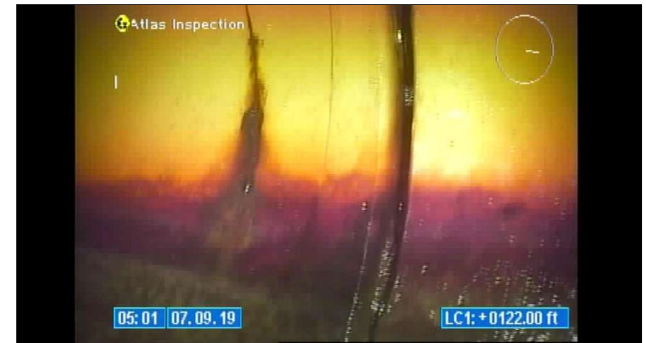
122.0\_IWB\_From-03\_To-05.jpg

**Date:** 7/09/2019  
**Distance:** 122 ft  
**Obs:**  
 IWB - Infiltration  
 Weeper Barrel  
**Comments:**  
 EER: 1. Related to CM  
 at 122.00'.

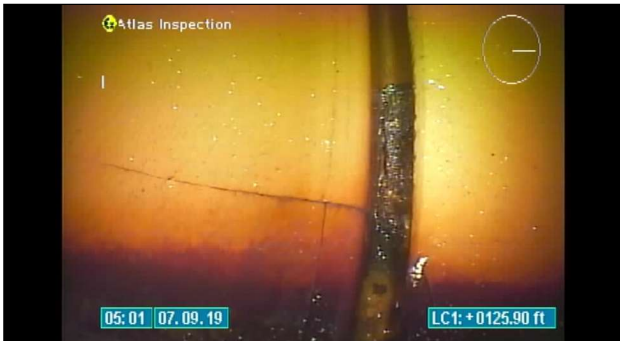
125.9\_CM\_From-12\_To-05.jpg

**Date:** 7/09/2019  
**Distance:** 125.9 ft  
**Obs:**  
 CM - Crack Multiple  
**Comments:**  
 EER: 1

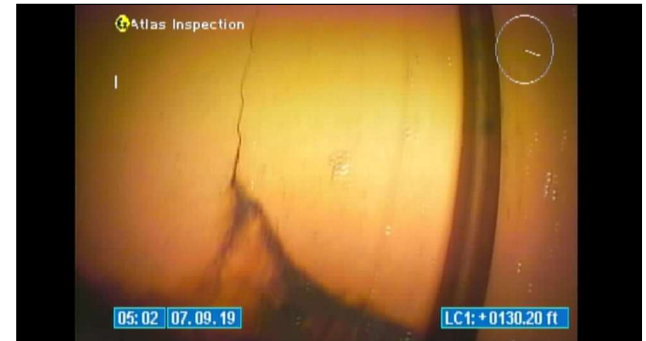
130.2\_CS\_From-01\_To-04.jpg

**Date:** 7/09/2019  
**Distance:** 130.2 ft  
**Obs:**  
 CS - Crack Spiral  
**Comments:**  
 EER: 1

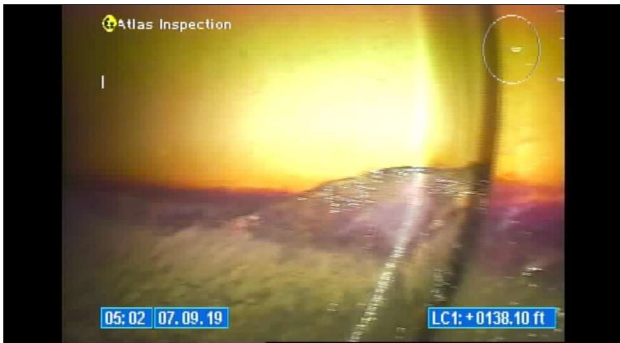
138.4\_DAE\_From-04\_To-05.jpg

**Date:** 7/09/2019  
**Distance:** 138.4 ft  
**Obs:**  
 DAE - Deposits Attached Encrustation  
**Comments:**  
 EER: 1

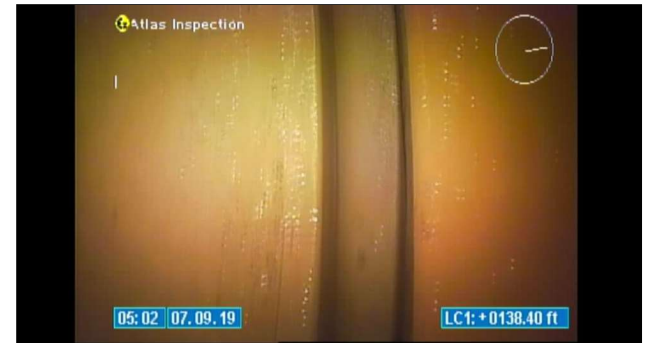
138.4\_JSM\_From-\_To-.jpg

**Date:** 7/09/2019  
**Distance:** 138.4 ft  
**Obs:**  
 JSM - Joint Separated Medium  
**Comments:**  
 EER: 1

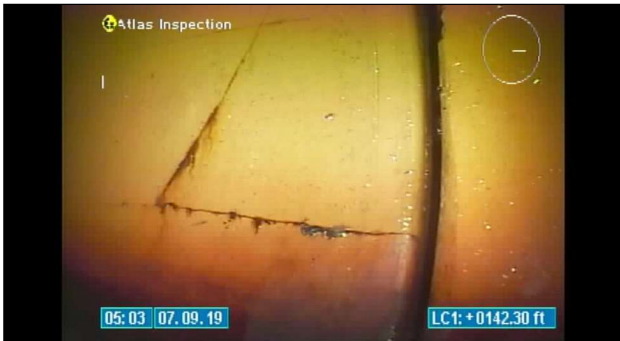
142.3\_CM\_From-02\_To-03.jpg

**Date:** 7/09/2019  
**Distance:** 142.3 ft  
**Obs:**  
 CM - Crack Multiple  
**Comments:**  
 EER: 1

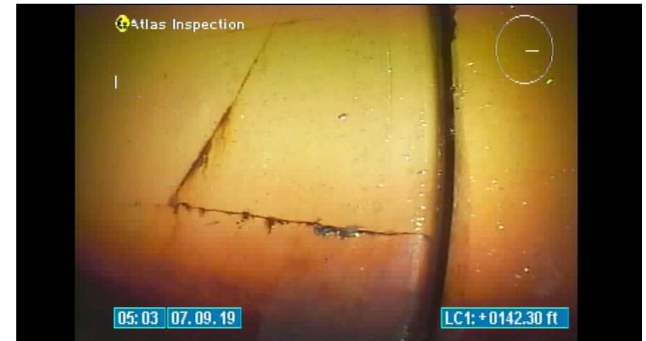
142.3\_ISB\_From-02\_To-03.jpg

**Date:** 7/09/2019  
**Distance:** 142.3 ft  
**Obs:**  
 ISB - Infil Stain Barrel  
**Comments:**  
 EER: 1. Related to CM at 142.3'.

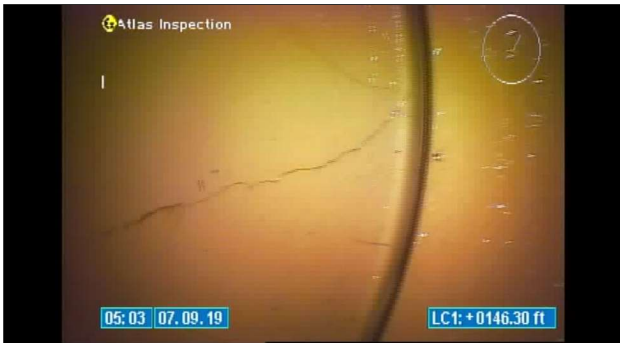
146.3\_CM\_From-11\_To-03.jpg

**Date:** 7/09/2019  
**Distance:** 146.3 ft  
**Obs:**  
 CM - Crack Multiple  
**Comments:**  
 EER: 1

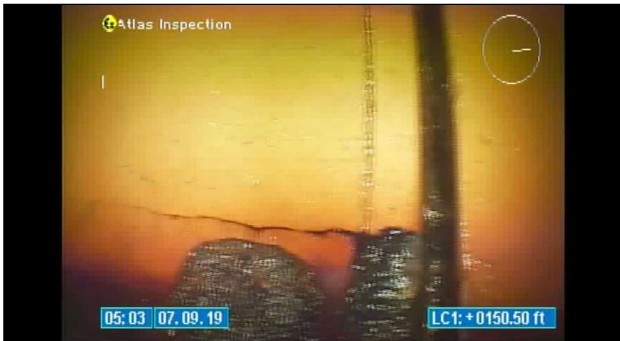
150.5\_FM\_From-02\_To-04.jpg

**Date:** 7/09/2019  
**Distance:** 150.5 ft  
**Obs:**  
 FM - Fracture Multiple  
**Comments:**  
 EER: 2

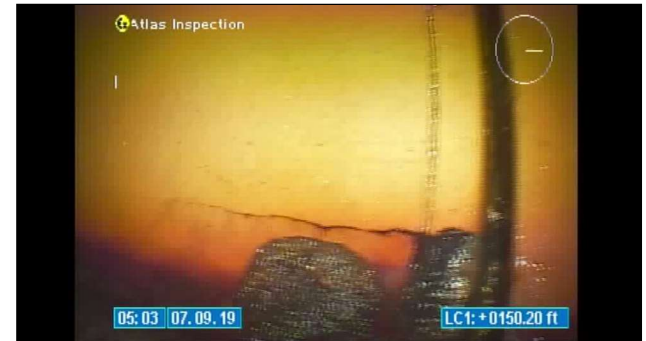
150.5\_IWB\_From-04\_To-.jpg

**Date:** 7/09/2019  
**Distance:** 150.5 ft  
**Obs:**  
 IWB - Infiltration Weeper Barrel  
**Comments:**  
 EER: 1. Related to FM at 150.5'.

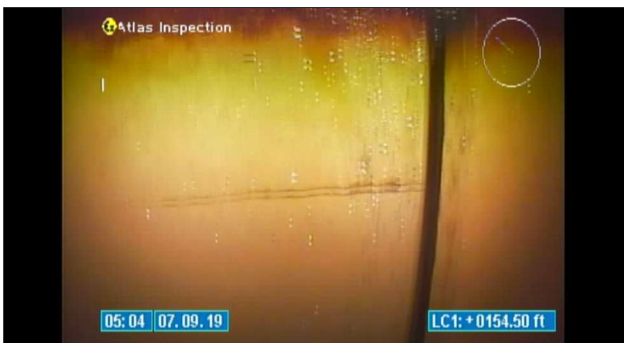
153.5\_CL\_From-10\_To-.jpg

**Date:** 7/09/2019  
**Distance:** 153.5 ft  
**Obs:**  
 CL - Crack Longitudinal  
**Comments:**  
 EER: 1

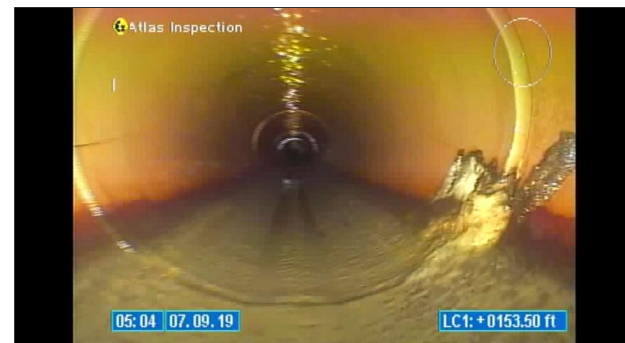
153.5\_DAE\_From-04\_To-05.jpg

**Date:** 7/09/2019  
**Distance:** 153.5 ft  
**Obs:**  
 DAE - Deposits Attached Encrustation  
**Comments:**  
 EER: 1

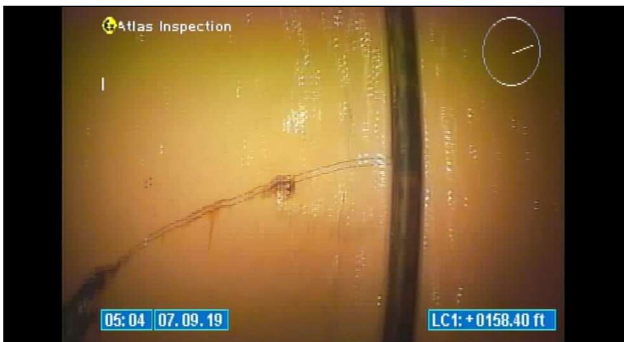
158.4\_CS\_From-02\_To-05.jpg

**Date:** 7/09/2019  
**Distance:** 158.4 ft  
**Obs:**  
 CS - Crack Spiral  
**Comments:**  
 EER: 1

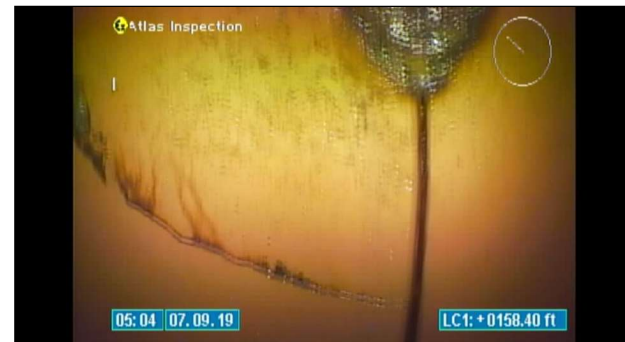
158.4\_CS\_From-07\_To-09.jpg

**Date:** 7/09/2019  
**Distance:** 158.4 ft  
**Obs:**  
 CS - Crack Spiral  
**Comments:**  
 EER: 1

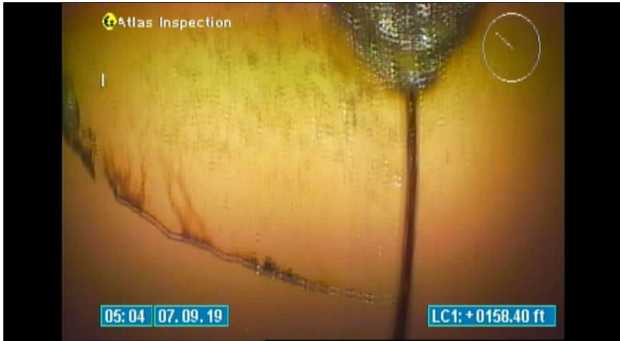
158.4\_IWB\_From-07\_To-09.jpg

**Date:** 7/09/2019  
**Distance:** 158.4 ft  
**Obs:**  
 IWB - Infiltration  
 Weeper Barrel  
**Comments:**  
 EER: 1. Related to the  
 CS 158.4',

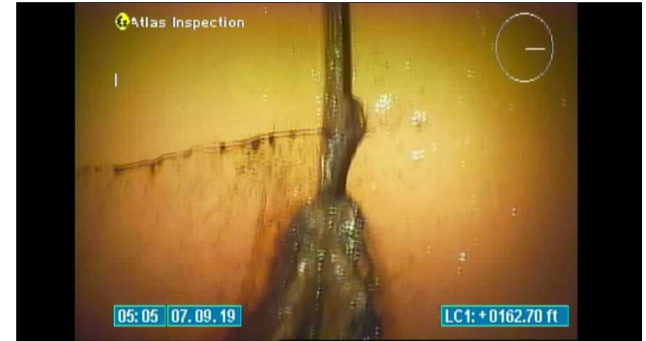
162.7\_CL\_From-03\_To-.jpg

**Date:** 7/09/2019  
**Distance:** 162.7 ft  
**Obs:**  
 CL - Crack Longitudinal  
**Comments:**  
 EER: 1

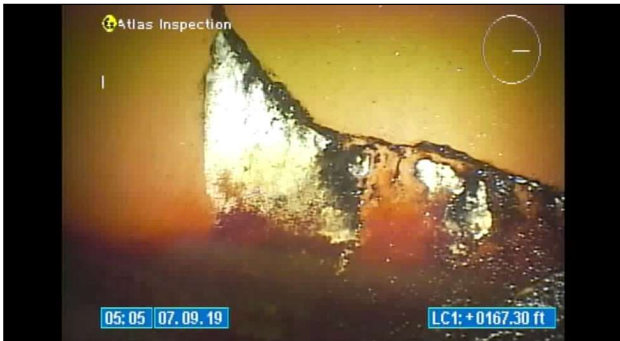
167.3\_CS\_From-03\_To-05.jpg

**Date:** 7/09/2019  
**Distance:** 167.3 ft  
**Obs:**  
 CS - Crack Spiral  
**Comments:**  
 EER: 1

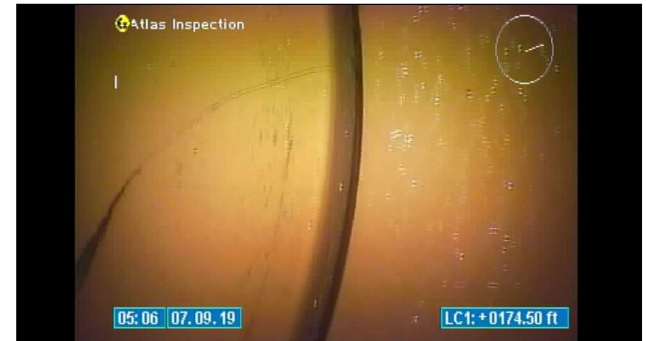
174.5\_CS\_From-02\_To-05.jpg

**Date:** 7/09/2019  
**Distance:** 174.5 ft  
**Obs:**  
 CS - Crack Spiral  
**Comments:**  
 EER: 1

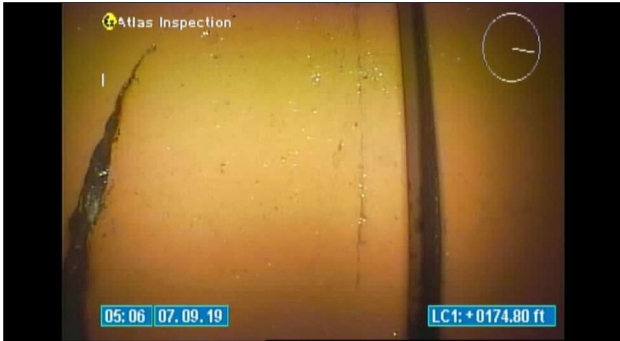
174.5\_IWB\_From-03\_To-05.jpg

**Date:** 7/09/2019  
**Distance:** 174.5 ft  
**Obs:**  
 IWB - Infiltration Weeper Barrel  
**Comments:**  
 EER: 1. Related to CS at 174.5'.

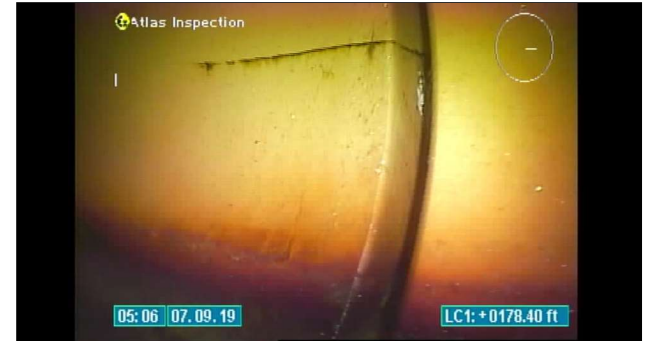
178.8\_CL\_From-03\_To-.jpg

**Date:** 7/09/2019  
**Distance:** 178.8 ft  
**Obs:**  
 CL - Crack Longitudinal  
**Comments:**  
 EER: 1

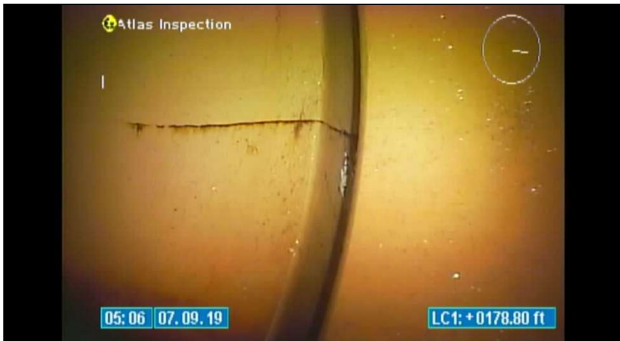
178.8\_IS\_From-03\_To-.jpg

**Date:** 7/09/2019  
**Distance:** 178.8 ft  
**Obs:**  
 ISB - Infil Stain Barrel  
**Comments:**  
 EER: 1. Related to the CL at 178.8'.

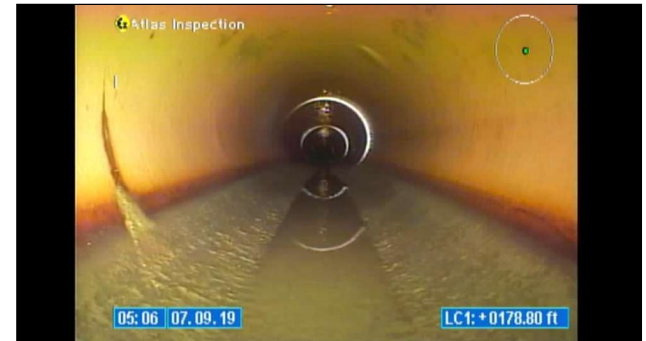
180.0\_CC\_From-08\_To-09.jpg

**Date:** 7/09/2019  
**Distance:** 180 ft  
**Obs:**  
 CC - Crack Circumferential  
**Comments:**  
 EER: 1

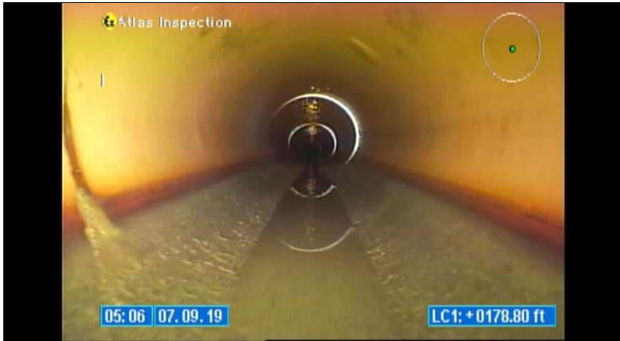
180.0\_DNF\_From-07\_To-08.jpg

**Date:** 7/09/2019  
**Distance:** 180 ft  
**Obs:**  
 DNF - Deposits  
 Ingressed Fine  
**Comments:**  
 EER: 1. Related to the  
 CC at 180.0'.

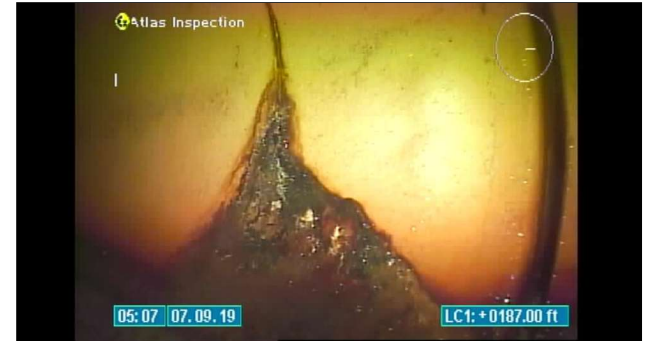
187.8\_CS\_From-02\_To-05.jpg

187.8		CS - Crack Spiral		X	02 05 EER: 1
187.8	S02	DAE - Deposits Attached Encrustation	005	X	07 08 EER: 1
187.8		IWB - Infiltration Weeper Barrel		X	04 05 EER: 1. Related to the CS at 187.8'.

**Date:** 7/09/2019  
**Distance:** 187.8 ft  
**Obs:**  
 CS - Crack Spiral  
**Comments:**  
 EER: 1

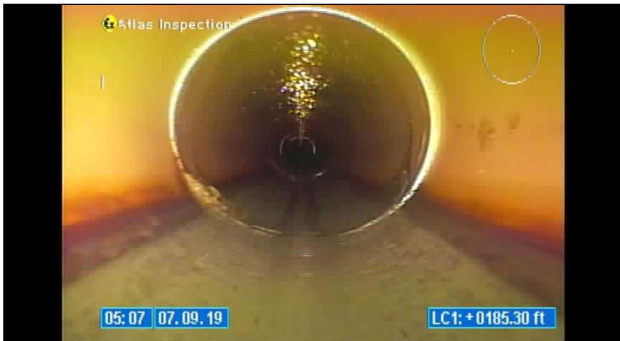
187.8\_DAE\_From-07\_To-08.jpg

**Date:** 7/09/2019  
**Distance:** 187.8 ft  
**Obs:**  
 DAE - Deposits Attached  
 Encrustation  
**Comments:**  
 EER: 1

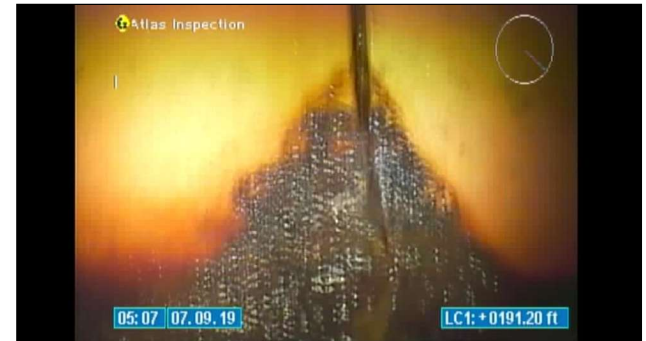
190.9\_DAE\_From-04\_To-05.jpg

**Date:** 7/09/2019  
**Distance:** 190.9 ft  
**Obs:**  
 DAE - Deposits Attached  
 Encrustation  
**Comments:**  
 EER: 1

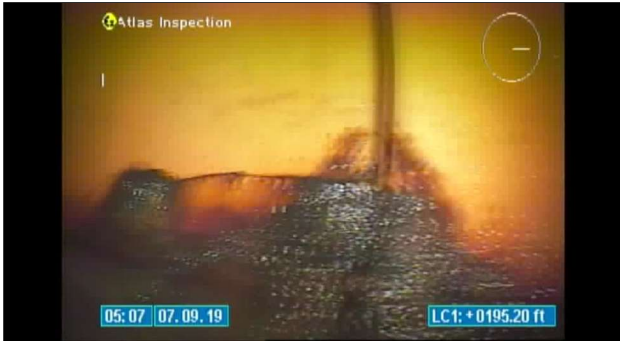
195.2\_CL\_From-05\_To-.jpg

**Date:** 7/09/2019  
**Distance:** 195.2 ft  
**Obs:**  
 CL - Crack Longitudinal  
**Comments:**  
 EER: 1

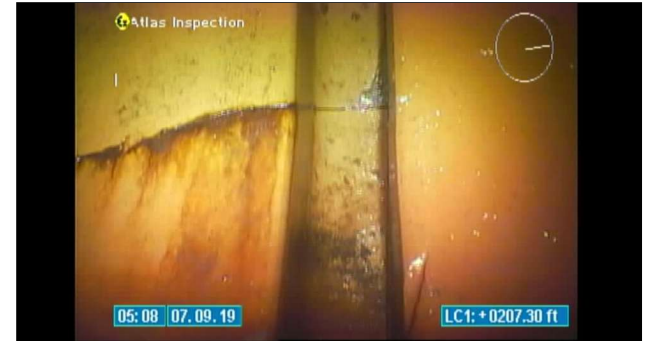
207.3\_CS\_From-03\_To-05.jpg

**Date:** 7/09/2019  
**Distance:** 207.3 ft  
**Obs:**  
 CS - Crack Spiral  
**Comments:**  
 EER: 1

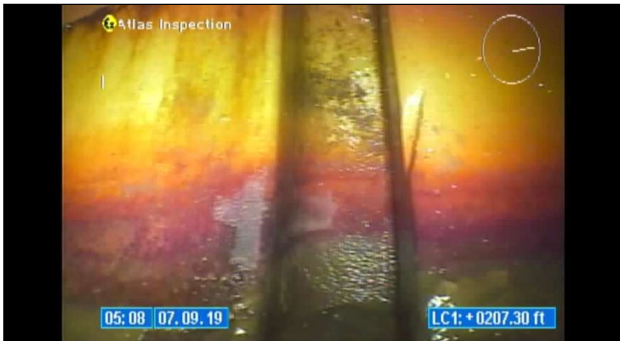
207.3\_JSM\_From-\_To-.jpg

**Date:** 7/09/2019  
**Distance:** 207.3 ft  
**Obs:**  
 JSM - Joint Separated Medium  
**Comments:**  
 EER: 1

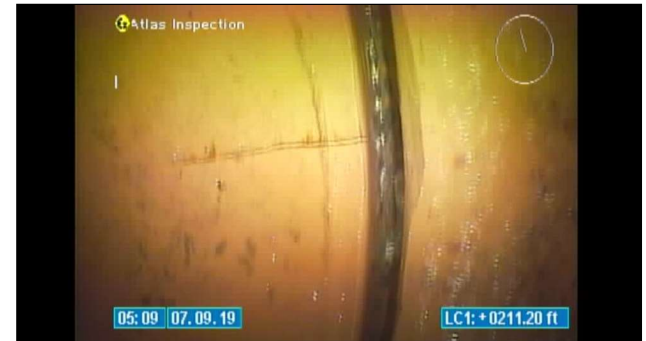
211.2\_CM\_From-10\_To-02.jpg

**Date:** 7/09/2019  
**Distance:** 211.2 ft  
**Obs:**  
 CM - Crack Multiple  
**Comments:**  
 EER: 1

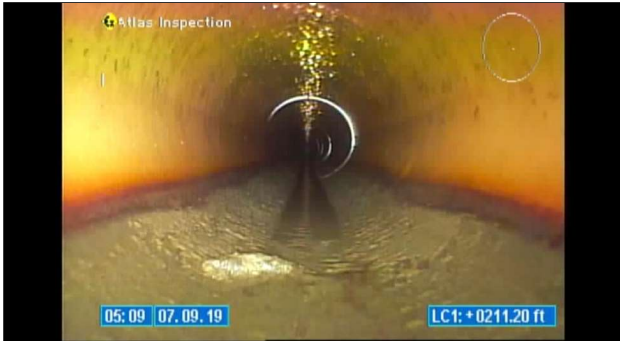
212.0\_OBZ\_From-07\_To-.jpg

**Date:** 7/09/2019  
**Distance:** 212 ft  
**Obs:** OBZ - Obstruction Other  
**Comments:**  
 EER: 1. Unknown Material

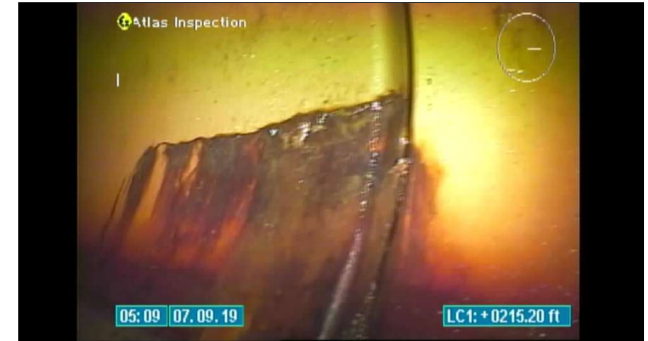
215.5\_CL\_From-03\_To-.jpg

**Date:** 7/09/2019  
**Distance:** 215.5 ft  
**Obs:** CL - Crack Longitudinal  
**Comments:**  
 EER: 1

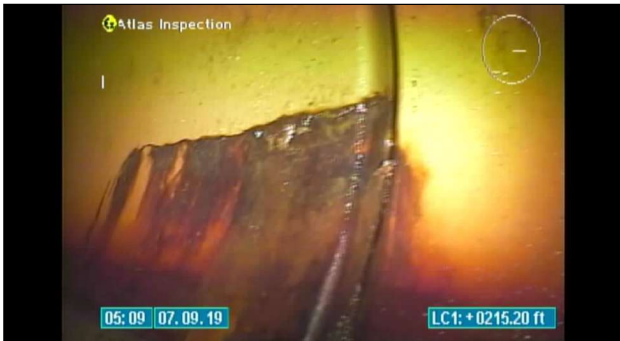
215.5\_IW\_From-03\_To-05.jpg

**Date:** 7/09/2019  
**Distance:** 215.5 ft  
**Obs:** IWB - Infiltration Weeper Barrel  
**Comments:**  
 EER: 1. Related to the CL at 215.5'.

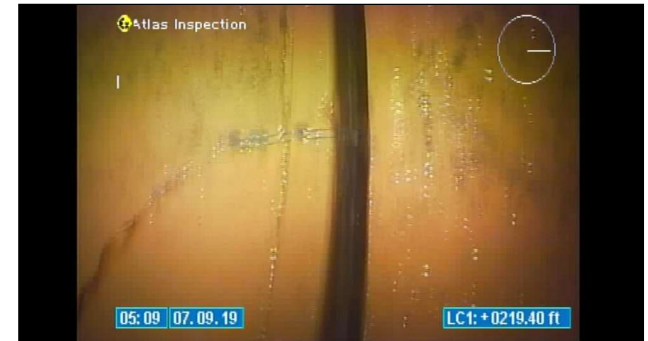
219.4\_CS\_From-03\_To-05.jpg

**Date:** 7/09/2019  
**Distance:** 219.4 ft  
**Obs:** CS - Crack Spiral  
**Comments:**  
 EER: 1

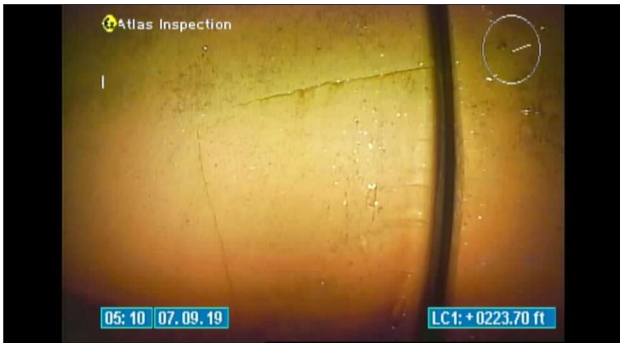
223.7\_CS\_From-03\_To-05.jpg

**Date:** 7/09/2019  
**Distance:** 223.7 ft  
**Obs:**  
 CS - Crack Spiral  
**Comments:**  
 EER: 1

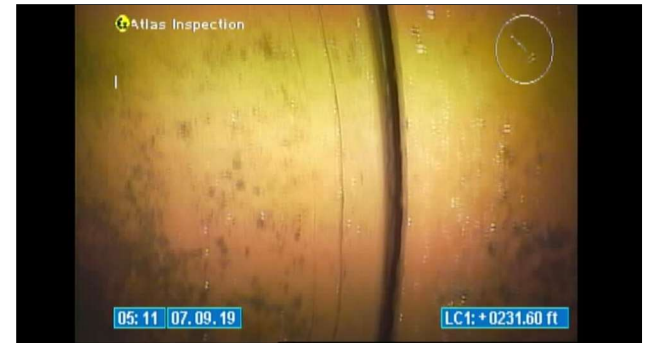
231.6\_CC\_From-09\_To-12.jpg

**Date:** 7/09/2019  
**Distance:** 231.6 ft  
**Obs:**  
 CC - Crack Circumferential  
**Comments:**  
 EER: 1

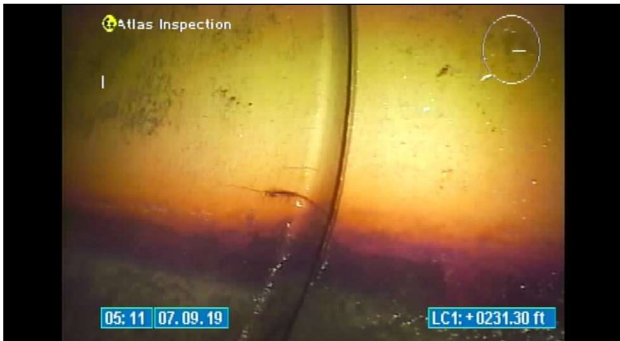
231.6\_CL\_From-04\_To-.jpg

**Date:** 7/09/2019  
**Distance:** 231.6 ft  
**Obs:**  
 CL - Crack Longitudinal  
**Comments:**  
 EER: 1

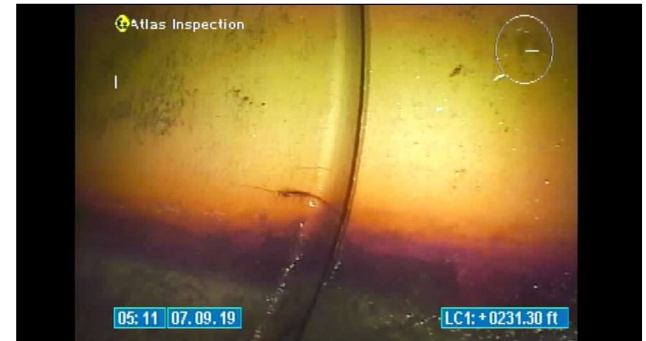
231.6\_IS\_From-04\_To-.jpg

**Date:** 7/09/2019  
**Distance:** 231.6 ft  
**Obs:**  
 ISB - Infil Stain Barrel  
**Comments:**  
 EER: 1. Related to the CL at 231.6'.

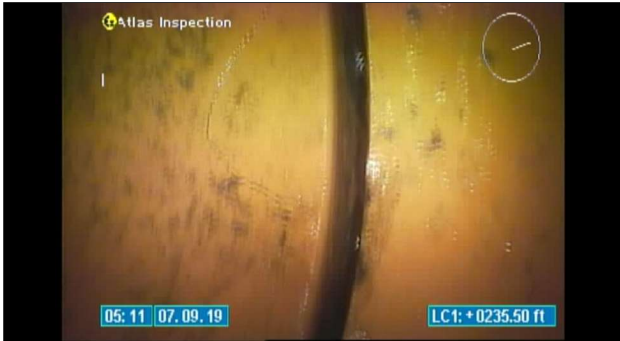
235.9\_CS\_From-03\_To-04.jpg

**Date:** 7/09/2019  
**Distance:** 235.9 ft  
**Obs:**  
 CS - Crack Spiral  
**Comments:**  
 EER: 1

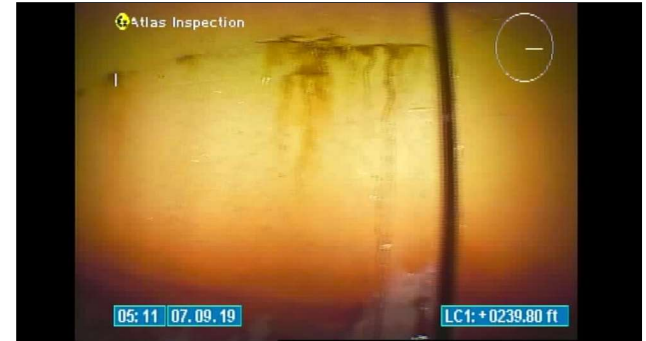
239.8\_CL\_From-02\_To-.jpg

**Date:** 7/09/2019  
**Distance:** 239.8 ft  
**Obs:**  
 CL - Crack Longitudinal  
**Comments:**  
 EER: 1

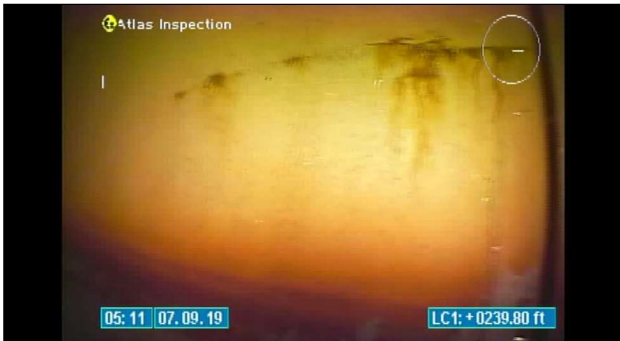
239.8\_IW\_From-02\_To-.jpg

**Date:** 7/09/2019  
**Distance:** 239.8 ft  
**Obs:**  
 IW - Infil Weeper  
**Comments:**  
 EER: 1. Related to the CL at 239.8'.

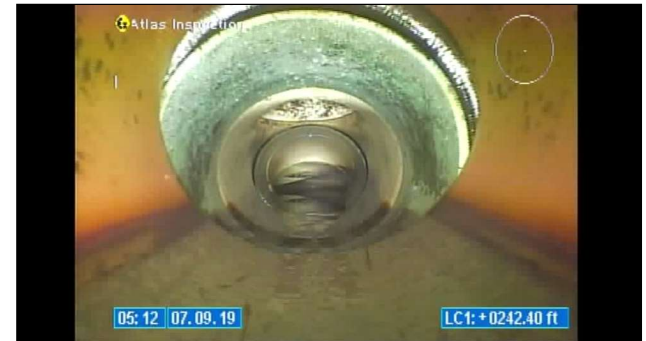
243.7\_JOM\_From-\_To-.jpg

**Date:** 7/09/2019  
**Distance:** 243.7 ft  
**Obs:**  
 JOM - Joint Offset Medium  
**Comments:**  
 EER: 2. At Acess Manhole
