**2022 ANNUAL PROGRESS REPORT  
SWMU 1 – OILY WATER SEWER  
HF SINCLAIR PUGET SOUND REFINING LLC**

HF Sinclair Puget Sound Refining LLC  
8505 South Texas Road  
Anacortes, WA 98221

February 27, 2023

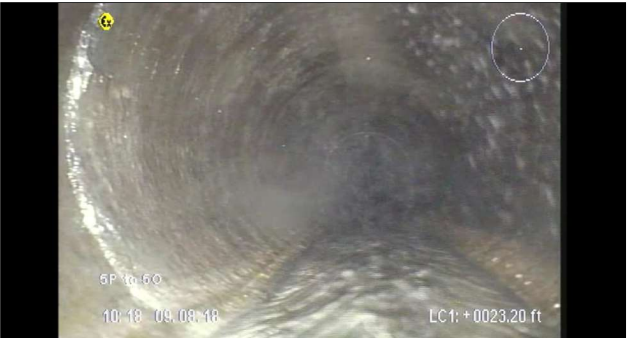
**Obs:**  
SRV - Surface Damage Reinforcement Visible

EER: 1.

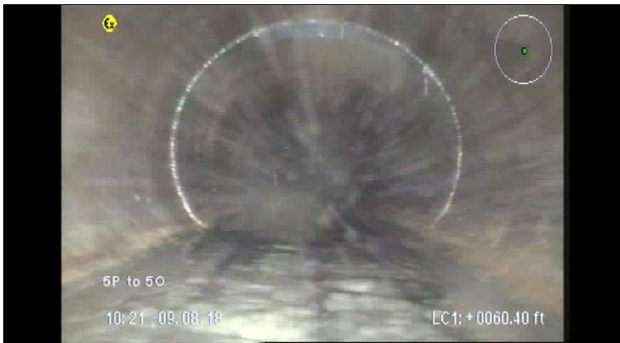
61.1\_RFJ\_From-12\_To-02.jpg

**Date:** 8/09/2018  
**Distance:** 61.1 ft  
**Obs:**  
 RFJ - Roots Fine Joint  
**Comments:**  
 EER: 1

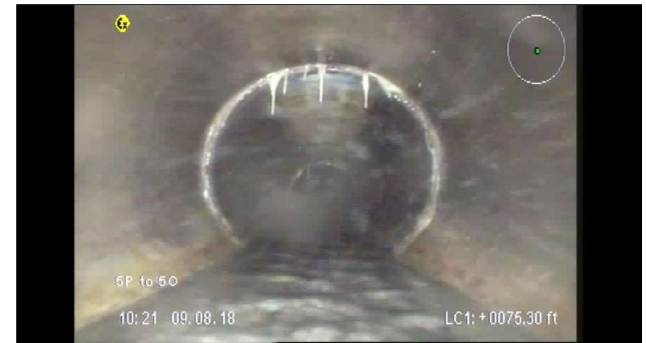
76.3\_DAE\_From-11\_To-01.jpg

**Date:** 8/09/2018  
**Distance:** 76.3 ft  
**Obs:**  
 DAE - Deposits Attached Encrustation  
**Comments:**  
 EER: 1. Related to the IWJ.

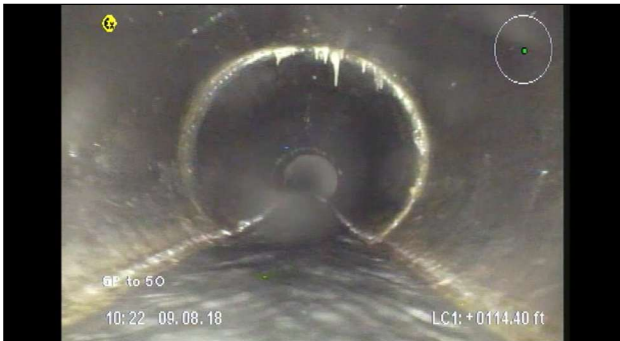
114.4\_DAE\_From-11\_To-01.jpg

**Date:** 8/09/2018  
**Distance:** 114.4 ft  
**Obs:**  
 DAE - Deposits Attached Encrustation  
**Comments:**  
 EER: 1. Related to the IWJ.

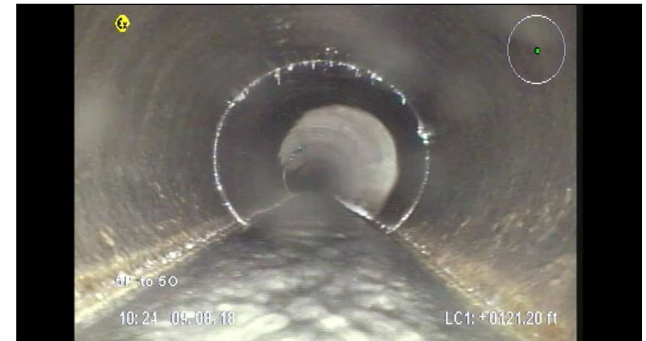
121.2\_RFJ\_From-10\_To-03.jpg

**Date:** 8/09/2018  
**Distance:** 121.2 ft  
**Obs:**  
 RFJ - Roots Fine Joint  
**Comments:**  
 EER: 1.

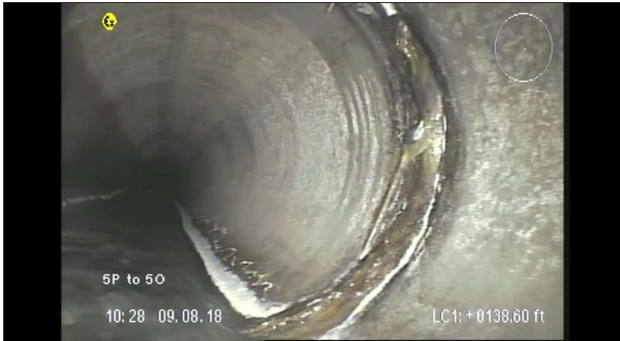
138.6\_DAE\_From-12\_To-03.jpg

**Obs:**  
DAE - Deposits Attached  
Encrustation

**Comments:**  
EER: 1. Related to the  
IWJ.

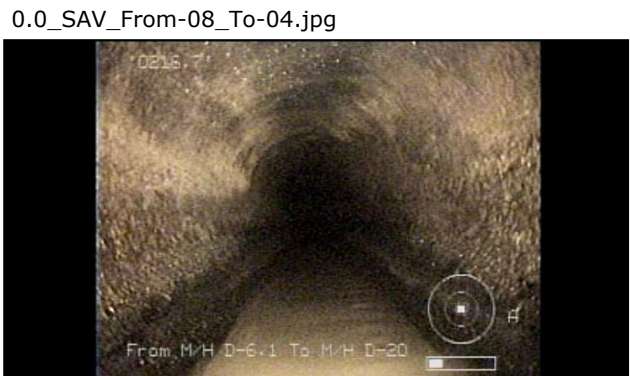
**Date:** 6/29/2017  
**Distance:** 0 ft  
**Obs:**  
 SAV - Surface  
 Aggregate Visible  
**Comments:**  
 EER: 1.

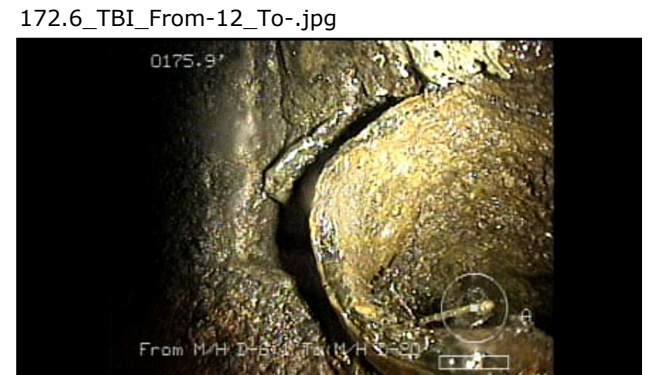
**Date:** 6/29/2017  
**Distance:** 172.6 ft  
**Obs:**  
 TBI - Tap Break-in  
 Intruding  
**Comments:**  
 EER: 1

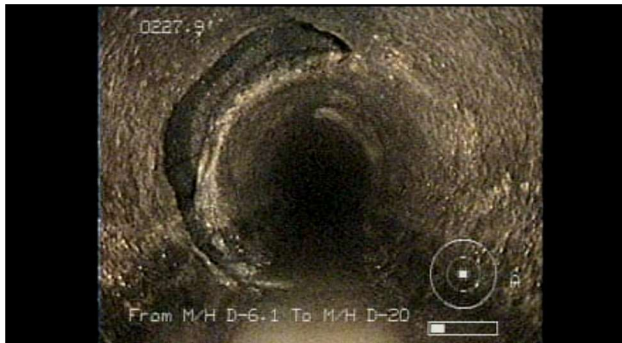
233.8\_IRC\_From-07\_To-.jpg

EER: 2. Runner is  
coming from manhole.

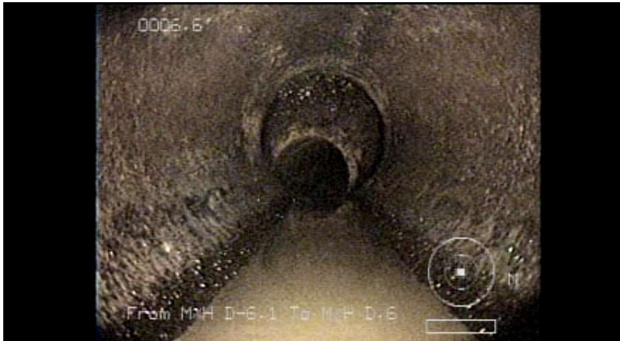
**Obs:**  
SAV - Surface  
Aggregate Visible

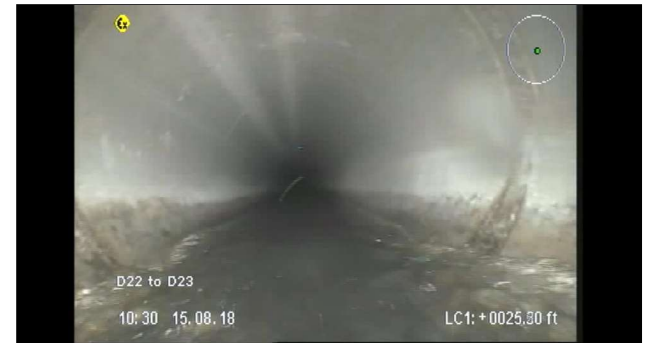
2.0\_SRI\_From-03\_To-04.jpg

**Date:** 8/08/2018  
**Distance:** 2 ft  
**Obs:**  
 SRI - Surface Damage  
 Roughness Increased  
**Comments:**  
 EER: 1

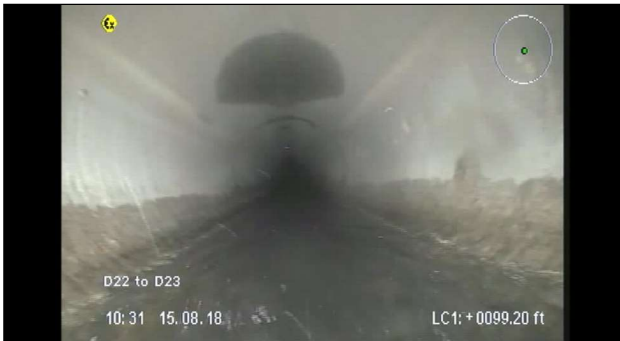
99.9\_IWB\_From-11\_To-01.jpg

**Date:** 8/08/2018  
**Distance:** 99.9 ft  
**Obs:**  
 IWB - Infiltration  
 Weeper Barrel  
**Comments:**  
 EER: 1

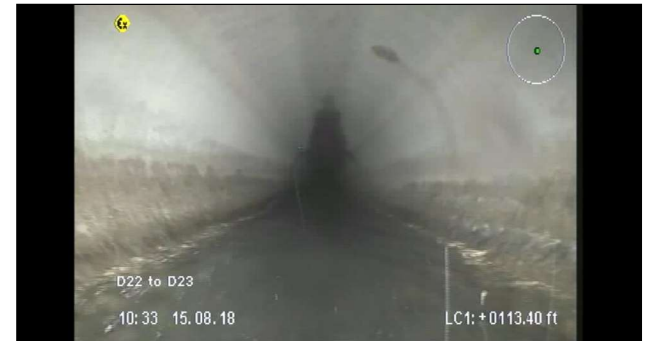
105.1\_ISB\_From-01\_To-.jpg

**Date:** 8/08/2018  
**Distance:** 105.1 ft  
**Obs:**  
 ISB - Infil Stain Barrel  
**Comments:**  
 EER: 1

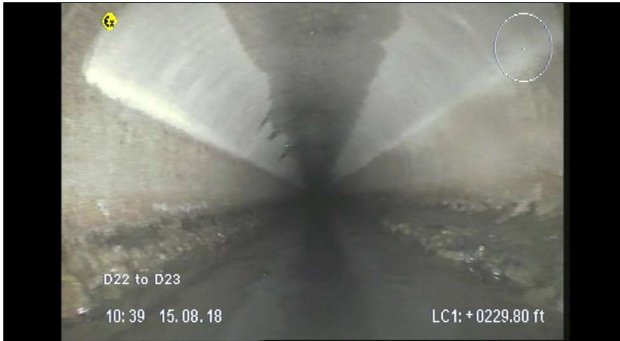
219.3\_IWB\_From-11\_To-01.jpg

**Date:** 8/08/2018  
**Distance:** 229.8 ft  
**Obs:**  
IWB - Infiltration  
Weeper Barrel  
**Comments:**  
EER: 1

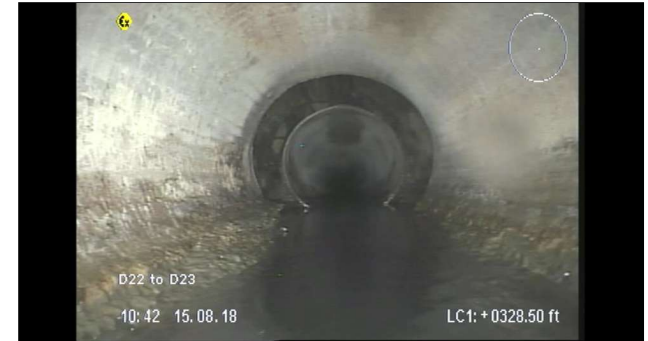
329.1\_DAE\_From-07\_To-08.jpg

326.3	F06	IWB - Infiltration Weeper Barrel					11	01	EER: 1
329.1		DAE - Deposits Attached Encrustation			010		07	08	EER: 1
333.2	F01	SRI - Surface Damage Roughness Increased					03	04

**Date:** 8/08/2018  
**Distance:** 329.1 ft  
**Obs:**  
DAE - Deposits Attached  
Encrustation  
**Comments:**  
EER: 1
