STATE OF WASHINGTON  
DEPARTMENT OF ECOLOGY

**Re: Opinion pursuant to WAC 173-340-515(5) on Remedial Action for the following  
Hazardous Waste Site:**

- **Site Name:** Midas Muffler Ballard
- **Site Address:** 7055 15th Avenue NW, Seattle, WA 98117
- **Facility/Site No.:** 19188572
- **Cleanup Site ID No.:** 16663
- **VCP Project No.:** NW3350

## **Enclosure A**

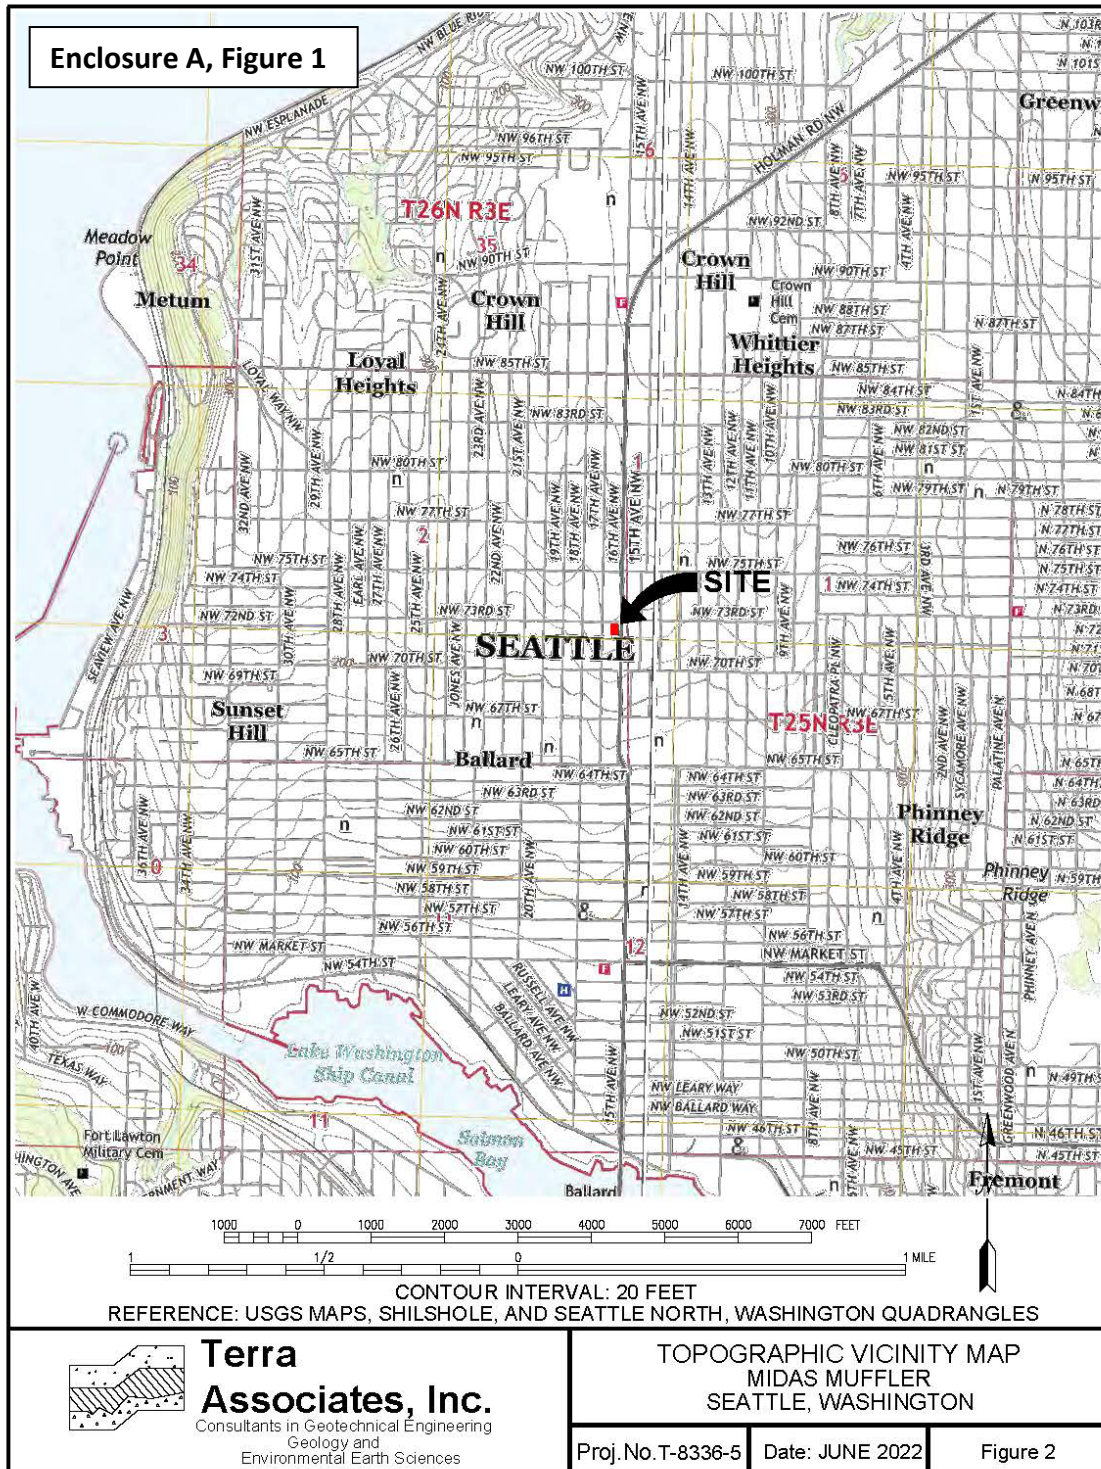
Enclosure A, Figure 2

An automotive repair facility was constructed on the Property in 1976 and operated from at least 1980 until 2021. As many as four below-ground hydraulic hoists were installed and used at the facility, along with two 250-gallon above-ground storage tanks (AST) used to store waste oil and lube oil. A diagnostic pit was also present in the southern portion of the building's shop area. The building on the Property is currently being remodeled for a new tenant (**Figure 2**).

Groundwater has been consistently encountered at approximately 45 to 49 ft bgs. Horizontal gradient and flow direction varies seasonally, but generally flows toward the southwest (**Figure 2**).
