## TECHNICAL MEMORANDUM

**SUBJECT:** South Park Landfill 2023 Annual Landfill Cap Inspection

**PROJECT NUMBER:** 553-1550-067

**PROJECT NAME:** South Park Landfill Site Coordination

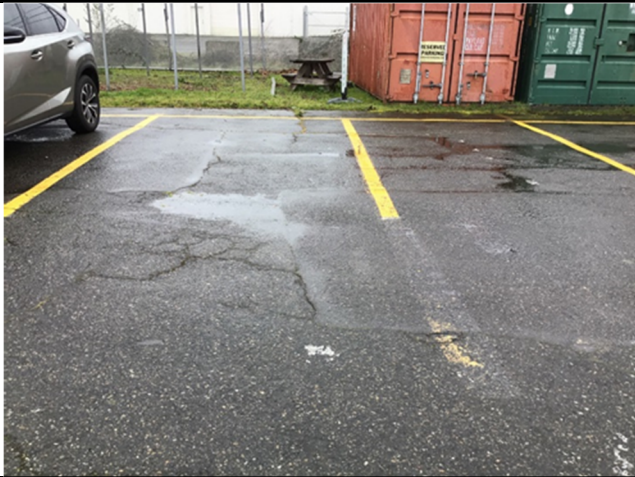
SRDS	Description	December 2022 Inspection		April 2023 Inspection				Photographs
		Conditions Observed and Recommended Action	Action Taken	Condition Status	Conditions Observed and Recommended Action	Timeline for Repair and/or Reinspection	Recommended Action Assignment	
<b>Asphalt Concrete</b>								
AC-1	Minor pavement cracking and ponding	Follow-up inspection	No actions taken or required	No significant changes observed	Follow-up reinspection	6 months	Site Coordinator

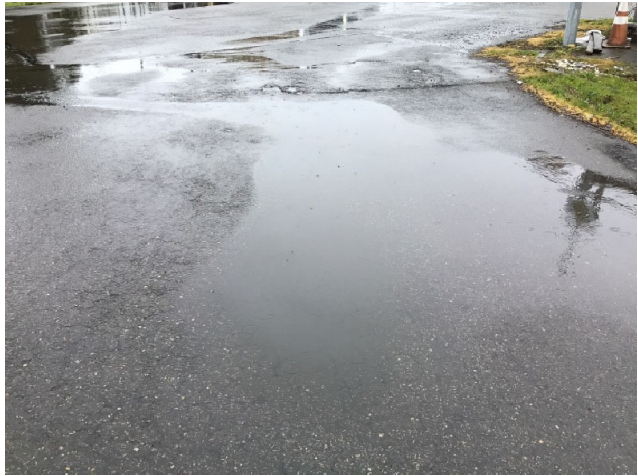
SRDS	Description	December 2022 Inspection		April 2023 Inspection				Photographs
		Conditions Observed and Recommended Action	Action Taken	Condition Status	Conditions Observed and Recommended Action	Timeline for Repair and/or Reinspection	Recommended Action Assignment	
AC-6	Minor pavement cracking and ponding	Additional areas of cracking. Continue to monitor for further deterioration during follow-up reinspection	No actions taken or required	No significant changes observed	Follow-up reinspection	6 months	Site Coordinator

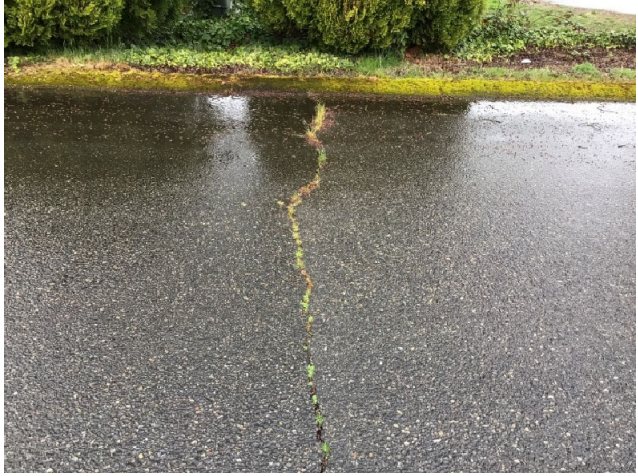
SRDS	Description	December 2022 Inspection		April 2023 Inspection				Photographs
		Conditions Observed and Recommended Action	Action Taken	Condition Status	Conditions Observed and Recommended Action	Timeline for Repair and/or Reinspection	Recommended Action Assignment	
AC-10	Minor pavement cracking with grass growing in the cracks	Follow-up inspection	No actions taken or required	No significant changes observed	Follow-up reinspection	6 months	Site Coordinator

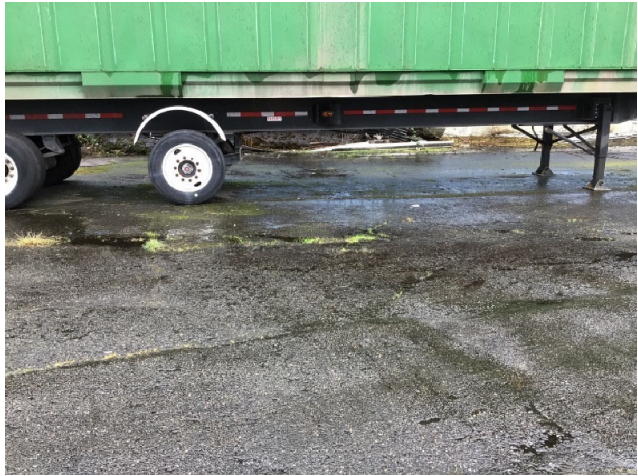
SRDS	Description	December 2022 Inspection		April 2023 Inspection				Photographs
		Conditions Observed and Recommended Action	Action Taken	Condition Status	Conditions Observed and Recommended Action	Timeline for Repair and/or Reinspection	Recommended Action Assignment	
AC-14	Minor pavement cracks with exposed moss	The spalling has continued to degrade the cap to the point where soil may be exposed. This area should be patched.	No action taken	No significant changes observed	Previous recommendation remains.	No later than end of calendar year	SRDS

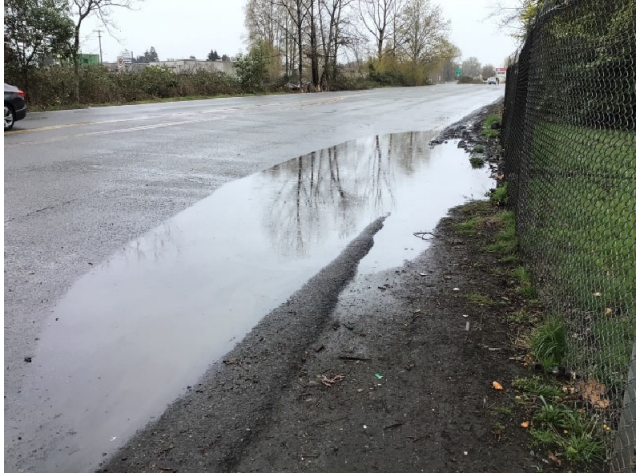
SRDS	Description	December 2022 Inspection		April 2023 Inspection				Photographs
		Conditions Observed and Recommended Action	Action Taken	Condition Status	Conditions Observed and Recommended Action	Timeline for Repair and/or Reinspection	Recommended Action Assignment	
AC-17	Ponding	Follow-up inspection	No actions taken or required	No significant changes observed	Follow-up reinspection	6 months	Site Coordinator

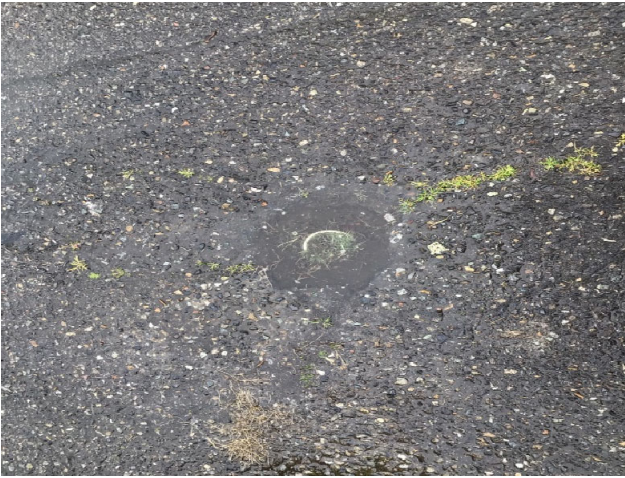
SRDS	Description	December 2022 Inspection		April 2023 Inspection				Photographs
		Conditions Observed and Recommended Action	Action Taken	Condition Status	Conditions Observed and Recommended Action	Timeline for Repair and/or Reinspection	Recommended Action Assignment	
AC-20	Open pipe in the ground			New location	Determine what the pipe is and cap it.	No later than end of calendar year	SRDS

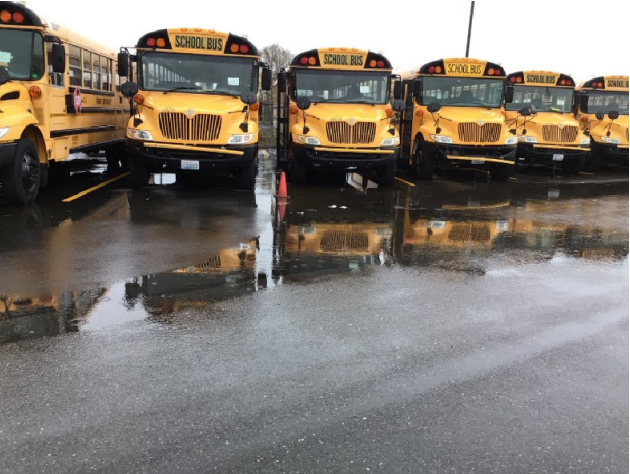
Center Point (SPPD) Location	Description	December 2022 Inspection		April 2023 Inspection				Photographs
		Conditions Observed and Recommended Action	Action Taken	Condition Status	Conditions Observed and Recommended Action	Timeline for Repair and/or Reinspection	Recommended Action Assignment	
<b>Asphalt Concrete</b>								
AC-1	Ponding	Follow-up inspection	No actions taken or required	No significant changes observed	Follow-up reinspection	6 months	Site Coordinator

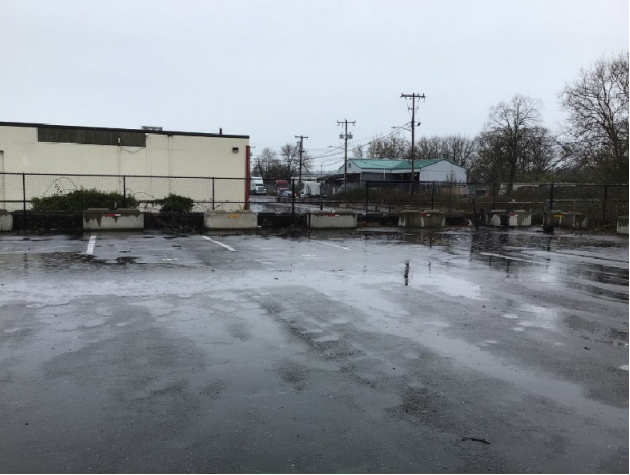
Center Point (SPPD) Location	Description	December 2022 Inspection		April 2023 Inspection				
		Conditions Observed and Recommended Action	Action Taken	Condition Status	Conditions Observed and Recommended Action	Timeline for Repair and/or Reinspection	Recommended Action Assignment	Photographs
AC-4	Ponding	Follow-up inspection	No actions taken or required	No significant changes observed.	A larger extent of ponding observed due to rainfall accumulation.  Follow-up reinspection	6 months	Site Coordinator

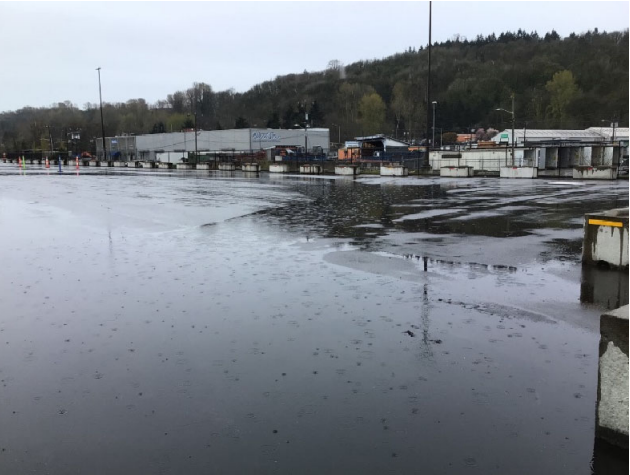
Center Point (SPPD) Location	Description	December 2022 Inspection		April 2023 Inspection				
		Conditions Observed and Recommended Action	Action Taken	Condition Status	Conditions Observed and Recommended Action	Timeline for Repair and/or Reinspection	Recommended Action Assignment	Photographs
AC-7	Several areas of ponding	Follow-up inspection	No actions taken or required	No significant changes observed	Ponding in larger extent observed due to rainfall accumulation.  Follow-up reinspection	6 months	Site Coordinator

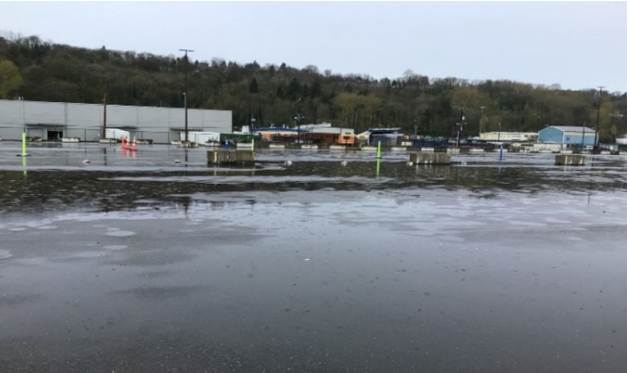
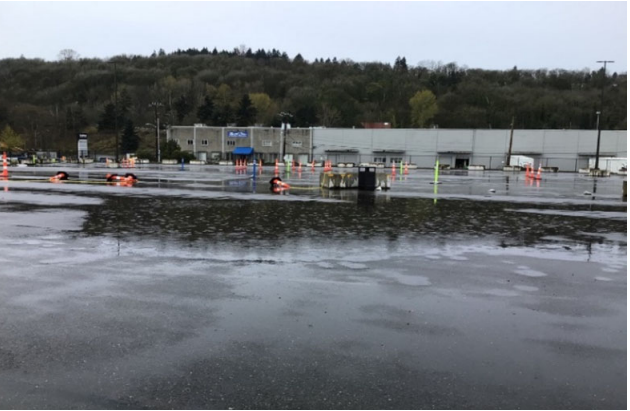
Center Point (SPPD) Location	Description	December 2022 Inspection		April 2023 Inspection				
		Conditions Observed and Recommended Action	Action Taken	Condition Status	Conditions Observed and Recommended Action	Timeline for Repair and/or Reinspection	Recommended Action Assignment	Photographs
AC-9	Ponding	Follow-up inspection	No actions taken or required	No significant changes observed	Ponding in larger extent observed due to rainfall accumulation.  Follow-up reinspection	6 months	Site Coordinator

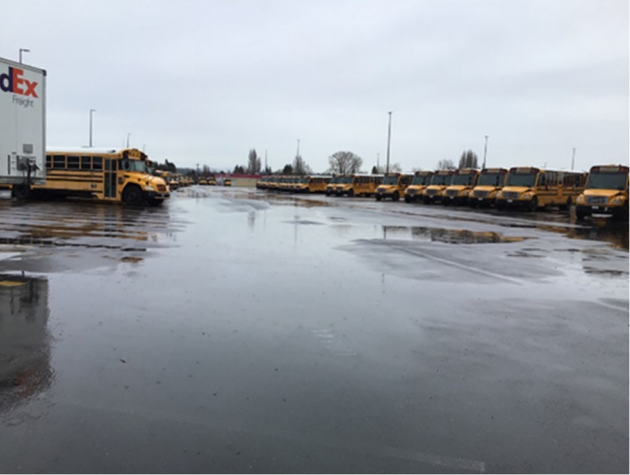
Center Point (SPPD) Location	Description	December 2022 Inspection		April 2023 Inspection				Photographs
		Conditions Observed and Recommended Action	Action Taken	Condition Status	Conditions Observed and Recommended Action	Timeline for Repair and/or Reinspection	Recommended Action Assignment	
AC-11	Ponding	Follow-up inspection	No actions taken or required	No significant changes observed	Follow-up reinspection	6 months	Site Coordinator

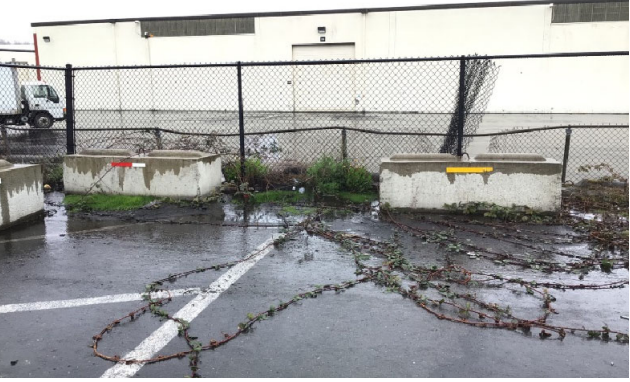
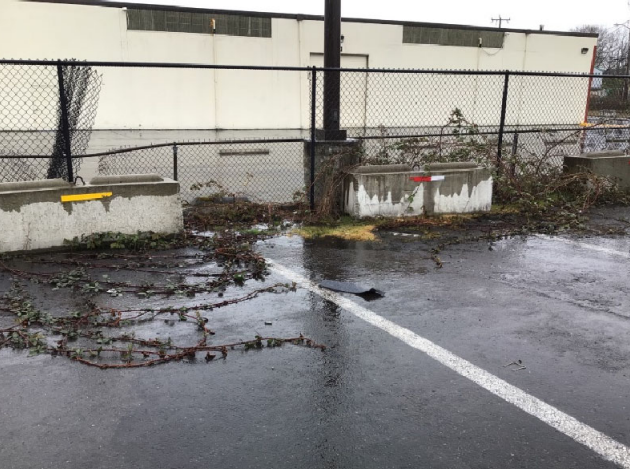
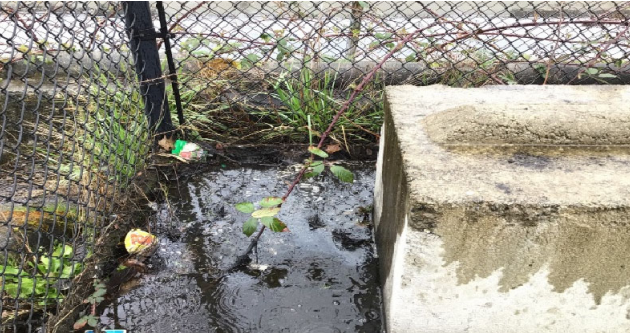
Center Point (SPPD) Location	Description	December 2022 Inspection		April 2023 Inspection				
		Conditions Observed and Recommended Action	Action Taken	Condition Status	Conditions Observed and Recommended Action	Timeline for Repair and/or Reinspection	Recommended Action Assignment	Photographs
AC-13	Blackberry shrubs growth and stagnated water behind the concrete blocks			New Location	Remove blackberry shrubs and clear pathways to allow proper water flow into the storm drains	No later than end of calendar year	CenterPoint

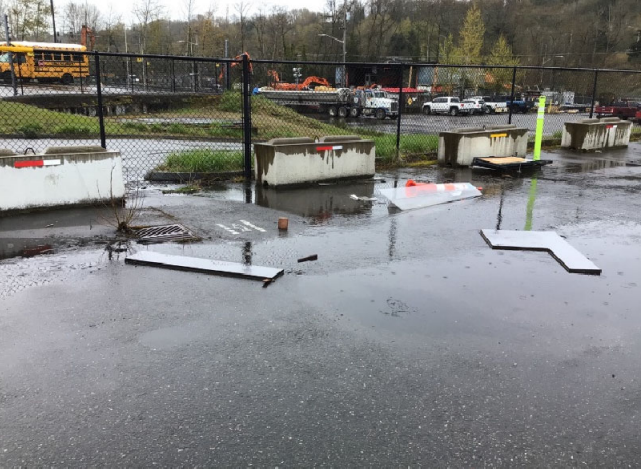
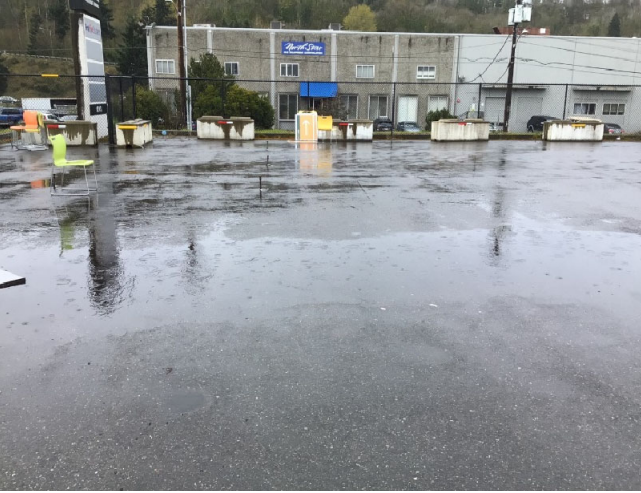
Center Point (SPPD) Location	Description	December 2022 Inspection		April 2023 Inspection				
		Conditions Observed and Recommended Action	Action Taken	Condition Status	Conditions Observed and Recommended Action	Timeline for Repair and/or Reinspection	Recommended Action Assignment	Photographs
AC-14	Ponding			New Location	Follow-up reinspection	6 months	Site Coordinator

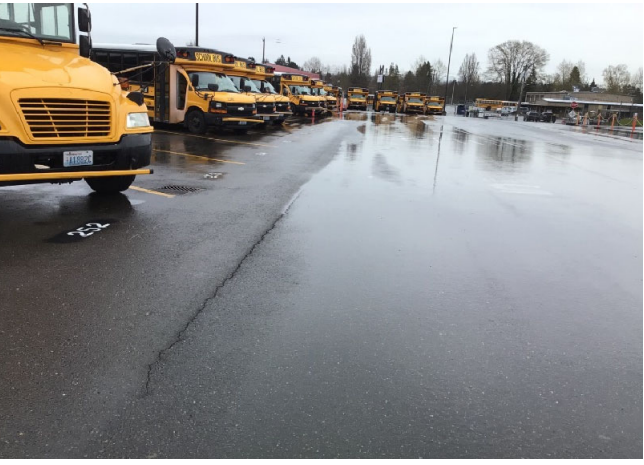
Center Point (SPPD) Location	Description	December 2022 Inspection		April 2023 Inspection				
		Conditions Observed and Recommended Action	Action Taken	Condition Status	Conditions Observed and Recommended Action	Timeline for Repair and/or Reinspection	Recommended Action Assignment	Photographs
AC-15	Minor Cracking			New Location	Follow-up reinspection	6 months	Site Coordinator

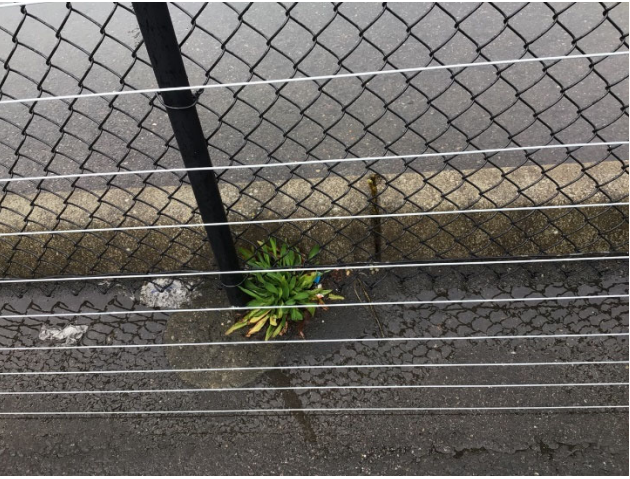
Center Point (SPPD) Location	Description	December 2022 Inspection		April 2023 Inspection				
		Conditions Observed and Recommended Action	Action Taken	Condition Status	Conditions Observed and Recommended Action	Timeline for Repair and/or Reinspection	Recommended Action Assignment	Photographs
AC-19	Holes near fence allowing growth of grasses			New location	Remove plants and seal cap penetrations.	No later than end of calendar year	CenterPoint

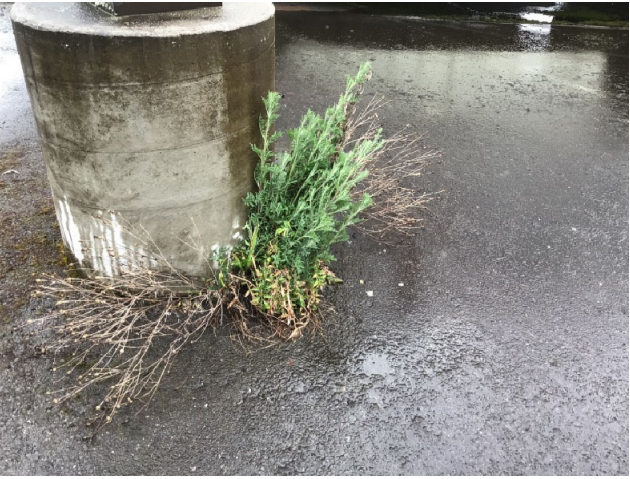
Center Point (SPPD) Location	Description	December 2022 Inspection		April 2023 Inspection				Photographs
		Conditions Observed and Recommended Action	Action Taken	Condition Status	Conditions Observed and Recommended Action	Timeline for Repair and/or Reinspection	Recommended Action Assignment	
AC-22	Holes near concrete post allowing invasive plant growth			New location	Remove plants and seal cap penetrations.	No later than end of calendar year	CenterPoint

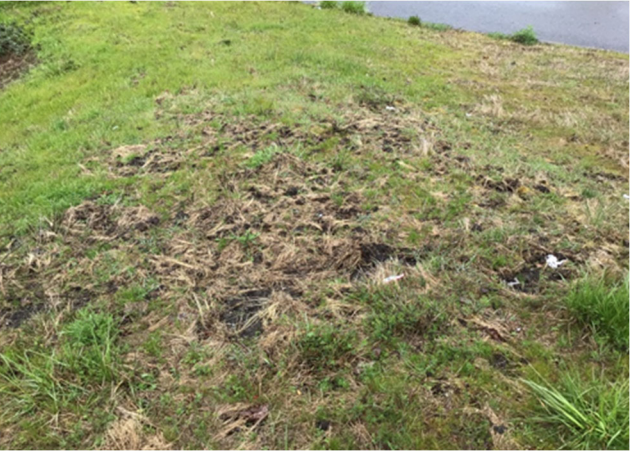
Center Point (SPPD) Location	Description	December 2022 Inspection		April 2023 Inspection				
		Conditions Observed and Recommended Action	Action Taken	Condition Status	Conditions Observed and Recommended Action	Timeline for Repair and/or Reinspection	Recommended Action Assignment	Photographs
G-3	Loss of vegetation and minimal erosion of soil	Minimal erosion of soil, netting from vegetation correction is visible. Geomembrane is not exposed. Reinspect every 6 months. If loss of vegetation or erosion exposes the geomembrane, the actions recommended in the 2021 annual inspection should be taken.	No actions taken or required	Improved	Improved vegetation.  Follow-up reinspection	6 months	Site Coordinator

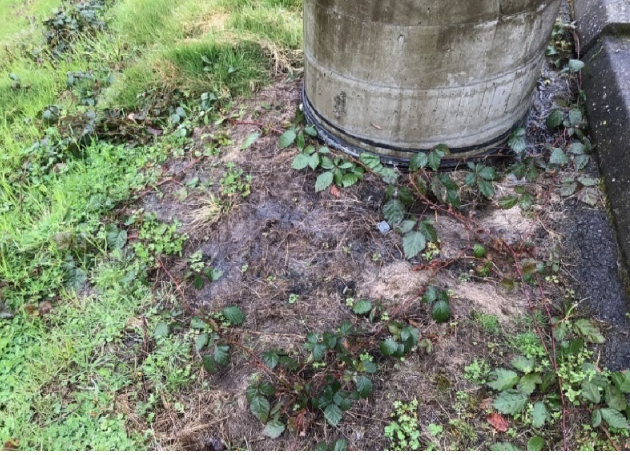
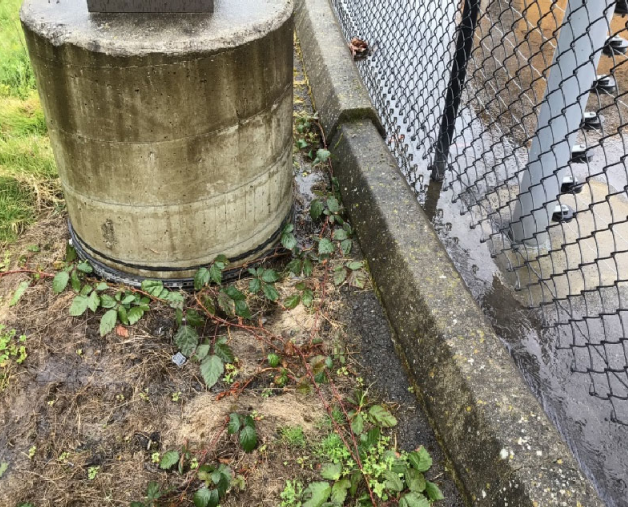
Center Point (SPPD) Location	Description	December 2022 Inspection		April 2023 Inspection				
		Conditions Observed and Recommended Action	Action Taken	Condition Status	Conditions Observed and Recommended Action	Timeline for Repair and/or Reinspection	Recommended Action Assignment	Photographs
G-4	Loss of grass cover along with blackberry shrubs growth in the area	April 2022 recommendations remain. Blackberry shrubs have been introduced to the area since the April 2022 inspection. Remove blackberries before the roots spread and become invasive, may need to re-seed the grass.	Action Not Yet Completed	Worse	Loss of grass around the concrete post exposing the soil and growth of blackberry shrubs around the region.  Remove the blackberry shrubs before the roots spread and re-seed the grass.	No later than end of calendar year	CenterPoint

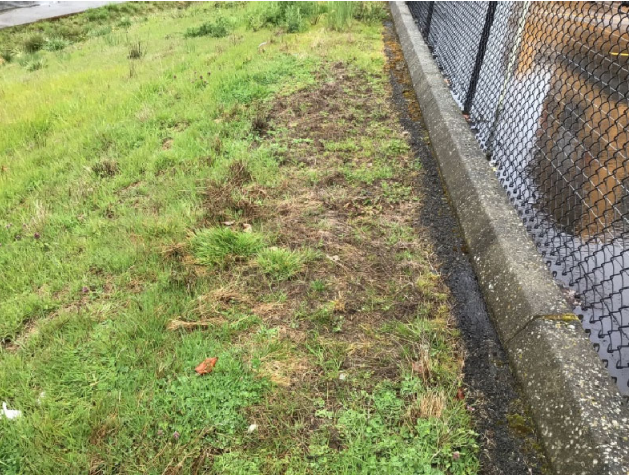
Center Point (SPPD) Location	Description	December 2022 Inspection		April 2023 Inspection				Photographs
		Conditions Observed and Recommended Action	Action Taken	Condition Status	Conditions Observed and Recommended Action	Timeline for Repair and/or Reinspection	Recommended Action Assignment	
G-5	New grass cover over previously exposed geomembrane	See Location G-4 2022 recommendations.	Action Not Yet Completed	Improved	Follow-up reinspection	6 months	Site Coordinator

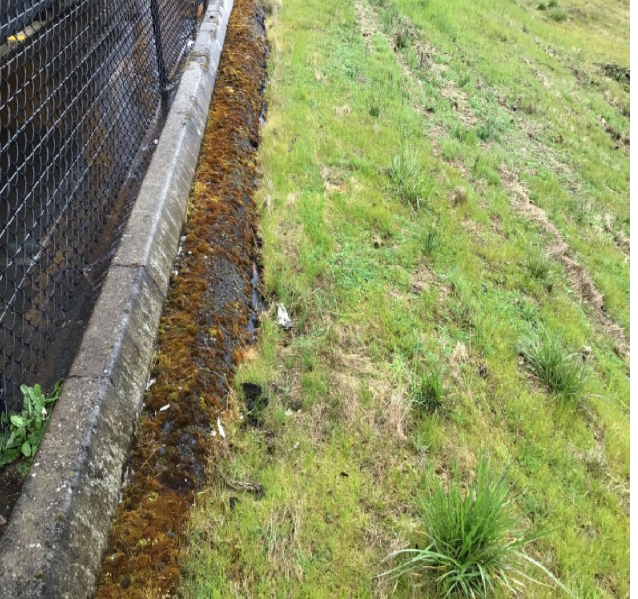
Center Point (SPPD) Location	Description	December 2022 Inspection		April 2023 Inspection				
		Conditions Observed and Recommended Action	Action Taken	Condition Status	Conditions Observed and Recommended Action	Timeline for Repair and/or Reinspection	Recommended Action Assignment	Photographs
G-7	Exposed and damaged geomembrane at the parking area interface	The geomembrane remains exposed at G 7 and G-10. These locations are of the highest concern due to the potential compromise of the landfill cap. The configuration of the geomembrane and cover at the interface of the parking area does not appear to be in accordance with Figure 5 of the Interim Action Work Plan (IAWP). The geomembrane appears to be directly below the asphalt with no drainage layer or surfacing layer in between. Along with Site Coordinator, prepare a plan to reestablish cover over the geomembrane. Most likely, the area should be exposed, and the geomembrane tested for damage before repairs are made. The crest of slope should then be provided cover to the maximum extent possible considering the existing asphalt and curb configuration	Action Not Yet Completed	Some improvement	Improved growth of grasses over the geomembrane. Exposed geomembrane remains. Add soil to exposed geomembrane and re-seed grasses. Previous recommendations remain.	60 days	CenterPoint will work in coordination with Site Coordinator to establish a solution

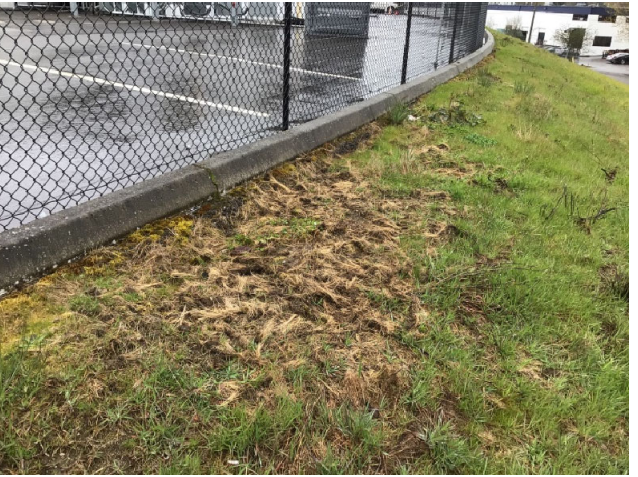
Center Point (SPPD) Location	Description	December 2022 Inspection		April 2023 Inspection				
		Conditions Observed and Recommended Action	Action Taken	Condition Status	Conditions Observed and Recommended Action	Timeline for Repair and/or Reinspection	Recommended Action Assignment	Photographs
G-10	Exposed and damaged geomembrane at the parking area interface.	See Location G-4 2022 recommendations.	No documentation of actions taken	Improved	No exposed or damaged geomembrane visible during inspection. Poor growth of vegetation in this area.  Follow-up reinspection	6 months	Site Coordinator

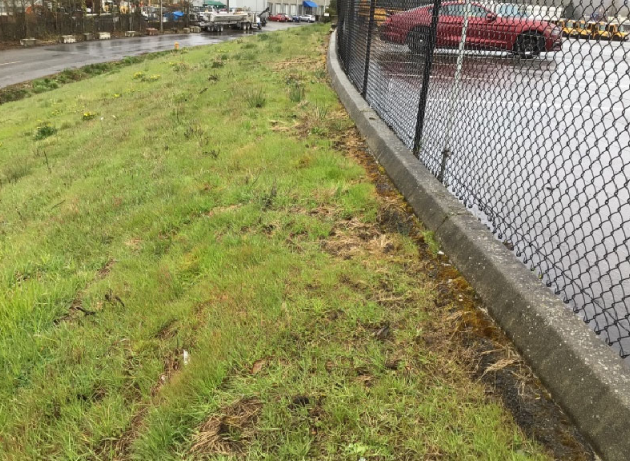
Center Point (SPPD) Location	Description	December 2022 Inspection		April 2023 Inspection				
		Conditions Observed and Recommended Action	Action Taken	Condition Status	Conditions Observed and Recommended Action	Timeline for Repair and/or Reinspection	Recommended Action Assignment	Photographs
G-13	Grass growing unevenly. The upper portion of the slope has started to slough off.			New location	If this condition worsens take appropriate steps for prevention of sloughing.  Follow-up reinspection	6 months	CenterPoint/Site Coordinator

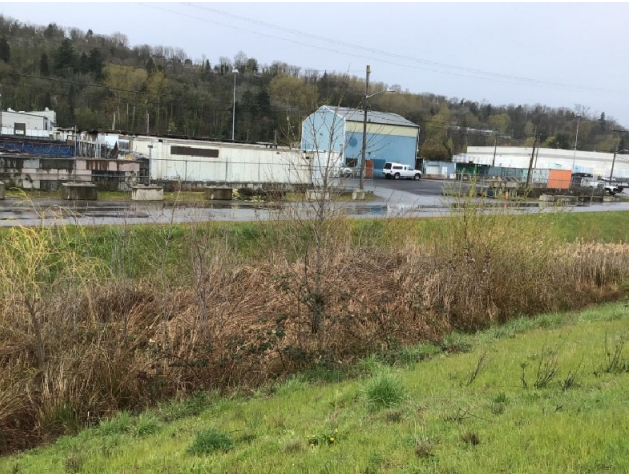
Center Point (SPPD) Location	Description	December 2022 Inspection		April 2023 Inspection				
		Conditions Observed and Recommended Action	Action Taken	Condition Status	Conditions Observed and Recommended Action	Timeline for Repair and/or Reinspection	Recommended Action Assignment	Photographs
SW-2	Invasive/Deep Rooted Plants	The willow (salix sp.) and black cottonwood (populus balsamifera) growing along the edge of the west bioswale are native but deep-rooted species that should be removed so that it does not damage the geomembrane on that side. This recommendation remains from April 2022.	Action Not Yet Completed	No Significant Change Observed	Previous recommendations remain	No later than end of calendar year	CenterPoint

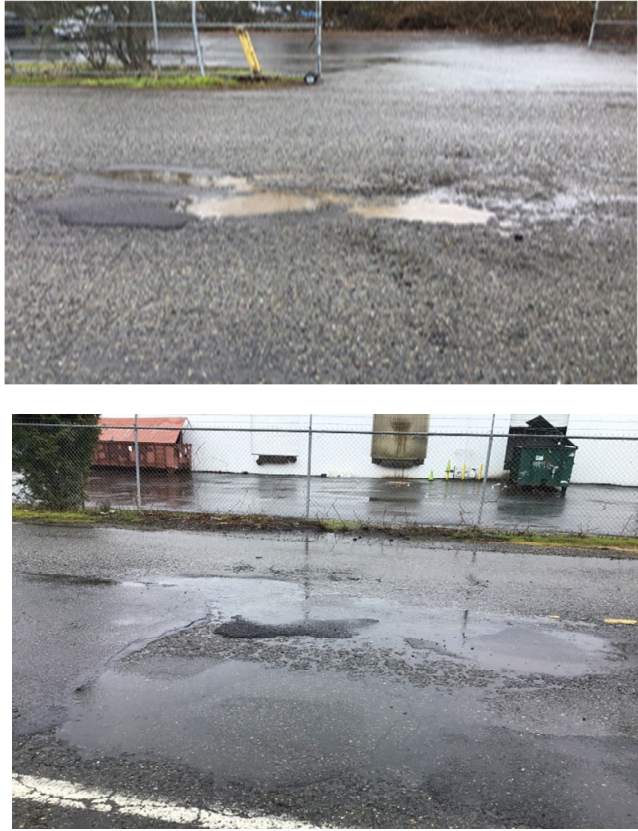
ROW Location	Description	December 2022 Inspection		April 2023 Inspection				Photographs
		Conditions Observed and Recommended Action	Action Taken	Condition Status	Conditions Observed and Recommended Action	Timeline for Repair and/or Reinspection	Recommended Action Assignment	
<b>Asphalt Concrete</b>								
AC-1	Cracks and pavement repair	Roadway is in poor condition, there are large open cracks and ruts in the asphalt pavement. SDOT previously repaired a portion of this location but did not cover the entire area. Recommend coordination with SDOT.	No action taken	Worse	Cracks got worse with ponding. Repair/repatching should be coordinated with SDOT	60 days	SPU to coordinate with SDOT

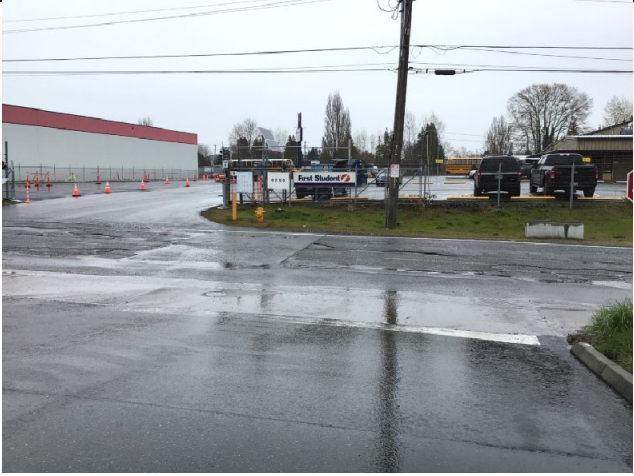
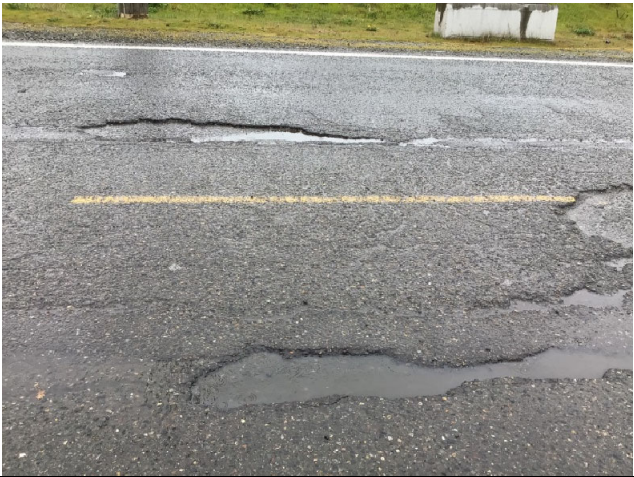
ROW Location	Description	December 2022 Inspection		April 2023 Inspection				Photographs
		Conditions Observed and Recommended Action	Action Taken	Condition Status	Conditions Observed and Recommended Action	Timeline for Repair and/or Reinspection	Recommended Action Assignment	
AC-2	Asphalt open cracking	Follow-up inspection	No action taken or required	Worse	Cracks got bigger with ponding. Repatching should be coordinated with SDOT	No later than end of calendar year	SPU to coordinate with SDOT

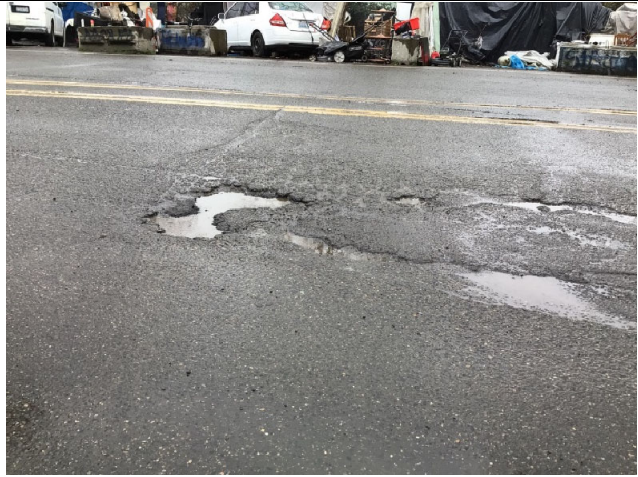
ROW Location	Description	December 2022 Inspection		April 2023 Inspection				Photographs
		Conditions Observed and Recommended Action	Action Taken	Condition Status	Conditions Observed and Recommended Action	Timeline for Repair and/or Reinspection	Recommended Action Assignment	
AC-4	Potholes in the middle of roadway			New location	Repatch work should be arranged with SDOT	No later than end of calendar year	SPU to coordinate with SDOT
