# NE 99<sup>th</sup> Street / Leichner Landfill Liner Installation Documentation Report

Leichner Landfill  
9009 NE 94<sup>th</sup> Avenue  
Vancouver, WA 98662

04223030.10 | August 15, 2023

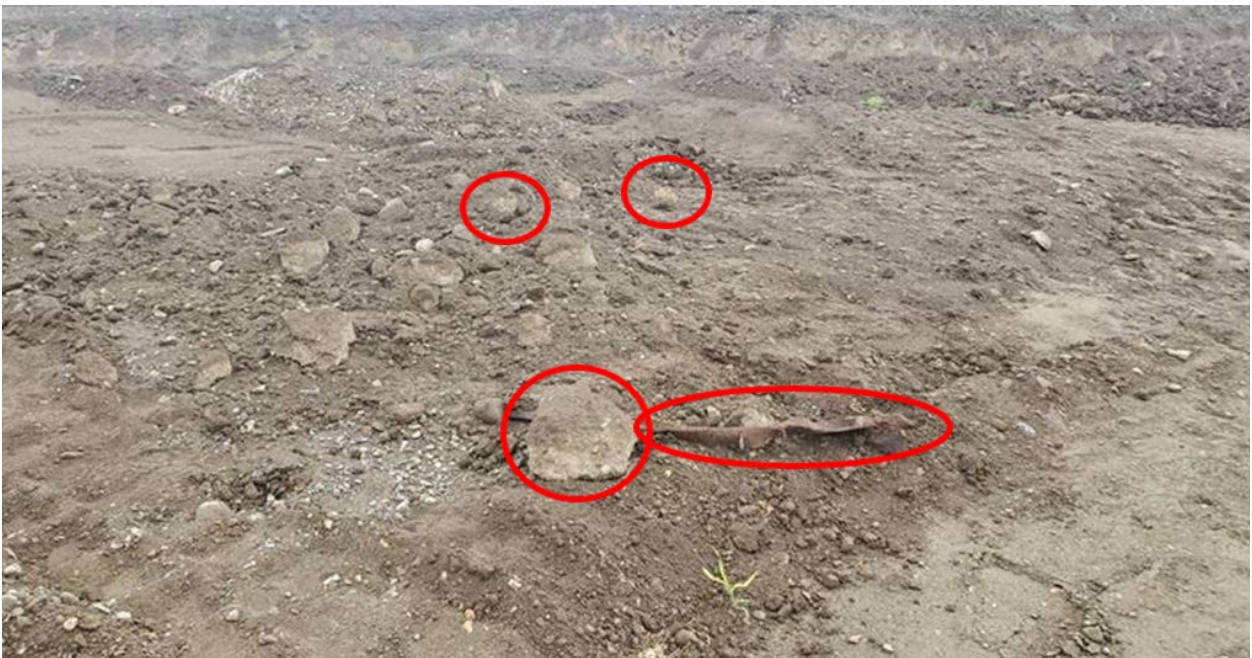
The subgrade soil contains many irreducible objects greater than ½ inch that the specifications indicate are not allowed. These objects include rocks, wood debris, and pieces of metal. (See the items circled in Photos 1 and 2, below). The stormwater pipe inlets are surrounded by what appears to be 1-inch crushed rock. Fractured rock of any size is not acceptable per specifications.

*Photo 2 - Soil includes rocks, wood debris, and metal.*

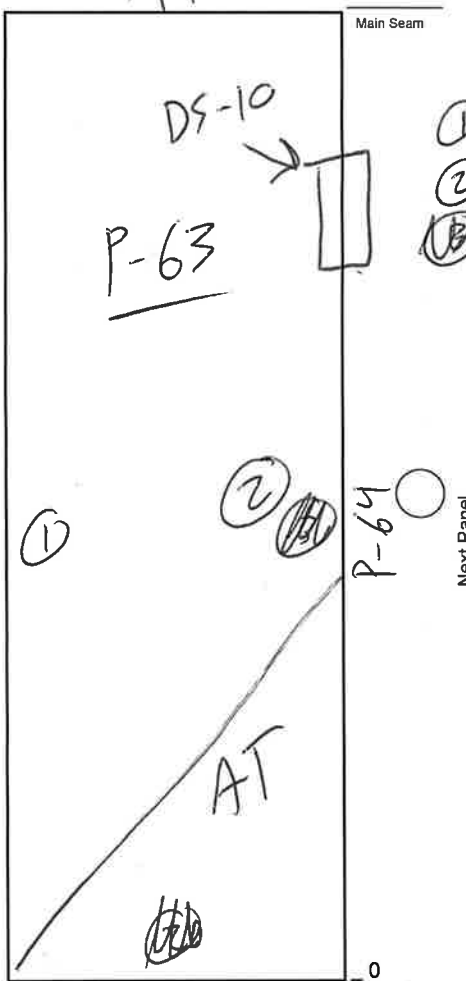
Destructive Seam Sample Lab Test			Comments
Sample No.	Date Removed	Pass/Fail	
DS-10	6-28-23	F	ACFWest repairs entire seam. DS-9 → DS-10 = 741' Σ = 741 + 4231' = 4972' Remaining seam = 290'

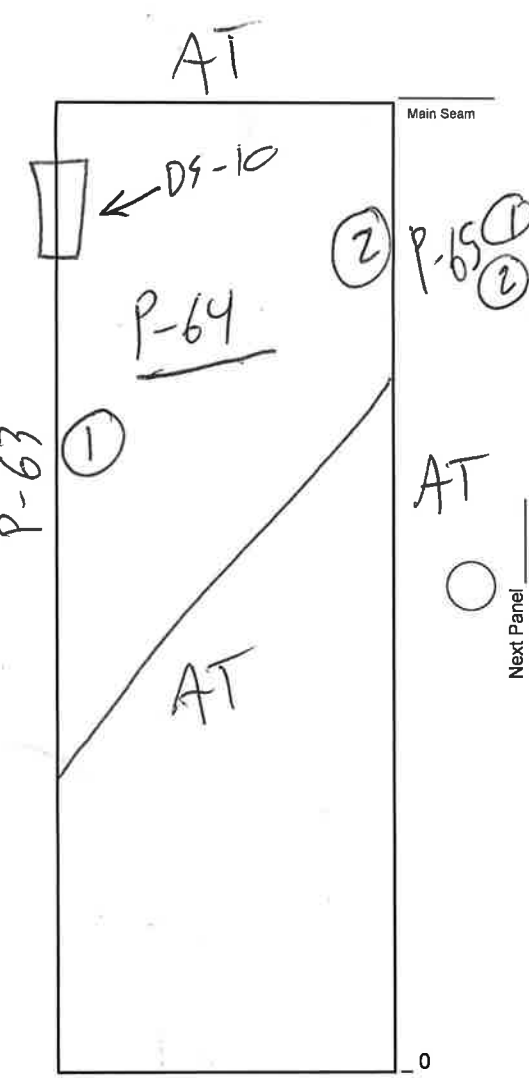
Destructive Seam Sample Lab Test			Comments
Sample No.	Date Removed	Pass/Fail	
DS-10	6-28-23	F	ACF West repairs entire seam

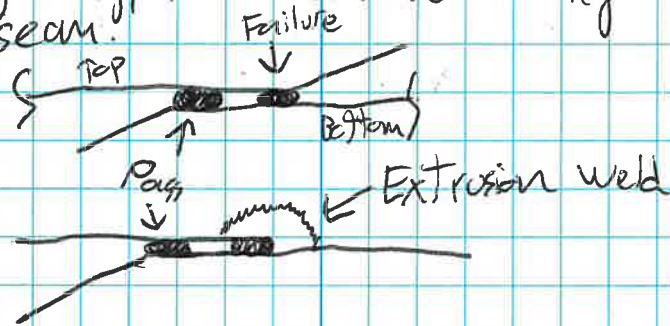
1219 - Destructive seam lab results received, all good except DS-10, which had side A peel strength of 56 (avg) and Non-FTB NSF failure code for all 5 coupons.

1300 - Discussion w/Jeff, Hans & SR. Two field coupons taken N&S of DS-10 failed peel tests, decision is to repair entire seam. ACF West proposes cutting excess off fusion weld, grinding, then extrusion welding seam.

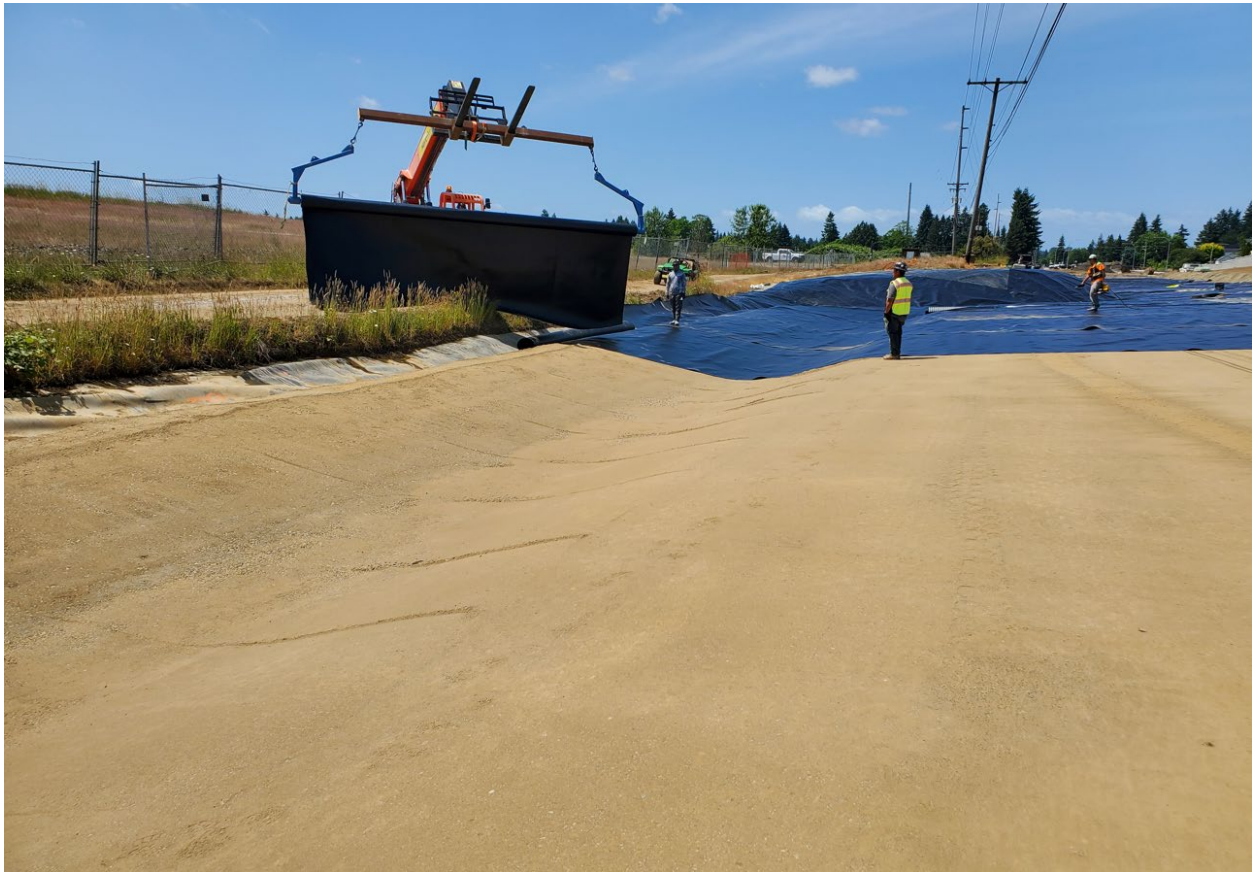
**June 15<sup>th</sup>, 2023:** Deployment of geomembrane liner over prepared subgrade.

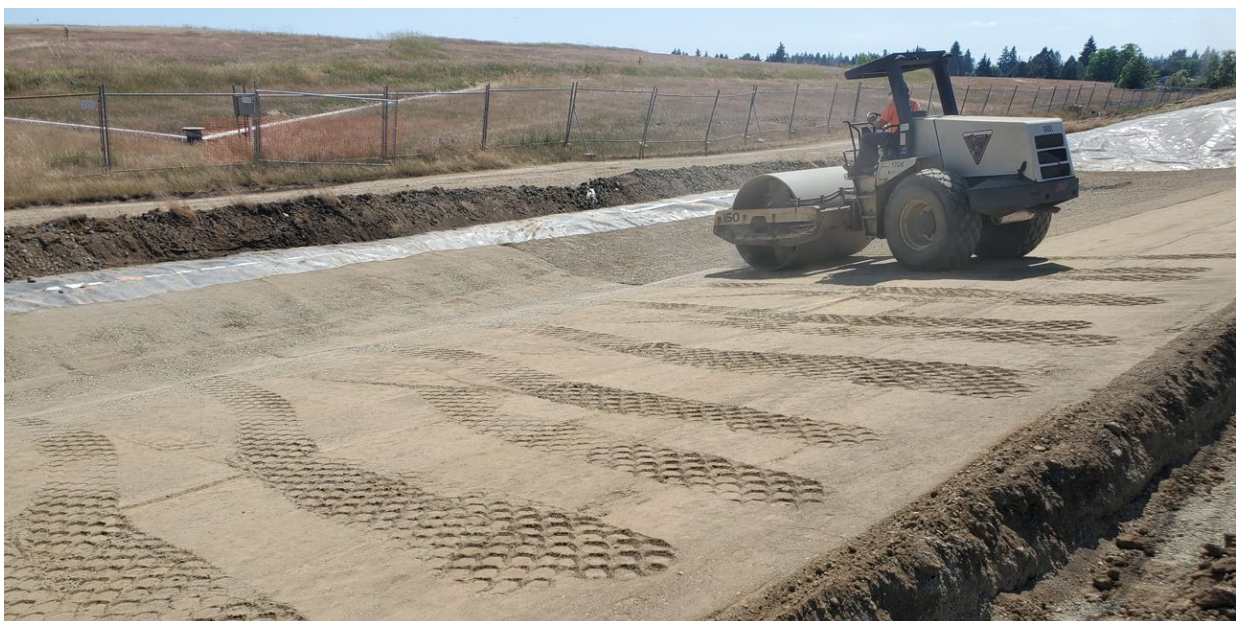
**June 15<sup>th</sup>, 2023:** Preparation of subgrade for liner deployment.

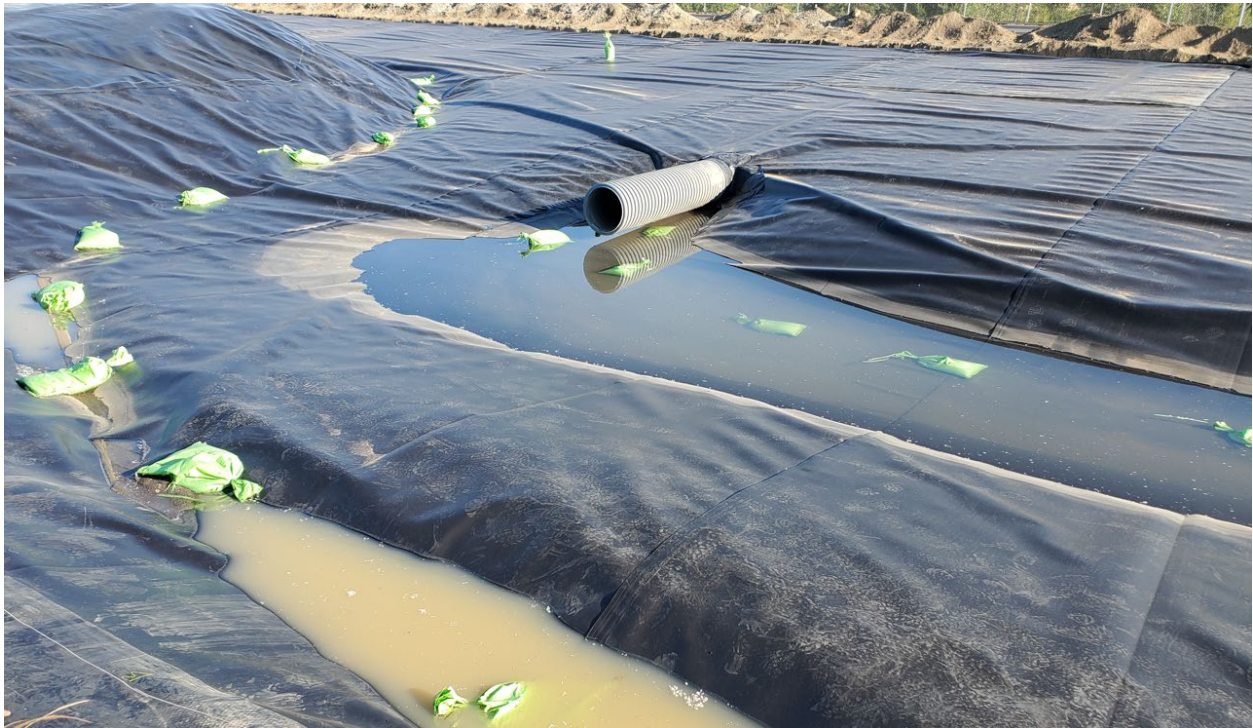
June 22<sup>nd</sup>, 2023: Stormwater ponding on liner after weekend rains.

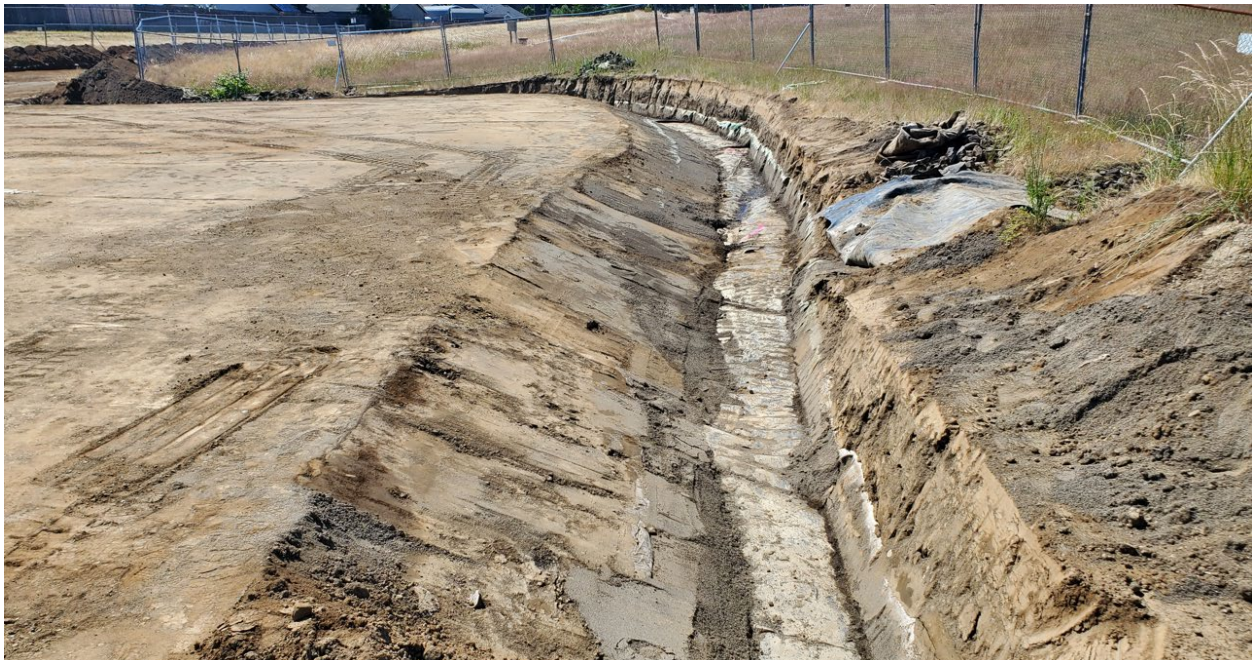
Time	Description	Action	Inform
0730	Arrive onsite & meet with John (CCPW). Exposure of existing liner @ E end of site showed it to be anywhere from 1'-6' below SG of liner area. Discussion <del>at</del> of tie-in via fusion welding or tuck per plans. Existing liner appears to have been damaged in many spots while being uncovered. SG prep continues, fractured rock & rock > 0.5" present. Muttter addressing by tossing clean soil over rock and compacting.		
1010	Meeting w/ CCPW to discuss liner installation @ SE end/area of LF. See email for pictures & details.		
1130	Meet w/ CCPW & Brad (witter super). Communicate SCS suggested solution to tie-in issue. Agreed. - 1' sand over ex. liner, tuck liner when continuous grade cannot be achieved. Backfill & compact thoroughly. Drain pipes 5' both directions place G/T over sand, encapsulate w/ drain rock, G/T, then tuck new liner. In		
Attachments: areas where SG $\geq$ 1.5' from ex. liner sand layer will be thinned to ensure new liner secured.

June 22<sup>nd</sup>, 2023: Exposed existing Landfill cover liner in northeast corner of Landfill.

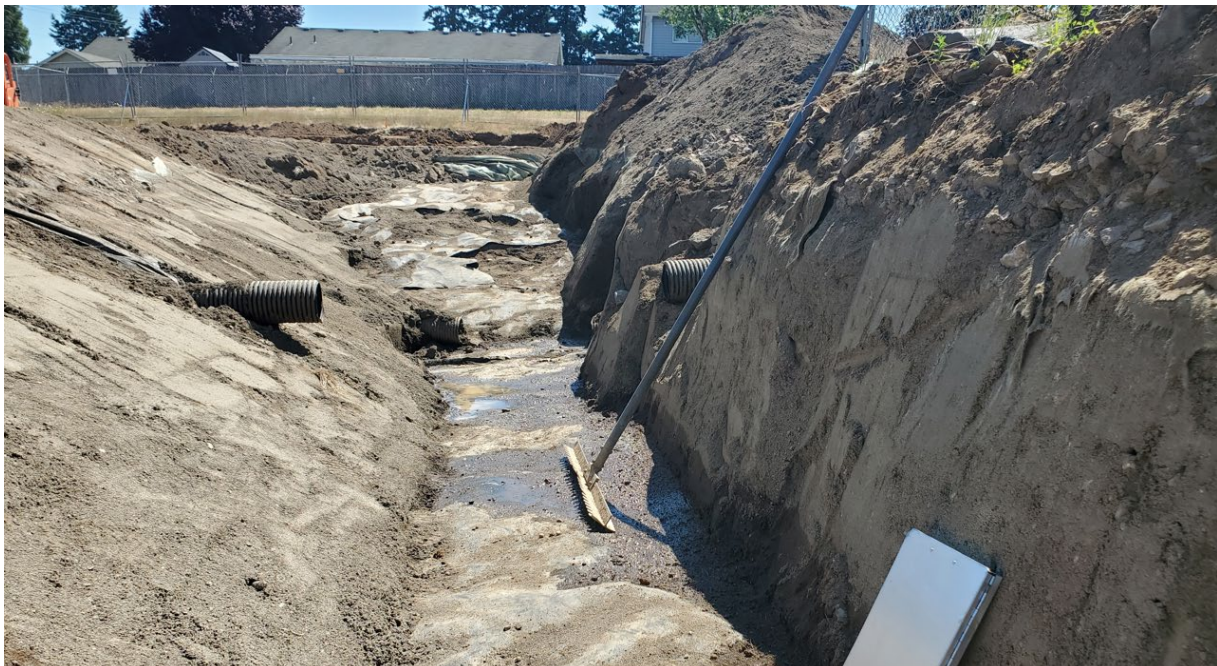
June 22<sup>nd</sup>, 2023: Exposed corrugated plastic drain pipes above Landfill cover liner.

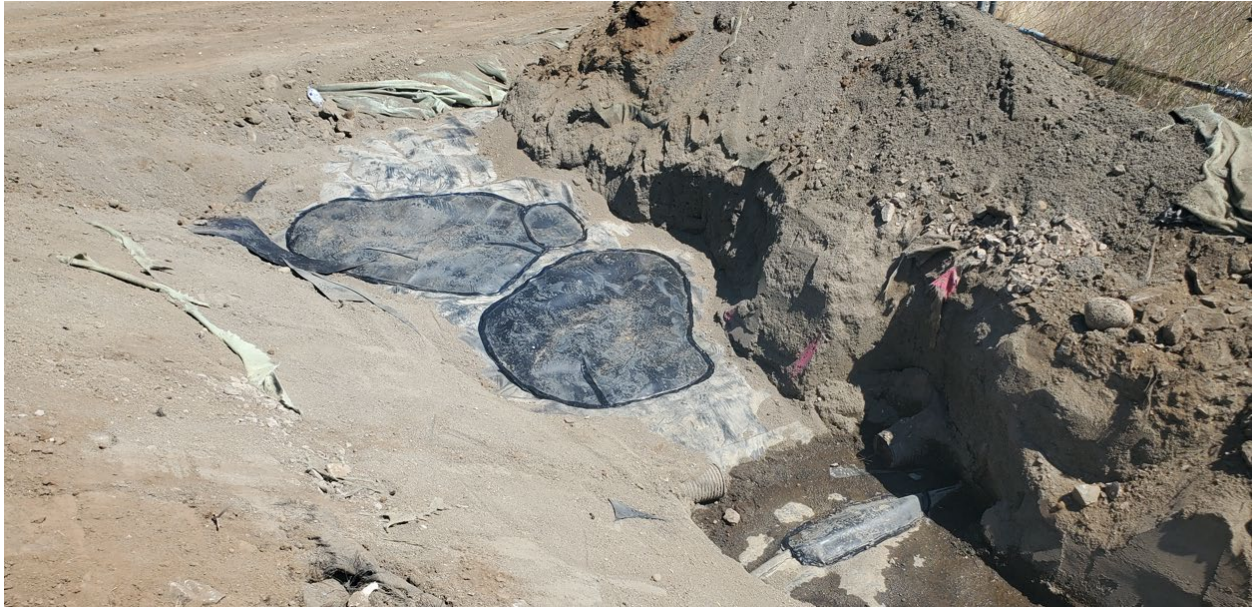
**June 22<sup>nd</sup>, 2023:** Repairs to existing Landfill cover liner.

Time	Description	Action	Inform
1324	ACFW performing repairs on ex. liner in SE area. Nutter exposing liner for repair. Patches and other work continuing on new liner.		
1509	Conversation w/ Nutter. Change order "close enough" for work to resume per prescribed changes. ACFW continuing to repair/patch ex. liner in trench before sand can be placed. Nutter continuing to prepare sub-grade. No updates from CCPW.		
1608	ACFWest departs for the day. Liner sewered and job site cleaned up. Nutter continuing work, digging AT along E end of work area.		
1630	CCPW + engineers onsite to evaluate project, right away major issues *potentially* identified. Grade appears to be incorrect, trapping water in some places. They will convene and determine what, if any, changes will be made moving forward.

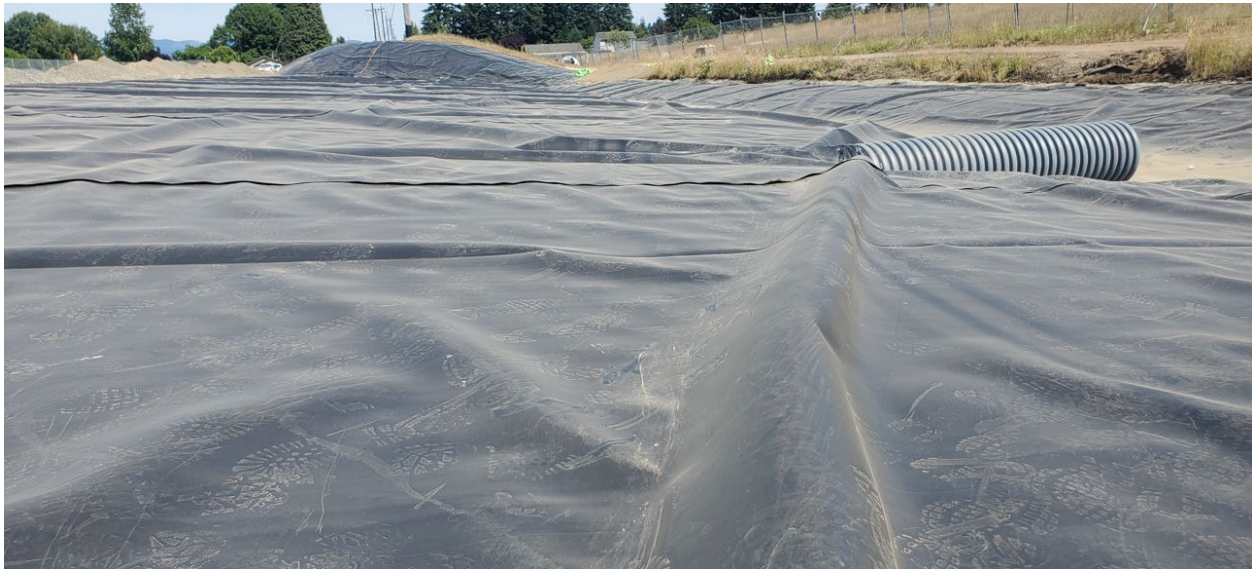
- 1300 - Discussion w/ Bart. Walk site and show condition of liner. CCPW wants to know why ACF West did not install liner in such a way as to avoid excessive wrinkling.
- 1433 - Follow-up w/ Bart. Nutter will resume filling @ 6:30 AM Thursday. They will fill from S to N and will cut and cap any wrinkles that cannot be walked out.
- 1636 - ACF West Departs NE 99<sup>th</sup>.  
 - Destruct samples provided prior to departure.
- 1640 - SCS Departs NE 99<sup>th</sup>.

**June 27<sup>th</sup>, 2023:** Large wrinkles developing in deployed liner due to thermal expansion of HDPE.

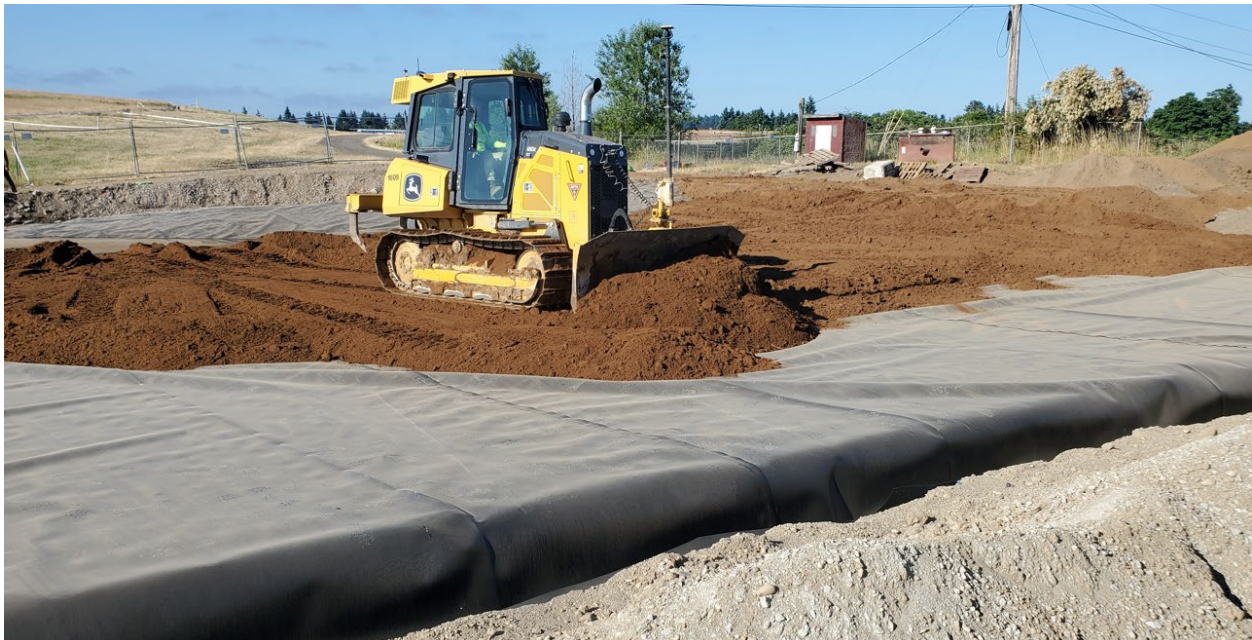
**June 29<sup>th</sup>, 2023:** Spreading of cover layer soil, wrinkles in geomembrane being “walked” to anchor trench where extra material can be removed.

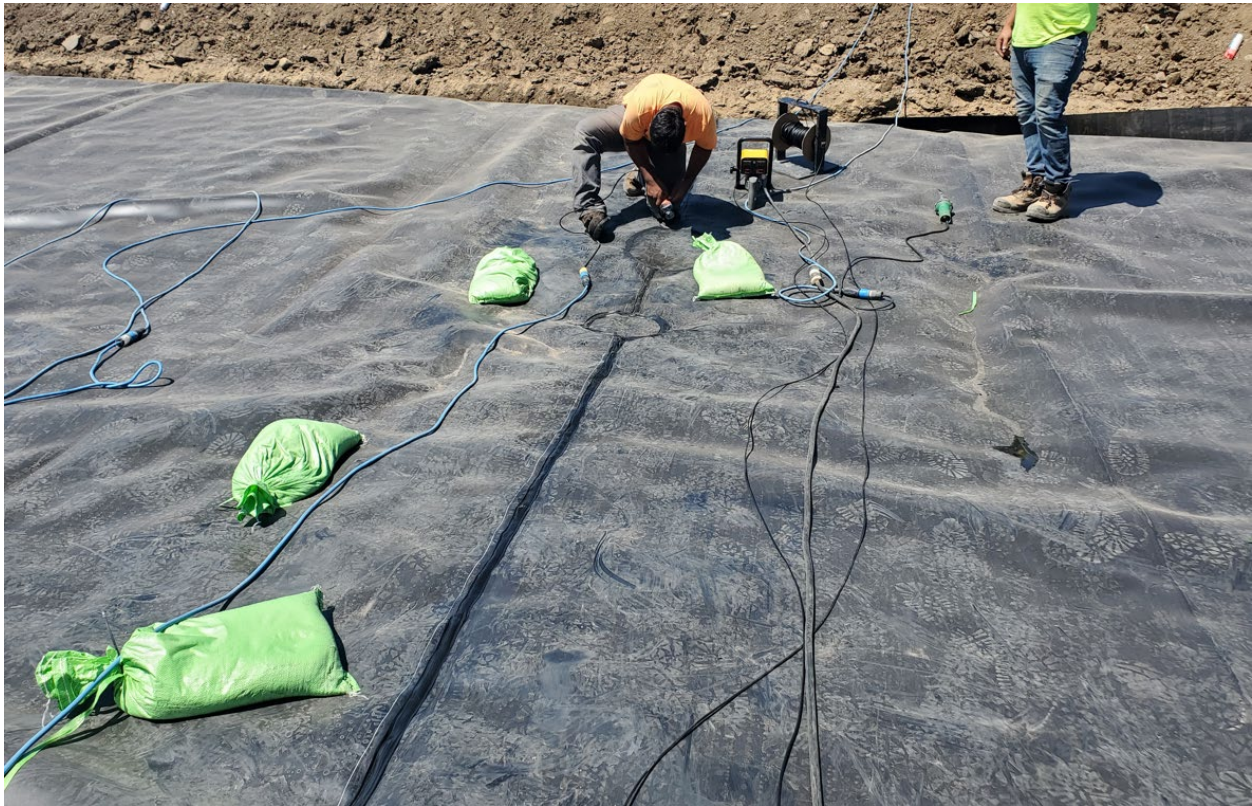
**June 29<sup>th</sup>, 2023:** Repair and patching of seam containing failed DS-10 destructive sample.

1400 - Extrusion welding repair of DS-10 seam going well. Sample pulled for field verification of weld strength. Weld visually appears excellent.

1435 - Repair of DS-10 weld nearly complete. Liner is being trimmed, grinded, and welded as described prior.
