**Re: Geotechnical Construction Completion Letter**

Texaco Strickland Site  
Project No. 180357

**PRECONSTRUCTION CONDITION SURVEY PHOTO LOG** | September 19, 2022

**POSTCONSTRUCTION CONDITION SURVEY PHOTO LOG** | January 10, 2023 and January 25, 2023

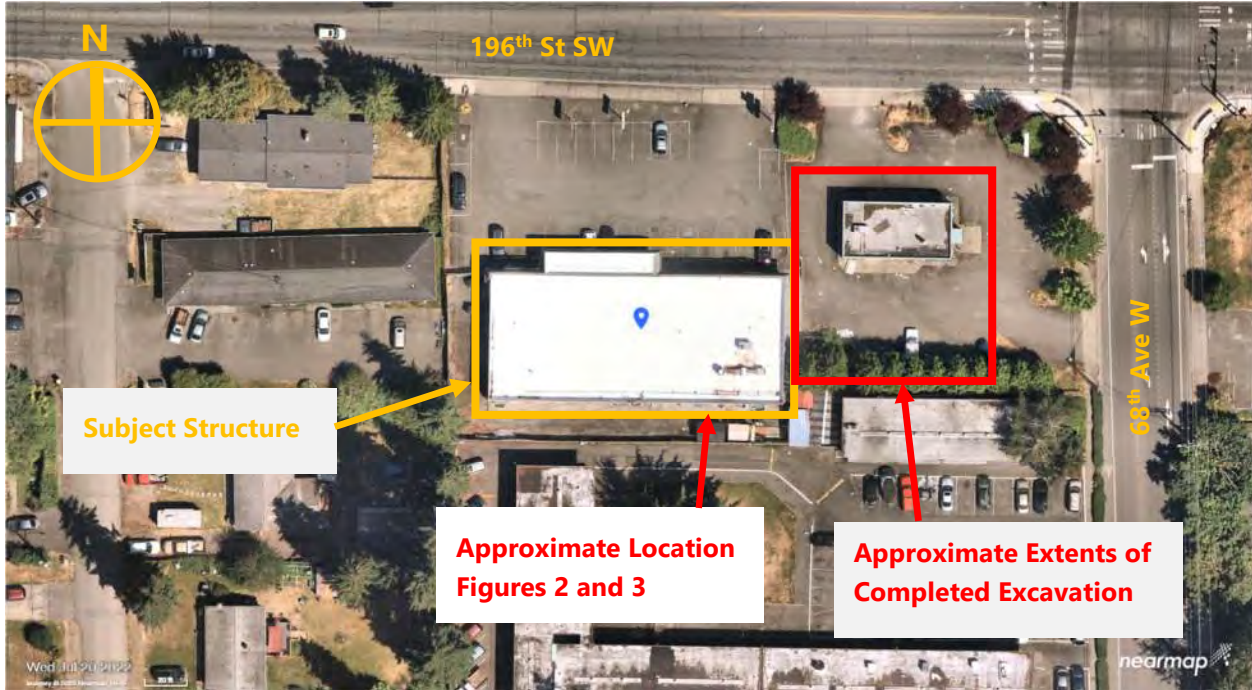
Figure 1. Aerial view of subject property on July 20, 2022. Image © 2022 Nearmap.

Between our preconstruction assessment on August 25, 2022 and January 10, 2023, the only measured change noted was a slightly widened crack along the loading dock on the south facade (location shown in Figure 1). On August 25, 2022, we marked two locations on the crack and measured the width of the crack in both locations. The upper portion of the crack was measured to be 11mm wide (Figure 2a), while the lower portion of the crack was measured to be 2.5mm wide (Figure 3a). When we surveyed the condition of the Subject Structure on January 10, 2023, the marks were erased; however, we were able to locate scratches in the concrete that appear to have been made by the pen used to mark the locations in August 2022 and measured the width of the crack in those locations. The upper portion of the crack was

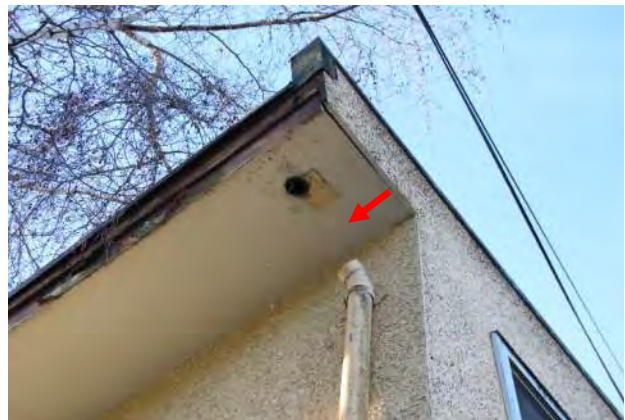
On January 10, 2023, we noted that a section of the downspout for the roof gutter at the northeast corner of the Subject Structure had separated from the rest of the downspout and had fallen off the structure, as shown in Figure 4. The fallen section of downspout was resting on the ground.

Figure 4b. Downspout at northeast corner of Subject Structure on January 10, 2023 (red arrow indicates location of fallen section).

Damage to the downspout shown in Figure 4 could have been caused by the following mechanisms:

- Vibrations from external sources, such as construction activities or seismic sources loosening the connections between the downspout segments
- Equipment striking the downspout
- Deterioration of the downspout due to age (e.g., corrosion)

There is no clear evidence indicating which of these mechanisms caused the damage; however, it is our opinion that this damage is cosmetic in nature and is not an indication of further damage.

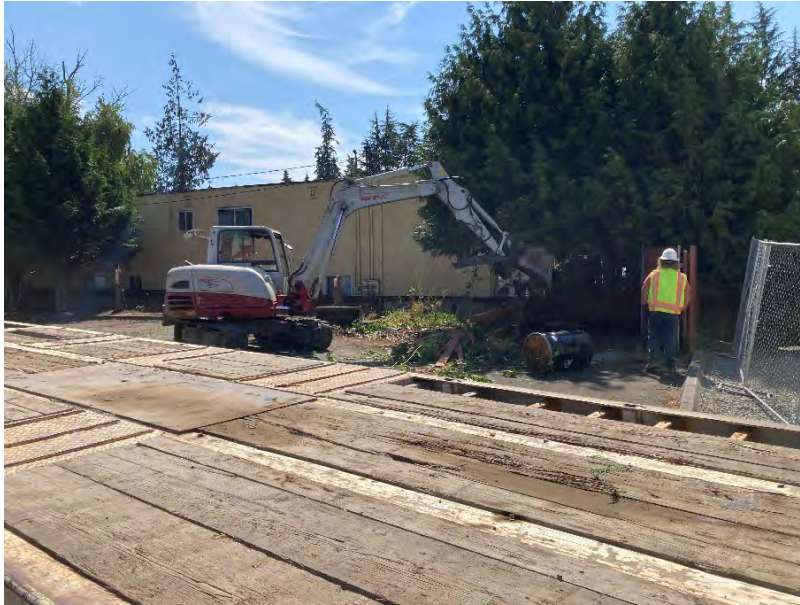
Photo 1: Brush and dumpster area demolition and clearing, viewing south.

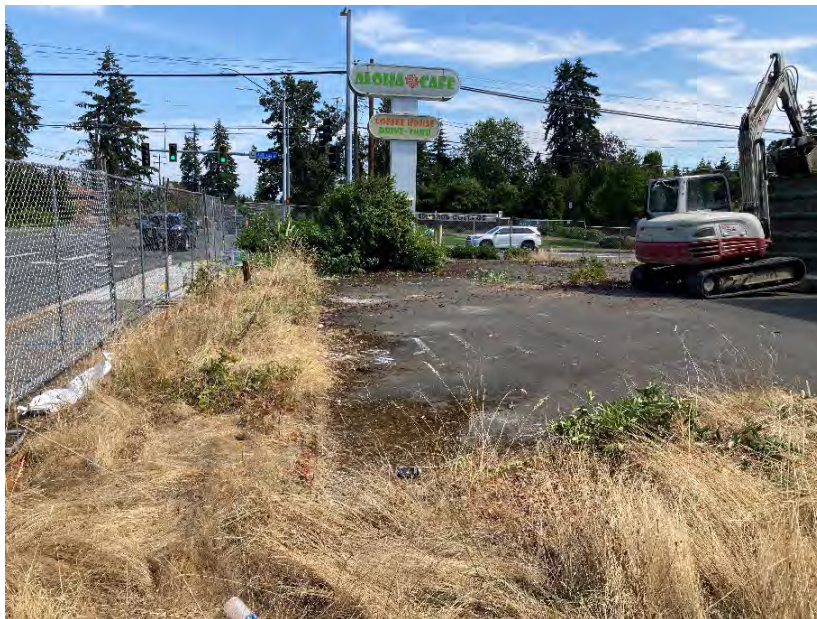
Photo 2: Perimeter fence installed, viewing east.

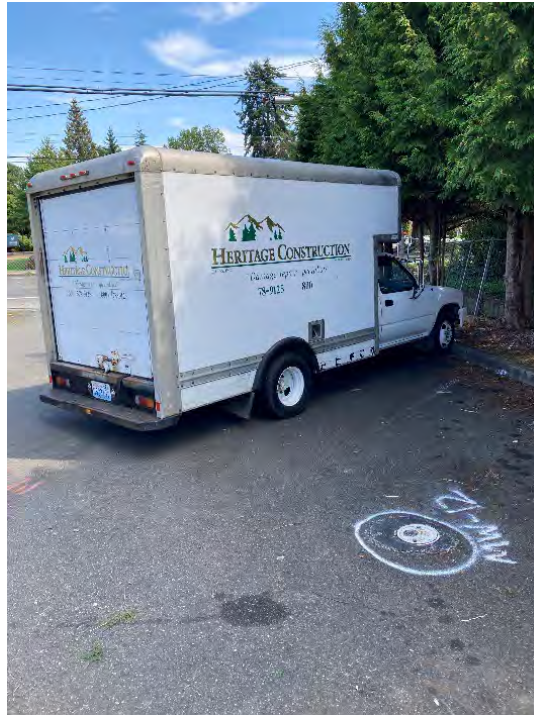
While on-site we observed a parked box truck in the southeast corner of the site. Its owner could not be located, nor did the visible phone numbers on the back of the truck provide information on the owner's whereabouts. We contacted a towing company with signs on-site but were told an account would need to be set up between them and the site owners before any vehicles can be towed.

Photo 3: Box truck parked in site southeast corner.

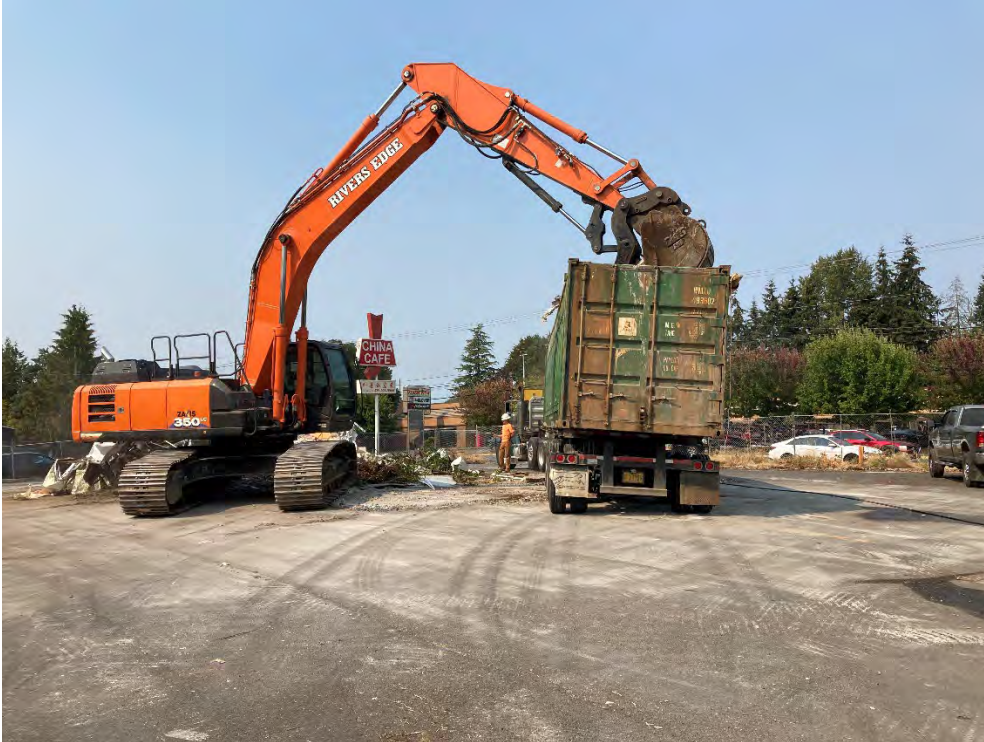
Photo 1: Completion of building demolition, REES is controlling for dust with a garden hose in the photo.

gentler while working to minimize dust, but we recommended they get water for dust control. REES then stopped work on demolition and set up a garden hose connected to the water meter to control dust.

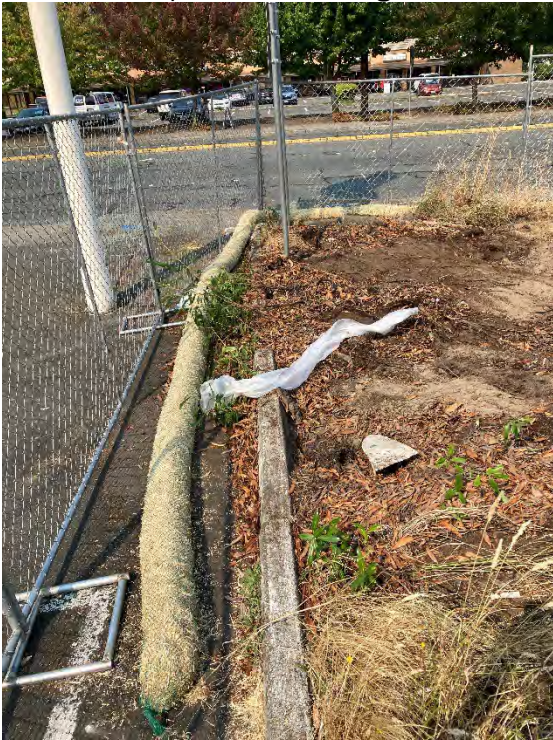
Photo 2: Installed straw wattle in the northwest corner of the site for erosion control.

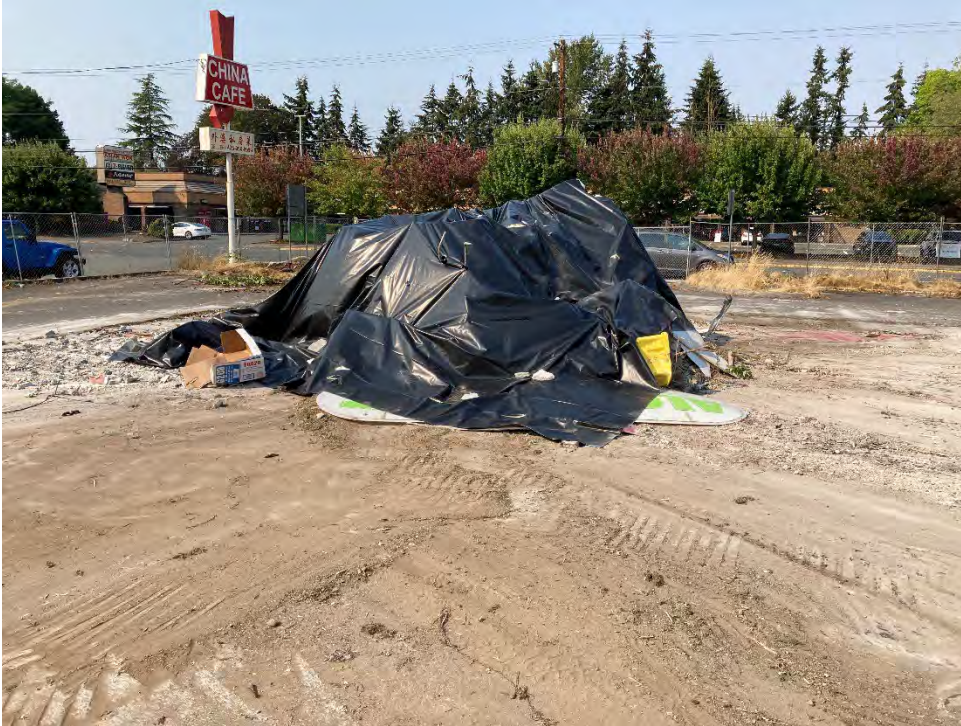
Photo 3: Building debris pile covered with plastic at the end of the day.

- At the end of the day, we spoke with REES to ask what their plans were to cover the debris stockpile over the weekend. They said they would park the excavator upwind with the bucket clamped around the pile. We recommended they cover the pile with anchored plastic sheeting. REES responded by saying they would ask Clayton with Rivers Edge and Daniel with Aspect to discuss and determine a path forward. While waiting for a response, REES remembered they had plastic sheeting on-site already and decided to cover the debris stockpile.

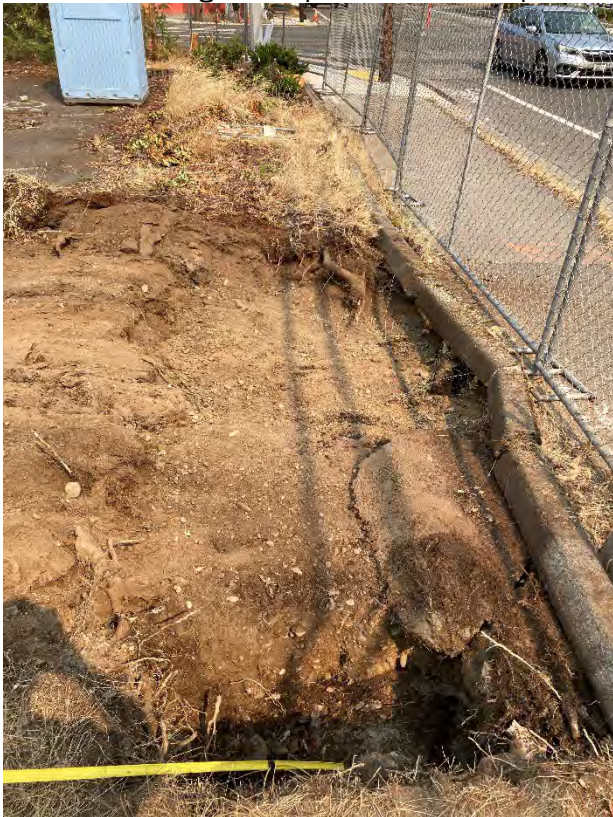
Photo 4: Minor excavation for water meter location on the west side of the site.

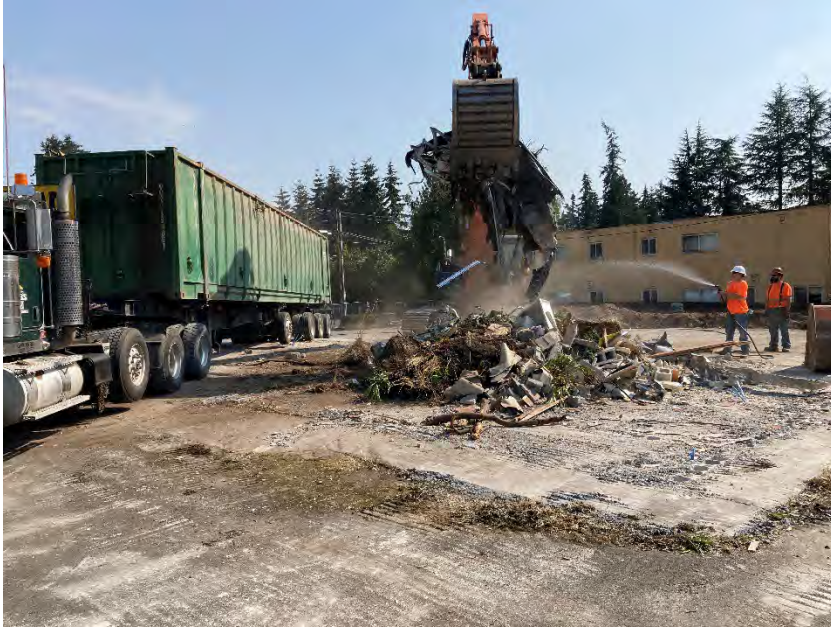
Photo 1: Final building debris pile being loaded into dumpster for disposal, dust control being deployed via garden hose.

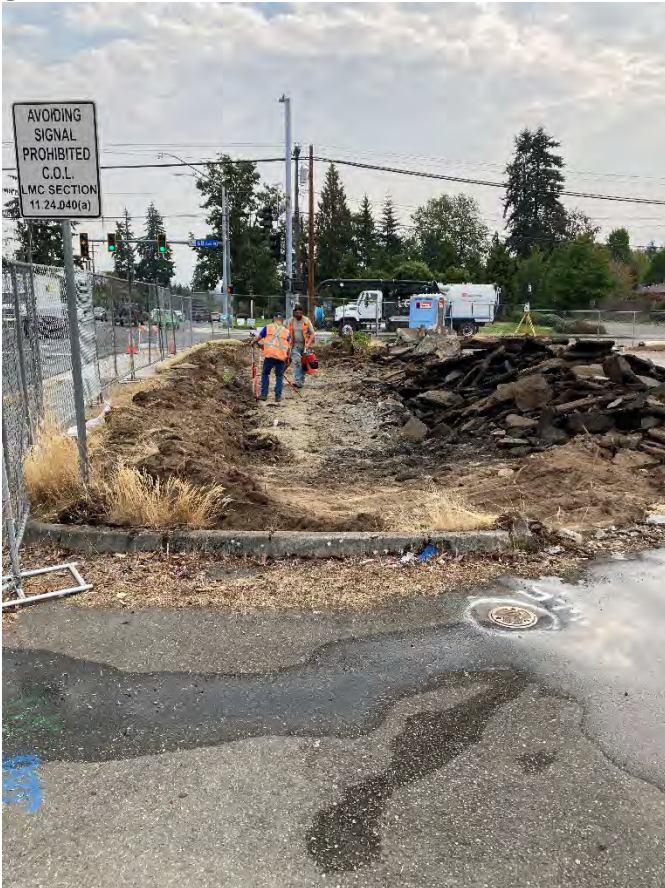
Photo 2: Asphalt being peeled back by REES at the north end of the site.

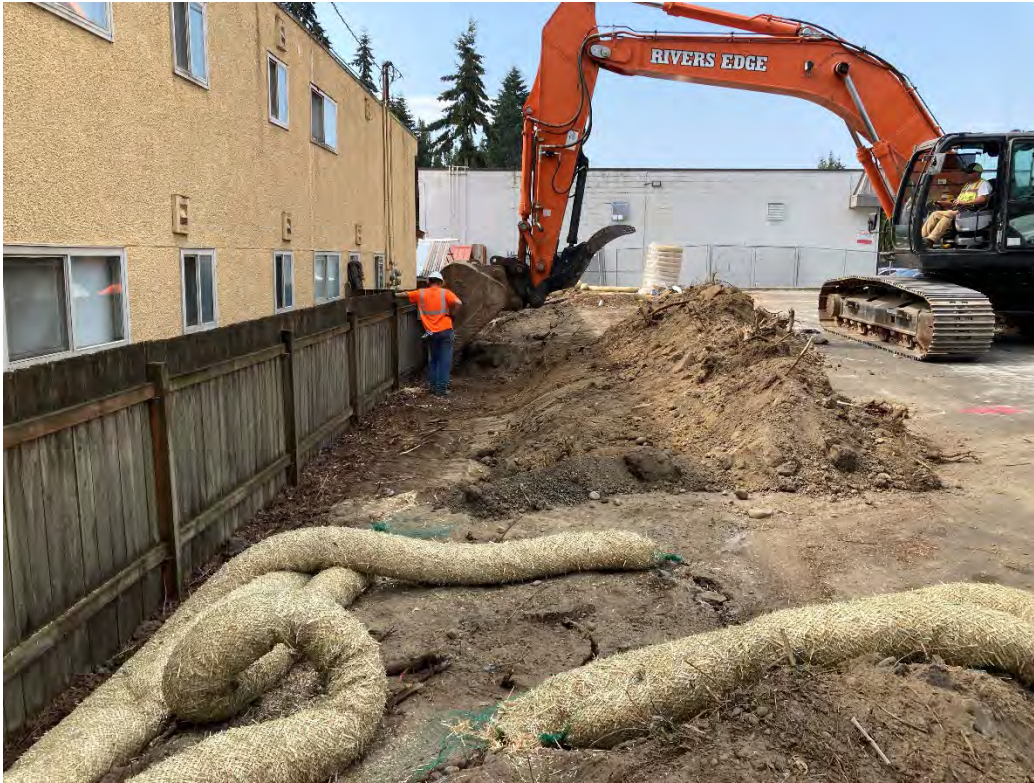
Photo 3: Soil being scraped from the incline at the south end of the site. Straw wattle at the ready for deployment as erosion control.

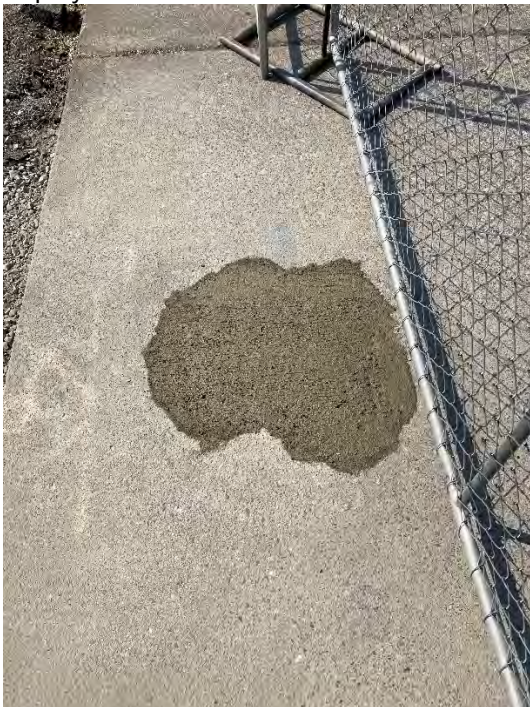
Photo 4: Water main patch.

- We spoke with REES about the plans for today and the rest of the week. We discussed their plan to backfill the water main pothole. We recommended that when the sidewalk is repaired at the end of work, the pothole backfill should be re-compacted.

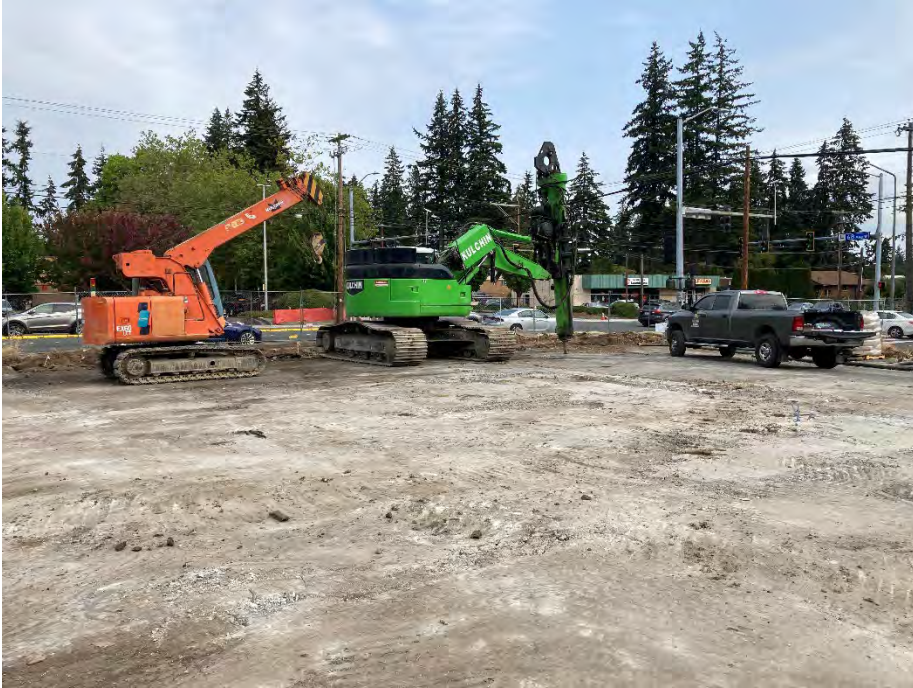
Photo 1: Kulchin's drill rig has been delivered to the site.

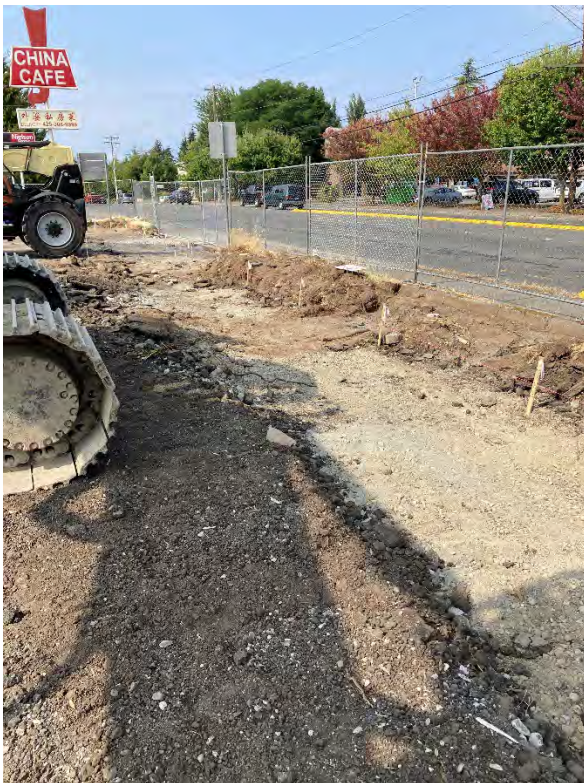
Photo 2: Northern shoring wall with piling staked out.

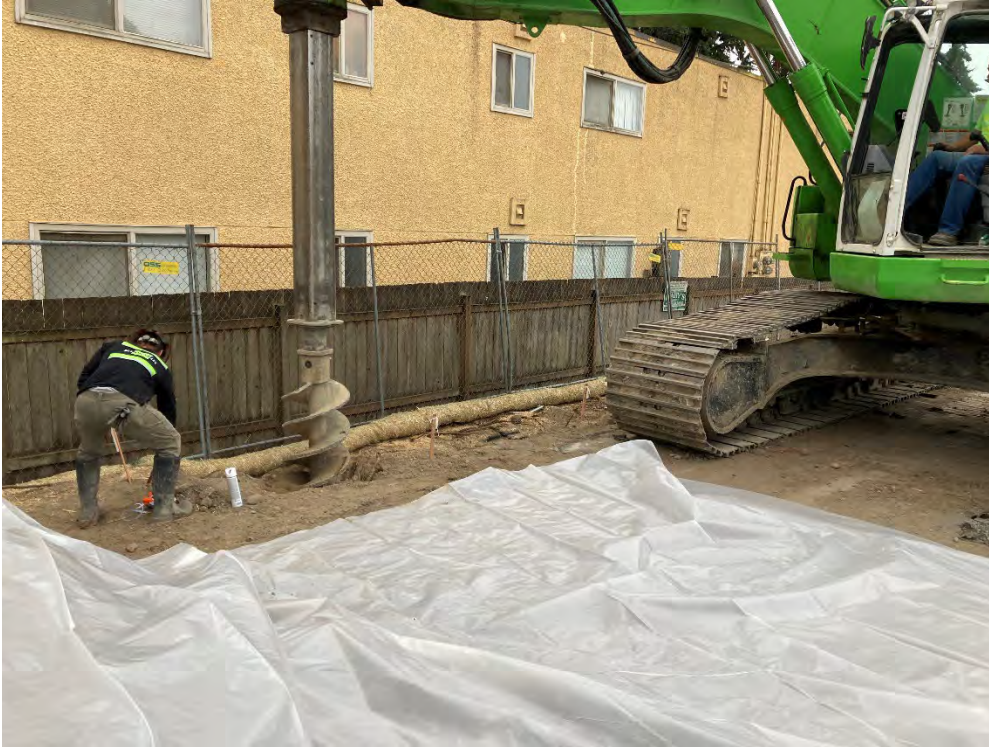
Photo 1: Drilling of the first soldier pile wall by Kulchin.

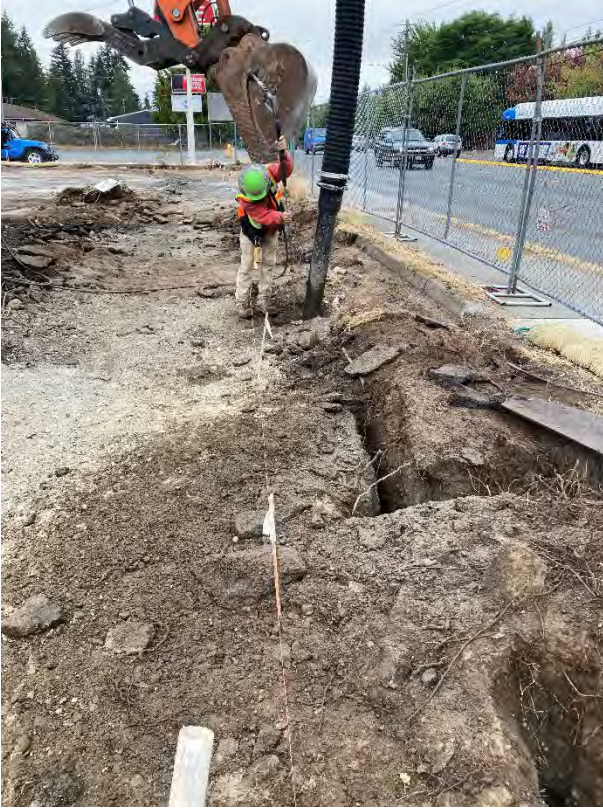
Photo 3: Ongoing potholing and locating of communication/fiber lines on the north end of the site.

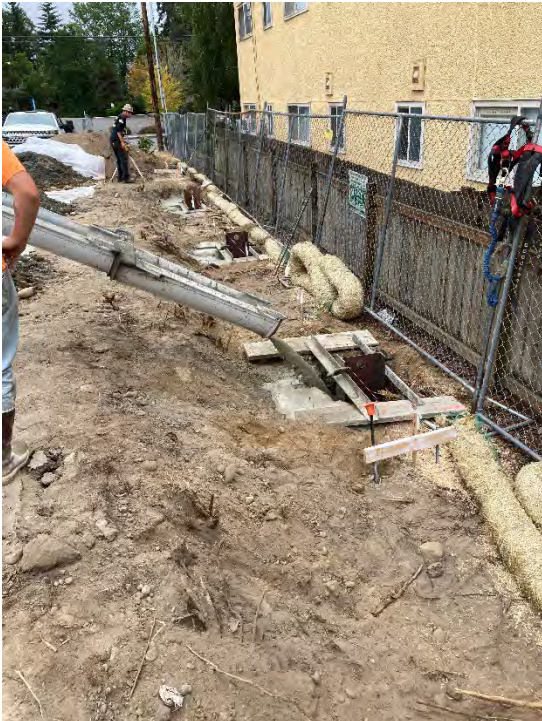
Photo 4: Soldier pile installation progress along the south shoring wall.

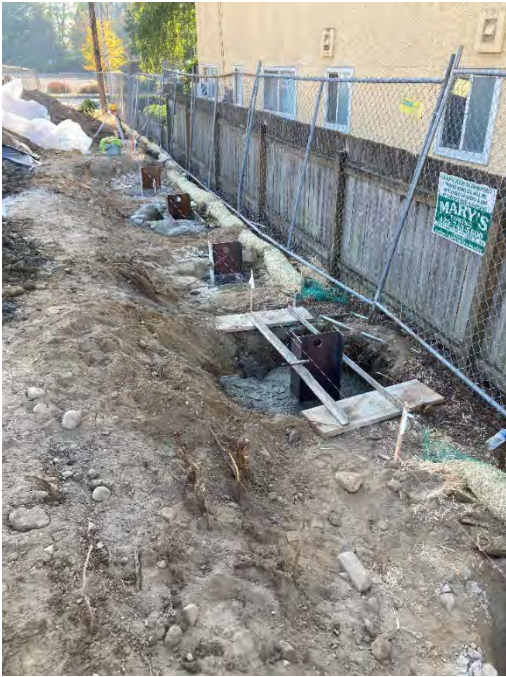
Photo 1: South Soldier Pile Wall, all piles installed viewing east.

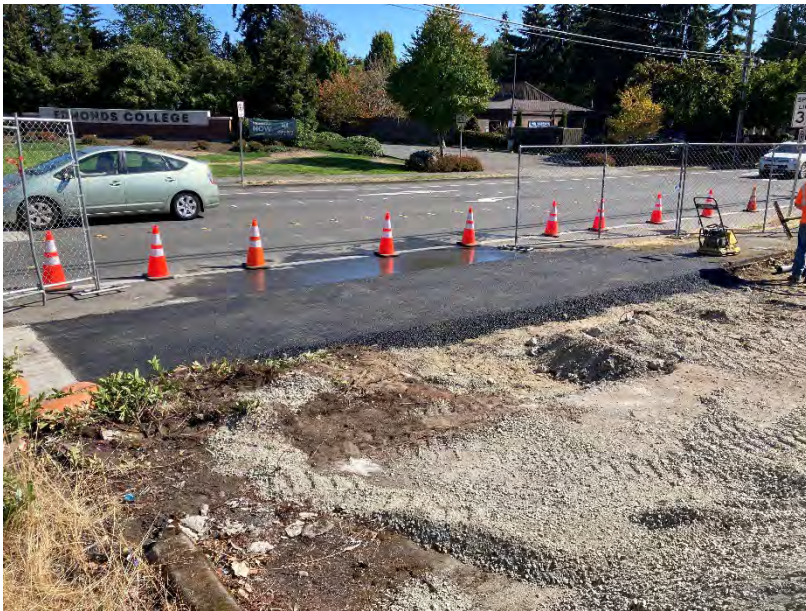
Photo 2: Quarry spalls installed for the stabilized construction entrance on 68<sup>th</sup> Avenue, viewing southeast.

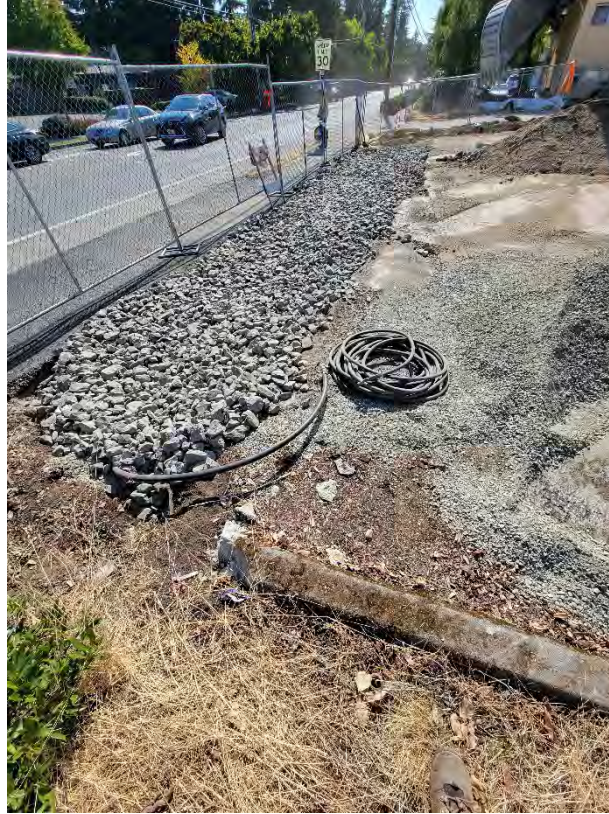
Photo 3: Quarry spalls installed for the stabilized construction entrance on 68<sup>th</sup> Avenue, looking southeast.

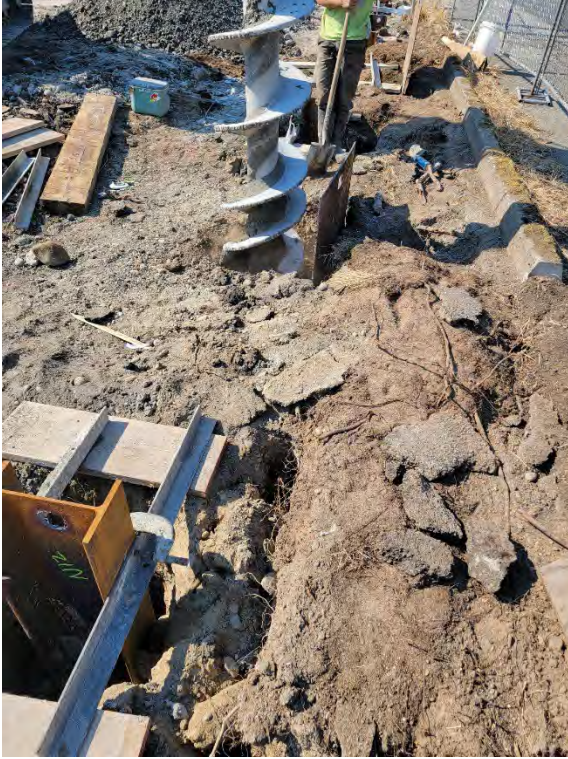
Photo 1: Drilling of soldier pile.

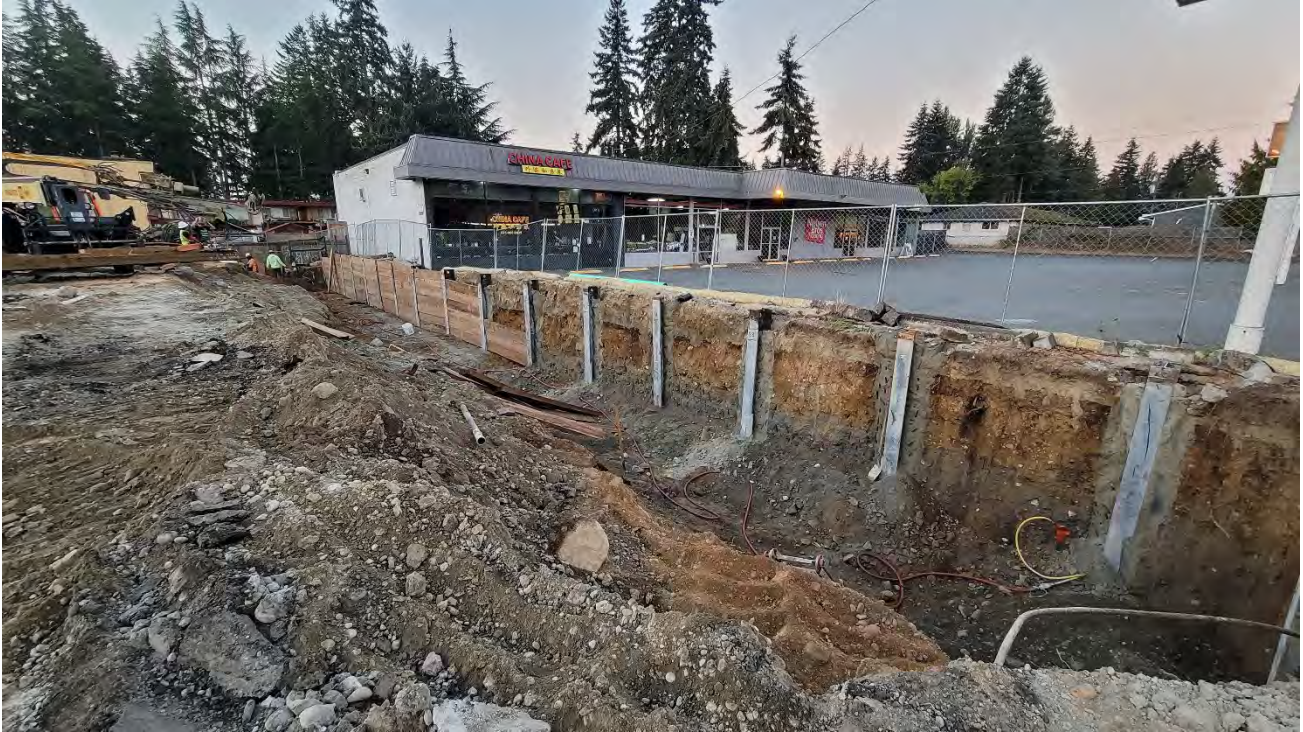
Photo 1: Extent of excavation at the end of 9/26/22. Photo looking west.

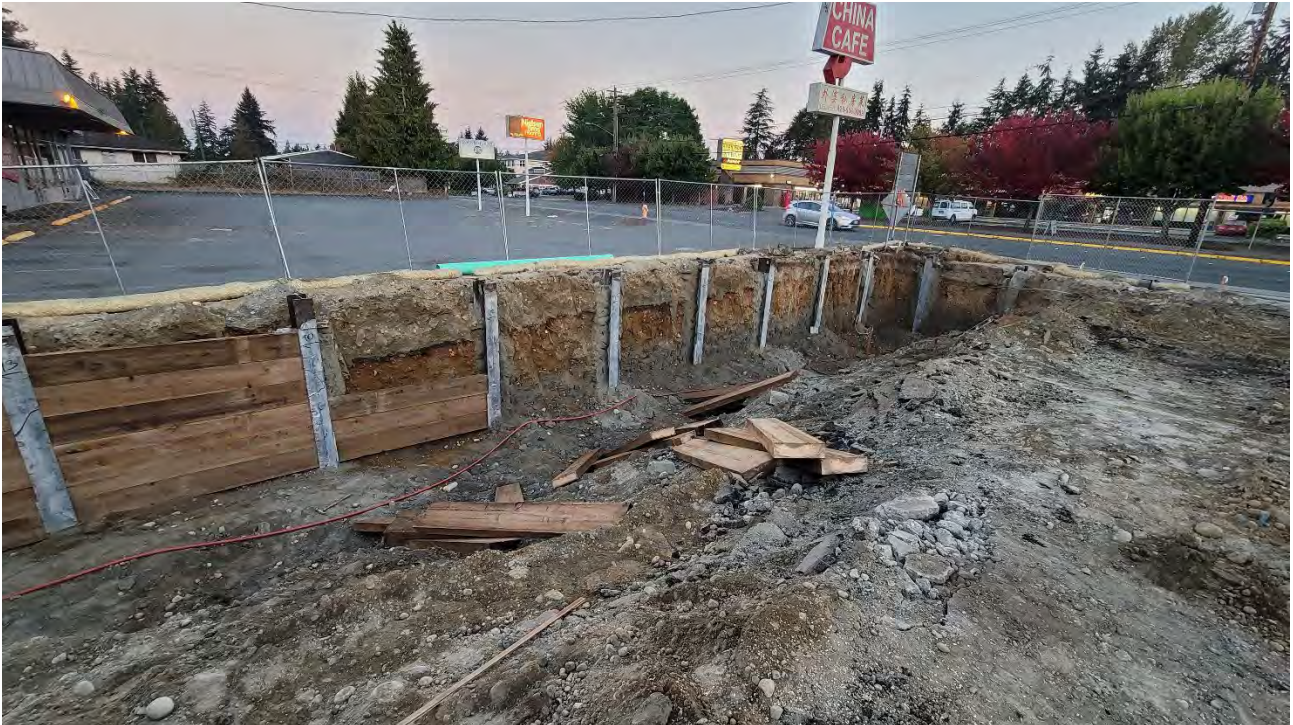
Photo 2: Extent of excavation at the end of 9/26/22. Photo looking northwest.

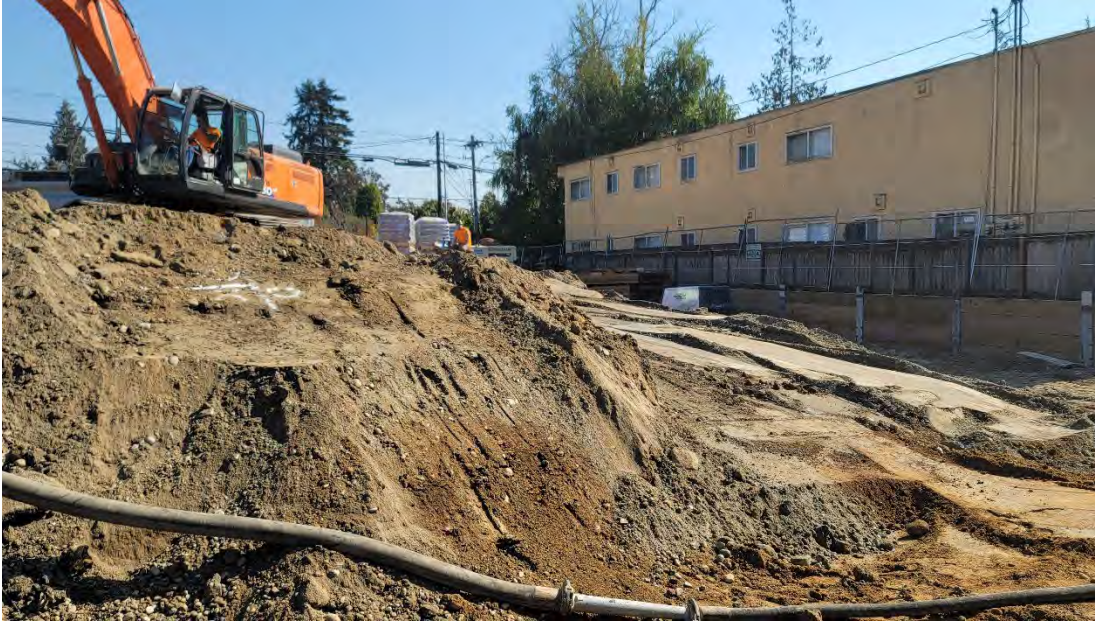
Photo 1: Soil ramp for soil nail drill access in the southwest corner of the site. Photo looking south.

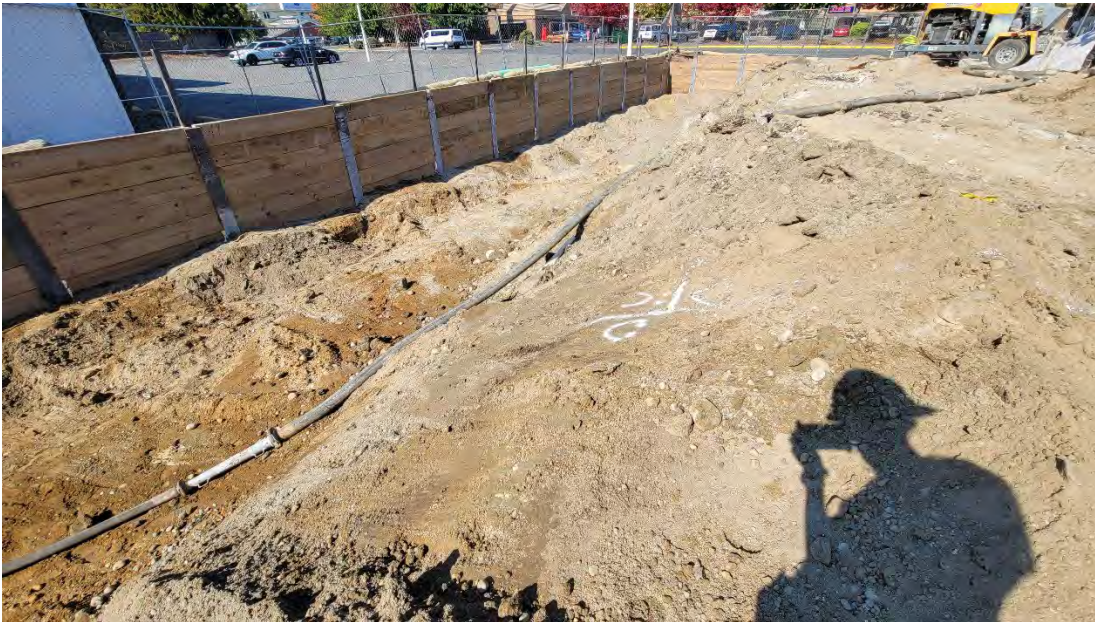
Photo 2: Lagging progressing north along the west wall and east along the north wall to N03. Photo looking northwest.

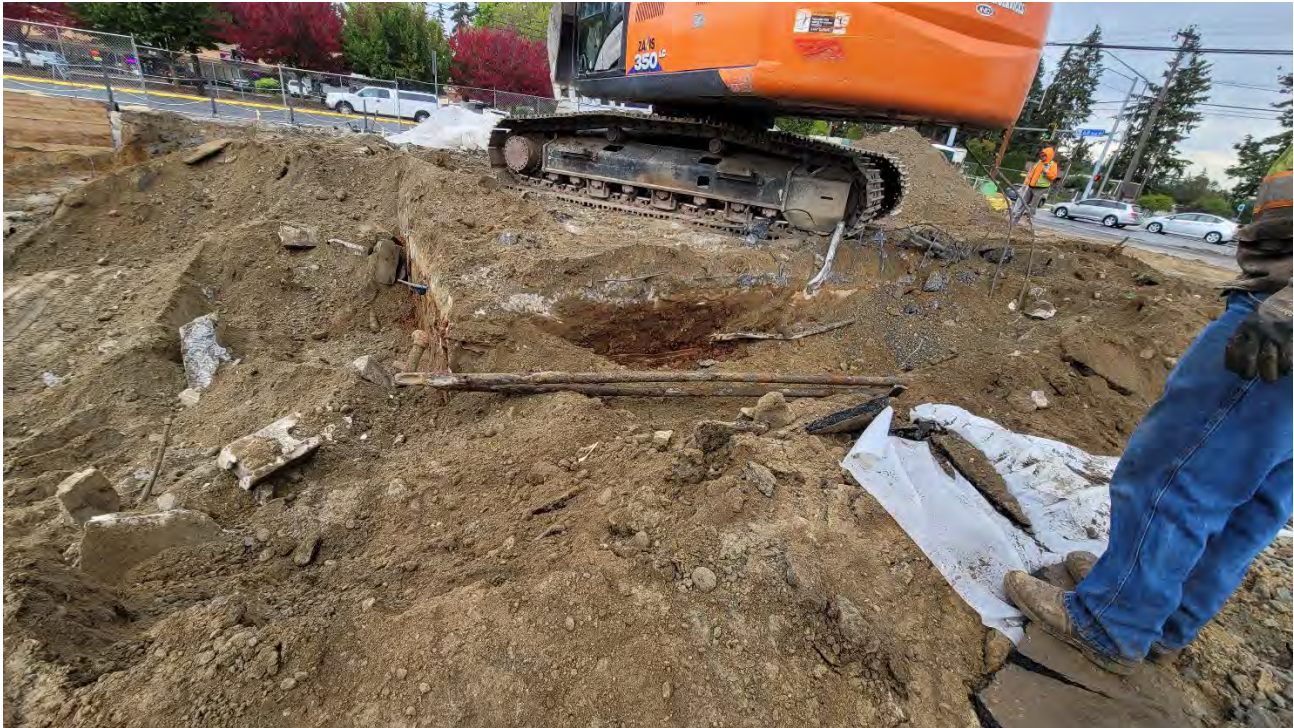
Two pipes were uncovered beneath the foundation of the former building that are approximately in-line with an in-place storage tank. PID readings from the pipes are 1-2 ppm and no odors were detected.

Photo 1: View of pipe discovered near north side of site, adjacent to a known UST. Photo looking north.

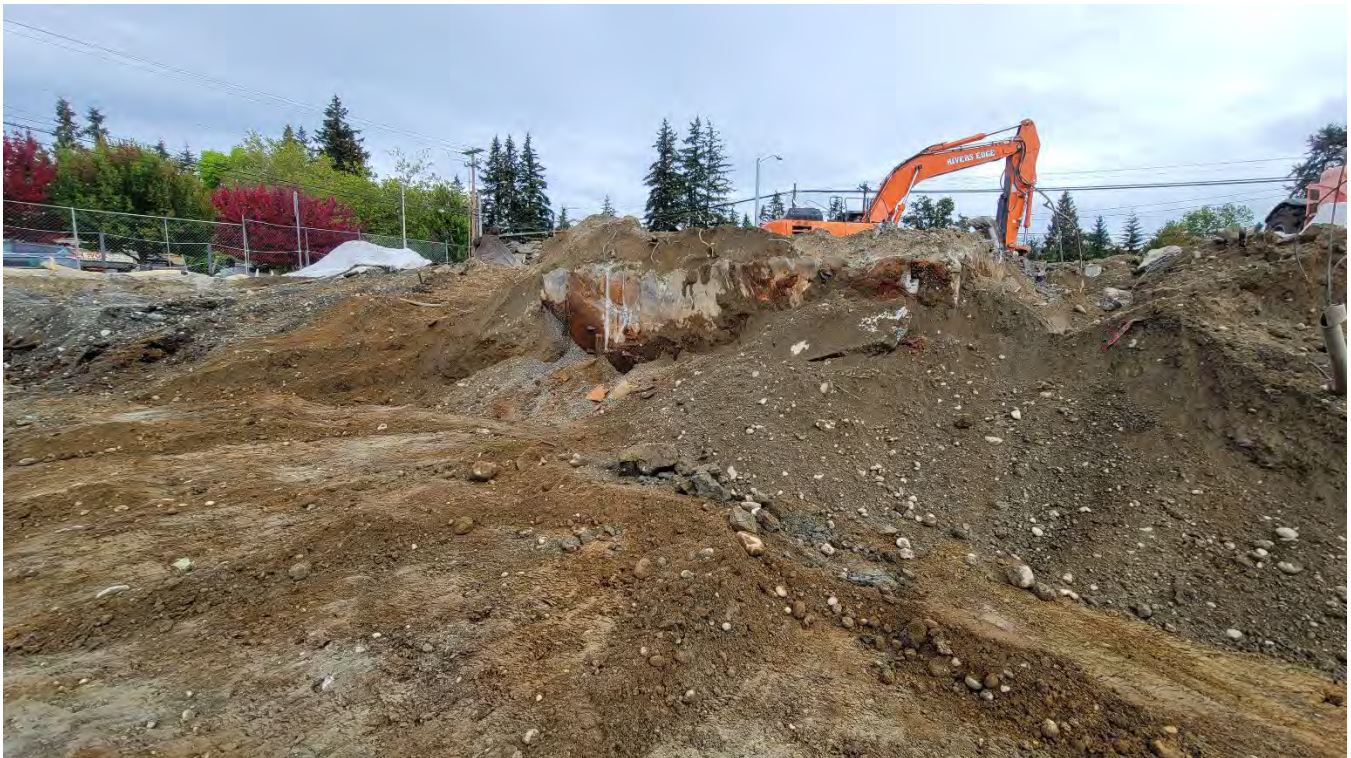
Photo 2: Photo of excavation advancing up to former building foundation. Photo looking northeast.

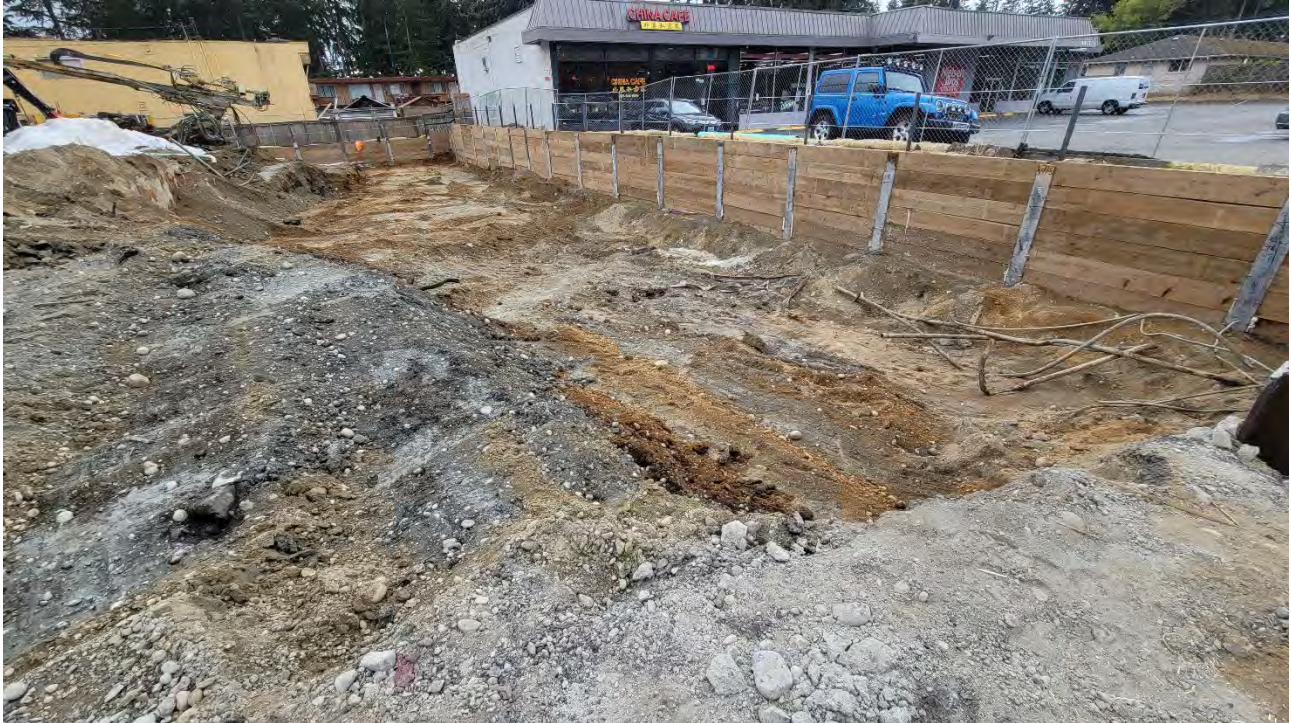
Photo 3: Excavation of clean soil progressing west to approximate elevation 444. Photo looking southwest.

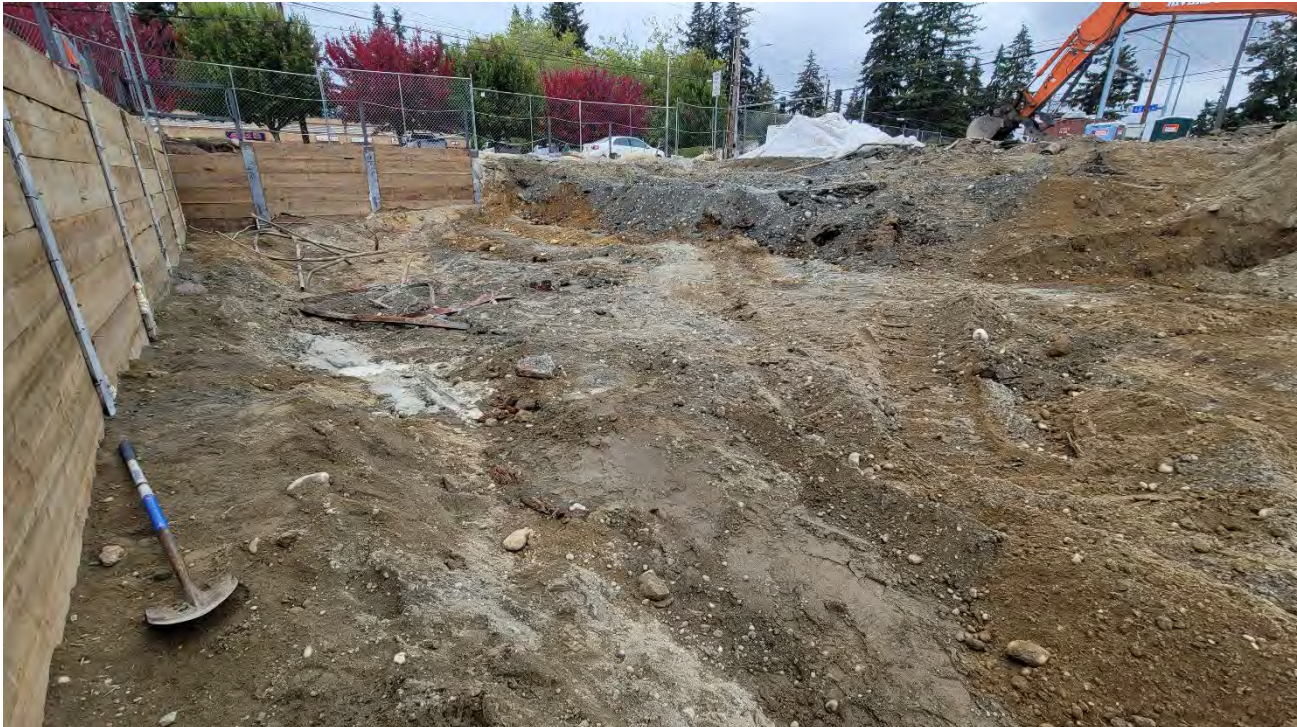
Photo 4: Excavation of clean soil progressing west to approximate elevation 444. Photo looking north.

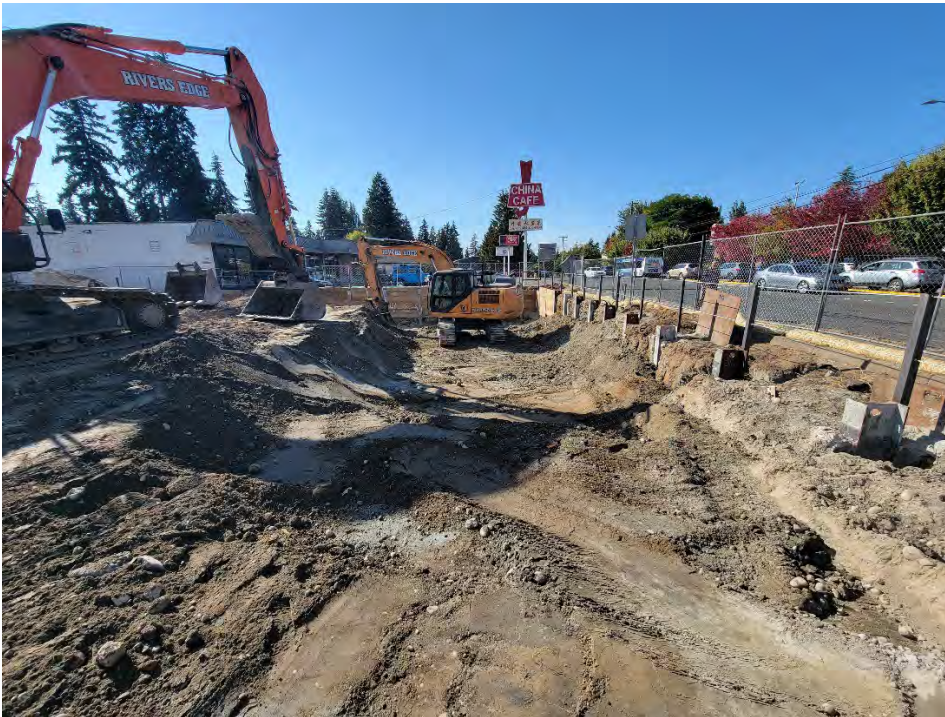
Photo 2: North Sidewalk facing West

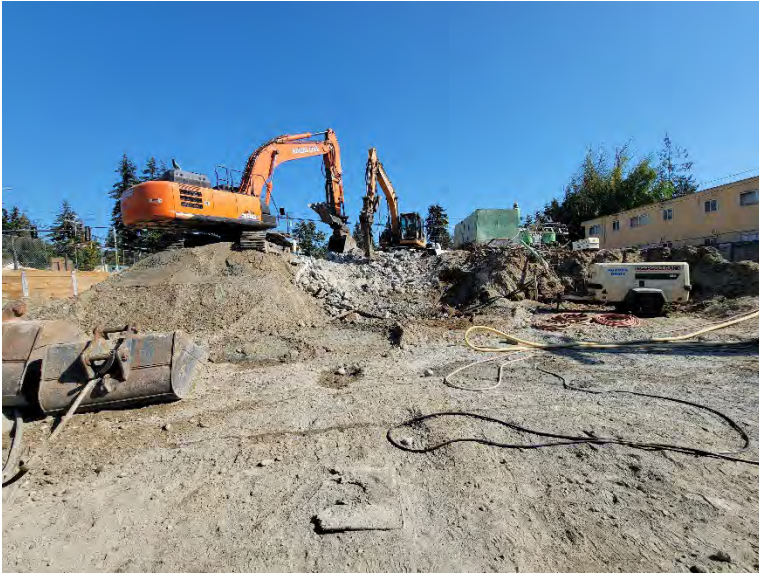
Figure 1 REES removing slab and footing of former building

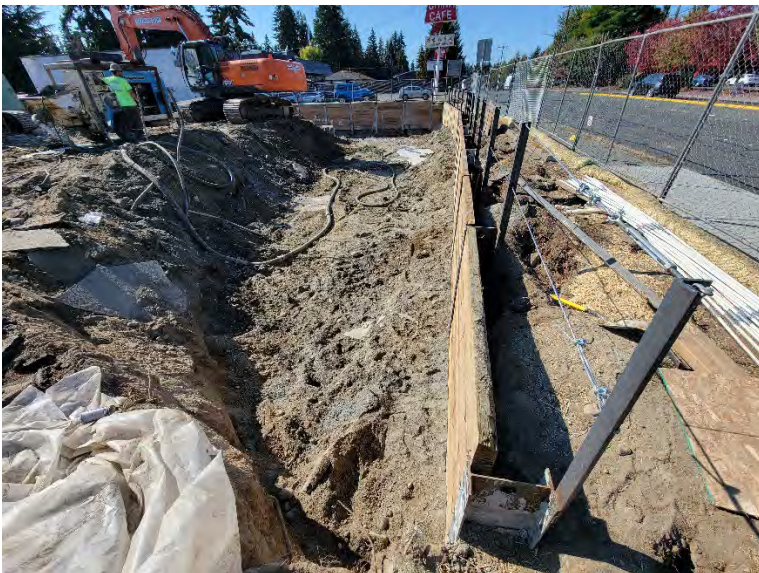
Figure 2 Northern sidewall benched and lagged

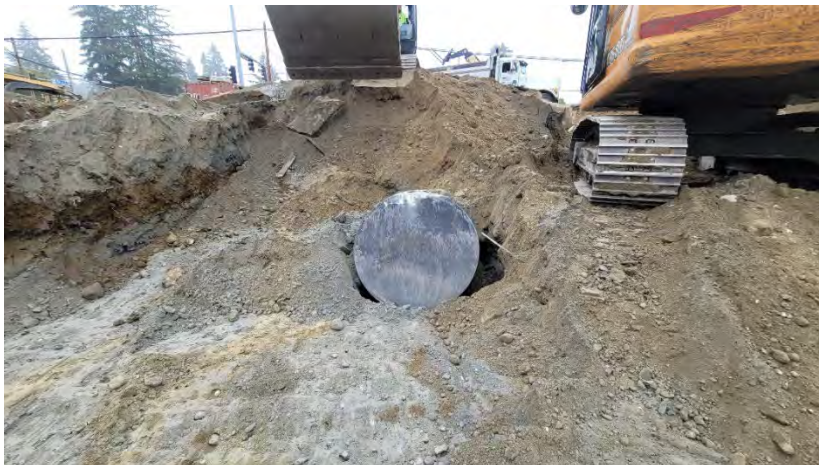
Photo 1. UST 2, just after discovery.

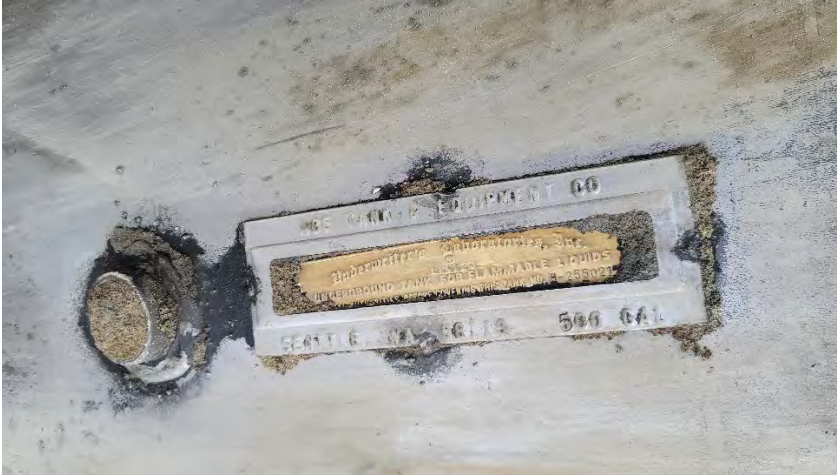
*Photo 2. Label found on the side of UST 2.*
