**Re: Geotechnical Construction Completion Letter**

Texaco Strickland Site  
Project No. 180357

**PRECONSTRUCTION CONDITION SURVEY PHOTO LOG** | September 19, 2022

**POSTCONSTRUCTION CONDITION SURVEY PHOTO LOG** | January 10, 2023 and January 25, 2023

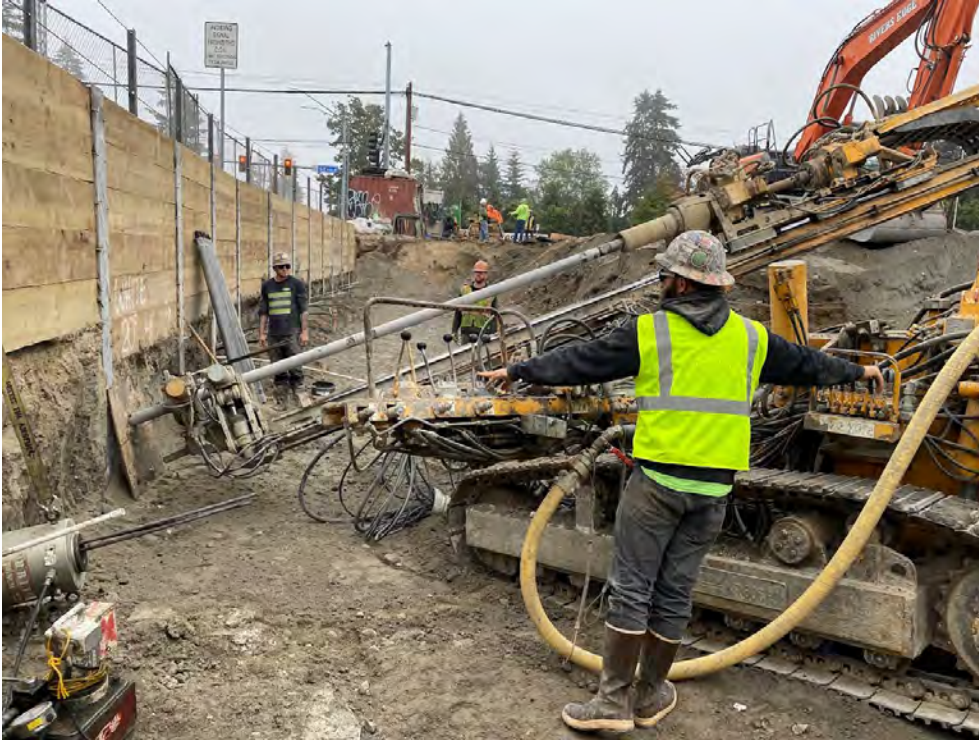
*Photo 3: Drill rig positioned to drill the tieback in north wall*

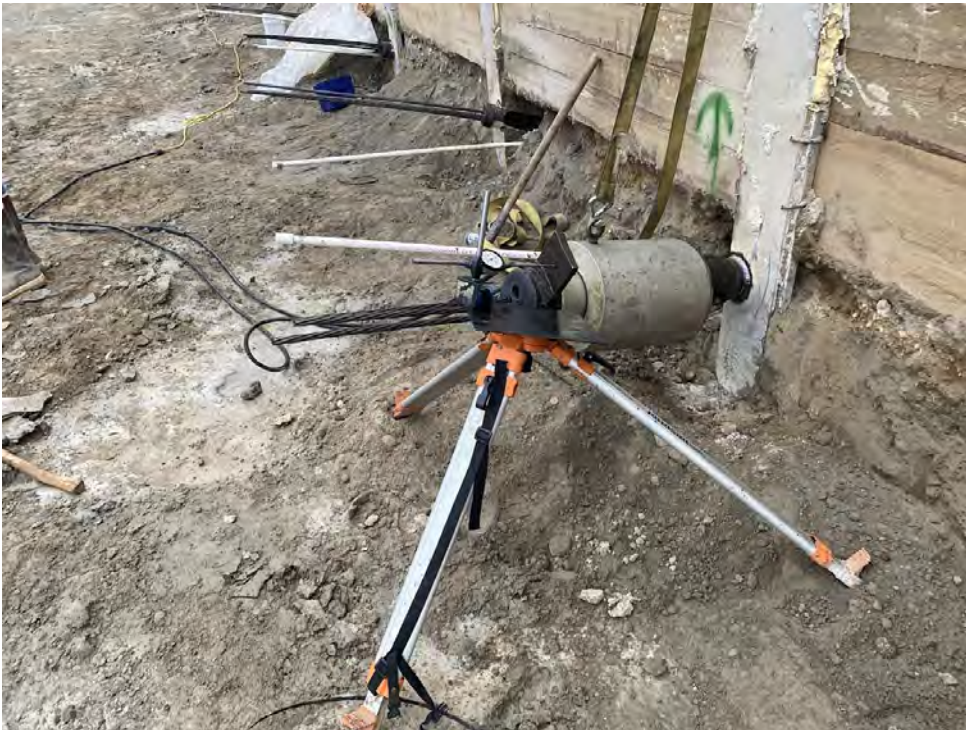
*Photo 4: Rig setup to test tieback in west wall.*

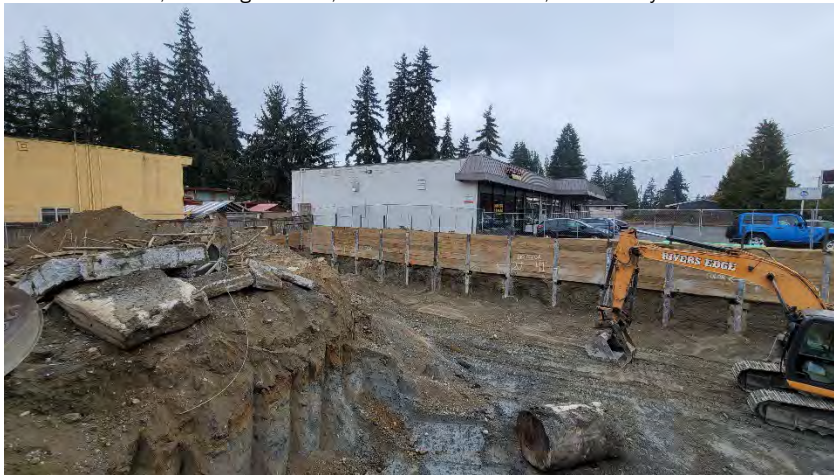
Figure 1. Facing the west, note the obvious color change (blue-gray to more gray-brown) that appears to follow the clean / contaminated boundary. The blue-gray dirt shows obvious signs of contamination (high PID readings, heavy petroleum-like odors, and moderate to heavy sheens).

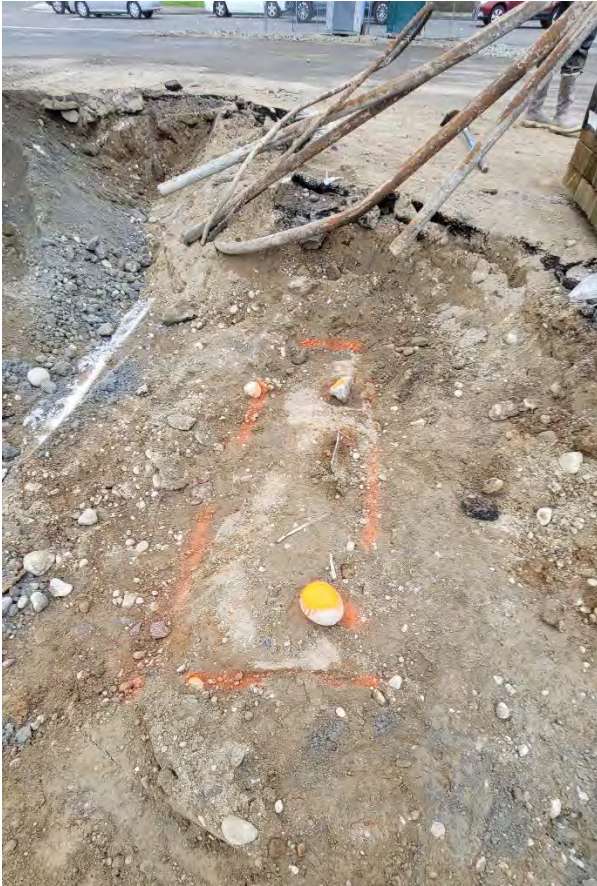
Figure 2. UST 3 is outlined in orange spray-paint. The rocks that are painted orange are covering the tank ports.

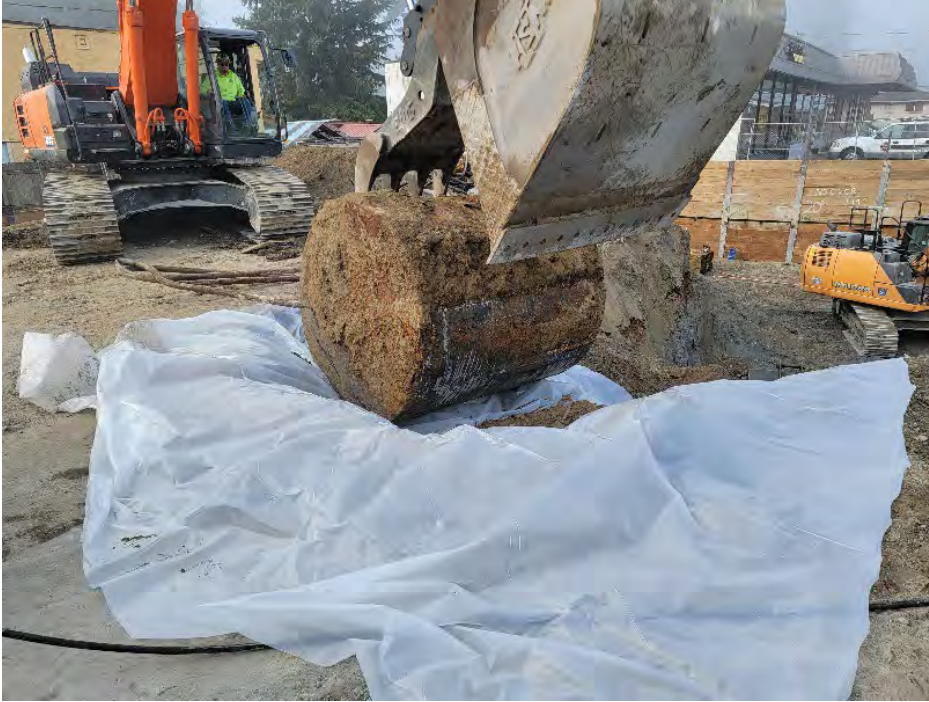
Photo 1: UST 3 after being pulled.

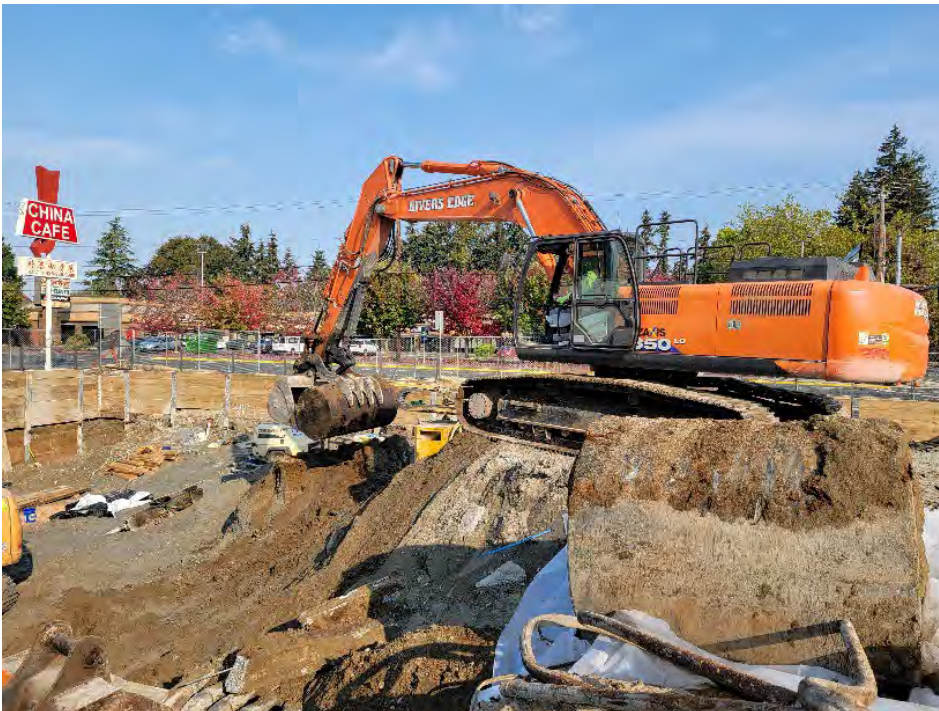
Photo 2: UST 1 being pulled (background) UST 3 in foreground.

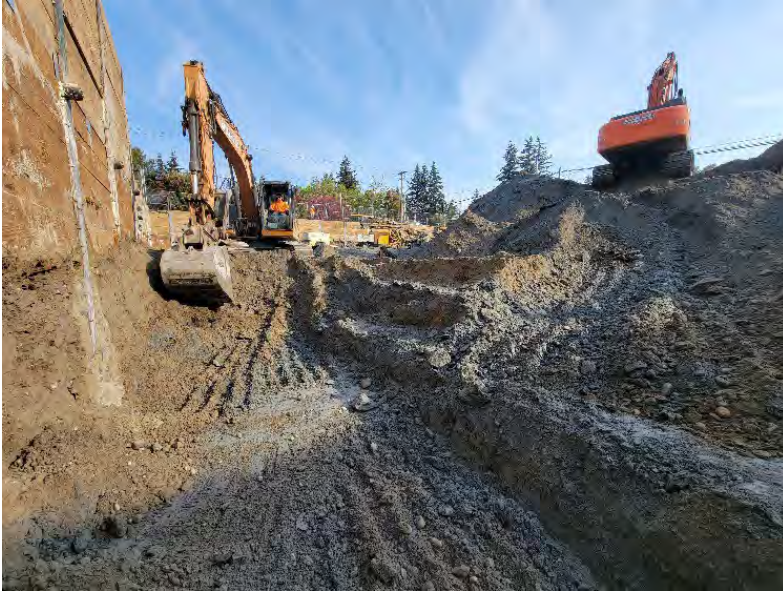
*Photo 1: Actively excavating western sidewall (facing north)*

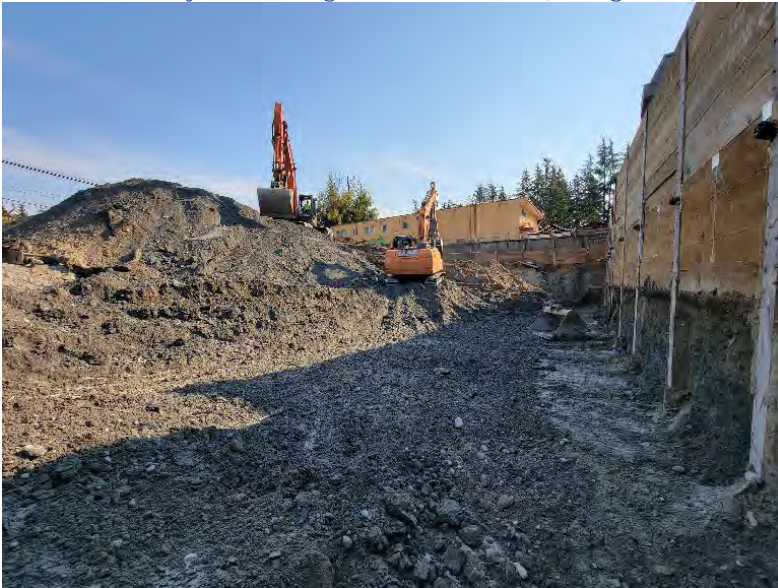
*Photo 2: Western section of site at end of day (facing south)*

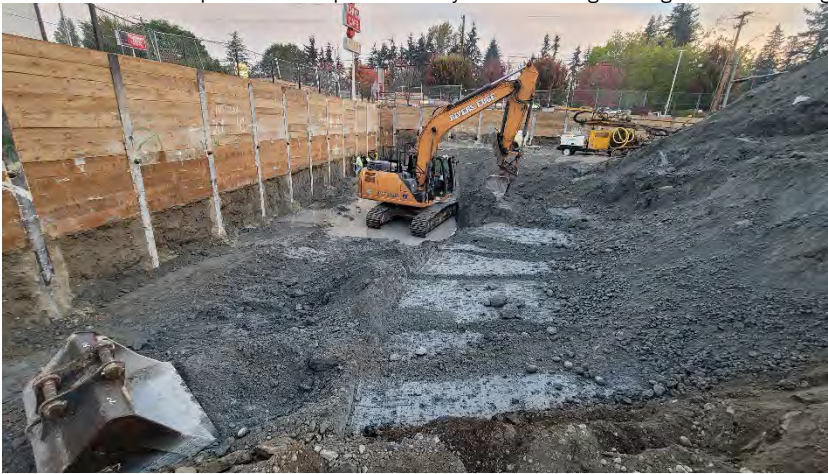
Photo 1. Excavation along the western edge of the site, facing north, at the beginning of the day.

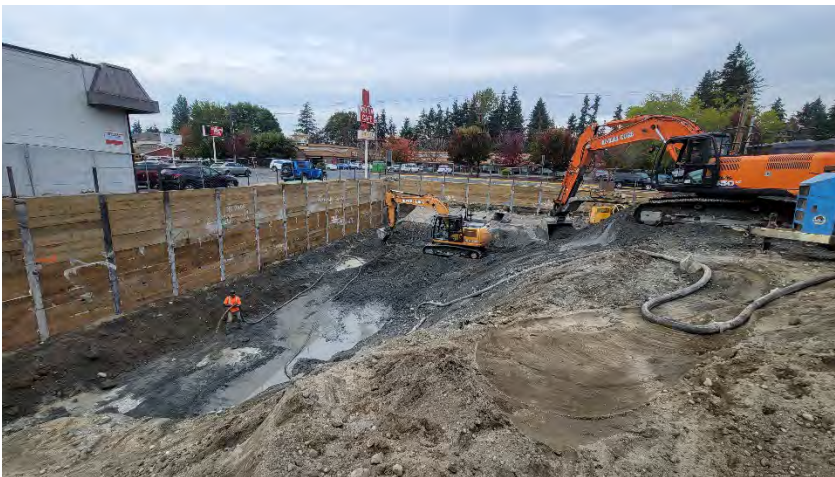
Photo 2. Excavation along the west wall, standing in a similar location to Photo 1—facing north, near the end of the day.

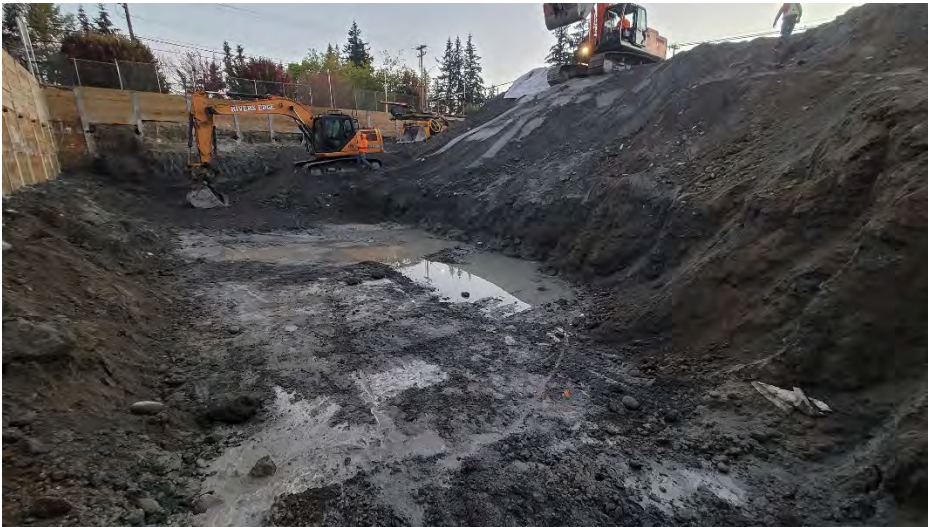
*Photo 1. Groundwater seepage at the base of the excavation before digging began for the day.*

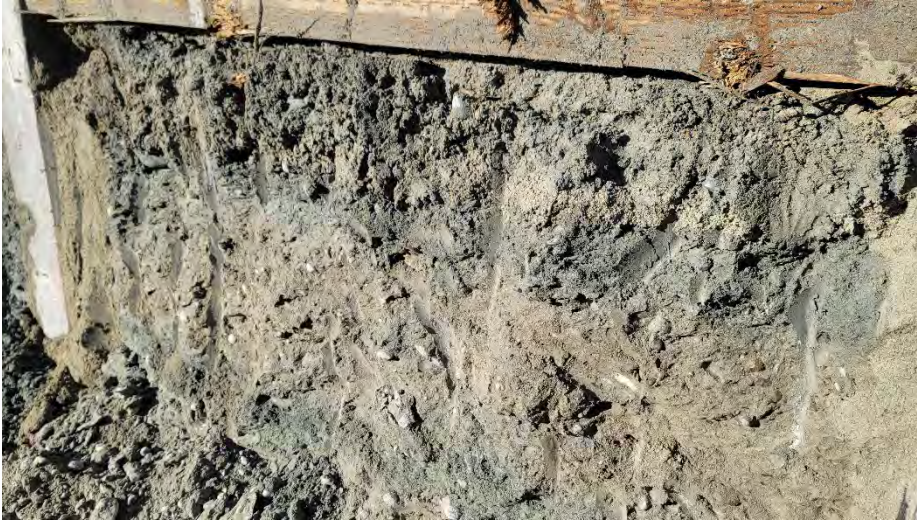
*Photo 2. Example of the soil being excavated from the west end of the site at this depth. Soil is brown to gray, fine to medium sand and silt with fine to coarse gravel and is very compacted, which can make it difficult to break up.*

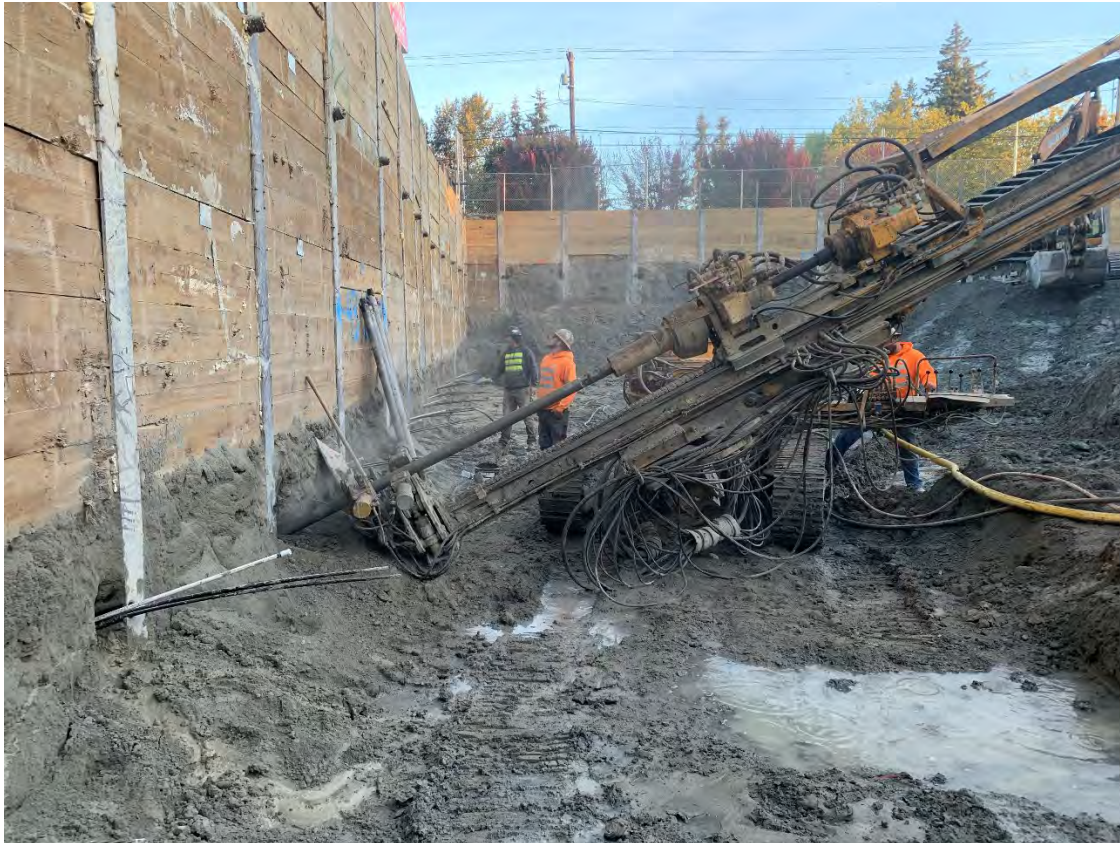
Installation of tieback W6/R2 was attempted today but was unsuccessful due to an obstruction encountered at approximately 20 feet downhole. Kulchin attempted to drill through the obstruction with a hammer bit but was unsuccessful. We observed Kulchin fill the abandoned hole with grout. We understand that Kulchin plans to attempt to install tieback W6/R2 approximately 1-foot lower than the planned elevation to avoid the obstruction.

Photo 1. Installation of W6/R2 1' lower than original location.

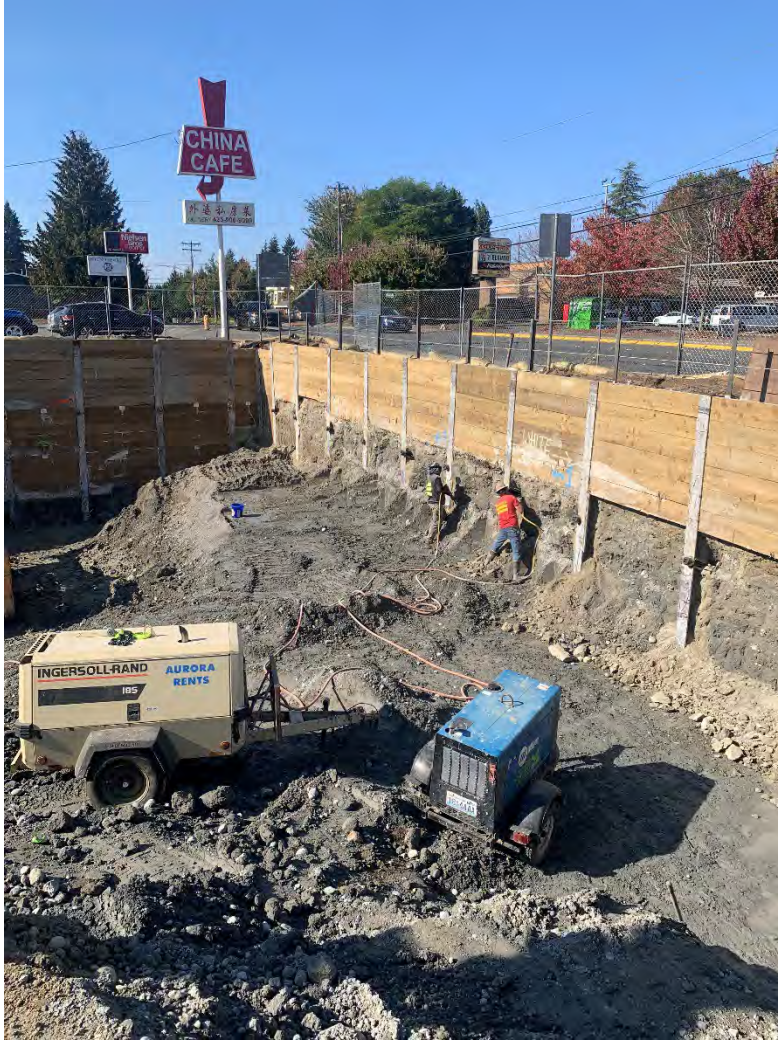
Photo 2. Preparing the north wall for lagging.

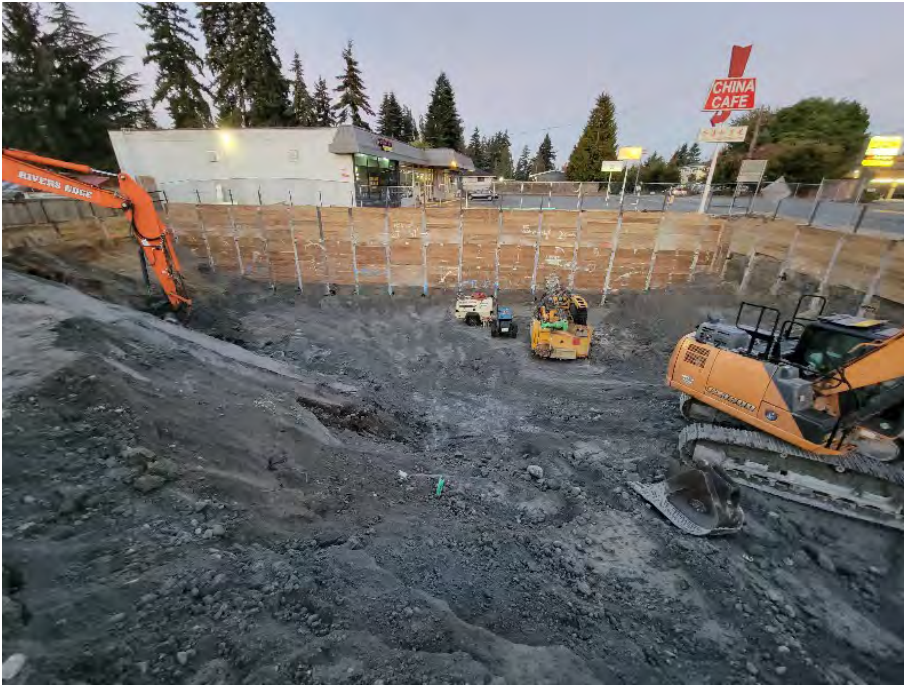
Photo 1: Current excavation extents at the beginning of the day, looking west.

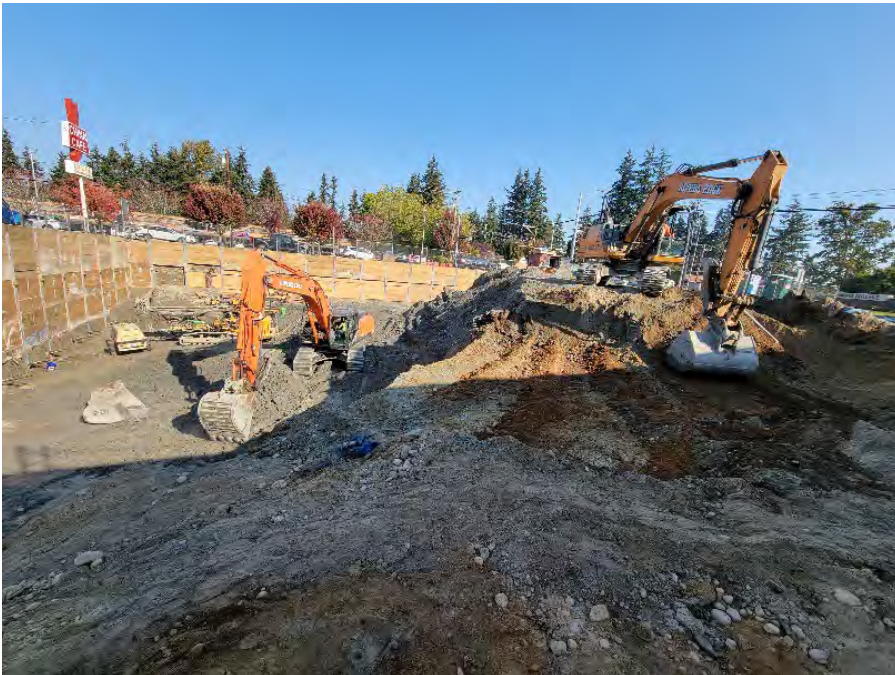
Photo 2: Excavation progression, excavating in contaminated (left) and clean (right).

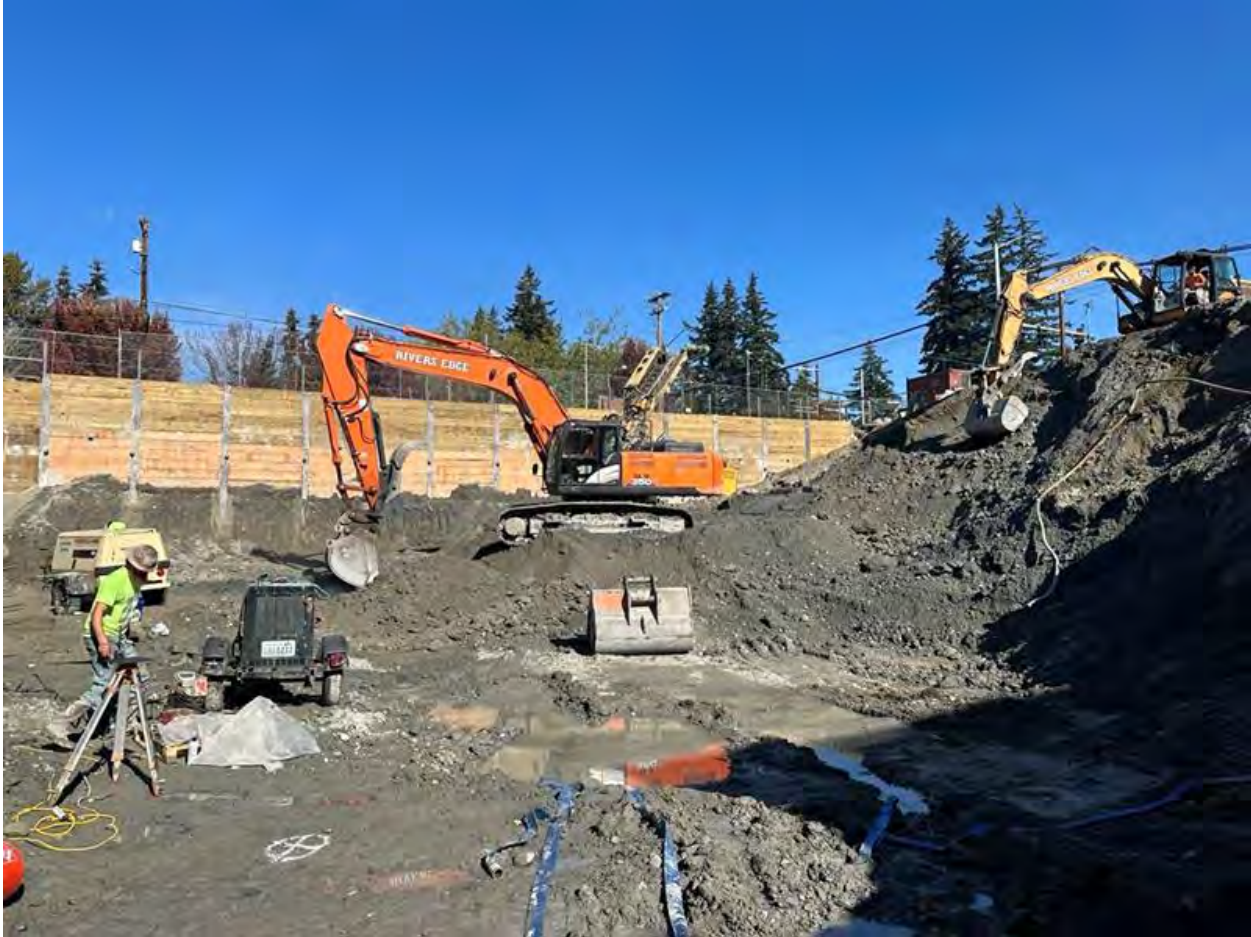
*Photo 1: Excavation progression at elevation ~431 facing North.*

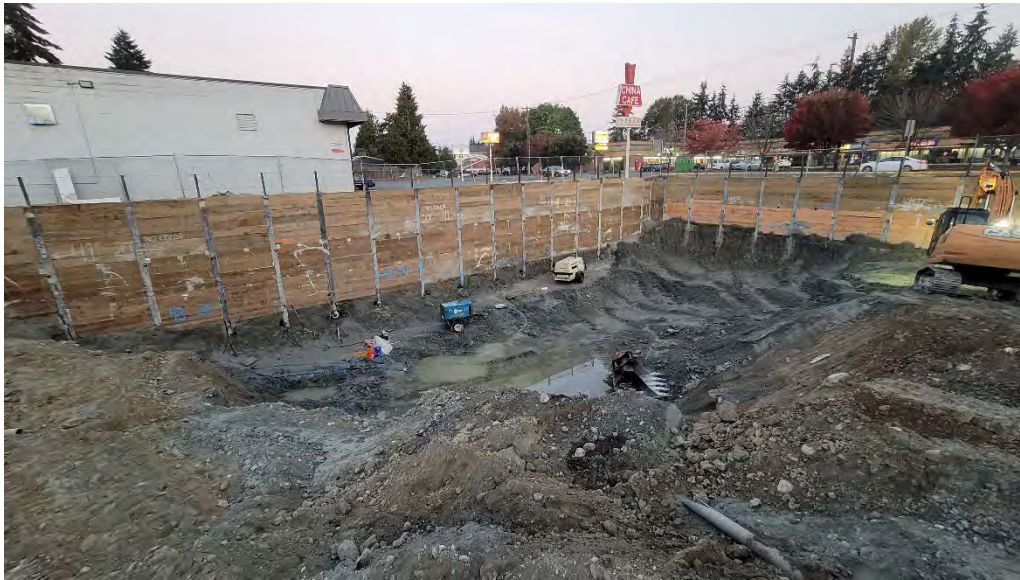
Figure 1. The northwest corner of the excavation as seen at the beginning of the day today (10/17)

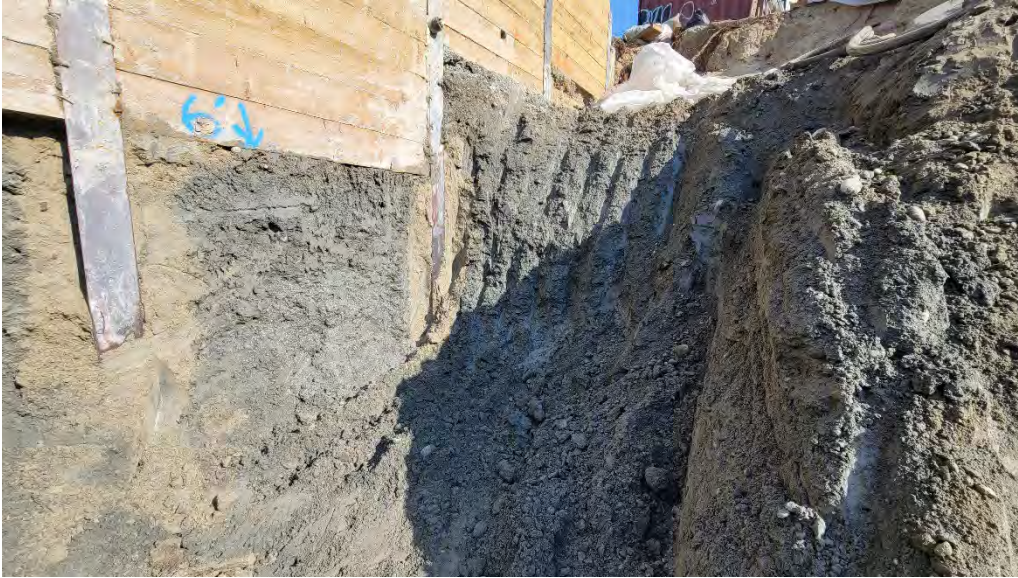
Figure 2. Photo of the northeast corner of the site, near pile N12 and N13, showing the amount of groundwater seepage in this location.

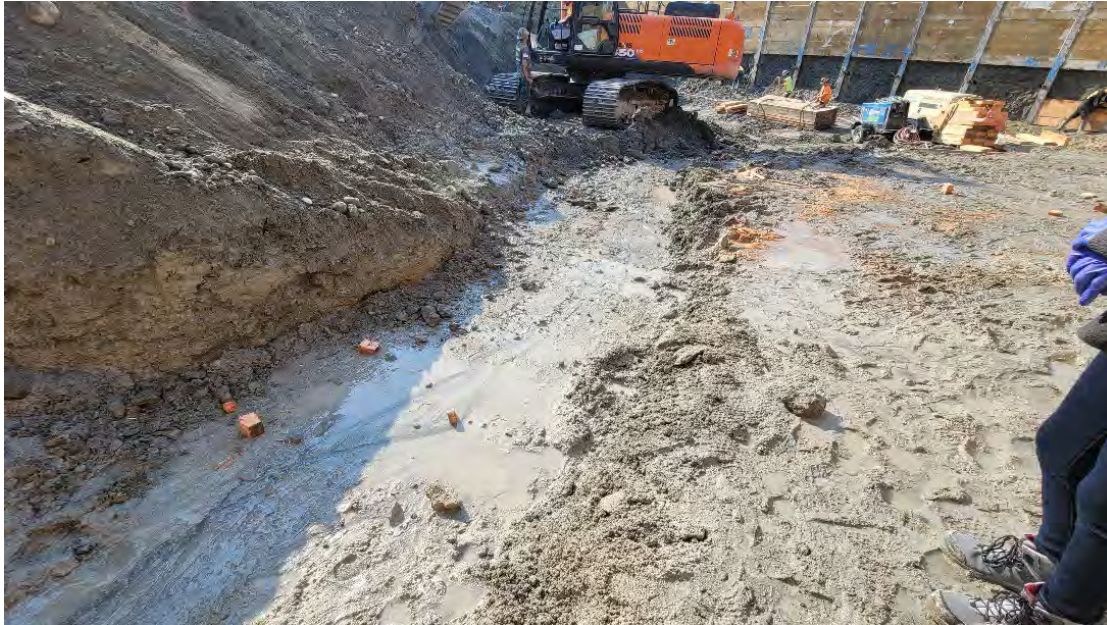
Figure 1. Mitigating groundwater seepage from the northeast corner of the site.

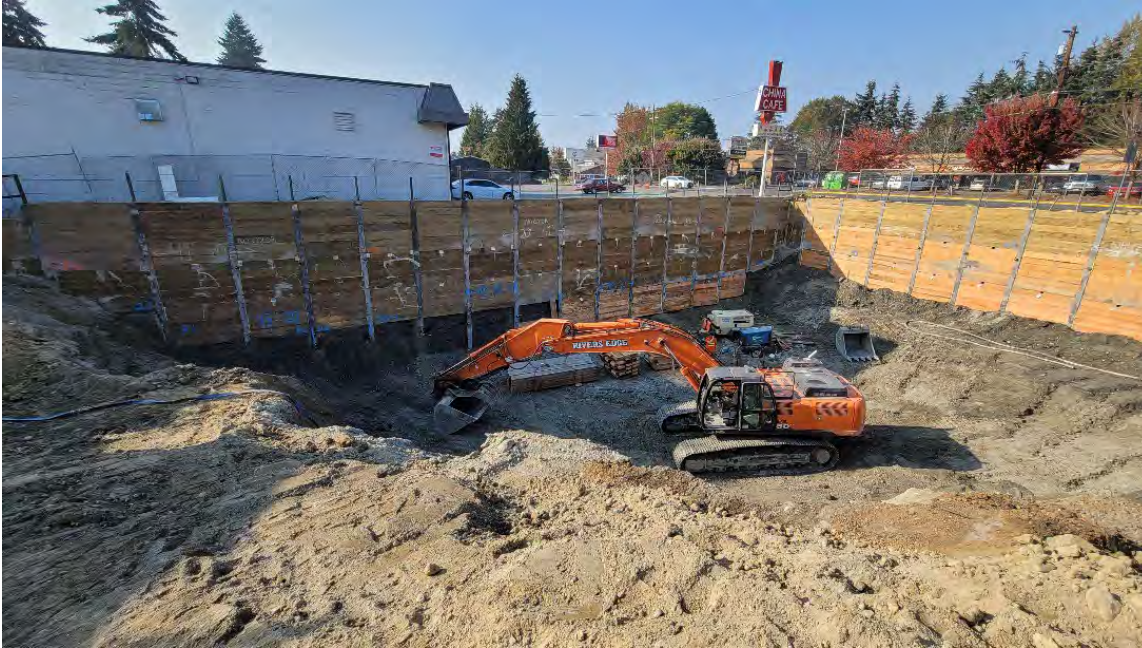
Figure 2. The site towards the end of the day, facing northwest.

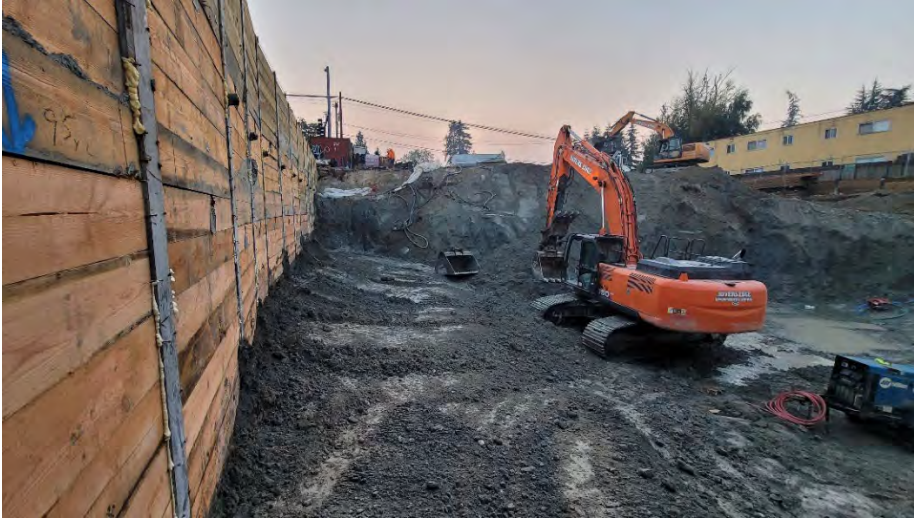
*Photo 1. The site near the beginning of the day, facing southeast, showing the extent of groundwater seepage overnight.*

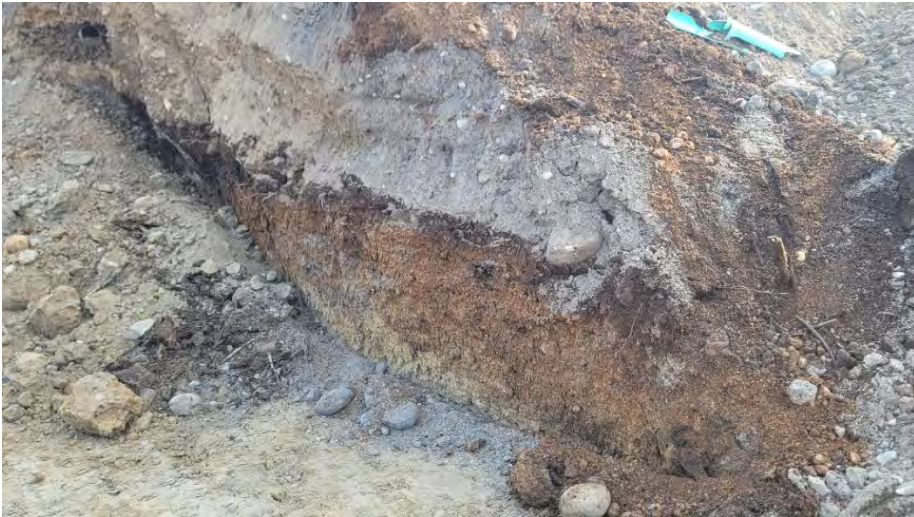
*Photo 2. Contact between fill and native material near the southeast corner of the site.*

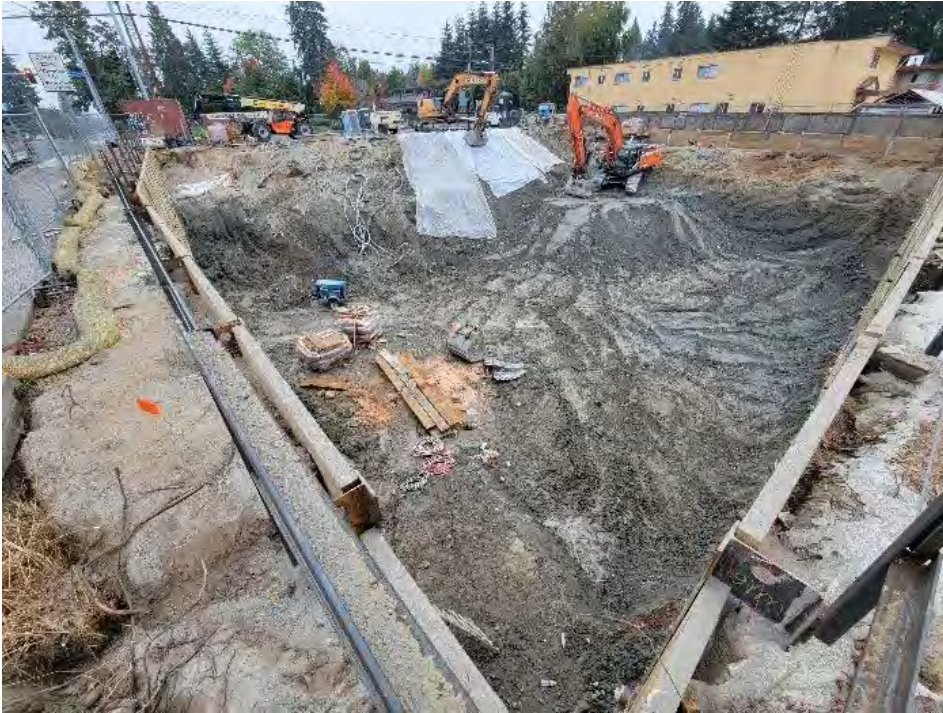
Photo 1: End of day excavation extends facing southeast

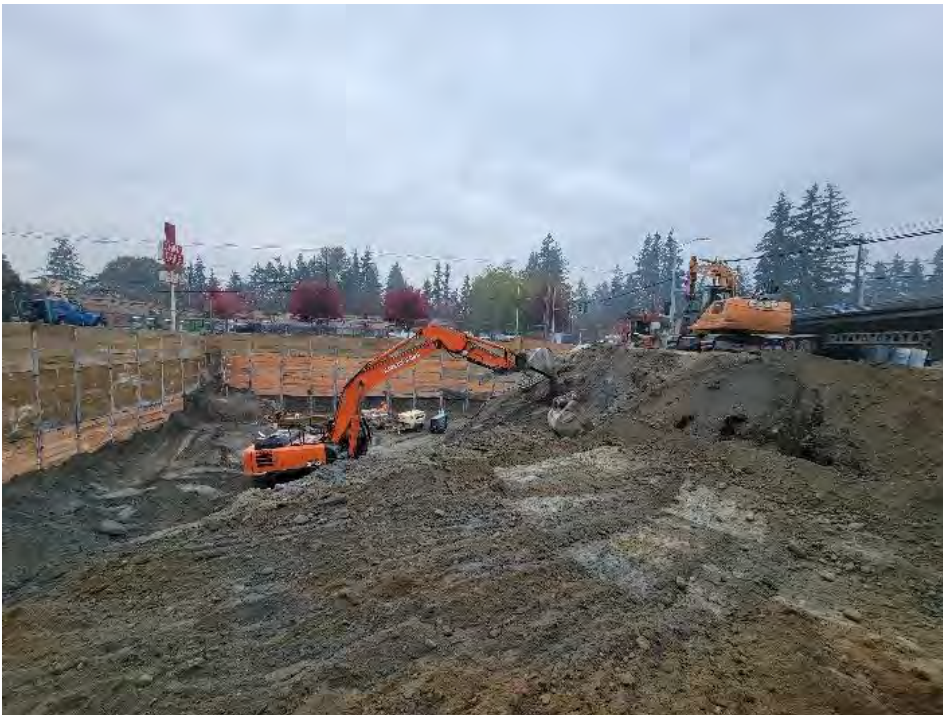
Photo 2: Excavator actively moving contaminated soil to the loading zone

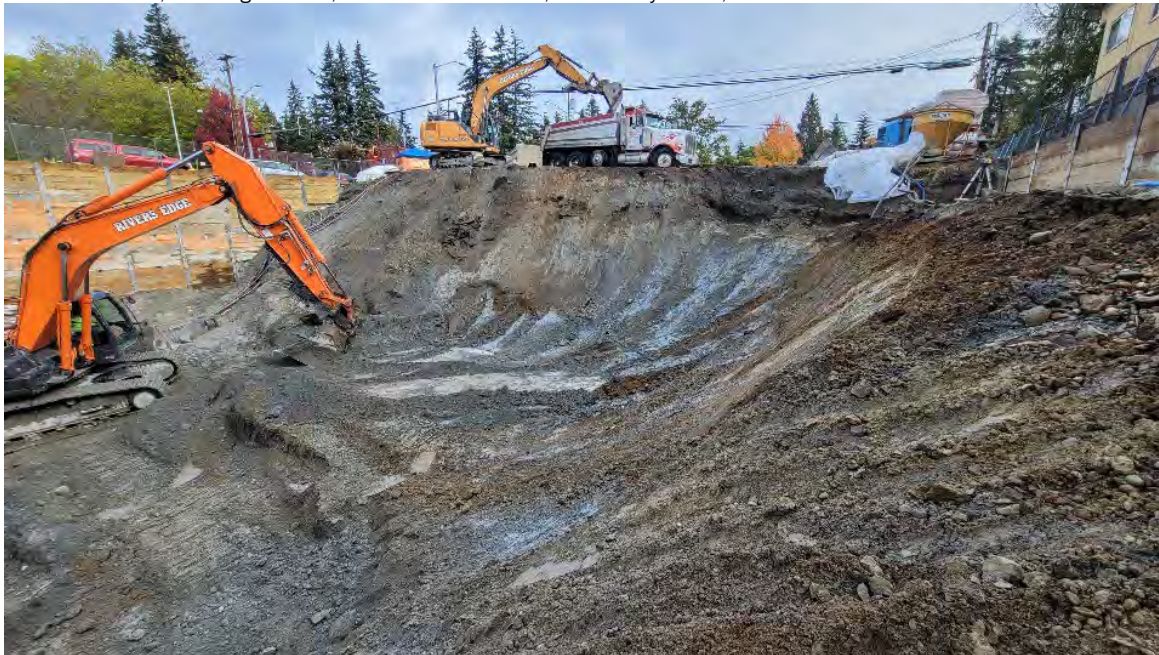
Figure 1. Looking northeast, showing the eastern sidewall of the excavation.

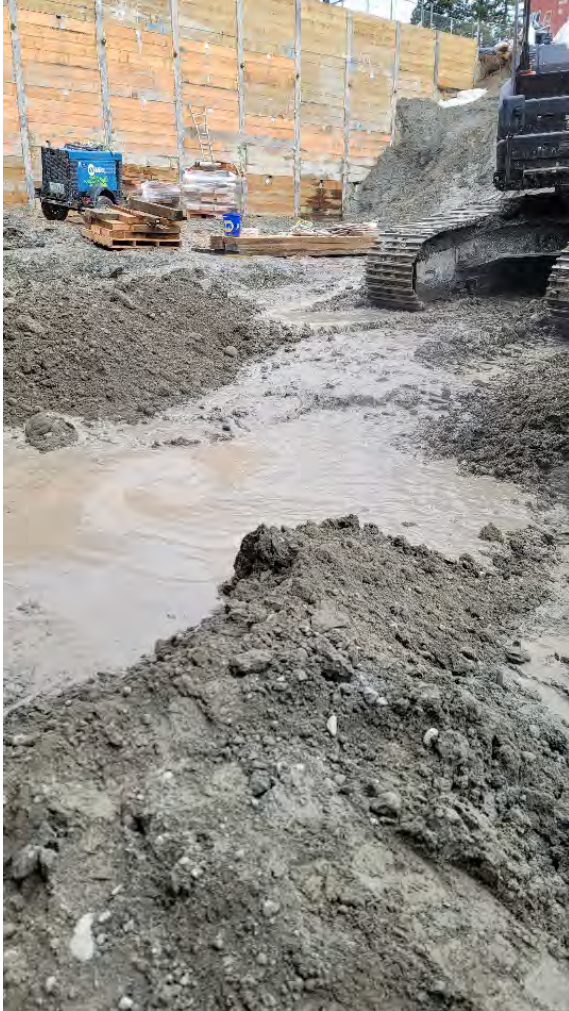
Figure 2. Groundwater seepage following light rains earlier in the day.

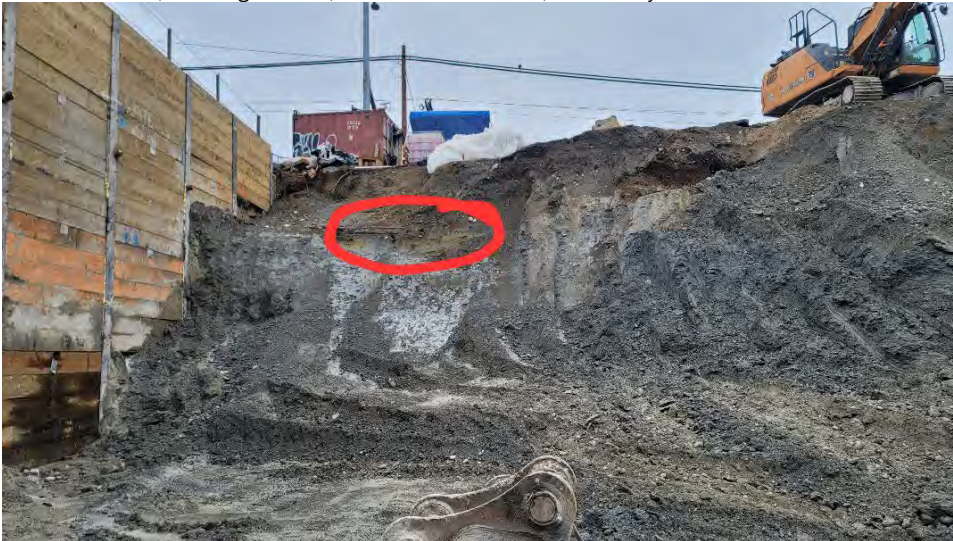
Figure 1. Contaminated sand layer in the eastern sidewall.

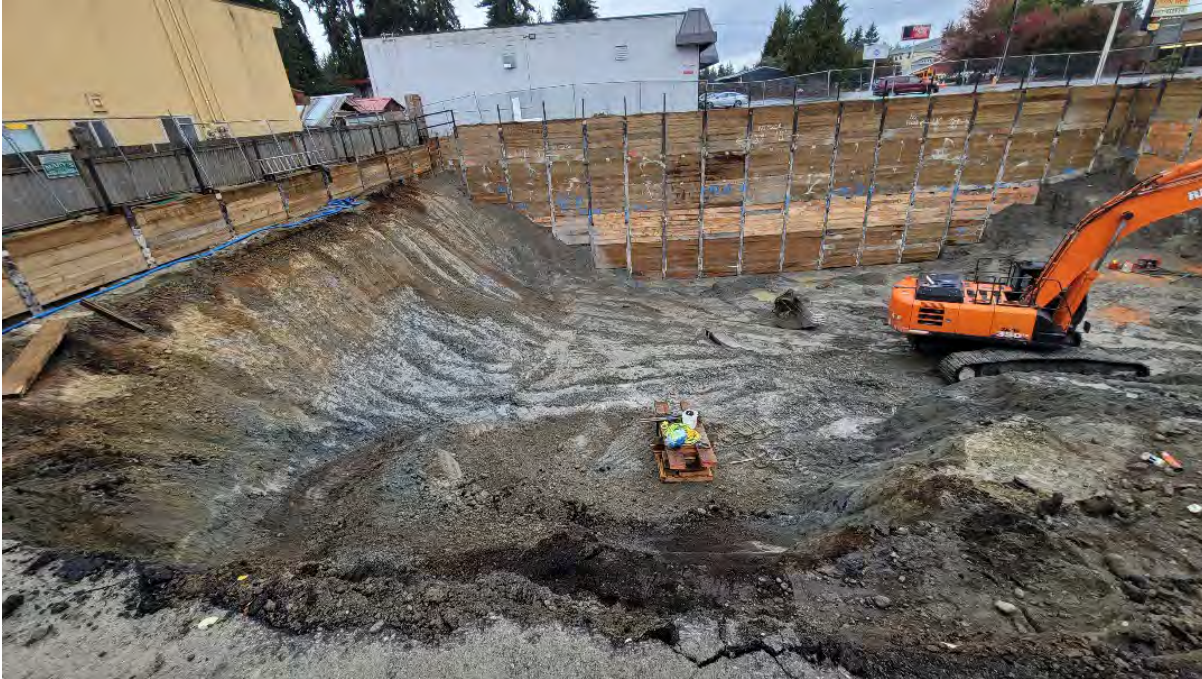
Figure 2. Looking west showing the mostly completed southern edge of the excavation.

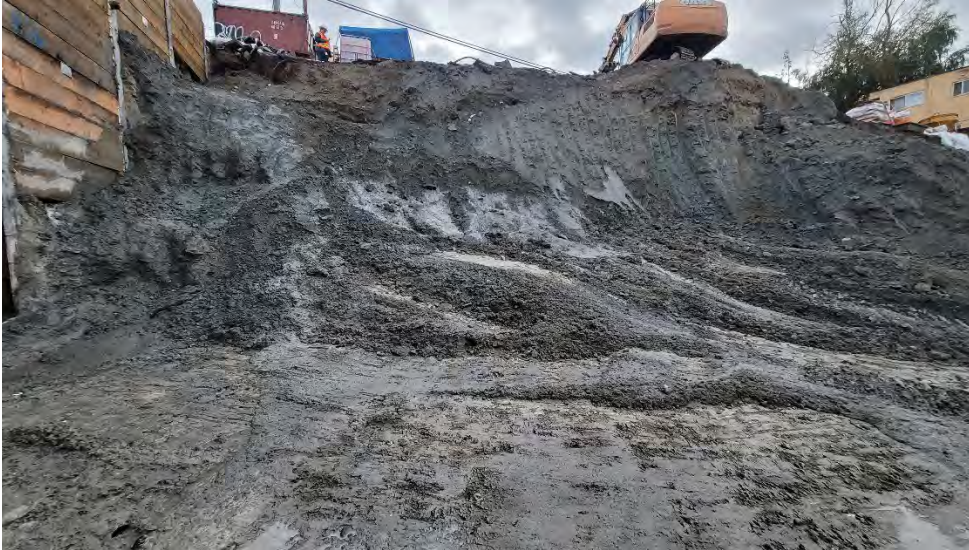
Figure 1. Eastern extent of the excavation near the beginning of the day.

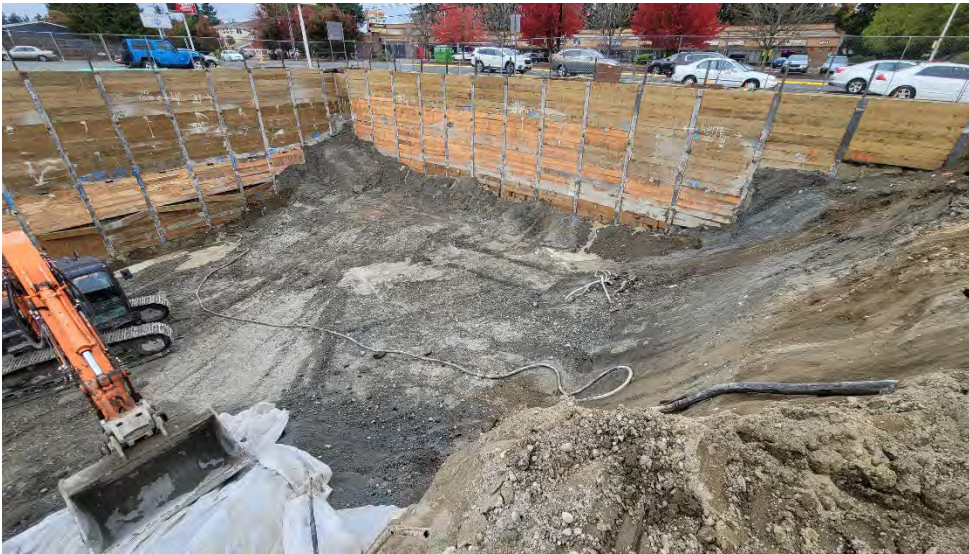
Figure 2. The northern extent of the excavation near the end of the day.

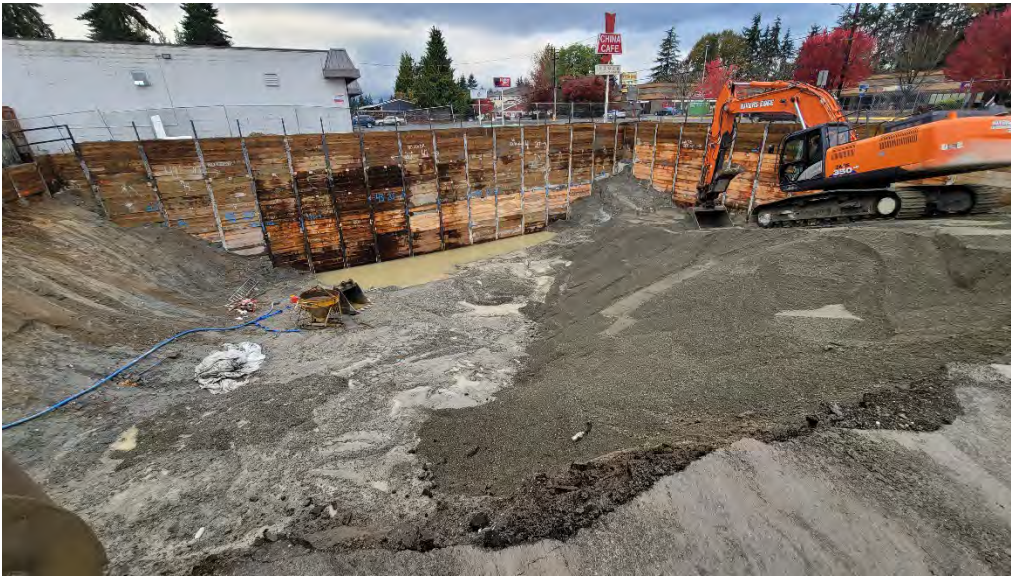
*Photo 1. Amount of groundwater accumulation and back fill gravel near the beginning of the day.*

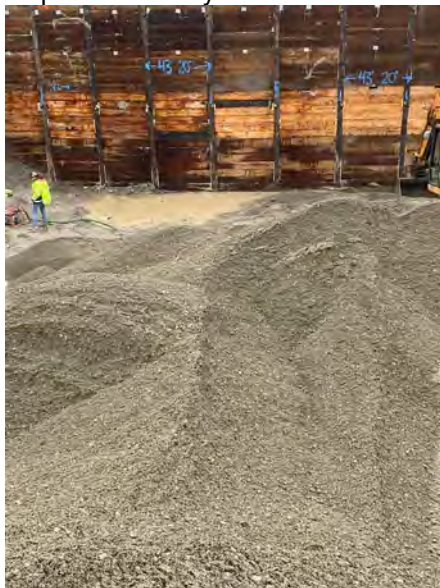
Water intrusion along the base of the west wall was being pumped to on site container tank. HMA on standby while dewatering was performed to place material and compacted. It was discussed with Rivers Edge personnel that HMA to return in the P.M. to evaluate any material placed and perform compaction testing.

Water Accumulation Area / West Wall

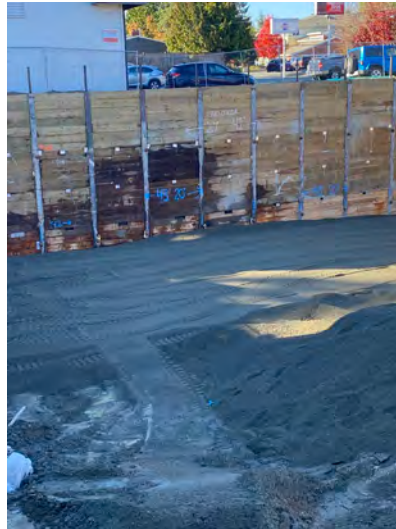
I observed that the site activity was continued backfilling. Aspect Consulting personnel on site verifying firmness of compacted material by the t-probe method. HMA to return the following day to perform compaction tests on placed and compacted material.

Placed & Compacted Gravel Barrow

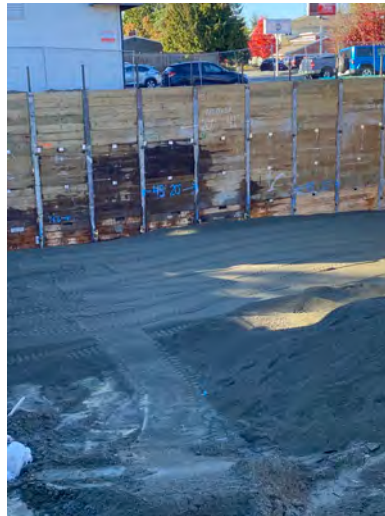
Upon return to site, material was placed and compacted in 12" loose lifts and compacted in place with a smooth roller drum in vibratory mode. Two compactions tests were performed and achieving a minimum 95% or greater at the tested locations. See attached compaction test report for specific results and locations. Backfill activity temporarily postponed until further notice.

Rolled, Compacted & Tested Area

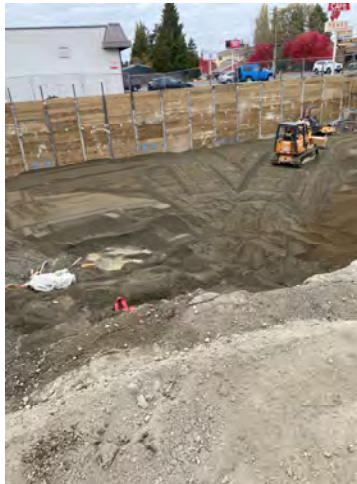
Grading 1<sup>st</sup> 12" Lift @ 18' BG

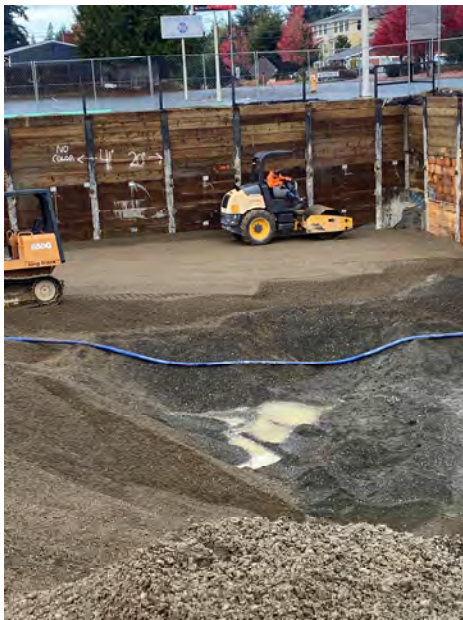
Compacting @ NW Area

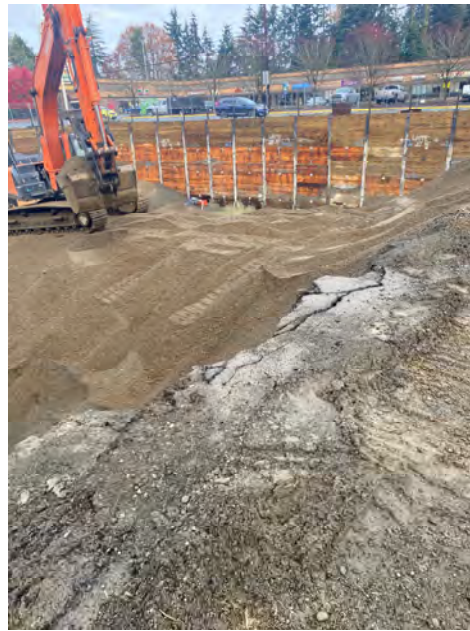
Removing Import Material @ Access Ramp

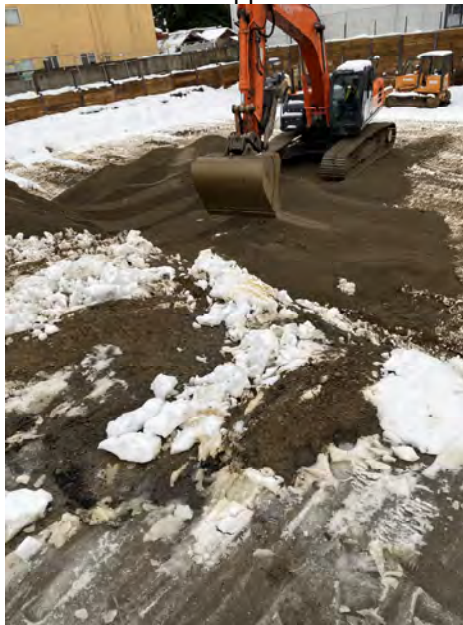
Placing Material Import Material @ Access Ramp / South Area

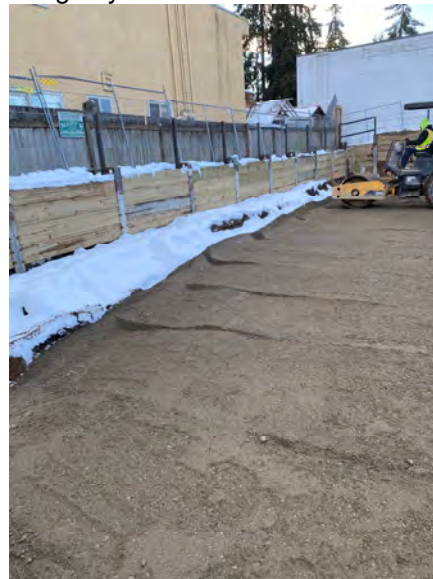
Compacting Import Material / South Area

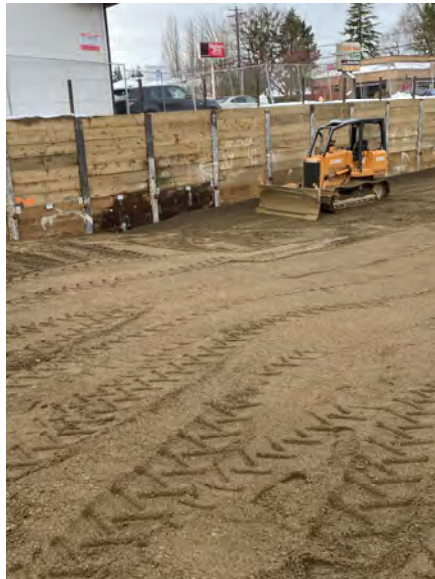
Tested West Area of Site
