**Re: Geotechnical Construction Completion Letter**

Texaco Strickland Site  
Project No. 180357

**PRECONSTRUCTION CONDITION SURVEY PHOTO LOG** | September 19, 2022

**POSTCONSTRUCTION CONDITION SURVEY PHOTO LOG** | January 10, 2023 and January 25, 2023

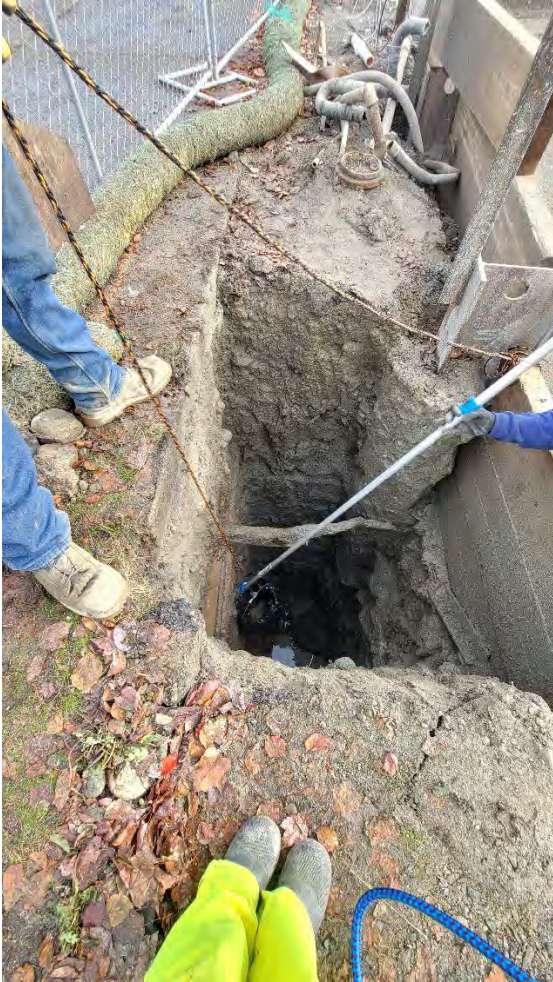
Figure 2. Sampling method, a garden trowel attached to an extendable pole to break up the soil with a lined bucket under it to catch the soil for sampling.

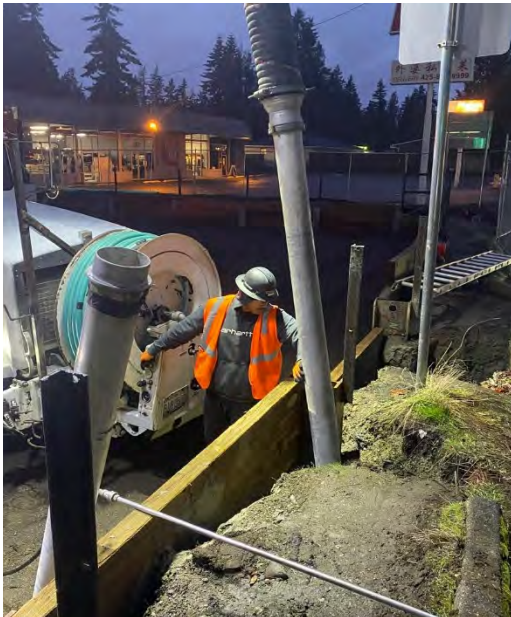
Figure 1. The beginning of removal of the N07-N7.5 cell using the vac truck and high-pressure water wands

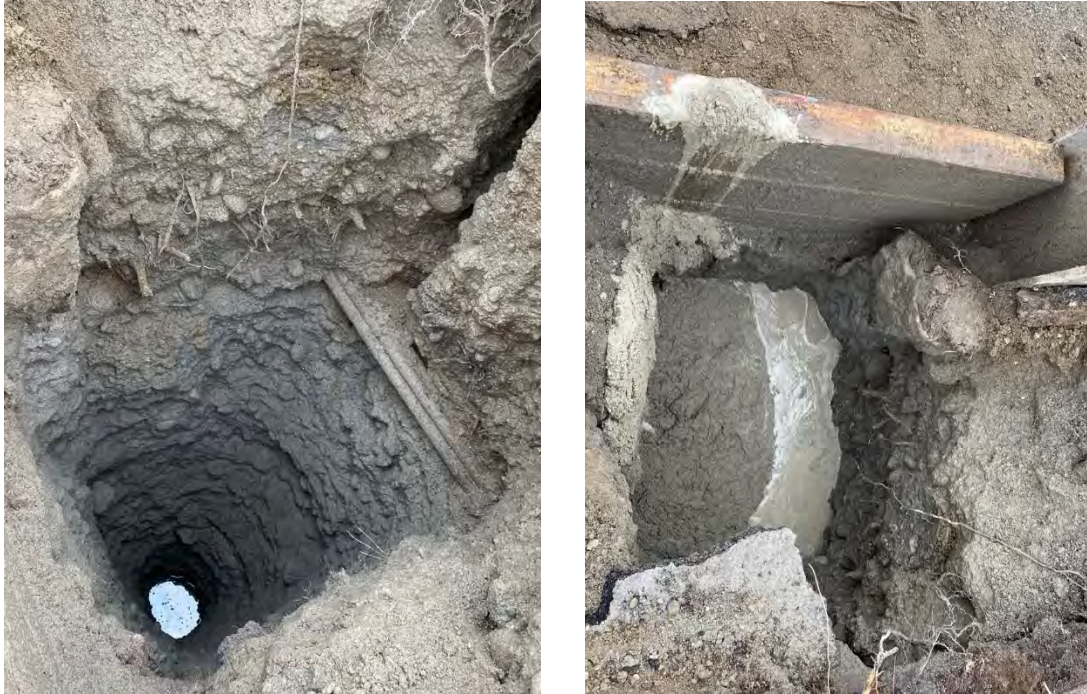
Figure 2. The bottom of the excavation at the N07-N7.5 cell filled with water from the high-pressure water wands used to cut through dense fill materials (left). The N07-N7.5 cell after being filled with controlled density fill (cdf) material (right).

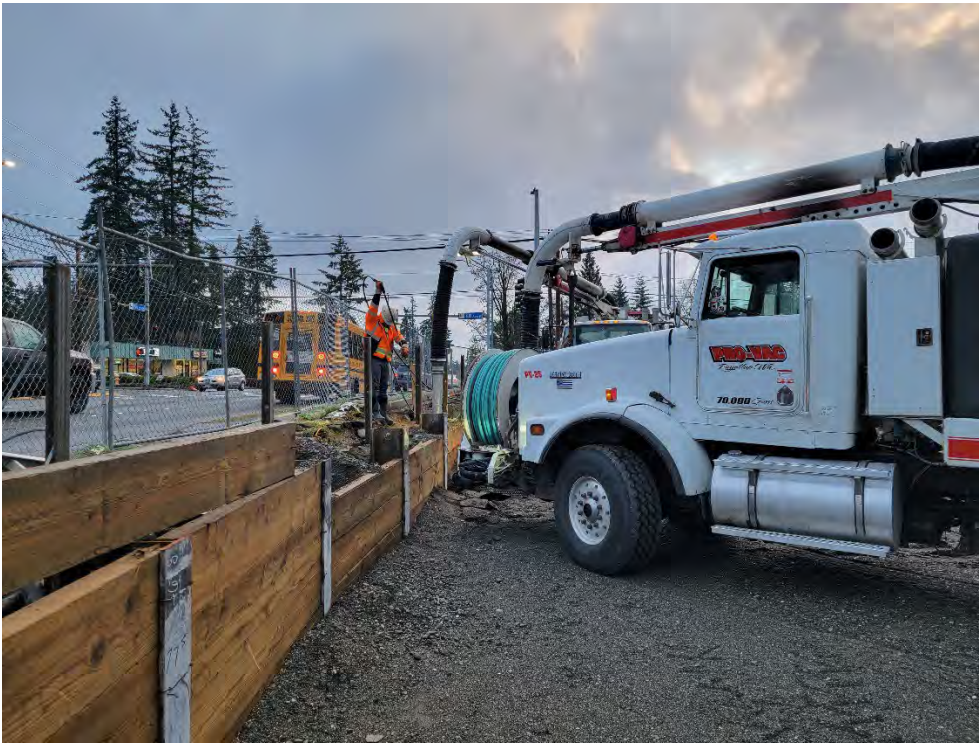
*Photo 1. The beginning of removal of the N08-N08.5 cell using the vac truck and high-pressure water wands.*

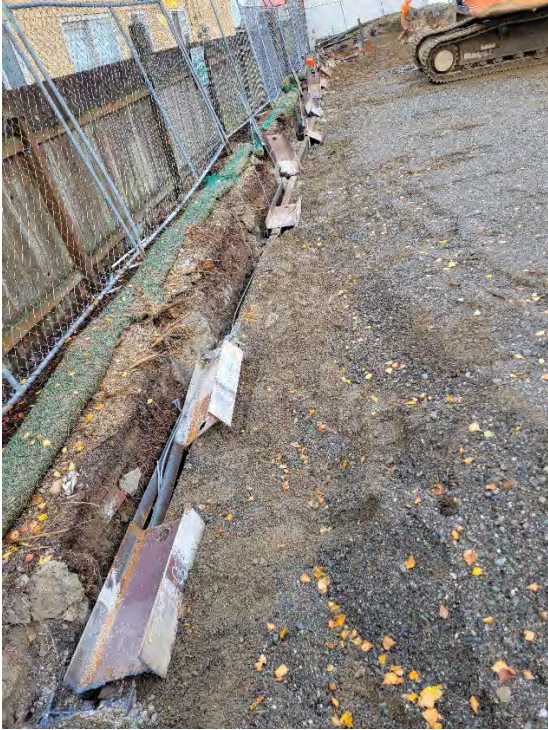
*Photo 2. Top approximately 2-feet of soldier piles removed along the south wall.*

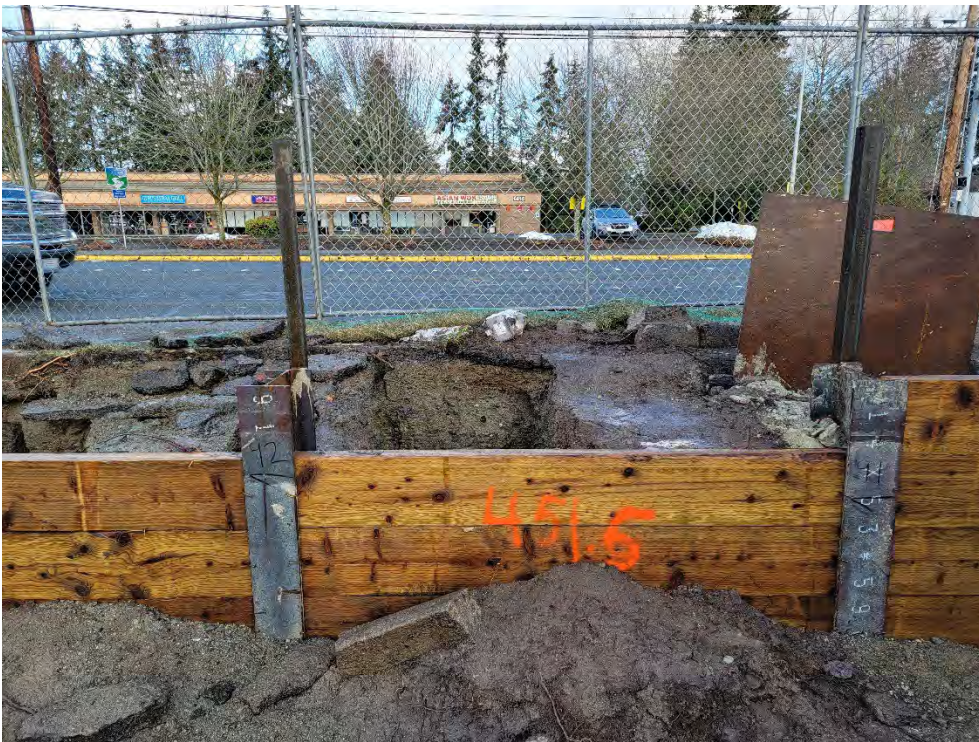
*Photo 3. Photo of cell N08-N08.5 after vector excavation completed.*

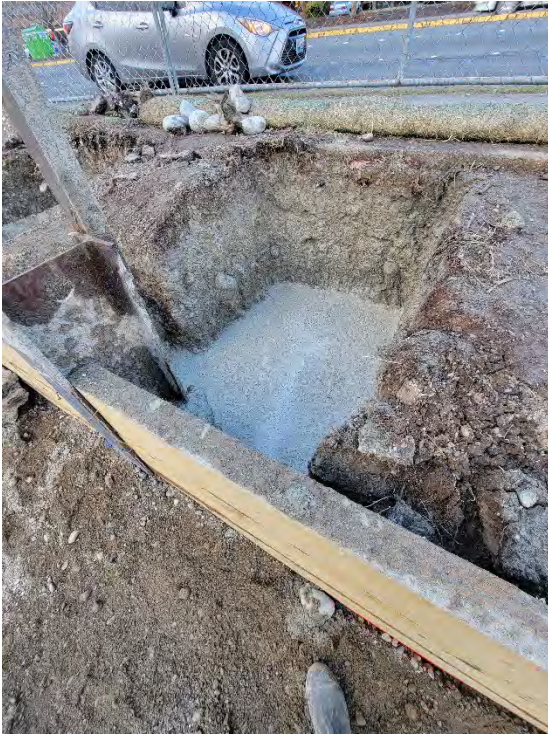
Photo 1. Overexcavation N10 to N10.5 backfilled with CDF.

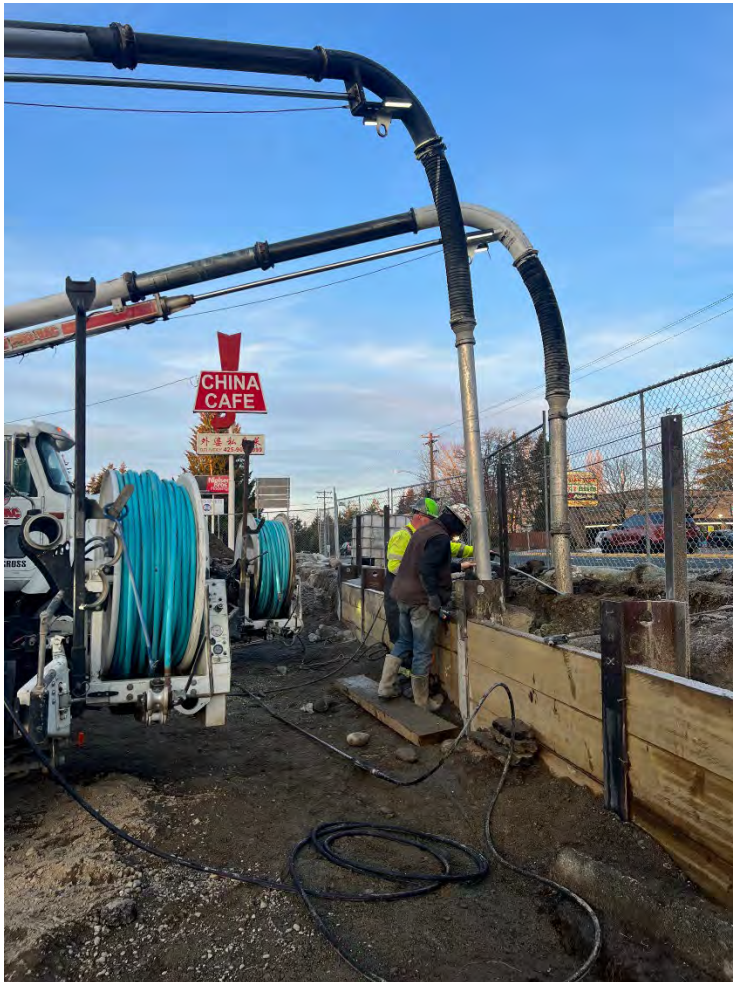
*Photo 1. The beginning of removal of the N08.5-N09 cell using the vac truck and high-pressure water wands.*

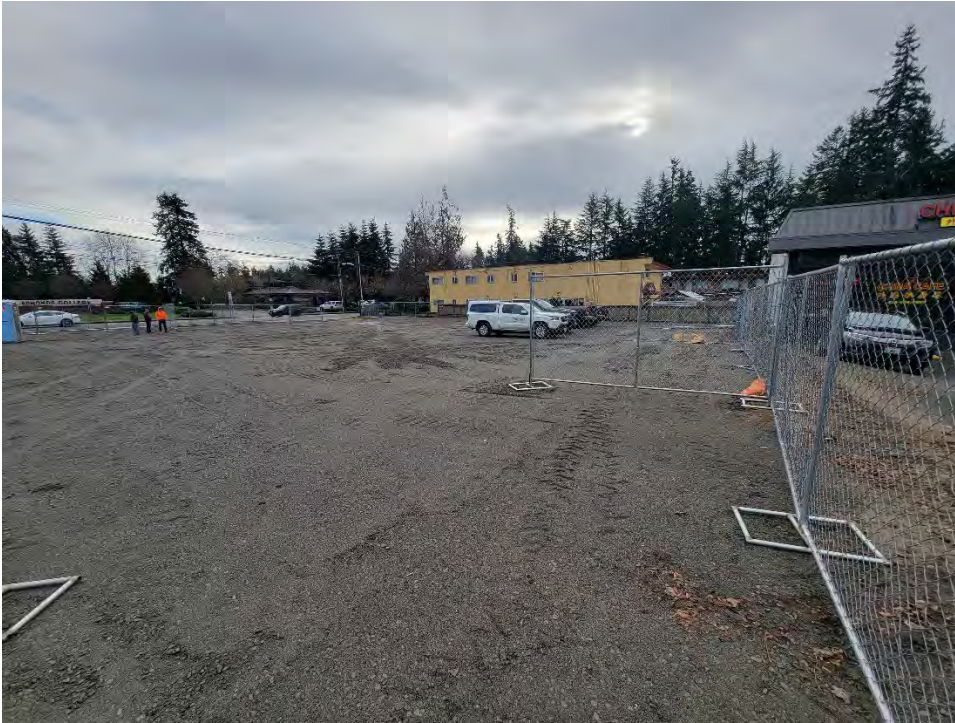
*Photo 1. Final restored Site conditions as of 1/6/2023, looking southeast.*

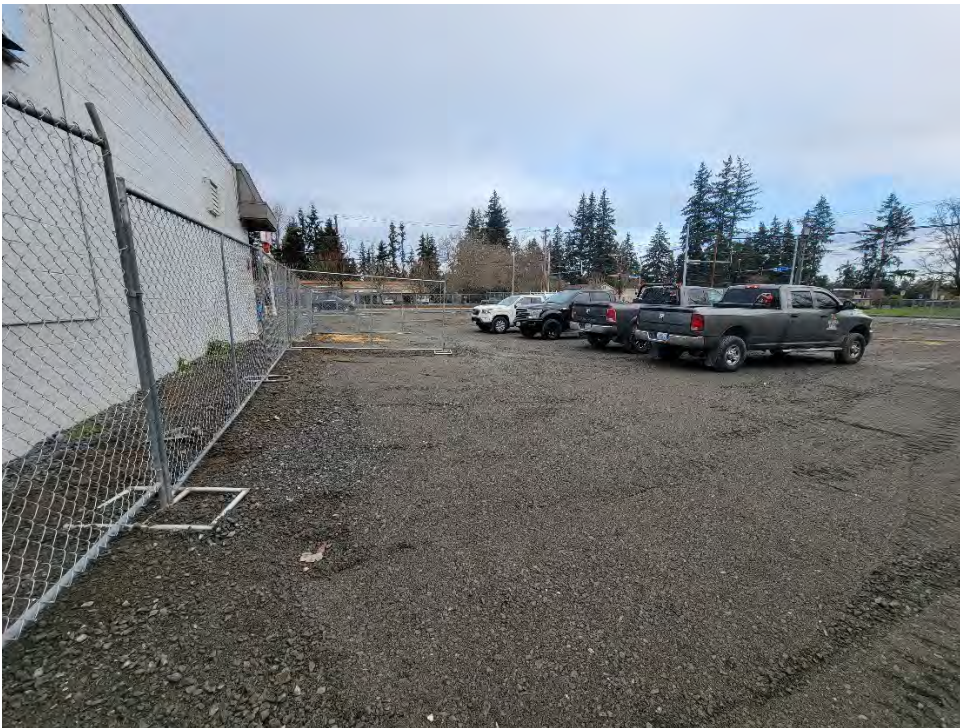
*Photo 2. Final restored Site conditions as of 1/6/2023, looking north along the west side of the Site.*

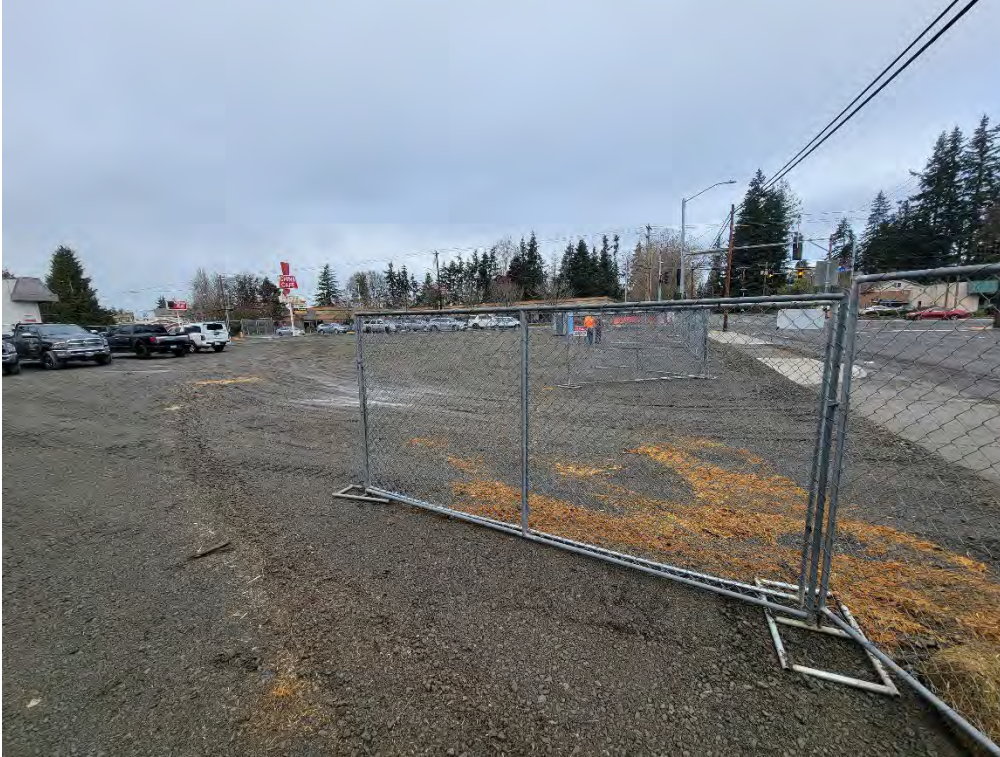
*Photo 3. Final restored Site conditions as of 1/6/2023, looking north along the east side of the Site.*
