# North Boeing Field/ Georgetown Steam Plant Site Remedial Investigation/Feasibility Study

Assessment of Infiltration and Inflow to  
North Boeing Field Storm Drain System

## VOLUME I

February 2011

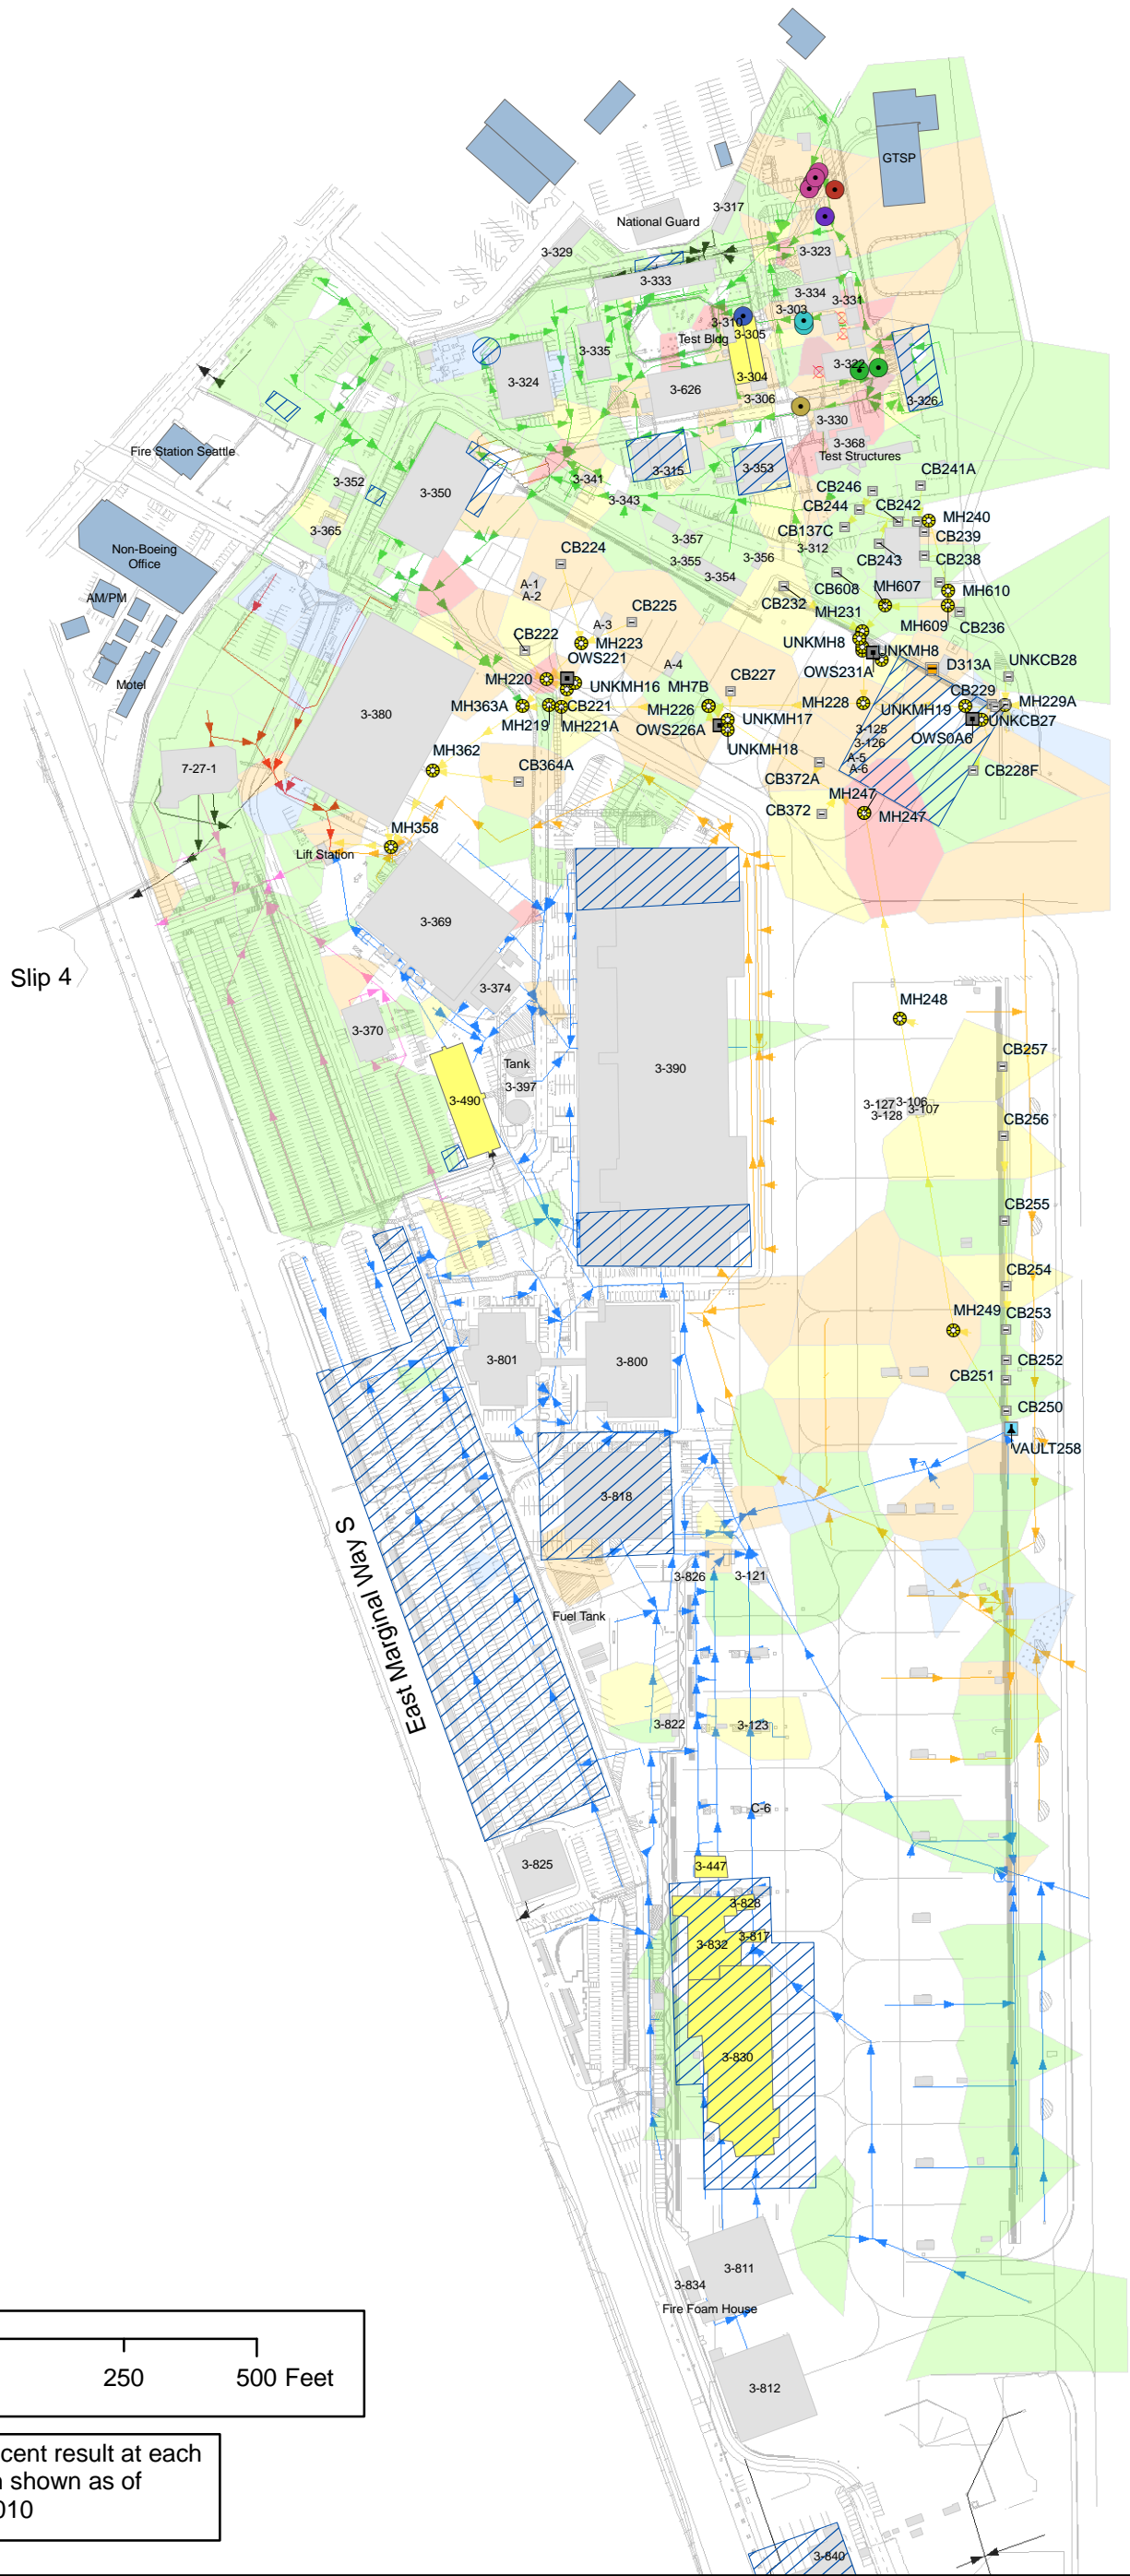
**Figure 4-2. NBF-GTSP Areas with Potential Historical PCB Sources**

PCB-containing transformers or capacitors were historically located near Buildings A-5, A-6, 3-125, and 3-126 (Landau 2006) (Figure 4-2).

A PCB-containing transformer or capacitor was historically located west of former Building 3-490 (Landau 2000) (Figure 4-2). PCB concentrations in the nearby SD structures exceeded the LAET.

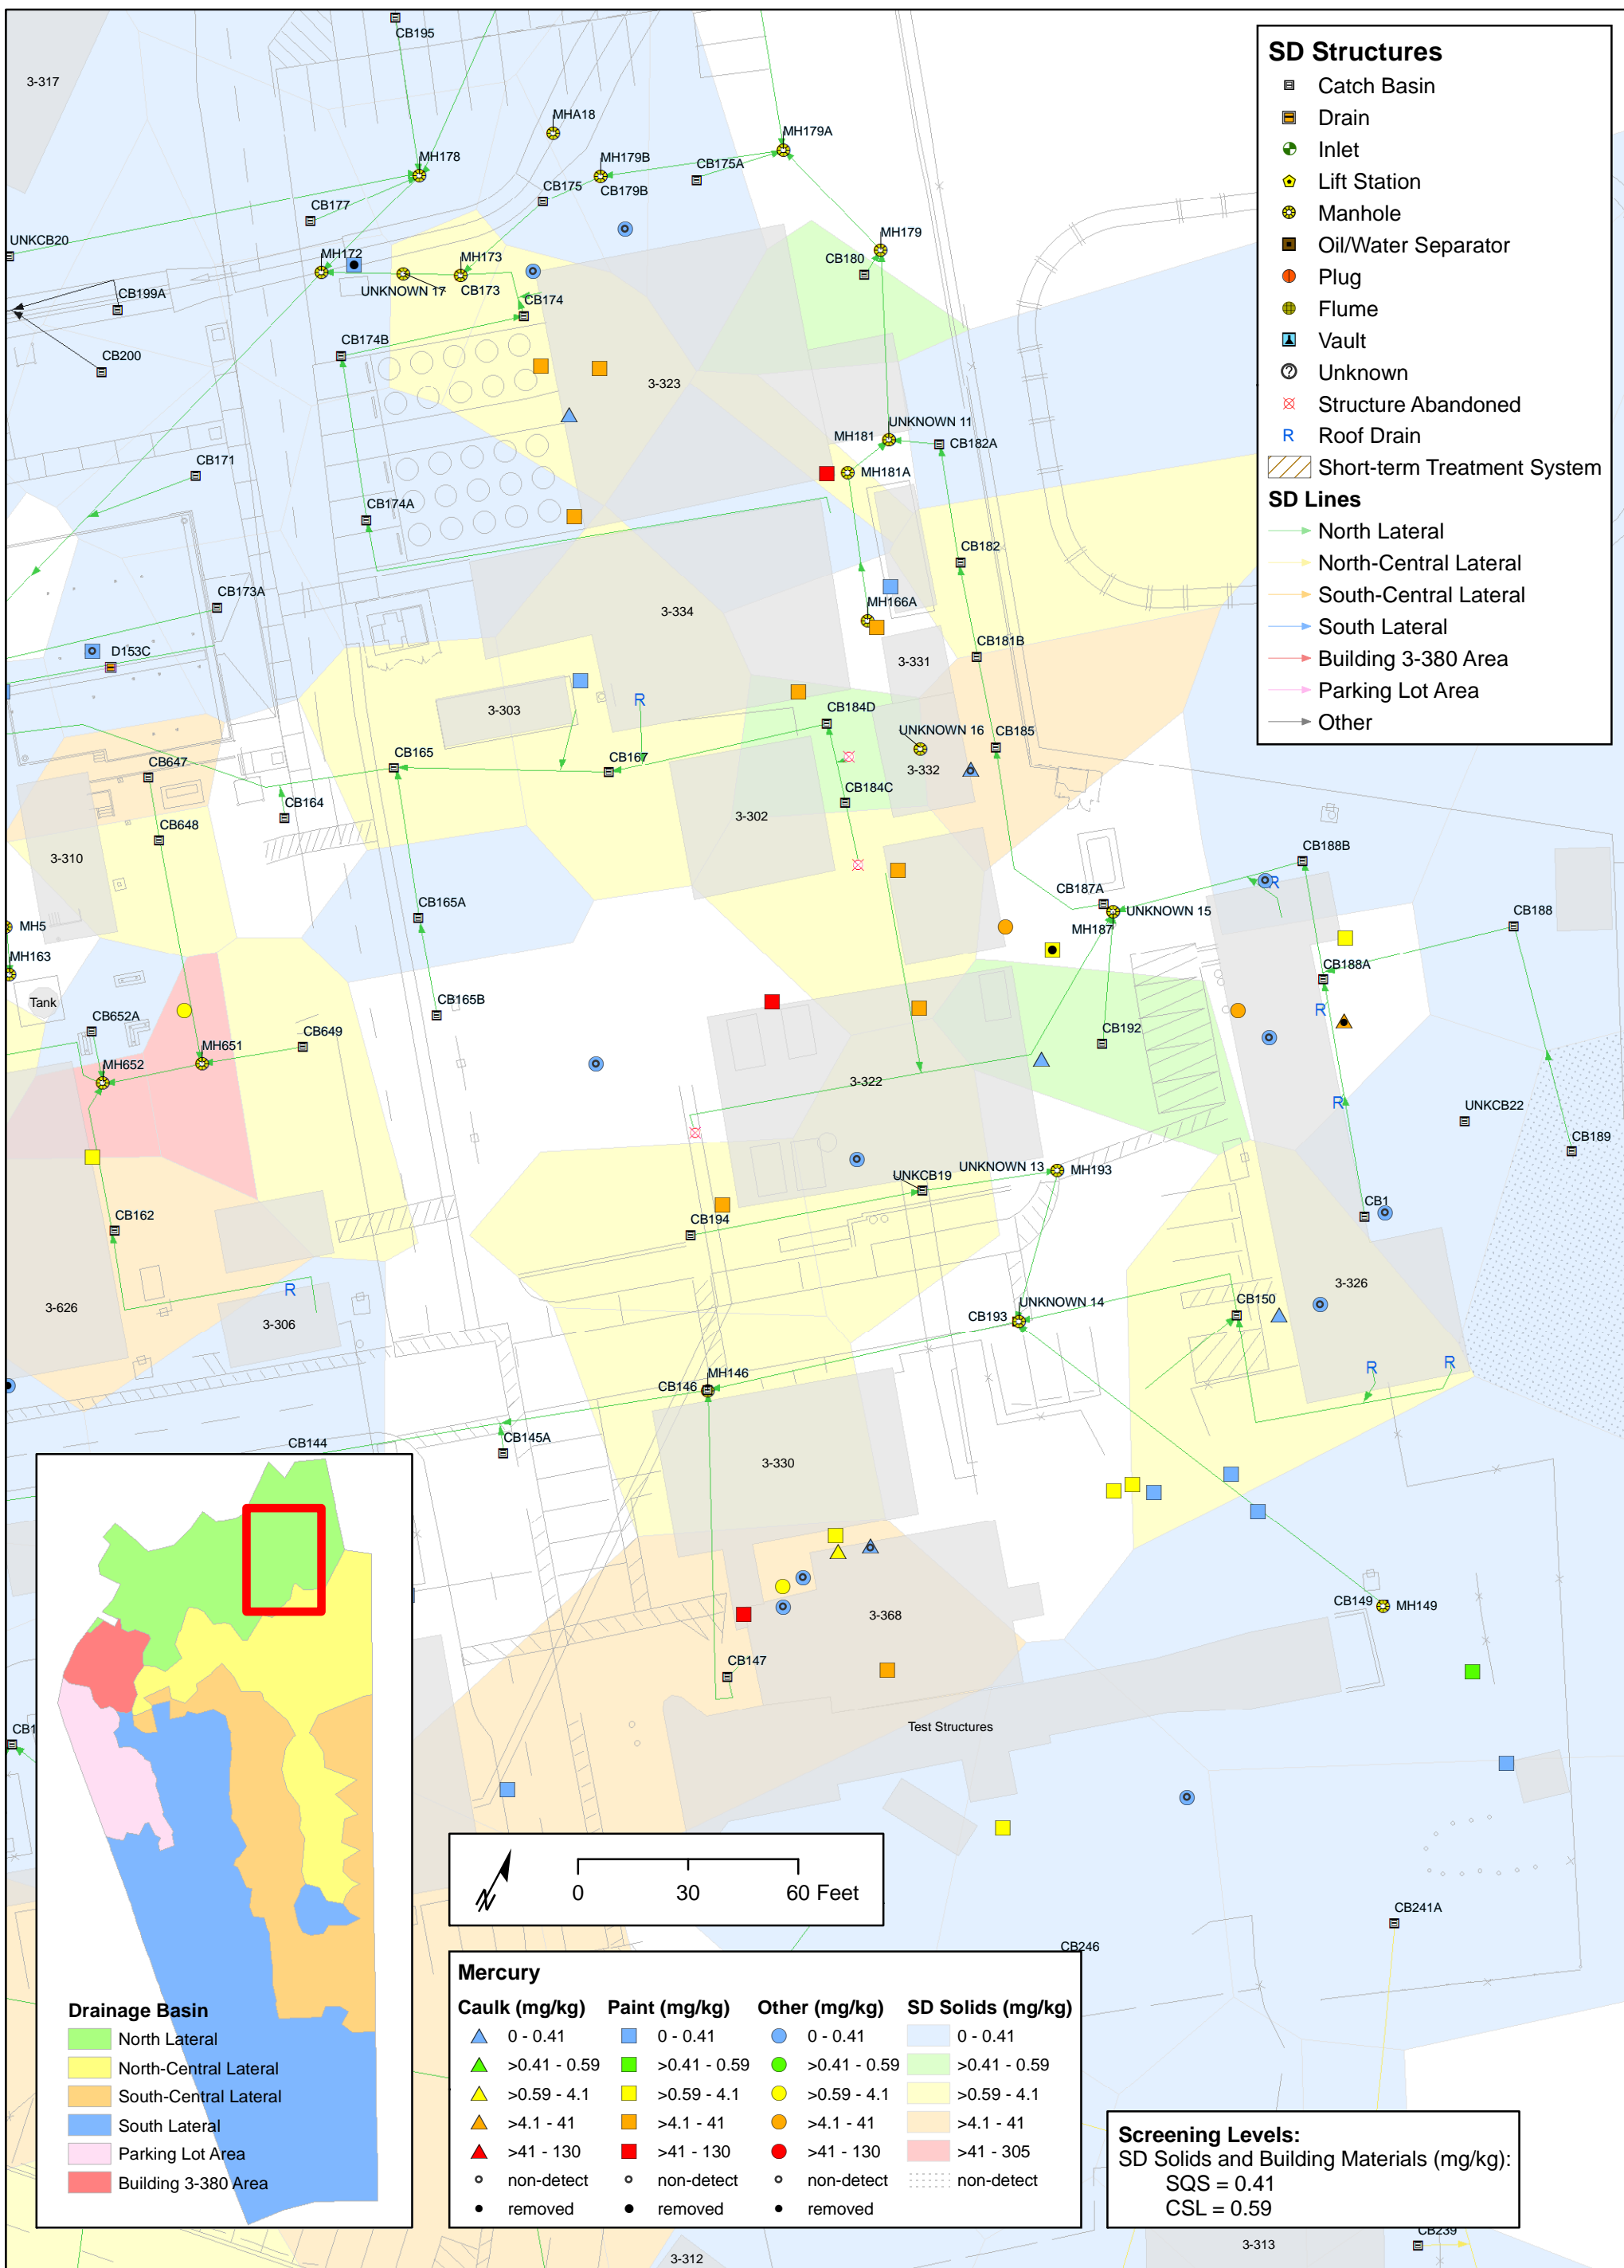
Figure 4-5. Mercury in Building Materials Near Building 3-322 at NBF-GTSP Site

In July 2010, Boeing collected caulk, paint, roofing materials, and downspouts solids samples from this building (Table 4-3) (Landau 2010d). Mercury exceeded the CSL screening level in caulk and paint samples and in the downspout solids sample (Figure 4-5). Cadmium was detected above the CSL screening level in one paint sample and below the SQS screening level in the caulk, roofing materials, and downspout solids sample (Figure 4-6). Copper was detected at concentrations below the SQS screening level in all the building materials samples (Figure 4-7). Lead was detected above the CSL screening level in paint samples and below the SQS screening level in the roofing materials and downspouts solids samples (Figure 4-8). Zinc was detected above the CSL screening level in caulk and paint samples and below the SQS screening level in the roofing materials and downspout solids samples (Figure 4-9).

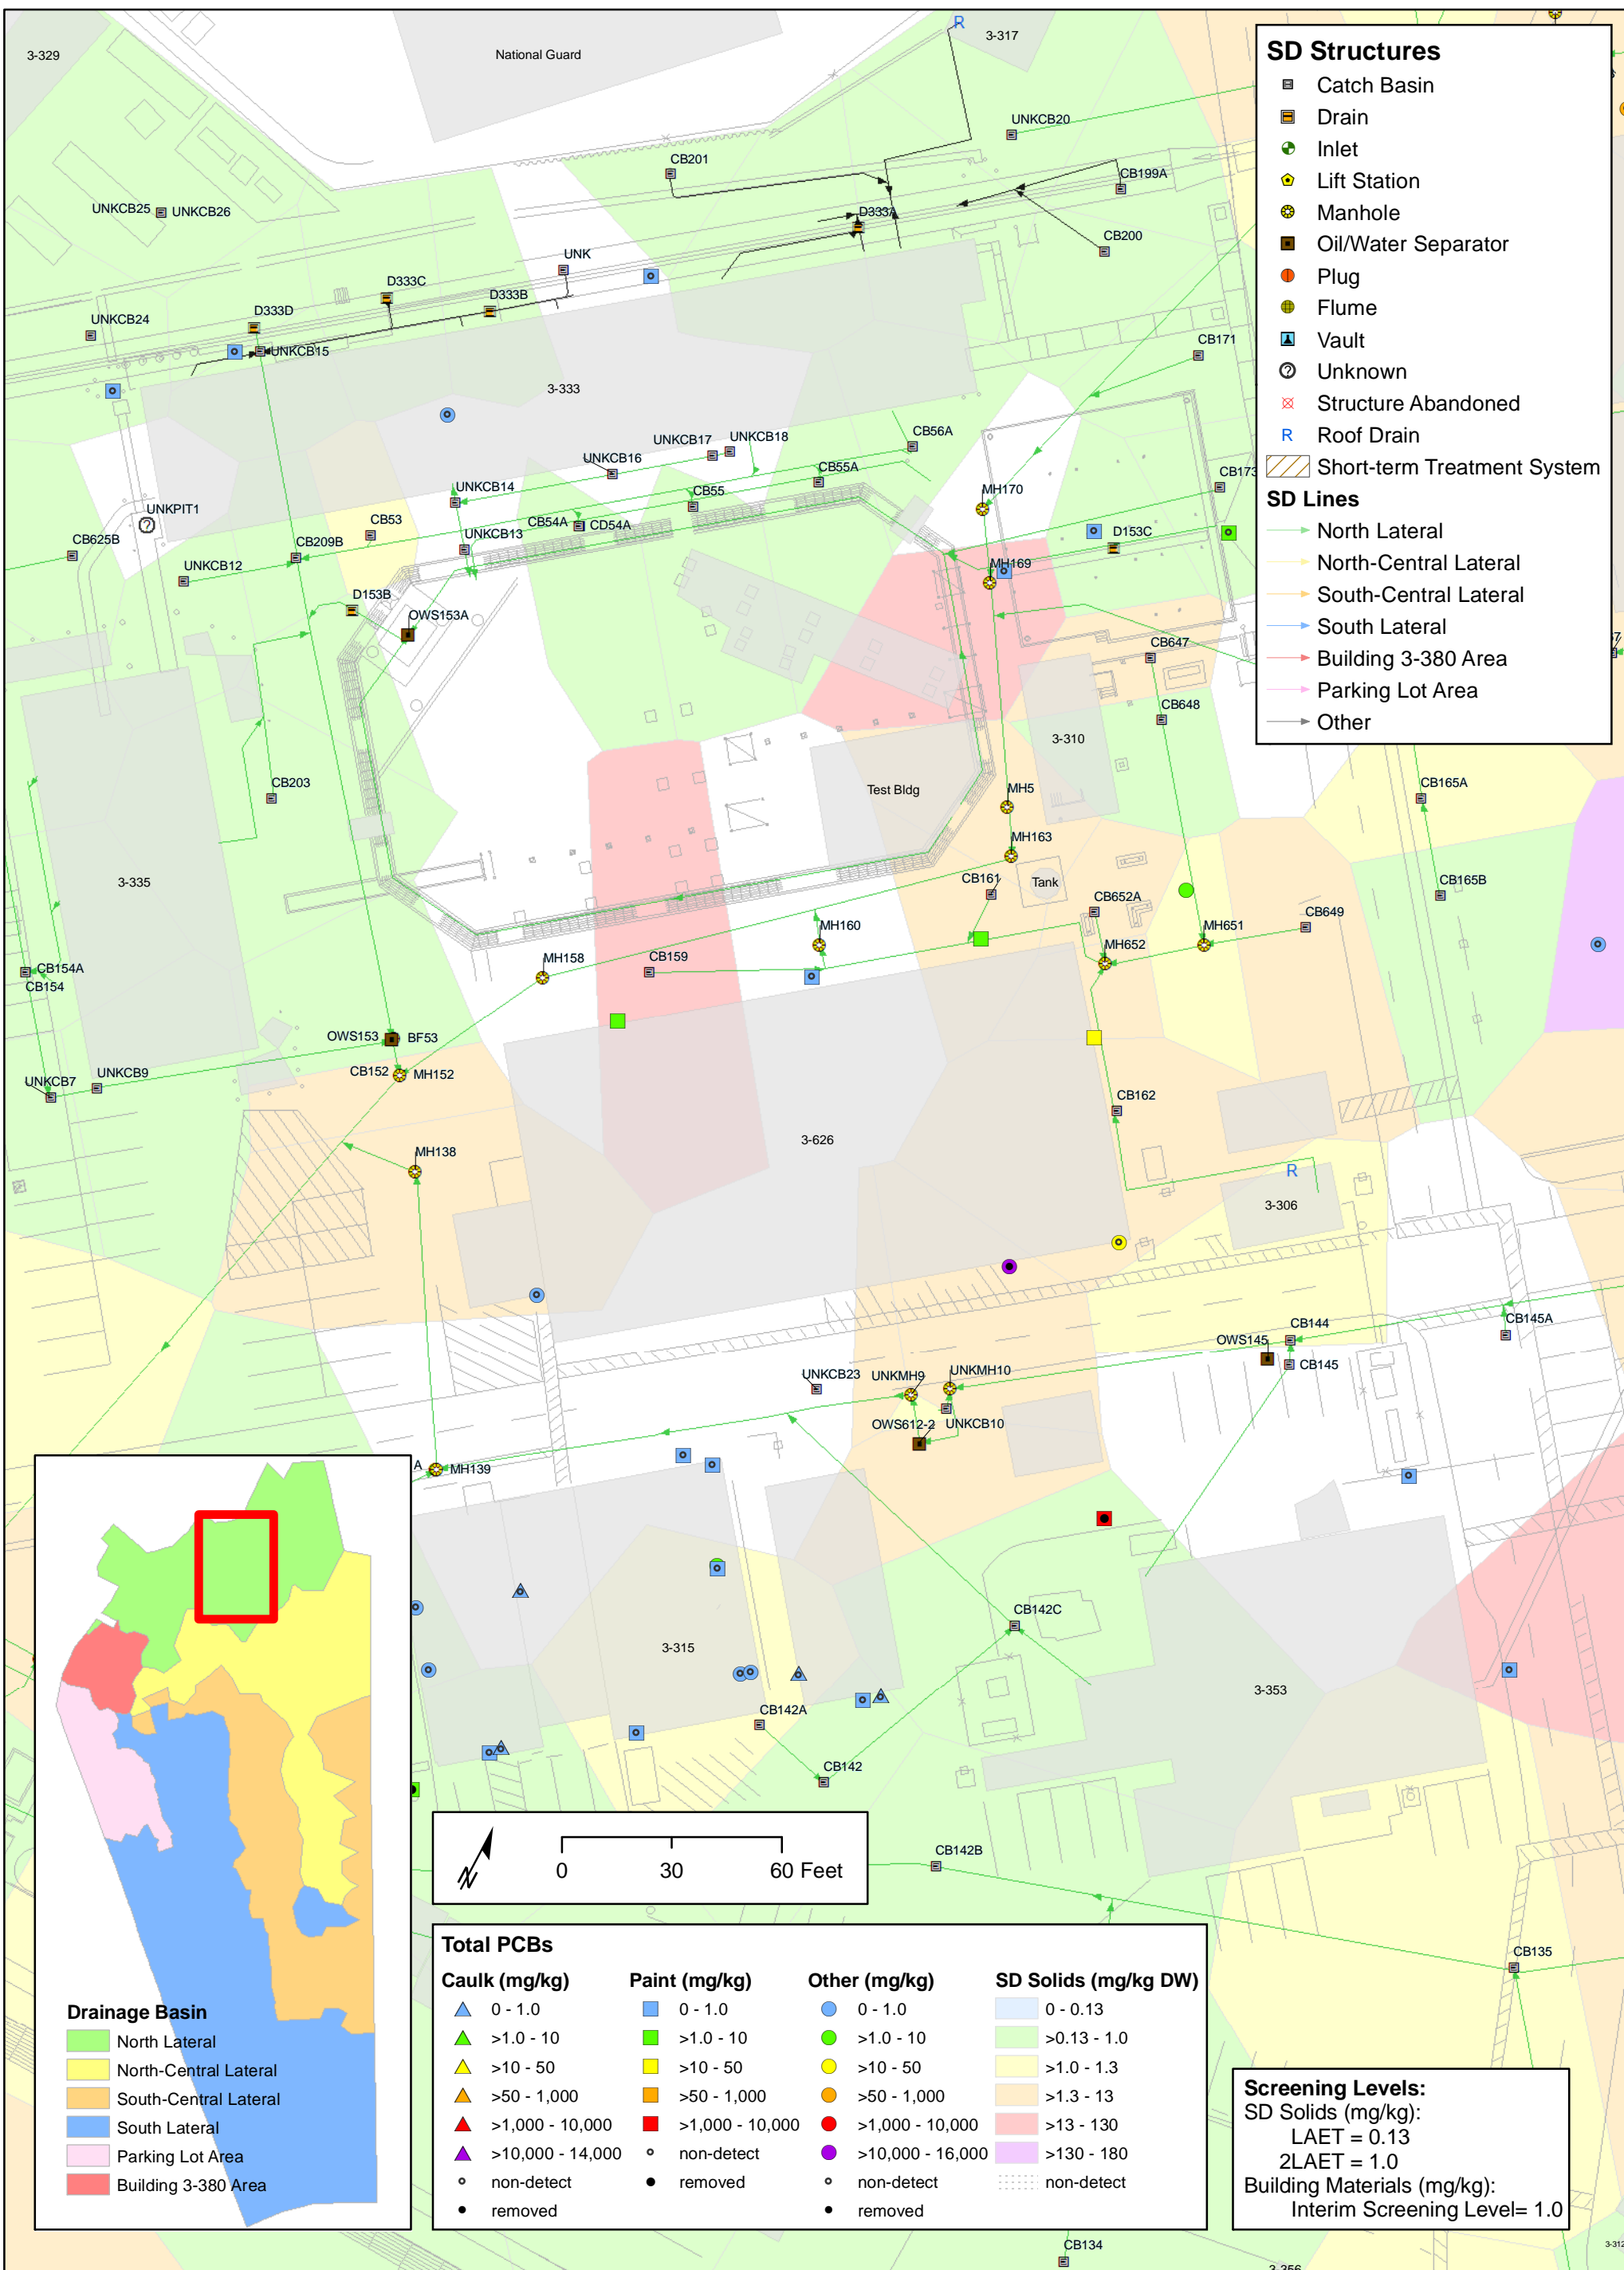
Figure 4-10. Total PCBs in Building Materials Near Building 3-626 at NBF-GTSP Site

Building 3-626 is constructed with concrete block walls and metal siding. The beige paint on the walls is in fair condition. Caulk on the door jambs and vents is also in fair condition. Downspouts from the roof discharge to the SD system and the ground. Rubber gaskets are present on the roll-up and sliding doors. An outdoor compressor on a stained concrete pad is present on the western side of the building (Appendix E, Photo 20). Exterior ladders and safety cages are painted white. Several yellow-painted on bollards are present near doors and building corners. Equipment that is painted orange, red, blue, and green is stored outside building. Exterior utilities with flanges and galvanized piping are present (Appendix E, Photo 80). Mercury, cadmium, copper, lead, and zinc concentrations exceeded the CSL in one or more SD solids samples collected from the catch basins in the immediate vicinity of the building (Figures 4-11 through 4-15).

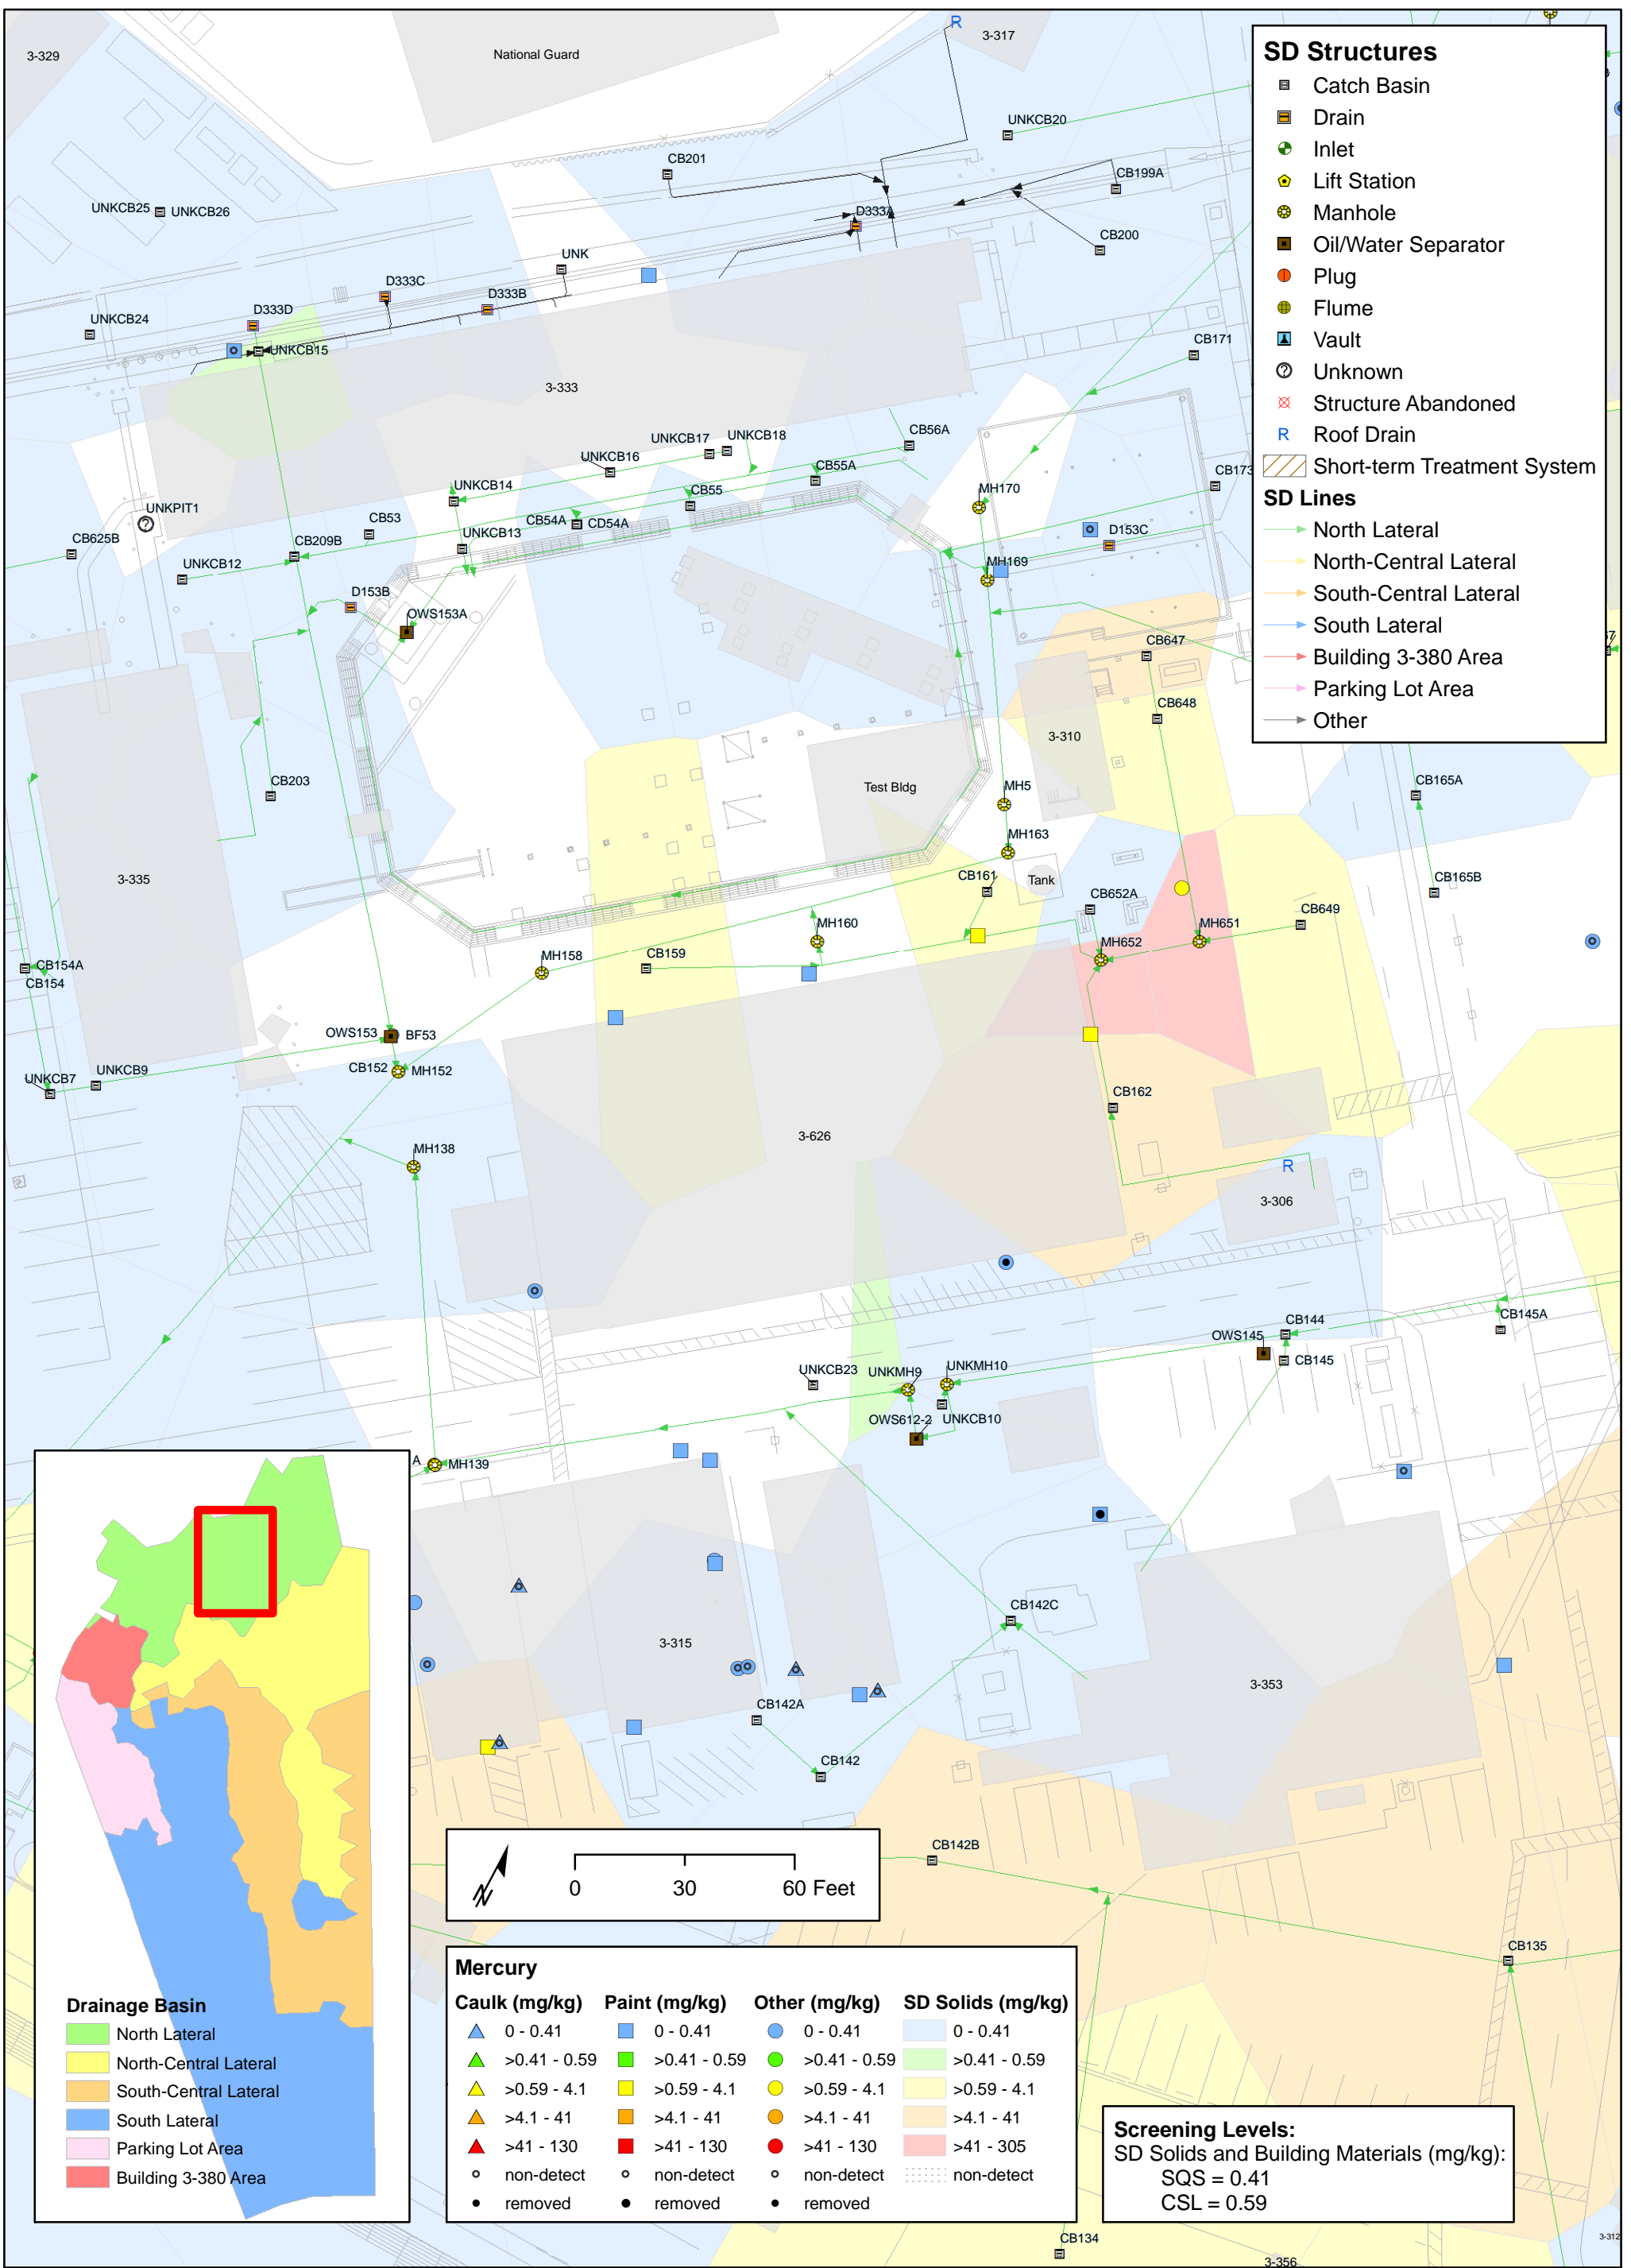
Figure 4-11. Mercury in Building Materials Near Building 3-626 at NBF-GTSP Site

In July 2010, Boeing collected paint and foam samples from this building (Table 4-3) (Landau 2010d). Concentrations of mercury, cadmium, copper, lead, and zinc exceeded the CSL screening level in the one or more of the paint samples (Figures 4-11 through 4-15). In the foam sample, zinc was detected at a concentration which exceeded the CSL screening level (Figure 4-15) and mercury, cadmium, copper and lead were detected in the sample at concentrations below the SQS screening level (Figures 4-11 through 4-14). Due to the presence of PCBs in the sample (which exceeded the SQS screening level) foam in the immediate vicinity of the sample was removed from the building (Landau 2010d).

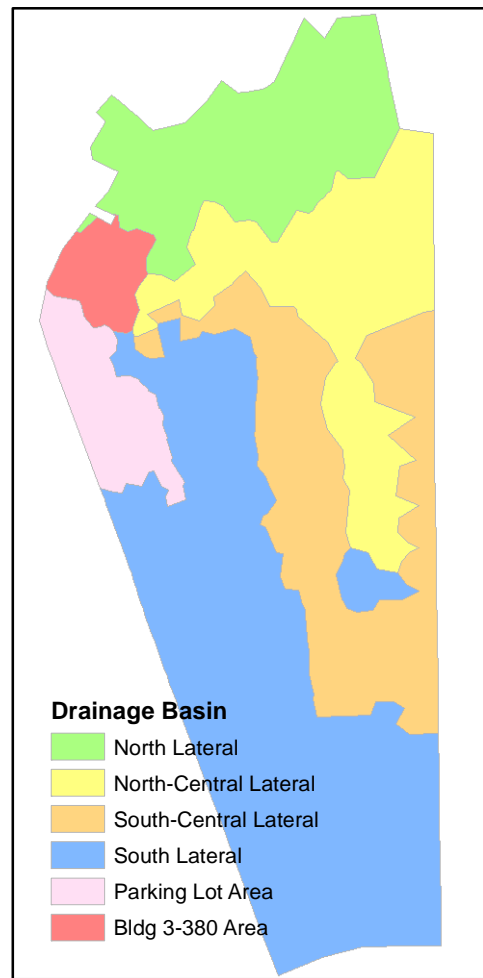
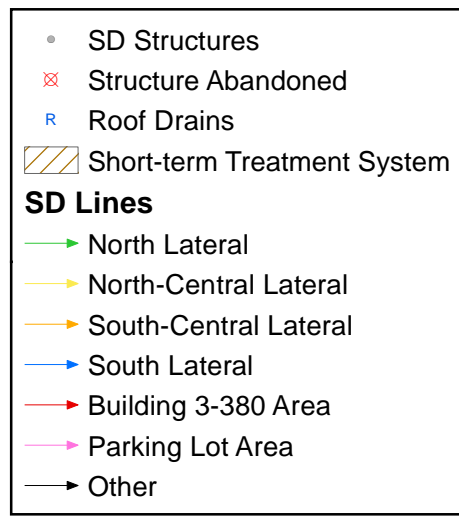
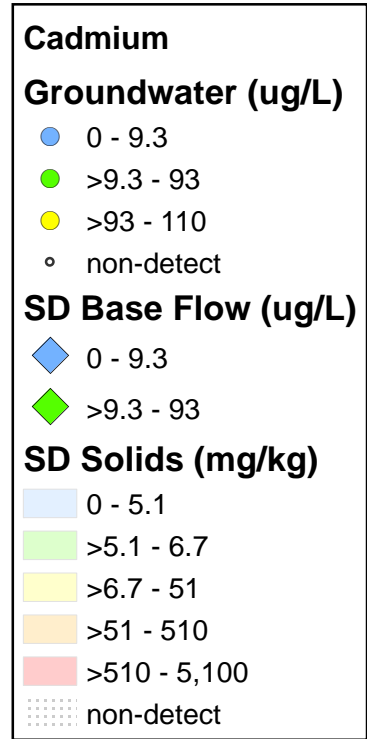
**Figure 5-22. Mercury in Groundwater and SD Base Flow at NBF-GTSP Site**

Mercury concentrations in groundwater generally exceed the WQS screening levels (Figure 5-22). At Buildings 3-369 and 3-380, the mercury concentrations detected in all recent groundwater samples exceeded the WQS screening level by a factor of 100 or more. A single detection of mercury exceeding the WQS screening level by a factor of 1,000 or more was observed on Concourse B. A mix of mercury concentrations below and exceeding the WQS screening levels was observed at the GTSP facility and the NBF-GTSP fence line. The MDLs exceeded the screening levels for all samples collected from the NBF-FTC, Concourse A, Building 3-800, former Building 3-360, and Building 7-27-1 areas.

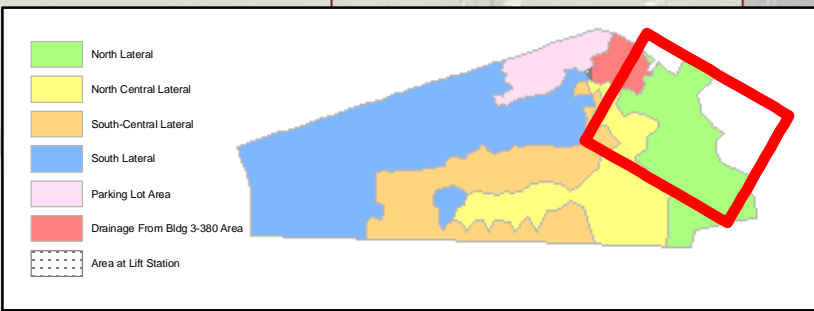
**Figure 5-31. Results of 2007 Storm Drain Video Inspection**

- Areas of the SD system that are potentially submerged and in which significant problems were reported during the 2007, 2008, and 2010 video inspections (Figures 5-31, 5-32, and 5-33) should be repaired and/or replaced as soon as possible.
