# Cleanup Action Completion Report

## East Bay Redevelopment Site

September 2023

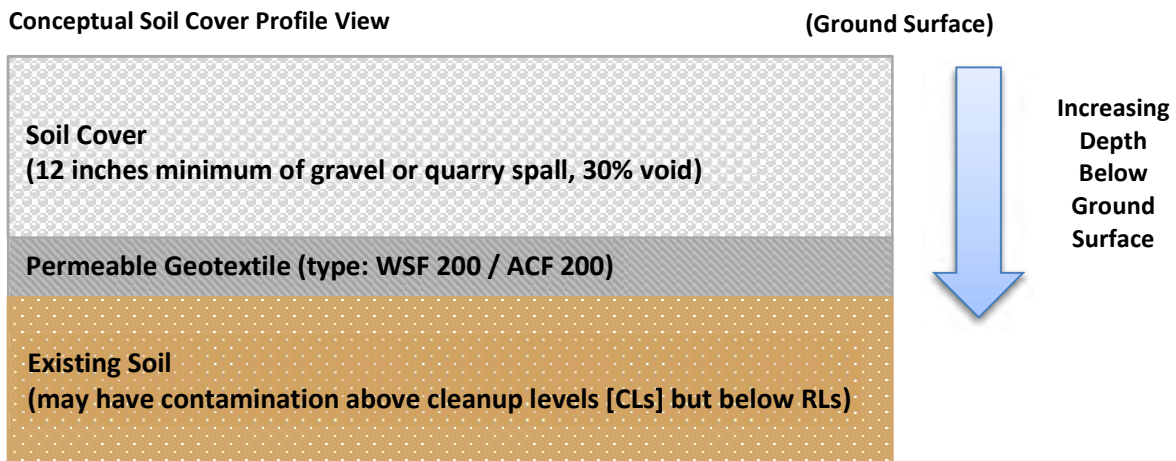
Below is a conceptual profile view of the soil cover components. See Figure 7 for a plan view of the soil cover locations at the site.

Note: Not to scale

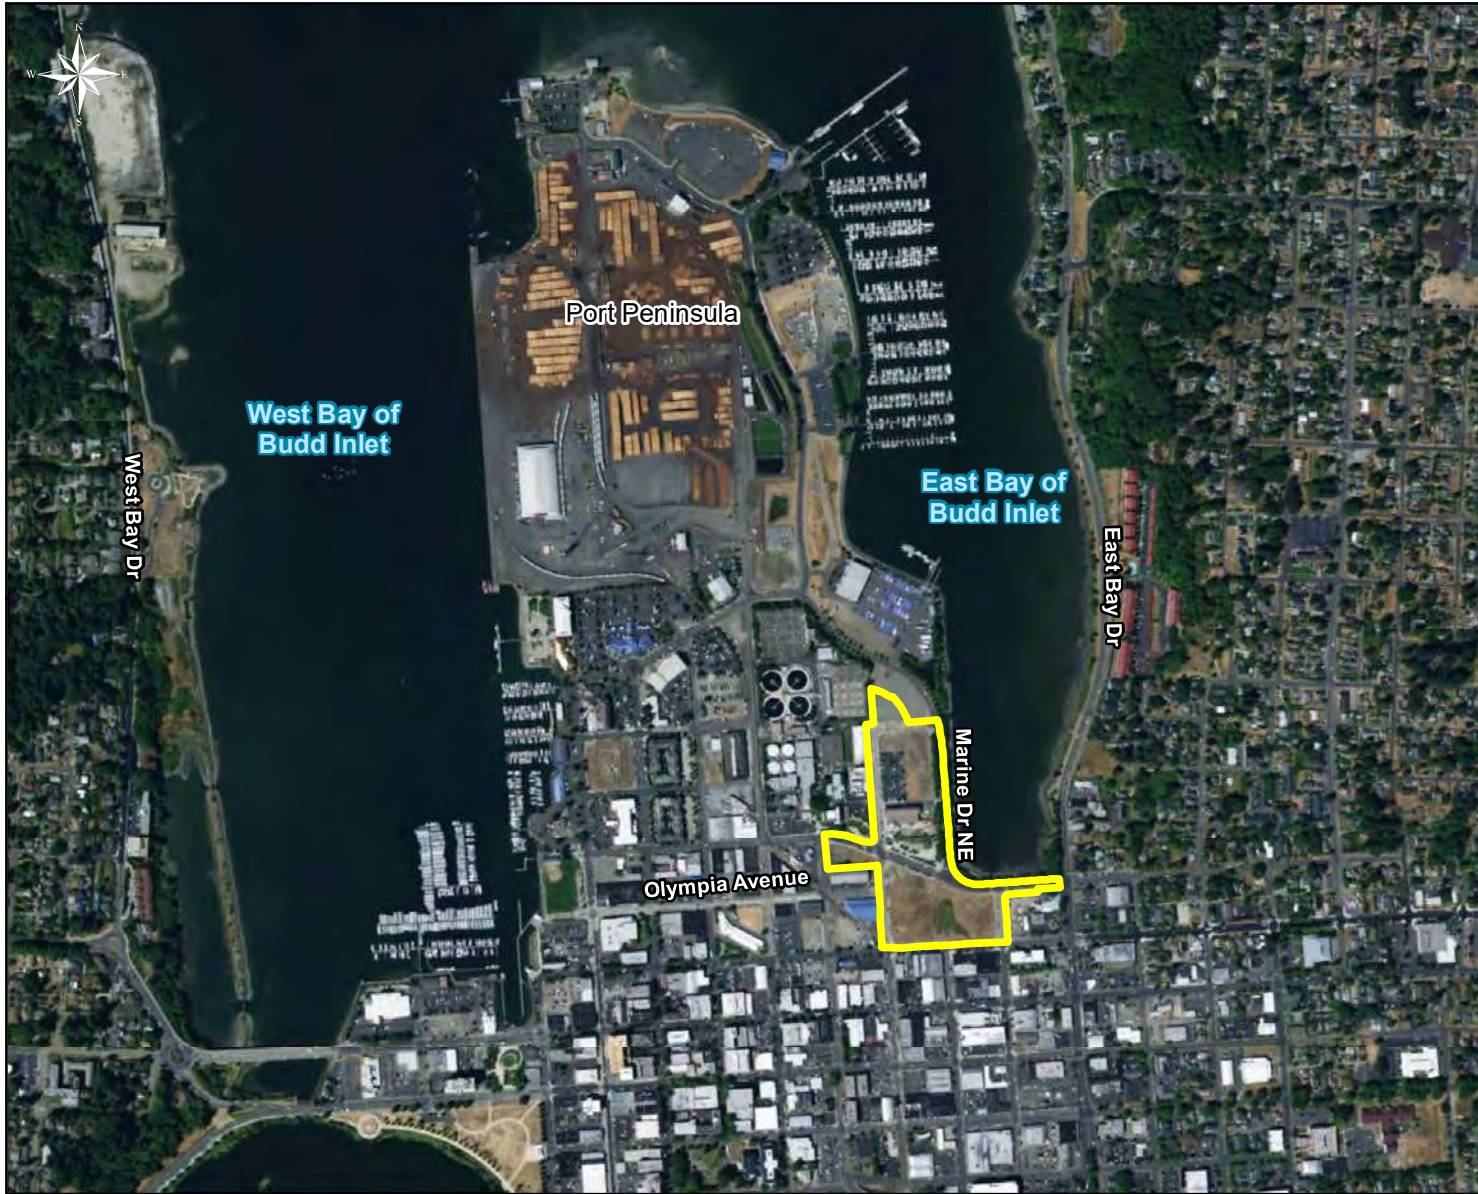
Figure 1

Vicinity Map  
Cleanup Action Completion Report  
East Bay Redevelopment Site

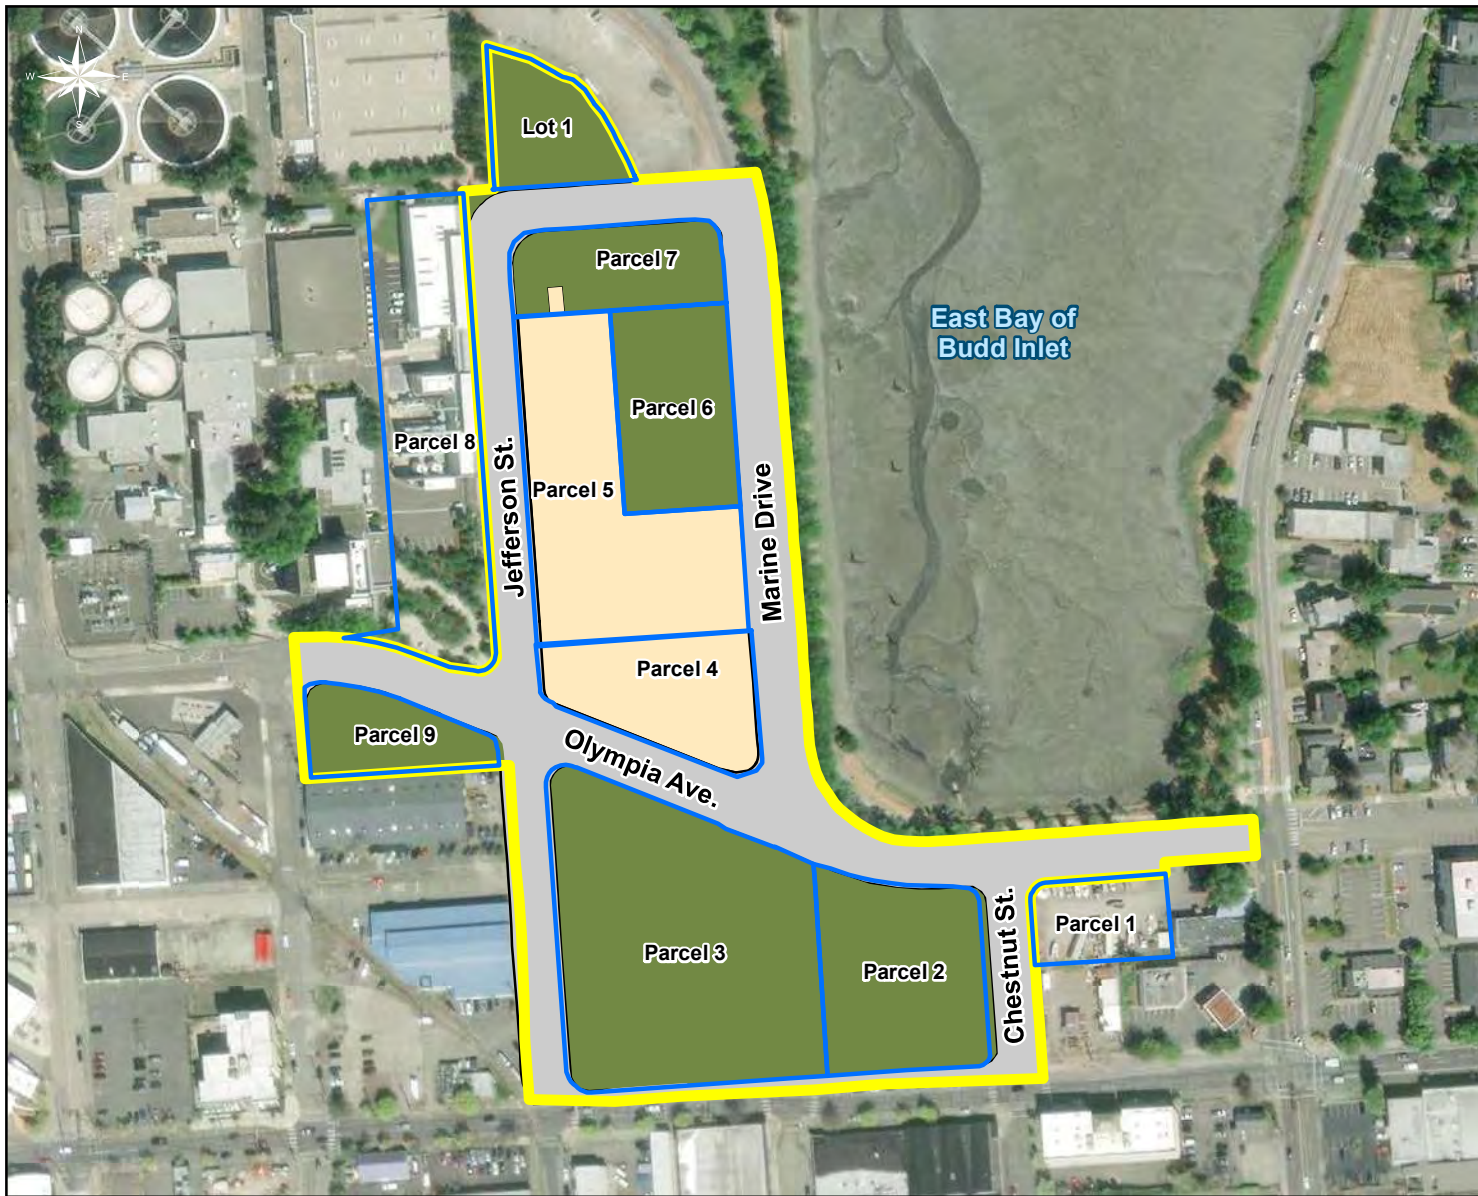
Figure 2

Cleanup action activities have been conducted at this Model Toxics Control Act (MTCA) site since 2010. Site cleanup actions included two IAs (i.e., an Infrastructure IA and a Parcel 4/Parcel 5 IA) and the 2017 cleanup activities (see Figure 2).<sup>1</sup> The Infrastructure IA was conducted in 2009/2010 on Port-maintained streets. The Parcel 4/Parcel 5 IA was conducted from 2010 through 2012 on City of Olympia (City) and Lacey, Olympia, Tumwater, and Thurston County Clean Water Alliance (LOTT) property. The 2017 cleanup action was conducted in Parcels 2, 3, 6, 7, 9, and Lot 1 from July through November 2017.

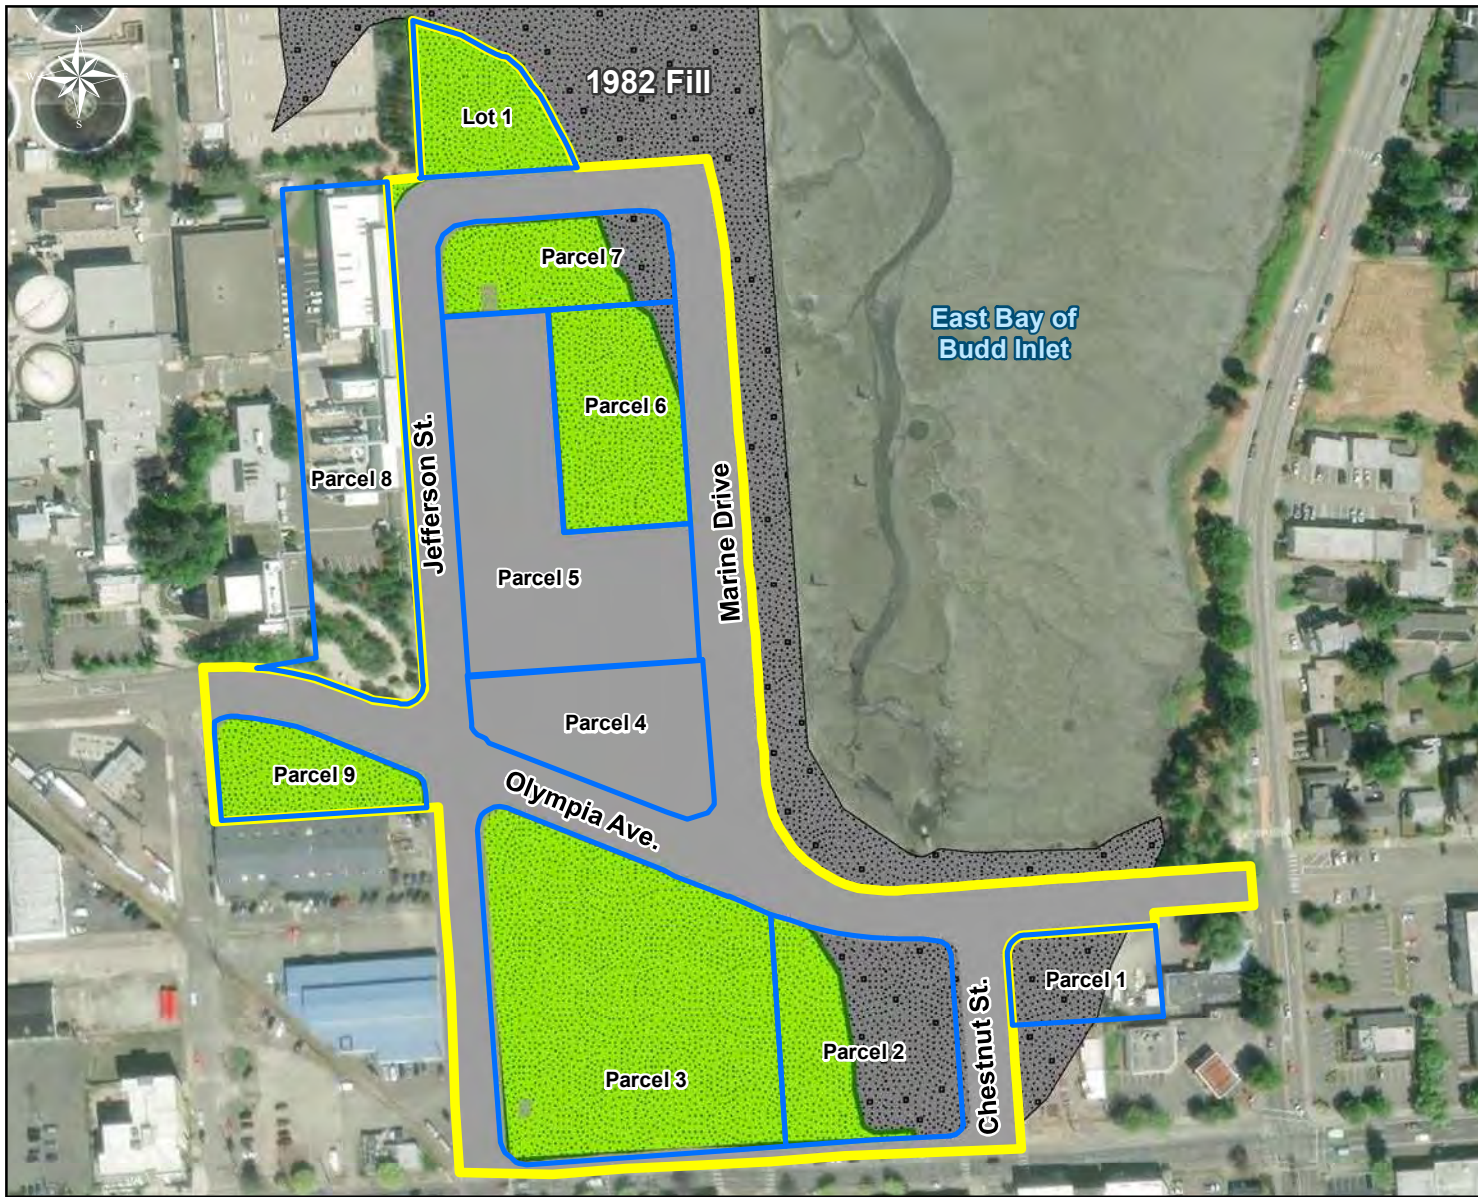
Figure 7

For the cover component of the site remedy, a minimum of 12 inches of soil cover was installed throughout Parcels 2, 3, 6, 7, 9, and Lot 1 wherever clean 1982 fill had not been placed (see Figure 7). After the existing site soil was graded and soil with RL exceedances was excavated, a permeable geotextile liner (type WSF 200/ACF 200 Woven Geotextile) was placed in the areas designated to have the soil cover installed. In larger areas requiring multiple liners for full coverage, adjacent geotextiles were overlapped a minimum of one foot at geotextile edges. Approximately 9,917 cubic yards of clean permeable ballast gravel with a 30% void ratio were imported, stockpiled, and placed over the geotextile to make up the 12-inch-minimum-thickness soil cover.<sup>4</sup> Details regarding the geotextile liner are presented in Appendix L and details about the aggregate type are presented in Appendix M.

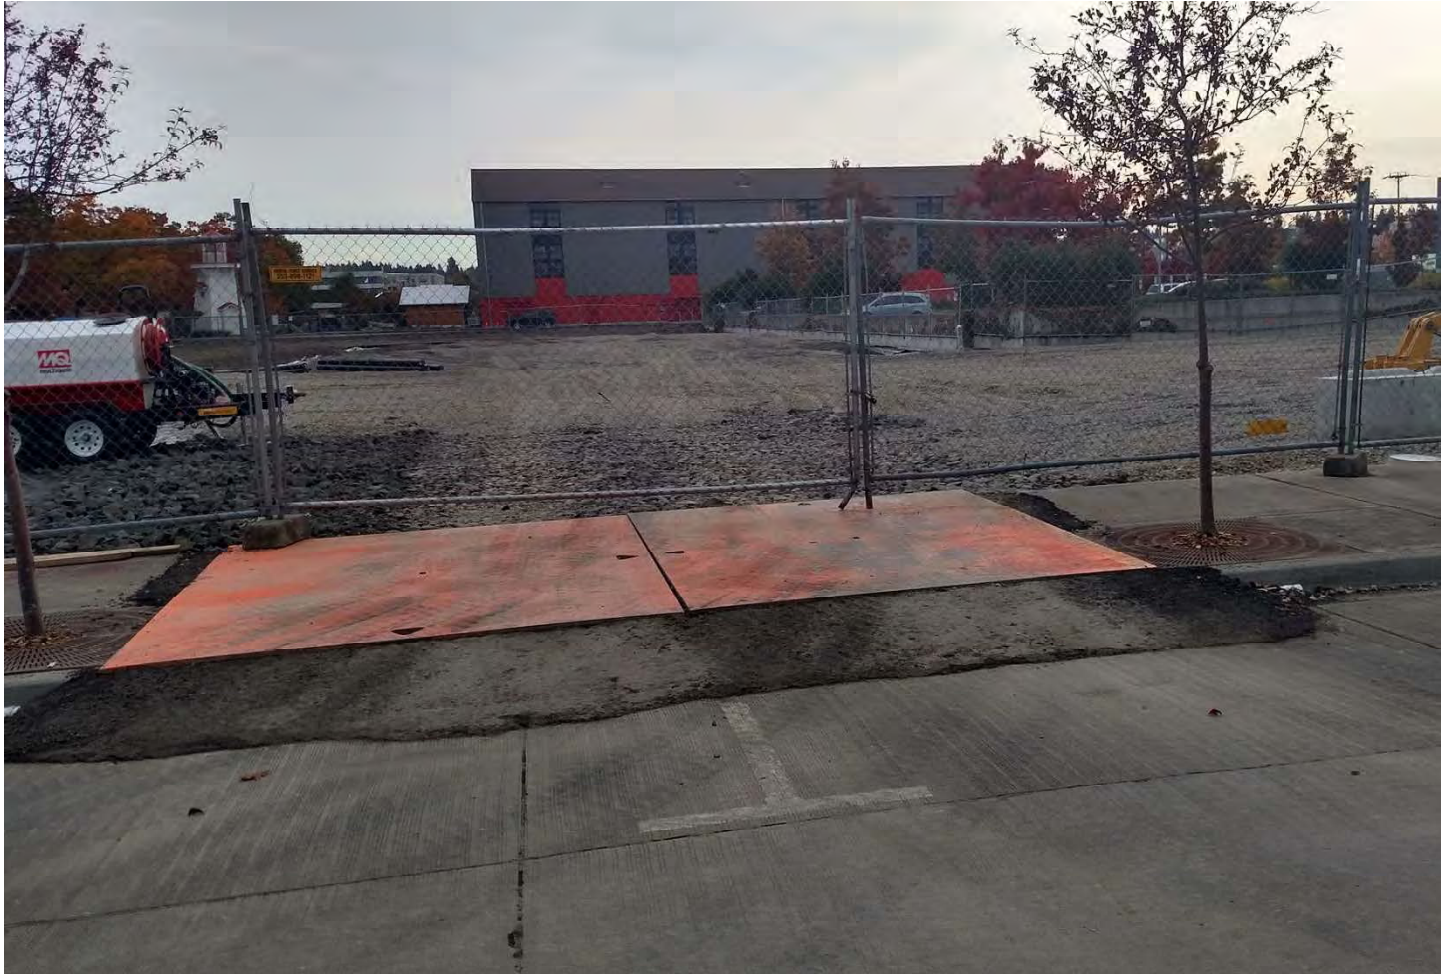
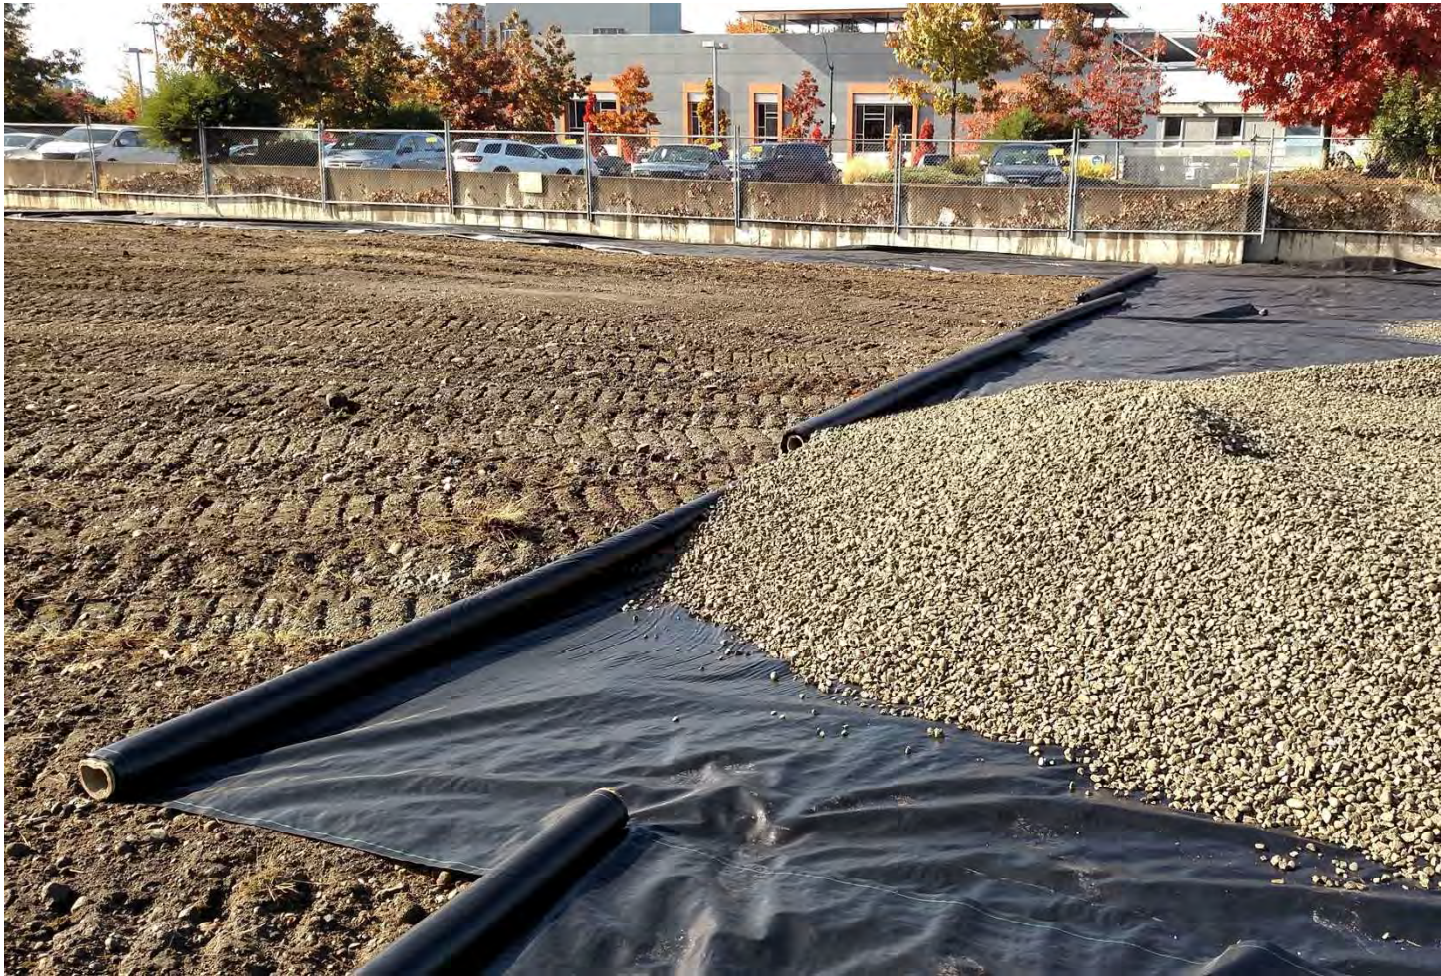
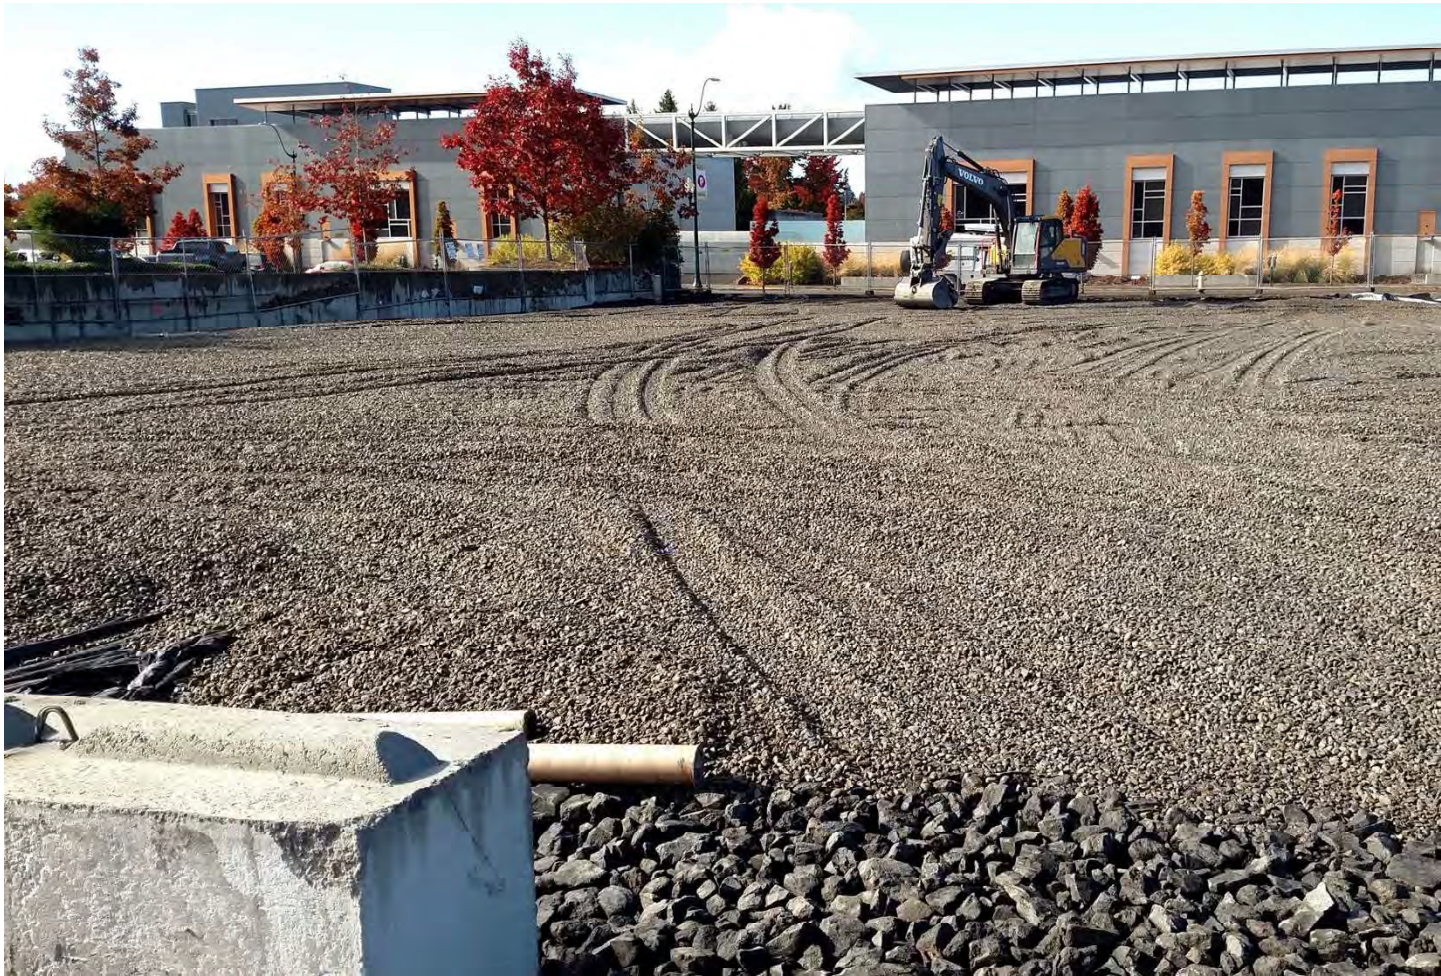
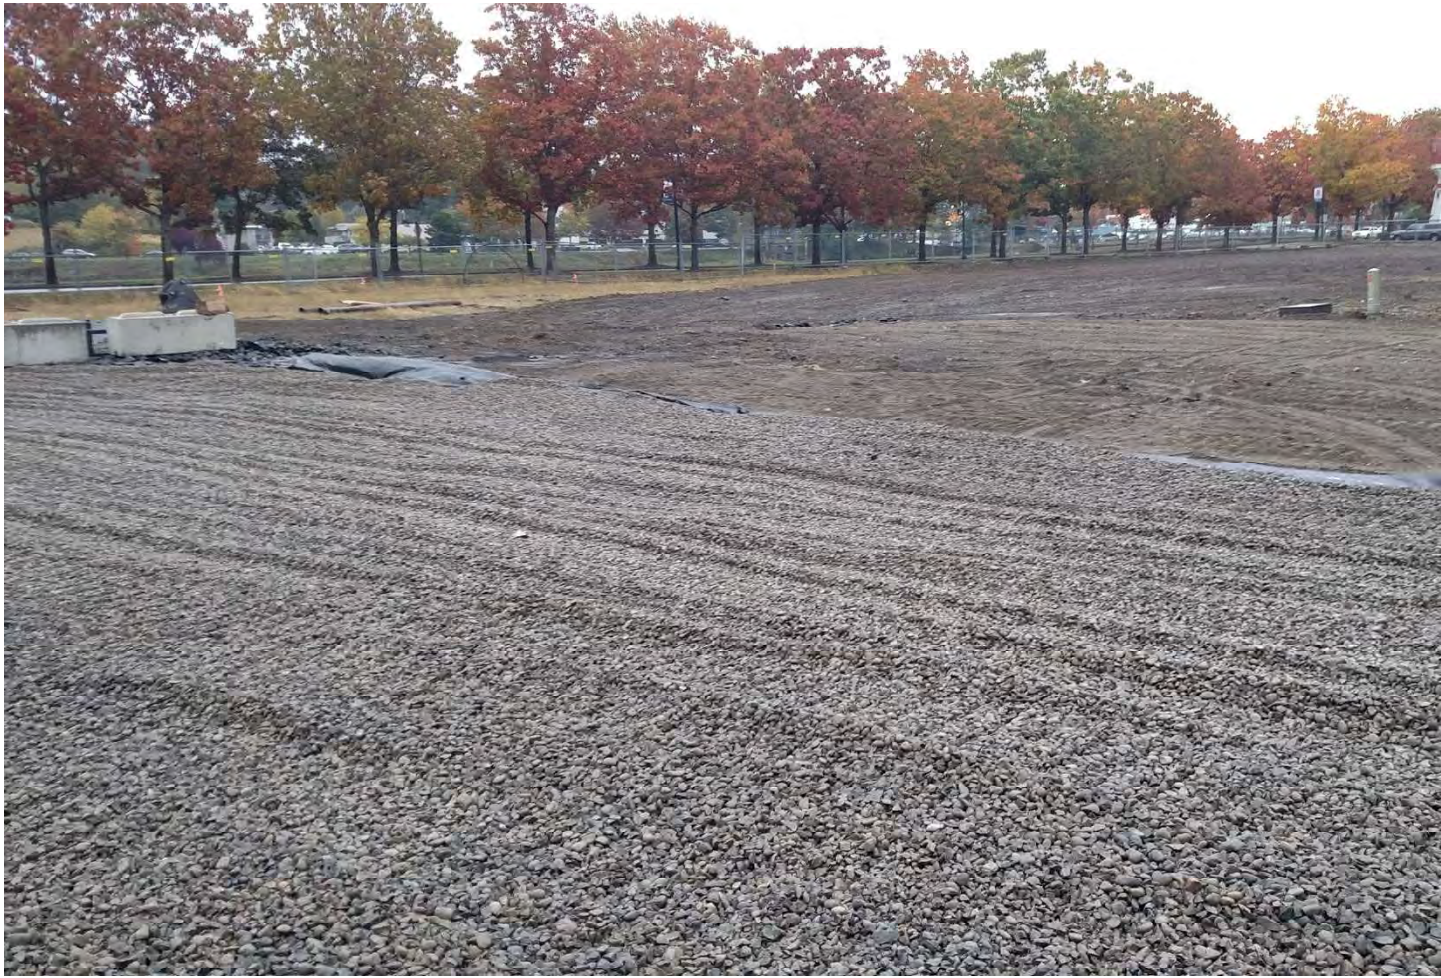
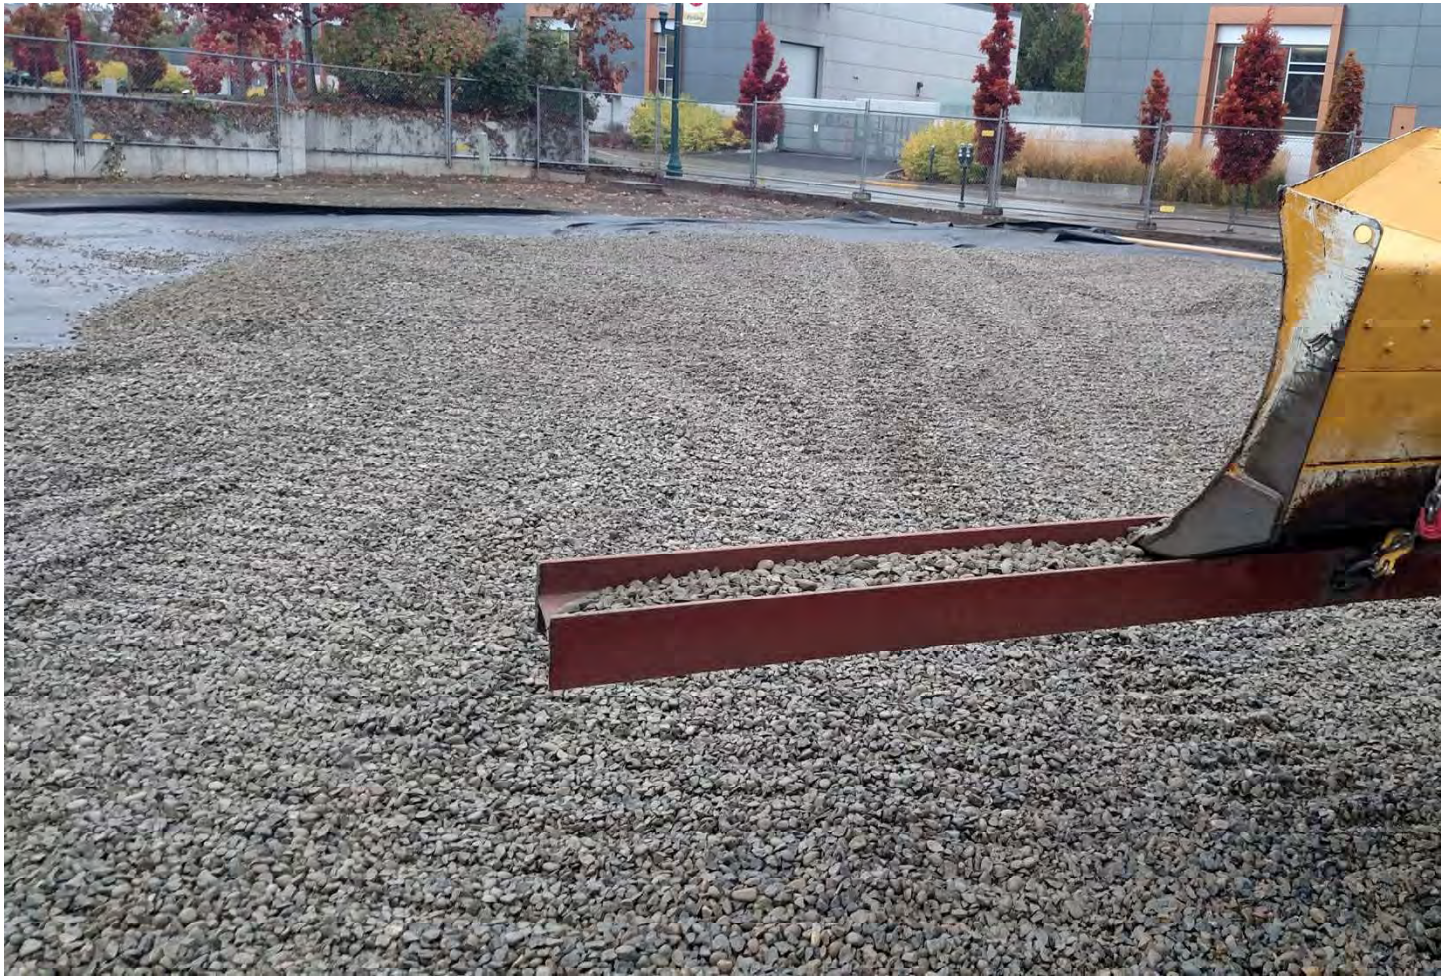
**General Notes:** Contractor started with a safety meeting at 7:00 am. Contractor focused on stockpiling gravel cover and placing the geotextile fabric and gravel cover on Parcels 6/7. Stormwater BMPs are holding up to the rain. Additional preventative measures were taken to ensure that the wind and rain do not cause issues.
