Completion Report

North Cascade Ford Site 116 W Ferry Street, Sedro-Woolley, WA

Facility/Site No. 68313566 Cleanup Site No. 12075

October 27, 2023 Project No. M2584.01.002

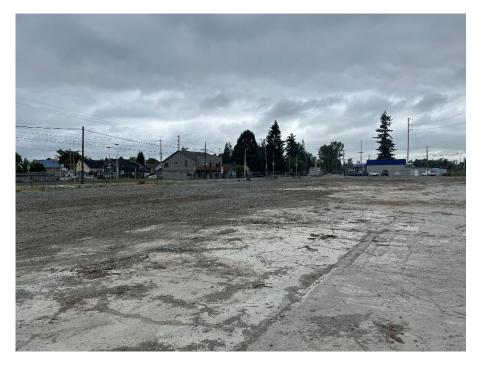
Photo No. 3.

Photo looking southwest at the southern gravel area <u>prior to</u> removing intermixed railroad tie debris and gravel.

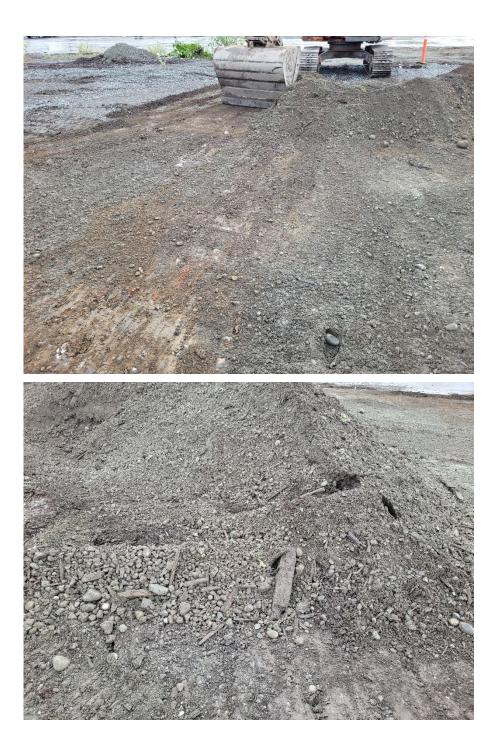
Photo No. 4.

Photo looking west from the east side of the northern gravel area after removal of the intermixed gravel and railroad tie debris, prior to gravel replacement.

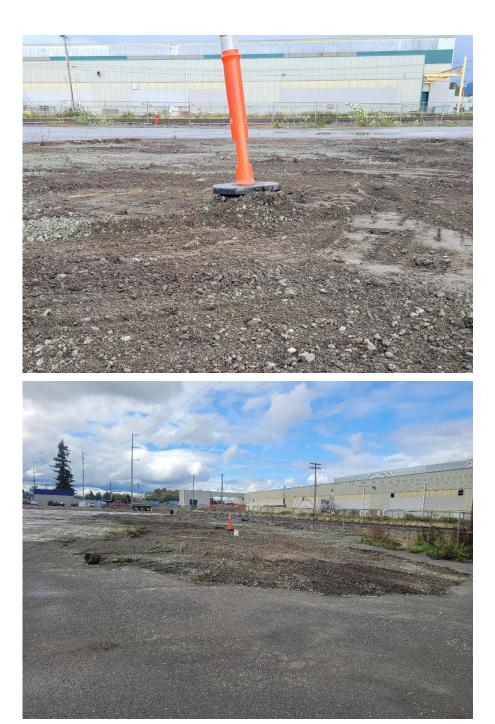
Photo No. 7.

Photo looking southwest from the northeast corner of the northern gravel area after removal of the intermixed gravel and railroad tie debris, prior to gravel replacement.

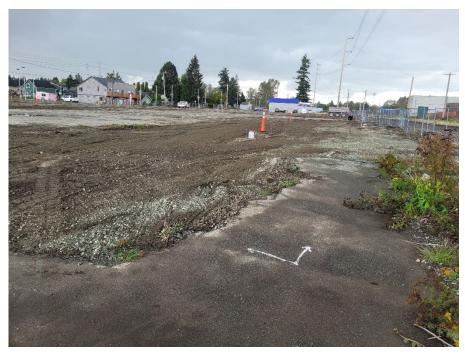
Photo No. 9.

Photo looking northeast from the southwest corner of the northern gravel area after removal of the intermixed gravel and railroad tie debris and sweeping of the concrete pad areas, prior to gravel replacement.

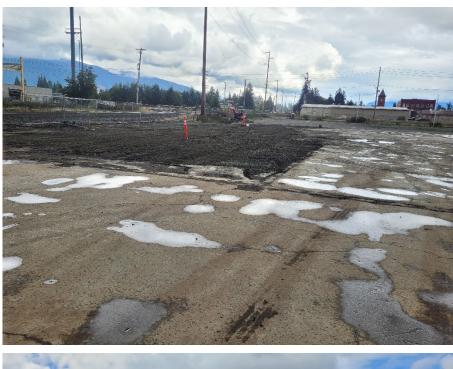
Photo No. 11.

Photo looking west across the southern gravel area after removal of the intermixed gravel and railroad tie debris, prior to gravel replacement.

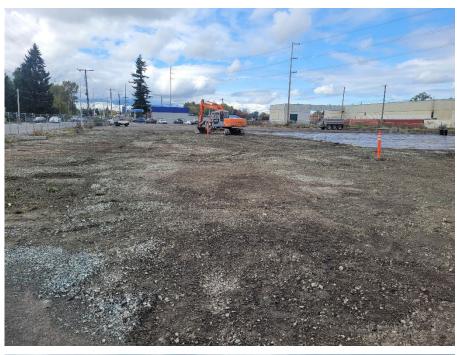
Photo No. 13.

Photo looking east from the southwest corner of the southern gravel area after removal of the intermixed gravel and railroad tie debris, prior to gravel replacement.

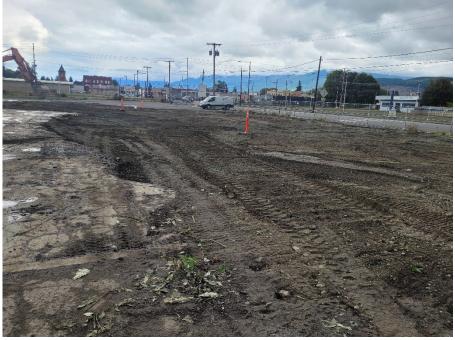
Photo looking west from the southeast corner of the northern gravel area after gravel replacement towards the traffic cone covering the damaged MW01R well casing.

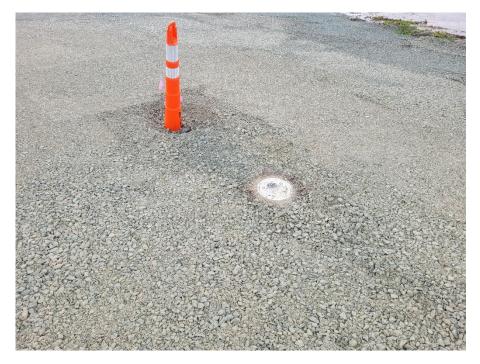
Photo No. 29.

Photo looking southeast at the replacement monitoring well MW01R2 after gravel replacement in the center-right in relation to the damaged MW01R well casing (underlying the traffic cone).
