COLLEGE AVENUE STEAM PLANT ADAPTIVE REUSE

Integrated Cleanup and Implementation Plan

Port of
Whitman
County

PORT OF WHITMAN COUNTY
March 30, 2020

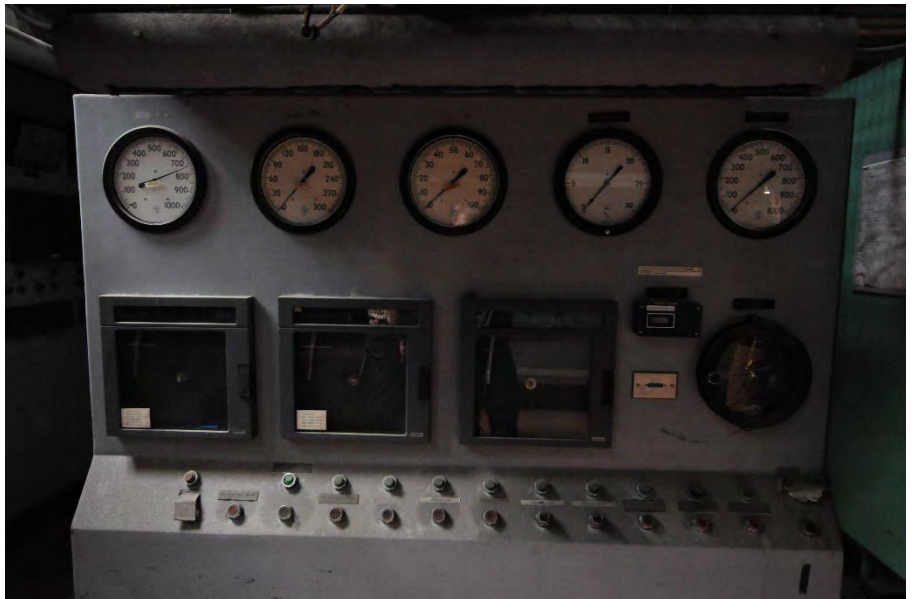
Photo No. 38.

High ceiling section
boiler systems

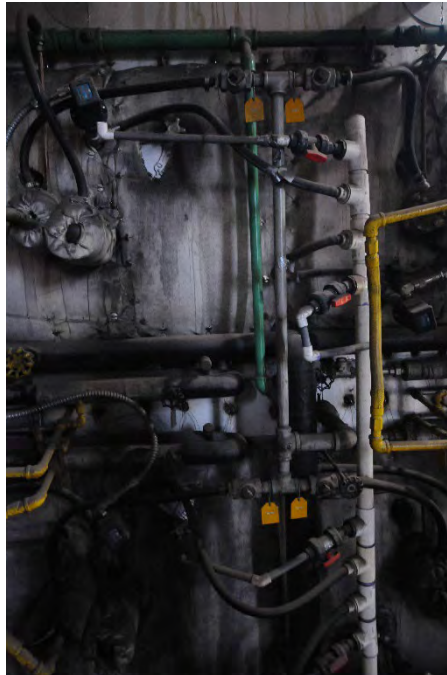
Photo No. 40.

High ceiling section
boiler systems

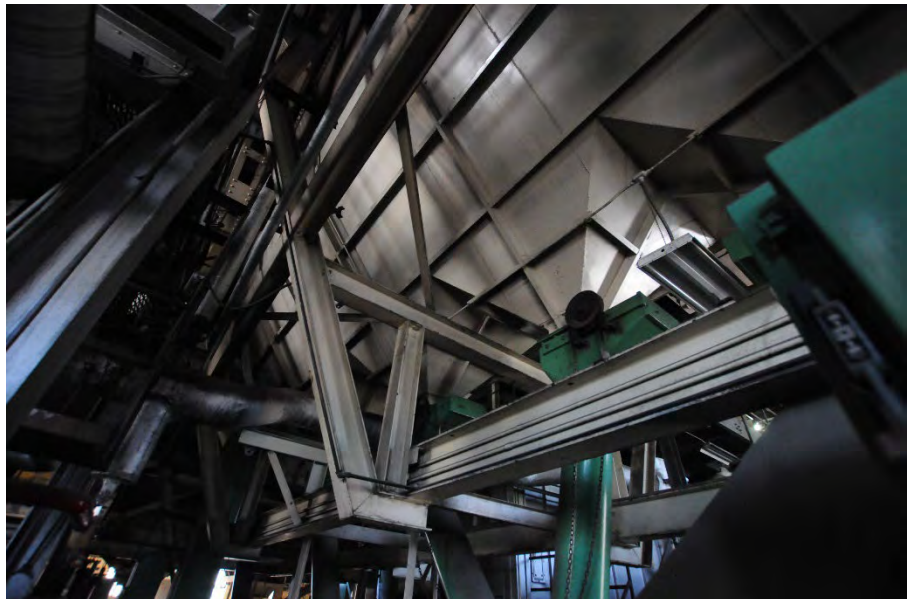
Photo No. 42.

High ceiling section
boiler systems

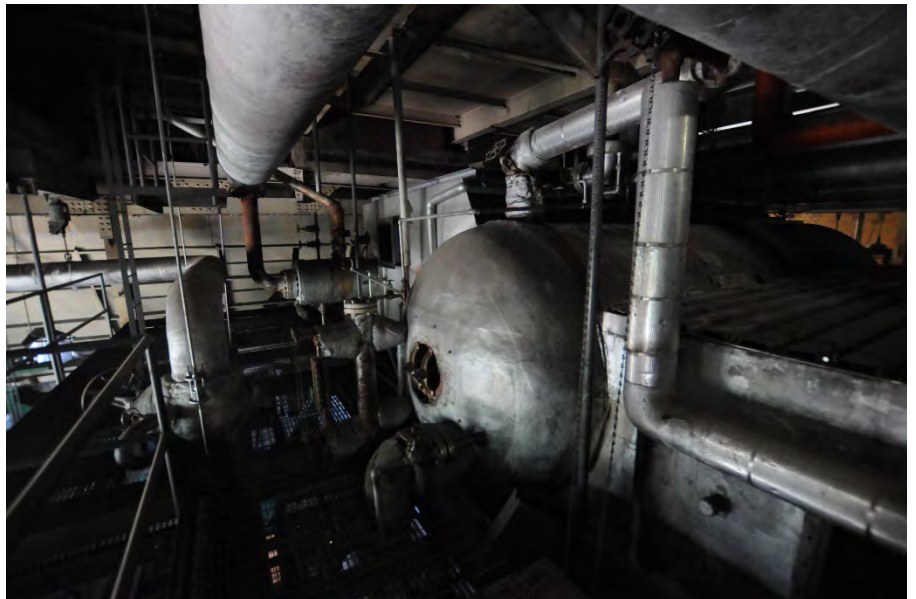
Photo No. 44.

High ceiling section
boiler systems

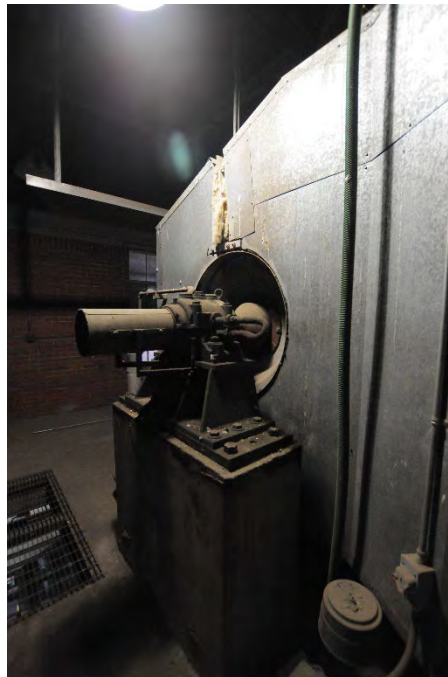
Photo No. 46.

High ceiling section
boiler systems

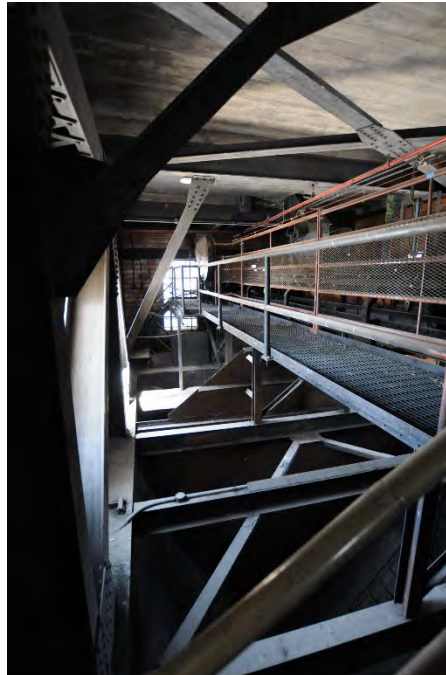
Photo No. 48.

Coal loader at top of
high ceiling section

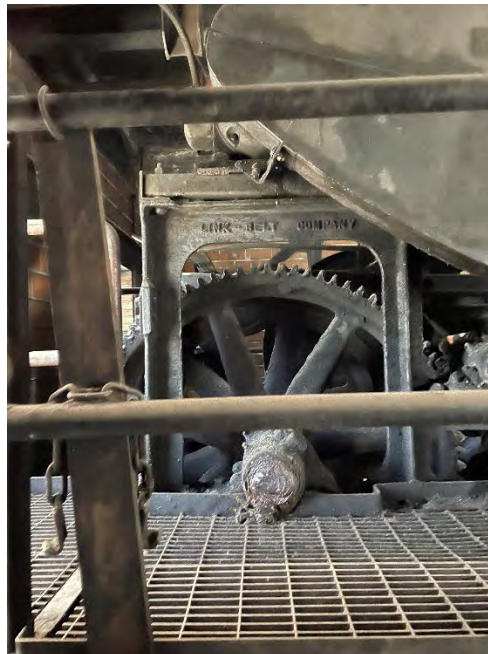
Photo No. 50.

Coal loader at top of high ceiling section

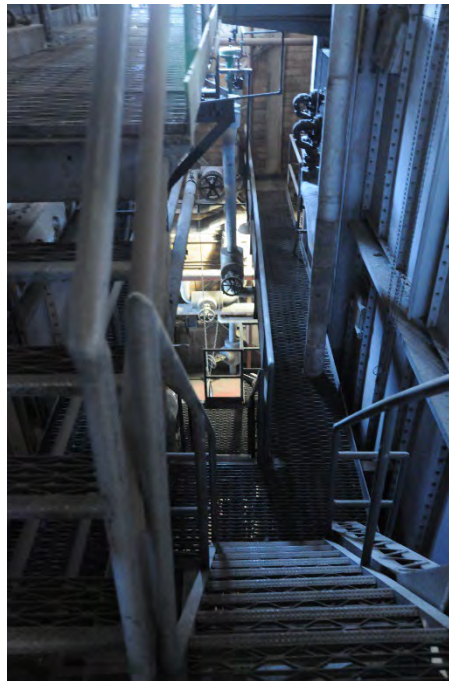
Photo No. 52.

High ceiling section
boiler systems

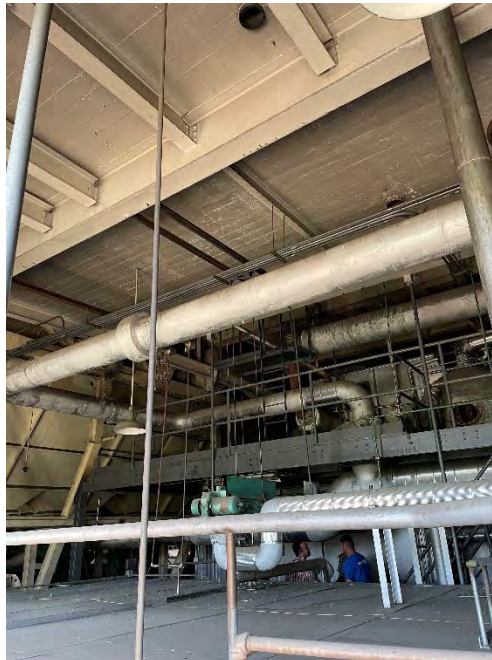
Photo No. 54.

High ceiling section
boiler systems

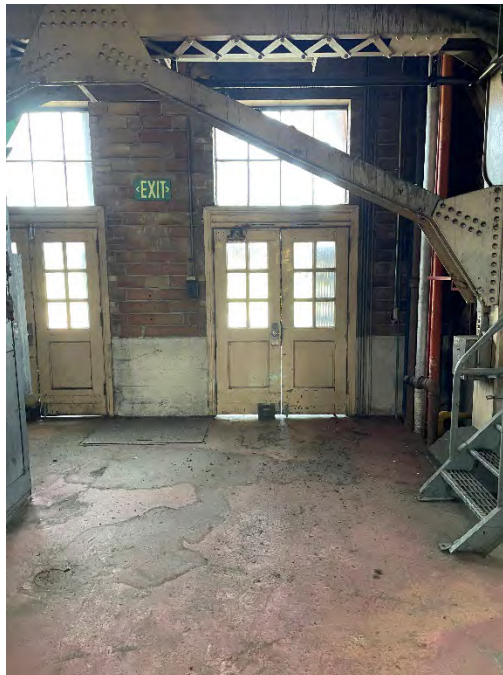
Photo No. 56.

West facing entrance
from inside

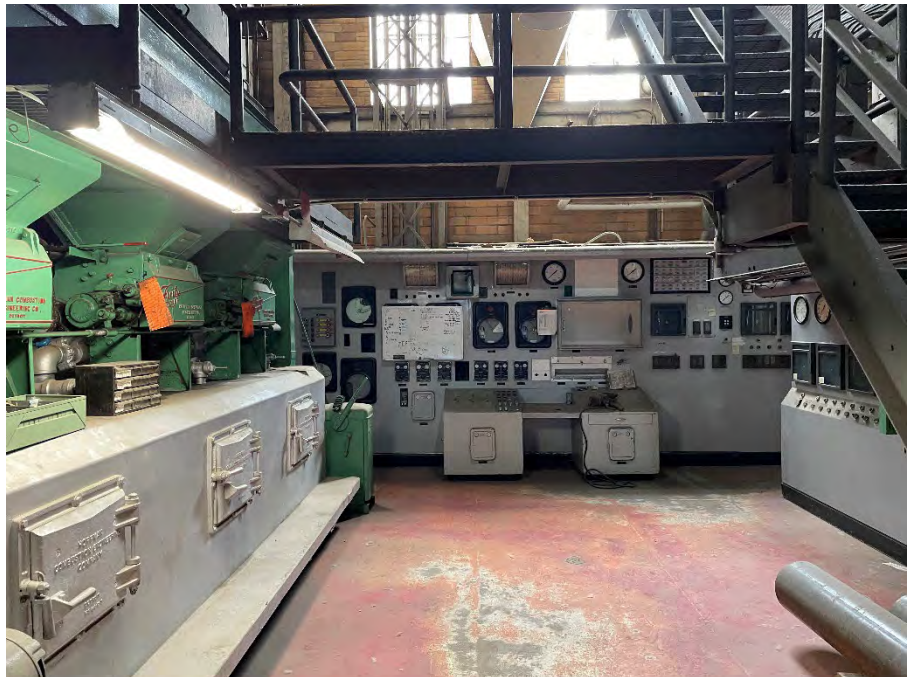
Photo No. 58.

High ceiling section
boiler systems

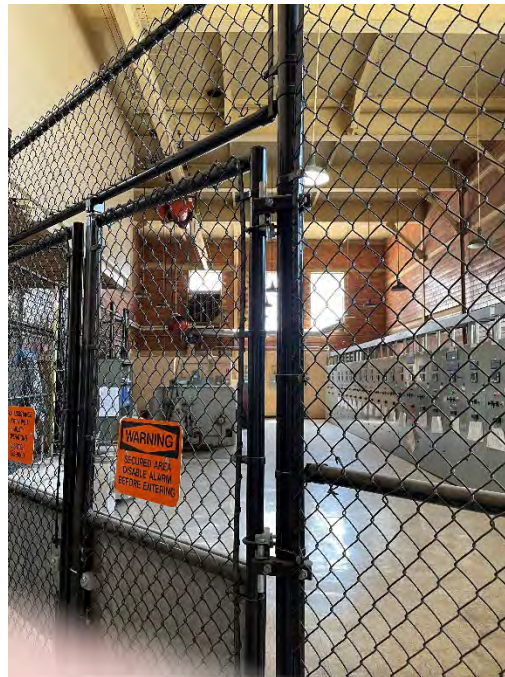
Photo No. 60.

Switch gear area in
southern section

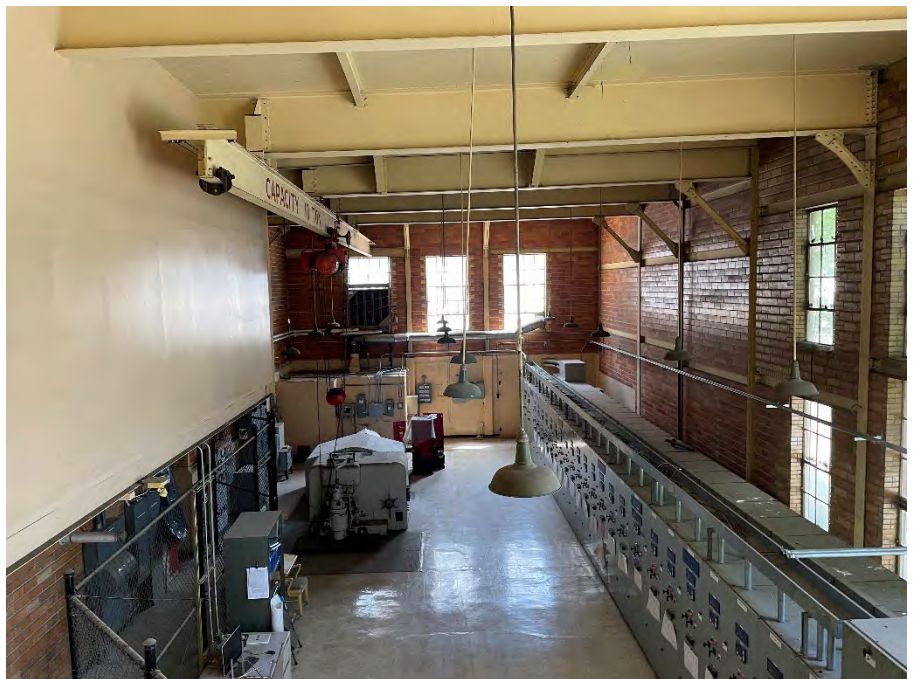
Photo No. 62.

Switch gear area in southern section

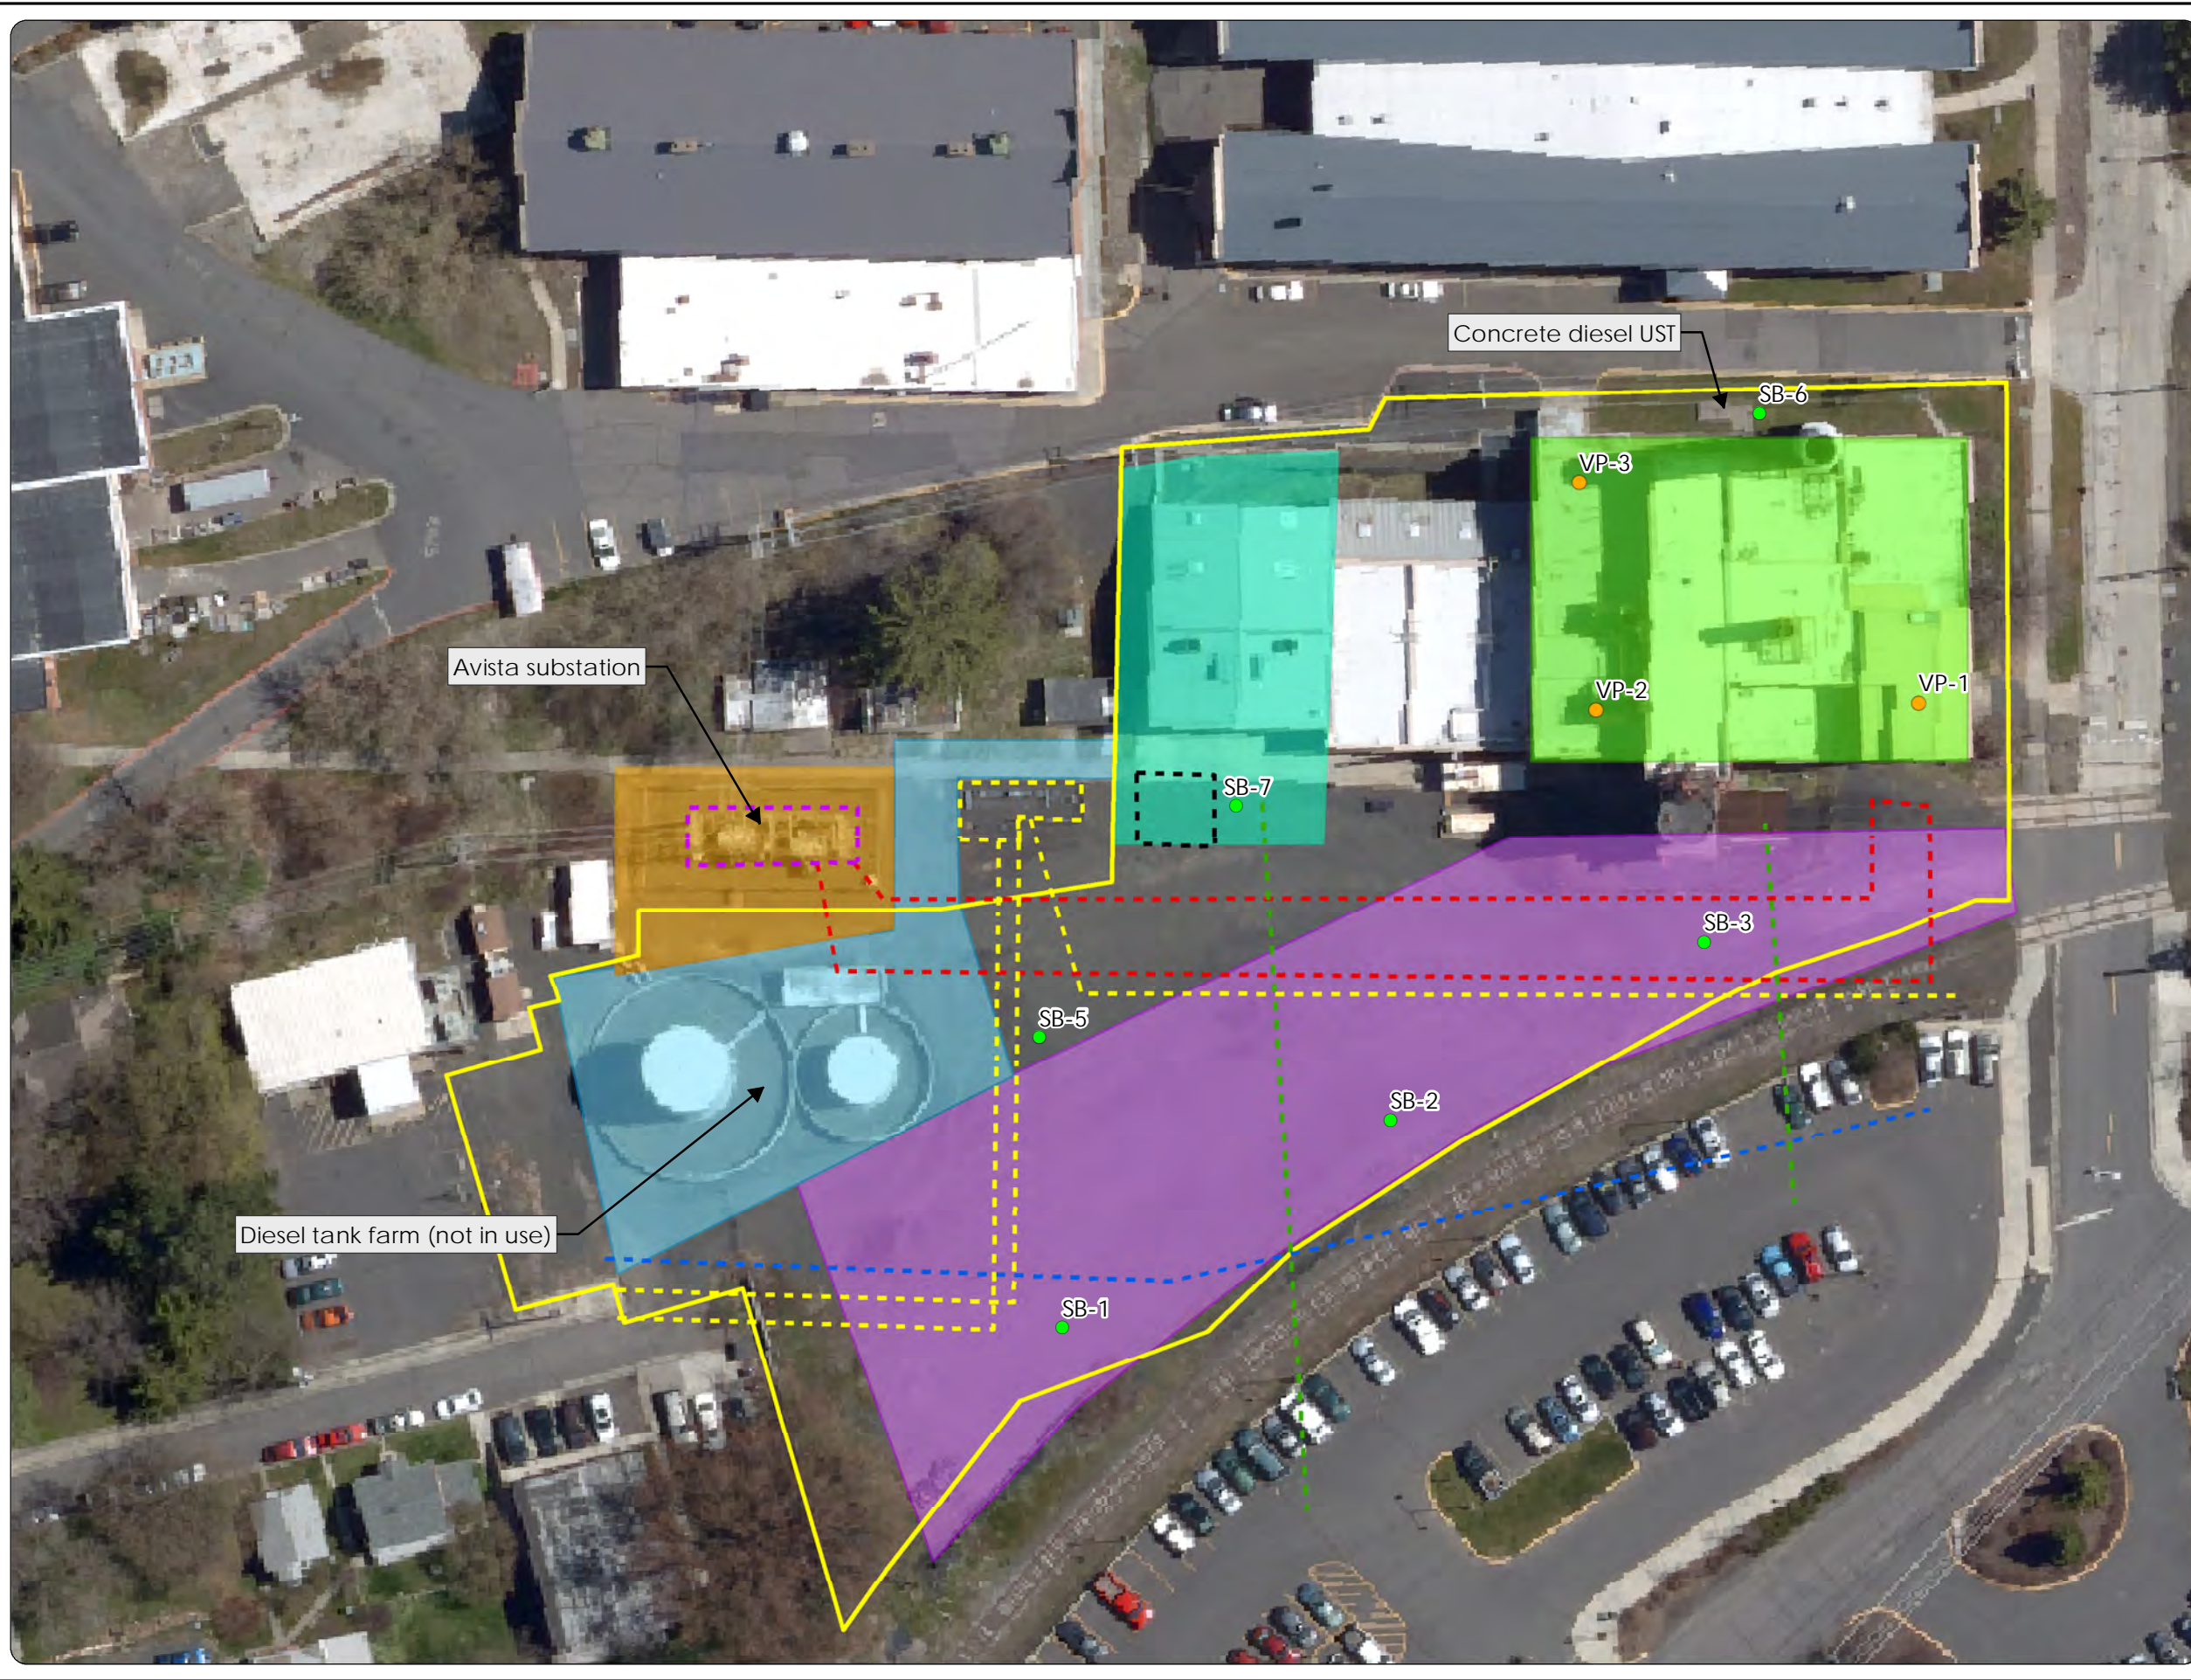
Figure 1-3
Sample Locations
 College Avenue Steam Plant
 Port of Whitman County
 Pullman, Washington

Boring location SB-5 was advanced downgradient of the location of the former diesel AST tank farm and the Avista electrical substation (see Figure 1-3). The boring was advanced to 20 ft bgs. Subsurface soil consisted of silty sand and sandy silt, with coal fragments from 3.0-3.8 ft bgs. Soil was field screen using a photoionization detector. Soil samples were collected from depths of 5 and 15 ft bgs. Soil samples collected from location SB-5 were analyzed for the following:

Boring location SB-7 was completed downgradient of the historical oil storage area and Avista electrical substation (see Figure 1-3). The boring was advanced to 21 ft bgs. Soils were screened in approximately 3-foot intervals, when recovered. Dark brown gravelly sand with silt and trace coal fragments were observed from the surface to a depth of 5.4 ft bgs, when recovered. Below that, brown silt was observed, becoming sandy from 12.5 to 20 ft bgs. Samples were collected at 7.5 and 18.5 ft bgs. Samples were analyzed for the following:

Soil vapor was collected at sample points VP-1, VP-2, and VP-3 (Figure 1-3). Each of the soil vapor samples were analyzed for VOCs and helium (Table 4-3). Helium analysis was completed to determine whether the sample train was sealed and confirm that only vapor from beneath the concrete slab was collected in each sample. All three samples were non-detect for helium.

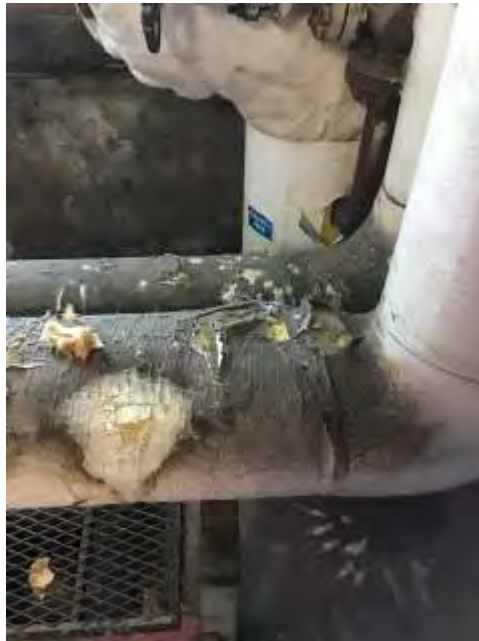
Sample ID:	Sample Type:	
1-1-TSI-1	TSI	
Sample Location:	Detailed Sample Location:	
Room 101	Condensate pipe in northwest corner of room.	
Sample Quantity:	38 linear feet.	
Sample Color:	XRF:	
Misc Sample Material:	Sample Condition:	Sample Friable?:
	Damaged or significantly damaged	Yes

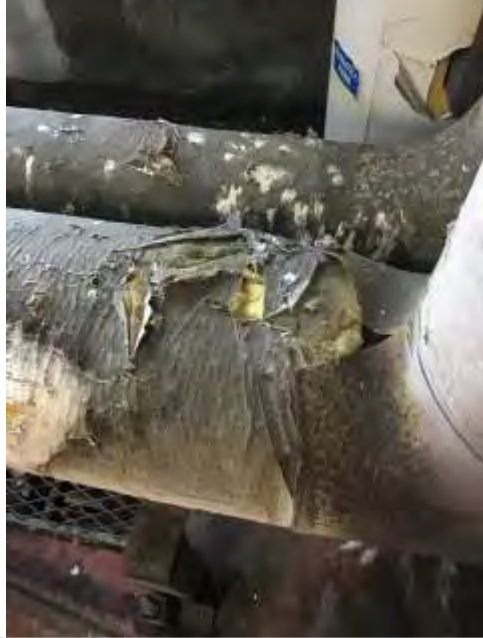
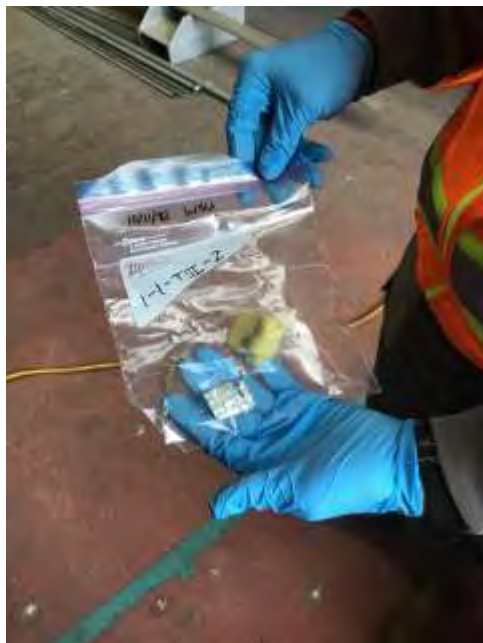
Additional Sample Notes:		White pipe wrapping with yellow insulation.
Sample ID:	Sample Type:	
1-1-TSI-2	TSI	
Sample Location:	Detailed Sample Location:	
Room 101	Condensate pipe in northwest corner of room.	
Sample Quantity:	38 linear feet.	
Sample Color:	XRF:	
Misc Sample Material:	Sample Condition:	Sample Friable?:
	Damaged or significantly damaged	Yes

White pipe wrapping with yellow insulation.

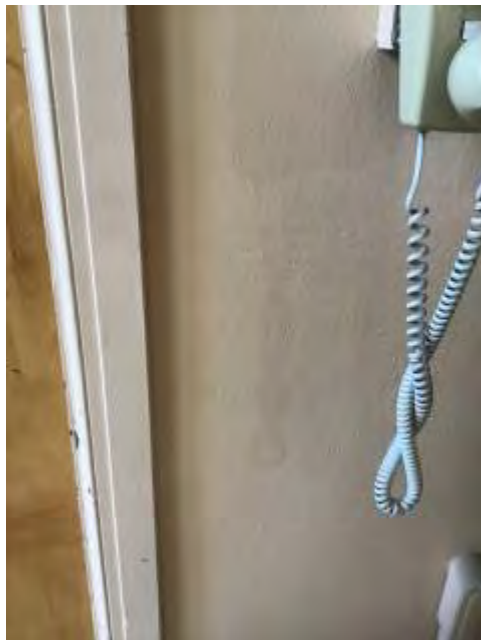
Sample ID:	Sample Type:
1-1-PB-2	PB
Sample Location:	Detailed Sample Location:
Room 102	West wall north of room 105 doorway.
Sample Quantity:	N/A
Sample Color:	XRF:
Tan	0.071

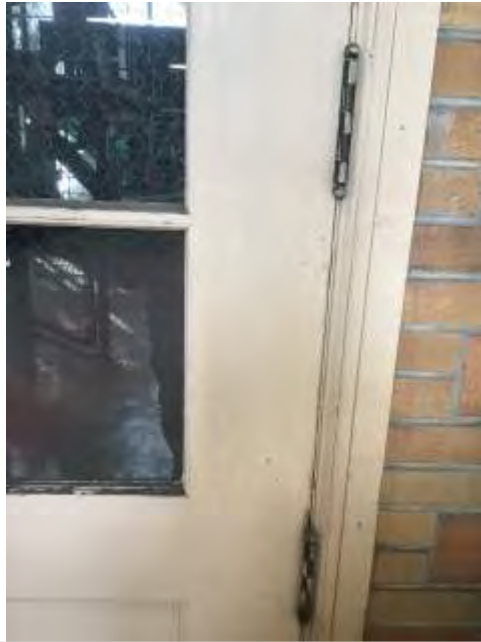
Sample ID:	Sample Type:
1-1-PB-3	PB
Sample Location:	Detailed Sample Location:
Room 102	North double doors between room 102 and 101.
Sample Quantity:	N/A
Sample Color:	XRF:
Tan	0.177

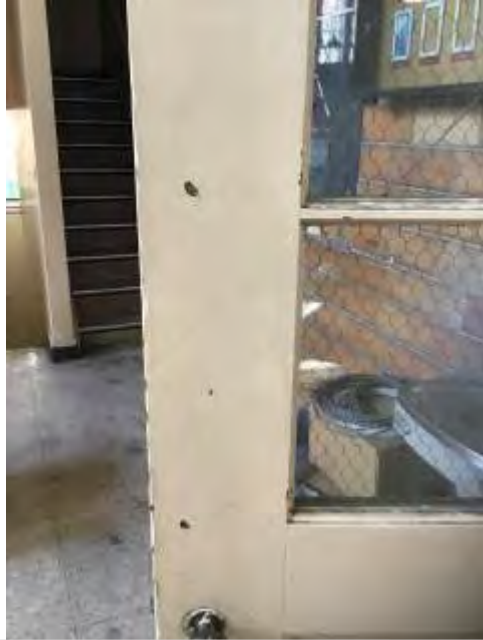
Sample ID:	Sample Type:
1-1-PB-4	PB
Sample Location:	Detailed Sample Location:
Room 102	North double door between room 102 and 101.
Sample Quantity:	N/A
Sample Color:	XRF:
Tan	0.224

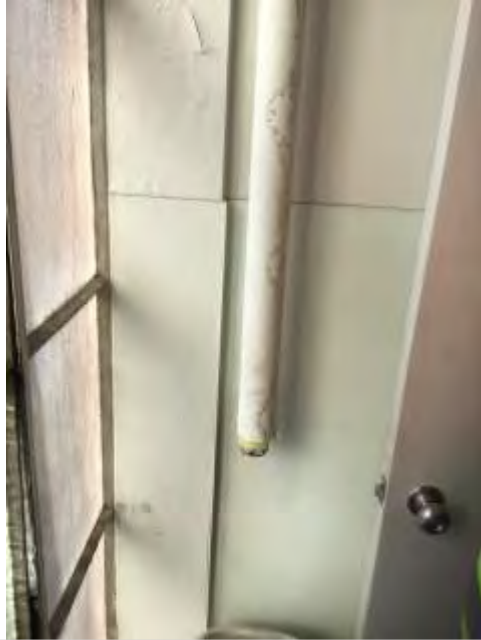
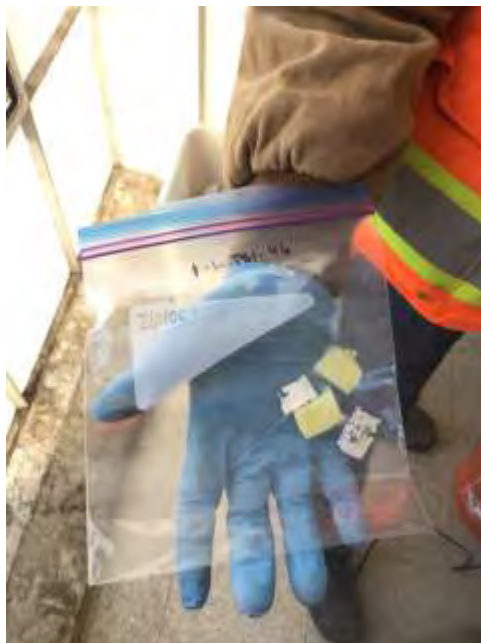
Additional Sample Notes:		
Sample ID:	Sample Type:	
1-1-TSI-46	TSI	
Sample Location:	Detailed Sample Location:	
Room 107	Pipe in northwest corner of room 107.	
Sample Quantity:	38 linear feet.	
Sample Color:	XRF:	
Misc Sample Material:	Sample Condition:	Sample Friable?:
	Damaged or significantly damaged; Potential ACBM with potential for significant damage	Yes

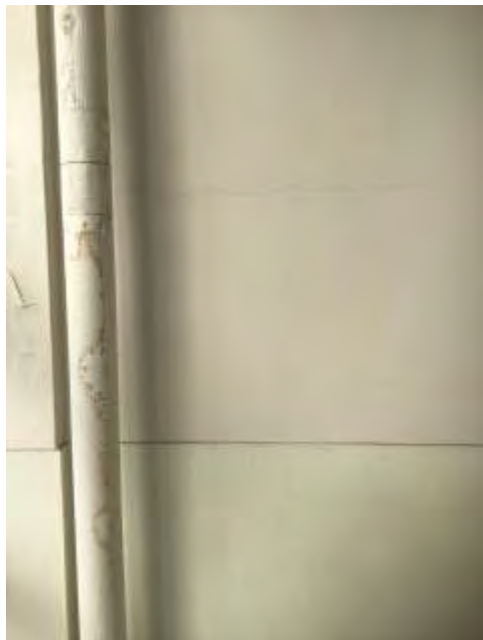
Sample ID:	Sample Type:
1-2-PB-6	PB
Sample Location:	Detailed Sample Location:
Room 107	North wall of room 107.
Sample Quantity:	120 square feet.
Sample Color:	XRF:
White	1.63

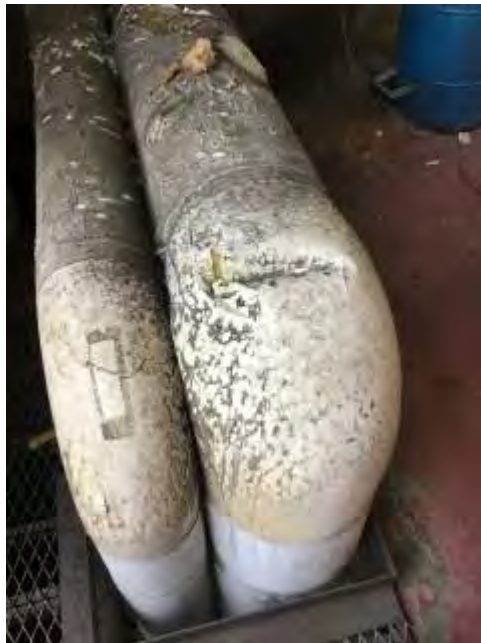
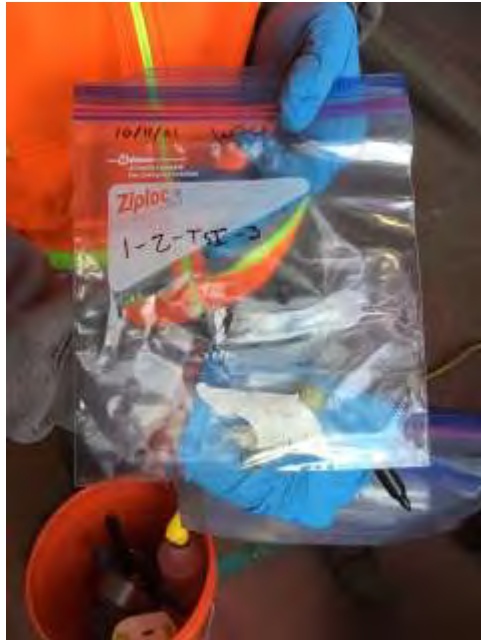
1-2-TSI-3

Damaged or significantly damaged	Yes
--	----------------------------------	-----

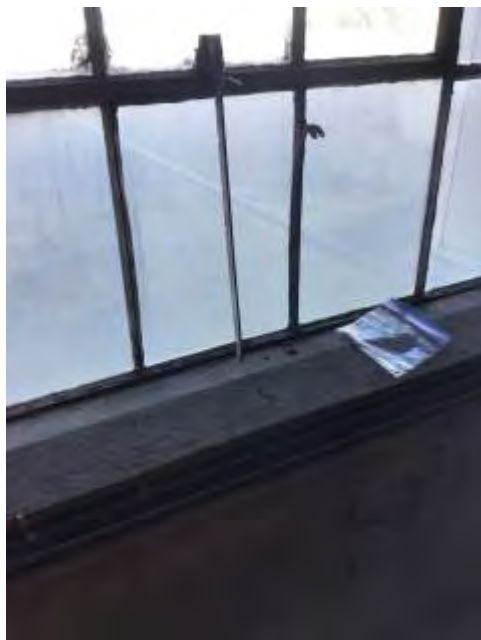
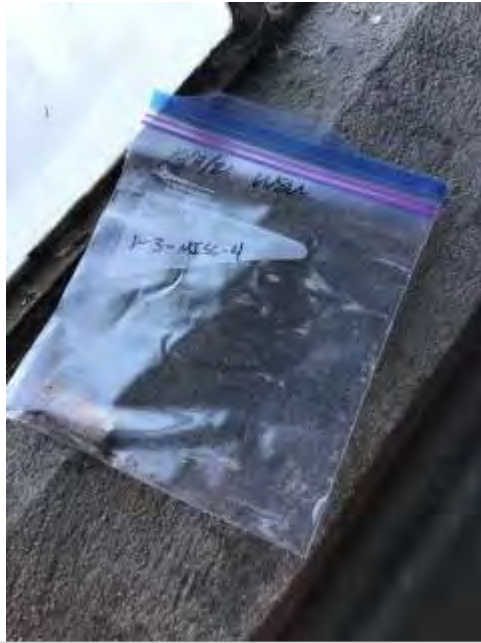
Additional Sample Notes:		White pipe covering with yellow insulation.
Sample ID:	Sample Type:	
1-3-MISC-4	MISC	
Sample Location:	Detailed Sample Location:	
Room 101	Window at northwest corner of room.	
Sample Quantity:	4,030 linear feet.	
Misc Sample Material:	Sample Condition:	Sample Friable?:
Window glazing.	Potential ACBM with potential for damage	Yes

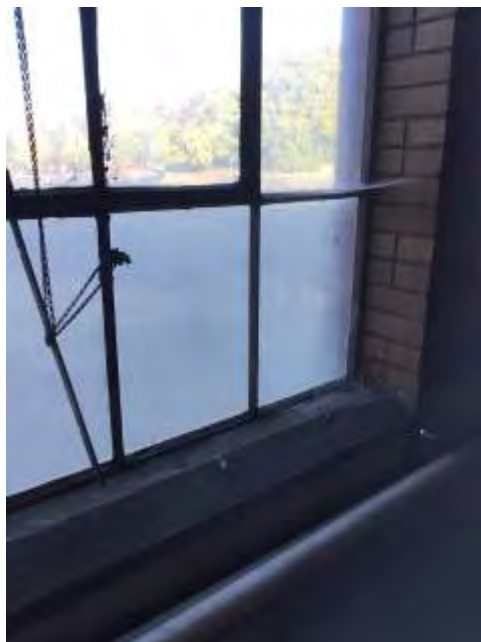
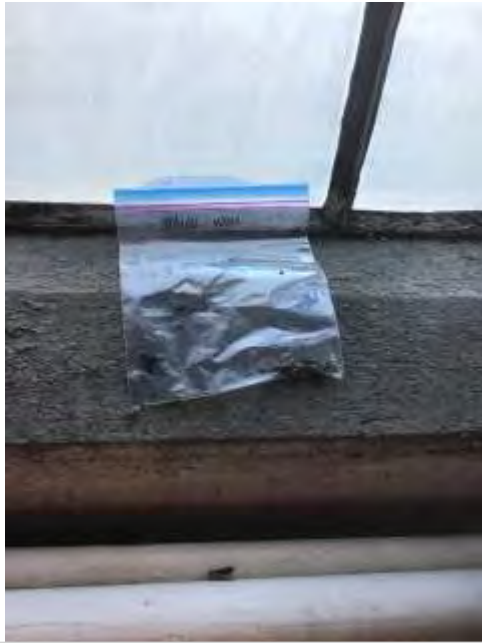
Sample ID:	Sample Type:	
1-3-MISC-5	MISC	
Sample Location:	Detailed Sample Location:	
Room 101	Window at west wall.	
Sample Quantity:	4,030 linear feet.	
Misc Sample Material:	Sample Condition:	Sample Friable?:
Window glazing.	Potential ACBM with potential for damage	Yes

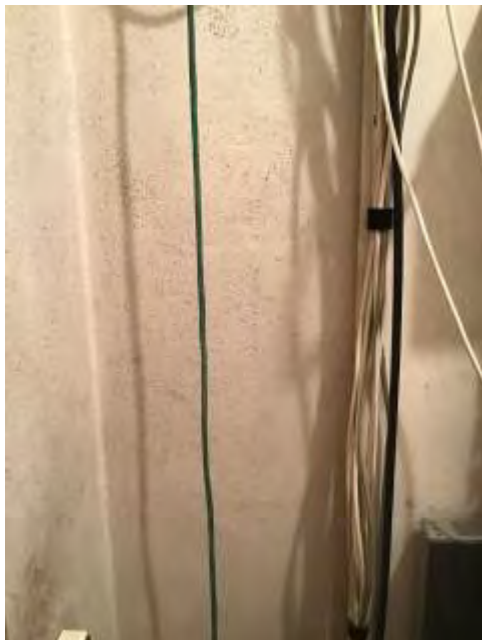
Sample ID:	Sample Type:
1-3-PB-7	PB
Sample Location:	Detailed Sample Location:
Room 106T	East wall in room 106T.
Sample Quantity:	N/A
Sample Color:	XRF:
Off-white	ND

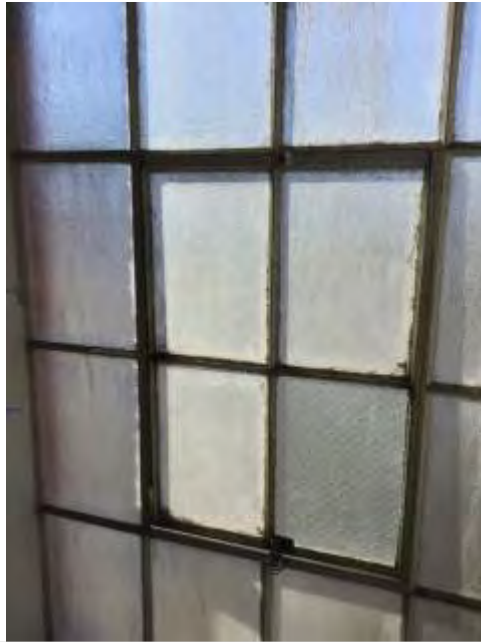
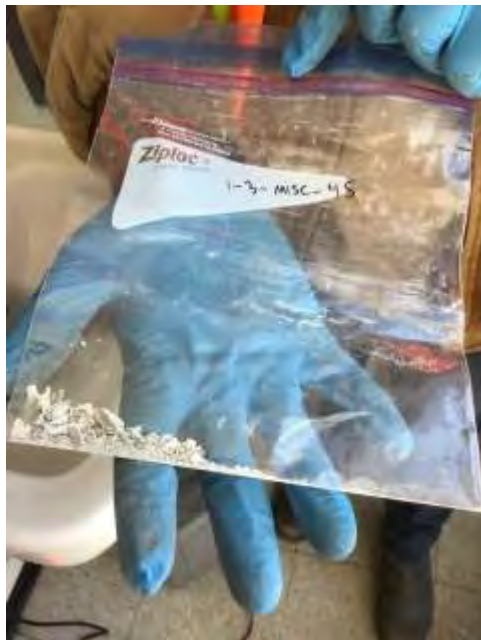
Additional Sample Notes:		
Sample ID:	Sample Type:	
1-3-MISC-45	MISC	
Sample Location:	Detailed Sample Location:	
Room 107	West wall window frame in room 107.	
Sample Quantity:	4,030 linear feet.	
Misc Sample Material:	Sample Condition:	Sample Friable?:
Window glazing.	Potential ACBM with potential for damage	No

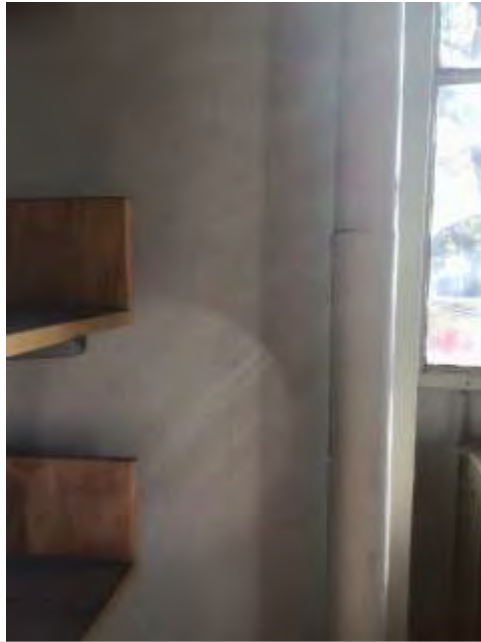
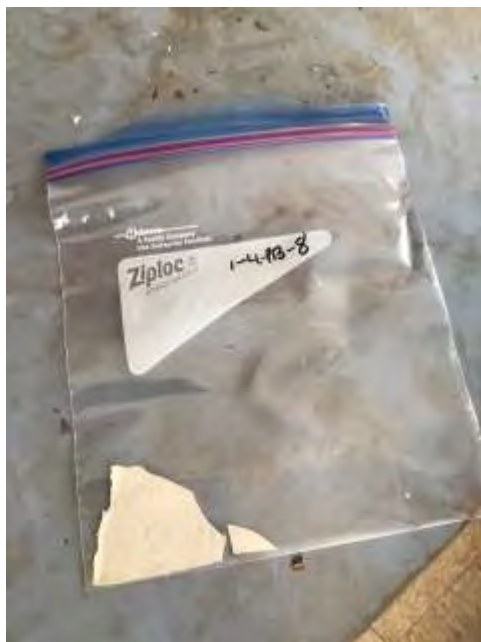
Sample ID:	Sample Type:
1-4-PB-8	PB
Sample Location:	Detailed Sample Location:
Room 104	South wall east of window in room 104.
Sample Quantity:	N/A
Sample Color:	XRF:
White	0.181

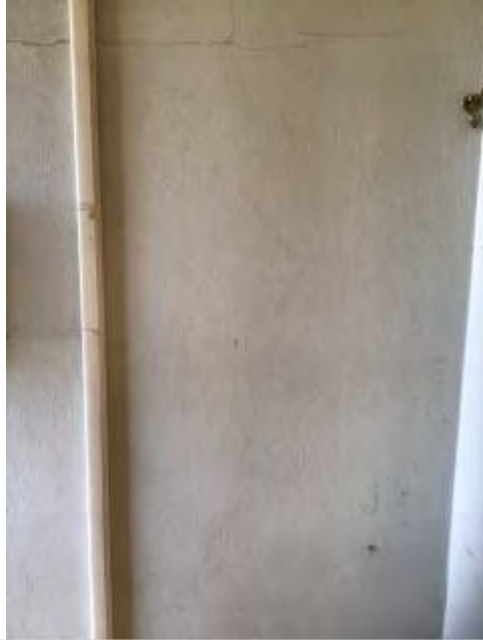
Sample ID:	Sample Type:
1-4-PB-10	PB
Sample Location:	Detailed Sample Location:
Room 105	East side of north wall.
Sample Quantity:	N/A
Sample Color:	XRF:
White	0.211

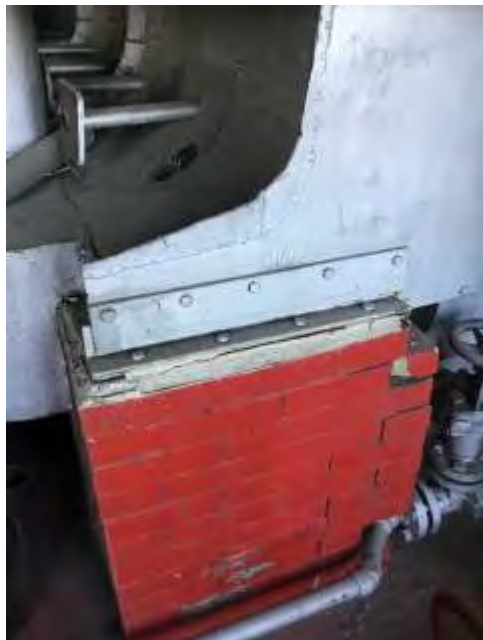
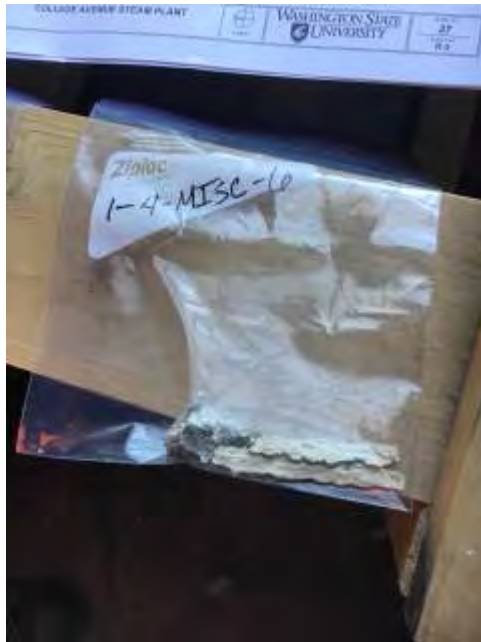
Sample ID:	Sample Type:	
1-4-MISC-6	MISC	
Sample Location:	Detailed Sample Location:	
Room 101	Above red brick on northwest corner of northwest boiler.	
Sample Quantity:	3.5 linear feet.	
Misc Sample Material:	Sample Condition:	Sample Friable?:
Tan cementitious material.	Potential ACBM with potential for damage	Yes

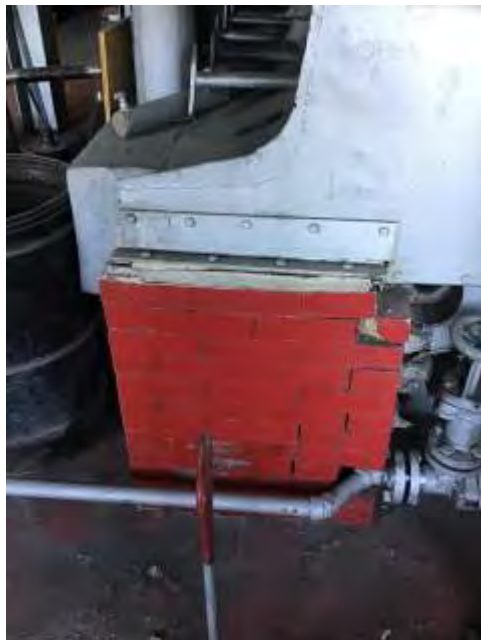
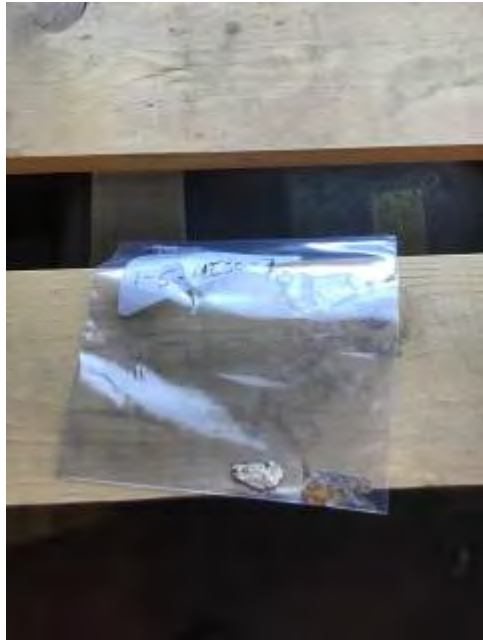
Sample ID:	Sample Type:	
1-5-MISC-7	MISC	
Sample Location:	Detailed Sample Location:	
Room 101	Red brick on northwest corner of northwest boiler.	
Sample Quantity:	8 square feet.	
Misc Sample Material:	Sample Condition:	Sample Friable?:
Red brick.	Potential ACBM with potential for damage	Yes

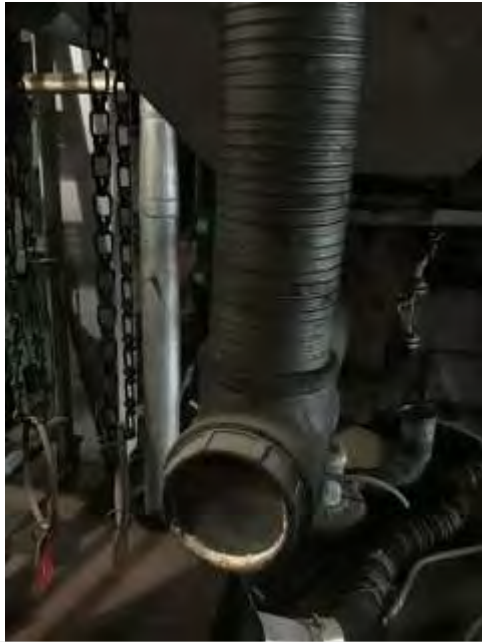
Sample ID:	Sample Type:
1-5-PB-34	PB
Sample Location:	Detailed Sample Location:
Room 101	North side of northeast boiler.
Sample Quantity:	N/A
Sample Color:	XRF:
Silver	ND

Additional Sample Notes:	Silver paint on various steam equipment in room 101.
---------------------------------	--

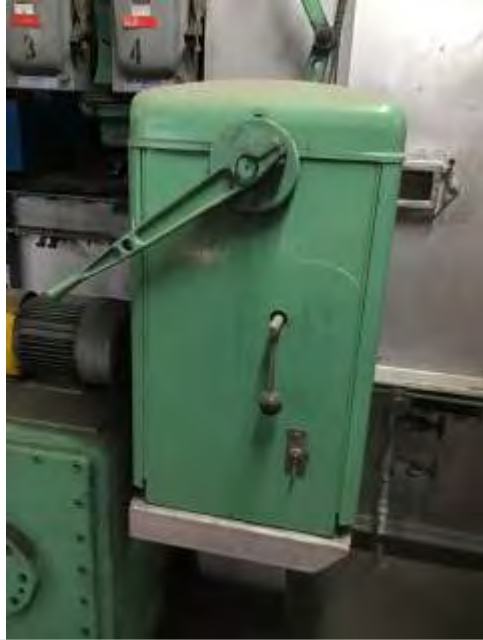
Sample ID:	Sample Type:
1-6-PB-12	PB
Sample Location:	Detailed Sample Location:
Room 101	Hydraulic Drive on northwest side of south middle boiler.
Sample Quantity:	N/A
Sample Color:	XRF:
Green	0.326

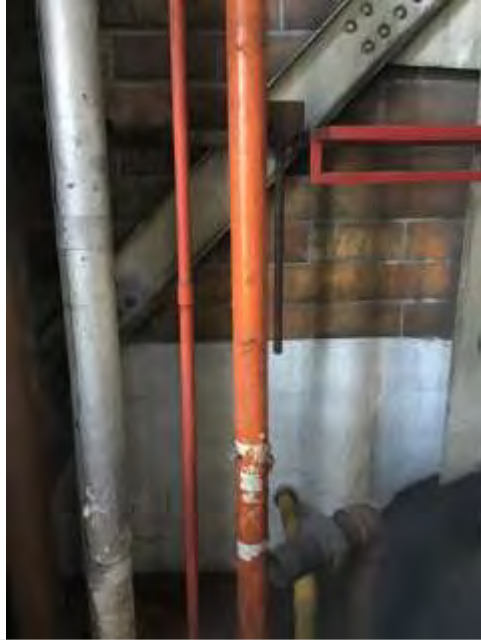
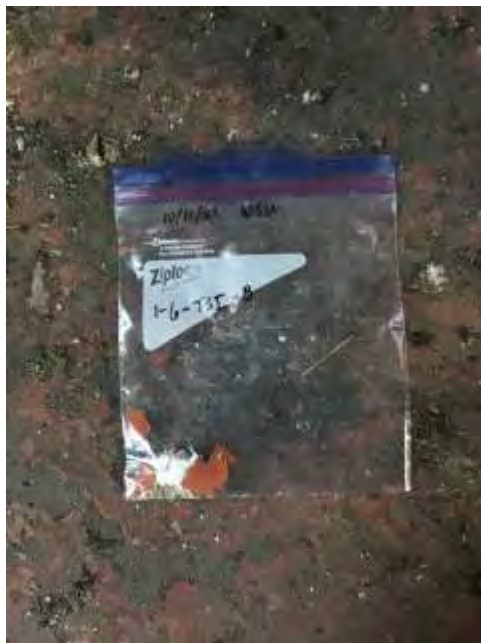
Additional Sample Notes:		
Sample ID:	Sample Type:	
1-6-TSI-8	TSI	
Sample Location:	Detailed Sample Location:	
Room 101	Red pipe by double doors on west side of room.	
Sample Quantity:	20 linear feet.	
Sample Color:	XRF:	
Misc Sample Material:	Sample Condition:	Sample Friable?:
Tan cementitious material	Damaged or significantly damaged	Yes

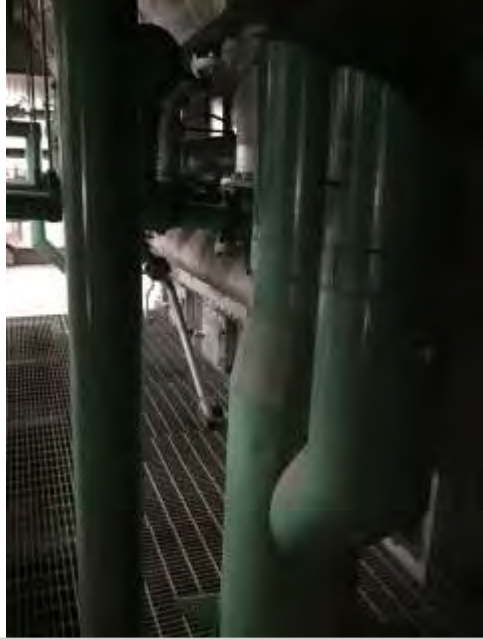
Additional Sample Notes:	Red pipe wrap with fibrous white insulation.
Sample ID:	Sample Type:
1-6-PB-38	PB
Sample Location:	Detailed Sample Location:
Room 101	Green pipe on south end of south middle boiler.
Sample Quantity:	N/A
Sample Color:	XRF:
Green	0.375

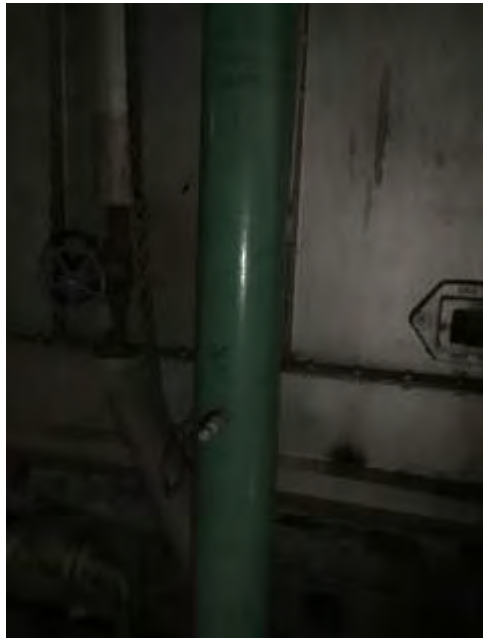
Sample ID:	Sample Type:
1-6-PB-36	PB
Sample Location:	Detailed Sample Location:
Room 101	East side of northeast boiler.
Sample Quantity:	N/A
Sample Color:	XRF:
Green	0.503

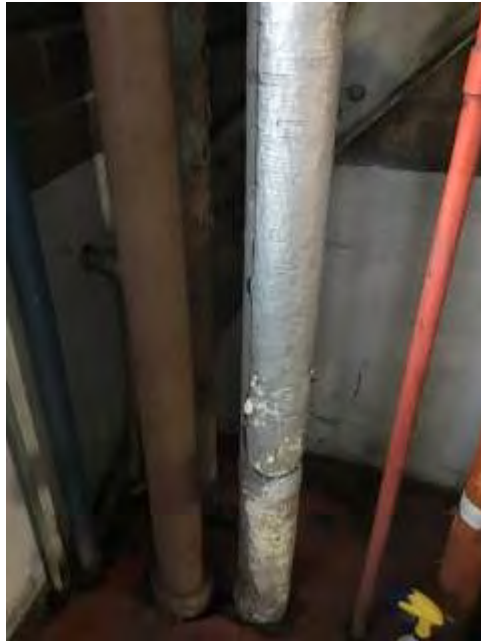
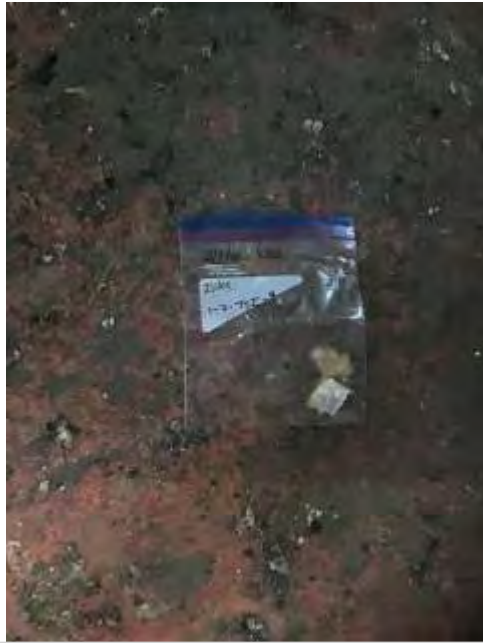
Additional Sample Notes:	Green paint on various steam equipment in 101.	
Sample ID:	Sample Type:	
1-7-TSI-9	TSI	
Sample Location:	Detailed Sample Location:	
Room 101	Silver pipe by double doors on west side of room.	
Sample Quantity:	30 linear feet.	
Sample Color:	XRF:	
Misc Sample Material:	Sample Condition:	Sample Friable?:
Tan cementitious material	Damaged or significantly damaged	Yes

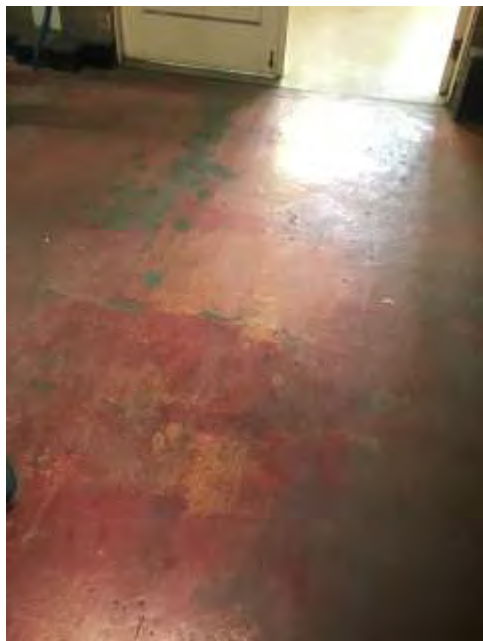
Additional Sample Notes:	Silver pipe wrap with yellow fibrous insulation
Sample ID:	Sample Type:
1-7-PB-13	PB
Sample Location:	Detailed Sample Location:
Room 101	Floor on south side of room in front of double door between room 102 and 101.
Sample Quantity:	N/A
Sample Color:	XRF:
Red	0.188

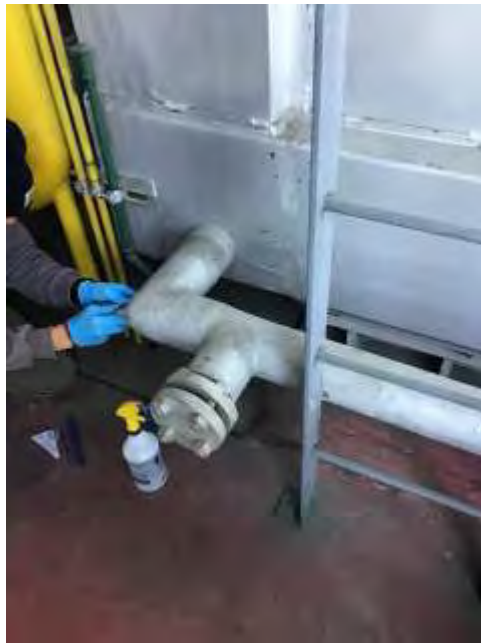
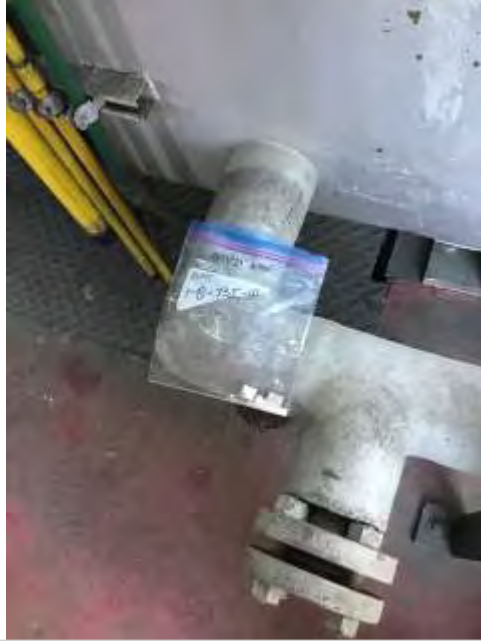
1-8-TSI-10

Tan cementitious material	Damaged or significantly damaged	Yes
---------------------------	----------------------------------	-----

White fibrous insulation with various colors of pipe wrap covers (e.g., also includes red pipe in southwest corner of room that runs to north section of room). Difficult to quantify due to distribution and various wrap colors.
