COLLEGE AVENUE STEAM PLANT ADAPTIVE REUSE

Integrated Cleanup and Implementation Plan

Port of
Whitman
County

PORT OF WHITMAN COUNTY
March 30, 2020

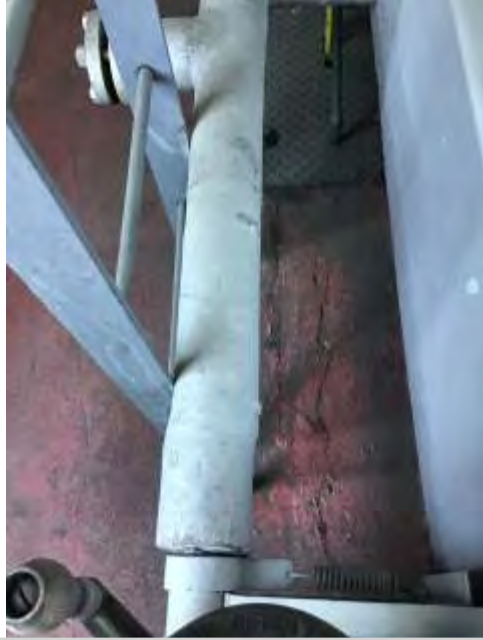
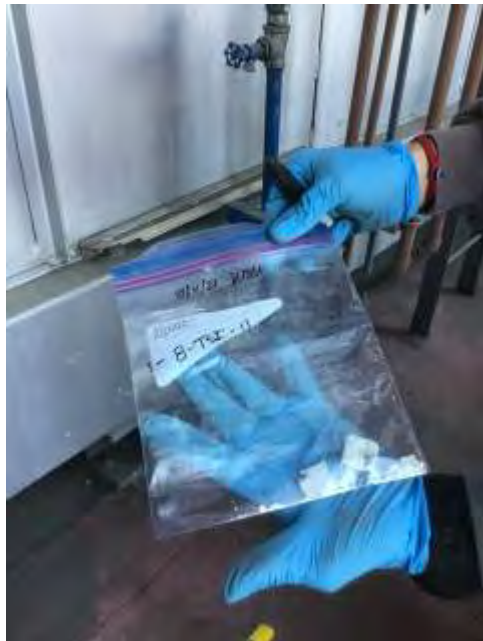
Sample ID:	Sample Type:	
1-8-TSI-11	TSI	
Sample Location:	Detailed Sample Location:	
Room 101	Silver pipe on boiler by staircase to lower floor on west side of room.	
Sample Quantity:	3,000 linear feet.	
Sample Color:	XRF:	
Misc Sample Material:	Sample Condition:	Sample Friable?:
Tan cementitious material	Damaged or significantly damaged	Yes

White fibrous insulation with various colors of pipe wrap covers (e.g., also includes red pipe in southwest corner of room that runs to north section of room). Difficult to quantify due to distribution and various wrap colors.

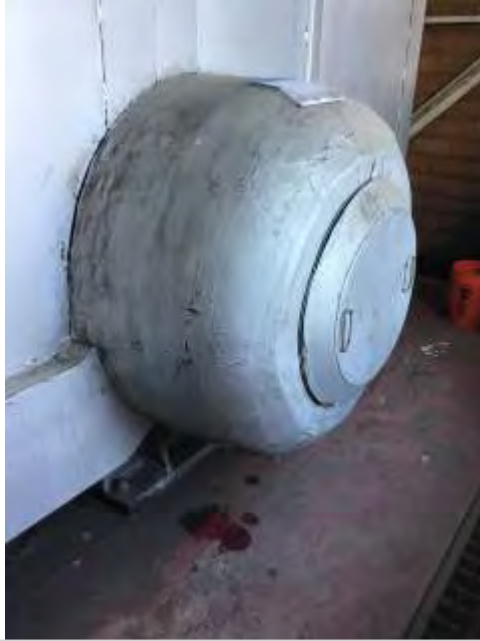
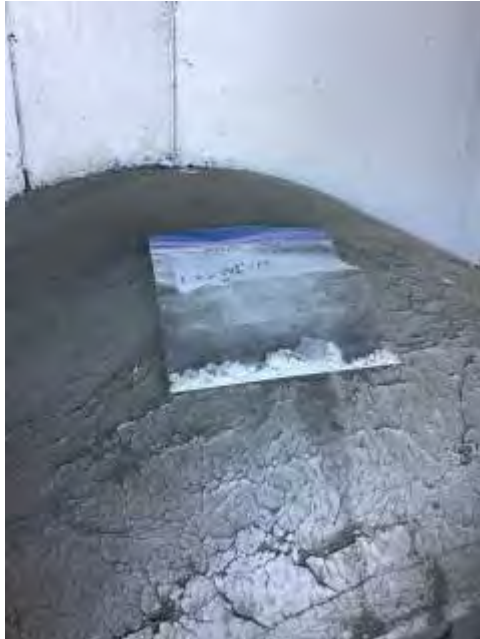
1-8-TSI-12

Misc Sample Material:	Sample Condition:	Sample Friable?:
Tan cementitious material	Damaged or significantly damaged	Yes

Additional Sample Notes:	White fibrous insulation with various colors of pipe wrap covers (e.g., also includes red pipe in southwest corner of room that runs to north section of room). Difficult to quantify due to distribution and various wrap colors.
---------------------------------	--

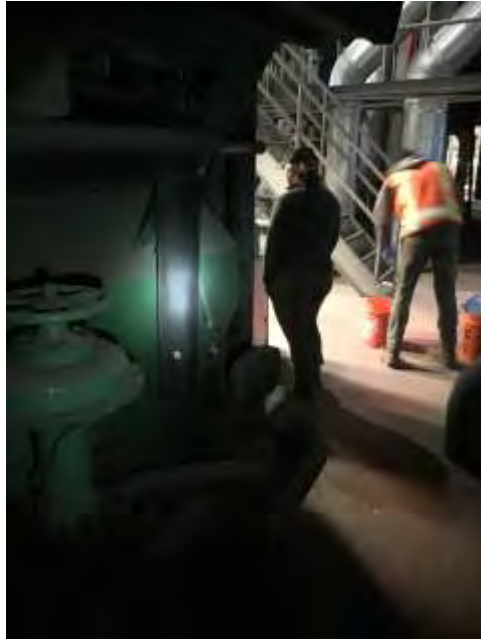
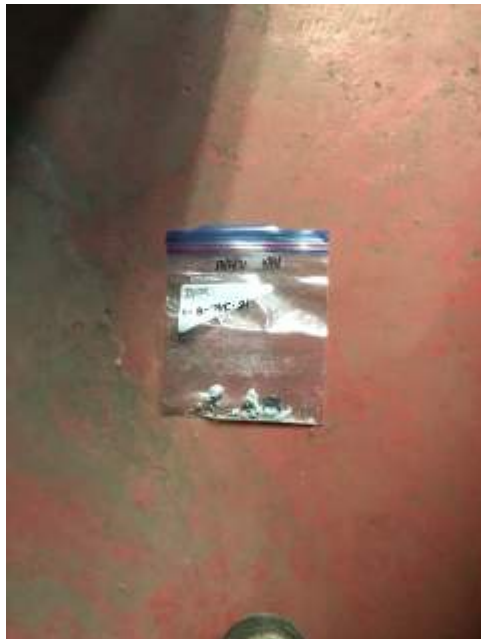
1-8-TSI-21

Room 101	Dark gray pipe between boilers 4 and 5.	
Sample Quantity:	3,000 linear feet.	
Sample Color:	XRF:	
Misc Sample Material:	Sample Condition:	Sample Friable?:
Tan cementitious material	Damaged or significantly damaged	Yes

Additional Sample Notes:	Dark gray pipe wrap with white fibrous insulation. Insulation appears to be consistent with Homogenous Area 8. Difficult to quantify due to distribution and various wrap colors.
---------------------------------	---

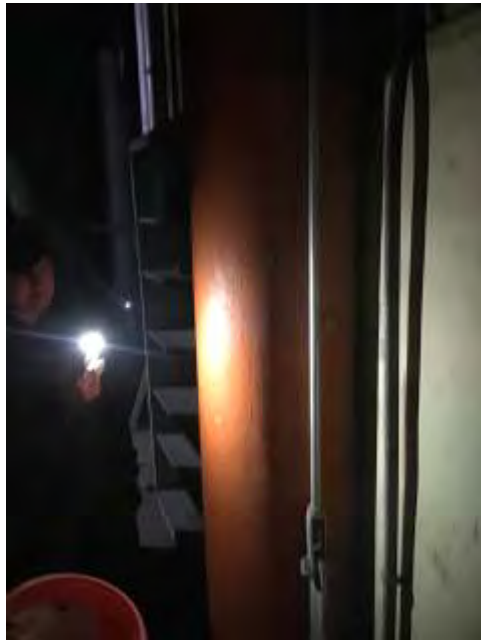
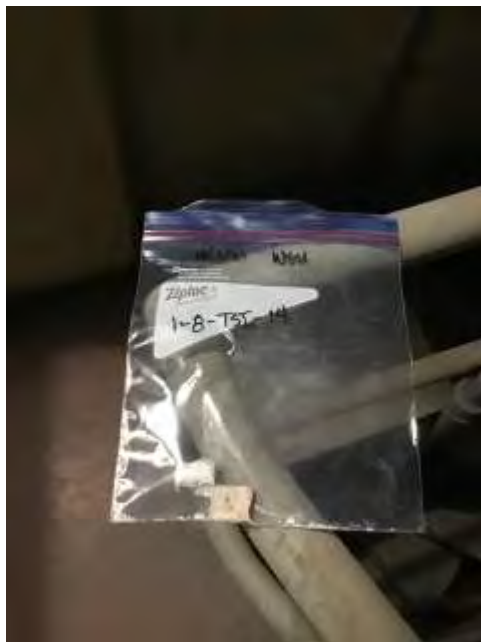
Sample ID:	Sample Type:	
1-8-TSI-14	TSI	
Sample Location:	Detailed Sample Location:	
Room 101	Orange pipe in southeast corner of room.	
Sample Quantity:	3,000 linear feet.	
Sample Color:	XRF:	
Misc Sample Material:	Sample Condition:	Sample Friable?:
Tan cementitious material	Damaged or significantly damaged	Yes

Additional Sample Notes:	White fibrous insulation with various colors of pipe wrap covers (e.g., also includes red pipe in southwest corner of room that runs to north section of room). Difficult to quantify due to distribution and various wrap colors.
---------------------------------	--

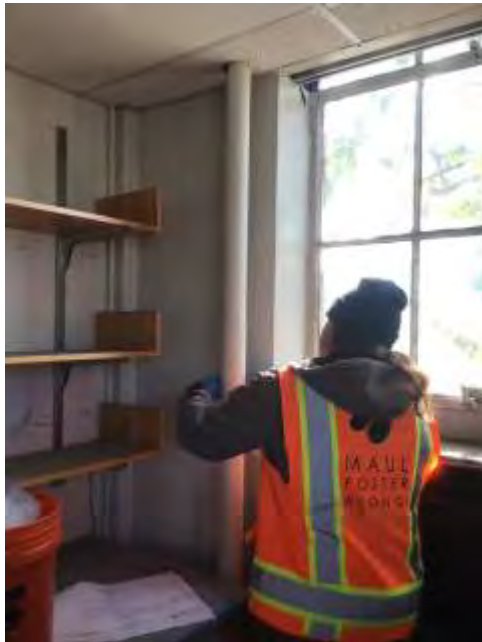
Sample ID:	Sample Type:	
1-8-TSI-32	TSI	
Sample Location:	Detailed Sample Location:	
Room 104	Southeast corner of room on white pipe.	
Sample Quantity:	3,000 linear feet.	
Sample Color:	XRF:	
Misc Sample Material:	Sample Condition:	Sample Friable?:
	Damaged or significantly damaged	Yes

Additional Sample Notes:	White pipe wrap with yellow insulation.
---------------------------------	---

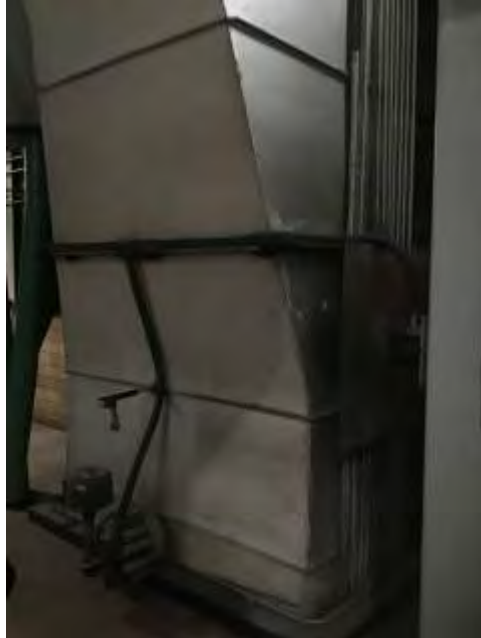
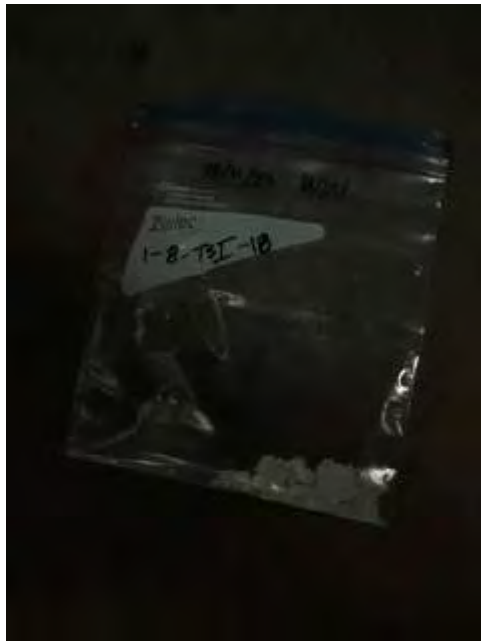
Sample ID:	Sample Type:	
1-8-TSI-18	TSI	
Sample Location:	Detailed Sample Location:	
Room 101	East side of room.	
Sample Quantity:	3,000 linear feet.	
Sample Color:	XRF:	
Misc Sample Material:	Sample Condition:	Sample Friable?:
Tan cementitious material	Damaged or significantly damaged	Yes

Gray duct cover with white fibrous insulation. Insulation appears to be consistent with Homogenous Area 8. Difficult to quantify due to distribution and various wrap colors.

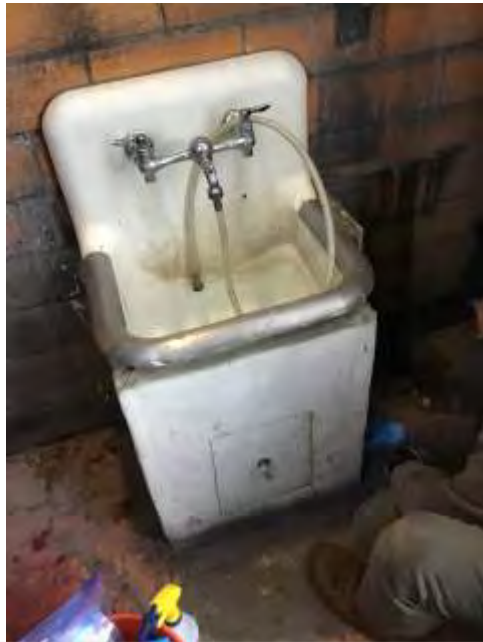
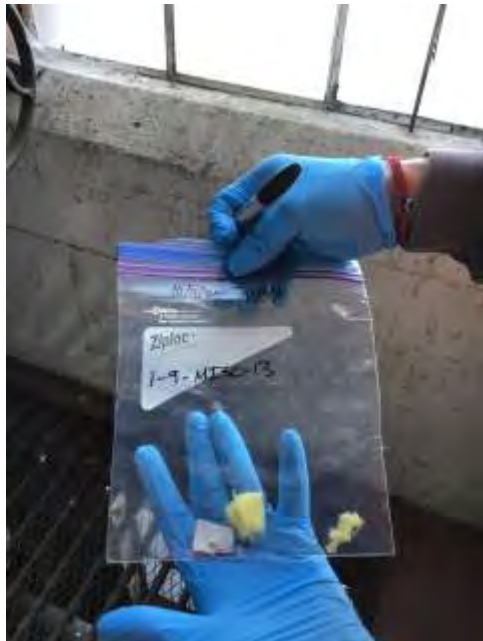
1-9-MISC-13

Potential ACBM with potential for damage

Additional Sample Notes:	Yellow fibrous insulation.
---------------------------------	----------------------------

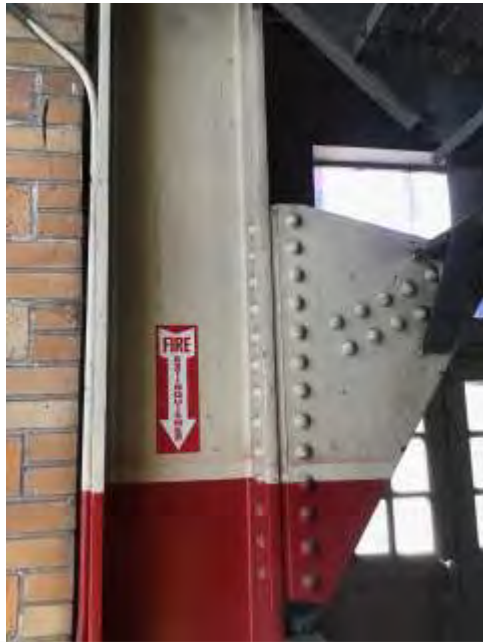
Sample ID:	Sample Type:
1-9-PB-15	PB
Sample Location:	Detailed Sample Location:
Room 101	West metal support beam above fire extinguisher.
Sample Quantity:	3,000 square feet.
Sample Color:	XRF:
White	5.00

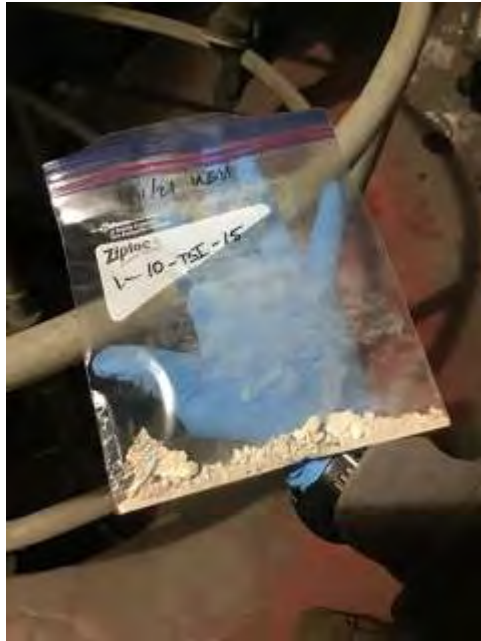
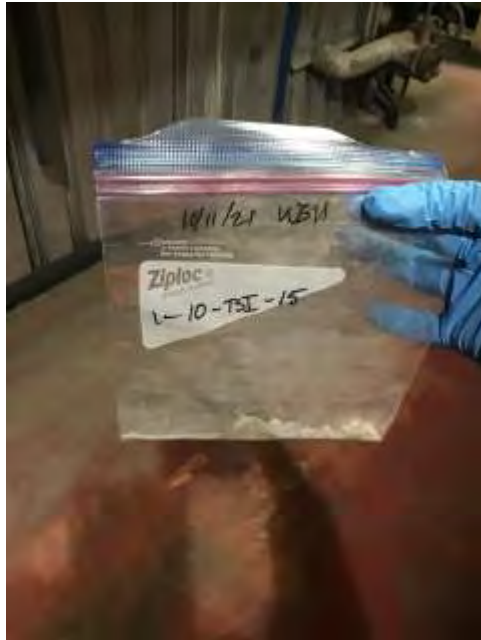
Additional Sample Notes:		
Sample ID:	Sample Type:	
1-10-TSI-15	TSI	
Sample Location:	Detailed Sample Location:	
Room 101	Southeast corner of room on corrugated boiler.	
Sample Quantity:	2 linear feet.	
Sample Color:	XRF:	
Misc Sample Material:	Sample Condition:	Sample Friable?:
Tan cementitious material	Damaged or significantly damaged	Yes

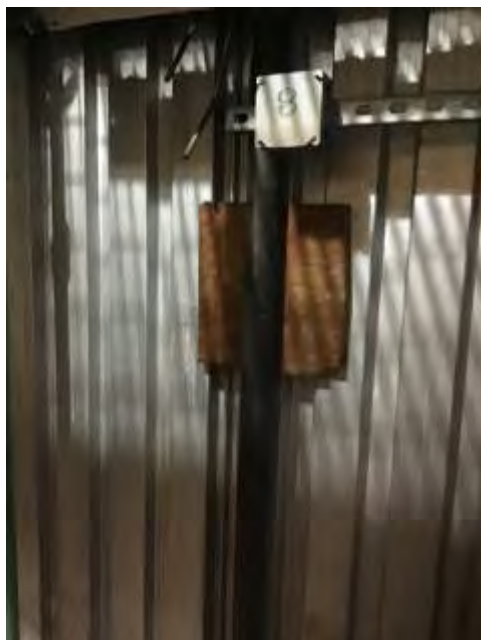
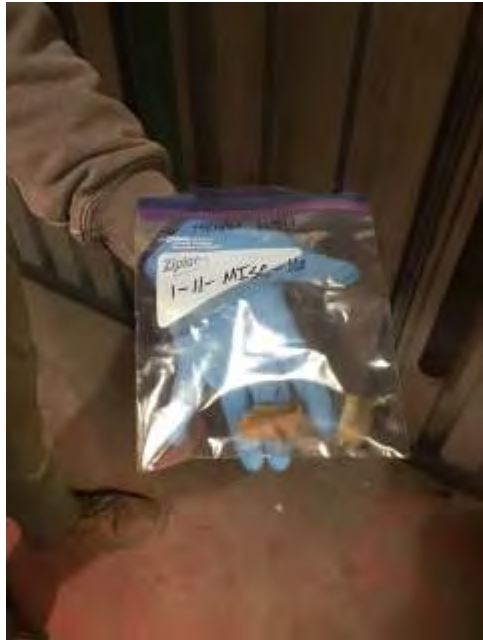
Additional Sample Notes:	Gray insulation and fabric.	
Sample ID:	Sample Type:	
1-11-MISC-16	MISC	
Sample Location:	Detailed Sample Location:	
Room 101	Southeast corner of room on corrugated boiler wall.	
Sample Quantity:	2 linear feet.	
Misc Sample Material:	Sample Condition:	Sample Friable?:
Tan soundproofing material.	Potential ACBM with potential for damage	Yes

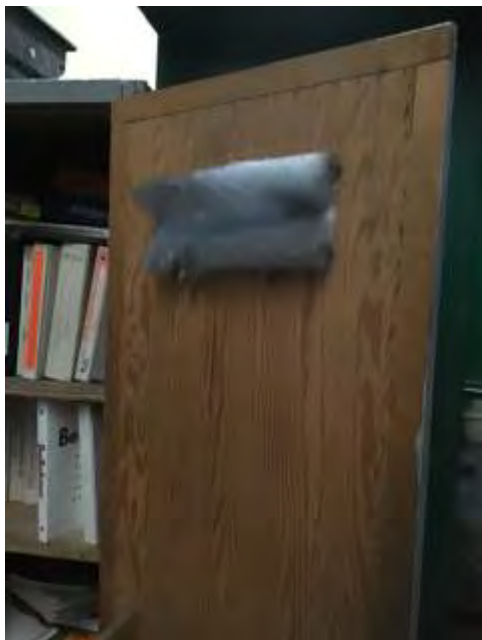
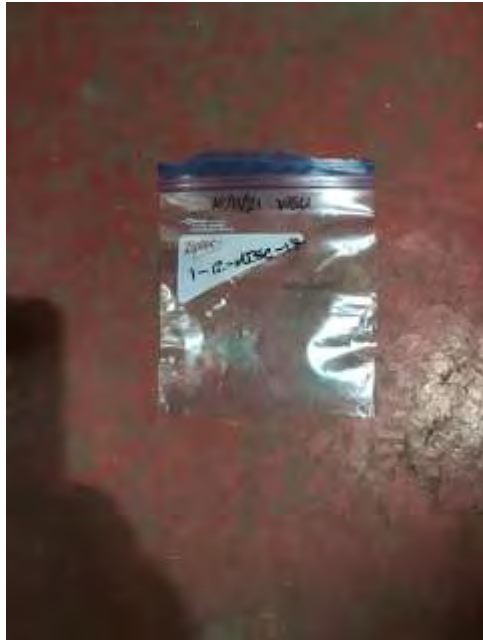
Sample ID:	Sample Type:	
1-12-MISC-17	MISC	
Sample Location:	Detailed Sample Location:	
Room 101	Green cabinet in southeast corner of room.	
Sample Quantity:	Less than 5 square feet.	
Misc Sample Material:	Sample Condition:	Sample Friable?:
Gray fibrous material.	Damaged or significantly damaged friable miscellaneous ACM	Yes

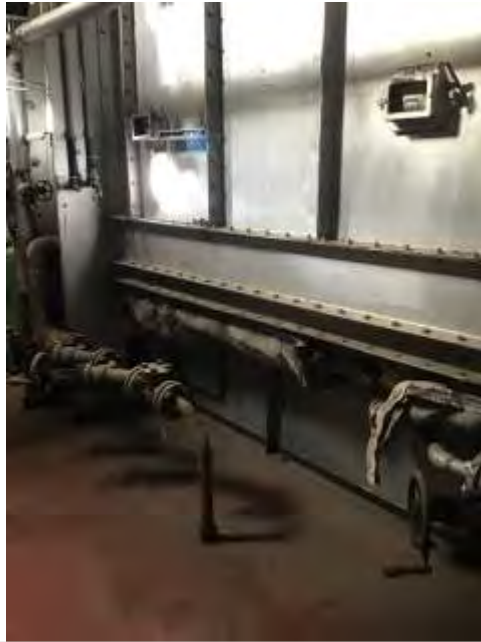
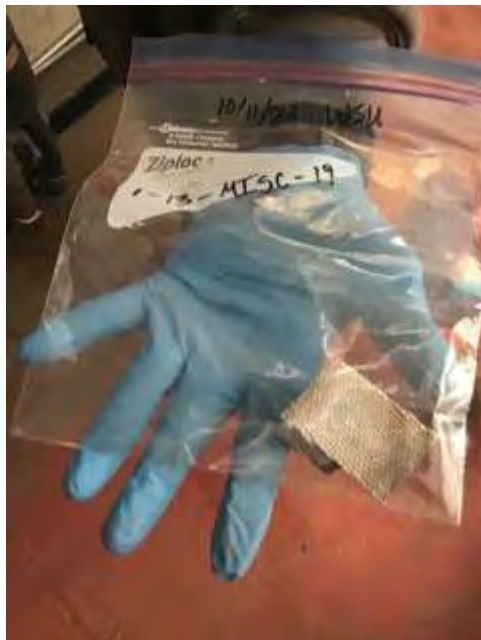
Additional Sample Notes:		
Sample ID:	Sample Type:	
1-13-MISC-19	MISC	
Sample Location:	Detailed Sample Location:	
Room 101	Soundproofing material on boiler in northeast corner of room.	
Sample Quantity:	15 square feet.	
Misc Sample Material:	Sample Condition:	Sample Friable?:
Gray and tan soundproofing material wrap.	Potential ACBM with potential for damage	Yes

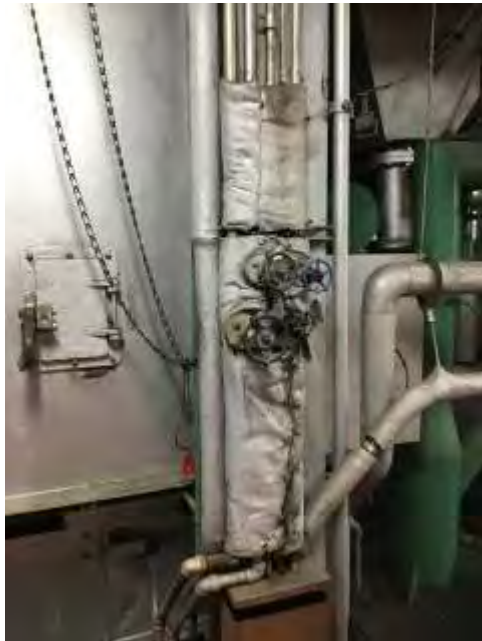
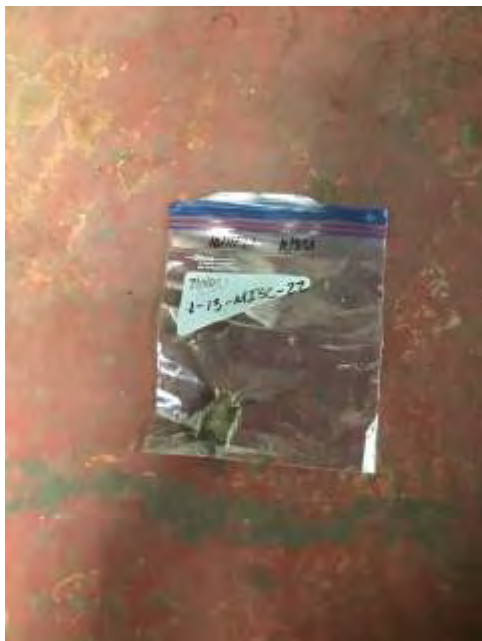
Additional Sample Notes:		
Sample ID:	Sample Type:	
1-13-MISC-22	MISC	
Sample Location:	Detailed Sample Location:	
Room 101	Fabric material on southeast boiler by double doors on south end of room.	
Sample Quantity:	15 square feet.	
Misc Sample Material:	Sample Condition:	Sample Friable?:
Gray fabric material.	Potential ACBM with potential for damage	Yes

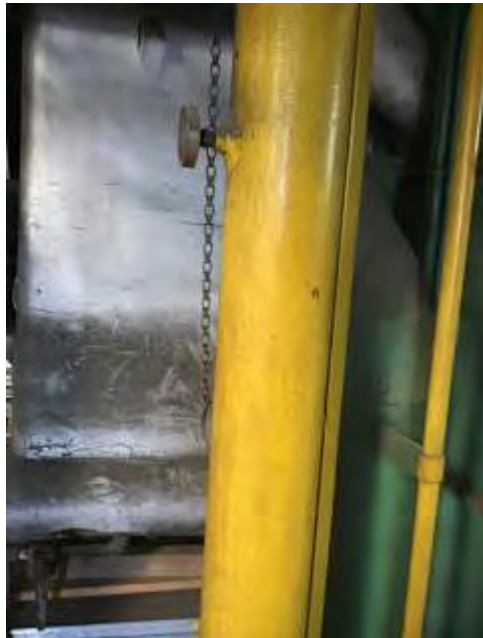
Sample ID:	Sample Type:
1-14-PB-29	PB
Sample Location:	Detailed Sample Location:
Room 101	North pipe on the northwest corner of north middle boiler.
Sample Quantity:	600 linear feet.
Sample Color:	XRF:
Yellow	5.00

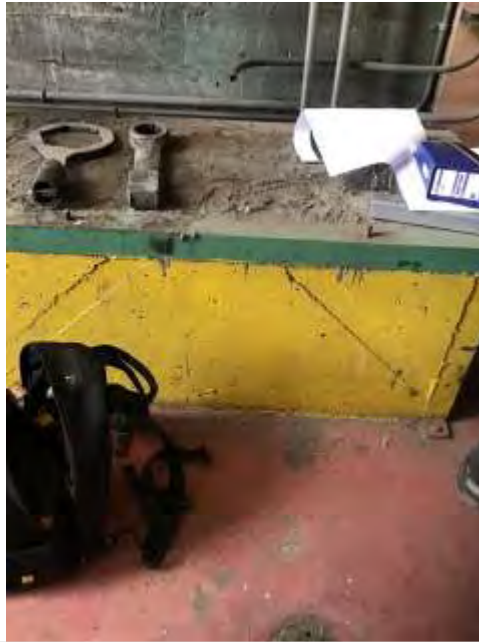
Sample ID:	Sample Type:
1-14-PB-30	PB
Sample Location:	Detailed Sample Location:
Room 101	North concrete bench west of north door.
Sample Quantity:	600 linear feet.
Sample Color:	XRF:
Yellow	2.83

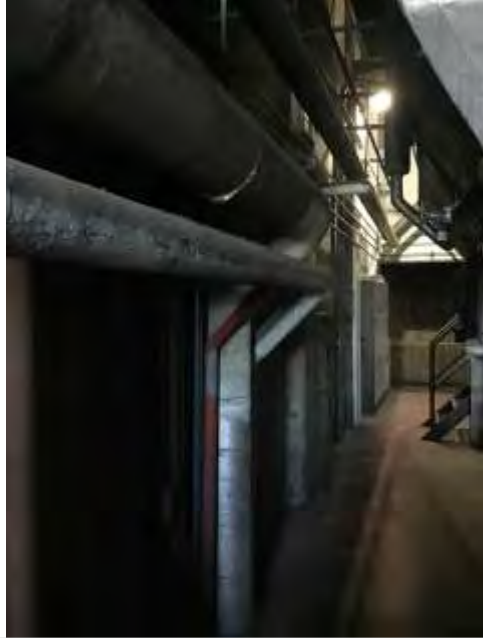
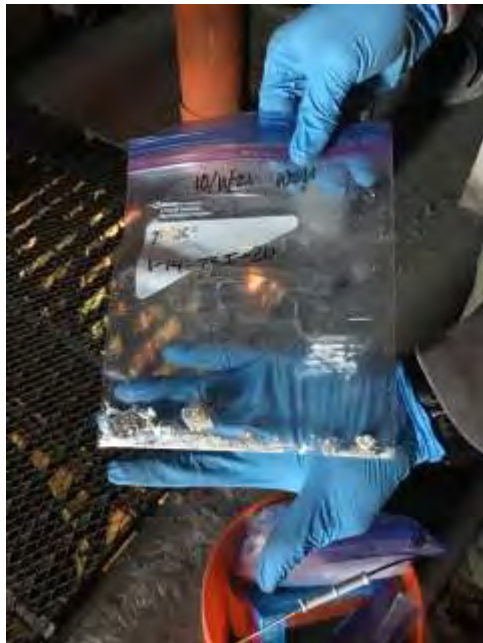
Sample ID:	Sample Type:	
1-14-TSI-20	TSI	
Sample Location:	Detailed Sample Location:	
Room 101	White patch on pipe in north portion of room.	
Sample Quantity:	5 linear feet.	
Sample Color:	XRF:	
Misc Sample Material:	Sample Condition:	Sample Friable?:
	Damaged or significantly damaged	Yes

Additional Sample Notes:	White patch on silver pipe with white fibrous insulation.
---------------------------------	---

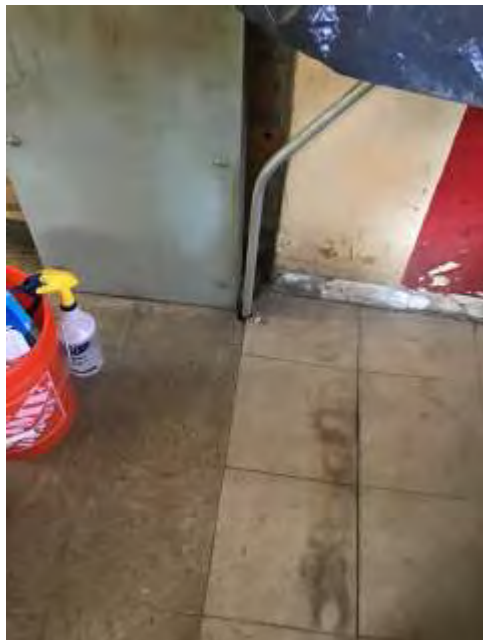
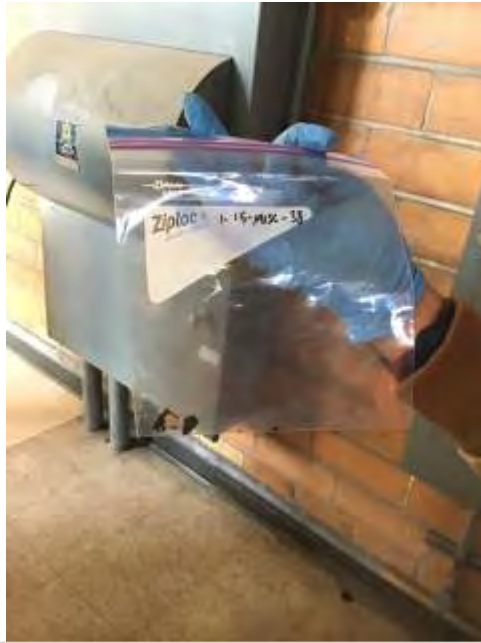
Sample ID:	Sample Type:	
1-15-MISC-38	MISC	
Sample Location:	Detailed Sample Location:	
Room 102	North wall west of single doorway in room 102.	
Sample Quantity:	3,000 square feet.	
Misc Sample Material:	Sample Condition:	Sample Friable?:
Tan 12" x 12" vinyl floor tile with black mastic.	Potential ACBM with potential for damage	No

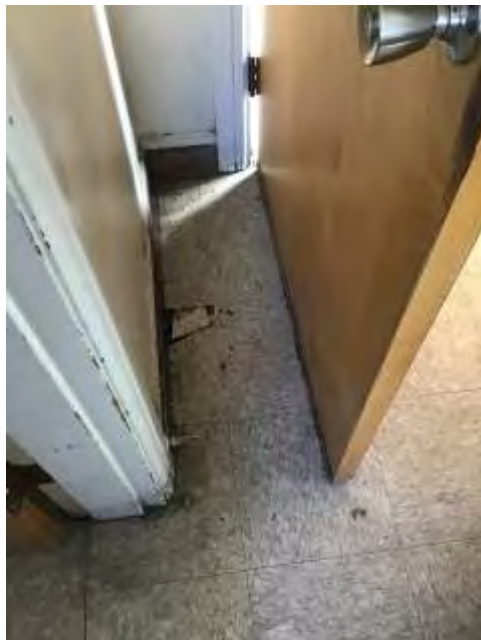
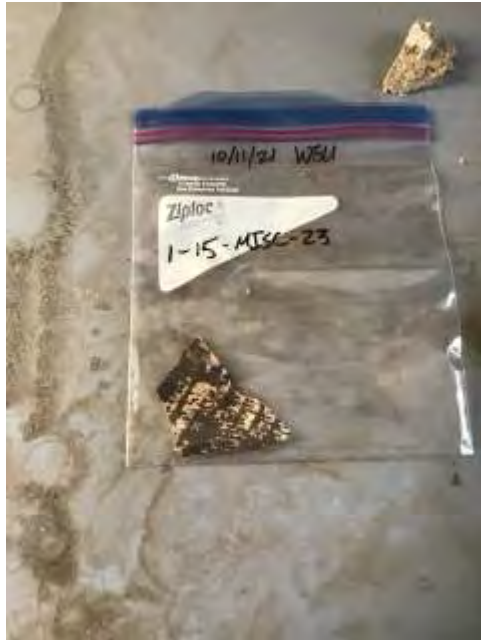
Sample ID:	Sample Type:	
1-15-MISC-23	MISC	
Sample Location:	Detailed Sample Location:	
Room 104	Northeast corner of room.	
Sample Quantity:	3,000 square feet.	
Misc Sample Material:	Sample Condition:	Sample Friable?:
Tan 12" x 12" vinyl floor tile with black mastic.	Potential ACBM with potential for damage	No

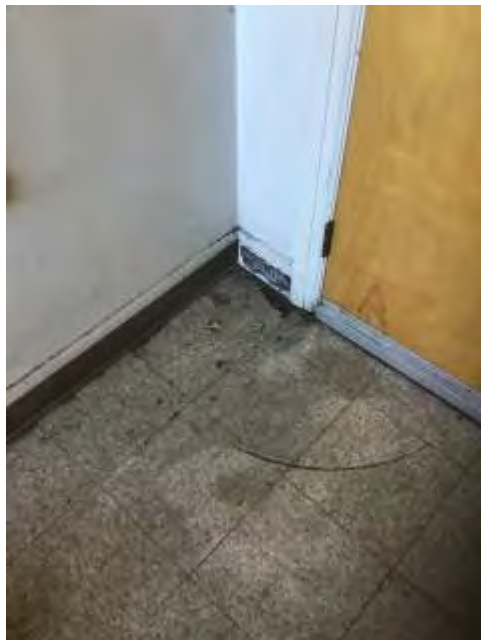
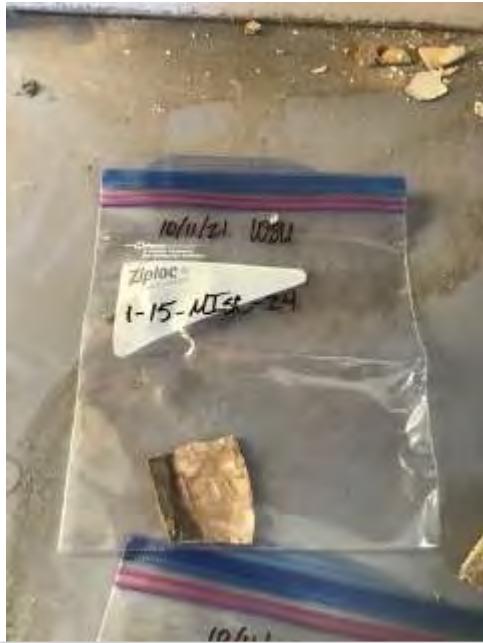
Sample ID:	Sample Type:	
1-15-MISC-24	MISC	
Sample Location:	Detailed Sample Location:	
Room 105	Northeast corner of room.	
Sample Quantity:	3,000 square feet.	
Misc Sample Material:	Sample Condition:	Sample Friable?:
Tan 12" x 12" vinyl floor tile with black mastic.	Potential ACBM with potential for damage	No

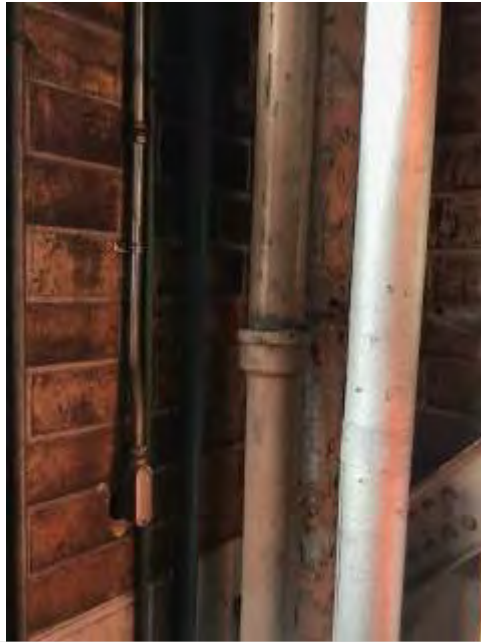
Sample ID:	Sample Type:
1-16-PB-22	PB
Sample Location:	Detailed Sample Location:
Room 101	West wall north of double door.
Sample Quantity:	N/A
Sample Color:	XRF:
Brown	0.015

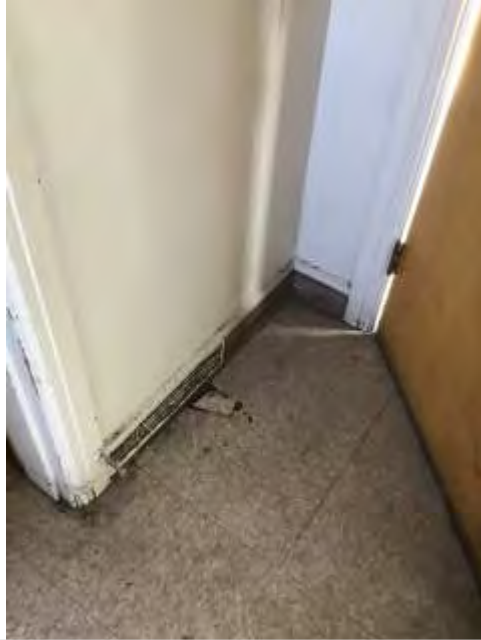
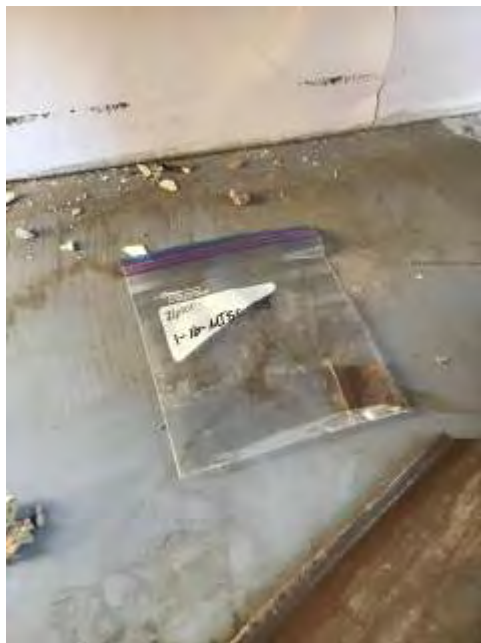
Sample ID:	Sample Type:	
1-16-MISC-25	MISC	
Sample Location:	Detailed Sample Location:	
Room 104	East wall of room.	
Sample Quantity:	80 linear feet.	
Misc Sample Material:	Sample Condition:	Sample Friable?:
Brown cove base with brown mastic.	Potential ACBM with potential for damage	No

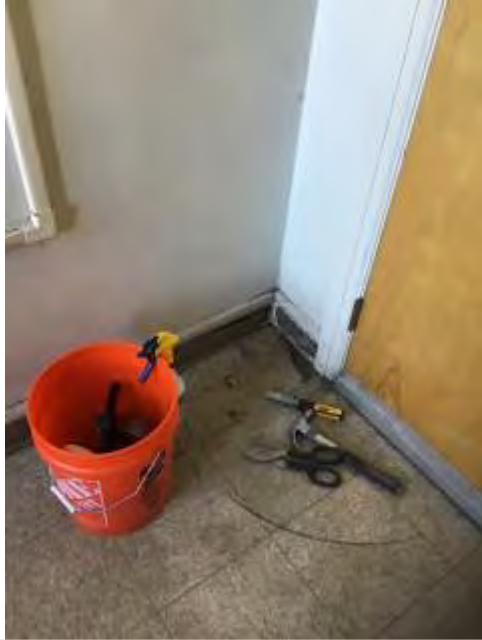
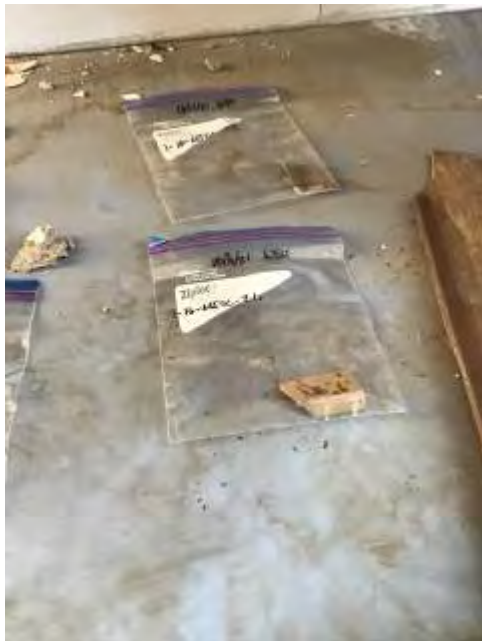
1-16-MISC-26

Potential ACBM with potential for damage

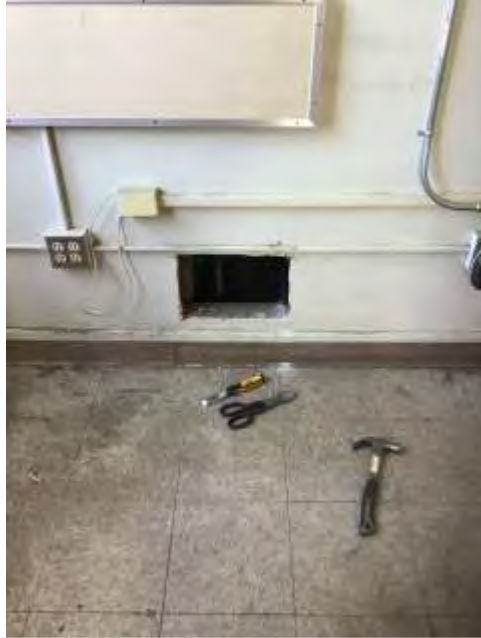
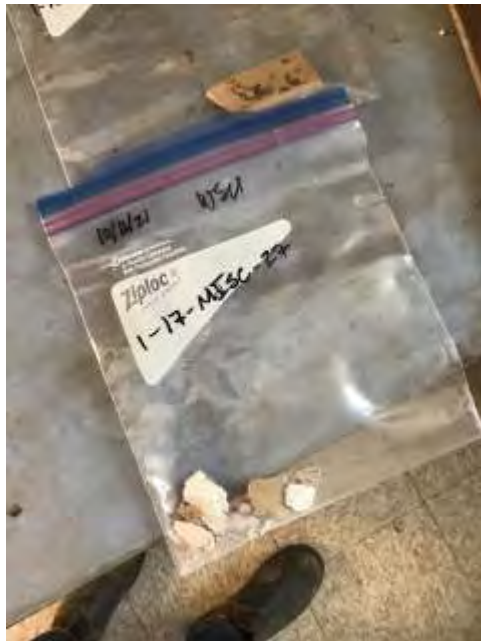
1-17-MISC-27

Potential ACBM with potential for damage

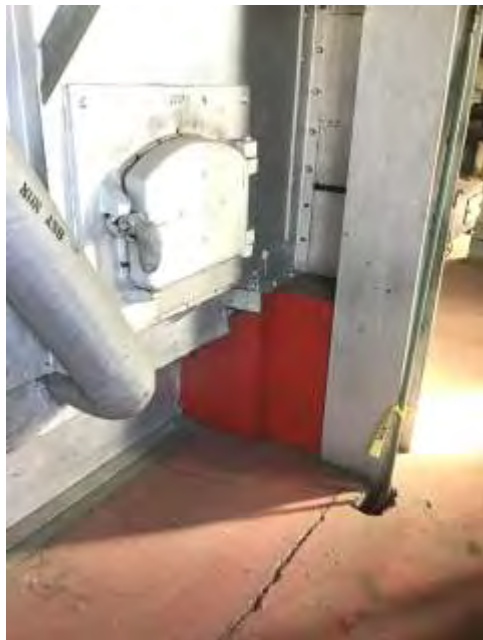
Sample ID:	Sample Type:
1-18-PB-25	PB
Sample Location:	Detailed Sample Location:
Room 101	Brick on southwest corner of northwest boiler.
Sample Quantity:	N/A
Sample Color:	XRF:
Red	ND

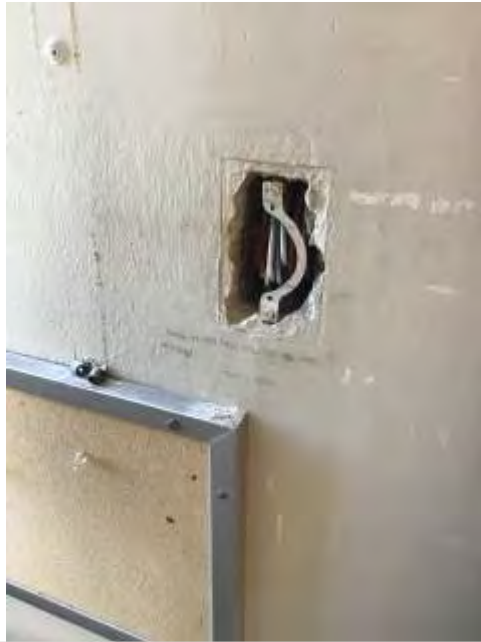
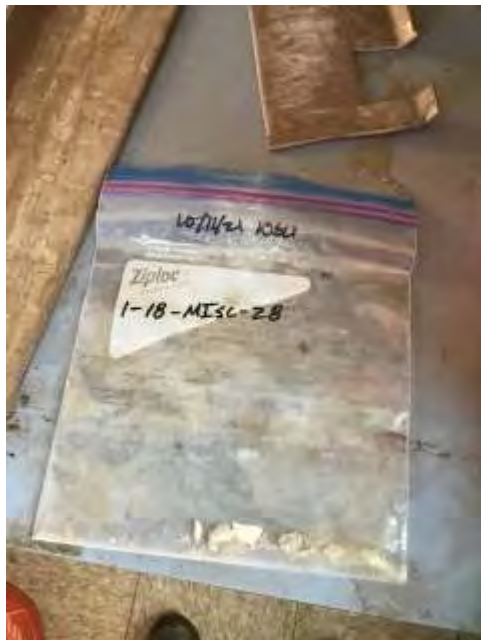
Additional Sample Notes:		
Sample ID:	Sample Type:	
1-18-MISC-28	MISC	
Sample Location:	Detailed Sample Location:	
Room 104	North wall of room in light switch casing.	
Sample Quantity:	785 square feet.	
Misc Sample Material:	Sample Condition:	Sample Friable?:
Light gray cementitious wallboard.	Potential ACBM with potential for damage	Yes

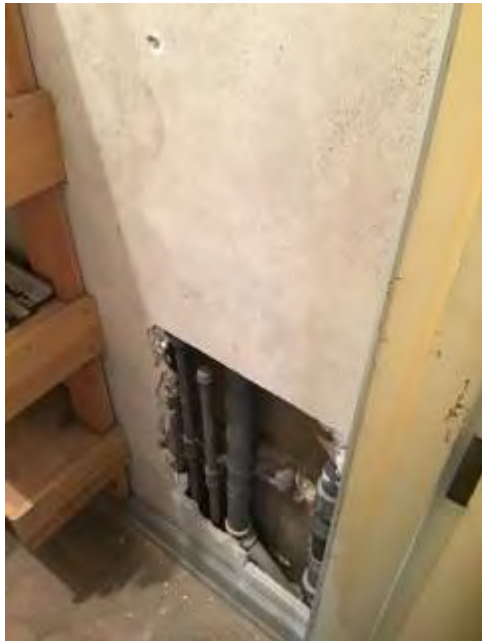
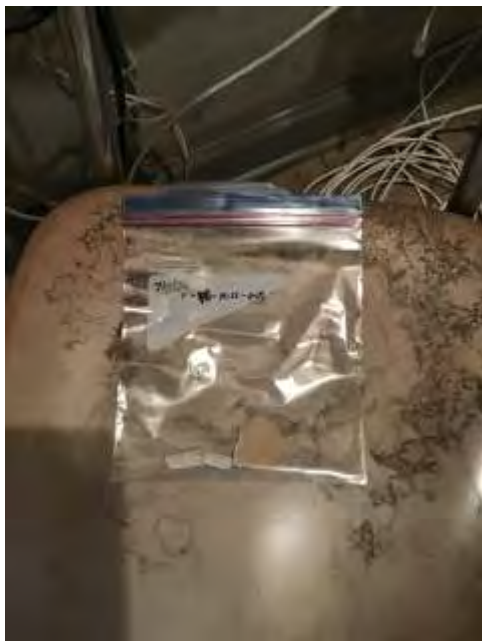
Additional Sample Notes:		
Sample ID:	Sample Type:	
1-18-MISC-43	MISC	
Sample Location:	Detailed Sample Location:	
Room 106T	West wall by door in room 106T.	
Sample Quantity:	785 square feet.	
Misc Sample Material:	Sample Condition:	Sample Friable?:
White drywall with cementitious wallboard.	Damaged or significantly damaged friable miscellaneous ACM	Yes

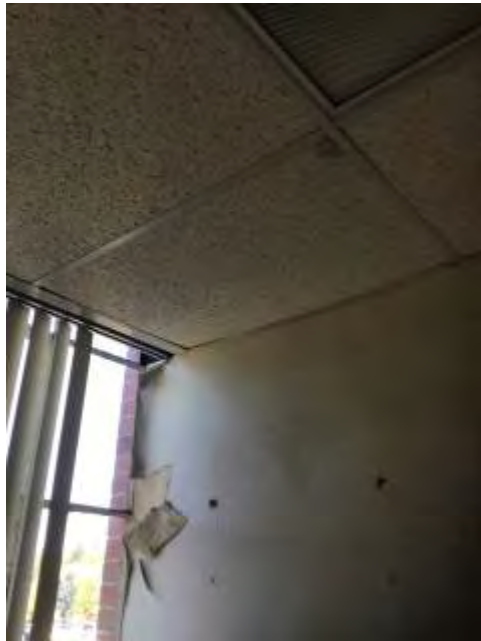
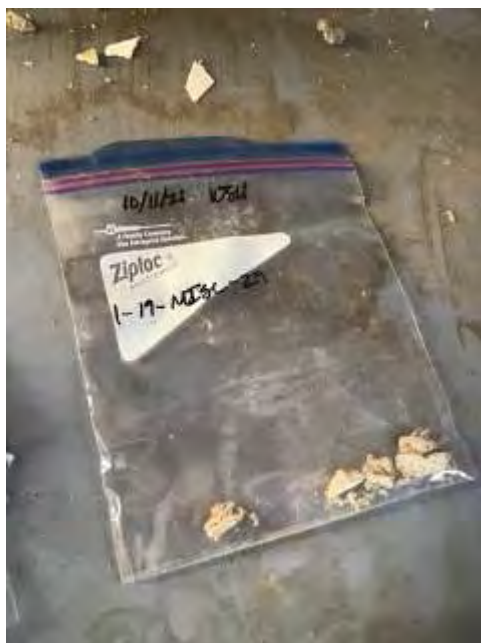
Additional Sample Notes:		
Sample ID:	Sample Type:	
1-19-MISC-29	MISC	
Sample Location:	Detailed Sample Location:	
Room 104	Northwest corner of room above light switch.	
Sample Quantity:	180 square feet.	
Misc Sample Material:	Sample Condition:	Sample Friable?:
White 18" x 36" ceiling tile with randomized stipple pattern.	Potential ACBM with potential for damage	Yes

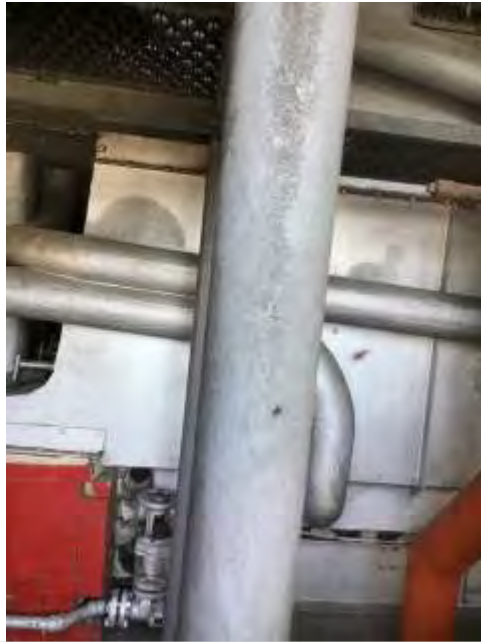
Sample ID:	Sample Type:
1-19-PB-26	PB
Sample Location:	Detailed Sample Location:
Room 101	Support pole in northwest corner of room 101.
Sample Quantity:	N/A
Sample Color:	XRF:
Gray	0.111

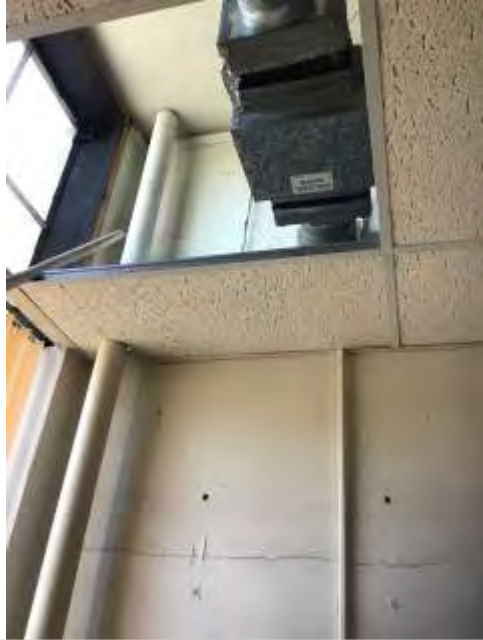
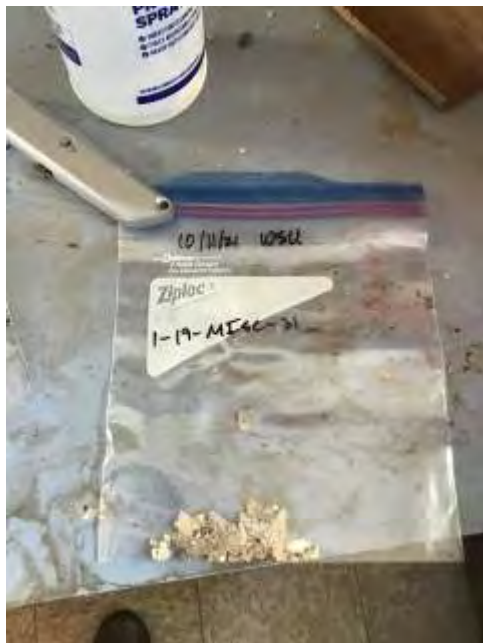
Sample ID:	Sample Type:	
1-19-MISC-31	MISC	
Sample Location:	Detailed Sample Location:	
Room 105	Northwest corner of room.	
Sample Quantity:	180 square feet.	
Misc Sample Material:	Sample Condition:	Sample Friable?:
White 18" x 36" ceiling tile with randomized stipple pattern.	Potential ACBM with potential for damage	Yes

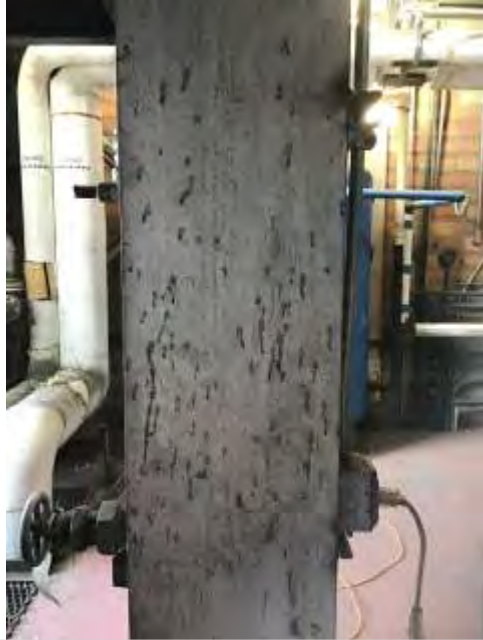
Sample ID:	Sample Type:
1-20-PB-27	PB
Sample Location:	Detailed Sample Location:
Room 101	Northwest support beam of northwest boiler.
Sample Quantity:	3,000 linear feet.
Sample Color:	XRF:
Silver	2.47

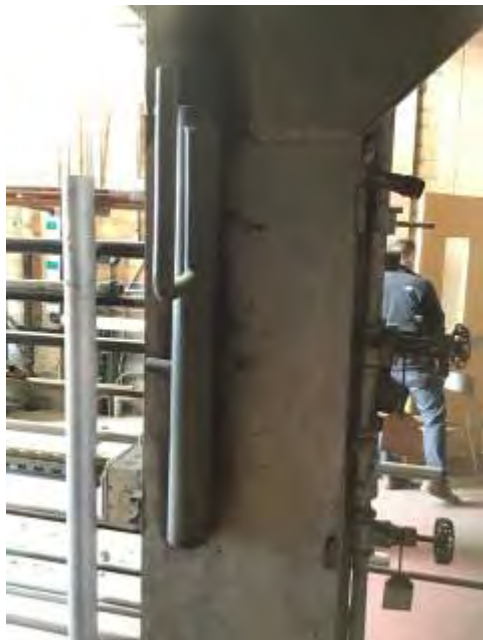
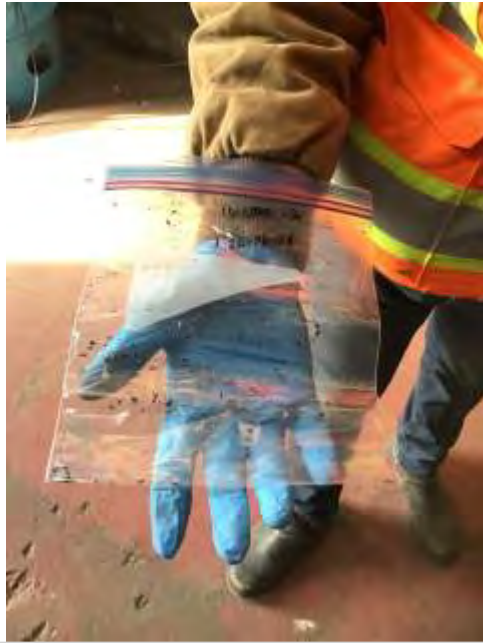
Additional Sample Notes:	Quantity difficult to estimate.
Sample ID:	Sample Type:
1-20-PB-28	PB
Sample Location:	Detailed Sample Location:
Room 101	Northeast support beam of northwest boiler.
Sample Quantity:	3,000 linear feet.
Sample Color:	XRF:
Silver	1.66

Quantity difficult to estimate. Submitted paint chip sample to laboratory for analysis.

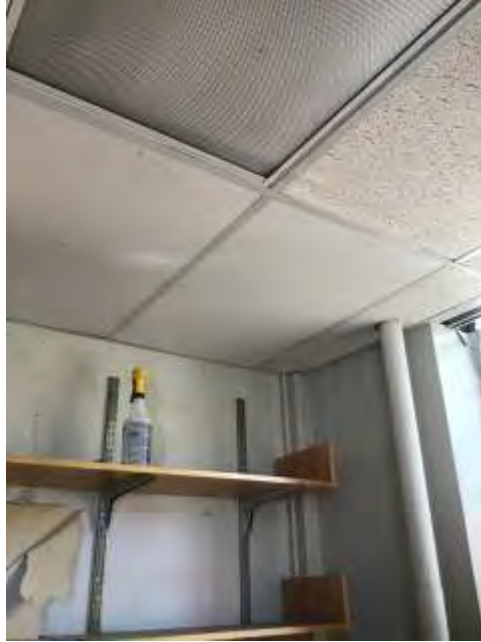
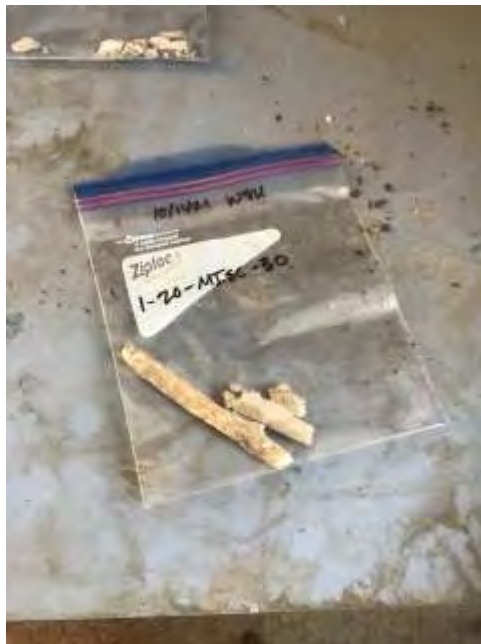
1-20-MISC-30

Potential ACBM with potential for damage

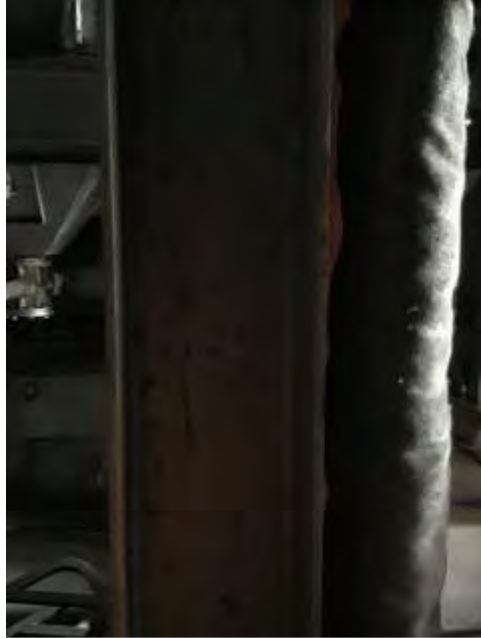
Sample ID:	Sample Type:
1-20-PB-33	PB
Sample Location:	Detailed Sample Location:
Room 101	Support beam on northwest corner of northeast boiler.
Sample Quantity:	3,000 linear feet.
Sample Color:	XRF:
Silver	0.040

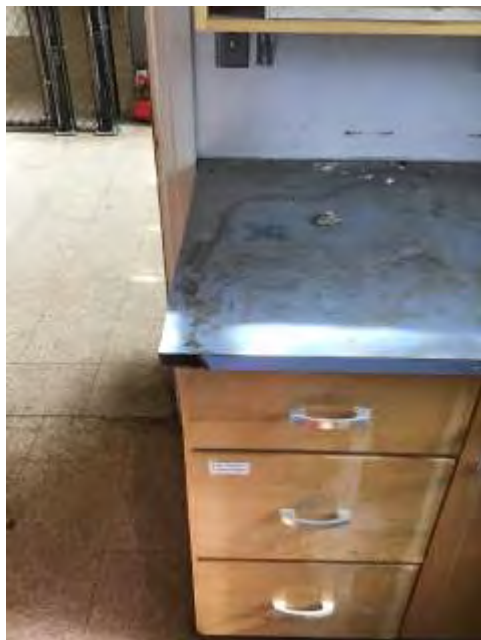
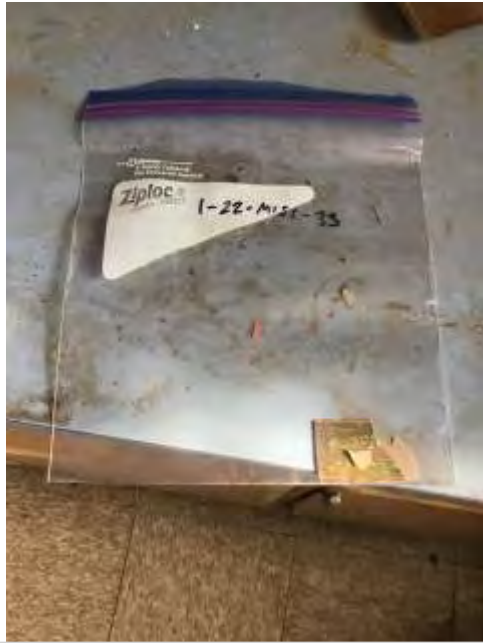
Sample ID:	Sample Type:	
1-21-MISC-33	MISC	
Sample Location:	Detailed Sample Location:	
104	Gray blue counter top on east side of room.	
Sample Quantity:	12 square feet.	
Misc Sample Material:	Sample Condition:	Sample Friable?:
Gray blue laminate countertop with black and green mastic.	Potential ACBM with potential for damage	No

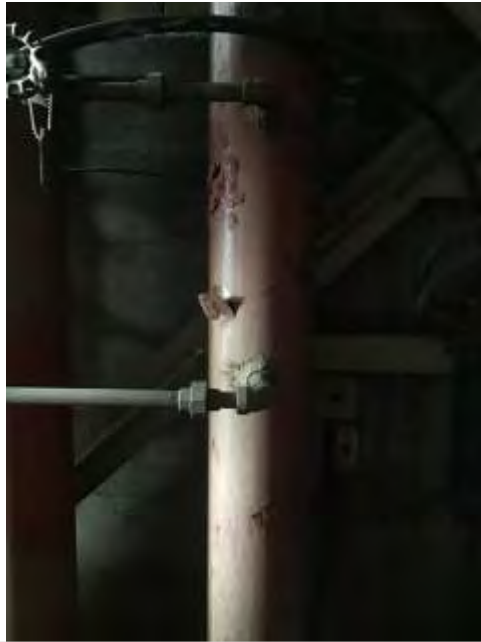
Sample ID:	Sample Type:
1-21-PB-32	PB
Sample Location:	Detailed Sample Location:
Room 101	Pipe north of north middle boiler.
Sample Quantity:	70 linear feet.
Sample Color:	XRF:
Brown	1.208

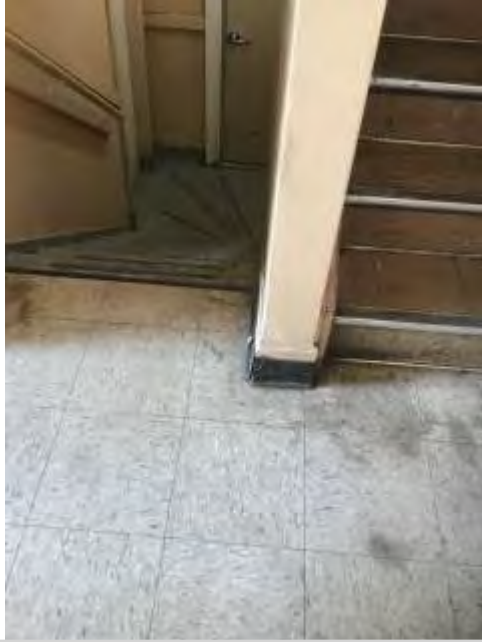
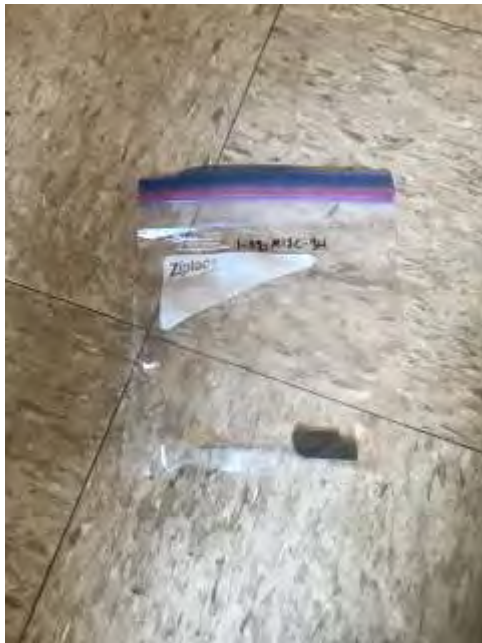
Sample ID:	Sample Type:	
1-22-MISC-34	MISC	
Sample Location:	Detailed Sample Location:	
Room 102	Northwest corner of room by stairs.	
Sample Quantity:	240 linear feet.	
Misc Sample Material:	Sample Condition:	Sample Friable?:
Dark brown cove base with brown mastic.	Potential ACBM with potential for damage	No

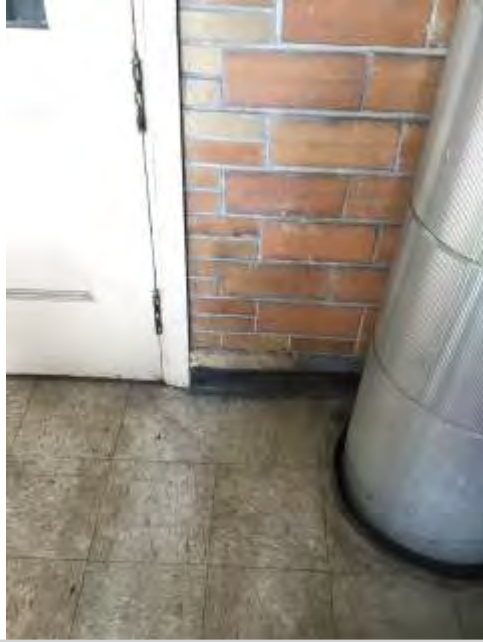
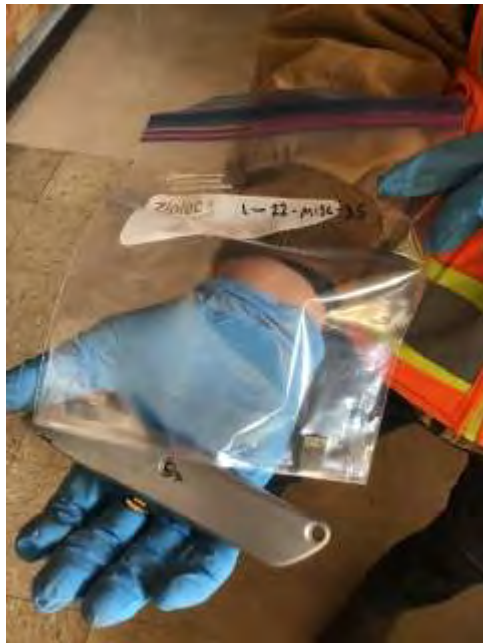
Sample ID:	Sample Type:	
1-22-MISC-35	MISC	
Sample Location:	Detailed Sample Location:	
Room 102	North wall east of double door.	
Sample Quantity:	240 linear feet.	
Misc Sample Material:	Sample Condition:	Sample Friable?:
Dark brown cove base with brown mastic.	Potential ACBM with potential for damage	No
