COLLEGE AVENUE STEAM PLANT ADAPTIVE REUSE

Integrated Cleanup and Implementation Plan

Port of
Whitman
County

PORT OF WHITMAN COUNTY
March 30, 2020

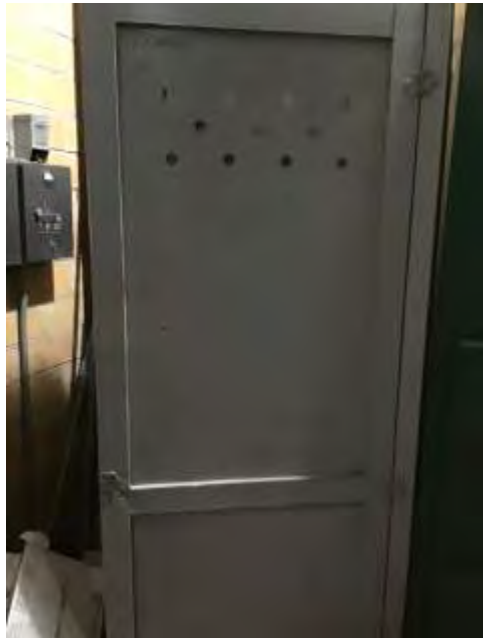
Sample ID:	Sample Type:
1-23-PB-41	PB
Sample Location:	Detailed Sample Location:
Room 101	Light gray cabinet in southeast corner of room 101.
Sample Quantity:	N/A
Sample Color:	XRF:
Light gray	0.048

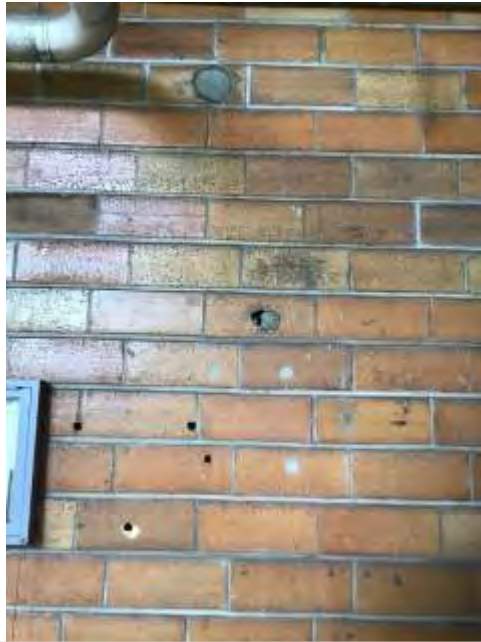
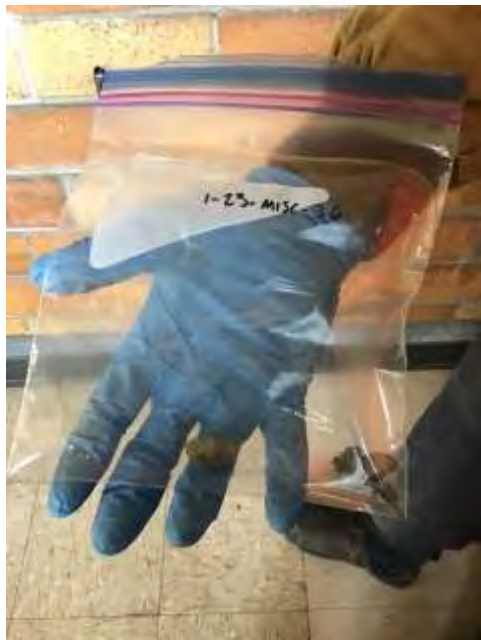
Additional Sample Notes:		
Sample ID:	Sample Type:	
1-23-MISC-36	MISC	
Sample Location:	Detailed Sample Location:	
Room 102	North wall, west of transformer box and east of the double doors.	
Sample Quantity:	Less than 5 square feet.	
Misc Sample Material:	Sample Condition:	Sample Friable?:
Gray cementitious patching material.	Potential ACBM with potential for damage	No

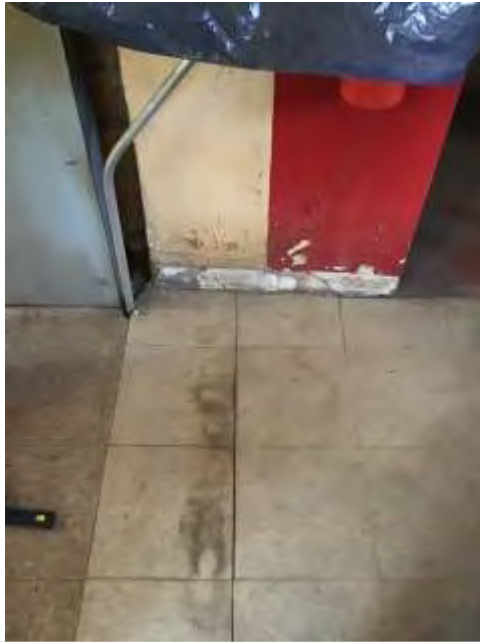
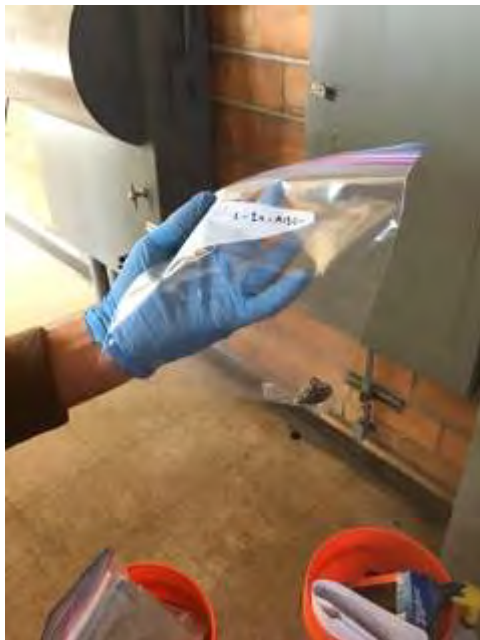
Additional Sample Notes:		
Sample ID:	Sample Type:	
1-24-MISC-37	MISC	
Sample Location:	Detailed Sample Location:	
Room 102	North wall west of single doorway.	
Sample Quantity:	77.5 square feet.	
Misc Sample Material:	Sample Condition:	Sample Friable?:
Light gray 12" x 12" vinyl floor tile with gray mastic.	Potential ACBM with potential for damage	No

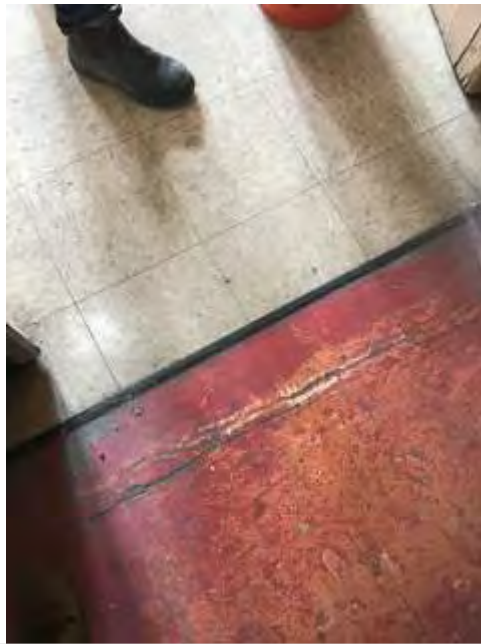
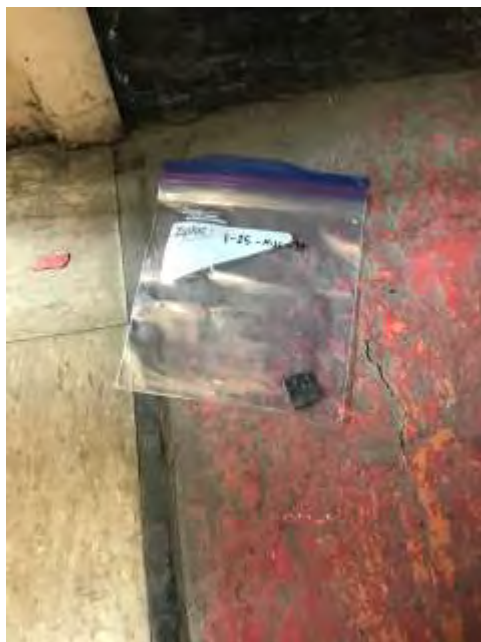
1-25-MISC-39

Black transition strip with brown mastic.	Potential ACBM with potential for damage	No
---	--	----

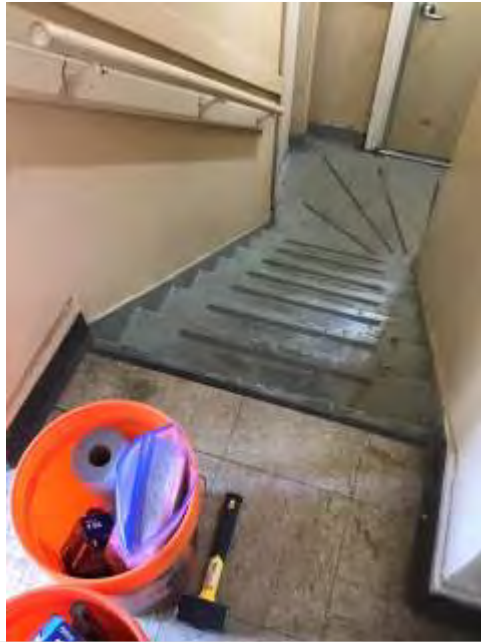
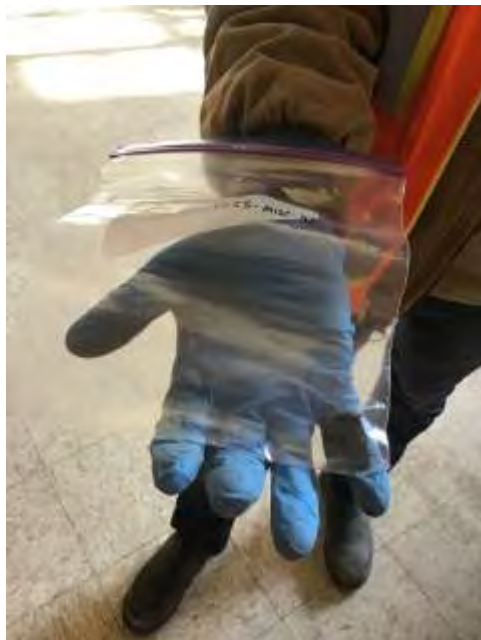
Additional Sample Notes:		
Sample ID:	Sample Type:	
1-25-MISC-47	MISC	
Sample Location:	Detailed Sample Location:	
Room 102	West stairway moving down in room 102.	
Sample Quantity:	11 linear feet.	
Misc Sample Material:	Sample Condition:	Sample Friable?:
Black transition strip with brown mastic.	Potential ACBM with potential for damage	No

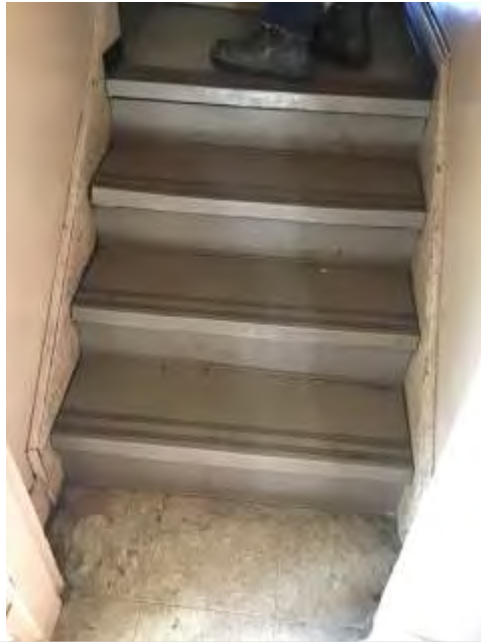
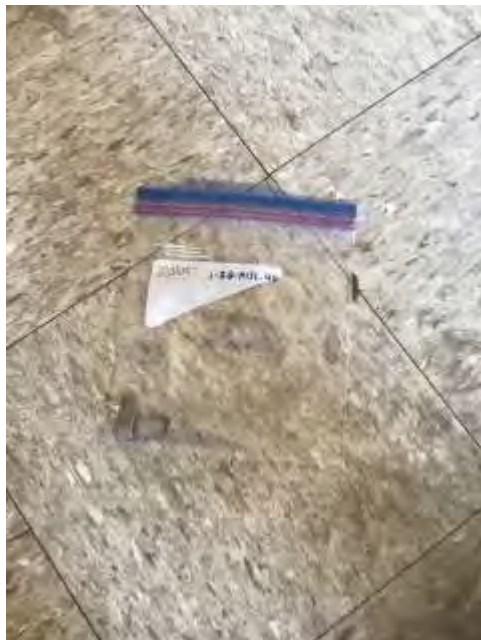
1-26-MISC-40

Rubber stair tread with clear mastic.	Potential ACBM with potential for damage	No
---------------------------------------	--	----

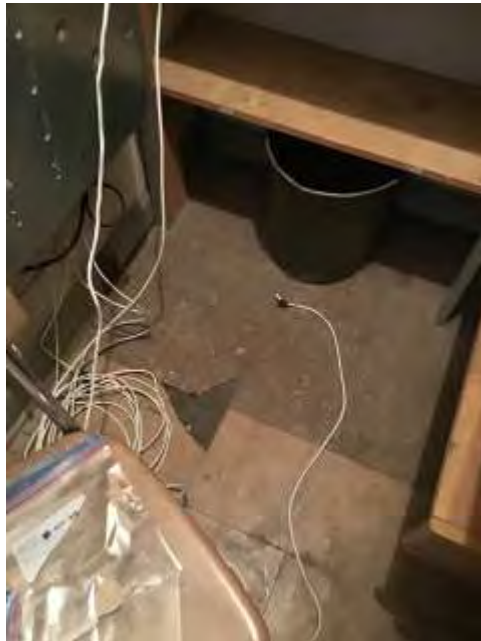
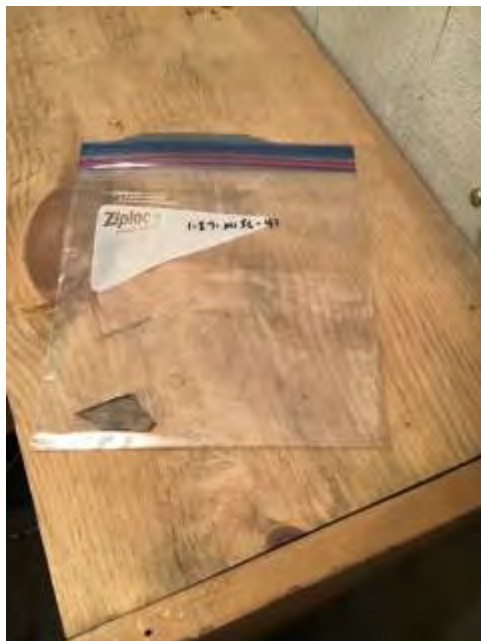
Additional Sample Notes:		
Sample ID:	Sample Type:	
1-27-MISC-41	MISC	
Sample Location:	Detailed Sample Location:	
Room 106T	Center floor of room 106T.	
Sample Quantity:	16 square feet.	
Misc Sample Material:	Sample Condition:	Sample Friable?:
Dark brown patterned 9 x 9 vinyl floor tiles with black mastic.	Potential ACBM with potential for damage	No

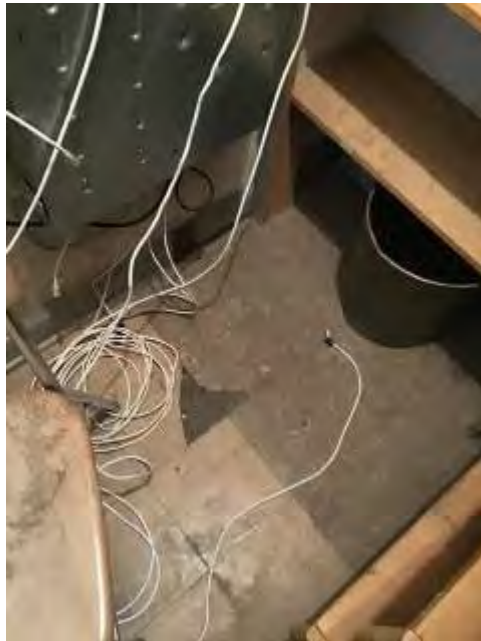
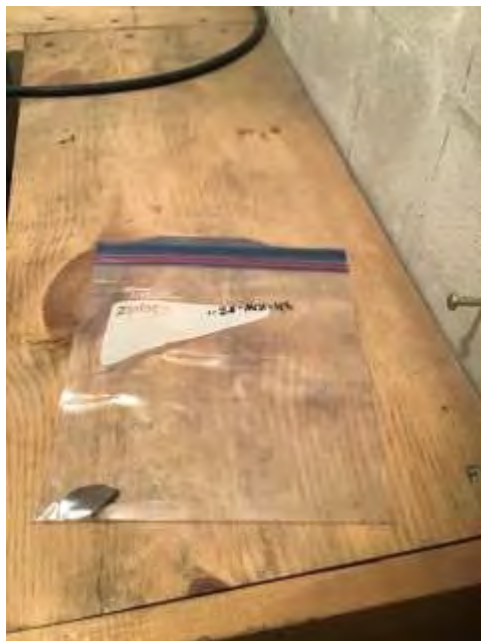
Additional Sample Notes:		
Sample ID:	Sample Type:	
1-28-MISC-42	MISC	
Sample Location:	Detailed Sample Location:	
Room 106T	Center floor of room 106T.	
Sample Quantity:	76 square feet.	
Misc Sample Material:	Sample Condition:	Sample Friable?:
Light tan patterned 9" x 9" vinyl floor tile with black mastic.	Damaged or significantly damaged; Potential ACBM with potential for damage	No

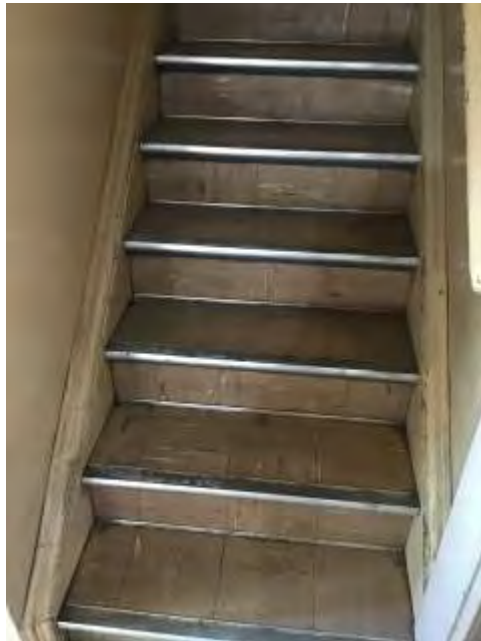
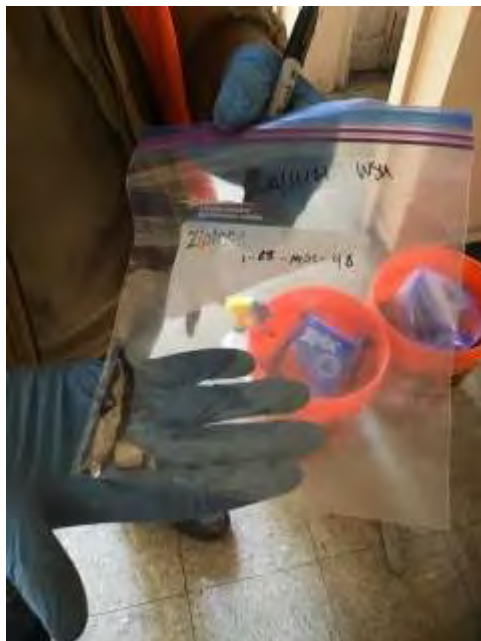
Additional Sample Notes:		
Sample ID:	Sample Type:	
1-28-MISC-48	MISC	
Sample Location:	Detailed Sample Location:	
Room 102	West stairway moving up in room 102.	
Sample Quantity:	76 square feet.	
Misc Sample Material:	Sample Condition:	Sample Friable?:
Light tan patterned 9" x 9" vinyl floor tile with black mastic.	Potential ACBM with potential for damage	No

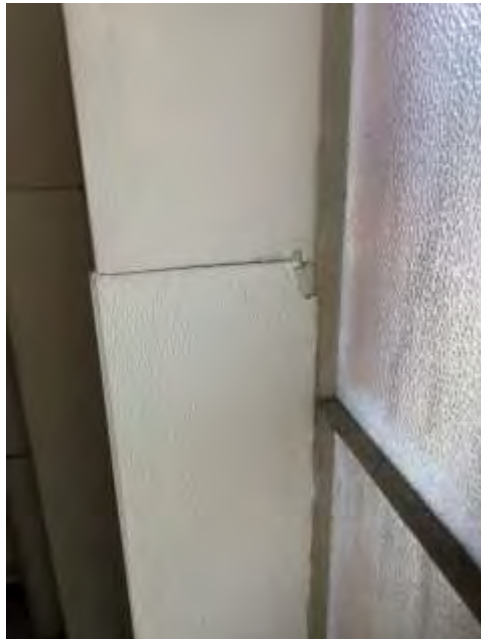
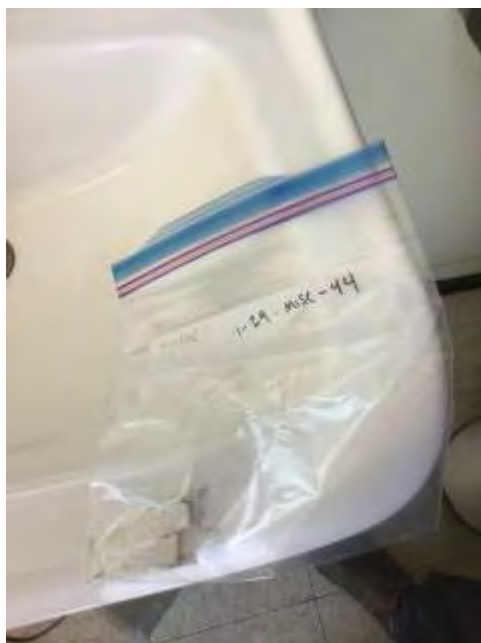
Additional Sample Notes:		
Sample ID:	Sample Type:	
1-29-MISC-44	MISC	
Sample Location:	Detailed Sample Location:	
Room 107	West wall next to window in room 107.	
Sample Quantity:	60 square feet.	
Misc Sample Material:	Sample Condition:	Sample Friable?:
White plastic waterproofing material with pale yellow adhesive.	Potential ACBM with potential for damage	No

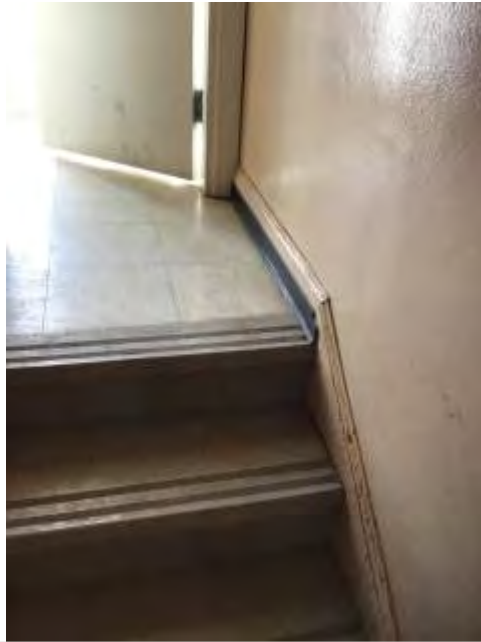
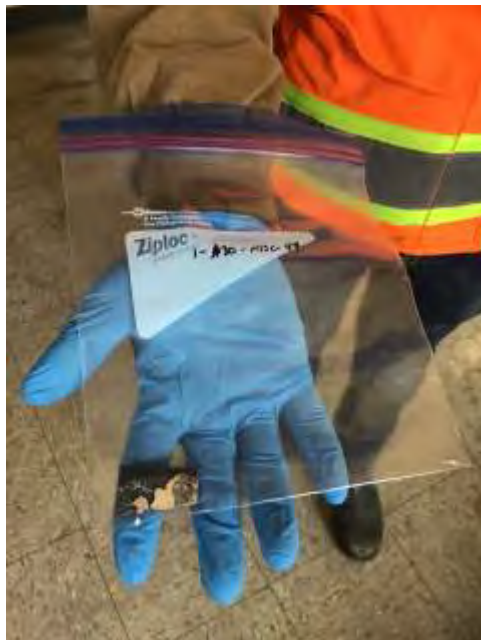
Additional Sample Notes:		
Sample ID:	Sample Type:	
1-30-MISC-49	MISC	
Sample Location:	Detailed Sample Location:	
Top of stairway from room 102 to 107.	North wall at the top of stairs.	
Sample Quantity:	20 linear feet.	
Misc Sample Material:	Sample Condition:	Sample Friable?:
Black cove base with tan mastic	Potential ACBM with potential for damage	No

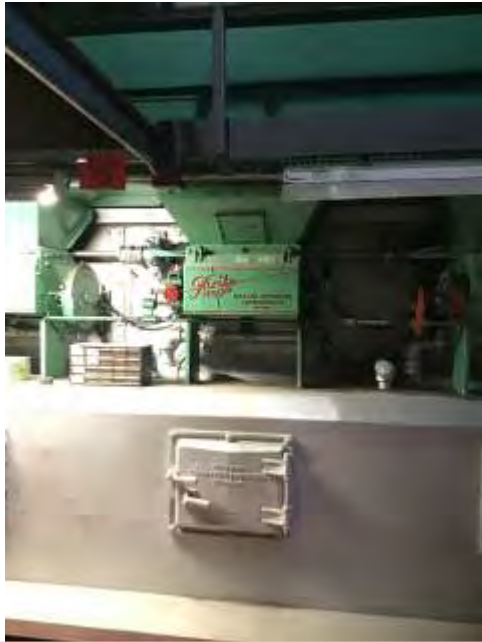
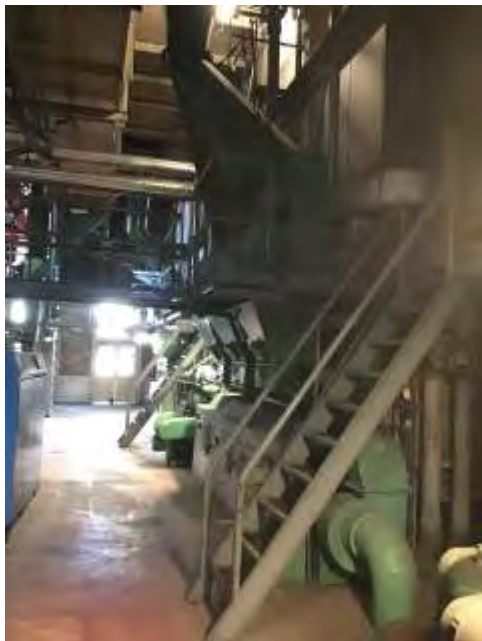
General Fixture Location:	Detailed Fixture Location:
Room 101	Throughout the room.
Type of Fixture:	Quantity:
Boilers and steam equipment.	6
Condition:	Additional Fixture Notes:
Good	Associated motors, residual mechanical fluids and coal dust.

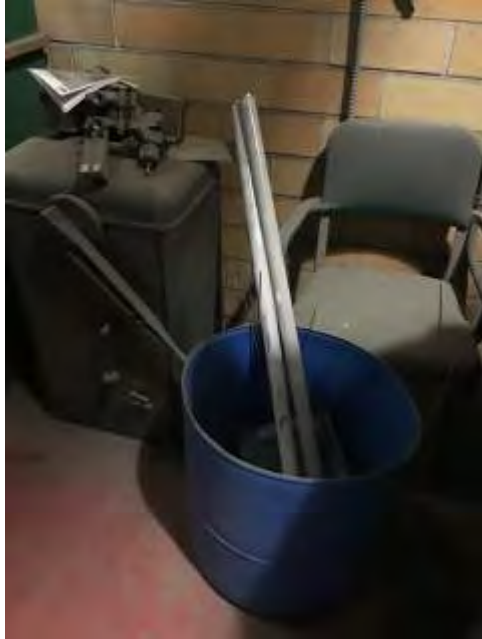
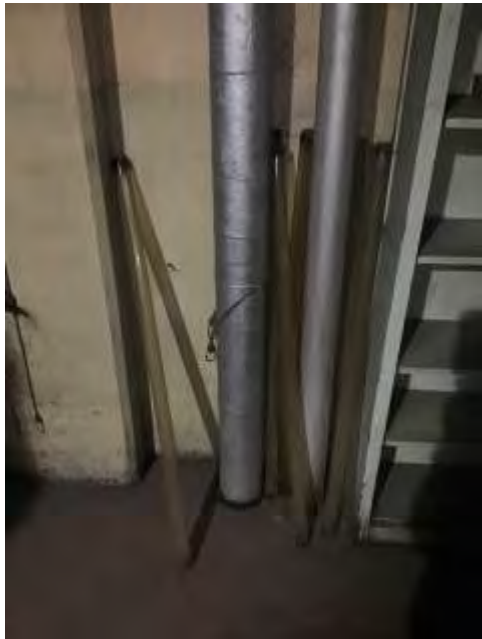
General Fixture Location:	Detailed Fixture Location:
Room 101	Southeast corner of room 101.
Type of Fixture:	Quantity:
Fluorescent light bulbs.	13
Condition:	Additional Fixture Notes:
Good

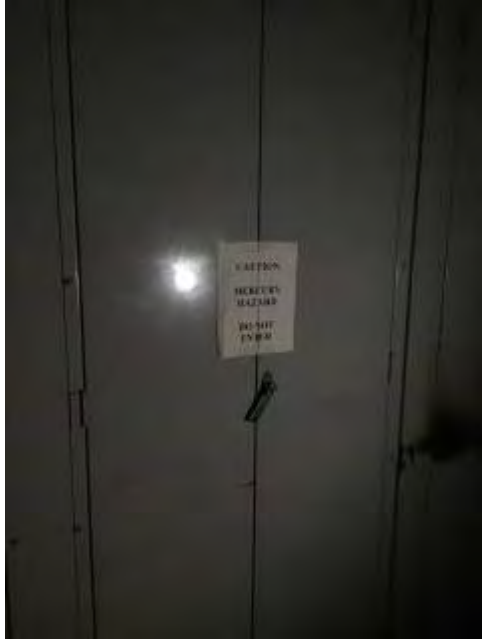
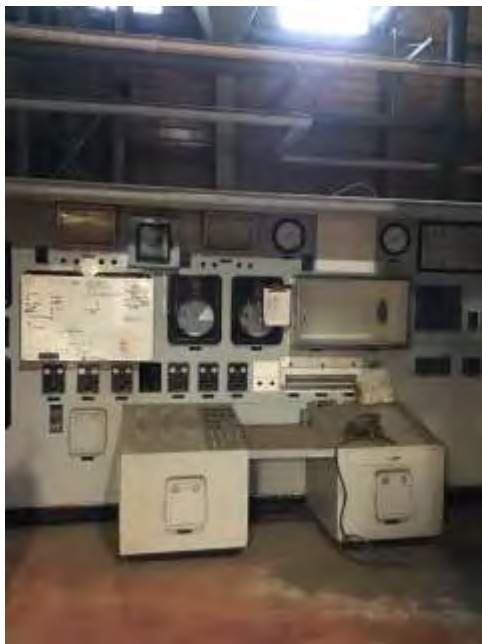
General Fixture Location:	Detailed Fixture Location:
Room 101	East wall behind control panels.
Type of Fixture:	Quantity:
	1
Condition:	Additional Fixture Notes:
Good	Boiler and equipment control panels containing mercury.

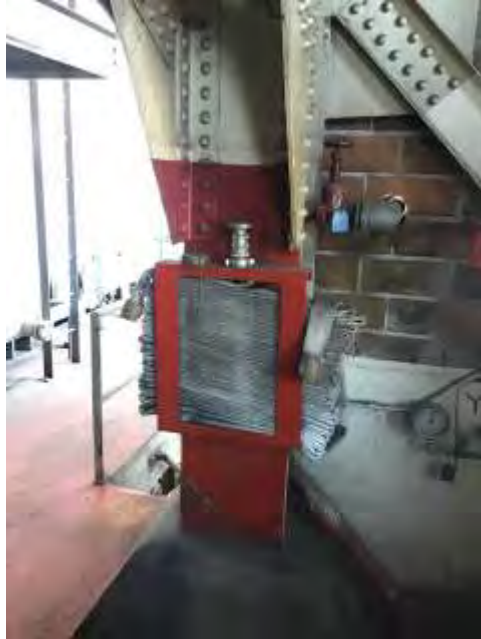
General Fixture Location:	Detailed Fixture Location:
Room 101	West wall south of double doors.
Type of Fixture:	Quantity:
Fire hose.	1
Condition:	Additional Fixture Notes:
Good	Assumed asbestos containing material in fire hose.

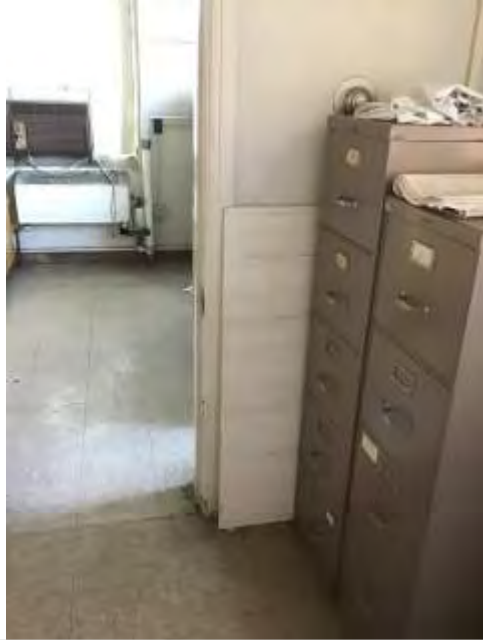
General Fixture Location:	Detailed Fixture Location:
Room 105	West of south door.
Type of Fixture:	Quantity:
Fire-resistant board.	1
Condition:	Additional Fixture Notes:
Good

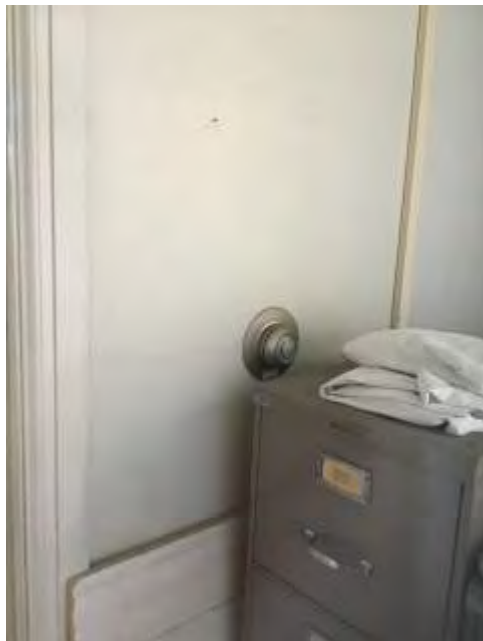
General Fixture Location:	Detailed Fixture Location:
Room 105 and 104	West of door between room 105 and 104.
Type of Fixture:	Quantity:
	2
Condition:	Additional Fixture Notes:
Good	Assumed mercury containing thermostats.

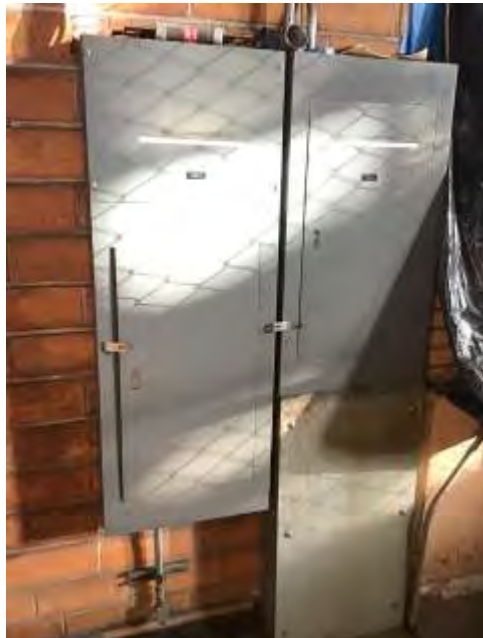
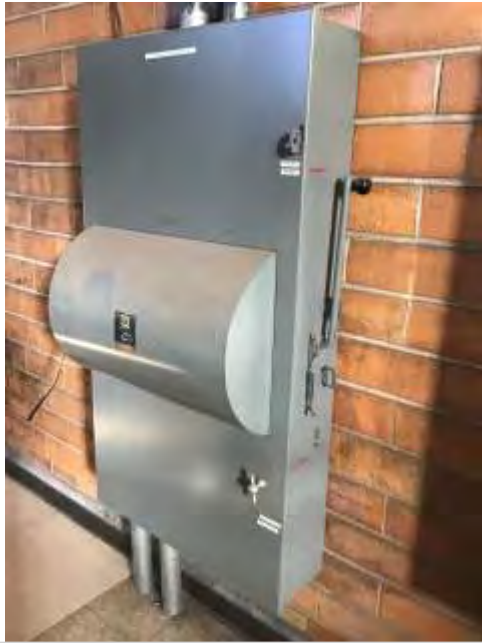
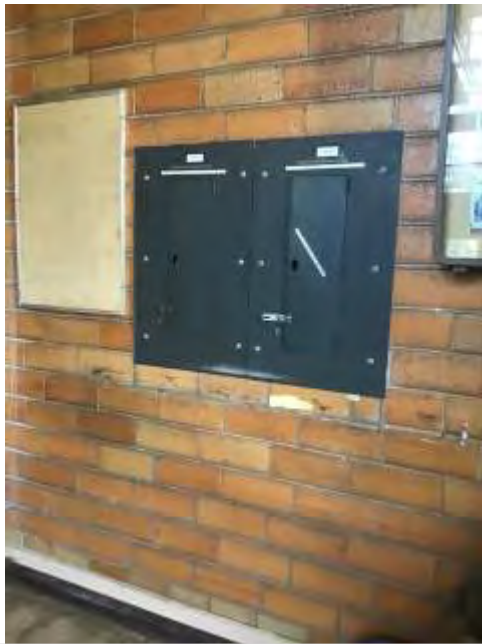
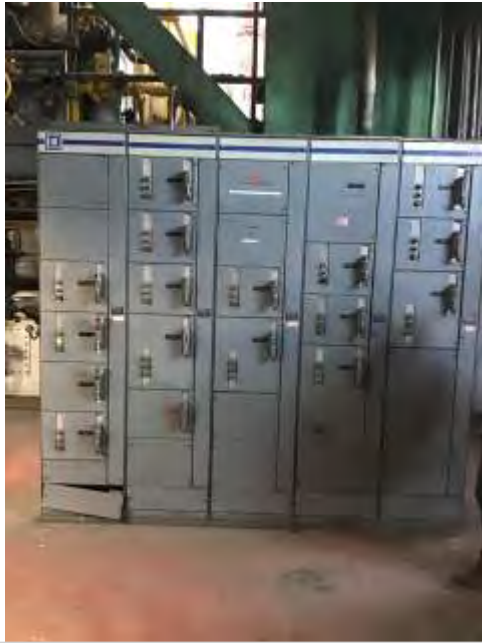
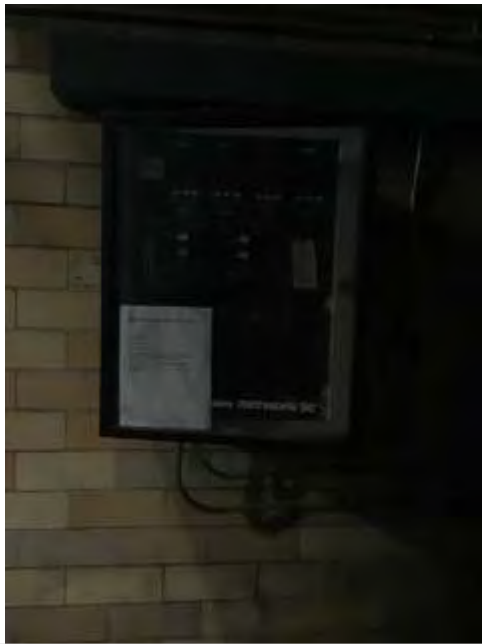
General Fixture Location:	Detailed Fixture Location:
Throughout first floor.	
Type of Fixture:	Quantity:
Electrical equip	Several.
Condition:	Additional Fixture Notes:
Good	Electrical equipment: 13 breaker/electrical panels, 2 motor control center.

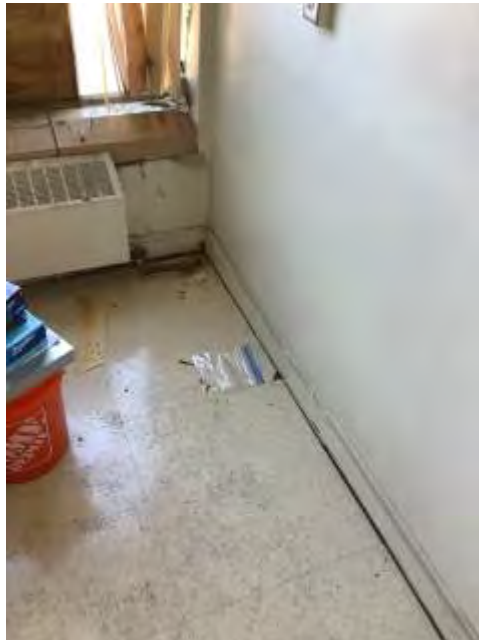
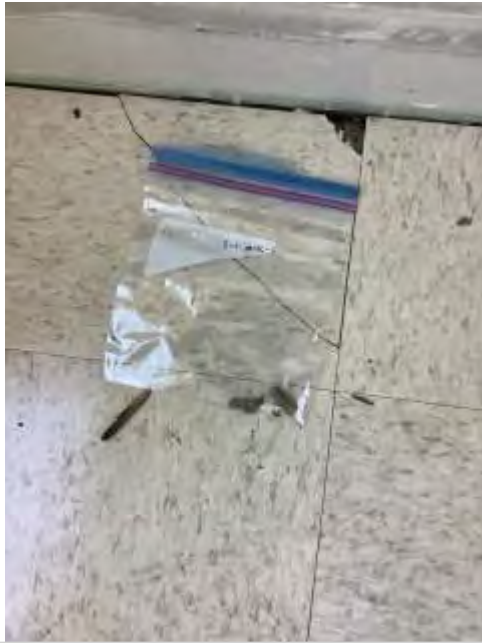
Sample ID:	Sample Type:	
2-1-MISC-1	MISC	
Sample Location:	Detailed Sample Location:	
Room 202	Northwest corner floor.	
Sample Quantity:	66 square feet.	
Misc Sample Material:	Sample Condition:	Sample Friable?:
White stipple pattern 12" x 12" vinyl floor tile with black mastic.	Potential ACBM with potential for damage	No

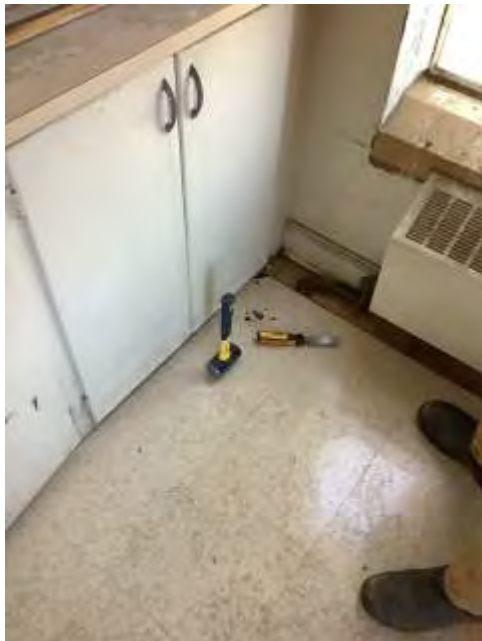
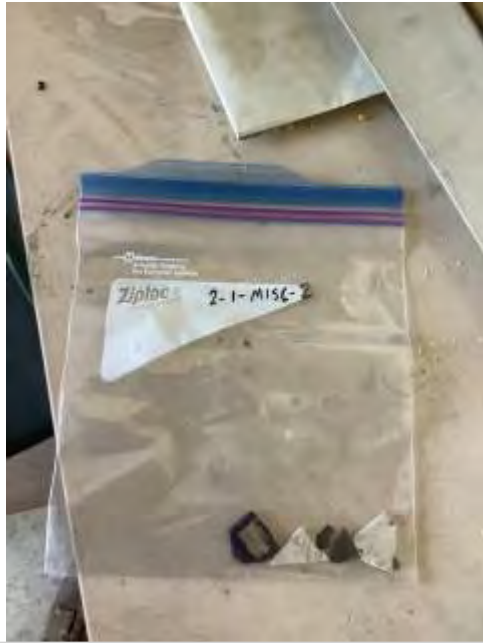
Sample ID:	Sample Type:	
2-1-MISC-2	MISC	
Sample Location:	Detailed Sample Location:	
Room 203	Southeast corner floor.	
Sample Quantity:	66 square feet.	
Misc Sample Material:	Sample Condition:	Sample Friable?:
White stipple pattern 12" x 12" vinyl floor tile with black mastic.	Potential ACBM with potential for damage	No

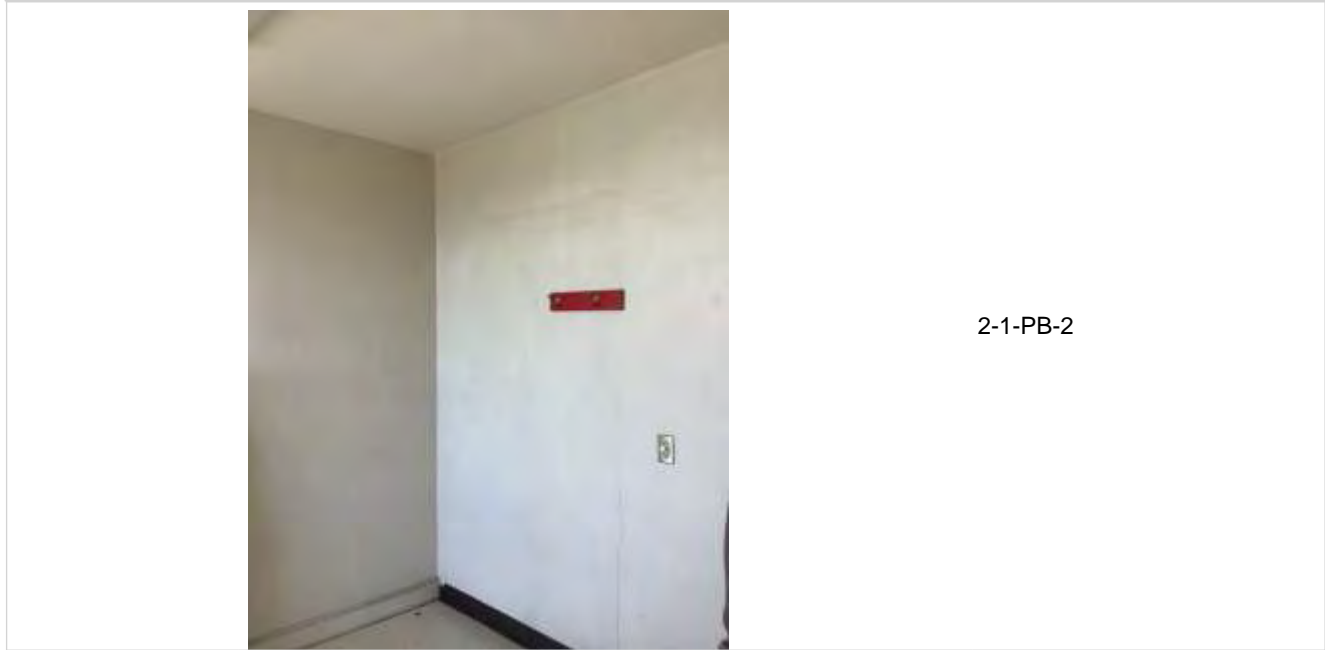
Sample ID:	Sample Type:
2-1-PB-2	PB
Sample Location:	Detailed Sample Location:
Room 204	Northeast corner of room.
Sample Quantity:	NA
Sample Color:	XRF:
White	0.043

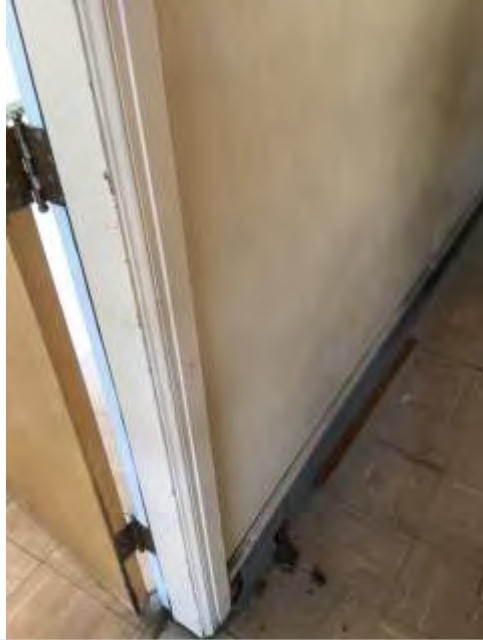
Sample ID:	Sample Type:
2-2-PB-3	PB
Sample Location:	Detailed Sample Location:
Room 200S	Catwalk outside of room 204.
Sample Quantity:	NA
Sample Color:	XRF:
Tan	0.085

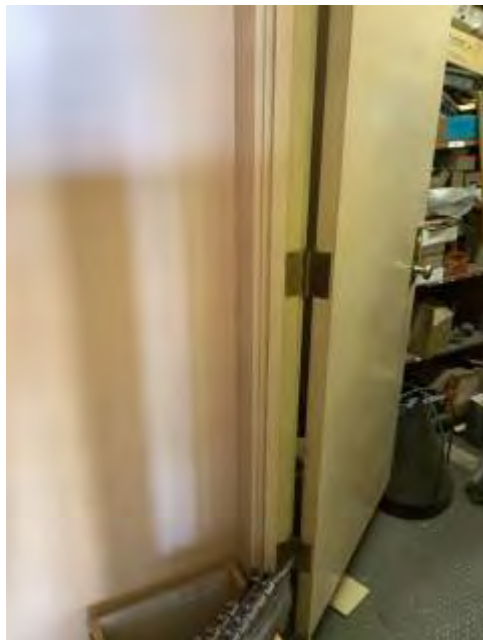
Sample ID:	Sample Type:
2-2-PB-4	PB
Sample Location:	Detailed Sample Location:
Room 200S	Catwalk outside of room 201.
Sample Quantity:	NA
Sample Color:	XRF:
Tan	0.219

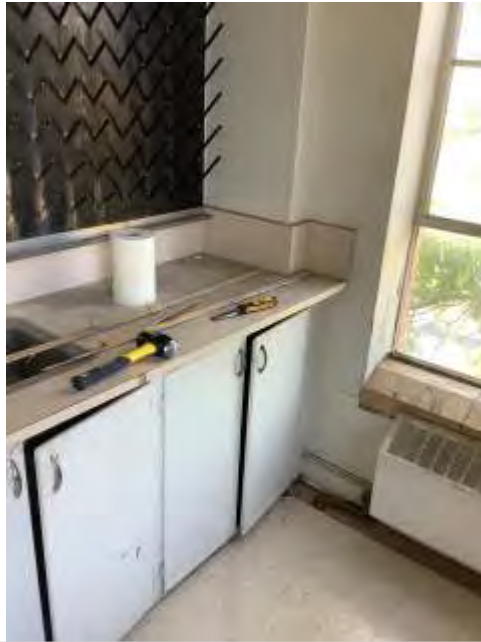
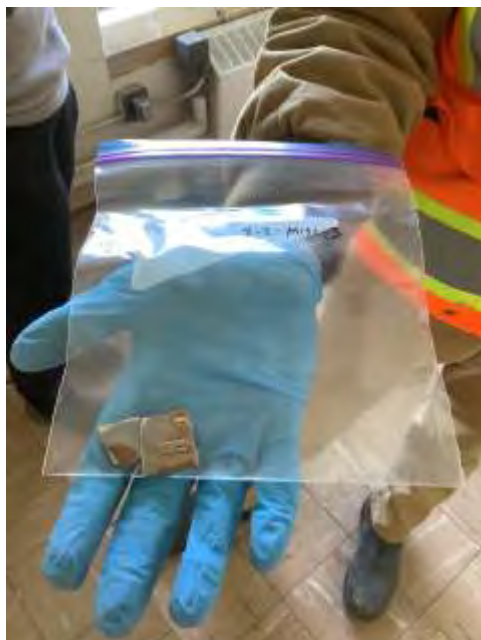
Additional Sample Notes:		
Sample ID:	Sample Type:	
2-2-MISC-3	MISC	
Sample Location:	Detailed Sample Location:	
Room 203	Southeast corner of counter.	
Sample Quantity:	22 square feet.	
Misc Sample Material:	Sample Condition:	Sample Friable?:
Tan laminate countertop with clear mastic.	Potential ACBM with potential for damage	No

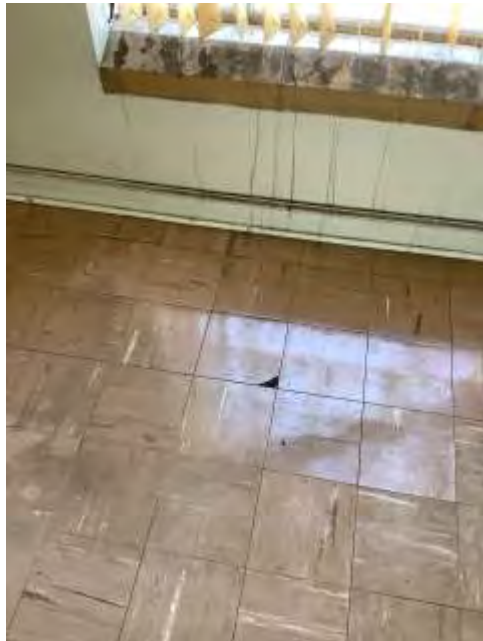
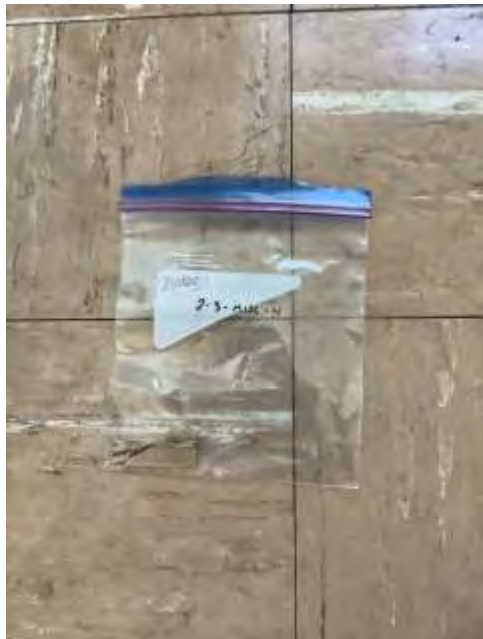
Additional Sample Notes:		
Sample ID:	Sample Type:	
2-3-MISC-4	MISC	
Sample Location:	Detailed Sample Location:	
Room 202	West side of floor.	
Sample Quantity:	175 square feet.	
Misc Sample Material:	Sample Condition:	Sample Friable?:
Light brown patterned 9" x 9" vinyl floor tile with black mastic.	Potential ACBM with potential for damage	No

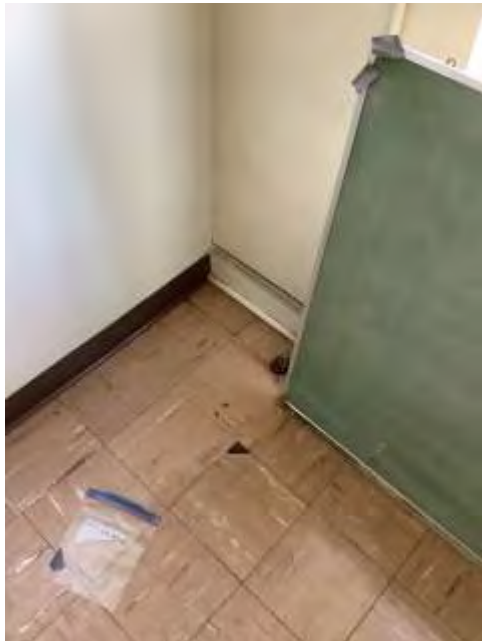
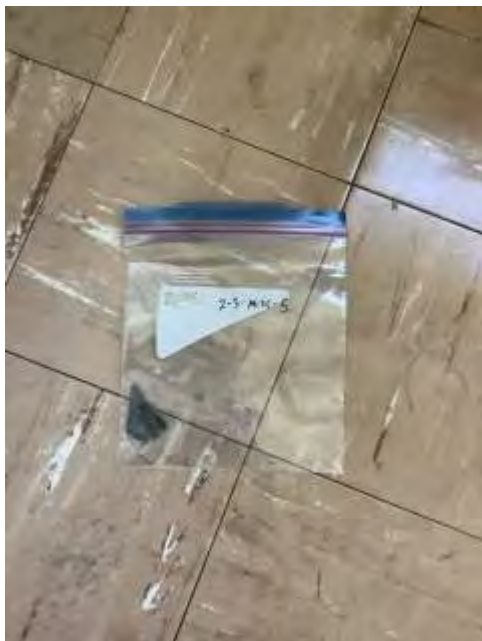
Additional Sample Notes:		
Sample ID:	Sample Type:	
2-3-MISC-5	MISC	
Sample Location:	Detailed Sample Location:	
Room 203	Southwest corner of floor.	
Sample Quantity:	175 square feet.	
Misc Sample Material:	Sample Condition:	Sample Friable?:
Light brown patterned 9" x 9" vinyl floor tile with black mastic.	Potential ACBM with potential for damage	No

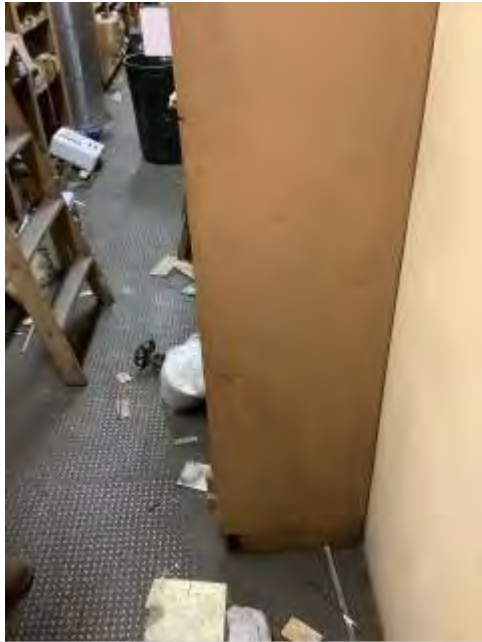
Sample ID:	Sample Type:
2-3-PB-5	PB
Sample Location:	Detailed Sample Location:
Room 201	Cabinet inside doorway.
Sample Quantity:	NA
Sample Color:	XRF:
Dark tan	0.330

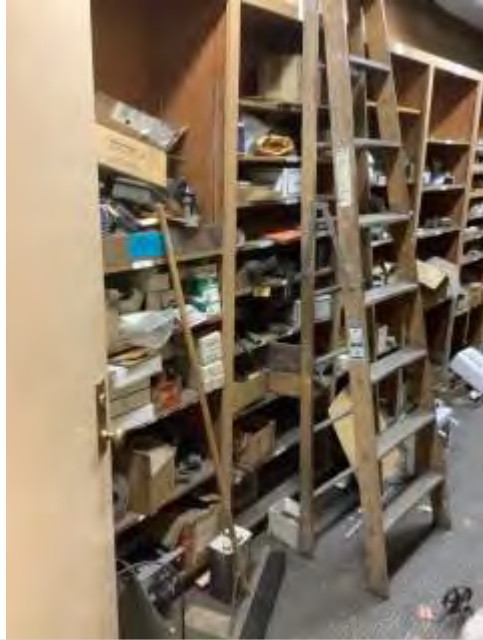
Sample ID:	Sample Type:
2-3-PB-6	PB
Sample Location:	Detailed Sample Location:
Room 201	Cabinet on north wall.
Sample Quantity:	NA
Sample Color:	XRF:
Dark tan	0.268

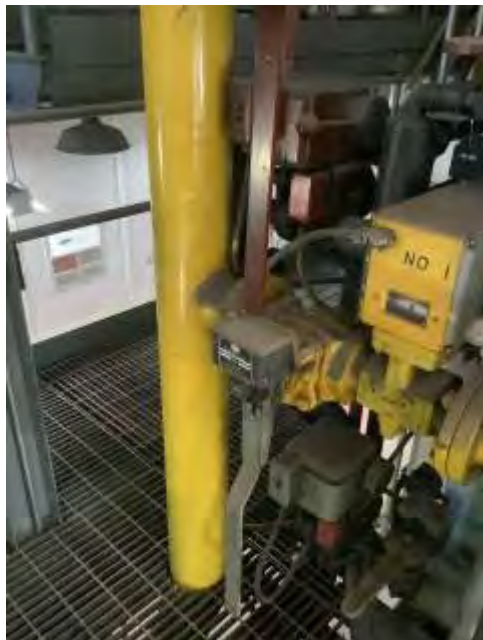
Sample ID:	Sample Type:
2-4-PB-7	PB
Sample Location:	Detailed Sample Location:
Room 101	Yellow pipe on first catwalk, west side of room.
Sample Quantity:	600 linear feet.
Sample Color:	XRF:
Yellow	3.22

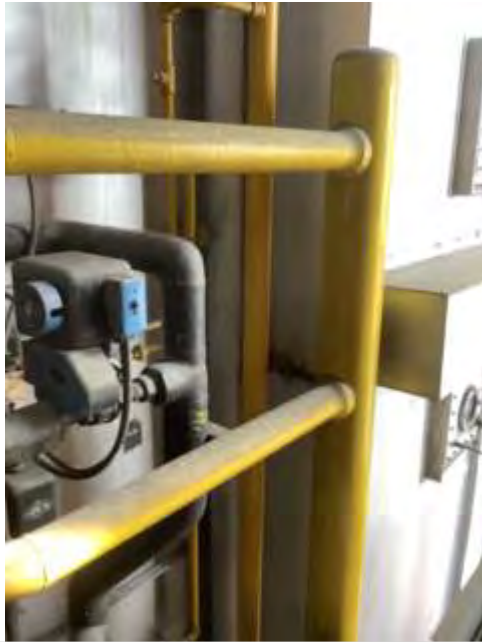
Sample ID:	Sample Type:
2-4-PB-8	PB
Sample Location:	Detailed Sample Location:
Room 101	Yellow pipe on first catwalk, west side of room.
Sample Quantity:	600 linear feet.
Sample Color:	XRF:
Yellow	4.94

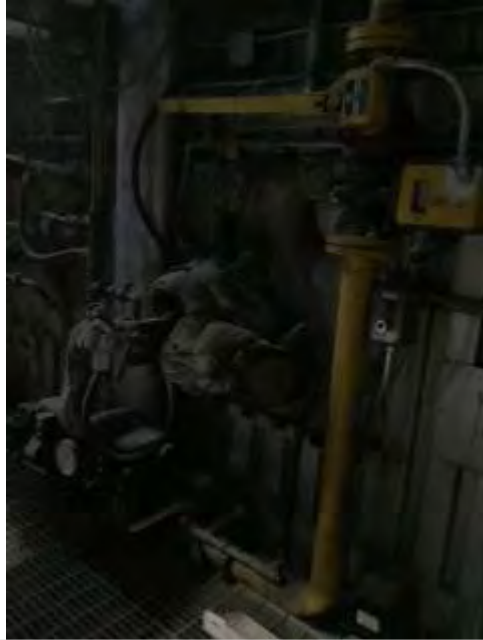
Sample ID:	Sample Type:
2-4-PB-12	PB
Sample Location:	Detailed Sample Location:
Room 101	Yellow pipe on first catwalk, east side of room.
Sample Quantity:	600 linear feet.
Sample Color:	XRF:
Yellow	3.28

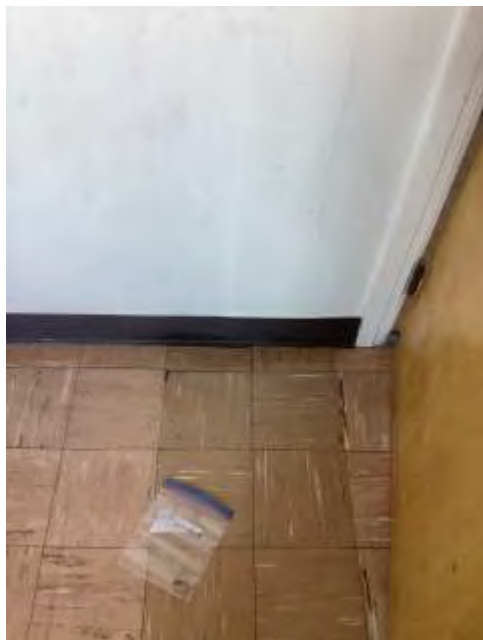
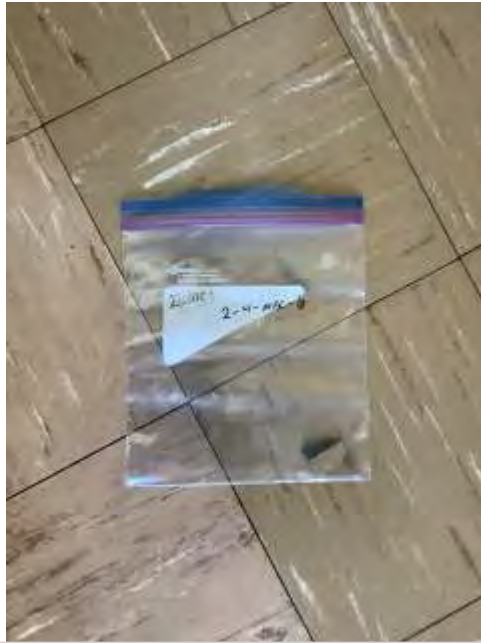
Sample ID:	Sample Type:	
2-4-MISC-6	MISC	
Sample Location:	Detailed Sample Location:	
Room 202	East side of floor north of door.	
Sample Quantity:	20 square feet.	
Misc Sample Material:	Sample Condition:	Sample Friable?:
Brown stripped patterned 9" x 9" vinyl floor tile with black mastic.	Potential ACBM with potential for damage	No

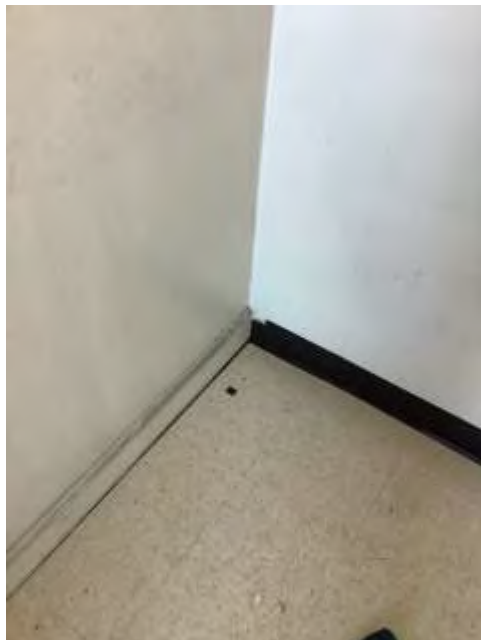
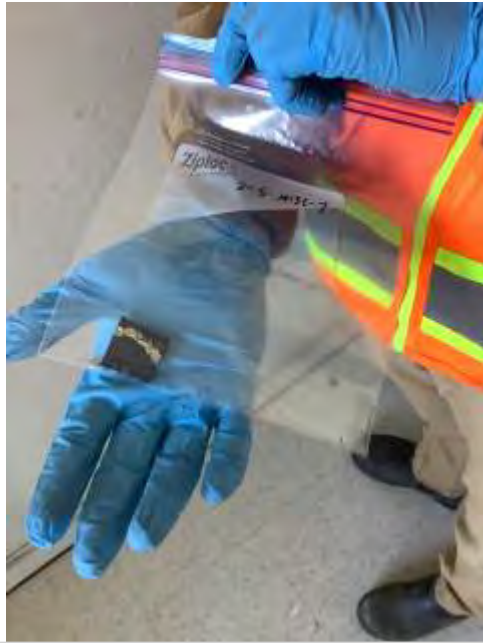
Sample ID:	Sample Type:	
2-5-MISC-7	MISC	
Sample Location:	Detailed Sample Location:	
Room 202	Northeast corner of room.	
Sample Quantity:	30 linear feet.	
Misc Sample Material:	Sample Condition:	Sample Friable?:
Black cove base with tan mastic.	Potential ACBM with potential for damage	No

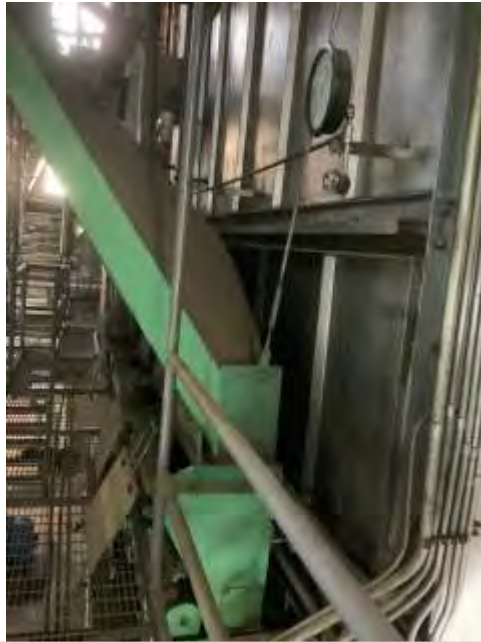
Sample ID:	Sample Type:
2-5-PB-9	PB
Sample Location:	Detailed Sample Location:
Room 101	Light green pipe on first catwalk in center of room.
Sample Quantity:	NA
Sample Color:	XRF:
Light green	0.242

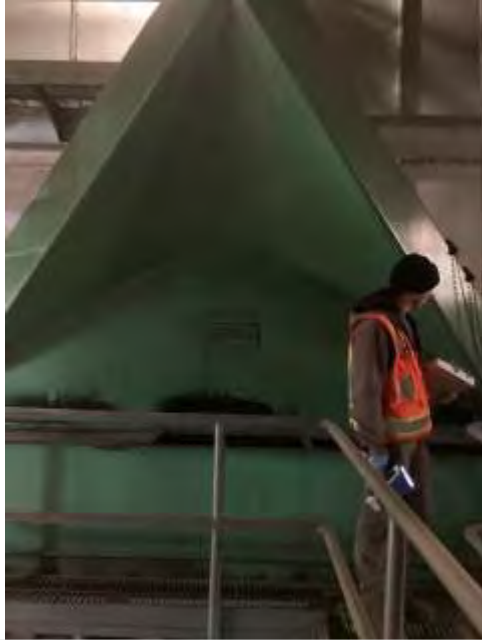
Sample ID:	Sample Type:
2-5-PB-10	PB
Sample Location:	Detailed Sample Location:
Room 101	Light green pipe on first catwalk in center of room.
Sample Quantity:	NA
Sample Color:	XRF:
Light green	0.108

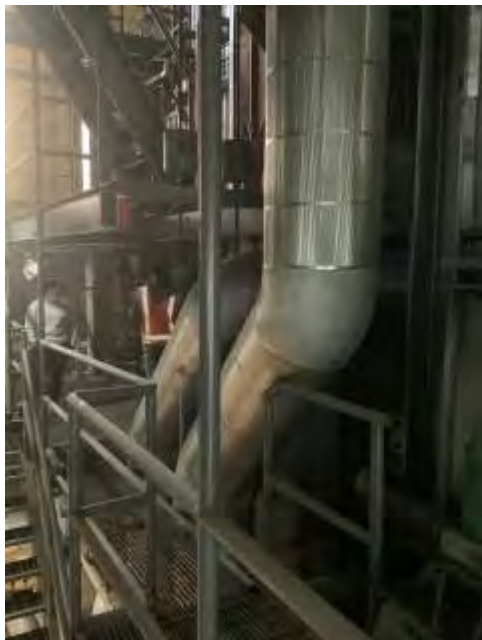
Sample ID:	Sample Type:
2-6-PB-11	PB
Sample Location:	Detailed Sample Location:
Room 101	Silver pipe on first catwalk in center of room.
Sample Quantity:	NA
Sample Color:	XRF:
Silver	ND

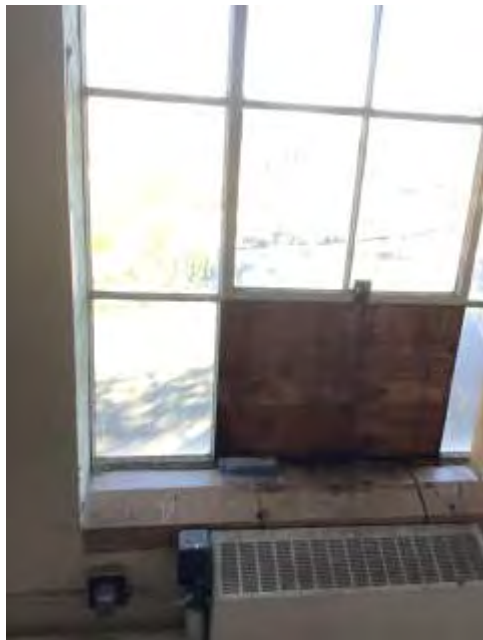
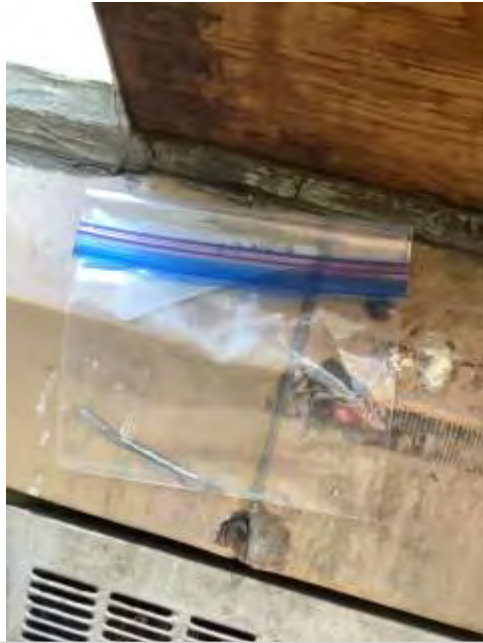
Sample ID:	Sample Type:	
2-7-MISC-9	MISC	
Sample Location:	Detailed Sample Location:	
Room 202	Northwest window.	
Sample Quantity:	4,030 linear feet.	
Misc Sample Material:	Sample Condition:	Sample Friable?:
Window glazing.	Potential ACBM with potential for damage	No

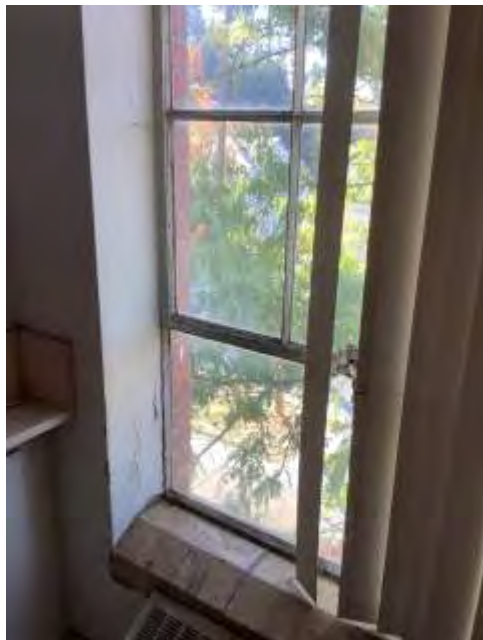
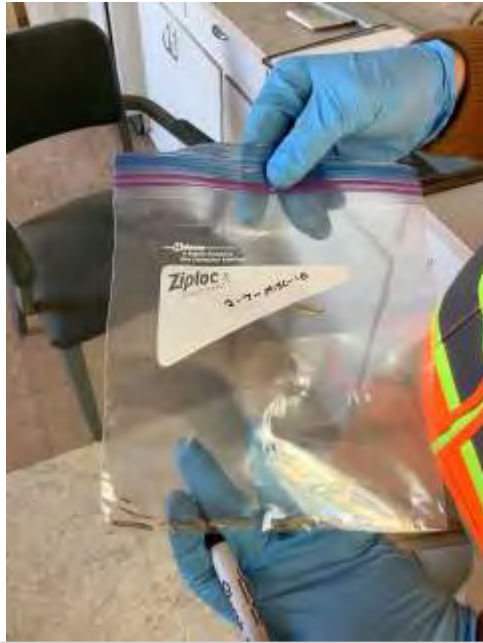
Sample ID:	Sample Type:	
2-7-MISC-10	MISC	
Sample Location:	Detailed Sample Location:	
Room 203	Southeast window.	
Sample Quantity:	4,030 linear feet.	
Misc Sample Material:	Sample Condition:	Sample Friable?:
Window glazing.	Potential ACBM with potential for damage	No
