COLLEGE AVENUE STEAM PLANT ADAPTIVE REUSE

Integrated Cleanup and Implementation Plan

Port of
Whitman
County

PORT OF WHITMAN COUNTY
March 30, 2020

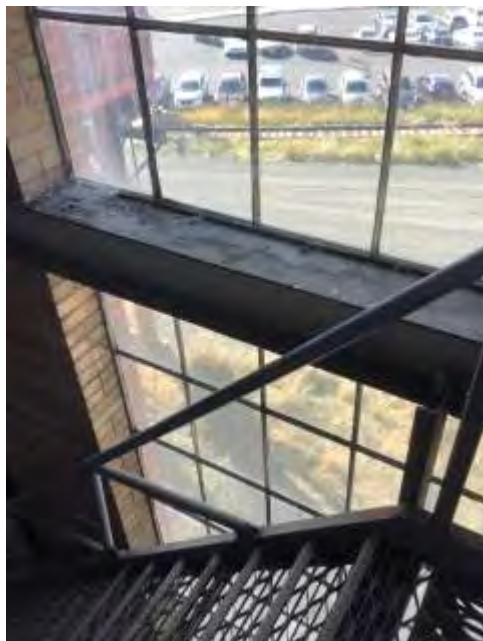
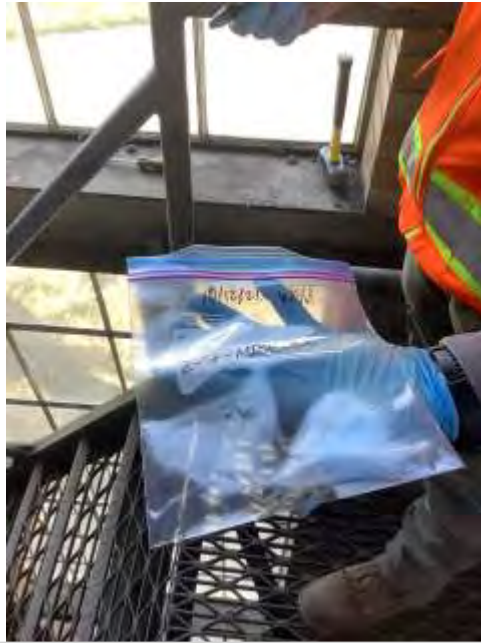
Sample ID:	Sample Type:	
2-7-MISC-33	MISC	
Sample Location:	Detailed Sample Location:	
Room 101	Northwest corner; highest catwalk.	
Sample Quantity:	4,030 linear feet.	
Misc Sample Material:	Sample Condition:	Sample Friable?:
Window glazing.	Damaged or significantly damaged friable miscellaneous ACM	Yes

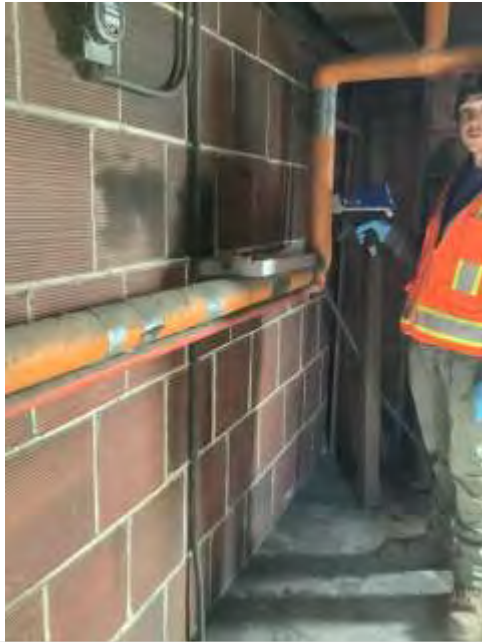
Additional Sample Notes:	
Sample ID:	Sample Type:
2-7-PB-24	PB
Sample Location:	Detailed Sample Location:
Room 204	Red pipe
Sample Quantity:	750 linear feet.
Sample Color:	XRF:
Red	1.164

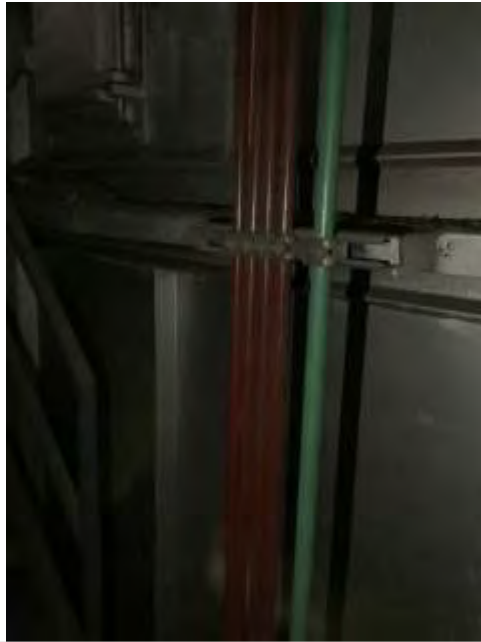
Sample ID:	Sample Type:
2-8-PB-25	PB
Sample Location:	Detailed Sample Location:
Room 101	Red pipe on first catwalk, east side of room.
Sample Quantity:	NA
Sample Color:	XRF:
Red	ND

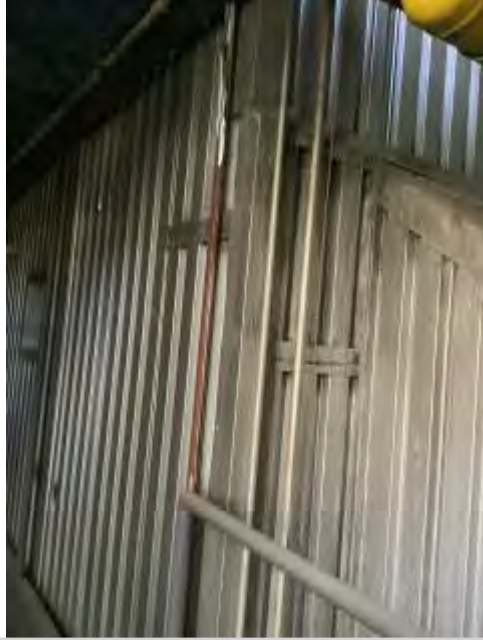
Sample ID:	Sample Type:
2-8-PB-14	PB
Sample Location:	Detailed Sample Location:
Room 101	Red pipe on first catwalk, east side of room.
Sample Quantity:	100 linear feet.
Sample Color:	XRF:
Reddish brown	0.075

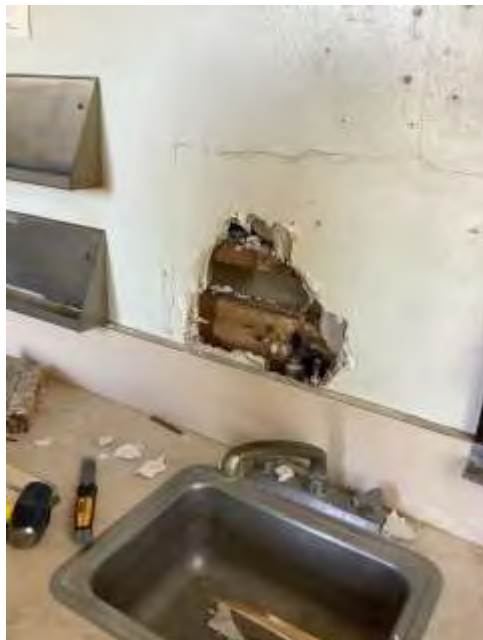
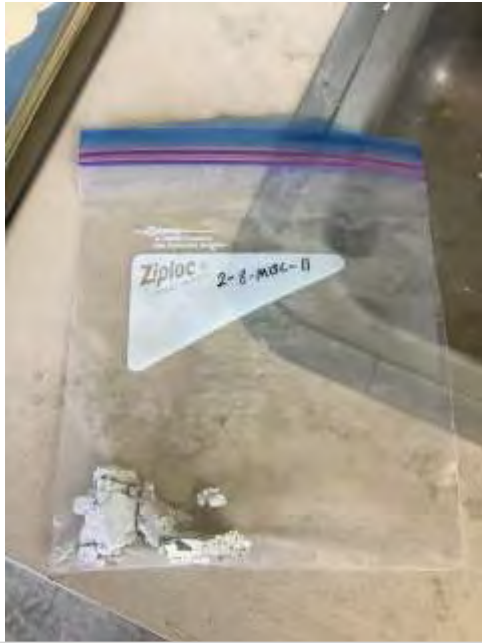
Sample ID:	Sample Type:	
2-8-MISC-11	MISC	
Sample Location:	Detailed Sample Location:	
Room 203	East wall above sink.	
Sample Quantity:	1,000 square feet.	
Misc Sample Material:	Sample Condition:	Sample Friable?:
White drywall with cementitious wallboard.	Potential ACBM with potential for damage	No;Yes

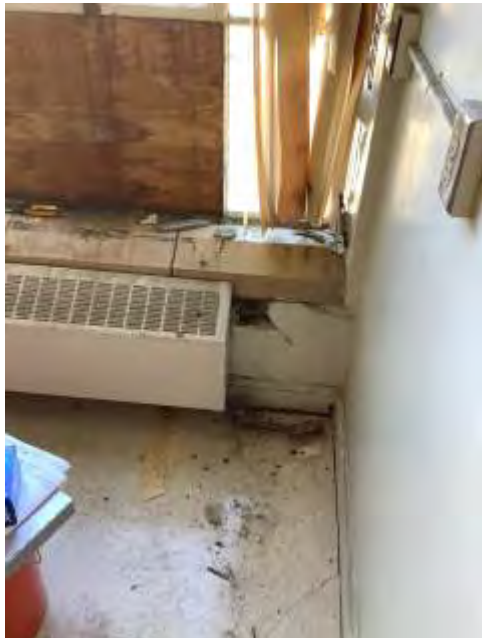
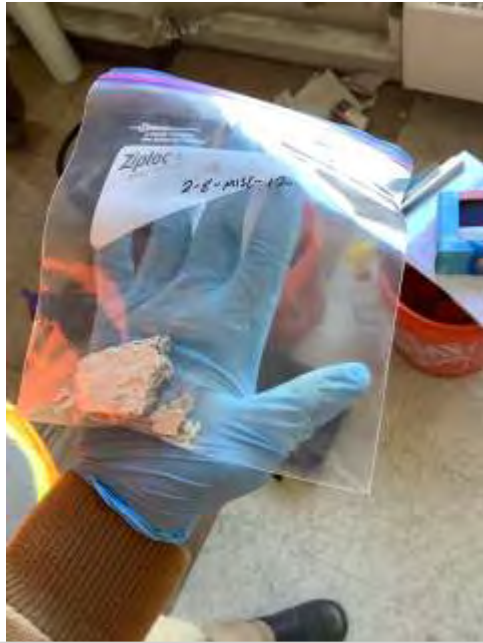
2-8-MISC-12

Misc Sample Material: White drywall with cementitious wallboard. **Sample Condition:** Potential ACBM with potential for damage **Sample Friable?:** No

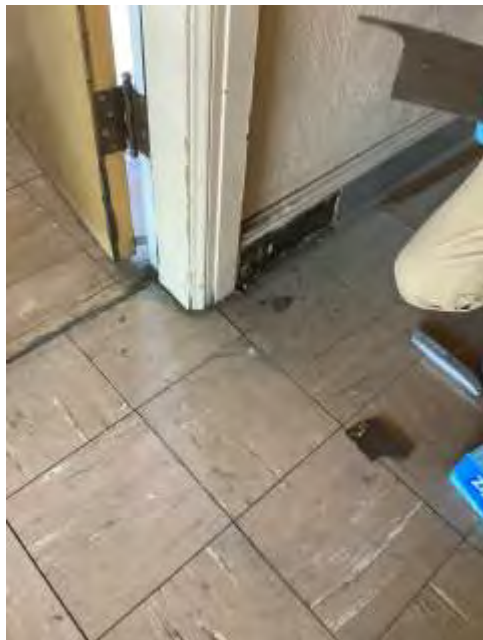
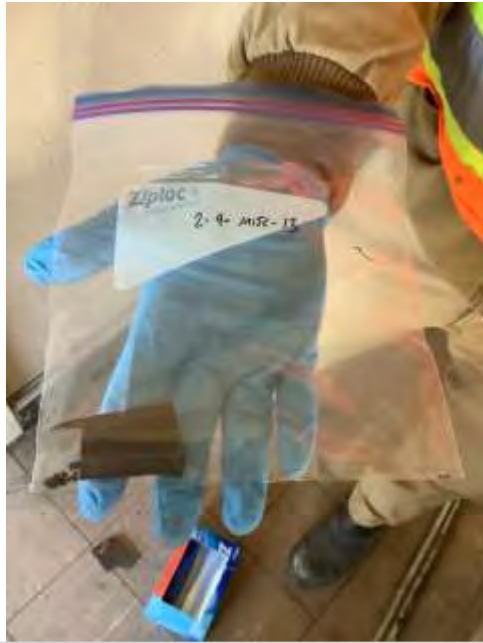
Sample ID:	Sample Type:	
2-9-MISC-13	MISC	
Sample Location:	Detailed Sample Location:	
Room 200S	West wall north of door to room 202.	
Sample Quantity:	14 linear feet.	
Misc Sample Material:	Sample Condition:	Sample Friable?:
Brown cove base with brown mastic.	Potential ACBM with potential for damage	No

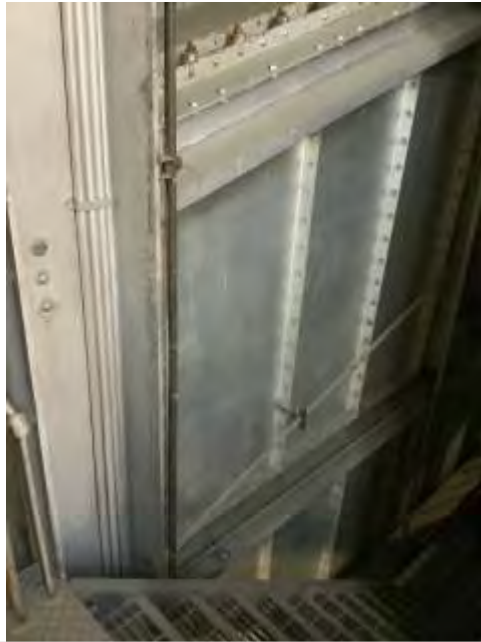
Sample ID:	Sample Type:
2-9-PB-19	PB
Sample Location:	Detailed Sample Location:
Room 101	Gray boiler siding on second catwalk, east side of room.
Sample Quantity:	NA
Sample Color:	XRF:
Gray	0.035

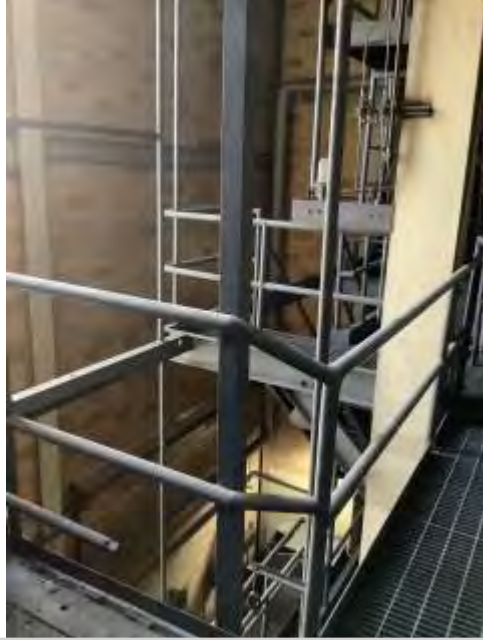
Sample ID:	Sample Type:
2-10-PB-17	PB
Sample Location:	Detailed Sample Location:
Room 101	Gray railing on second catwalk on east side of room.
Sample Quantity:	NA
Sample Color:	XRF:
Gray	0.007

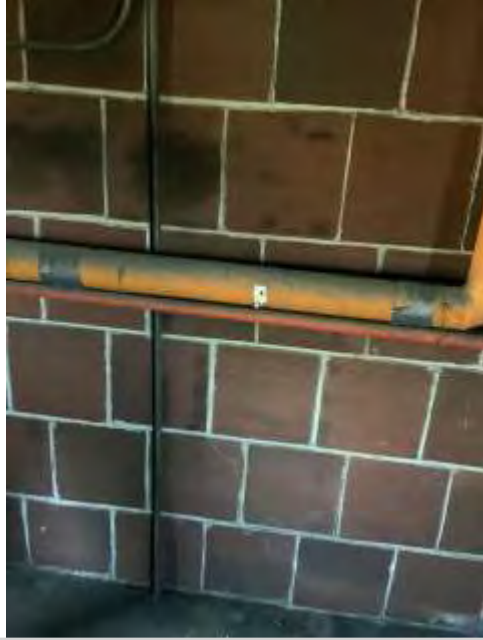
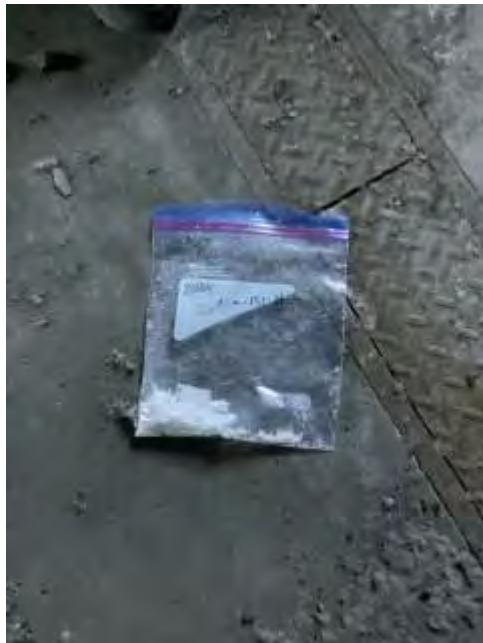
Additional Sample Notes:		
Sample ID:	Sample Type:	
2-10-TSI-14	TSI	
Sample Location:	Detailed Sample Location:	
Room 204	Pipe on east wall south of single door.	
Sample Quantity:	14 linear feet.	
Sample Color:	XRF:	
Misc Sample Material:	Sample Condition:	Sample Friable?:
	Damaged or significantly damaged	Yes

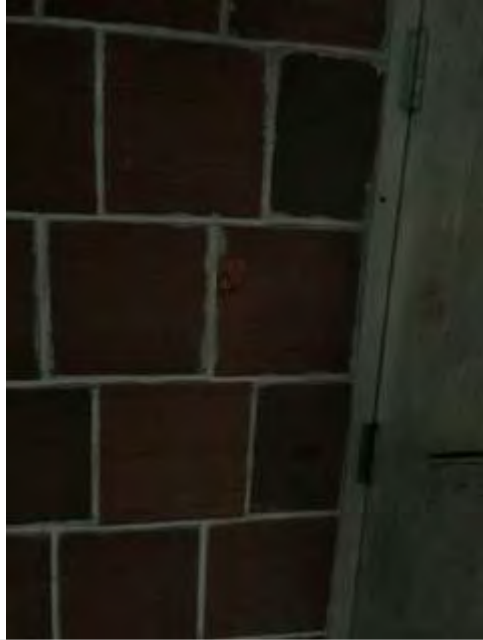
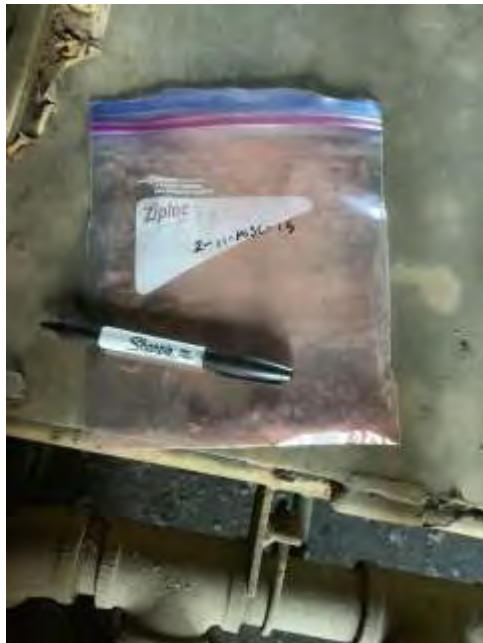
Sample ID:	Sample Type:	
2-11-MISC-15	MISC	
Sample Location:	Detailed Sample Location:	
Room 204	West wall south of double door.	
Sample Quantity:	615 square feet.	
Misc Sample Material:	Sample Condition:	Sample Friable?:
Red 12" x 12" brick.	Potential ACBM with potential for damage	No

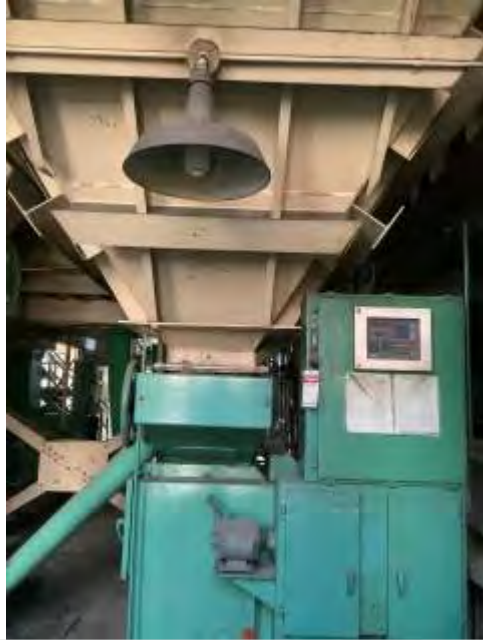
Sample ID:	Sample Type:
2-11-PB-18	PB
Sample Location:	Detailed Sample Location:
Room 101	Tan boiler part on second catwalk on east side of room.
Sample Quantity:	NA
Sample Color:	XRF:
Tan	0.101

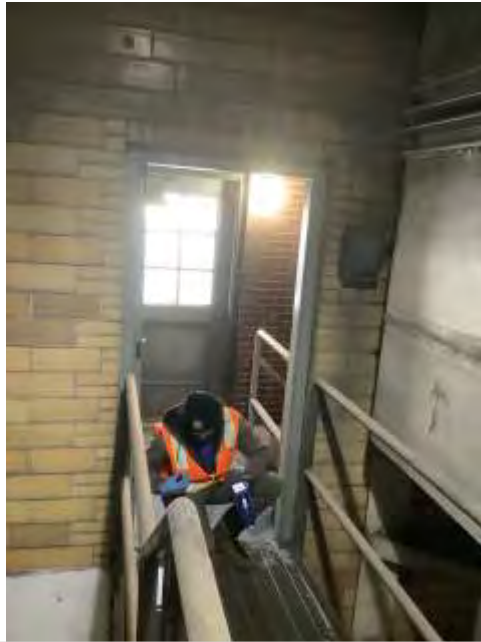
Sample ID:	Sample Type:
2-12-PB-20	PB
Sample Location:	Detailed Sample Location:
Room 101	Gray door frame on second catwalk, east side of room.
Sample Quantity:	NA
Sample Color:	XRF:
Gray	0.517

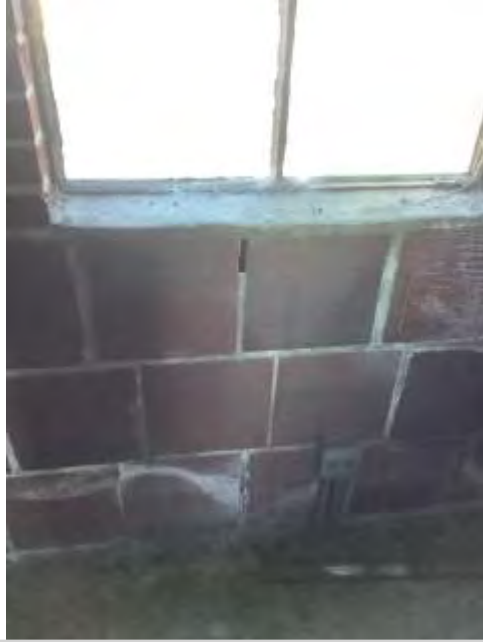
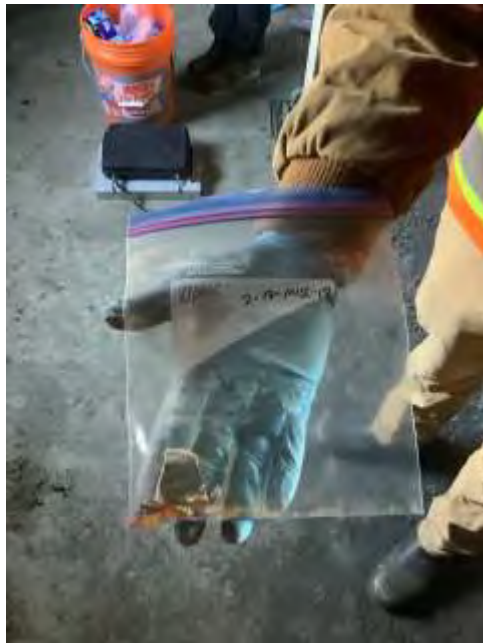
Sample ID:	Sample Type:	
2-12-MISC-18	MISC	
Sample Location:	Detailed Sample Location:	
Room 204	North wall below window.	
Sample Quantity:	550 linear feet.	
Misc Sample Material:	Sample Condition:	Sample Friable?:
Gray brick mortar.	Potential ACBM with potential for damage	No

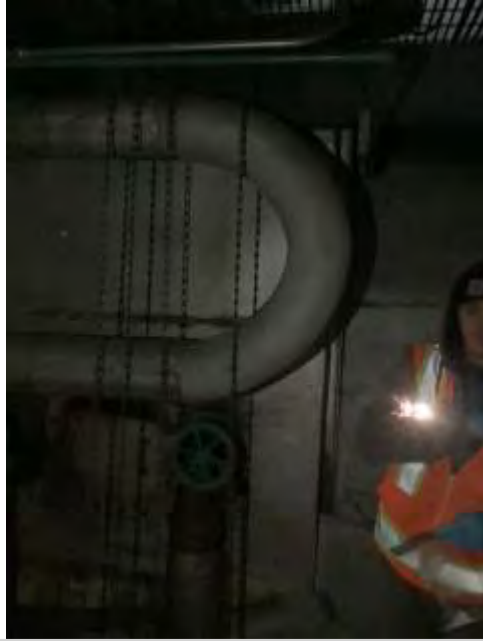
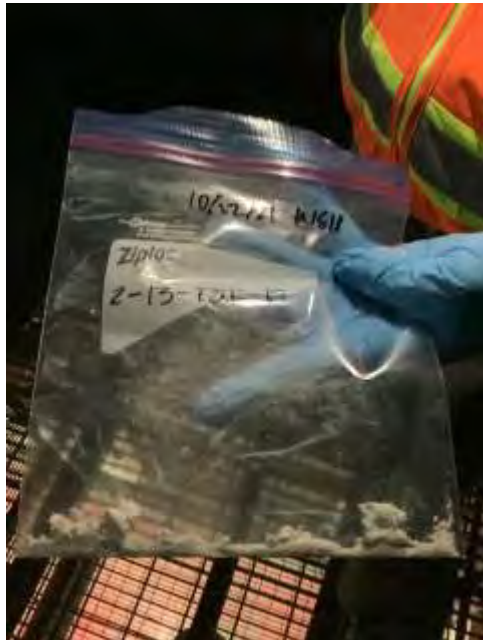
Additional Sample Notes:		
Sample ID:	Sample Type:	
2-13-TSI-19	TSI	
Sample Location:	Detailed Sample Location:	
Room 101	Second catwalk on southwest side of Boiler 6.	
Sample Quantity:	3,000 linear feet.	
Sample Color:	XRF:	
Misc Sample Material:	Sample Condition:	Sample Friable?:
	Damaged or significantly damaged	Yes

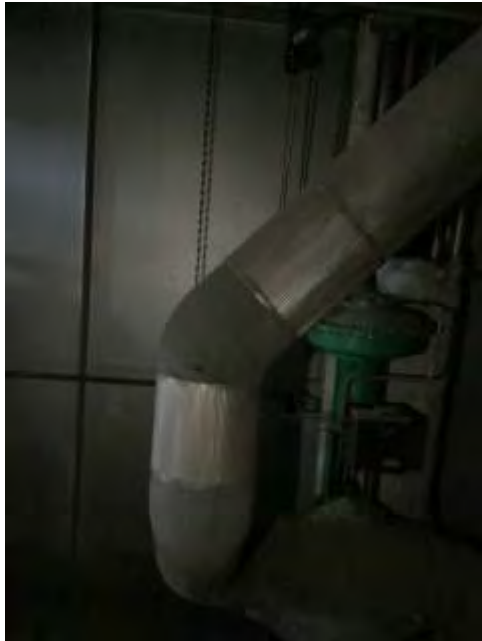
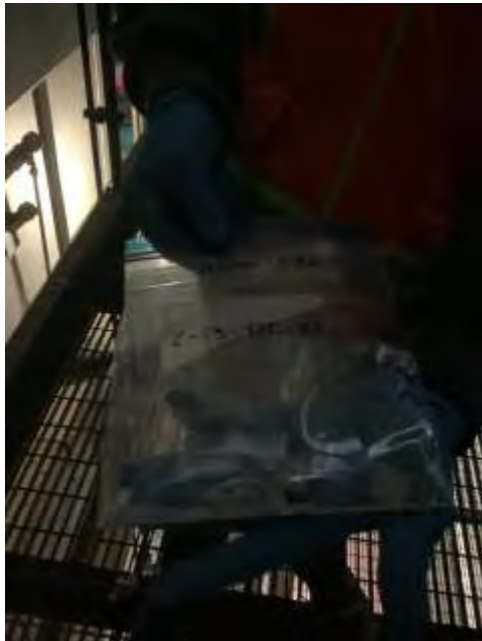
Additional Sample Notes:	Silver pipe with white insulation.
Sample ID:	Sample Type:
2-13-TSI-20	TSI
Sample Location:	Detailed Sample Location:
Room 101	Second catwalk on southwest side of Boiler 6.
Sample Quantity:	3,000 linear feet.
Sample Color:	XRF:

Misc Sample Material:	Sample Condition:	Sample Friable?:
	Damaged or significantly damaged	Yes

Additional Sample Notes:	Silver pipe with white insulation.
---------------------------------	------------------------------------

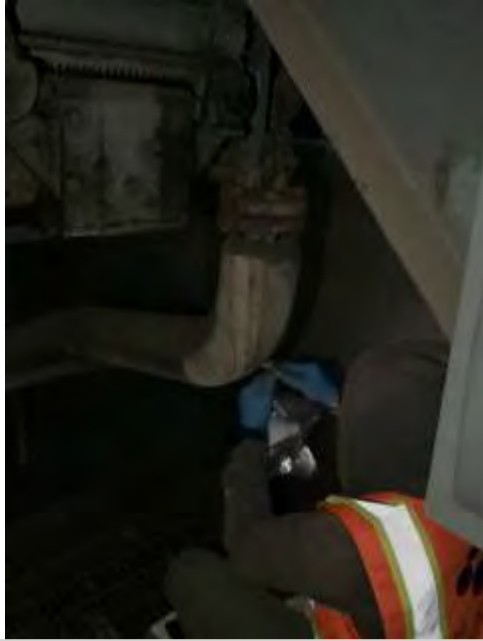
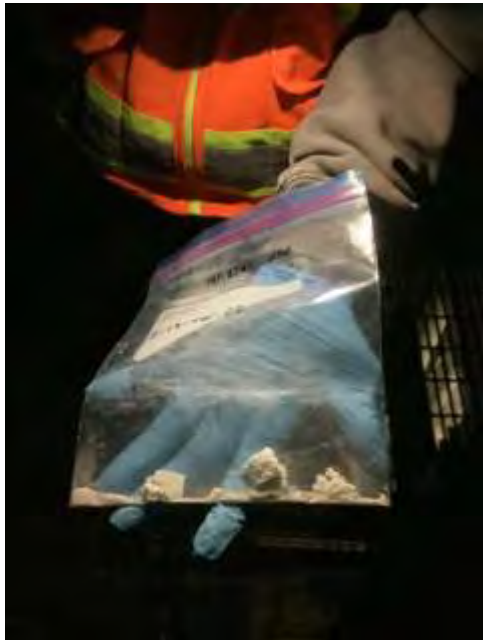
Sample ID:	Sample Type:
2-13-TSI-22	TSI
Sample Location:	Detailed Sample Location:
Room 101	Second catwalk on southwest side of Boiler 6.
Sample Quantity:	3,000 linear feet.

Sample Color:	XRF:	
Misc Sample Material:	Sample Condition:	Sample Friable?:
	Damaged or significantly damaged	Yes

Additional Sample Notes:	Elbow on silver pipe.
---------------------------------	-----------------------

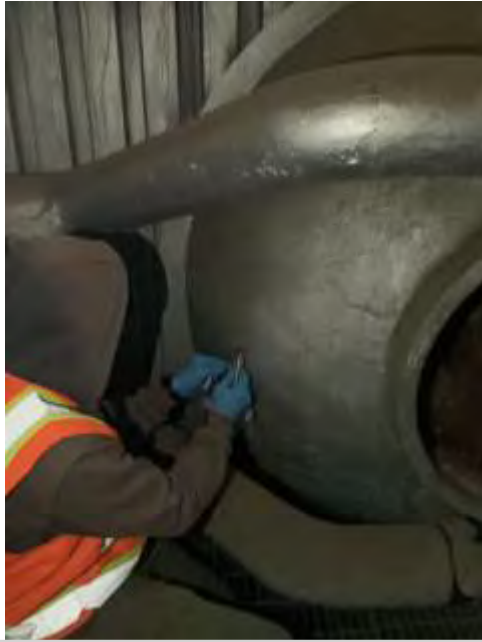
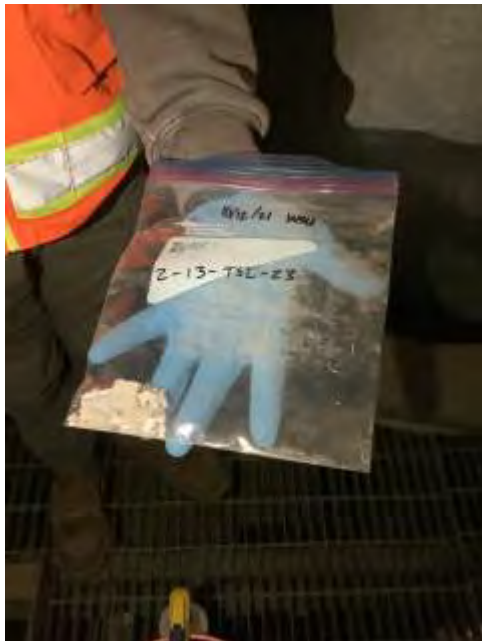
2-13-TSI-23

Room 101	Second catwalk on southeast side of Boiler 6.	
Sample Quantity:	3,000 linear feet.	
Sample Color:	XRF:	
Misc Sample Material:	Sample Condition:	Sample Friable?:
	Damaged or significantly damaged	Yes

Additional Sample Notes:	Silver pipe with white insulation.
---------------------------------	------------------------------------

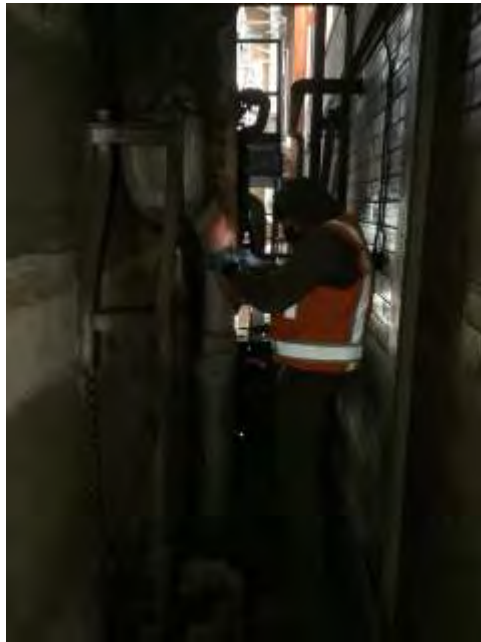
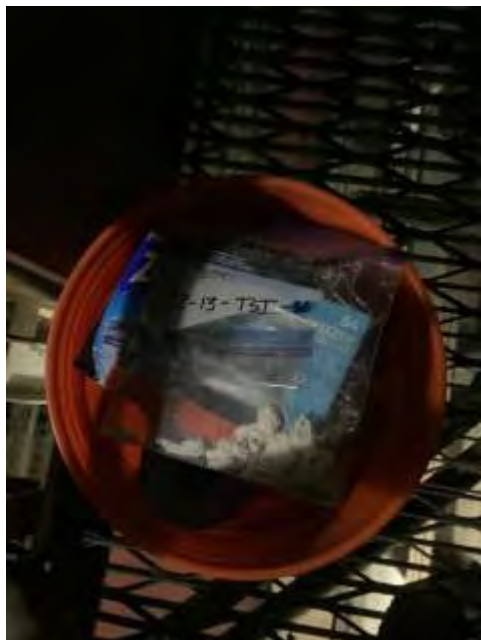
2-13-TSI-30	TSI	
Sample Location:	Detailed Sample Location:	
Room 101	Located throughout northeast side of room on and around Boiler 2 by staircase entrance.	
Sample Quantity:	3,000 linear feet.	
Sample Color:	XRF:	
Misc Sample Material:	Sample Condition:	Sample Friable?:
	Damaged or significantly damaged	No

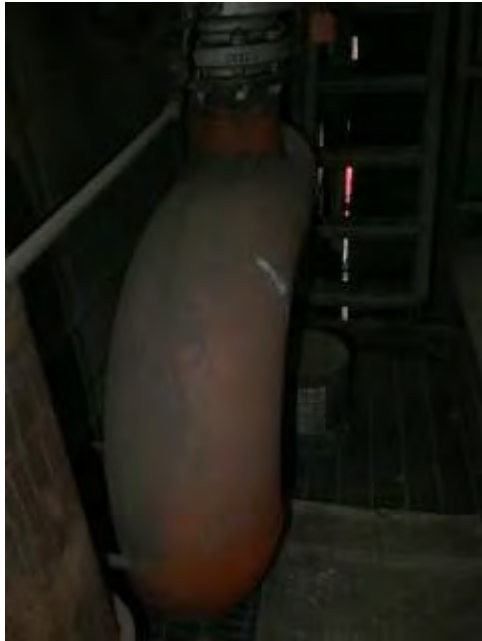
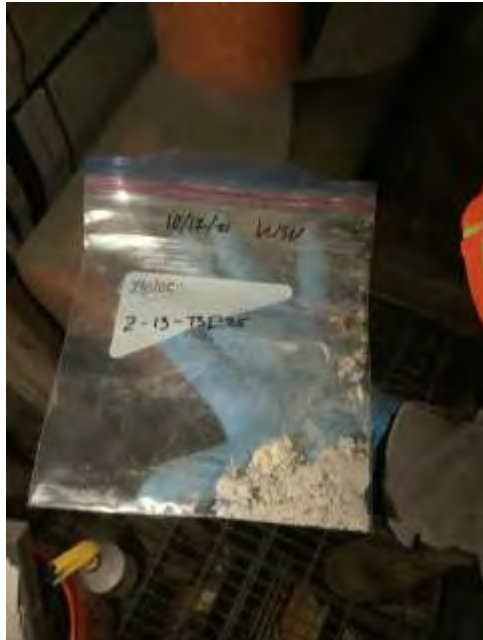
Additional Sample Notes:	Orange pipe wrap with white insulation.	
Sample ID:	Sample Type:	
2-13-TSI-25	TSI	
Sample Location:	Detailed Sample Location:	
Room 101	Second catwalk on south side of Boiler 6.	
Sample Quantity:	3,000 linear feet.	
Sample Color:	XRF:	
Misc Sample Material:	Sample Condition:	Sample Friable?:
	Damaged or significantly damaged	Yes

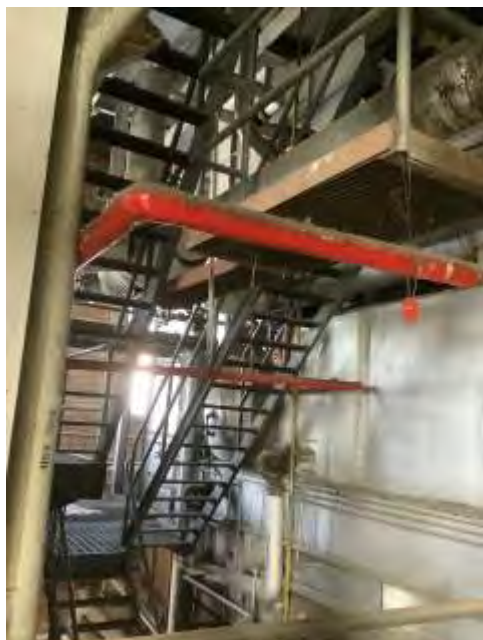
Additional Sample Notes:	Orange pipe with white insulation.
Sample ID:	Sample Type:
2-13-PB-21	PB
Sample Location:	Detailed Sample Location:
Room 101	Red pipe on west side of Boiler 4.
Sample Quantity:	NA
Sample Color:	XRF:
Red	ND

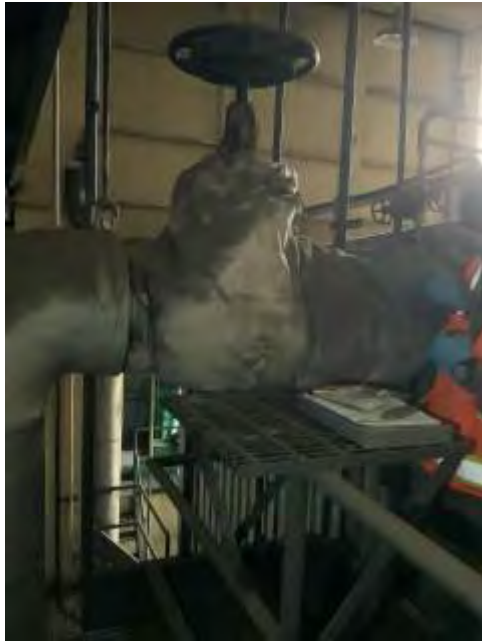
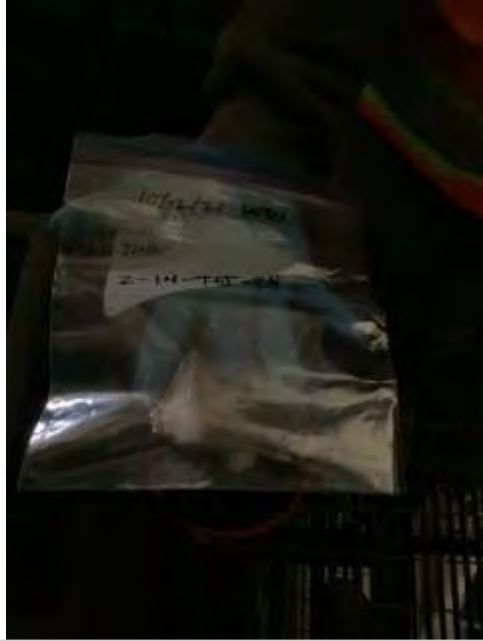
2-14-TSI-24

Misc Sample Material:	Sample Condition:	Sample Friable?:
------------------------------	--------------------------	-------------------------

Damaged or significantly damaged	Yes
--	----------------------------------	-----

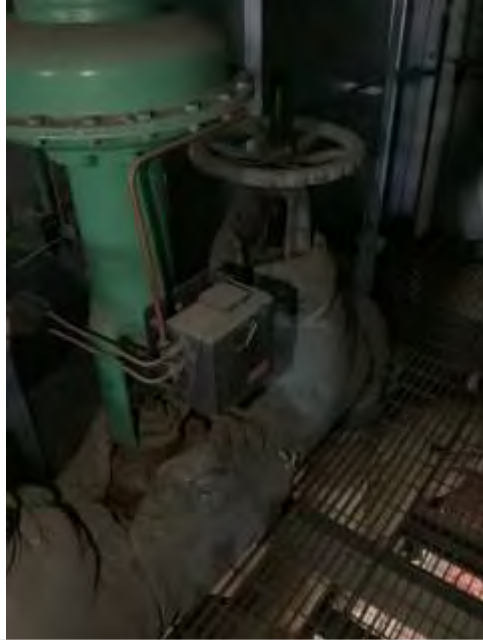
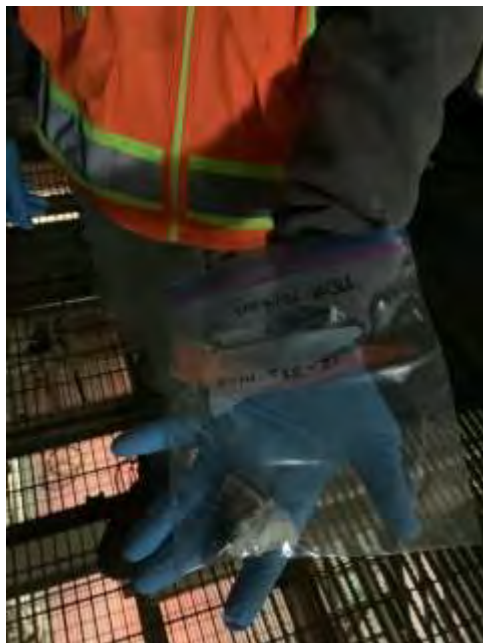
Additional Sample Notes:		Silver pipe with white insulation.	
Sample ID:		Sample Type:	
2-14-TSI-21		TSI	
Sample Location:		Detailed Sample Location:	
Room 101		Second catwalk on southwest side of Boiler 6.	
Sample Quantity:		500 linear feet.	
Sample Color:		XRF:	
Misc Sample Material:		Sample Condition:	Sample Friable?:
		Damaged or significantly damaged	Yes

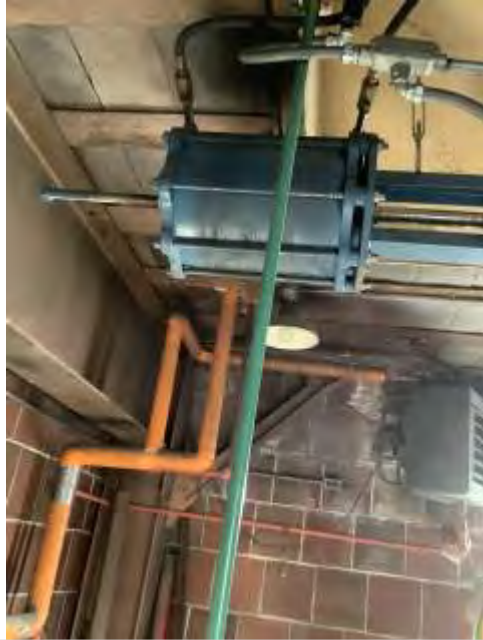
Additional Sample Notes:	Silver pipe with white insulation.
Sample ID:	Sample Type:
2-14-PB-23	PB
Sample Location:	Detailed Sample Location:
Room 101	Blue mechanical part in room 204.
Sample Quantity:	NA
Sample Color:	XRF:
Blue	ND

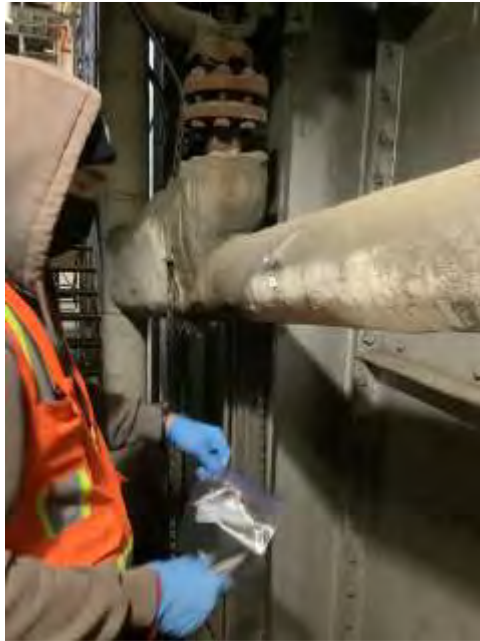
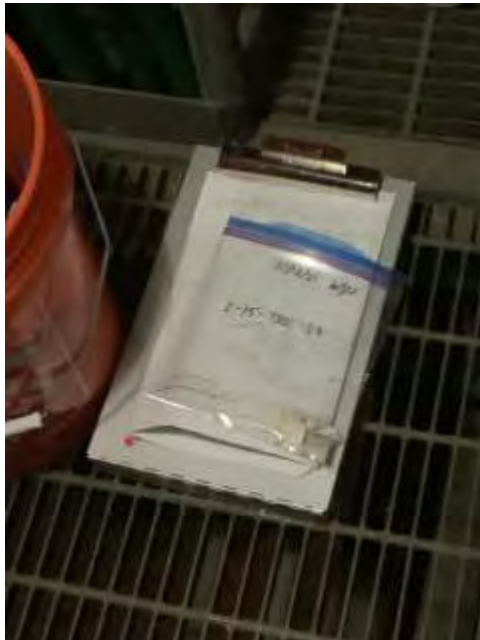
Additional Sample Notes:		Tan / white pipe wrap with white insulation.	
Sample ID:		Sample Type:	
2-15-TSI-27		TSI	
Sample Location:		Detailed Sample Location:	
Room 101		East side of room by staircase entrance.	
Sample Quantity:		35 linear feet.	
Sample Color:		XRF:	
Misc Sample Material:		Sample Condition:	Sample Friable?:
		Damaged or significantly damaged	No

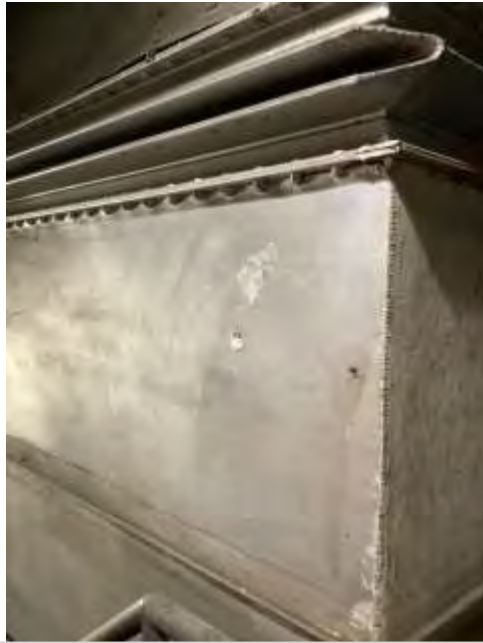
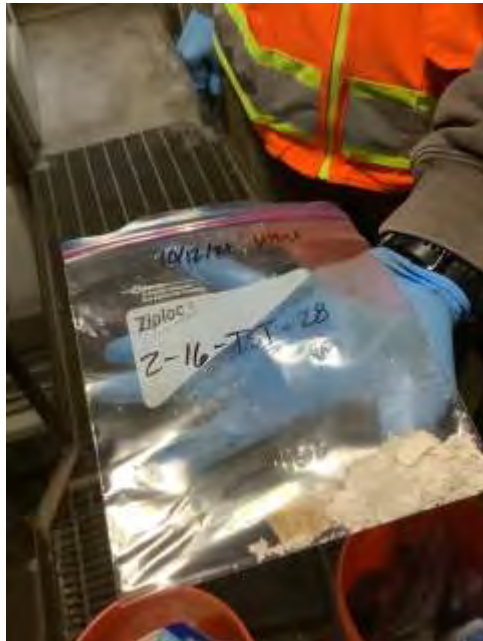
Additional Sample Notes:	White pipe wrap with white insulation.
Sample ID:	Sample Type:
2-16-TSI-28	TSI
Sample Location:	Detailed Sample Location:
Room 101	Located throughout northeast side of room on and around Boiler 2 by staircase entrance.
Sample Quantity:	Difficult to quantify.
Sample Color:	XRF:

Misc Sample Material:	Sample Condition:	Sample Friable?:
	Damaged or significantly damaged	No

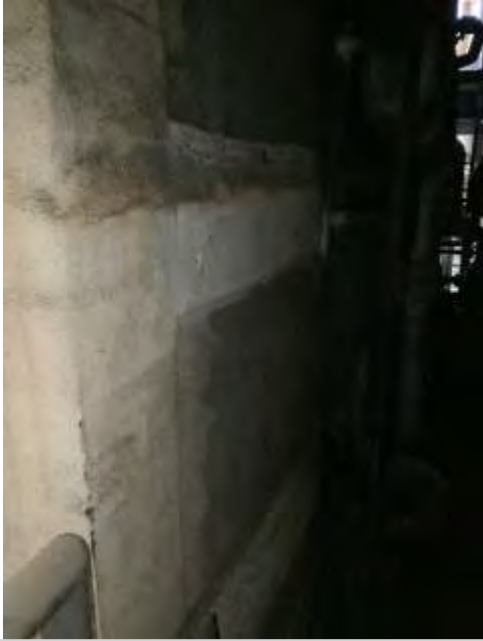
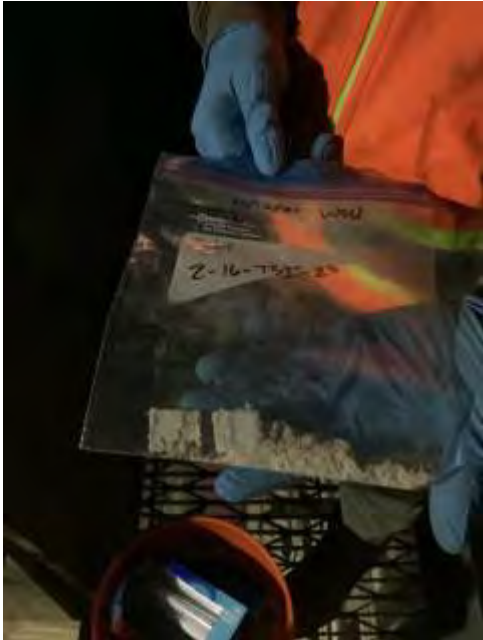
Sample ID:	Sample Type:
2-16-TSI-29	TSI
Sample Location:	Detailed Sample Location:
Room 101	Located throughout northeast side of room on and around Boiler 2 by staircase entrance.
Sample Quantity:	Difficult to quantify.

Sample Color:	XRF:	
Misc Sample Material:	Sample Condition:	Sample Friable?:
	Damaged or significantly damaged	No

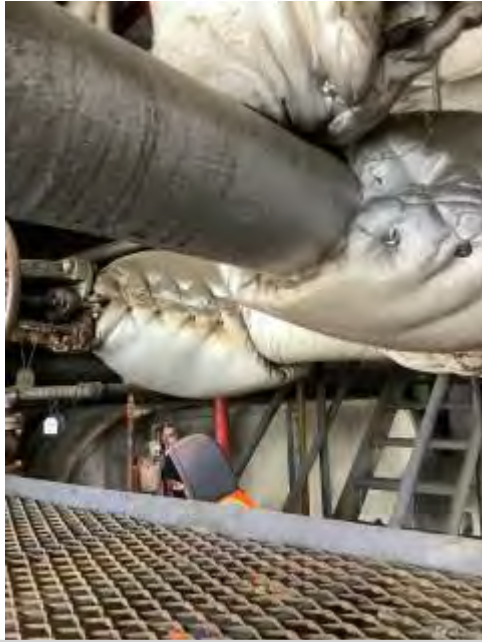
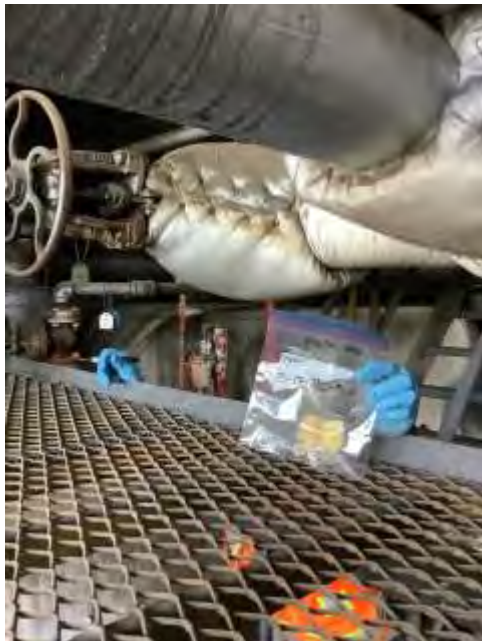
2-17-TSI-31

Room 101	North side of room, highest catwalk by Boiler 4.	
Sample Quantity:	20 linear feet.	
Sample Color:	XRF:	
Misc Sample Material:	Sample Condition:	Sample Friable?:
	Damaged or significantly damaged	Yes

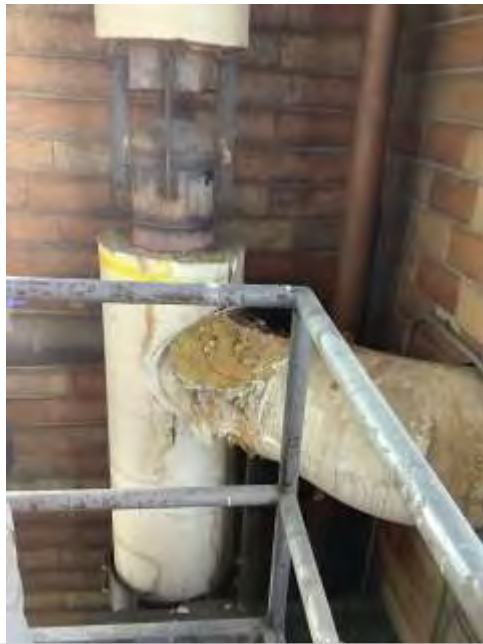
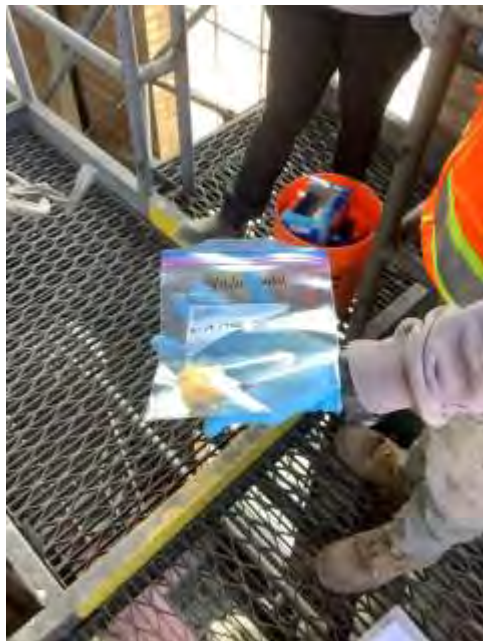
2-17-TSI-32	TSI	
Sample Location:	Detailed Sample Location:	
Room 101	Northwest corner of room, highest catwalk by Boiler 3.	
Sample Quantity:	20 linear feet.	
Sample Color:	XRF:	
Misc Sample Material:	Sample Condition:	Sample Friable?:
	Damaged or significantly damaged	Yes

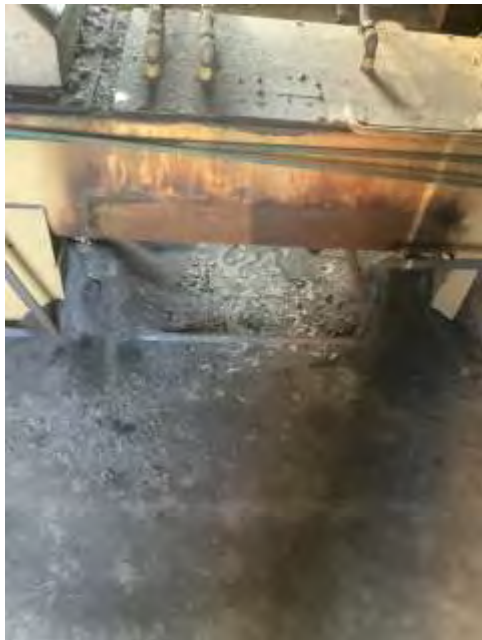
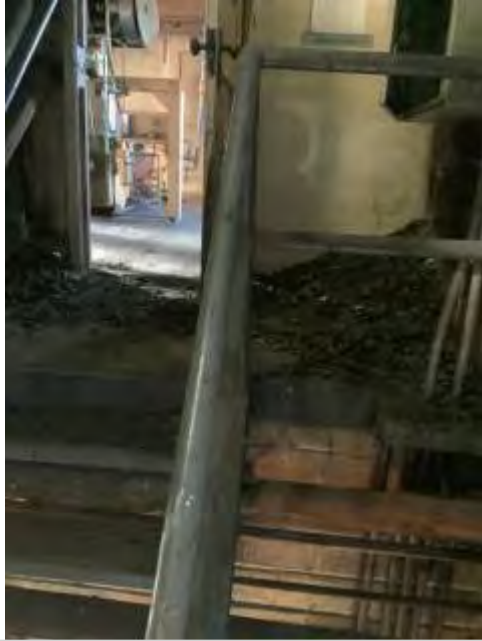
General Fixture Location:	Detailed Fixture Location:
Room 204	Throughout room 204
Type of Fixture:	Quantity:
Coal dust	Throughout room
Condition:	Additional Fixture Notes:
Other	Coal dust exposure.

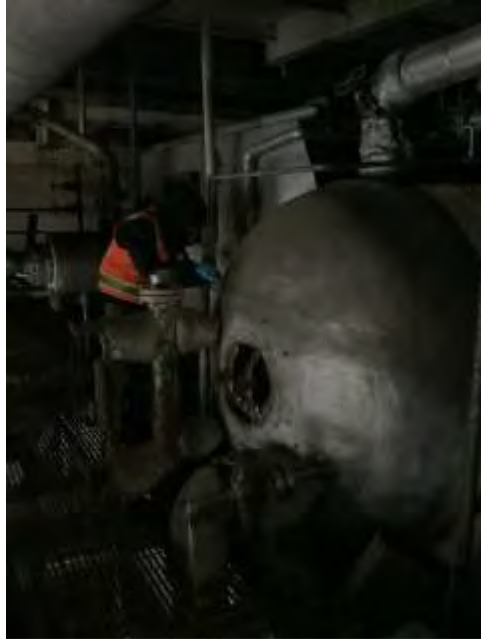
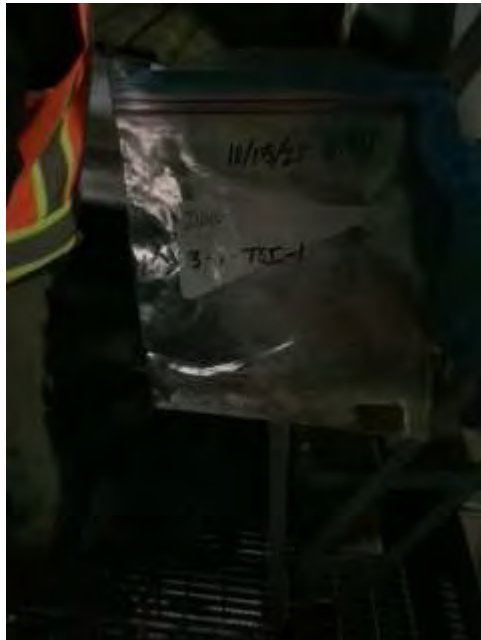
Additional Sample Notes:		White pipe insulation with white wrapping.
Sample ID:	Sample Type:	
3-1-TSI-1	TSI	
Sample Location:	Detailed Sample Location:	
Room 101	Highest catwalk.	
Sample Quantity:	3,000 linear feet.	
Sample Color:	XRF:	
Misc Sample Material:	Sample Condition:	Sample Friable?:
	Damaged or significantly damaged	Yes

White insulation with silver wrapping on boiler. Area of sampling not included on schematic of upper mezzanine.

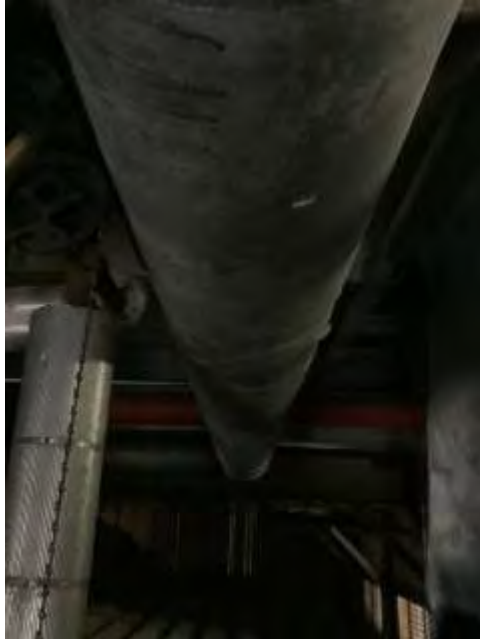
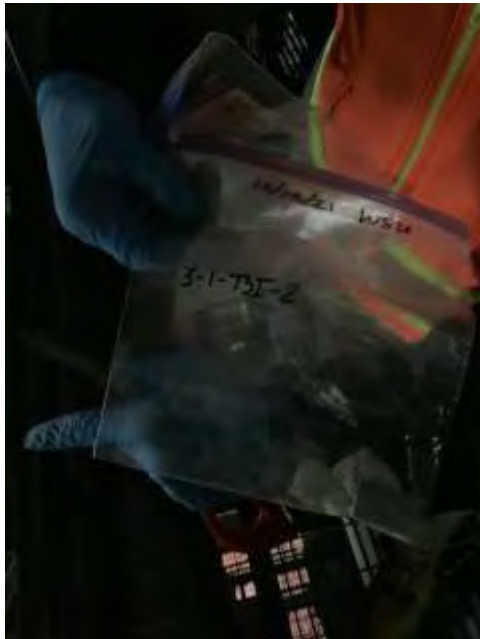
3-1-TSI-2

Misc Sample Material:	Sample Condition:	Sample Friable?:
	Damaged or significantly damaged	Yes

Additional Sample Notes:	White pipe insulation with white wrapping. Area of sampling not included on schematic of upper mezzanine.
---------------------------------	---

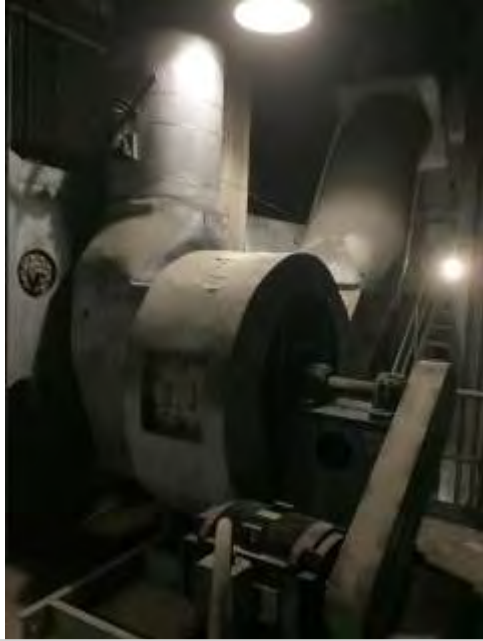
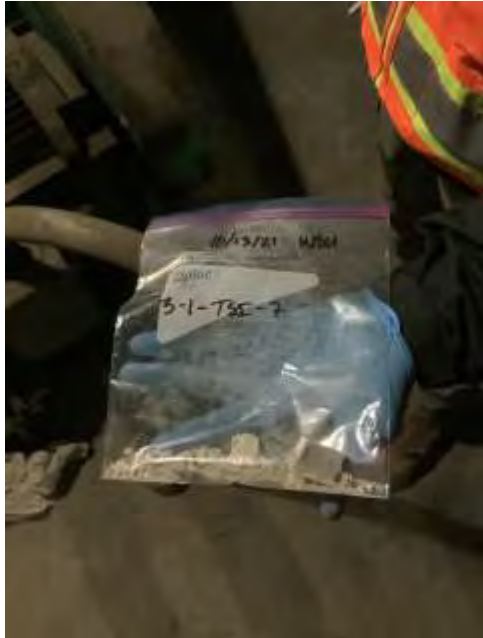
Sample ID:	Sample Type:
3-1-TSI-7	TSI
Sample Location:	Detailed Sample Location:
Room 302	Vent near staircase to lower level.
Sample Quantity:	3,000 linear feet

Sample Color:	XRF:	
Misc Sample Material:	Sample Condition:	Sample Friable?:
	Damaged or significantly damaged	Yes

Additional Sample Notes:	White vent insulation with white wrapping.
---------------------------------	--

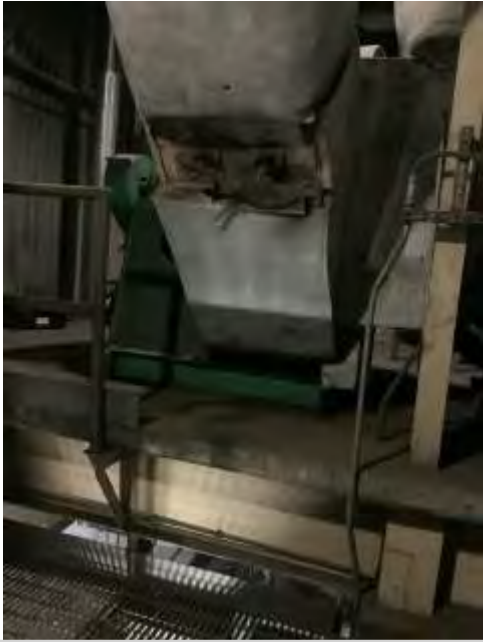
3-1-TSI-9

Room 302	Vent near staircase to lower level.	
Sample Quantity:	3,000 linear feet.	
Sample Color:	XRF:	
Misc Sample Material:	Sample Condition:	Sample Friable?:
	Damaged or significantly damaged	Yes

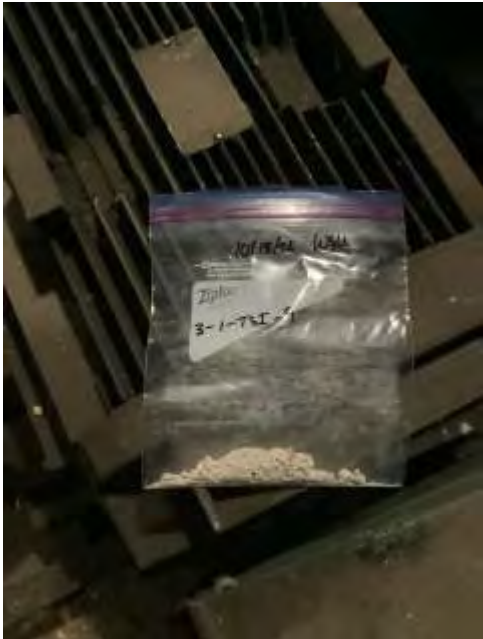
Additional Sample Notes:	White vent insulation with white wrapping.
---------------------------------	--

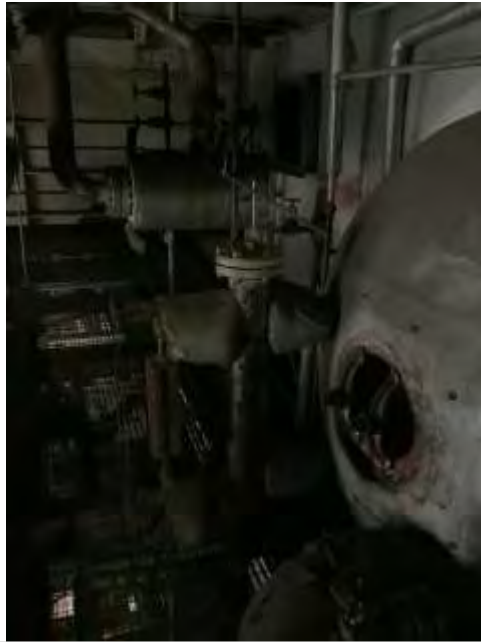
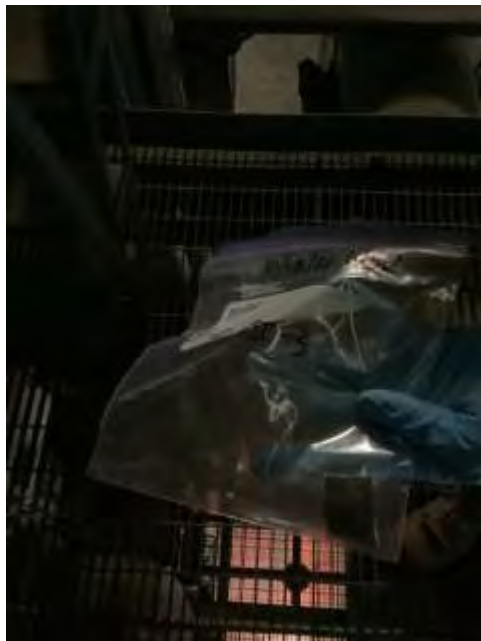
3-2-TSI-3	TSI	
Sample Location:	Detailed Sample Location:	
Room 101	Highest catwalk.	
Sample Quantity:	700 linear feet.	
Sample Color:	XRF:	
Misc Sample Material:	Sample Condition:	Sample Friable?:
	Damaged or significantly damaged	Yes

Additional Sample Notes:	Fabric insulation on pipe coming off of boiler. Area of sampling not included on schematic of upper mezzanine.
---------------------------------	--

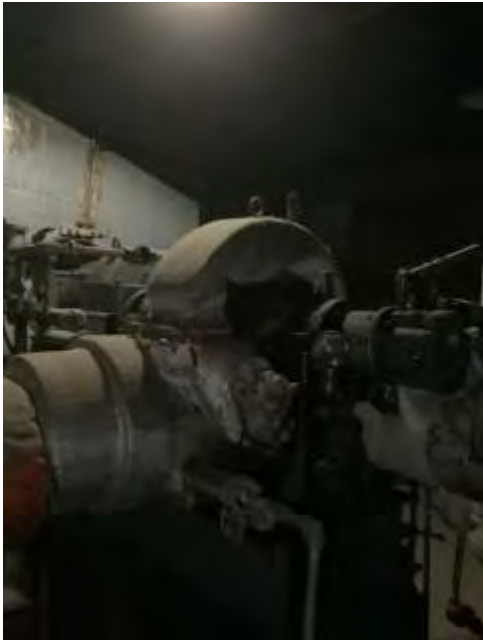
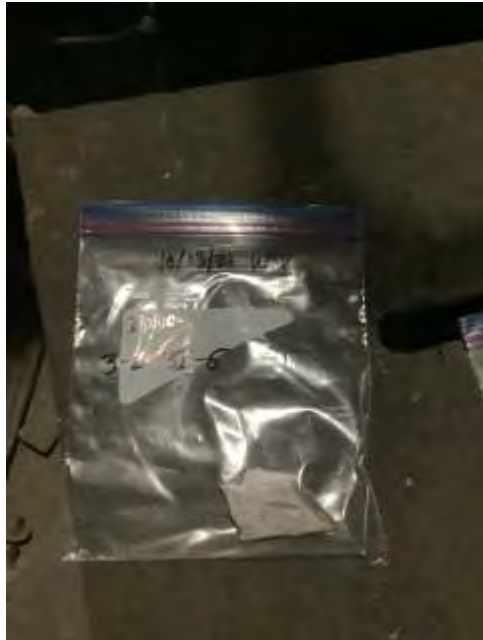
Sample ID:	Sample Type:	
3-2-TSI-6	TSI	
Sample Location:	Detailed Sample Location:	
Room 302	Pipe near west roof access.	
Sample Quantity:	700 linear feet.	
Sample Color:	XRF:	
Misc Sample Material:	Sample Condition:	Sample Friable?:
	Damaged or significantly damaged	Yes

Additional Sample Notes:	White pipe insulation with silver wrapping.
Sample ID:	Sample Type:
3-2-PB-3	PB
Sample Location:	Detailed Sample Location:
Catwalk above coal hopper.	By staircase.
Sample Quantity:	700 linear feet.
Sample Color:	XRF:
Gray	5.00

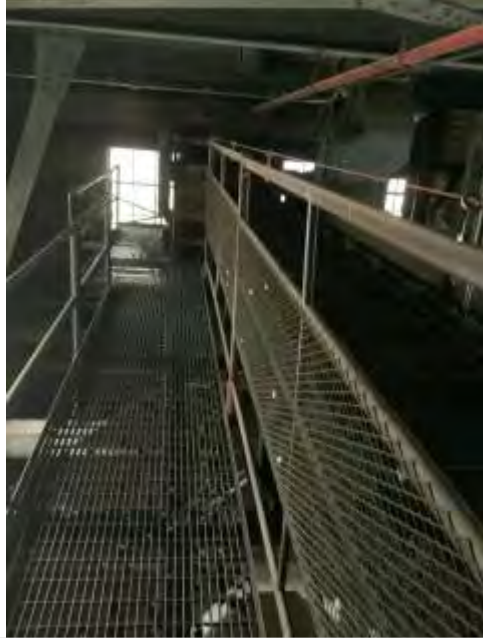
3-3-PB-5

Additional Sample Notes:	Brown catwalk railing.
Sample ID:	Sample Type:
3-3-PB-6	PB
Sample Location:	Detailed Sample Location:
Catwalk above coal hopper.	By staircase.
Sample Quantity:	NA
Sample Color:	XRF:
Brown	ND
