COLLEGE AVENUE STEAM PLANT ADAPTIVE REUSE

Integrated Cleanup and Implementation Plan

Port of
Whitman
County

PORT OF WHITMAN COUNTY
March 30, 2020

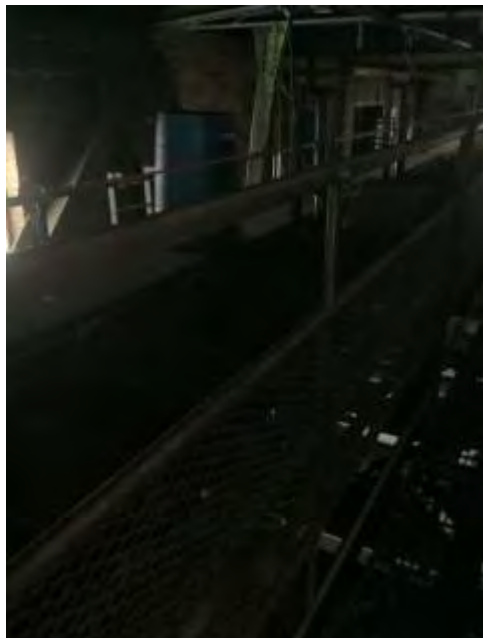
Additional Sample Notes:	Brown catwalk railing.
Sample ID:	Sample Type:
3-3-PB-6	PB
Sample Location:	Detailed Sample Location:
Catwalk above coal hopper.	By staircase.
Sample Quantity:	NA
Sample Color:	XRF:
Brown	ND

Additional Sample Notes:	Brown catwalk railing.	
Sample ID:	Sample Type:	
3-3-TSI-4	TSI	
Sample Location:	Detailed Sample Location:	
Room 302	Motor part near west roof access.	
Sample Quantity:	40 linear feet.	
Sample Color:	XRF:	
Misc Sample Material:	Sample Condition:	Sample Friable?:
	Damaged or significantly damaged	Yes

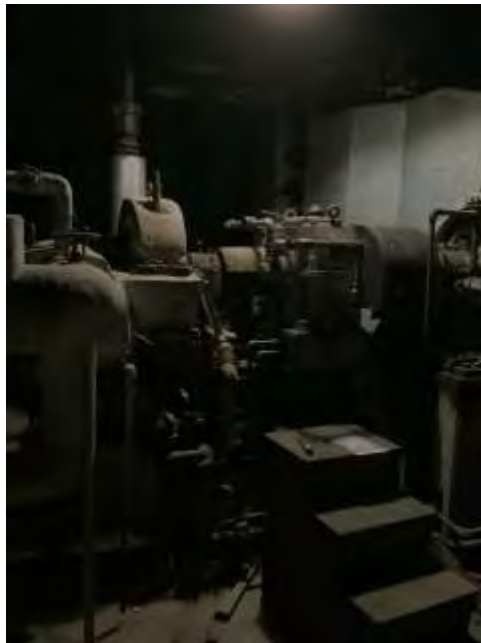
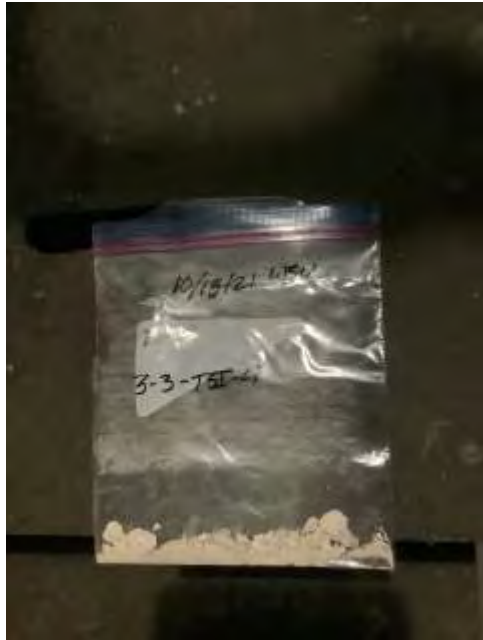
3-3-TSI-4

Additional Sample Notes:		White insulation on mechanical part.	
Sample ID:		Sample Type:	
3-3-TSI-10		TSI	
Sample Location:		Detailed Sample Location:	
Room 302		Motor part near west roof access.	
Sample Quantity:		40 linear feet.	
Sample Color:		XRF:	
Misc Sample Material:		Sample Condition:	Sample Friable?:
		Damaged or significantly damaged	Yes

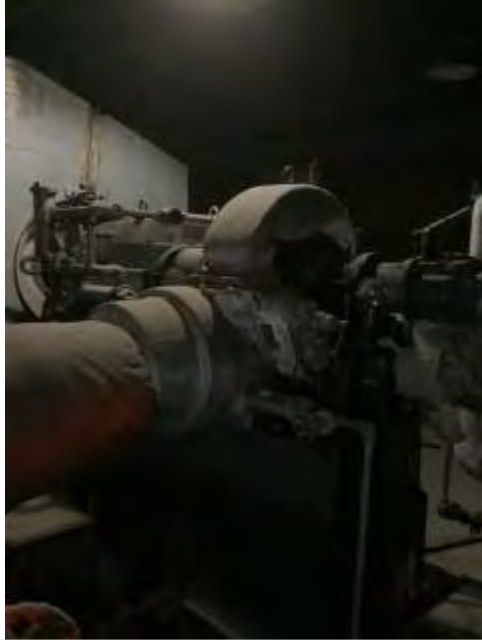
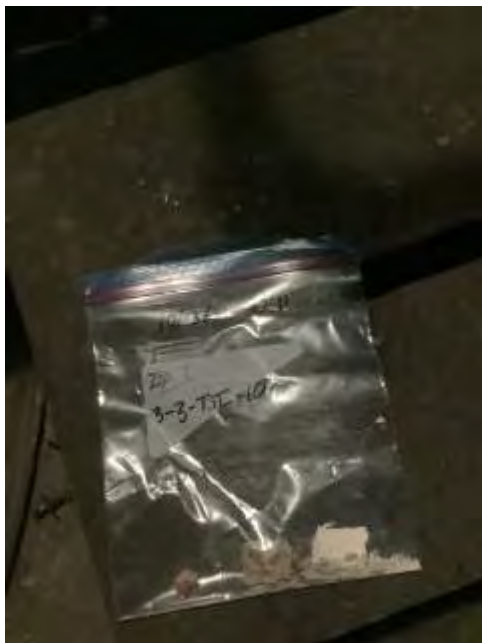
3-3-TSI-10

Additional Sample Notes:	White insulation on mechanical part.	
Sample ID:	Sample Type:	
3-4-TSI-8	TSI	
Sample Location:	Detailed Sample Location:	
Room 302	Pipe near motor.	
Sample Quantity:	6 linear feet.	
Sample Color:	XRF:	
Misc Sample Material:	Sample Condition:	Sample Friable?:
	Damaged or significantly damaged	Yes

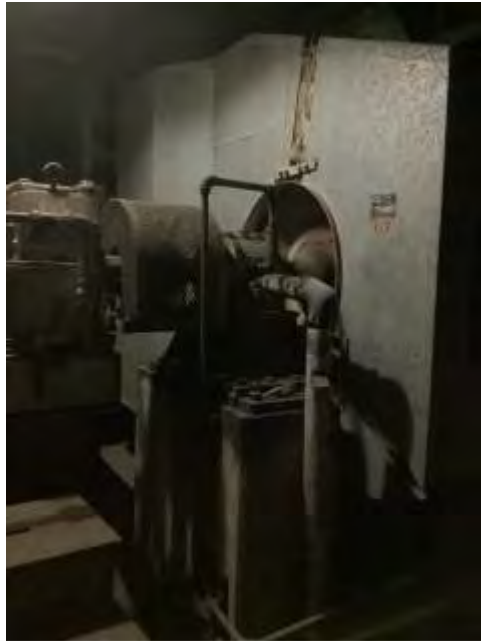
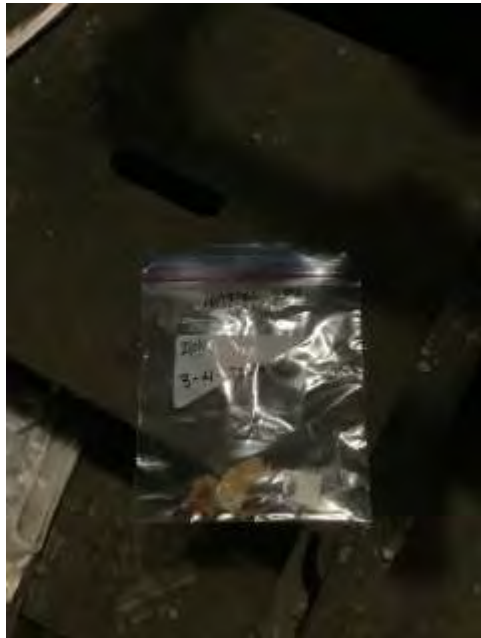
3-4-TSI-8

Additional Sample Notes:	Yellow insulation with white wrapping.
Sample ID:	Sample Type:
3-4-PB-7	PB
Sample Location:	Detailed Sample Location:
Room 302	On equipment by east side door.
Sample Quantity:	NA
Sample Color:	XRF:
Silver	ND

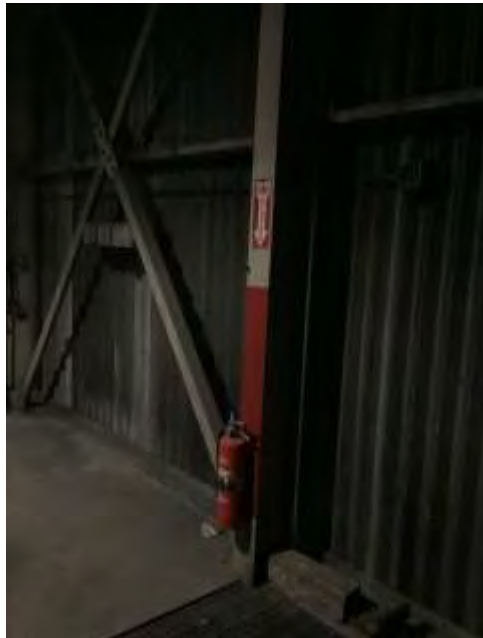
Additional Sample Notes:	Silver piping.
Sample ID:	Sample Type:
3-5-PB-9	PB
Sample Location:	Detailed Sample Location:
Room 302	By west side door.
Sample Quantity:	NA
Sample Color:	XRF:
Red	0.528

Additional Sample Notes:	Red fire extinguisher marking paint.
---------------------------------	--------------------------------------

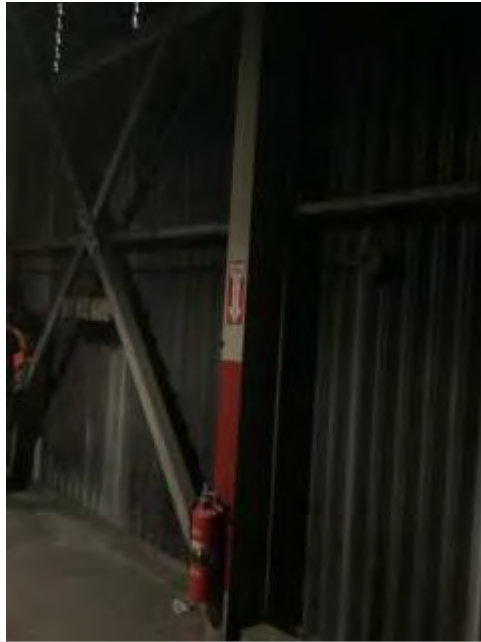
Sample ID:	Sample Type:
3-6-PB-10	PB
Sample Location:	Detailed Sample Location:
Room 302	By west side door.
Sample Quantity:	NA
Sample Color:	XRF:
Tan	0.531

Additional Sample Notes:	Tan paint above fire extinguisher.
---------------------------------	------------------------------------

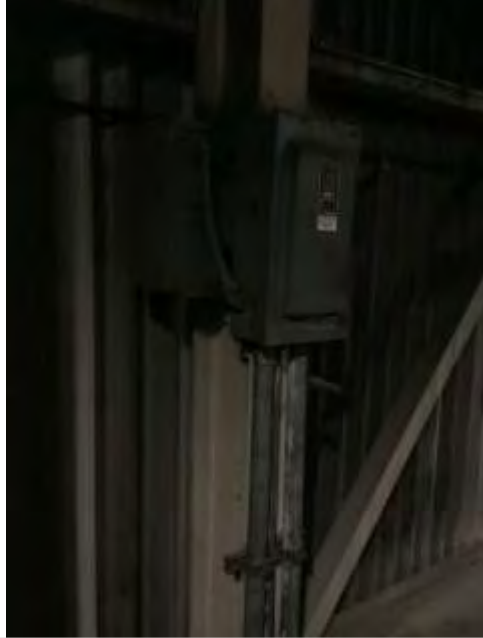
Sample ID:	Sample Type:
3-6-PB-11	PB
Sample Location:	Detailed Sample Location:
Room 302	By west side door.
Sample Quantity:	NA
Sample Color:	XRF:
Tan	0.922

Additional Sample Notes:	Tan paint on I-beam next to safety switch box.
---------------------------------	--

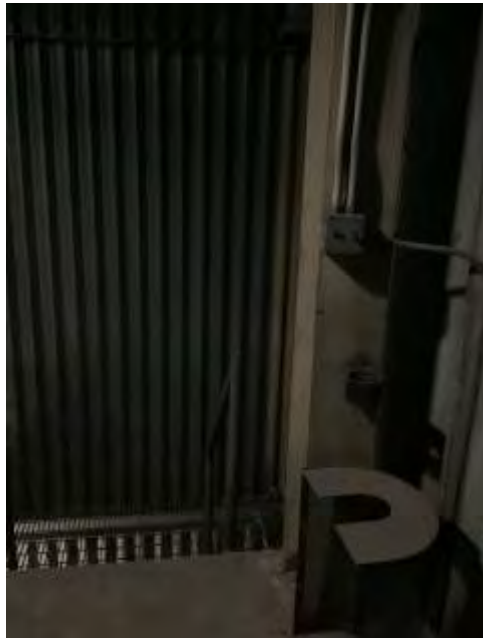
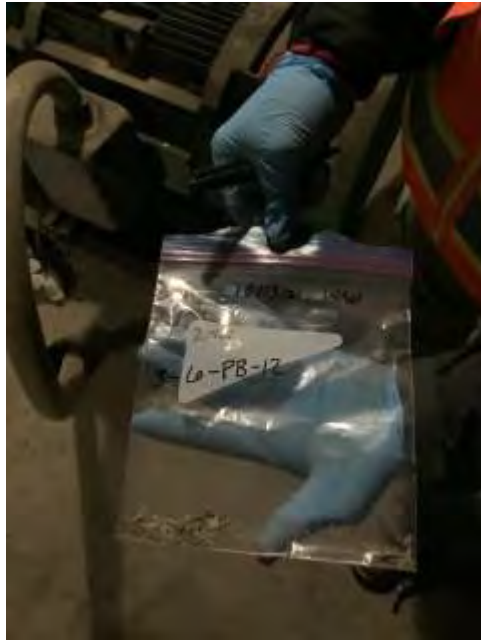
Sample ID:	Sample Type:
3-6-PB-12	PB
Sample Location:	Detailed Sample Location:
Room 302	By staircase.
Sample Quantity:	NA
Sample Color:	XRF:
Tan	0.920

Additional Sample Notes:	Tan paint on I-beam. Sample collected for laboratory analysis.
Sample ID:	Sample Type:
3-7-PB-13	PB
Sample Location:	Detailed Sample Location:
Room 302	East door.
Sample Quantity:	NA
Sample Color:	XRF:
Tan	ND

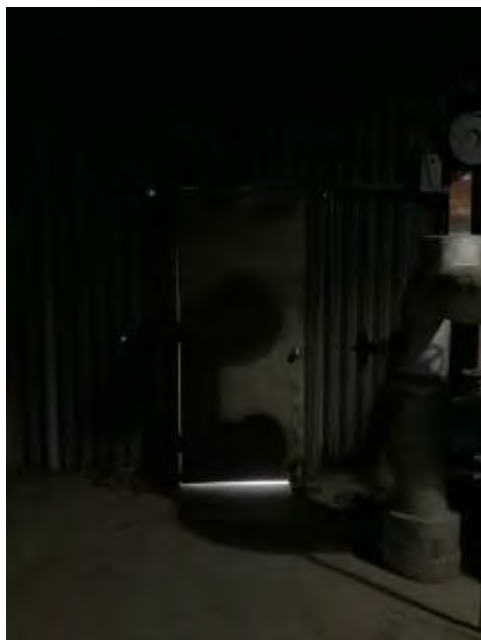
3-7-PB-13

Additional Sample Notes:	Tan paint on door.
---------------------------------	--------------------

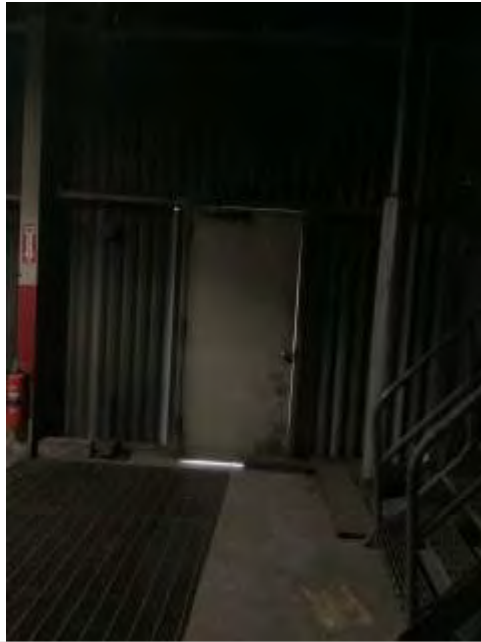
Sample ID:	Sample Type:
3-7-PB-14	PB
Sample Location:	Detailed Sample Location:
Room 302	West door.
Sample Quantity:	NA
Sample Color:	XRF:
Tan	ND

Additional Sample Notes:	Tan paint on door.
---------------------------------	--------------------

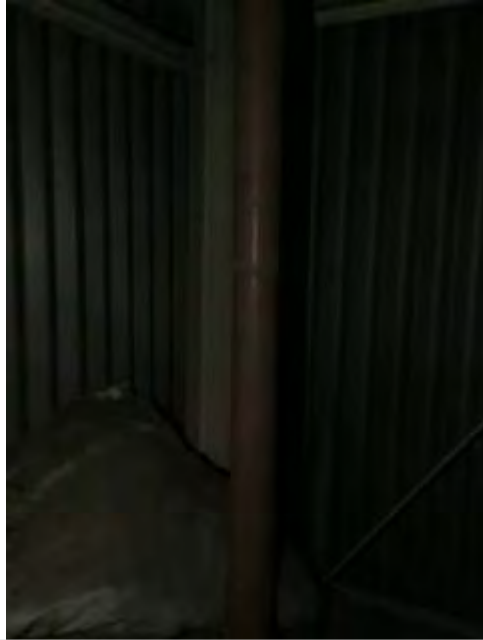
Sample ID:	Sample Type:
3-8-PB-15	PB
Sample Location:	Detailed Sample Location:
Room 302	Southeast corner of room 302.
Sample Quantity:	NA
Sample Color:	XRF:
Brown	ND

Additional Sample Notes:		Brown paint on pipe to ceiling.
Sample ID:	Sample Type:	
3-8-MISC-11	MISC	
Sample Location:	Detailed Sample Location:	
Room 303	Window on west side of room.	
Sample Quantity:	4,030 linear feet.	
Misc Sample Material:	Sample Condition:	Sample Friable?:
Window glazing	Damaged or significantly damaged friable miscellaneous ACM	No

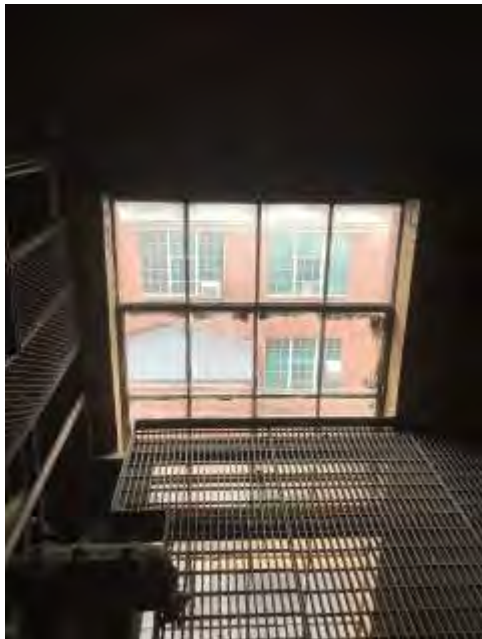
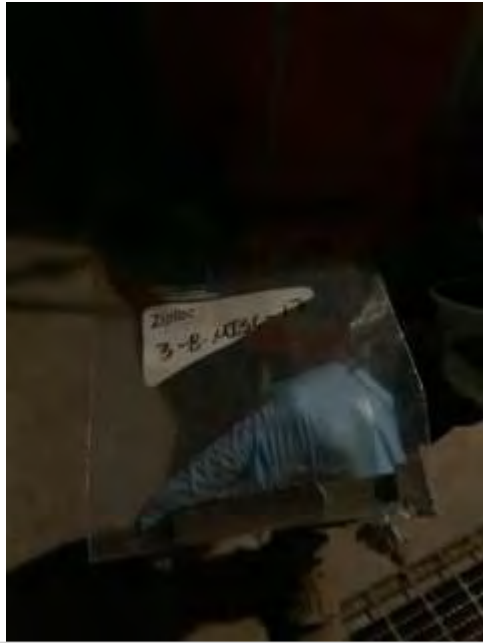
Sample ID:	Sample Type:	
3-8-MISC-12	MISC	
Sample Location:	Detailed Sample Location:	
Room 303	Window on west side of room.	
Sample Quantity:	4,030 linear feet.	
Misc Sample Material:	Sample Condition:	Sample Friable?:
Window glazing.	Damaged or significantly damaged friable miscellaneous ACM	No

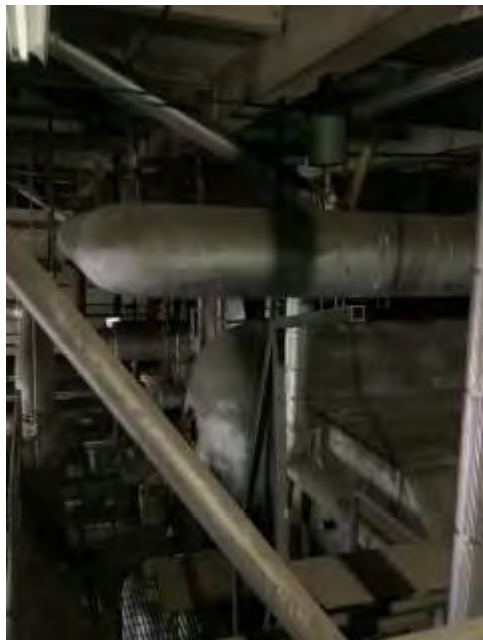
Additional Sample Notes:	Door.
Sample ID:	Sample Type:
3-11-PB-19	PB
Sample Location:	Detailed Sample Location:
Room 101	Highest catwalk.
Sample Quantity:	NA
Sample Color:	XRF:
Silver	ND

Additional Sample Notes:	Silver paint on boiler.
---------------------------------	-------------------------

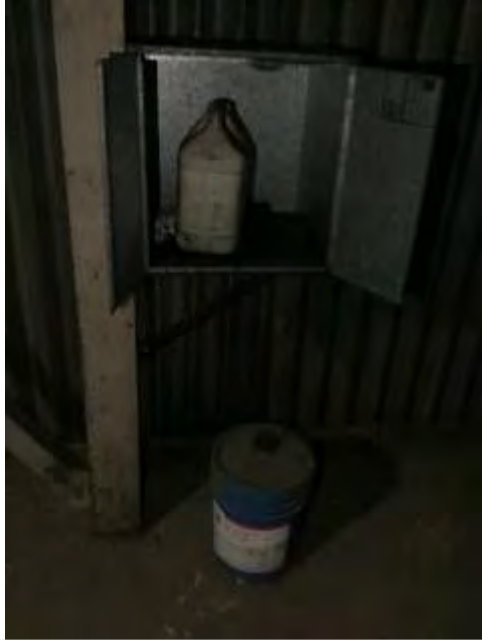
General Fixture Location:	Detailed Fixture Location:
Room 302	East wall.
Type of Fixture:	Quantity:
Unmarked jug and turbine oil container.	2
Condition:	Additional Fixture Notes:
Poor

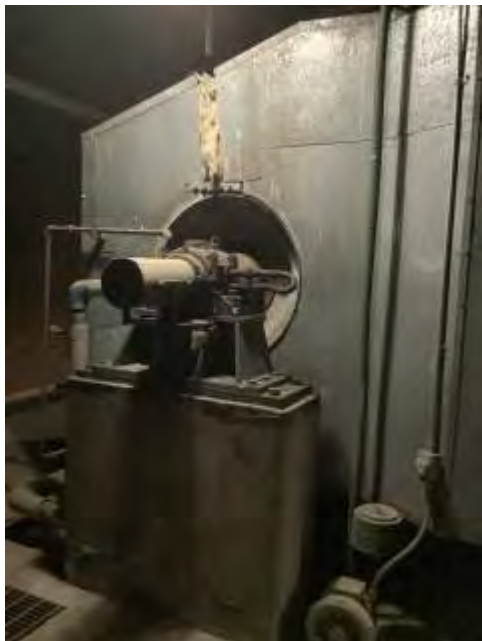
General Fixture Location:	Detailed Fixture Location:
Room 302	
Type of Fixture:	Quantity:
Potential mechanical fluid-containing fixture.	Throughout room
Condition:	Additional Fixture Notes:
Poor

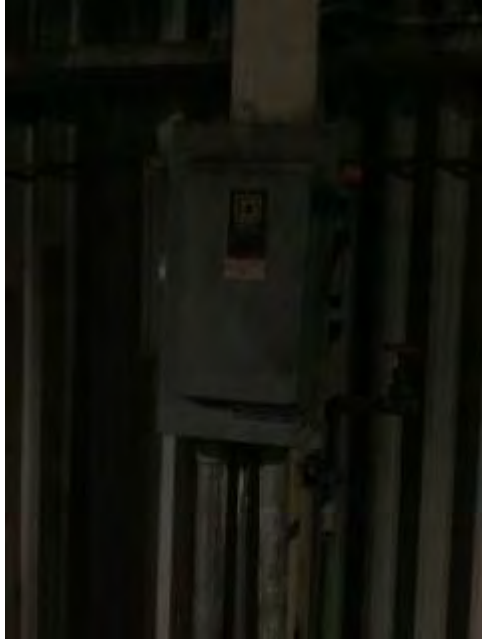
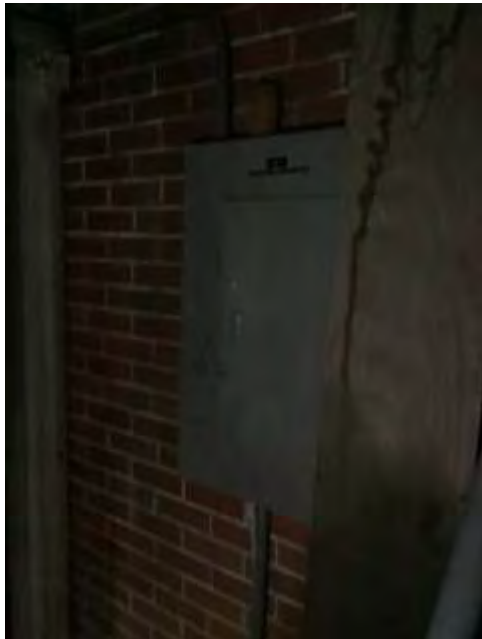
General Fixture Location:	Detailed Fixture Location:
Room 302	West side of room.
Type of Fixture:	Quantity:
Potential electrical hazard.	2
Condition:	Additional Fixture Notes:
Good	1 control panel, 1 safety switch.

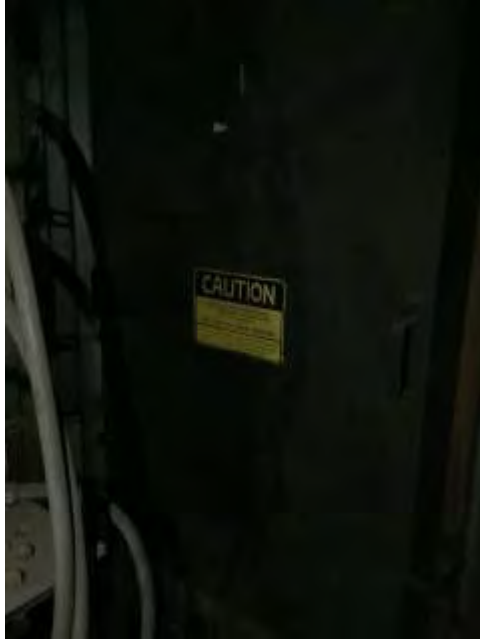
General Fixture Location:	Detailed Fixture Location:
Room 303M	
Type of Fixture:	Quantity:
Potentially pressurized confined spaces.	17
Condition:	Additional Fixture Notes:
Good

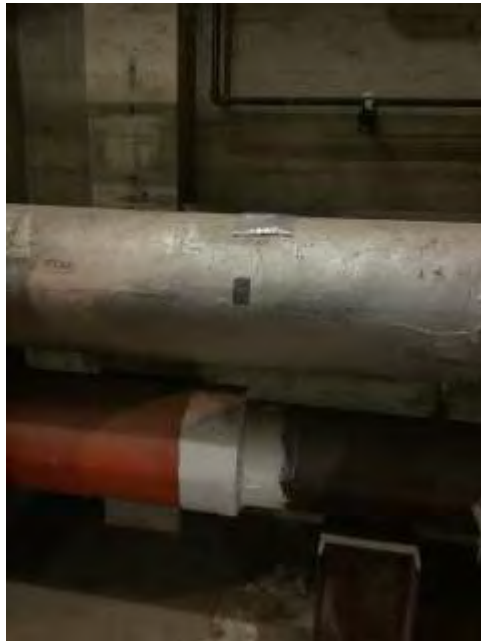
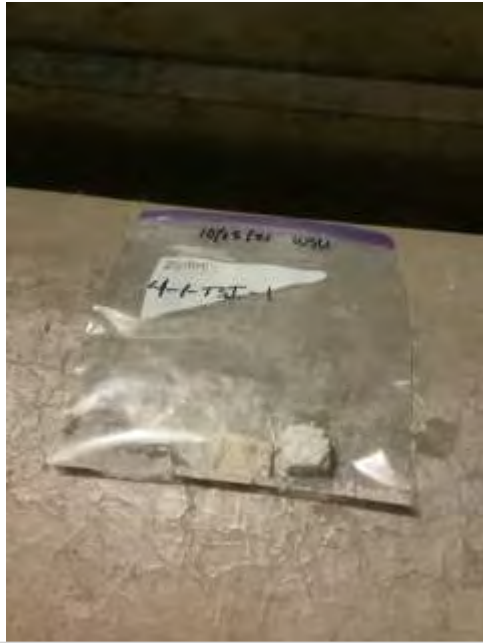
Sample ID:	Sample Type:	
4-1-TSI-1	TSI	
Sample Location:	Detailed Sample Location:	
Room 21	By entrance to room 22.	
Sample Quantity:	600 linear feet.	
Sample Color:	XRF:	
Misc Sample Material:	Sample Condition:	Sample Friable?:
	Damaged or significantly damaged	Yes

Additional Sample Notes:		White insulation with silver fabric patch.	
Sample ID:		Sample Type:	
4-1-TSI-6		TSI	
Sample Location:		Detailed Sample Location:	
Room 23		Northeast corner of room.	
Sample Quantity:		600 linear feet.	
Sample Color:		XRF:	
Misc Sample Material:		Sample Condition:	Sample Friable?:
		Damaged or significantly damaged	Yes

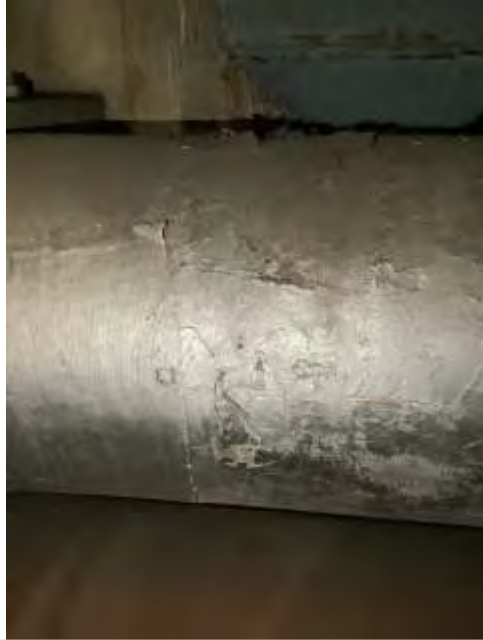
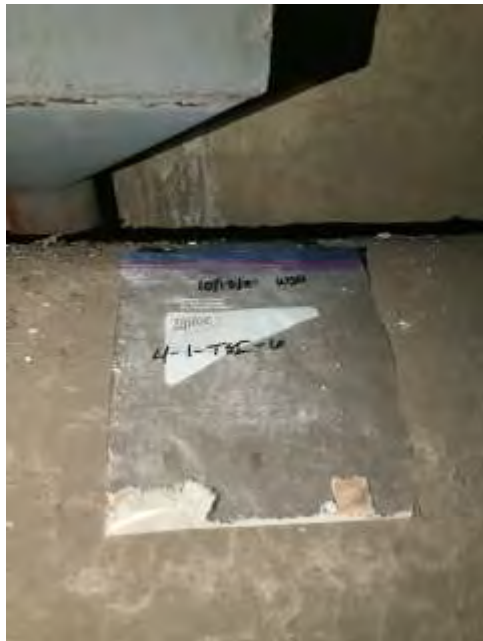
4-1-TSI-6

Additional Sample Notes:	White insulation with silver fabric patch.	
Sample ID:	Sample Type:	
4-1-TSI-10	TSI	
Sample Location:	Detailed Sample Location:	
Room 11	Southeast portion of room by entrance to room 23.	
Sample Quantity:	600 linear feet.	
Sample Color:	XRF:	
Misc Sample Material:	Sample Condition:	Sample Friable?:
	Damaged or significantly damaged	Yes

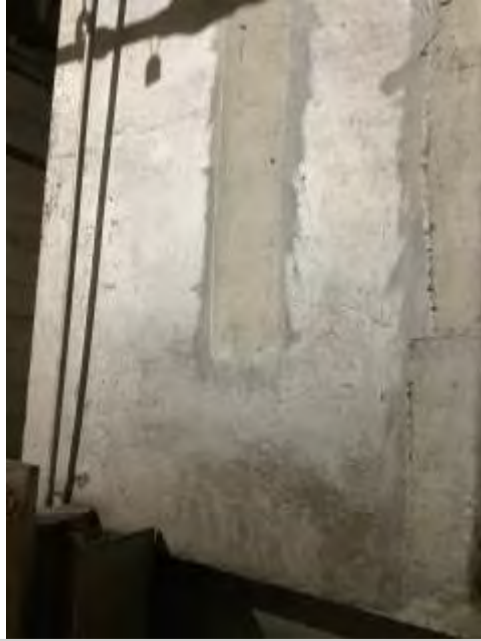
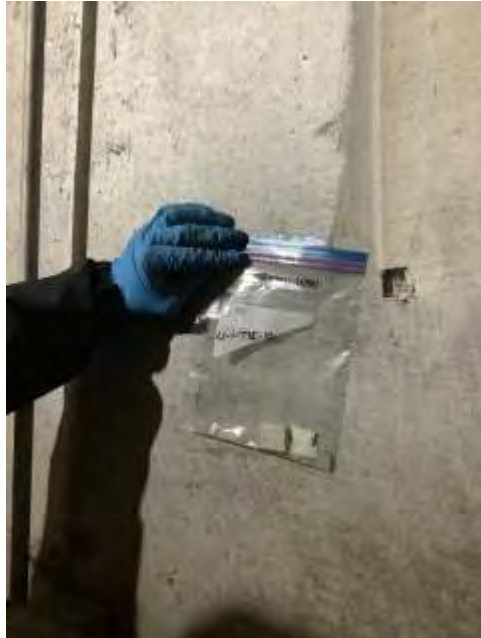
4-1-TSI-10

Additional Sample Notes:	White insulation with silver fabric patch on boiler.
Sample ID:	Sample Type:
4-1-TSI-17	TSI
Sample Location:	Detailed Sample Location:
Room 11	Northeast portion of room between northeast staircase and elevator.
Sample Quantity:	600 linear feet.
Sample Color:	XRF:

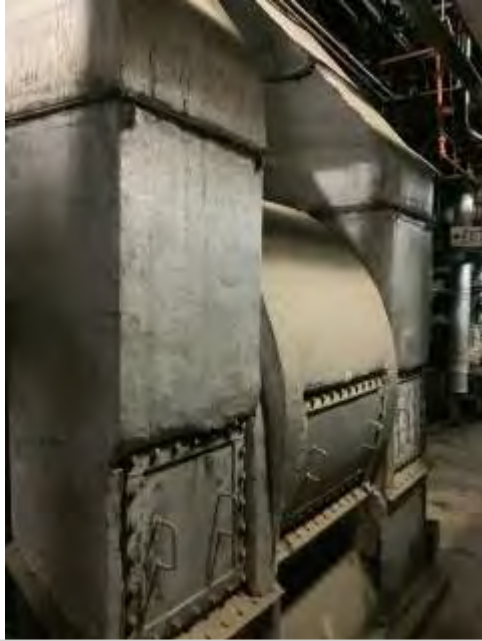
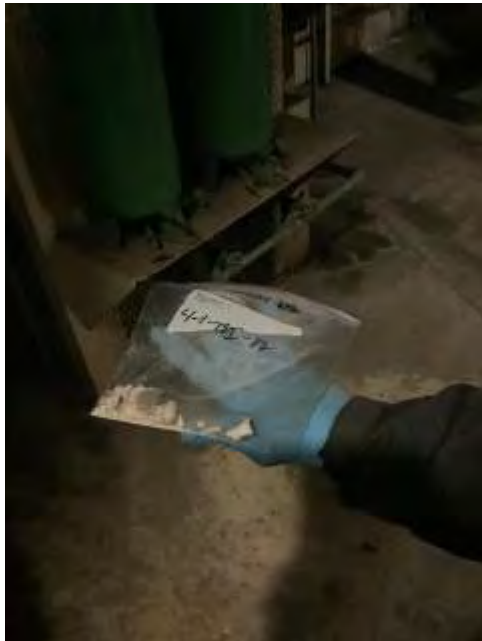
4-1-TSI-17

Misc Sample Material:	Sample Condition:	Sample Friable?:
	Damaged or significantly damaged	Yes

Additional Sample Notes:	White insulation with silver fabric patch on machinery.
---------------------------------	---

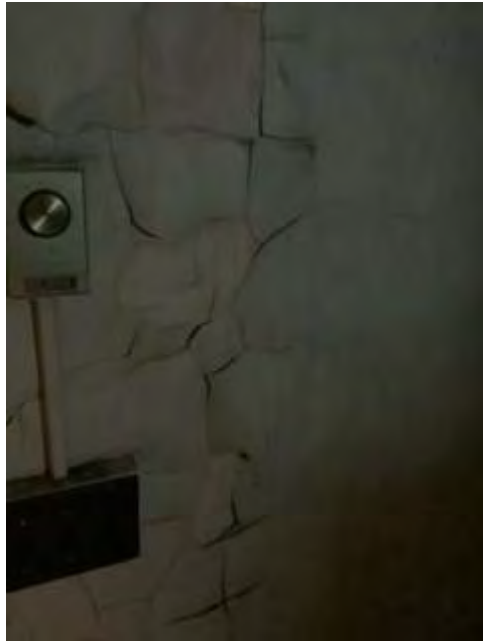
Sample ID:	Sample Type:
4-1-PB-1	PB
Sample Location:	Detailed Sample Location:
Room 17	East wall south of door.
Sample Quantity:	N/A

Sample Color:	XRF:
Light green	0.336

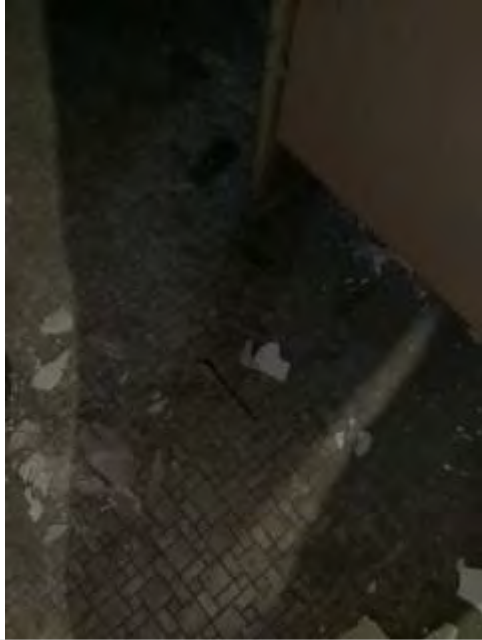
Sample ID:	Sample Type:
4-1-PB-2	PB
Sample Location:	Detailed Sample Location:
Room 17	Paint chip on floor nest to bathroom stall.
Sample Quantity:	N/A
Sample Color:	XRF:
Light green	0.237

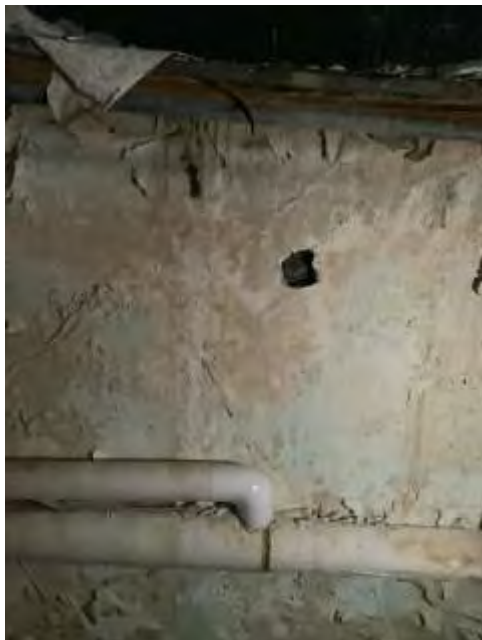
Sample ID:	Sample Type:
4-1-PB-60	PB
Sample Location:	Detailed Sample Location:
Room 15	Paint on south wall of room.
Sample Quantity:	N/A
Sample Color:	XRF:
Light green	0.014

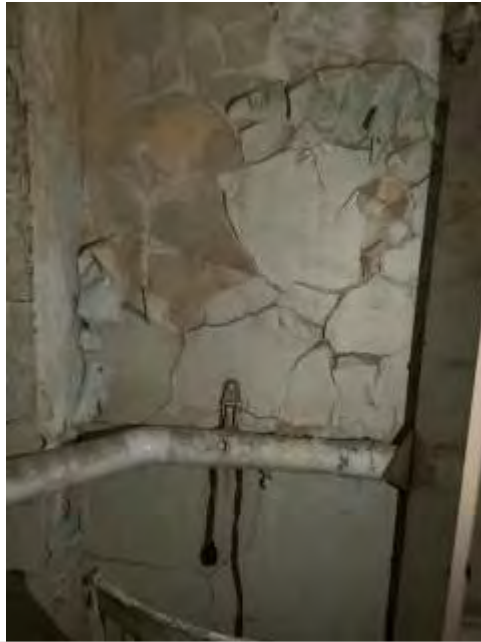
Sample ID:	Sample Type:
4-1-PB-61	PB
Sample Location:	Detailed Sample Location:
Room 15	Southwest corner of room.
Sample Quantity:	N/A
Sample Color:	XRF:
Light green	0.135

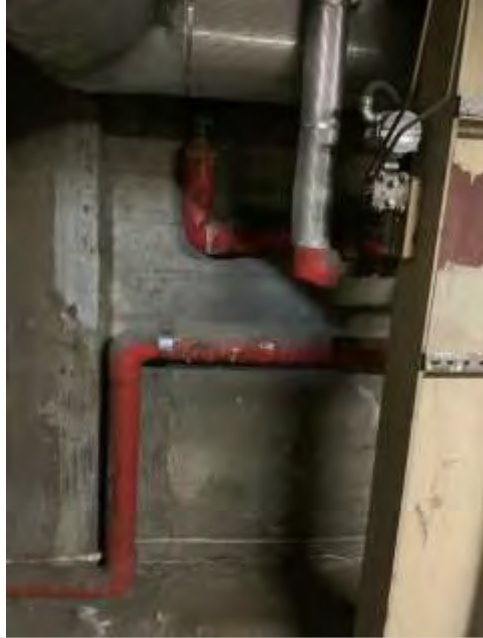
Sample ID:	Sample Type:
4-2-PB-52	PB
Sample Location:	Detailed Sample Location:
Room 11	Red wrapped pipe on south wall of room.
Sample Quantity:	N/A
Sample Color:	XRF:
Red	ND

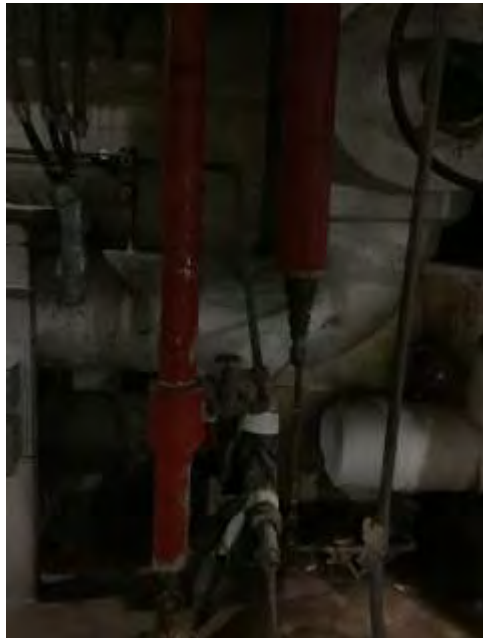
Sample ID:	Sample Type:
4-2-PB-3	PB
Sample Location:	Detailed Sample Location:
Room 21	Pipe in southwest corner of room 21.
Sample Quantity:	N/A
Sample Color:	XRF:
Red	ND

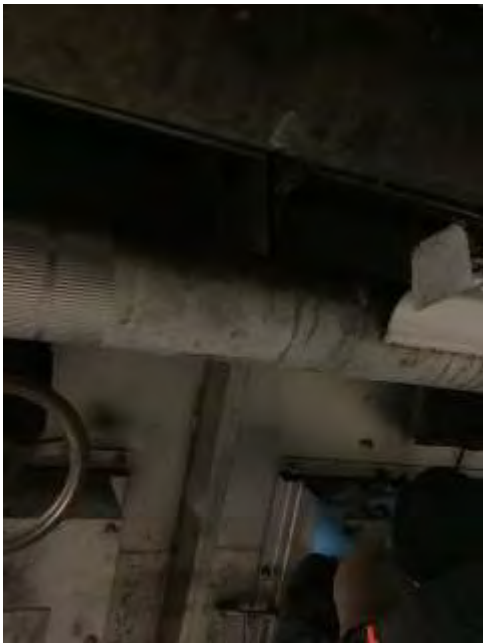
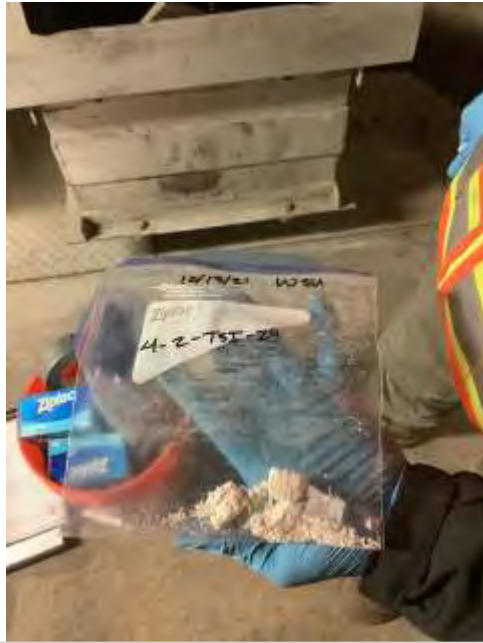
4-2-TSI-29

Damaged or significantly damaged	Yes
--	----------------------------------	-----

Additional Sample Notes:		White insulation with silver painted wrap.	
Sample ID:		Sample Type:	
4-2-TSI-31		TSI	
Sample Location:		Detailed Sample Location:	
Room 11		Center of room.	
Sample Quantity:		1,200 linear feet.	
Sample Color:		XRF:	
Misc Sample Material:		Sample Condition:	Sample Friable?:
		Damaged or significantly damaged	Yes

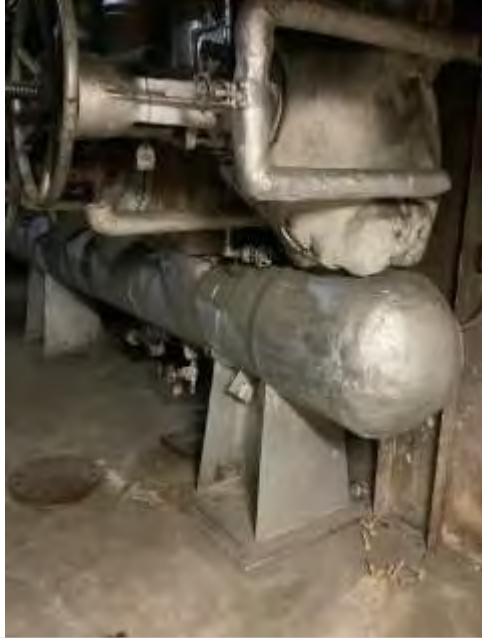
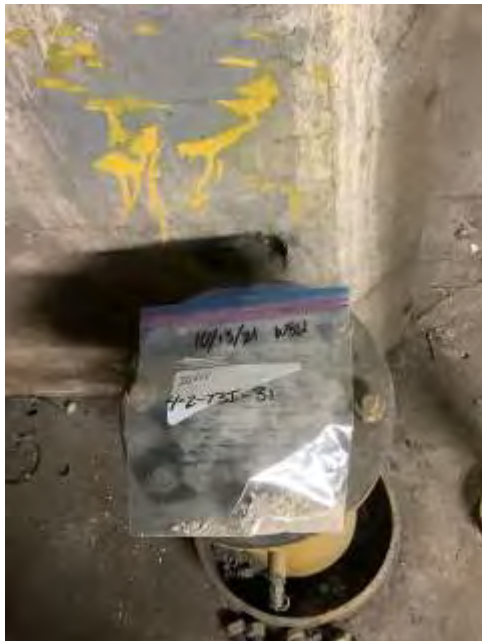
4-2-TSI-31

Additional Sample Notes:	White insulation with silver painted wrap.
Sample ID:	Sample Type:
4-2-PB-7	PB
Sample Location:	Detailed Sample Location:
Room 21	Pipe in southwest corner of room 21.
Sample Quantity:	N/A
Sample Color:	XRF:
Red	ND

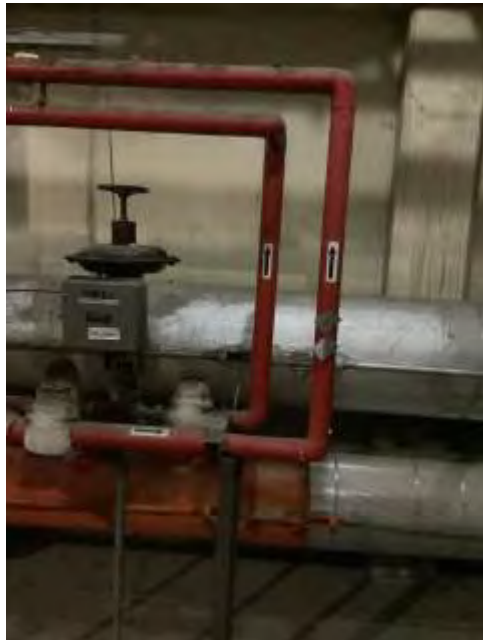
Additional Sample Notes:	
Sample ID:	Sample Type:
4-2-PB-25	PB
Sample Location:	Detailed Sample Location:
Room 23	Red pipe wrap on the south side of room.
Sample Quantity:	N/A
Sample Color:	XRF:
Red	0.919

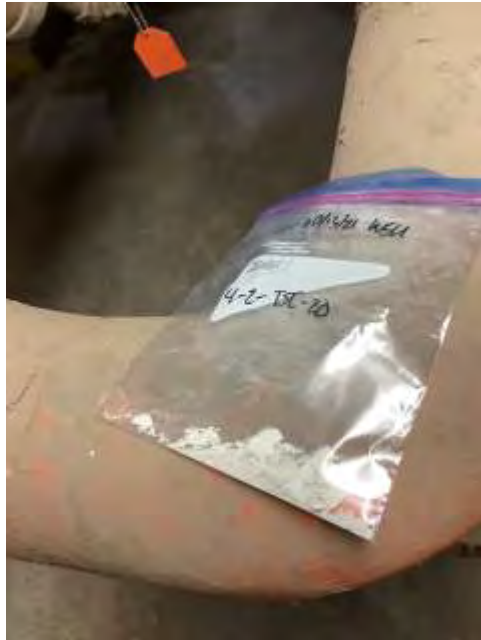
Additional Sample Notes:		
Sample ID:	Sample Type:	
4-2-TSI-20	TSI	
Sample Location:	Detailed Sample Location:	
Room 11	Northeast portion of room near northeast staircase.	
Sample Quantity:	1,200 linear feet.	
Sample Color:	XRF:	
Misc Sample Material:	Sample Condition:	Sample Friable?:
	Damaged or significantly damaged	Yes

Additional Sample Notes:		White insulation with orange painted wrap.	
Sample ID:		Sample Type:	
4-2-TSI-22		TSI	
Sample Location:		Detailed Sample Location:	
Room 11		Northeast portion of room.	
Sample Quantity:		1,200 linear feet.	
Sample Color:		XRF:	
Misc Sample Material:		Sample Condition:	Sample Friable?:
		Damaged or significantly damaged	Yes

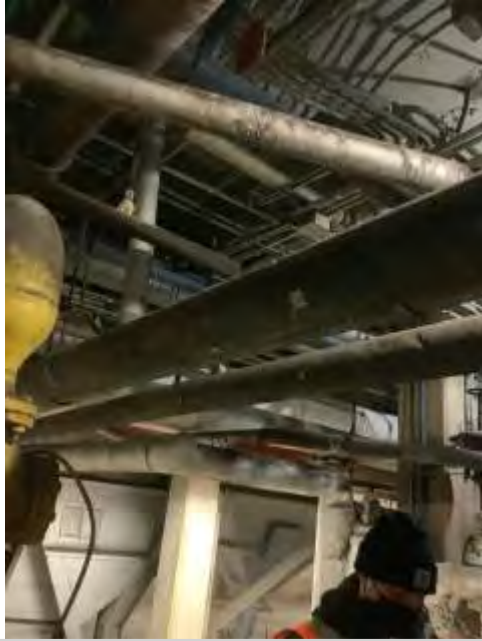
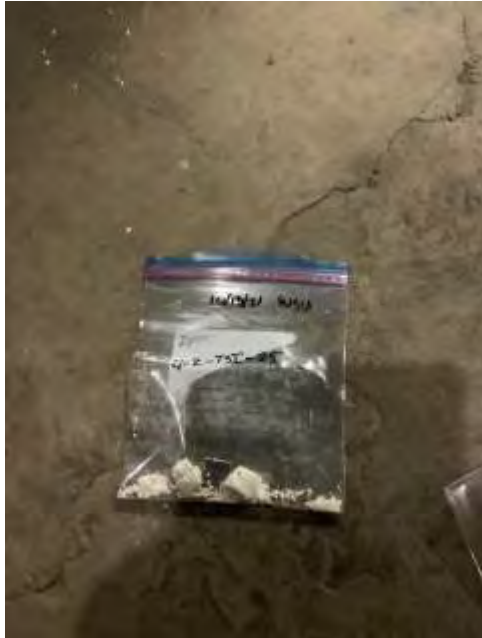
Additional Sample Notes:	White insulation with white painted wrap.	
Sample ID:	Sample Type:	
4-2-TSI-25	TSI	
Sample Location:	Detailed Sample Location:	
Room 11	On west side of room by staircase down.	
Sample Quantity:	1,200 linear feet.	
Sample Color:	XRF:	
Misc Sample Material:	Sample Condition:	Sample Friable?:
	Damaged or significantly damaged	Yes

Additional Sample Notes:	White insulation with orange painted wrap.
Sample ID:	Sample Type:
4-2-TSI-7	TSI
Sample Location:	Detailed Sample Location:
Room 23	Northeast corner of room.
Sample Quantity:	1,200 linear feet.
Sample Color:	XRF:

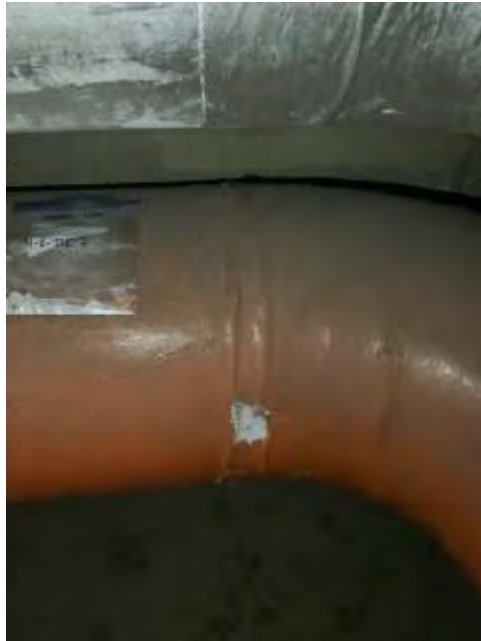
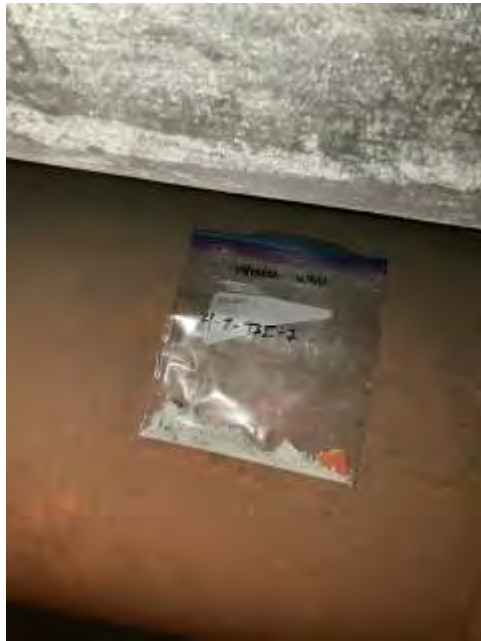
4-2-TSI-7

Misc Sample Material:	Sample Condition:	Sample Friable?:
	Damaged or significantly damaged	Yes

Additional Sample Notes:	White insulation with orange painted wrap.
---------------------------------	--

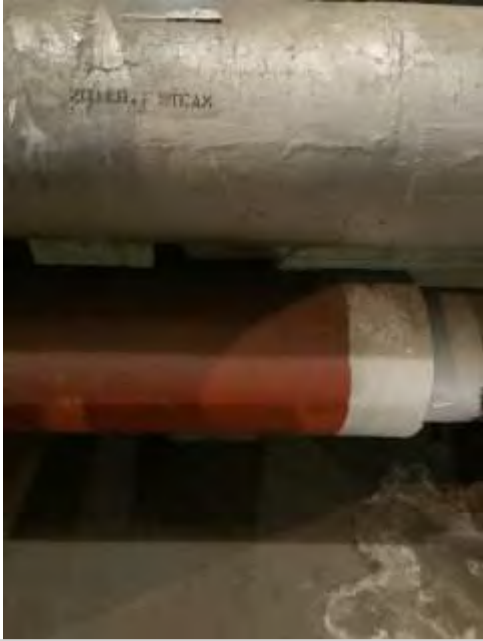
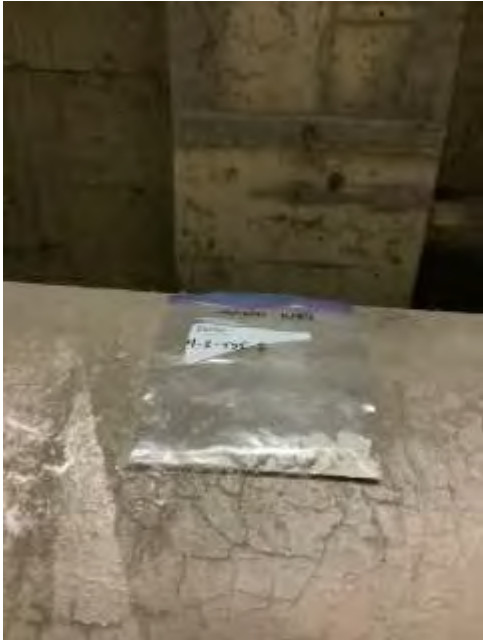
Sample ID:	Sample Type:
4-2-TSI-2	TSI
Sample Location:	Detailed Sample Location:
Room 21	By entrance to room 22.
Sample Quantity:	1,200 linear feet.

Sample Color:	XRF:	
Misc Sample Material:	Sample Condition:	Sample Friable?:
	Damaged or significantly damaged	Yes

Additional Sample Notes:	White insulation with orange painted wrap.
---------------------------------	--

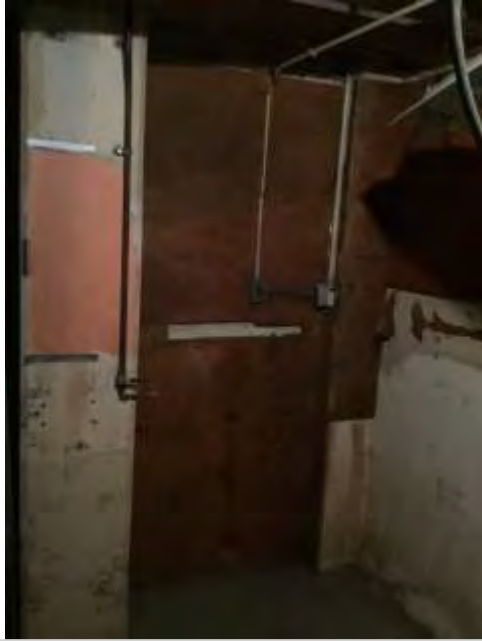
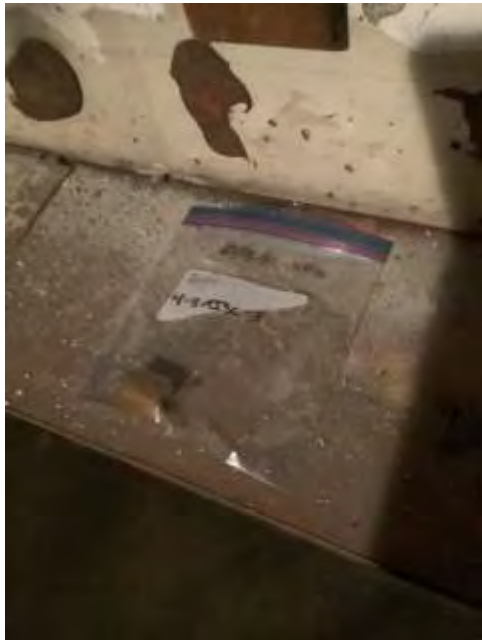
4-3-MISC-3

Room 22	East wall.	
Sample Quantity:	110 square feet.	
Misc Sample Material:	Sample Condition:	Sample Friable?:
Brown soundproofing wall pad.	Potential ACBM with potential for damage	Yes

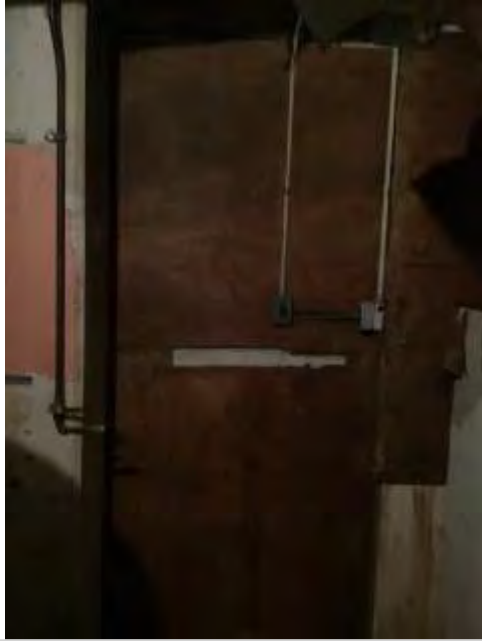
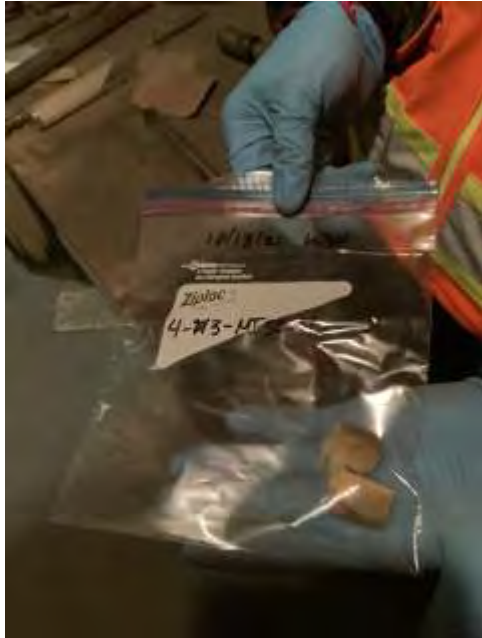
4-3-MISC-4

Room 22	North wall.	
Sample Quantity:	110 square feet.	
Misc Sample Material:	Sample Condition:	Sample Friable?:
Brown soundproofing wall pad.	Potential ACBM with potential for damage	Yes

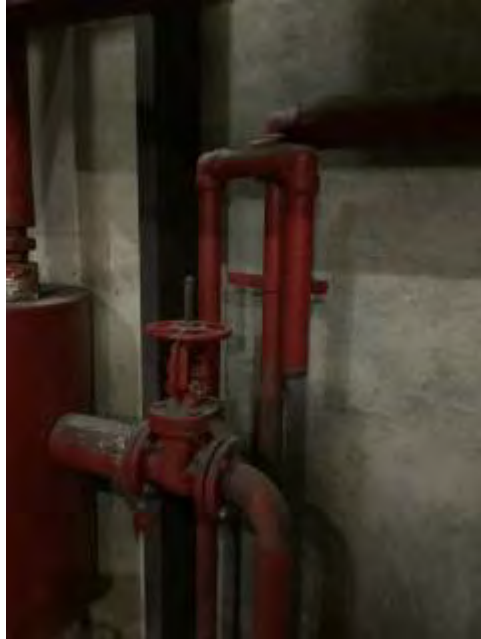
4-3-PB-20

Room 23	Red pipe in southwest corner.
Sample Quantity:	145 linear feet.
Sample Color:	XRF:
Red	ND

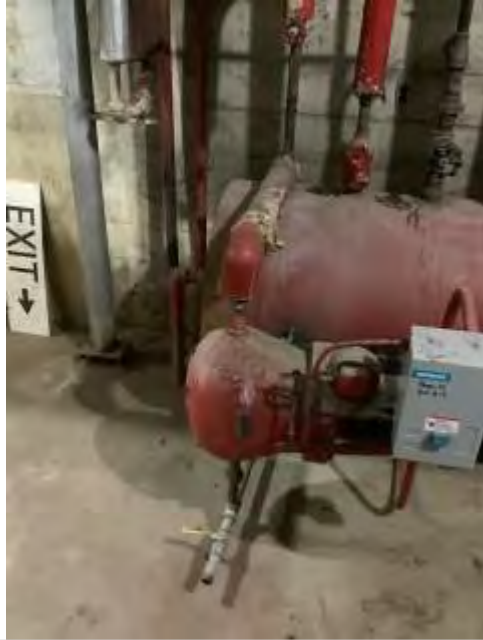
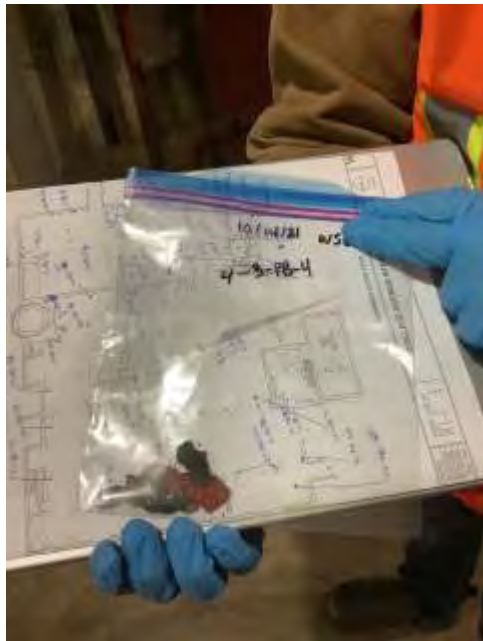
Sample ID:	Sample Type:
4-3-PB-4	PB
Sample Location:	Detailed Sample Location:
Room 21	Tank on north wall east of entrance.
Sample Quantity:	145 linear feet.
Sample Color:	XRF:
Red	1.346

Did not XRF tank due to high heat. Submitted sample to laboratory for analysis.

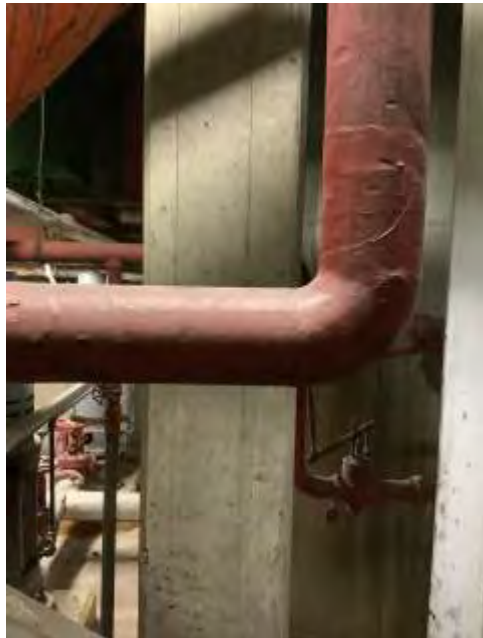
Sample ID:	Sample Type:
4-3-PB-43	PB
Sample Location:	Detailed Sample Location:
Room 11	Red pipe on the north side of room south of active tank.
Sample Quantity:	145 linear feet.
Sample Color:	XRF:
Red	5.0

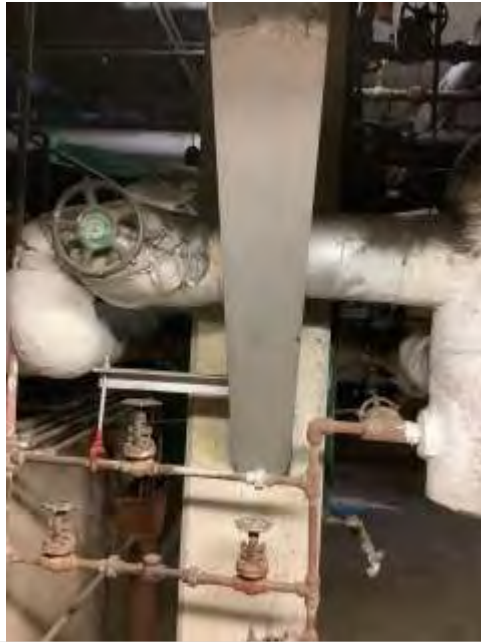
Sample ID:	Sample Type:
4-4-PB-30	PB
Sample Location:	Detailed Sample Location:
Room 11	Silver support on west side of room east of sun basement entrance.
Sample Quantity:	N/A
Sample Color:	XRF:
Silver	ND

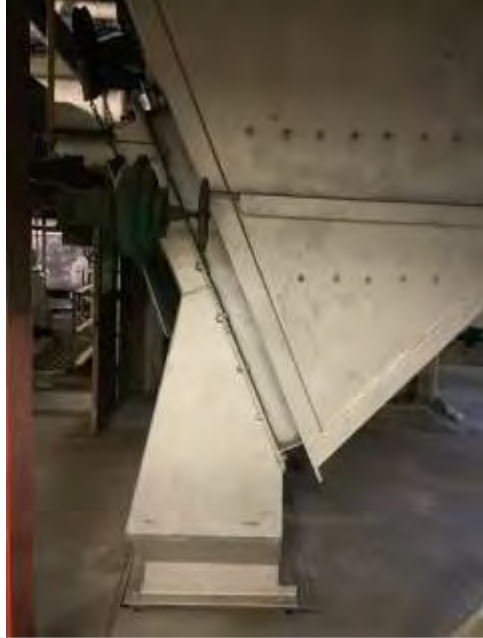
Sample ID:	Sample Type:
4-4-PB-33	PB
Sample Location:	Detailed Sample Location:
Room 11	Silver painted equipment on west side of room north of sub basement door.
Sample Quantity:	N/A
Sample Color:	XRF:
Silver	ND

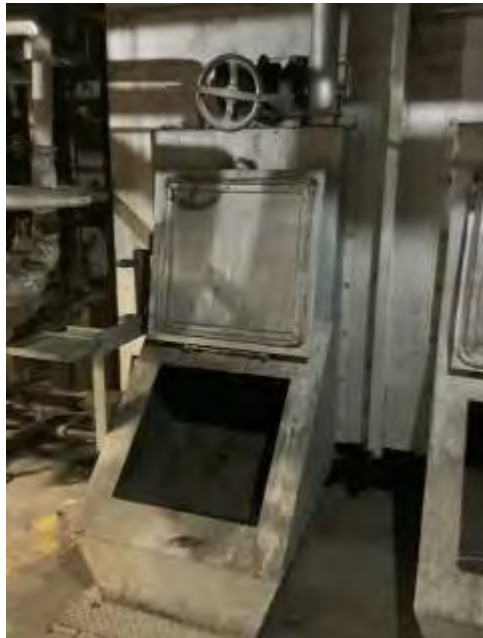
Additional Sample Notes:	
Sample ID:	Sample Type:
4-4-PB-47	PB
Sample Location:	Detailed Sample Location:
Room 11	Underside of lid on southwest face of northeast boiler.
Sample Quantity:	N/A
Sample Color:	XRF:
Silver	0.071

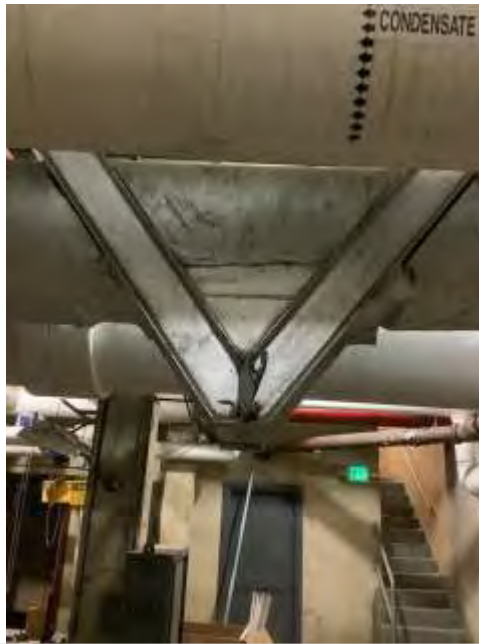
Sample ID:	Sample Type:
4-4-PB-5	PB
Sample Location:	Detailed Sample Location:
Room 21	Silver pipe support on north ceiling.
Sample Quantity:	N/A
Sample Color:	XRF:
Silver	0.024

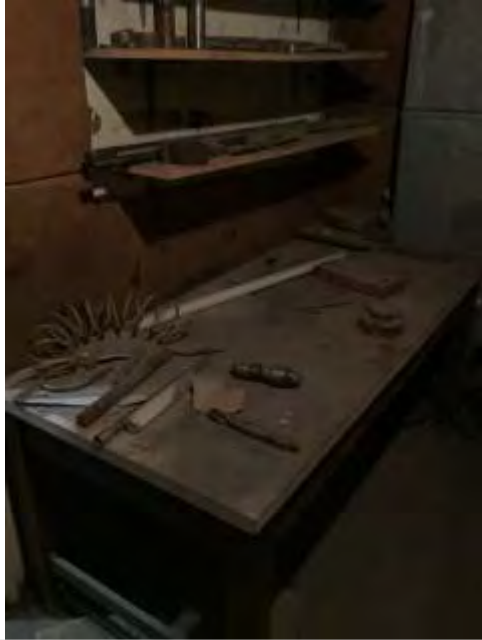
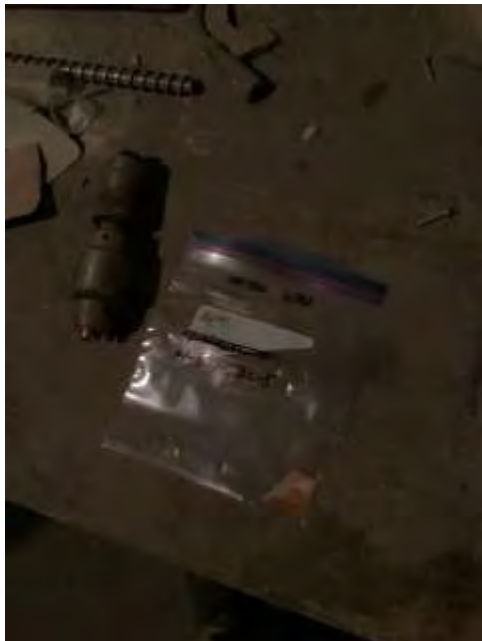
Sample ID:	Sample Type:	
4-4-MISC-5	MISC	
Sample Location:	Detailed Sample Location:	
Room 22	Northwest corner tabletop.	
Sample Quantity:	15 square feet.	
Misc Sample Material:	Sample Condition:	Sample Friable?:
Off-white laminate tabletop with clear adhesive.	Potential ACBM with potential for damage	Yes
