COLLEGE AVENUE STEAM PLANT ADAPTIVE REUSE

Integrated Cleanup and Implementation Plan

Port of
Whitman
County

PORT OF WHITMAN COUNTY
March 30, 2020

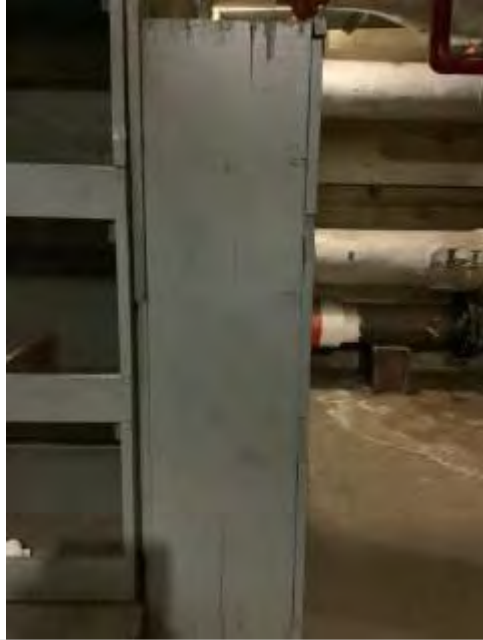
Sample ID:	Sample Type:
4-5-PB-6	PB
Sample Location:	Detailed Sample Location:
Room 21	Cabinet in center of room north of room 22.
Sample Quantity:	N/A
Sample Color:	XRF:
Gray	0.063

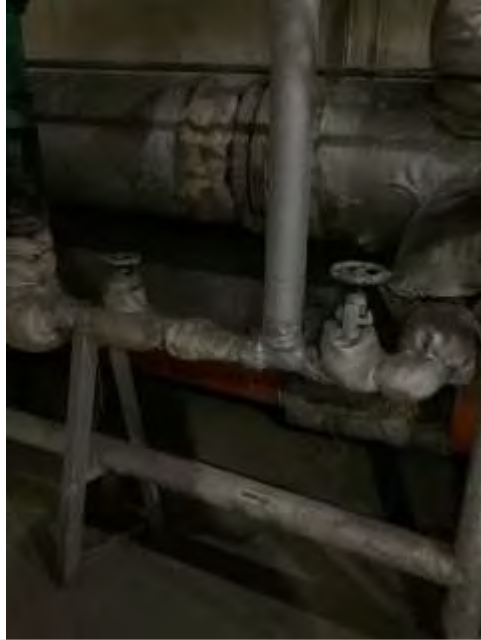
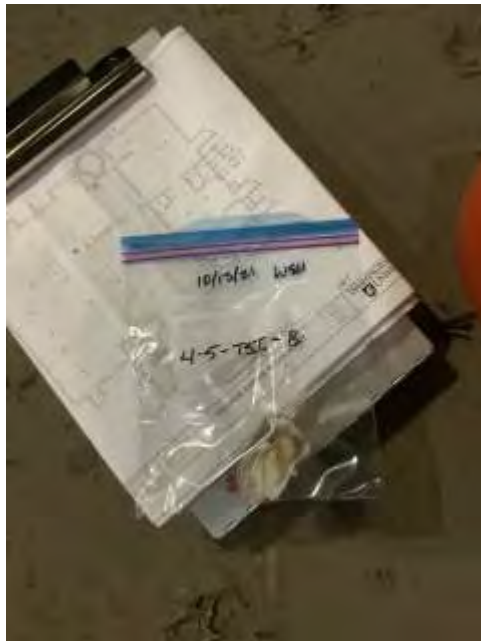
Additional Sample Notes:		
Sample ID:	Sample Type:	
4-5-TSI-8	TSI	
Sample Location:	Detailed Sample Location:	
Room 23	Southeast corner of room.	
Sample Quantity:	200 linear feet.	
Sample Color:	XRF:	
Misc Sample Material:	Sample Condition:	Sample Friable?:
	Damaged or significantly damaged	Yes

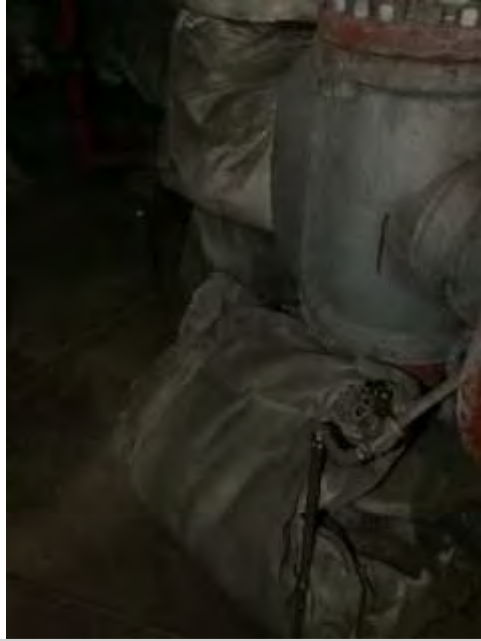
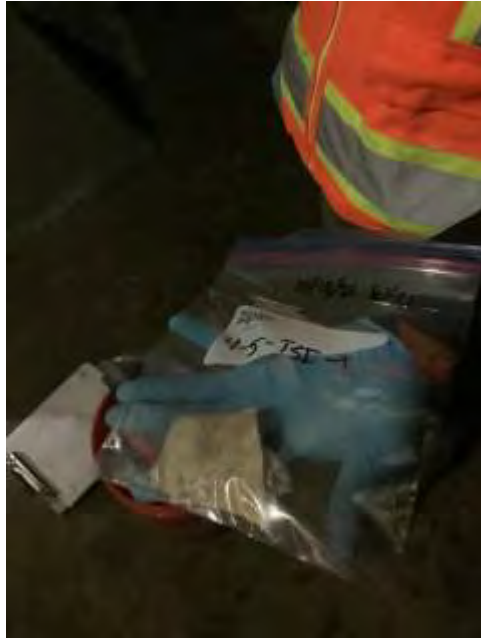
Additional Sample Notes:		Silver steam pipe fabric wrap.	
Sample ID:		Sample Type:	
4-5-TSI-9		TSI	
Sample Location:		Detailed Sample Location:	
Room 11		Southeast corner of room by entrance to room 23.	
Sample Quantity:		200 linear feet.	
Sample Color:		XRF:	
Misc Sample Material:		Sample Condition:	Sample Friable?:
		Damaged or significantly damaged	Yes

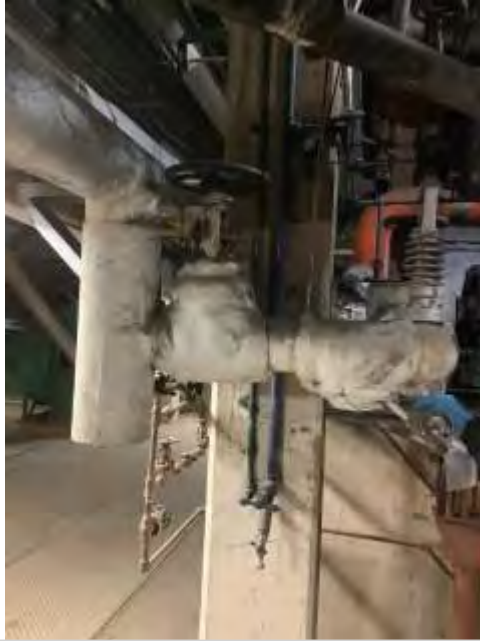
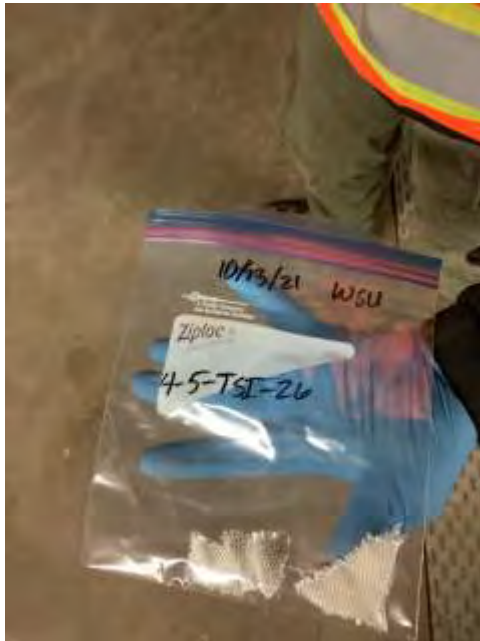
Additional Sample Notes:	Silver steam pipe fabric wrap.
Sample ID:	Sample Type:
4-5-TSI-26	TSI
Sample Location:	Detailed Sample Location:
Room 11	On west side of room by staircase down.
Sample Quantity:	200 linear feet.
Sample Color:	XRF:

Misc Sample Material:	Sample Condition:	Sample Friable?:
	Damaged or significantly damaged	Yes

Additional Sample Notes:	Silver steam pipe fabric wrap.
---------------------------------	--------------------------------

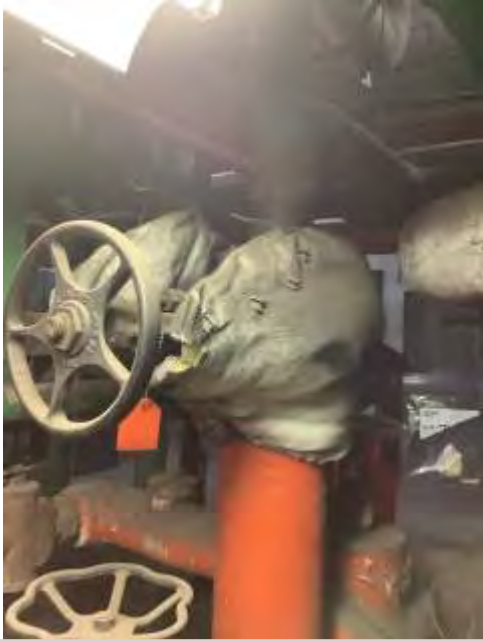
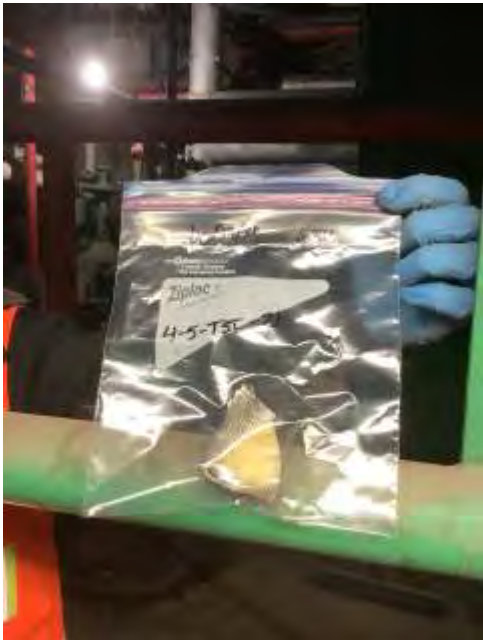
Sample ID:	Sample Type:
4-5-TSI-21	TSI
Sample Location:	Detailed Sample Location:
Room 11	Northeast portion of room near northeast staircase.
Sample Quantity:	200 linear feet.

Sample Color:	XRF:	
Misc Sample Material:	Sample Condition:	Sample Friable?:
	Damaged or significantly damaged	Yes

Additional Sample Notes:	Silver steam pipe fabric wrap.
---------------------------------	--------------------------------

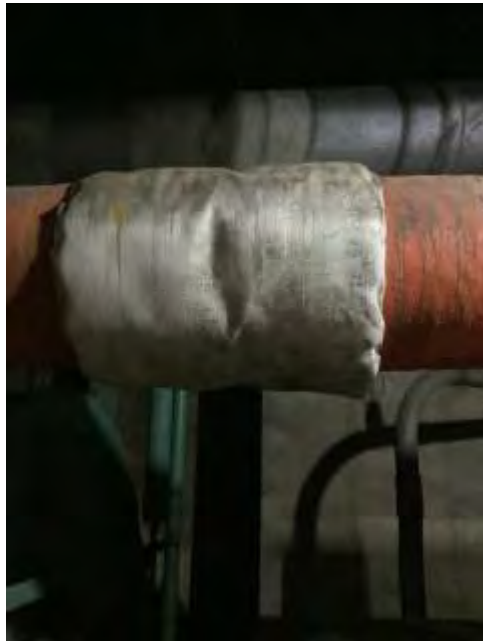
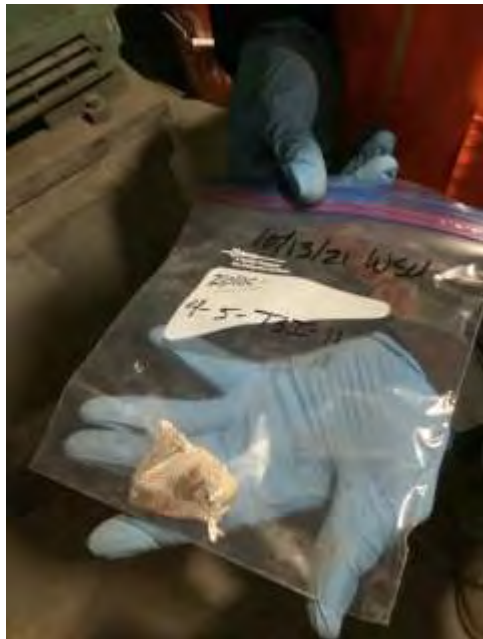
4-5-TSI-11

Room 11	East portion of room by spiral staircase.	
Sample Quantity:	200 linear feet.	
Sample Color:	XRF:	
Misc Sample Material:	Sample Condition:	Sample Friable?:
	Damaged or significantly damaged	Yes

Additional Sample Notes:	Silver steam pipe fabric wrap.
---------------------------------	--------------------------------

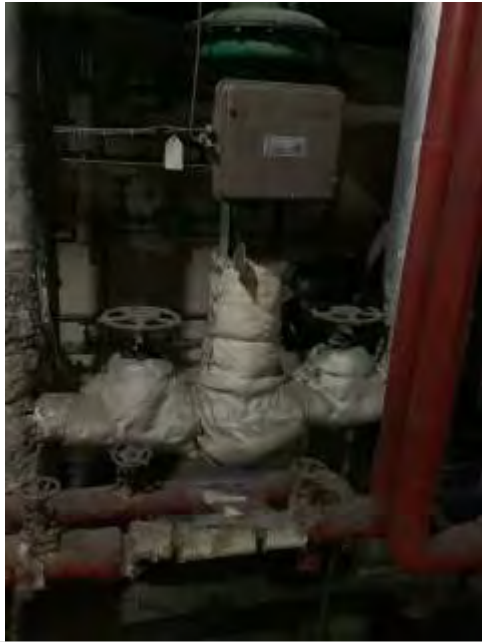
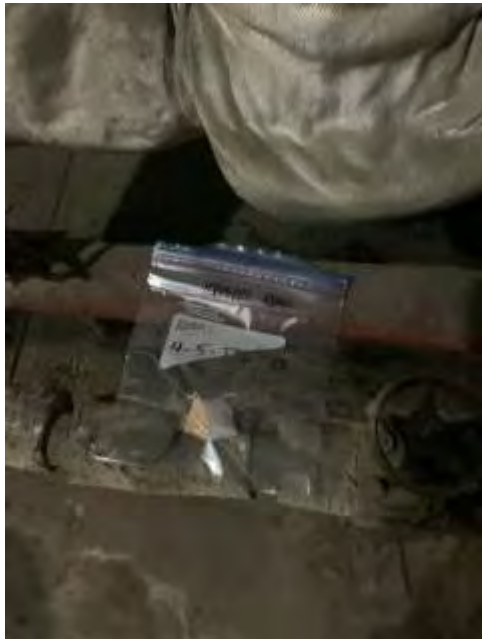
4-5-TSI-13	TSI	
Sample Location:	Detailed Sample Location:	
Room 11	East portion of room north of spiral staircase.	
Sample Quantity:	200 linear feet.	
Sample Color:	XRF:	
Misc Sample Material:	Sample Condition:	Sample Friable?:
	Damaged or significantly damaged	Yes

Additional Sample Notes:	Silver steam pipe fabric wrap.
---------------------------------	--------------------------------

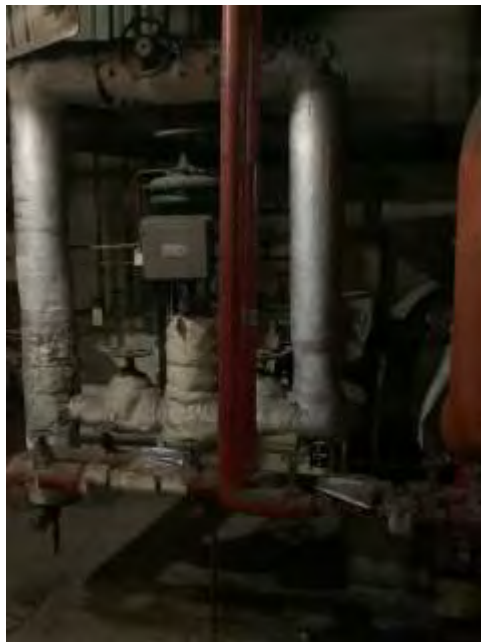
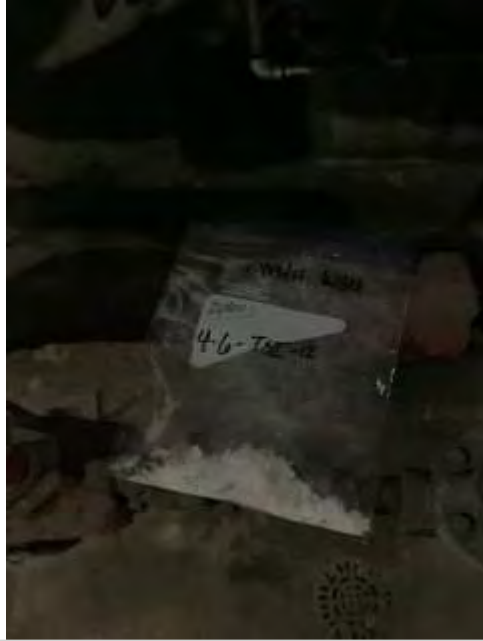
Sample ID:	Sample Type:	
4-6-TSI-12	TSI	
Sample Location:	Detailed Sample Location:	
Room 11	East portion of room north of spiral staircase.	
Sample Quantity:	40 linear feet.	
Sample Color:	XRF:	
Misc Sample Material:	Sample Condition:	Sample Friable?:
	Damaged or significantly damaged	Yes

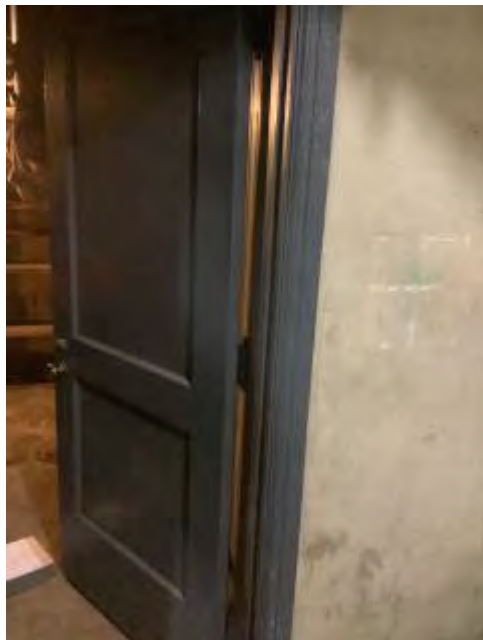
Additional Sample Notes:	Red steam pipe fabric wrap.
Sample ID:	Sample Type:
4-6-PB-8	PB
Sample Location:	Detailed Sample Location:
Room 21	Door frame to room 18.
Sample Quantity:	N/A
Sample Color:	XRF:
Blue gray	0.086

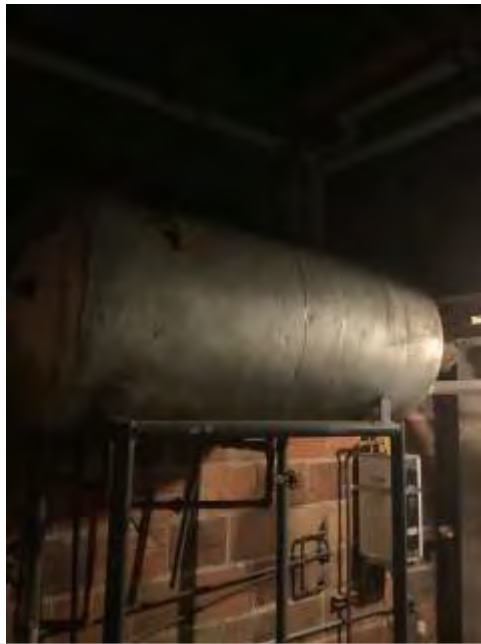
Sample ID:	Sample Type:
4-7-PB-9	PB
Sample Location:	Detailed Sample Location:
Room 18	Tank in southeast corner of room.
Sample Quantity:	5 linear feet.
Sample Color:	XRF:
Silver	5.00

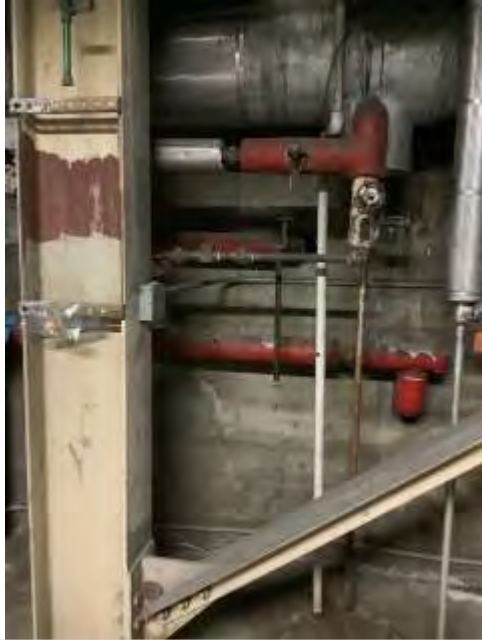
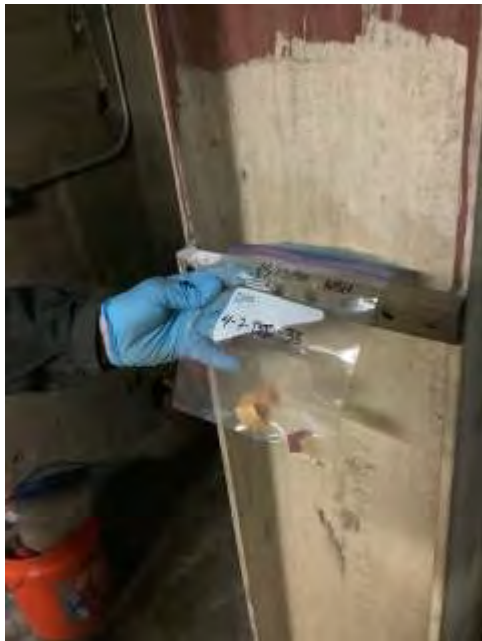
Sample ID:	Sample Type:	
4-7-TSI-33	TSI	
Sample Location:	Detailed Sample Location:	
Room 11	Center of room.	
Sample Quantity:	500 linear feet.	
Sample Color:	XRF:	
Misc Sample Material:	Sample Condition:	Sample Friable?:
	Damaged or significantly damaged	Yes

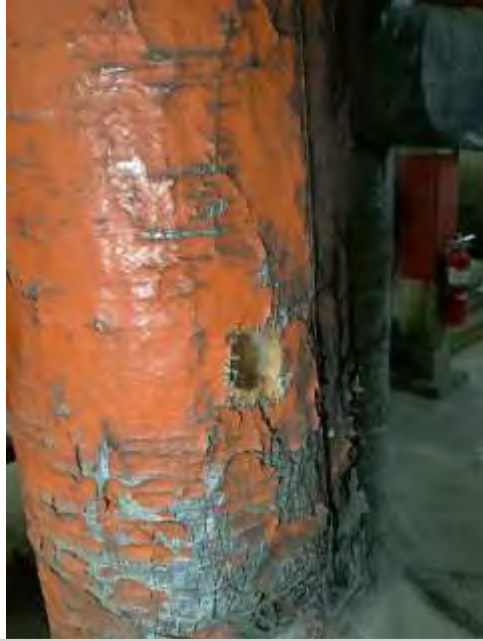
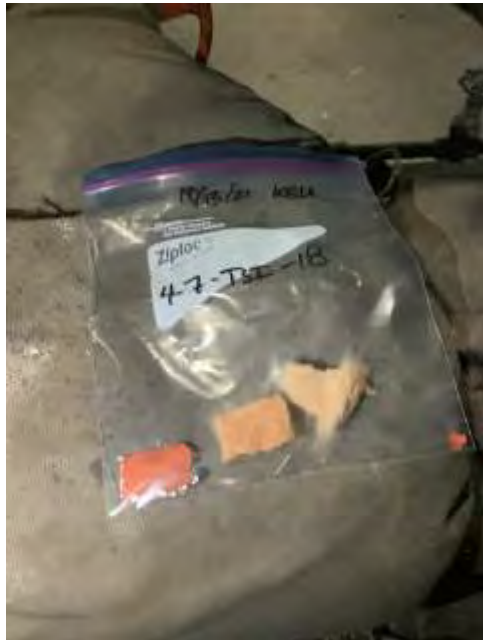
Additional Sample Notes:		Yellow insulation with red painted silver wrap.
Sample ID:	Sample Type:	
4-7-TSI-18	TSI	
Sample Location:	Detailed Sample Location:	
Room 11	Northeast portion of room between northeast staircase and elevator.	
Sample Quantity:	500 linear feet.	
Sample Color:	XRF:	
Misc Sample Material:	Sample Condition:	Sample Friable?:
	Damaged or significantly damaged	Yes

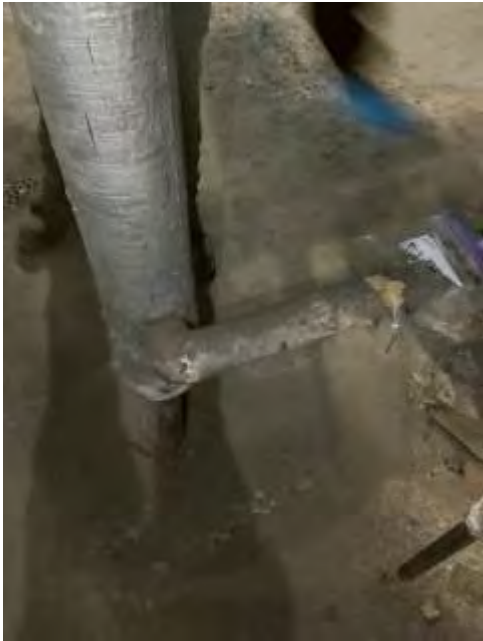
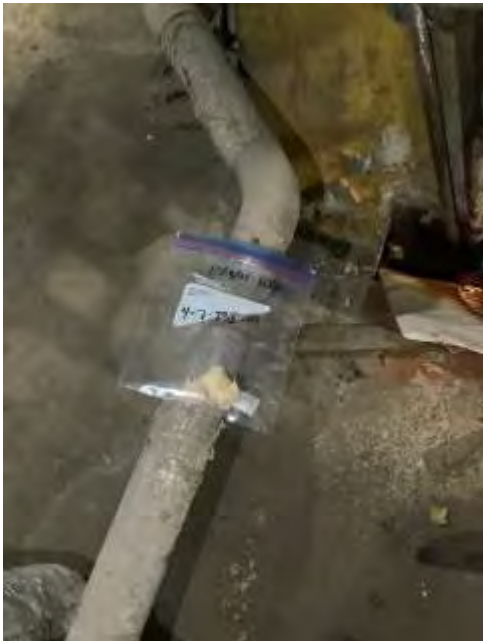
Additional Sample Notes:	Orange steam pipe fabric wrap with yellow insulation.
Sample ID:	Sample Type:
4-7-TSI-19	TSI
Sample Location:	Detailed Sample Location:
Room 11	Northeast portion of room between northeast staircase and elevator.
Sample Quantity:	500 linear feet.
Sample Color:	XRF:

Misc Sample Material:	Sample Condition:	Sample Friable?:
	Damaged or significantly damaged	Yes

Additional Sample Notes:	Orange steam pipe fabric wrap with yellow insulation.
---------------------------------	---

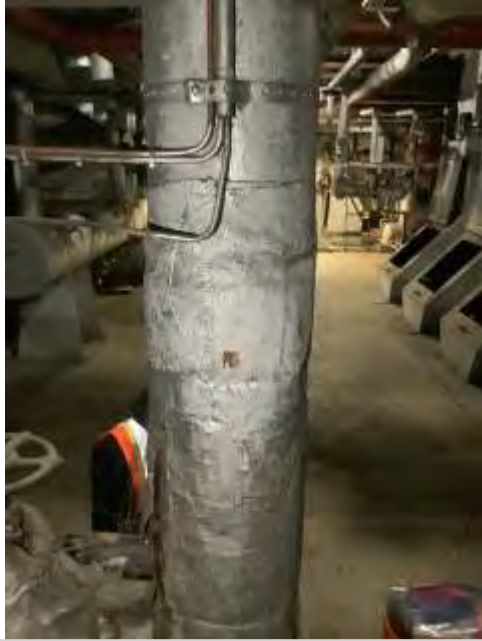
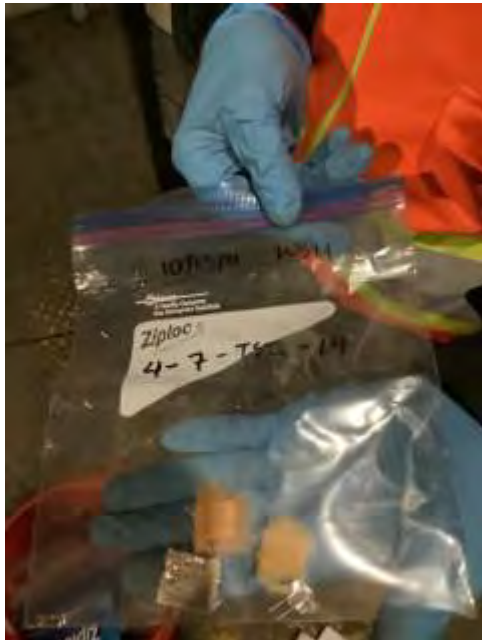
Sample ID:	Sample Type:
4-7-TSI-14	TSI
Sample Location:	Detailed Sample Location:
Room 11	East portion of room north of spiral staircase.
Sample Quantity:	500 linear feet.

Sample Color:	XRF:	
Misc Sample Material:	Sample Condition:	Sample Friable?:
	Damaged or significantly damaged	Yes

Additional Sample Notes:	Silver steam pipe fabric wrap with yellow insulation.
---------------------------------	---

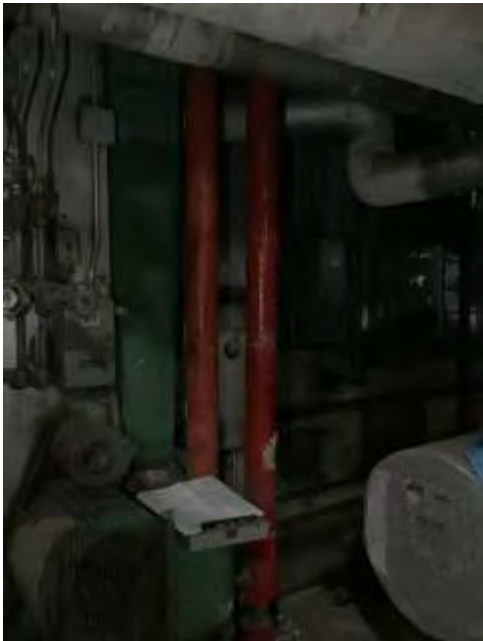
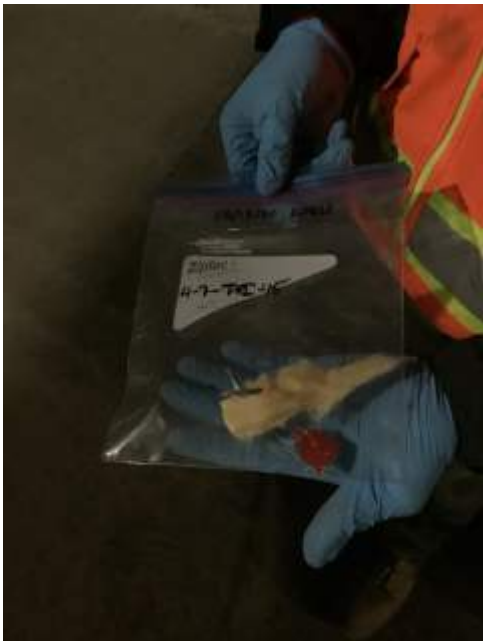
4-7-TSI-15

Room 11	East portion of room north of spiral staircase.	
Sample Quantity:	500 linear feet.	
Sample Color:	XRF:	
Misc Sample Material:	Sample Condition:	Sample Friable?:
	Damaged or significantly damaged	Yes

Additional Sample Notes:	Red steam pipe fabric wrap with yellow insulation.
---------------------------------	--

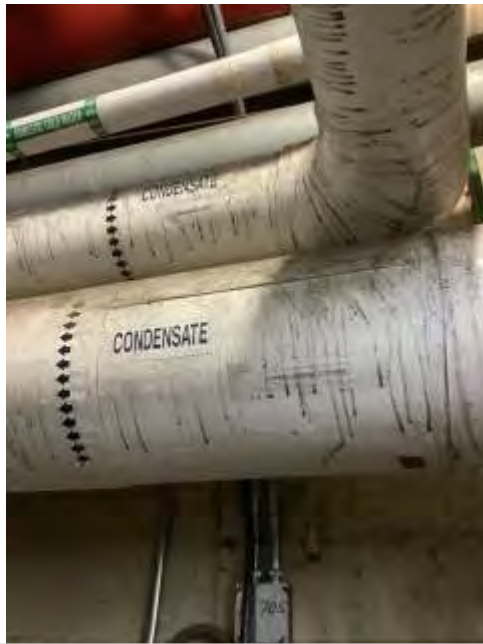
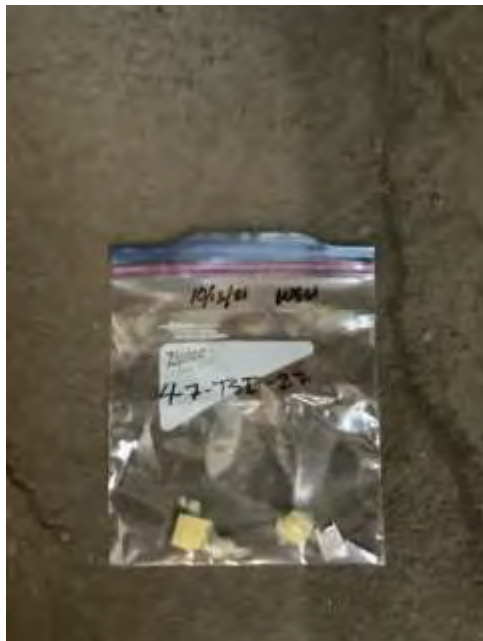
4-7-TSI-27	TSI	
Sample Location:	Detailed Sample Location:	
Room 11	West portion of room by staircase to room 101.	
Sample Quantity:	500 linear feet.	
Sample Color:	XRF:	
Misc Sample Material:	Sample Condition:	Sample Friable?:
	Damaged or significantly damaged	Yes

Additional Sample Notes: White condensate pipe with yellow insulation.

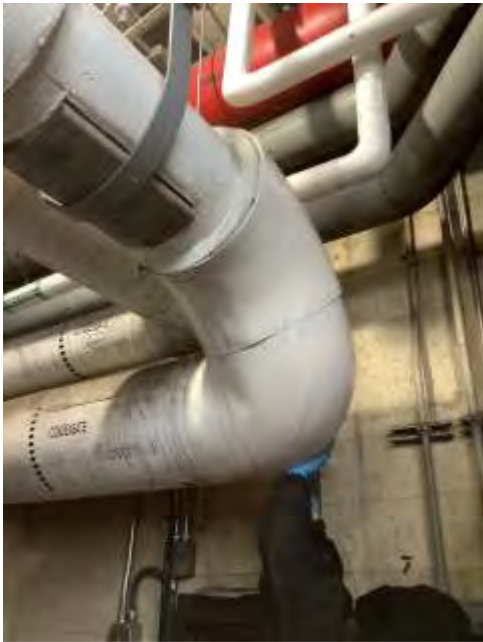
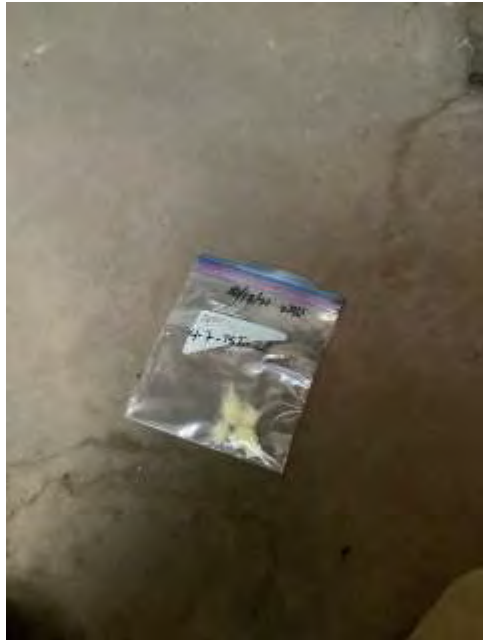
Sample ID:	Sample Type:	
4-7-TSI-28	TSI	
Sample Location:	Detailed Sample Location:	
Room 11	West portion of room by staircase to room 101.	
Sample Quantity:	500 linear feet.	
Sample Color:	XRF:	
Misc Sample Material:	Sample Condition:	Sample Friable?:
	Damaged or significantly damaged	Yes

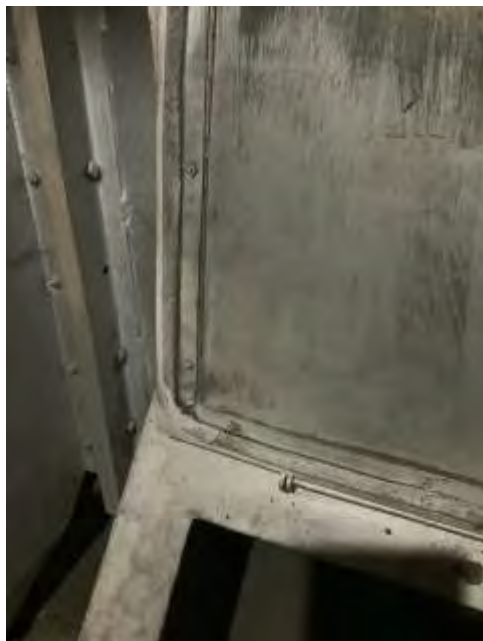
Additional Sample Notes:		White condensate line elbow with yellow insulation.
Sample ID:	Sample Type:	
4-8-MISC-16	MISC	
Sample Location:	Detailed Sample Location:	
Room 11	By control wheels and conveying systems.	
Sample Quantity:	80 linear feet.	
Misc Sample Material:	Sample Condition:	Sample Friable?:
Silver woven heat-resistant seal material on hatch interior.	Potential ACBM with potential for damage	No

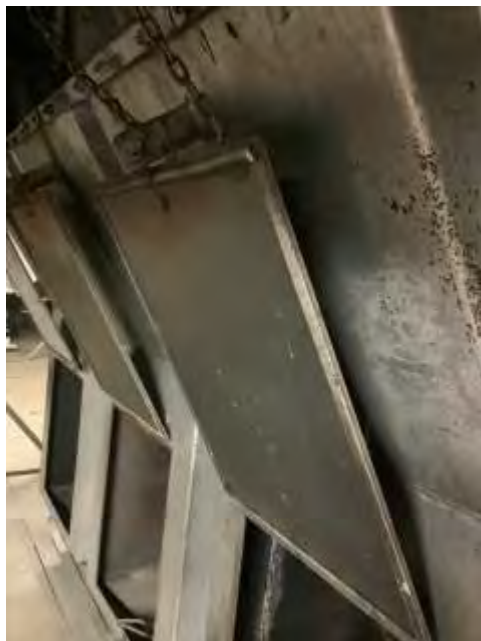
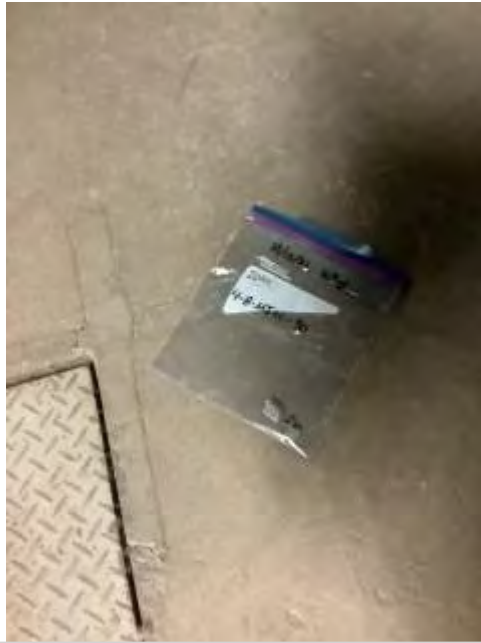
Sample ID:	Sample Type:	
4-8-MISC-30	MISC	
Sample Location:	Detailed Sample Location:	
Room 11	By control wheels and conveying systems.	
Sample Quantity:	80 linear feet.	
Misc Sample Material:	Sample Condition:	Sample Friable?:
Silver woven heat-resistant seal material on hatch interior.	Potential ACBM with potential for damage	No

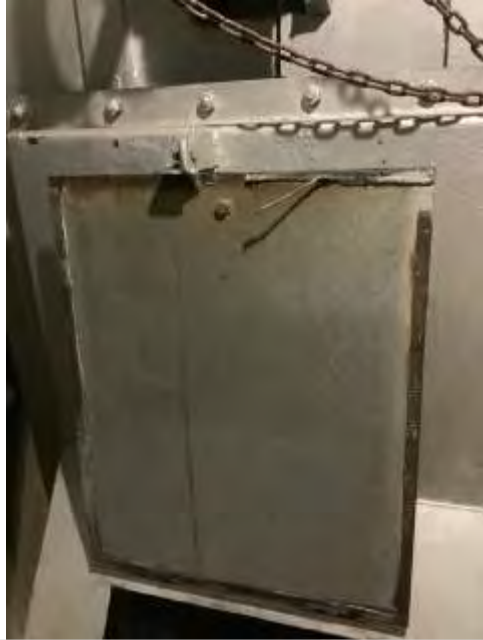
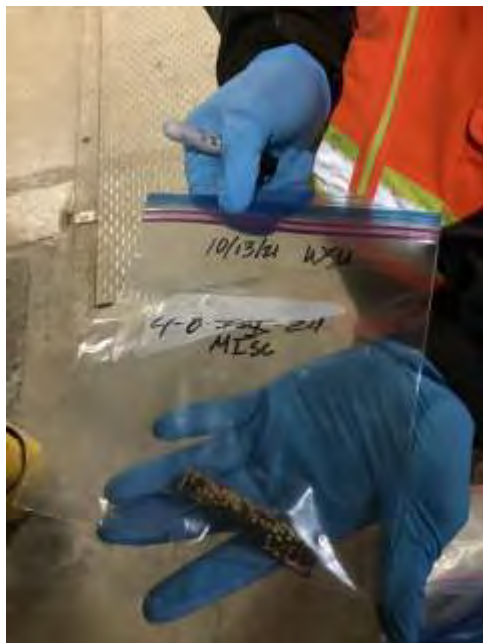
Sample ID:	Sample Type:	
4-8-MISC-24	MISC	
Sample Location:	Detailed Sample Location:	
Room 11	By control wheels and conveying systems.	
Sample Quantity:	80 linear feet.	
Misc Sample Material:	Sample Condition:	Sample Friable?:
Silver woven heat-resistant seal material on hatch interior.	Potential ACBM with potential for damage	No

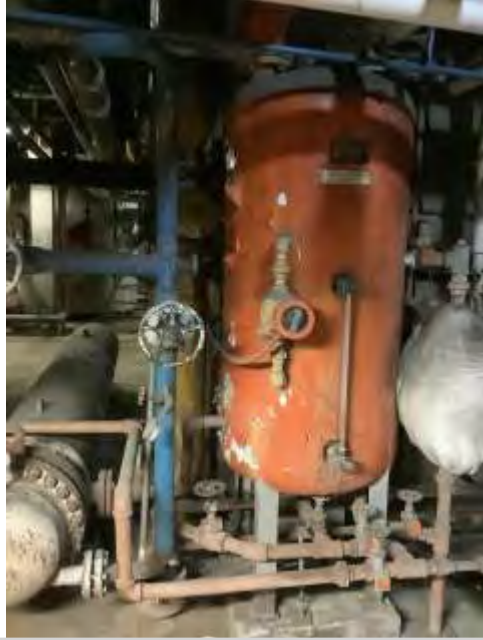
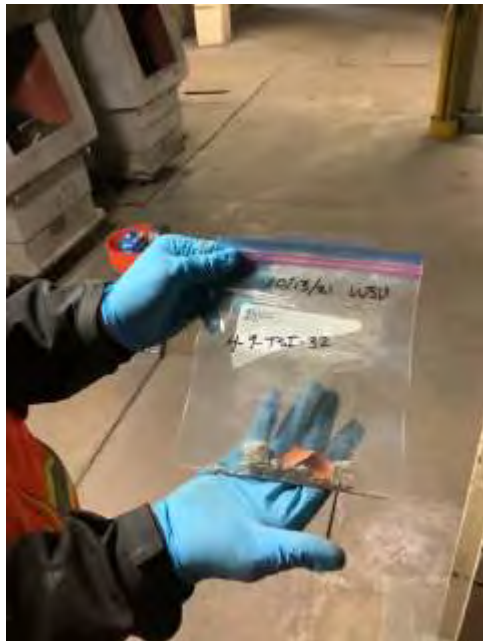
Additional Sample Notes:		
Sample ID:	Sample Type:	
4-9-TSI-32	TSI	
Sample Location:	Detailed Sample Location:	
Room 11	Northeast portion of room.	
Sample Quantity:	20 linear feet.	
Sample Color:	XRF:	
Misc Sample Material:	Sample Condition:	Sample Friable?:
	Damaged or significantly damaged	Yes

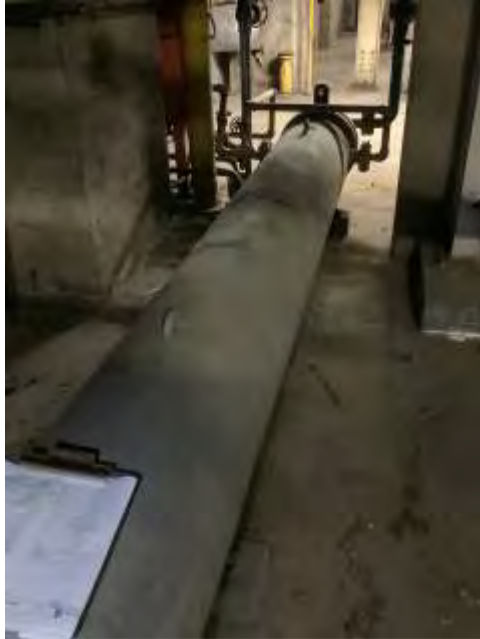
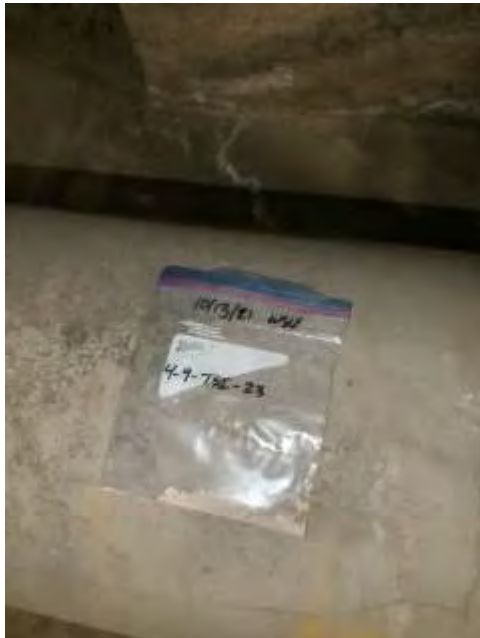
Additional Sample Notes:	White tank insulation with orange wrap.	
Sample ID:	Sample Type:	
4-9-TSI-23	TSI	
Sample Location:	Detailed Sample Location:	
Room 11	Northeast portion of room.	
Sample Quantity:	20 linear feet.	
Sample Color:	XRF:	
Misc Sample Material:	Sample Condition:	Sample Friable?:
	Damaged or significantly damaged	Yes

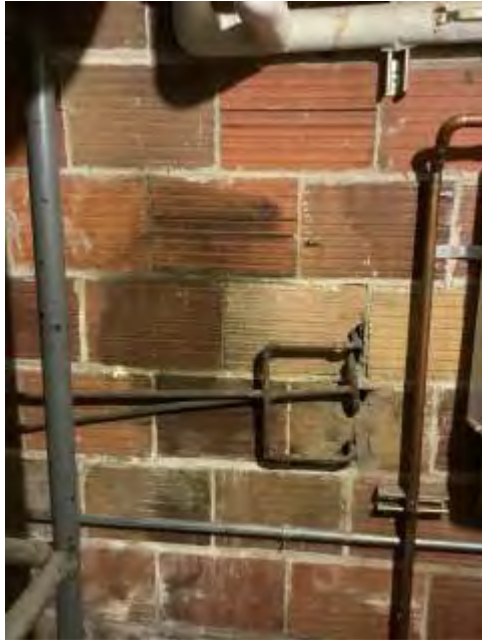
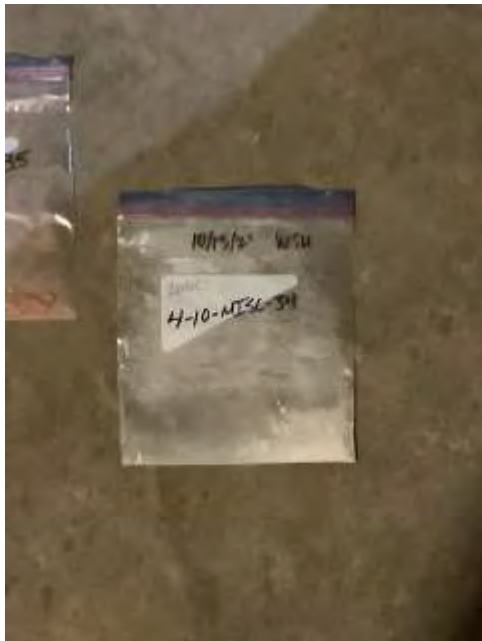
Additional Sample Notes:	White tank insulation with gray painted wrap and fabric patch.	
Sample ID:	Sample Type:	
4-10-MISC-34	MISC	
Sample Location:	Detailed Sample Location:	
Room 18	East wall of room.	
Sample Quantity:	350 linear feet.	
Misc Sample Material:	Sample Condition:	Sample Friable?:
Gray brick mortar.	Potential ACBM with potential for damage	No

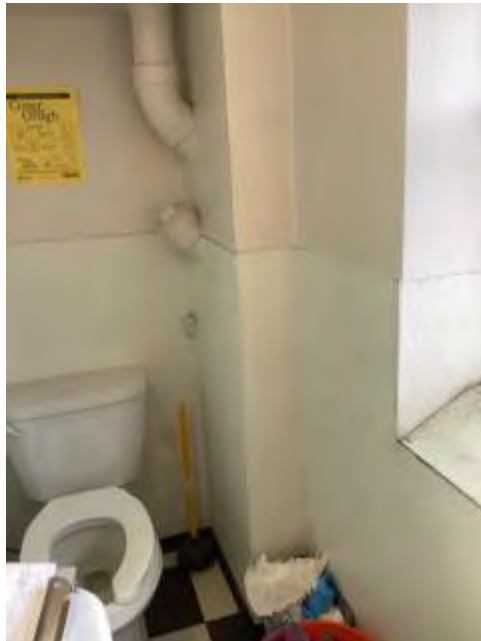
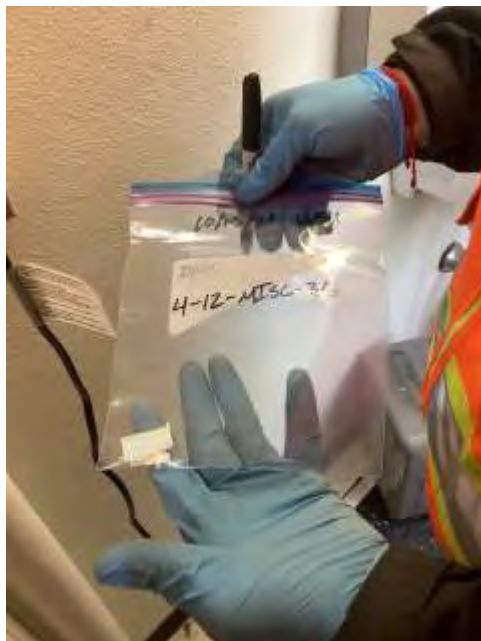
Additional Sample Notes:		
Sample ID:	Sample Type:	
4-12-MISC-36	MISC	
Sample Location:	Detailed Sample Location:	
Bathroom by west exit in stairwell.		
Sample Quantity:	60 square feet.	
Misc Sample Material:	Sample Condition:	Sample Friable?:
White textured waterproofing tile.	Damaged or significantly damaged friable miscellaneous ACM	No

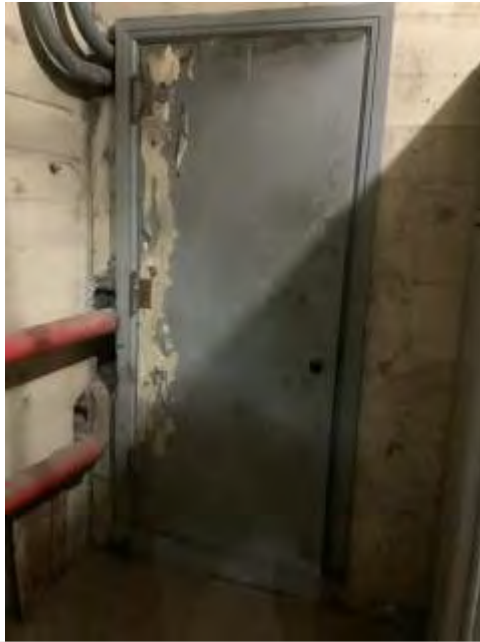
Sample ID:	Sample Type:
4-12-PB-14	PB
Sample Location:	Detailed Sample Location:
Room 21	Door to room 15.
Sample Quantity:	24 square feet.
Sample Color:	XRF:
Gray	4.11

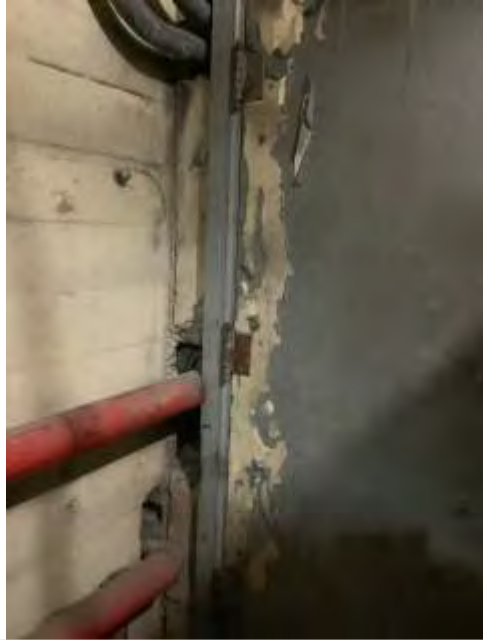
Sample ID:	Sample Type:
4-13-PB-15	PB
Sample Location:	Detailed Sample Location:
Room 21	Paint under new paint on door to room 15.
Sample Quantity:	24 square feet.
Sample Color:	XRF:
Light tan	3.40

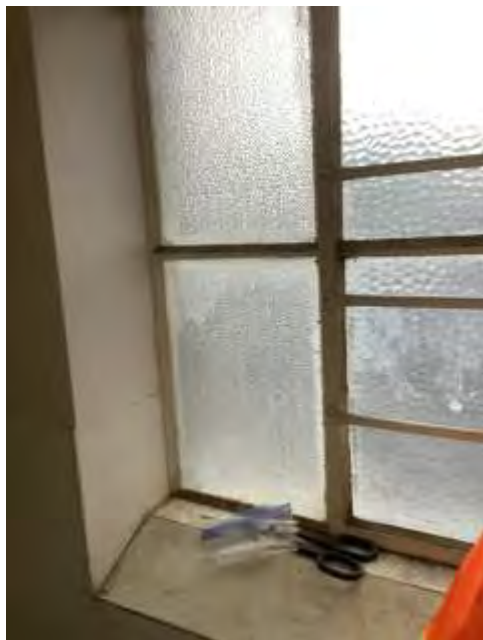
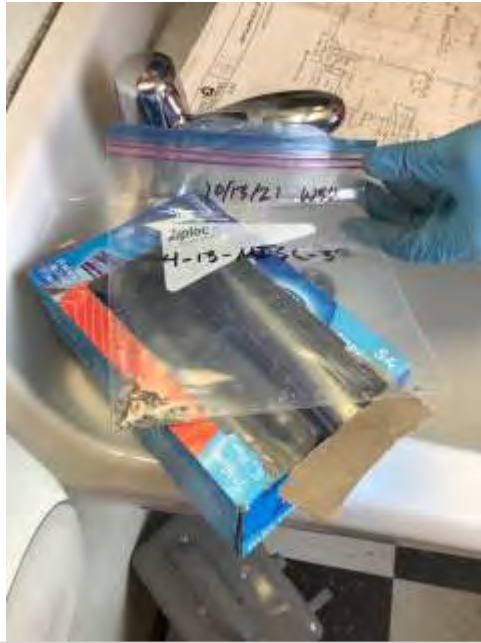
Sample ID:	Sample Type:	
4-13-MISC-37	MISC	
Sample Location:	Detailed Sample Location:	
Bathroom by exit		
Sample Quantity:	30 linear feet.	
Misc Sample Material:	Sample Condition:	Sample Friable?:
Window glazing.	Damaged or significantly damaged friable miscellaneous ACM	No

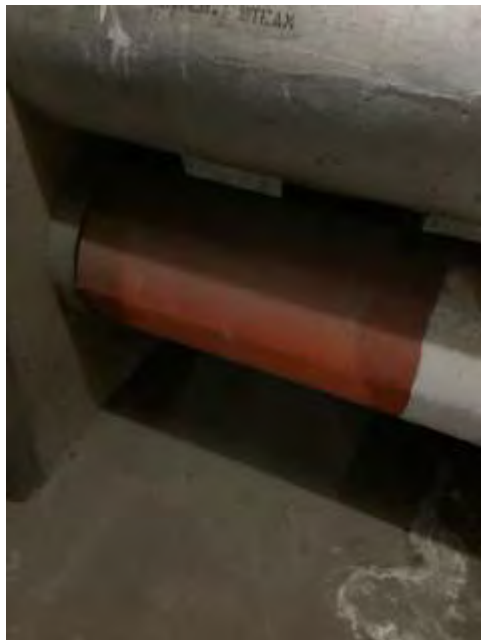
Sample ID:	Sample Type:
4-14-PB-16	PB
Sample Location:	Detailed Sample Location:
Room 21	Orange pipe on south wall west of room 22.
Sample Quantity:	600 linear feet.
Sample Color:	XRF:
Orange	5.00

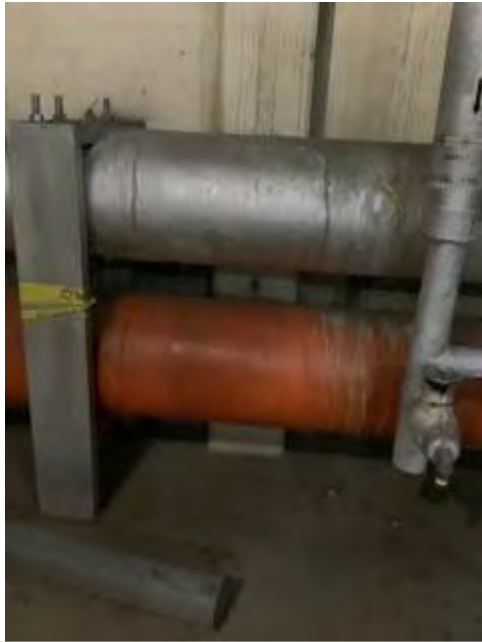
Sample ID:	Sample Type:
4-14-PB-21	PB
Sample Location:	Detailed Sample Location:
Room 23	Orange pipe on east wall.
Sample Quantity:	600 linear feet.
Sample Color:	XRF:
Orange	3.70

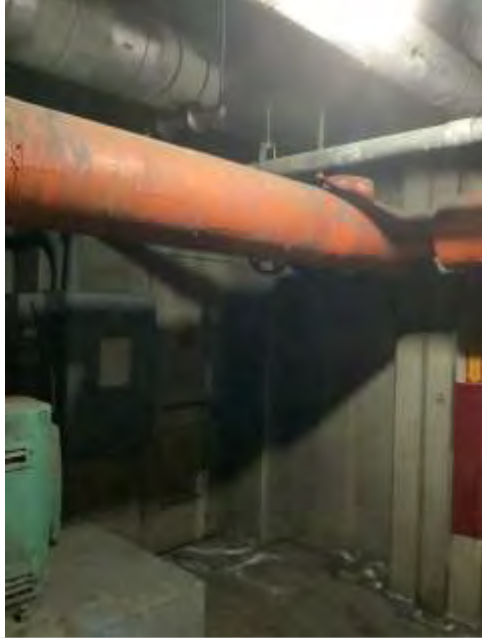
Sample ID:	Sample Type:
4-14-PB-55	PB
Sample Location:	Detailed Sample Location:
Room 11	Orange pipe wrap in southeast corner of room north of spiral staircase.
Sample Quantity:	600 linear feet
Sample Color:	XRF:
Orange	1.275

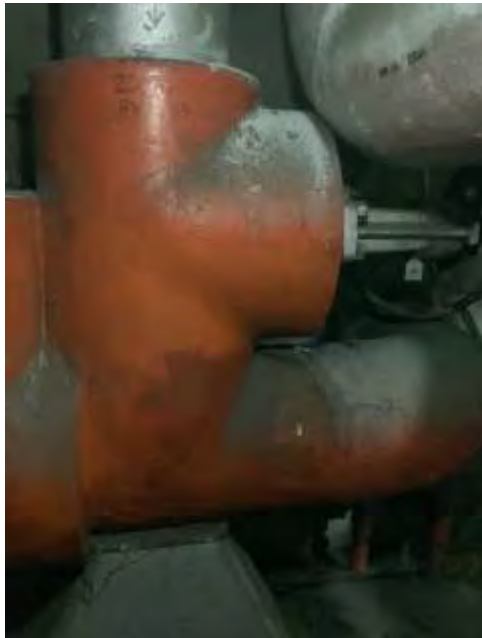
Sample ID:	Sample Type:
4-14-PB-57	PB
Sample Location:	Detailed Sample Location:
Room 11	Southeast corner of room east of doorway.
Sample Quantity:	600 linear feet.
Sample Color:	XRF:
Orange	4.49

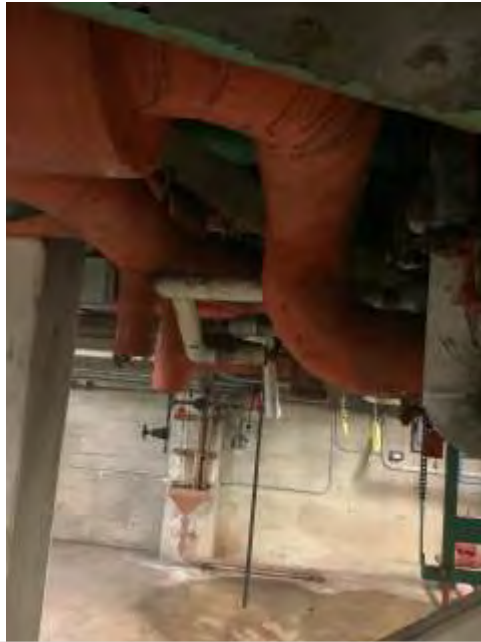
Sample ID:	Sample Type:
4-14-PB-42	PB
Sample Location:	Detailed Sample Location:
Room 11	Orange pipe in northwest corner of room west of active tank.
Sample Quantity:	600 linear feet.
Sample Color:	XRF:
Orange	5.0

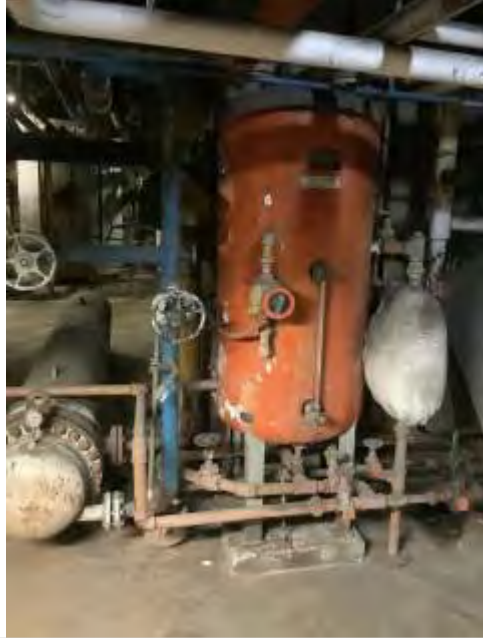
Sample ID:	Sample Type:
4-14-PB-50	PB
Sample Location:	Detailed Sample Location:
Room 11	Orange tank in center of room between the two north boilers.
Sample Quantity:	600 linear feet.
Sample Color:	XRF:
Orange	1.223

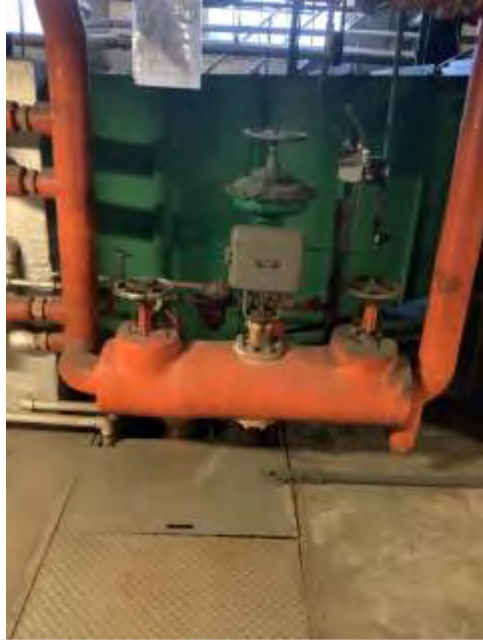
Additional Sample Notes:	Submitted sample to laboratory for analysis.
Sample ID:	Sample Type:
4-14-PB-27	PB
Sample Location:	Detailed Sample Location:
Room 11	Orange pipe in southwest corner of room.
Sample Quantity:	600 linear feet.
Sample Color:	XRF:
Orange	3.32

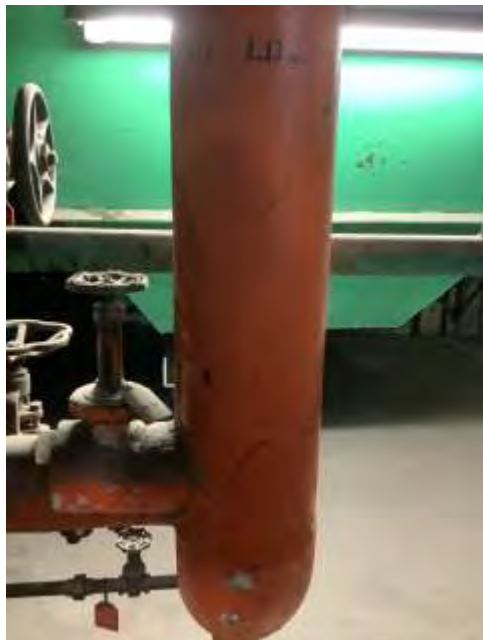
Sample ID:	Sample Type:
4-14-PB-44	PB
Sample Location:	Detailed Sample Location:
Room 11	Northeast corner of room west of exit doorway.
Sample Quantity:	600 linear feet.
Sample Color:	XRF:
Orange	2.43

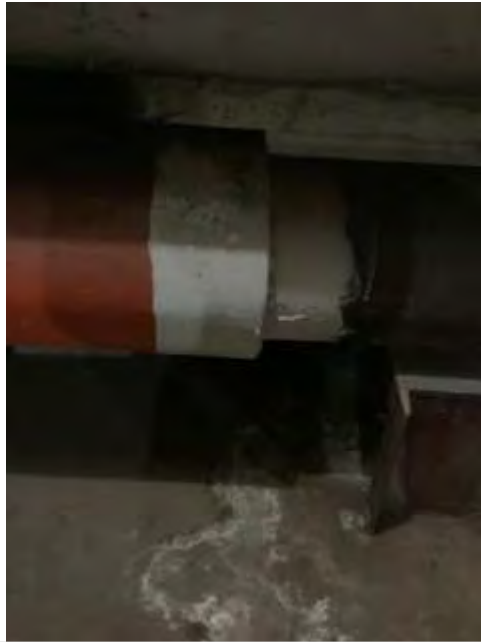
Sample ID:	Sample Type:
4-15-PB-17	PB
Sample Location:	Detailed Sample Location:
Room 21	White paint on orange pipe on south wall west of room 22.
Sample Quantity:	2 linear feet.
Sample Color:	XRF:
White	5.00

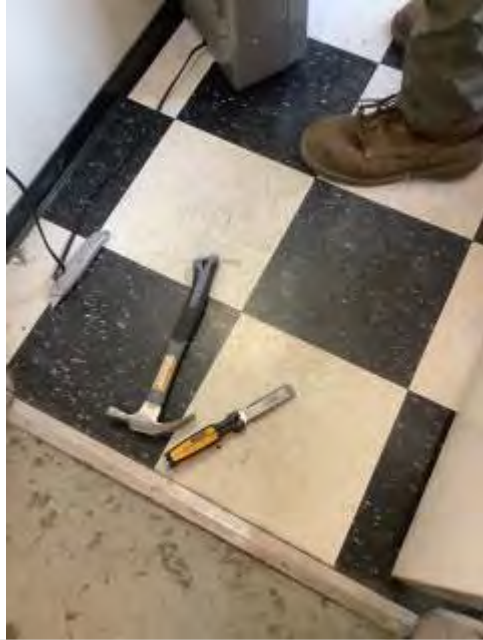
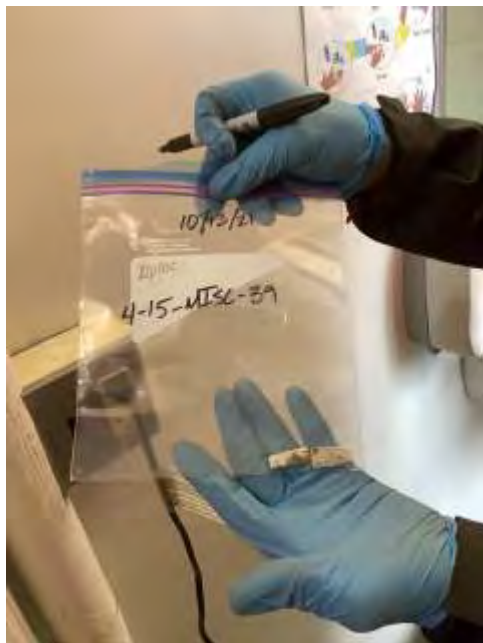
Sample ID:	Sample Type:	
4-15-MISC-39	MISC	
Sample Location:	Detailed Sample Location:	
Bathroom by exit		
Sample Quantity:	20 square feet.	
Misc Sample Material:	Sample Condition:	Sample Friable?:
White 12" x 12" linoleum floor tile with yellow adhesive.	Damaged or significantly damaged friable miscellaneous ACM	No

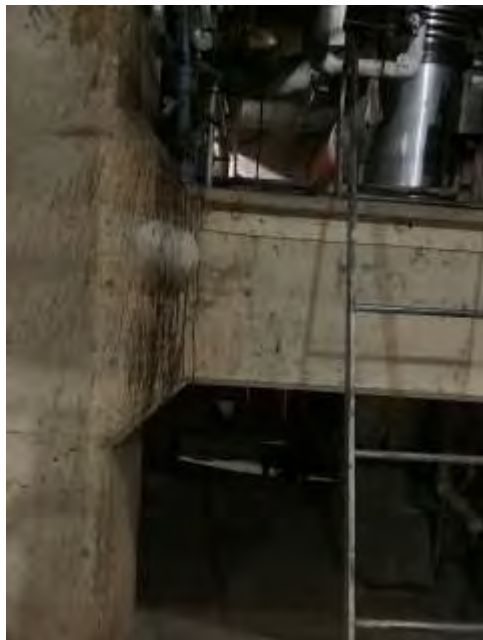
Sample ID:	Sample Type:
4-16-PB-24	PB
Sample Location:	Detailed Sample Location:
Room 23	Tan paint on northwest corner of wall.
Sample Quantity:	N/A
Sample Color:	XRF:
Tan	ND

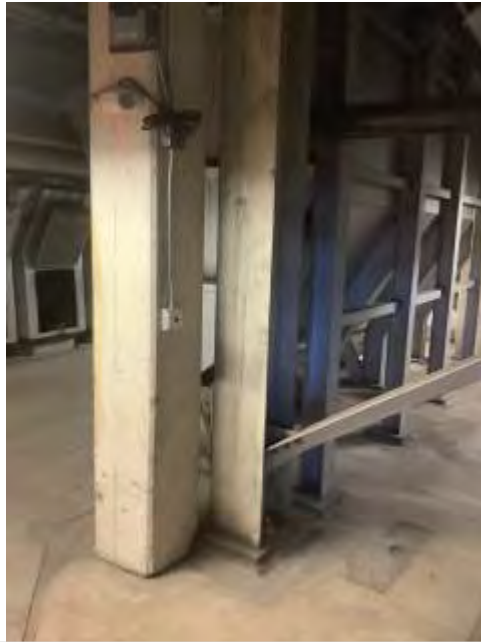
Sample ID:	Sample Type:
4-16-PB-28	PB
Sample Location:	Detailed Sample Location:
Room 11	Support beam in southwest center of room.
Sample Quantity:	N/A
Sample Color:	XRF:
Tan	ND

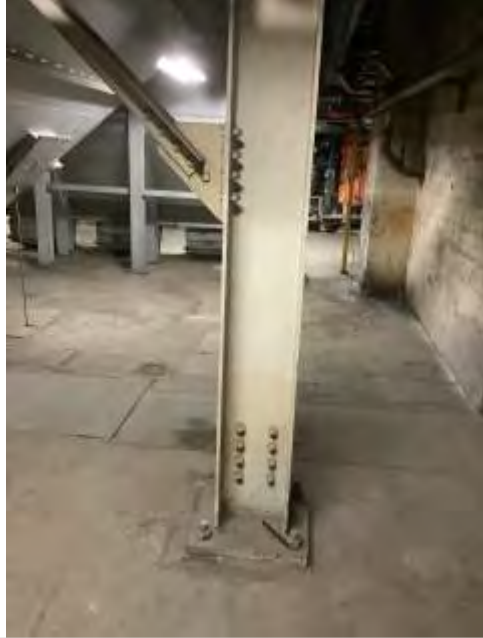
Sample ID:	Sample Type:
4-16-PB-51	PB
Sample Location:	Detailed Sample Location:
Room 11	Support beam on south side of room east of green air equipment.
Sample Quantity:	N/A
Sample Color:	XRF:
White	0.005
