COLLEGE AVENUE STEAM PLANT ADAPTIVE REUSE

Integrated Cleanup and Implementation Plan

Port of
Whitman
County

PORT OF WHITMAN COUNTY
March 30, 2020

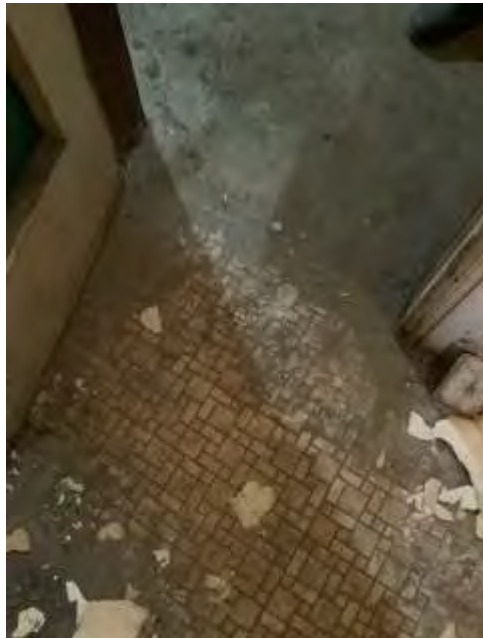
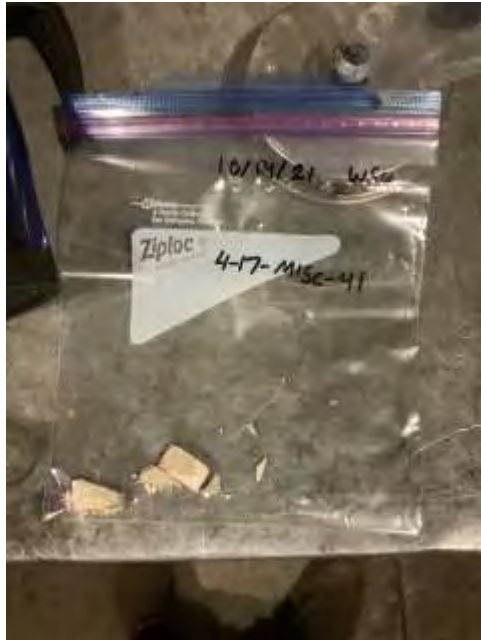
Sample ID:	Sample Type:	
4-17-MISC-41	MISC	
Sample Location:	Detailed Sample Location:	
Room 17	Northeast floor in front of door.	
Sample Quantity:	180 square feet.	
Misc Sample Material:	Sample Condition:	Sample Friable?:
Tan 1"-2" square tile with brown adhesive.	Potential ACBM with potential for damage	No

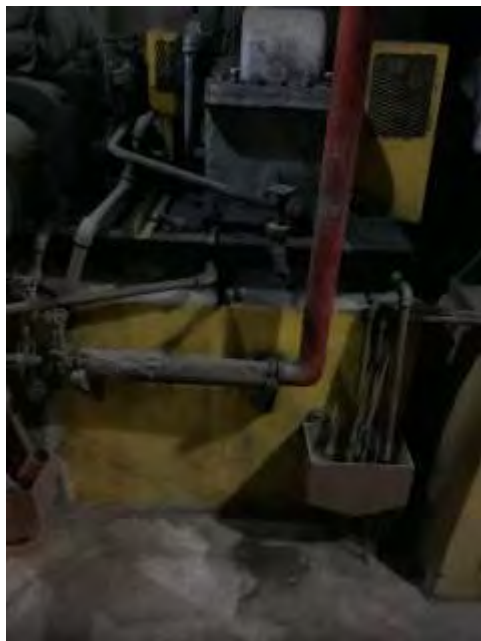
Additional Sample Notes:	
Sample ID:	Sample Type:
4-17-PB-45	PB
Sample Location:	Detailed Sample Location:
Room 11	Yellow concrete block In northeast corner of room south of exit doorway.
Sample Quantity:	N/A
Sample Color:	XRF:
Yellow	ND

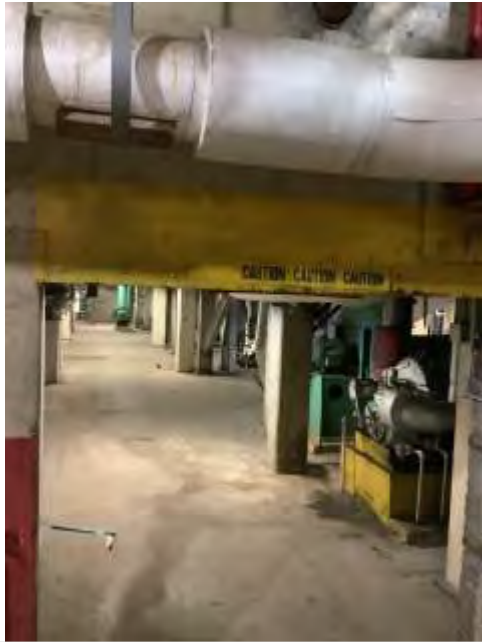
Sample ID:	Sample Type:
4-17-PB-19	PB
Sample Location:	Detailed Sample Location:
Room 21	Yellow caution paint above doorway to room 11.
Sample Quantity:	N/A
Sample Color:	XRF:
Yellow	ND

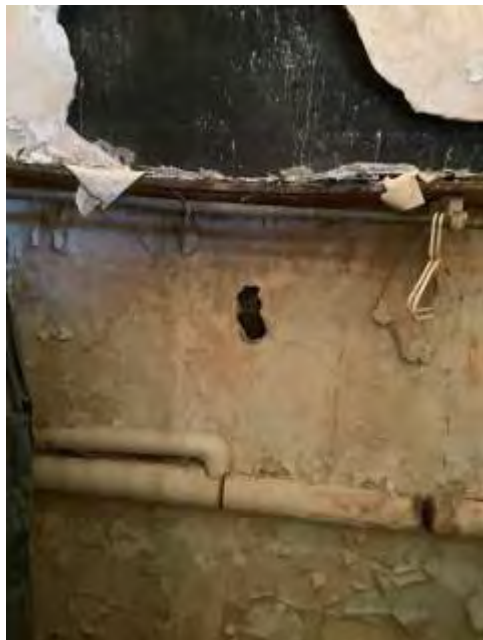
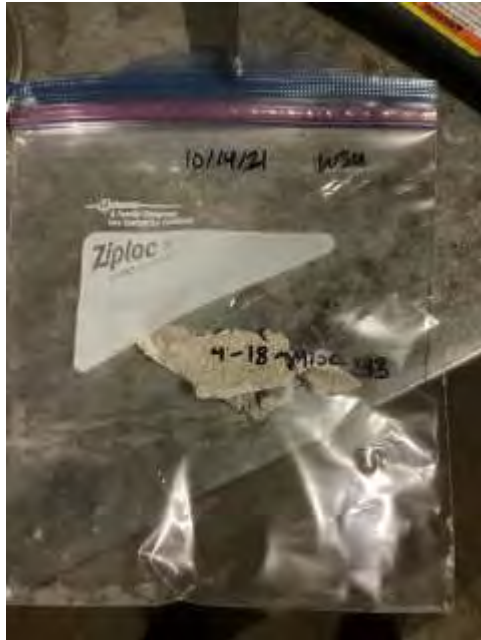
Sample ID:	Sample Type:	
4-18-MISC-43	MISC	
Sample Location:	Detailed Sample Location:	
Room 17	South wall of room.	
Sample Quantity:	920 square feet.	
Misc Sample Material:	Sample Condition:	Sample Friable?:
White drywall with gray cementitious wallboard.	Potential ACBM with potential for damage	No

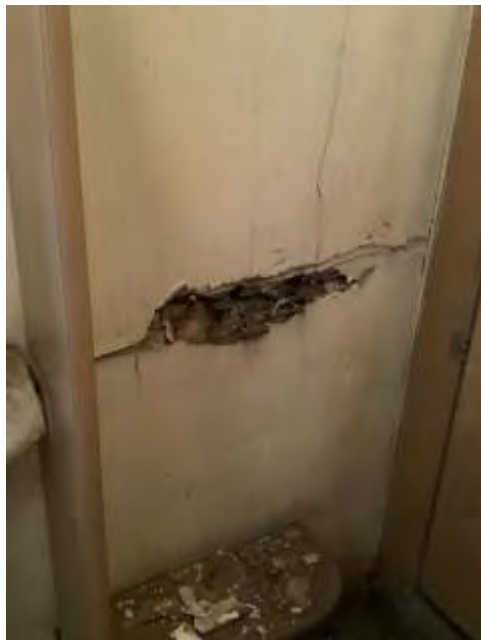
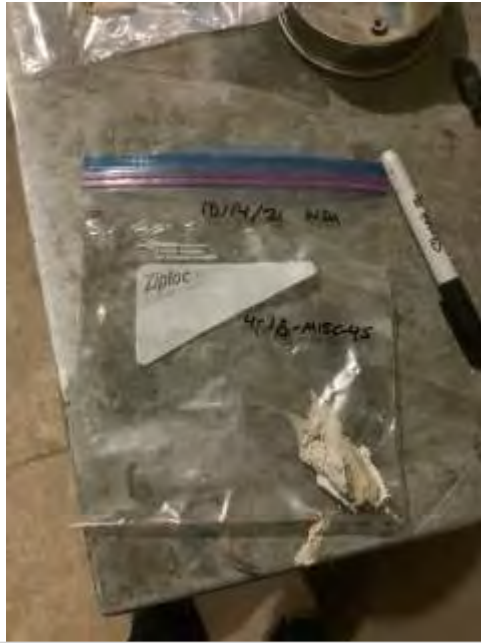
Sample ID:	Sample Type:	
4-18-MISC-45	MISC	
Sample Location:	Detailed Sample Location:	
Room 17	West wall in northwest corner.	
Sample Quantity:	920 square feet.	
Misc Sample Material:	Sample Condition:	Sample Friable?:
White drywall with gray cementitious wallboard.	Potential ACBM with potential for damage	No

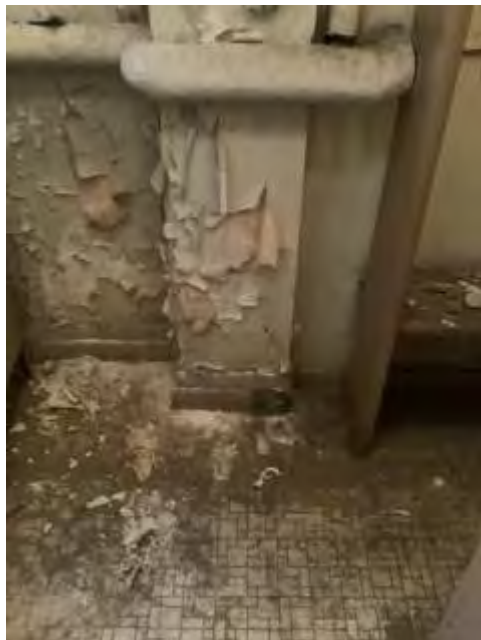
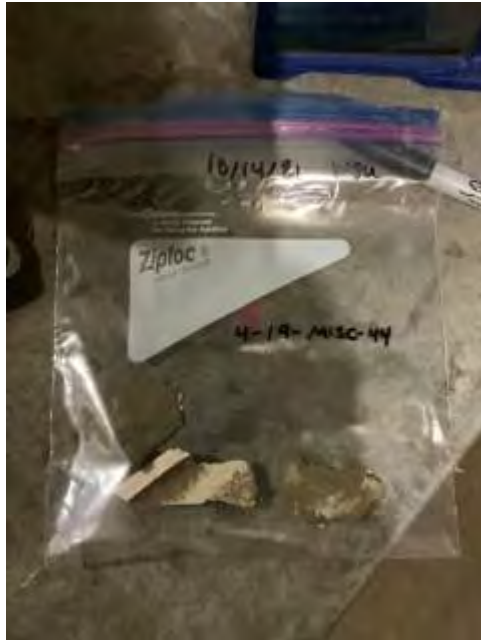
Sample ID:	Sample Type:	
4-19-MISC-44	MISC	
Sample Location:	Detailed Sample Location:	
Room 17	West wall in northwest corner.	
Sample Quantity:	60 linear feet.	
Misc Sample Material:	Sample Condition:	Sample Friable?:
Tan cove base with green adhesive.	Potential ACBM with potential for damage	No

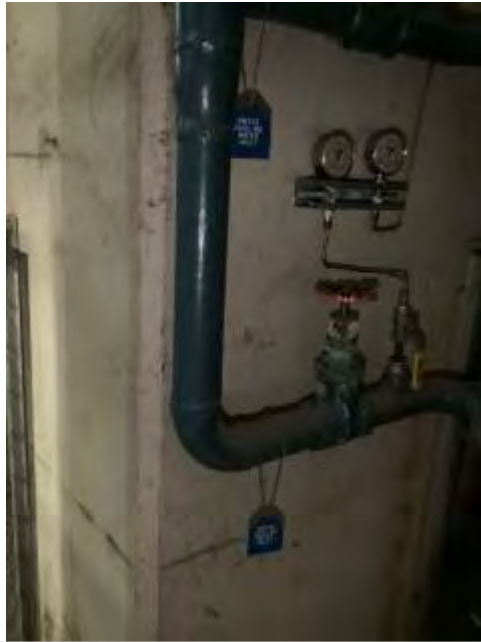
Sample ID:	Sample Type:
4-19-PB-23	PB
Sample Location:	Detailed Sample Location:
Room 23	Blue pipe in northeast corner.
Sample Quantity:	N/A
Sample Color:	XRF:
Blue	0.306

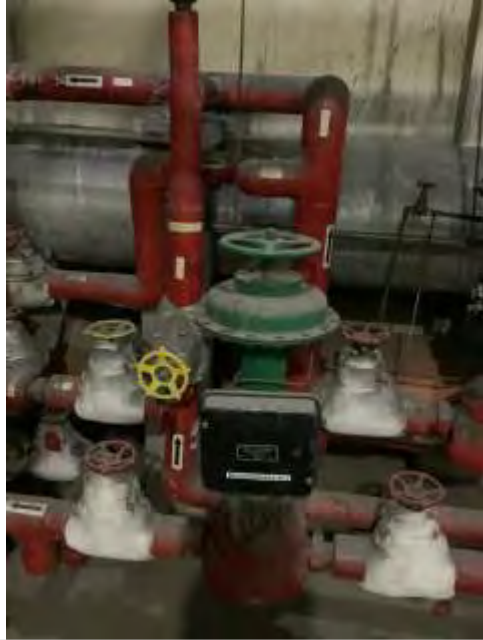
Sample ID:	Sample Type:
4-20-PB-26	PB
Sample Location:	Detailed Sample Location:
Room 23	Green equipment on south side of room.
Sample Quantity:	N/A
Sample Color:	XRF:
Green	0.908

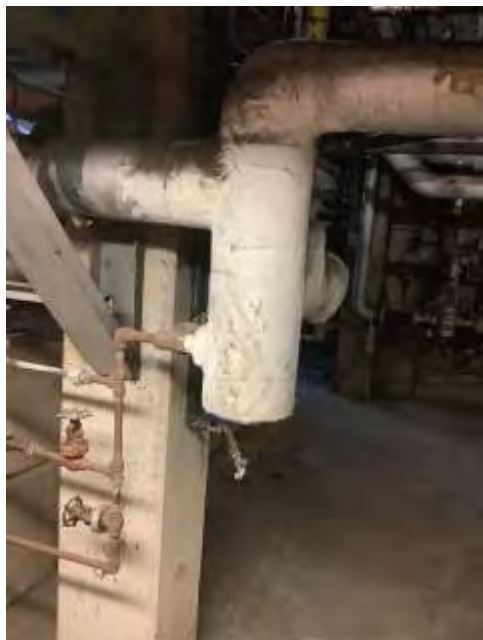
Sample ID:	Sample Type:
4-21-PB-29	PB
Sample Location:	Detailed Sample Location:
Room 11	White pipe wrap on west side of room east of sun basement entrance.
Sample Quantity:	N/A
Sample Color:	XRF:
White	ND

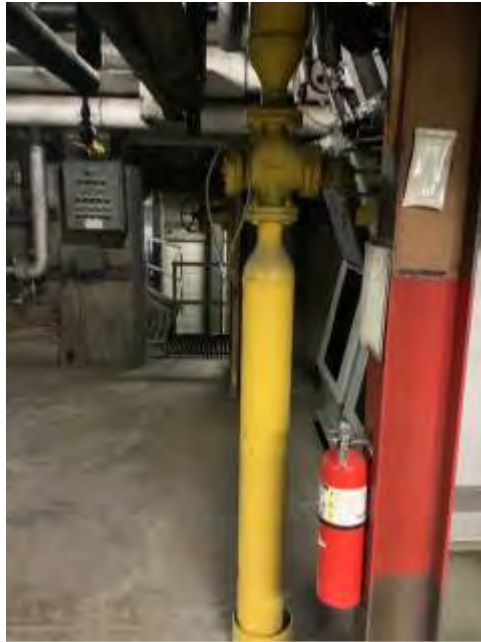
Sample ID:	Sample Type:
4-22-PB-31	PB
Sample Location:	Detailed Sample Location:
Room 11	Yellow pipe on east side of room east of door to sub basement.
Sample Quantity:	140 linear feet.
Sample Color:	XRF:
Yellow	5.00

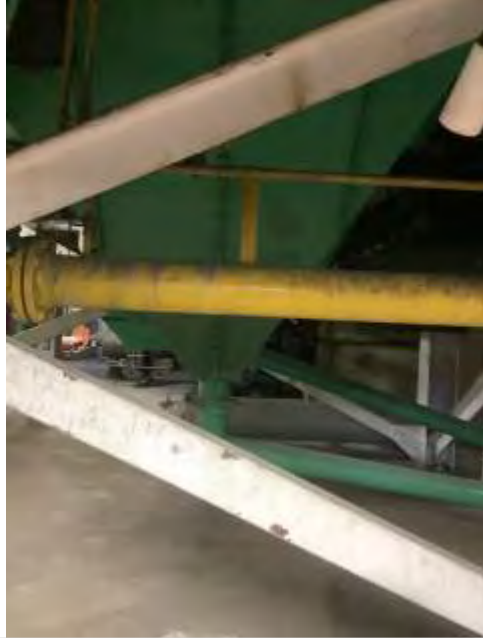
Sample ID:	Sample Type:
4-22-PB-37	PB
Sample Location:	Detailed Sample Location:
Room 11	North side of room north of northwest boiler.
Sample Quantity:	140 linear feet.
Sample Color:	XRF:
Yellow	3.67

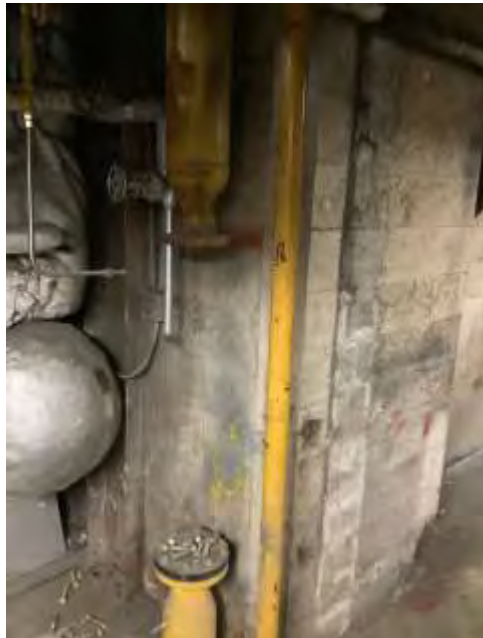
Sample ID:	Sample Type:
4-22-PB-48	PB
Sample Location:	Detailed Sample Location:
Room 11	Center of room east of southwest boiler.
Sample Quantity:	140 linear feet.
Sample Color:	XRF:
Yellow	4.38

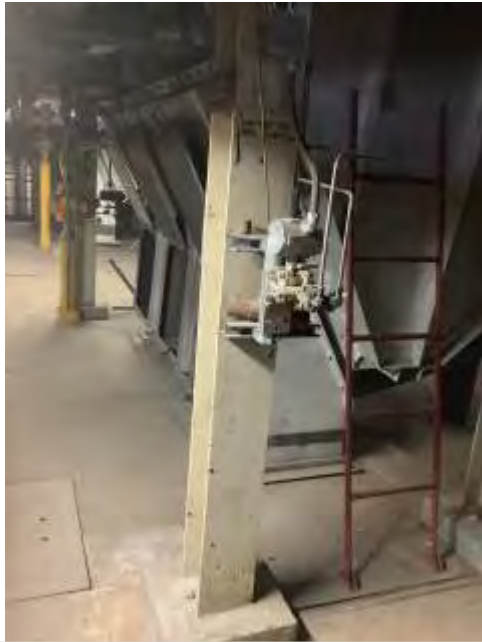
Sample ID:	Sample Type:
4-23-PB-49	PB
Sample Location:	Detailed Sample Location:
Room 11	Support in center of room between the two north boilers.
Sample Quantity:	280 linear feet.
Sample Color:	XRF:
Bright white	5.00

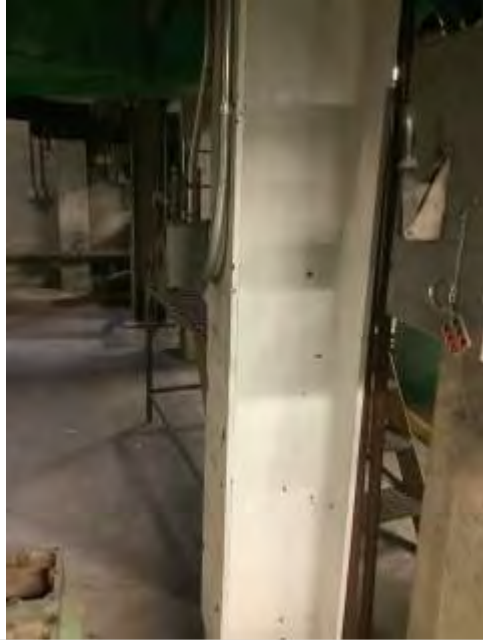
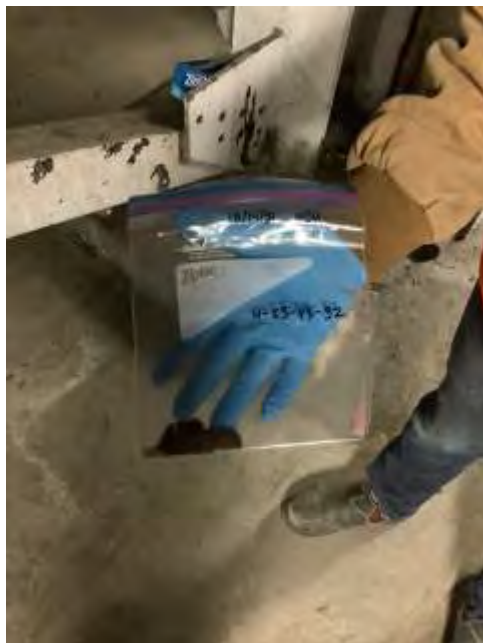
Sample ID:	Sample Type:
4-23-PB-32	PB
Sample Location:	Detailed Sample Location:
Room 11	Support in northwest corner.
Sample Quantity:	264 linear feet.
Sample Color:	XRF:
Bright white	5.00

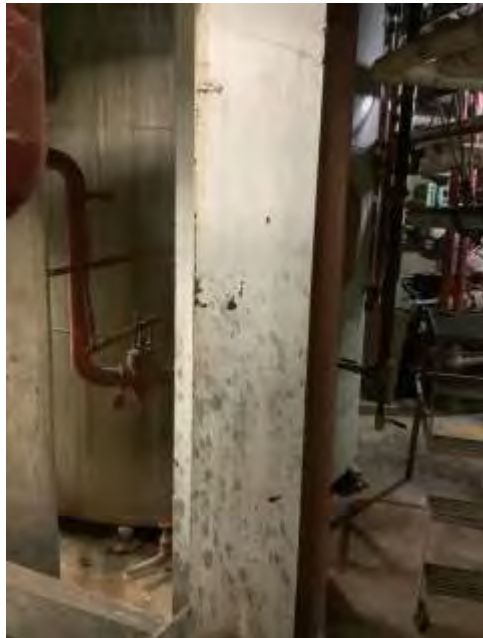
Sample ID:	Sample Type:
4-23-PB-35	PB
Sample Location:	Detailed Sample Location:
Room 11	North side of room south of active tank.
Sample Quantity:	280 linear feet.
Sample Color:	XRF:
White	5.00

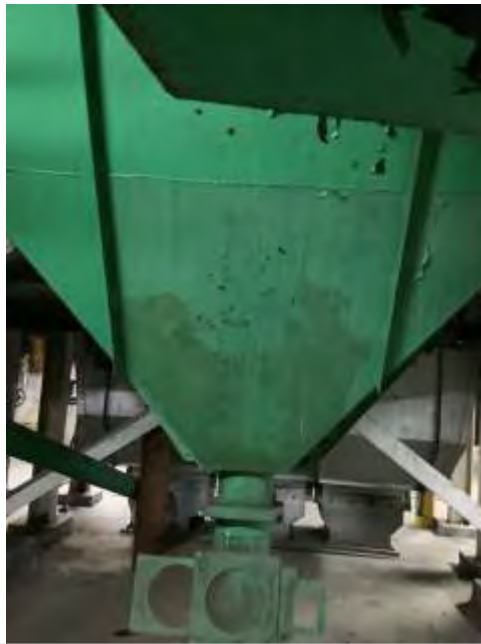
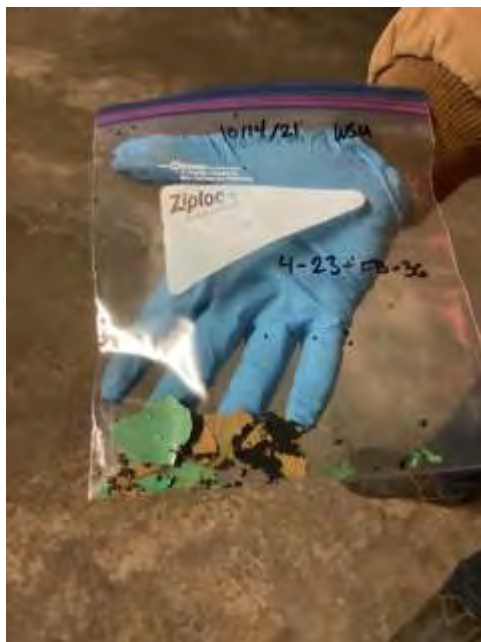
Additional Sample Notes:	
Sample ID:	Sample Type:
4-24-PB-36	PB
Sample Location:	Detailed Sample Location:
Room 11	North side of room north of northwest boiler.
Sample Quantity:	100 linear feet.
Sample Color:	XRF:
Green	0.241

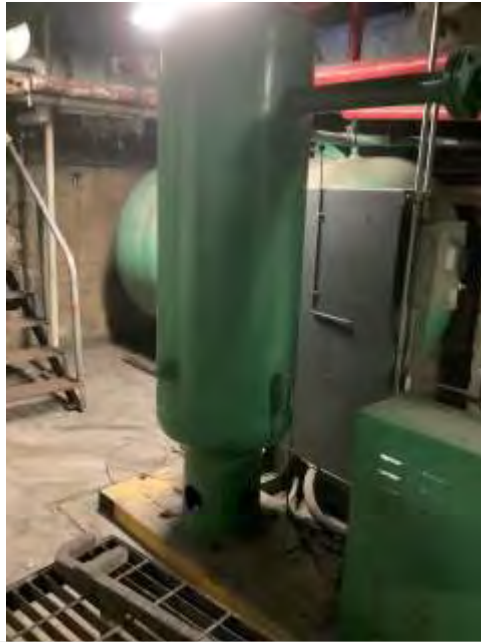
Sample ID:	Sample Type:
4-24-PB-40	PB
Sample Location:	Detailed Sample Location:
Room 11	Northwest corner of room.
Sample Quantity:	100 linear feet.
Sample Color:	XRF:
Green	ND

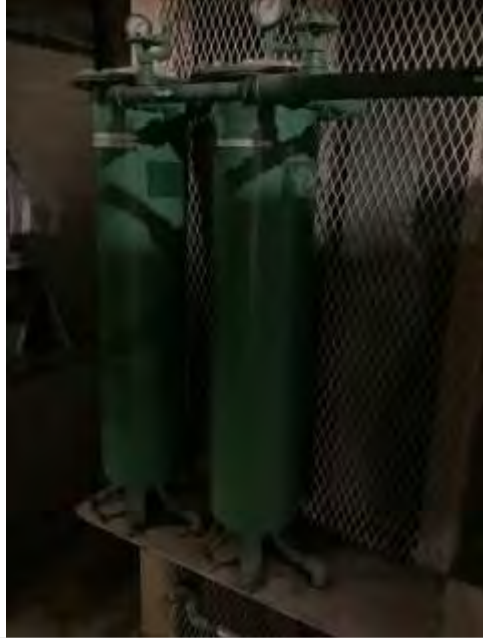
Sample ID:	Sample Type:
4-24-PB-46	PB
Sample Location:	Detailed Sample Location:
Room 11	East side of room east of northeast boiler.
Sample Quantity:	100 linear feet.
Sample Color:	XRF:
Green	1.178

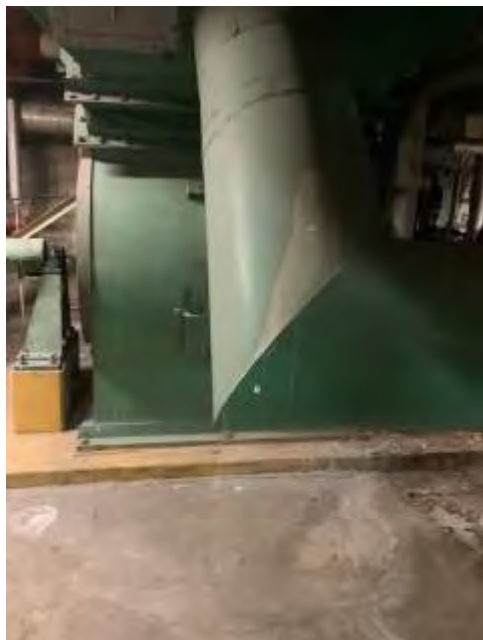
Additional Sample Notes:	Difficult to quantify.
Sample ID:	Sample Type:
4-24-PB-53	PB
Sample Location:	Detailed Sample Location:
Room 11	Green pipe and equipment on south side of room east of entrance to room 21.
Sample Quantity:	100 linear feet.
Sample Color:	XRF:
Green	0.220

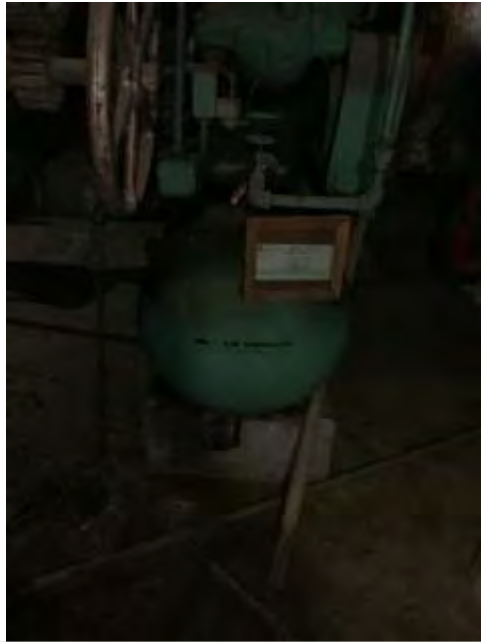
Sample ID:	Sample Type:
4-24-PB-58	PB
Sample Location:	Detailed Sample Location:
Room 11	Southwest corner of room.
Sample Quantity:	100 linear feet.
Sample Color:	XRF:
Green	0.084

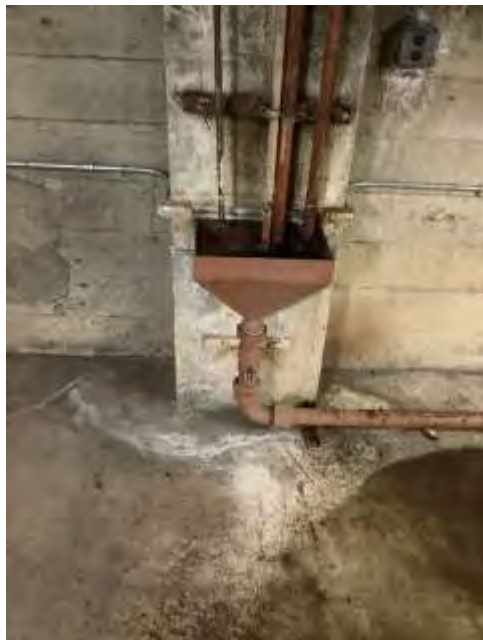
Sample ID:	Sample Type:
4-25-PB-41	PB
Sample Location:	Detailed Sample Location:
Room 11	Drain pipe in northwest corner of room west of active tank.
Sample Quantity:	N/A
Sample Color:	XRF:
Reddish brown	ND

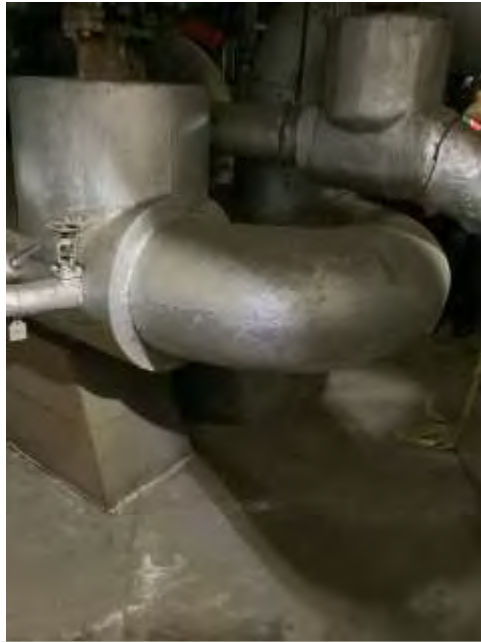
Sample ID:	Sample Type:
4-26-PB-56	PB
Sample Location:	Detailed Sample Location:
Room 11	Silver pipe wrap southeast corner of room.
Sample Quantity:	N/A
Sample Color:	XRF:
Silver	ND

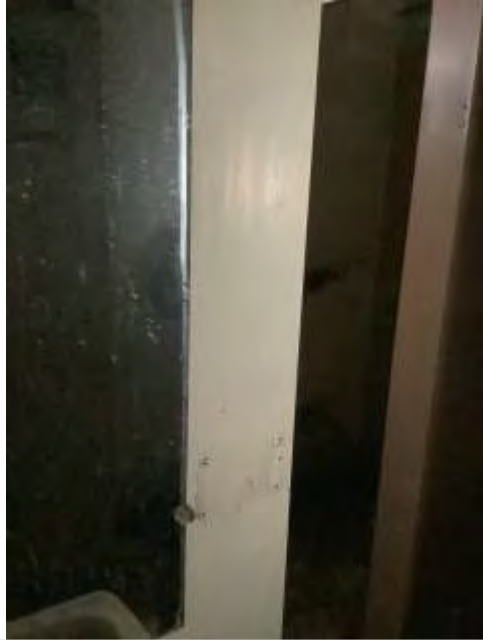
Sample ID:	Sample Type:
4-27-PB-62	PB
Sample Location:	Detailed Sample Location:
Room 15	East side of center wall of room next to mirror.
Sample Quantity:	N/A
Sample Color:	XRF:
Tan	0.008

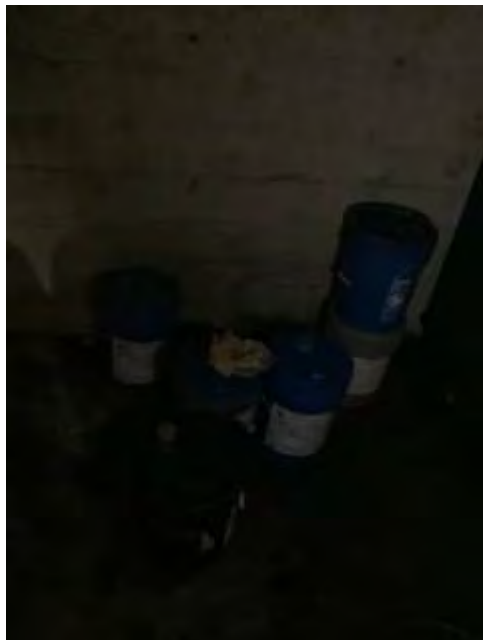
General Fixture Location:	Detailed Fixture Location:
Room 15	Throughout room.
Type of Fixture:	Quantity:
Mechanical fluid hazard.	Throughout room.
Condition:	Additional Fixture Notes:
Good	Mechanical fluid containers throughout room.

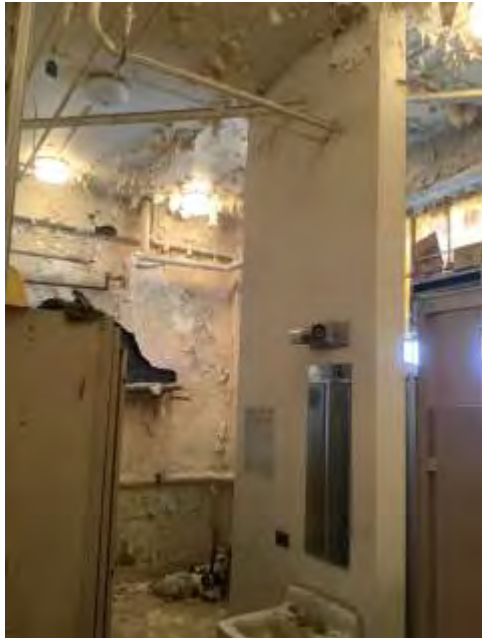
General Fixture Location:	Detailed Fixture Location:
Room 17	Throughout room.
Type of Fixture:	Quantity:
Potential lead paint hazard.	Throughout room.
Condition:	Additional Fixture Notes:
Severely damaged	Paint peeling off walls and ceiling.

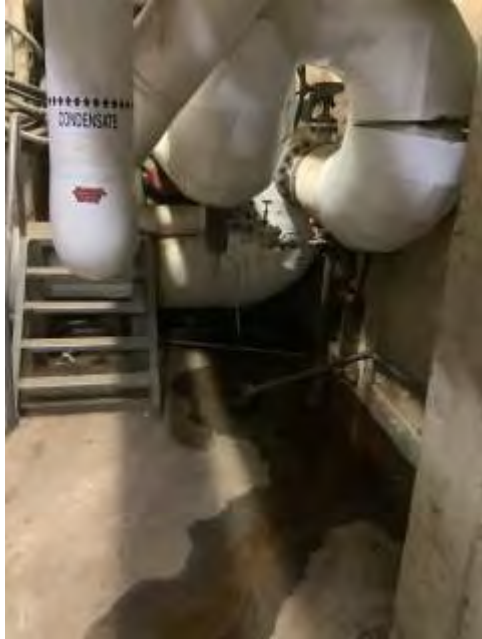
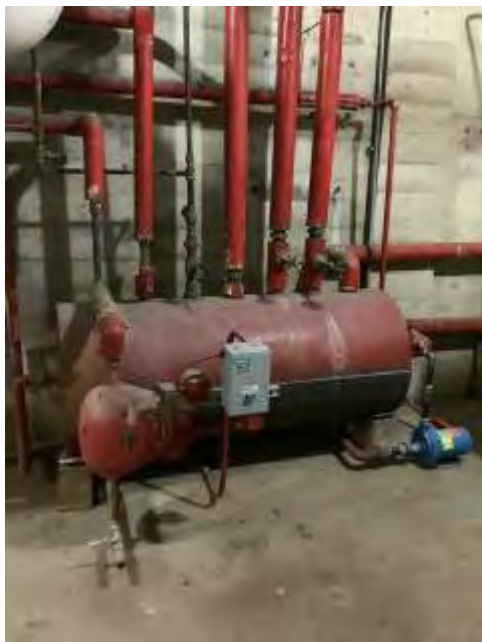
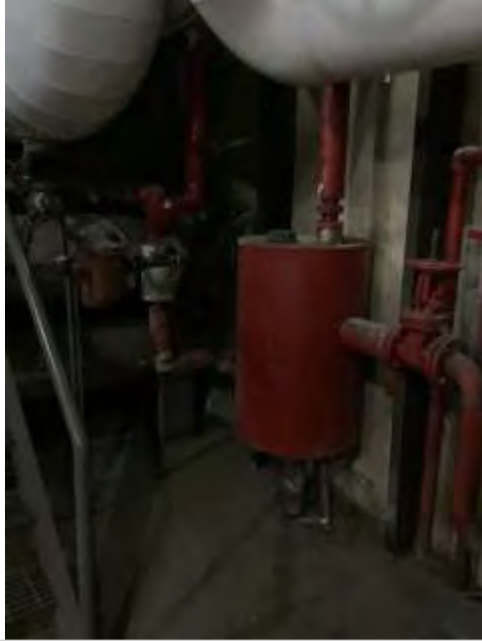
General Fixture Location:	Detailed Fixture Location:
Room 21 and room 23	Throughout rooms.
Type of Fixture:	Quantity:
Hot pipes and tanks.	Several
Condition:	Additional Fixture Notes:
Good	Burn hazard from hot pipes and tanks.

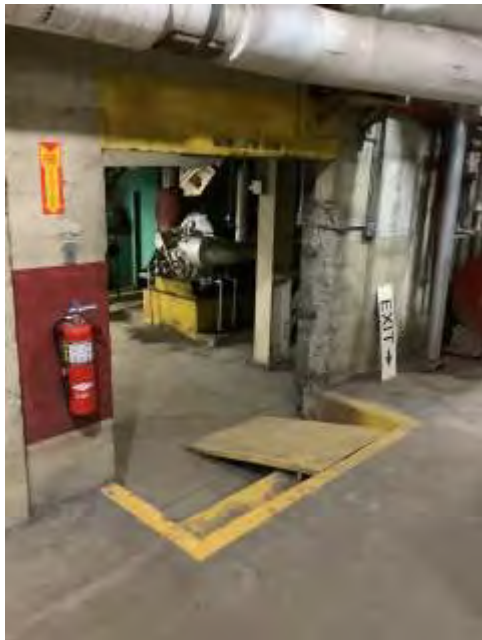
General Fixture Location:	Detailed Fixture Location:
Room 21	North wall.
Type of Fixture:	Quantity:
Low clearance.	1
Condition:	Additional Fixture Notes:
Good	Low ceiling hazard.

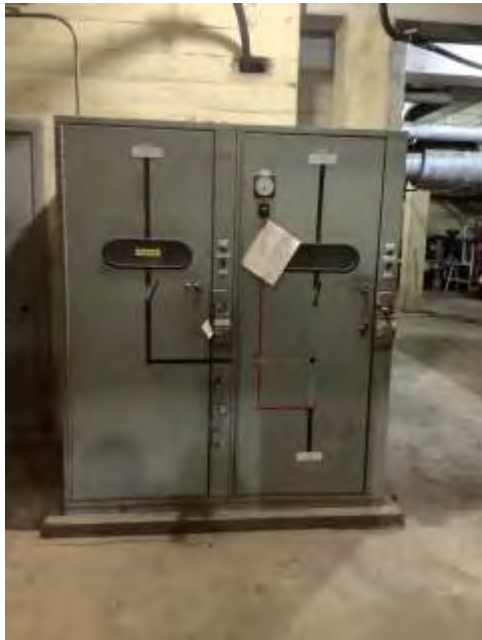
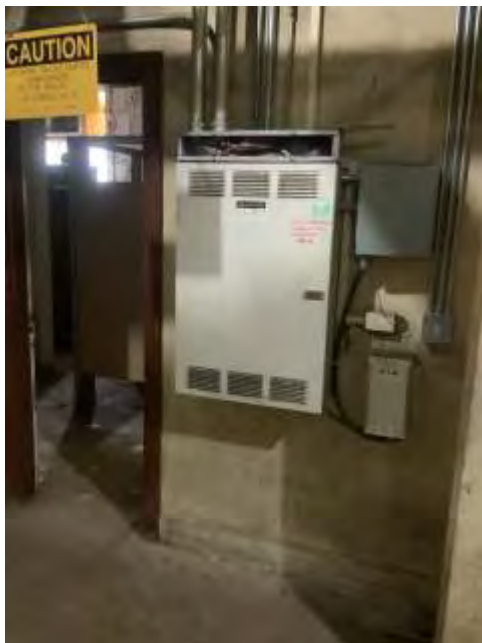
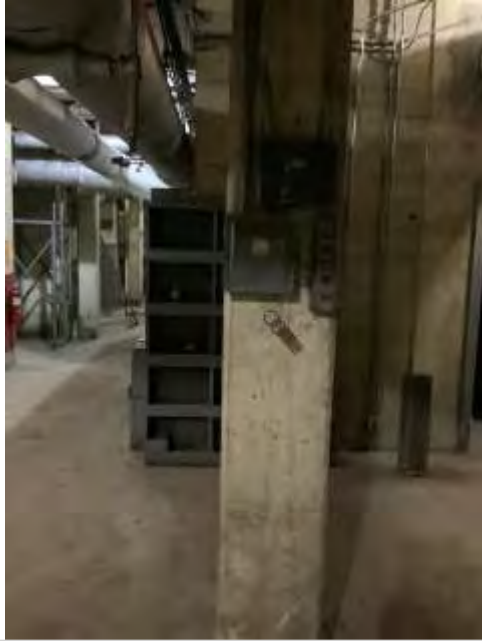
General Fixture Location:	Detailed Fixture Location:
Room 21	Throughout room.
Type of Fixture:	Quantity:
Electrical hazard.	3
Condition:	Additional Fixture Notes:
Good	1 electric source control unit, 1 electrical control panel, 1 electrical switch box.

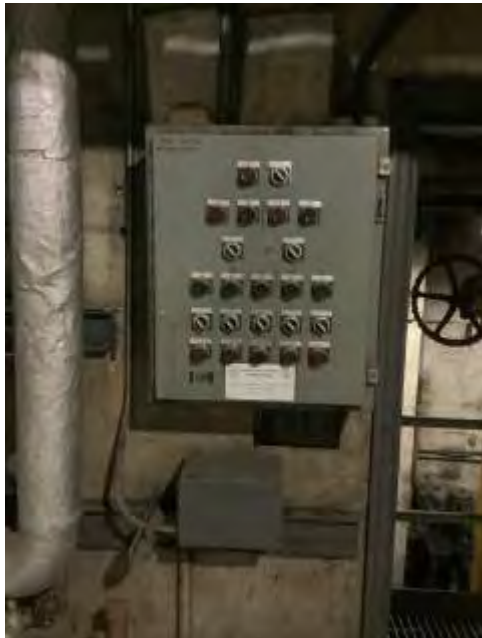
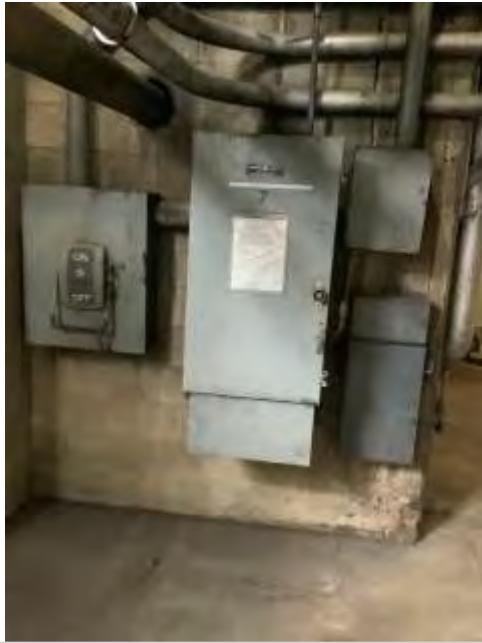
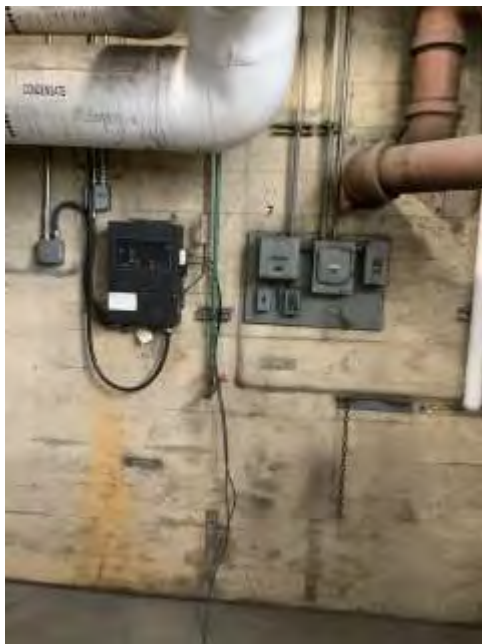
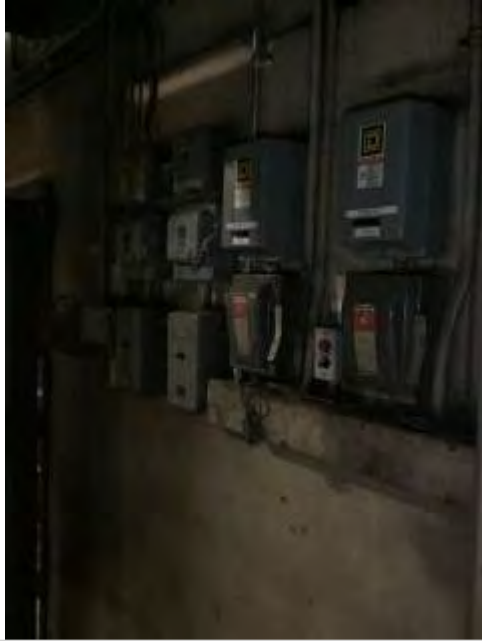
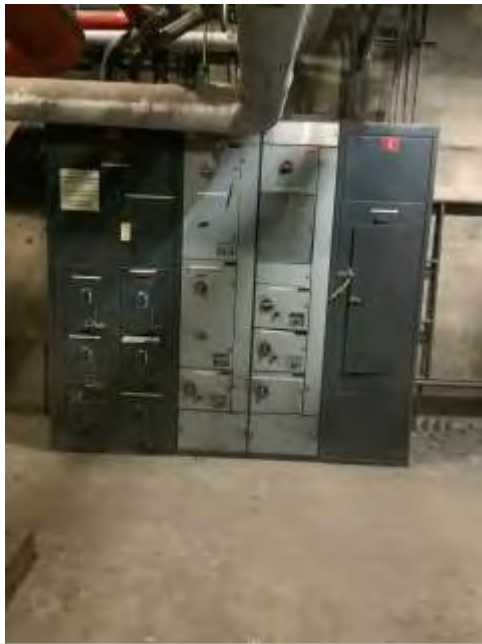
General Fixture Location:	Detailed Fixture Location:
Room 11	Throughout room.
Type of Fixture:	Quantity:
Electrical fixtures.	25
Condition:	Additional Fixture Notes:
Good	1 control box, 20 control switch, 3 electrical boxes, 1 motor control center.

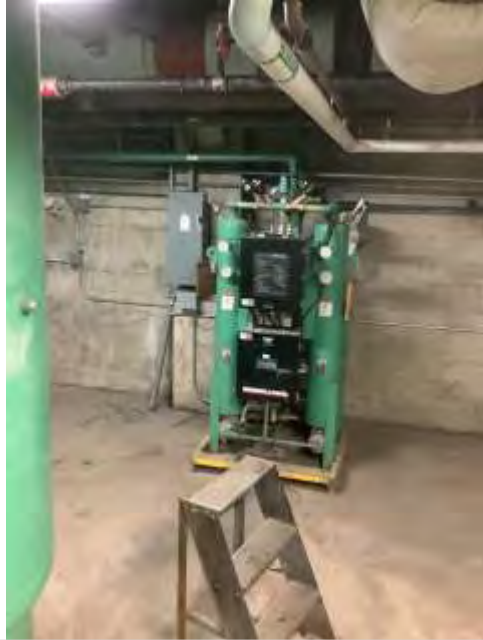
General Fixture Location:	Detailed Fixture Location:
Room 11	North side of room.
Type of Fixture:	Quantity:
Active steam equipment.	Several
Condition:	Additional Fixture Notes:
Good	Active tanks, pumps, and lines.

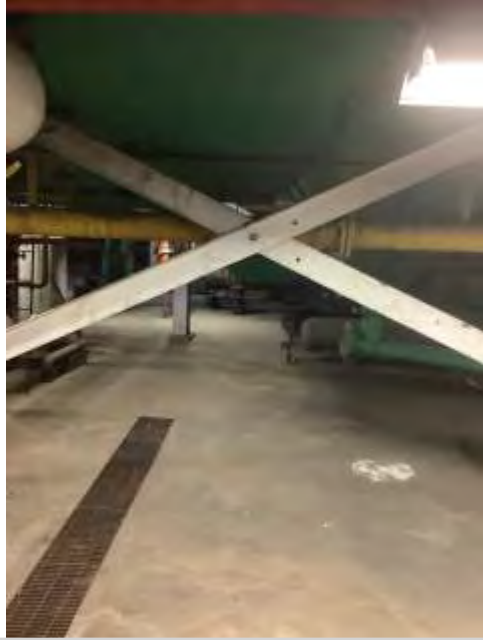
General Fixture Location:	Detailed Fixture Location:
Room 11	Throughout room.
Type of Fixture:	Quantity:
Low clearance.	Several
Condition:	Additional Fixture Notes:
Good	Low pipes and supports.

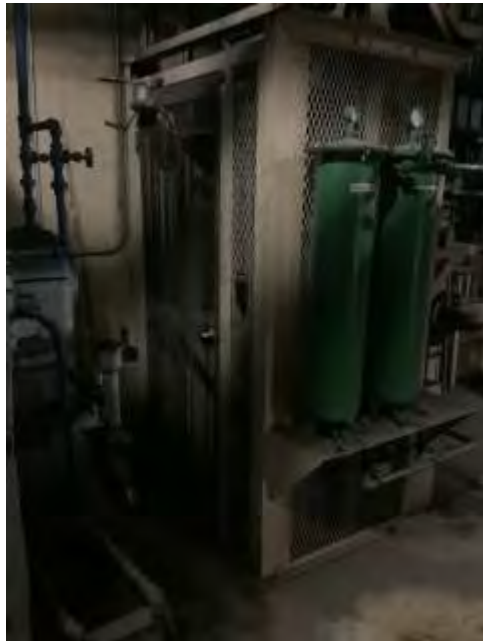
General Fixture Location:	Detailed Fixture Location:
Room 11	East side of room.
Type of Fixture:	Quantity:
Elevator shaft.	1
Condition:	Additional Fixture Notes:
Good	Potential hazard related to mechanical operation.

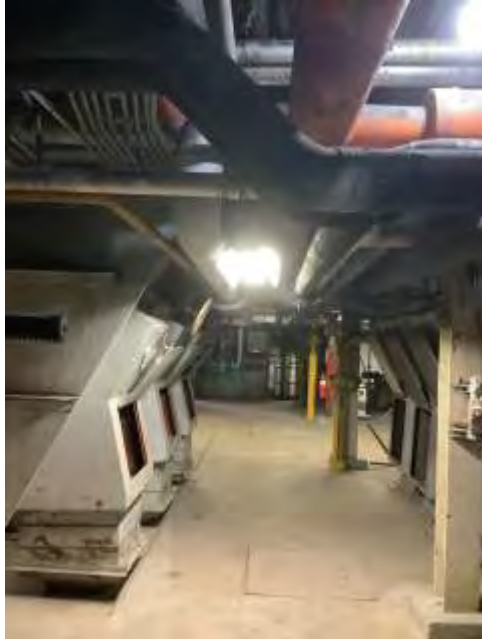
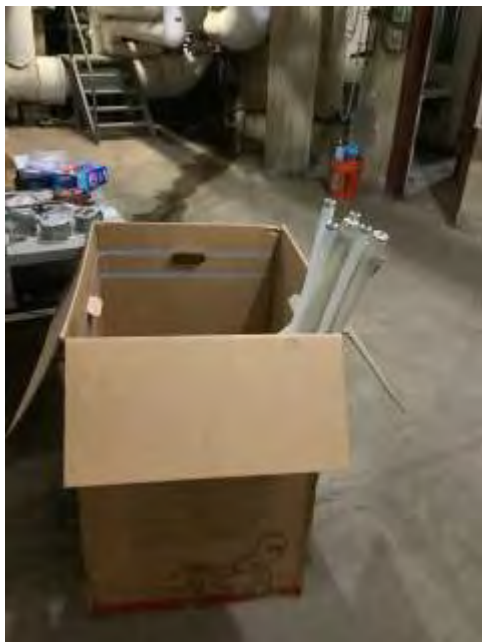
General Fixture Location:	Detailed Fixture Location:
Room 11, 21, 23	Throughout rooms.
Type of Fixture:	Quantity:
Fluorescent light fixtures.	43
Condition:	Additional Fixture Notes:
Good	34 lights in place and active, 9 in box in room 21.

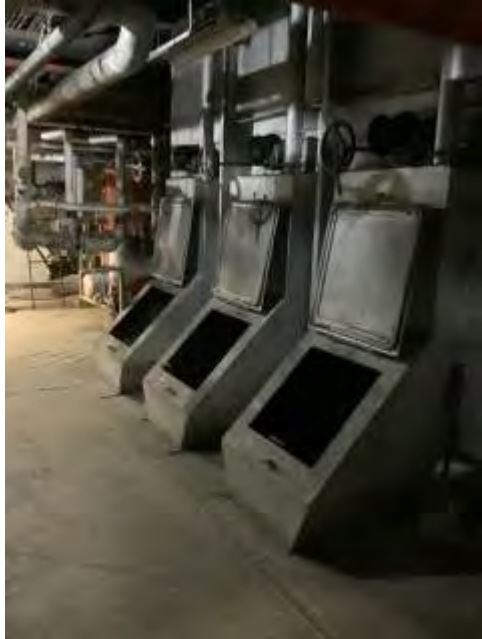
General Fixture Location:	Detailed Fixture Location:
Room 11	Throughout room.
Type of Fixture:	Quantity:
Steam equipment.	Several
Condition:	Additional Fixture Notes:
Good	Mechanical fluid hazard related to inactive and active equipment.

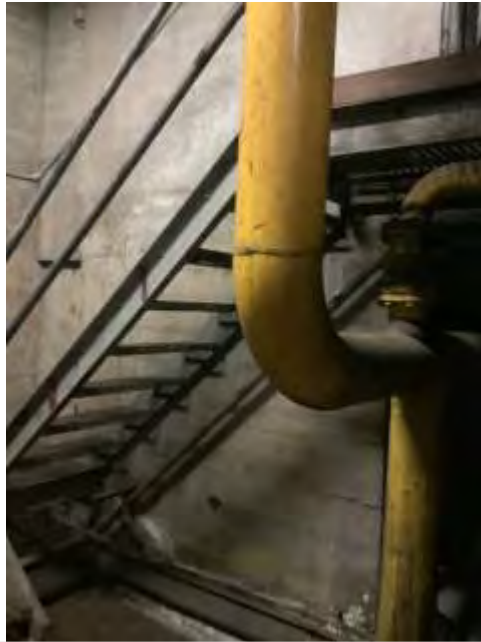
Sample ID:	Sample Type:
5-1-PB-1	PB
Sample Location:	Detailed Sample Location:
Room B1	West hall entrance.
Sample Quantity:	110 linear feet.
Sample Color:	XRF:
Yellow	0.023

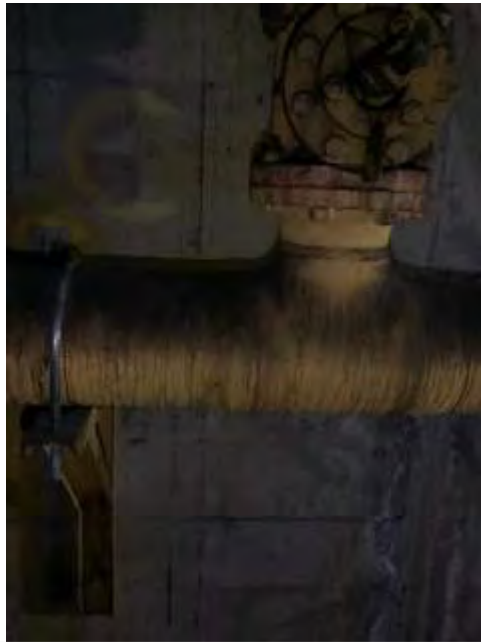
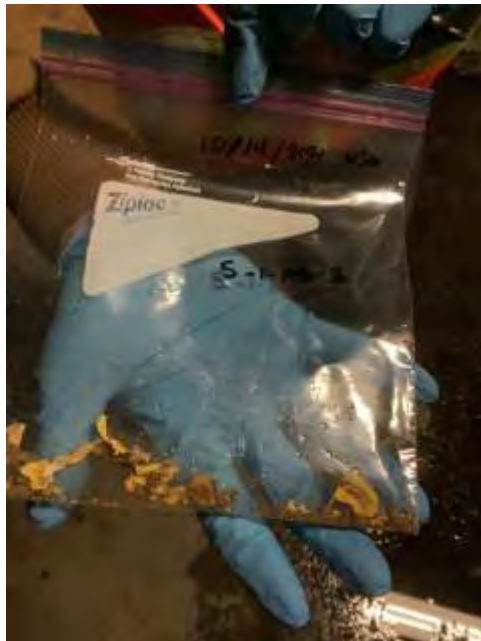
Sample ID:	Sample Type:
5-1-PB-2	PB
Sample Location:	Detailed Sample Location:
Room B1	Center of hallway.
Sample Quantity:	110 linear feet.
Sample Color:	XRF:
Yellow	ND

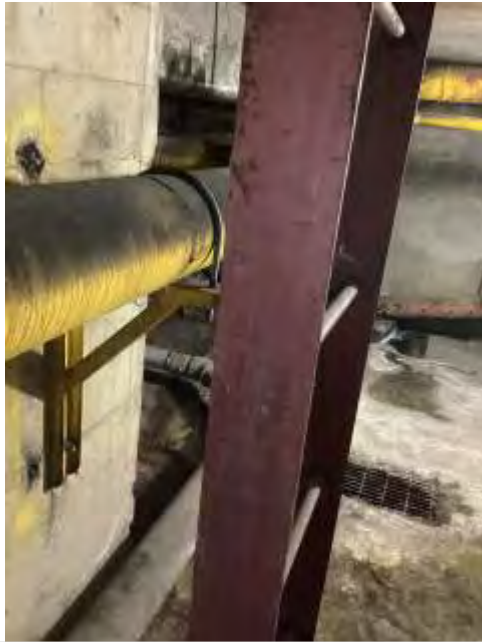
Sample ID:	Sample Type:
5-3-PB-6	PB
Sample Location:	Detailed Sample Location:
Room B1	East end in the center of hall.
Sample Quantity:	N/A
Sample Color:	XRF:
Brown	ND

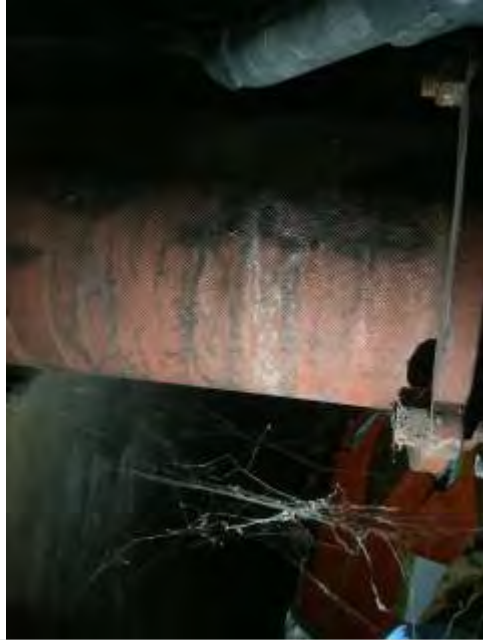
Sample ID:	Sample Type:
5-4-PB-7	PB
Sample Location:	Detailed Sample Location:
Room B1	Center of hallway.
Sample Quantity:	N/A
Sample Color:	XRF:
Reddish brown	ND

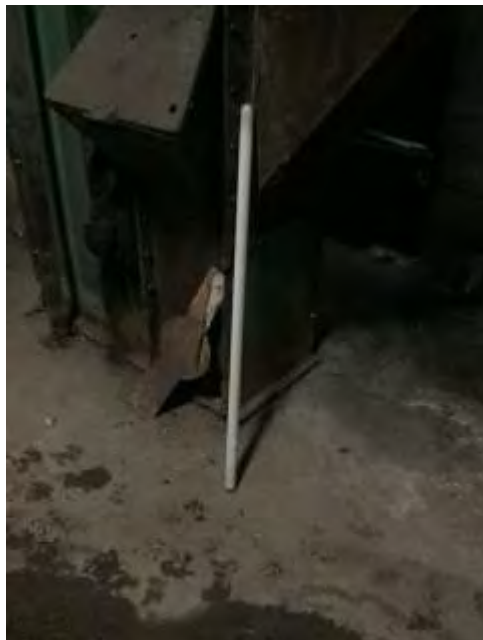
General Fixture Location:	Detailed Fixture Location:
Room B1	Southeast corner of room.
Type of Fixture:	Quantity:
Fluorescent bulbs.	3
Condition:	Additional Fixture Notes:
Good

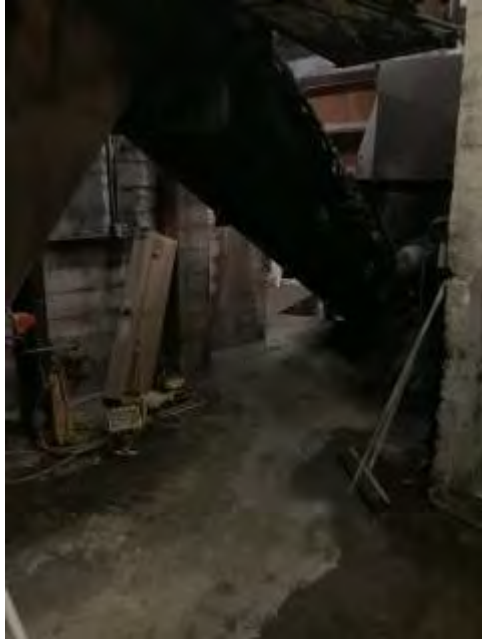
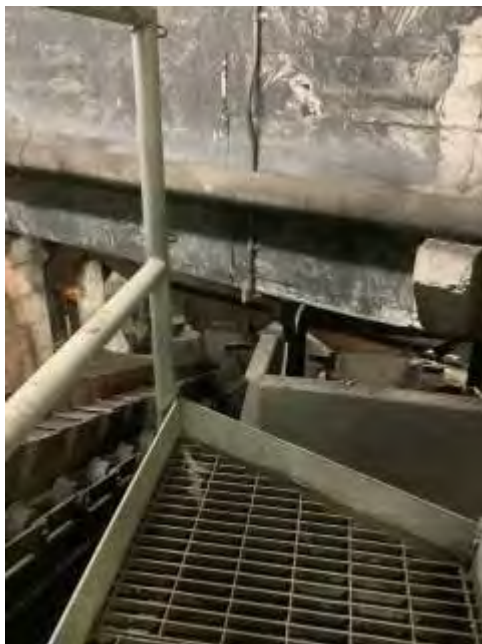
General Fixture Location:	Detailed Fixture Location:
Room B2	Whole room.
Type of Fixture:	Quantity:
Confined space.	1
Condition:	Additional Fixture Notes:
Good	Confined space hazard in room B2.

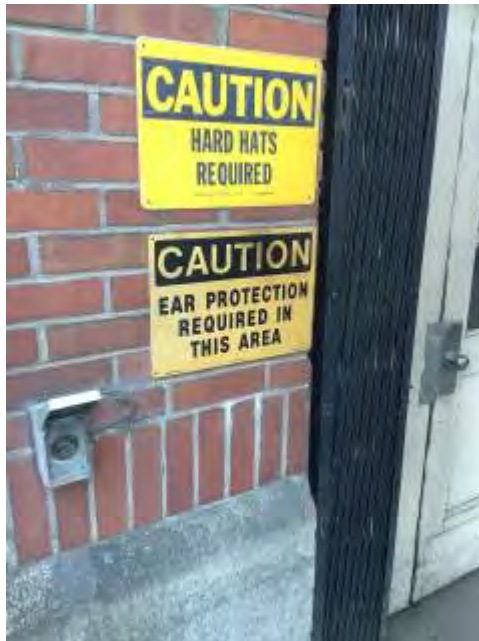
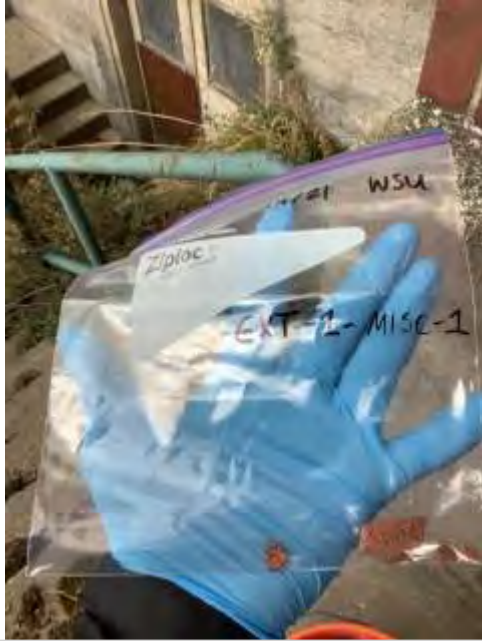
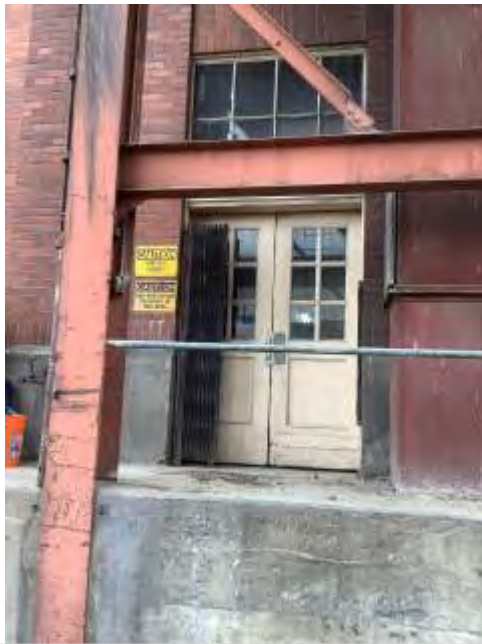
Sample ID:	Sample Type:	
EXT-1-MISC-1	MISC	
Sample Location:	Detailed Sample Location:	
West exterior side of structure.	West exterior side of room 101 north of double doors next to ash pit tower.	
Sample Quantity:	15,000 square feet.	
Misc Sample Material:	Sample Condition:	Sample Friable?:
Red brick	Potential ACBM with potential for damage; Remaining friable ACBM or friable suspected ACBM	No

Additional Sample Notes:	Difficult to quantify material.
---------------------------------	---------------------------------

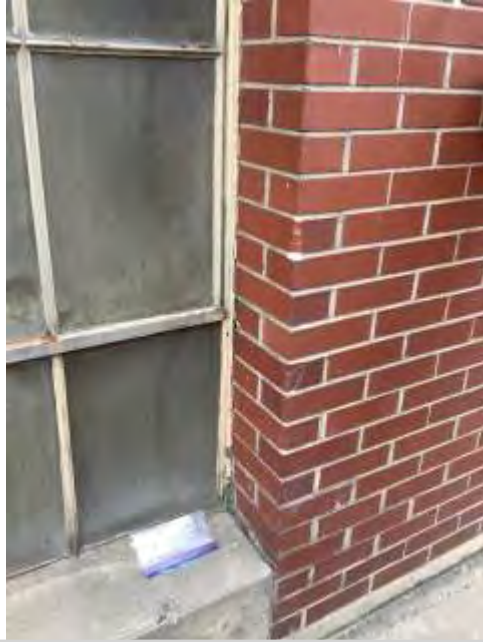
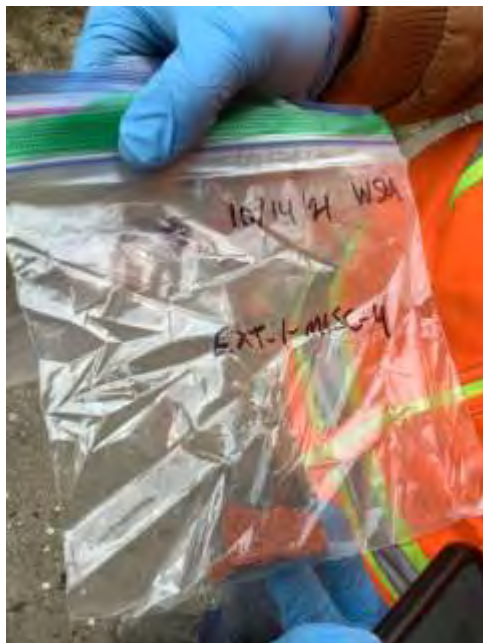
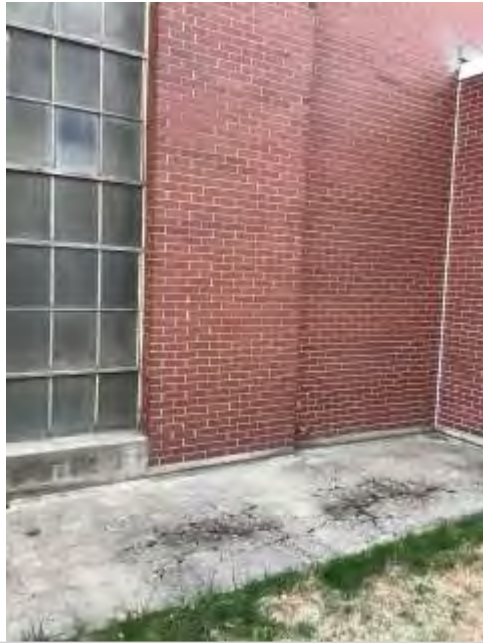
EXT-1-MISC-4

Red brick	Potential ACBM with potential for damage	No
-----------	--	----

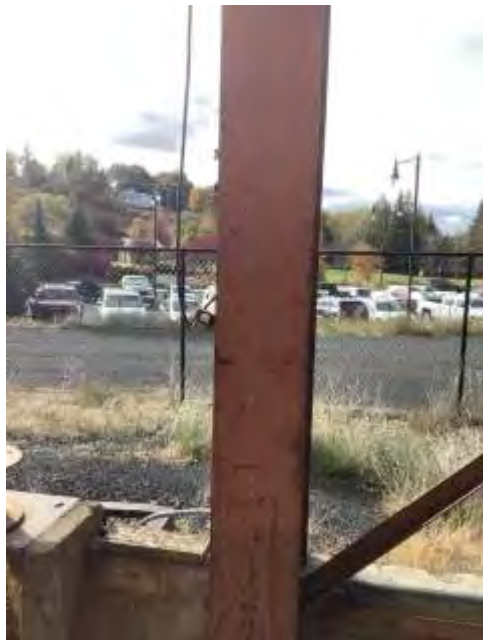
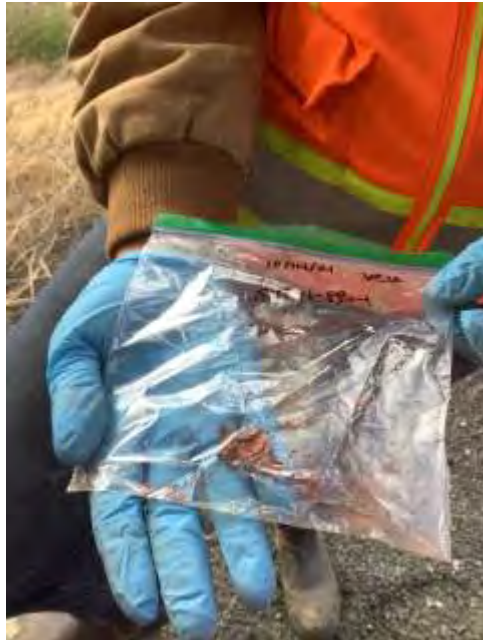
EXT-1-PB-1

Brownish red	1.47
--------------	------

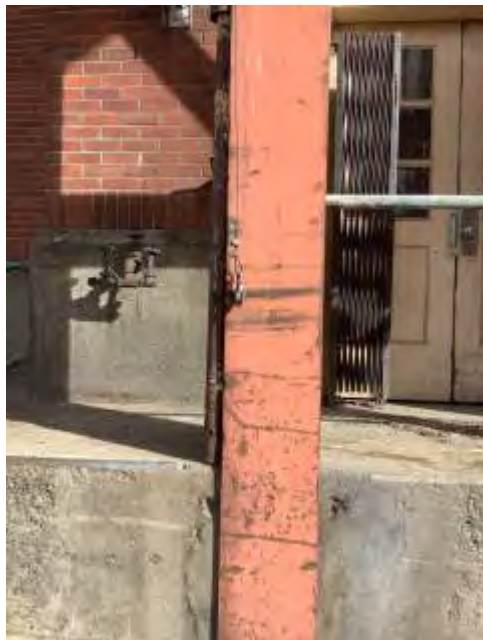
Additional Sample Notes:	Submitted sample to laboratory for analysis.
Sample ID:	Sample Type:
EXT-1-PB-2	PB
Sample Location:	Detailed Sample Location:
West exterior support beams.	Northeast support beam of ash pit outside of room 101.
Sample Quantity:	272 linear feet.
Sample Color:	XRF:
Brownish red	1.15
