COLLEGE AVENUE STEAM PLANT ADAPTIVE REUSE

Integrated Cleanup and Implementation Plan

Port of
Whitman
County

PORT OF WHITMAN COUNTY
March 30, 2020

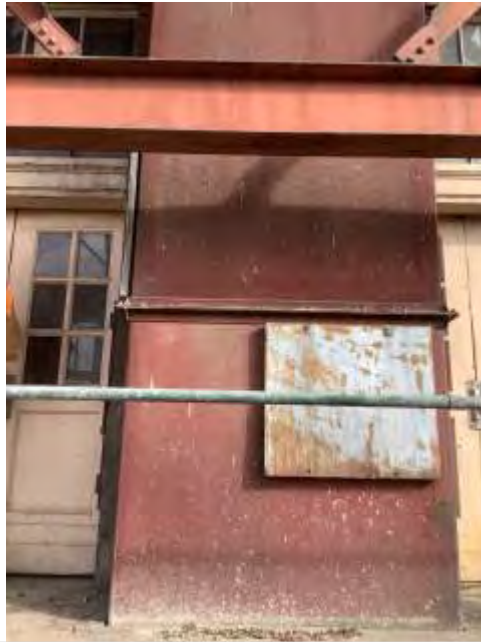
Sample ID:	Sample Type:
EXT-2-PB-3	PB
Sample Location:	Detailed Sample Location:
West exterior side of room 101.	Vent on west exterior side of room 101 in between double doors.
Sample Quantity:	N/A
Sample Color:	XRF:
Dark brown red	0.120

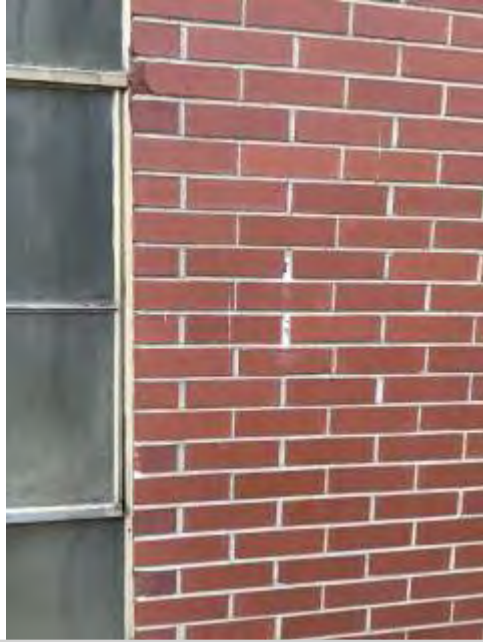
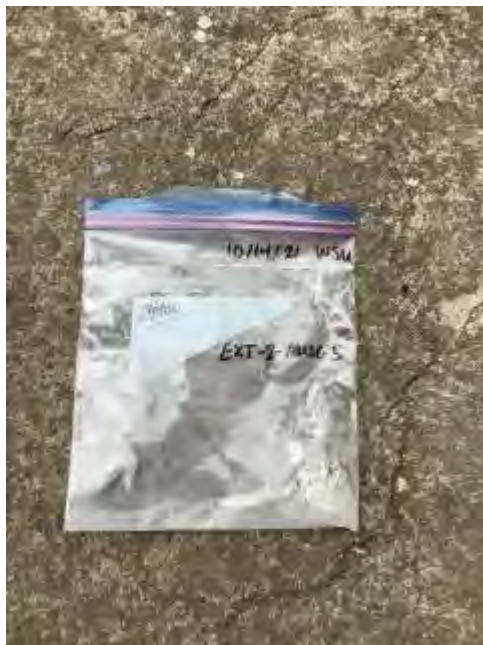
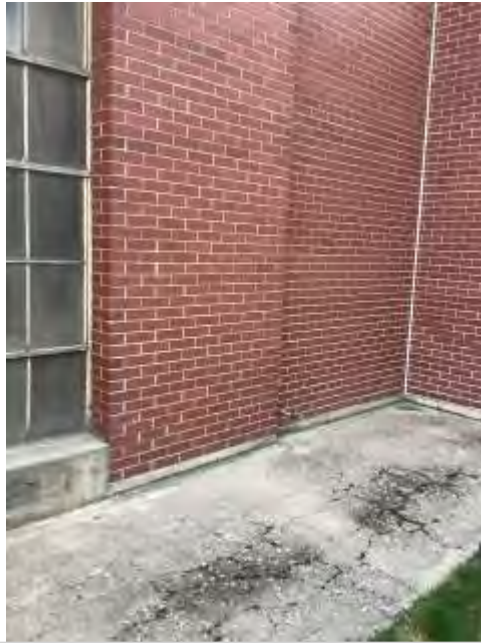
Sample ID:	Sample Type:	
EXT-2-MISC-5	MISC	
Sample Location:	Detailed Sample Location:	
East exterior side of structure.	East exterior side of room 101 south of stairwell exit door and north of windows.	
Sample Quantity:	75,000 linear feet.	
Misc Sample Material:	Sample Condition:	Sample Friable?:
Gray brick mortar	Potential ACBM with potential for damage	No

Additional Sample Notes:		Difficult to quantify material.
Sample ID:		Sample Type:
EXT-2-MISC-2		MISC
Sample Location:		Detailed Sample Location:
West exterior side of structure.		West exterior side of room 101 north of double doors next to ash pit tower.
Sample Quantity:		75,000 linear feet.
Misc Sample Material:		Sample Condition:
Gray brick mortar		Potential ACBM with potential for damage
		Sample Friable?:
		No

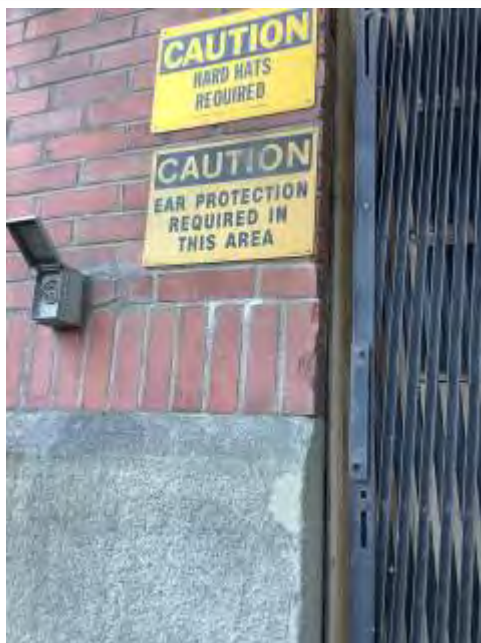
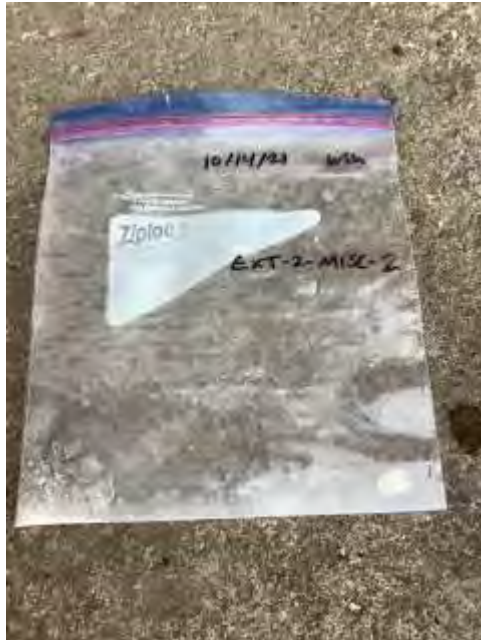
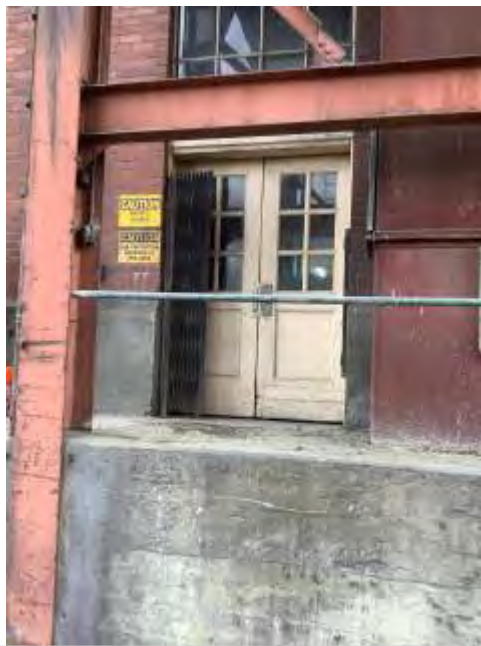
EXT-2-MISC-2

Additional Sample Notes:	Difficult to quantify material.
---------------------------------	---------------------------------

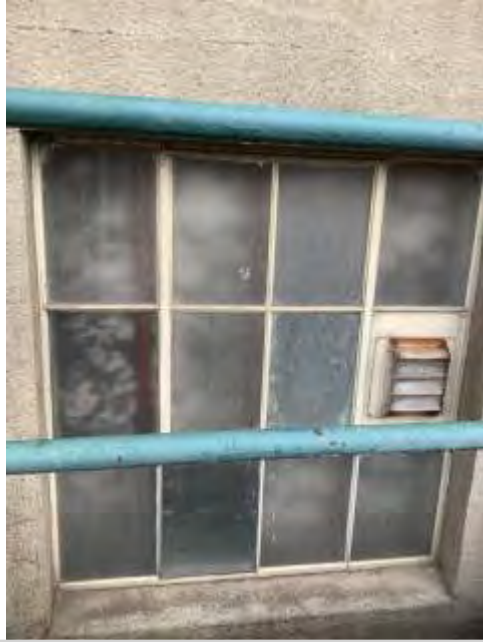
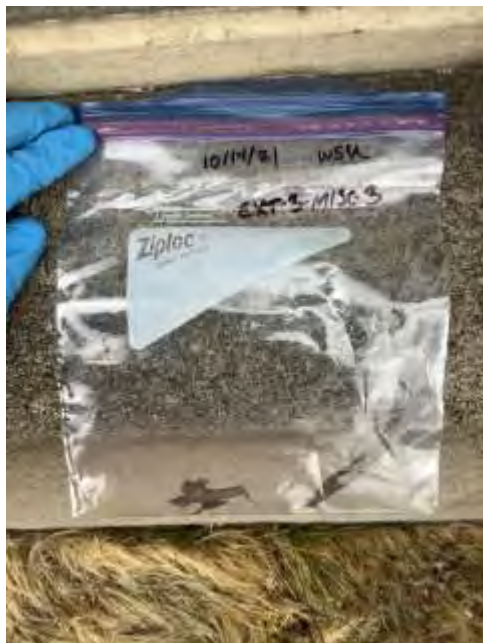
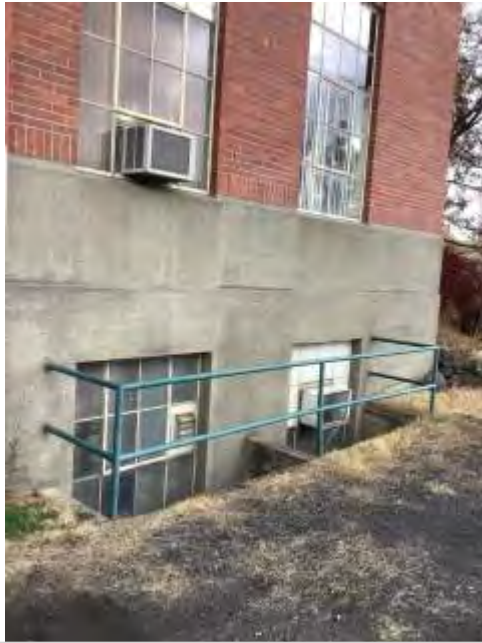
EXT-3-MISC-3

Window glazing.	Potential ACBM with potential for damage	No
-----------------	--	----

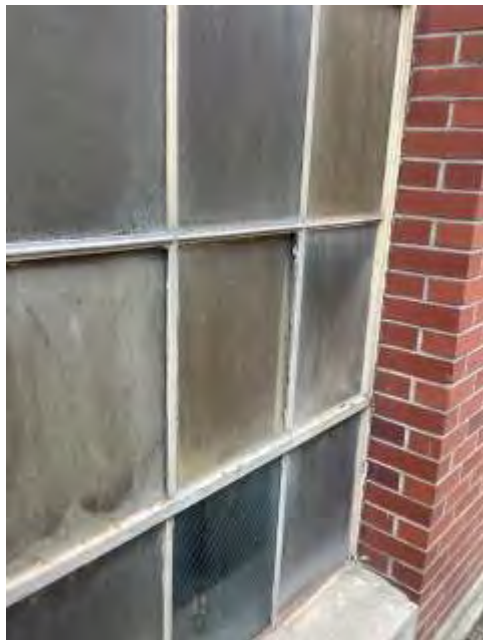
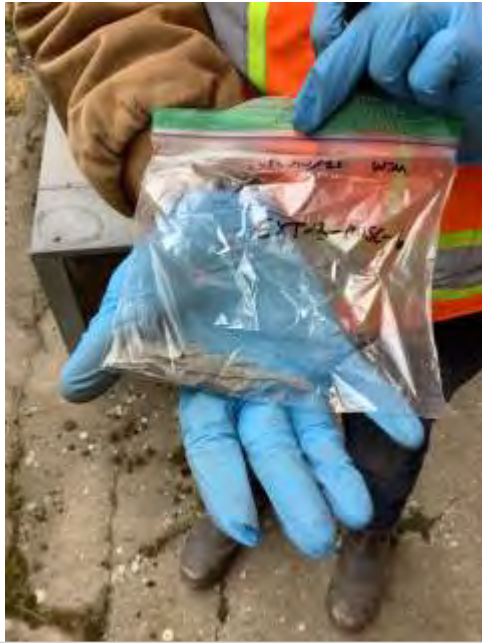
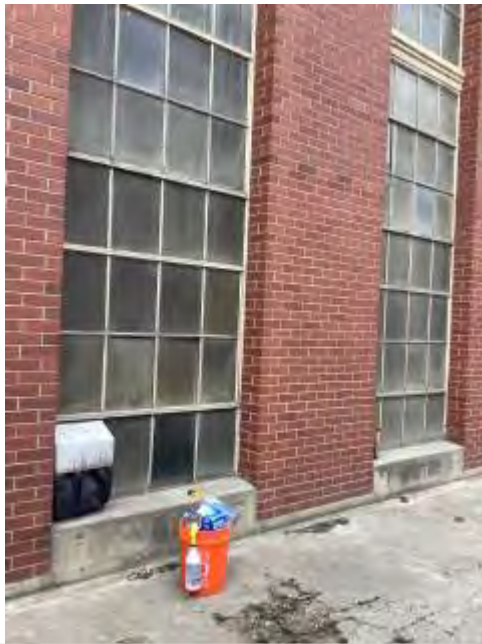
Sample ID:	Sample Type:	
EXT-3-MISC-6	MISC	
Sample Location:	Detailed Sample Location:	
East exterior side of structure.	South window on exterior east wall of room 101.	
Sample Quantity:	4,030 linear feet.	
Misc Sample Material:	Sample Condition:	Sample Friable?:
Window glazing	Potential ACBM with potential for damage	No

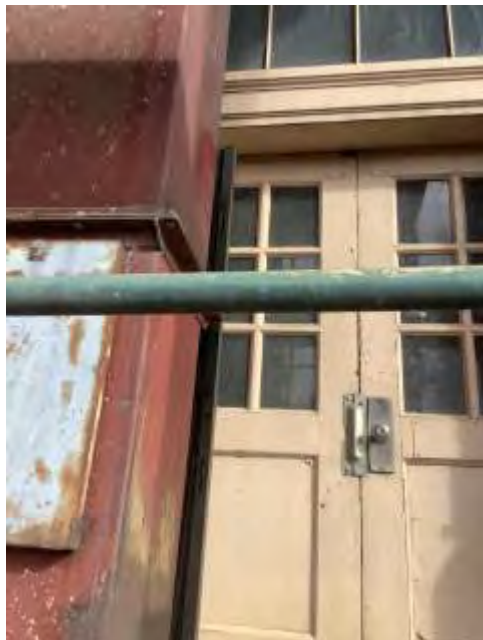
Additional Sample Notes:	
Sample ID:	Sample Type:
EXT-4-PB-5	PB
Sample Location:	Detailed Sample Location:
West exterior side of room 101.	Railing on west exterior side of room 101 in front of double doors.
Sample Quantity:	N/A
Sample Color:	XRF:
Green	0.173

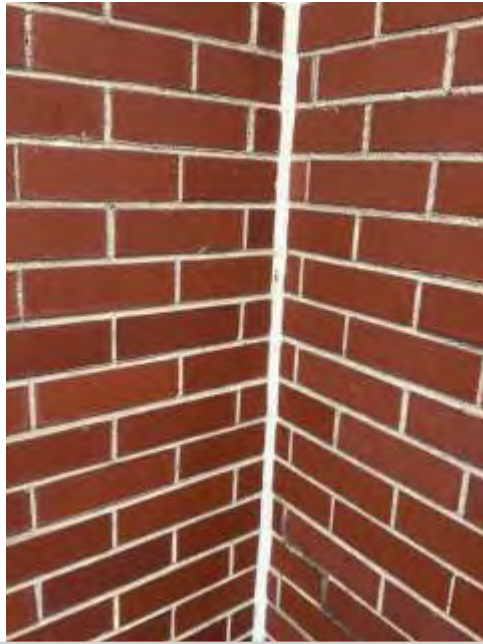
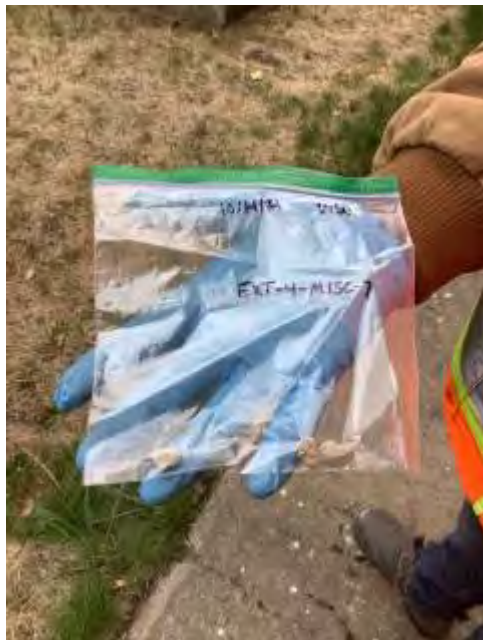
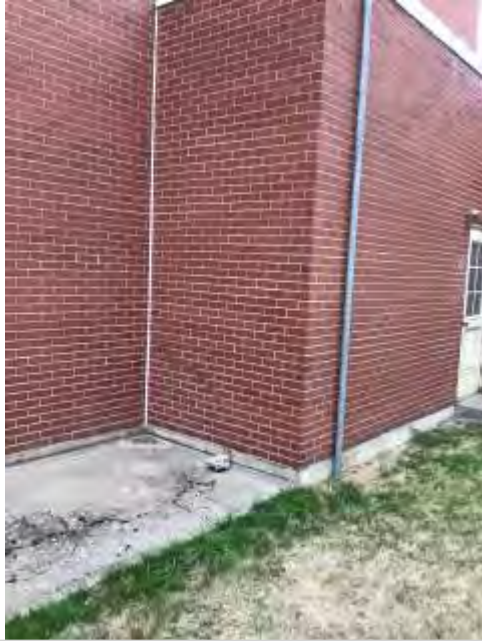
Additional Sample Notes:		
Sample ID:	Sample Type:	
EXT-4-MISC-7	MISC	
Sample Location:	Detailed Sample Location:	
East exterior side of structure.	North corner of east exterior wall of room 101 south of stairwell exit.	
Sample Quantity:	37 linear feet.	
Misc Sample Material:	Sample Condition:	Sample Friable?:
White brick caulking.	Potential ACBM with potential for damage	No

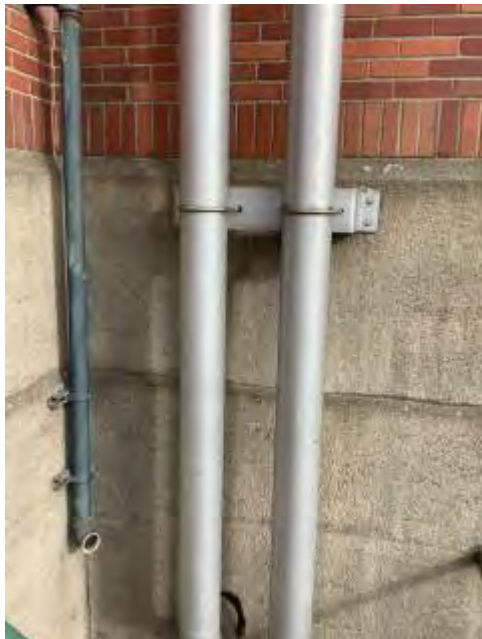
Additional Sample Notes:	
Sample ID:	Sample Type:
EXT-5-PB-6	PB
Sample Location:	Detailed Sample Location:
West exterior side of room 101.	Silver pipe on west exterior side of room 101 and south of double doors.
Sample Quantity:	25 linear feet.
Sample Color:	XRF:
Silver	1.213

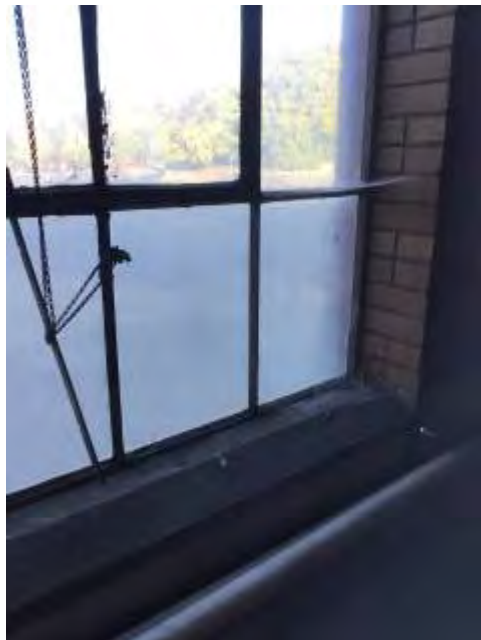
Sample ID:	Sample Type:	
1-3-MISC-5	MISC	
Sample Location:	Detailed Sample Location:	
Room 101	Window at west wall.	
Sample Quantity:	4,030 linear feet.	
Misc Sample Material:	Sample Condition:	Sample Friable?:
Window glazing.	Potential ACBM with potential for damage	Yes

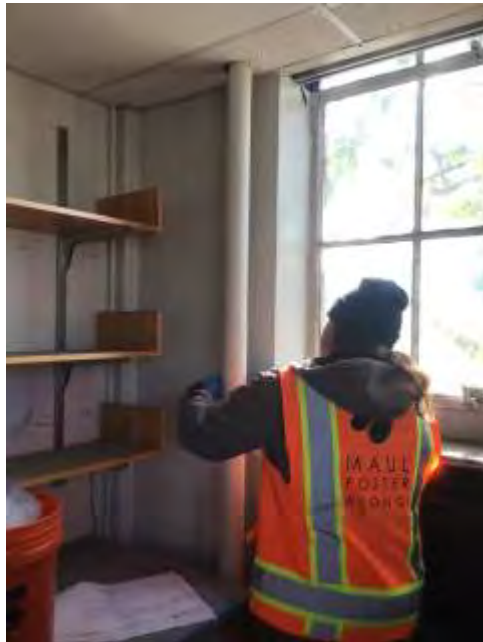
Sample ID:	Sample Type:	
1-8-TSI-32	TSI	
Sample Location:	Detailed Sample Location:	
Room 104	Southeast corner of room on white pipe.	
Sample Quantity:	3,000 linear feet.	
Sample Color:	XRF:	
Misc Sample Material:	Sample Condition:	Sample Friable?:
	Damaged or significantly damaged	Yes

Additional Sample Notes:	White pipe wrap with yellow insulation.
---------------------------------	---

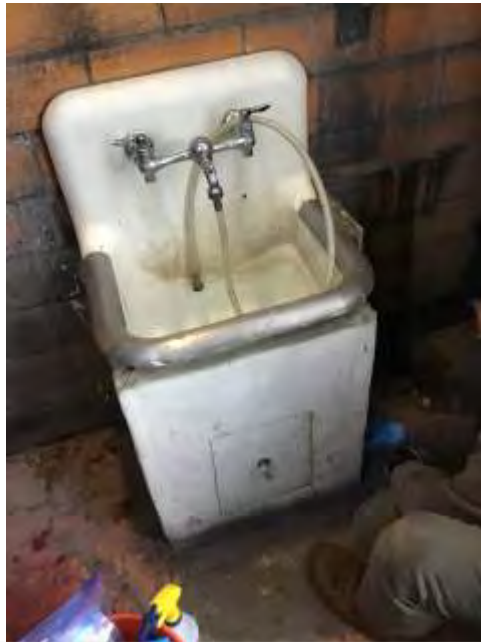
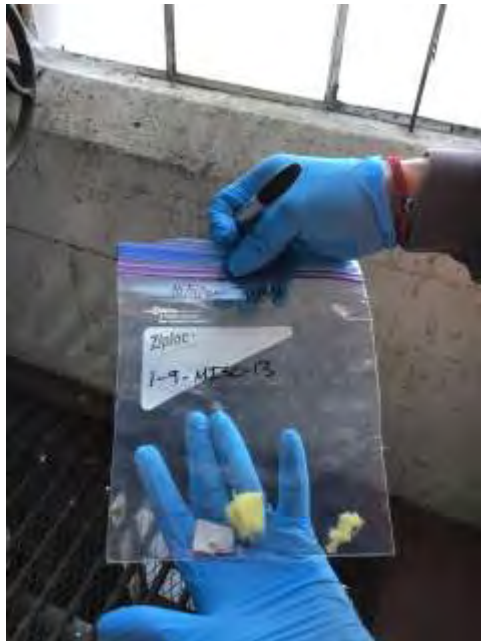
1-9-MISC-13

Additional Sample Notes:	Yellow fibrous insulation.
---------------------------------	----------------------------

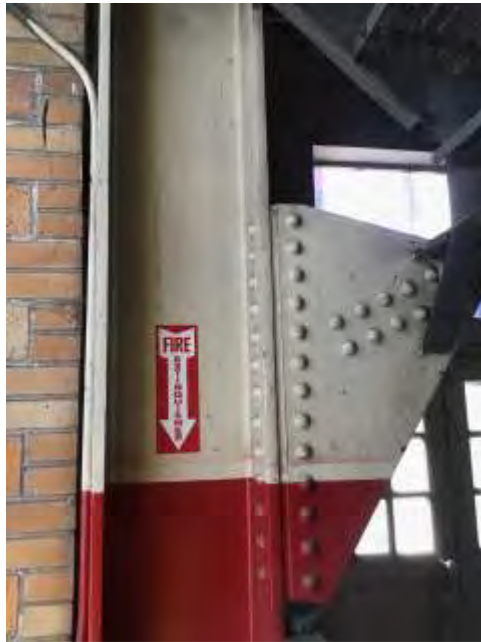
Sample ID:	Sample Type:
1-9-PB-15	PB
Sample Location:	Detailed Sample Location:
Room 101	West metal support beam above fire extinguisher.
Sample Quantity:	3,000 square feet.
Sample Color:	XRF:
White	5.00

Additional Sample Notes:	Difficult to quantify.
---------------------------------	------------------------

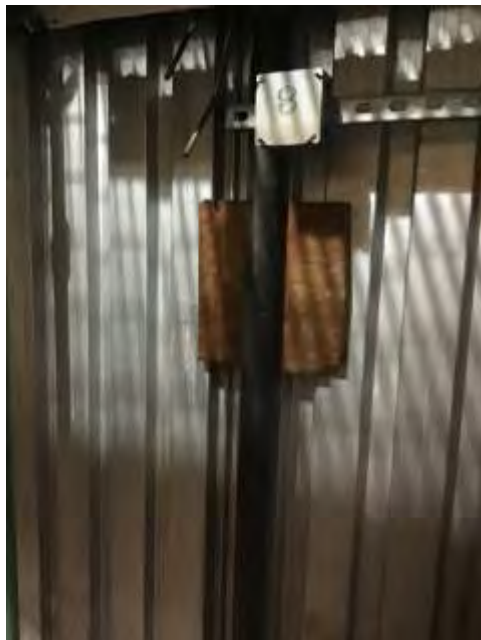
Additional Sample Notes:	Gray insulation and fabric.	
Sample ID:	Sample Type:	
1-11-MISC-16	MISC	
Sample Location:	Detailed Sample Location:	
Room 101	Southeast corner of room on corrugated boiler wall.	
Sample Quantity:	2 linear feet.	
Misc Sample Material:	Sample Condition:	Sample Friable?:
Tan soundproofing material.	Potential ACBM with potential for damage	Yes

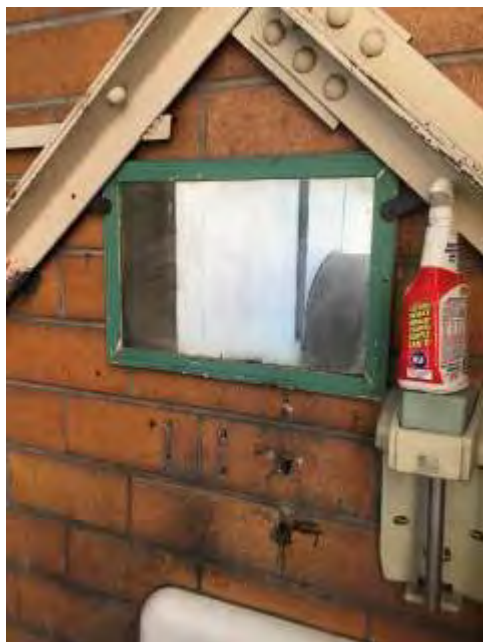
Additional Sample Notes:	Soundproofing material.
Sample ID:	Sample Type:
1-11-PB-17	PB
Sample Location:	Detailed Sample Location:
Room 101	Mirror above sink in southwest corner of room 101.
Sample Quantity:	N/A
Sample Color:	XRF:
Green	0.472

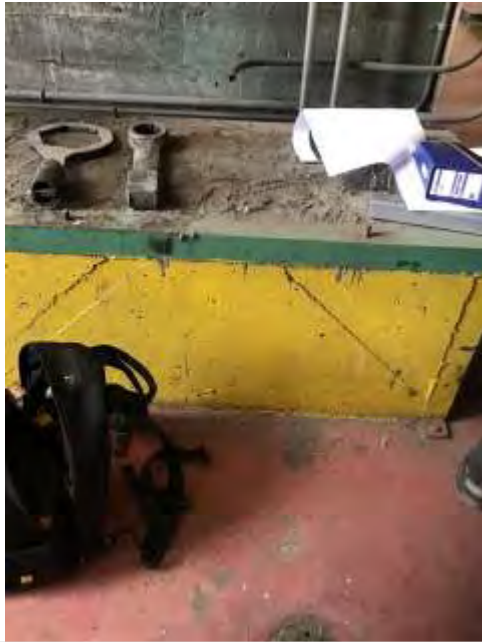
Sample ID:	Sample Type:
1-14-PB-30	PB
Sample Location:	Detailed Sample Location:
Room 101	North concrete bench west of north door.
Sample Quantity:	600 linear feet.
Sample Color:	XRF:
Yellow	2.83

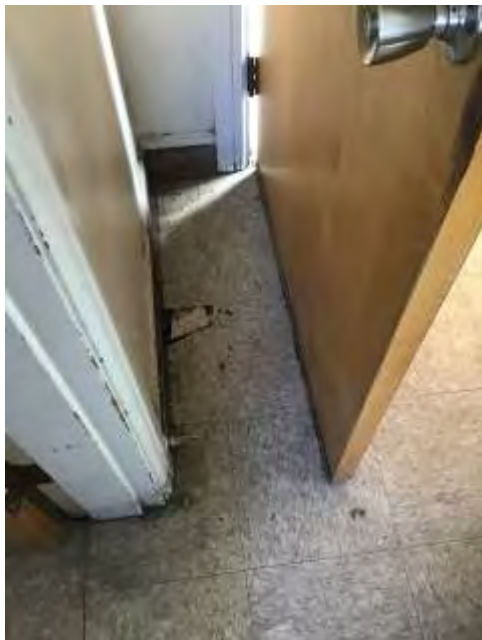
Sample ID:	Sample Type:	
1-15-MISC-23	MISC	
Sample Location:	Detailed Sample Location:	
Room 104	Northeast corner of room.	
Sample Quantity:	3,000 square feet.	
Misc Sample Material:	Sample Condition:	Sample Friable?:
Tan 12" x 12" vinyl floor tile with black mastic.	Potential ACBM with potential for damage	No

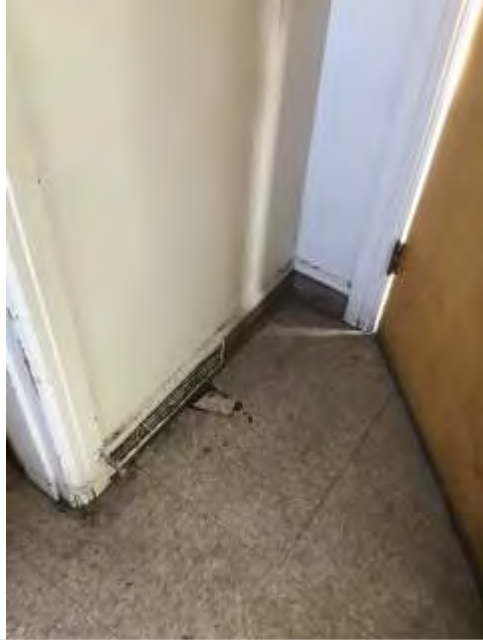
Sample ID:	Sample Type:	
1-16-MISC-25	MISC	
Sample Location:	Detailed Sample Location:	
Room 104	East wall of room.	
Sample Quantity:	80 linear feet.	
Misc Sample Material:	Sample Condition:	Sample Friable?:
Brown cove base with brown mastic.	Potential ACBM with potential for damage	No

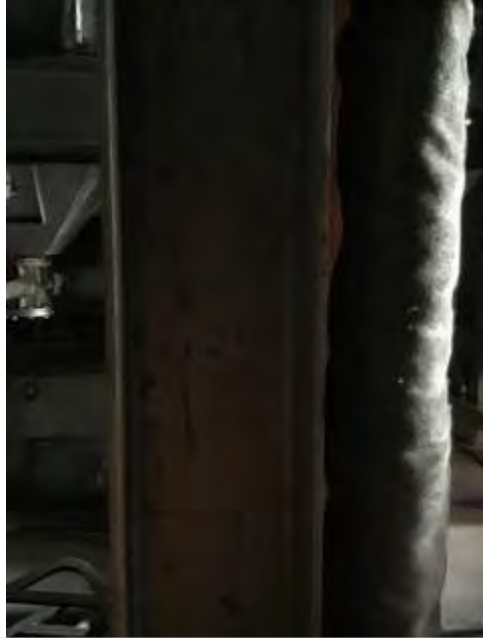
Sample ID:	Sample Type:
1-20-PB-33	PB
Sample Location:	Detailed Sample Location:
Room 101	Support beam on northwest corner of northeast boiler.
Sample Quantity:	3,000 linear feet.
Sample Color:	XRF:
Silver	0.040

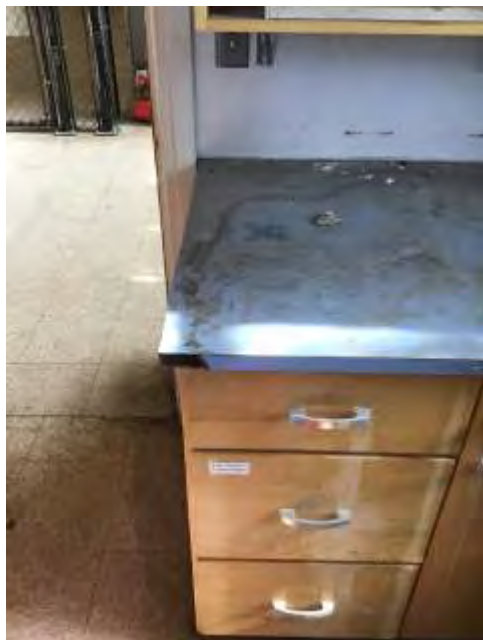
Sample ID:	Sample Type:	
1-21-MISC-33	MISC	
Sample Location:	Detailed Sample Location:	
104	Gray blue counter top on east side of room.	
Sample Quantity:	12 square feet.	
Misc Sample Material:	Sample Condition:	Sample Friable?:
Gray blue laminate countertop with black and green mastic.	Potential ACBM with potential for damage	No

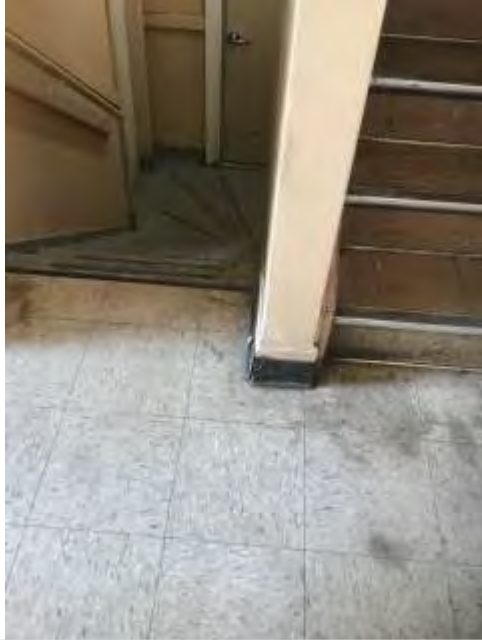
Sample ID:	Sample Type:	
1-22-MISC-34	MISC	
Sample Location:	Detailed Sample Location:	
Room 102	Northwest corner of room by stairs.	
Sample Quantity:	240 linear feet.	
Misc Sample Material:	Sample Condition:	Sample Friable?:
Dark brown cove base with brown mastic.	Potential ACBM with potential for damage	No

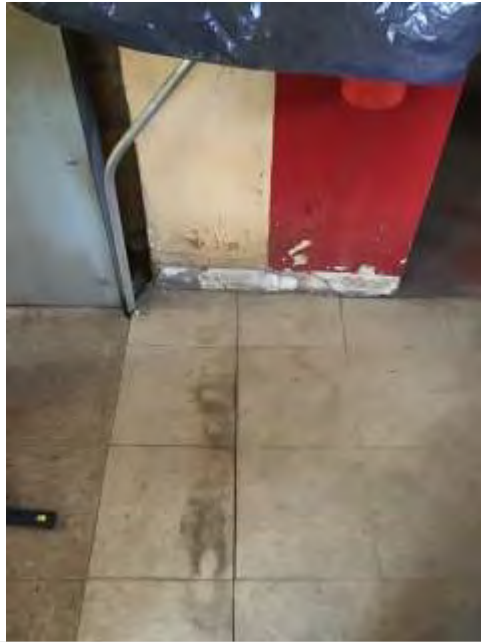
1-24-MISC-37

Light gray 12" x 12" vinyl floor tile with gray mastic.	Potential ACBM with potential for damage	No
---	--	----

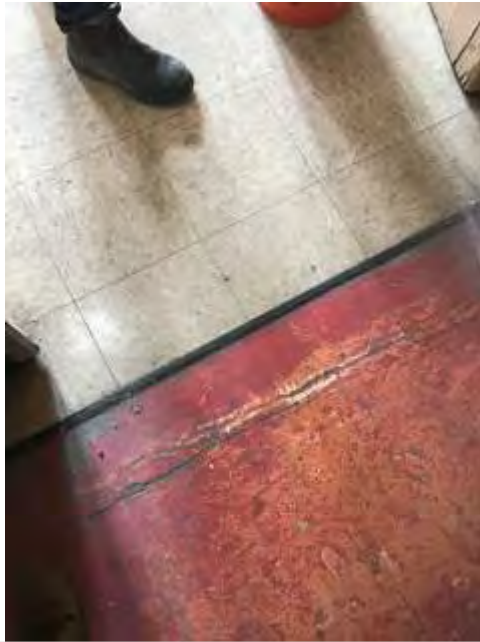
1-25-MISC-39

Black transition strip with brown mastic.	Potential ACBM with potential for damage	No
---	--	----

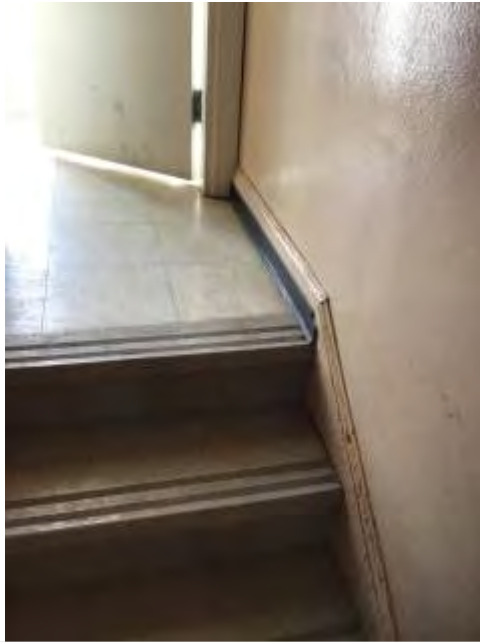
Additional Sample Notes:		
Sample ID:	Sample Type:	
1-30-MISC-49	MISC	
Sample Location:	Detailed Sample Location:	
Top of stairway from room 102 to 107.	North wall at the top of stairs.	
Sample Quantity:	20 linear feet.	
Misc Sample Material:	Sample Condition:	Sample Friable?:
Black cove base with tan mastic	Potential ACBM with potential for damage	No

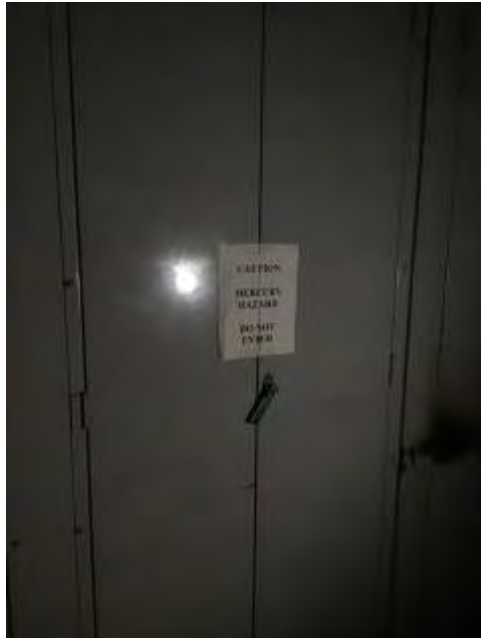
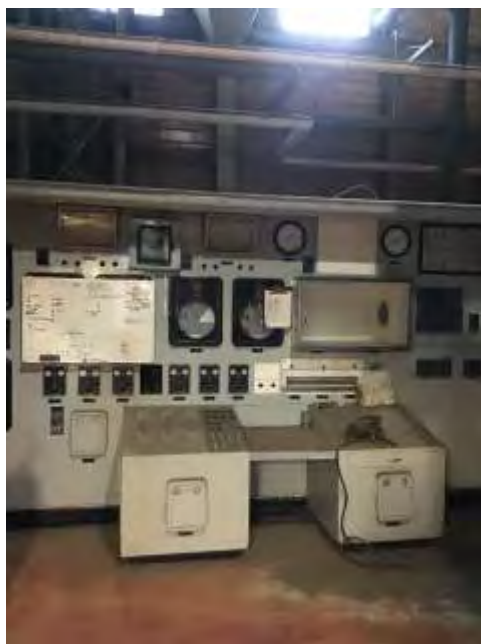
General Fixture Location:	Detailed Fixture Location:
Room 101	East wall behind control panels.
Type of Fixture:	Quantity:
	1
Condition:	Additional Fixture Notes:
Good	Boiler and equipment control panels containing mercury.

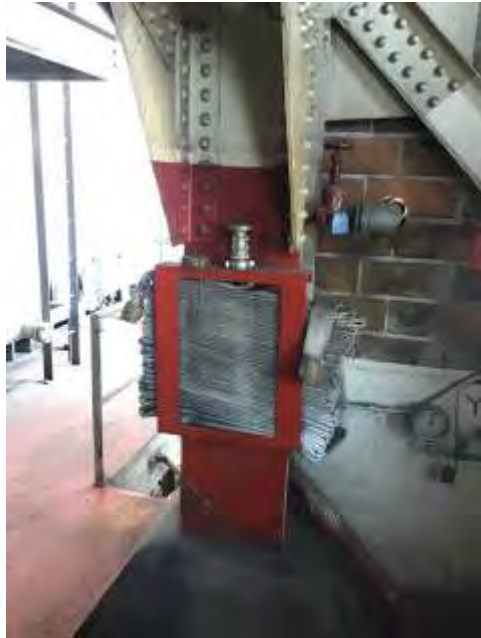
General Fixture Location:	Detailed Fixture Location:
Room 101	West wall south of double doors.
Type of Fixture:	Quantity:
Fire hose.	1
Condition:	Additional Fixture Notes:
Good	Assumed asbestos containing material in fire hose.

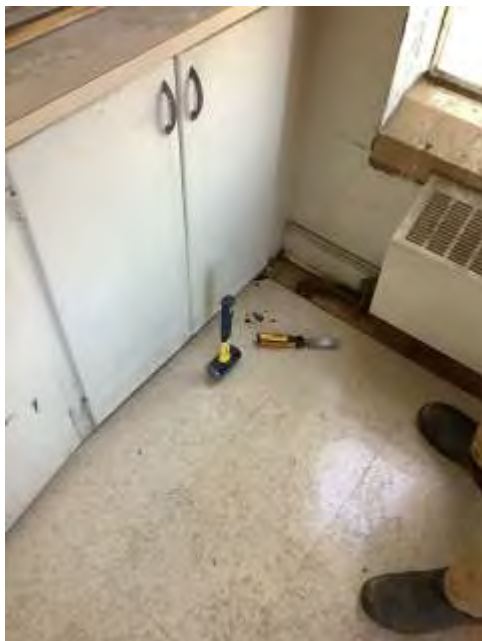
Sample ID:	Sample Type:	
2-1-MISC-2	MISC	
Sample Location:	Detailed Sample Location:	
Room 203	Southeast corner floor.	
Sample Quantity:	66 square feet.	
Misc Sample Material:	Sample Condition:	Sample Friable?:
White stipple pattern 12" x 12" vinyl floor tile with black mastic.	Potential ACBM with potential for damage	No

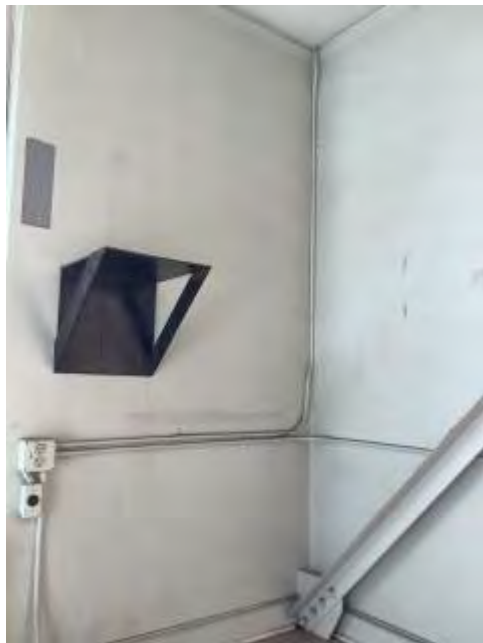
Sample ID:	Sample Type:
2-1-PB-1	PB
Sample Location:	Detailed Sample Location:
Room 203	Southeast corner of room.
Sample Quantity:	NA
Sample Color:	XRF:
White	0.180

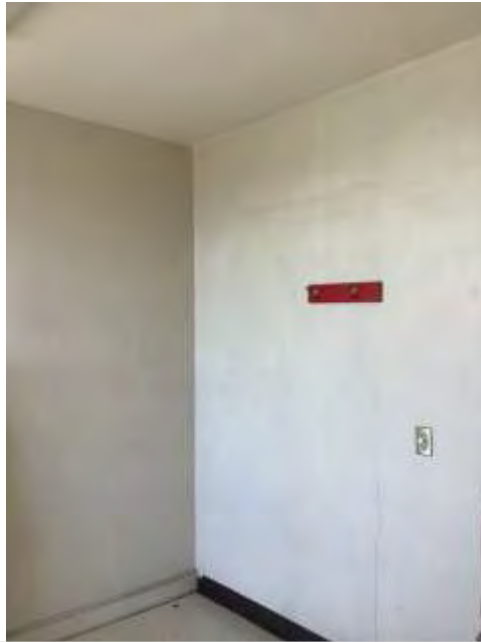
Sample ID:	Sample Type:
2-1-PB-2	PB
Sample Location:	Detailed Sample Location:
Room 204	Northeast corner of room.
Sample Quantity:	NA
Sample Color:	XRF:
White	0.043

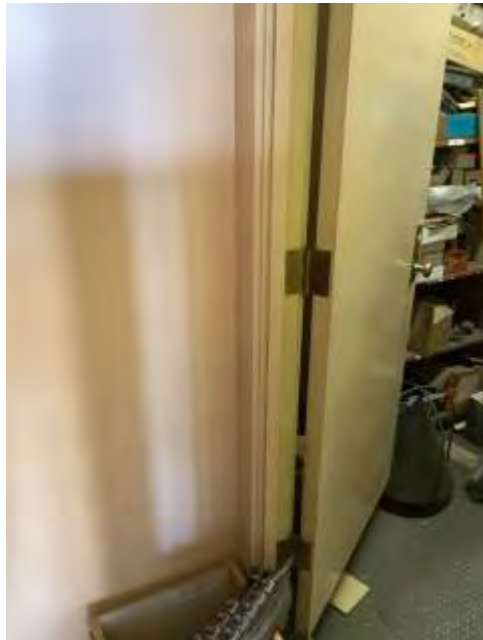
Sample ID:	Sample Type:
2-2-PB-4	PB
Sample Location:	Detailed Sample Location:
Room 200S	Catwalk outside of room 201.
Sample Quantity:	NA
Sample Color:	XRF:
Tan	0.219

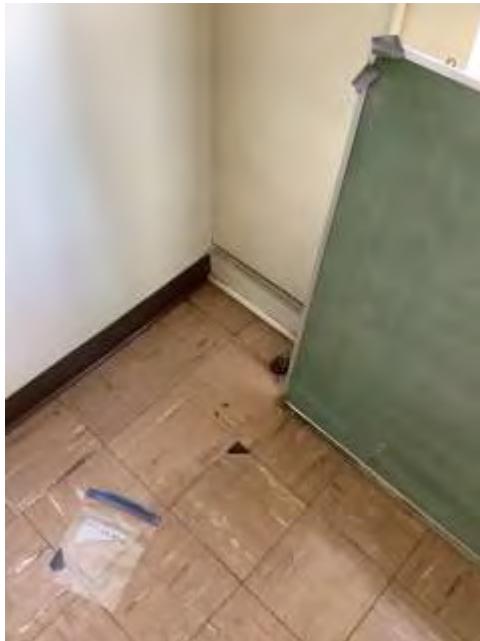
Additional Sample Notes:		
Sample ID:	Sample Type:	
2-3-MISC-5	MISC	
Sample Location:	Detailed Sample Location:	
Room 203	Southwest corner of floor.	
Sample Quantity:	175 square feet.	
Misc Sample Material:	Sample Condition:	Sample Friable?:
Light brown patterned 9" x 9" vinyl floor tile with black mastic.	Potential ACBM with potential for damage	No

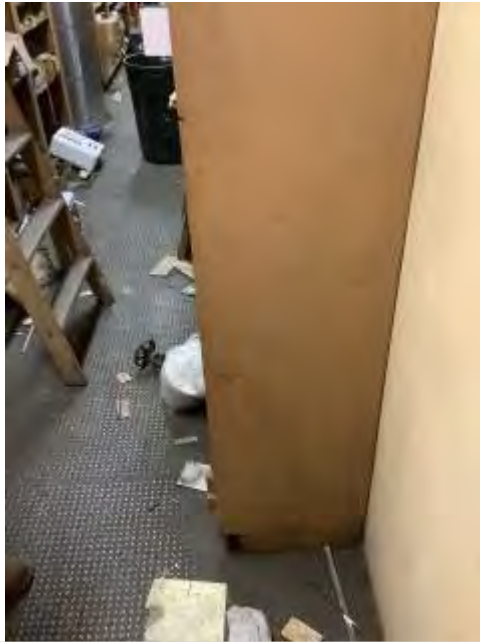
Sample ID:	Sample Type:
2-3-PB-5	PB
Sample Location:	Detailed Sample Location:
Room 201	Cabinet inside doorway.
Sample Quantity:	NA
Sample Color:	XRF:
Dark tan	0.330

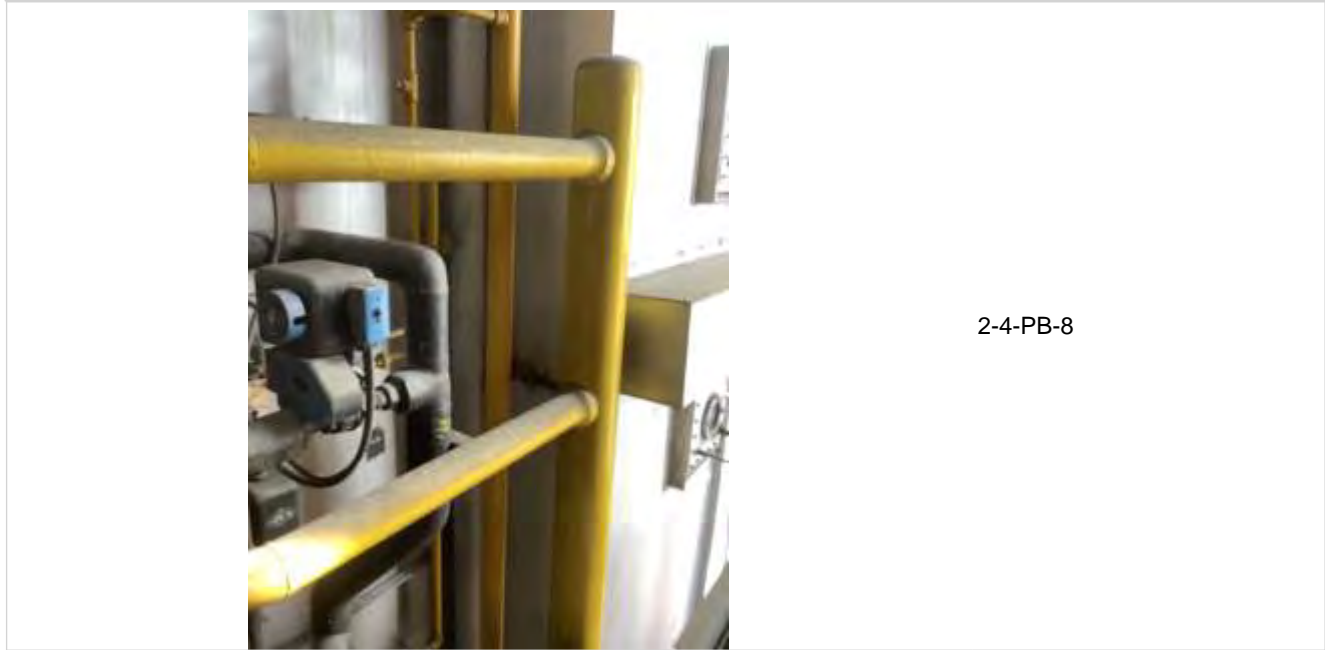
Sample ID:	Sample Type:
2-4-PB-8	PB
Sample Location:	Detailed Sample Location:
Room 101	Yellow pipe on first catwalk, west side of room.
Sample Quantity:	600 linear feet.
Sample Color:	XRF:
Yellow	4.94

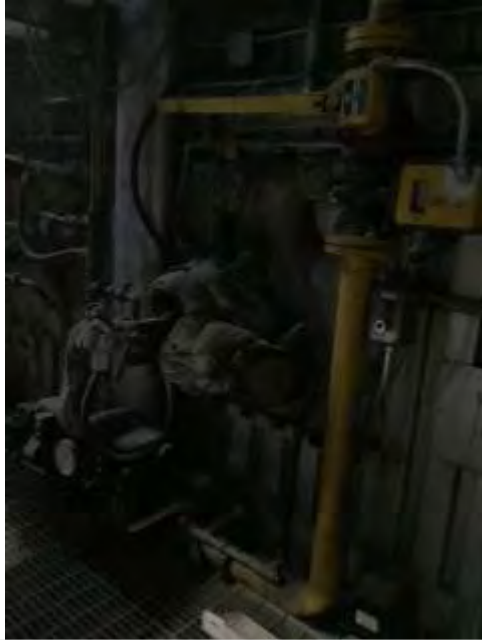
Sample ID:	Sample Type:
2-4-PB-12	PB
Sample Location:	Detailed Sample Location:
Room 101	Yellow pipe on first catwalk, east side of room.
Sample Quantity:	600 linear feet.
Sample Color:	XRF:
Yellow	3.28

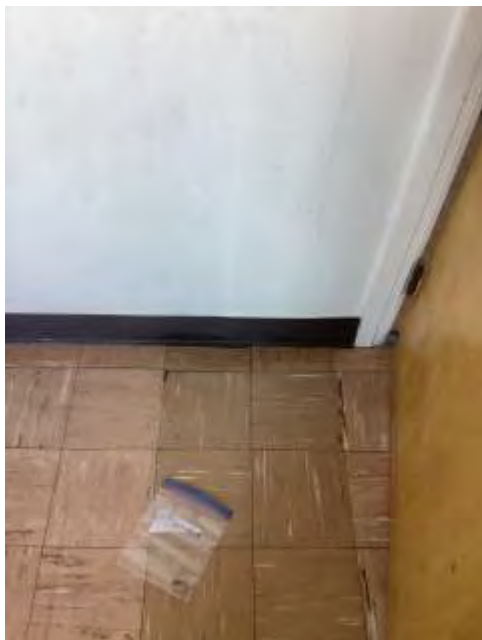
Sample ID:	Sample Type:	
2-4-MISC-6	MISC	
Sample Location:	Detailed Sample Location:	
Room 202	East side of floor north of door.	
Sample Quantity:	20 square feet.	
Misc Sample Material:	Sample Condition:	Sample Friable?:
Brown stripped patterned 9" x 9" vinyl floor tile with black mastic.	Potential ACBM with potential for damage	No

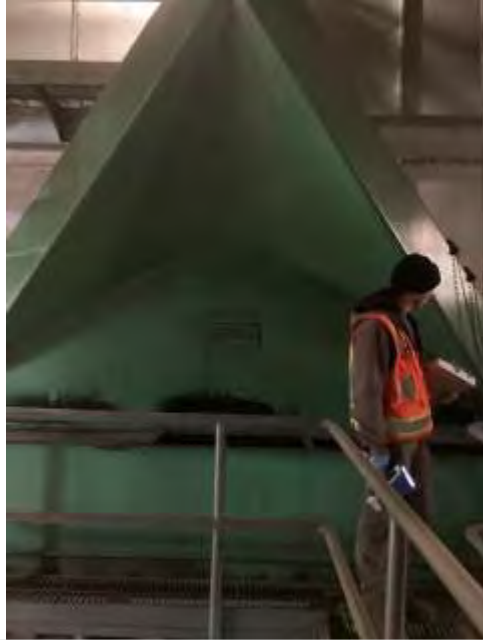
Sample ID:	Sample Type:
2-5-PB-10	PB
Sample Location:	Detailed Sample Location:
Room 101	Light green pipe on first catwalk in center of room.
Sample Quantity:	NA
Sample Color:	XRF:
Light green	0.108

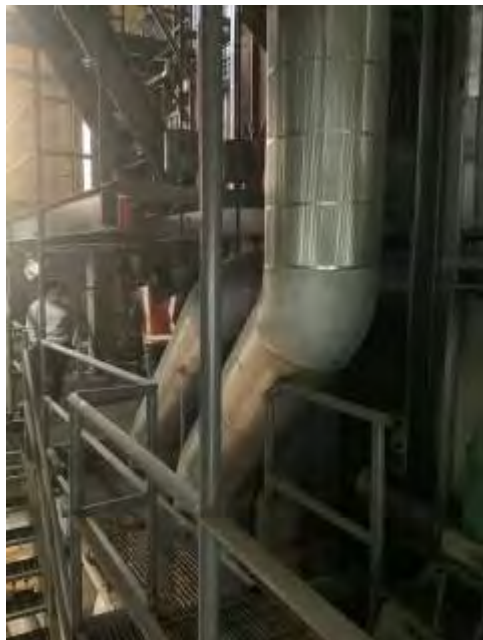
Sample ID:	Sample Type:
2-6-PB-11	PB
Sample Location:	Detailed Sample Location:
Room 101	Silver pipe on first catwalk in center of room.
Sample Quantity:	NA
Sample Color:	XRF:
Silver	ND

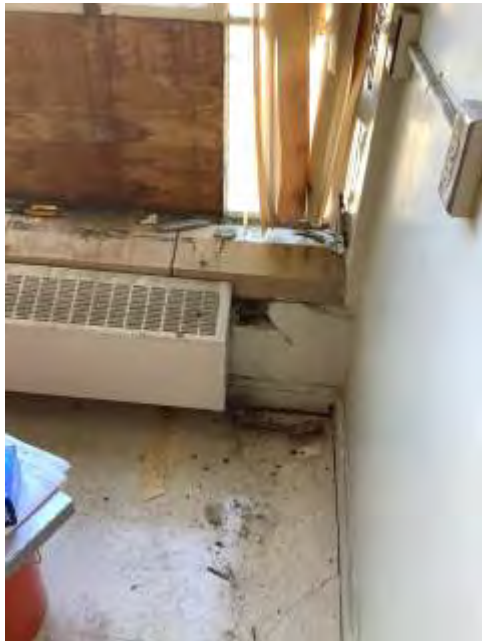
Sample ID:	Sample Type:	
2-8-MISC-12	MISC	
Sample Location:	Detailed Sample Location:	
Room 202	Northwest corner wall under window.	
Sample Quantity:	1,000 square feet.	
Misc Sample Material:	Sample Condition:	Sample Friable?:
White drywall with cementitious wallboard.	Potential ACBM with potential for damage	No

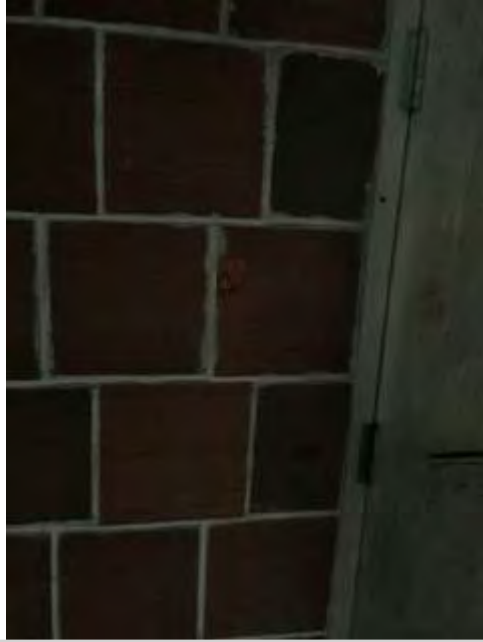
Sample ID:	Sample Type:	
2-11-MISC-15	MISC	
Sample Location:	Detailed Sample Location:	
Room 204	West wall south of double door.	
Sample Quantity:	615 square feet.	
Misc Sample Material:	Sample Condition:	Sample Friable?:
Red 12" x 12" brick.	Potential ACBM with potential for damage	No

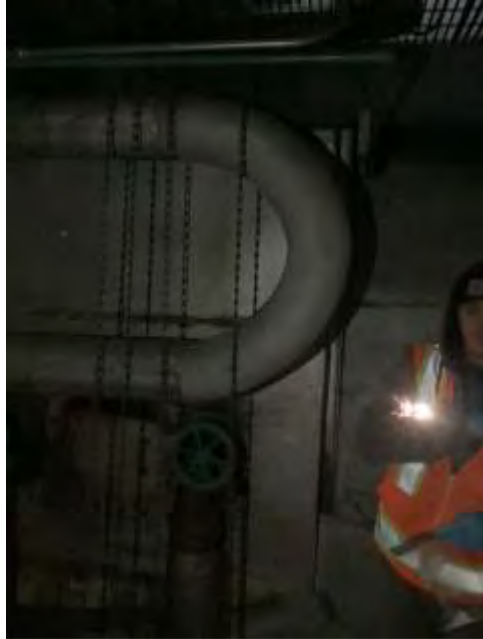
Additional Sample Notes:		
Sample ID:	Sample Type:	
2-13-TSI-19	TSI	
Sample Location:	Detailed Sample Location:	
Room 101	Second catwalk on southwest side of Boiler 6.	
Sample Quantity:	3,000 linear feet.	
Sample Color:	XRF:	
Misc Sample Material:	Sample Condition:	Sample Friable?:
	Damaged or significantly damaged	Yes

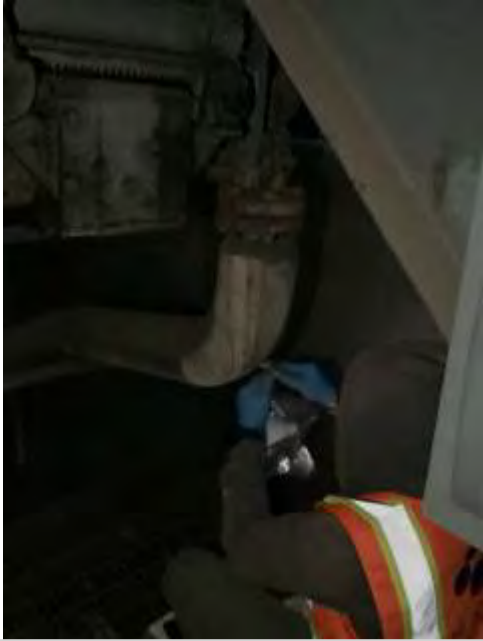
2-13-TSI-22

Sample Color:	XRF:	
Misc Sample Material:	Sample Condition:	Sample Friable?:
	Damaged or significantly damaged	Yes

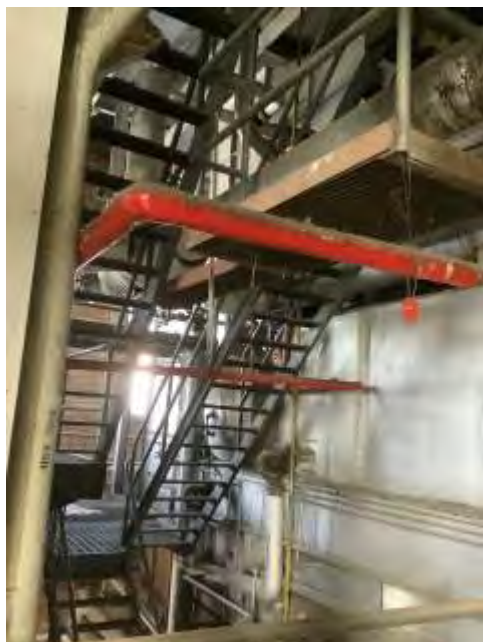
Additional Sample Notes:	Orange pipe with white insulation.
Sample ID:	Sample Type:
2-13-PB-21	PB
Sample Location:	Detailed Sample Location:
Room 101	Red pipe on west side of Boiler 4.
Sample Quantity:	NA
Sample Color:	XRF:
Red	ND

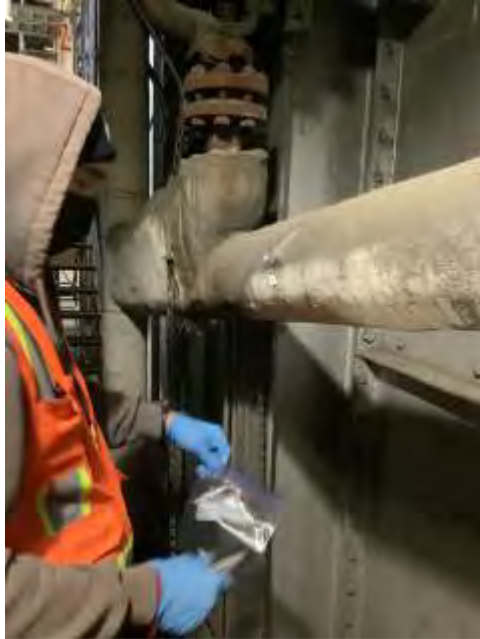
Additional Sample Notes:	Tan / white pipe wrap with white insulation.	
Sample ID:	Sample Type:	
2-15-TSI-27	TSI	
Sample Location:	Detailed Sample Location:	
Room 101	East side of room by staircase entrance.	
Sample Quantity:	35 linear feet.	
Sample Color:	XRF:	
Misc Sample Material:	Sample Condition:	Sample Friable?:
	Damaged or significantly damaged	No

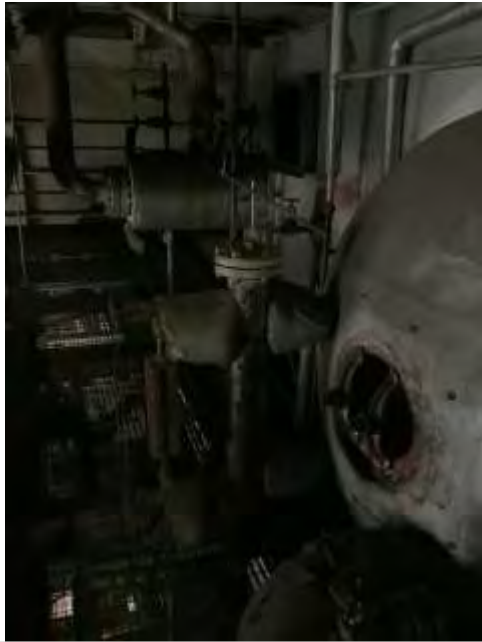
3-2-TSI-3	TSI	
Sample Location:	Detailed Sample Location:	
Room 101	Highest catwalk.	
Sample Quantity:	700 linear feet.	
Sample Color:	XRF:	
Misc Sample Material:	Sample Condition:	Sample Friable?:
	Damaged or significantly damaged	Yes

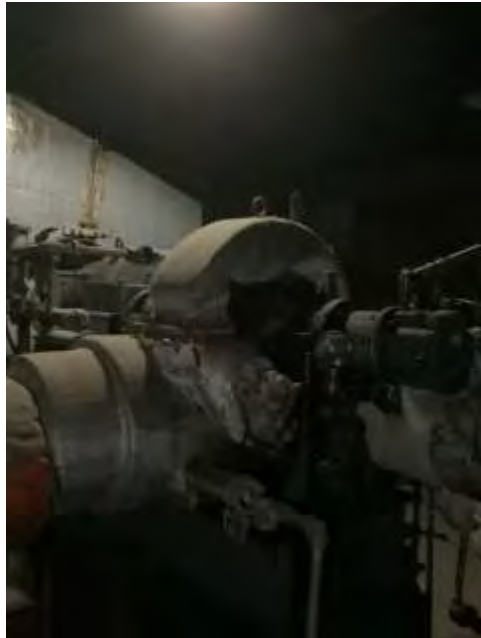
Sample ID:	Sample Type:	
3-2-TSI-6	TSI	
Sample Location:	Detailed Sample Location:	
Room 302	Pipe near west roof access.	
Sample Quantity:	700 linear feet.	
Sample Color:	XRF:	
Misc Sample Material:	Sample Condition:	Sample Friable?:
	Damaged or significantly damaged	Yes

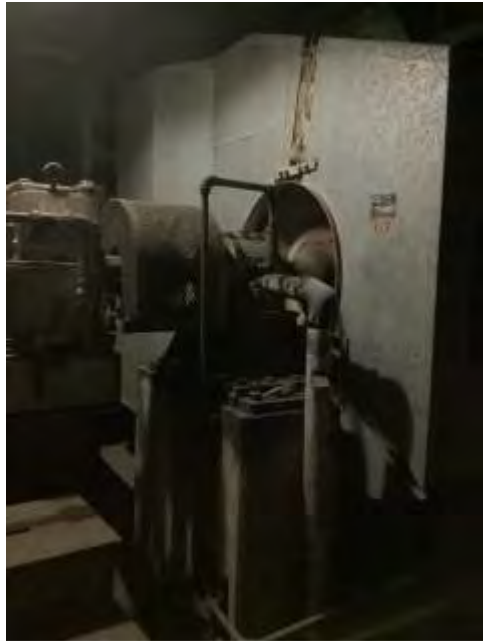
Additional Sample Notes:		White insulation on mechanical part.
Sample ID:	Sample Type:	
3-4-TSI-8	TSI	
Sample Location:	Detailed Sample Location:	
Room 302	Pipe near motor.	
Sample Quantity:	6 linear feet.	
Sample Color:	XRF:	
Misc Sample Material:	Sample Condition:	Sample Friable?:
	Damaged or significantly damaged	Yes

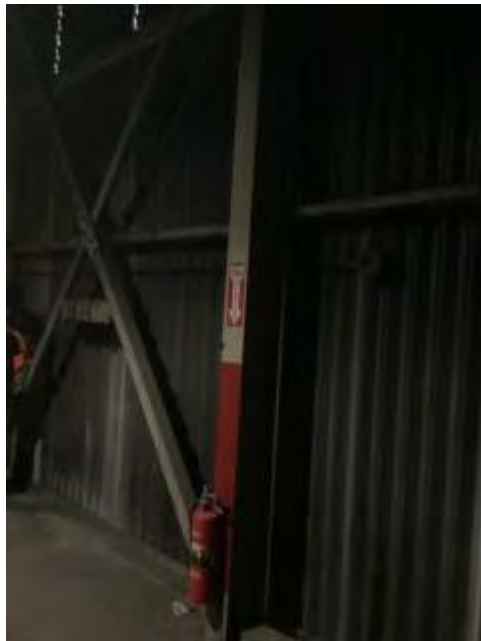
Sample ID:	Sample Type:
3-6-PB-10	PB
Sample Location:	Detailed Sample Location:
Room 302	By west side door.
Sample Quantity:	NA
Sample Color:	XRF:
Tan	0.531

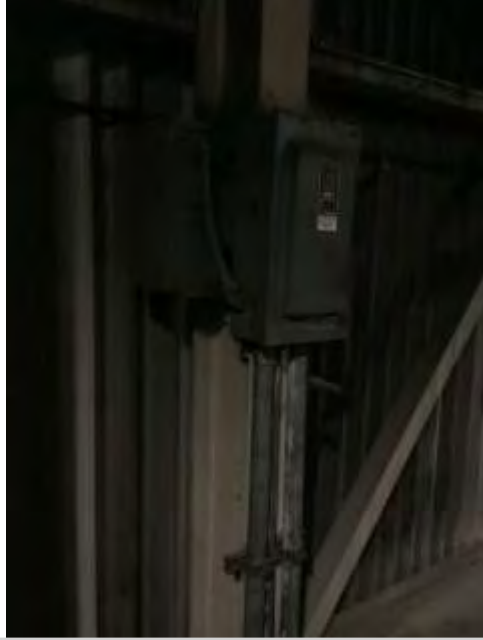
Sample ID:	Sample Type:
3-6-PB-11	PB
Sample Location:	Detailed Sample Location:
Room 302	By west side door.
Sample Quantity:	NA
Sample Color:	XRF:
Tan	0.922

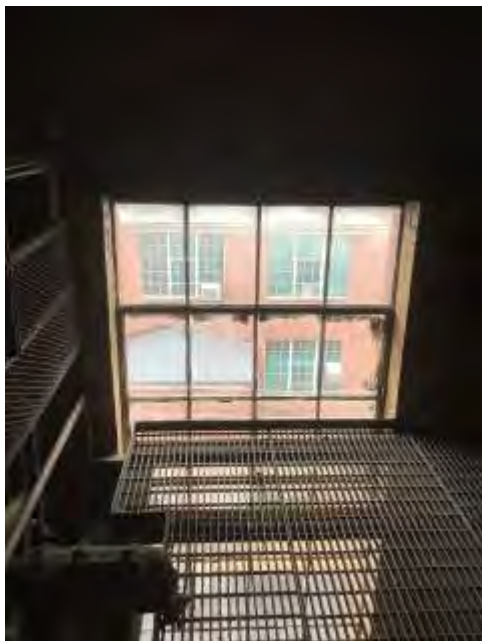
Sample ID:	Sample Type:	
3-8-MISC-12	MISC	
Sample Location:	Detailed Sample Location:	
Room 303	Window on west side of room.	
Sample Quantity:	4,030 linear feet.	
Misc Sample Material:	Sample Condition:	Sample Friable?:
Window glazing.	Damaged or significantly damaged friable miscellaneous ACM	No

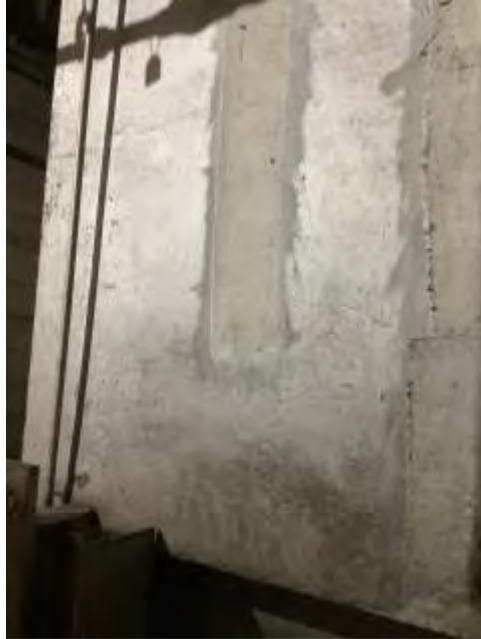
Additional Sample Notes:		White insulation with silver fabric patch.
Sample ID:	Sample Type:	
4-1-TSI-10	TSI	
Sample Location:	Detailed Sample Location:	
Room 11	Southeast portion of room by entrance to room 23.	
Sample Quantity:	600 linear feet.	
Sample Color:	XRF:	
Misc Sample Material:	Sample Condition:	Sample Friable?:
	Damaged or significantly damaged	Yes
