COLLEGE AVENUE STEAM PLANT ADAPTIVE REUSE

Integrated Cleanup and Implementation Plan

Port of
Whitman
County

PORT OF WHITMAN COUNTY
March 30, 2020

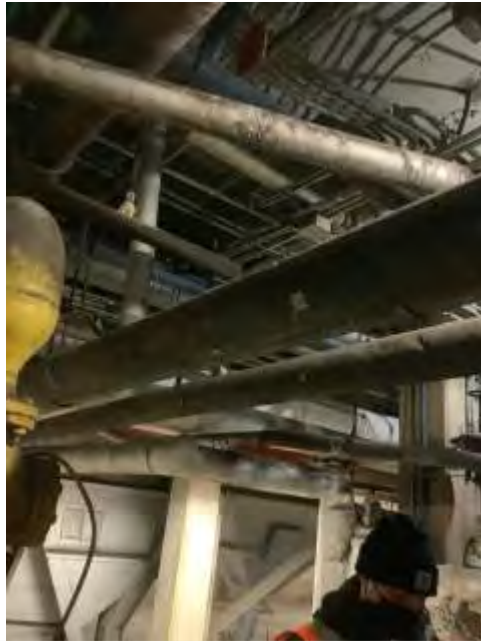
Additional Sample Notes:	White insulation with white painted wrap.	
Sample ID:	Sample Type:	
4-2-TSI-25	TSI	
Sample Location:	Detailed Sample Location:	
Room 11	On west side of room by staircase down.	
Sample Quantity:	1,200 linear feet.	
Sample Color:	XRF:	
Misc Sample Material:	Sample Condition:	Sample Friable?:
	Damaged or significantly damaged	Yes

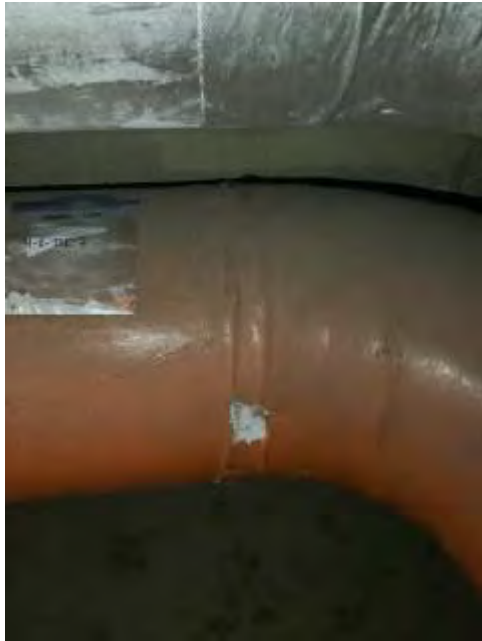
Additional Sample Notes:	White insulation with orange painted wrap.
Sample ID:	Sample Type:
4-2-TSI-7	TSI
Sample Location:	Detailed Sample Location:
Room 23	Northeast corner of room.
Sample Quantity:	1,200 linear feet.
Sample Color:	XRF:

Misc Sample Material:	Sample Condition:	Sample Friable?:
	Damaged or significantly damaged	Yes

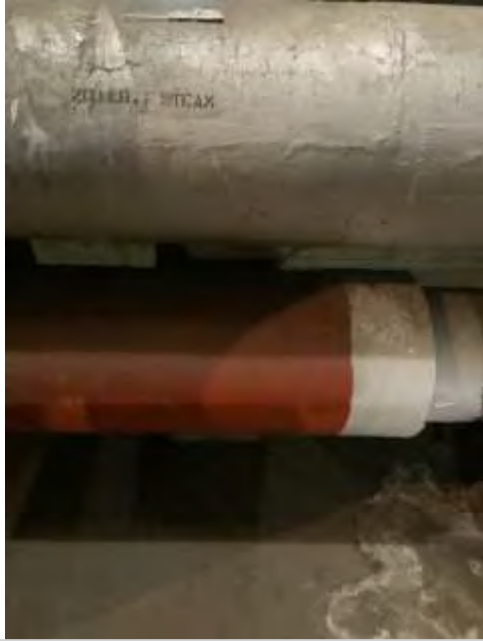
Sample ID:	Sample Type:
4-2-TSI-2	TSI
Sample Location:	Detailed Sample Location:
Room 21	By entrance to room 22.
Sample Quantity:	1,200 linear feet.

Sample Color:	XRF:	
Misc Sample Material:	Sample Condition:	Sample Friable?:
	Damaged or significantly damaged	Yes

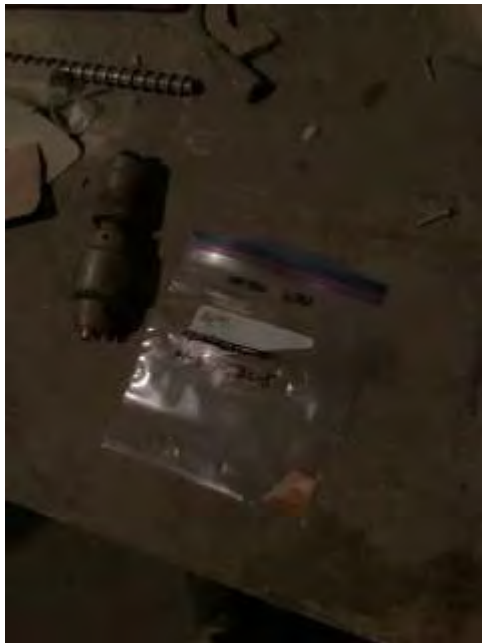
Sample ID:	Sample Type:	
4-4-MISC-5	MISC	
Sample Location:	Detailed Sample Location:	
Room 22	Northwest corner tabletop.	
Sample Quantity:	15 square feet.	
Misc Sample Material:	Sample Condition:	Sample Friable?:
Off-white laminate tabletop with clear adhesive.	Potential ACBM with potential for damage	Yes

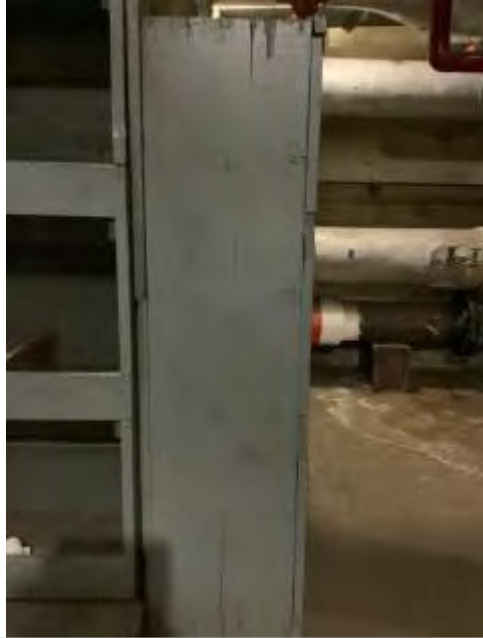
Sample ID:	Sample Type:
4-5-PB-6	PB
Sample Location:	Detailed Sample Location:
Room 21	Cabinet in center of room north of room 22.
Sample Quantity:	N/A
Sample Color:	XRF:
Gray	0.063

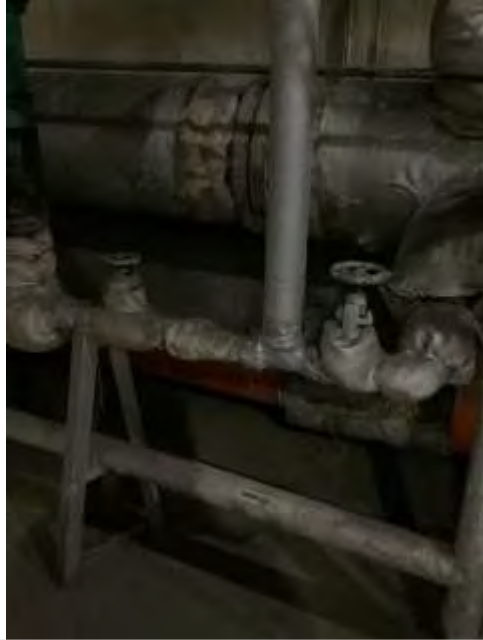
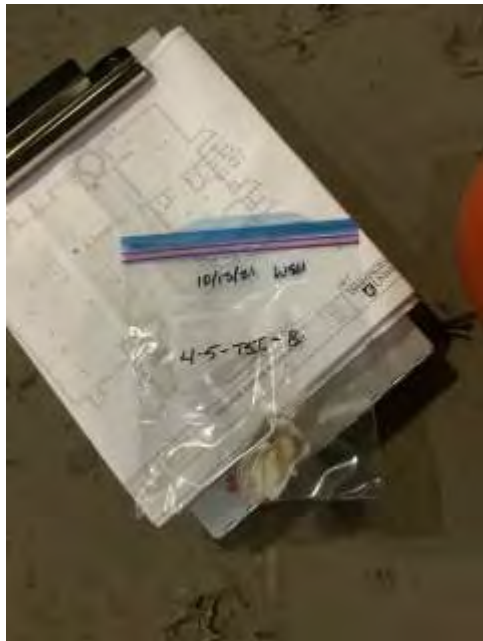
Additional Sample Notes:		
Sample ID:	Sample Type:	
4-5-TSI-8	TSI	
Sample Location:	Detailed Sample Location:	
Room 23	Southeast corner of room.	
Sample Quantity:	200 linear feet.	
Sample Color:	XRF:	
Misc Sample Material:	Sample Condition:	Sample Friable?:
	Damaged or significantly damaged	Yes

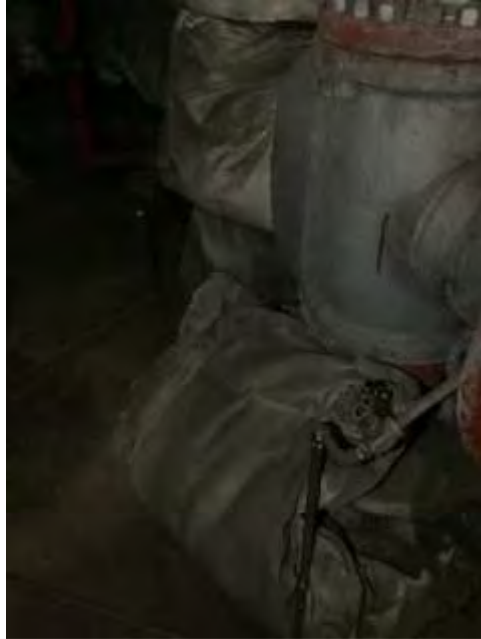
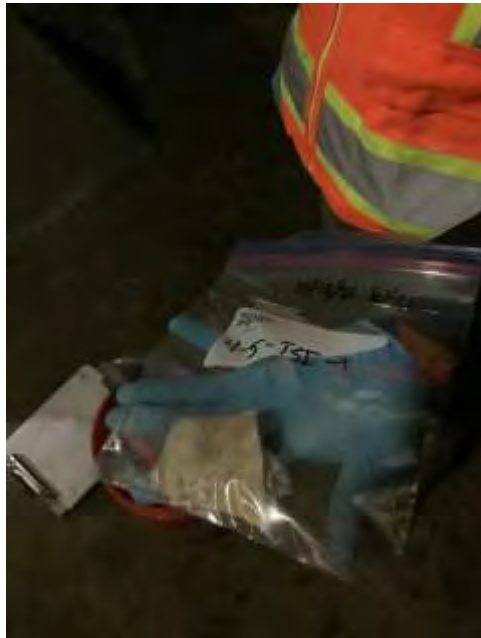
Additional Sample Notes:		Silver steam pipe fabric wrap.	
Sample ID:		Sample Type:	
4-5-TSI-9		TSI	
Sample Location:		Detailed Sample Location:	
Room 11		Southeast corner of room by entrance to room 23.	
Sample Quantity:		200 linear feet.	
Sample Color:		XRF:	
Misc Sample Material:		Sample Condition:	Sample Friable?:
		Damaged or significantly damaged	Yes

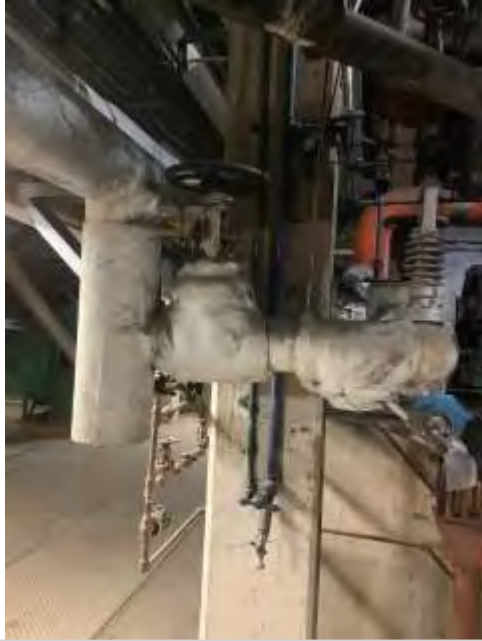
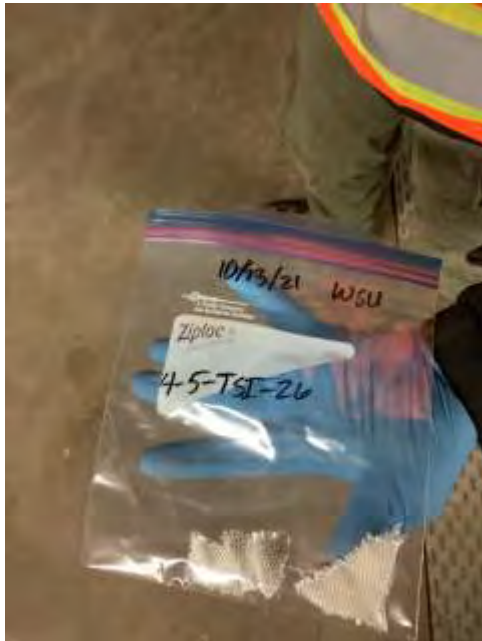
Additional Sample Notes:	Silver steam pipe fabric wrap.
Sample ID:	Sample Type:
4-5-TSI-26	TSI
Sample Location:	Detailed Sample Location:
Room 11	On west side of room by staircase down.
Sample Quantity:	200 linear feet.
Sample Color:	XRF:

Misc Sample Material:	Sample Condition:	Sample Friable?:
	Damaged or significantly damaged	Yes

Additional Sample Notes:	Silver steam pipe fabric wrap.
---------------------------------	--------------------------------

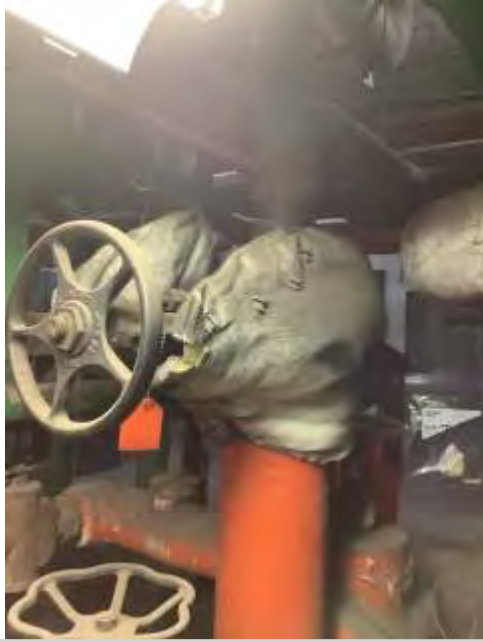
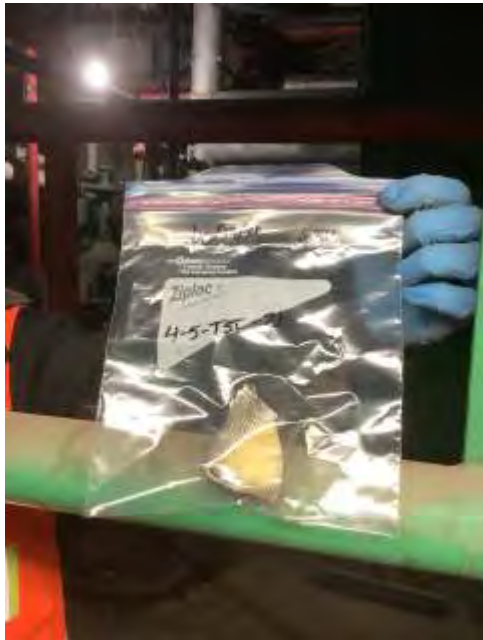
Sample ID:	Sample Type:
4-5-TSI-21	TSI
Sample Location:	Detailed Sample Location:
Room 11	Northeast portion of room near northeast staircase.
Sample Quantity:	200 linear feet.

Sample Color:	XRF:	
Misc Sample Material:	Sample Condition:	Sample Friable?:
	Damaged or significantly damaged	Yes

Additional Sample Notes:	Silver steam pipe fabric wrap.
---------------------------------	--------------------------------

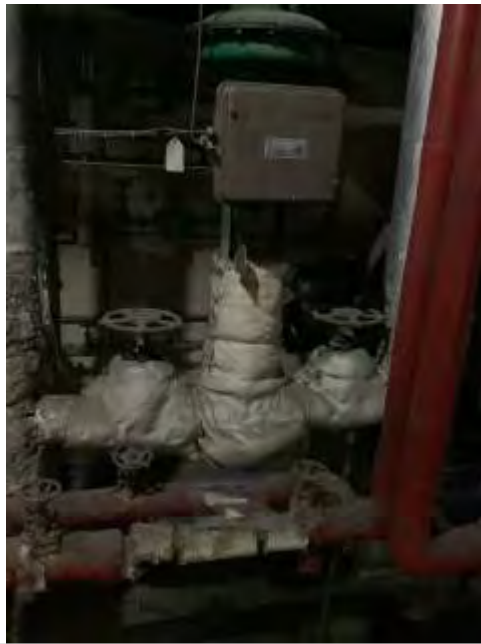
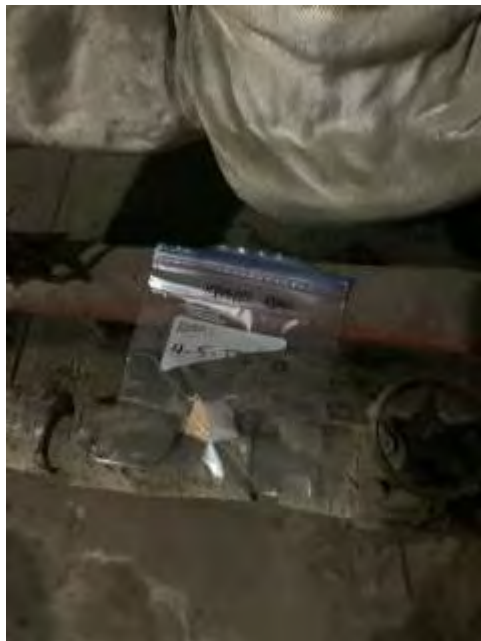
4-5-TSI-13	TSI	
Sample Location:	Detailed Sample Location:	
Room 11	East portion of room north of spiral staircase.	
Sample Quantity:	200 linear feet.	
Sample Color:	XRF:	
Misc Sample Material:	Sample Condition:	Sample Friable?:
	Damaged or significantly damaged	Yes

Additional Sample Notes:	Silver steam pipe fabric wrap.
---------------------------------	--------------------------------

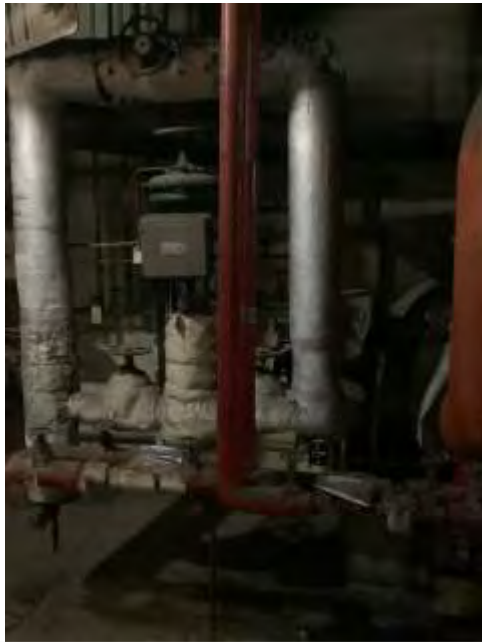
Sample ID:	Sample Type:	
4-6-TSI-12	TSI	
Sample Location:	Detailed Sample Location:	
Room 11	East portion of room north of spiral staircase.	
Sample Quantity:	40 linear feet.	
Sample Color:	XRF:	
Misc Sample Material:	Sample Condition:	Sample Friable?:
	Damaged or significantly damaged	Yes

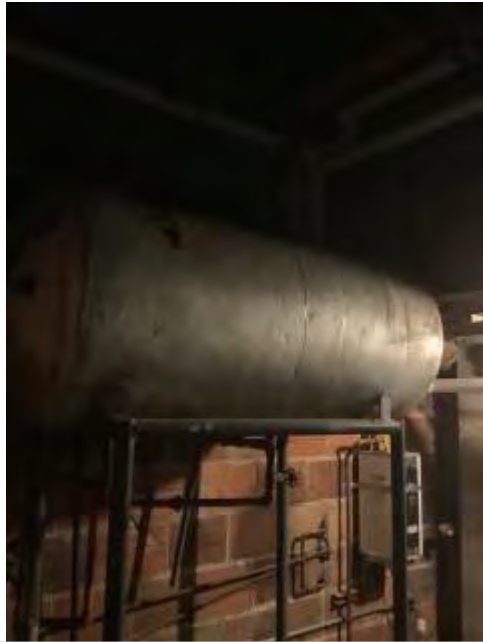
Sample ID:	Sample Type:
4-7-PB-9	PB
Sample Location:	Detailed Sample Location:
Room 18	Tank in southeast corner of room.
Sample Quantity:	5 linear feet.
Sample Color:	XRF:
Silver	5.00

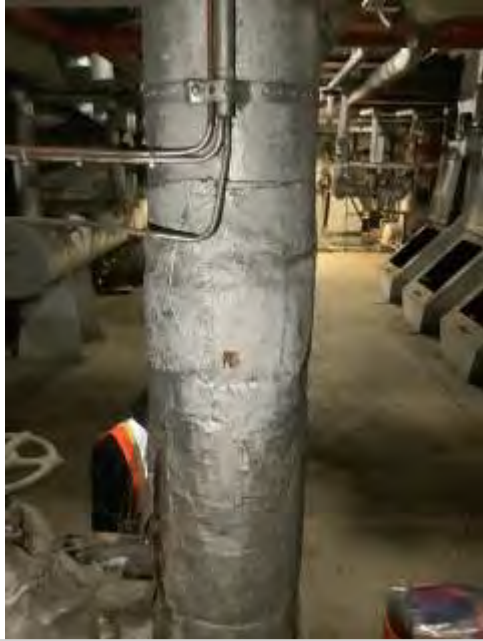
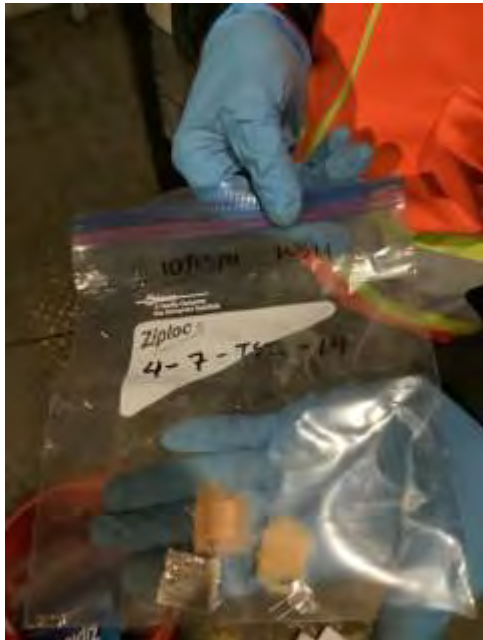
4-7-TSI-14

Sample Color:	XRF:	
Misc Sample Material:	Sample Condition:	Sample Friable?:
	Damaged or significantly damaged	Yes

Additional Sample Notes:	Silver steam pipe fabric wrap with yellow insulation.
---------------------------------	---

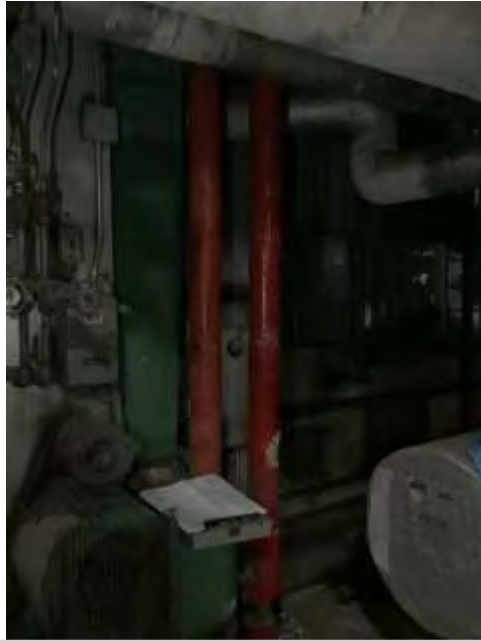
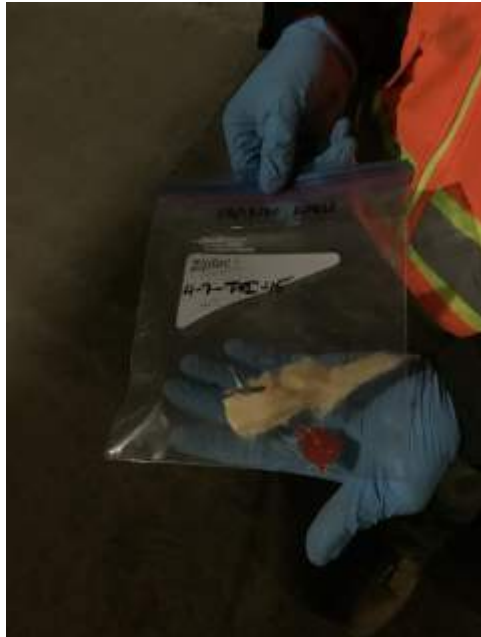
4-7-TSI-15

Room 11	East portion of room north of spiral staircase.	
Sample Quantity:	500 linear feet.	
Sample Color:	XRF:	
Misc Sample Material:	Sample Condition:	Sample Friable?:
	Damaged or significantly damaged	Yes

Additional Sample Notes:	Red steam pipe fabric wrap with yellow insulation.
---------------------------------	--

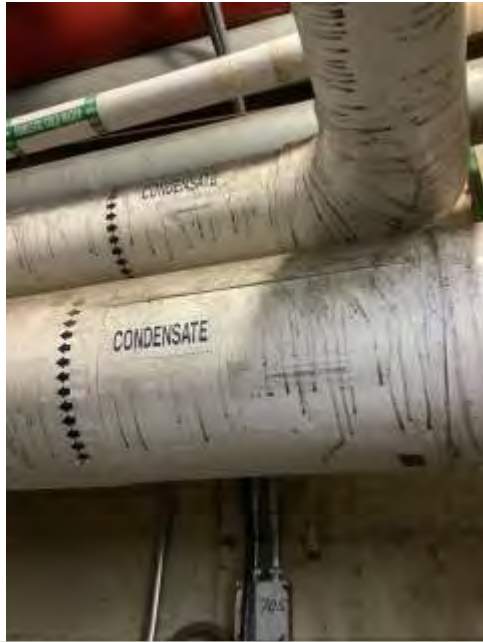
4-7-TSI-27	TSI	
Sample Location:	Detailed Sample Location:	
Room 11	West portion of room by staircase to room 101.	
Sample Quantity:	500 linear feet.	
Sample Color:	XRF:	
Misc Sample Material:	Sample Condition:	Sample Friable?:
	Damaged or significantly damaged	Yes

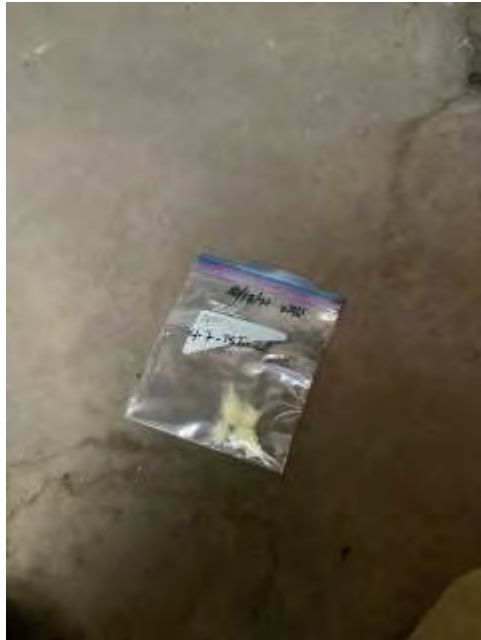
Sample ID:	Sample Type:	
4-7-TSI-28	TSI	
Sample Location:	Detailed Sample Location:	
Room 11	West portion of room by staircase to room 101.	
Sample Quantity:	500 linear feet.	
Sample Color:	XRF:	
Misc Sample Material:	Sample Condition:	Sample Friable?:
	Damaged or significantly damaged	Yes

Additional Sample Notes:		White condensate line elbow with yellow insulation.
Sample ID:	Sample Type:	
4-8-MISC-16	MISC	
Sample Location:	Detailed Sample Location:	
Room 11	By control wheels and conveying systems.	
Sample Quantity:	80 linear feet.	
Misc Sample Material:	Sample Condition:	Sample Friable?:
Silver woven heat-resistant seal material on hatch interior.	Potential ACBM with potential for damage	No

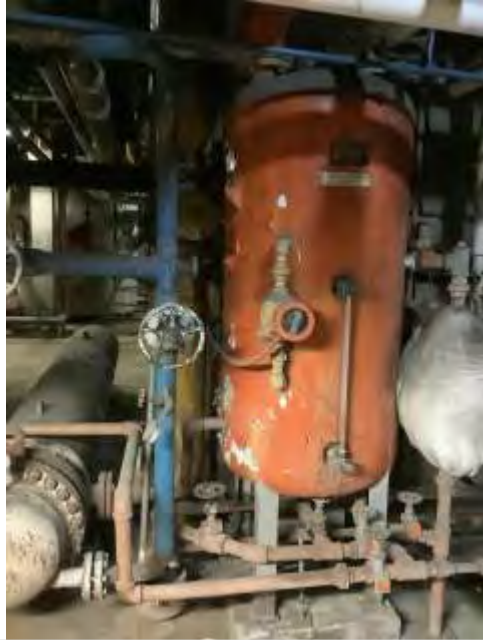
Additional Sample Notes:		
Sample ID:	Sample Type:	
4-9-TSI-32	TSI	
Sample Location:	Detailed Sample Location:	
Room 11	Northeast portion of room.	
Sample Quantity:	20 linear feet.	
Sample Color:	XRF:	
Misc Sample Material:	Sample Condition:	Sample Friable?:
	Damaged or significantly damaged	Yes

Additional Sample Notes:		White tank insulation with orange wrap.			
Sample ID:		Sample Type:			
4-9-TSI-23		TSI			
Sample Location:		Detailed Sample Location:			
Room 11		Northeast portion of room.			
Sample Quantity:		20 linear feet.			
Sample Color:		XRF:			
Misc Sample Material:		Sample Condition:		Sample Friable?:	
		Damaged or significantly damaged		Yes

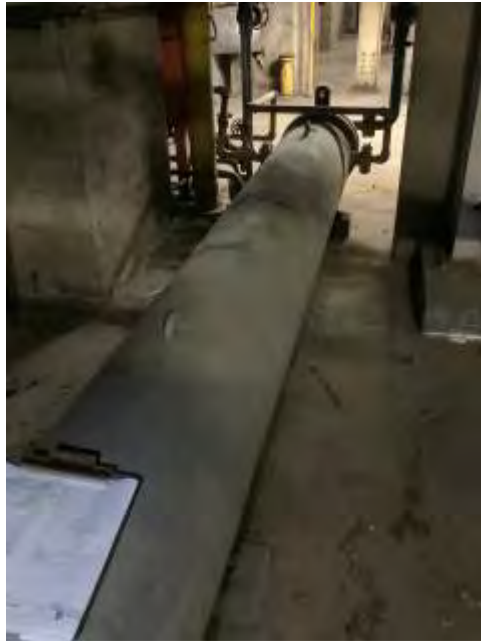
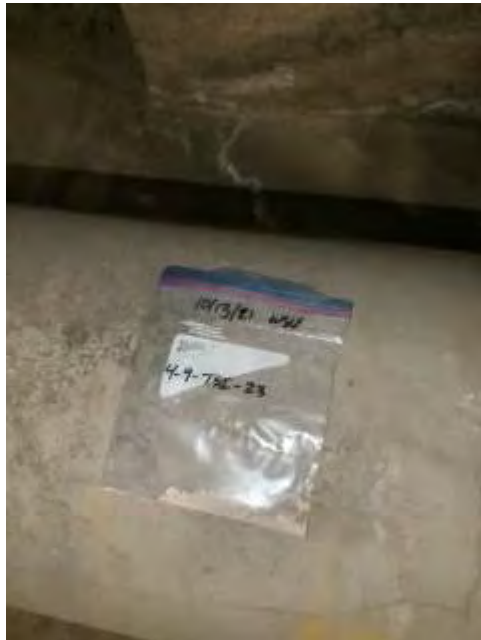
4-9-TSI-23

Additional Sample Notes:	White tank insulation with gray painted wrap and fabric patch.	
Sample ID:	Sample Type:	
4-10-MISC-34	MISC	
Sample Location:	Detailed Sample Location:	
Room 18	East wall of room.	
Sample Quantity:	350 linear feet.	
Misc Sample Material:	Sample Condition:	Sample Friable?:
Gray brick mortar.	Potential ACBM with potential for damage	No

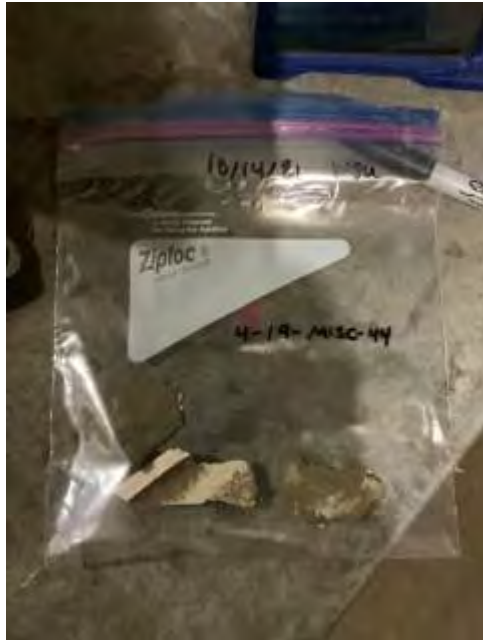
Sample ID:	Sample Type:	
4-19-MISC-44	MISC	
Sample Location:	Detailed Sample Location:	
Room 17	West wall in northwest corner.	
Sample Quantity:	60 linear feet.	
Misc Sample Material:	Sample Condition:	Sample Friable?:
Tan cove base with green adhesive.	Potential ACBM with potential for damage	No

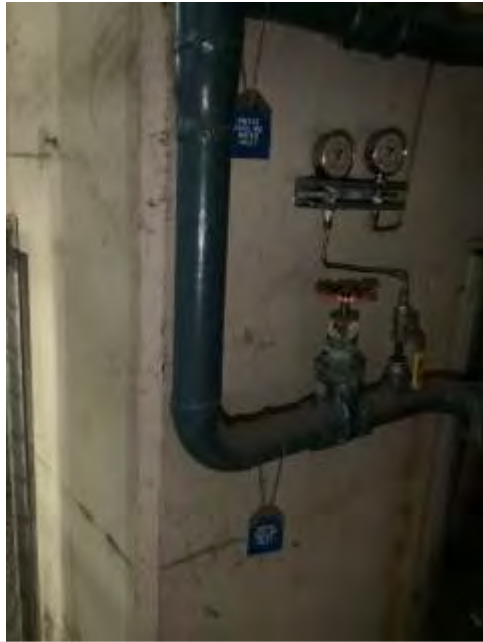
Sample ID:	Sample Type:
4-19-PB-23	PB
Sample Location:	Detailed Sample Location:
Room 23	Blue pipe in northeast corner.
Sample Quantity:	N/A
Sample Color:	XRF:
Blue	0.306

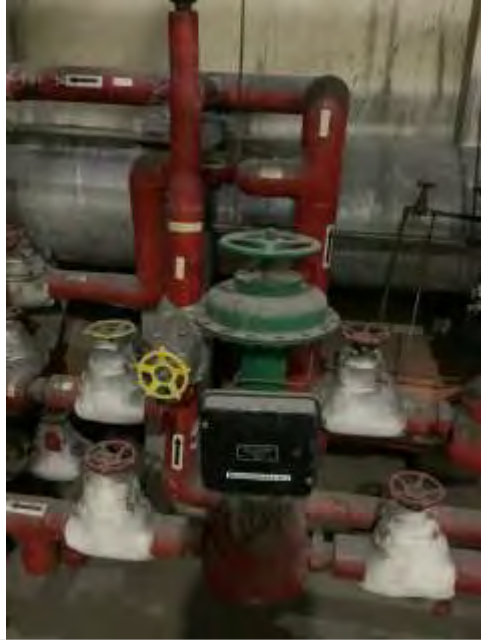
Sample ID:	Sample Type:
4-20-PB-26	PB
Sample Location:	Detailed Sample Location:
Room 23	Green equipment on south side of room.
Sample Quantity:	N/A
Sample Color:	XRF:
Green	0.908

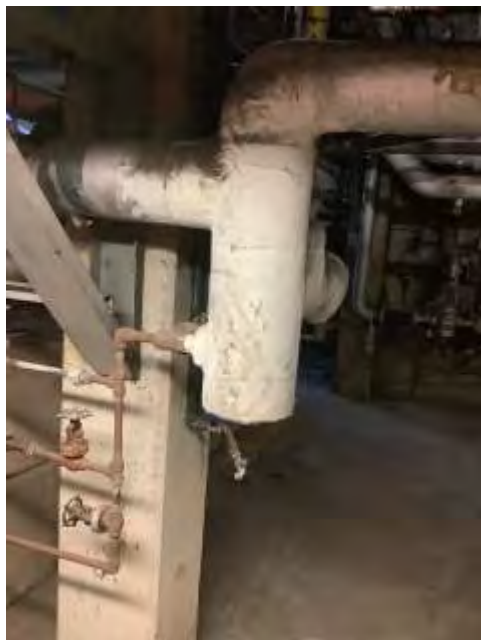
Sample ID:	Sample Type:
4-21-PB-29	PB
Sample Location:	Detailed Sample Location:
Room 11	White pipe wrap on west side of room east of sun basement entrance.
Sample Quantity:	N/A
Sample Color:	XRF:
White	ND

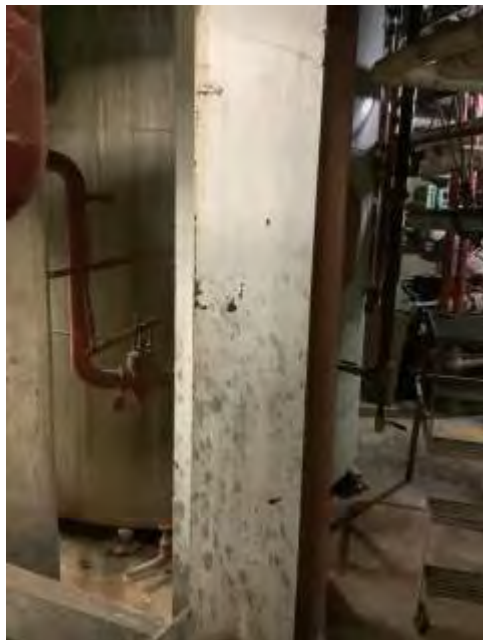
Sample ID:	Sample Type:
4-23-PB-35	PB
Sample Location:	Detailed Sample Location:
Room 11	North side of room south of active tank.
Sample Quantity:	280 linear feet.
Sample Color:	XRF:
White	5.00

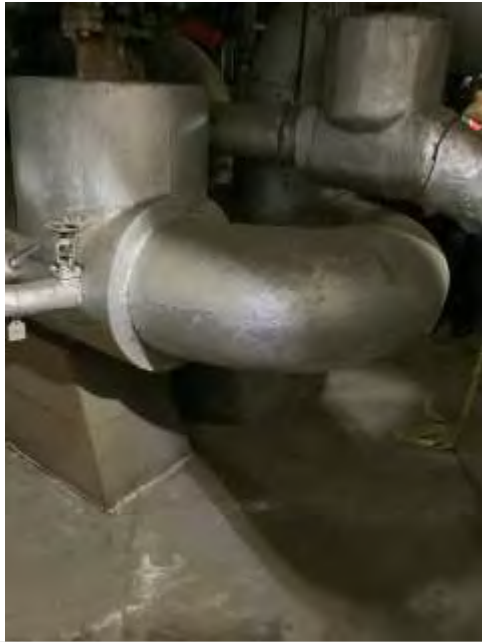
Sample ID:	Sample Type:
4-26-PB-56	PB
Sample Location:	Detailed Sample Location:
Room 11	Silver pipe wrap southeast corner of room.
Sample Quantity:	N/A
Sample Color:	XRF:
Silver	ND

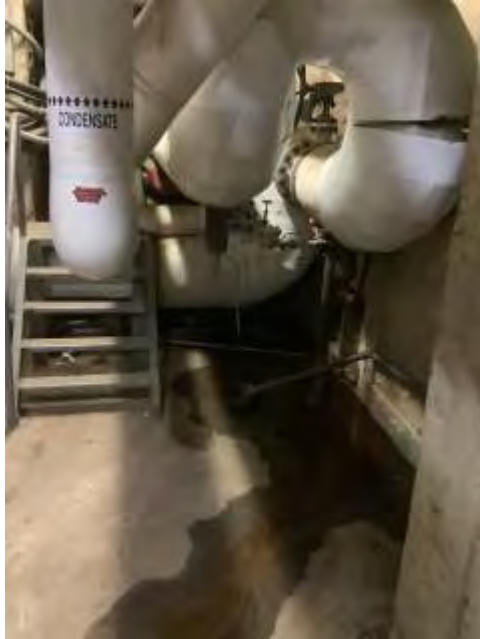
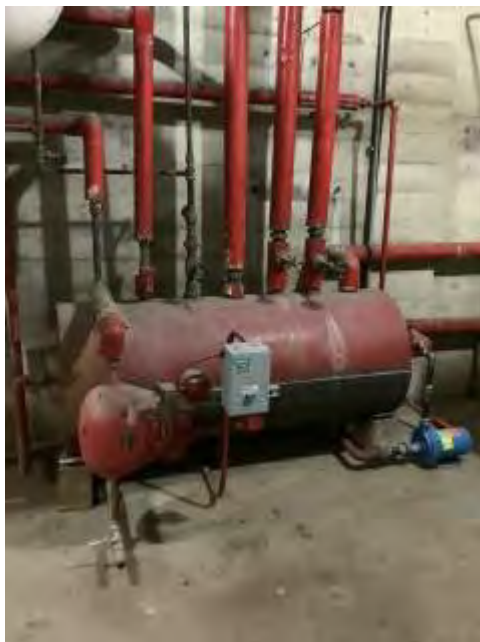
General Fixture Location:	Detailed Fixture Location:
Room 21 and room 23	Throughout rooms.
Type of Fixture:	Quantity:
Hot pipes and tanks.	Several
Condition:	Additional Fixture Notes:
Good	Burn hazard from hot pipes and tanks.

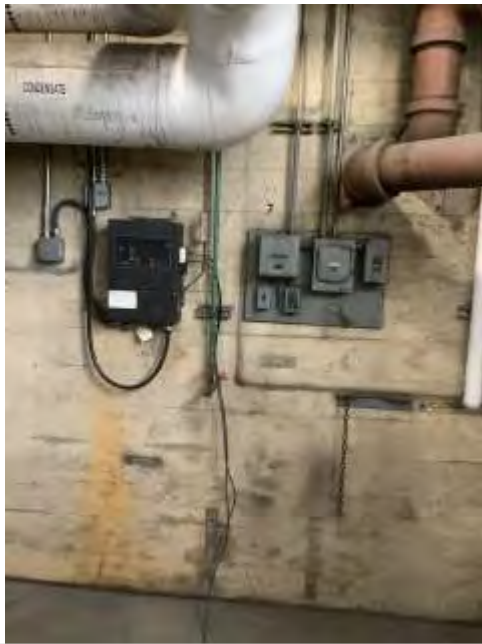
General Fixture Location:	Detailed Fixture Location:
Room 11	Throughout room.
Type of Fixture:	Quantity:
Electrical fixtures.	25
Condition:	Additional Fixture Notes:
Good	1 control box, 20 control switch, 3 electrical boxes, 1 motor control center.

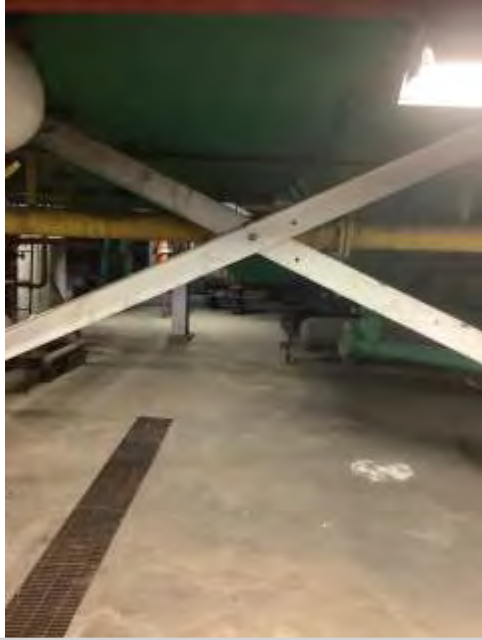
General Fixture Location:	Detailed Fixture Location:
Room 11	Throughout room.
Type of Fixture:	Quantity:
Low clearance.	Several
Condition:	Additional Fixture Notes:
Good	Low pipes and supports.

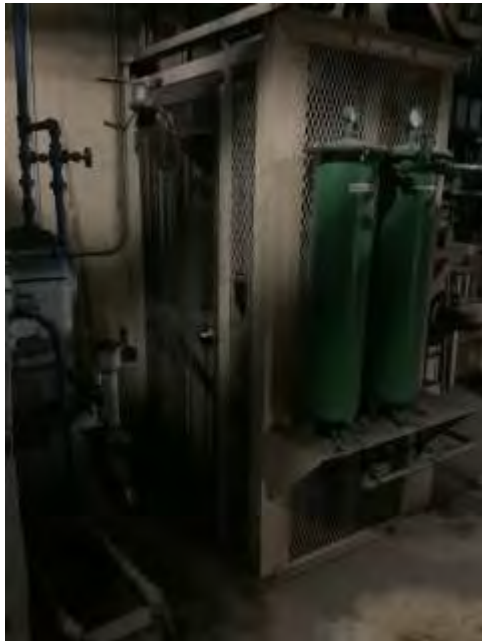
General Fixture Location:	Detailed Fixture Location:
Room 11	East side of room.
Type of Fixture:	Quantity:
Elevator shaft.	1
Condition:	Additional Fixture Notes:
Good	Potential hazard related to mechanical operation.

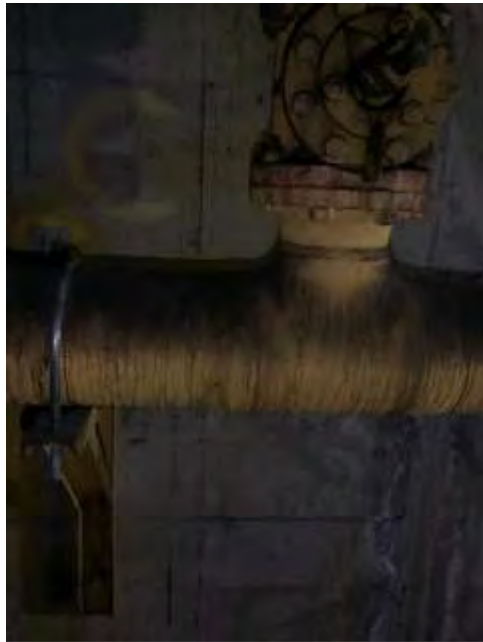
Sample ID:	Sample Type:
5-1-PB-2	PB
Sample Location:	Detailed Sample Location:
Room B1	Center of hallway.
Sample Quantity:	110 linear feet.
Sample Color:	XRF:
Yellow	ND

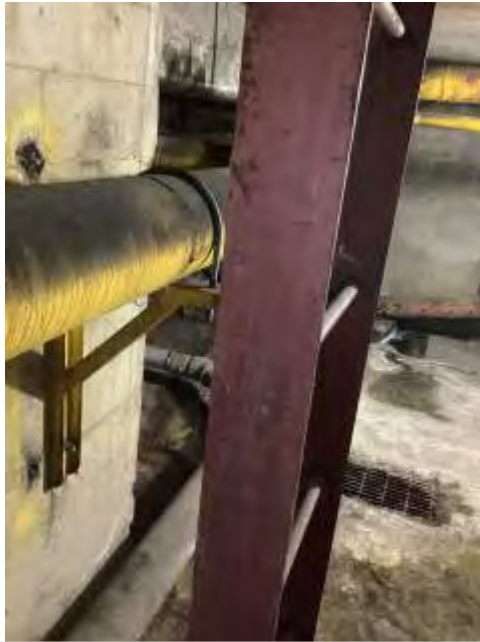
Sample ID:	Sample Type:
5-3-PB-6	PB
Sample Location:	Detailed Sample Location:
Room B1	East end in the center of hall.
Sample Quantity:	N/A
Sample Color:	XRF:
Brown	ND

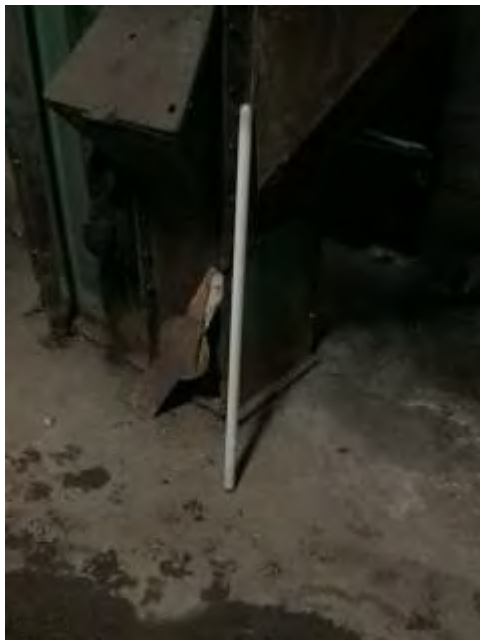
General Fixture Location:	Detailed Fixture Location:
Room B2	Whole room.
Type of Fixture:	Quantity:
Confined space.	1
Condition:	Additional Fixture Notes:
Good	Confined space hazard in room B2.

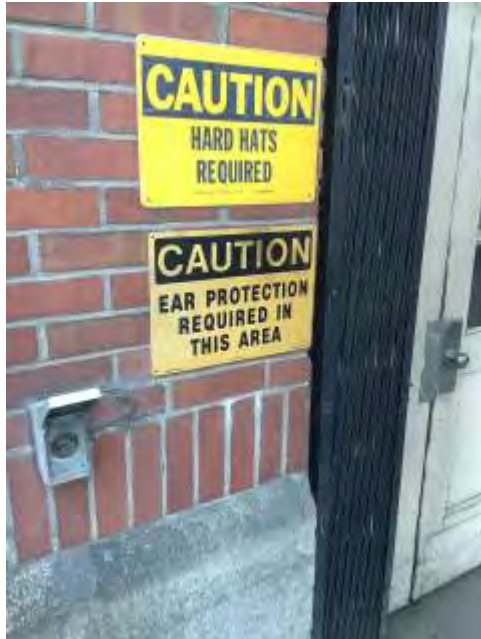
Sample ID:	Sample Type:	
EXT-1-MISC-1	MISC	
Sample Location:	Detailed Sample Location:	
West exterior side of structure.	West exterior side of room 101 north of double doors next to ash pit tower.	
Sample Quantity:	15,000 square feet.	
Misc Sample Material:	Sample Condition:	Sample Friable?:
Red brick	Potential ACBM with potential for damage; Remaining friable ACBM or friable suspected ACBM	No

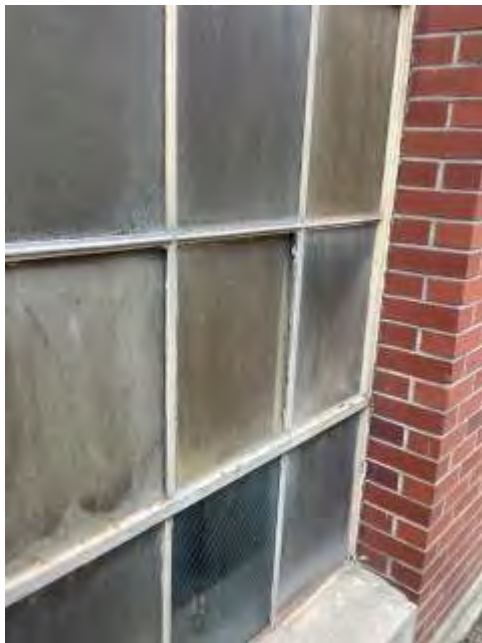
EXT-3-MISC-6

Misc Sample Material: Window glazing **Sample Condition:** Potential ACBM with potential for damage **Sample Friable?:** No
