**REPORT ON  
CUSTOM PLYWOOD MILL SITE  
PHASE III SUBTIDAL SEDIMENT CLEANUP  
CONSTRUCTION COMPLETION REPORT  
CLEANUP SITE IDENTIFICATION NO. 4533  
FIDALGO BAY  
ANACORTES, WASHINGTON**

by  
Haley & Aldrich, Inc.  
Seattle, Washington

for  
Washington State Department of Ecology  
Olympia, Washington

File No. 0202972-000 (19600-00)  
12 January 2024

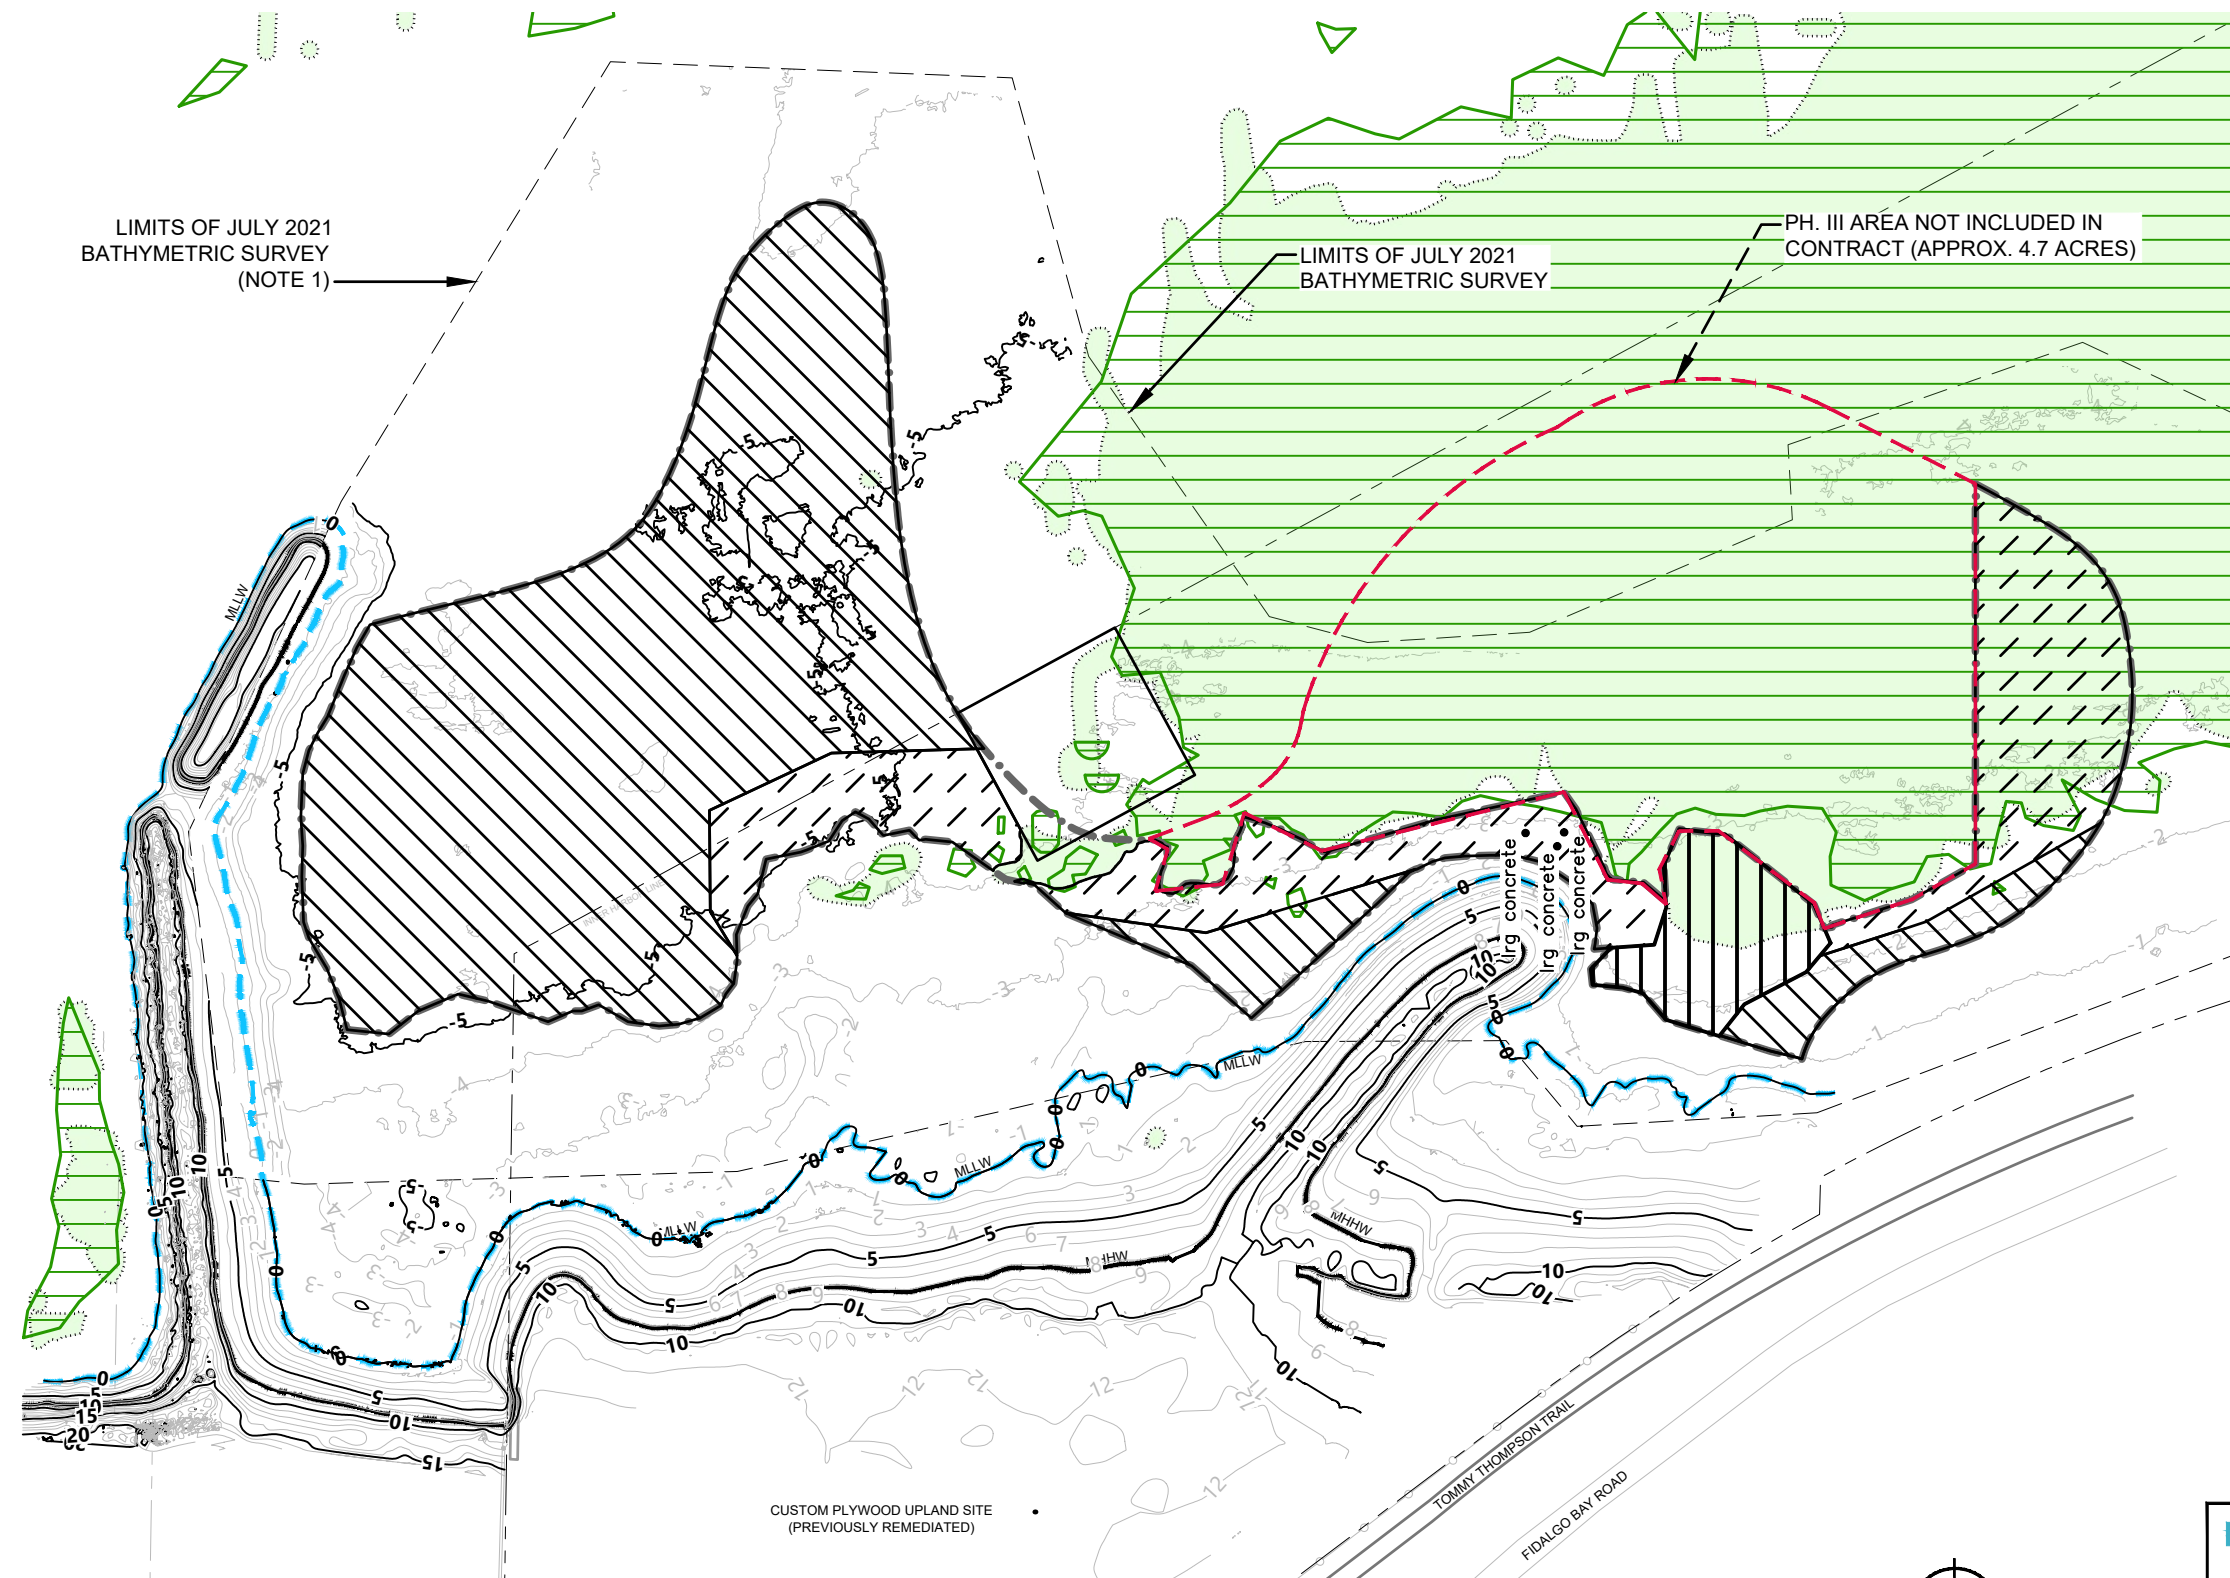
**FIGURE 2**

Subtidal thin-layer capping consisted of two target areas containing 10 to 25 ppt dioxin TEQ (as shown on Figure 2):

Figure 2 presents the overall Phase III cleanup area that was identified/determined by comparing dioxin concentrations in surface sediment to the remedial action levels described above. The cleanup area includes 4.7 acres of eelgrass that has been identified for a 2-inch TLC. Of the 4.7 acres of eelgrass, 4.1 acres were not included in this current design and construction work but may be addressed later, pending eelgrass health after placement in a 0.6-acre test area. Additional rationale used to establish the aquatic SMAs based on dioxins/furans can be found in the FS and CAP-EDR. See Section 7.4.

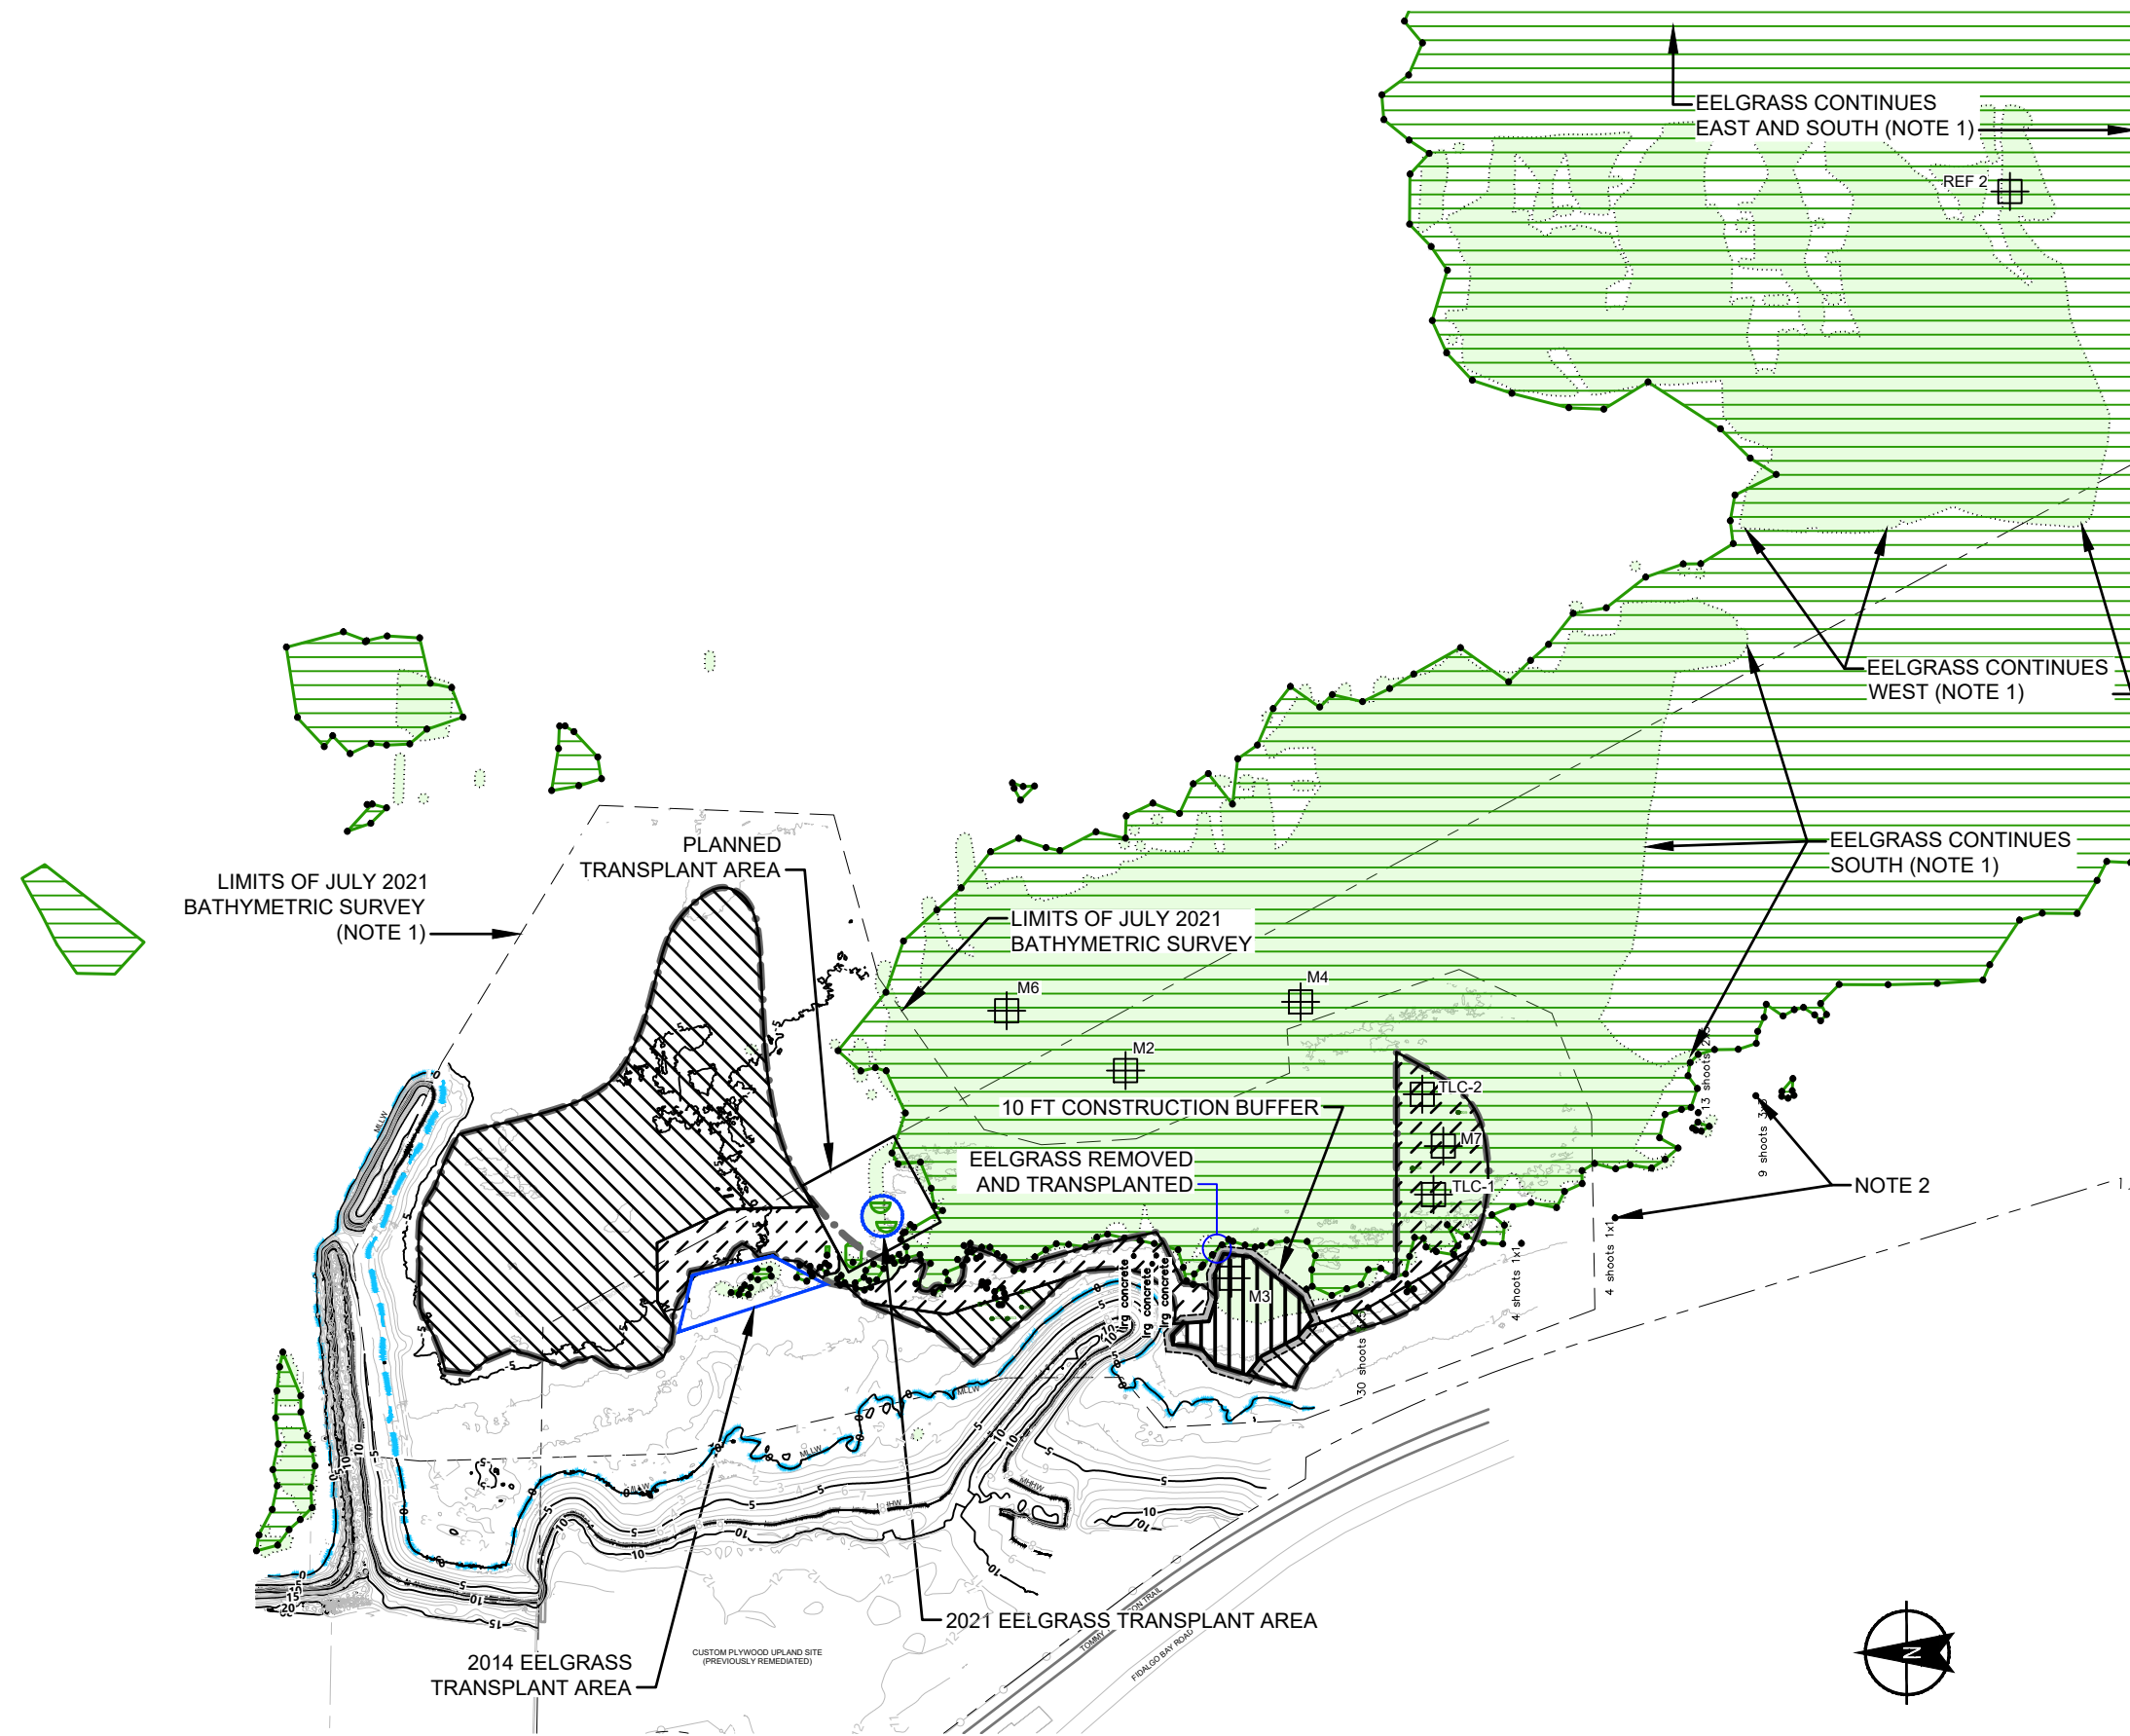
**FIGURE 3**

To prevent destruction of eelgrass from dredging within this area, eelgrass was transplanted from the dredge perimeter and from within a 10-foot buffer around the planned dredging boundary to the 2021 transplant area (Figure 3). Previous Phases identified a suitable mitigation area, resulting in proactive eelgrass transplant in 2014 to the north of the main bed and within the remedial action boundary (RAB). Subsequent monitoring of the 2014 transplant area found that the planted eelgrass persisted after planting, but has fluctuated and decreased in total area. In the time that the 2014 transplant area decreased, the northern boundary of the main bed extended towards the transplant area (Hart Crowser, 2020). As such, the mitigation area for Phase III was shifted to the southeast (Figure 3) to encourage new shoot recruitment between the northern main bed boundary and 2014 transplant area. Details regarding pre-construction transplanting can be found in Section 5.2.1 and Appendix C.

Transplanting for Phase III construction in 2021 included planting 494 planting units (PU) with an average of four shoots per PU for a total of 2,025 shoots. Transplanted shoots cover approximately 50 m<sup>2</sup> (538 ft<sup>2</sup>), planted at a density of 36 shoots/m<sup>2</sup> (~3 shoots/ft<sup>2</sup>). Shoots were transplanted into the identified 2021 transplant area in the westernmost corner, bridging an area between new recruitment and the 2014 transplant area (Figure 3).

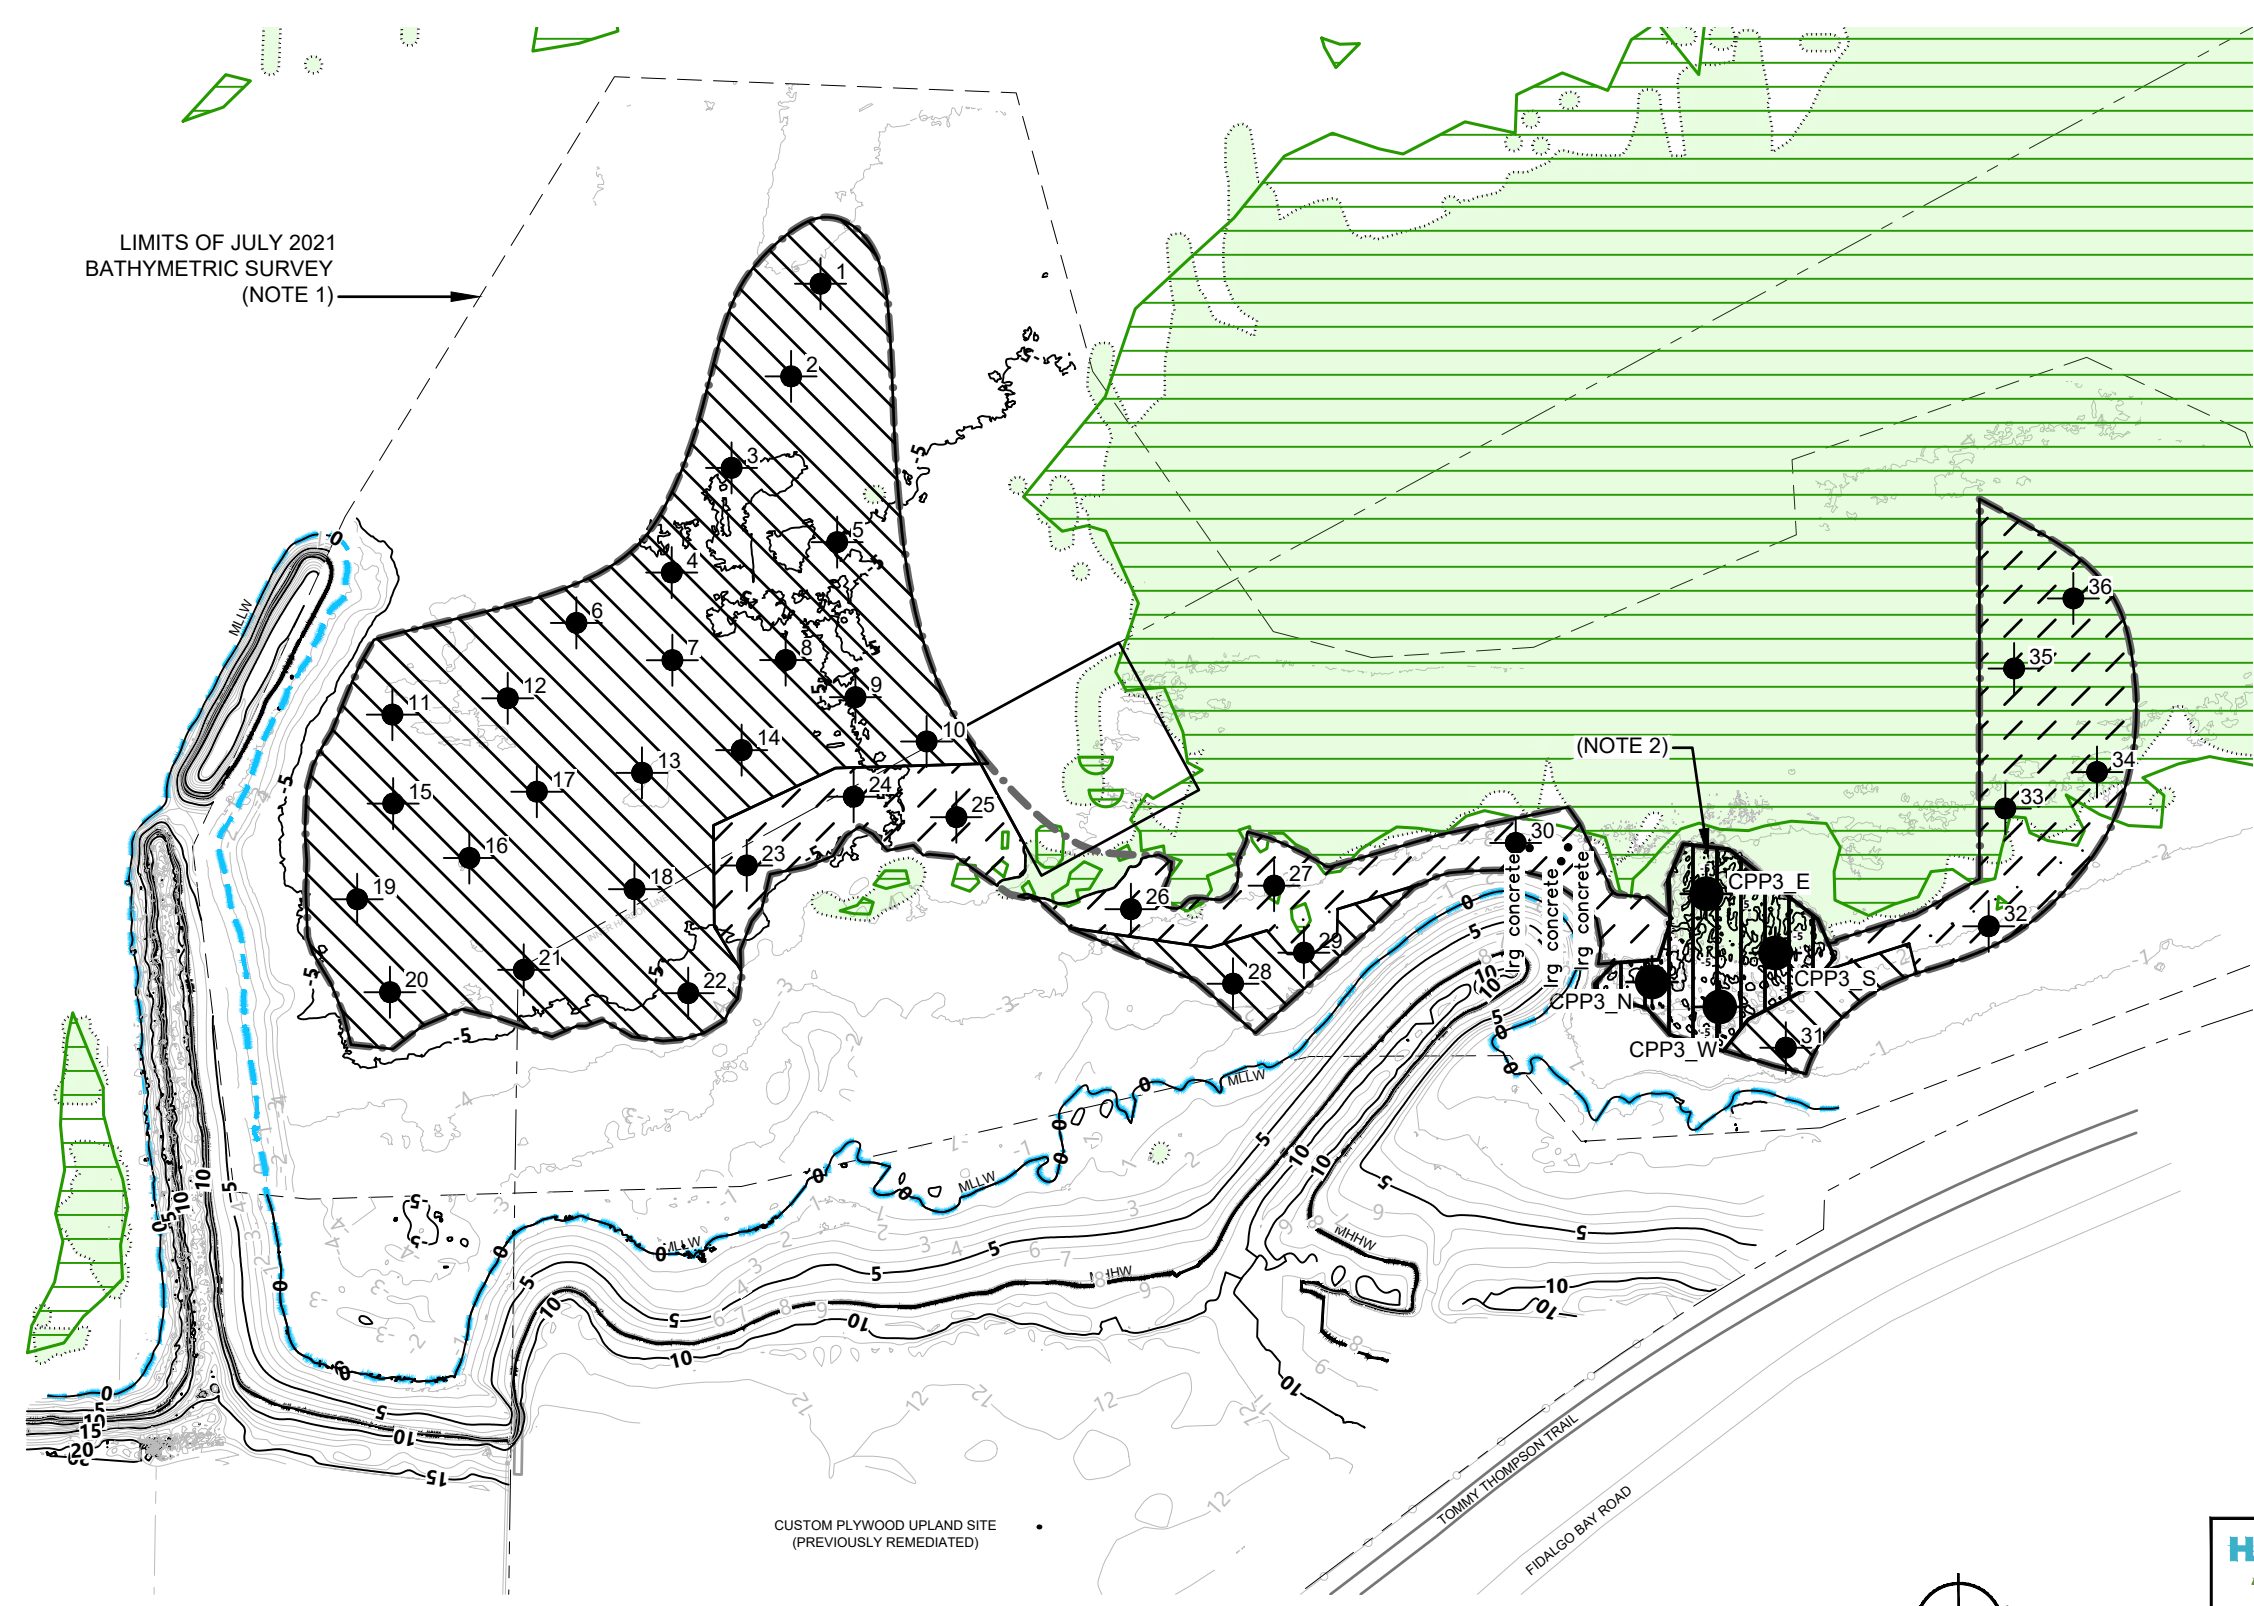
**DREDGE BOTTOM DOCUMENTATION SAMPLES AND TLC THICKNESS CHECK POINTS**

A target volume of approximately 1,500 CY of contaminated sediment (wet volume) was planned to be dredged (over a 0.37-acre footprint), loaded directly to barges for decanting/dewatering, and disposed of at an upland landfill facility. Dredging was performed to remove the upper 2 feet of sediment affected by wood waste and dioxins/furans in the 0.37-acre subtidal area on Figure 2. A total of 1,411 CY of sediment were dredged (Table 2). The extent of dredging is shown on Figure 4, and post-construction as-built drawings are provided in Appendices A02 to A05.

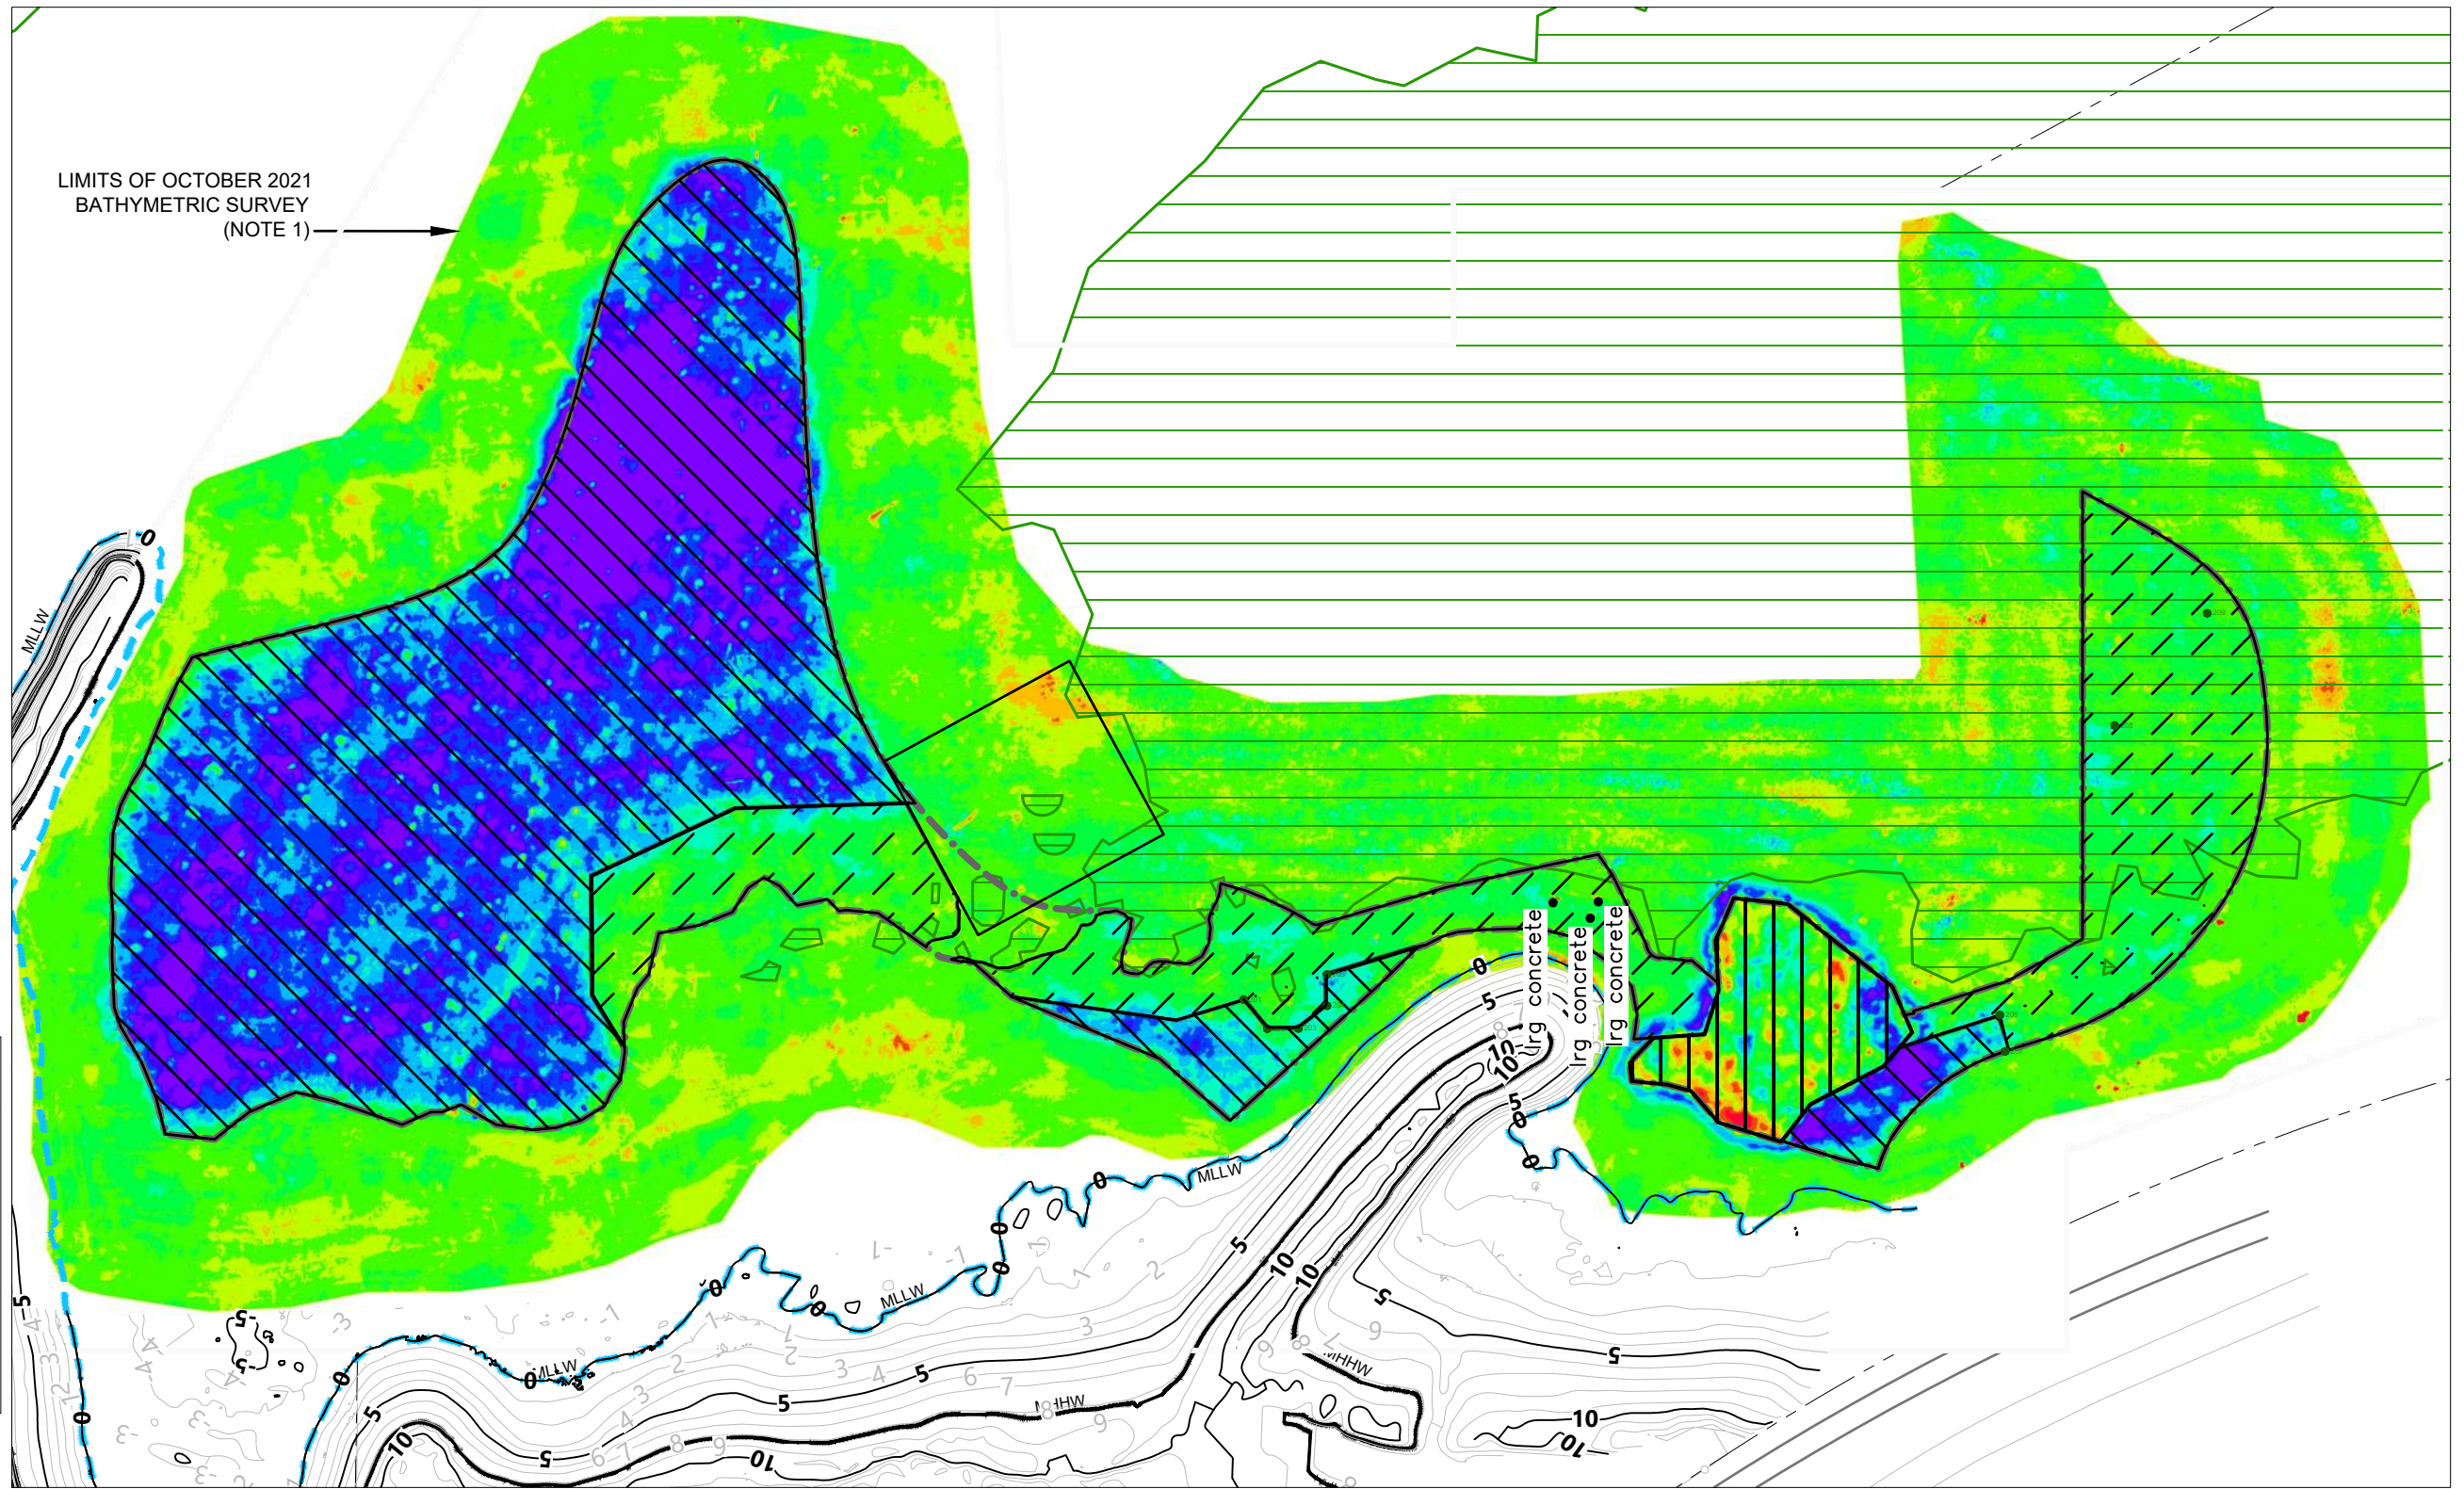
**FIGURE 7**

Several locations where spuds were placed were investigated by Grette divers following construction to gather additional information regarding the impact of spudding on benthic habitats. These areas were investigated visually though visibility proved to be challenging. Of the six locations observed, only two showed evidence of scarring or mounding likely caused by spudding. One spud location was directly adjacent to known eelgrass and was prioritized because of its proximity to the transplant area and potential for greater disturbance. Weather conditions led to movement of the barge while placing the spud, resulting in a small trench from the spud dragging before it was deep enough to stop barge movement. Divers did note a trench at this location approximately 2 feet wide by 8 to 10 feet long, about 1 to 1.5 feet deep. No eelgrass was present in or around the trench; therefore, we assume no eelgrass was damaged by this spud being dragged. This same trench is visible on the high-resolution bathymetry imagery included in Figure 7 (see call out).
