TECHNICAL MEMORANDUM

DATE: February 27, 2024

RE: **Former Mill E / Koppers Facility
2023 Annual Performance and Compliance Monitoring Report**

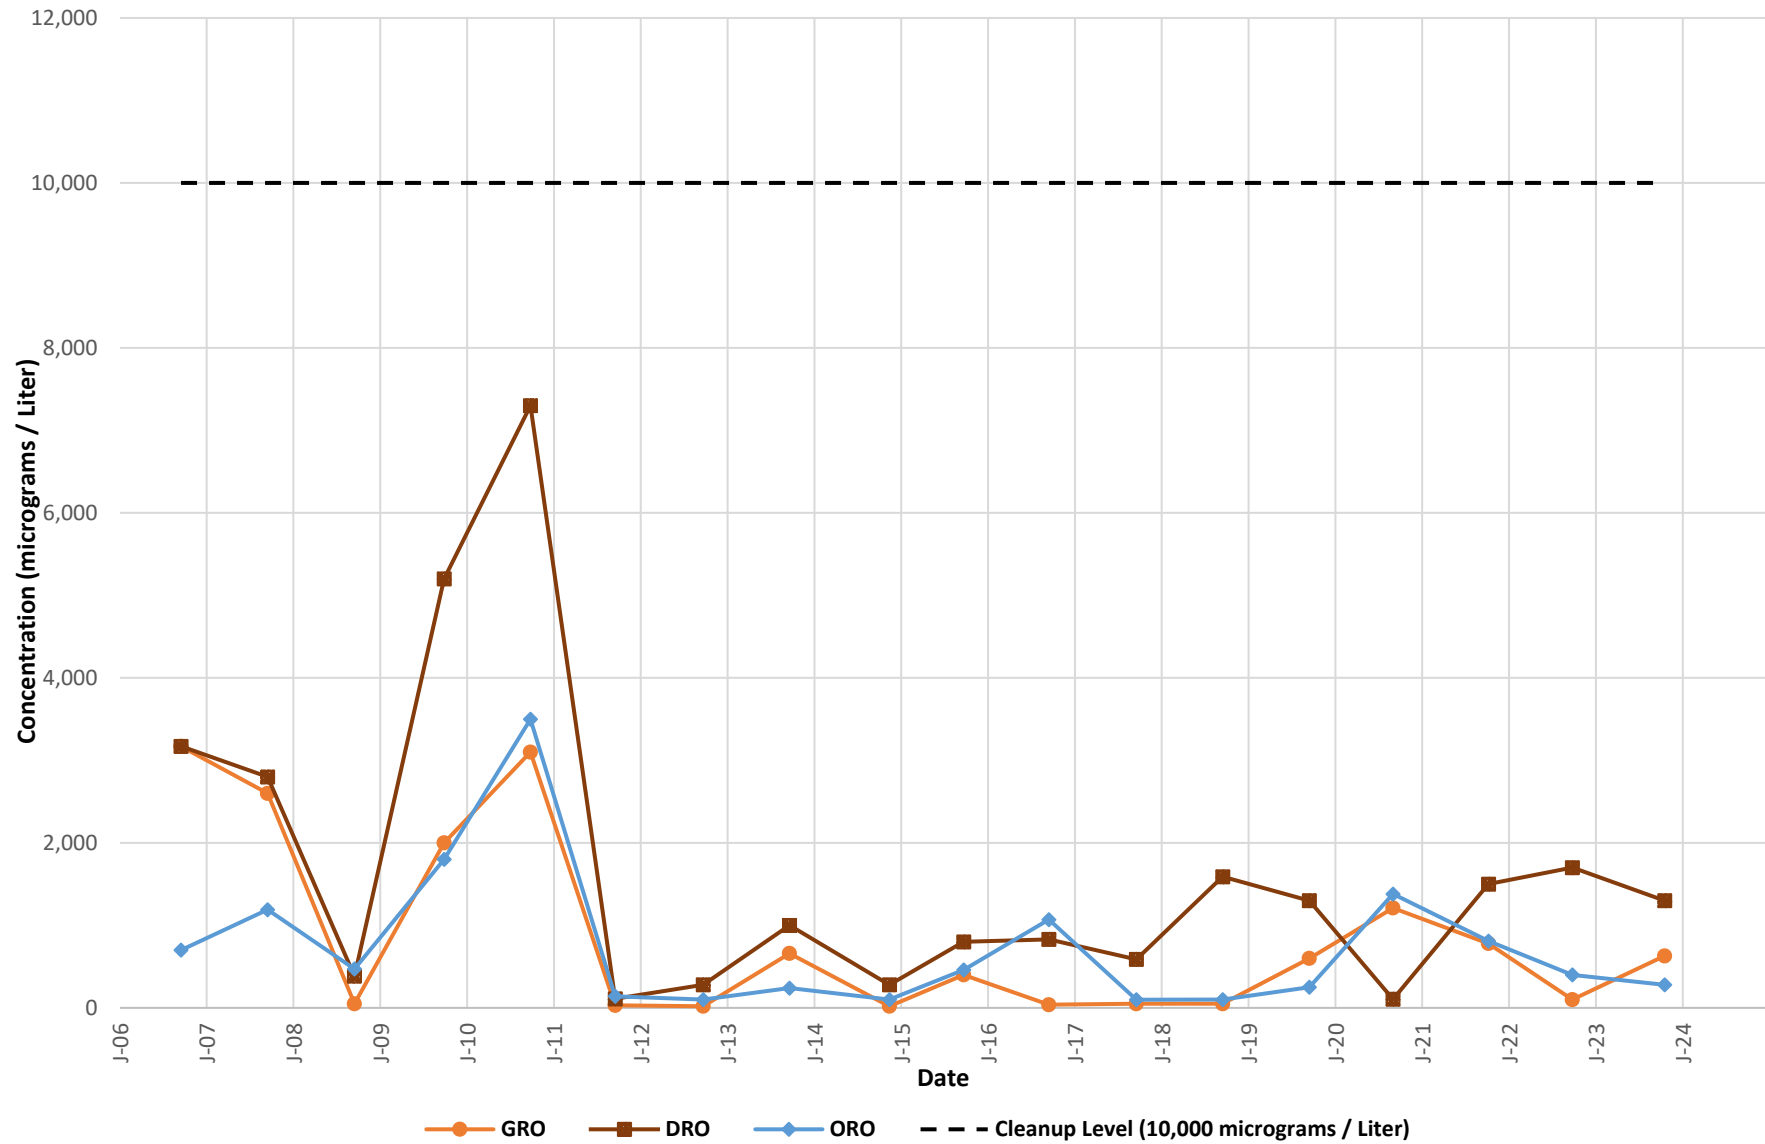
Figure 6
Groundwater Quality Trends for PZ-3A
Total Petroleum Hydrocarbons
Former Mill E/Koppers Facility
Everett, Washington

Groundwater analytical results are presented in Table 4 and a copy of the analytical laboratory report and chain of custody is included as Appendix A. The results are compared to the Washington State Model Toxics Control Act (MTCA) Method A and Method C cleanup levels that were established for the Site during the 1998 Consent Decree (Washington State Department of Ecology [Ecology], 1998). Concentrations of total petroleum hydrocarbons (TPH) including GRPH, DRPH, and ORPH were below the established MTCA cleanup level criteria of 10,000 micrograms per Liter ($\mu\text{g/L}$). PCP was not detected at a concentration exceeding the laboratory reporting limit. Total arsenic was detected at a concentration of 708 $\mu\text{g/L}$, which exceeds the established MTCA cleanup level criteria of 5 $\mu\text{g/L}$. Groundwater quality concentration trend (time-concentration) graphs over the past several years for TPH, PCP, and arsenic are presented on Figures 6 through 8, respectively.
