ASPHALT INSPECTION FORM

Darling Ingredients - Tacoma, Washington Facility

Facility No.: 25455514, Cleanup Site No.: 8475, VCP Project No.: SW1317

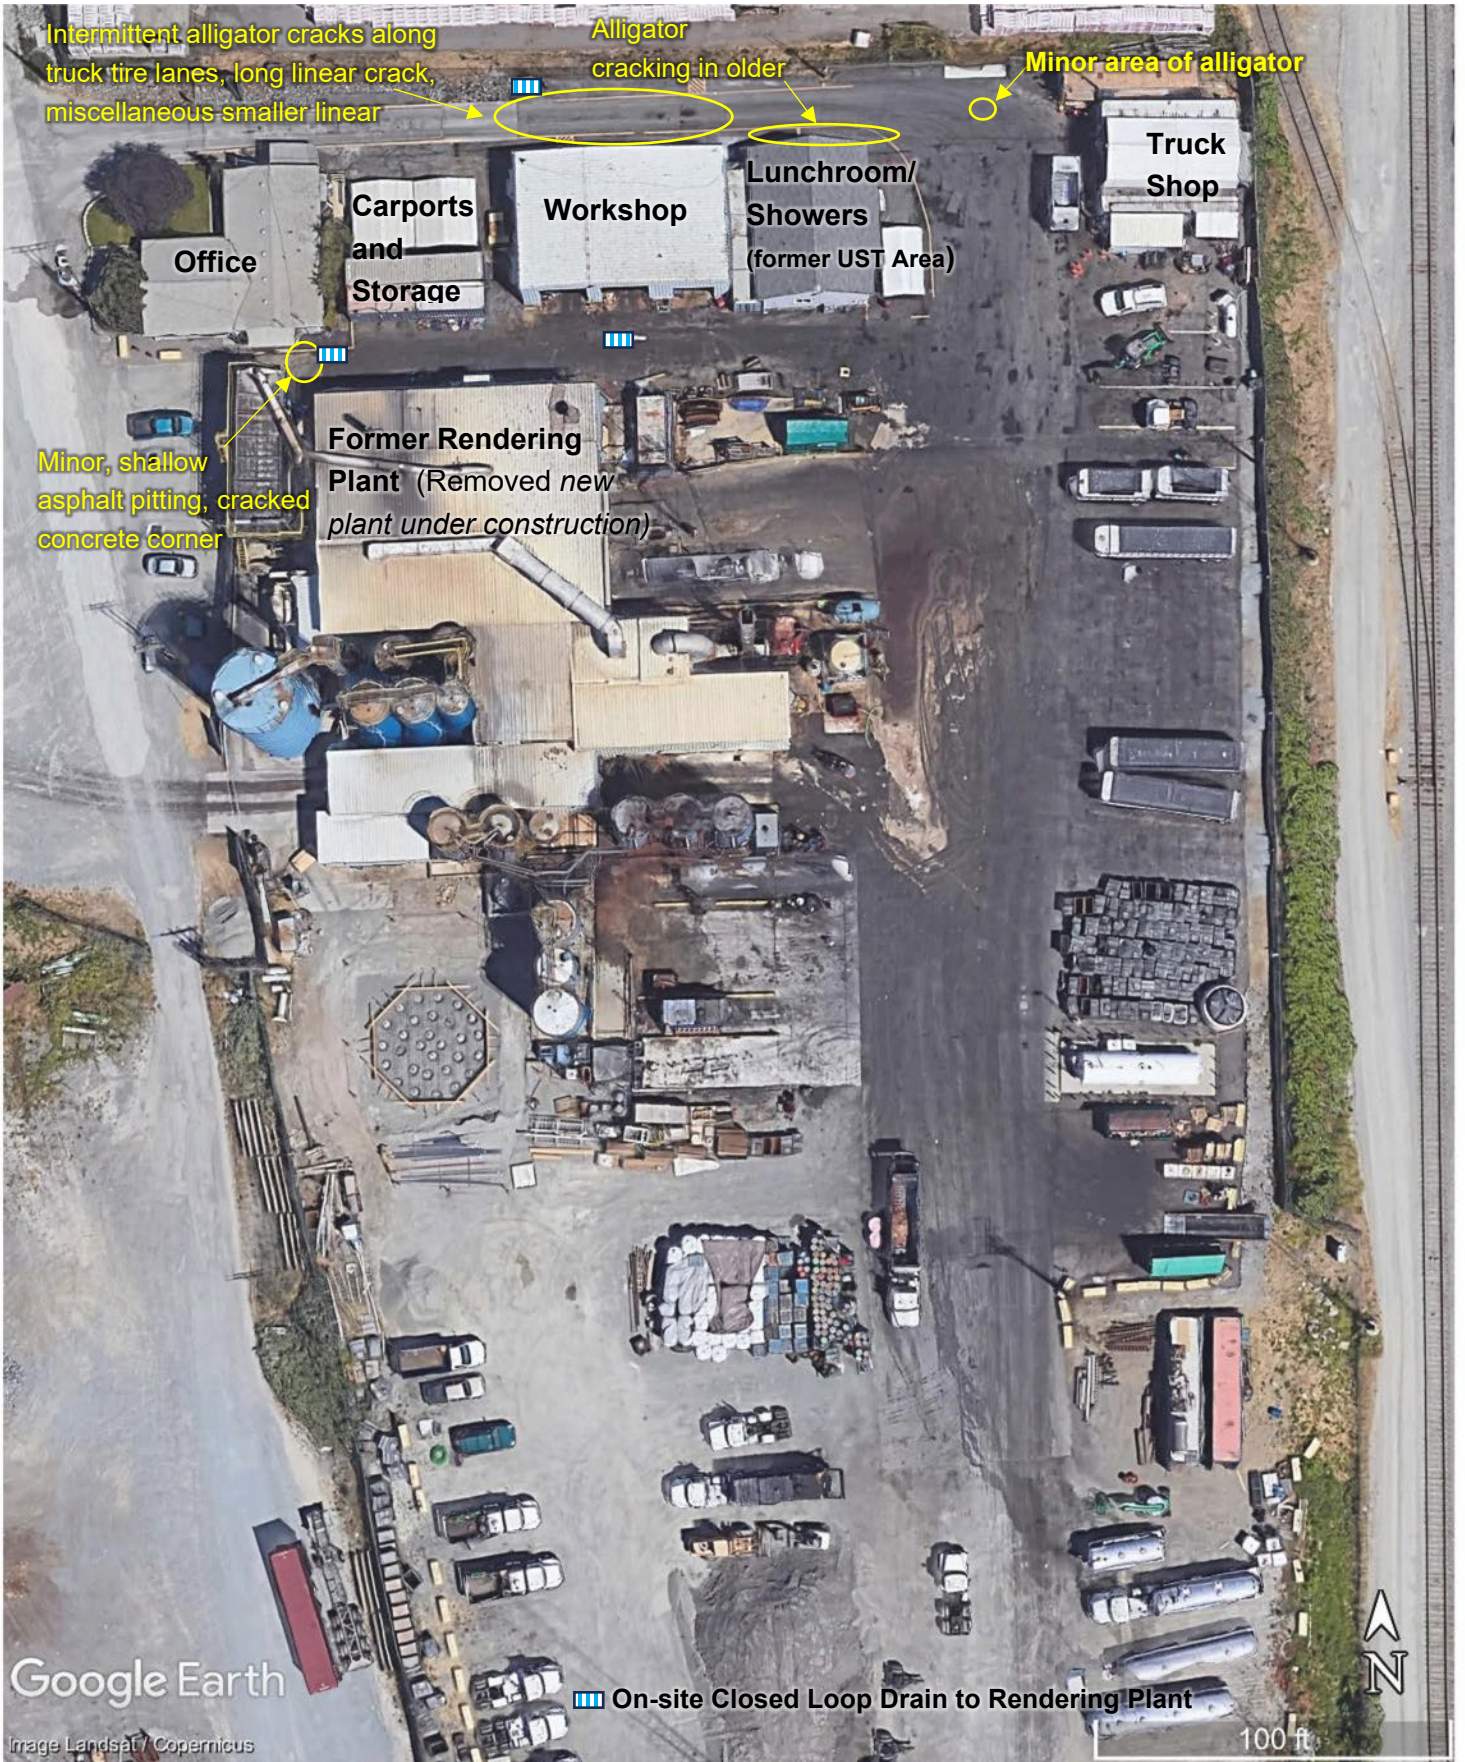
<p>List the location(s) of the areas identified that indicate potential degradation and describe the condition observed. Locate the locations on the map.</p> <p><i>Surface conditions appeared relatively unchanged since the 2023 asphalt inspection. Minimal truck traffic on site due to rendering plant being shut down from a fire; a new plant is under construction. See attached map and photograph log. Alligator cracks and some linear cracks observed primarily on the north side of the workshop and lunchroom buildings. The north gate with weigh scale is the main site entry for haul trucks in and out of the facility.</i></p> <p><i>Note: Crack locations on attached map are approximate.</i></p>

How many areas of the above types of cracking were identified? <i>Two primary areas along truck route north of workshop and lunchroom buildings, and one minor area of alligator cracking near truck shop at northeast corner of truck route.</i>	# of Areas <u> 3 </u>
List the location(s) of the cracks identified and describe the condition and pattern observed (hairline, linear, circular, etc.). Locate the crack areas on the map. <i>See map. Cracks observed appeared to be linear and alligator cracking. Multiple locations of asphalt joints along asphalt patches but appeared in good condition.</i>
