**FINAL Third Periodic Review
Louisiana Pacific Corp
(aka Pony Lumber Company LLC)**

**3701 Taylor Way, Tacoma, Pierce County, 98421
Facility Site ID: 1209, Cleanup Site ID: 2317**

February 2025

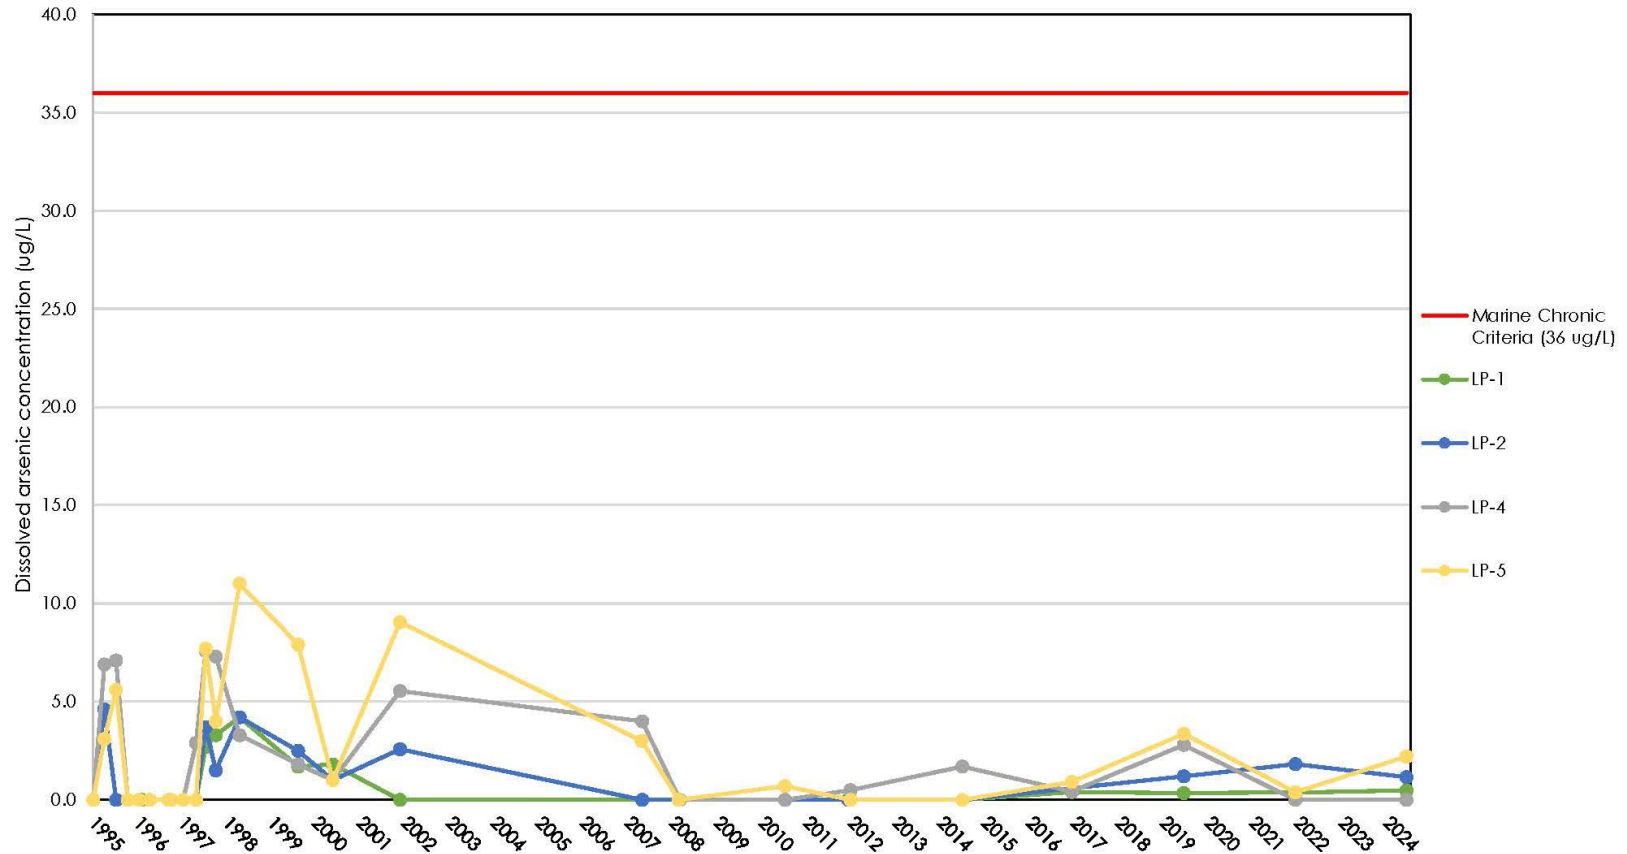
Figure 1. Dissolved Arsenic Trend Plot – 1995 to 2024 (MFA 2024)

Notes:
 All values were below applicable marine chronic criteria in 2024.
 See Table 2 for analytical data.
 Several of the concentrations are undetected results plotted at the reporting limit or are estimated values.
 ug/L = micrograms per liter.

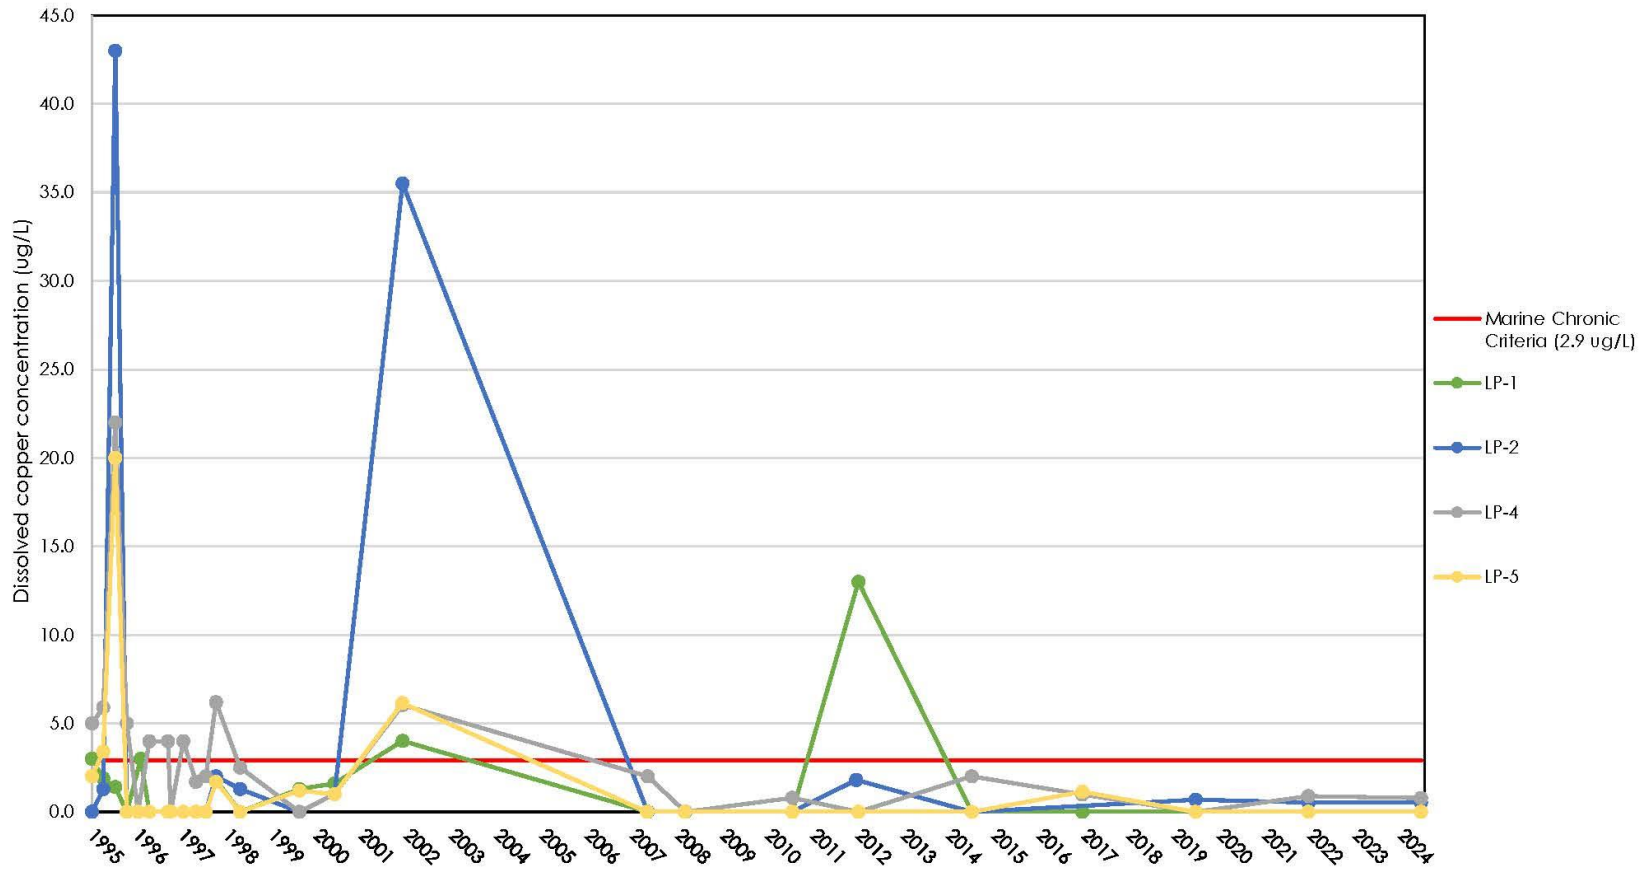
Figure 2. Dissolved Copper Trend Plot – 1995 to 2024 (MFA 2024)

Notes:
 All values were below applicable marine chronic criteria in 2024.
 See Table 2 for analytical data.
 Several of the concentrations are undetected results plotted at the reporting limit or are estimated values.
 ug/L = micrograms per liter.
