# PORT OF EVERETT: WEYERHAEUSER MILL A CLEANUP PROJECT

## BASELINE EELGRASS AND SHORELINE HABITAT SURVEY

FEBRUARY 3, 2023

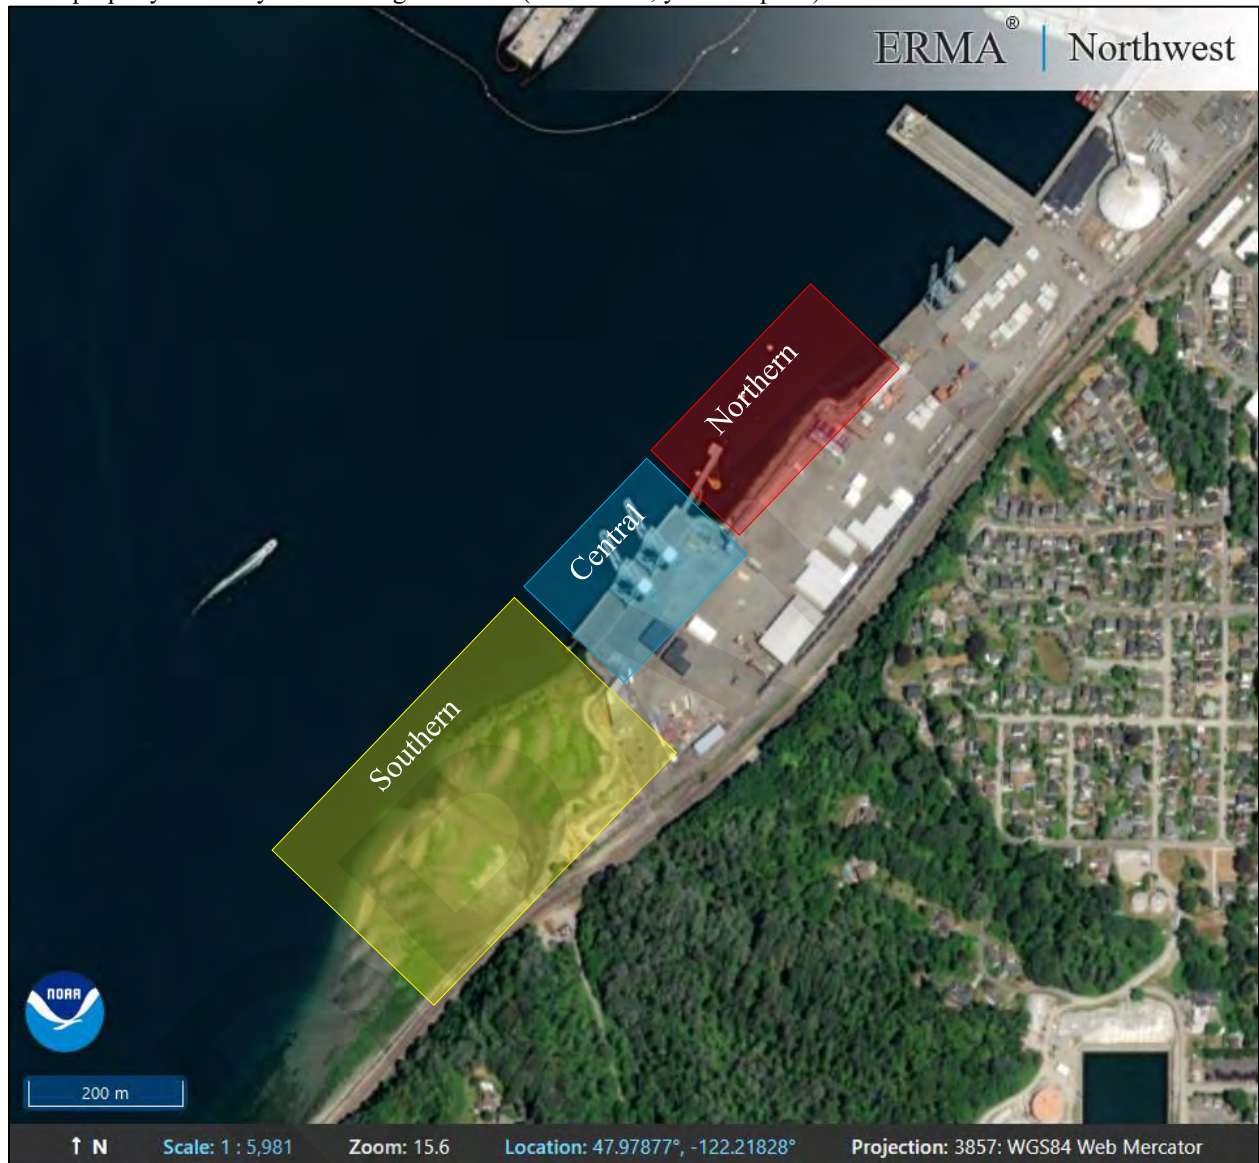
Three primary shoreline zones were noted on Site based on similarity of conditions (see Figure 2): 1.) the shoreline from the South Terminal wharf to the Pacific Terminal wharf further north, 2.) the shoreline beneath the South Terminal wharf, and 3.) the large sandy mudflat between the South Terminal wharf and property boundary South of Pigeon Creek. These areas will be discussed and referenced to as the “Northern”, “Central”, and “Southern” portions of the Site, respectively. The following results describe the entirety of the shoreline generally above 0 feet Mean Lower Low Water (MLLW). The shoreline survey datasheet is in Appendix A, with additional Site photographs in Appendix E; all shoreline survey photographs were taken on September 7, 2022, during the site visit.

**Figure 2. Location of the Shoreline Habitat Survey, and the zones of the Site.** The three zones include: 1.) the armored shoreline north of the South Terminal (“Northern”, red square), the armored shoreline covered by the wharf of the South Terminal (“Central”, blue square), and 3.) the armored shoreline and mudflats south of the South Terminal to the property boundary south of Pigeon Creek (“Southern”, yellow square).

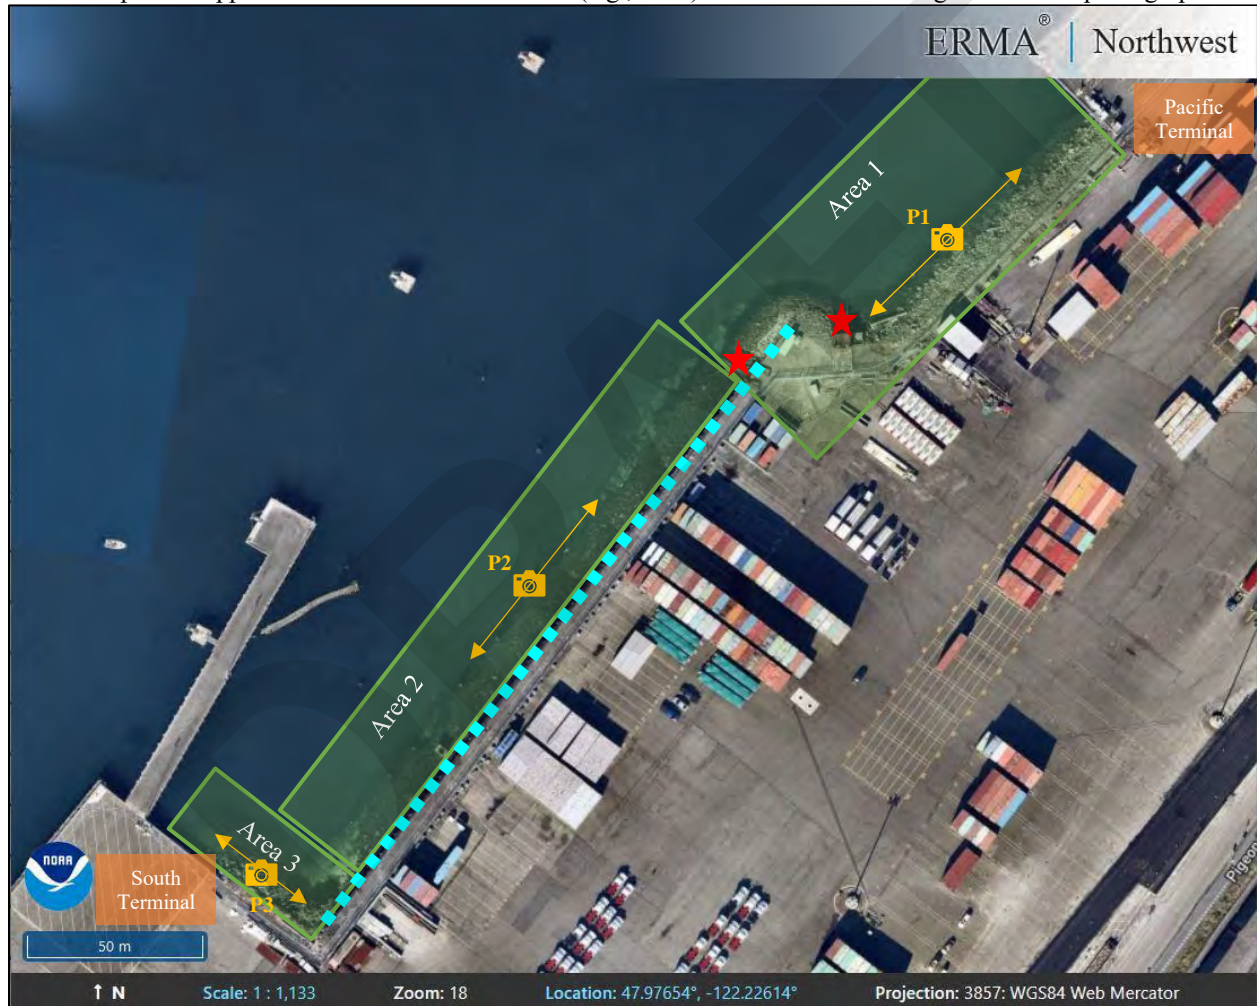
The following data for the Northern shoreline will be discussed as a whole, and in terms of three (3) areas (Areas 1-3; see Figure 3). Though similar conditions were observed throughout the entire shoreline, the slope angle differs between each area, as discussed below. The total linear distance of this shoreline is approximately 1,200 feet, ranging in width (top of bank to 0 ft MLLW) from 37 to 60 feet, with the exposed shoreline spanning a total of approximately 0.9 acres.

**Figure 3. Northern shoreline conditions** between the South and Pacific Terminals in the Port of Everett. The shoreline is separated into three areas (1, 2, and 3) represented by green boxes, the red stars are the locations of two sets of derelict rails leading down to the waterline, the blue dotted line represents the timber bulkhead, and the yellow cameras represent approximate Photo Point locations (e.g., “P1”) with arrows indicating direction of photographs.

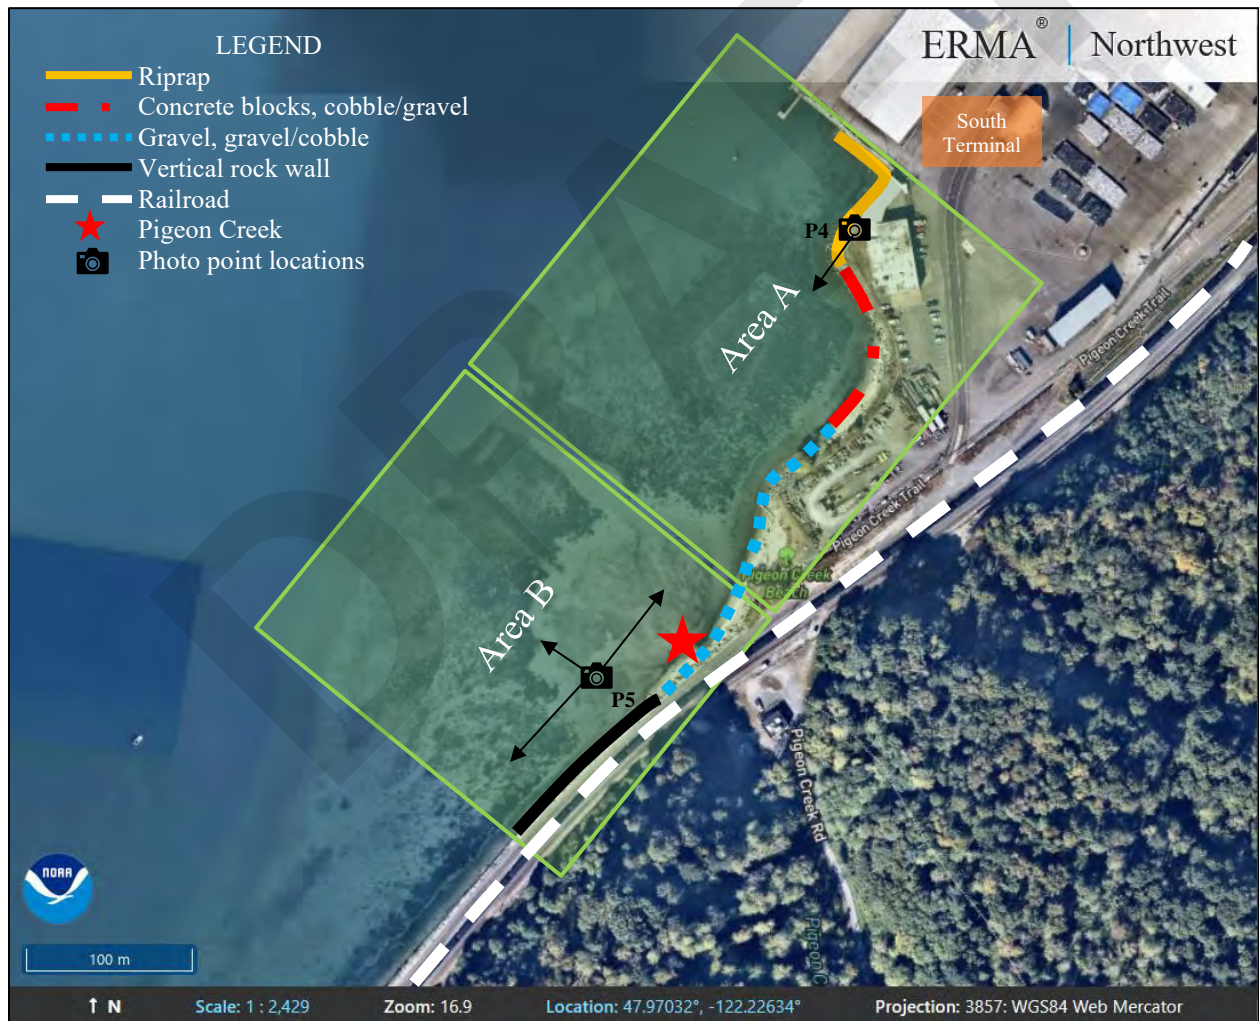
Most of the Southern shoreline is a mudflat, consisting of a mix of soft silt and sand. This mudflat is partially formed as the delta from the input of Pigeon Creek, which enters Puget Sound in this area. Upper intertidal areas include areas of gravel and shell hash. Armored slopes support the majority of this shoreline which is adjacent to developed industrial properties in the Port of Everett, and a railroad track. Photo Points displaying the Site as a whole are presented in Photograph 9 through Photograph 12.

**Figure 4. Southern shoreline conditions** from the South terminal to the property boundary line south of Pigeon Creek (creek entrance onto shoreline noted by the red star). The shoreline is separated into two areas (A and B) represented by green boxes, and the legend describes the primary types of substrates present along the armored boundaries of the shoreline. Approximate Photo Point locations (e.g. “P4”) are indicated by the cameras, with arrows noting direction of photograph taken. Note that these locations are generalized, and roughly estimate what is present on Site.

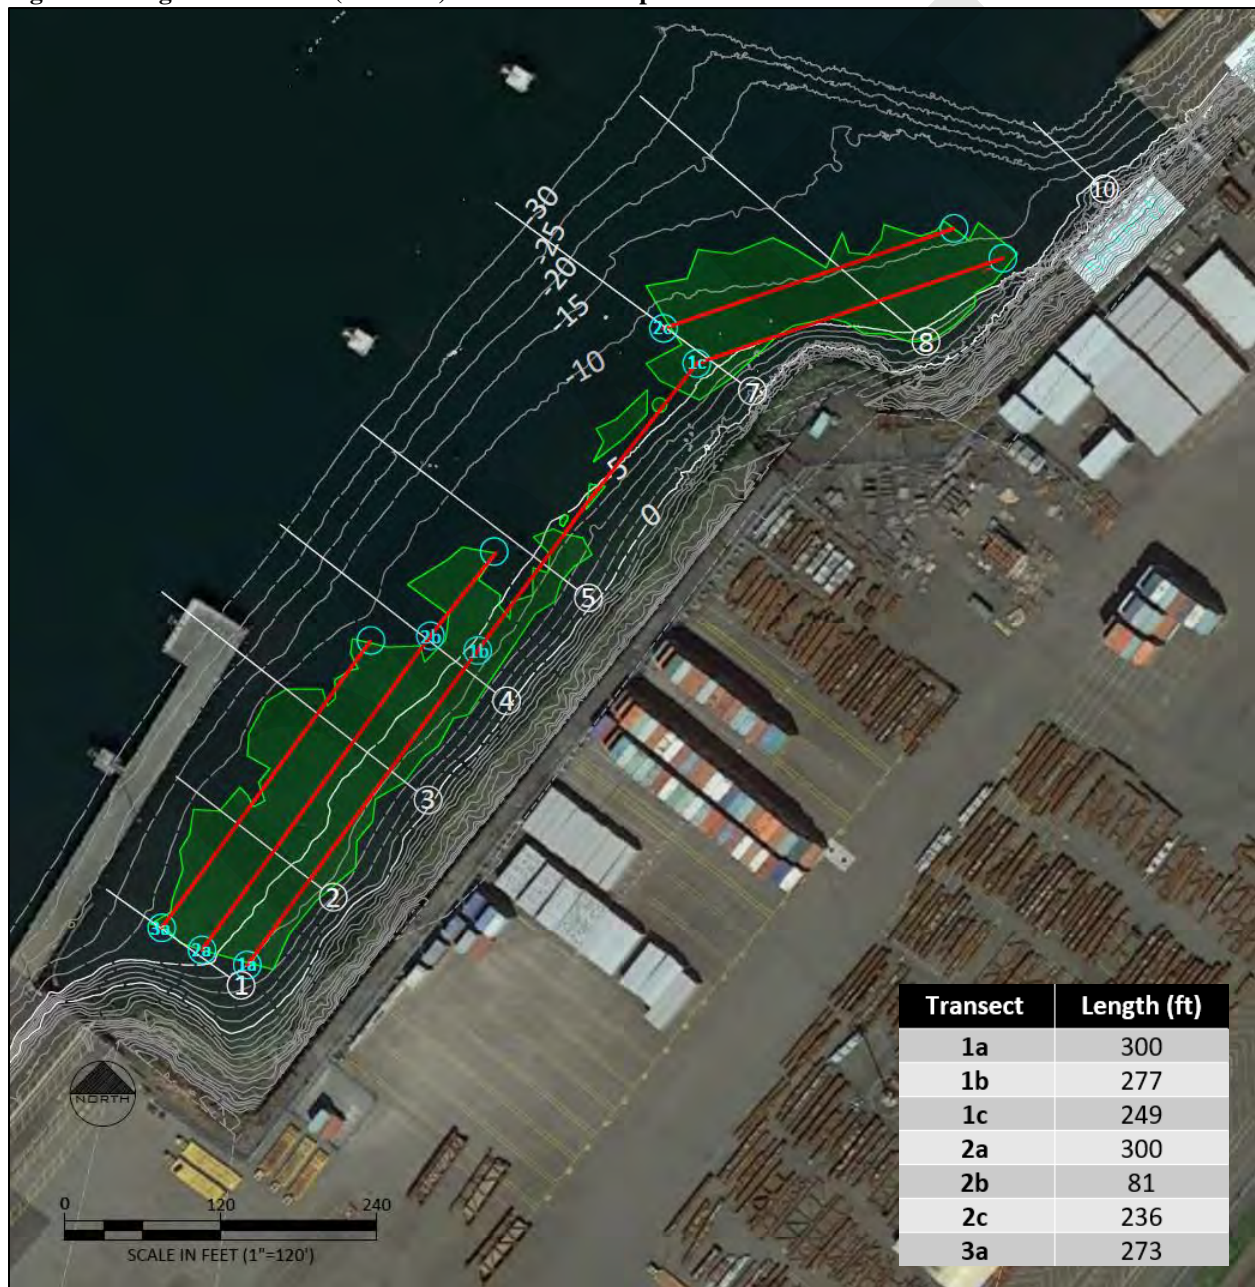
**Figure 5. Eelgrass transects (red lines) in the Northern portion of the Site.**

The northern eelgrass bed is divided by a gap in eelgrass coverage, with two dense sub-beds separated by approximately 200 ft of sparse, patchy eelgrass (Figure 5). This may be a result of substrate limitations, as substrate in this area is larger with a higher component of cobble than areas of higher eelgrass density (see Appendix B, Transect 1c).

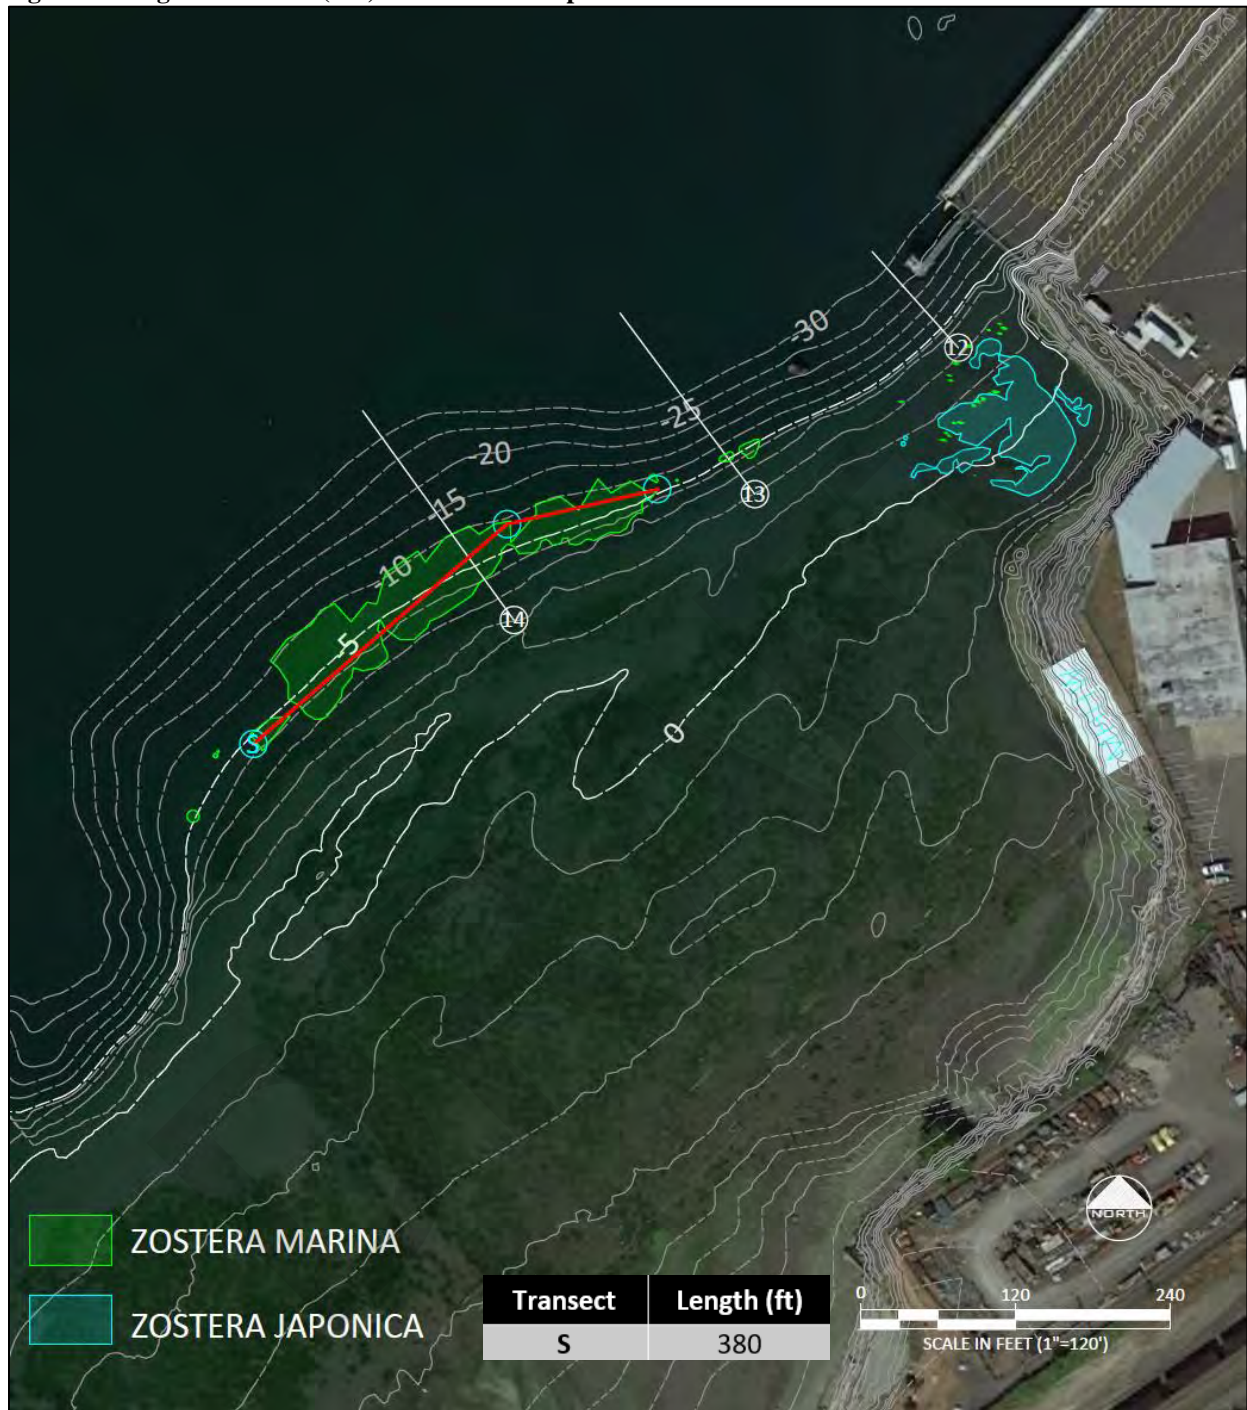
**Figure 6. Eelgrass transect (red) in the Southern portion of the Site.**

Dwarf eelgrass (*Z. japonica*) was not observed during SCUBA surveys; however, as identified during the Shoreline habitat survey, it is present at higher elevations in a single, 0.14-acre bed immediately south of the southern wharf (Figure 6, see Section 2).

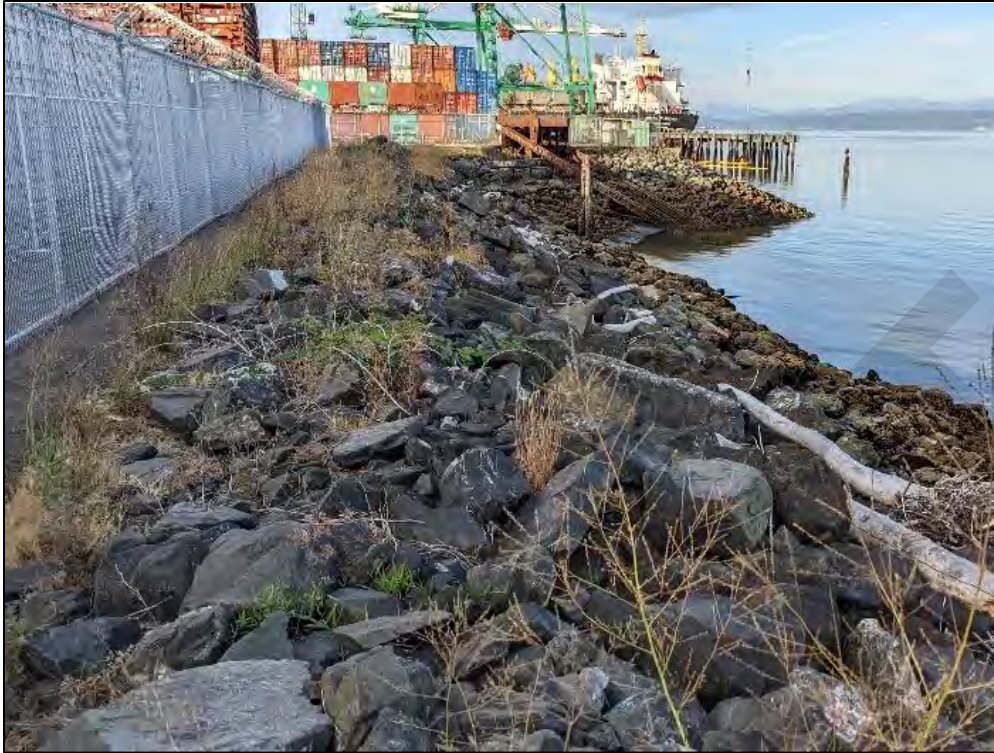
**Photograph 16. Sparsely vegetated upland areas of the Northern shoreline; typical conditions.** Area 1 (above) near the Pacific Terminal facing southwest, and Area 2/3 (below) facing southwest near the northern edge of the South Terminal.

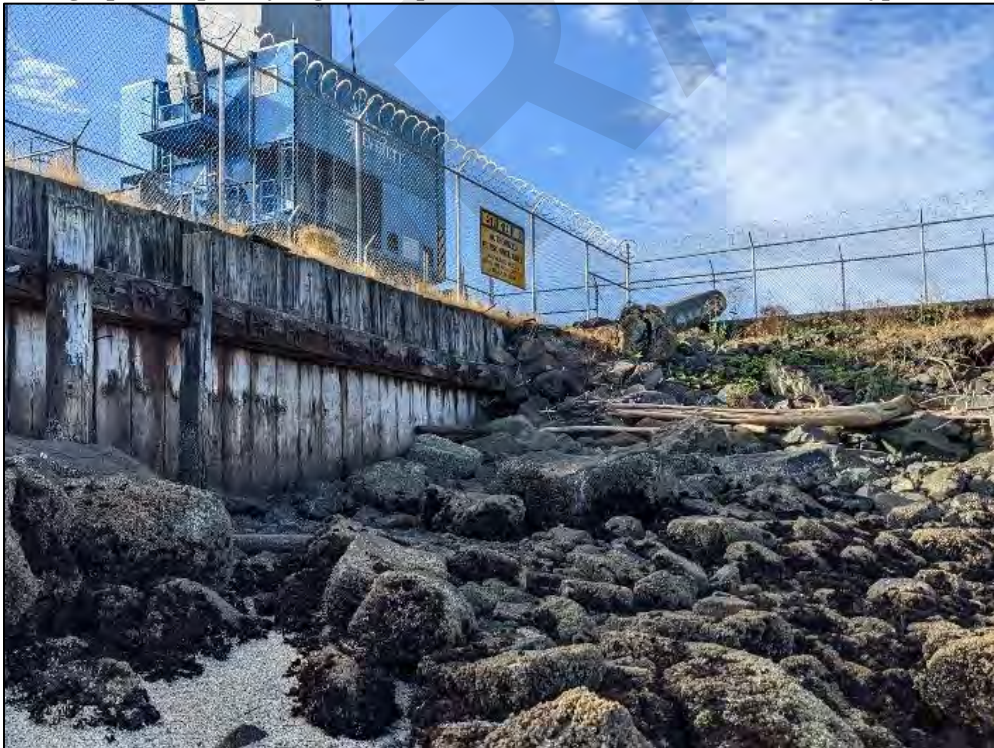
**Photograph 17. Sparsely vegetated upland areas of the Northern shoreline; typical conditions.**

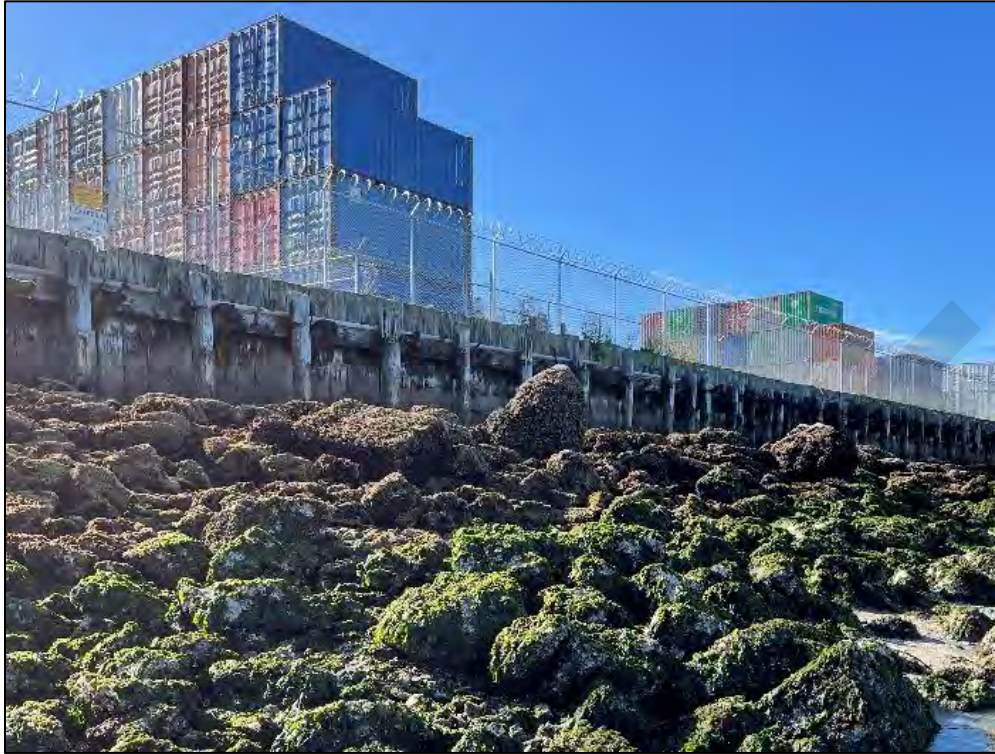
**Photograph 18. Sparsely vegetated upland area above timber abutment of the Northern shoreline (Area 2); typical conditions. Photograph taken facing South.**

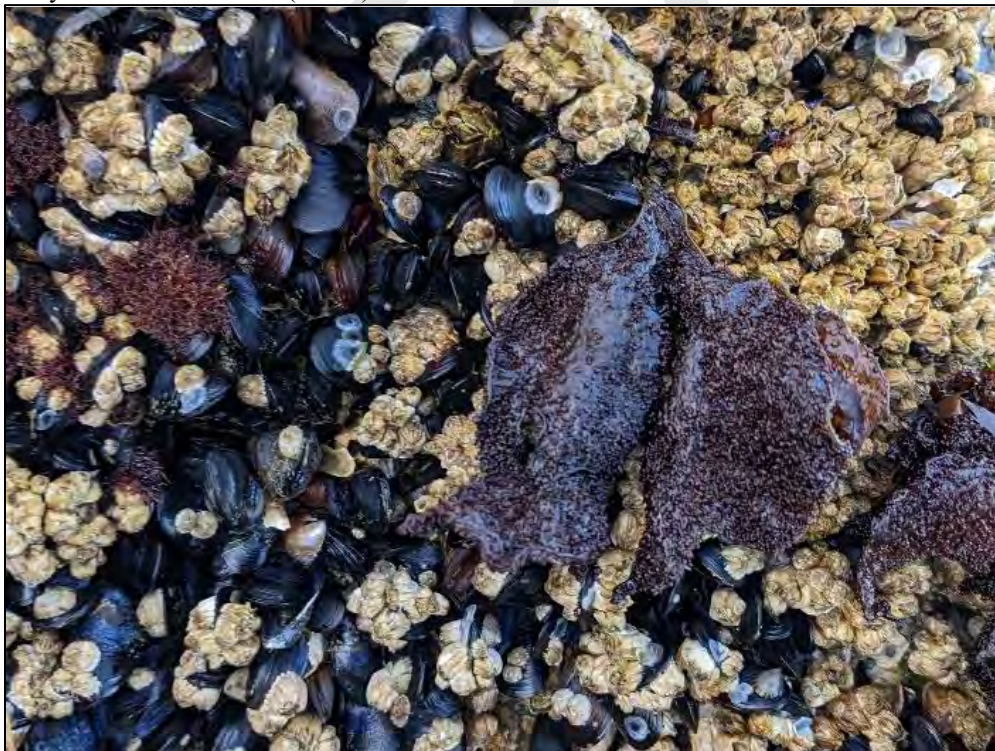
**Photograph 19. Macrofauna and algae along the Northern shoreline; typical conditions.** Example of Turkish washcloth, mussels, and barnacles covering riprap in Area 1 (above), and Ulva growing on rocky substrates in Area 2 (below).

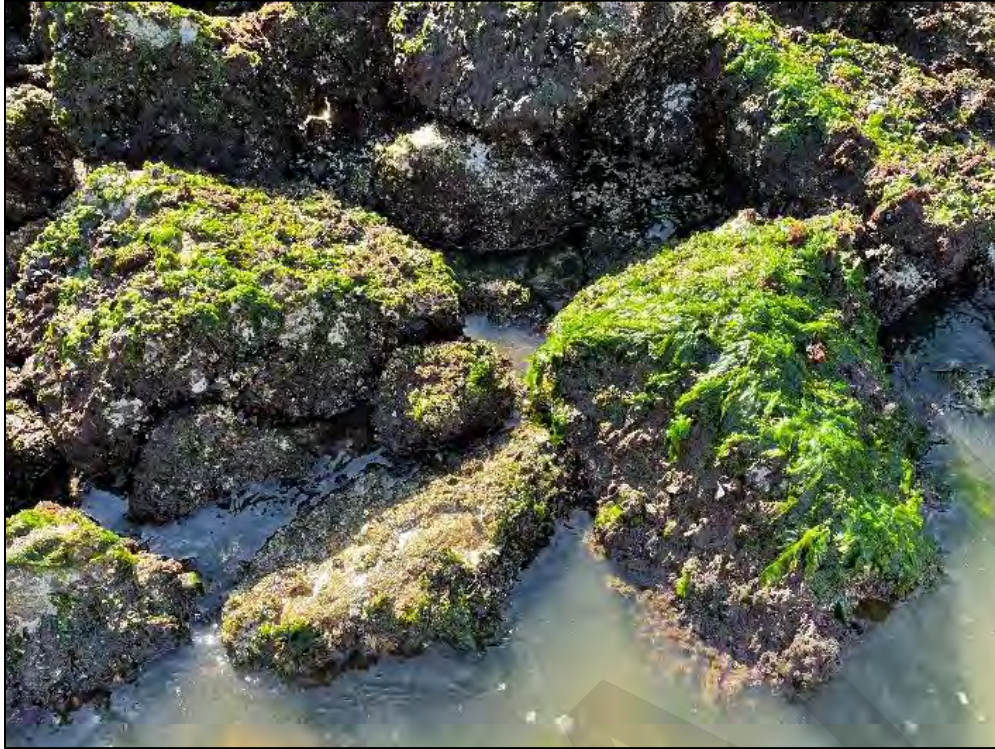
**Photograph 20. Macrofauna and algae along the Northern shoreline; typical conditions.**

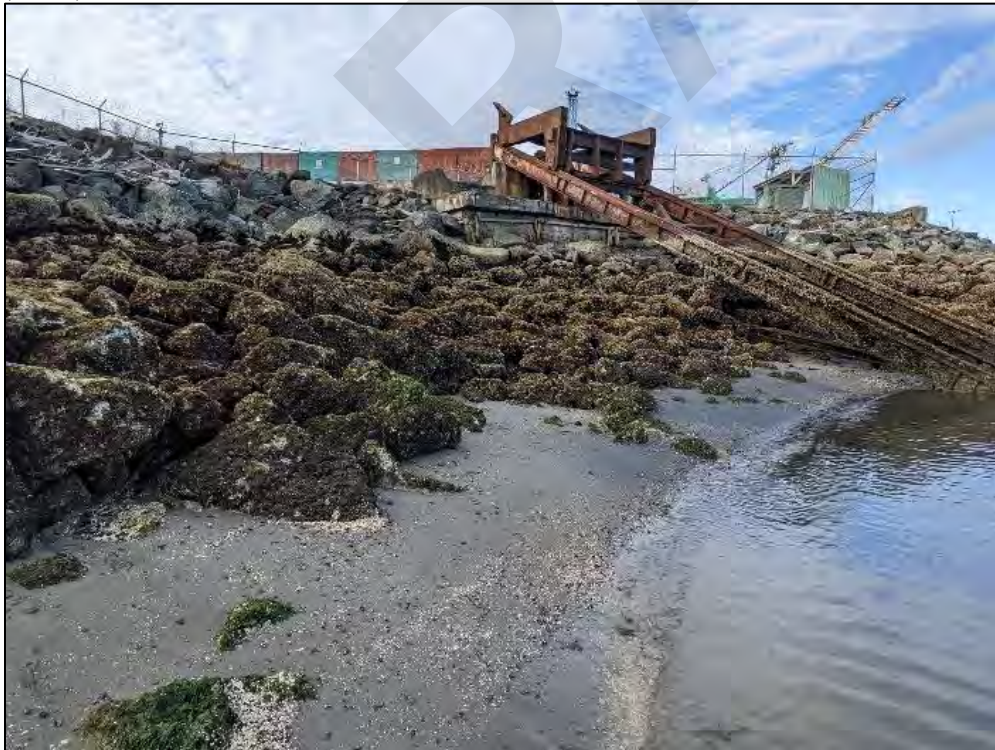
**Photograph 21. Beach-like areas in Area 1 of the Northern shoreline** next to the northern set of derelict rails (location of tracks in Figure 3). Photograph taken facing southeast (above) and further up the slope facing north (below).

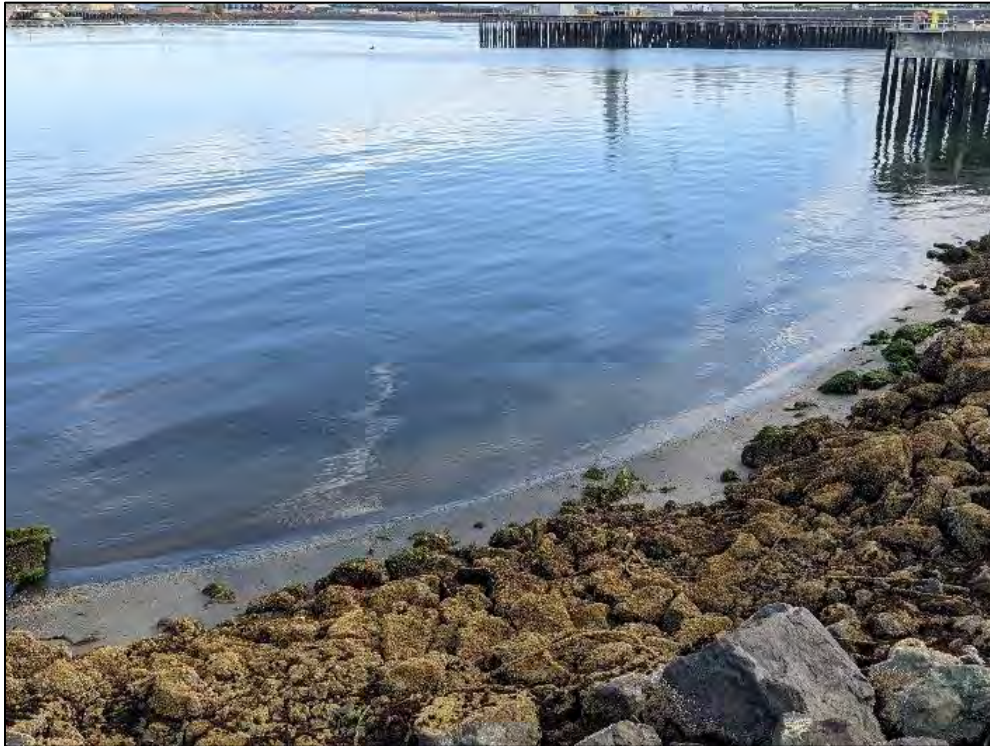
**Photograph 22. Beach-like areas in Area 1 of the Northern shoreline**

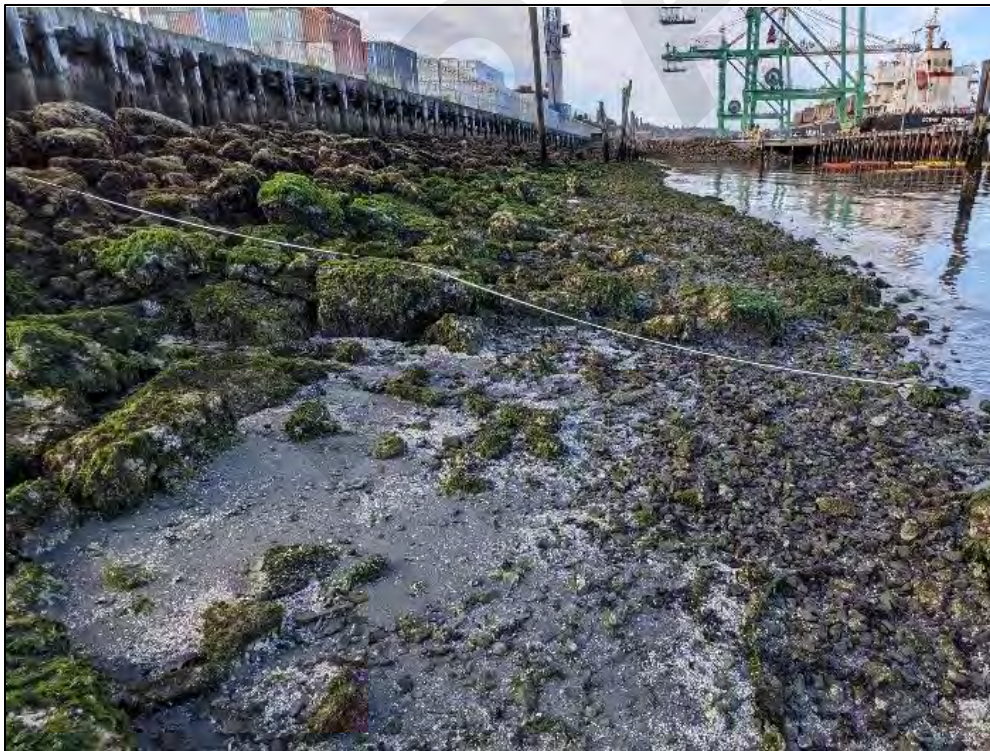
**Photograph 23. Small beach-like areas within Area 2 of the Northern shoreline.** Photographs taken facing southeast towards the South Terminal.

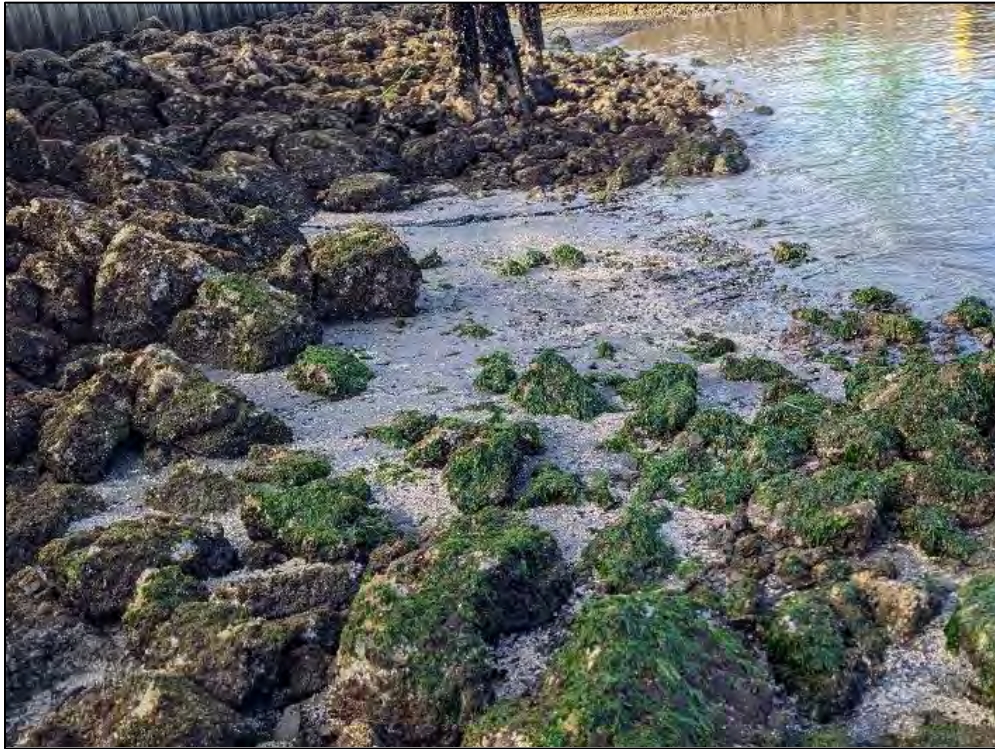
**Photograph 24. Small beach-like areas within Area 2 of the Northern shoreline.**

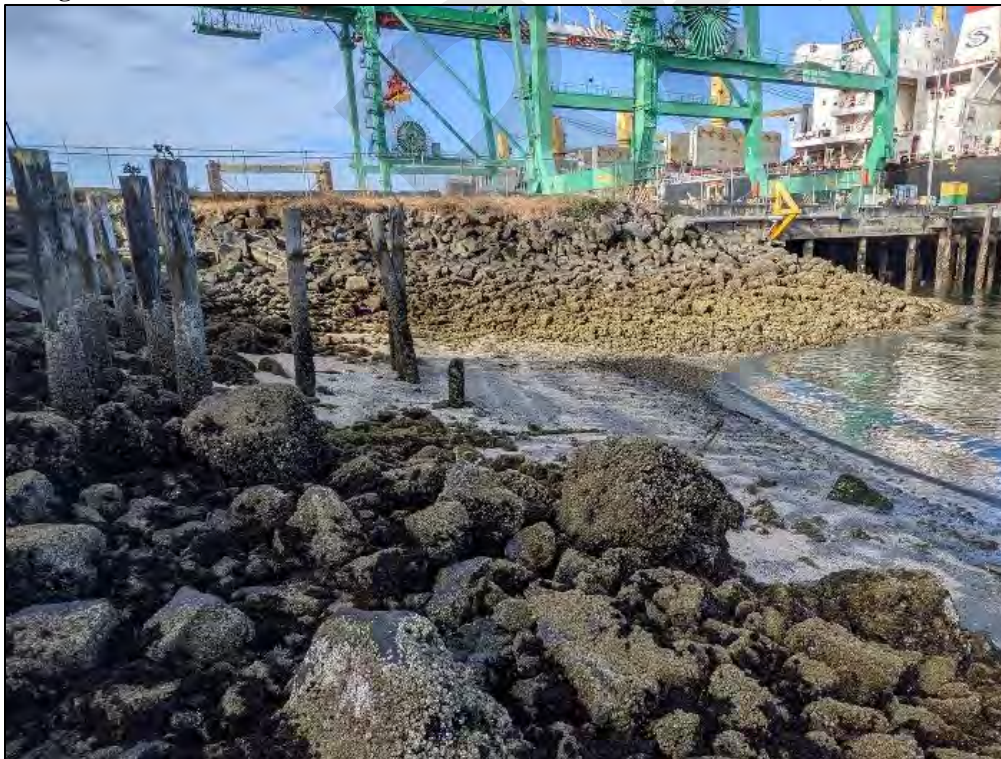
**Photograph 25. Large beach area within Area 2 of the Northern shoreline, adjacent to the South Terminal facing southwest towards the terminal.**

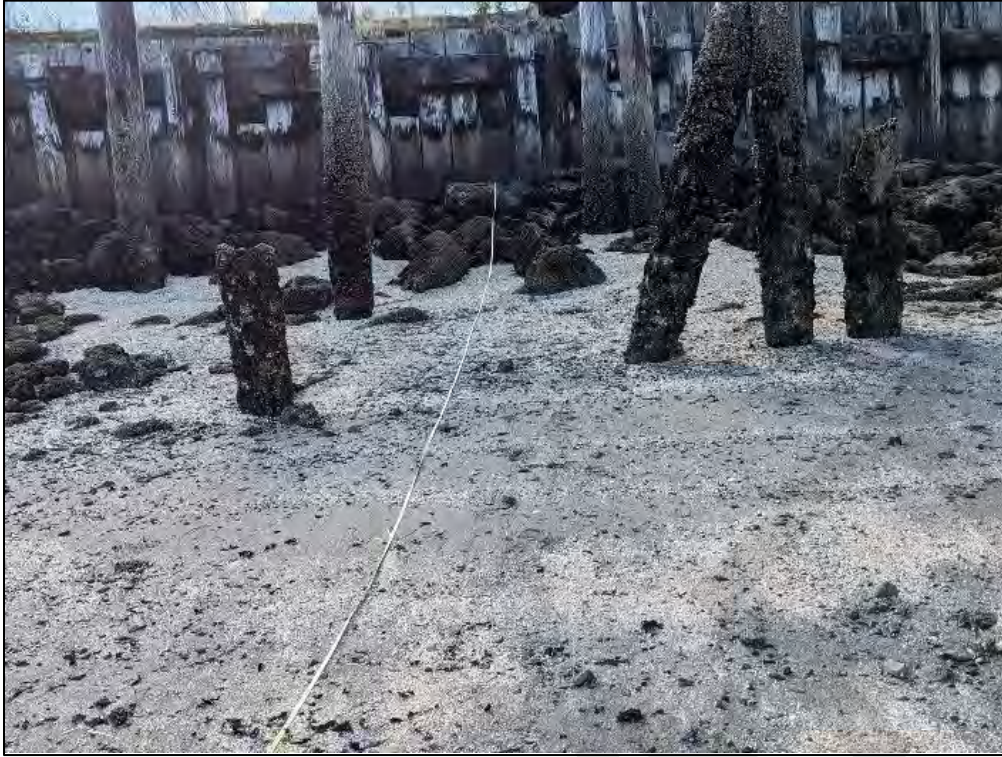
**Photograph 26. Beach area within Area 2, facing upslope.**

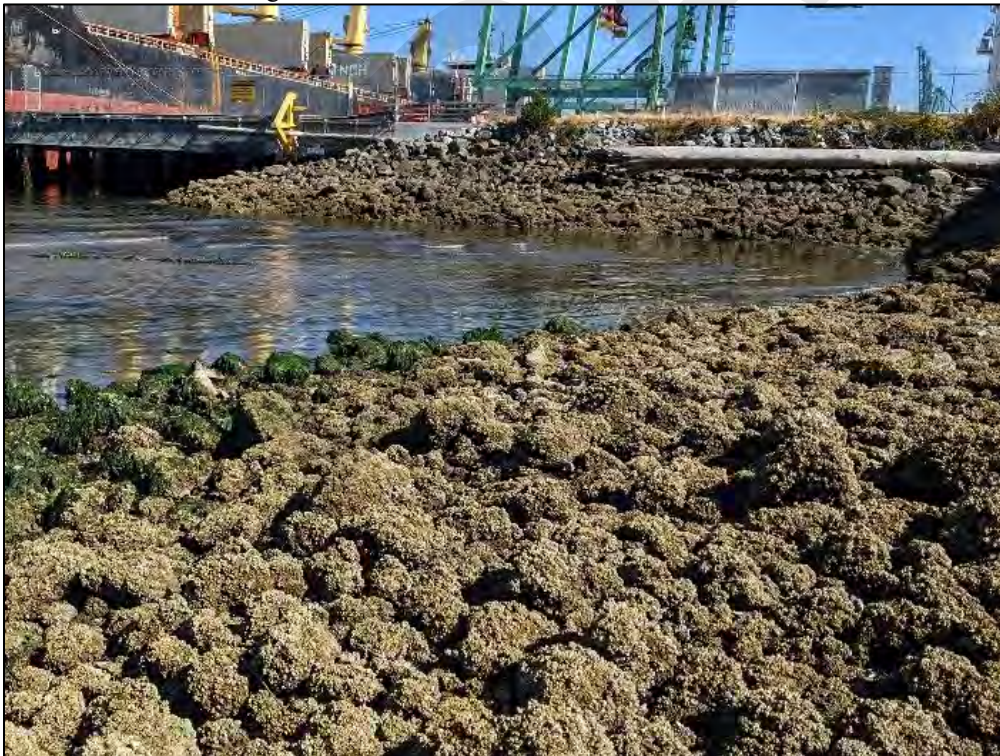
**Photograph 31. Armored slopes of the southern shoreline in Area A north of Pigeon Creek. Riprap slopes near the South Terminal facing North.**
