YAKIMA MILL SITE
 CITY OF YAKIMA, YAKIMA COUNTY, WASHINGTON

Photograph Locations at the Boise
Cascade Mill Site (aka Yakima Mill
Site) and East of Interstate 82

Fulcrum Environmental Consulting, Inc.
406 N 2nd St, Yakima, WA 98901
509.574.0839 | www.efulcrum.net
YMS East of I-82 . 11.13.2023 . RKM

Attachment B
Site Photographs

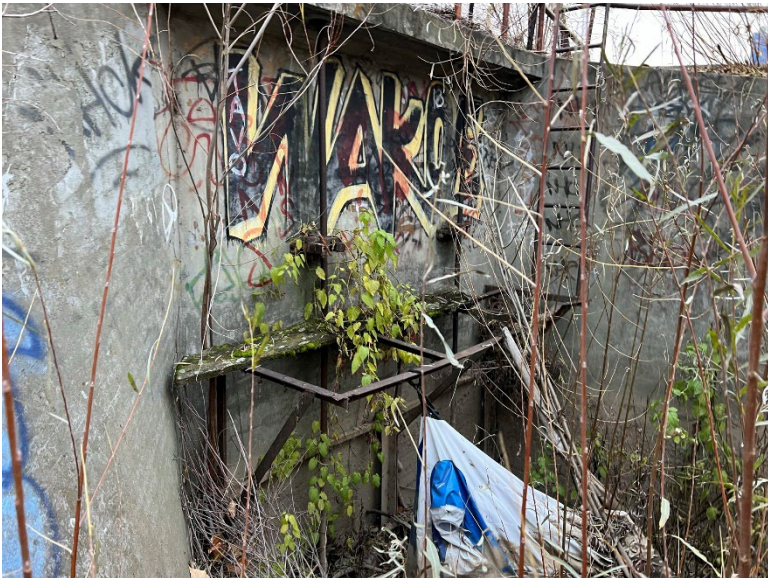
B1.3 Offsite, immediately north of Parcel A, the former head gate for the River Water Intake.

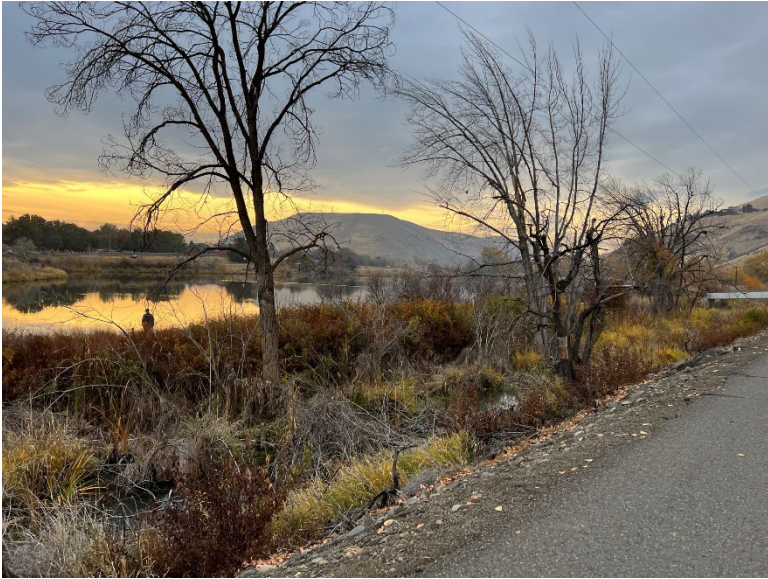
B2.1 Parcel A – River water intake ditch between Yakima Greenway and the Lake.

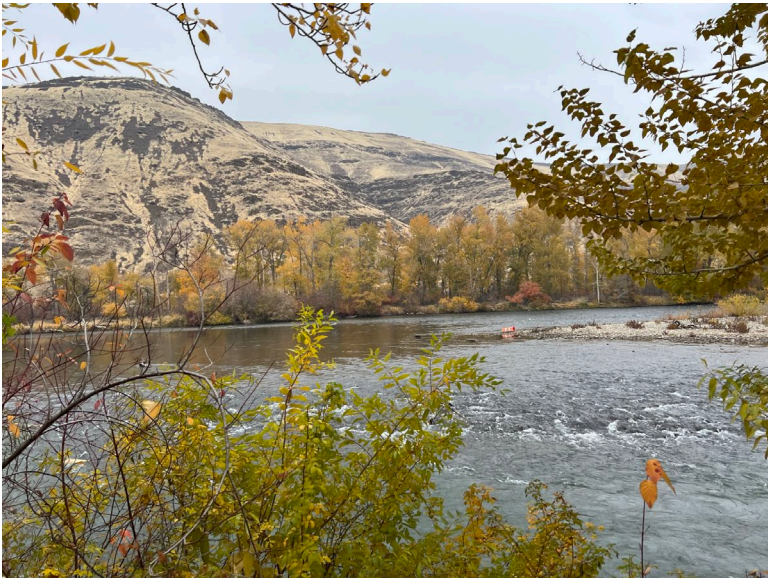
B2.3 Parcel A – The Yakima River and portion of island in the river.

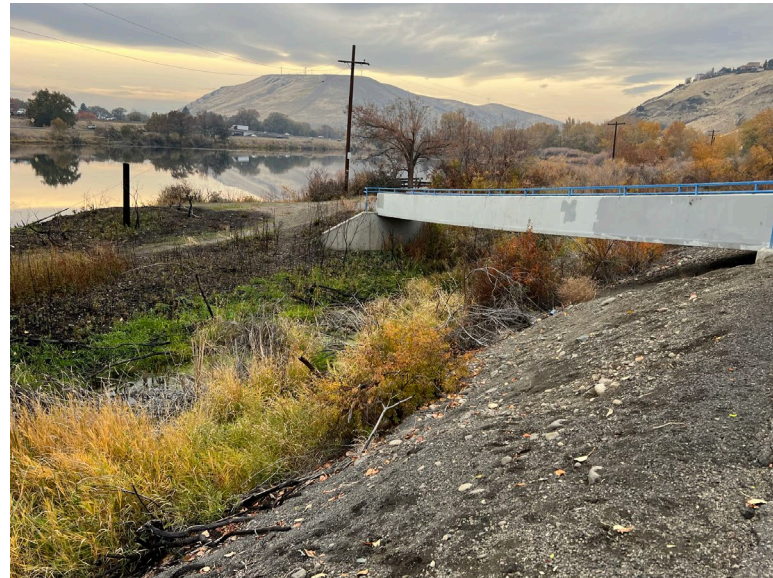
B2.4 Parcel A – Bridge connecting Yakima Greenway to Rotary Lake.

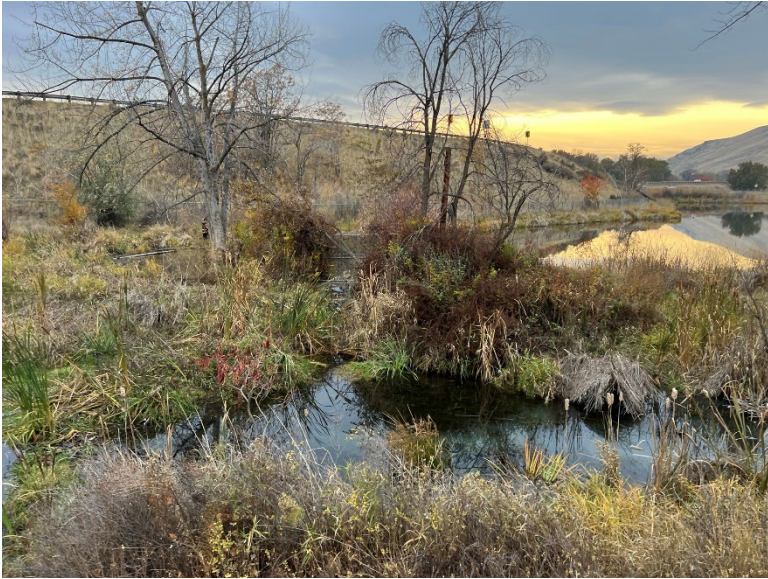
B3.1 Parcel A – The spillway at the south extent of Rotary Lake.

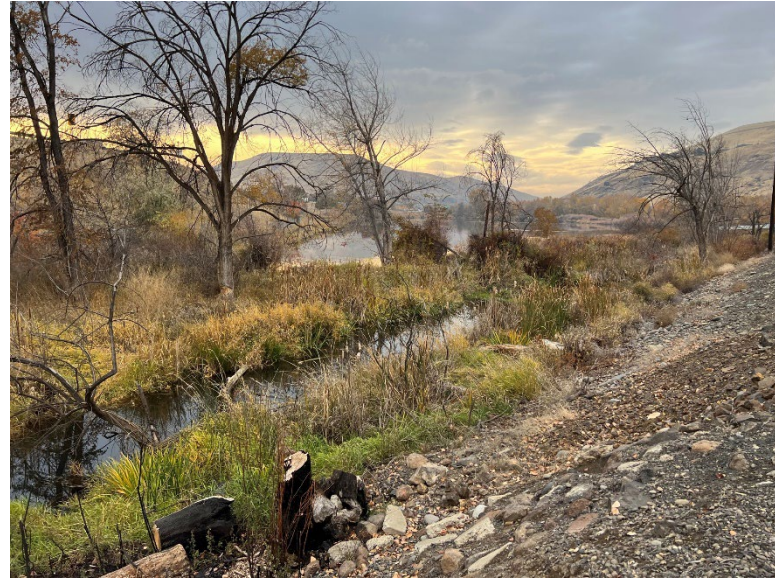
B3.2 Parcel A – The ditch located south of Rotary Lake, west of the Greenway.

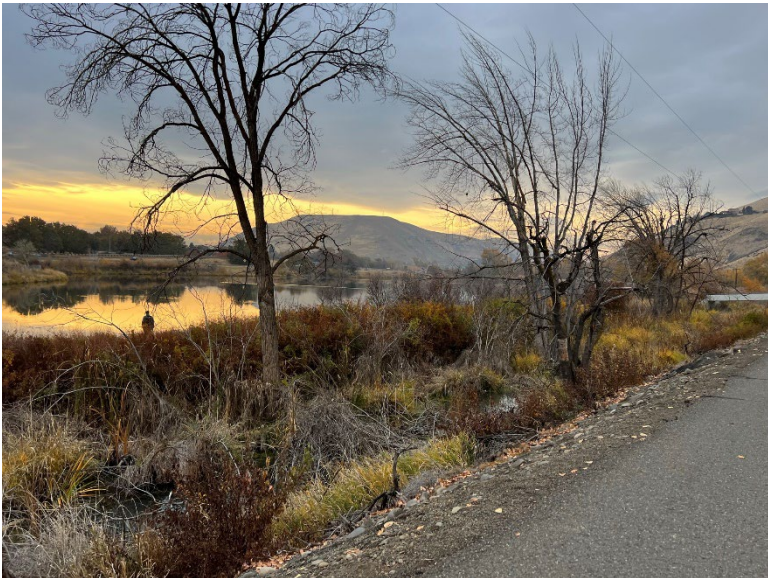
B3.3 Parcel A – Rotary Lake as viewed from the Yakima Greenway.

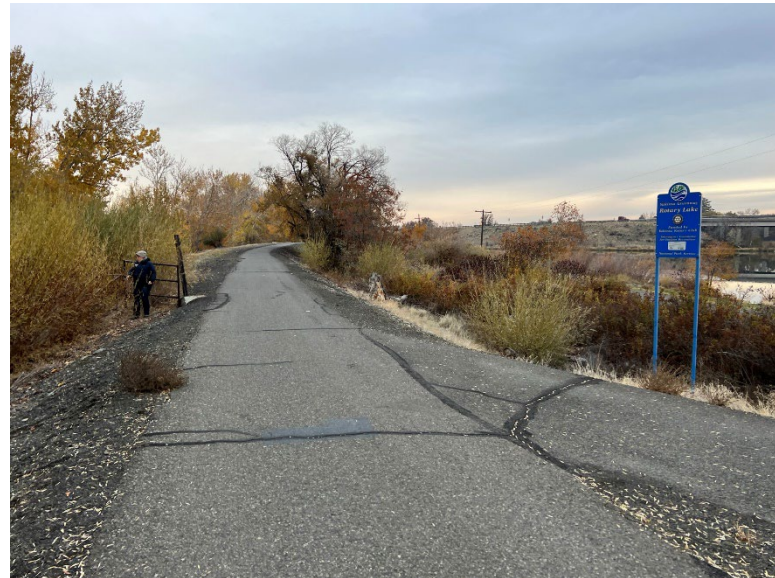
B3.4 Parcel A – Looking south from near the head gate at Parcel A.

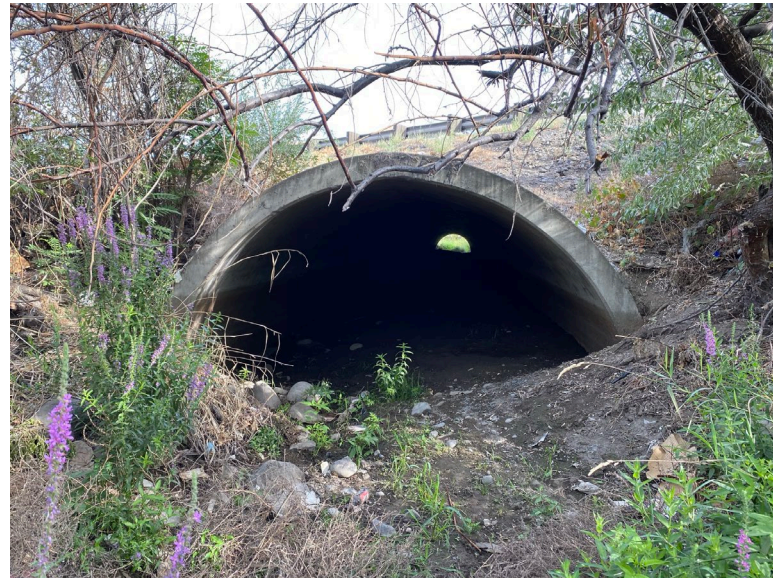
B4.4 One of the series of concrete culvert below east bound I-82.

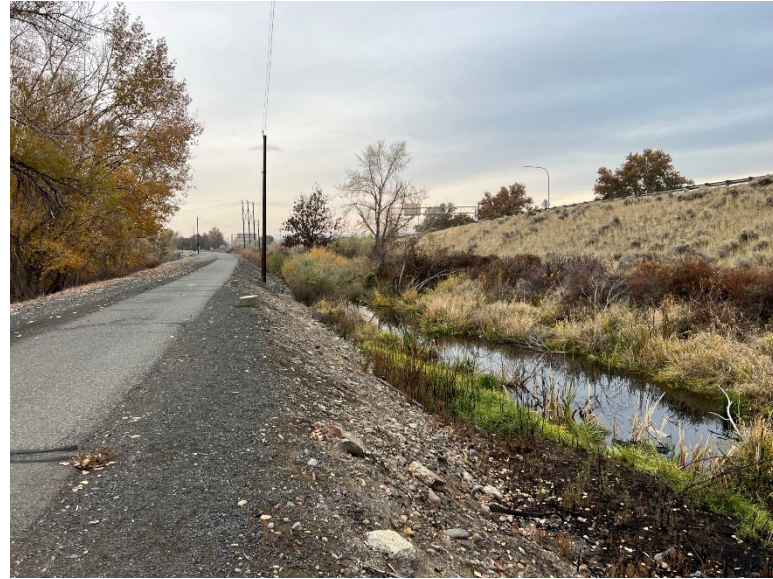
B5.2 Parcel B – An open section of the former River Water Intake ditch.

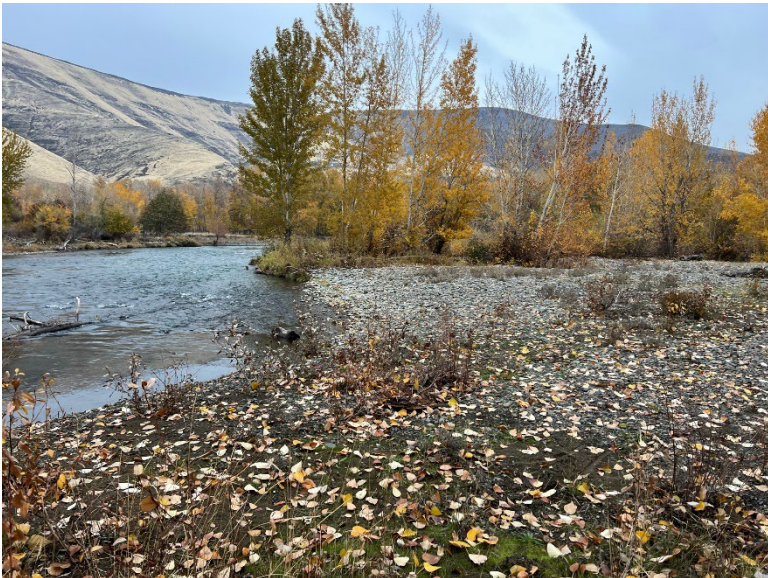
B5.3 Parcel B – A portion of the bank along the south side of the Yakima River.

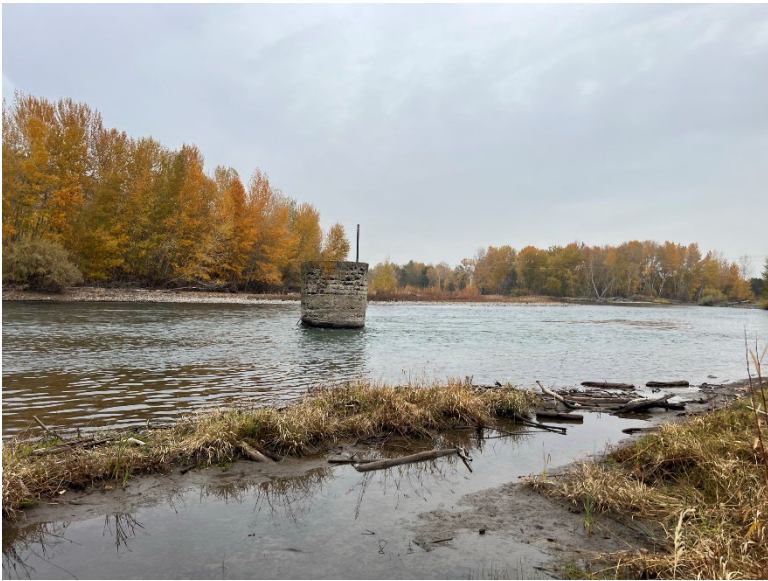
B6.1 A large concrete bridge footing located in the Yakima River east of Parcel B.

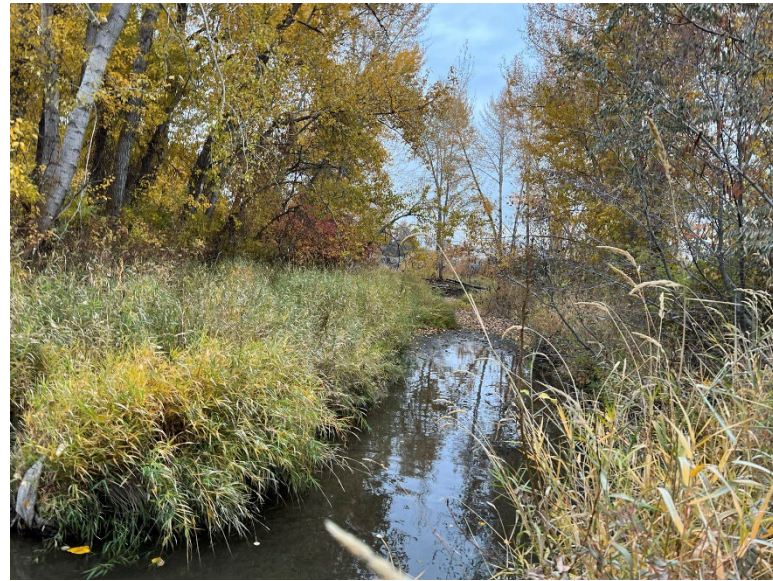
B6.2 Parcel B – A small water channel crossing near the west center of the parcel.

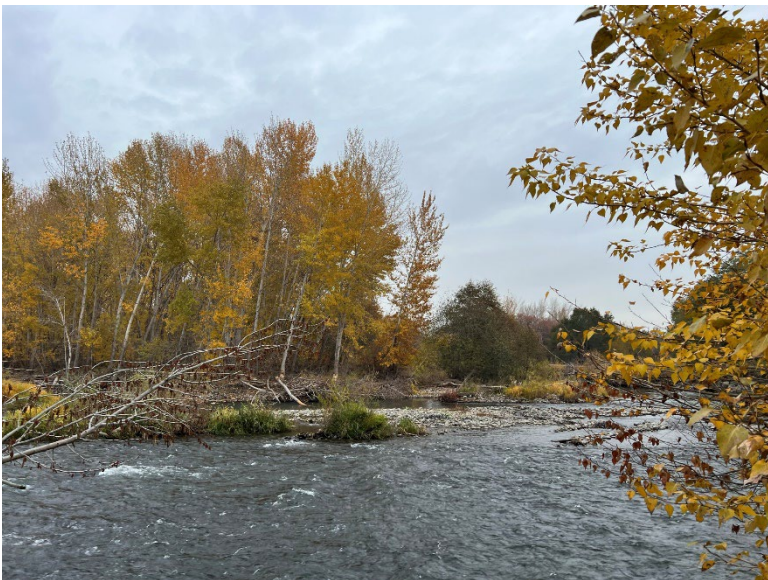
B6.3 Parcel B – The island portion of Parcel B shown from the bank to the west.

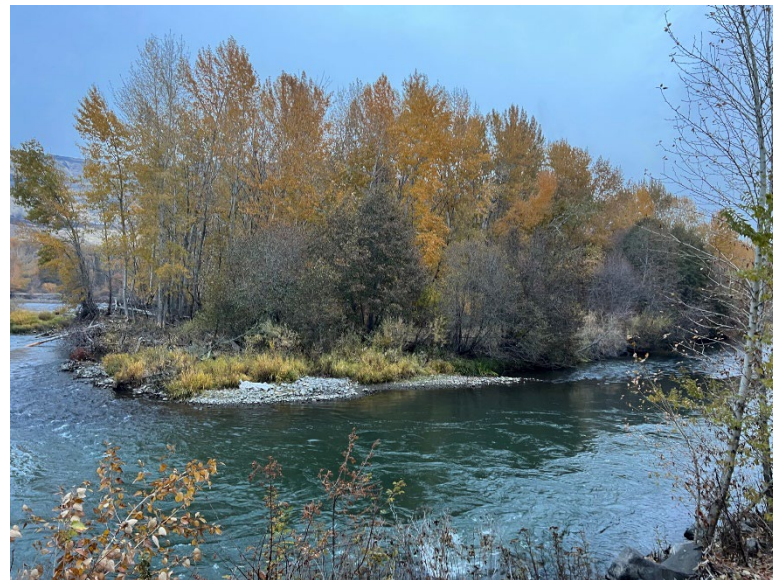
B6.4 Parcel B – The island portion of Parcel B shown from near the parking lot.

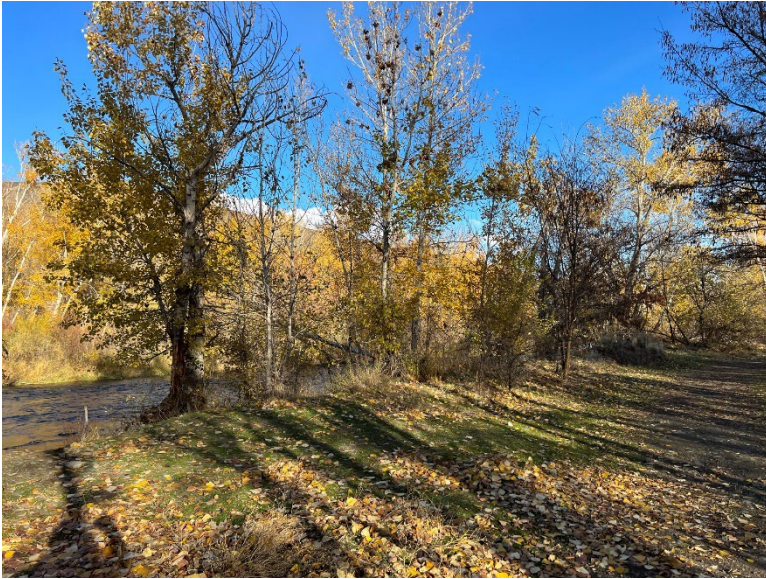
B7.1 Parcel C2 – The river bank along the north side of Parcel C2.

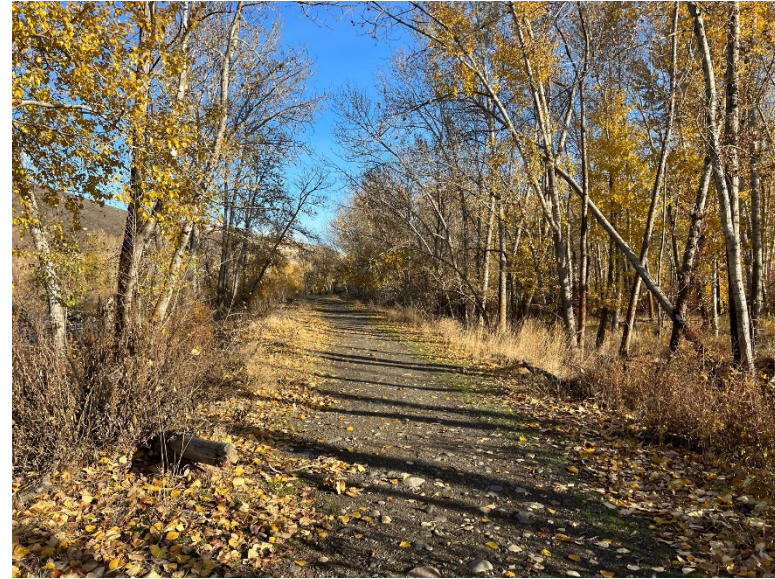
B7.2 Parcel C2 – A perimeter gravel and rock trail is present on the parcel and connects to the improved Yakima Greenway.

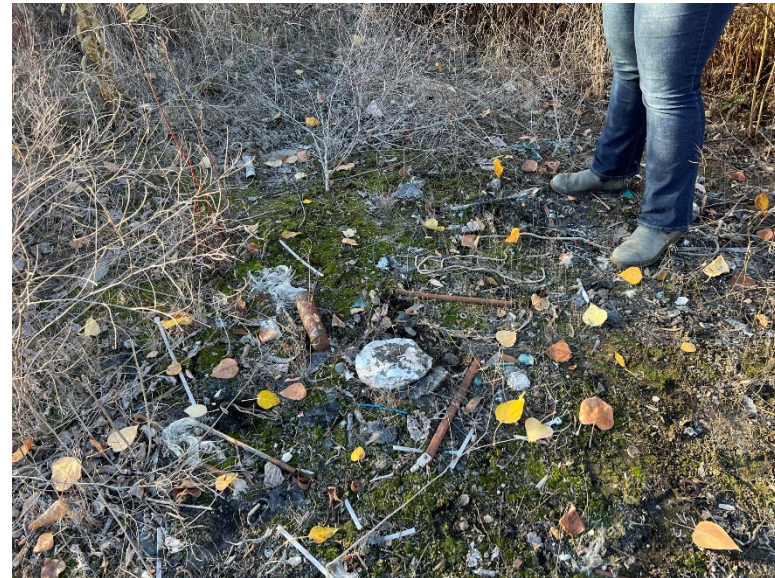
B7.4 Parcel C2 – An area of garbage associated with a campsite located on a river island.

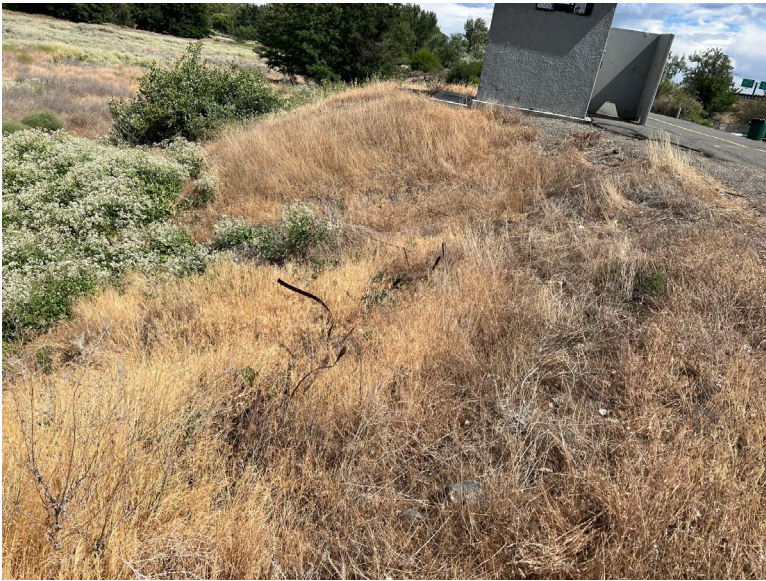
B8.1 Parcel C1 – A pit toilet is located at the parking lot.

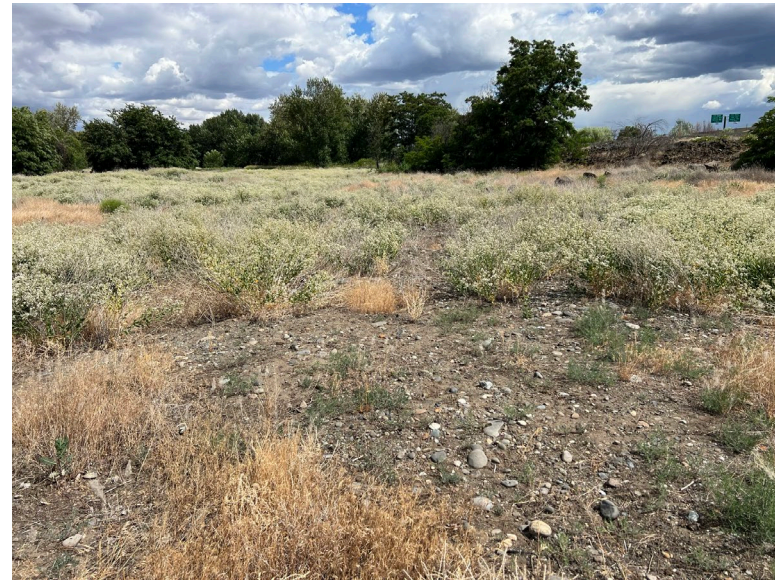
B8.2 Parcel C1 – The area east of the parking lot is the former interstate borrow pit footprint.

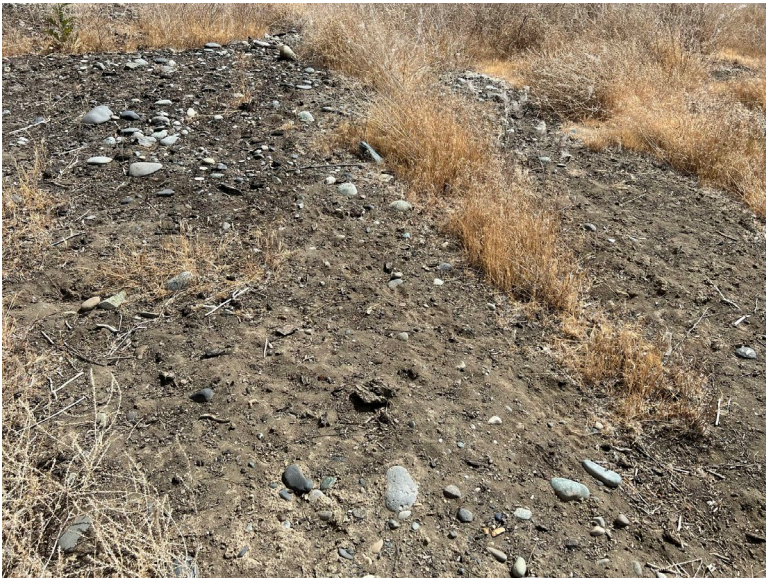
B8.3 Parcel C1 – Log yard material is present in the footprint of interstate borrow pit.

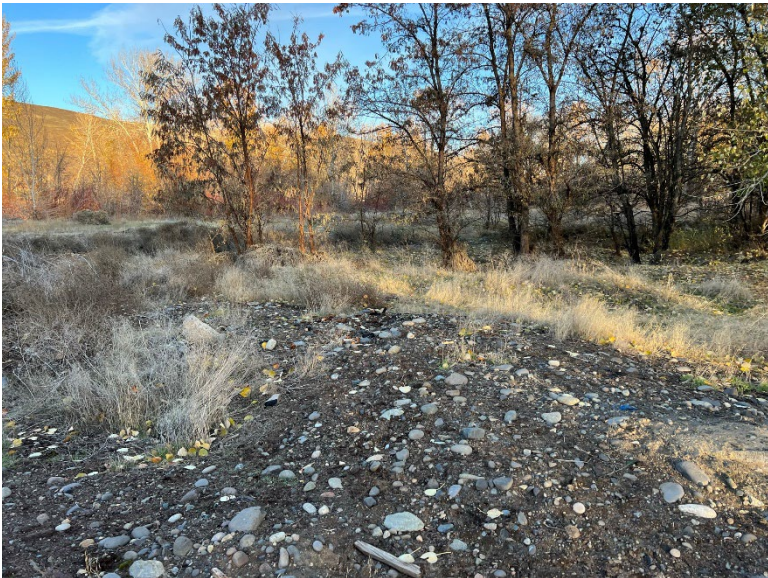
B9.3 Parcel C1 – Log yard materials were present in the east portion of the parcel near the former interstate borrow pit.

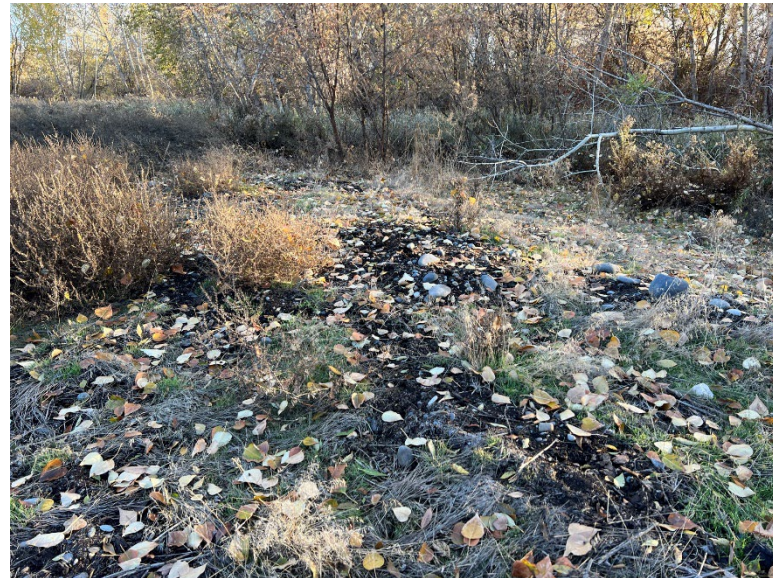
B9.4 Parcel C1 – Ground cover vegetation is present in areas without trees.

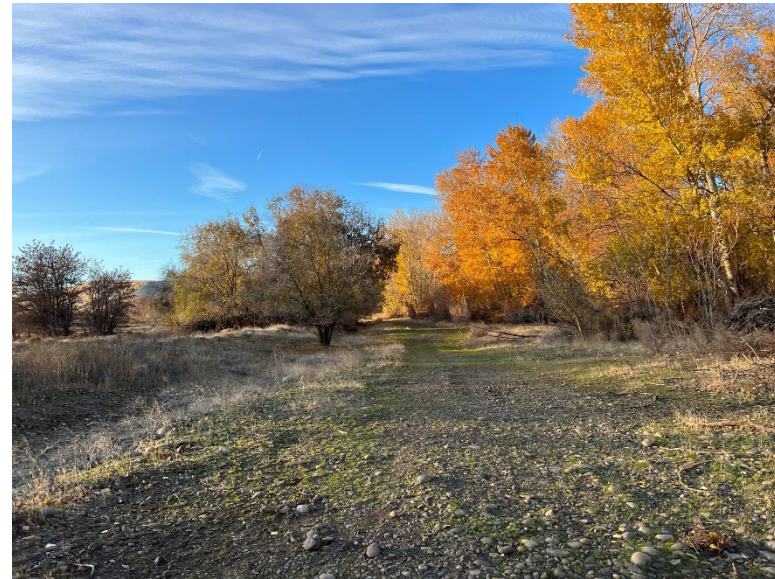
B10.2 Parcel C – Looking north at the walking path from near the northeast Parcel C1 pond.

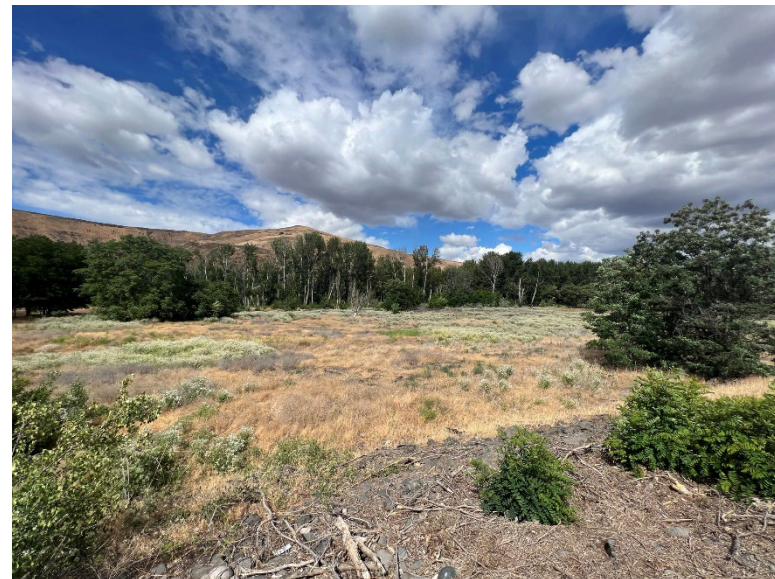
B10.4 Parcel C1 – The general footprint of interstate borrow pit ew as viewed from the Yakima Greenway.

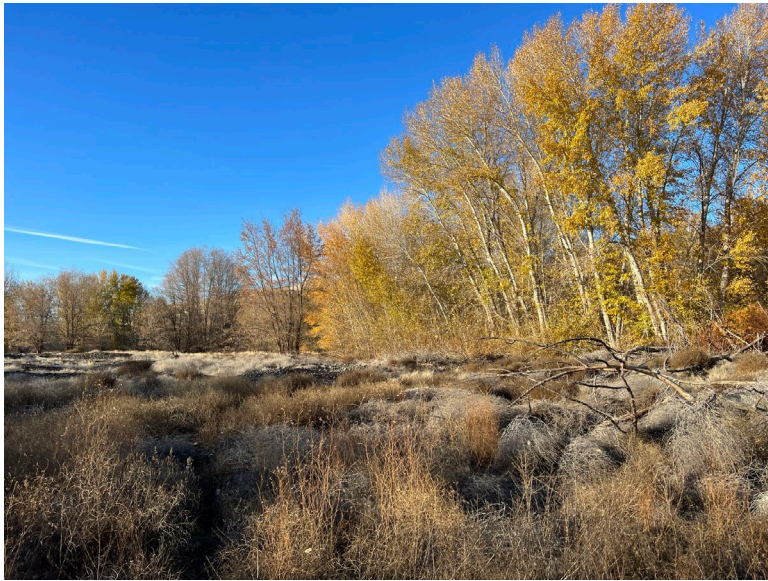
B11.1 Parcel D – Near the northeast extent of the parcel, an open area has log yard material at the surface.

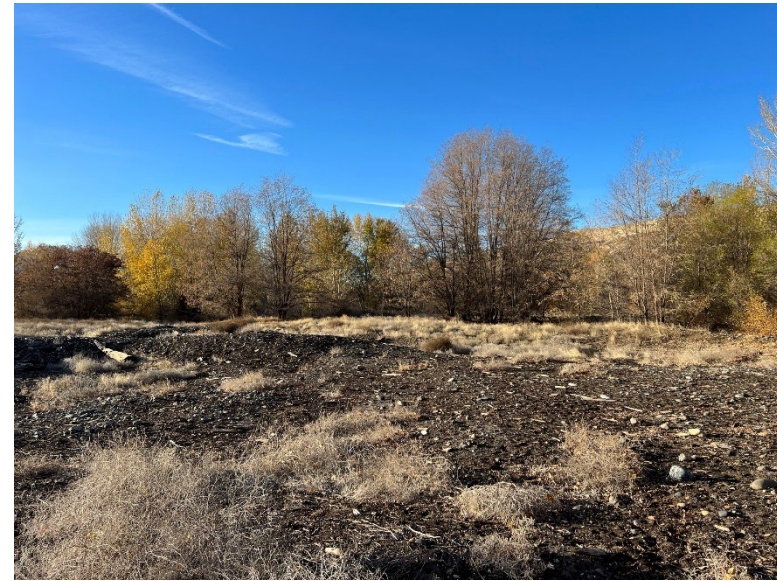
B11.2 Parcel D – The log yard material consists of mixed wood, bark, and rocks.

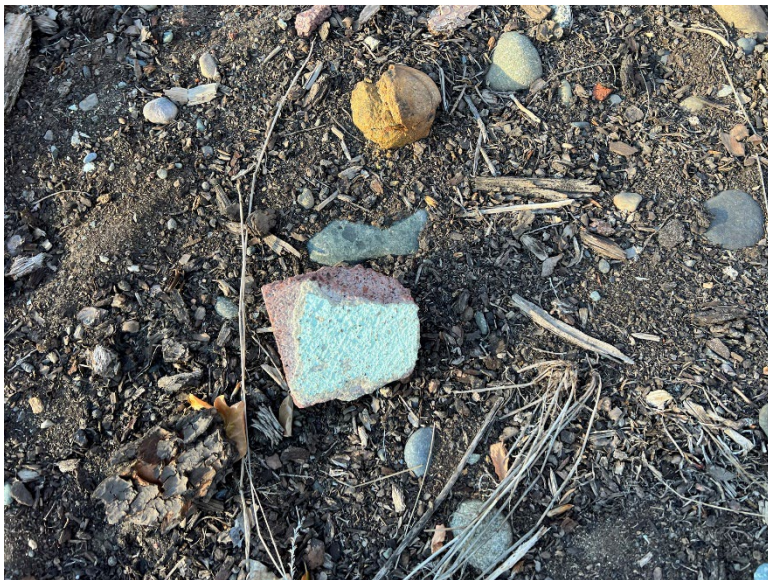
B11.3 Parcel D - A localized area of painted brick was present on the parcel.

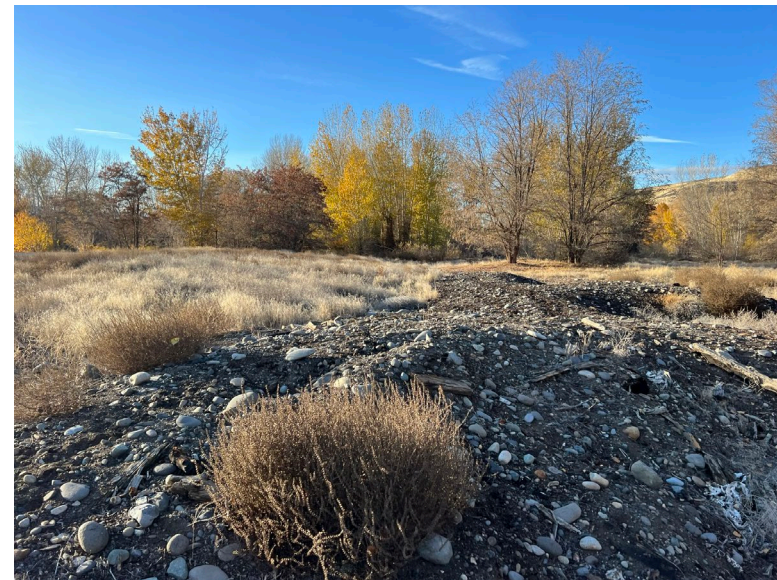
B11.4 Parcel D – The ground surface in the open areas is irregular.

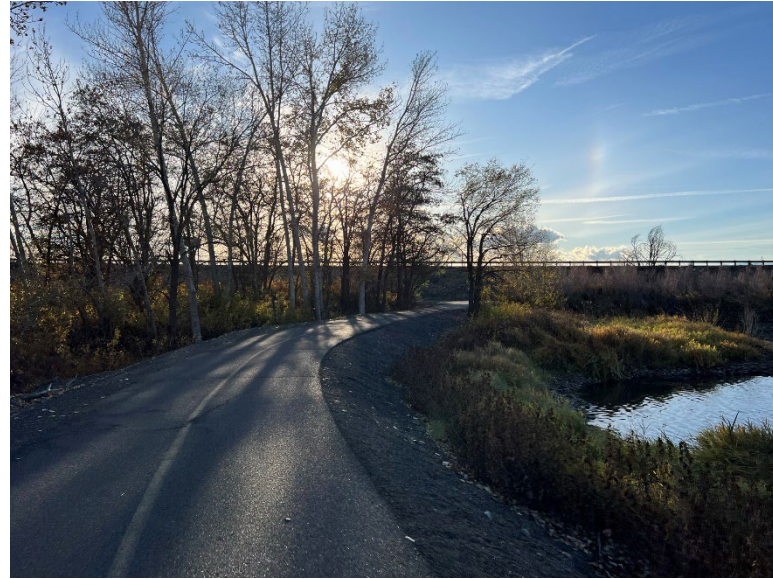
B13.2 Parcel D – The Yakima Greenway is located on the east and south sides of Cascade Mill Pond.

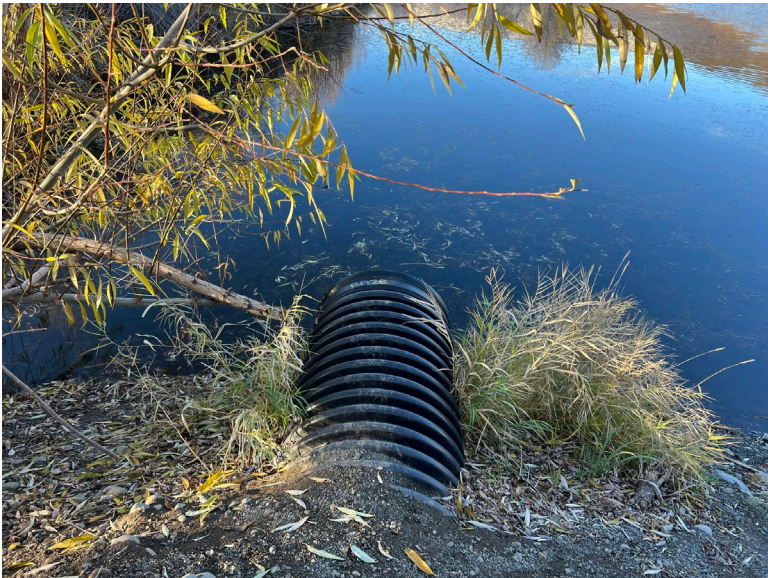
B13.3 Parcel D – The spillway culvert at the southwest corner of the Cascade Mill Pond.

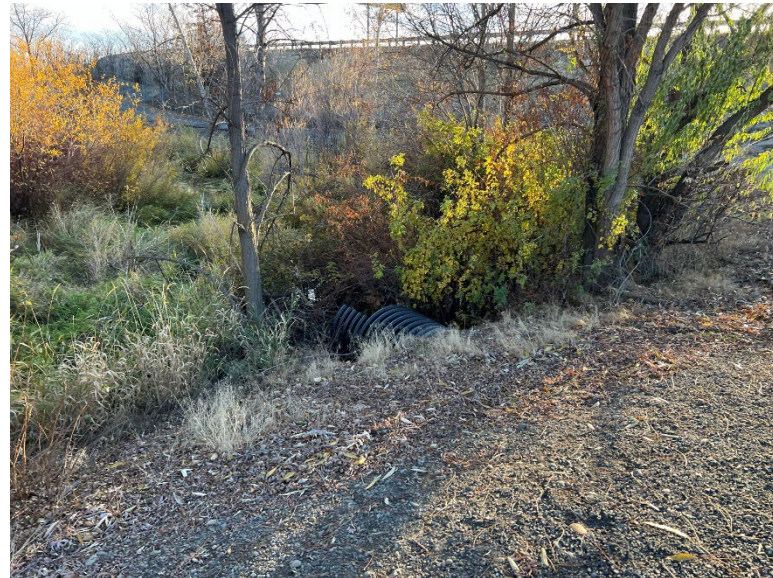
B13.4 Parcel D – The spillway culvert on the south side of the Yakima Greenway.

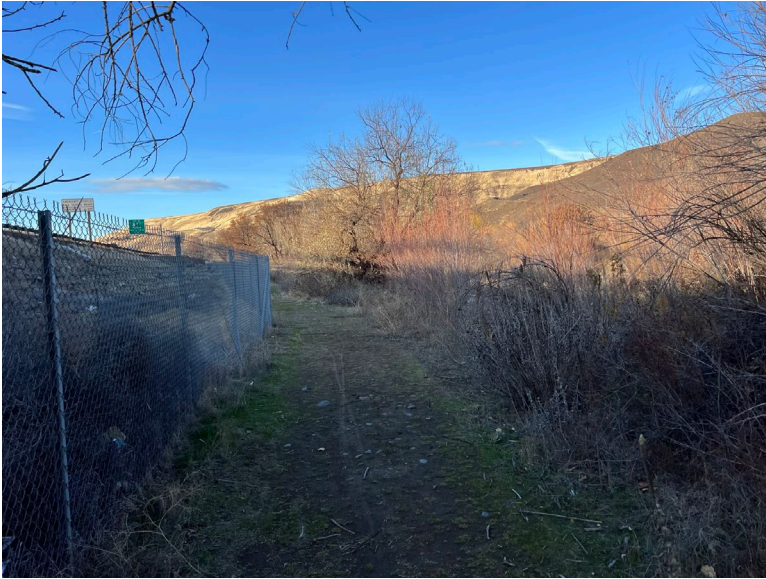
B14.1 Parcel D – The WSDOT right-of-way along the west side of the parcel.

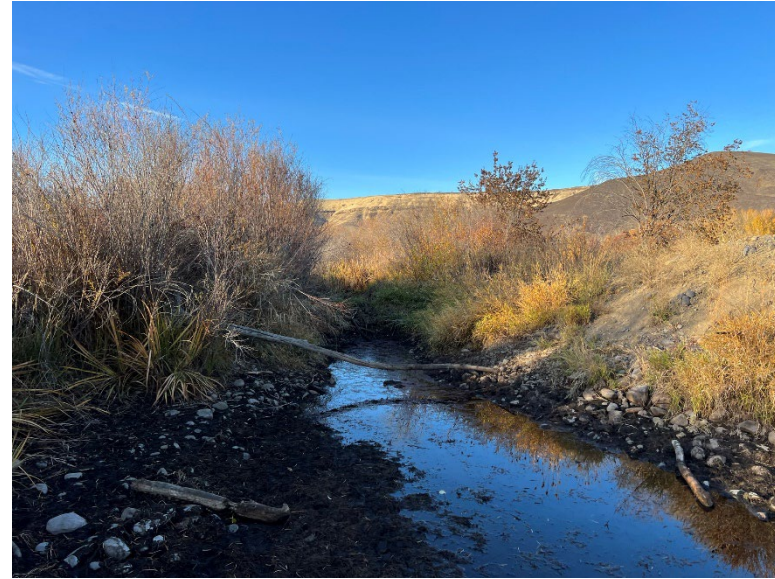
B14.2 Parcel D – The combined outfall enters near the southwest corner of Cascade Mill Pond.

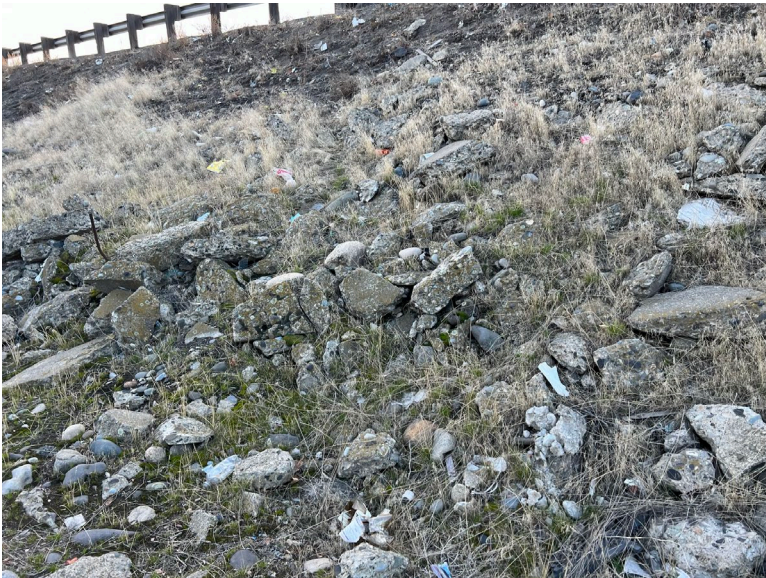
B14.3 Concrete debris from interstate construction is present offsite within the WSDOT right-of-way.

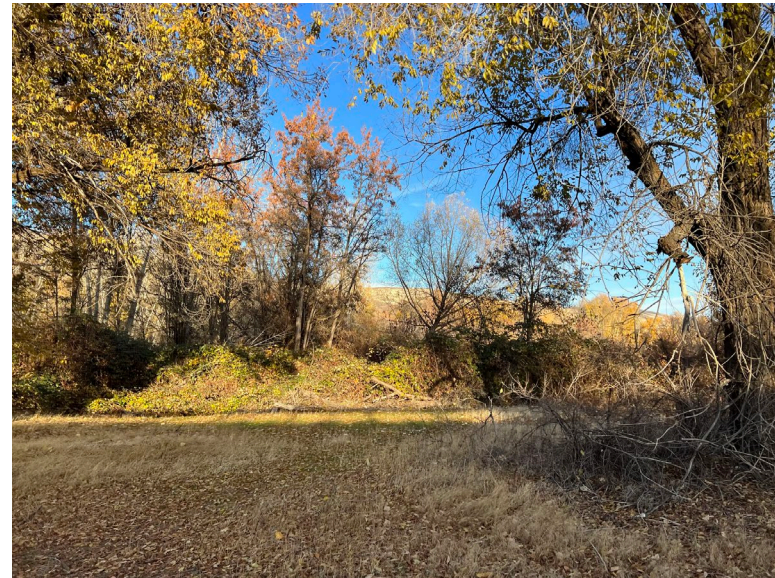
B14.4 Parcel D – Vegetation consists of open areas, thick blackberries and established trees.

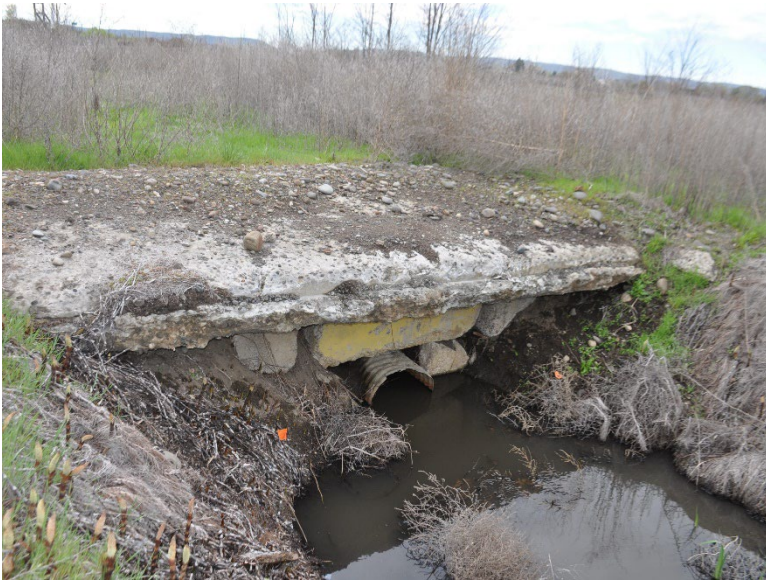
B15.1 – The Remnant Site Ditch where it enters to culvert on the Yakima Mill Site.

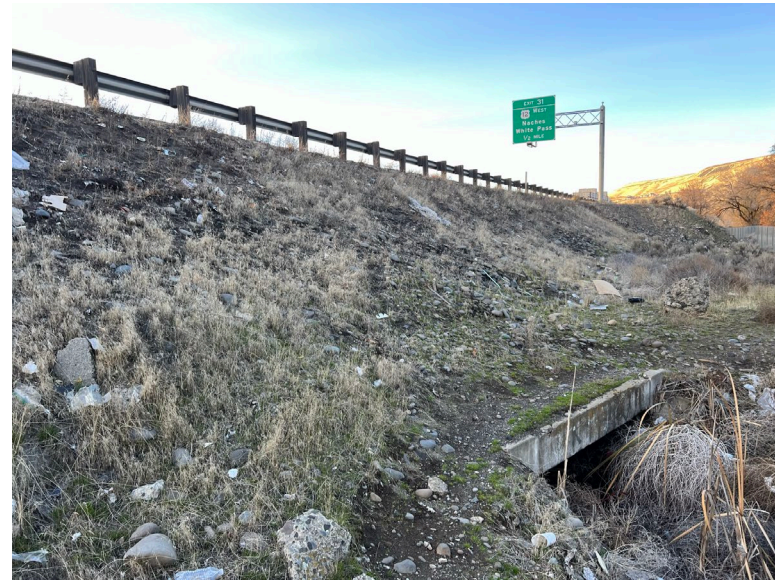
B15.2 Parcel D – The culvert carrying the Remnant Site Ditch where it emerges from beneath I-82.

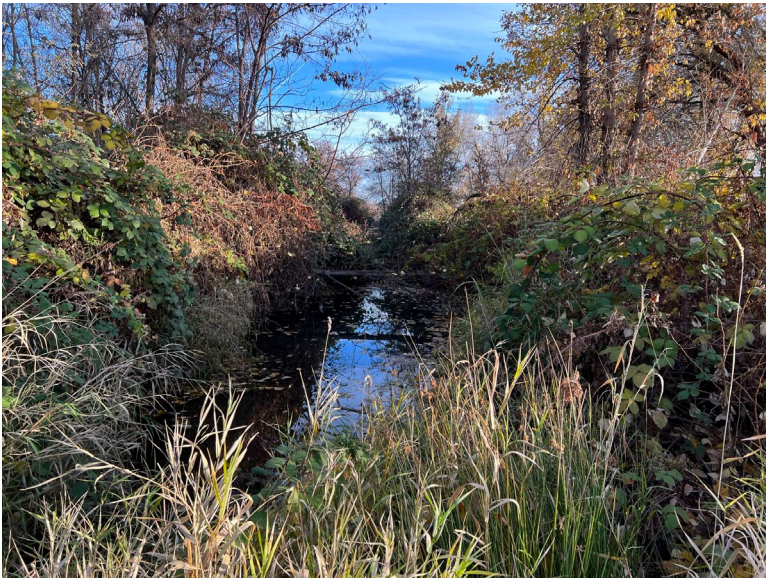
B15.3 Parcel D – The combined ditch is heavily vegetated.

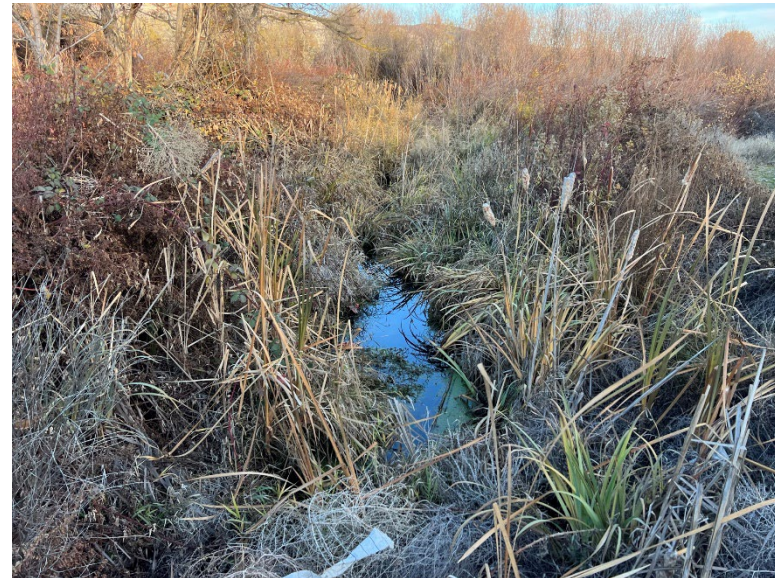
B15.4 Parcel D – The water was observed with low flow during this season.

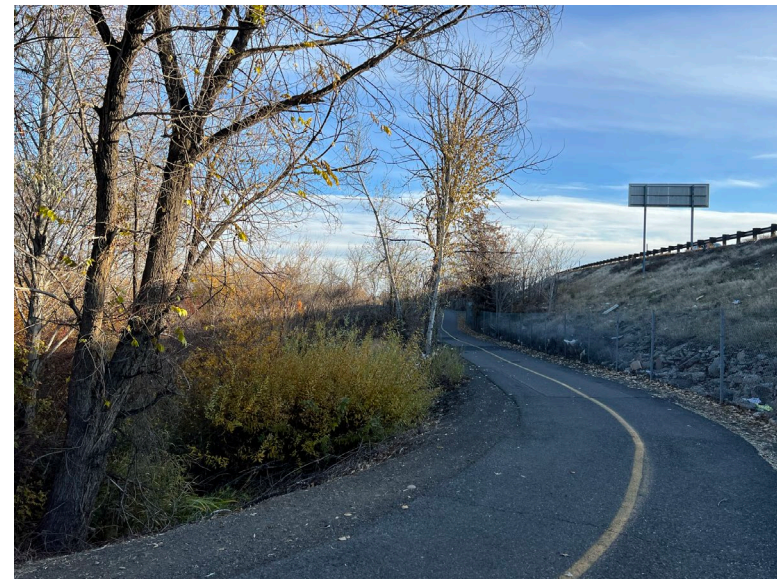
B16.4 Parcel D – The Yakima Greenway is located along the interstate fence south of the Cascade Mill Pond.

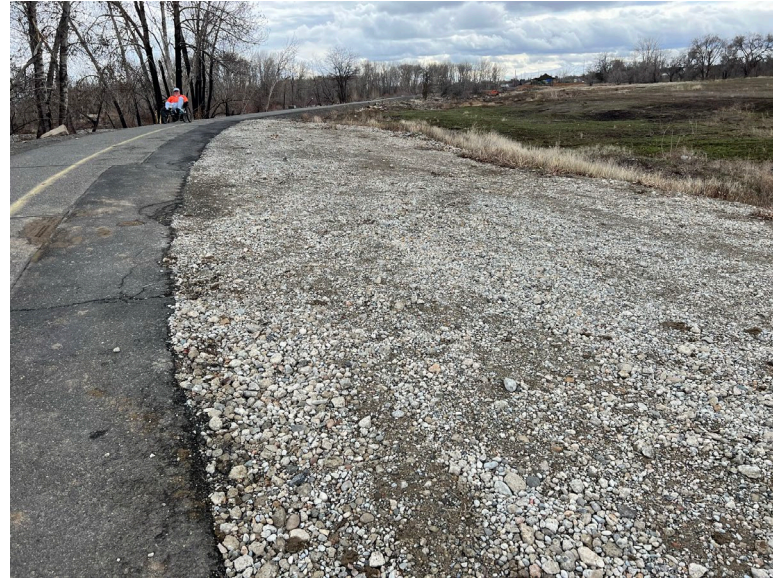
B17.2 Parcel D – An area of crushed concrete was placed during improvements to the playground.

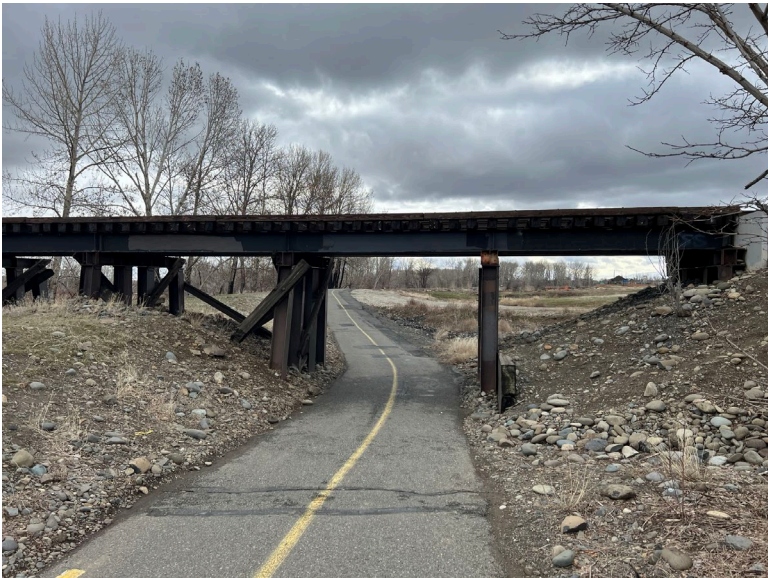
B17.3 Parcel D – The railroad trestle with the Yakima Greenway passing below.

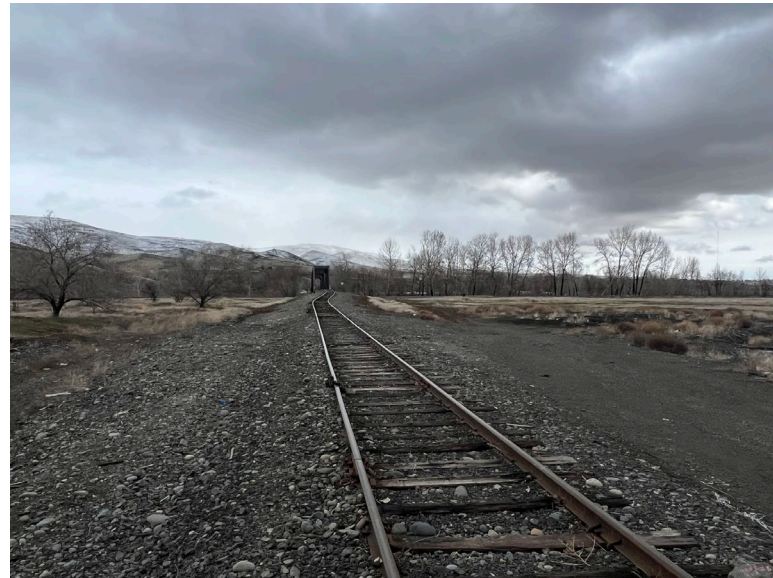
B17.4 Parcel D – The railroad tracks looking east at the bridge over the Yakima River.

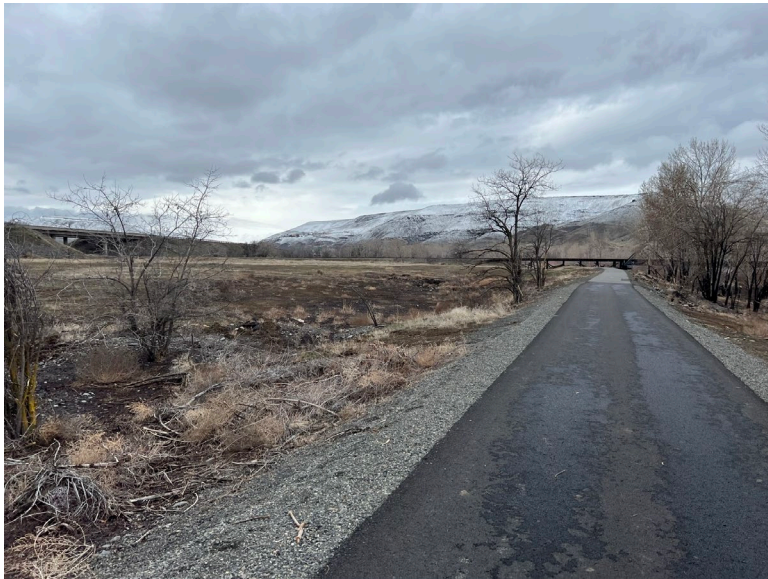
B18.1 Parcel E – The Yakima Greenway looking north towards the railroad tracks and trestle.

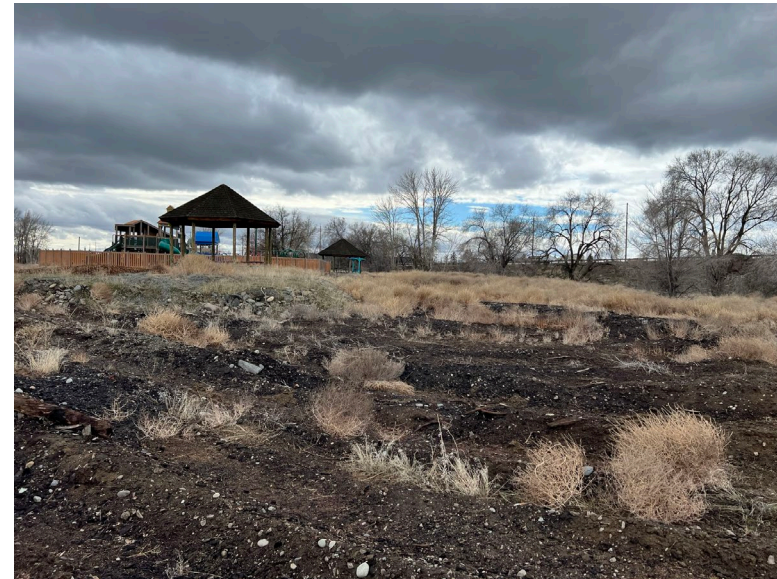
B18.2 Parcel E – Log yard materials are present at the ground surface with the playground beyond.

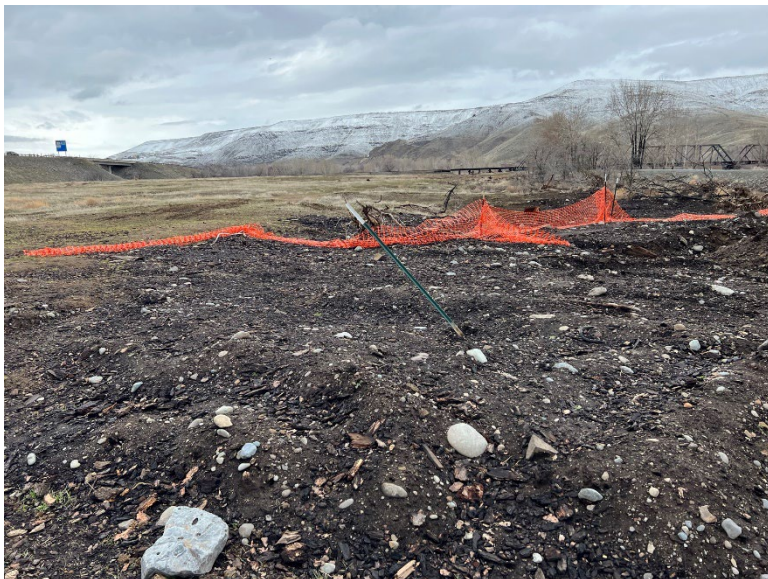
B18.3 Parcel E – An open excavated area of log yard material with an orange warning fence.

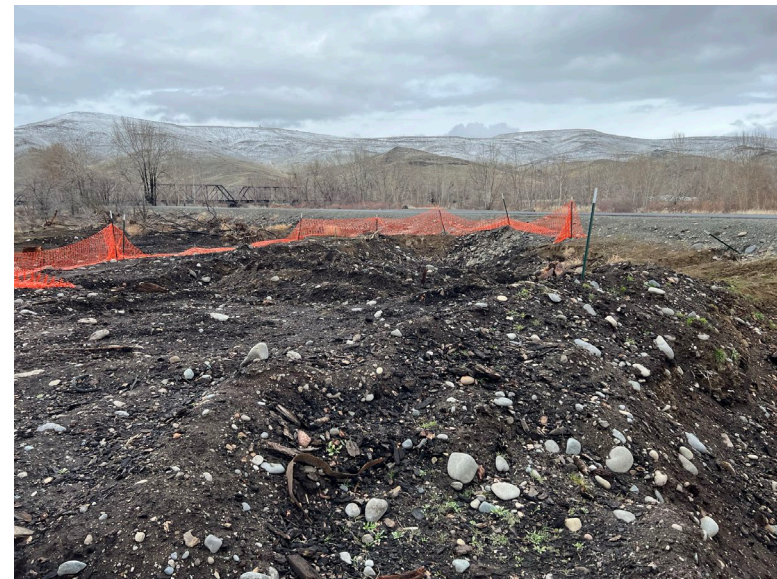
B18.4 Parcel E – The log yard material consists of mixed soil, wood debris, and rock.

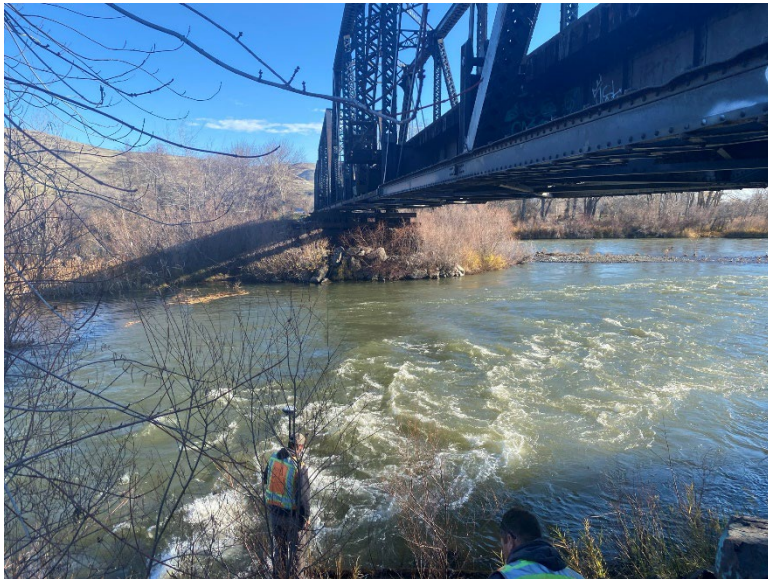
B19.1 Parcel D – The railroad bridge over the Yakima River.
