YAKIMA MILL SITE
 CITY OF YAKIMA, YAKIMA COUNTY, WASHINGTON

Photograph Locations at the Boise
Cascade Mill Site (aka Yakima Mill
Site) and East of Interstate 82

Fulcrum Environmental Consulting, Inc.
406 N 2nd St, Yakima, WA 98901
509.574.0839 | www.efulcrum.net
YMS East of I-82 . 11.13.2023 . RKM

Attachment B
Site Photographs

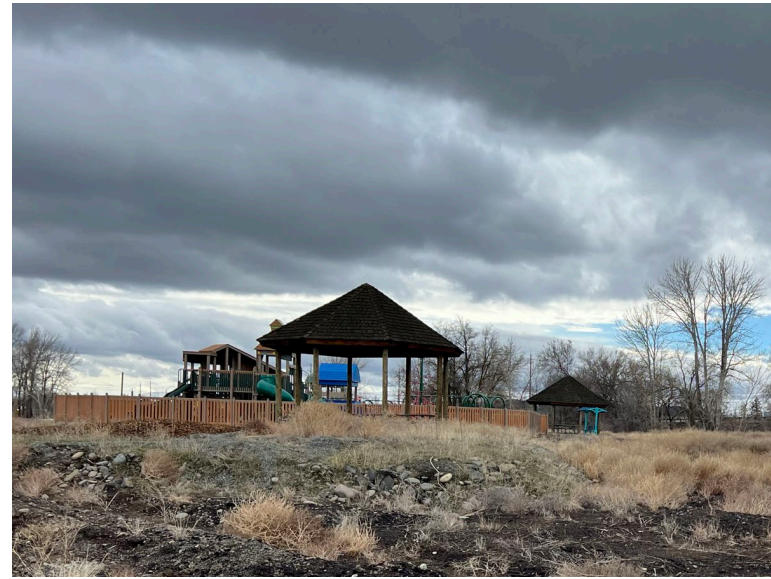
B19.2 Parcel E – The Sunrise Rotary Park McGuire Community Playground is located at the south end of Parcel E.

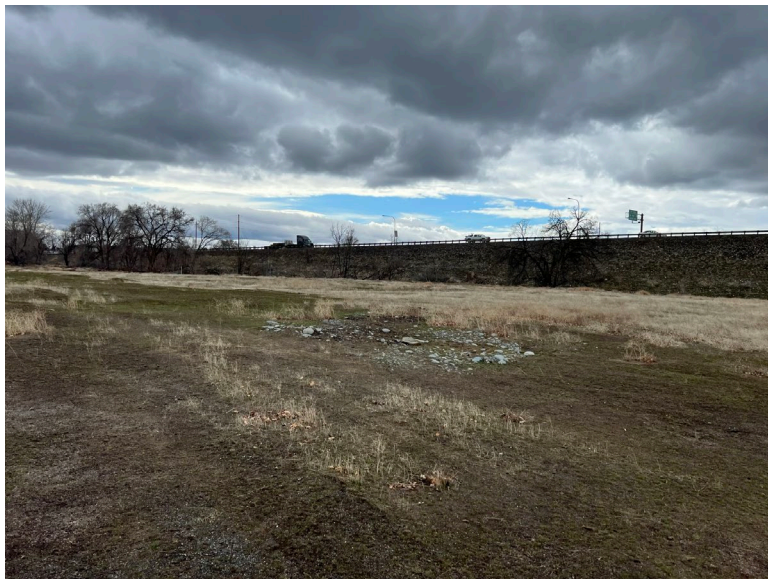
B19.3 Parcel D – The area south of the railroad tracks has ground cover vegetation. An area of mixed rock is visible in the photo.

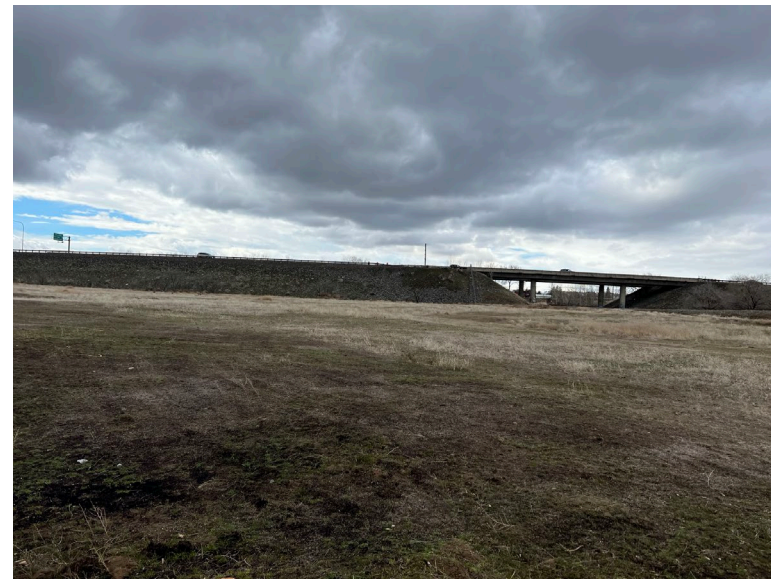
B19.4 Parcel D – A view across the south portion of Parcel D at the railroad underpass.

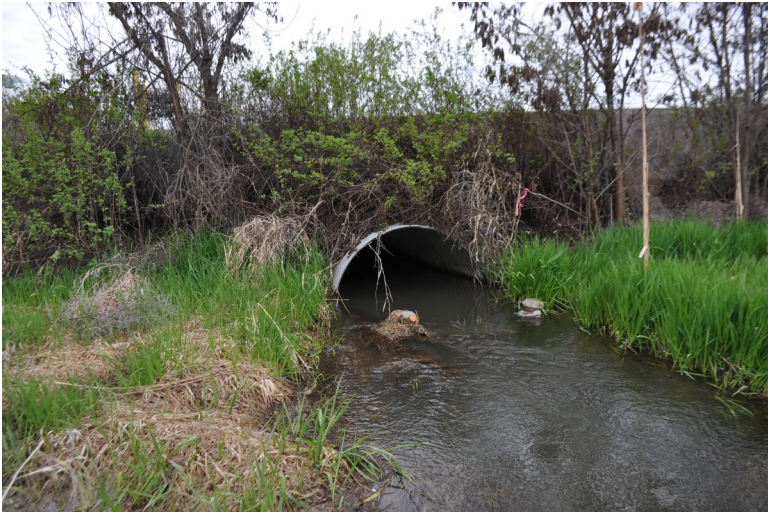
B20.1 – The Fruitvale Wasteway conveyance observed in April 2017.

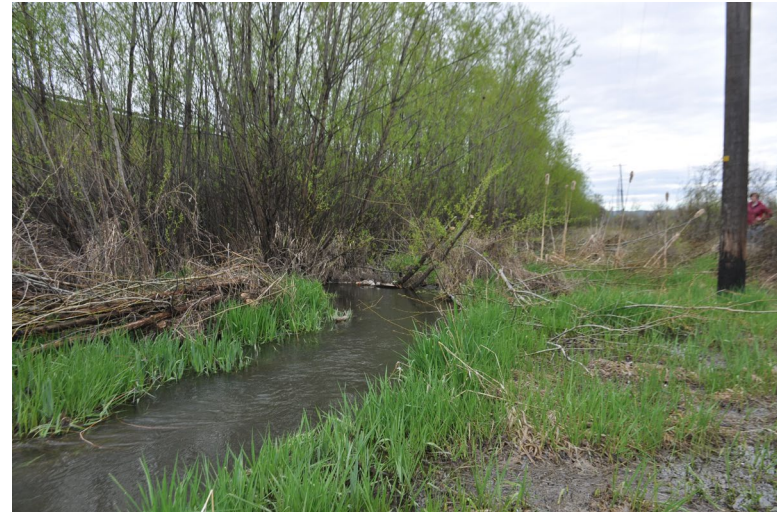
B20.2 – The section of the Fruitvale Wasteway on the westside of the I-82 corridor (April 2017).

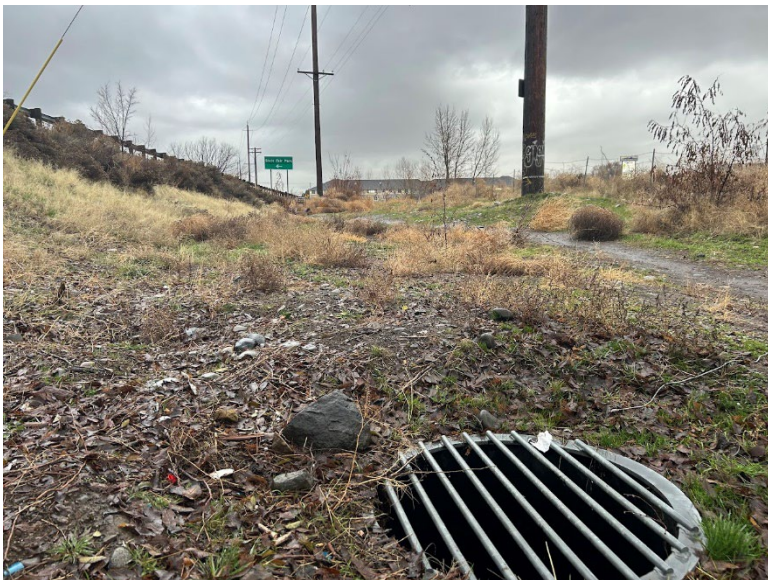
B20.3– The Fruitvale Wasteway is conveyed in piping along the south half of the Landfill Parcel.

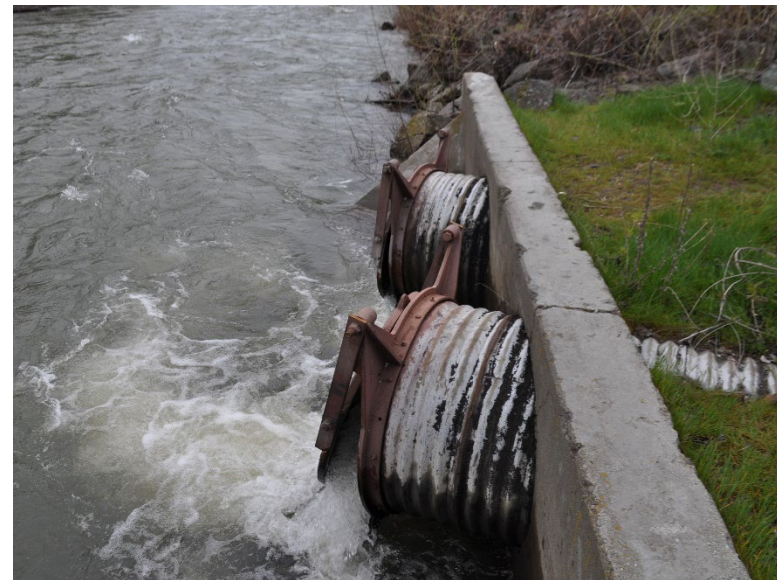
B20.3 Parcel E – The outfall of the Fruitvale Wasteway into the Yakima River (April 2017).

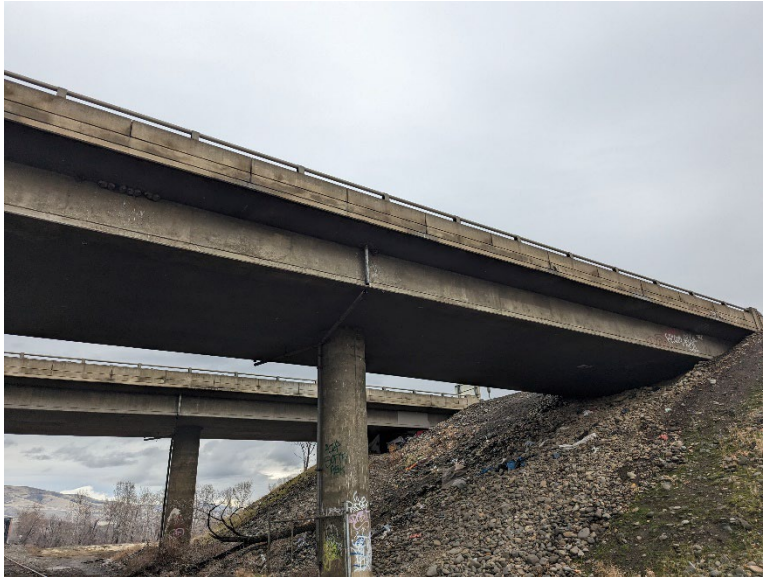
B21.1 Parcel E – Two overpasses cross above the railroad tracks and have visible downspouts extending from the road deck.

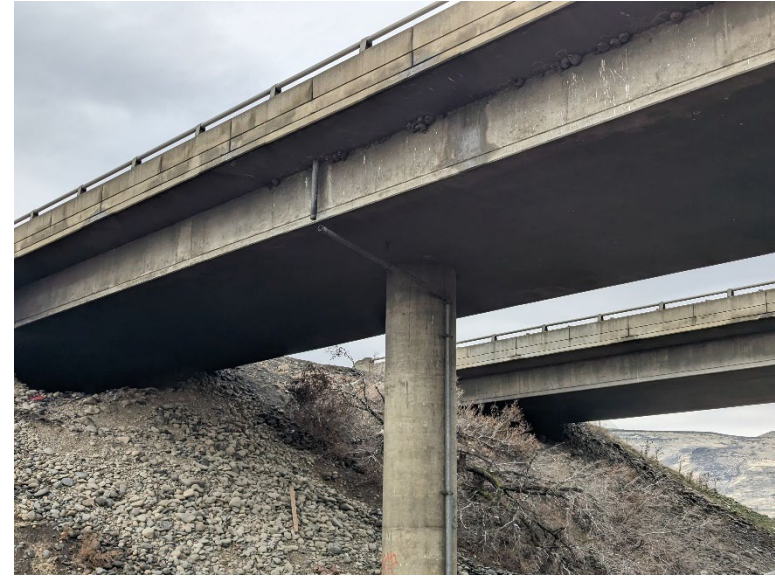
B21.2 Parcel E – A connective elbow is missing on the downspouts. Water discharges to the ground surface.

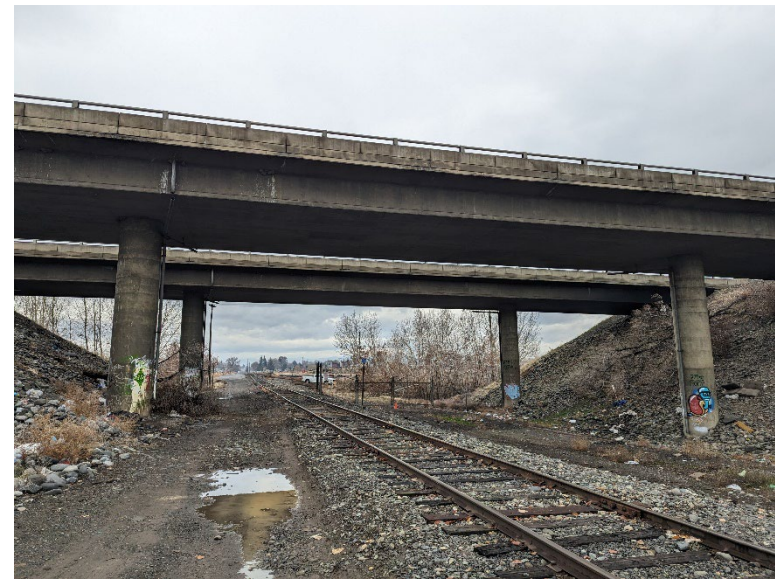
B21.4 – The overpass above the railroad tracks between the mill site and Parcel D (looking west towards the mill site).

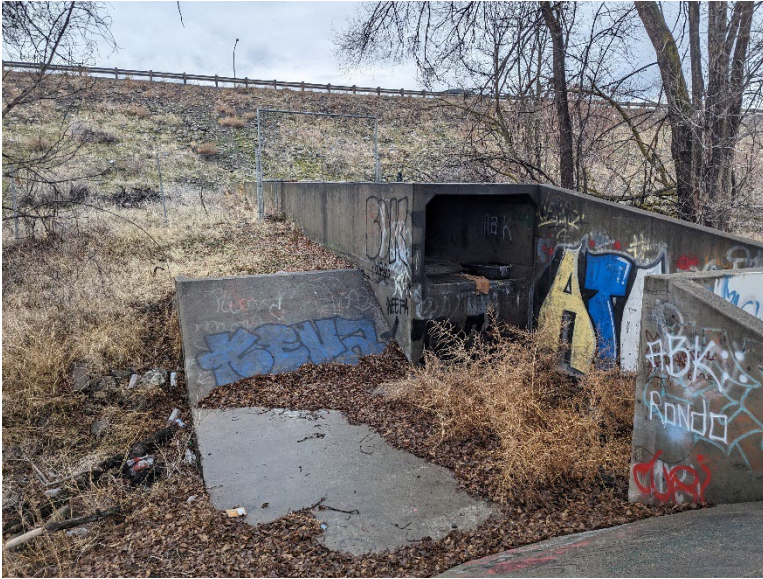
B22.1 Parcel E – The concrete culvert passing below I-82 from the mill site to Parcel E.

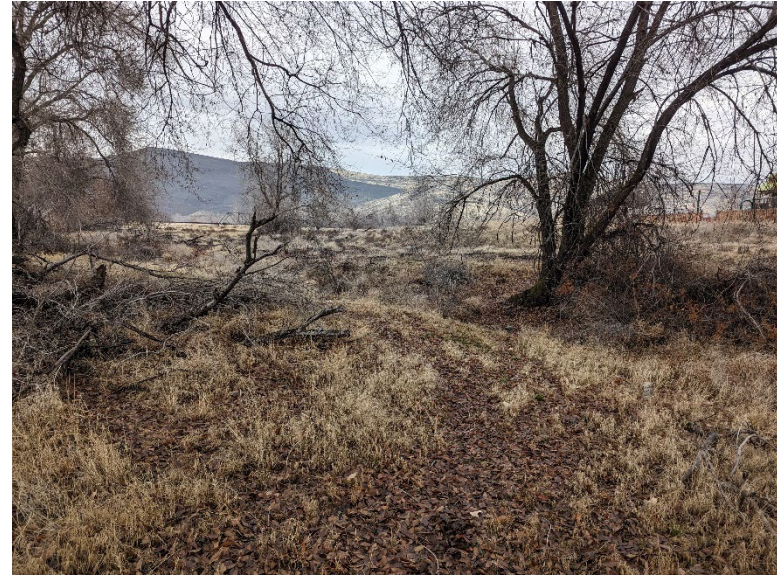
B22.2 Parcel E – A ditch along the east side of the I-82 corridor extends from the concrete culvert south.

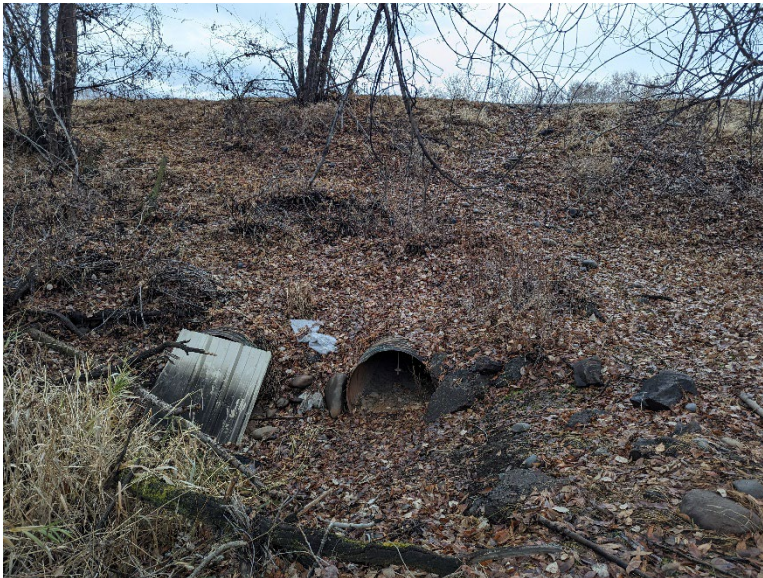
B22.3 Parcel E – Two 36-inch culverts through the levee beneath the Greenway.

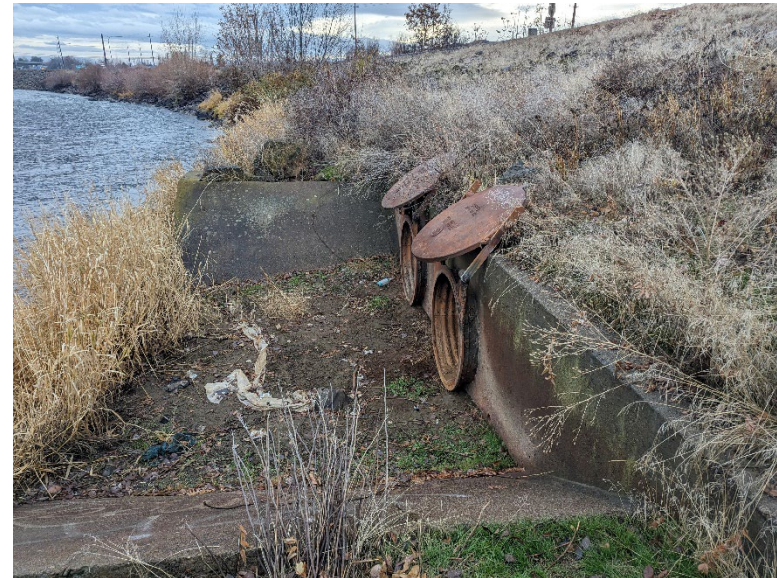
B22.4 – The two iron gates at the end of the culverts in a concrete foundation at the river bank.

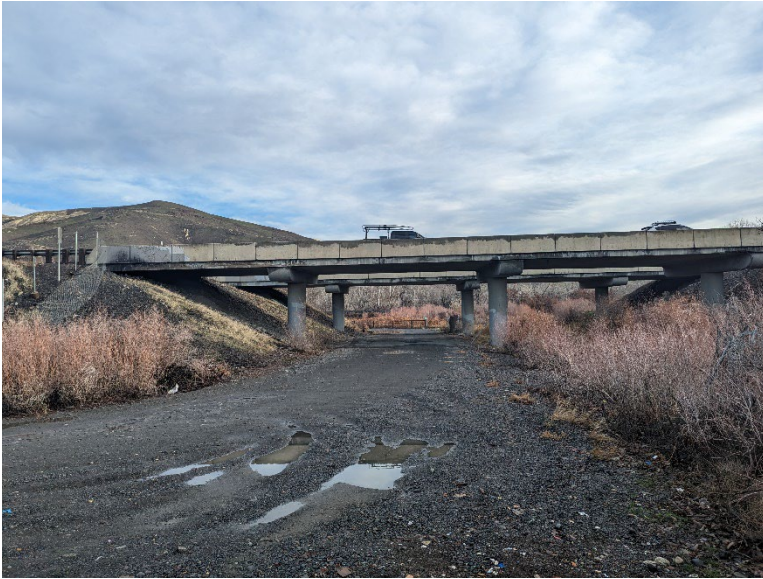
B23.1 – The north overpass is present above the access to Rotary Lake Park and Ride.

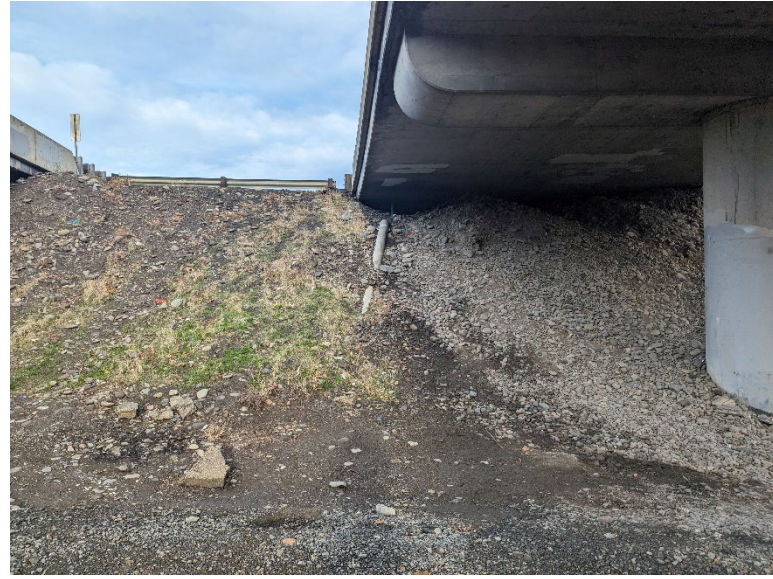
B23.2 – One of the metal culverts present beneath the overpass.

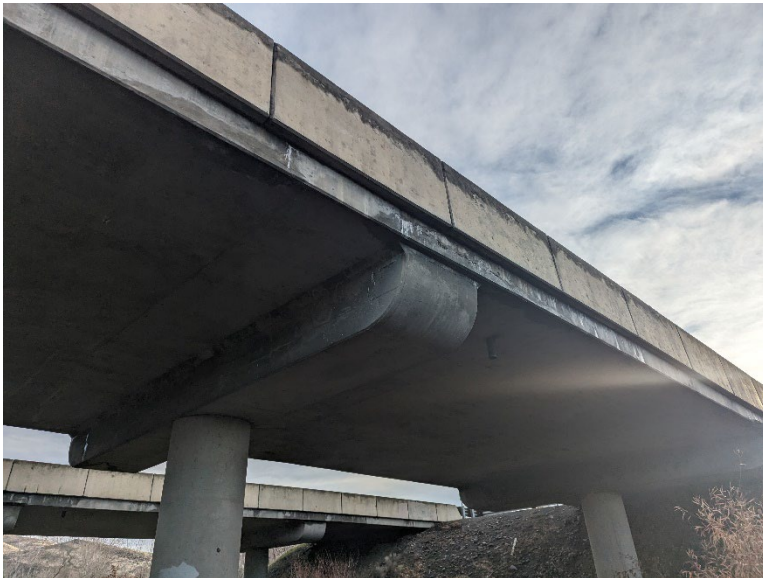
B23.3 – Pipes were observed extending from the bottom of the north overpass.

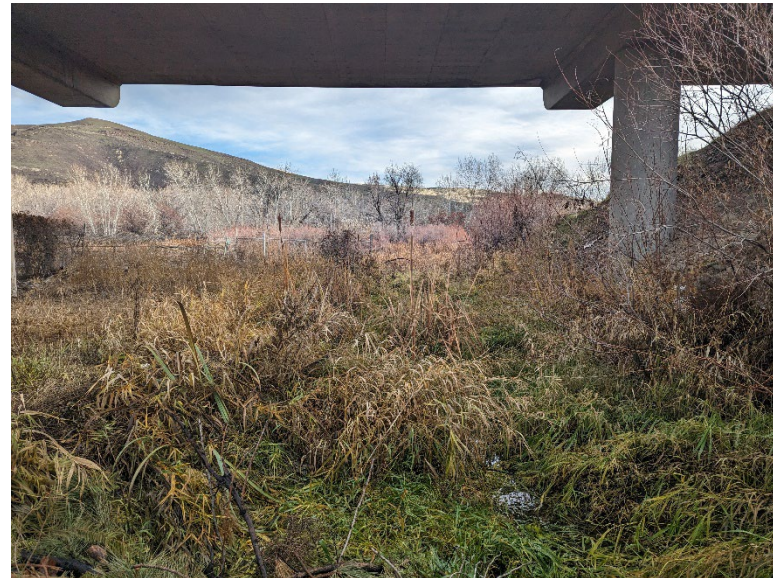
B23.4 – The comingled River Water Intake and North First Lateral Drain passes below I-82 at the north overpass.

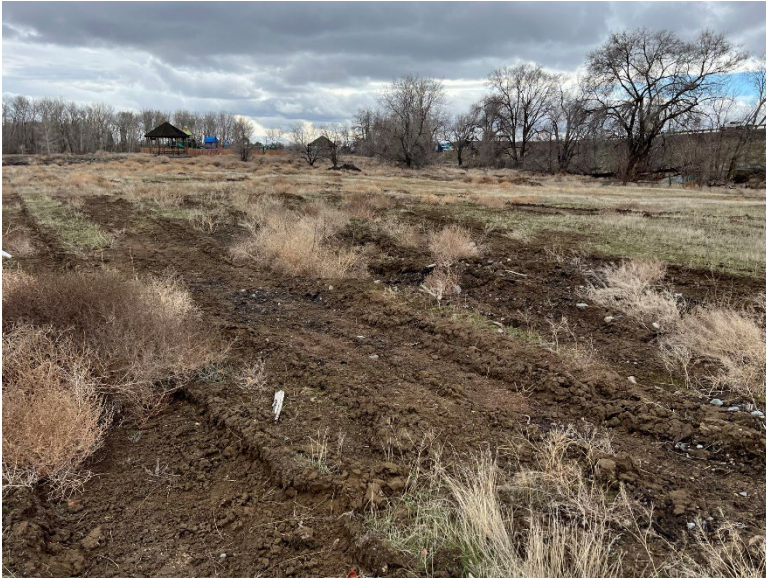
B24.1 Parcel E – Equipment tracks crossing the parcel near roadway test pit locations.

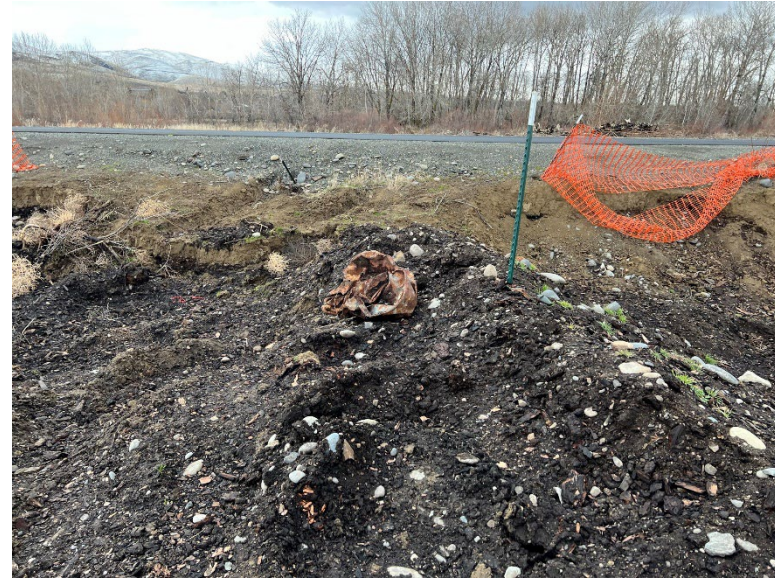
B24.2 Parcel E – Metal debris, including a crushed drum, was observed in the excavated area of log yard material.

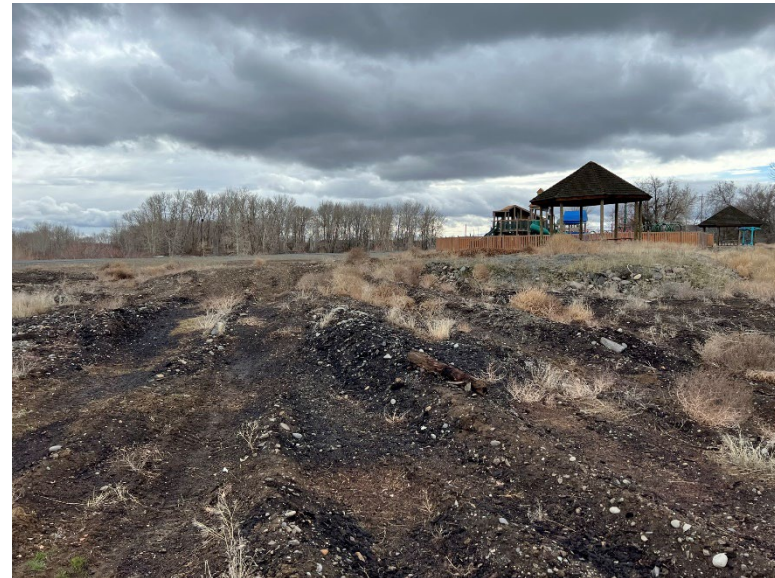
B24.4 Parcel E – Log yard material is present near the playground.

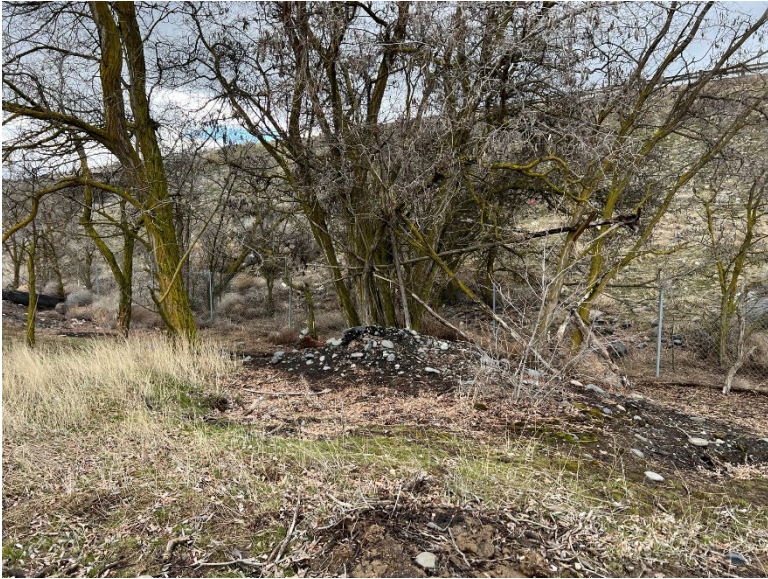
B25.1 Parcel D – Log yard material located along the WSDOT fence for I-82.

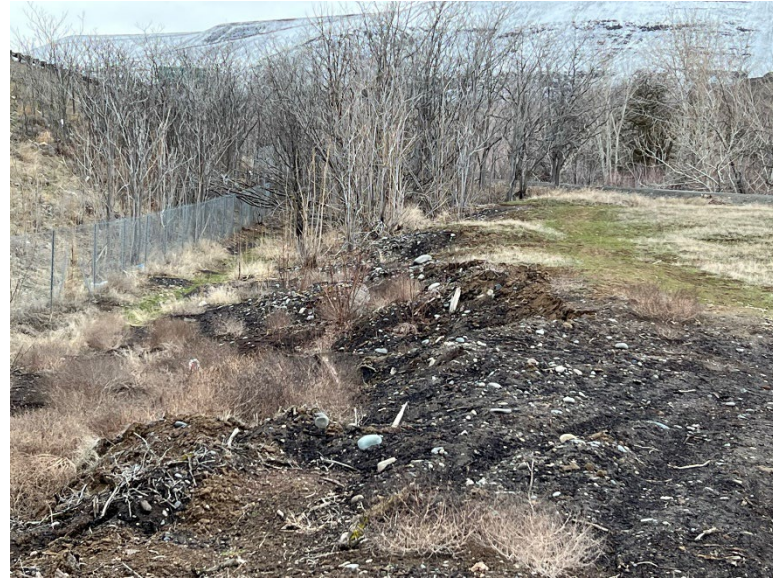
B25.2 Parcel D – Log yard materials are present at the ground surface and the elevation changes about 6-feet to the fence.

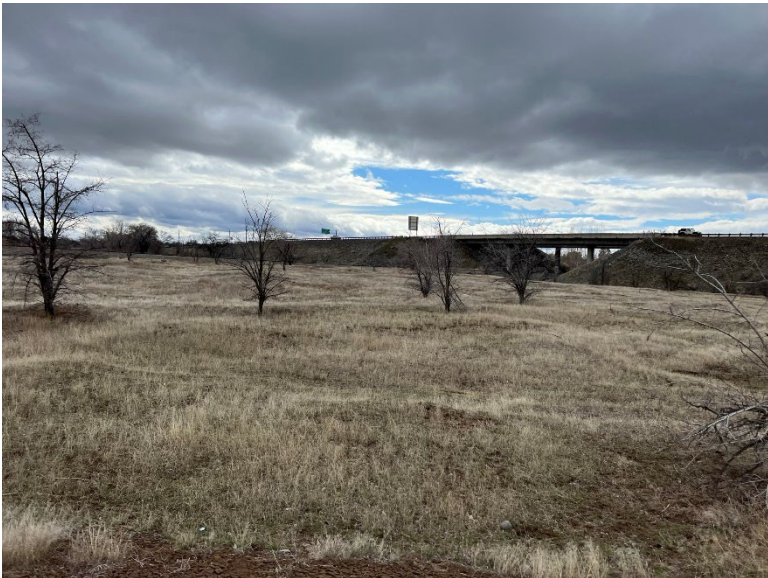
B25.3 Parcel D – Looking from the Greenway southwest across the undulating ground topography.

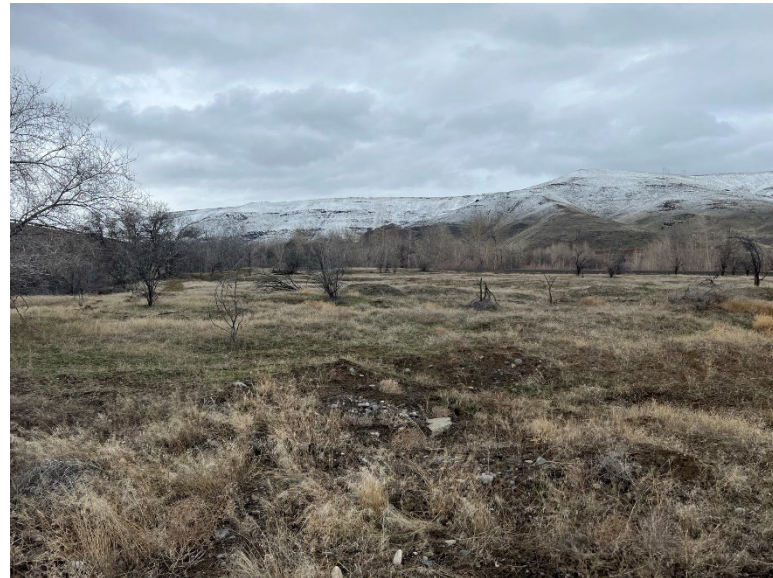
B25.4 Parcel D – Looking north along the east side of I-82 across the parcel north of the railroad tracks.

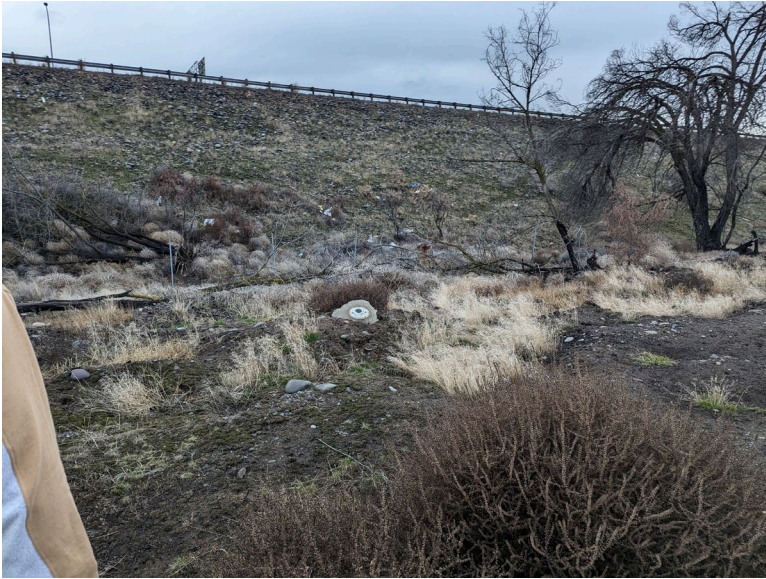
B26.1 Parcel E – A flush mount well monument located in the approximate future East-West Corridor roadway path.

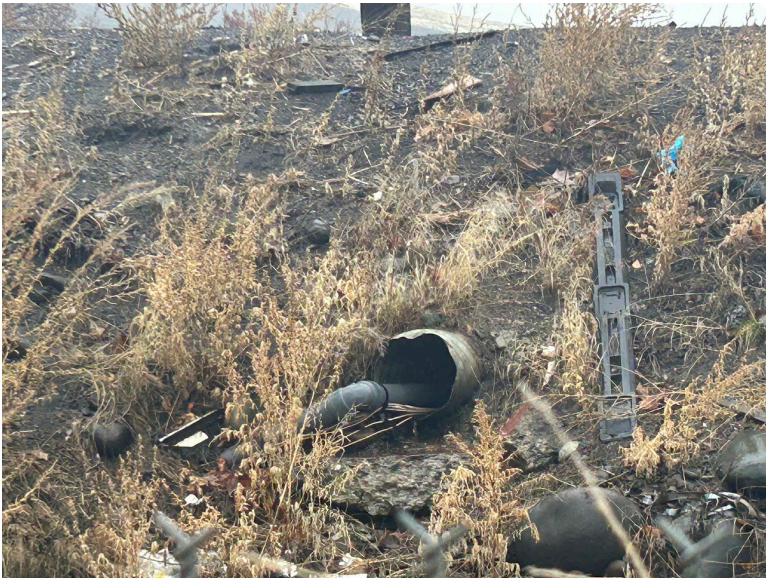
B26.3 – A 12-inch culvert in the slope of I-82 near MW-05 on the mill site.

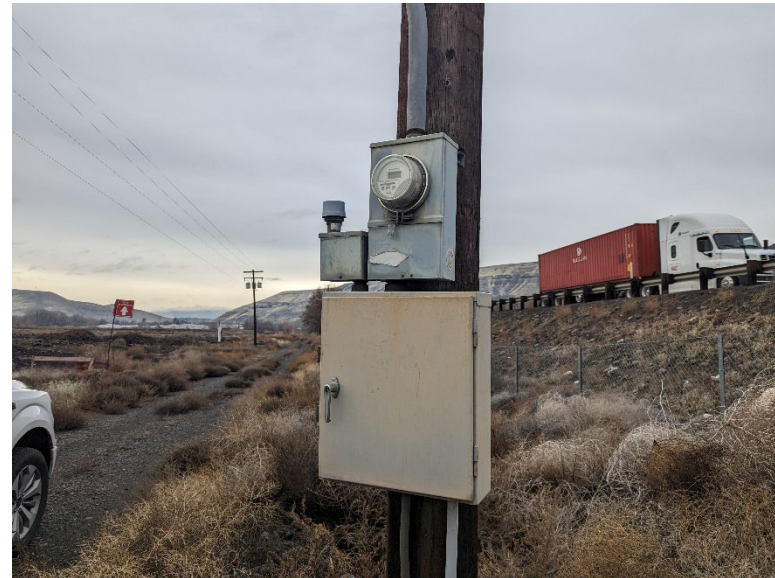
B26.4 – Electrical service near the culvert and MW-05 on the mill site.
