APPENDIX L (continued)
Field Report – Environmental

FIELD REPORT

Project:
Kite Hill Soil Cover Project

Location:
Gas Works Park, Seattle, WA

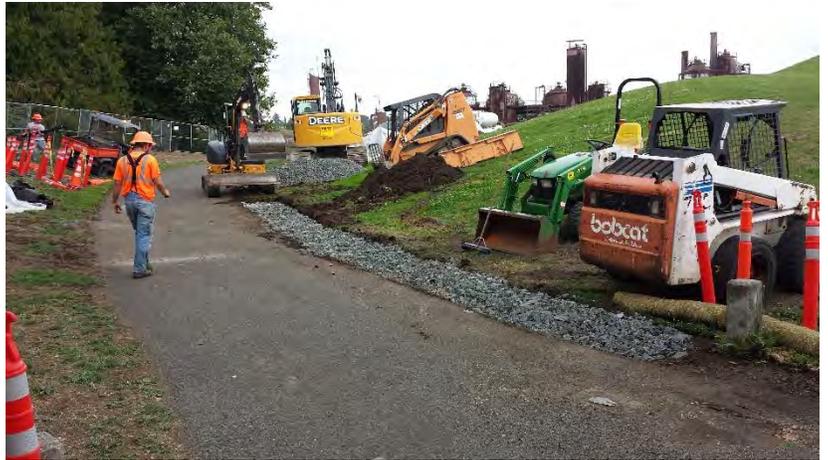
We observed the contractor install silt fence along the southeast corner of the property (see attached site plan). The contractor also installed quarry rock along the south side of the access lane where truck traffic was seen to be affecting the sod. We also observed that the contractor had previously installed a silt fence along the west and south side of the site along with infiltration trenches along the west side of the site.

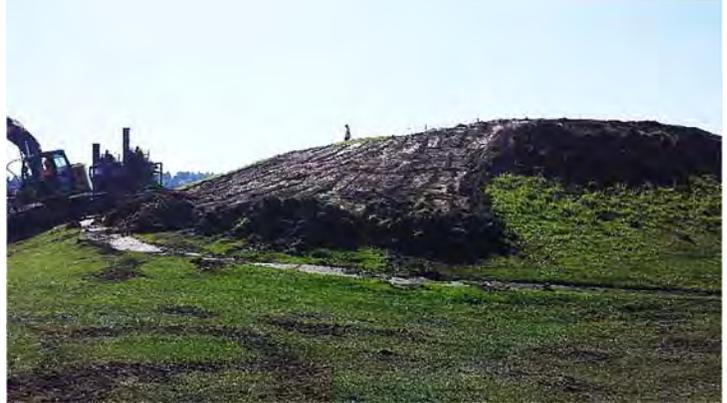
We observed the earthwork contractor excavating the sod/turf along the west and north sides of kite hill. The contractor removed the sod/turf along the top berm near the sun dial down the slope approximately 50 feet from the top berm. The contractor utilized a track hoe with a flat bucket to remove approximately 3 to 4 inches of sod/turf down the face of Kite Hill and approximately 8 inches along the berm of Kite Hill (see attached site plan).

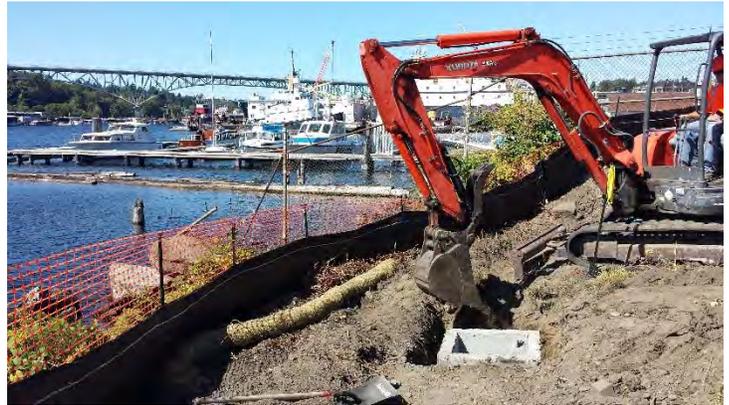
We observed the at-grade site conditions to consist mainly of sod/turf that slope down from kite hill to the boundary of the site properties. At this time temporary erosion and sedimentation control efforts included personnel tasked with cleaning soil that migrates onto hard surfaces during excavation, infiltration trenches/silt fencing with rock dams along the south and west perimeter of the site, and quarry spalls installed along the edge of asphalt pavement trucking route that is being used to deliver baker tanks on site. These efforts were observed to be functioning as intended so that soil was not observed to be leaving the site.

Based on our observations, it is our opinion that the temporary erosion and sedimentation control measures appear to be functioning in general accordance with the project plans and specifications.

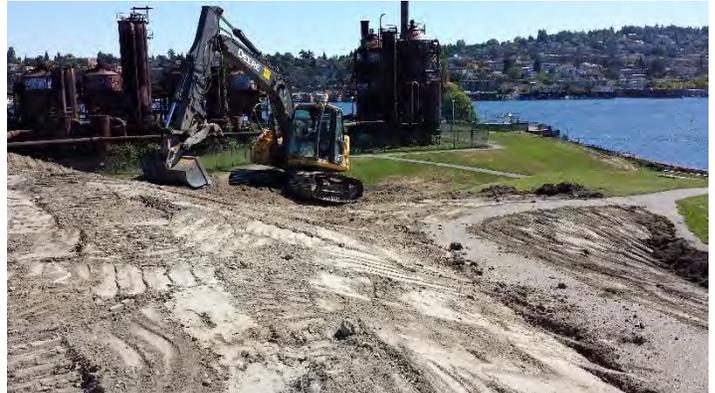
We observed the earthwork contractor excavating the sod/turf along the south and east sides of kite hill. The contractor removed the sod/turf along the top berm near the sun dial down the slope approximately 50 feet from the top berm. The contractor utilized a track hoe with a flat bucket to remove approximately 3 to 4 inches of sod/turf down the face of Kite Hill and approximately 18 inches along the berm of Kite Hill (see attached site plan).

The contractor continued tilling in the area east of Kite Hill (see attached site plan). The contractor utilized a John Deere tractor with a rear mounted tiller to reach the 12 inches of soil tilling that the plans specify. The contractor encountered trace concrete, brick and metal debris during tilling.

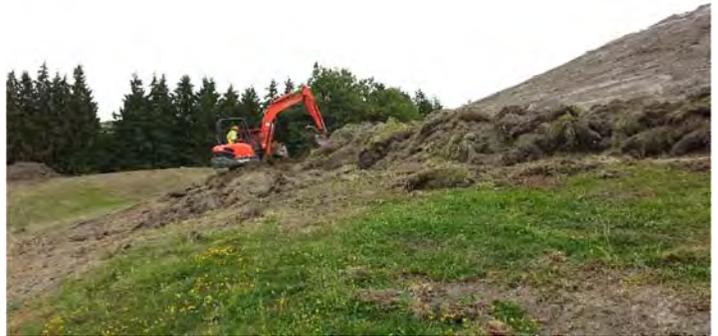
We observed the earthwork contractor excavating the sod/turf along the west property line. The contractor removed the sod/turf down the west side of the property line. The contractor utilized a track hoe with a flat bucket to remove approximately 12 inches of sod/turf at the property line and grades to 3 inches of sod/turf removal where the sod/turf area meets the proposed till area (see attached site plan).

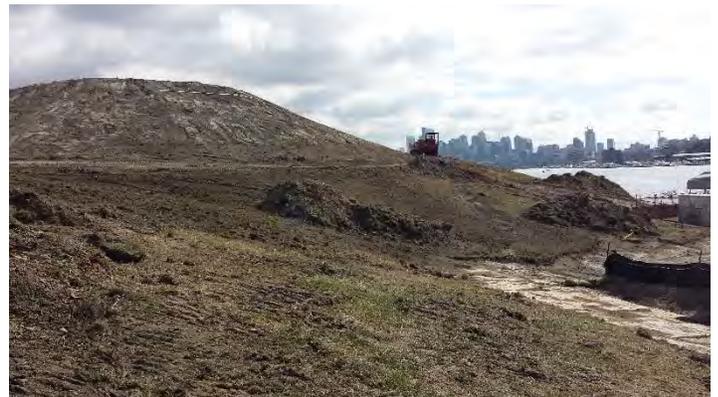
The contractor continued tilling all of the site (see attached site plan). The contractor utilized a John Deere tractor with a rear mounted tiller and a bobcat with a front mounted till approximately 2 to 3 inches throughout most of the site (see attached site plan). The contractor encountered occasional concrete, brick and metal debris during tilling.

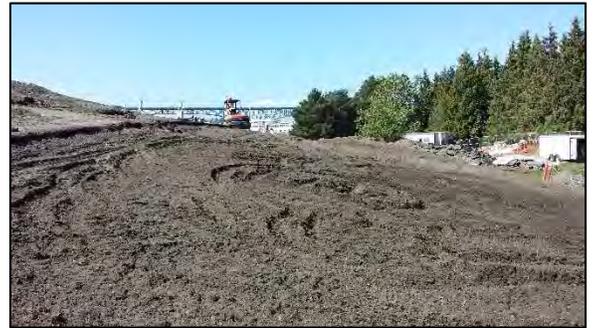
We observed the contractor continue tilling north and east of kite hill (see attached site plan). The contractor utilized a John Deere tractor with a rear mounted tiller and a bobcat with a front mounted tiller to break up and mix the sod and roots. The tilled areas were deemed acceptable after the material was clear of sod clumps and large organics. The areas probed between 8 and 10 inches. The contractor was also removing debris (brick, concrete, asphalt, metal) larger than 4 inches in diameter. See attached site plan for areas that tilling has been completed.

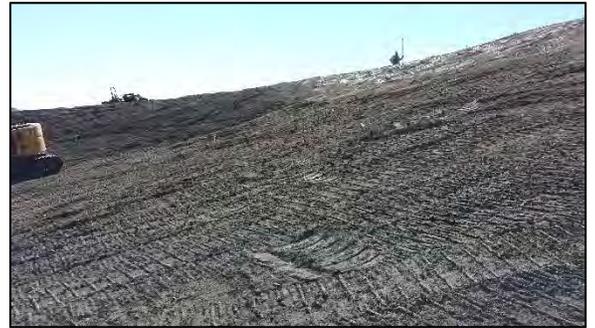
We observed the contractor continue tilling the area east and south of kite hill (see attached site plan). The contractor utilized a John Deere tractor with a rear mounted tiller and a bobcat with a front mounted tiller to break up and mix the sod and roots. The tilled areas were deemed acceptable after the material was clear of sod clumps and large organics. The areas probed between 8 and 10 inches. The contractor was also removing debris (brick, concrete, asphalt, metal) larger than 4 inches in diameter from the tilled area. See attached site plan for areas that tilling has been completed.

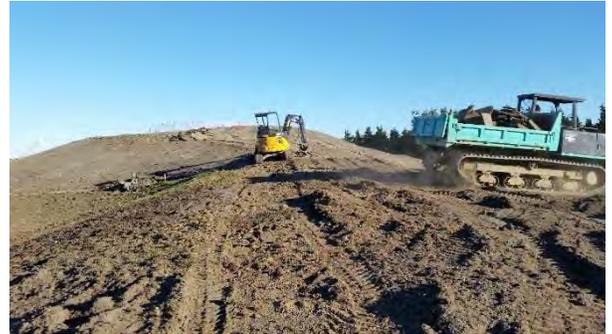
We observed the contractor removing debris (brick, concrete, asphalt, metal) larger than 4 inches in diameter using a mini-excavator. See attached site plan for areas that tilling has been completed. There was no tilling activity while we were on-site today.

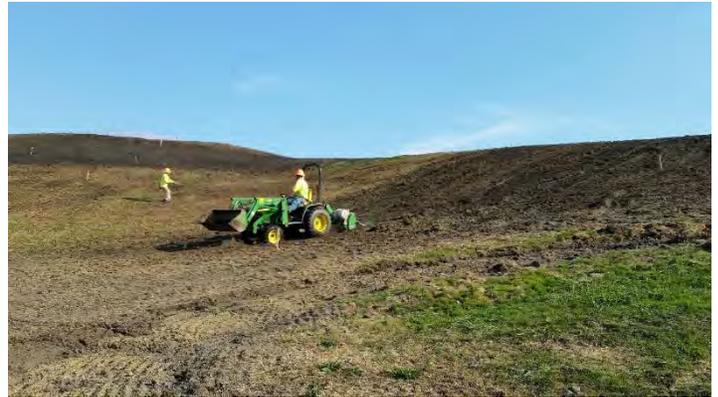
We observed the contractor continue tilling the area south of Kite Hill (see attached site plan). The contractor utilized a John Deere tractor with a rear mounted tiller to break up and mix the sod and roots. The tilled areas were deemed acceptable after the material was clear of sod clumps and large organics. The areas probed between 8 and 10 inches. The contractor was also removing debris (brick, concrete, asphalt, metal) larger than 4 inches in diameter from the tilled area. See attached site plan for areas that tilling has been completed.

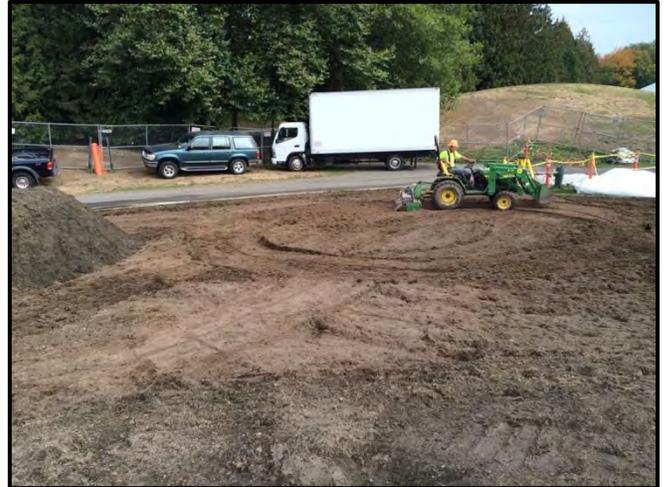
We observed the contractor place geo-grid (Tensar TX130S) on the prepared subgrade near the northeast quadrant of Kite Hill (see attached site plan). The subgrade was evaluated prior to placing the geo-grid to ensure that the subgrade was compacted properly and was free of pumping soil conditions and observed to be firm. We evaluated the subgrade by means of probing with a ½-inch diameter steel probe rod. Probe depths were generally in the range of 2- to 3-inches.

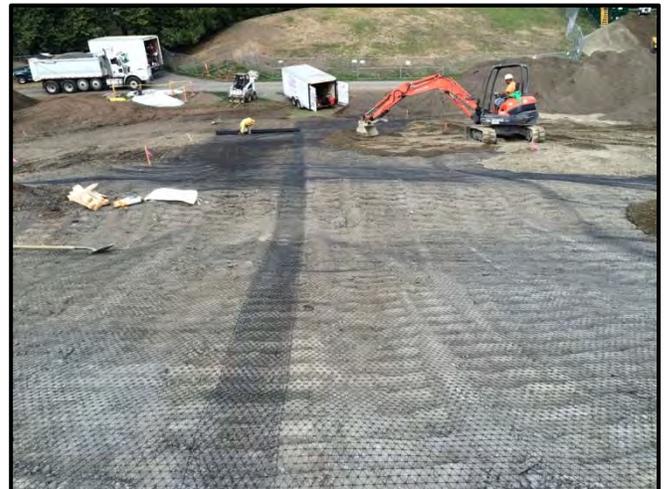
We also observed the contractor place an approximately 6-inch lift of City of Seattle Type 17 bank run gravel (City of Seattle Specification 9-03.12(2)B) over a portion of the geo-grid placed today (see attached site plan). The contractor was moisture conditioning the material utilizing a fire hose. The Type 17 placed today has not been compacted. We understand that compaction will occur once the contractor has a hoepac on site.

Based on our observation and evaluations, it is our opinion that the geo-grid and soil cap work performed today was completed in general accordance of those sections of the plans and specifications that pertain to the geotechnical aspects of the project.
