# Cleanup Action Report

*Union Pacific Railroad, Aluminum Recycling Trentwood Site*

**WSP USA Inc.**

May 3, 2024

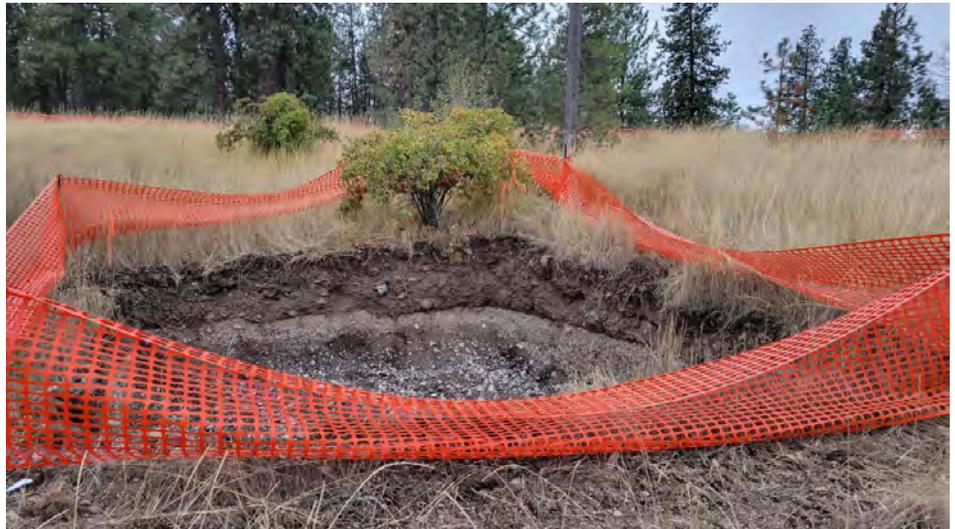
**PHOTOGRAPH 8**

Contractor adjusted the inbound haul road to avoid WSDOT Excavation #7. View looking west.

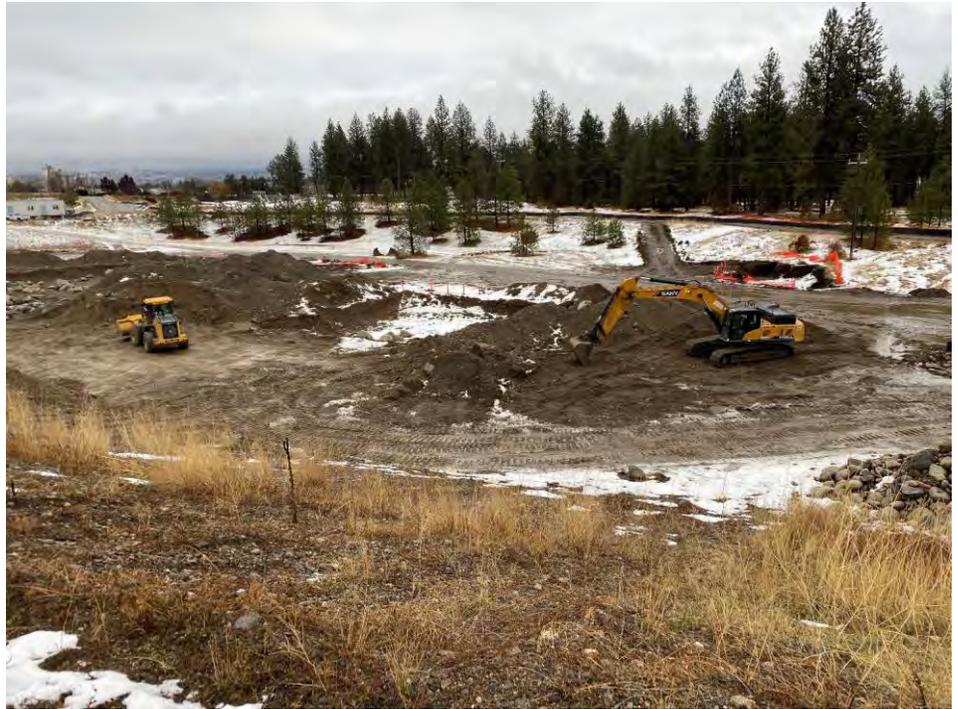
**PHOTOGRAPH 12**

Backfilling of Excavation #7 in 1-foot-thick loose lifts (or as able around boulders) and compaction with back of excavator bucket. View looking east.

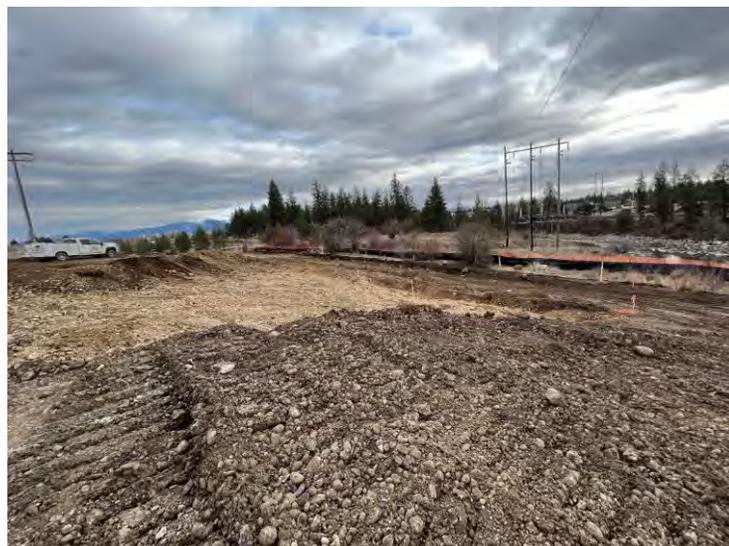
**PHOTOGRAPH 19**

Excavation #4 on WSDOT property with soil safety berm around edge. View looking southwest.

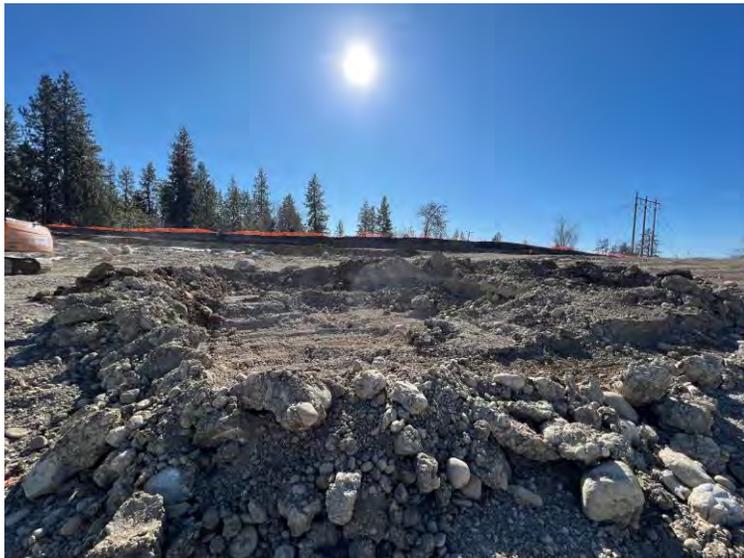
**PHOTOGRAPH 21**

Excavation and loading of Excavation #3 material to be hauled to the UPRR cap area. View looking west.

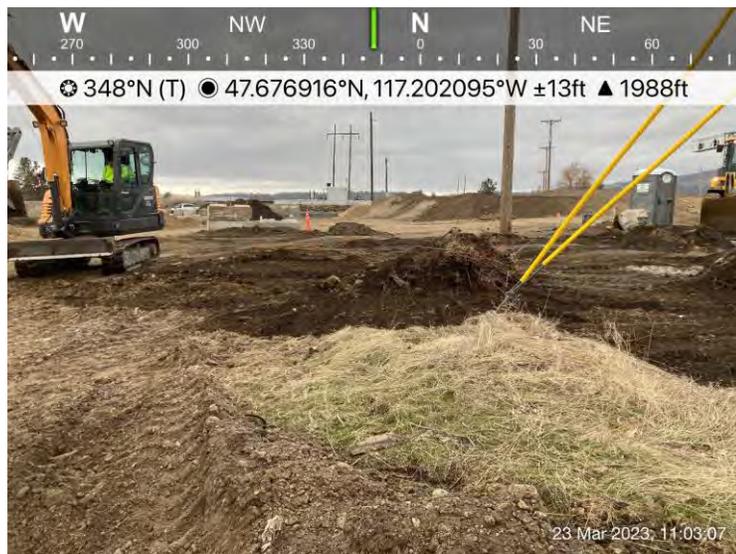
**PHOTOGRAPH 30**

CAT D6 dozer grading excavated materials placed on the UPRR side slope. View looking west.

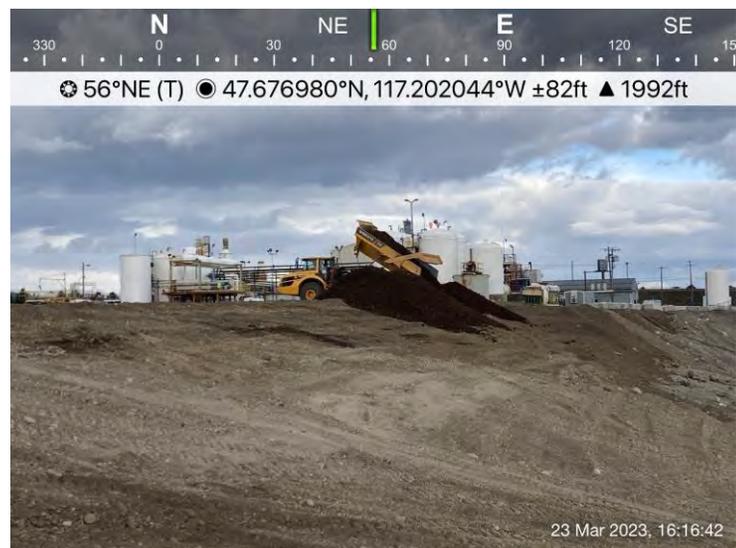
**PHOTOGRAPH 31**

Front-end loader transferring excavated materials from the stockpile located on the Pentzer property to the UPRR cap area. View looking north.

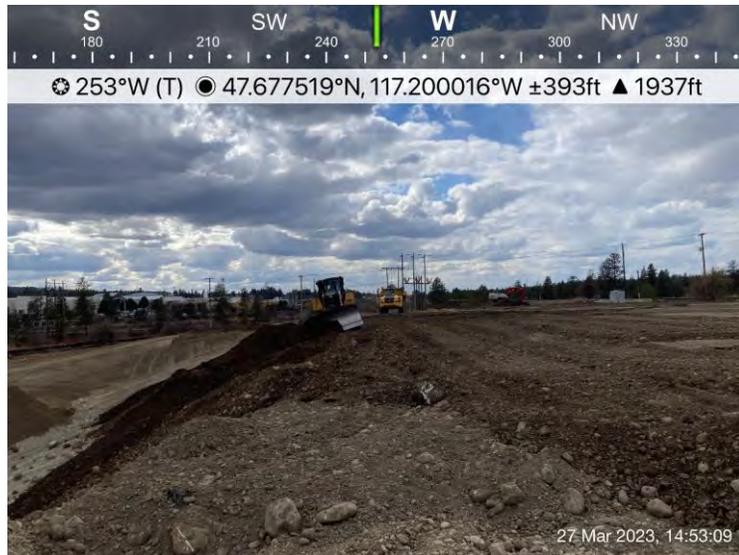
**PHOTOGRAPH 32**

CAT 259D compacting portions of the railroad ditch north of the UPRR cap area with the compactor attachment. View looking north.

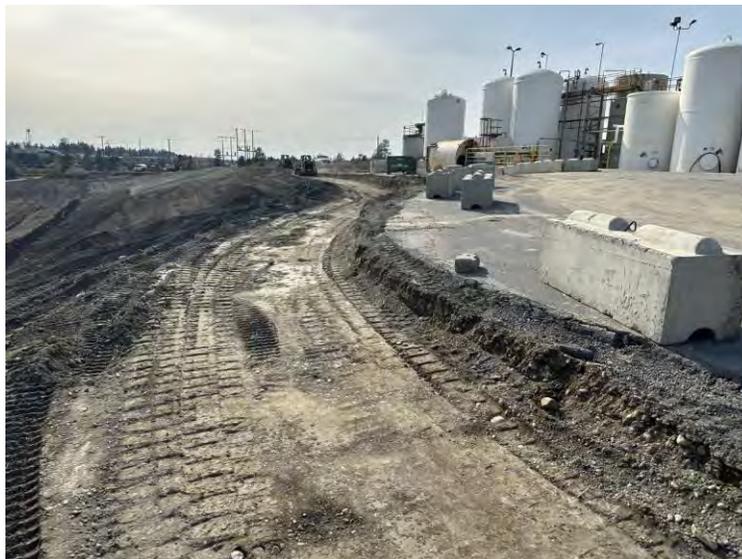
**PHOTOGRAPH 40**

Placement and compaction of the containment berm on the ecological cap area. View looking north.

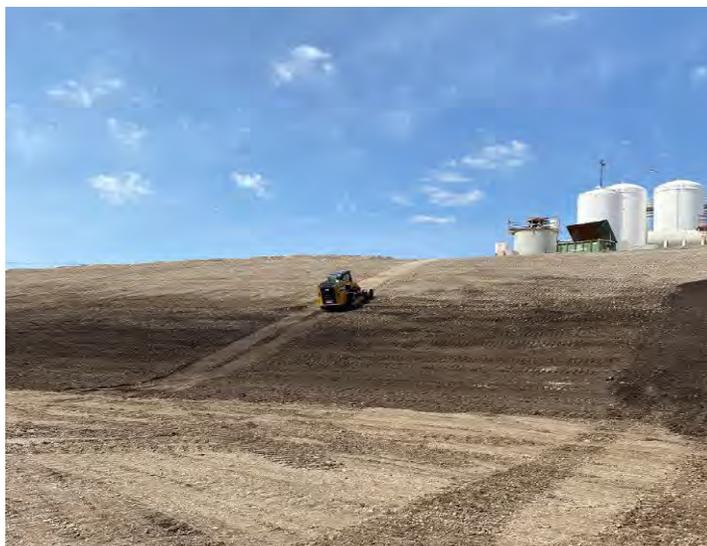
**PHOTOGRAPH 41**

A 5-ft buffer on the UPRR property was excavated along the Pentzer property. View looking north.

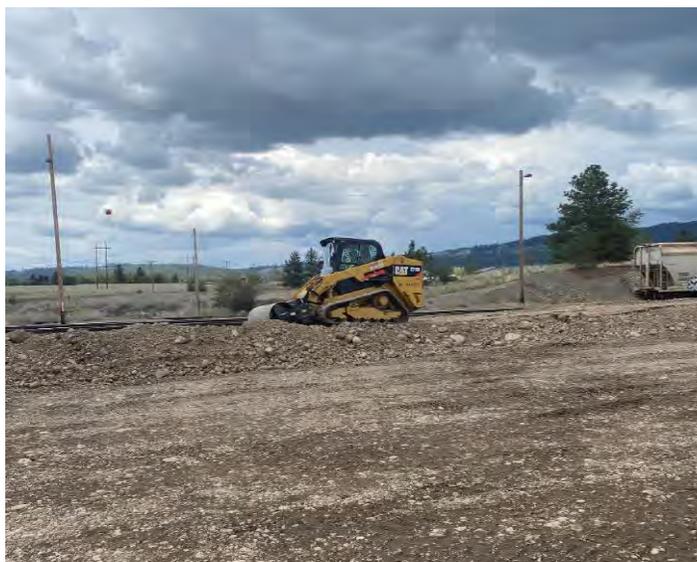
**PHOTOGRAPH 42**

Compaction of eastern UPRR containment berm complete. View looking north.

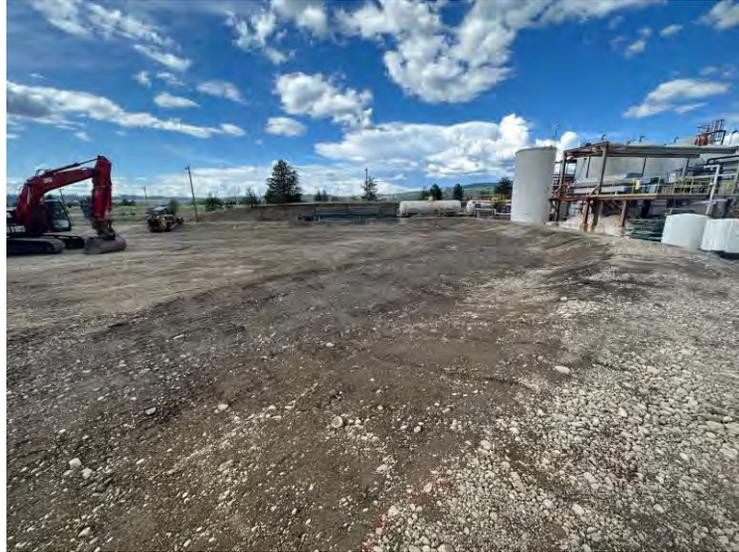
**PHOTOGRAPH 44**

Backfill and compaction of north-eastern wedge portion on Pentzer Property. View looking southwest.

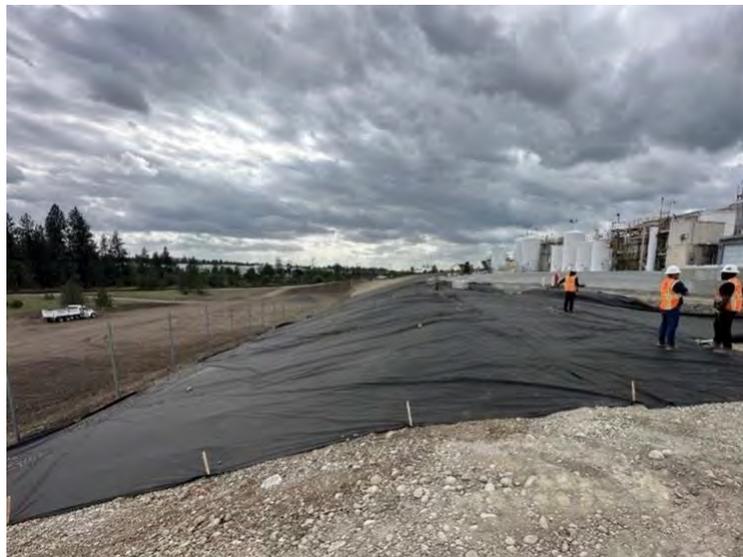
**PHOTOGRAPH 48**

Geotextile placement on eastern portion of UPRR side slope. View looking west.

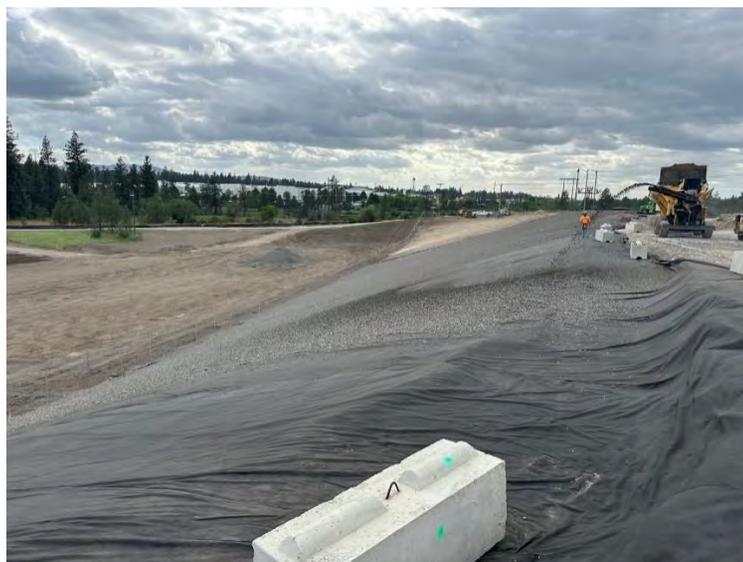
**PHOTOGRAPH 49**

1- to 2-inch clean crushed ballast placed in a 6-inch lift on eastern portion of UPRR side slope. View looking west.

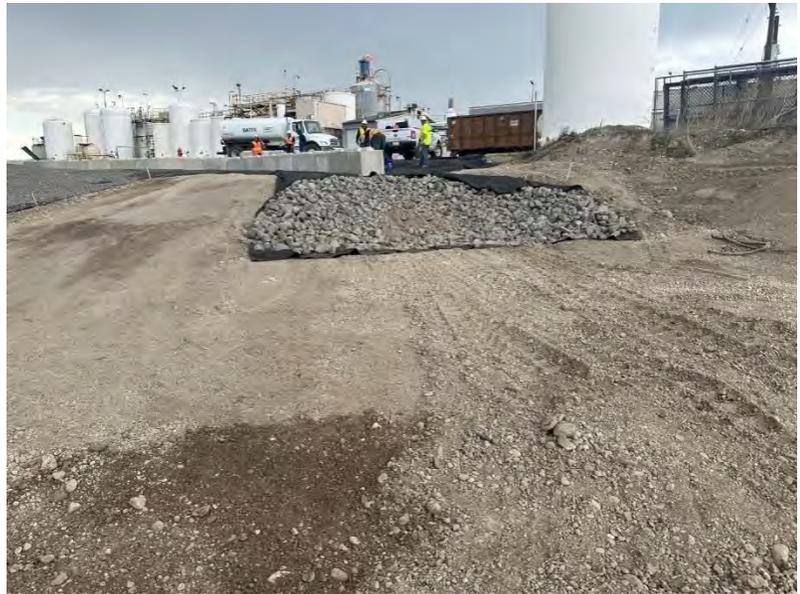
**PHOTOGRAPH 51**

Construction of ecology block surface water feature armored termination and armor rock apron. 2- to 8-inch quarry spalls used as armor rock. View looking northwest.

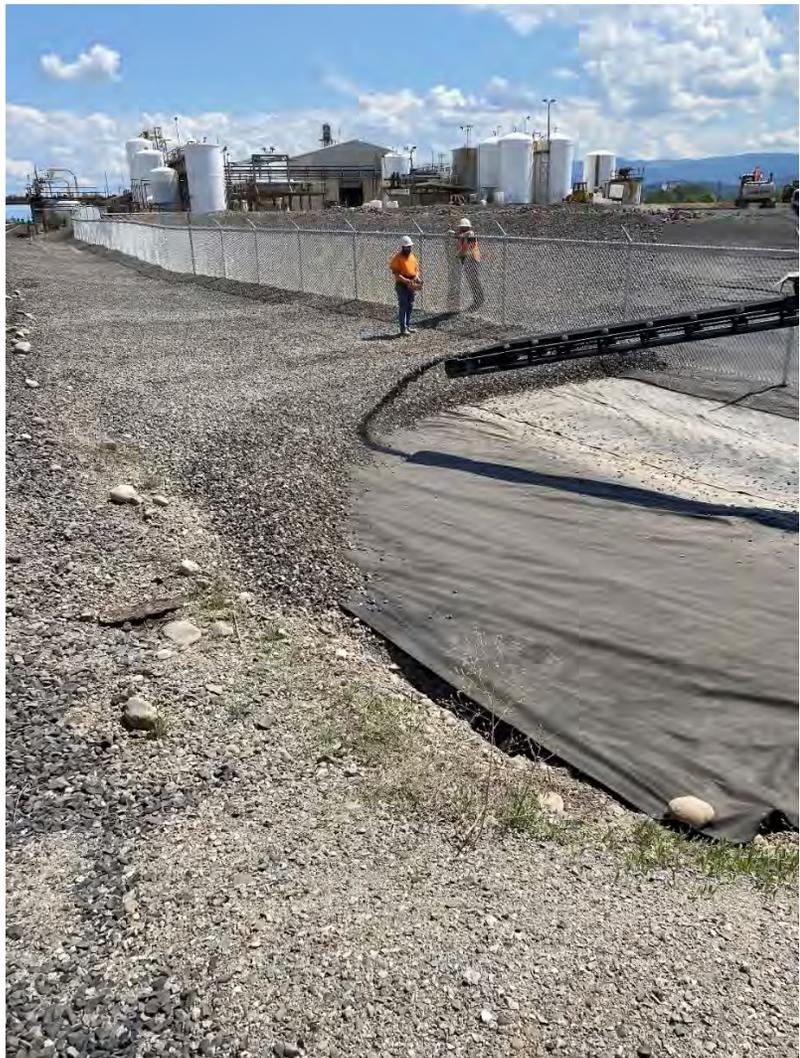
**PHOTOGRAPH 52**

1- to 2-inch clean crushed ballast placement in a 6-inch lift in the north railroad ditch using a CAS AT7 Rock Slinger. View looking east.

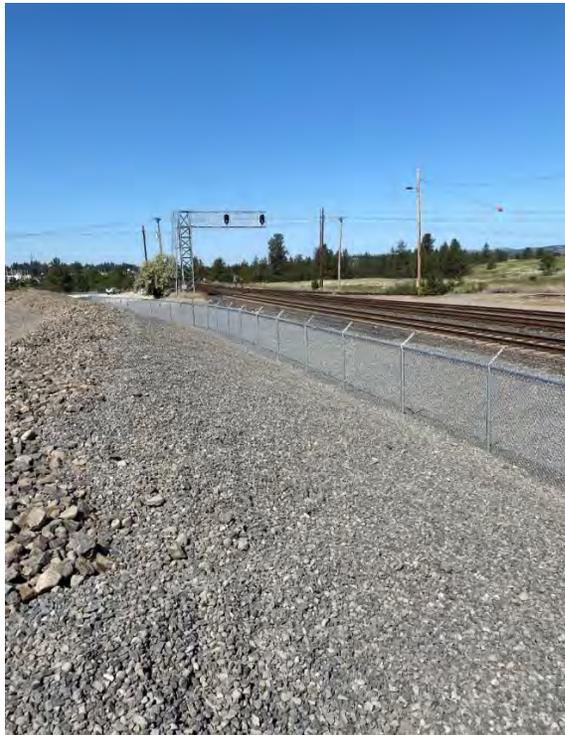
**PHOTOGRAPH 53**

1- to 2-inch clean crushed ballast placement in a 6-inch lift in the central area of the UPRR pad. View looking northwest.

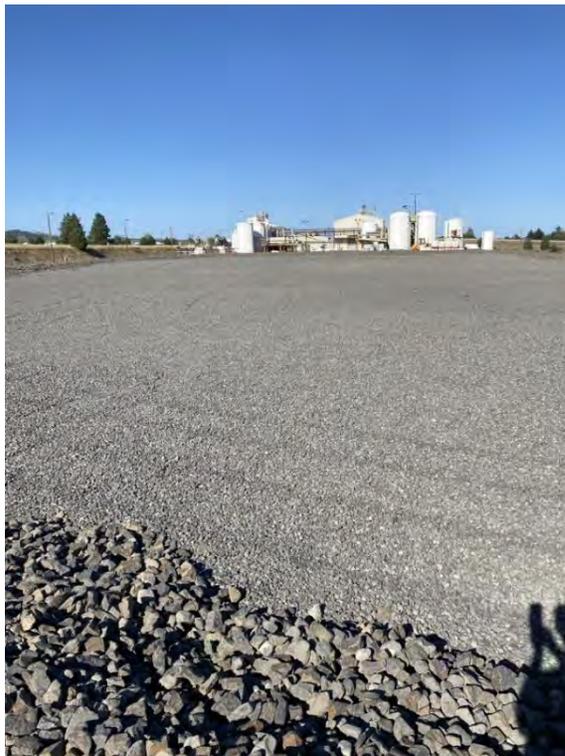
**PHOTOGRAPH 54**

Completed north railroad ditch with permanent fence, a 6-inch lift of 1- to 2-inch clean crushed ballast throughout the channel and side slopes, and 6-inch lift of 2- to 4-inch quarry spalls on containment berm. View looking west.

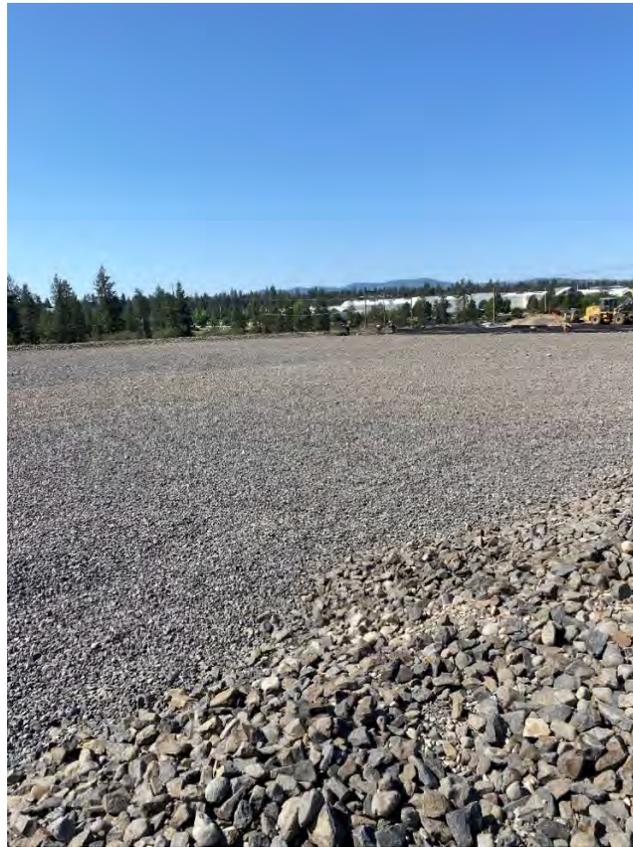
**PHOTOGRAPH 55**

Containment berm located in the northeastern corner of the UPRR pad property, completed with an 8-inch lift of 2- to 4-inch quarry spalls. 6-inch lift of 1- to 2-inch clean crushed ballast on the UPRR pad. View looking southeast.

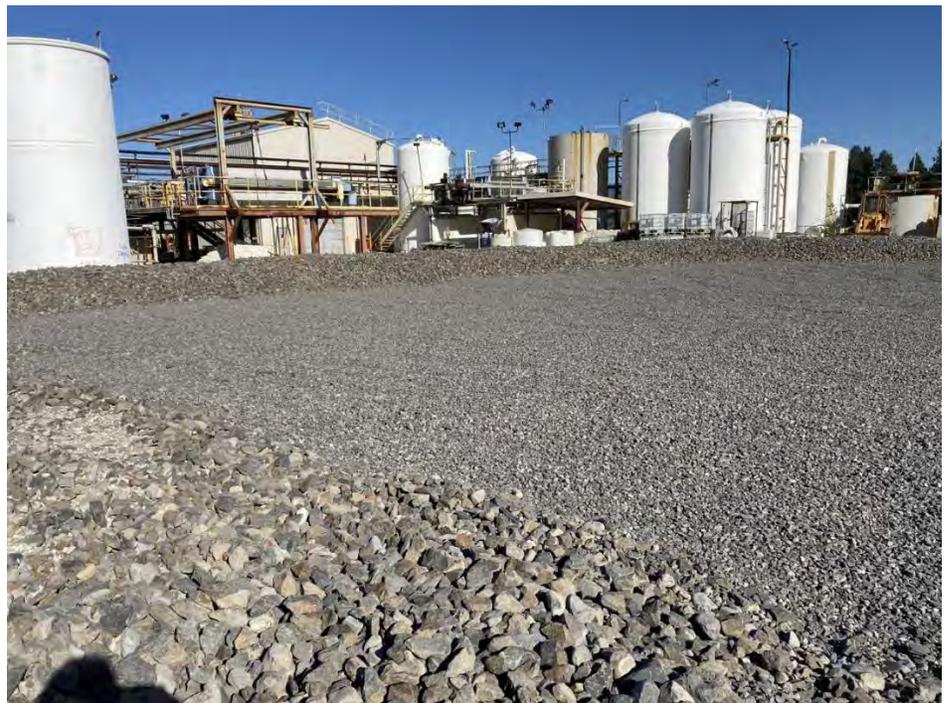
**PHOTOGRAPH 56**

1- to 2-inch clean crushed ballast placed in a 6-inch lift in the central area of the UPRR pad. View looking east.

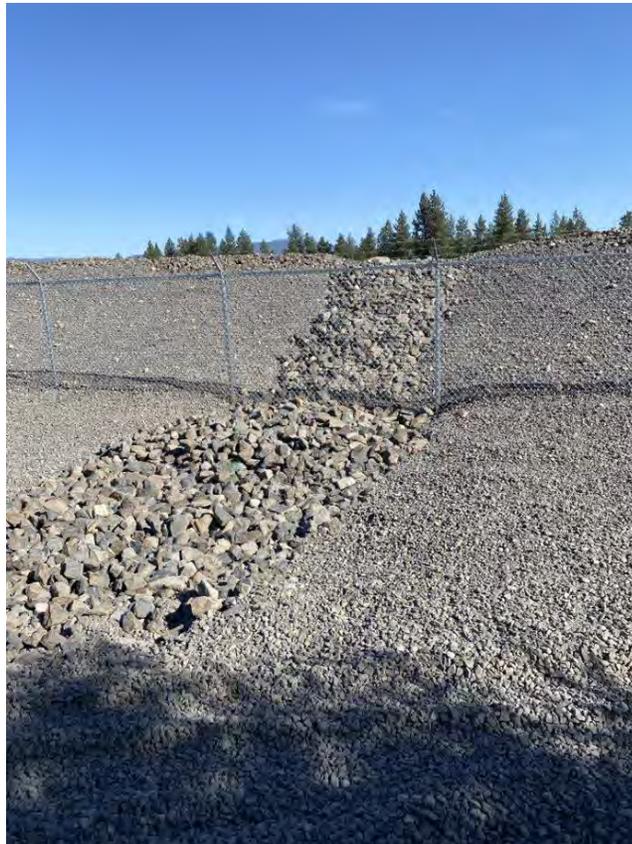
**PHOTOGRAPH 57**

Completed overflow channel with 2- to 8-inch quarry spalls in armor rock apron. View looking south.

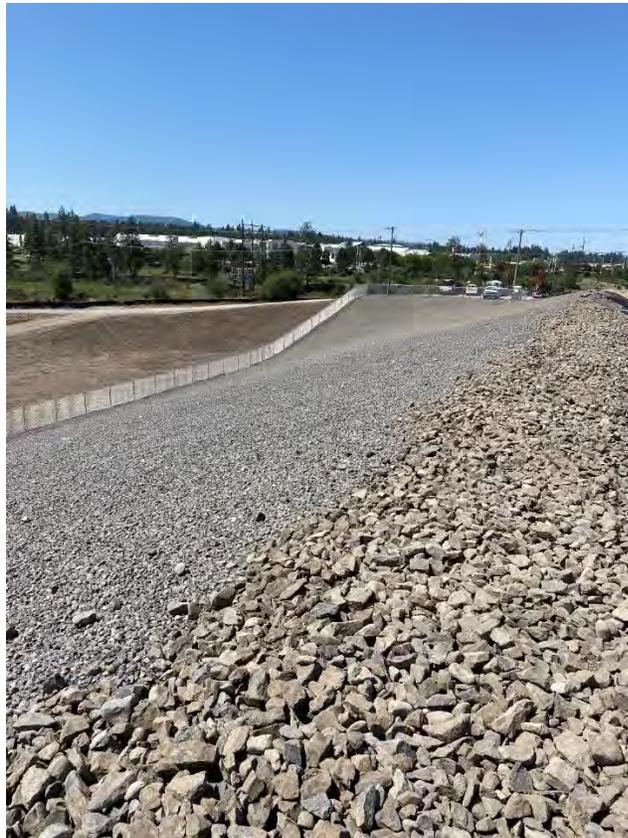
6-inch lift of clean crushed 1- to 2-inch ballast overlying geotextile on UPRR side slope enclosed with permanent fence. UPRR pad containment berm with 2- to 4-inch quarry spalls at right. View looking west.

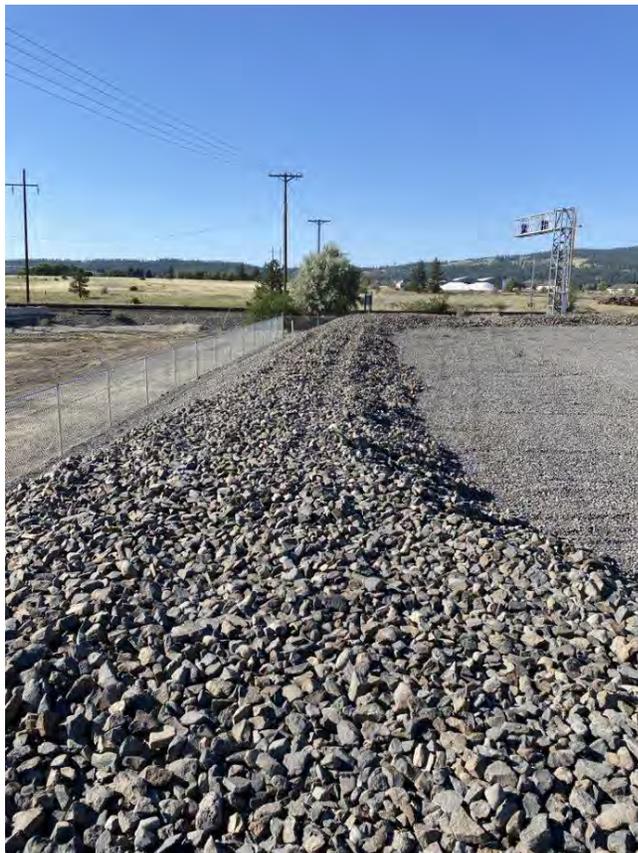
**PHOTOGRAPH 60**

Western portion of UPRR pad and containment berm. 2- to 4-inch quarry spalls on containment berm. Permanent fence on UPRR/Pentzer property line at left. View looking north.

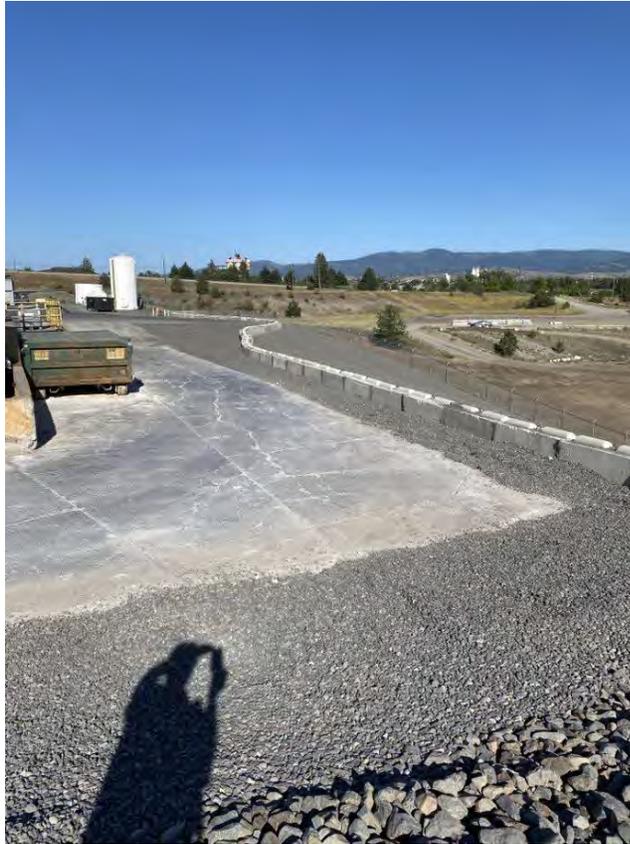
**PHOTOGRAPH 61**

Ecology block surface water feature with a 6-inch lift of 1- to 2-inch clean crushed ballast. View looking east.

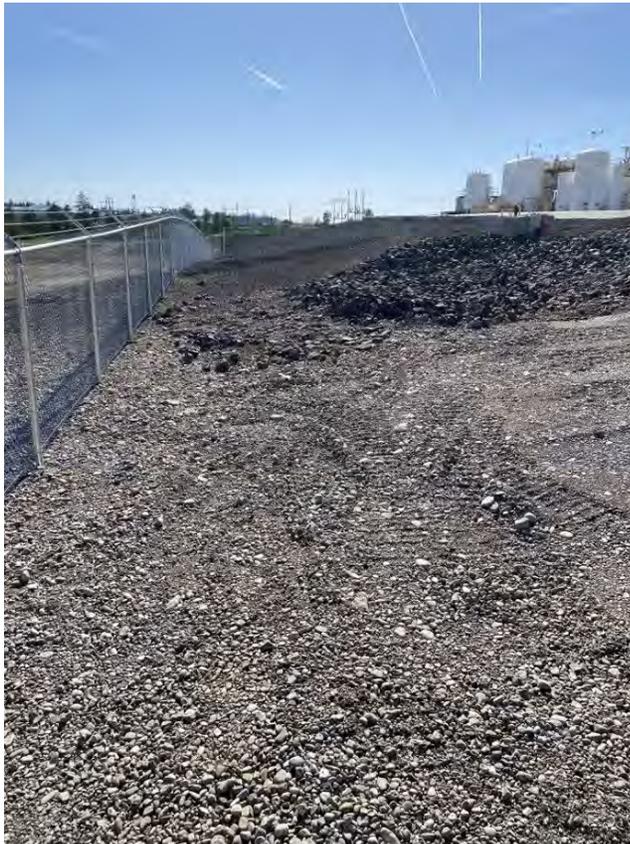
**PHOTOGRAPH 62**

Ecology block surface water feature armored termination and armor rock apron. Completed with a 1-foot lift of 2- to 8-inch quarry spalls. View looking west.

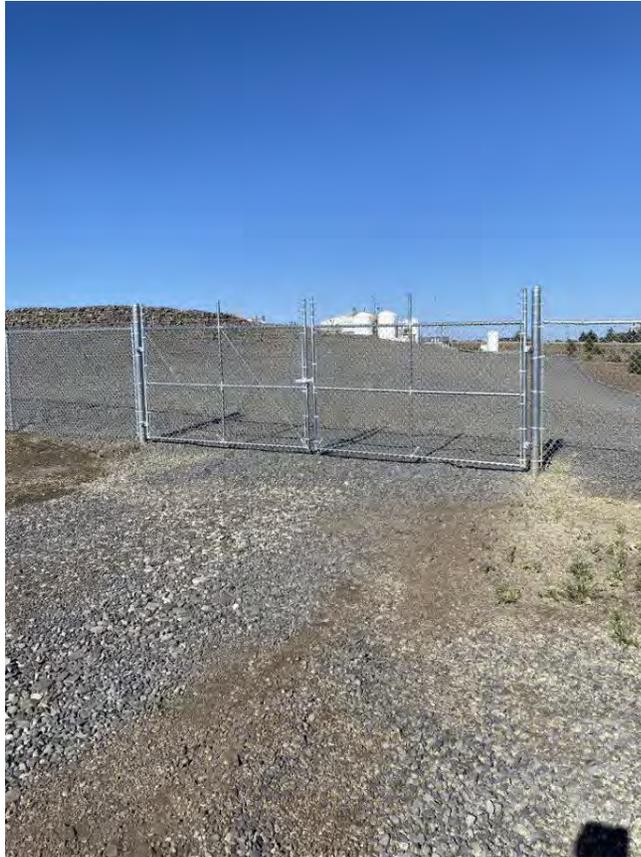
**PHOTOGRAPH 63**

UPRR property access gate situated on the southwest corner of the UPRR pad area, neighboring property owned by Pentzer. View looking east.
