SITE INSPECTION REPORT FOR
LYNNWOOD PLATING COMPANY, INC.
LYNNWOOD, WASHINGTON

TDD R10-8510-25B

Report Prepared By: Ecology and Environment, Inc.
Project Manager: William Carberry
Date: October 1986

SITE INSPECTION REPORT FOR
LYNNWOOD PLATING COMPANY, INC.
TDD R10-8510-25B

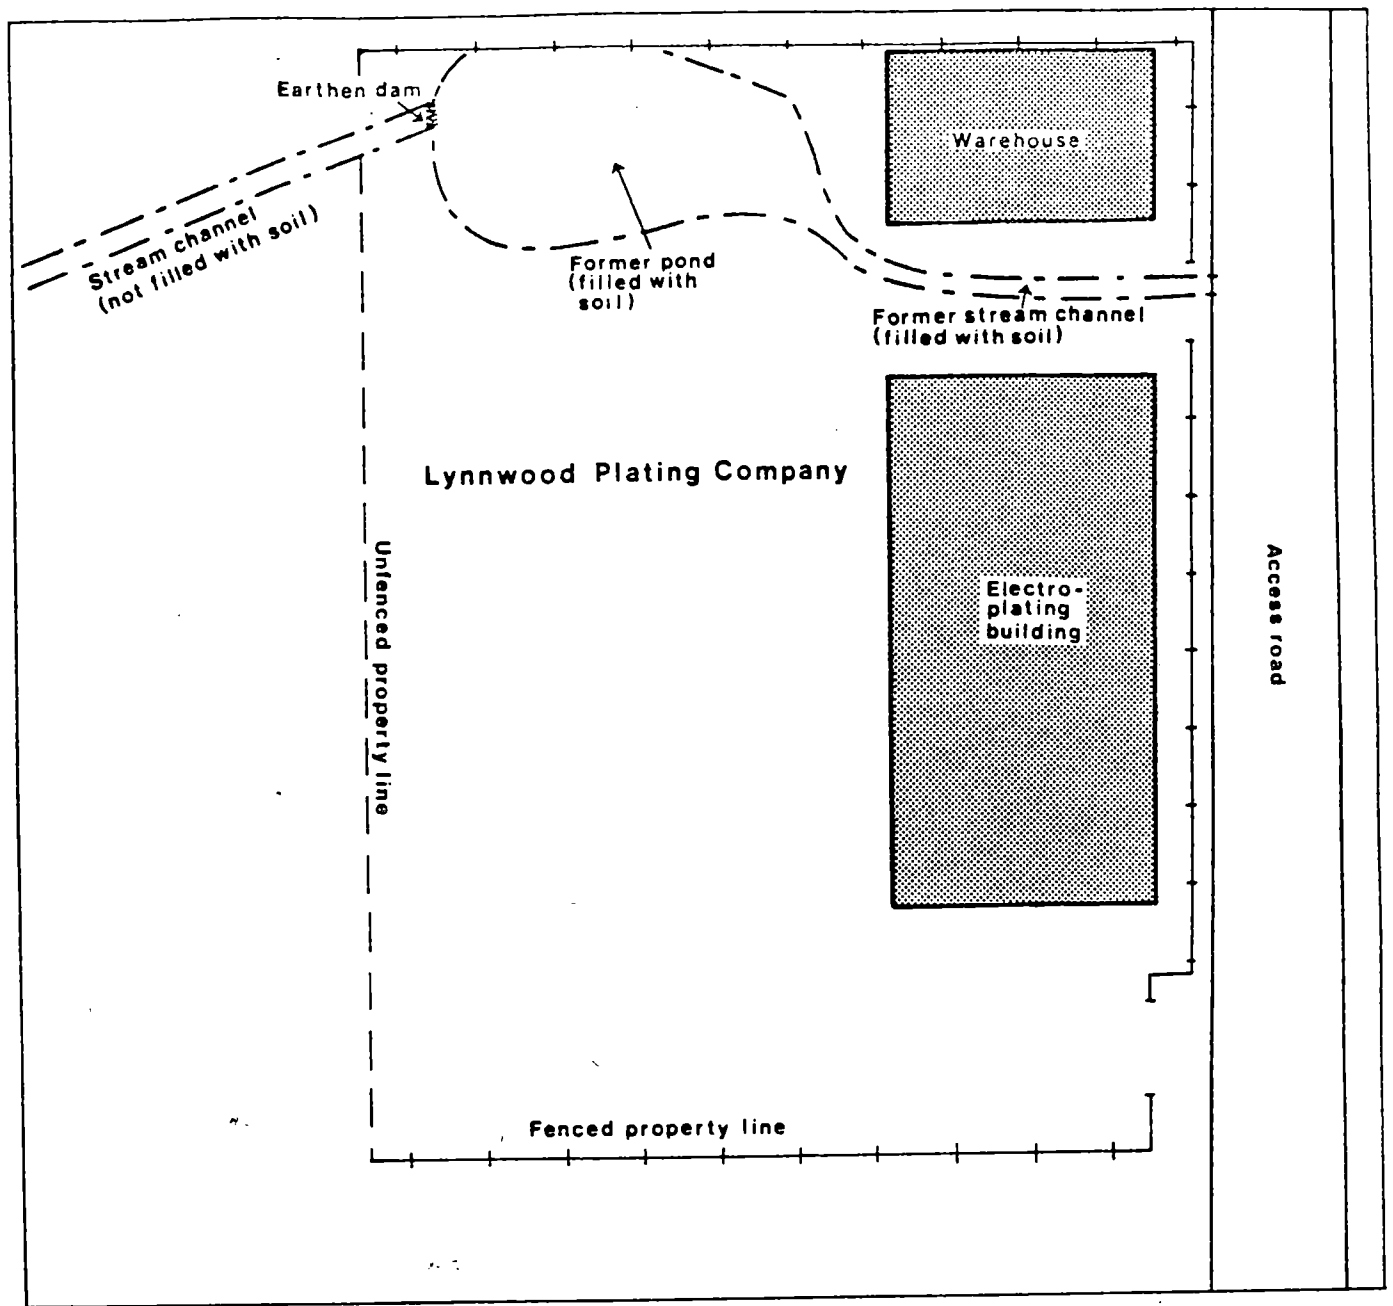
Figure 3. Site map of Lynnwood Plating Company, Lynnwood, Washington.

The 37,500 sq. ft. site is situated approximately 200 feet north of 196th St. SW in the Alderwood section of Lynnwood, WA. There are two buildings on-site, a 1,950 sq.ft. warehouse and a 5,900 sq. ft. combination office and electroplating building (see Figure 3). Both buildings are primarily of wood construction on a cement slab foundation.

An intermittent stream previously existed at the site. The stream flowed from east to west across the northern portion of the facility (2) (see Figure 3). Run-off from the site drained via this stream into a marsh located approximately 0.35 miles northwest of the site. Upgradient of the site, the stream has been filled in through

When Lynnwood Plating moved to its current location in July 1967 (2), an intermittent stream passed through the property (see Figure 3). The firm constructed an earthen dike across the stream channel and used the resulting pond as an evaporation/seepage pond for their electroplating wastewater. The wastewater was allowed to drain onto the floor of the electroplating room and then flowed toward the north end of the building via the floor culvert. The culvert emptied directly into the stream bed and the wastewater flowed into the pond. During periods of prolonged or heavy rain, the pond overflowed its dike and plating wastewater flowed further down-stream (2).

E&E also recommends that a fence be erected along the western boundary of the property to restrict access from adjacent properties. The other three boundaries are currently fenced.
