MEMORANDUM FOR THE RECORD

From: Leah Rohan, Environmental Engineer, City of Walla Walla
Date: August 20, 2024
Subject: Dye Testing of Janitorial Sink in 106 N. 2nd Avenue Building

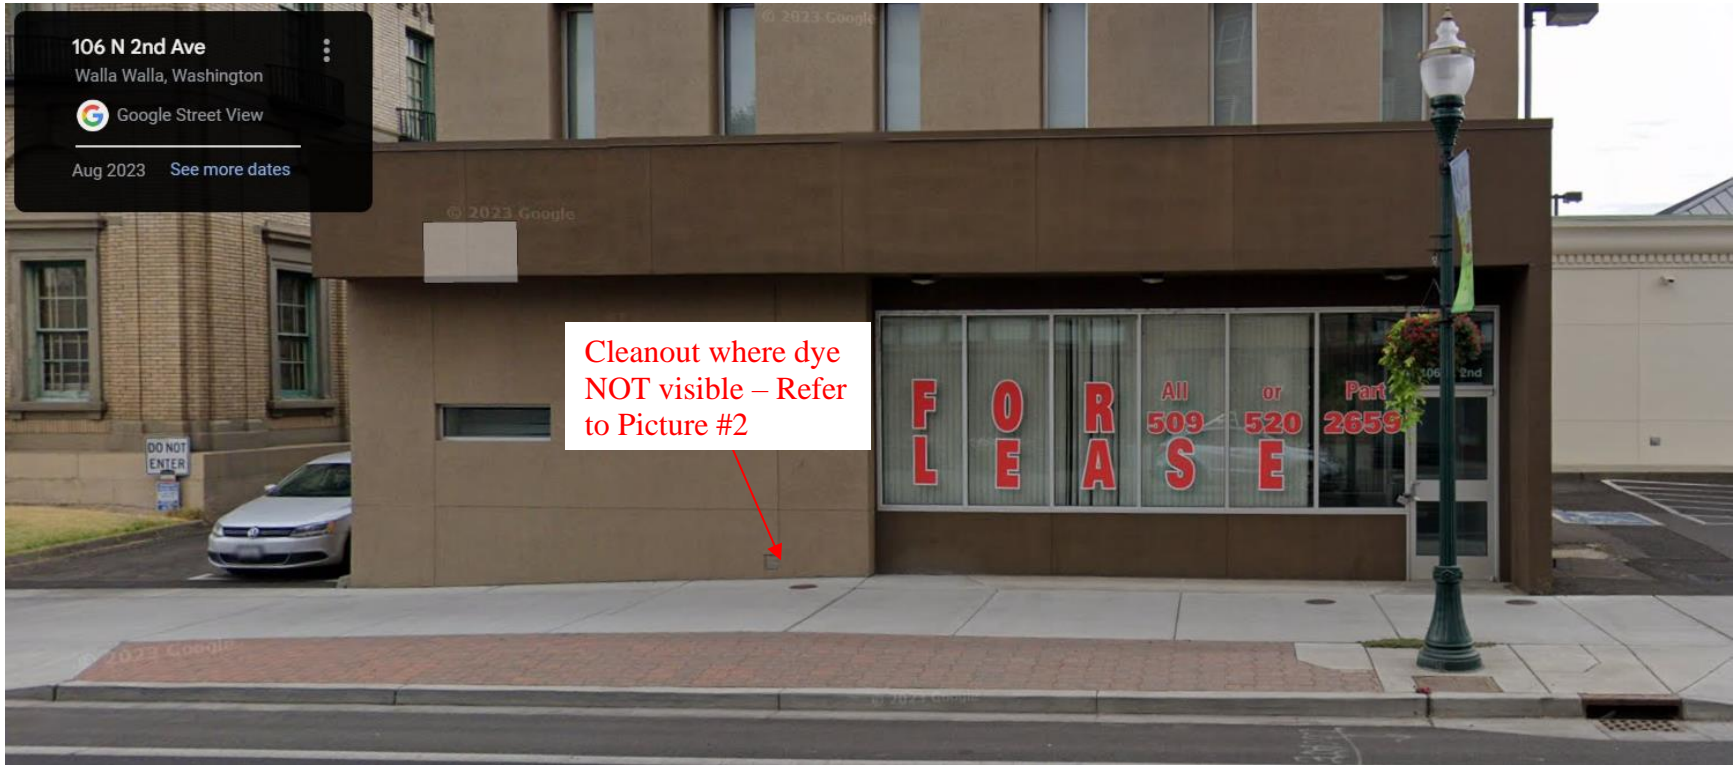
- The camera was first placed in the cleanout in the sidewalk on 2nd Avenue (refer to picture #2). Dye tablets were then placed in the janitorial sink (refer to picture # 1) located on the first floor of the building, and the water to the sink was slightly opened. No dyed water was visible in the cleanout on 2nd Avenue.

- The sewage sump for the building was inspected and green dyed water was visible in the sump (refer to pictures #3 and 4). The sump pump was manually activated to empty the sump. The water to the janitorial sink was then increased to full flow. The City streets crew performing the video inspection on 2nd Avenue was consulted and no dyed water was visible in the cleanout.

Figure 2: Street view of 106 N. 2nd Avenue building showing the cleanout where the video inspection was performed (Source: Google Maps)
