DATE: September 25, 2024  
TO: Mark Jusayan, Seattle Public Utilities  
Ashley Piatek, CenterPoint Properties  
FROM: Laura Lee, Amber Bailey, and Tiffany Neier, PE  
SUBJECT: South Park Landfill 2024 Annual Landfill Cap Inspection  
CC: Ryan Gardiner, Washington State Department of Ecology  
PROJECT NUMBER: 553-1550-067  
PROJECT NAME: South Park Landfill Site Coordinator

The purpose of this Technical Memorandum is to summarize the findings of the March 2024 annual landfill cap inspection at the South Park Landfill.

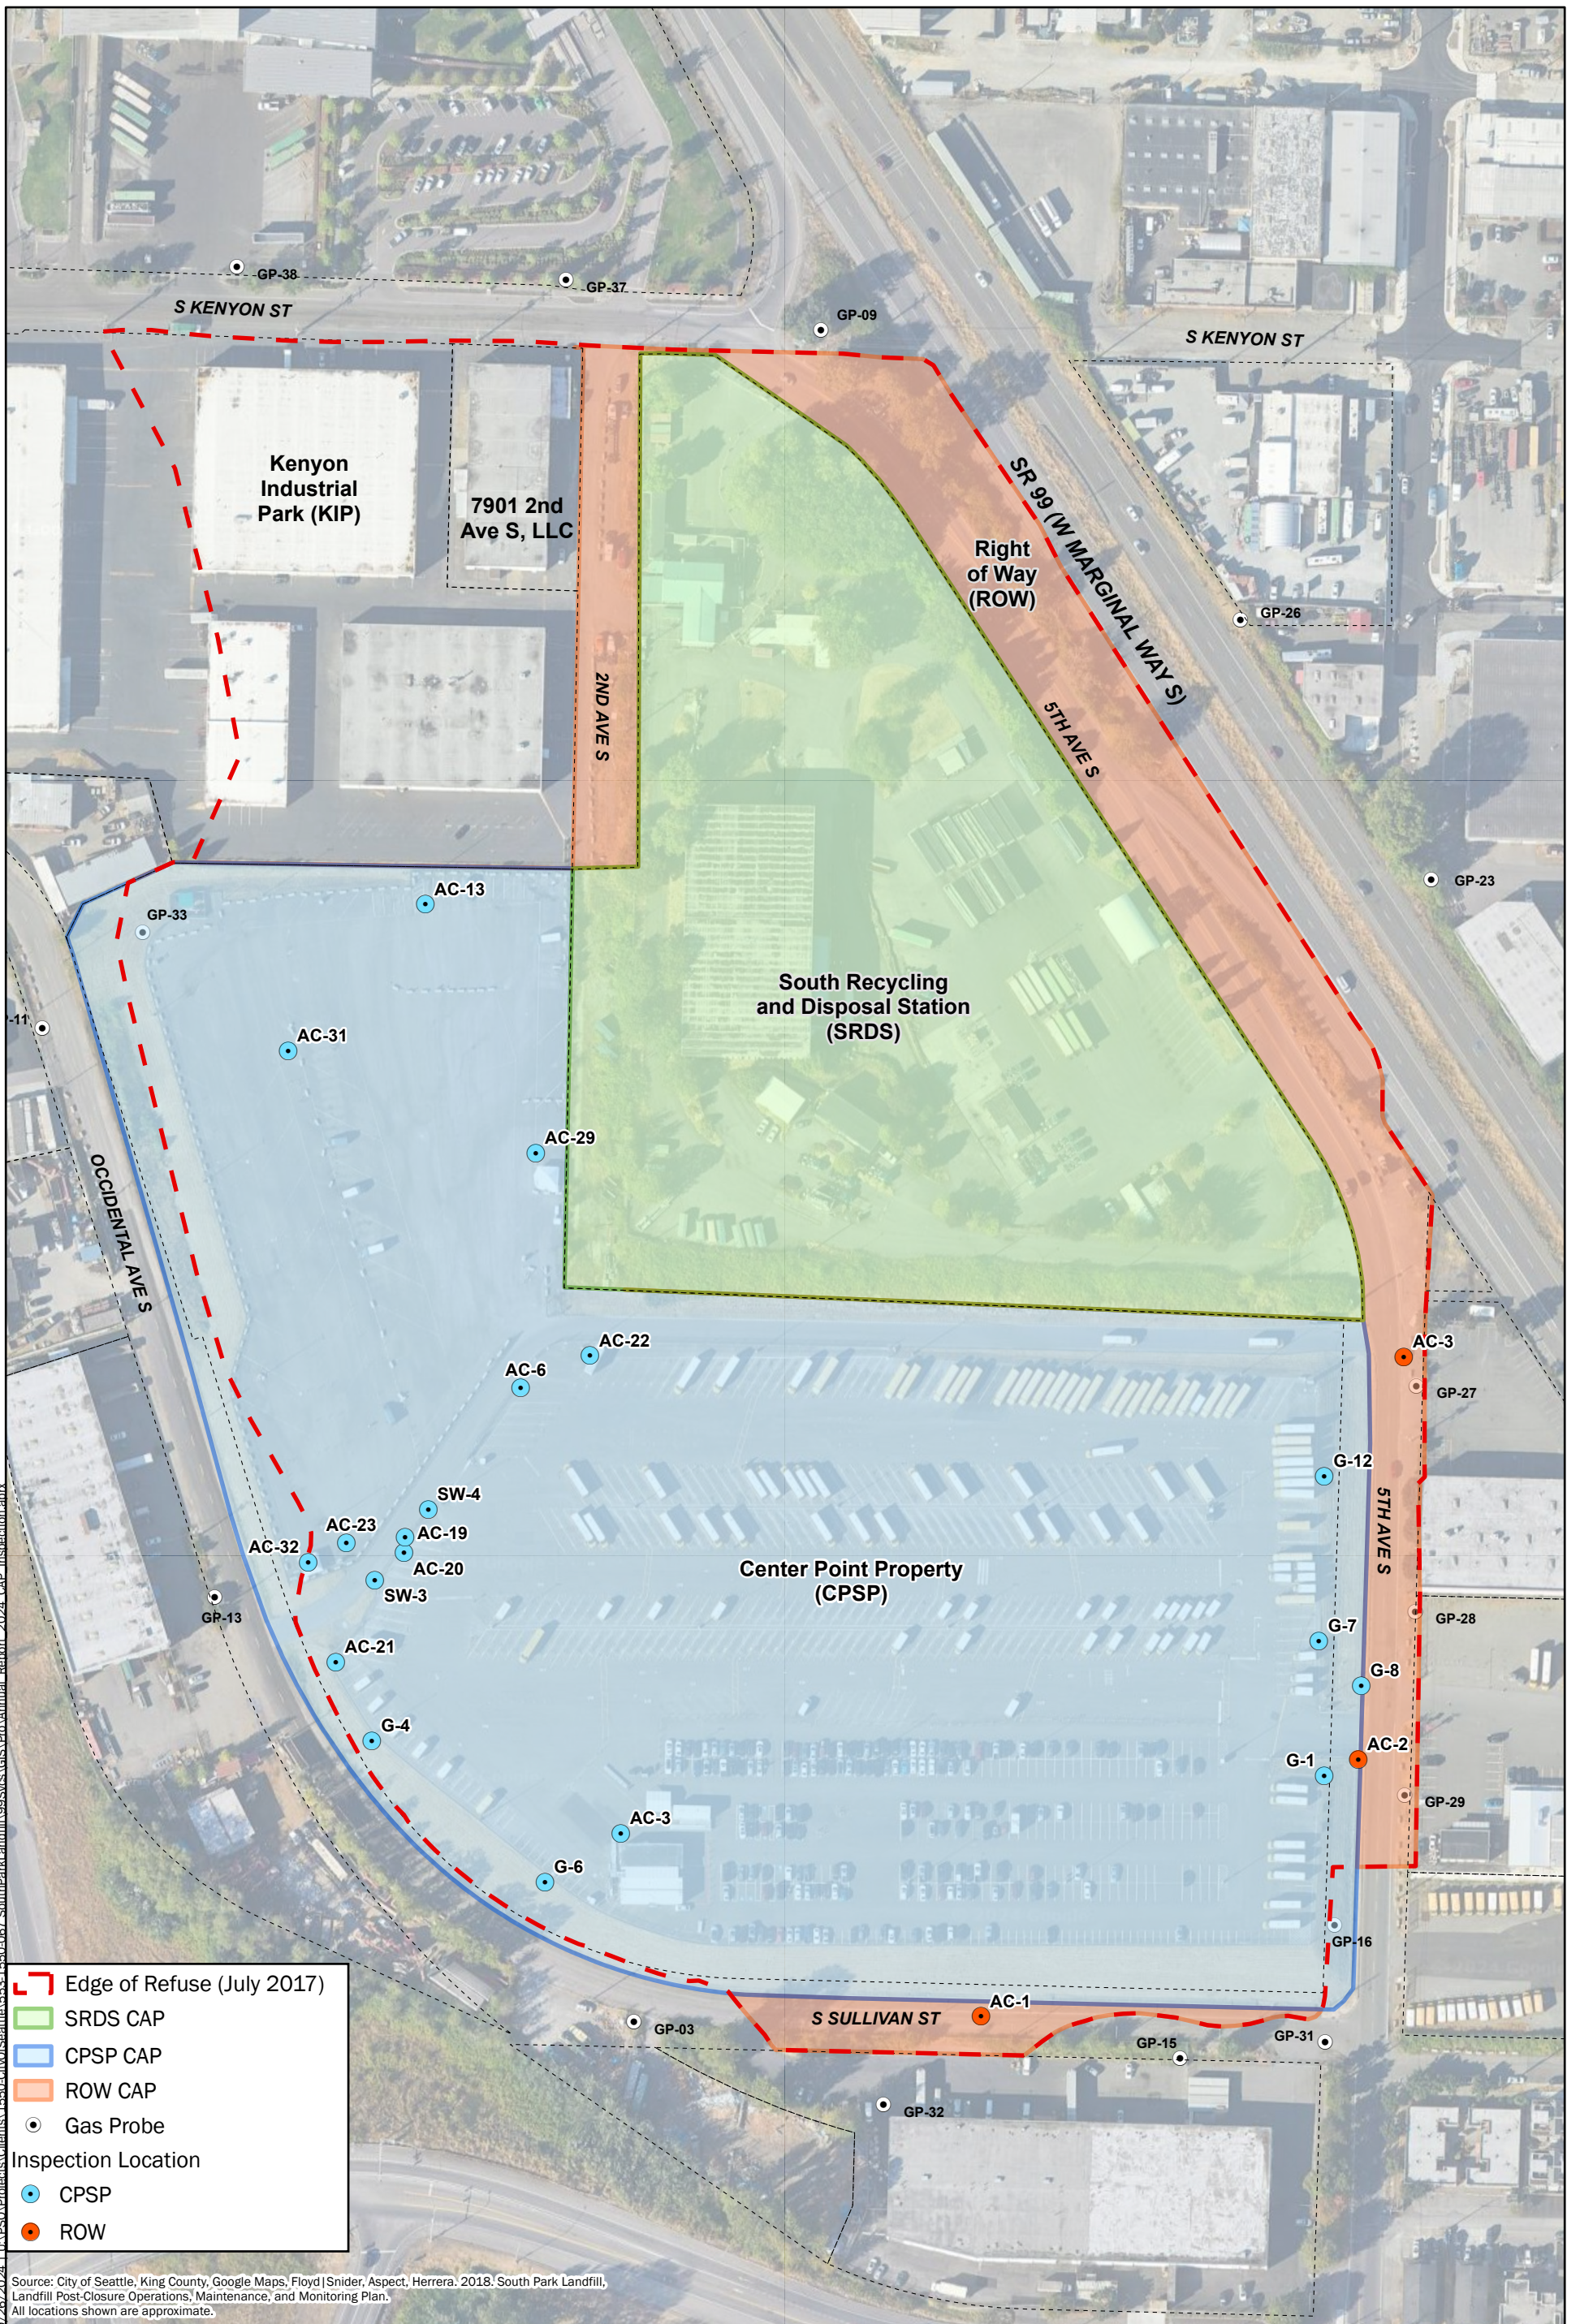
**Figure 1**  
Landfill Cap Inspection- March 2024  
Site Plan With Locations for Repair  
South Park Landfill  
Seattle, WA

Figure 1 shows the approximate bounds of the landfill cap for the two Consent Decree Settlement Area properties and the right-of-way (ROW) as defined in the Cleanup Action Plan. Figure 1 also shows the approximate landfill refuse extent which goes below two additional properties that are not currently included in the Settlement Area. Cap Inspection Form A, provided in Appendix A, was completed for the South Recycling and Disposal Station (SRDS) property, the CenterPoint South Park LLC (CPSP) property, and the ROW. Photographs were taken using a Trimble DA2 GNSS Receiver which used GPS to tag the photographs. The photographs are included in Tables 1 and 2 with numbered locations mapped on Figure 1.

Table 1 describes the issue or concern at each location on the CPSP property, status of previous repairs or change of condition if applicable, proposes a recommended action, and indicates a timeline for repairs or maintenance. Previous concerns identified primarily remain in the same general condition with improvements at several locations. Each location of concern is identified by number in Figure 1 and corresponding photographs are included in Table 1.

The ROW was inspected on two different dates: March 5, 2024, with a follow up visit on March 15 as explained above. There are four areas in the ROW that were identified as locations needing repair in the October 2023 cap inspection. ROW AC-1 and AC-2 represent a section of the road and not individual potholes and cracks due to the number locations that need repair. Several of the holes in the AC-1 and AC-2 areas were patched but there are still locations which have increasingly deep and large potholes. AC-4 was repaired but AC-3 was not. Table 2 describes the issue or concern at each location in the ROW, status of previous repairs or change of condition if applicable, proposes a recommended action, and indicates a timeline for repairs or maintenance. Each location of concern is identified by number in Figure 1 with corresponding photographs included in Table 2.
