# Site Reconnaissance and Data Review Report

Raplee Property  
Cleanup Site ID #5275

October 1, 2024

Project No. M1030.08.003

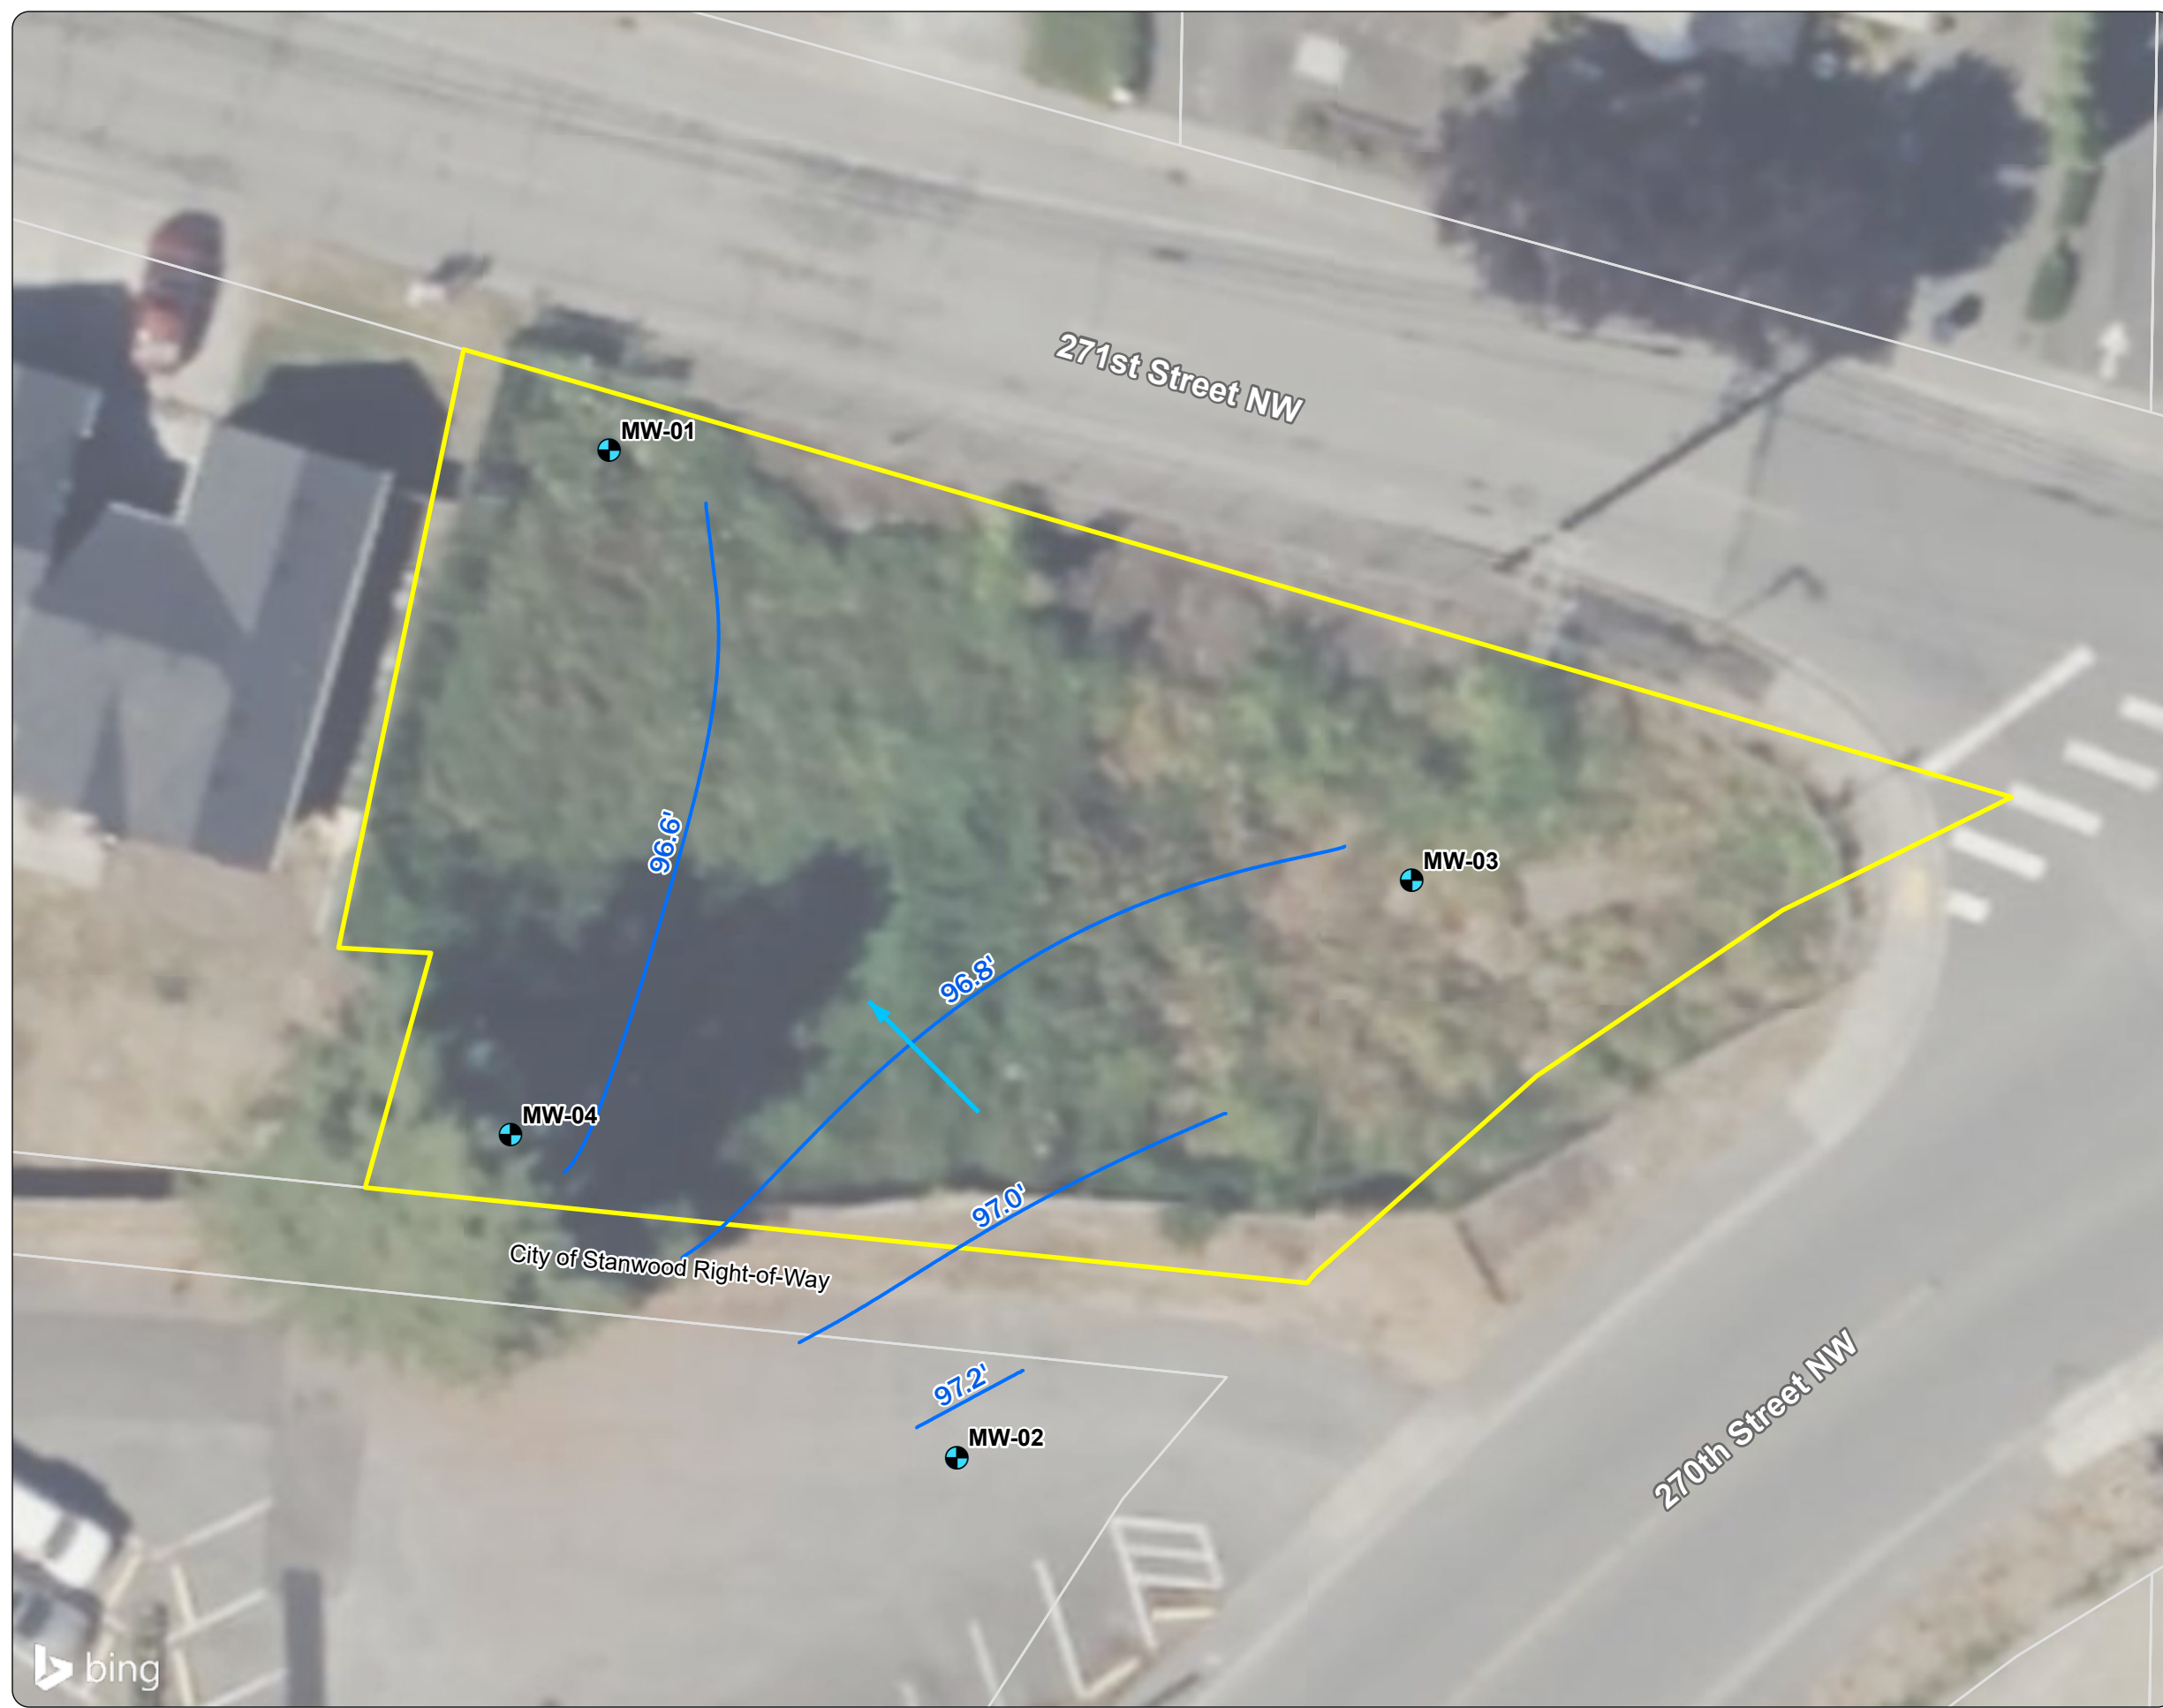
The condition of the four present monitoring wells was also assessed. All wells were located, opened, and water levels measured. Groundwater was encountered at depths ranging from 1.75 to 3.49 feet bgs (see Table 2-3 and Figure 2-4). Petroleum hydrocarbon-like odors were observed at monitoring wells MW-02 and MW-04; however, no NAPL was encountered in any of the wells during water level measurement with an interface probe or observed on the surface of the probe after its removal from the well.

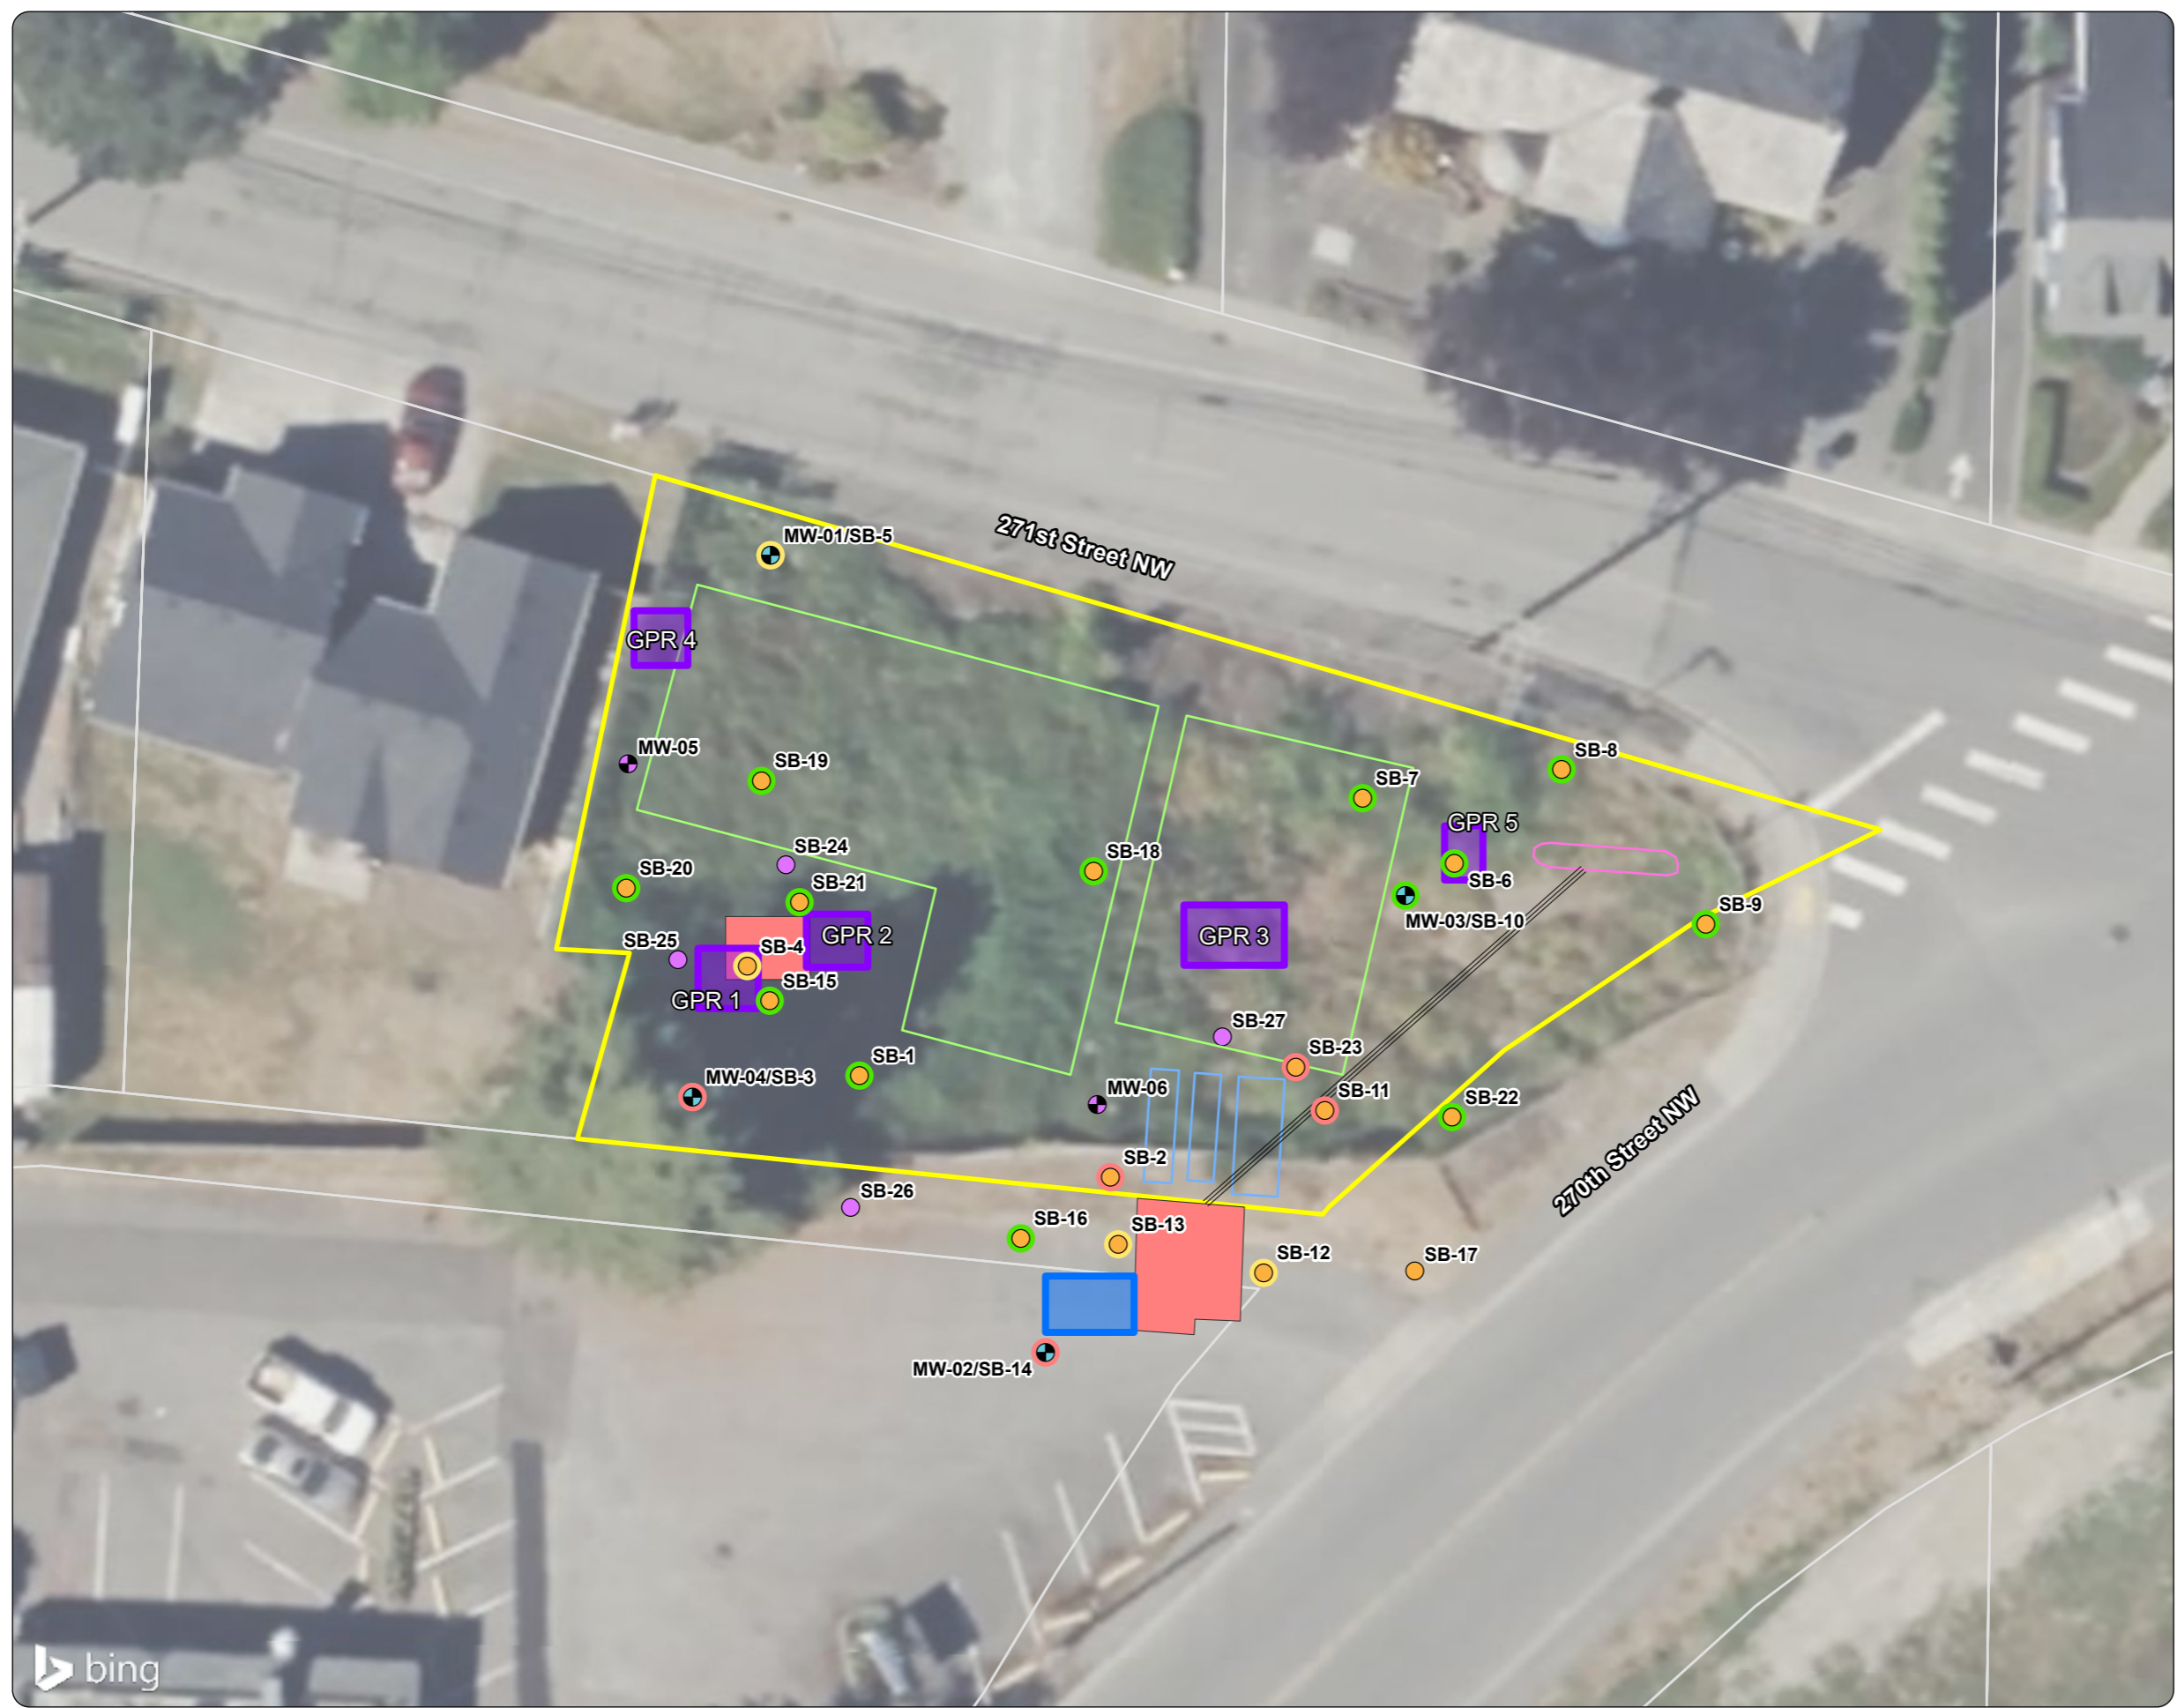
- **SB-24** in the west side of the Site to assess potential downgradient impacts from the existing western UST in the west portion of the Site.
- **SB-25** in the southwest corner of the Site to assess the presence of petroleum impacts and potential NAPL migration into MW-04 from the existing western UST.
- **SB-26** south of the fence, in between MW-02 and MW-04, to evaluate the source of NAPL previously observed in MW-04 and the potential for a NAPL migration pathway from the existing USTs in the southeast portion of the Site.
- **SB-27** near the center of the Site to assess the presence of petroleum impacts to the north of the existing and former USTs in the southeast portion of the Site near the soil CUL exceedances at former boring SB-23.

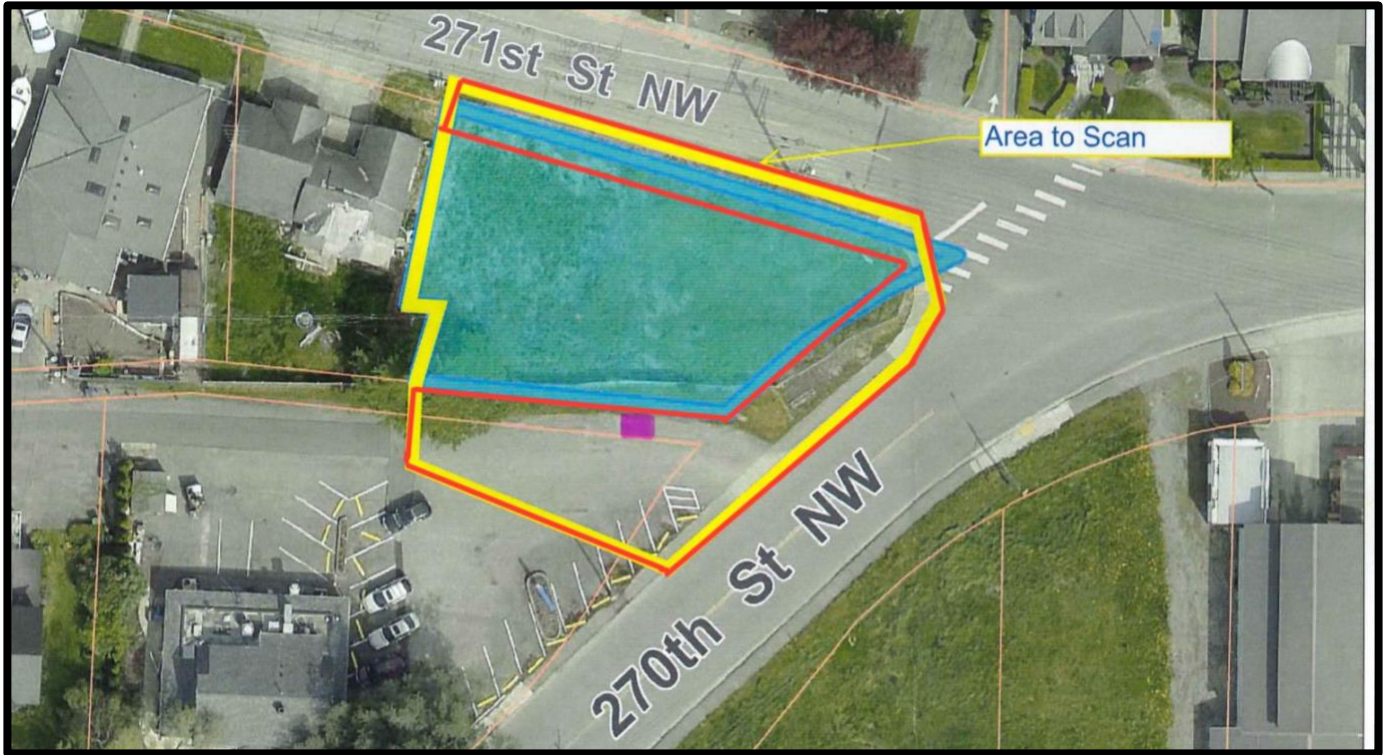
FINDINGS
<p>Upon arrival, GeoTest was directed to the requested area by the client. During the scan, indications of potential USTs were marked on the ground in pink spray paint. Areas obstructed by dense vegetation could not be scanned on this date. See Image 1 for the extent of the area that could be scanned. Findings are described below:</p> <ul style="list-style-type: none"> <li>- Indications of potential USTs were observed within a single 7' x 11' rectangular area near the southeast corner of the site fence line. These indications were observed at a depth of approximately 3' below ground surface. The client was notified of these findings prior to departure.</li> </ul>

**Image 1:** Site map with the extent of the requested area bordered in yellow, and the approximate extent of the area scanned on this date bordered in red. The blue border indicates the approximate boundary of the fence line. The pink highlighted area indicates the approximate location of observed UST indications.

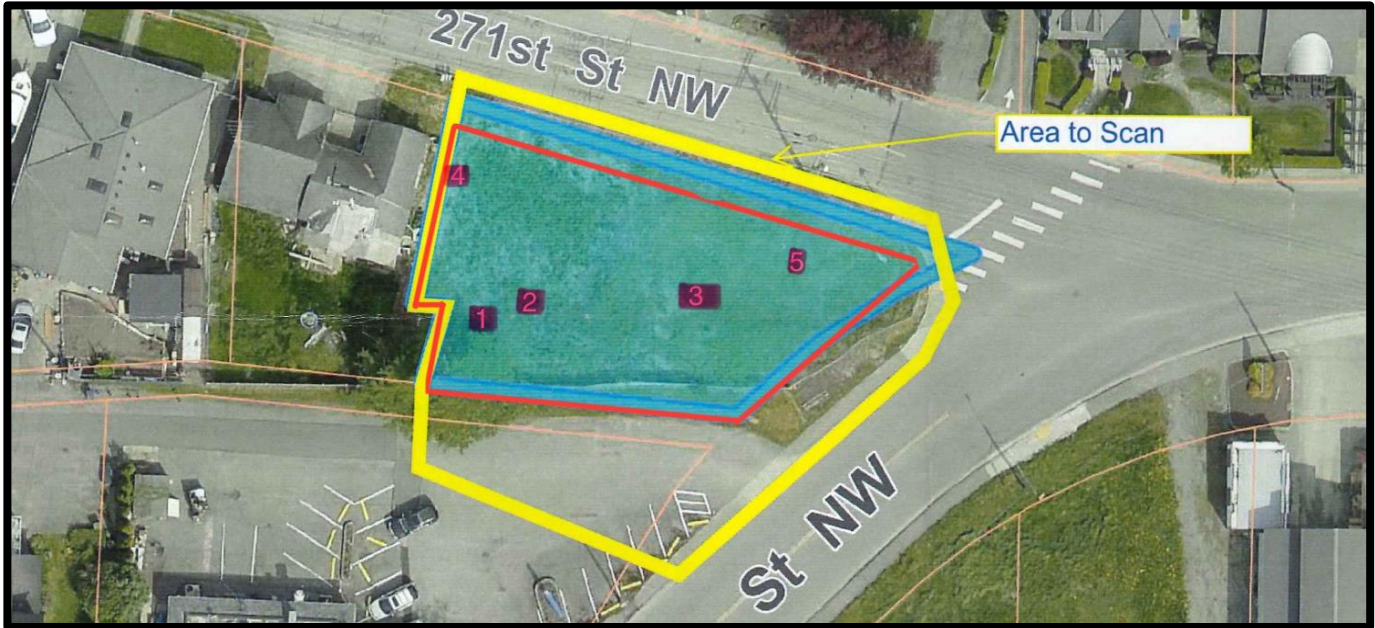
FINDINGS
<p>Upon arrival, GeoTest was directed to the requested area by a Department of Ecology (DOE) representative. During the scan, indications of potential USTs were marked on the ground in pink spray paint, along with the observed depth of each identified anomaly. Findings are described below:</p> <ul style="list-style-type: none"> <li>- Anomaly 1 (see Image 1 for approximate location) measured approximately 3' x 4' and was observed at approximately 2.5' below the scanned surface (BSS).</li> <li>- Anomaly 2 measured approximately 5' x 5' and was observed at approximately 3' BSS.</li> <li>- Anomaly 3 measured approximately 9' x 6' and was observed at approximately 5' BSS.</li> <li>- Anomaly 4 measured approximately 6' x 5+' and was observed at approximately 4' BSS. The site fence line obstructed the GPR scan from identifying the western edge of this anomaly.</li> <li>- Anomaly 5 measured approximately 3' x 4' and was observed at approximately 5' BSS.</li> </ul> <p>The results of the scan were communicated to the DOE representative prior to departure. GPR cross-sections and images of each identified anomaly can be found in the images included in this report.</p>

**Image 1:** Site map with the extent of the requested area bordered in yellow, and the approximate extent of the area scanned on this date bordered in red. The blue border indicates the approximate boundary of the fence line. The approximate location of subsurface anomalies identified on this date are marked and numbered in pink .

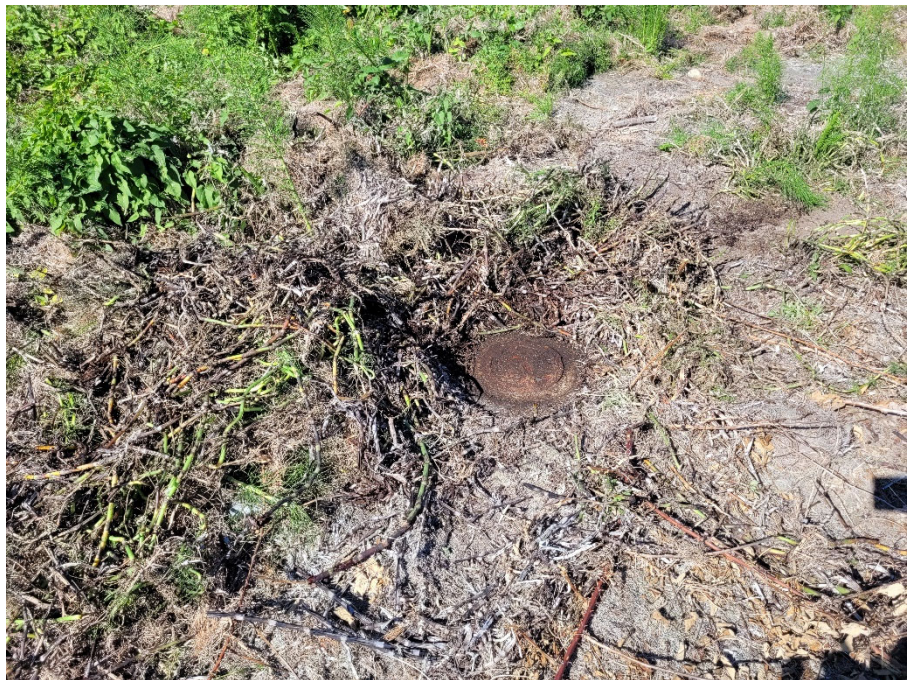
## Photo No. 22.

Photo looking southwest toward monitoring well MW-01 in the northwest corner of the Property.

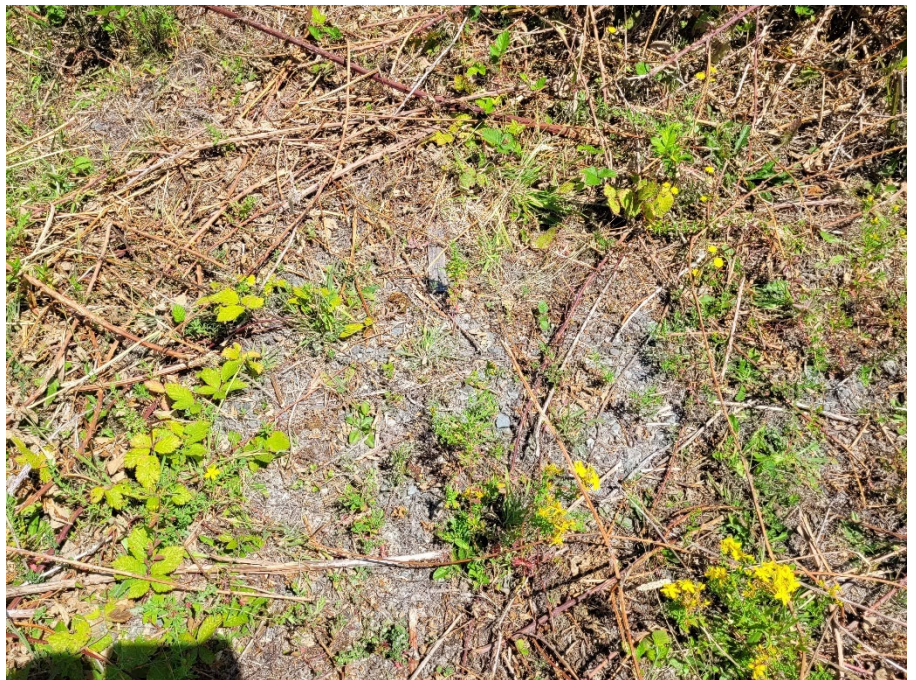
Photo from north of monitoring well MW-03 showing the gravel ground surface in the unpaved portion of the Property.

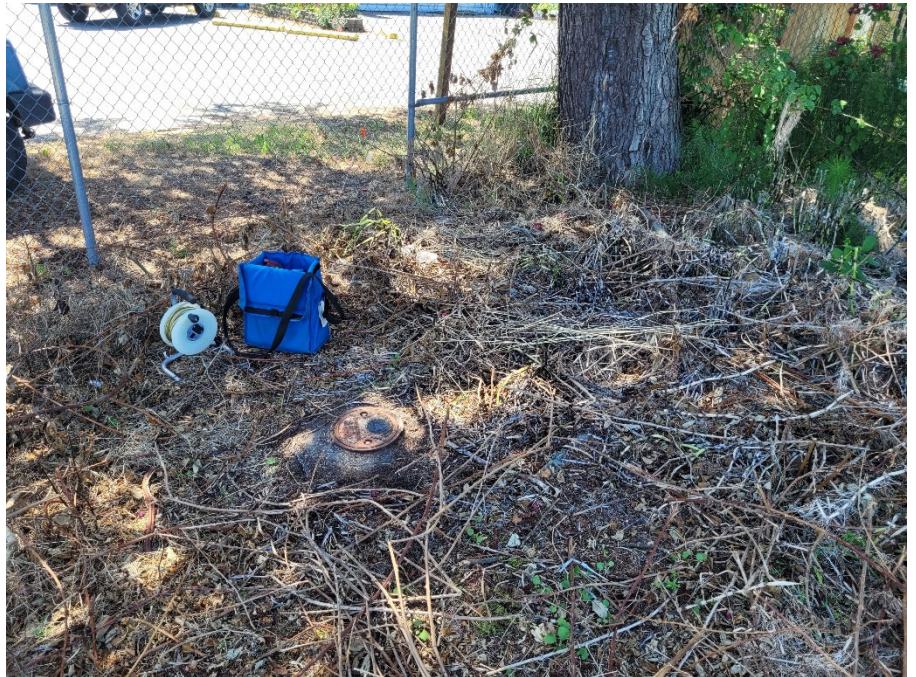
Photo looking southwest toward monitoring well MW-04 in the southwest corner of the Property.
