PORT OF EVERETT: WEYERHAEUSER MILL A CLEANUP PROJECT

BASELINE EELGRASS AND SHORELINE HABITAT SURVEY

FEBRUARY 3, 2023

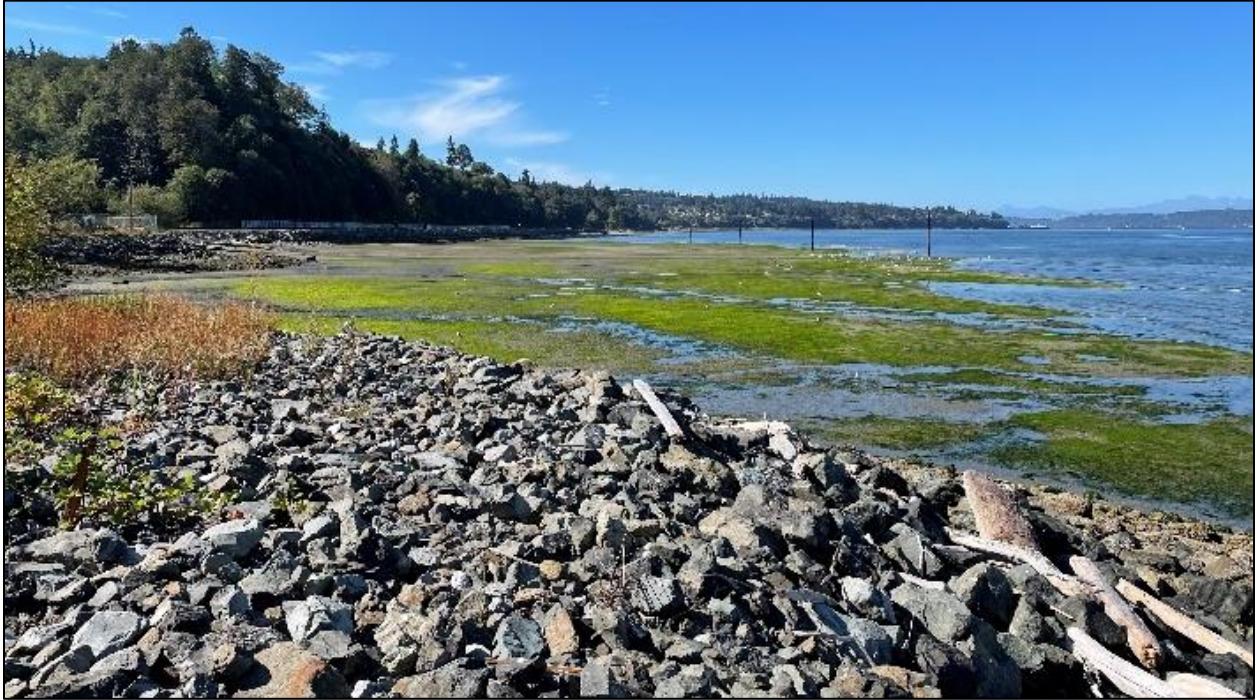
Photograph 9. Photo Point 4 in the Southern Shoreline. Photograph taken facing southwest.

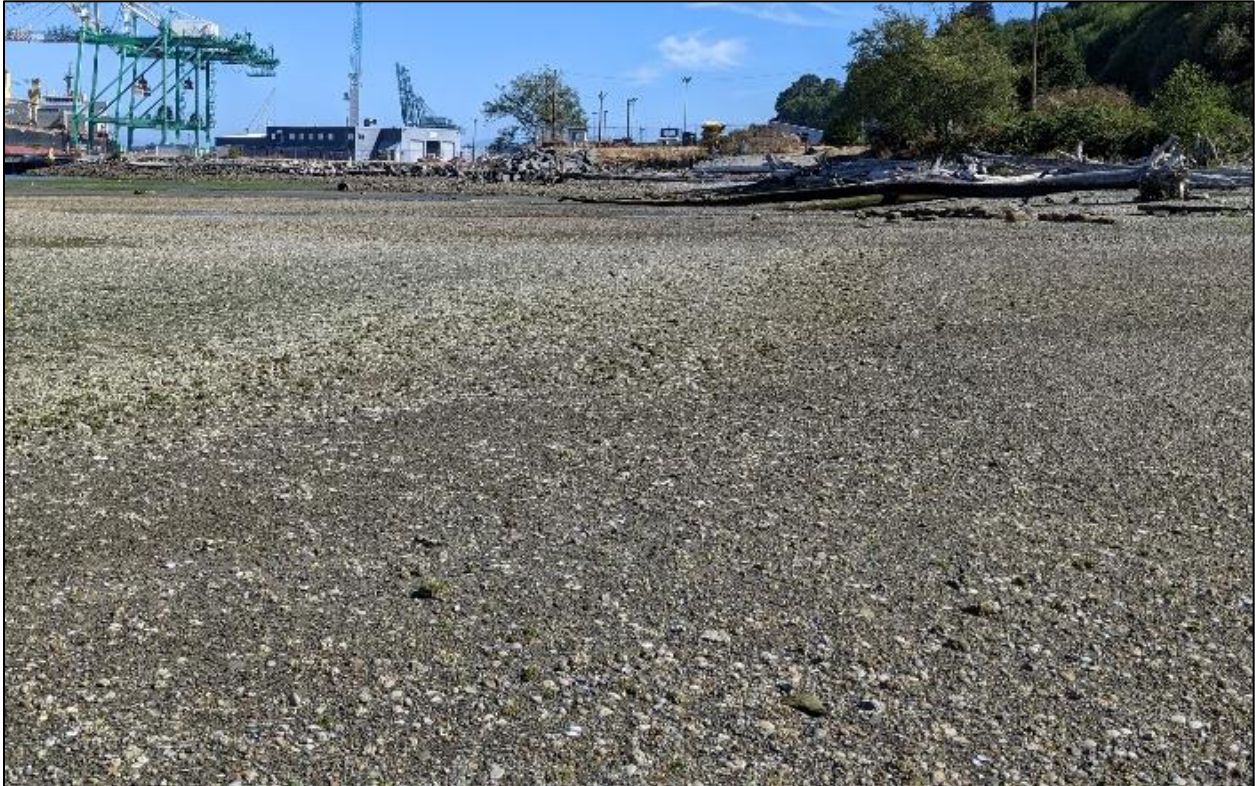
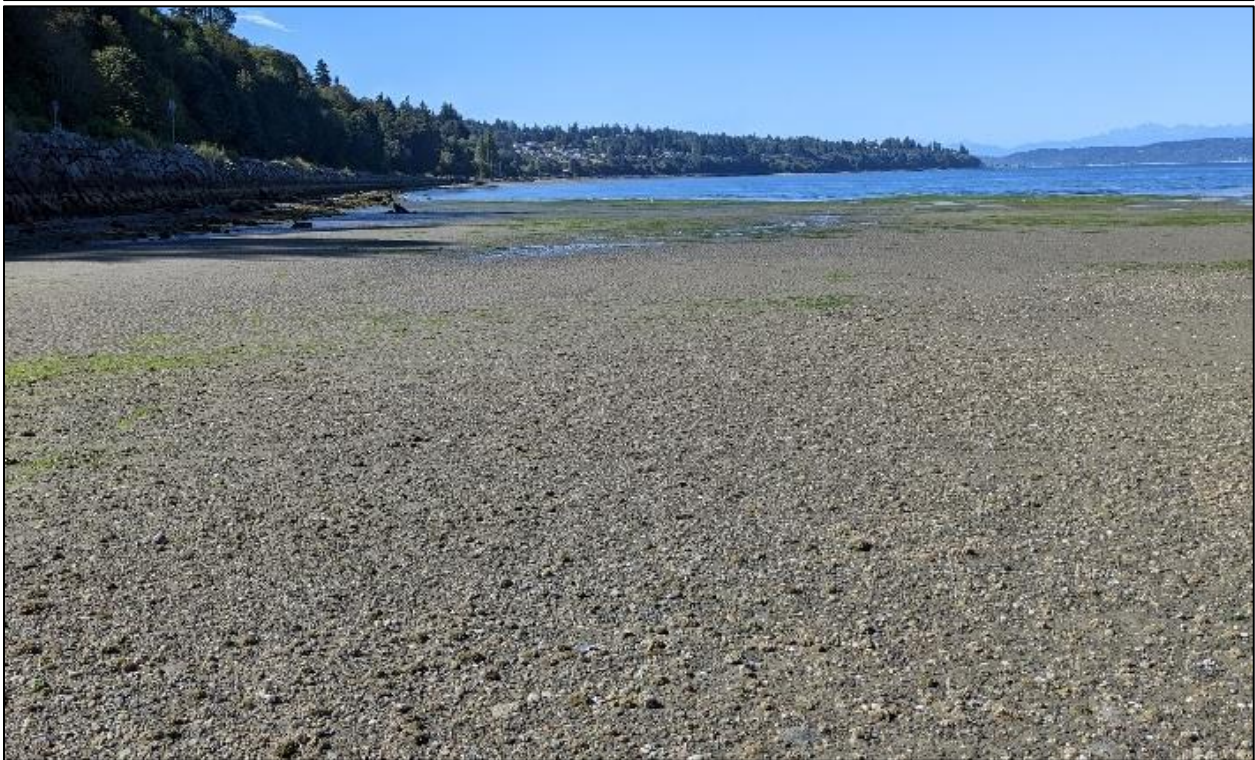
Photographs 10 & 11. Photo Point 5 in the Southern Shoreline. Photographs taken facing northeast (above) and southwest (below).

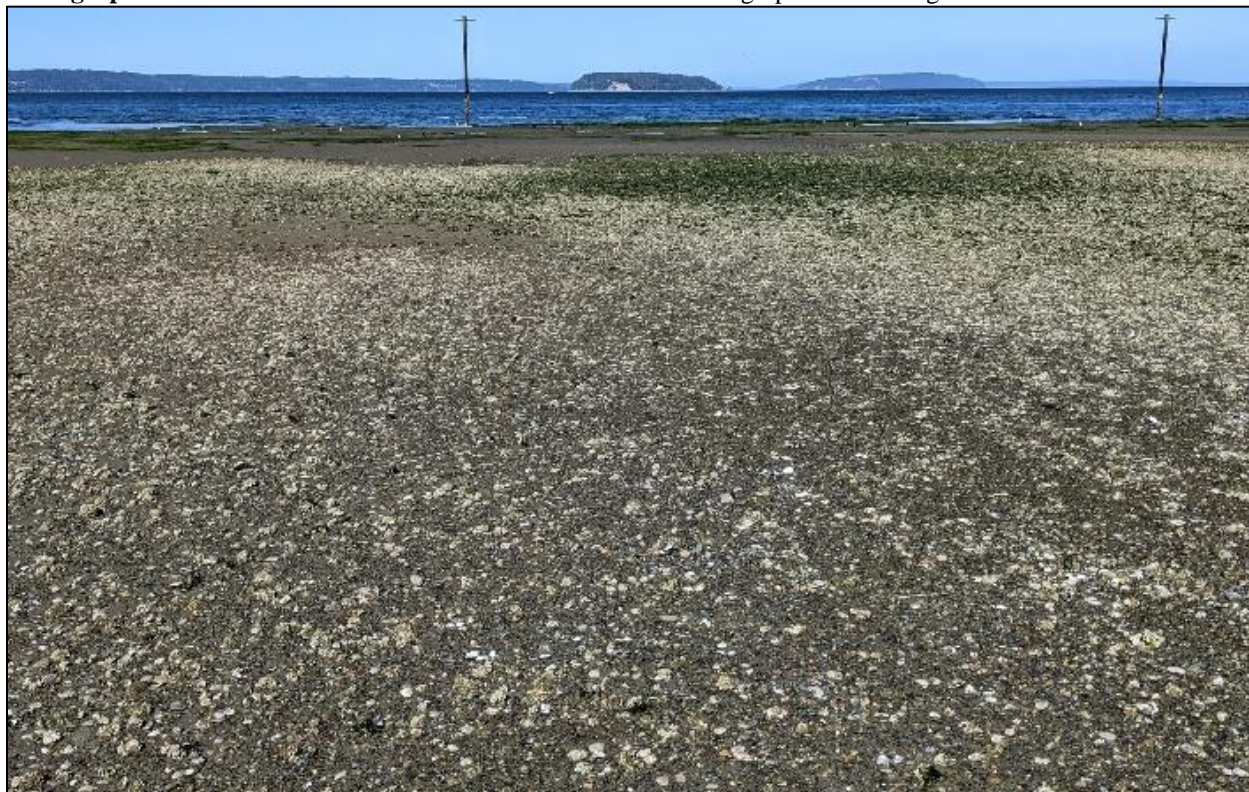
Photograph 12 . Photo Point 5 in the Southern Shoreline. Photograph taken facing northwest.

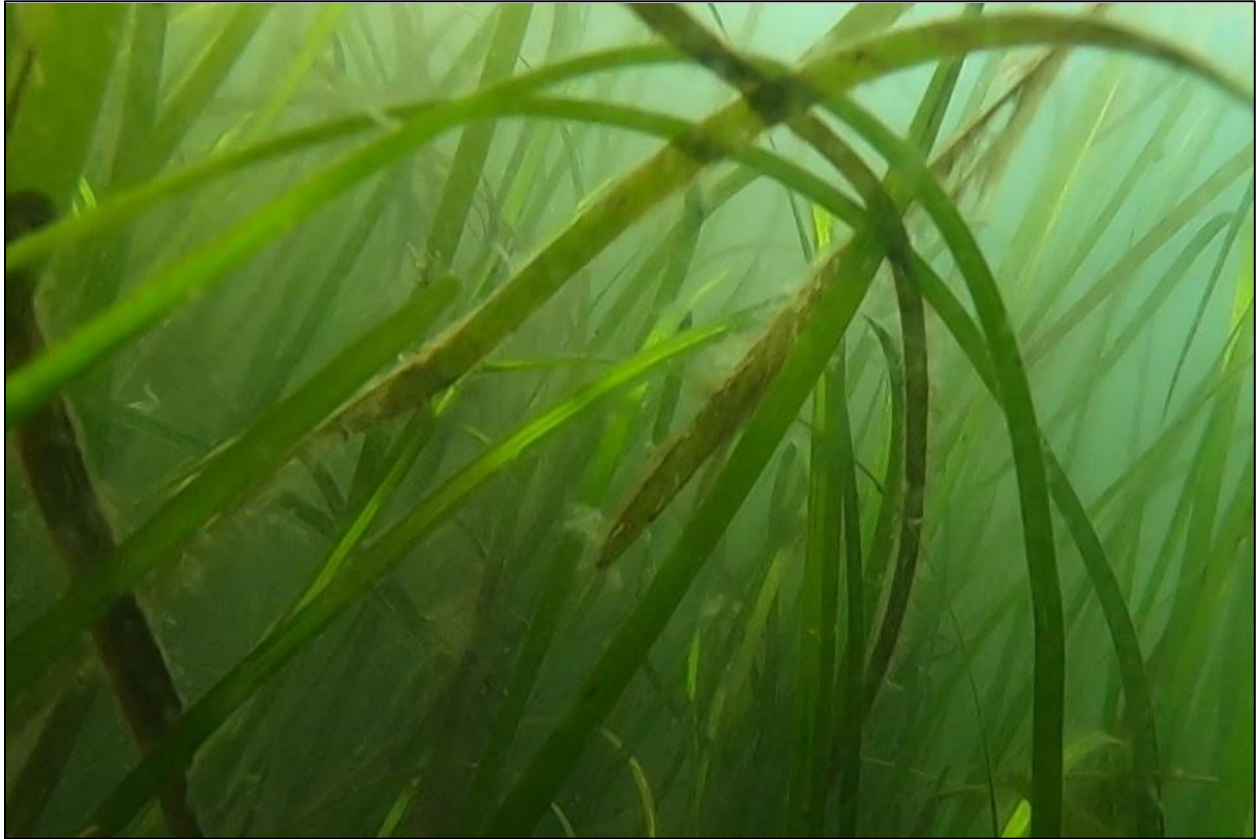
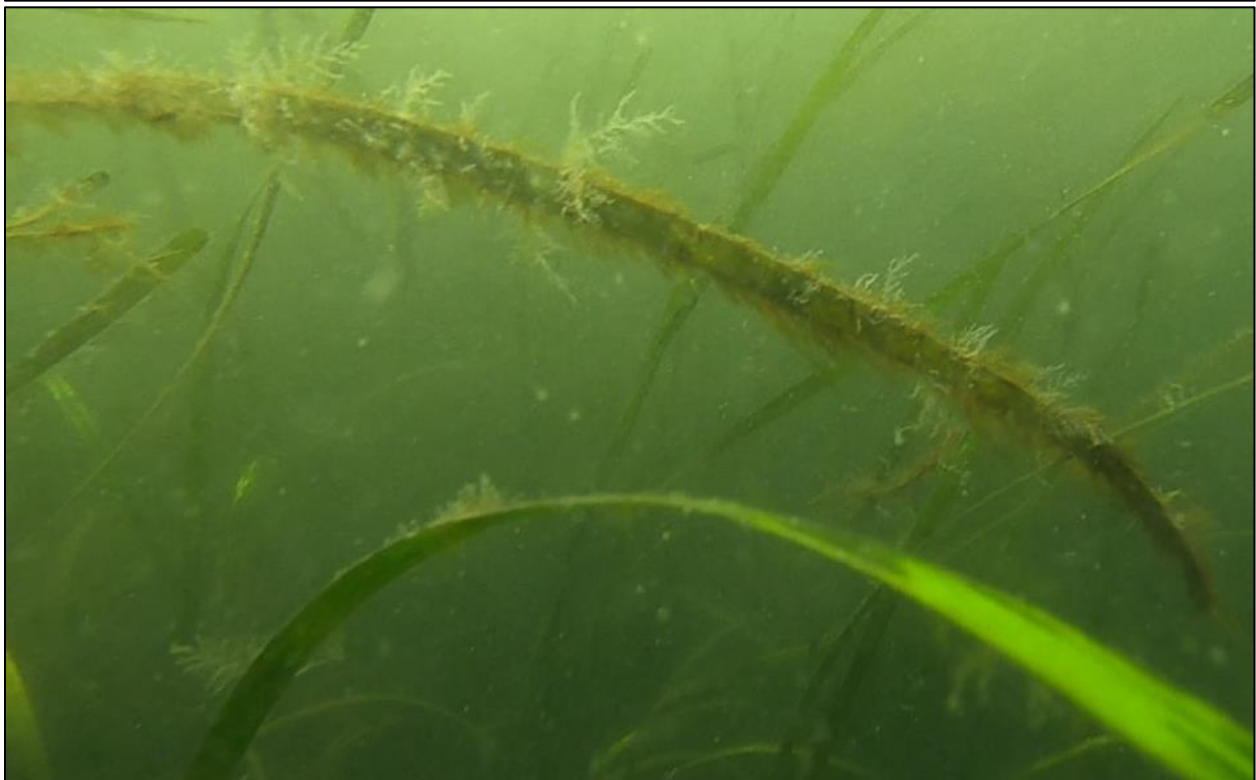
Overall, the eelgrass beds on Site appear healthy, with blades approximately 6 feet long, occasionally covered in epiphytes (Photographs 34 and 35). The eelgrass beds within the Northern and Southern Zones of the Site contain a dense, continuous community of eelgrass existing within elevations from approximately -3 to -13 ft MLLW. As mentioned previously, the eelgrass beds within the Southern Zone are smaller but more dense than beds observed in the Northern Zone (Tables 2 and 3). Due to inaccessible conditions, the Central Zone was not surveyed for eelgrass. However, eelgrass presence within this portion of the Site is extremely unlikely. The wharf of the South Terminal has created low light conditions likely not suitable for eelgrass proliferation. Bathymetry data also indicate that riprap beneath the wharf ends at approximately -35 ft MLLW, which is deeper than where eelgrass is observed in the Northern and Southern Zones of the Site. Large vessels mooring at the wharf also provide continual disturbance which could affect eelgrass presence.

Photographs 13 & 14. Eelgrass observed on Site (typical conditions) with an example of a dense patch of eelgrass (above), and eelgrass blades with epiphytes (below).

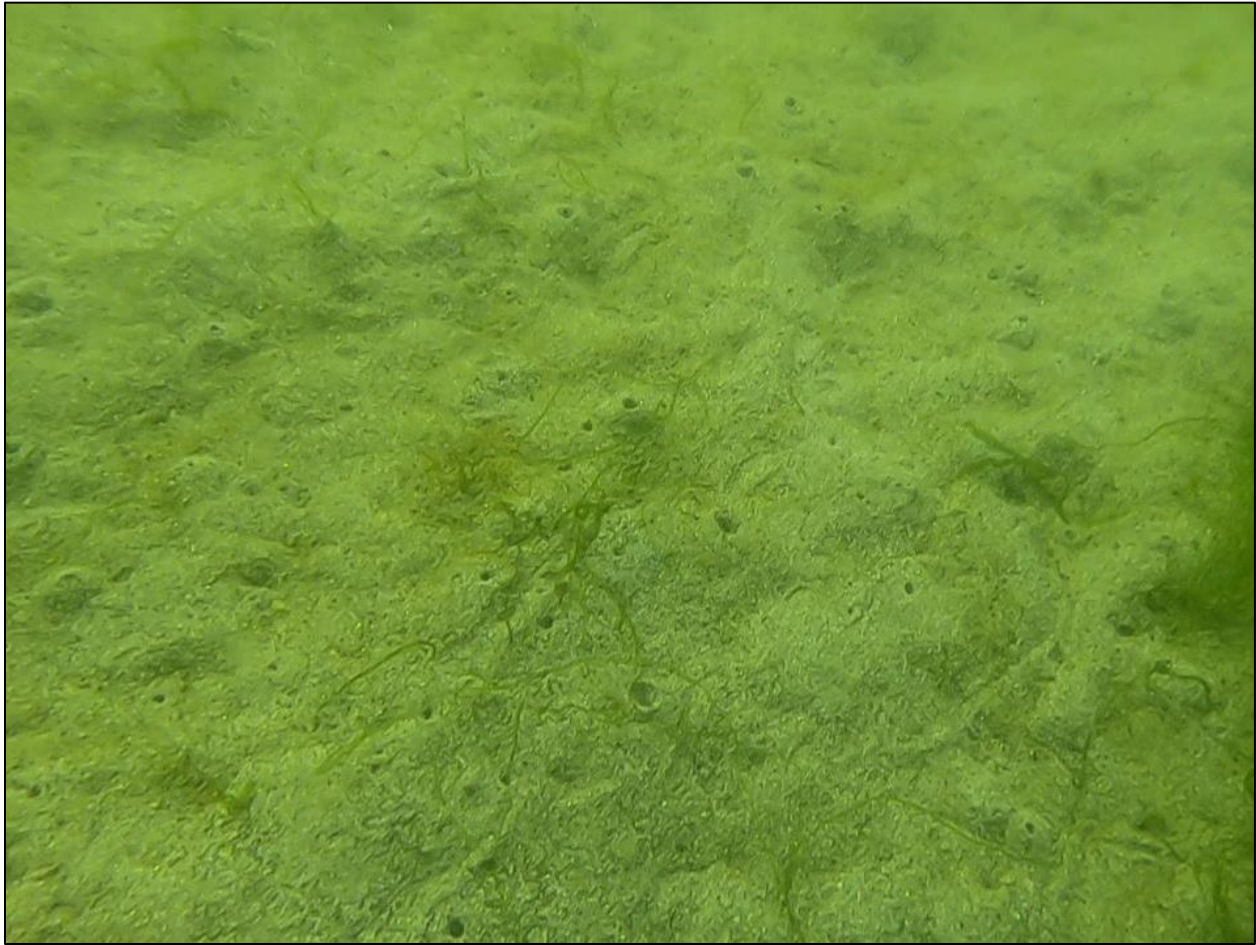
Similar to conditions observed in the Southern Zone during the Shoreline survey, some areas contain sandy sediments with holes leading to burrowed invertebrates (Photograph 15).

Photograph 15. Sandy substrates with invertebrate burrows.

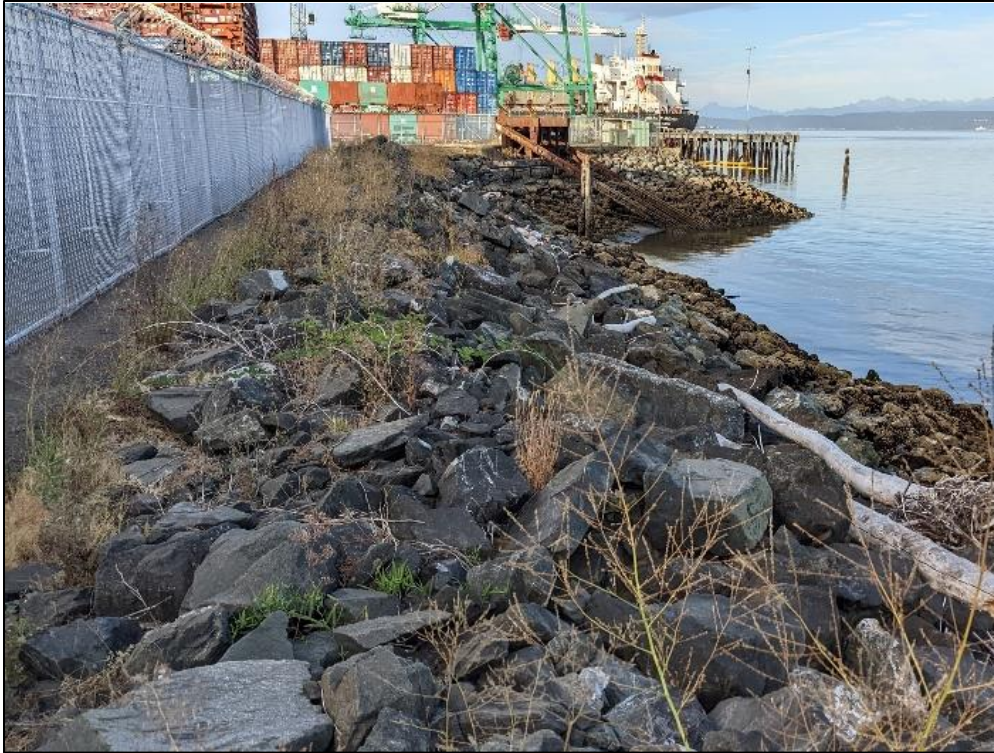
The Site is adjacent to industrial use properties that are highly developed and paved. Overall, the top of the bank of the Northern shoreline is flat and sparsely vegetated with assorted grasses and weeds growing up through cracks in pavement, timber bulkhead, and the uppermost riprap (Photograph 16 and Photograph 17; Appendix E). Some species observed include: English ivy (*Hedera helix*), Himalayan blackberry (*Rubus armeniacus*), and prickly lettuce (*Lactuca serriola*). English ivy and Himalayan blackberry are invasive species and classified as noxious weeds within Washington State.

Photograph 16. Sparsely vegetated upland areas of the Northern shoreline; typical conditions. Area 1 (above) near the Pacific Terminal facing southwest, and Area 2/3 (below) facing southwest near the northern edge of the South Terminal.

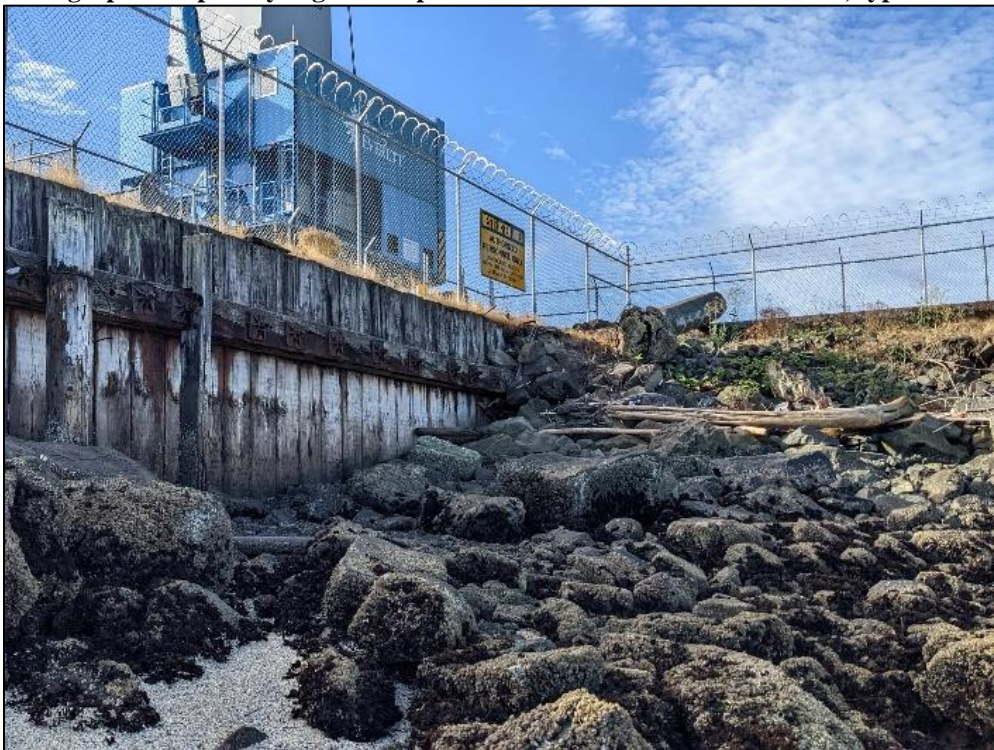
Photograph 17. Sparsely vegetated upland areas of the Northern shoreline; typical conditions.

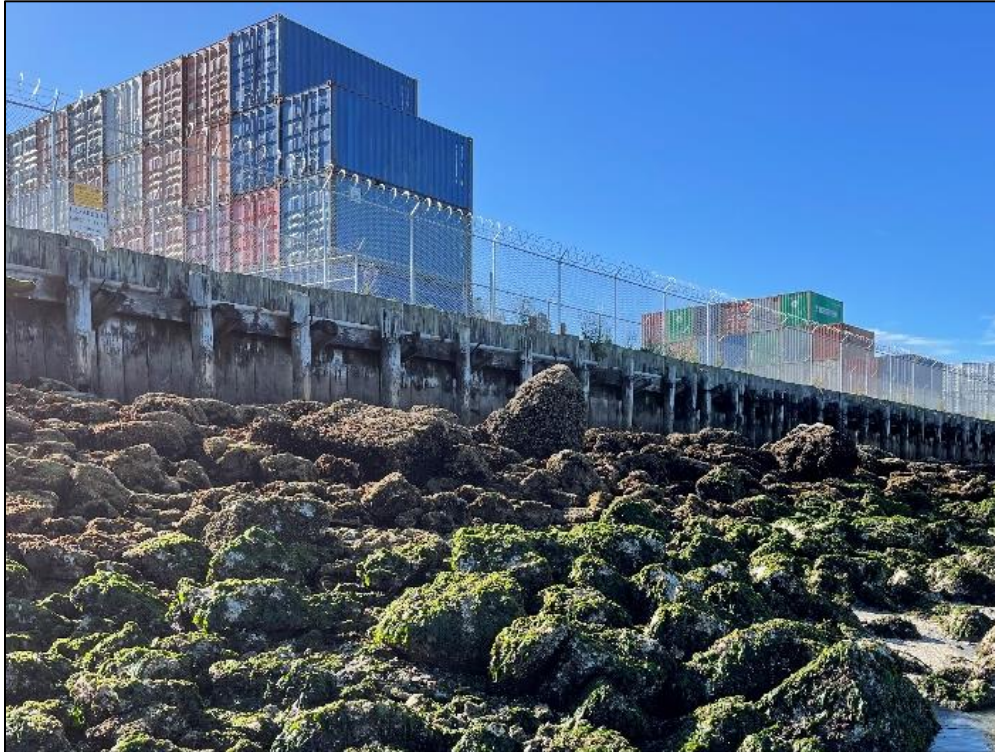
Photograph 18. Sparsely vegetated upland area above timber abutment of the Northern shoreline (Area 2); typical conditions. Photograph taken facing South.

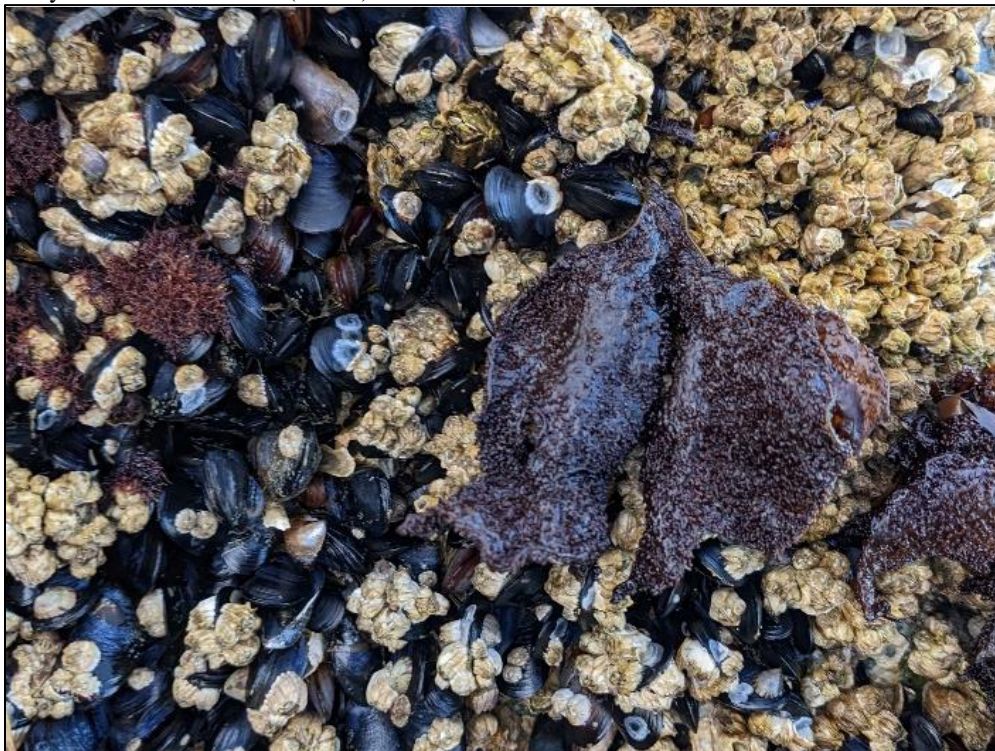
Photograph 19. Macrofauna and algae along the Northern shoreline; typical conditions. Example of Turkish washcloth, mussels, and barnacles covering riprap in Area 1 (above), and Ulva growing on rocky substrates in Area 2 (below).

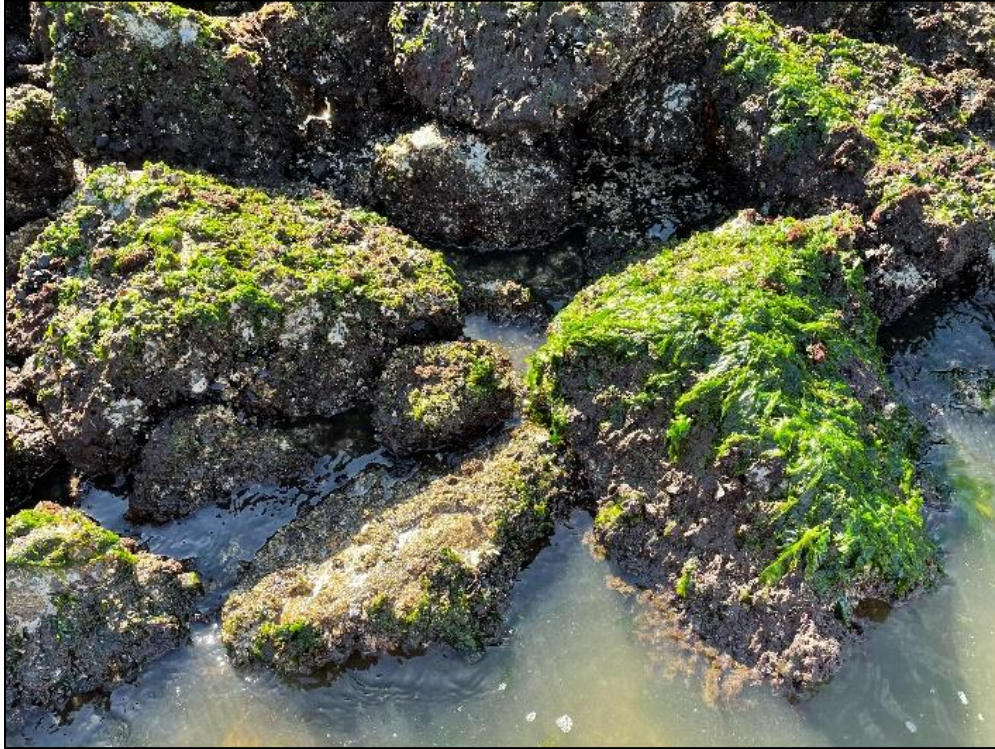
Photograph 20. Macrofauna and algae along the Northern shoreline; typical conditions.

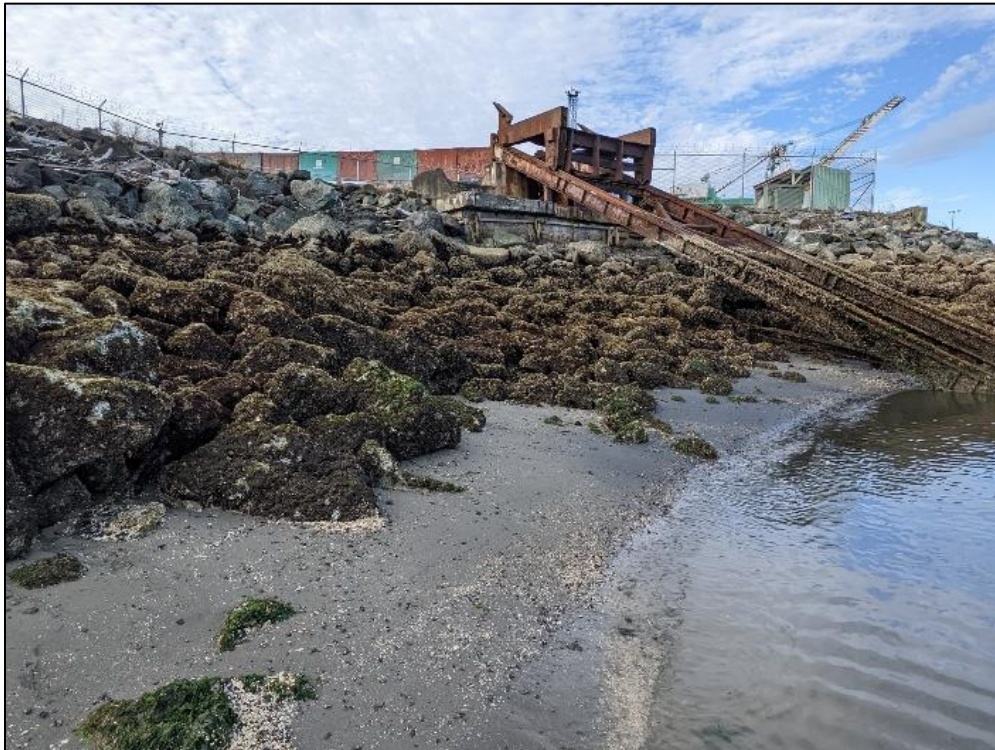
Photograph 21. Beach-like areas in Area 1 of the Northern shoreline next to the northern set of derelict rails (location of tracks in Figure 3). Photograph taken facing southeast (above) and further up the slope facing north (below).

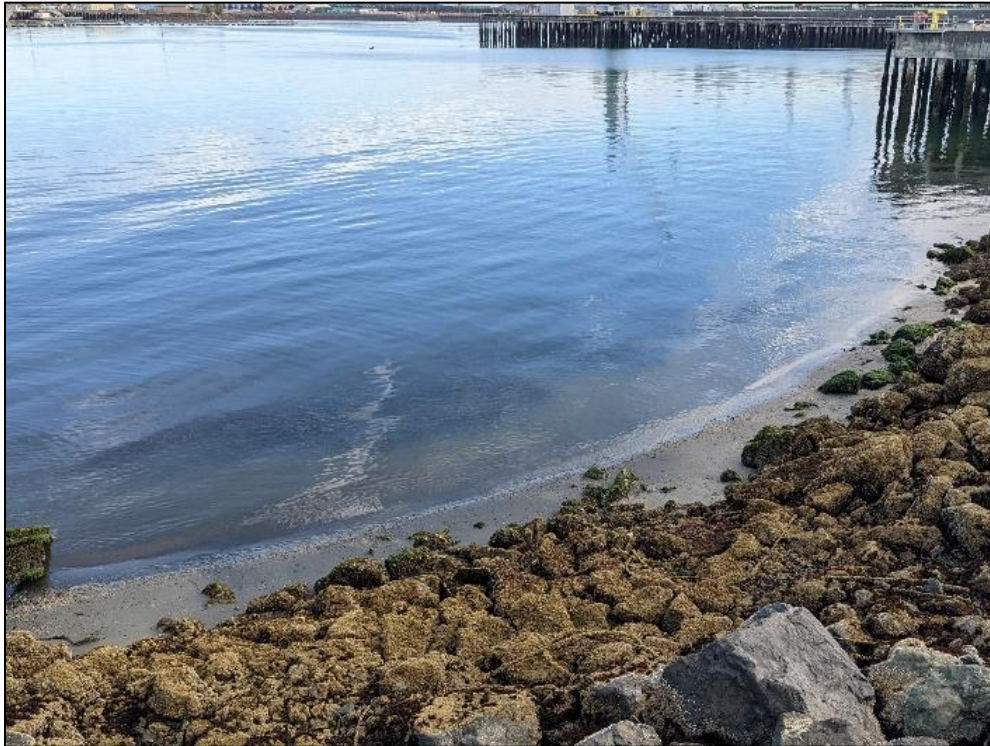
Photograph 22. Beach-like areas in Area 1 of the Northern shoreline

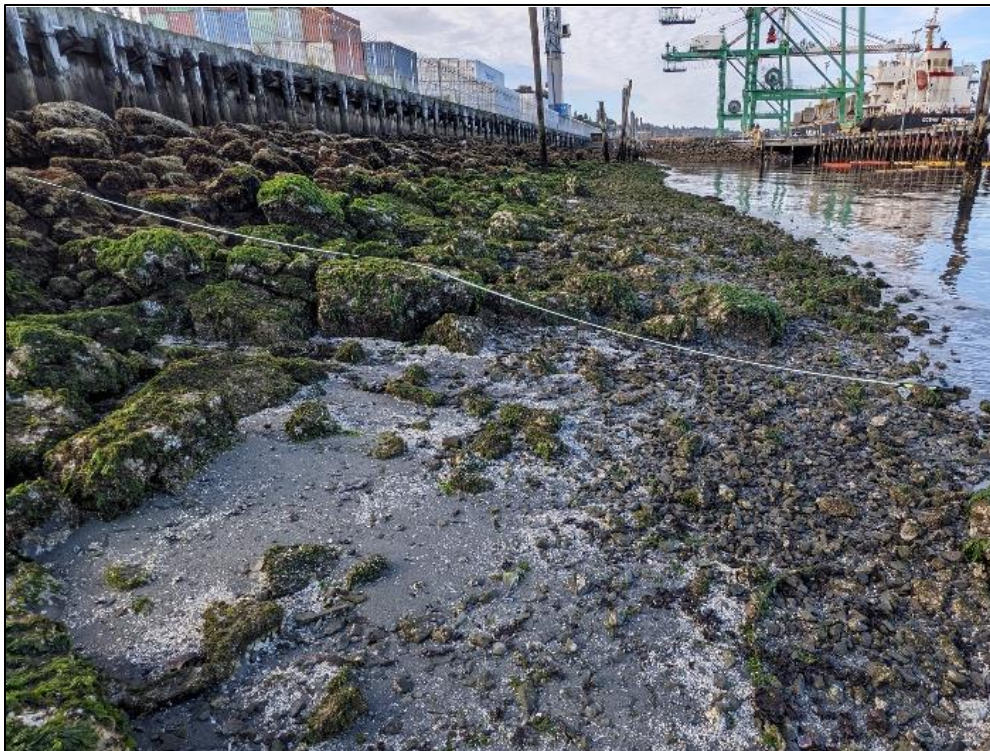
Photograph 23. Small beach-like areas within Area 2 of the Northern shoreline. Photographs taken facing southeast towards the South Terminal.

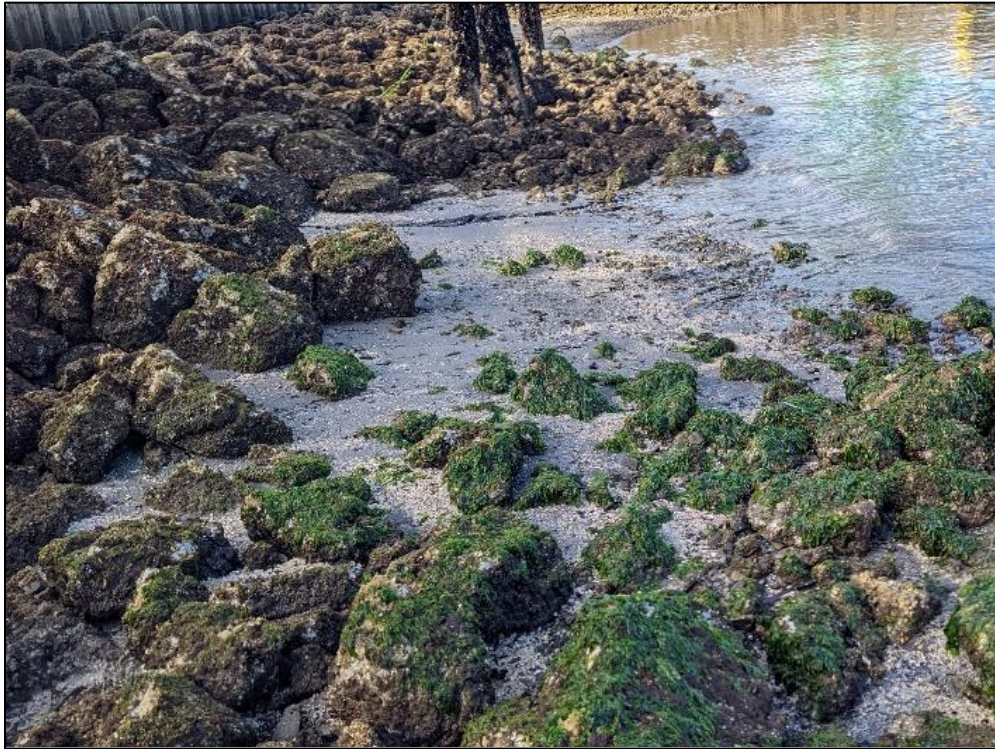
Photograph 24. Small beach-like areas within Area 2 of the Northern shoreline.

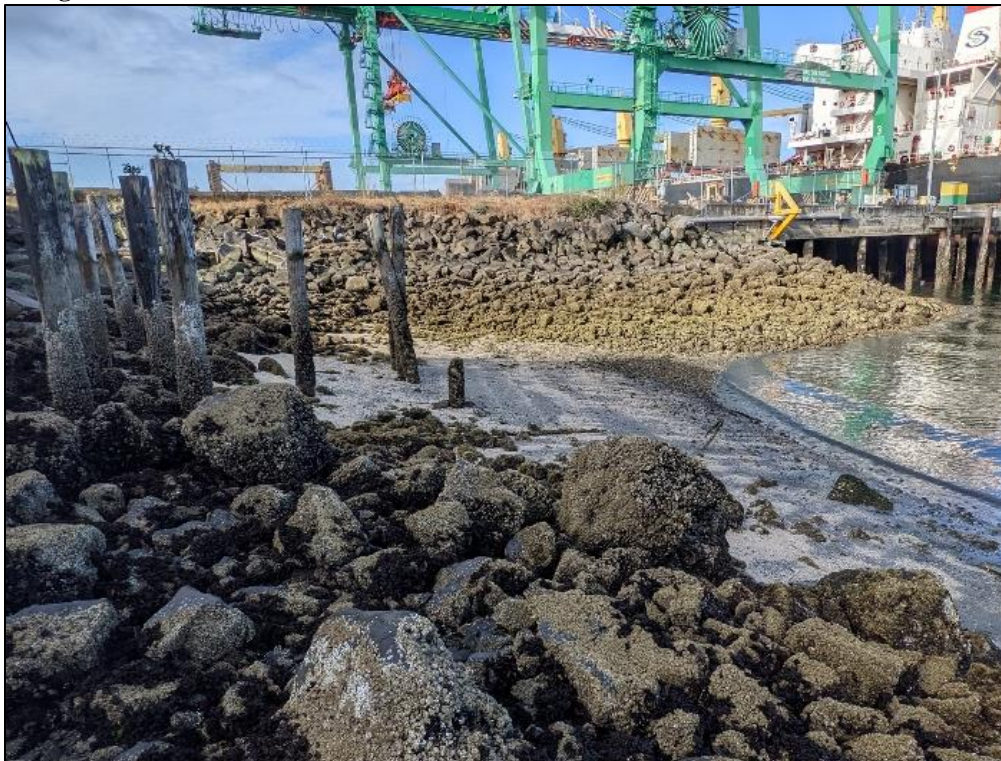
Photograph 25. Large beach area within Area 2 of the Northern shoreline, adjacent to the South Terminal facing southwest towards the terminal.

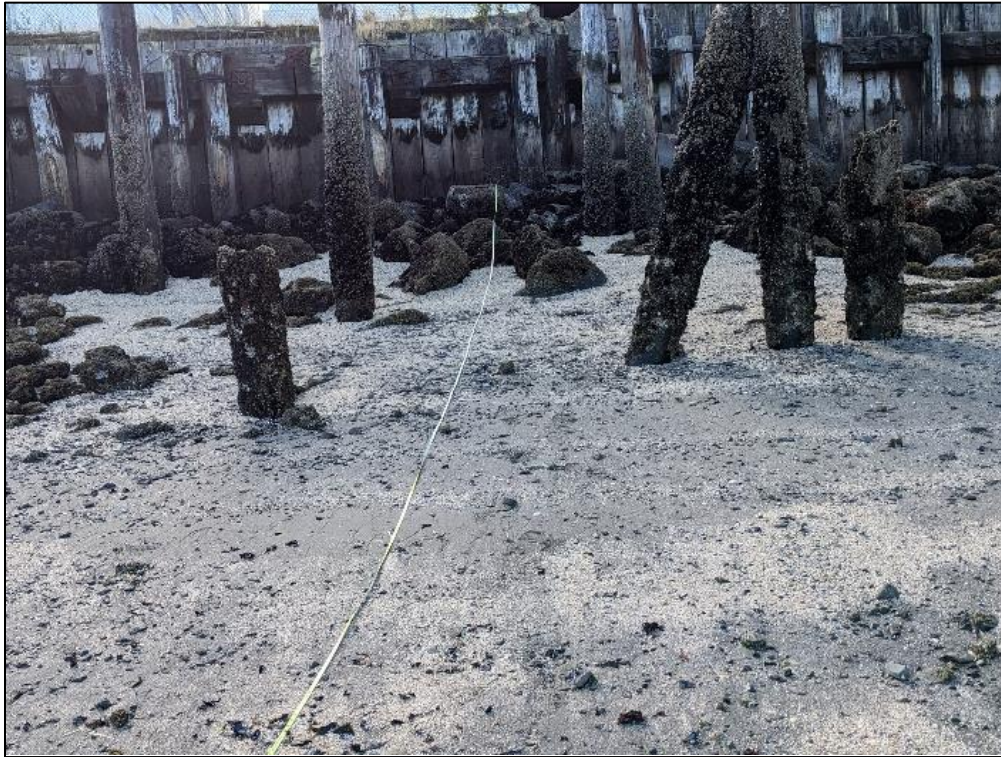
Photograph 26. Beach area within Area 2, facing upslope.

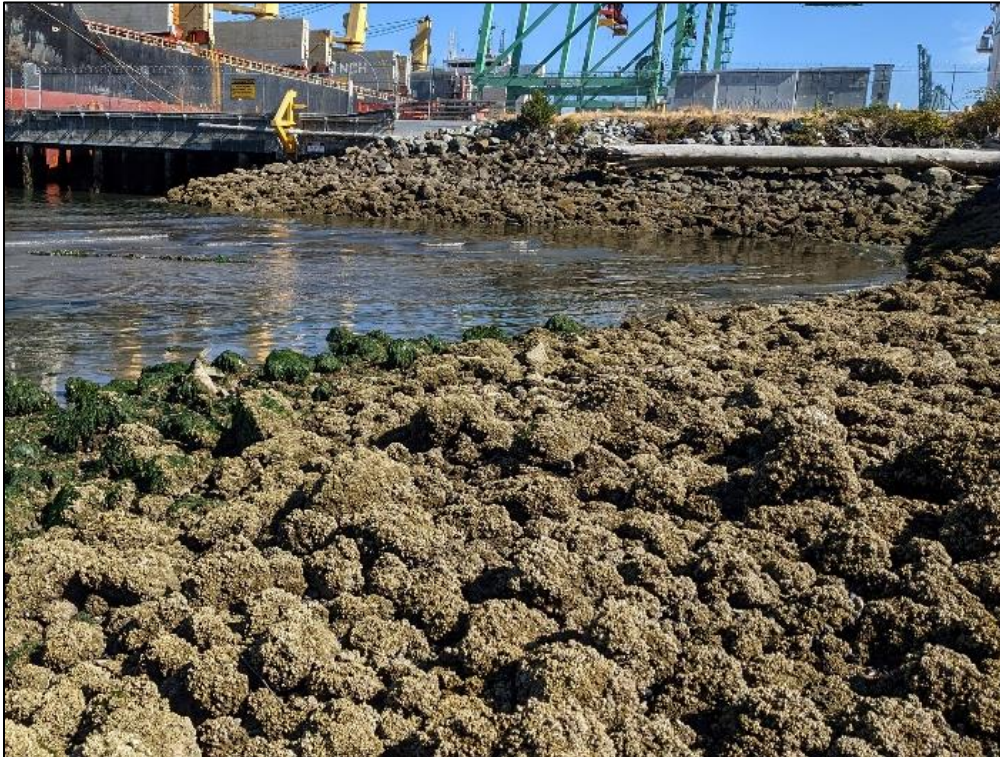
Photograph 31. Armored slopes of the southern shoreline in Area A north of Pigeon Creek. Riprap slopes near the South Terminal facing North.
