STATE OF WASHINGTON
DEPARTMENT OF ECOLOGY

Re: Stormwater Management at the City of Walla Walla Post Office and 106 N 2nd Ave Buildings:

- **Site Name:** Chevron Stillwater Holdings
- **Site Address:** 7 East Rose Street, WA 99362
- **Cleanup Site ID:** 16913
- **Facility/Site ID:** 70525886

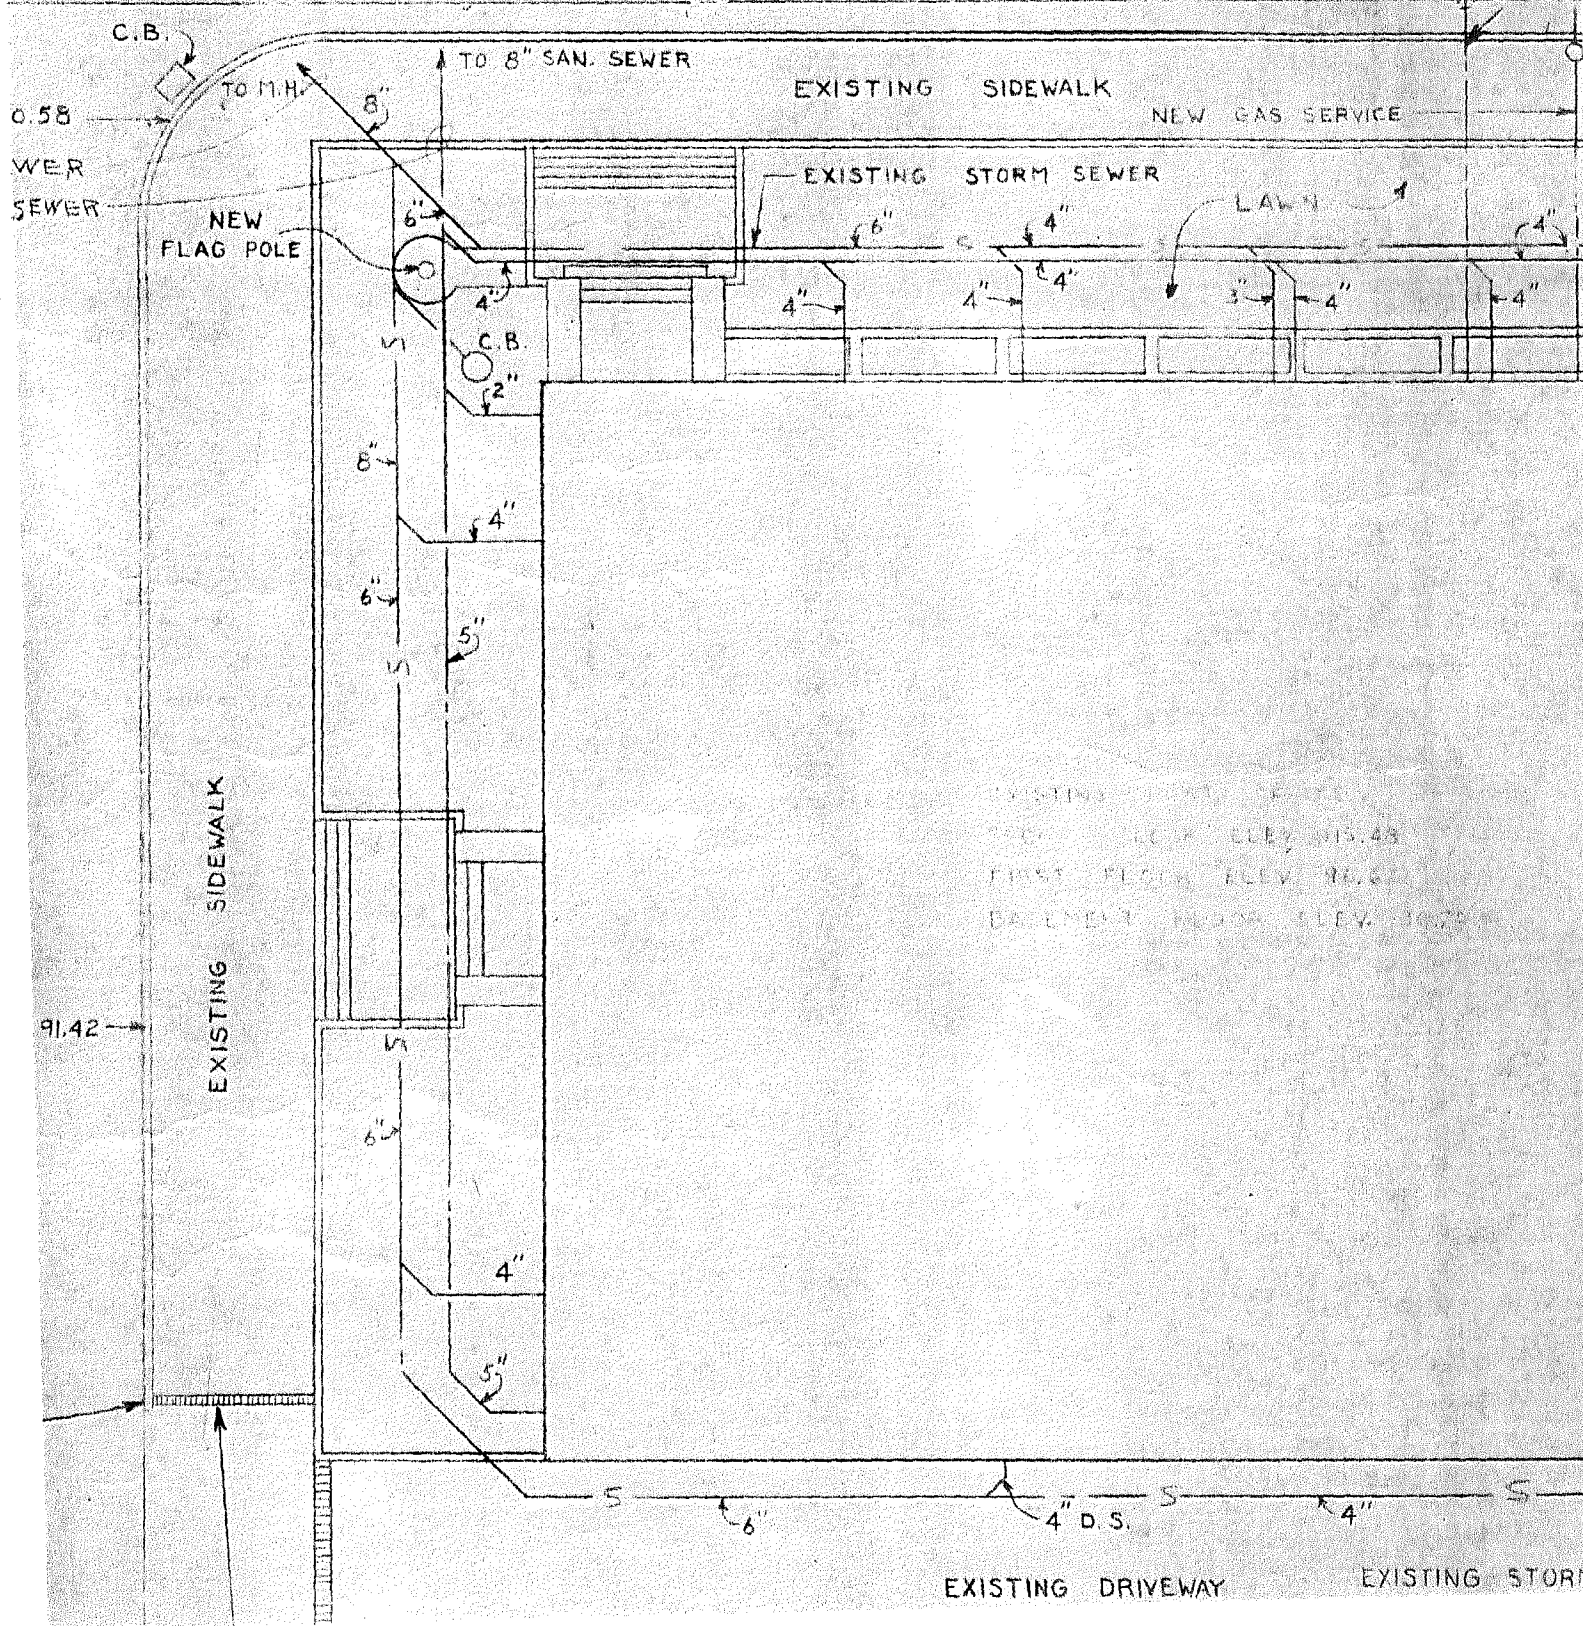
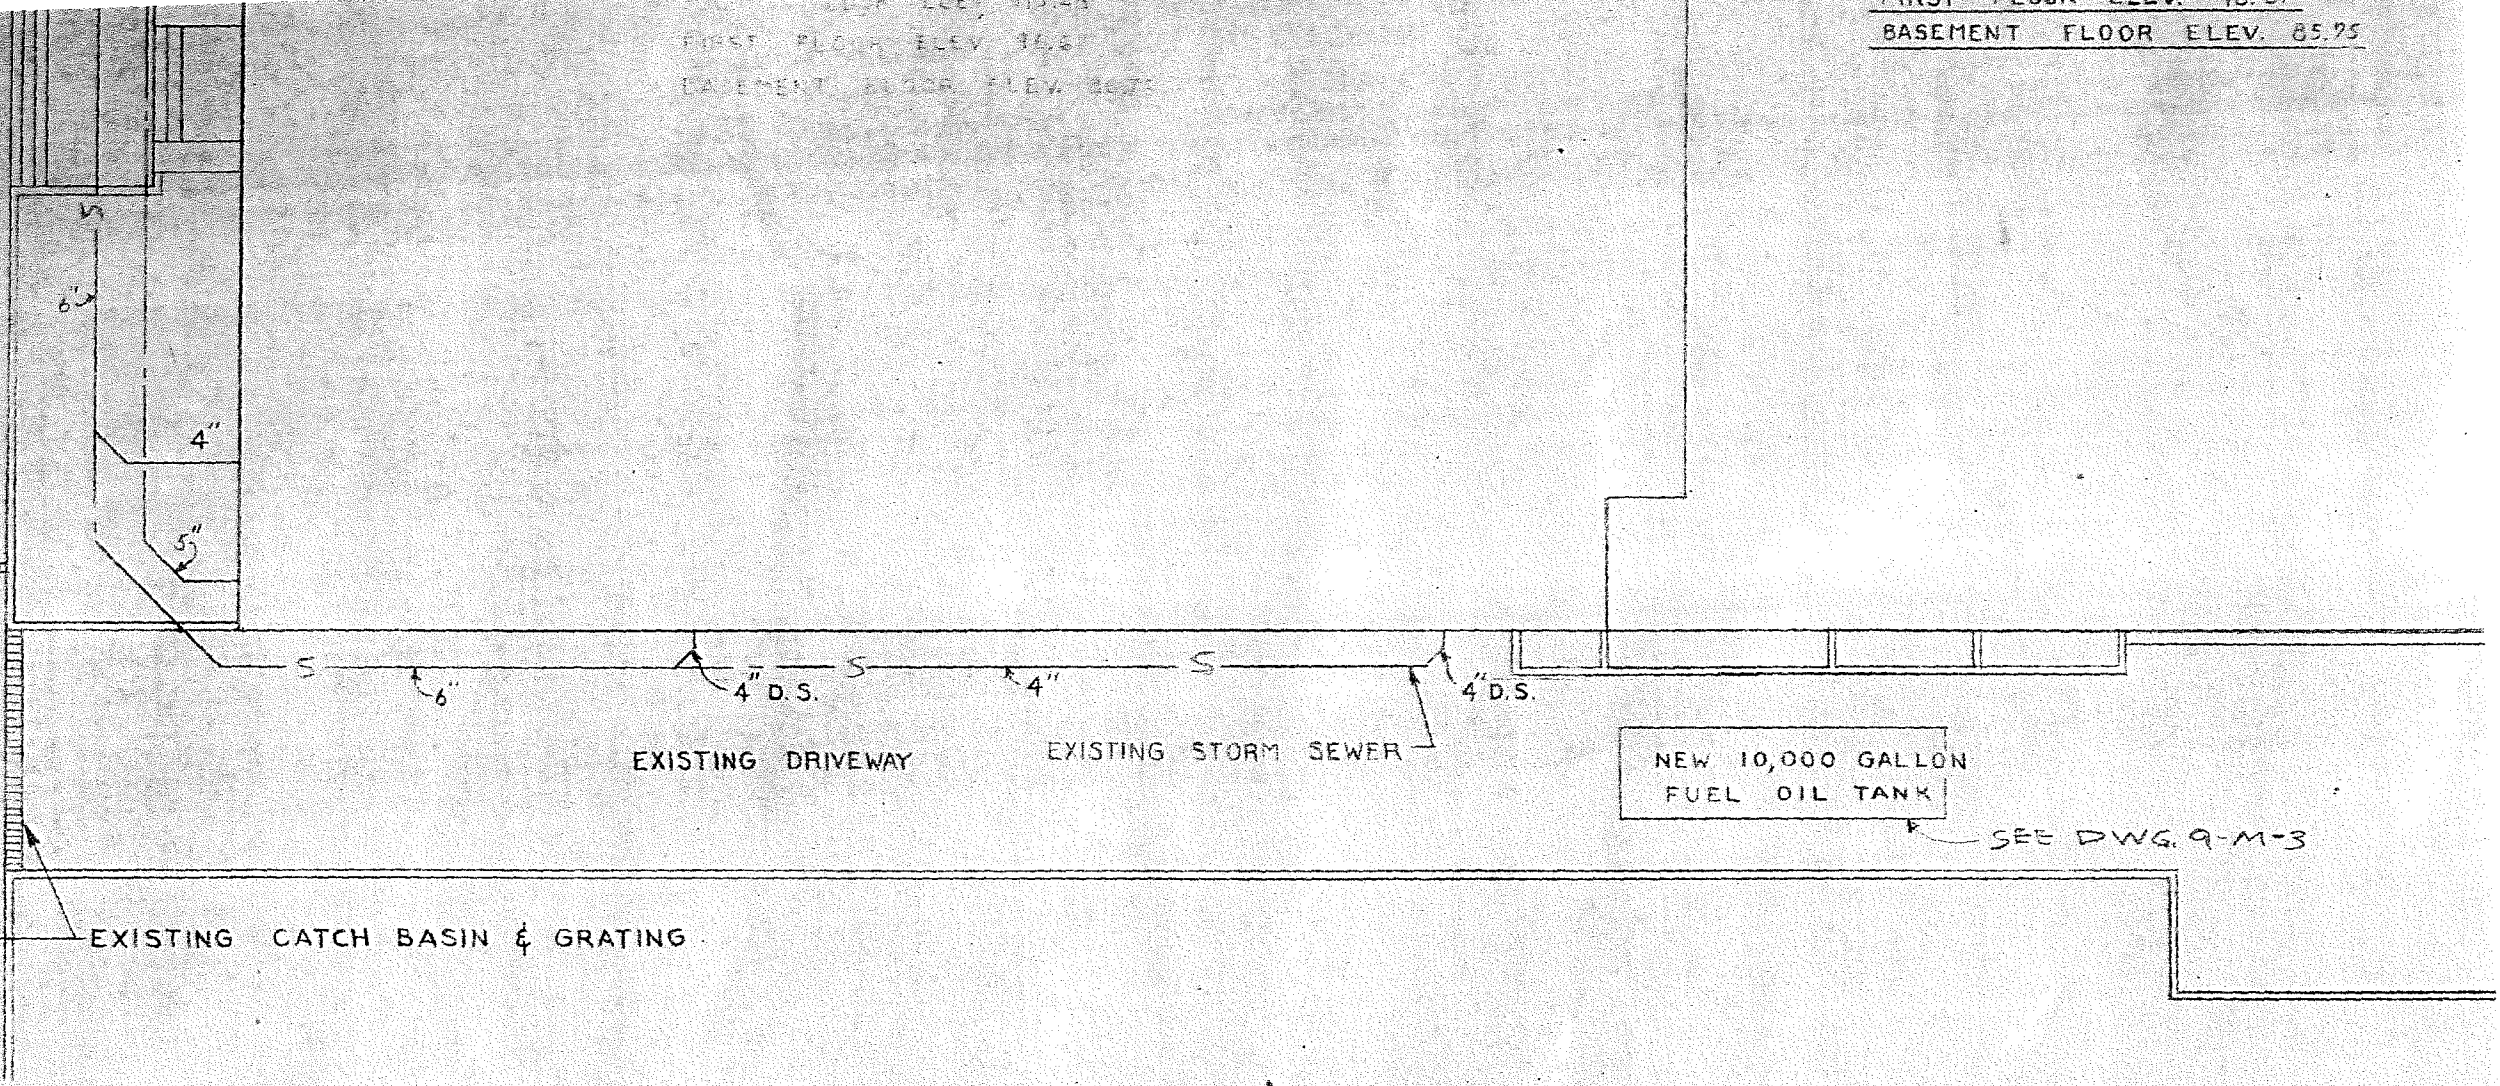
SITE PLAN

EXISTING SIDE

FIRST FLOOR ELEV. 95.45
FIRST FLOOR ELEV. 95.8
BASEMENT FLOOR ELEV. 85.75

NEW EXTENSION TO P.O.
FIRST FLOOR ELEV. 96.67
BASEMENT FLOOR ELEV. 85.75
