# Environmental Cap and Drainage System Inspection Report

Former Cascade Timber No. 3 Log Sort Yard  
(Ecology Facility ID #1206)

December 19, 2024

Project No. M0615.17.004

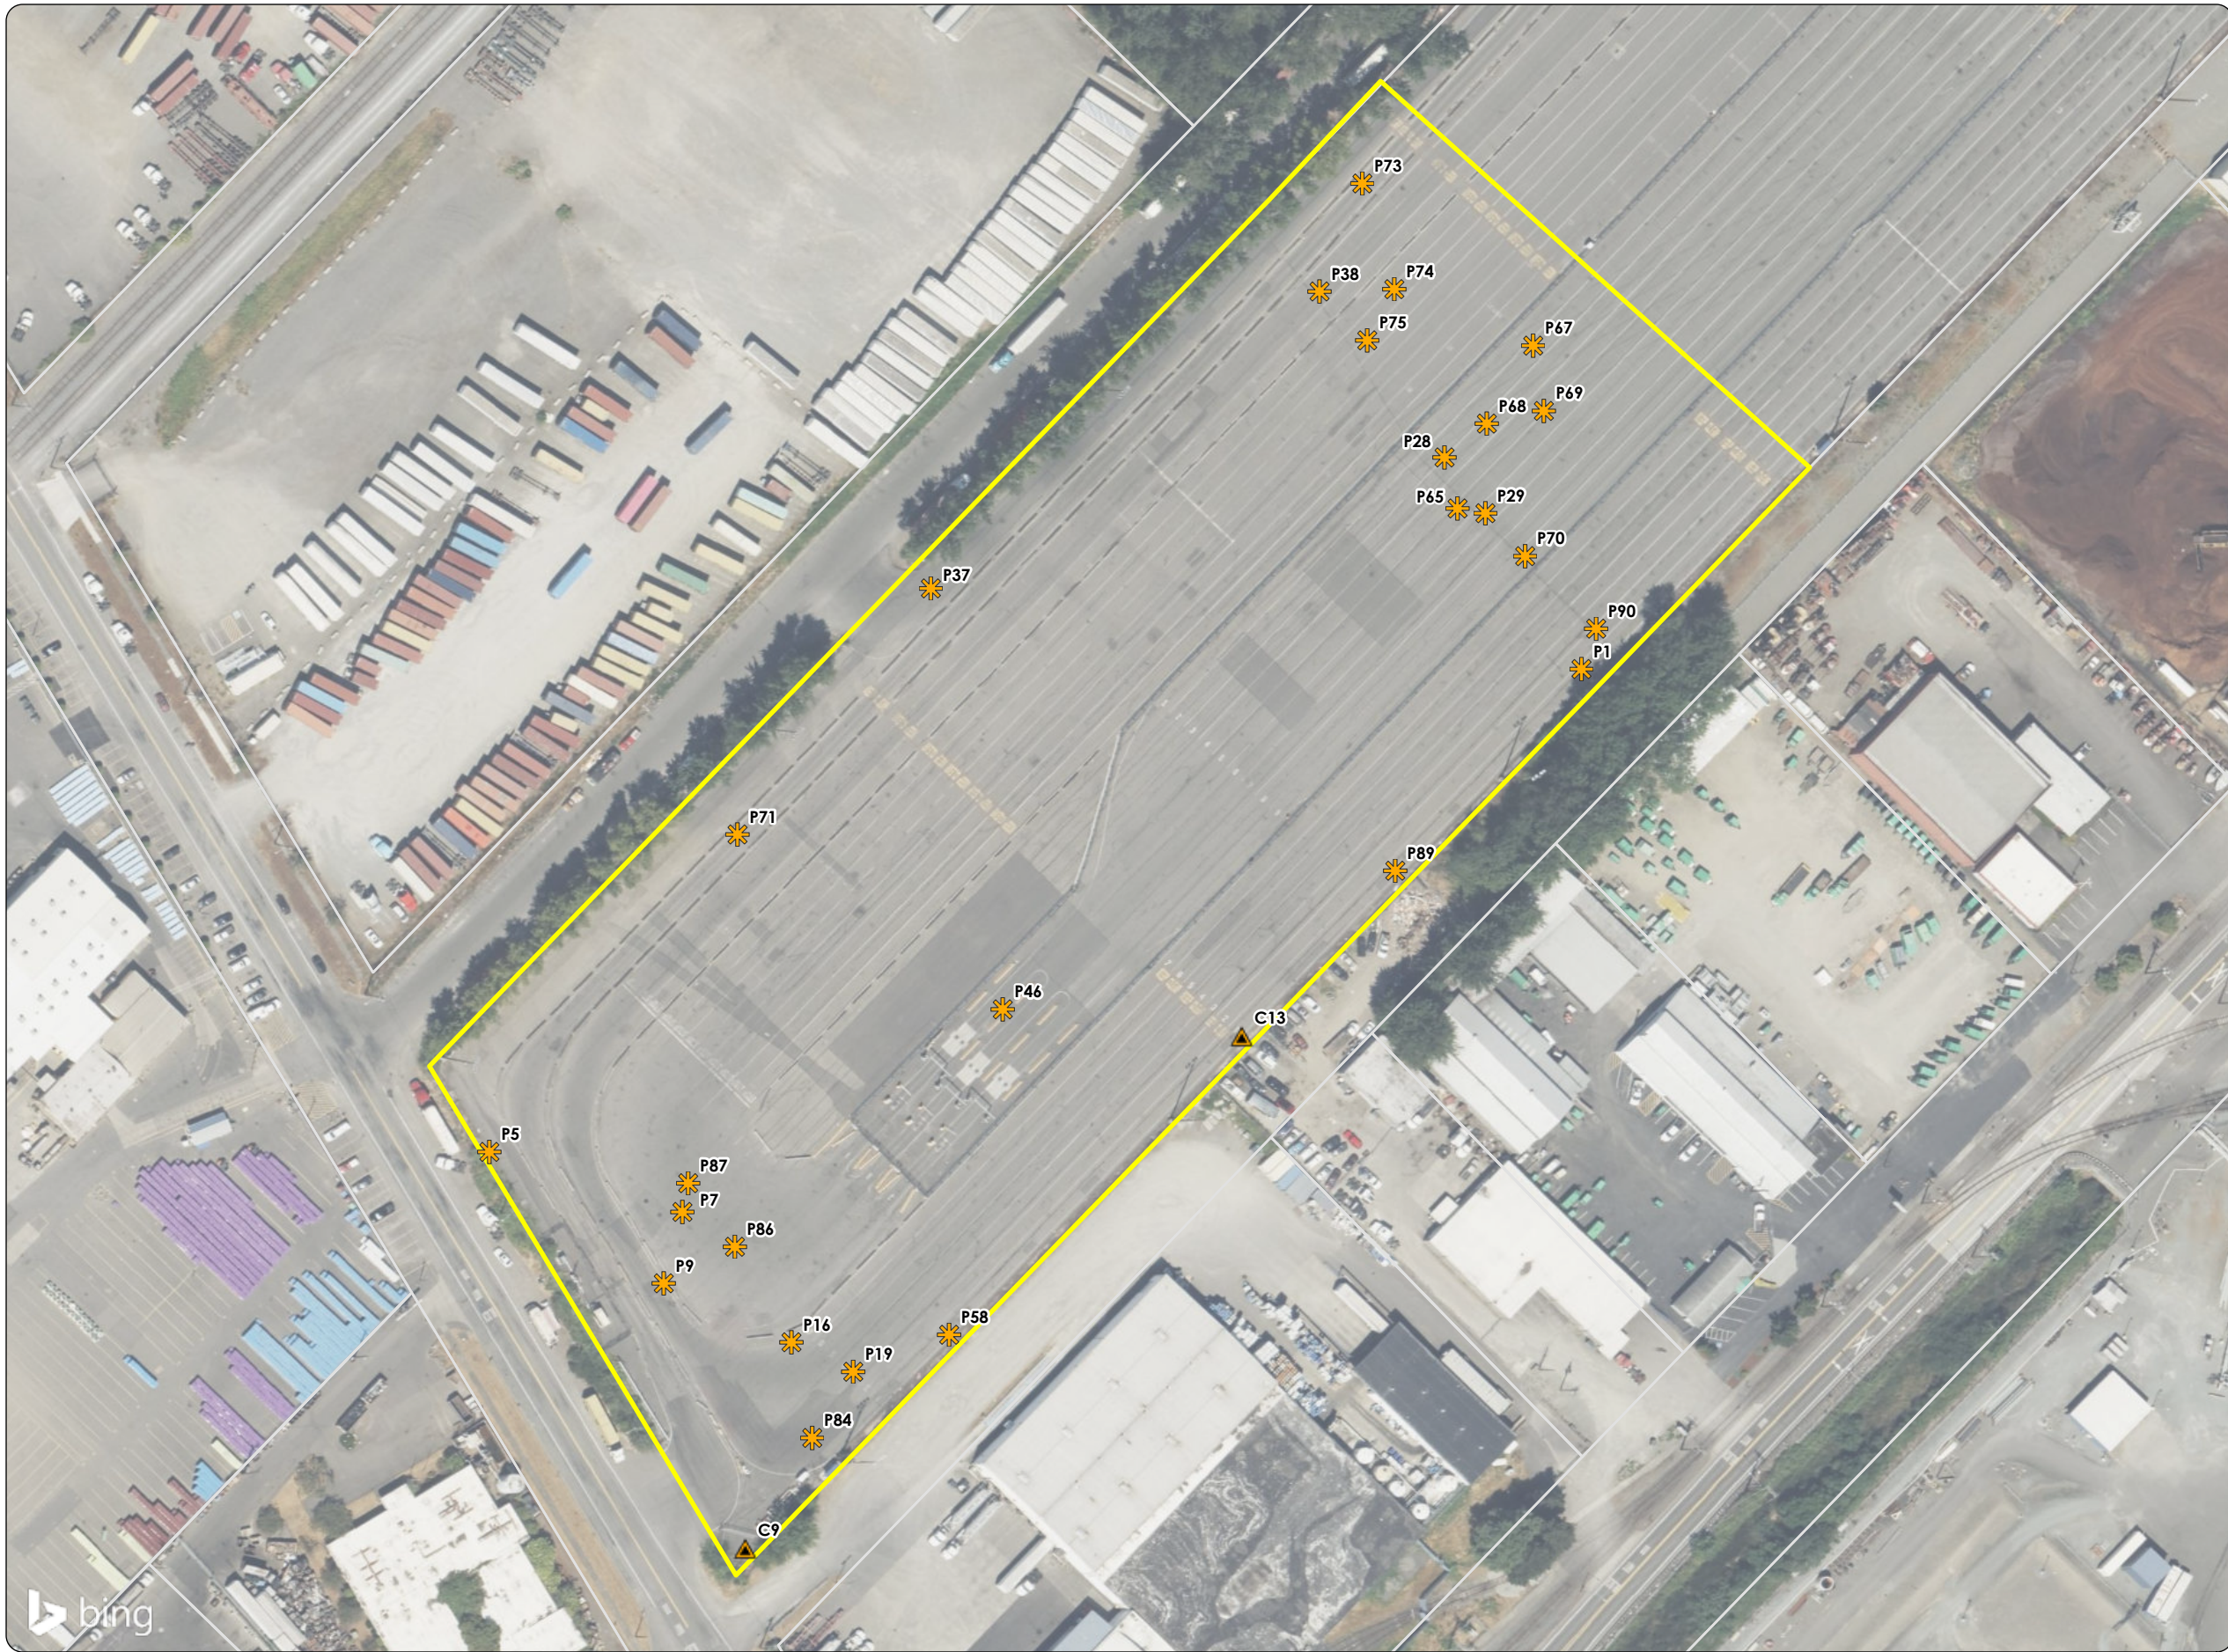
## Figure 2-1 Environmental Cap Issues Observations

| Required Inspection Element | Observed Condition | Recommended Action |
|---|---|---|
| Presence of cracks wider than 1/8 inch | Cracks wider than 1/8 inch were observed across the cap. | Repair pavement as shown in Figure 2-1 and described in Table 2-1. |
| Degradation, subsidence, general appearance | Limited degradation and deterioration were observed in asphalt surface. | Locations of pavement deterioration are shown in Figure 2-1 and described in Table 2-1. |

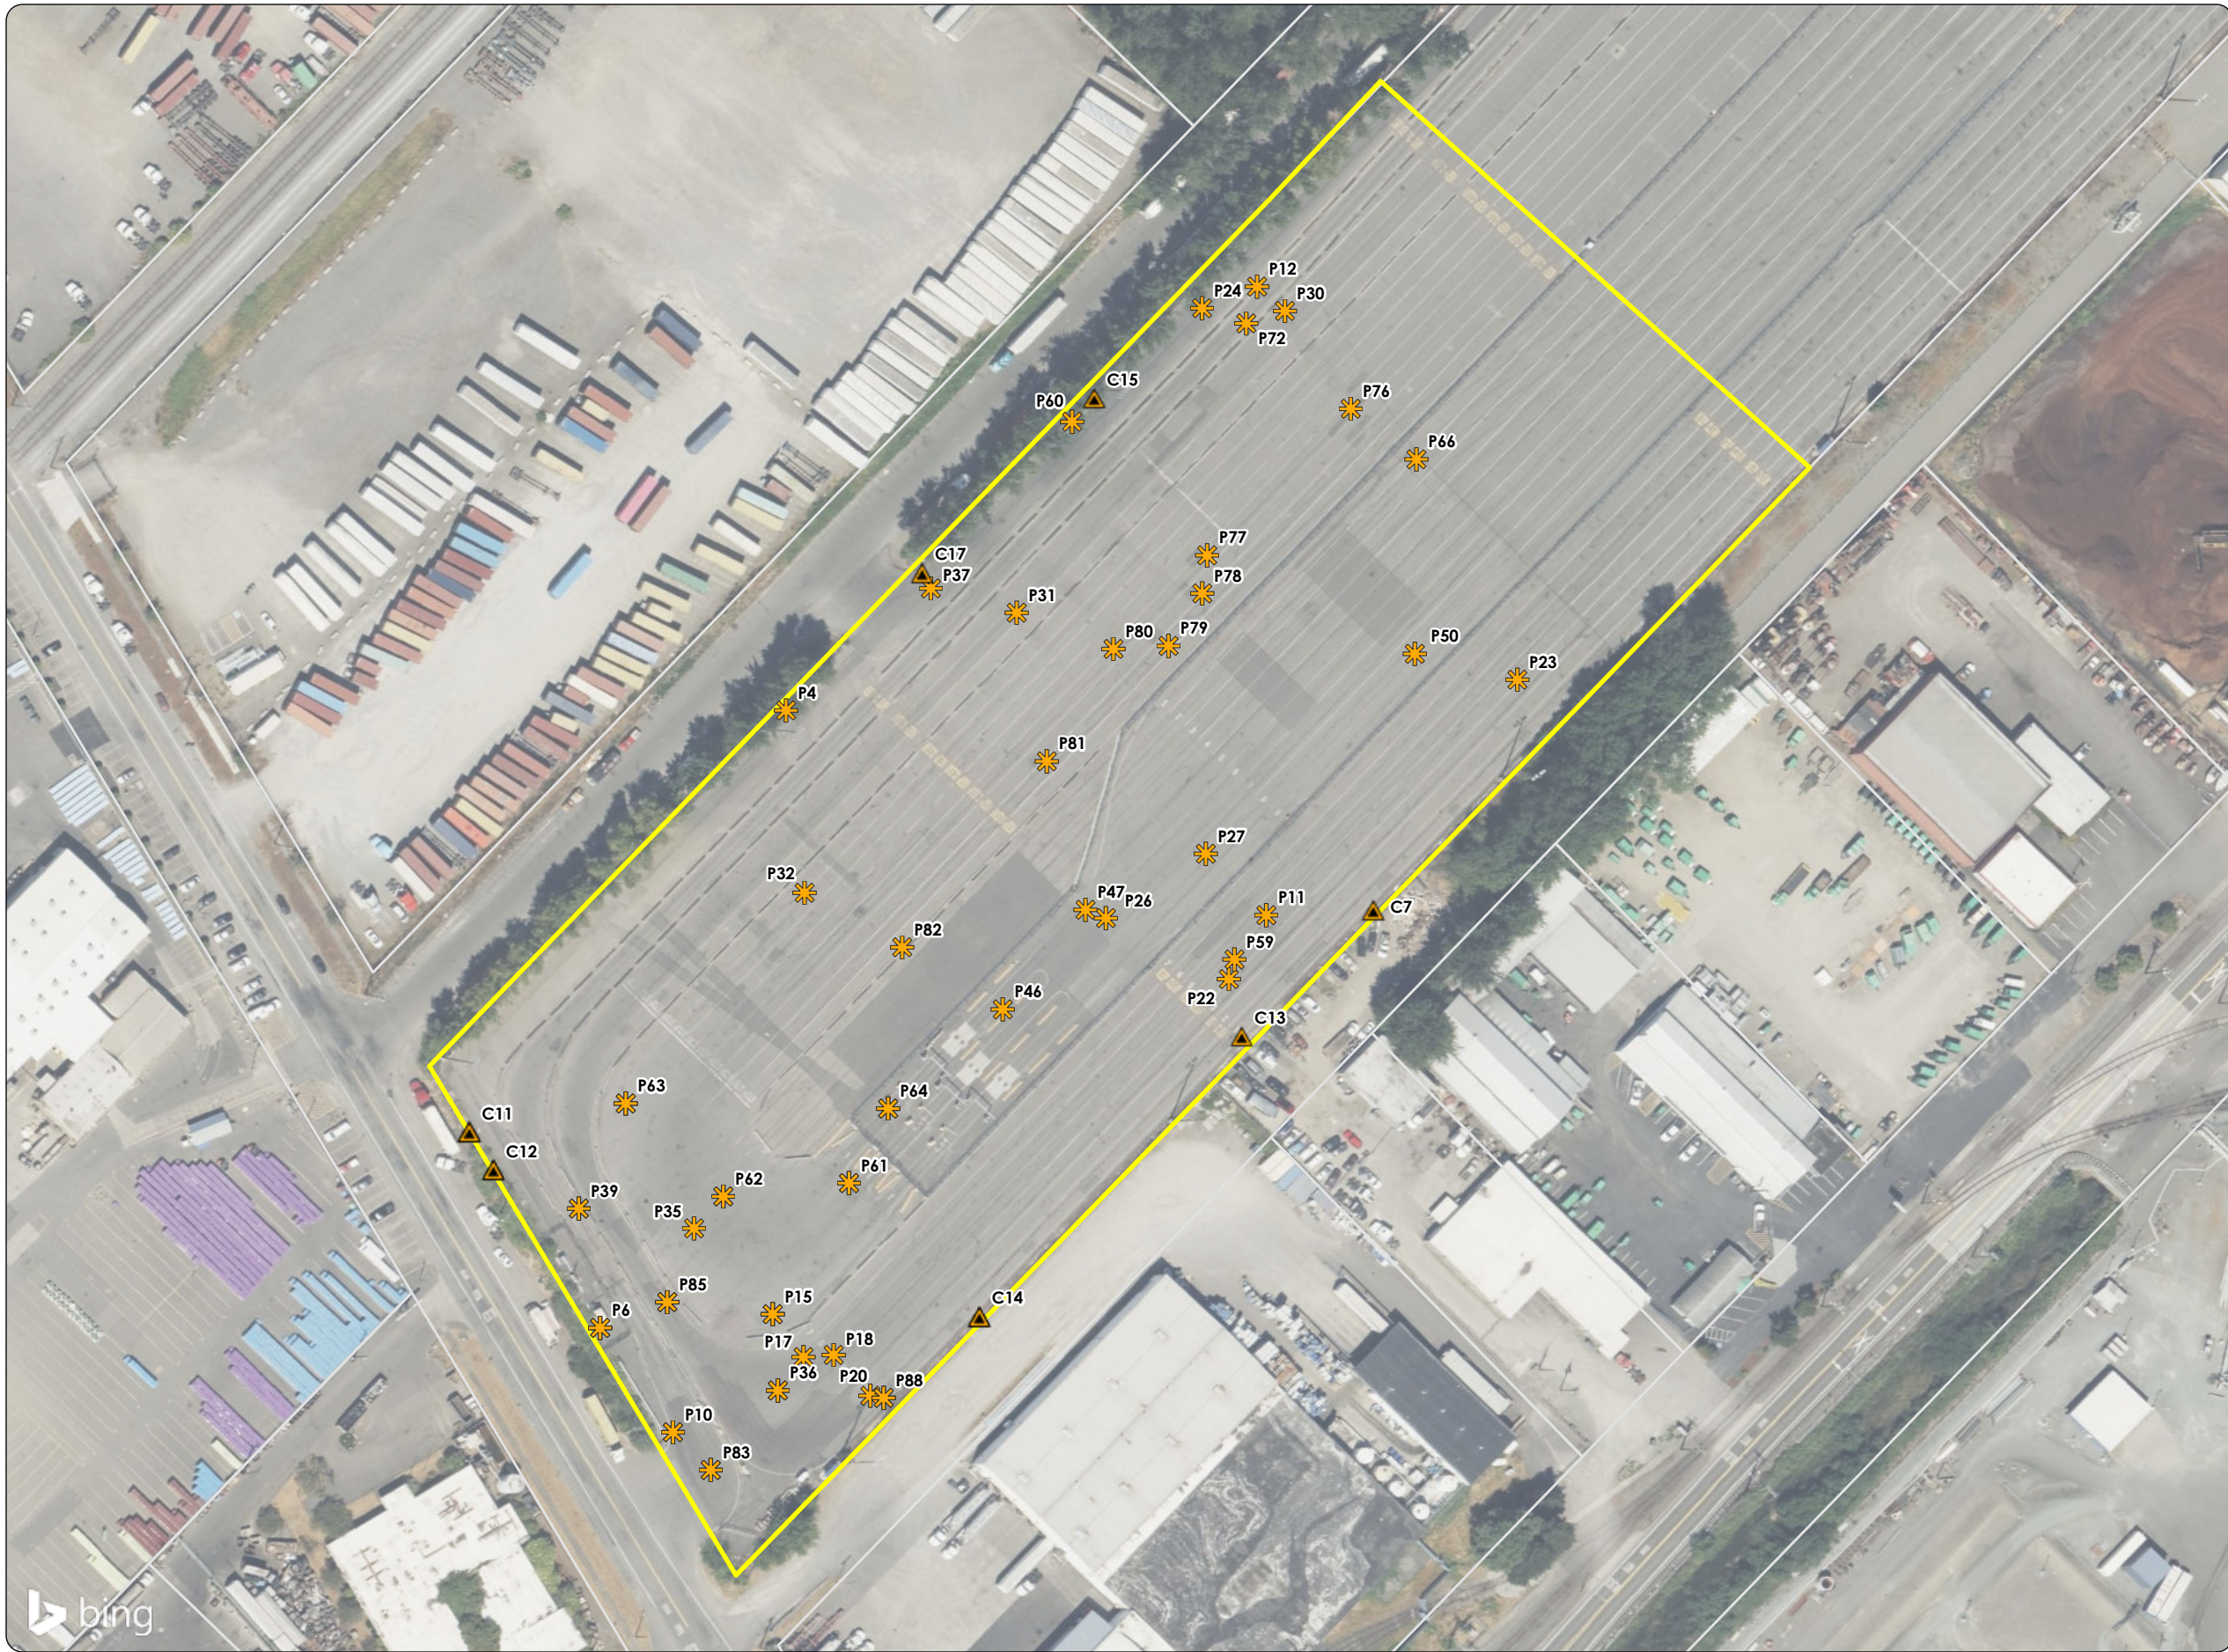
## Figure 2-2 Environmental Cap Repairs Observations

Pavement repairs observed during the 2024 inspection are presented in Figure 2-2 and described in Table 2-2. Details and photographs of the observed repairs are provided in the appendix that follows this report.

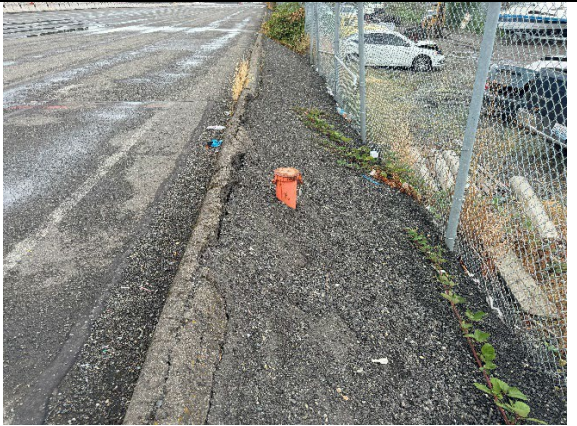
| ID <sup>1</sup> | Type of Structure | Observation | Recommended Actions | Photograph |
|---|---|--|--|--|
| C13 | Curb | Slope stabilized with recycled asphalt on the backside of degraded curb; approximately 15 lf | Monitor repair and reevaluate during next inspection cycle | |

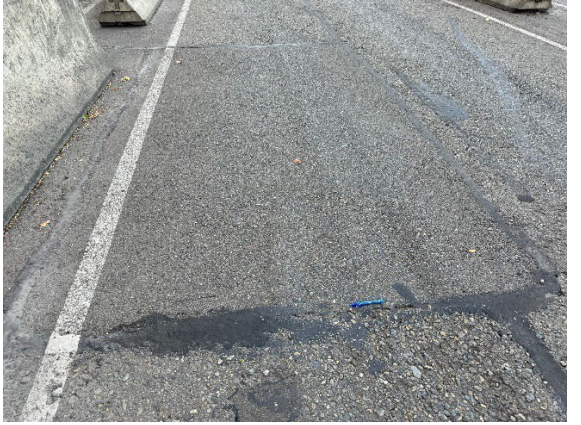
| ID <sup>1</sup> | Type of Structure | Observation | Recommended Actions | Photograph |
|---|---|--|---|--|
| P12 | Pavement | Repaired asphalt patch; approximately 5-foot-by-10-foot; some sealant missing; minor cracking adjacent to repair | Reseal edges and cracks | |

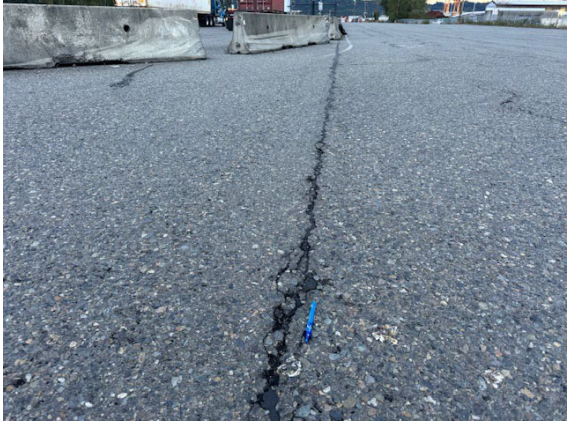
| ID <sup>1</sup> | Type of Structure | Observation | Recommended Actions | Photograph |
|---|---|--|---|--|
| P16 | Pavement | Previously sealed crack with sealant missing in places; crack extends northeast along the cap extent | Reseal crack | |

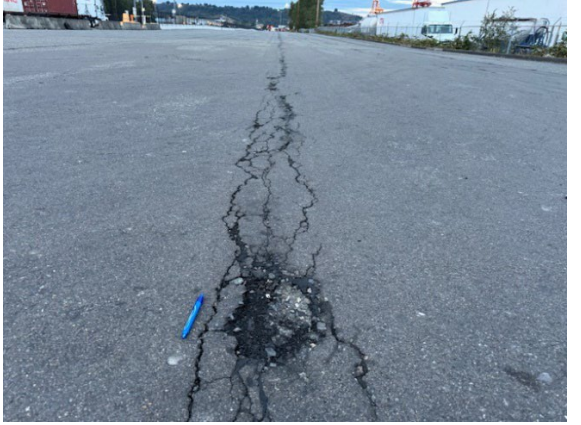
| ID <sup>1</sup> | Type of Structure | Observation | Recommended Actions | Photograph |
|---|---|---|---|--|
| P19 | Pavement | Crack previously sealed with sealant but missing in places; divots as deep as 1 inch and almost 1 foot wide in places; crack extends several hundred feet | Repair larger divot; reseal cracks | |

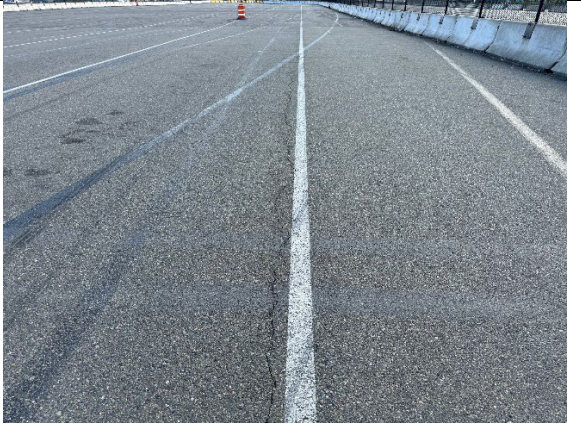
| ID <sup>1</sup> | Type of Structure | Observation | Recommended Actions | Photograph |
|---|---|---|---|--|
| P28 | Pavement | Linear crack approximately 75 lf and as wide as 0.25 inches | Seal crack | |

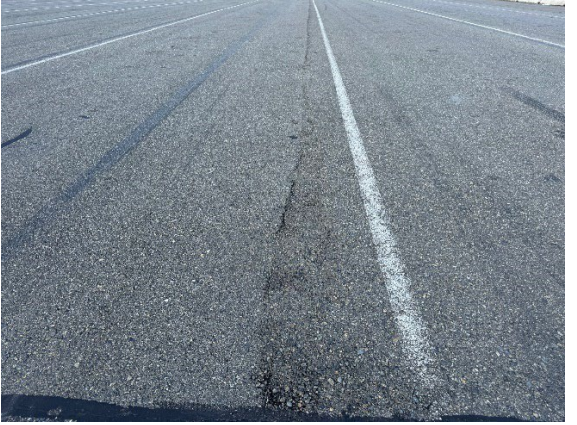
| ID <sup>1</sup> | Type of Structure | Observation | Recommended Actions | Photograph |
|---|---|--|---|--|
| P29 | Pavement | Linear crack in asphalt extending along drive lane from point approximately 75 lf; as wide as 1 inch in places | Seal crack | |

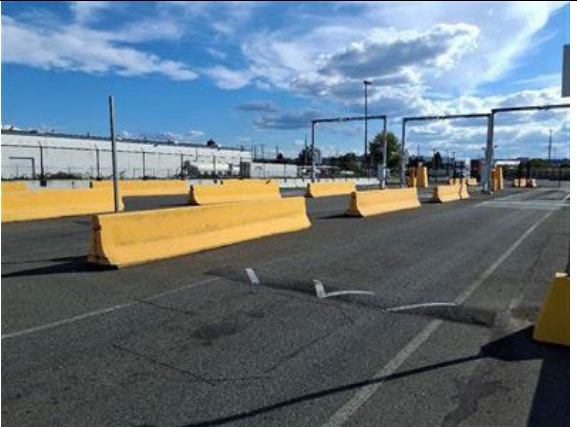
| ID <sup>1</sup> | Type of Structure | Observation | Recommended Actions | Photograph |
|---|---|--|--|--|
| P46 | Pavement | Asphalt repair near truck scale area; approximately 250-foot-by-150-foot area; wheel ruts present, but no visible cracking | Monitor and reevaluate wheel ruts during next inspection cycle | |

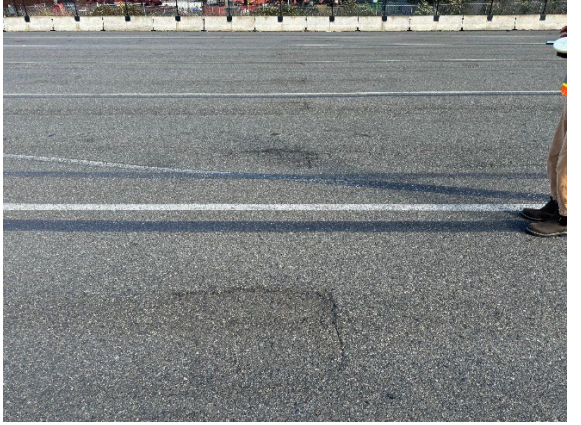
| ID <sup>1</sup> | Type of Structure | Observation | Recommended Actions | Photograph |
|---|---|---|---|--|
| P69 | Pavement | Depressions in asphalt with cracks; roughly 5 foot spacing along width of the cap; approximately 2-foot-by-3-foot depressions | Monitor and reevaluate during next inspection cycle | |

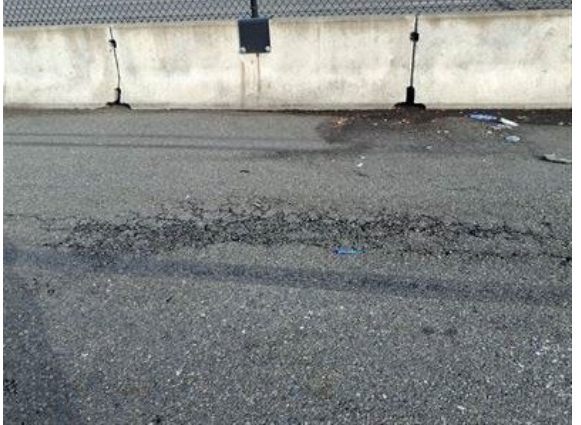
| ID <sup>1</sup> | Type of Structure | Observation | Recommended Actions | Photograph |
|---|---|---|---|--|
| P70 | Pavement | Alligator cracking in asphalt; approximately 10-foot-by-5-foot area | Seal cracks | |

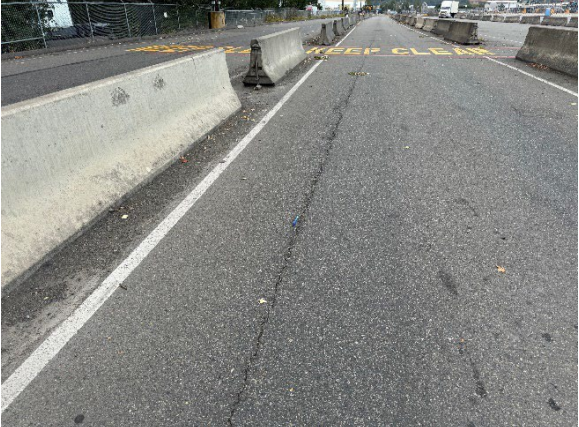
| ID <sup>1</sup> | Type of Structure | Observation | Recommended Actions | Photograph |
|---|---|---|---|--|
| P73 | Pavement | Linear crack approximately 40 lf; wider than 1/8 inch; runs along driveway lane | Seal crack | |

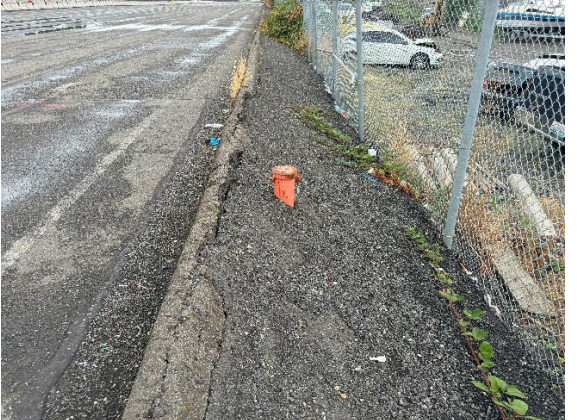
| ID <sup>1</sup> | Type of Structure | Observation | Recommended Actions | Photograph |
|---|---|--|--|--|
| C13 | Curb | Slope stabilized with recycled asphalt on the backside of degraded curb; approximately 15 lf | Monitor repair and reevaluate during next inspection cycle | |

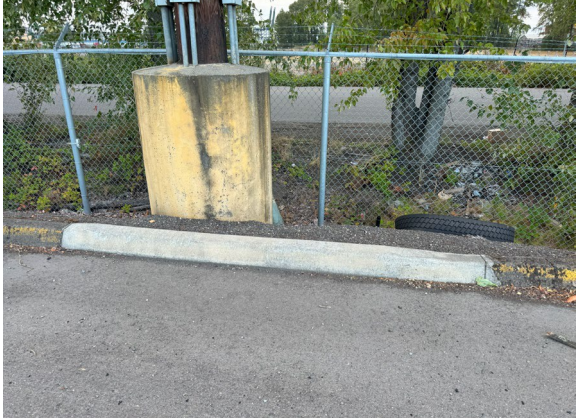
| ID <sup>1</sup> | Type of Structure | Observation | Recommended Actions | Photograph |
|---|---|--|---|--|
| C15 | Curb | Repaired concrete curb; approximately 6 lf | None | |

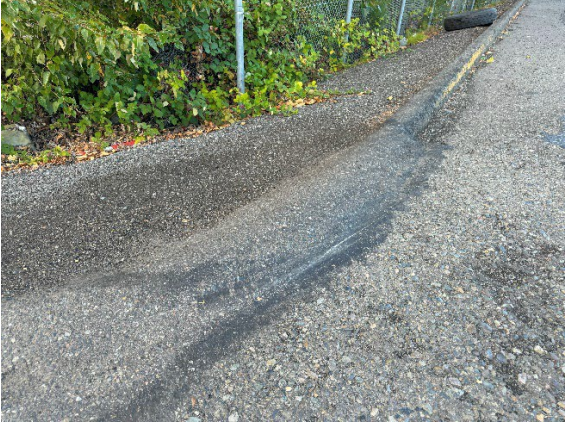
| ID <sup>1</sup> | Type of Structure | Observation | Recommended Actions | Photograph |
|---|---|--|---|--|
| C17 | Curb | Repaired curb at site entrance/exit; approximately 3 lf; | None | |

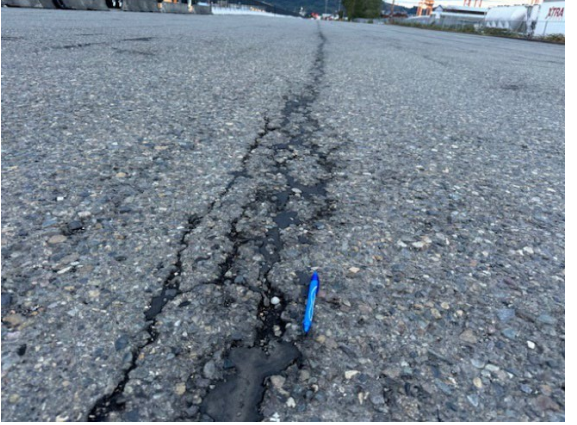
| ID <sup>1</sup> | Type of Structure | Observation | Recommended Actions | Photograph |
|---|---|---|---|--|
| P18 | Pavement | Sealed crack | None | |

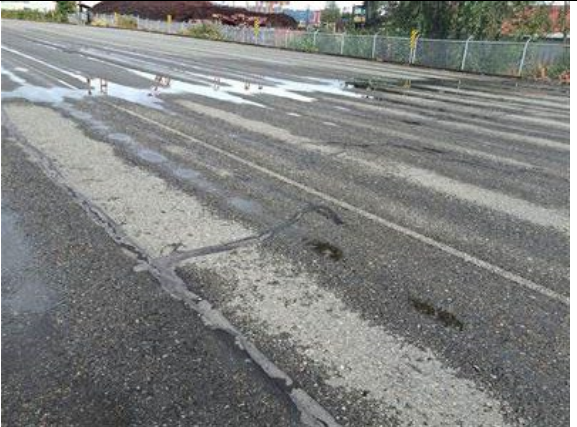
| ID <sup>1</sup> | Type of Structure | Observation | Recommended Actions | Photograph |
|---|---|---|---|--|
| P22 | Pavement | Sealed cracks | None | |

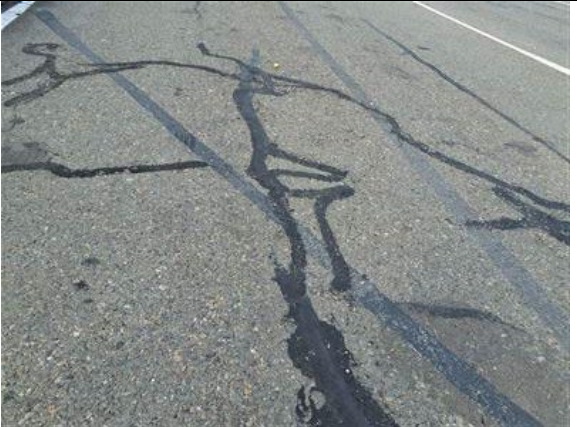
| ID <sup>1</sup> | Type of Structure | Observation | Recommended Actions | Photograph |
|---|---|---|---|--|
| P32 | Pavement | Sealed cracks | None | |

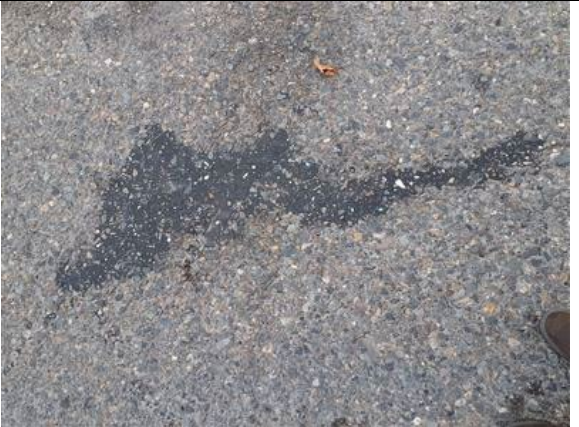
| ID <sup>1</sup> | Type of Structure | Observation | Recommended Actions | Photograph |
|---|---|---|---|--|
| P39 | Pavement | Gouge in asphalt filled with sealant | None | |

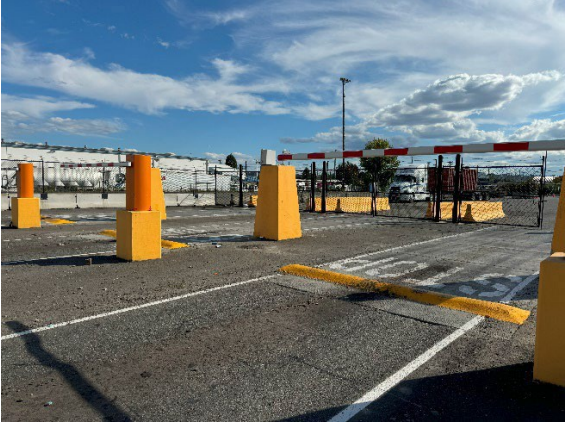
| ID <sup>1</sup> | Type of Structure | Observation | Recommended Actions | Photograph |
|---|---|---|---|--|
| P64 | Pavement | Cap repair with concrete and rebar at entrance of each truck scale lane; location of previous cap observation P25 | None | |

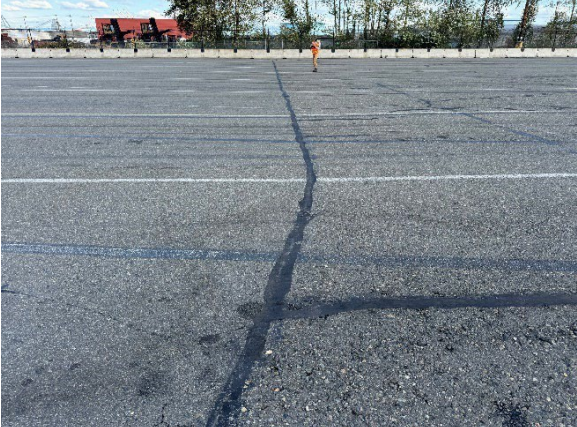
| ID <sup>1</sup> | Type of Structure | Observation | Recommended Actions | Photograph |
|---|---|---|---|--|
| P66 | Pavement | Sealed crack; extends width of cap | None | |

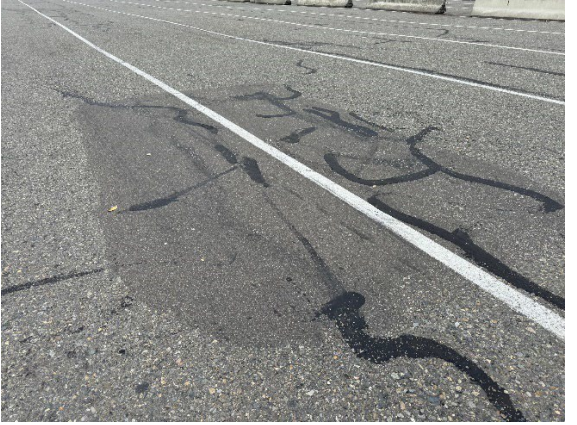
| ID <sup>1</sup> | Type of Structure | Observation | Recommended Actions | Photograph |
|---|---|--|---|--|
| P77 | Pavement | Sealed cracks and repaired asphalt; approximately 6-foot-by-11-foot area | None | |

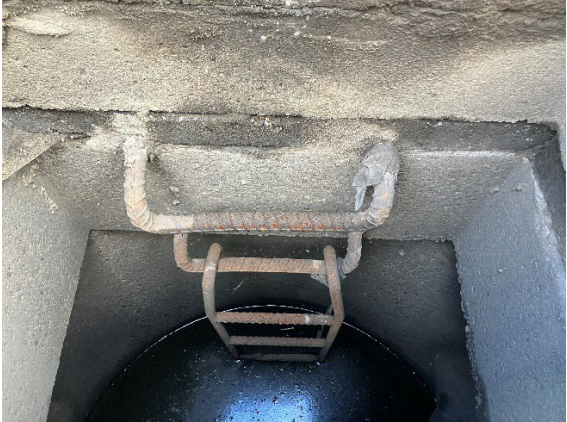
| ID | Type of Structure | Observed Condition | Sediment Accumulation | Additional observations | Recommended Actions | Photographs |
|---|---|--|--|---|--|---|
| CB4 | Catch basin | Structurally sound; functioning normally | Water in structure and too deep to measure | Trace floatables on surface | Replace insert; remove floatables in accordance with stormwater maintenance requirements | |

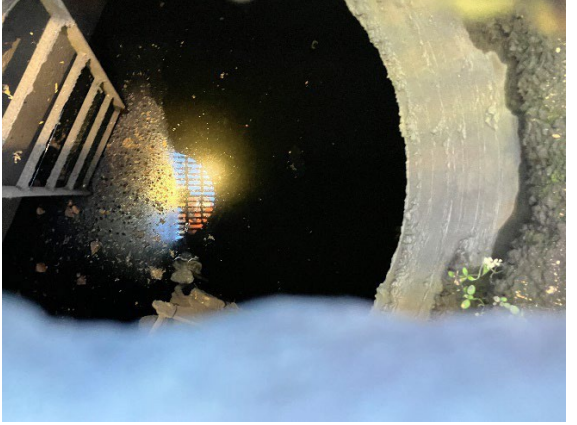
| ID | Type of Structure | Observed Condition | Sediment Accumulation | Additional observations | Recommended Actions | Photographs |
|---|---|--|--|--|---|--|
| OW2 | Oil/water separator | Structurally sound; functioning normally | Water in structure too deep to measure | Trace floatables on surface | Coordinate with Port to open structure for future inspections; remove floatables in accordance with stormwater maintenance requirements | |

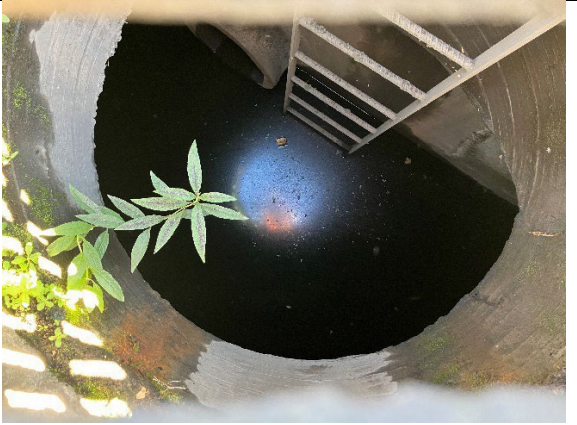
| ID | Type of Structure | Observed Condition | Sediment Accumulation | Additional observations | Recommended Actions | Photographs |
|---|---|--|--|--|---|--|
| SV1 | Spill containment vessel | Structurally sound; functioning normally | Water in structure and too deep to measure | Trace floatables on water surface; slight sheen on surface | Coordinate with Port to open structure for future inspections; remove floatables in accordance with stormwater maintenance requirements | |

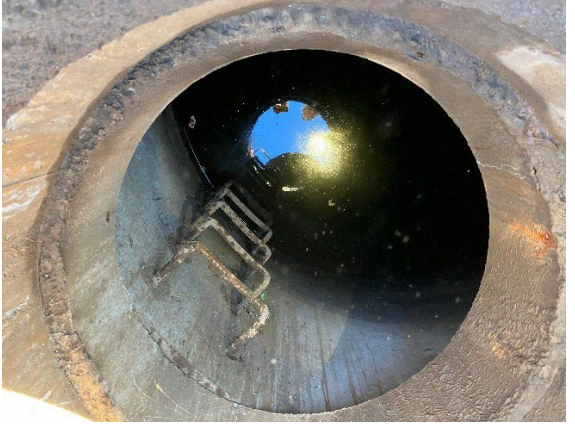
| ID | Type of Structure | Observed Condition | Sediment Accumulation | Additional observations | Recommended Actions | Photographs |
|---|---|--|--|---|---|--|
| SV2 | Spill containment vessel | Structurally sound; functioning normally | Water in structure and too deep to measure | Trace floatables on surface | Coordinate with Port to open structure for future inspections | |

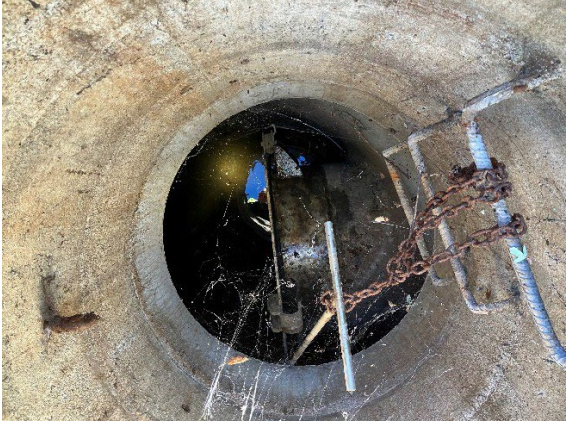
| ID | Type of Structure | Observed Condition | Sediment Accumulation | Additional observations | Recommended Actions | Photographs |
|---|---|--|--|---|---|--|
| WMH | Maintenance manhole | Structurally sound; functioning normally | Water in structure and too deep to measure | None | Coordinate with Port to open structure for future inspections | |

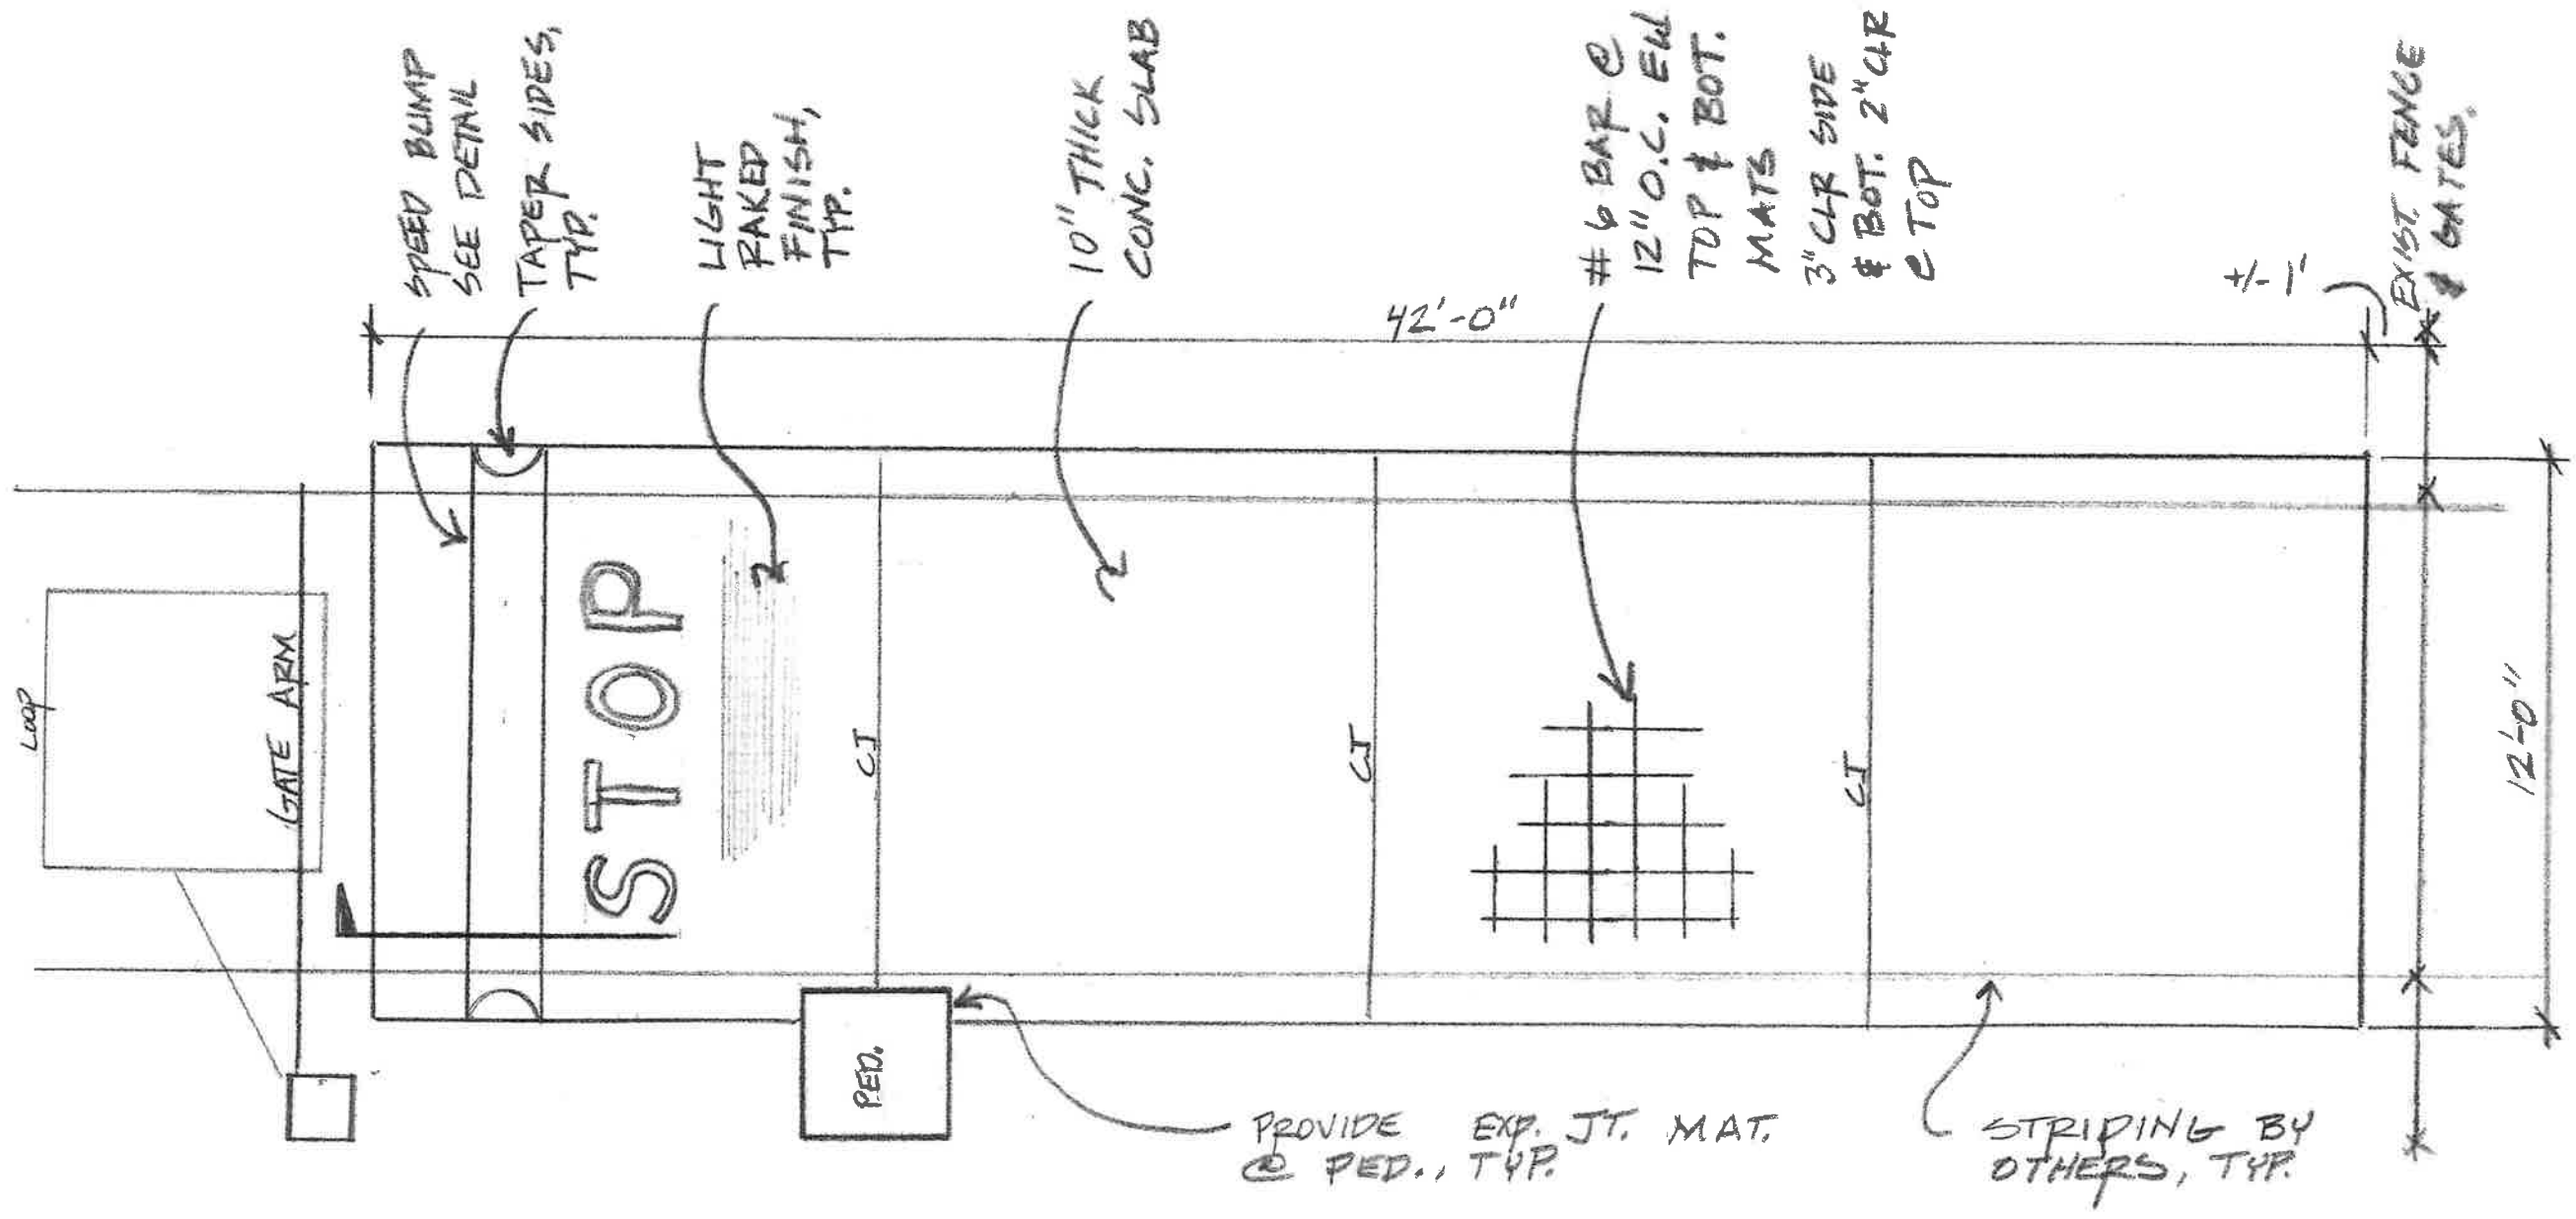
SLAB DETAIL TYP. of 3

Rutting and Pothole Repairs – total of three (3)  
10" mill, installation of rebar mats and concrete to eliminate ongoing rutting and potholes at the entry gate area.
