## **First Periodic Review**

### **Crownhill Elementary School Bremerton SD**

**1500 Rocky Point Rd NW, Bremerton, 98312, Kitsap  
County, Washington**

**Toxics Cleanup Program, Northwest Region**  
Washington State Department of Ecology  
February 2025

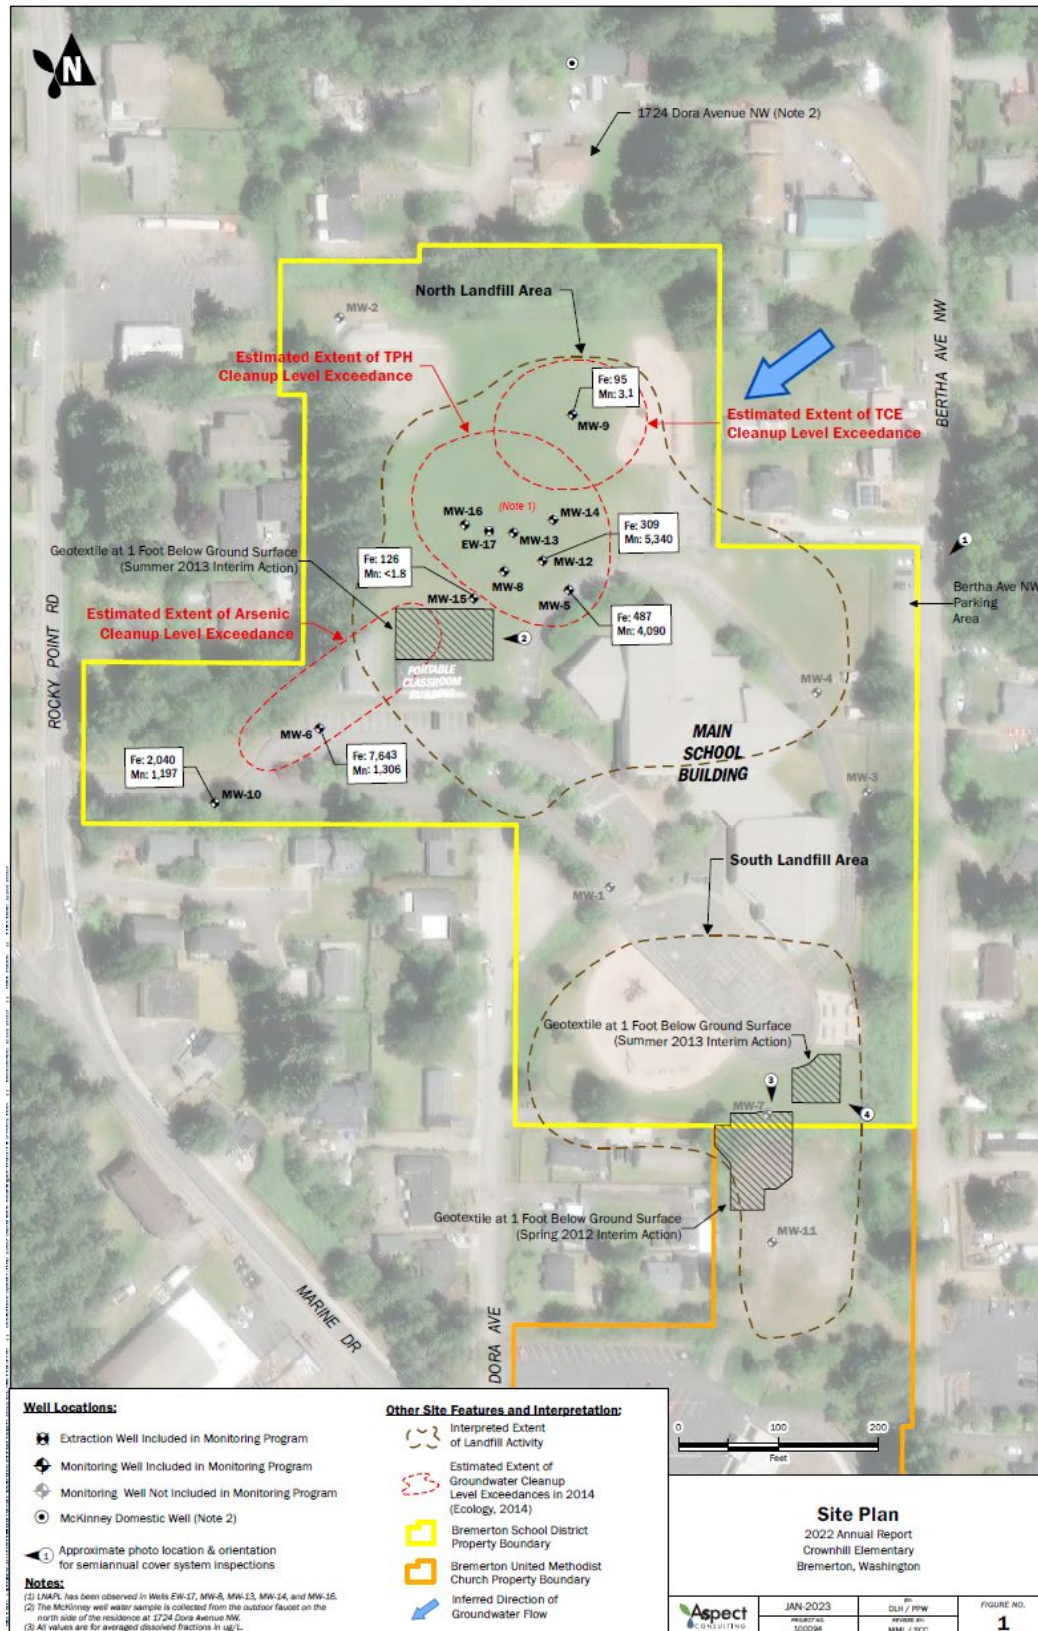
# Appendix B. Site Plan

The purpose of the RI was to collect data necessary to adequately characterize the nature and extent of Site contamination. Using multiple lines of evidence (e.g., historical photographs, Site assessment activity, construction observations), the RI identified two generalized areas of landfill accumulation, designated the 'north' and 'south' landfill areas. Figure 1 shows the interpreted boundaries of these two areas.

Three monitoring wells (MW-1 through MW-3) were installed at the Site in December 1994/January 1995, and another 13 wells (MW-4 through MW-16) during the RI (between March 2011 and October 2012; refer to Figure 1 for well locations). This network of 2-inch diameter wells is used to periodically monitor groundwater for a wide range of contaminants. Groundwater occurs beneath the Site at roughly 110-foot depth. Significant perched groundwater does not occur at the Site. Monitoring wells are completed to depths of approximately 125 feet and are screened across the water table. Groundwater flow is generally to the southwest at the Site. Groundwater monitoring occurs at intervals as defined in the 2015 groundwater/LNAPL monitoring and contingency plan.
