REGULATED BUILDING MATERIAL INSPECTION

PORT OF FRIDAY HARBOR JENSEN BOATYARD SELECT BUILDINGS 1293 TURN POINT ROAD FRIDAY HARBOR, WASHINGTON

Prepared by EMB Consulting, LLC May 15, 2023

EMB Consulting Project #: 1730

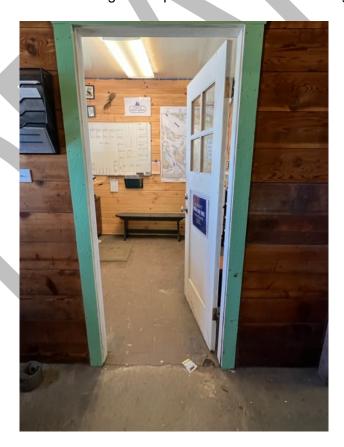
For the Office Building, two samples of exterior asphalt paper siding were collected and three samples of mortar, brick, and sealant were collected from the former wood burning stove stack. In addition, the 9" x 9" brown vinyl floor tile in the office was sampled. Only the 9" x 9" brown vinyl floor tile is confirmed ACM. There is an estimated 100 square feet of this material in the building. No other ACMs were identified during the inspection of the Office Building.
