# Environmental Cap and Drainage System Inspection Report

Former Murray Pacific No. 2 Log Sort Yard  
(Ecology Facility ID #1211)

February 28, 2025

Project No. M0615.18.004

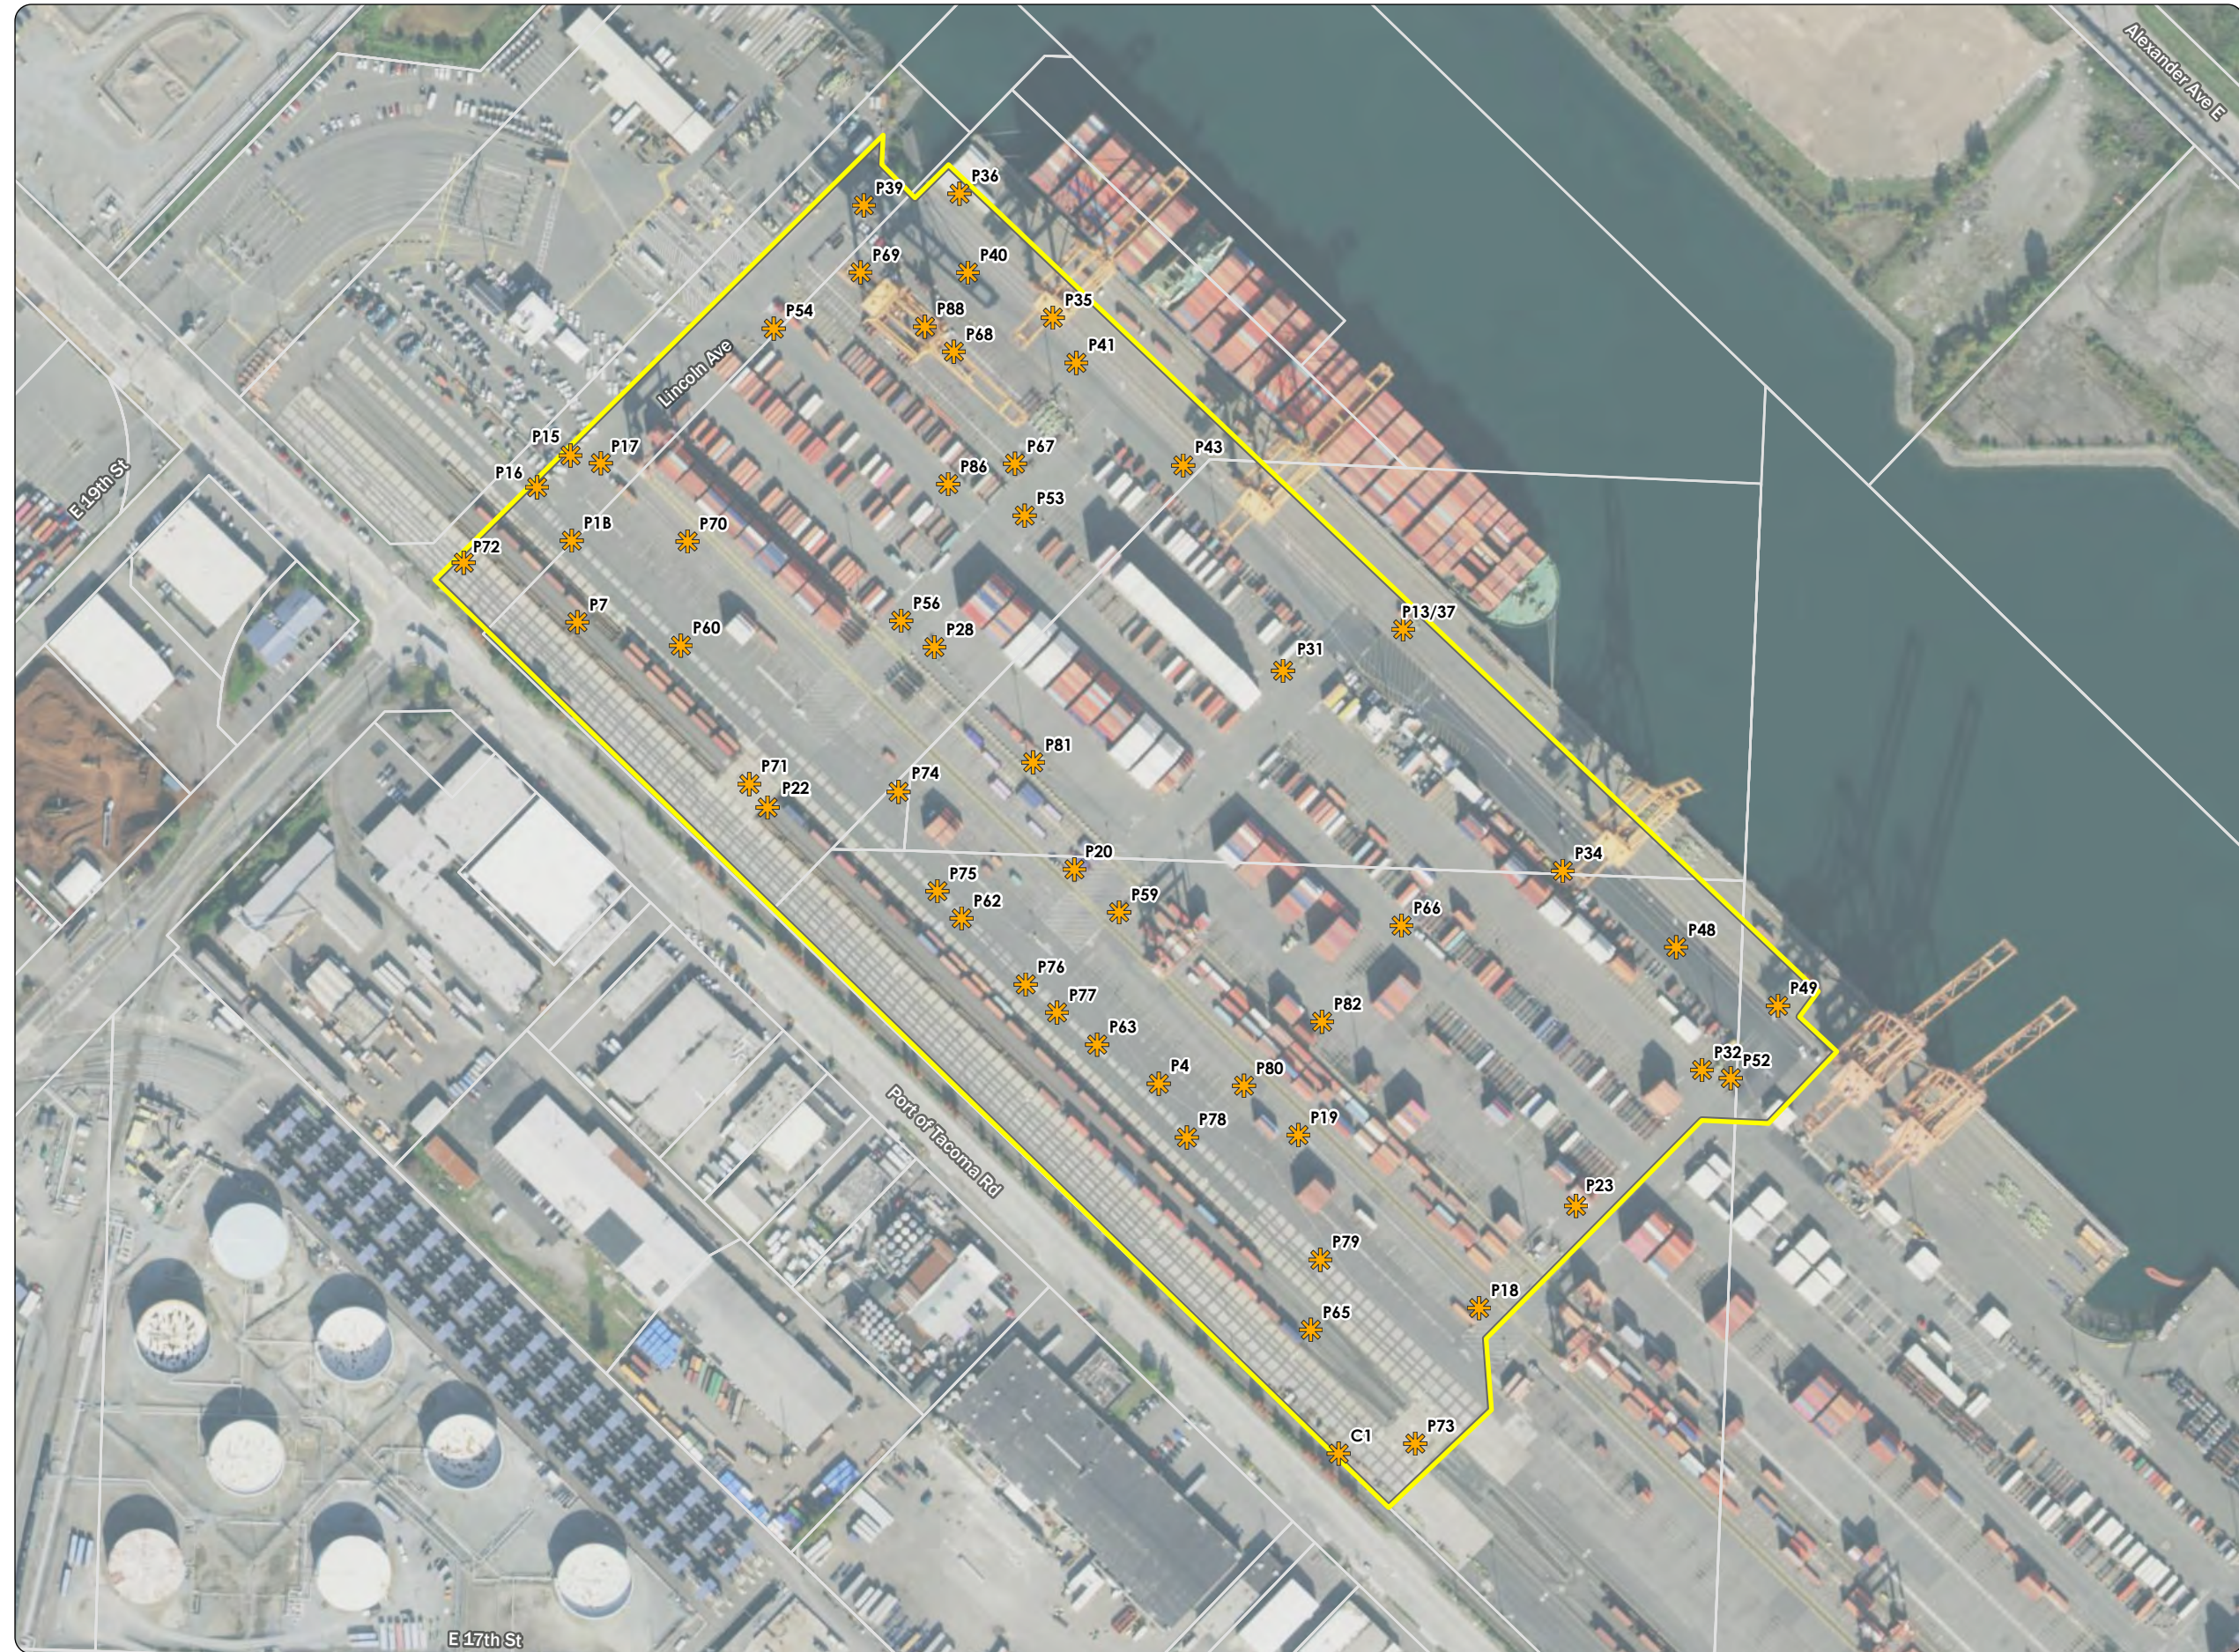
**Figure 2-1**  
**Environmental Cap**  
**Issues Observations**  
Former Murray Pacific  
No. 2 Sort Yard Site  
Tacoma, WA

Required Inspection Element	Observed Condition	Recommended Action
Presence of cracks wider than 1/8 inch	Cracks wider than 1/8 inch were observed across the Site and in concrete structures	Repair pavement as shown in Figure 2-1 and described in Table 2-1
Curb deterioration	Curb damage deterioration observed near the southeastern edge	Continue to monitor and reevaluate during next inspection cycle
Degradation, subsidence, general appearance	Surficial divots observed in asphalt across site; alligator cracking observed in portions of asphalt; damage to curb structures, damaged wheel stops; significant cracking and wear on concrete structures	Locations of pavement deterioration are shown in Figure 2-1 and described in Table 2-1. The more severe cracks should be prioritized for repair first.

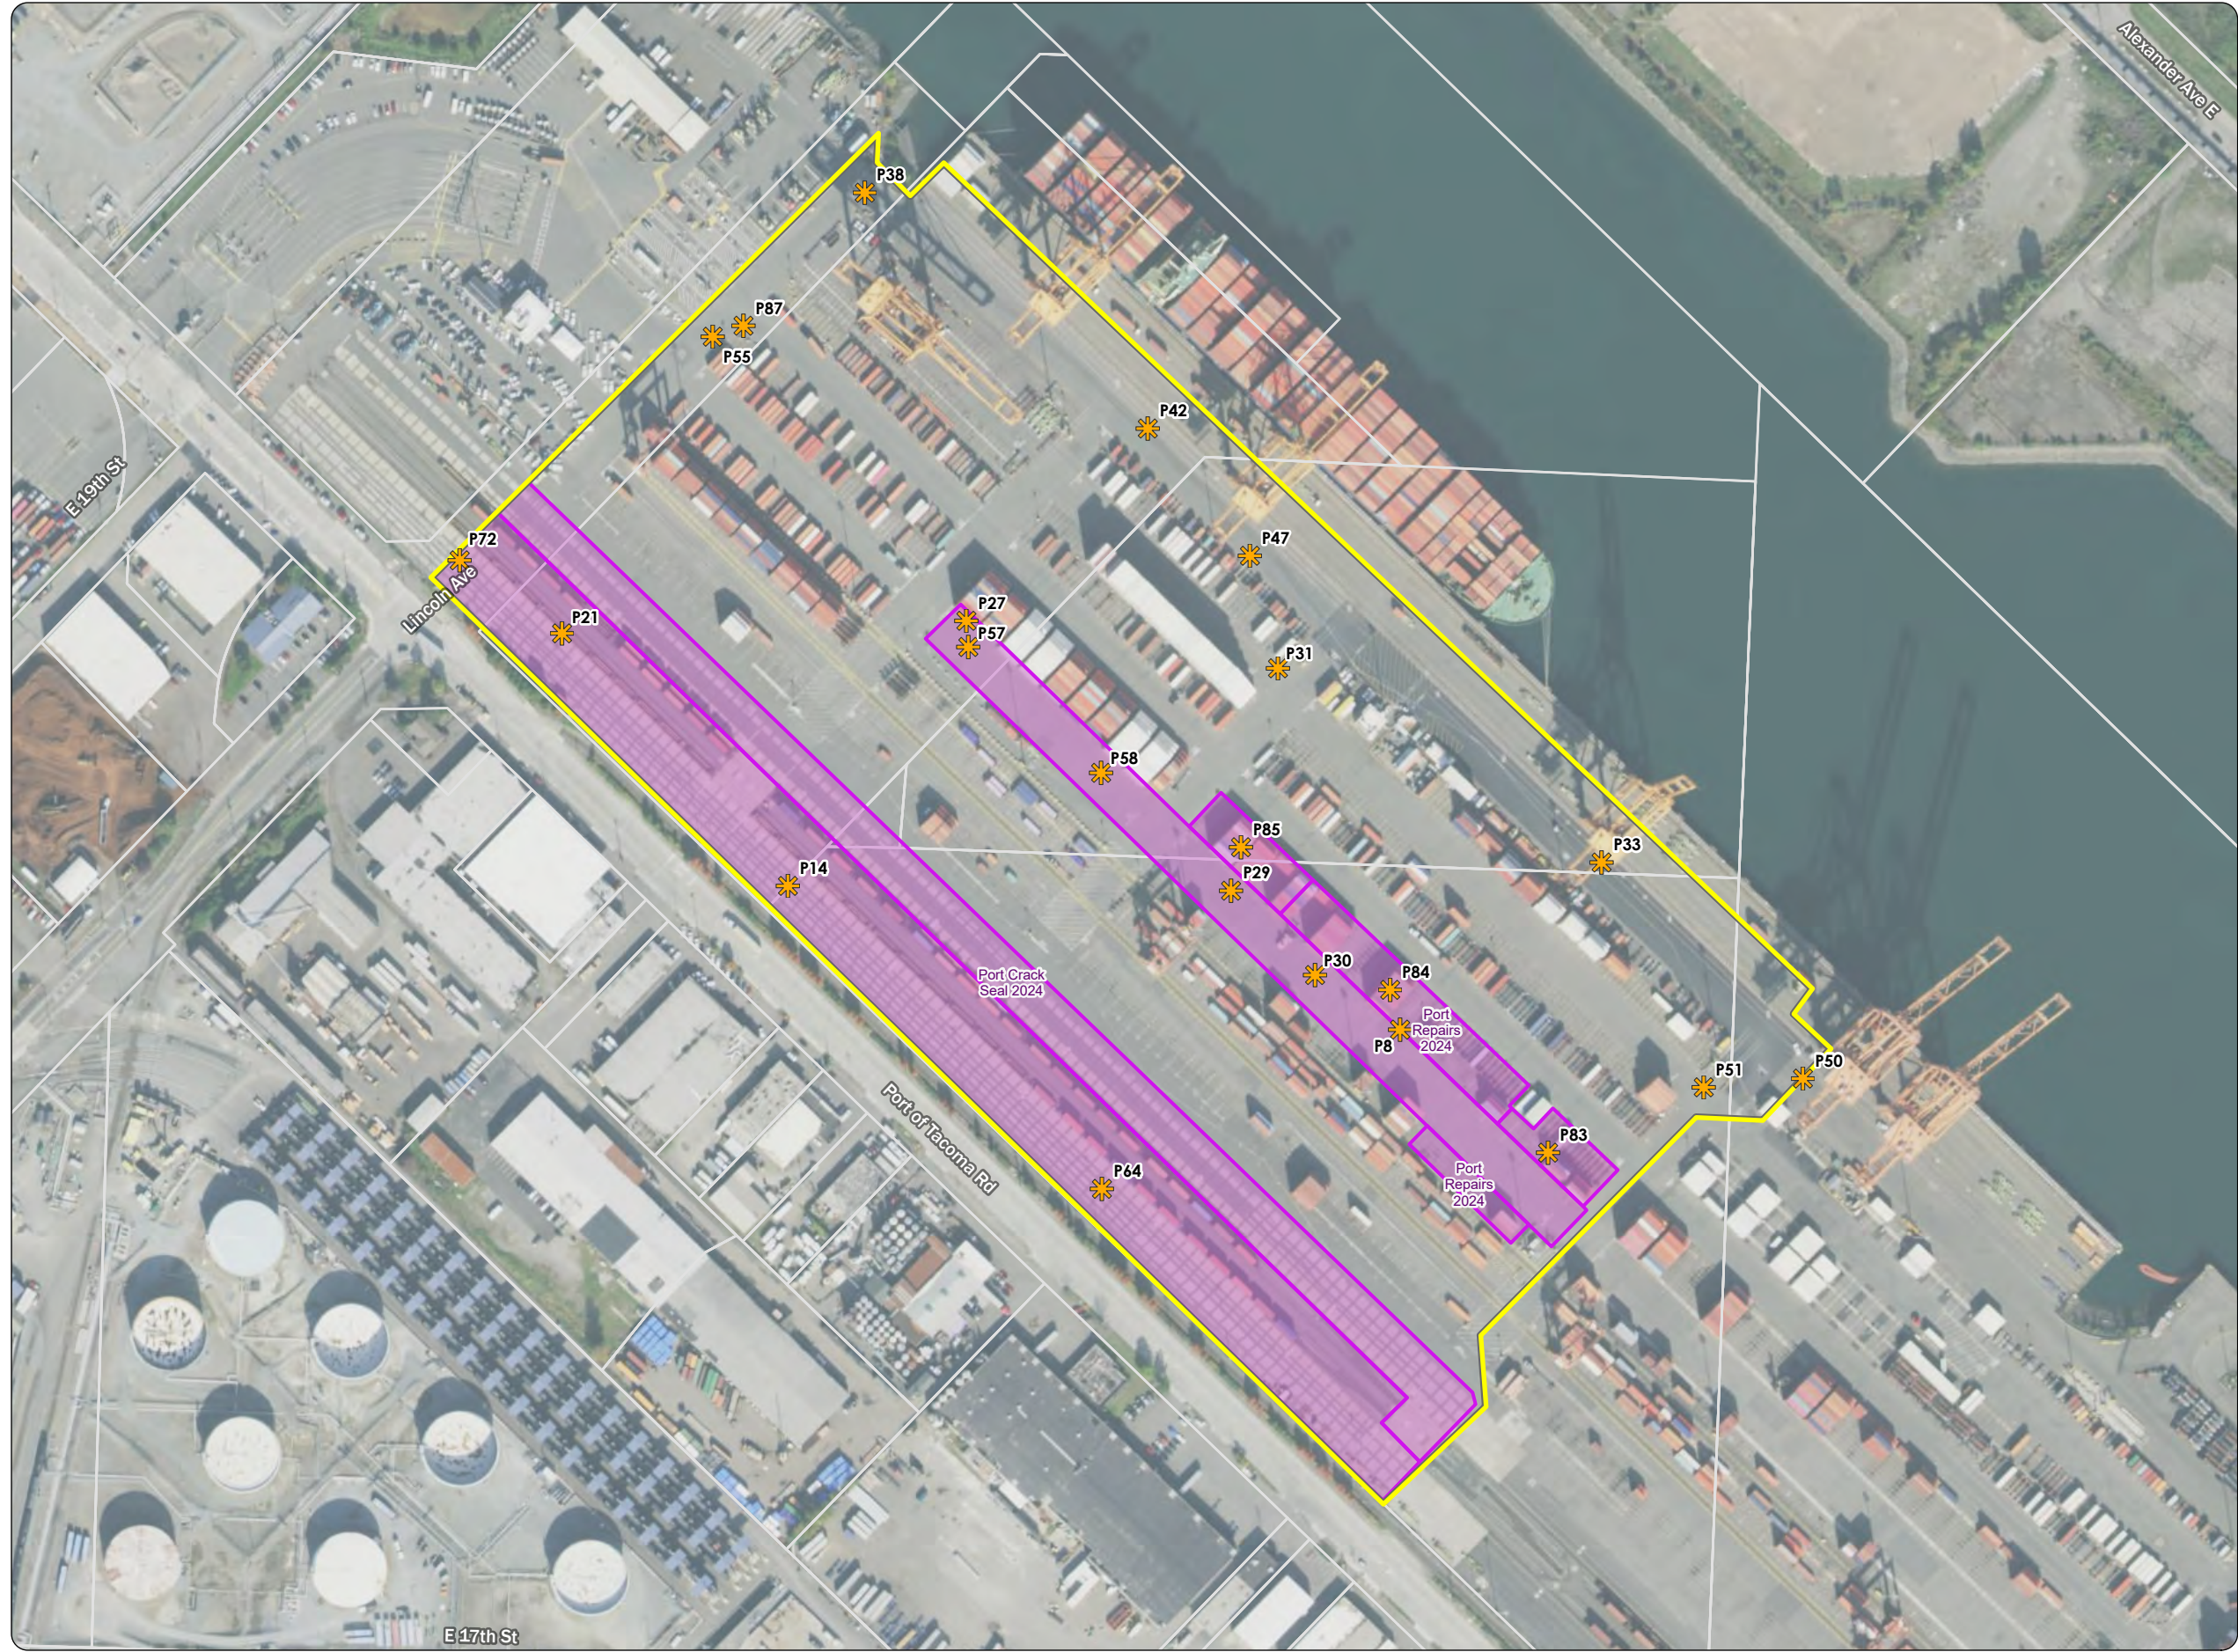
**Figure 2-2**  
**Environmental Cap**  
**Repairs Observations**  
Former Murray Pacific  
No. 2 Sort Yard Site  
Tacoma, WA

Pavement repairs were completed in 2024 and are summarized in Section 3 and the appendix. Pavement repairs observed during the 2024 inspection are presented in Figure 2-2 and described in Table 2-2. Photographs of the observed repairs are provided in Table 2-2.

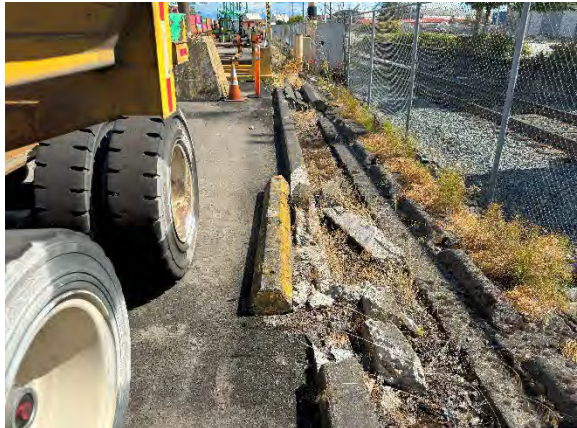
ID <sup>1</sup>	Type of Structure	Observation	Recommended Actions	Photograph
C1	Curb	Sections of curb damage extending approximately 100 lf feet; portions of damage extend through vertical profile; exposed rebar; large chunks missing	Repair curb

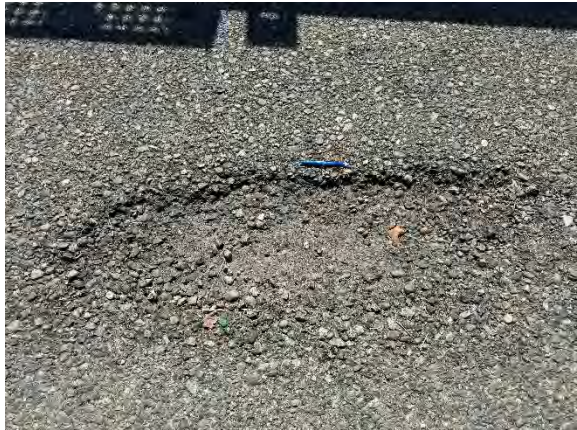
P7	Pavement	Divot in asphalt, approximately 3 feet long and less than 1 inch deep	Monitor and reevaluate during the next inspection cycle

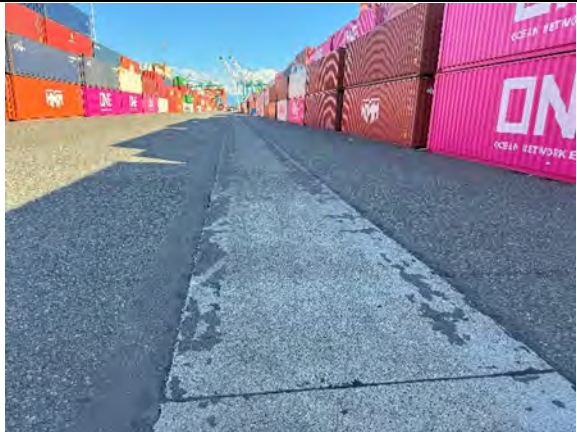
P19	Pavement	Joint between concrete and asphalt with separation wider than 1/8 inch; extends approximately 100 lf northwest from point	Reseal joint

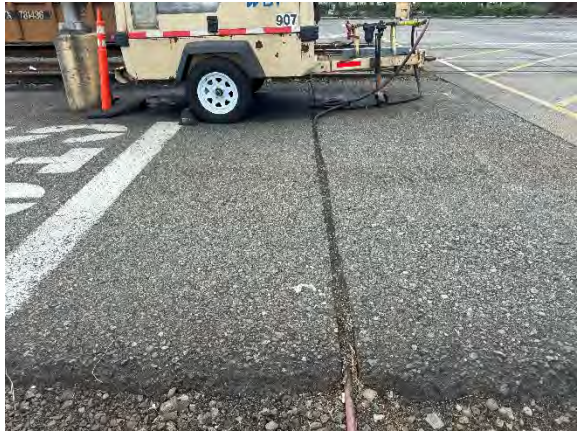
P22	Pavement	Sawcut and removed pavement between two rail tracks; 2 inches wide and 2 to 3 inches deep; dirt and vegetation accumulation in area of removed pavement	Monitor and reevaluate during next inspection cycle

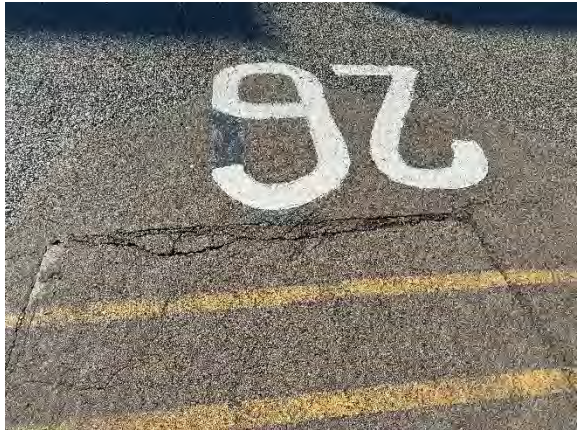
P28	Pavement	Separation wider than 1/8 inches in portions of joint between concrete structure and asphalt; gps point is northwest end of structure; extends approximately 500 feet along drive lane	Reseal joints

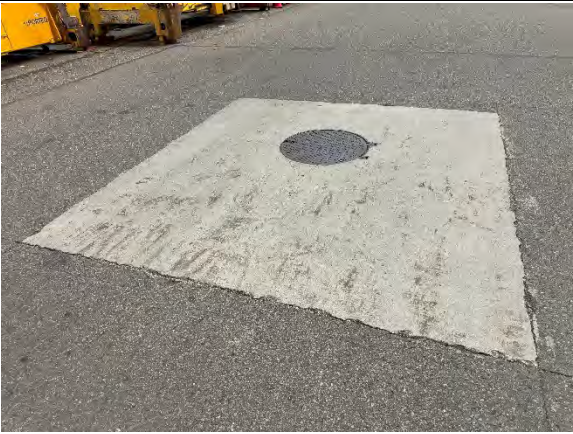
ID <sup>1</sup>	Type of Structure	Observation	Recommended Actions	Photograph
P34	Pavement	Previously repaired concrete around maintenance hole; no seal between asphalt and concrete	Seal joint between concrete and asphalt

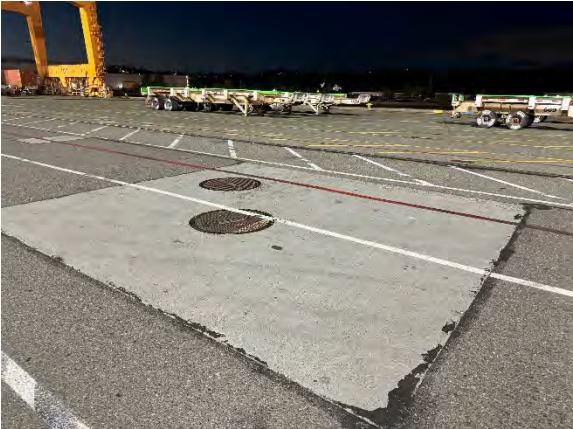
P35	Pavement	Previously repaired concrete around maintenance hole; wear of seal between concrete and asphalt	Reseal joint between concrete and asphalt

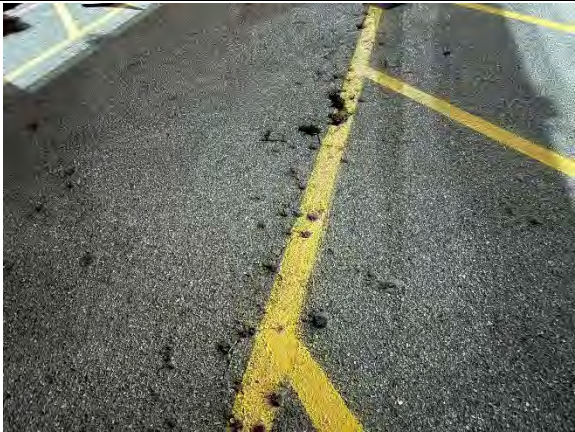
ID <sup>1</sup>	Type of Structure	Observation	Recommended Actions	Photograph
P36	Pavement	Divots as deep as 2 inches observed starting at this point and extending southeast several hundred feet; in line with pavement markings	Repair pavement

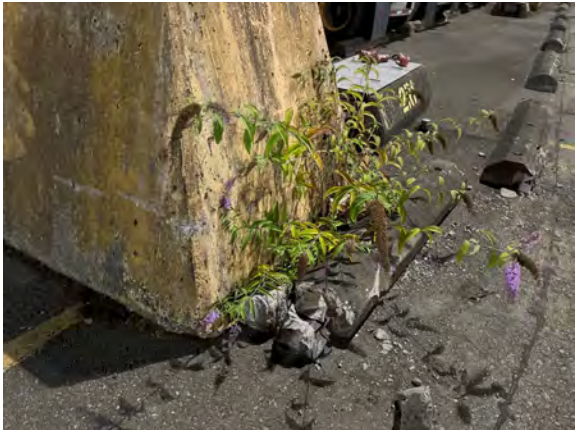
P39	Pavement	Crack wider than 1/8 inches with vegetation growth; approximately 10 lf	Remove vegetation and seal crack

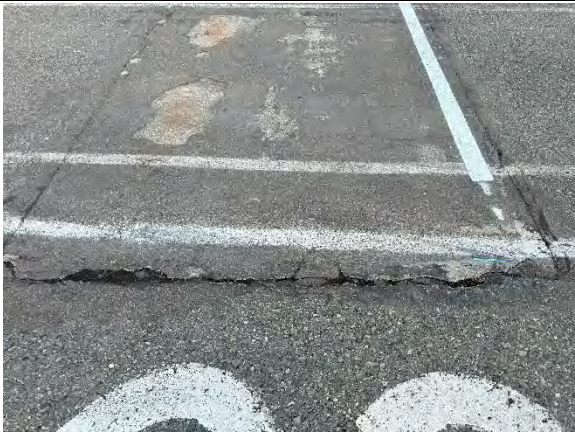
ID <sup>1</sup>	Type of Structure	Observation	Recommended Actions	Photograph
P53	Pavement	Previously sealed cracking in asphalt with visible sealant deterioration and unsealed portions	Reseal crack in asphalt

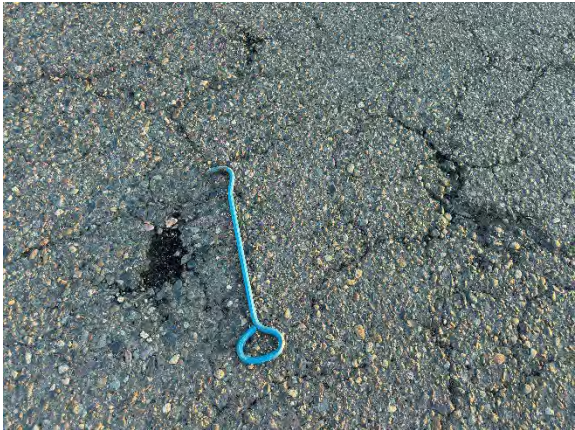
P54	Pavement	Alligator cracking as wide as 2 inches and as deep as 1 inch; approximately 4 foot by 4 foot area	Seal cracks in asphalt

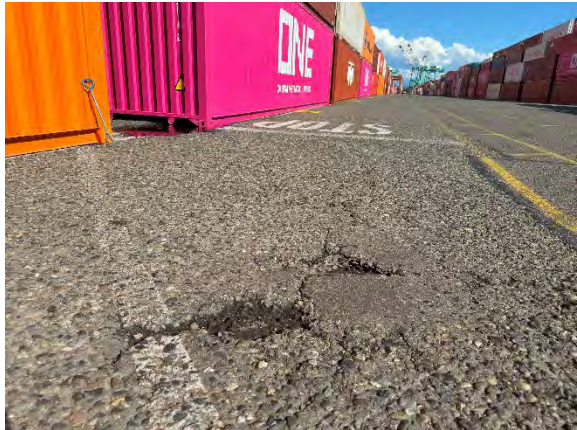
P59	Pavement	Cracking in asphalt as wide as 6 inches in places and up to 3 inches deep; approximately 3 lf depressions from container stacks	Seal cracks in asphalt

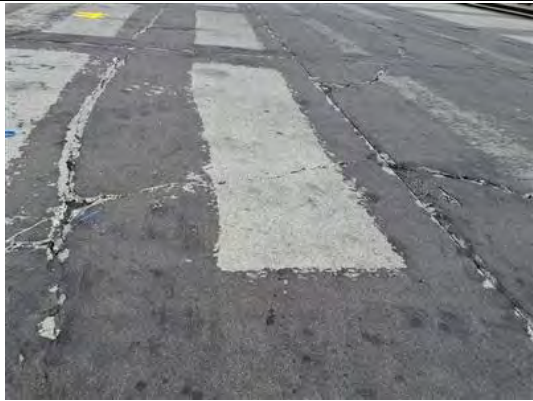
P62	Pavement	Degraded or missing asphalt patches	Reseal cracks. Feature repaired following cap inspection <sup>2</sup>

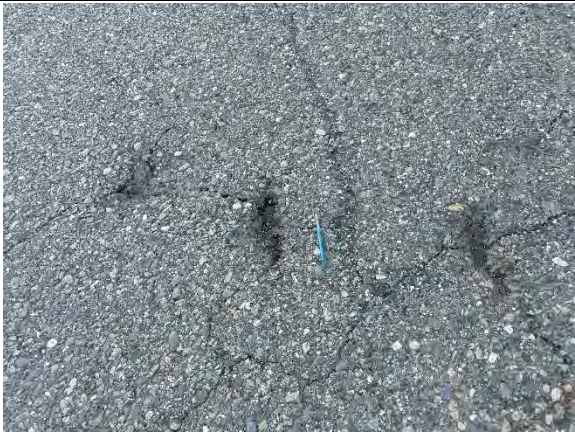
ID <sup>1</sup>	Type of Structure	Observation	Recommended Actions	Photograph
P66	Pavement	Multiple gouges in asphalt approximately 6 inches long each and 1.5 inches deep	Repair asphalt

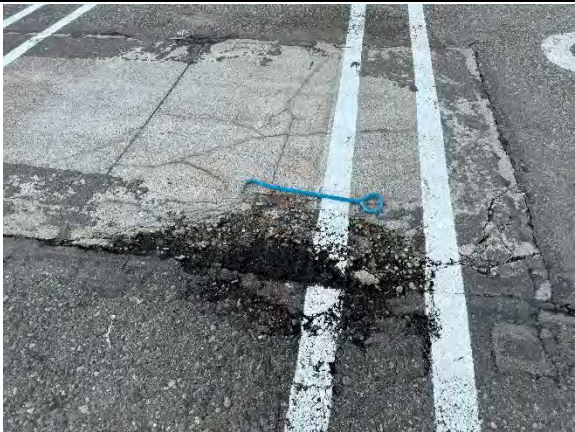
P67	Pavement	Cracking and damage to concrete; approximately 5 feet wide; approximately 1-foot-long gouge in concrete as deep as 2 inches	Repair concrete

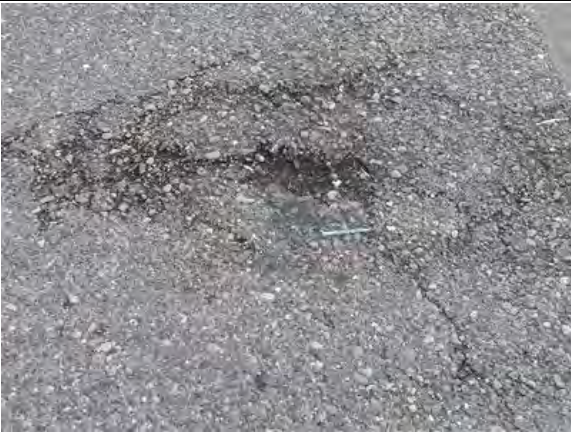
ID <sup>1</sup>	Type of Structure	Observation	Recommended Actions	Photograph
P80	Pavement	Divot in asphalt; approximately 1 foot by 6 inches by 1 inch; approximately 20 lf crack	Seal cracks and fill divot

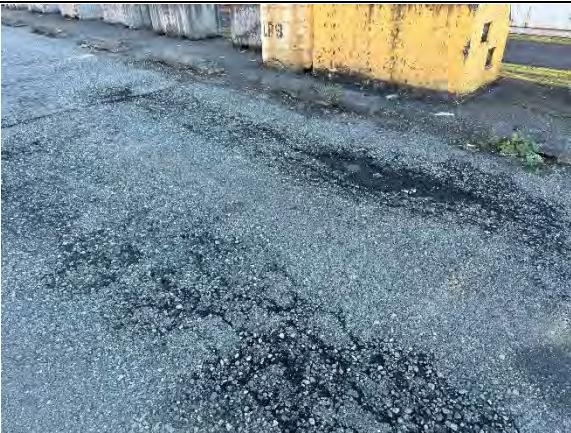
P81	Pavement	Alligator cracking in asphalt; approximately 10 foot by 20 foot area; asphalt depression; approximately 5 foot by 1 foot	Seal cracks and repair asphalt

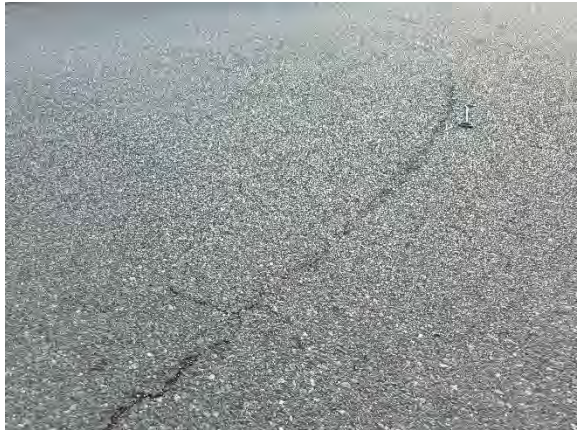
P86	Pavement	Gouge in asphalt; approximately 15 lf; wider than 1/8 inch	Seal gouge

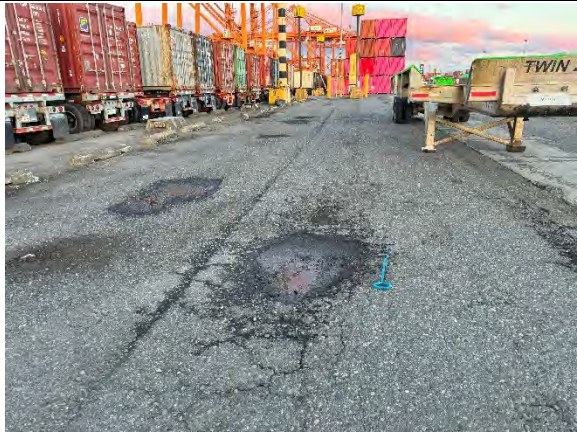
ID <sup>1</sup>	Type of Structure	Observation	Recommended Actions	Photograph
P88	Pavement	Depressions and divots from shipping containers; up to 3 feet by 2 feet and as deep as 2 inches	Repair divots and seal cracks

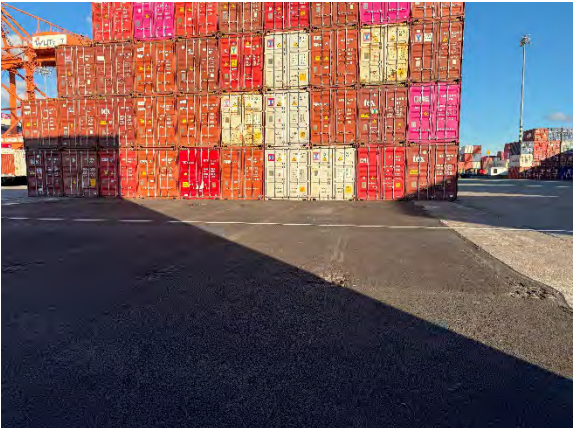
ID <sup>1</sup>	Type of Structure	Observation	Recommended Actions	Photograph
P8	Pavement	Asphalt repair; approximately 60 feet by 70 feet; degradation from shipping containers	Monitor and reevaluate during next inspection cycle

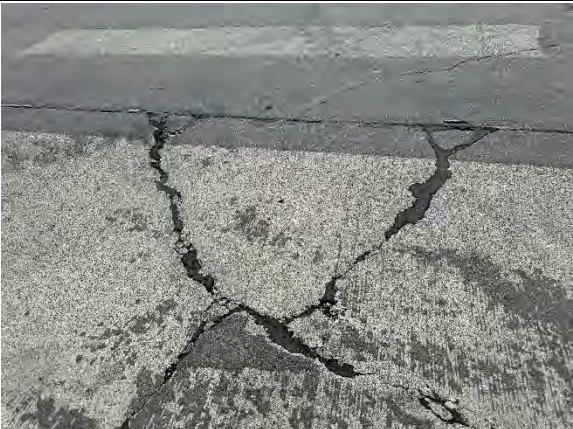
P14	Pavement	Sealed cracks in concrete; approximately 30 lf	Monitor and reevaluate during next inspection cycle

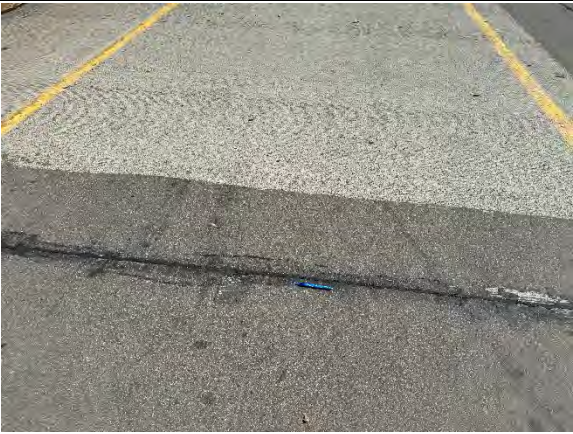
ID <sup>1</sup>	Type of Structure	Observation	Recommended Actions	Photograph
P21	Pavement	Sealant added between concrete pads	None

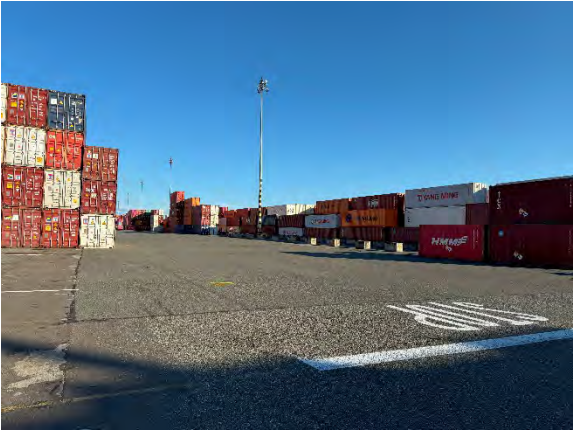
P27	Pavement	WUT 2022 asphalt repair; approximately 60 feet wide by several hundred feet long	None

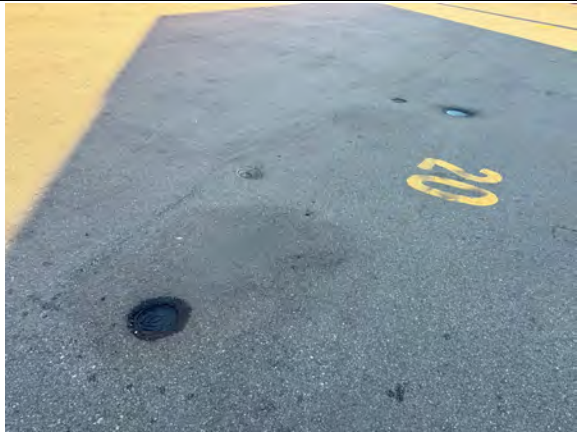
ID <sup>1</sup>	Type of Structure	Observation	Recommended Actions	Photograph
P29	Pavement	Cracks in asphalt around well covers repaired as part of larger asphalt repair (included in the asphalt repair described in P27)	None

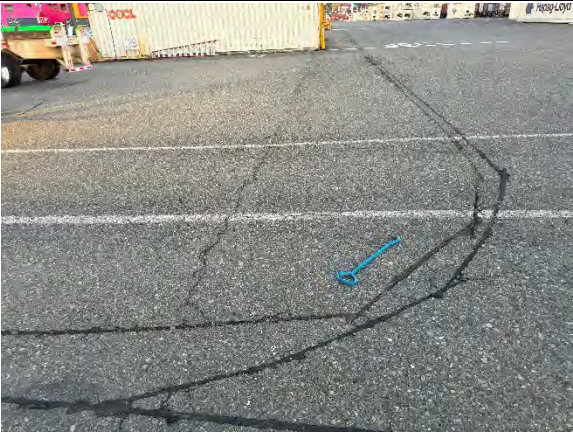
ID <sup>1</sup>	Type of Structure	Observation	Recommended Actions	Photograph
P31	Pavement	Partially sealed sawcut; extends approximately 250 lf	Seal crack in asphalt

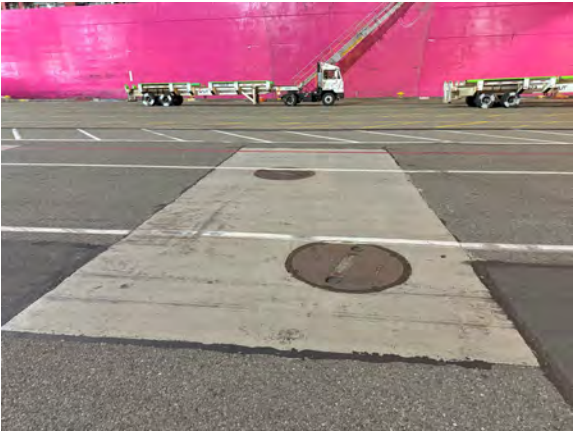
P33	Pavement	Sealant added around previously repaired concrete	None

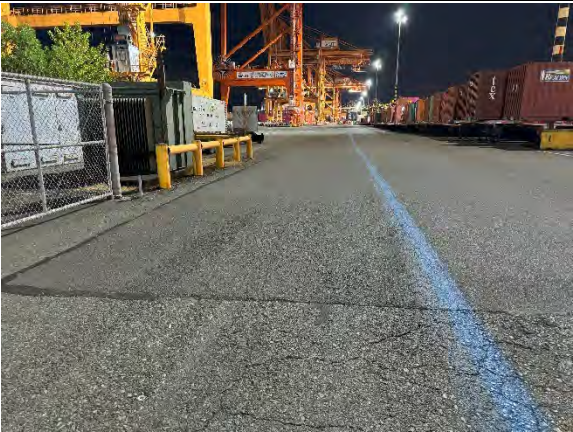
ID <sup>1</sup>	Type of Structure	Observation	Recommended Actions	Photograph
P38	Pavement	Asphalt repair; extends along dock; several hundred feet long by approximately 40 feet wide	None

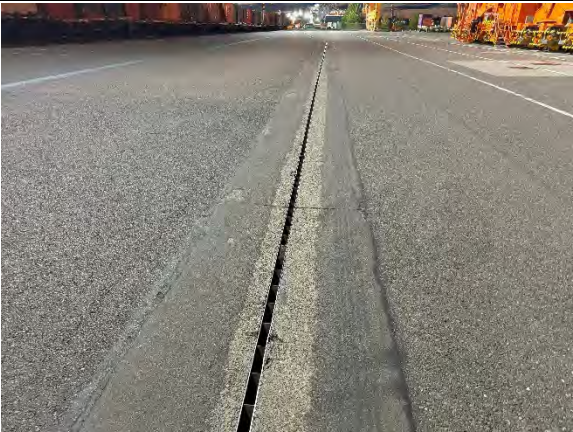
P42	Pavement	Sealant added and divots repaired	None

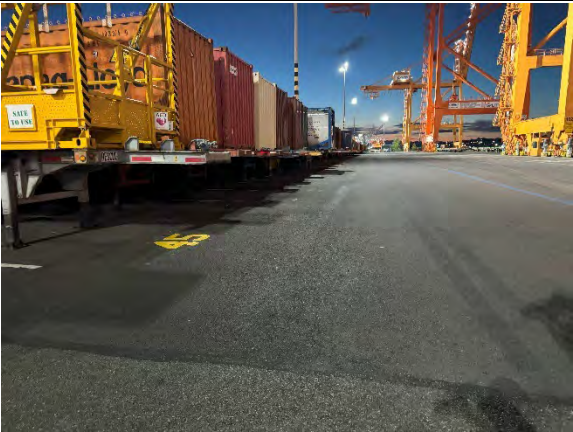
ID <sup>1</sup>	Type of Structure	Observation	Recommended Actions	Photograph
P47	Pavement	Approximately 30 feet wide by several hundred feet long asphalt repair	None

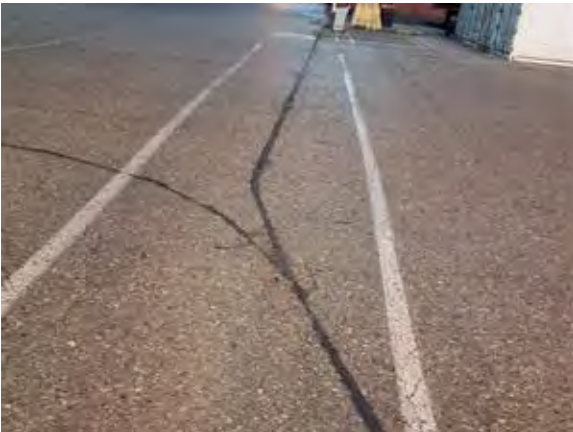
P50	Pavement	Repaired asphalt cracking in pavement	Monitor and reevaluate during next inspection cycle

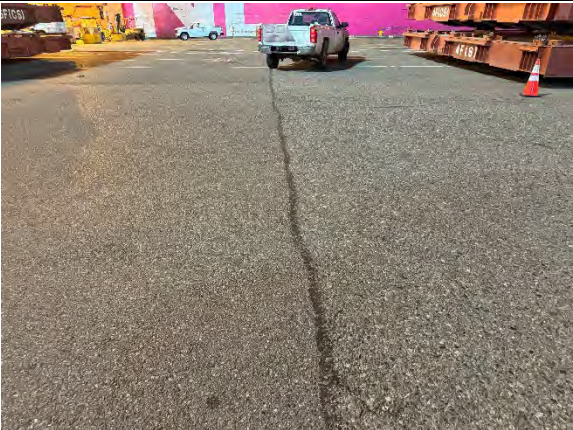
ID <sup>1</sup>	Type of Structure	Observation	Recommended Actions	Photograph
P51	Pavement	Sealed cracks	None

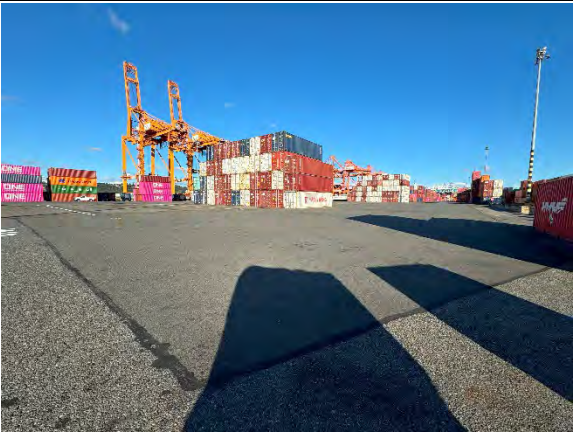
ID <sup>1</sup>	Type of Structure	Observation	Recommended Actions	Photograph
P57	Pavement	Divots and alligator cracking repaired as part of larger asphalt repair (included in the asphalt repair described in P27)	None

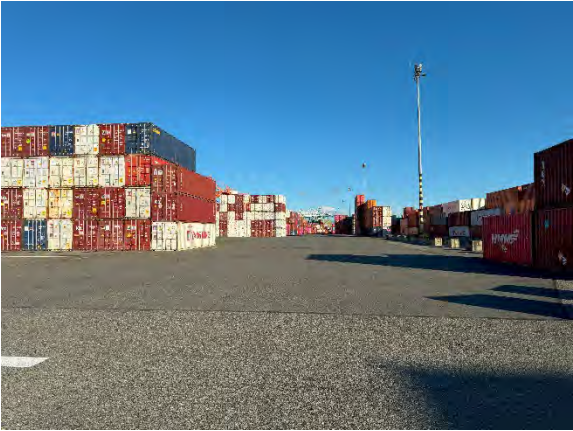
P58	Pavement	Alligator cracking repaired as part of larger asphalt repair (included in the asphalt repair described in P27)	None

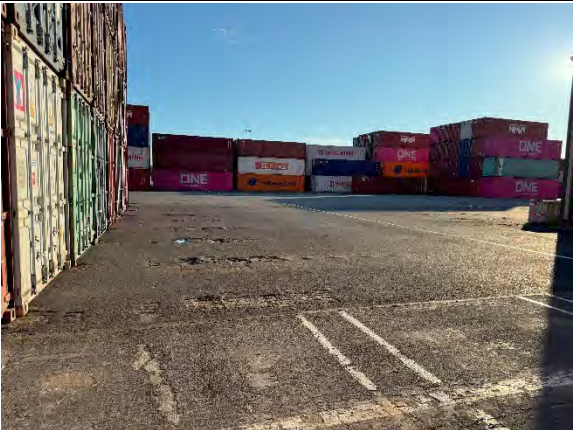
ID <sup>1</sup>	Type of Structure	Observation	Recommended Actions	Photograph
P83	Pavement	Port 2023 asphalt repair; approximately 80 feet long by 40 feet wide; degradation from shipping containers	Monitor and reevaluate during next inspection cycle

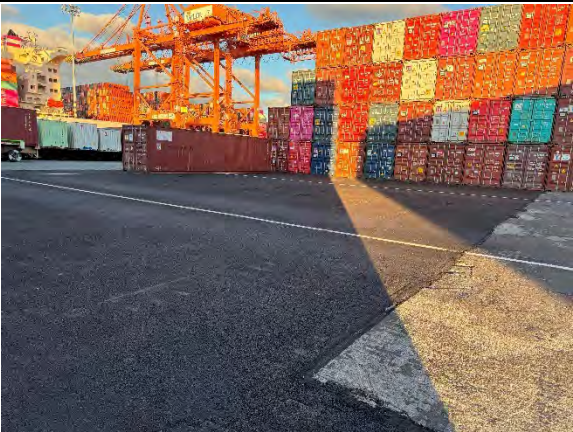
A photograph showing a paved area with white parking lines. In the background, there are several stacked shipping containers in various colors (red, blue, yellow, green) under a clear blue sky.
P84	Pavement	Port 2024 asphalt repair; approximately 80 feet long by 60 feet long; degradation in adjacent concrete	Monitor and reevaluate during next inspection cycle

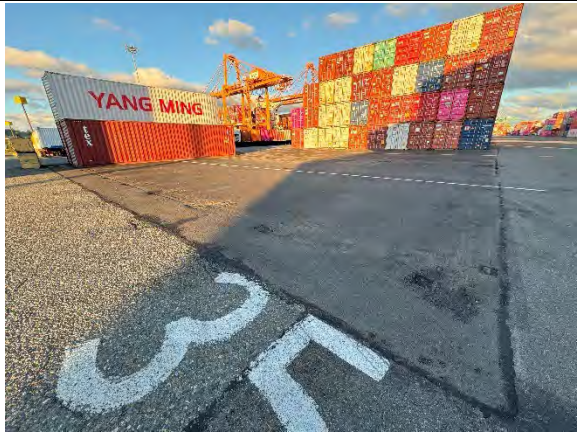
ID <sup>1</sup>	Type of Structure	Observation	Recommended Actions	Photograph
P85	Pavement	Port 2023 asphalt repair; approximately 80 feet long by 60 feet wide; divots from shipping containers present	Monitor and reevaluate during next inspection cycle

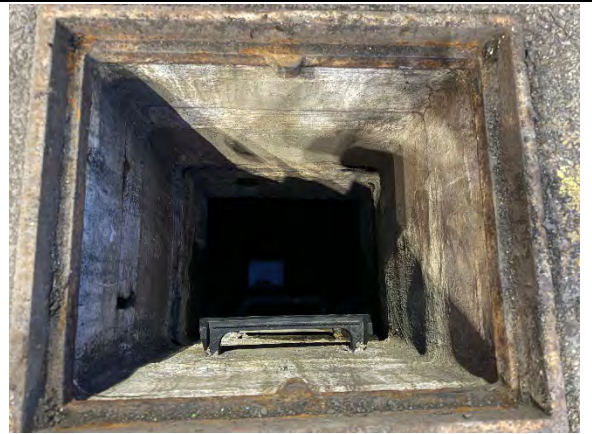
ID	Type of Structure	Observed Condition	Sediment Accumulation	Additional Observations	Recommended Actions	Photograph
CB5	Catch basin	Structure in good condition; functioning normally	Water in structure and too deep to measure	Trace floatables on water surface	Replace insert and remove floatables in accordance with stormwater maintenance requirements

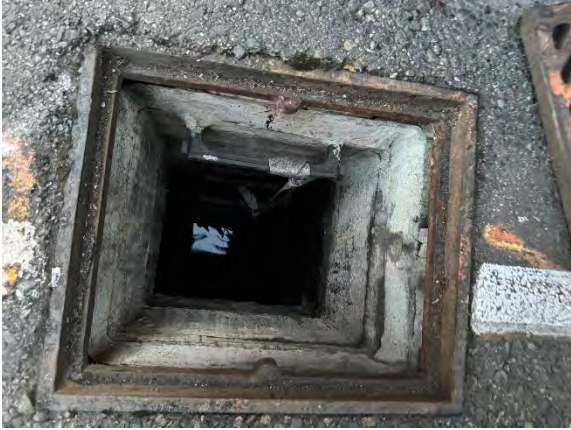
ID	Type of Structure	Observed Condition	Sediment Accumulation	Additional Observations	Recommended Actions	Photograph
CB7	Catch basin	Structure in good condition; functioning normally	Debris and sediment accumulation in filter; water in structure and too deep to measure	Organic and inorganic debris in insert; floatables	Replace insert and remove floatables from structure in accordance with stormwater maintenance requirements

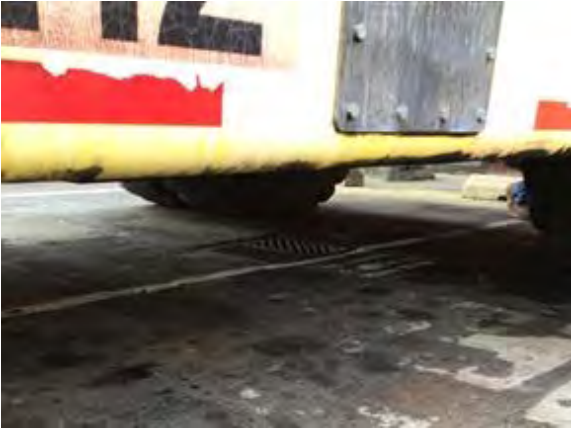
CB8	Catch basin	Unable to access	nm	Inaccessible due to equipment	Clear equipment in area to allow observation during next inspection cycle

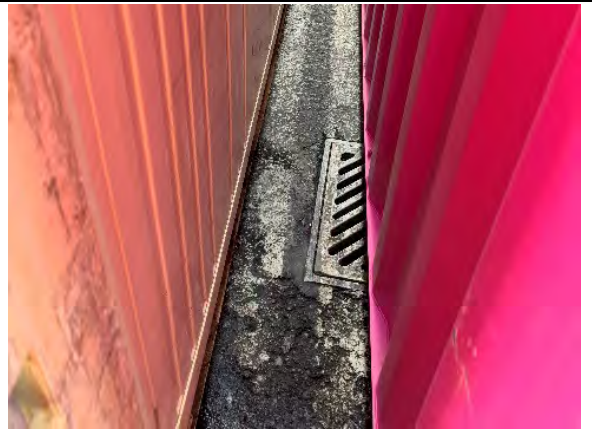
ID	Type of Structure	Observed Condition	Sediment Accumulation	Additional Observations	Recommended Actions	Photograph
CB10	Catch basin	Unable to access	nm	Structure inaccessible due to shipping containers; sediment accumulation in insert	Clear containers in area to allow observation during next inspection cycle; replace insert consistent with stormwater maintenance requirements

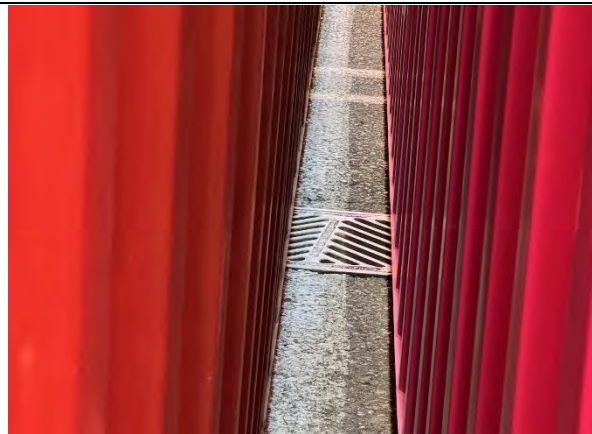
CB11	Catch basin	Unable to access	nm	Structure inaccessible due to shipping containers	Clear containers in area to allow observation during next inspection cycle

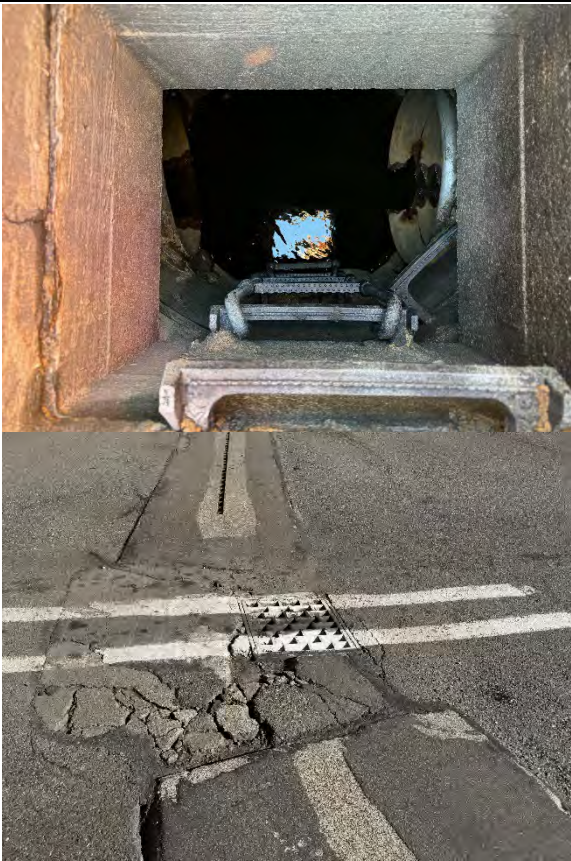
ID	Type of Structure	Observed Condition	Sediment Accumulation	Additional Observations	Recommended Actions	Photograph
CB13	Catch basin	Structure in good condition; functioning normally	Water in structure and too deep to measure	Cracking in asphalt around catch basin	Seals cracks around structure

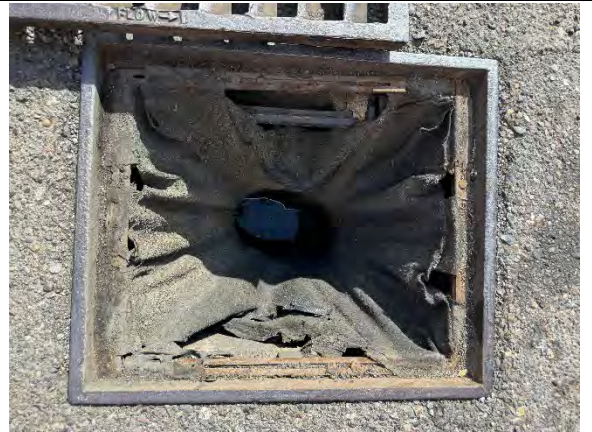
ID	Type of Structure	Observed Condition	Sediment Accumulation	Additional Observations	Recommended Actions	Photograph
CB15	Catch basin	Unable to inspect due to integrity of insert	Sediment accumulation in insert	Damaged insert	Replace insert in accordance with stormwater maintenance requirements

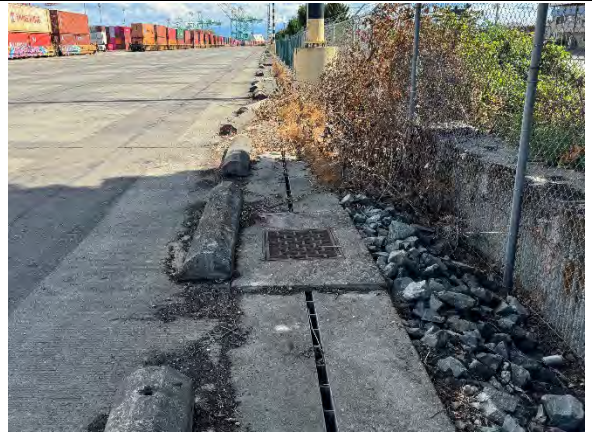
ID	Type of Structure	Observed Condition	Sediment Accumulation	Additional Observations	Recommended Actions	Photograph
CB17	Catch basin	Structure in good condition; functioning normally	nm	None	None

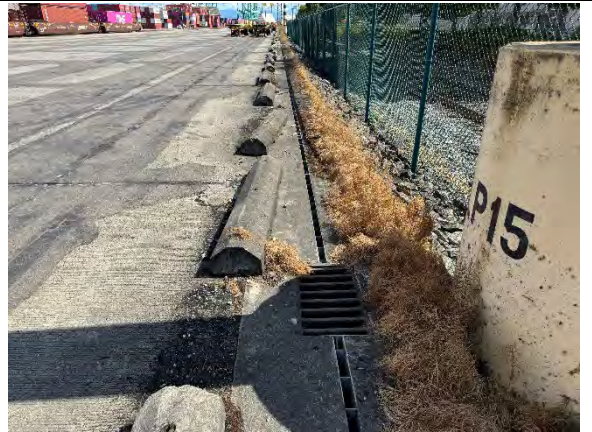
ID	Type of Structure	Observed Condition	Sediment Accumulation	Additional Observations	Recommended Actions	Photograph
CB19	Catch basin	Structure in good condition; functioning normally	nm	None	None

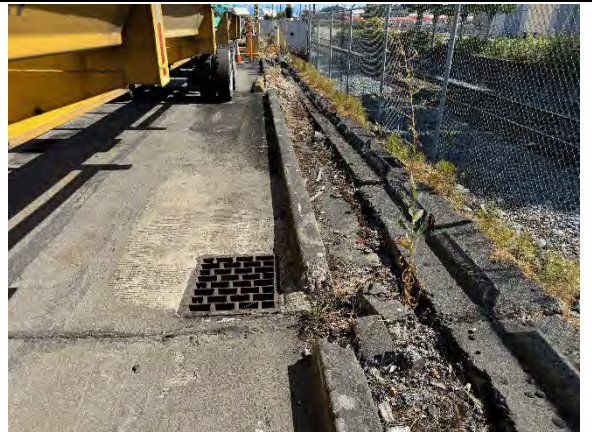
ID	Type of Structure	Observed Condition	Sediment Accumulation	Additional Observations	Recommended Actions	Photograph
CB21	Catch basin	Structure in good condition; functioning normally	nm	None	None

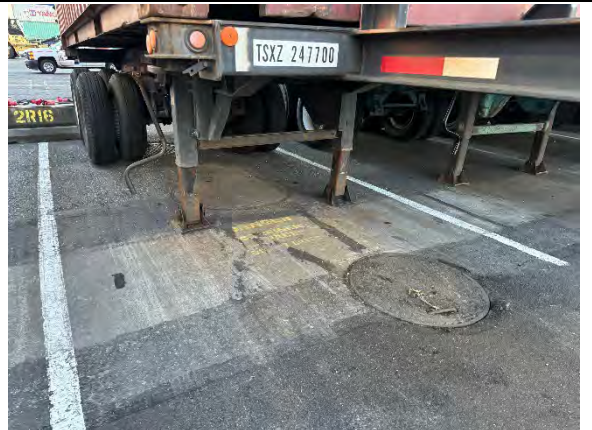
OWS1	Oil/water separator	Unable to locate	nm	Inaccessible due to equipment.	Clear equipment in area to allow observation during next inspection cycle	[No photograph available]
OWS2	Oil/water separator	Unable to access	nm	Inaccessible due to trailers	Clear trailers in area to allow observation during next inspection cycle

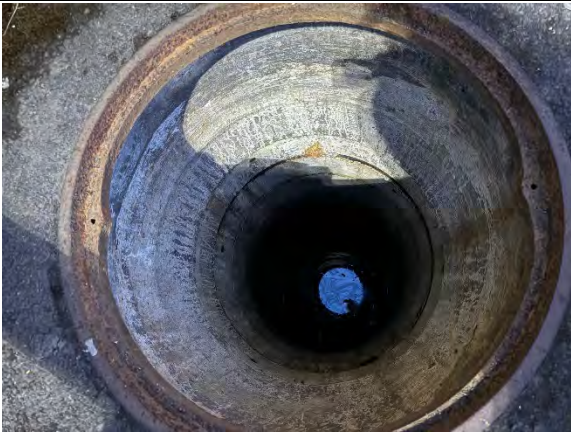
ID	Type of Structure	Observed Condition	Sediment Accumulation	Additional Observations	Recommended Actions	Photograph
OWS3	Oil/water separator	Structure in good condition; functioning normally	Water in structure and too deep to measure	Trace floatables on water surface	Remove floatables in accordance with stormwater maintenance requirements

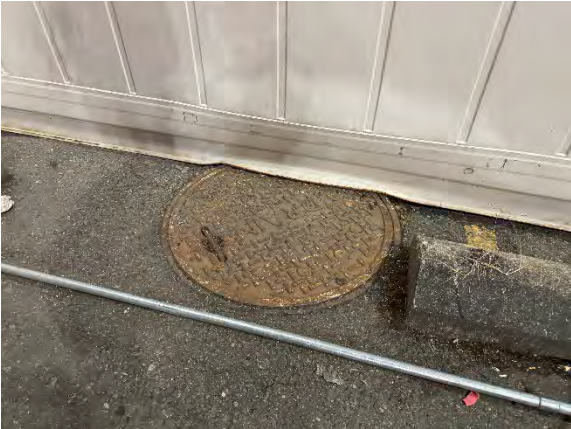
OWS4	Oil/Water Separator	Unable to access	nm	Inaccessible due to containers	Clear containers in area to allow observation during next inspection cycle
