# Environmental Cap and Drainage System Inspection Report

Former Murray Pacific No. 2 Log Sort Yard  
(Ecology Facility ID #1211)

February 28, 2025

Project No. M0615.18.004

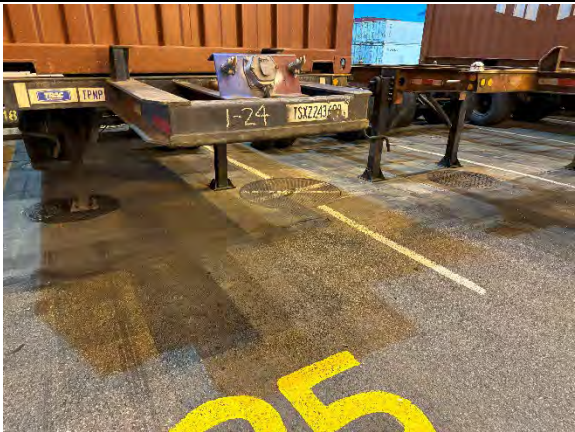
ID	Type of Structure	Observed Condition	Sediment Accumulation	Additional Observations	Recommended Actions	Photograph
OWS5	Oil/ Water Separator	Unable to access	nm	Inaccessible due to trailers	Clear trailers in area to allow observation during next inspection cycle

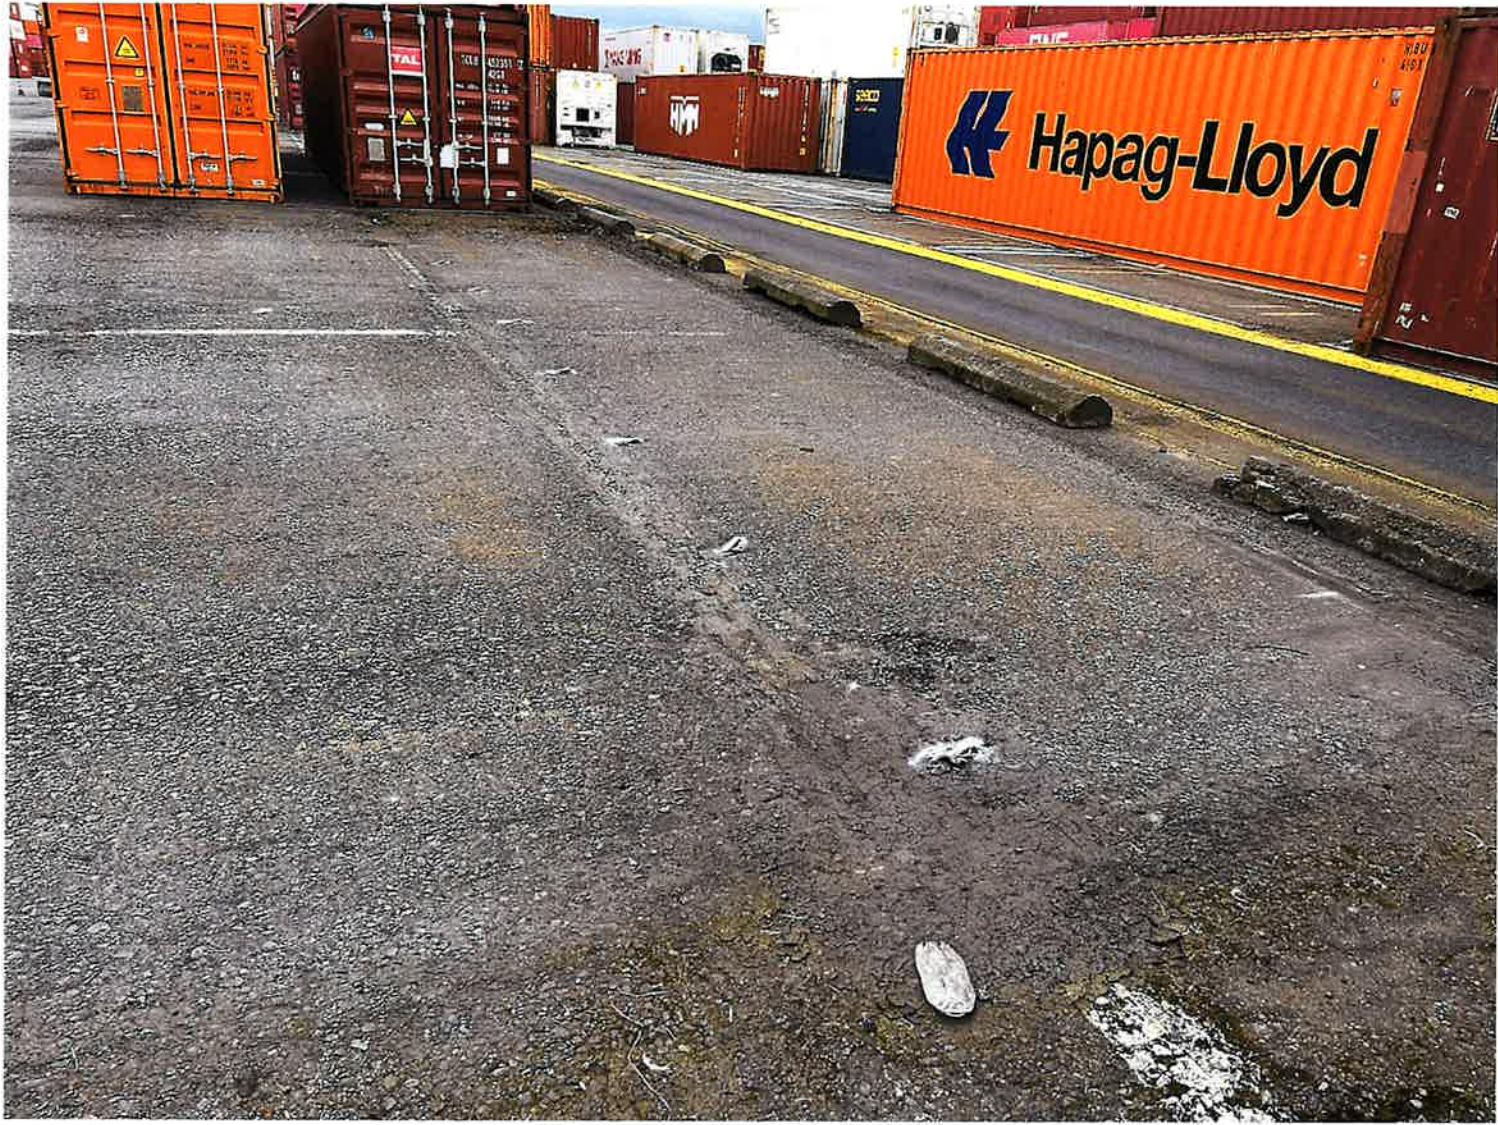
The Parking stops shown in this image are no longer necessary for terminal operations. Approximately 30 to 35 stops were removed as part of the 2024 effort. Each stop contained two hold down pins and as seen above previously removed stops simply had the pins bent over. Approximately 100 to 115 pins were removed as part of the 2024 work.

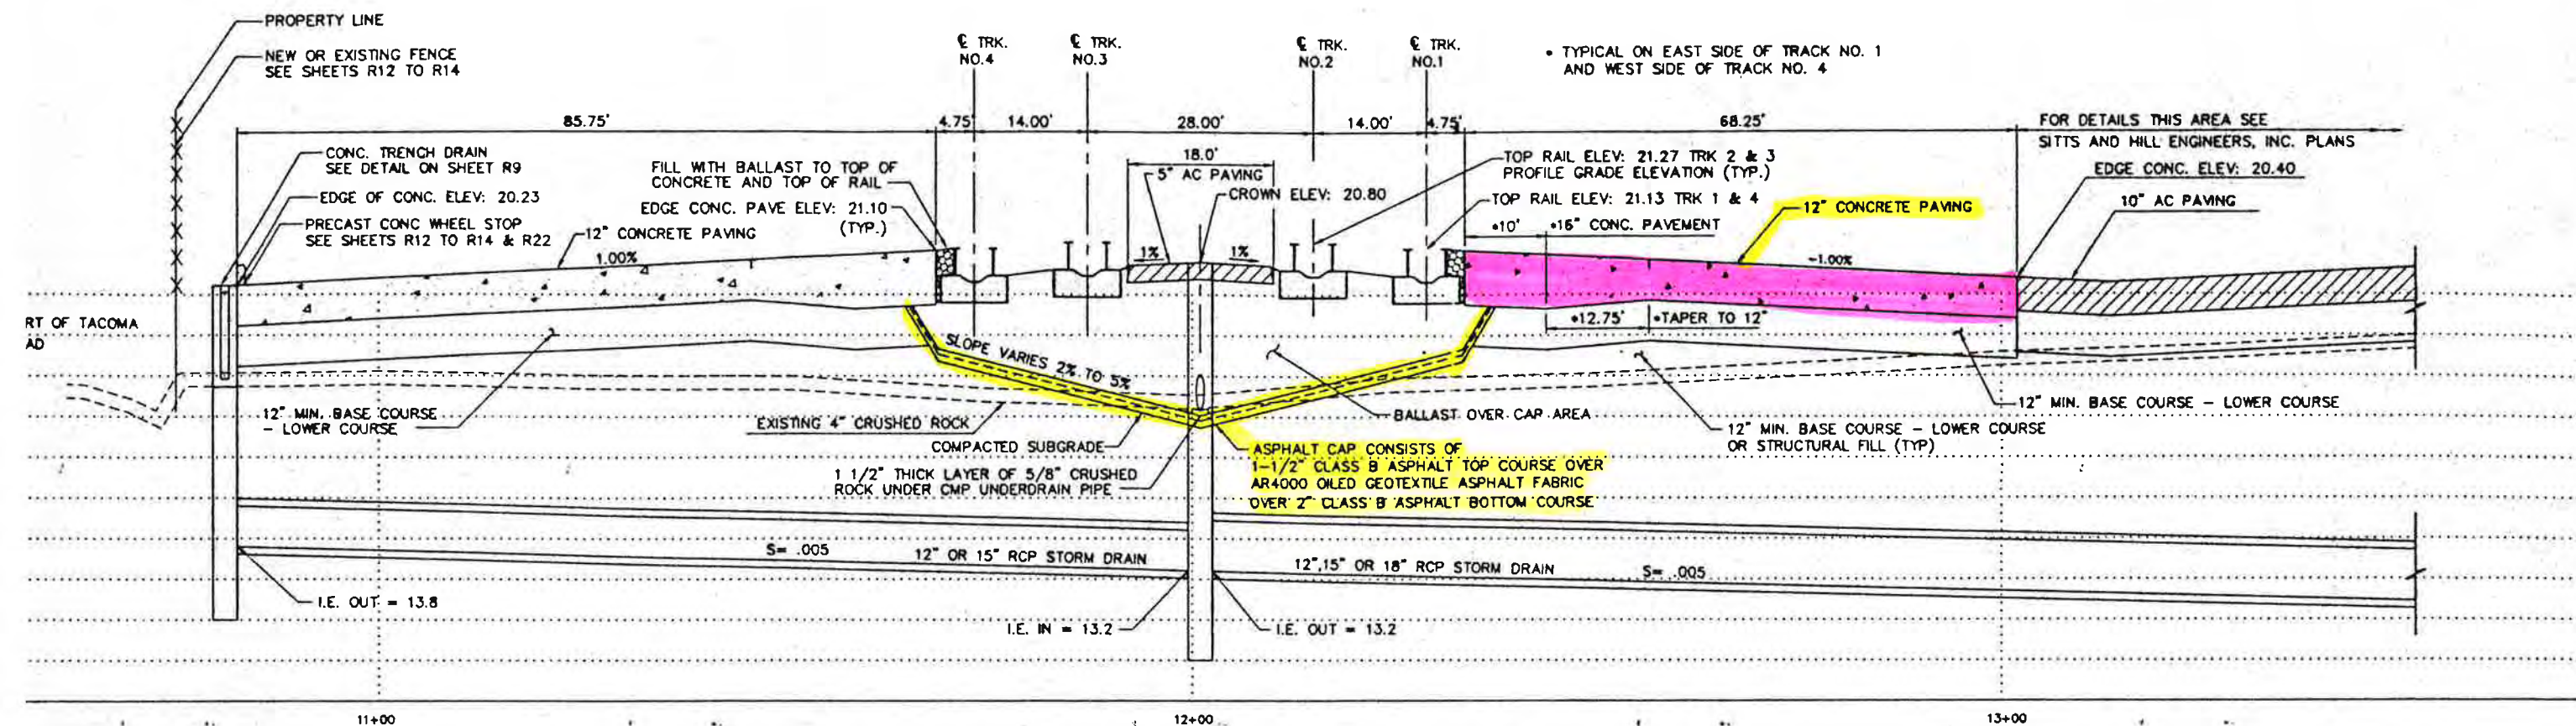
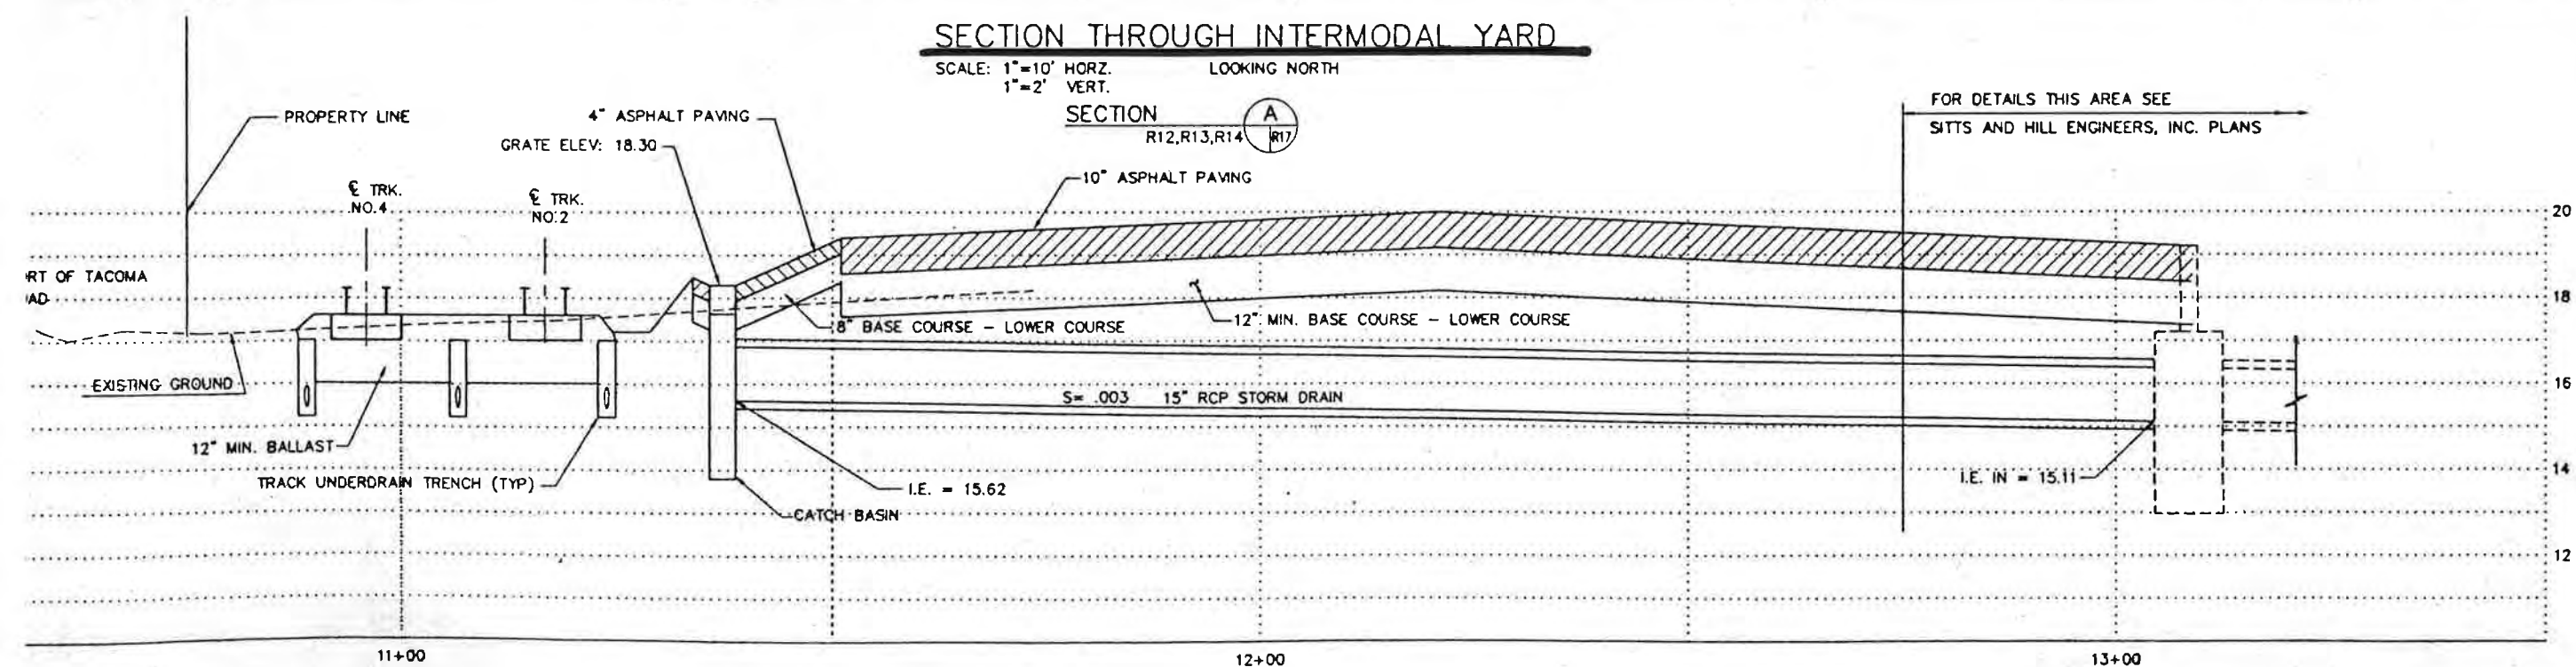
### SECTION THROUGH INTERMODAL YARD

In early September 2024 Puget Paving completed a crack sealing effort in the area depicted in blue above. This area is constructed of 12" concrete. The cracks and joints in the concrete panels were blown out to remove debris. Cracks were sealed with AR7000 Rubberized Mastic. In areas of larger concrete spalling the impacted concrete was removed and the area filled with asphalt paving.
