Subject:
Stimson Lumber Company, Former Josephine Mill No. 1, Pend Oreille County,
Washington, 2012 Annual Monitoring Maintenance and Repairs Report.

Photo Log - Former Josephine Mill No. 1

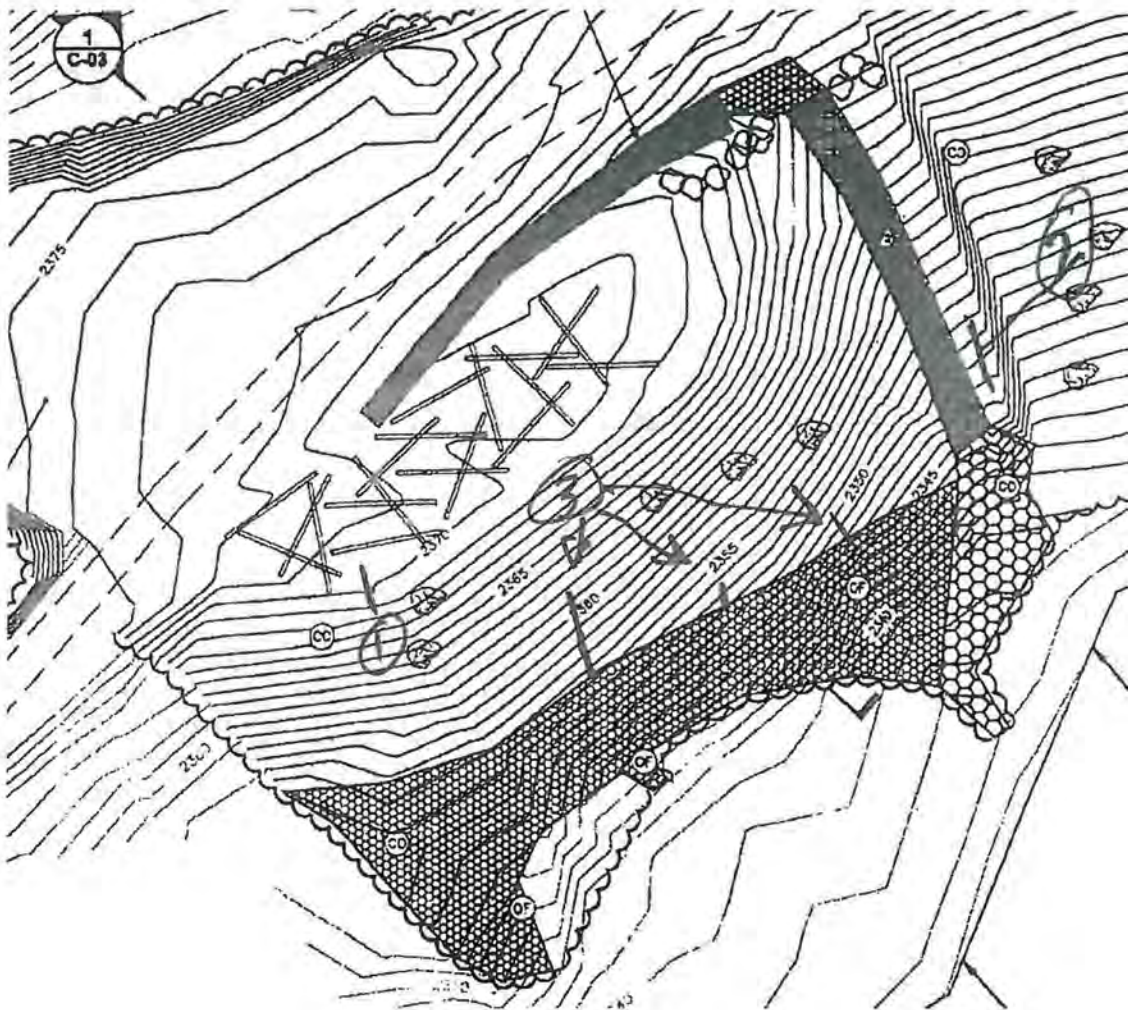
REMARKS: Explain all items needing attention or repair; use number to identify.	
<i>1</i>	<i>Erosion Rill to Fabric - Needs Repair</i>
<i>2</i>	<i>Addition of topsoil Needed. Exposed Drainage fabric (see pictures)</i>
	<i>Contd →</i>

③	Erosion Rills which should be repaired Before they get Deeper
④	Signage Needed
