2024 ANNUAL PROGRESS REPORT SWMU-1 OILY WATER SEWER

HF SINCLAIR PUGET SOUND REFINING LLC

March 2025

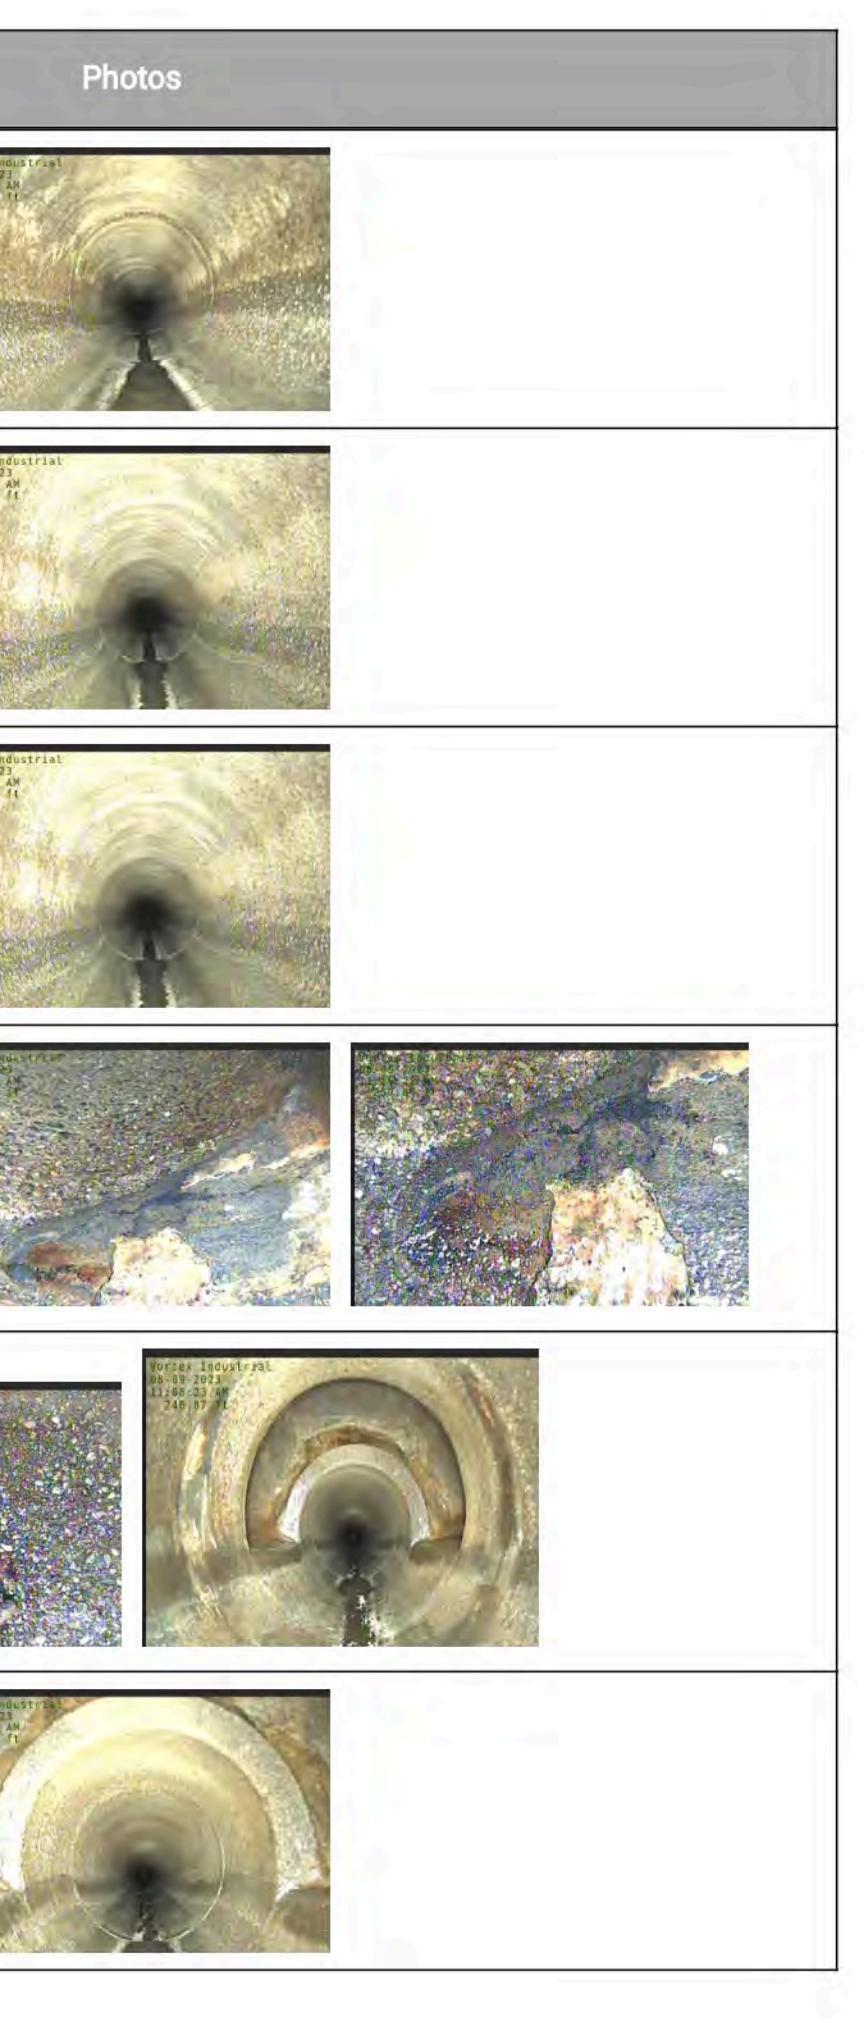
Description	Spatial Type	Distance (ft)	Туре	Percent	Clock	SR	O&M	с	PR	Remarks	
Crack Multiple	Point	176	Structural	0	5-6	3	0	0	1	Crack Multiple	Vortes 1 08-09-20 11:02-9 174-72
Crack Longitudinal	Point	221.5	Structural	0	8	2	0	0	1	Crack Longitudinal	Wortex 1 85-69-2 11,96-10 722:00
Crack Longitudinal	Point	221.5	Structural	0	4	2	0	0	1	Crack Longitudinal	201 GA 2 80 - 92 11:96 - 19 227 - 40
Crack Multiple	Point	250.8	Structural	0	6-7	3	0	0	1	Crack Multiple	Torreb. Industriant Models 2603 Trassiszent 201-11:07 Trassiszent 201-11:
Crack Longitudinal	Point	250.8	Structural	0	2	2	0	0	1	Crack Longitudinal	
Manhole	Point	253.4	Constructional	0		0	0	0	0	D-2.1

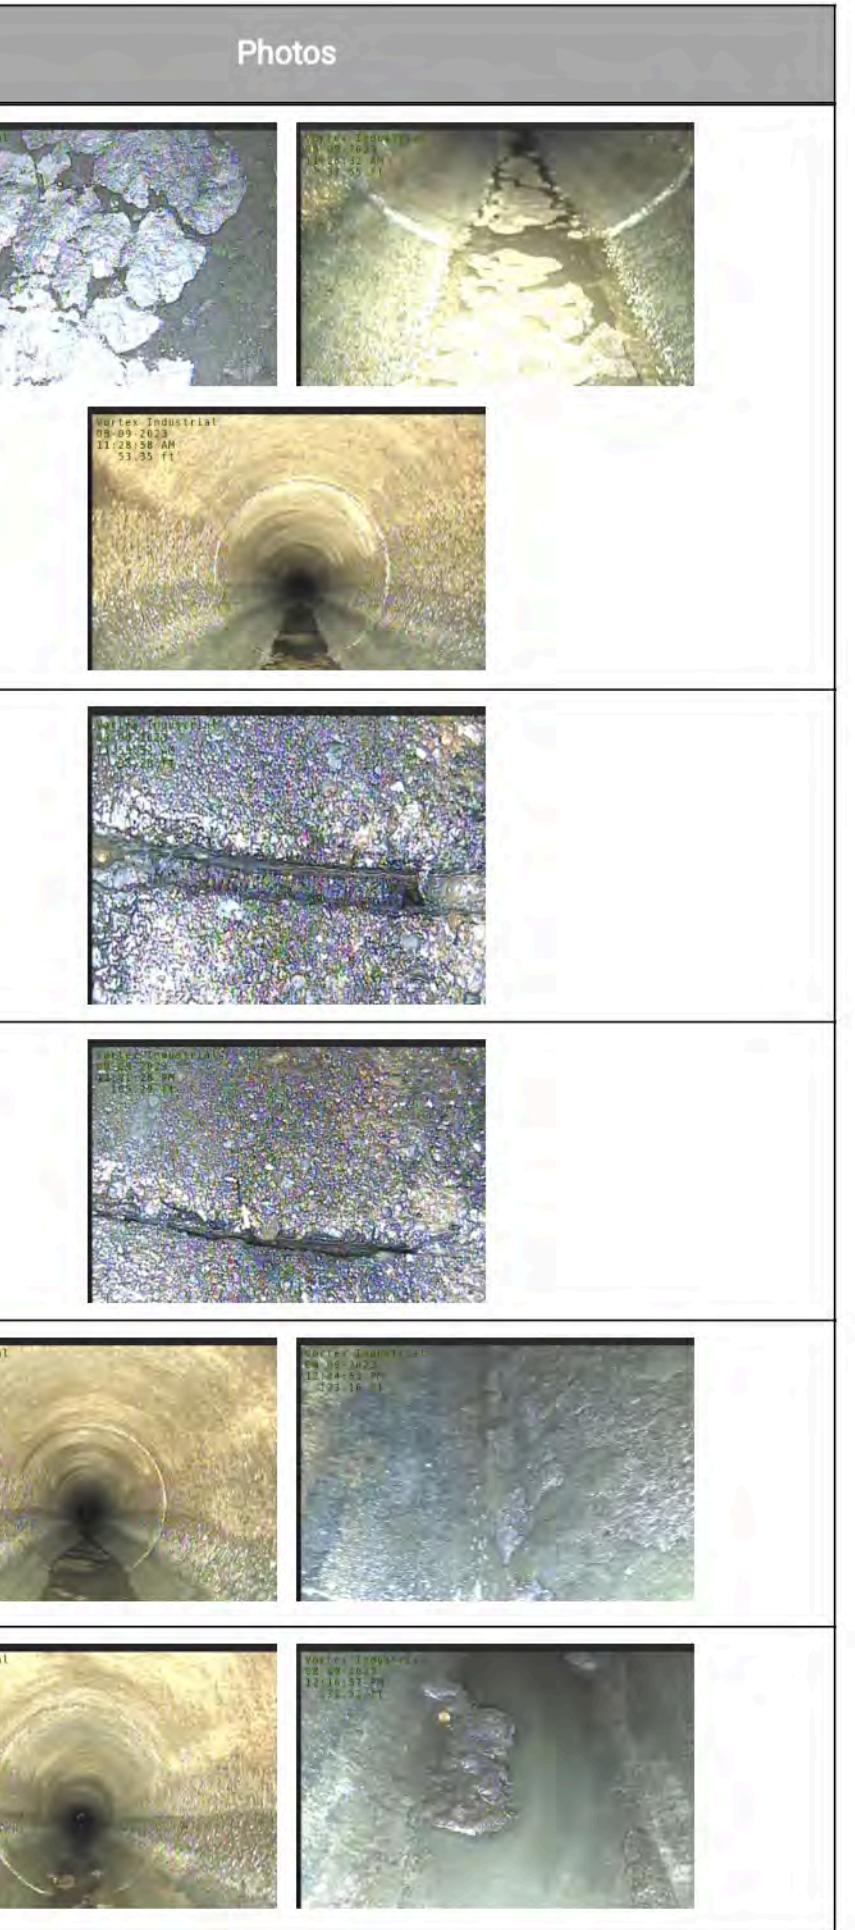
Į	Description	Spatial Type	Distance (ft)	Туре	Percent	Clock	SR	0&M	С	PR	Remarks	
	Deposits Settled Fine	Continuous	37.5 - 93.2	O&M	10	6	0	2	0	0	Deposits Settled Fine	
	Crack Circumferential	Point	93.3	Structural	0	4-5	1	0	0	1	Crack Circumferential	
	Crack Longitudinal	Point	105.29	Structural	0	5	2	0	0	1	Crack Longitudinal	
	Deposits Settled Fine	Continuous	119.2 - 127	0&M	10	6	0	2	0	0	Deposits Settled Fine	Yortex Industria 12 69-225 12 69-28 PM 13 72 17
	Deposits Settled Fine	Point	168.6	0&M	10	6	0	2	0	0	Deposits Settled Fine	Vortes Industrial 07 D9-7023 12105 PM 168-73 T1

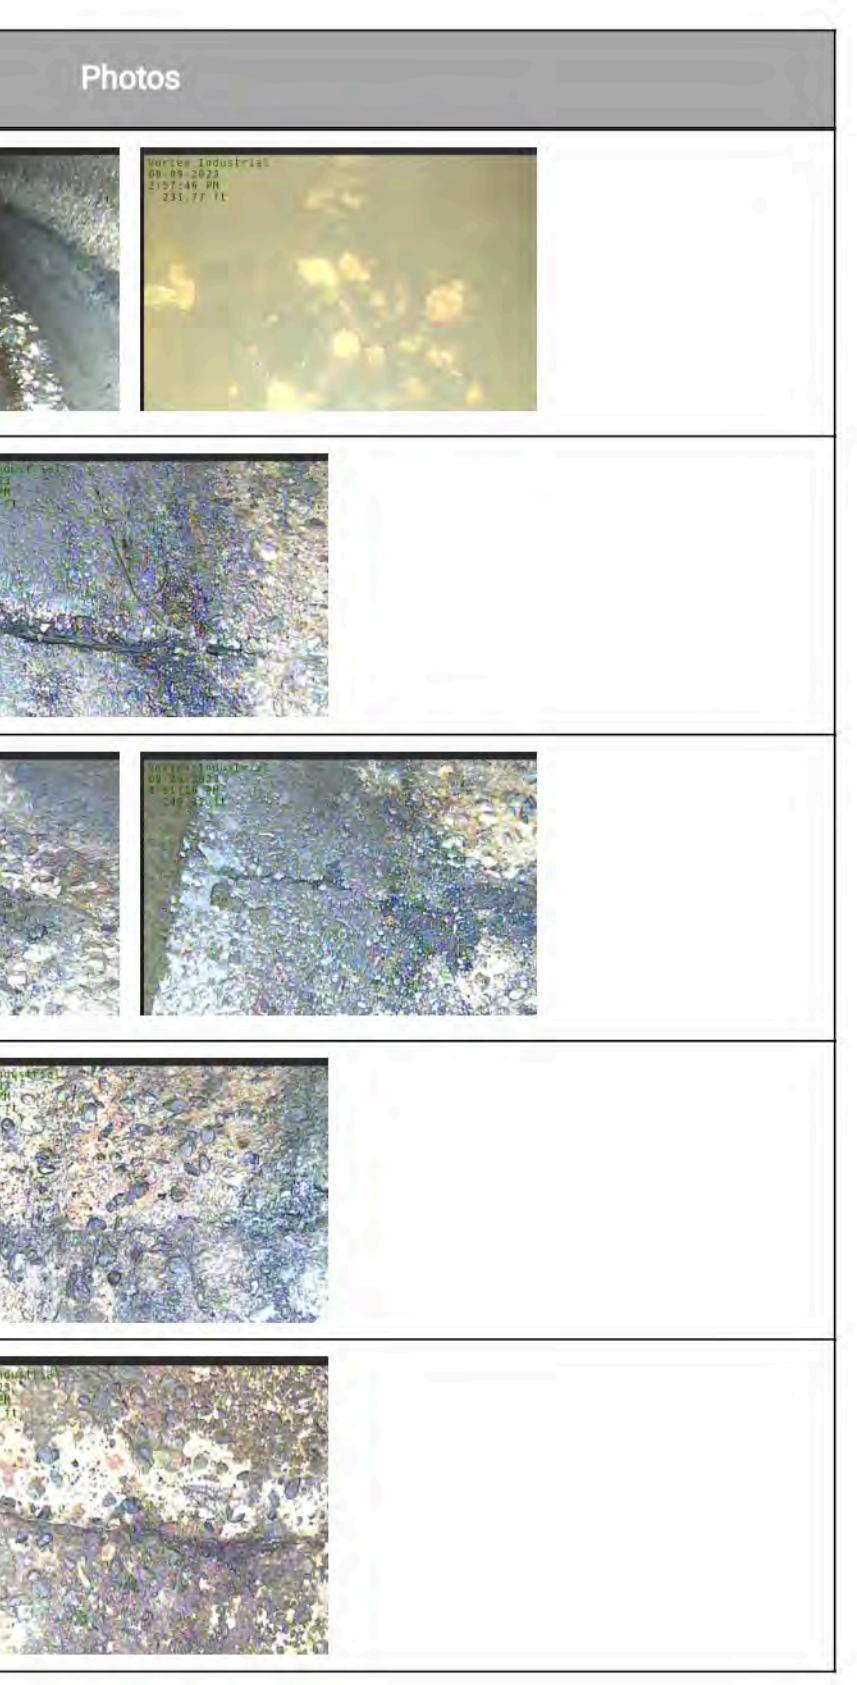
Description	Spatial Type	Distance (ft)	Туре	Percent	Clock	SR	0&M	С	PR	Remarks	
Deposits Settled Gravel	Continuous	228.1 - 236	O&M	10	6	0	2	0	0	Deposits Settled Gravel	
Crack Longitudinal	Point	237.5	Structural	0	5	2	0	0	1	Crack Longitudinal	
Crack Circumferential	Point	246.1	Structural	0	4-5	1	0	0	2	Crack Circumferential	
Crack Longitudinal	Point	261.9	Structural	0	8	2	0	0	1	Crack Longitudinal	
Crack Longitudinal	Point	268.5	Structural	0	2	2	0	0	1	Crack Longitudinal

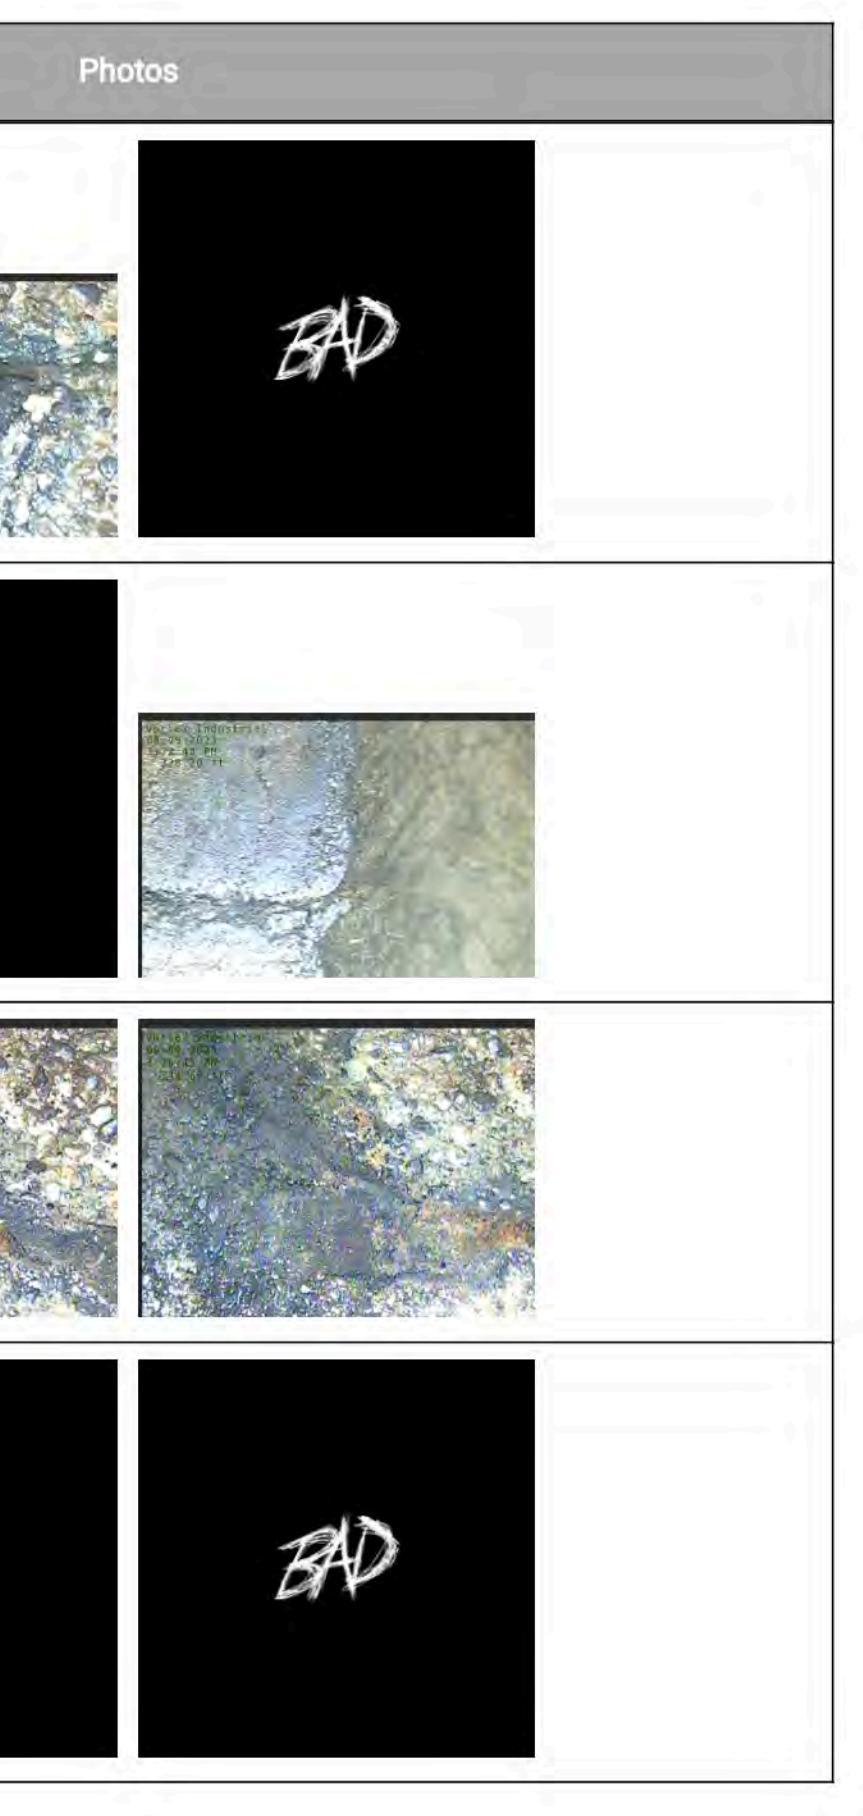
Description	Spatial Type	Distance (ft)	Туре	Percent	Clock	SR	0&M	С	PR	Remarks	
Crack Longitudinal	Point	292	Structural	0	5	2	0	0	1	Crack Longitudinal	
Crack Longitudinal	Point	327.9	Structural	0	7	2	0	0	1	Crack Longitudinal	BAD
Crack Circumferential	Point	334.6	Structural	0	3-5	1	0	0	2	Crack Circumferential	
Crack Circumferential	Point	337.6	Structural	0	5-6	1	0	0	1	Crack Circumferential	BAD

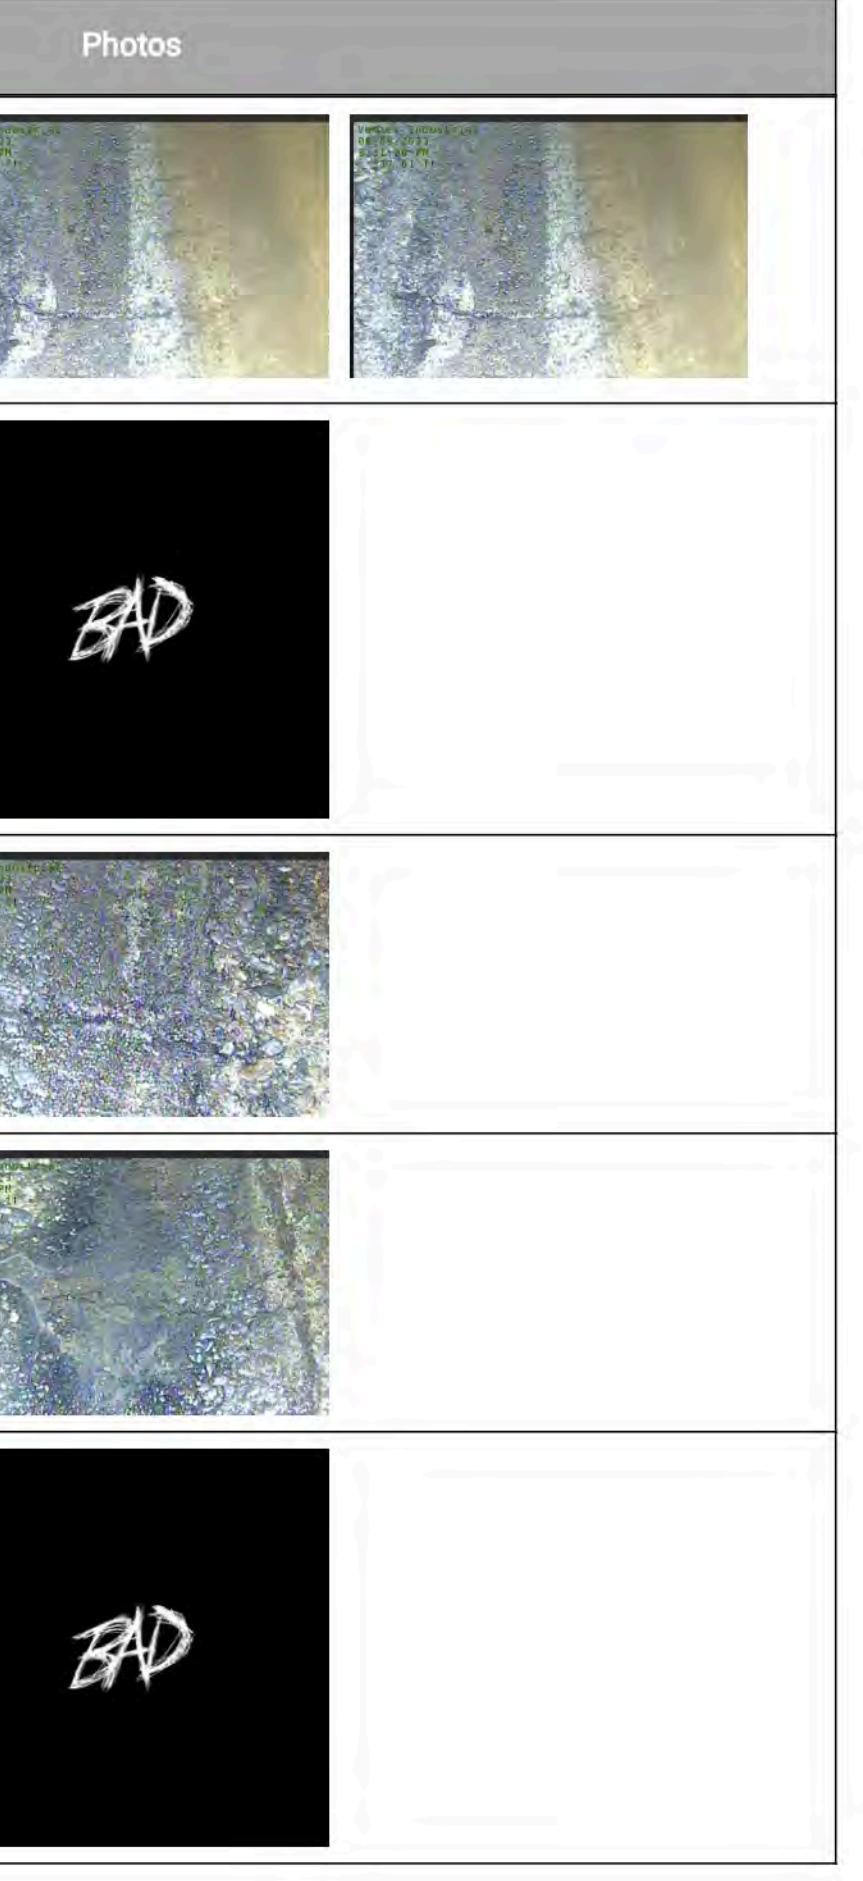
Description	Spatial Type	Distance (ft)	Туре	Percent	Clock	SR	0&M	С	PR	Remarks	
Crack Circumferential	Point	337.6	Structural	0	6-7	1	0	0	1	Crack Circumferential	Vorste Ludweitr, 445 99 99 2015 31,46 857 PH Relations R
Crack Circumferential	Point	341	Structural	0	4-7	1	0	0	1	Crack Circumferential	
Crack Circumferential	Point	341	Structural	0	5-6	1	0	0	1	Crack Circumferential	
Crack Circumferential	Point	343.8	Structural	0	6-7	1	0	0	1	Crack Circumferential	
Crack Circumferential	Point	347.3	Structural	0	4-5	1	0	0	1	Crack Circumferential

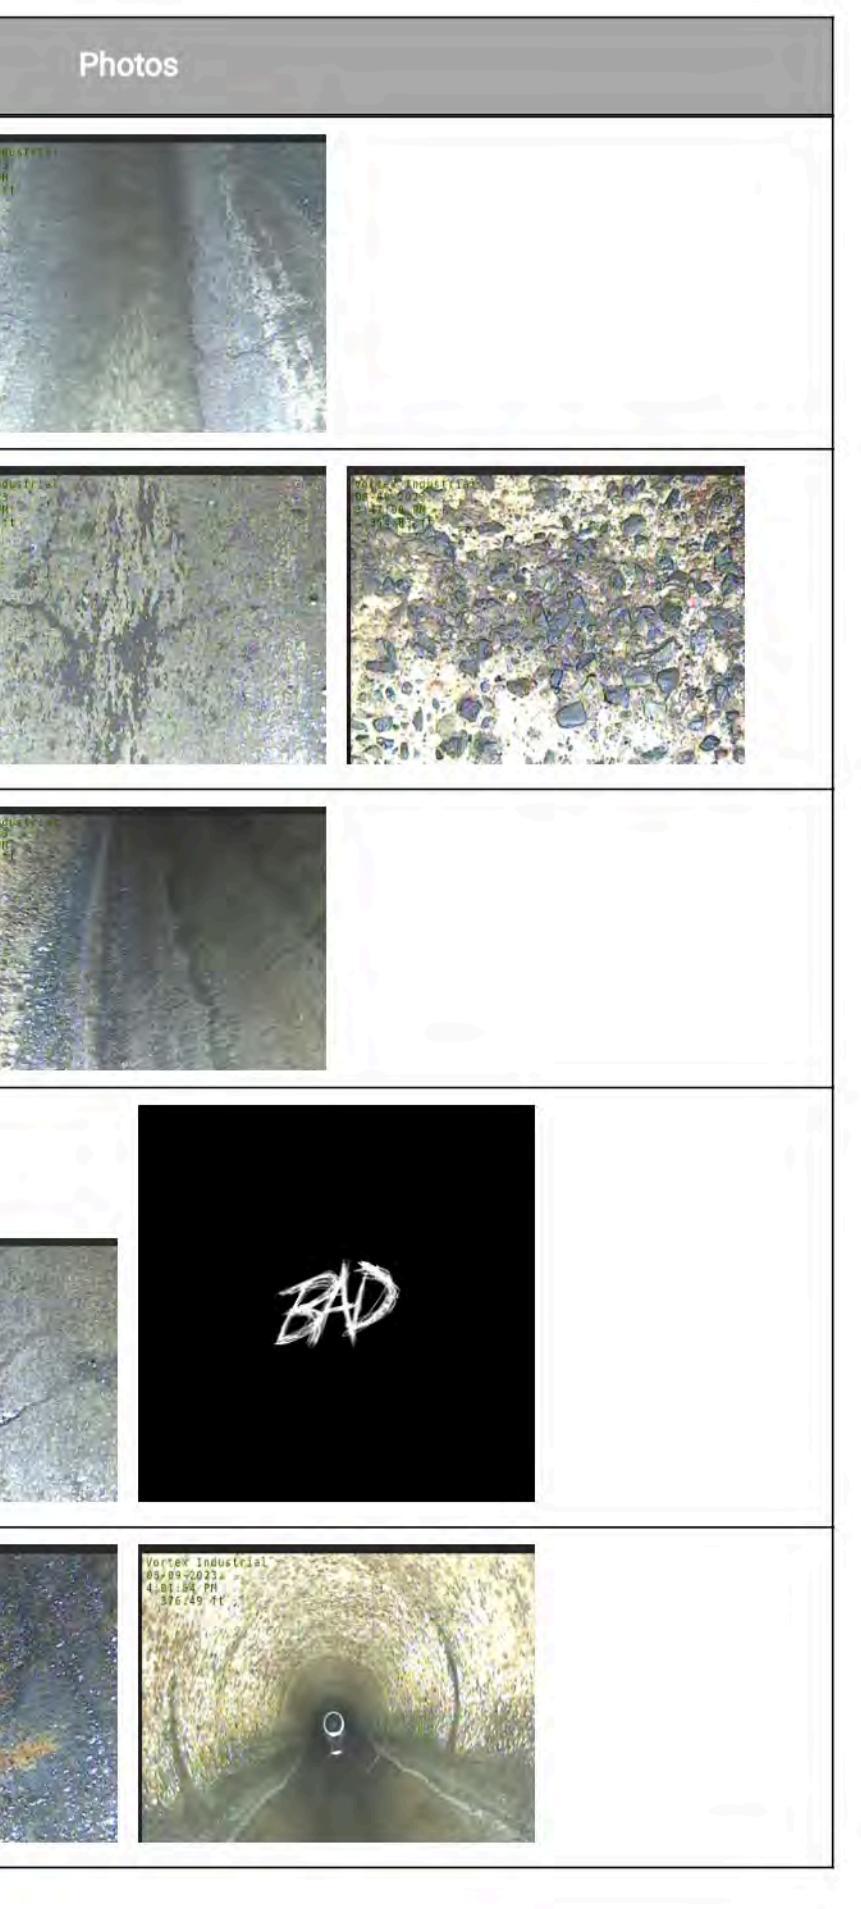
Description	Spatial Type	Distance (ft)	Туре	Percent	Clock	SR	0&M	С	PR	Remarks	
Crack Circumferential	Point	347.3	Structural	0	7-8	1	0	0	1	Crack Circumferential	
Crack Multiple	Point	354.8	Structural	0	5-10	2	0	0	1	Crack Multiple	
Crack Circumferential	Point	359.1	Structural	0	4-8	1	0	0	1	Crack Circumferential	
Crack Circumferential	Point	371	Structural	0	7-8	1	0	0	1	Crack Circumferential	
Crack Circumferential	Point	379.1	Structural	0	8-10	1	0	0	2	Crack Circumferential

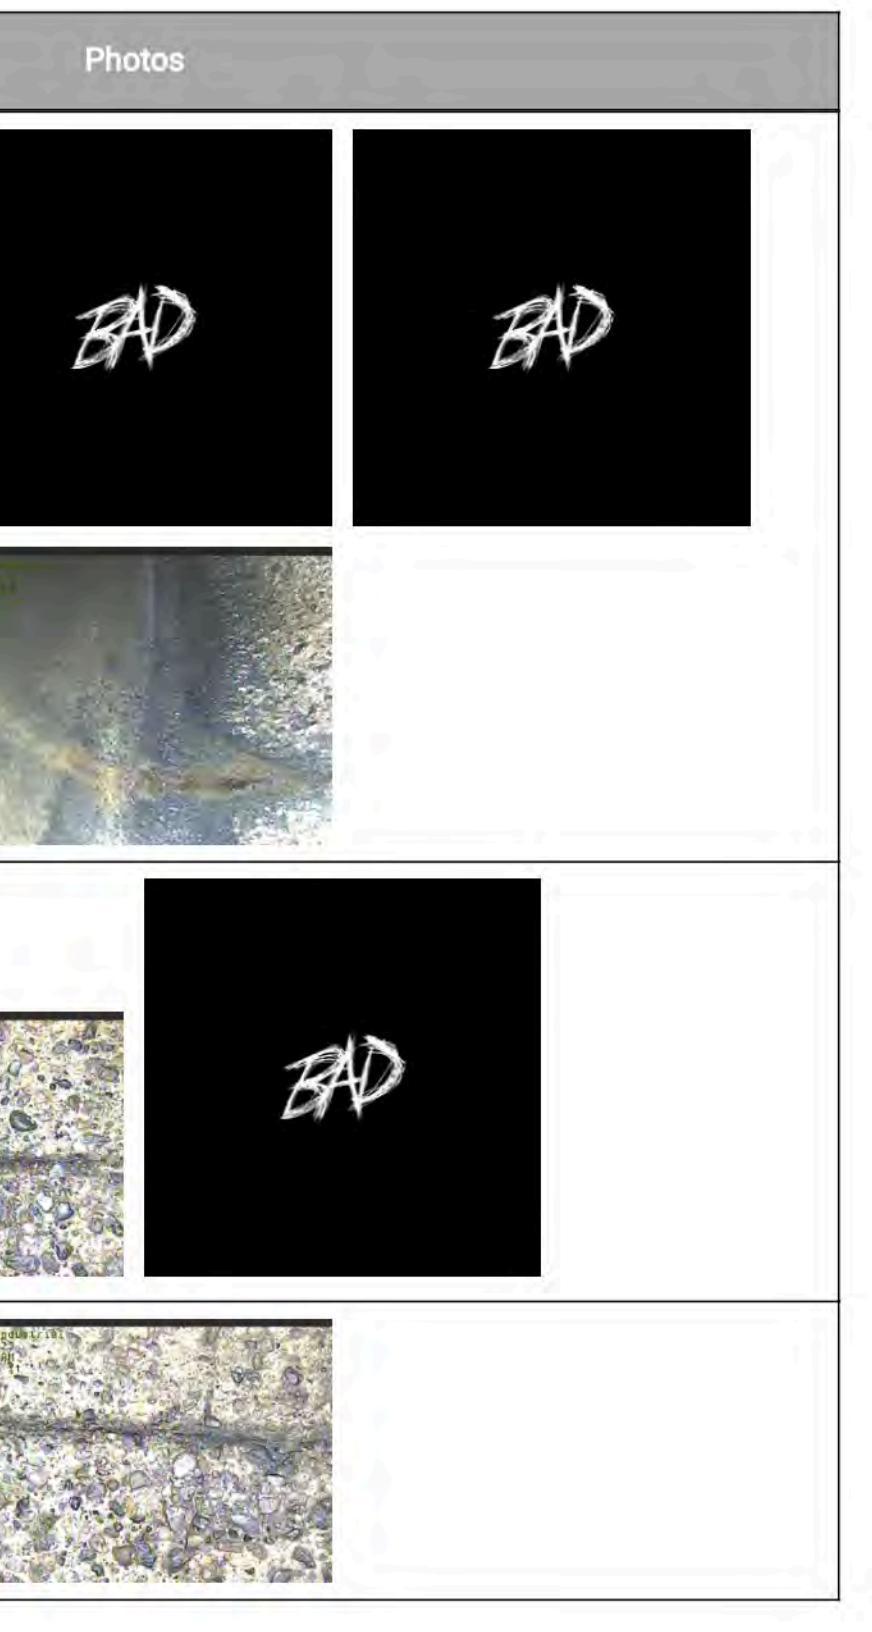
Description	Spatial Type	Distance (ft)	Туре	Percent	Clock	SR	0&M	С	PR	Remarks	
Crack Circumferential	Point	379.3	Structural	0	4-7	1	0	0	2	Crack Circumferential	
Crack Longitudinal	Point	388.6	Structural	0	1	2	0	0	1	Crack Longitudinal	Petter-Augustricht Billion sonner 2013 sonner 101 sonner 101 s
Crack Longitudinal	Point	395.1	Structural	0	11	2	0	0	1	Crack Longitudinal

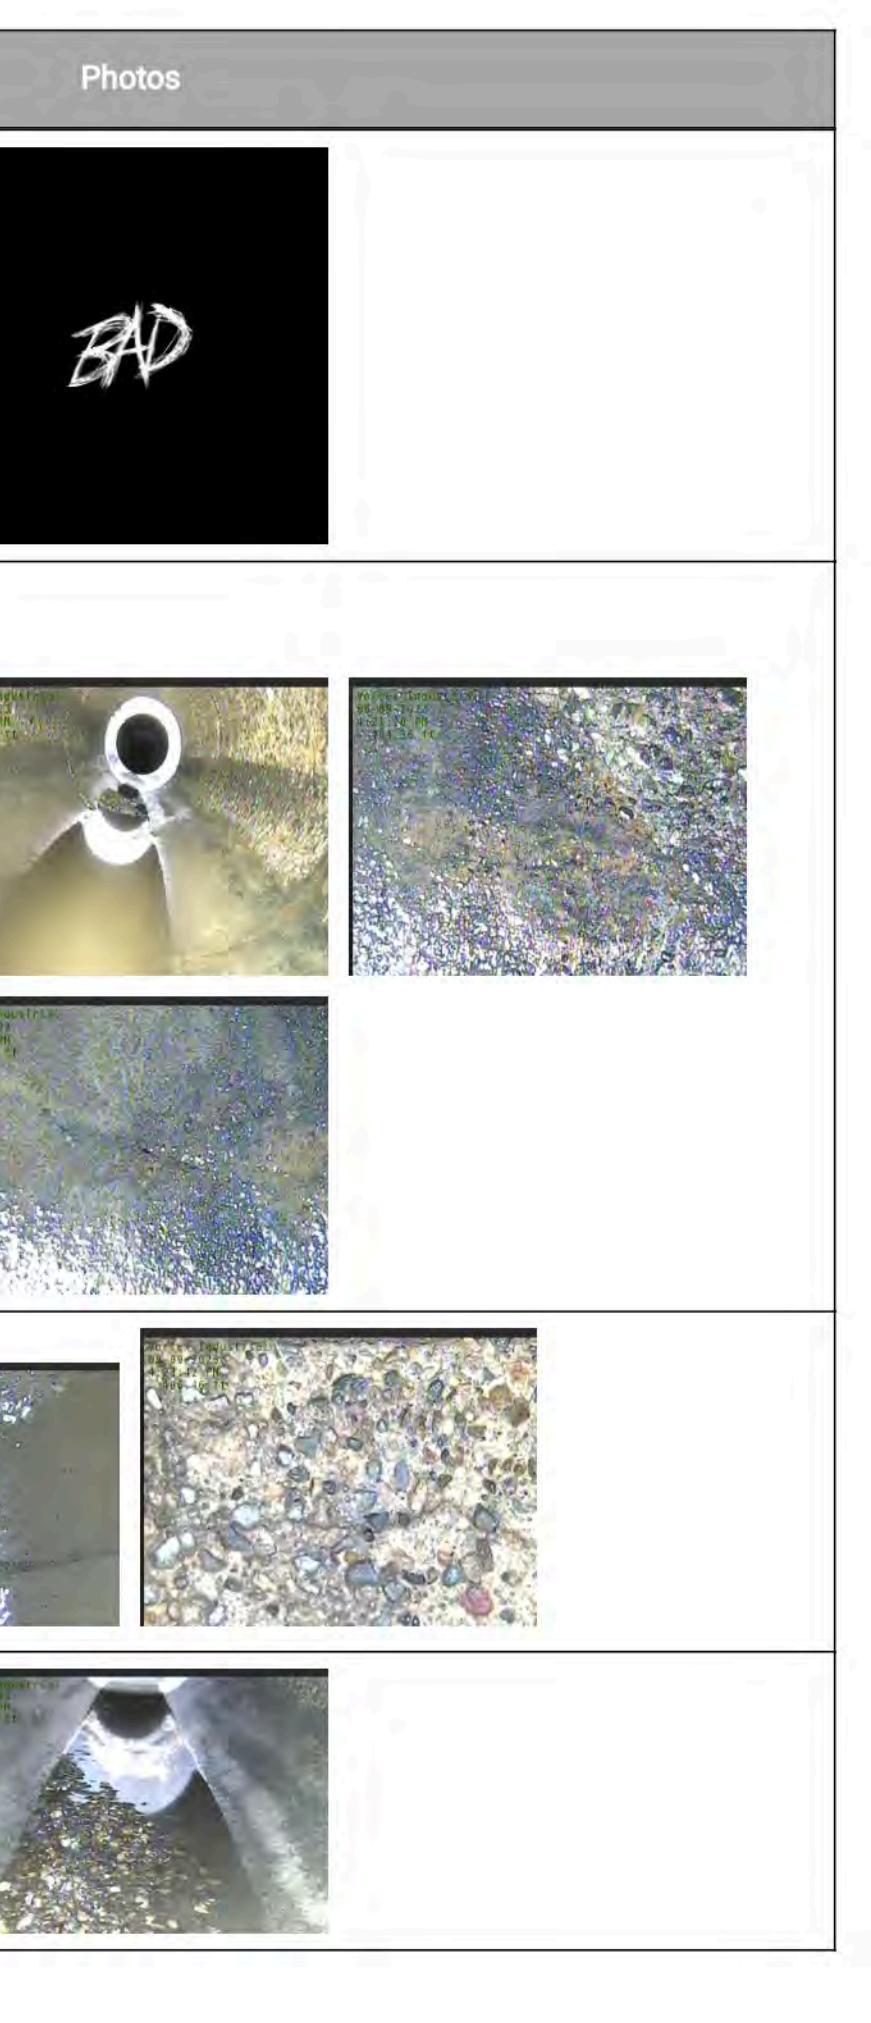
Description	Spatial Type	Distance (ft)	Туре	Percent	Clock	SR	0&M	С	PR	Remarks	
Crack Longitudinal	Point	395.1	Structural	0	9	2	0	0	1	Crack Longitudinal	
Crack Circumferential	Point	404.4	Structural	0	3-5	1	0	0	2	Crack Circumferential	
Crack Circumferential	Point	406.4	Structural	0	6-11	1	0	0	2	Crack Circumferential	
Deposits Settled Gravel	Point	406.7	O&M	10	6	0	2	0	0	Deposits Settled Gravel

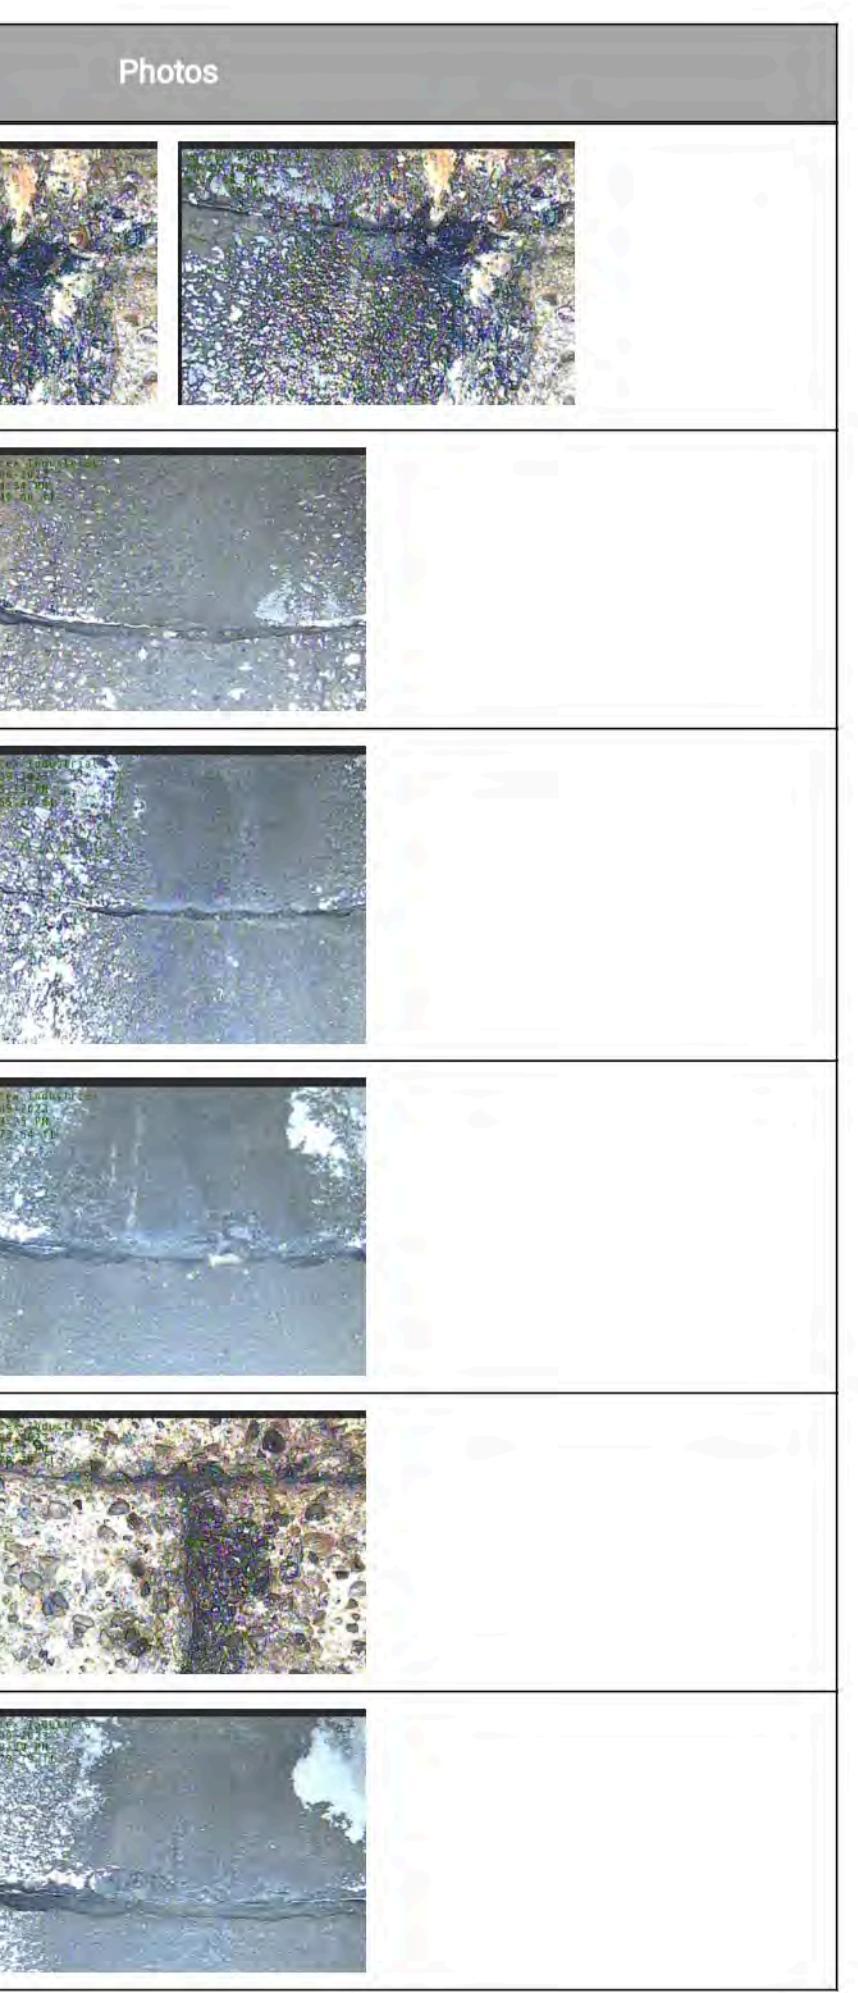
Description	Spatial Type	Distance (ft)	Туре	Percent	Clock	SR	0&M	С	PR	Remarks	
Crack Longitudinal	Point	7.8	Structural	0	5	2	0	0	1	Crack Longitudinal	
Crack Longitudinal	Point	49.6	Structural	0	6	2	0	0	1	Crack Longitudinal	
Crack Longitudinal	Point	55.4	Structural	0	6	2	0	0	1	Crack Longitudinal	
Crack Multiple	Point	73.7	Structural	0	6-7	3	0	0	1	Crack Multiple	
Crack Longitudinal	Point	79.8	Structural	0	12	2	0	0	2	Crack Longitudinal	
Crack Multiple	Point	79.8	Structural	0	6-7	3	0	0	1	Crack Multiple

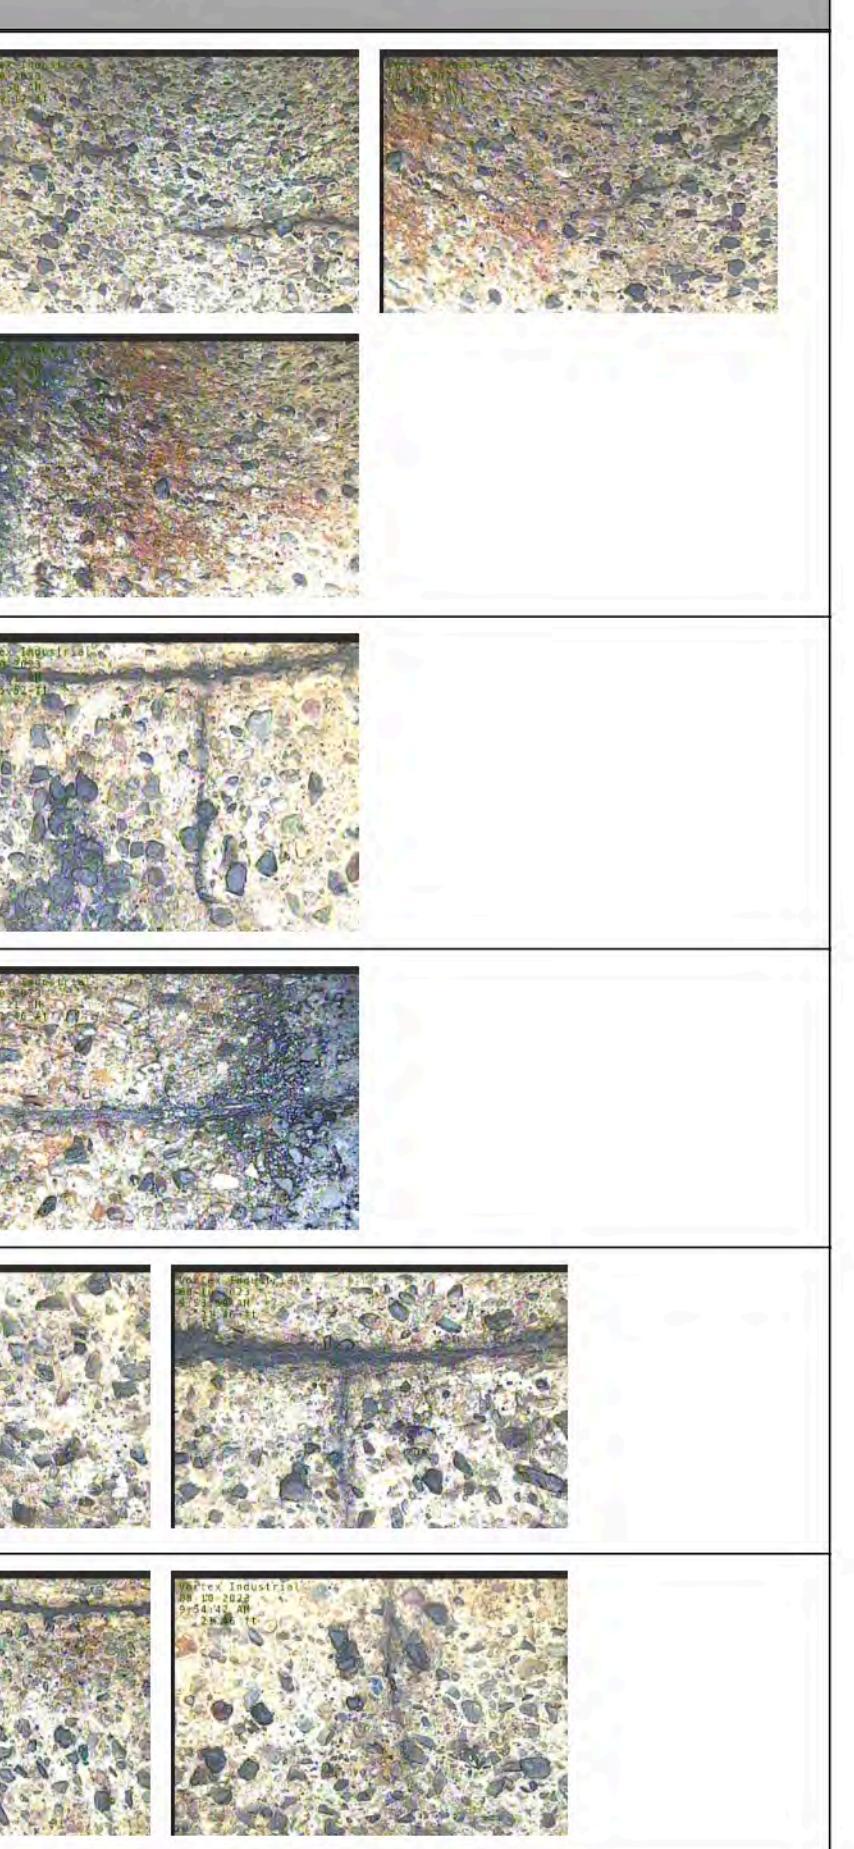
Description	Spatial Type	Distance (ft)	Туре	Percent	Clock	SR	0&M	С	PR	Remarks	
Crack Multiple	Point	9.2	Structural	0	10-3	3	0	0	1	Crack Multiple	
Crack Longitudinal	Point	15.5	Structural	0	10	2	0	0	1	Crack Longitudinal	
Crack Longitudinal	Point	21.5	Structural	0	7	2	0	0	1	Crack Longitudinal	
Crack Longitudinal	Point	21.5	Structural	0	10	2	0	0	1	Crack Longitudinal	
Crack Longitudinal	Point	21.5	Structural	0	3	2	0	0	1	Crack Longitudinal

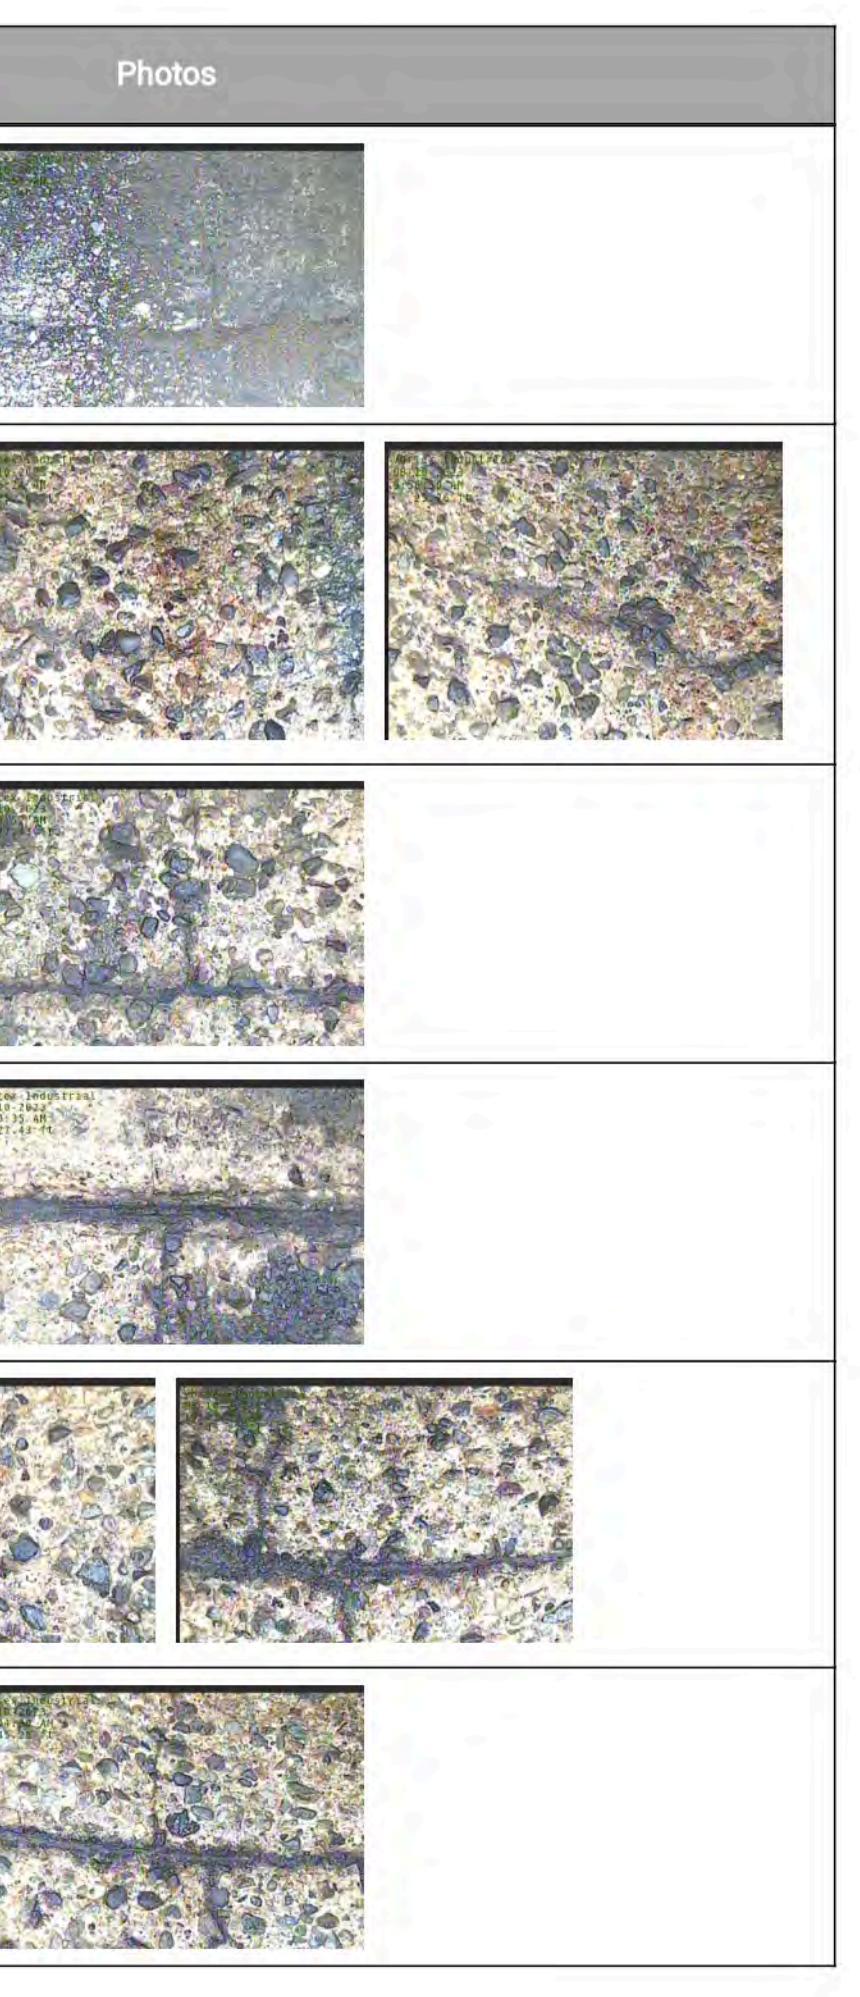
Description	Spatial Type	Distance (ft)	Туре	Percent	Clock	SR	0&M	С	PR	Remarks	
Crack Longitudinal	Point	21.5	Structural	0	6	2	0	0	1	Crack Longitudinal	
Crack Circumferential	Point	25.3	Structural	0	12- 12	1	0	0	1	Crack Circumferential	
Crack Longitudinal	Point	27.4	Structural	0	9	2	0	0	1	Crack Longitudinal	
Crack Longitudinal	Point	27.4	Structural	0	12	2	0	0	2	Crack Longitudinal	
Crack Longitudinal	Point	45.3	Structural	0	8	2	0	0	2	Crack Longitudinal	
Crack Longitudinal	Point	45.3	Structural	0	3	2	0	0	1	Crack Longitudinal

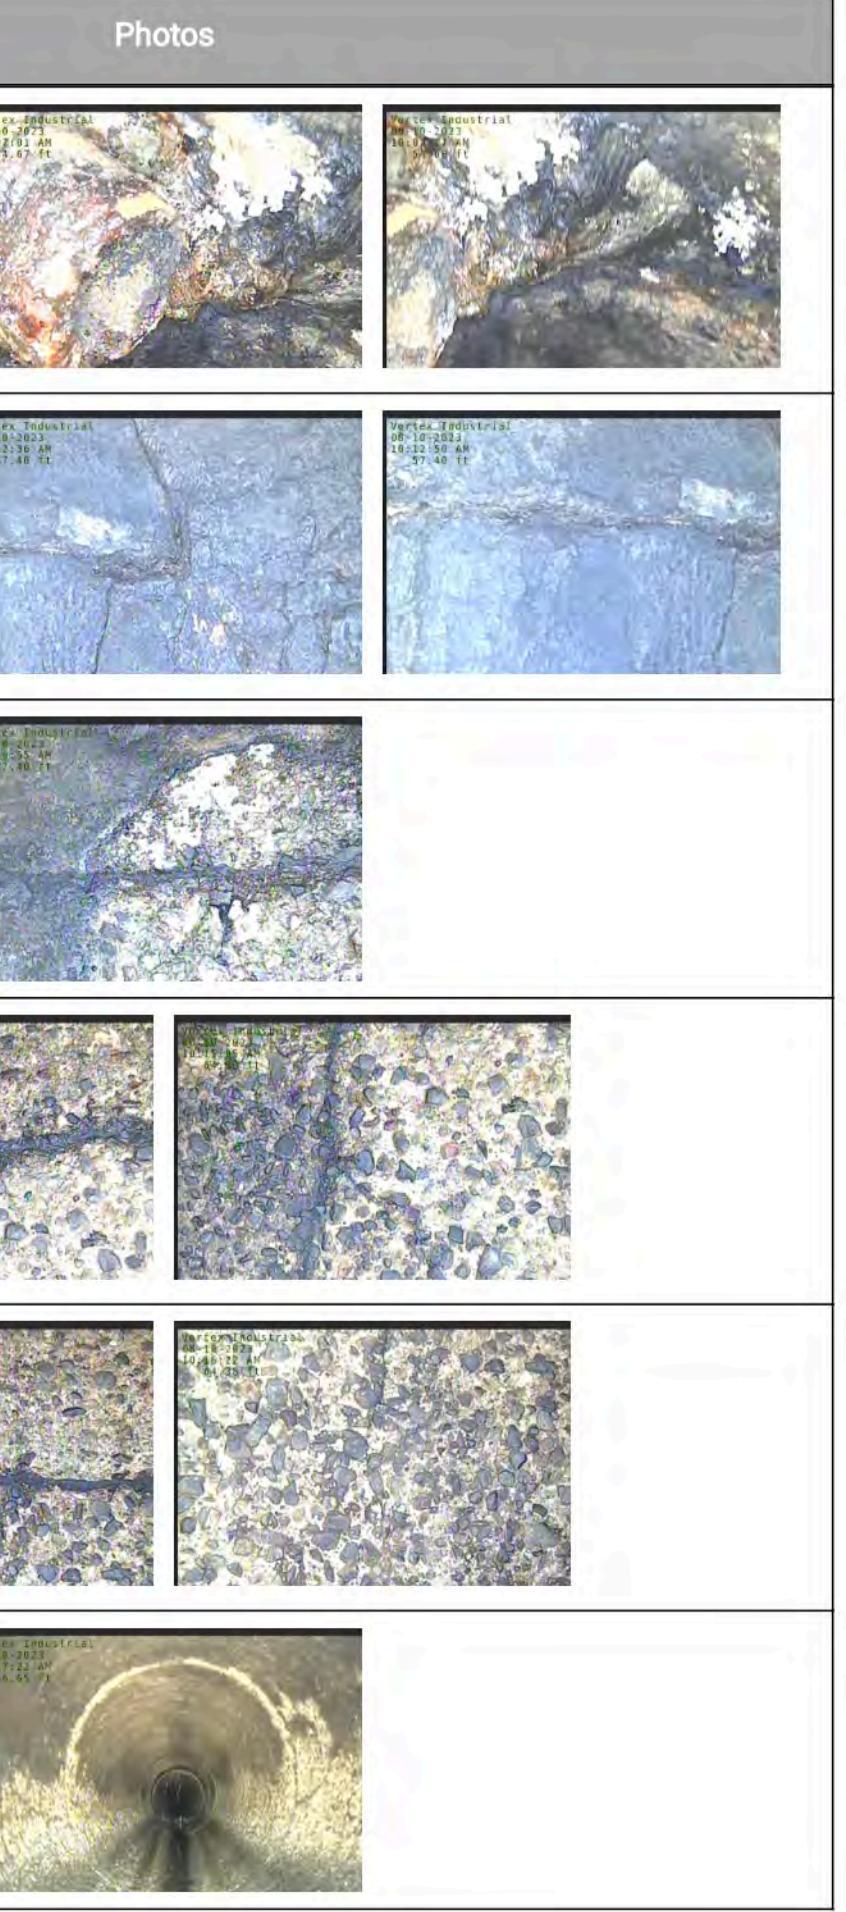
Description	Spatial Type	Distance (ft)	Туре	Percent	Clock	SR	O&M	С	PR	Remarks	
Tap Break-In Intruding	Point	54.7	Constructional	0	11	0	4	0	1	Tap Break-In Intruding	Warfs e Lindosert el 00-10-2023 10-2024 8-22-75 8-22-75 8-22-75 10-2024 10-20
Fracture Multiple	Point	57.4	Structural	0	10-3	4	0	0	2	Fracture Multiple	
Crack Longitudinal	Point	57.4	Structural	0	8	2	0	0	1	Crack Longitudinal	
Crack Longitudinal	Point	64.4	Structural	0	9	2	0	0	2	Crack Longitudinal	
Crack Longitudinal	Point	64.4	Structural	0	3	2	0	0	1	Crack Longitudinal	
Miscellaneous Water Level	Point	66.7	Miscellaneous	0		0	0	0	0	Miscellaneous Water Level

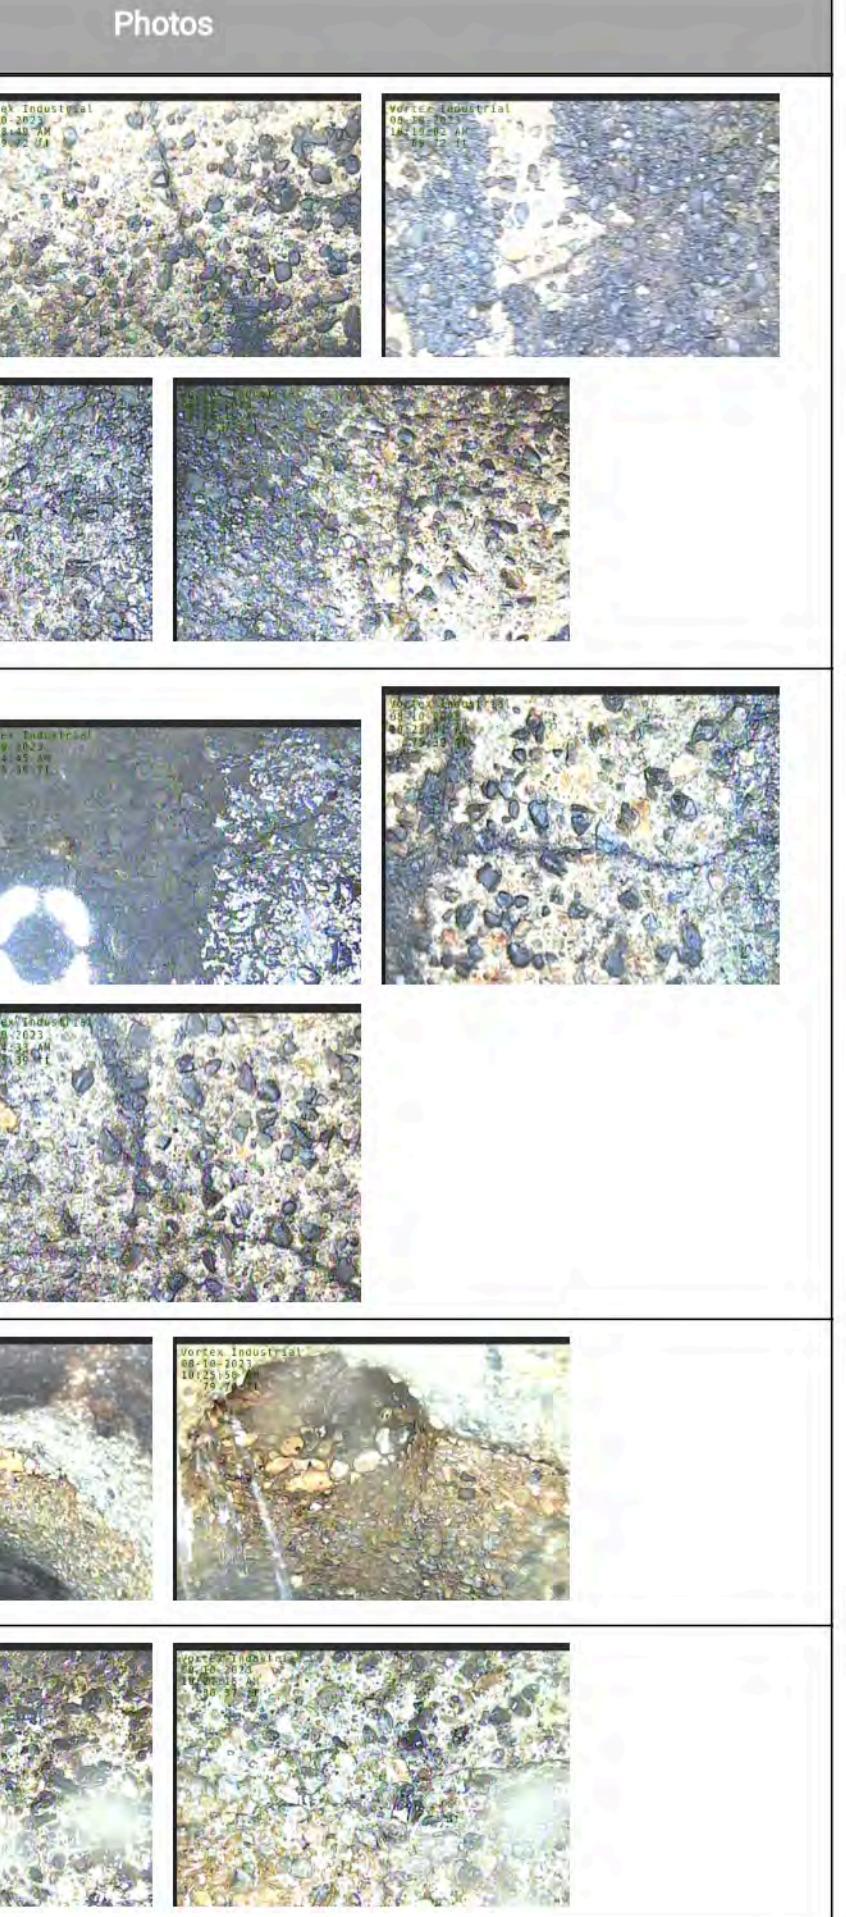
Description	Spatial Type	Distance (ft)	Туре	Percent	Clock	SR	0&M	С	PR	Remarks	
Crack Multiple	Point	69.7	Structural	0	3-6	3	0	0	1	Crack Multiple	
Crack Multiple	Point	75.4	Structural	0	12- 12	3	0	0	1	Crack Multiple	
Tap Factory Activity	Point	79	Constructional	0	12	0	0	0	0	Tap Factory Activity	Vortes Indust (441 81-10-2023 101:27:37:44 75:72:21
Crack Multiple	Point	80.4	Structural	0	12-2	3	0	0	1	Crack Multiple
