2024 ANNUAL PROGRESS REPORT SWMU-1 OILY WATER SEWER

HF SINCLAIR PUGET SOUND REFINING LLC

March 2025

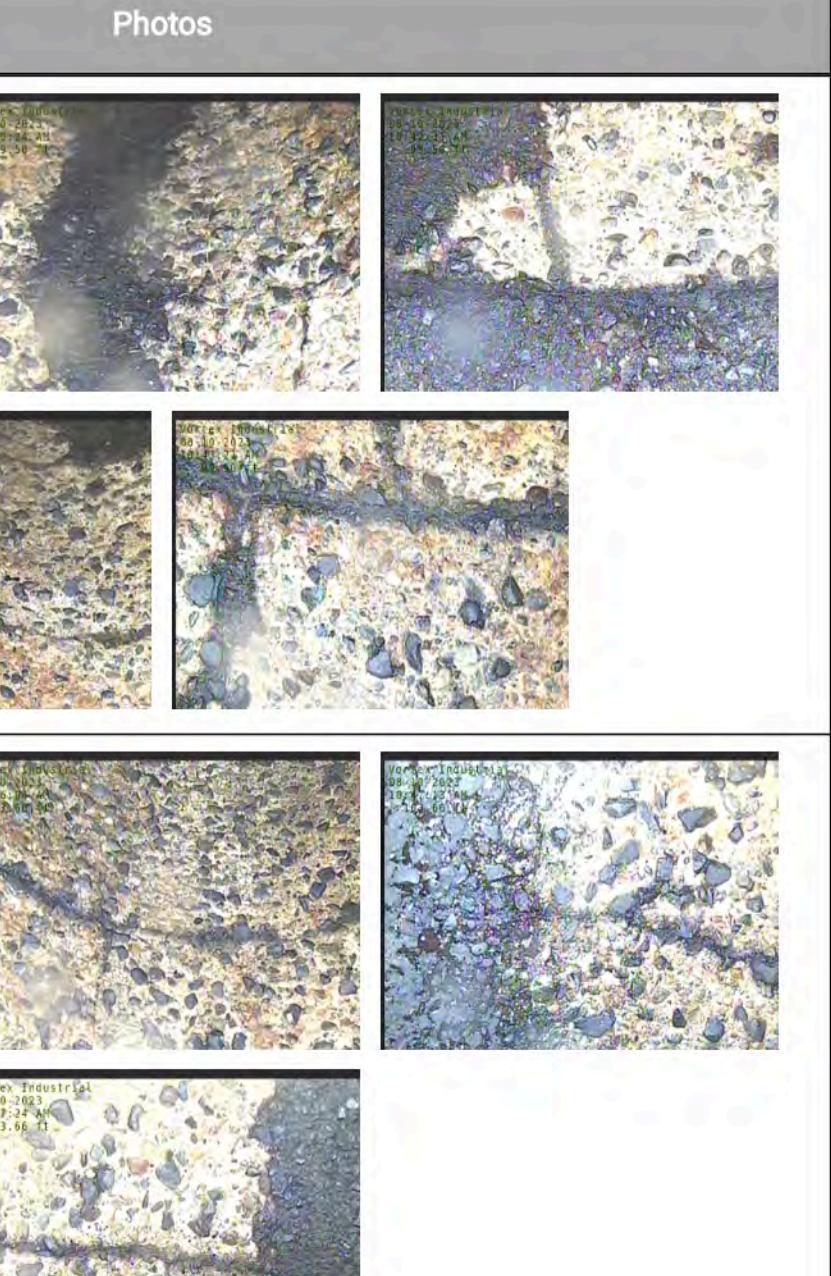
Description	Spatial Type	Distance (ft)	Туре	Percent	Clock	SR	O&M	С	PR	Remarks	
Crack Multiple	Point	99.5	Structural	0	12- 12	3	0	0	2	Crack Multiple	
Crack Multiple	Point	103.7	Structural	0	12- 12	3	0	0	2	Crack Multiple	Image: state stat

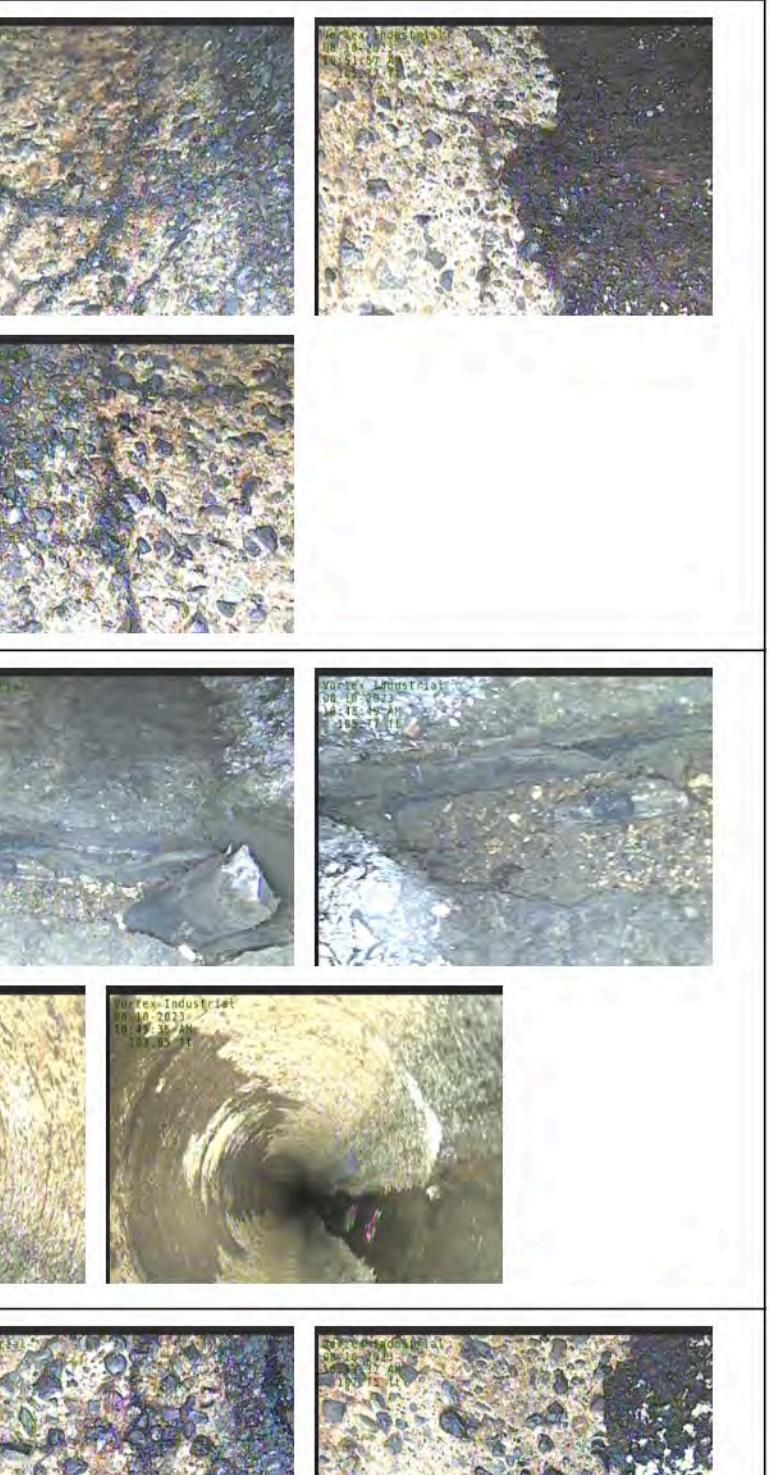
Description	Spatial Type	Distance (ft)	Туре	Percent	Clock	SR	O&M	С	PR	Remarks	Server
Crack Multiple	Point	105.8	Structural	0	8-4	3	0	0	2	Crack Multiple	Important
Fracture Circumferential	Point	105.8	Structural	0	5-7	2	0	0	3	Fracture Circumferential	Interest preserved I
Crack Multiple	Point	107.7	Structural	0	12- 12	1	0	0	1	Crack Multiple

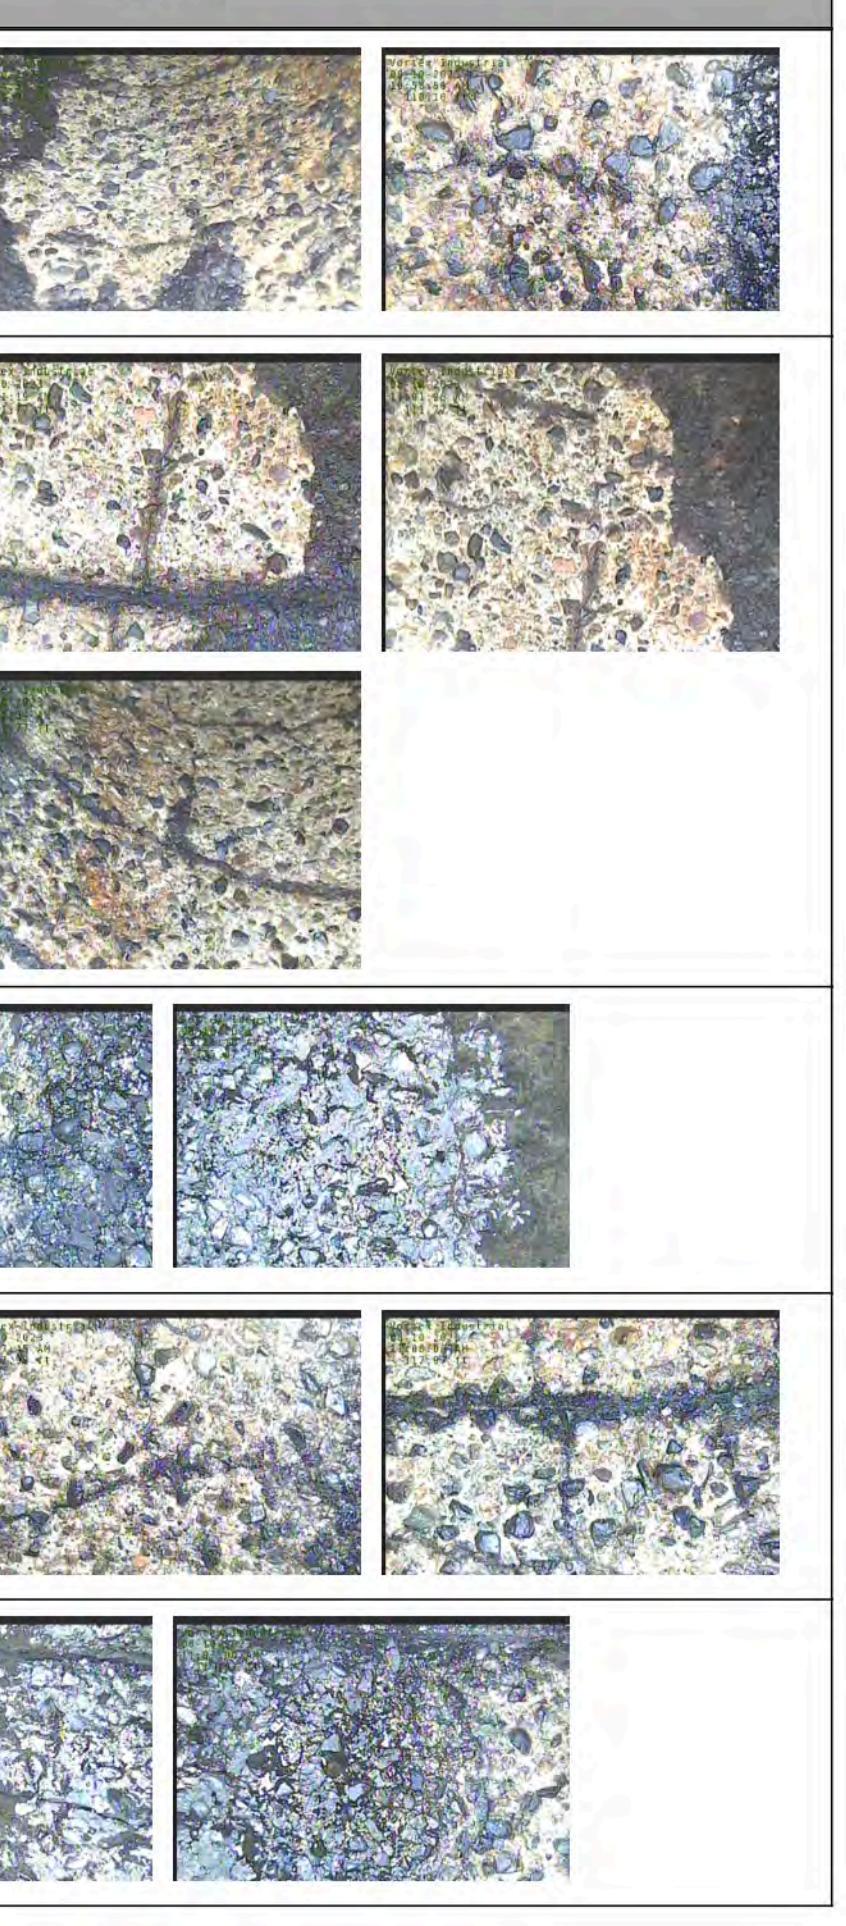
Description	Spatial Type	Distance (ft)	Туре	Percent	Clock	SR	0&M	С	PR	Remarks	
Crack Circumferential	Point	110.1	Structural	0	6-9	1	0	0	1	Crack Circumferential	
Crack Multiple	Point	111.8	Structural	0	8-4	2	0	0	1	Crack Multiple	
Crack Circumferential	Point	115.9	Structural	0	6-9	1	0	0	1	Crack Circumferential	
Crack Multiple	Point	117.9	Structural	0	8-10	3	0	0	1	Crack Multiple	
Crack Circumferential	Point	117.9	Structural	0	5-6	1	0	0	1	Crack Circumferential	11.37 AL 48 11.37 AL 48 11.37 AL 48

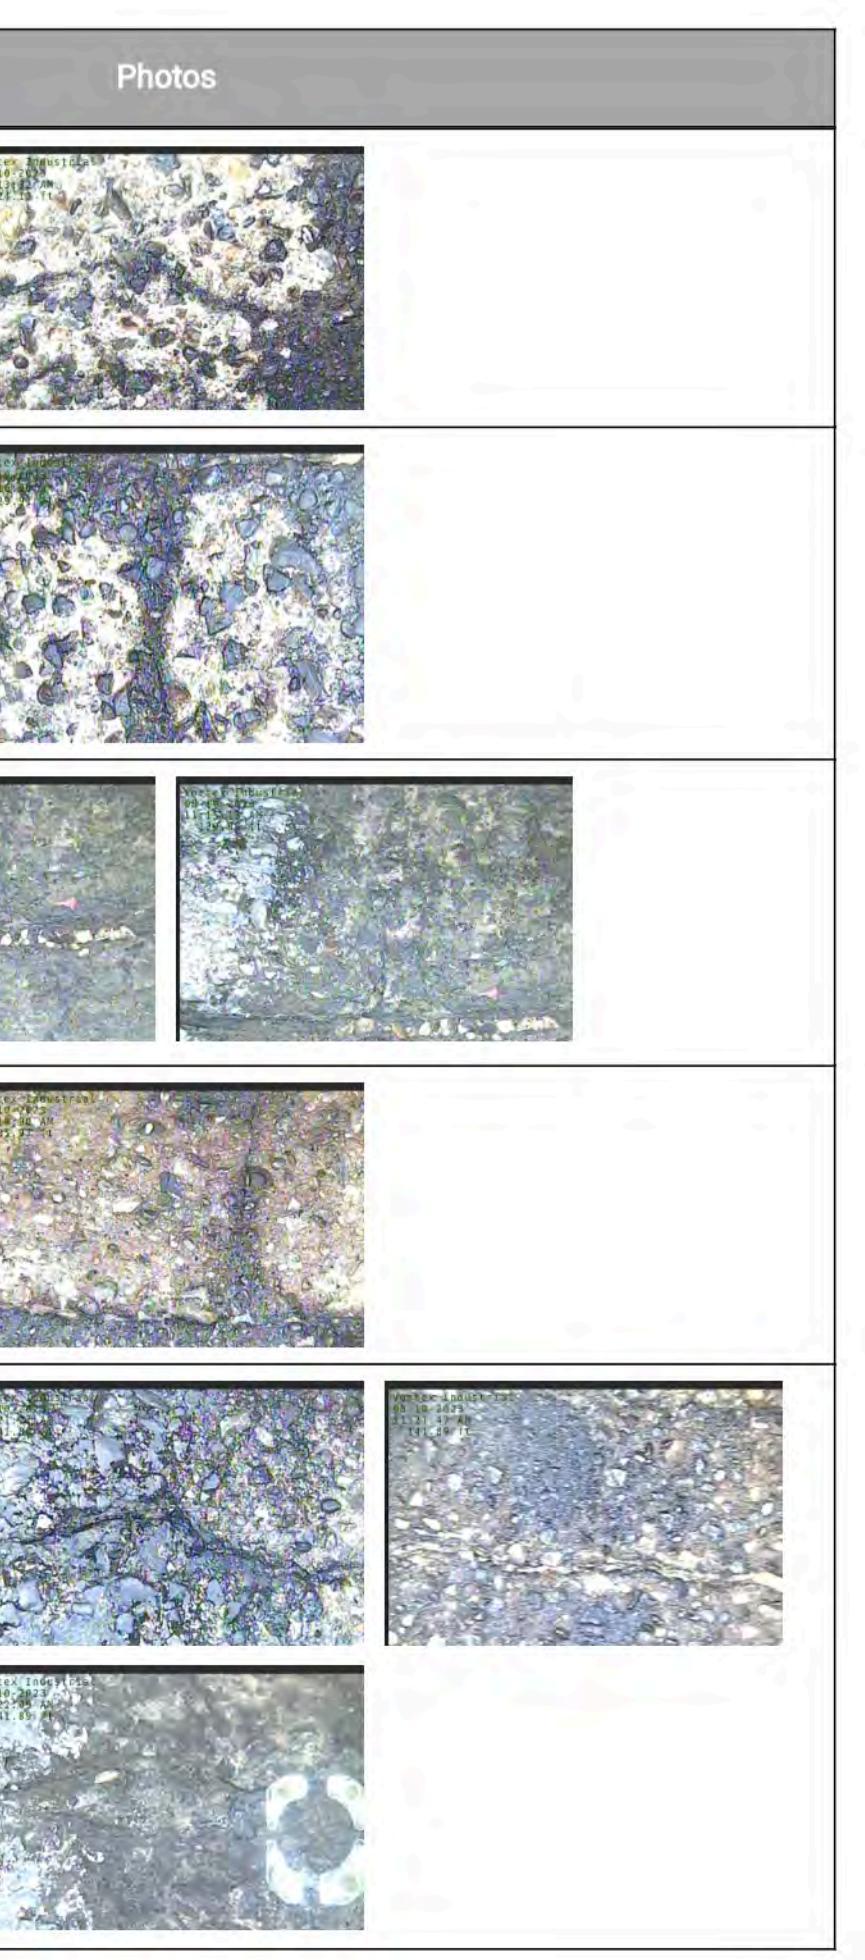
Description	Spatial Type	Distance (ft)	Туре	Percent	Clock	SR	0&M	С	PR	Remarks	
Crack Circumferential	Point	124.1	Structural	0	5-6	1	0	0	1	Crack Circumferential	
Crack Longitudinal	Point	129.8	Structural	0	9	2	0	0	2	Crack Longitudinal	
Crack Longitudinal	Point	129.8	Structural	0	6	2	0	0	1	Crack Longitudinal	
Crack Longitudinal	Point	135.8	Structural	0	11	2	0	0	1	Crack Longitudinal	
Crack Circumferential	Point	141.9	Structural	0	12- 12	1	0	0	2	Crack Circumferential	VALUE 1000000000000000000000000000000000000

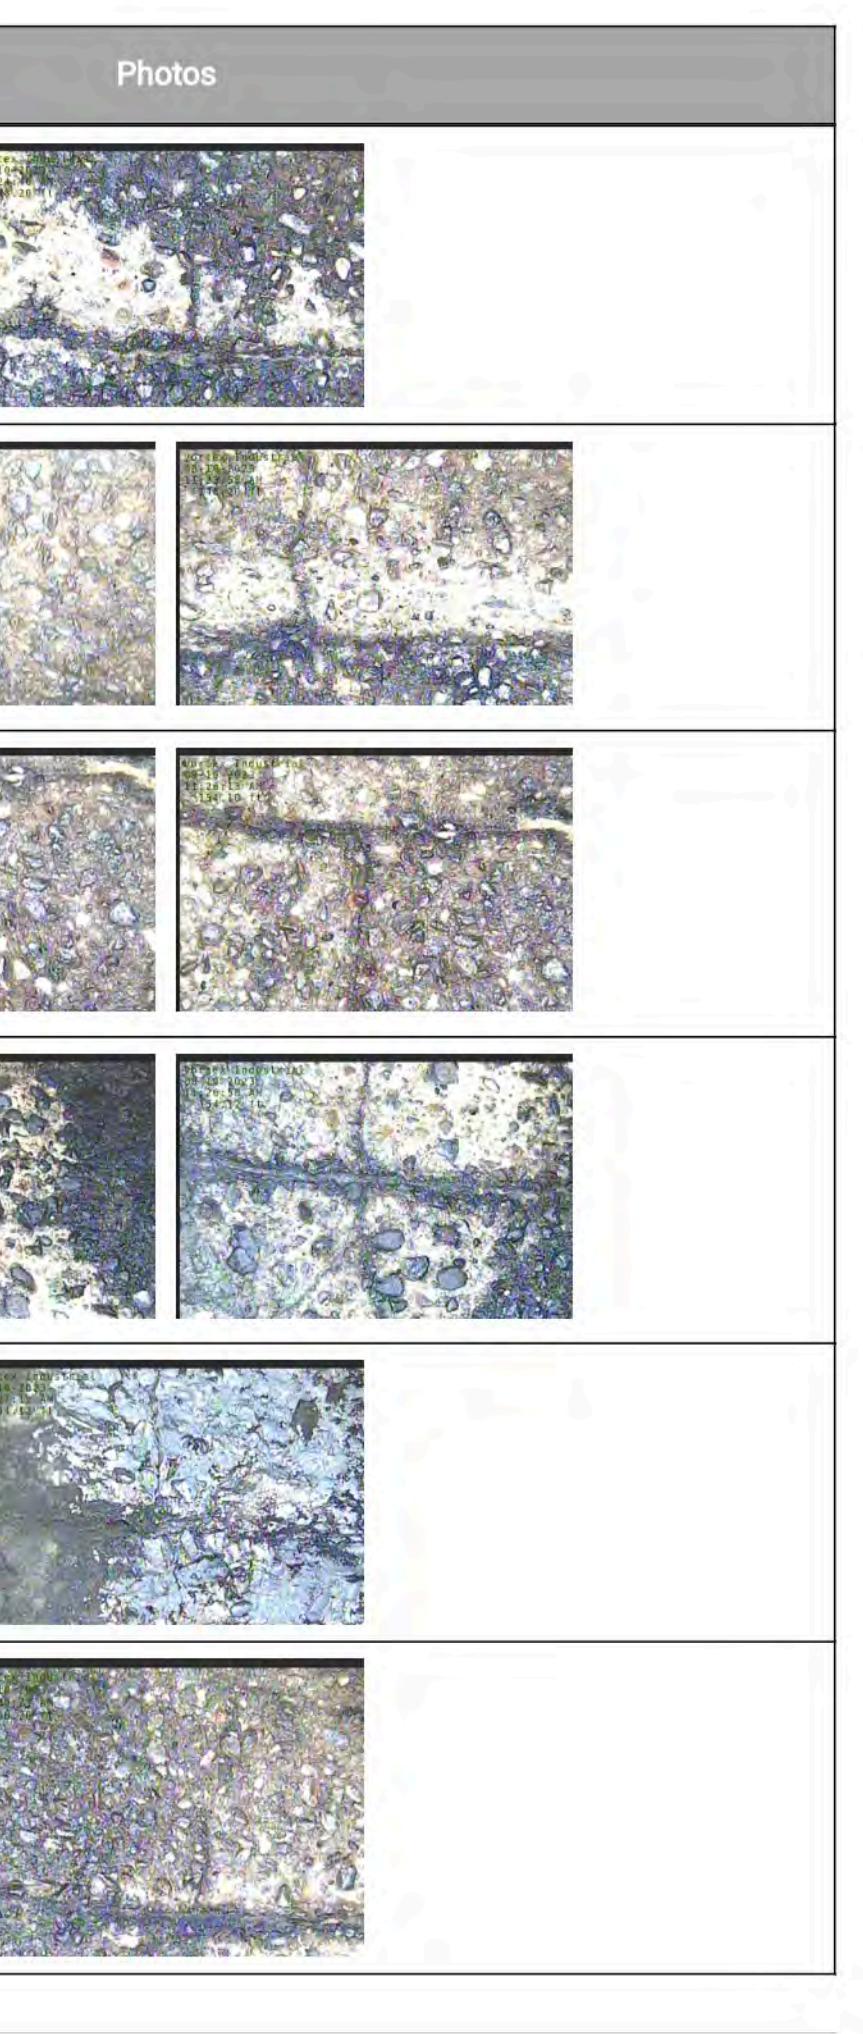
Description	Spatial Type	Distance (ft)	Туре	Percent	Clock	SR	0&M	С	PR	Remarks	
Crack Longitudinal	Point	148.2	Structural	0	2	2	0	0	1	Crack Longitudinal	
Crack Longitudinal	Point	148.2	Structural	0	11	2	0	0	1	Crack Longitudinal	Vorter, Industrial Vorter, Industrial Vorter, Schröner III. Vorter, Schröner Vorter, Schrön
Crack Longitudinal	Point	154.1	Structural	0	9	2	0	0	1	Crack Longitudinal	Ange Trichada Grant Die State Grant 11,520 grant 354 llo r T 4 4 4
Crack Longitudinal	Point	154.1	Structural	0	4	2	0	0	1	Crack Longitudinal	
Crack Longitudinal	Point	154.1	Structural	0	6	2	0	0	1	Crack Longitudinal	
Crack Longitudinal	Point	160.2	Structural	0	1	2	0	0	1	Crack Longitudinal

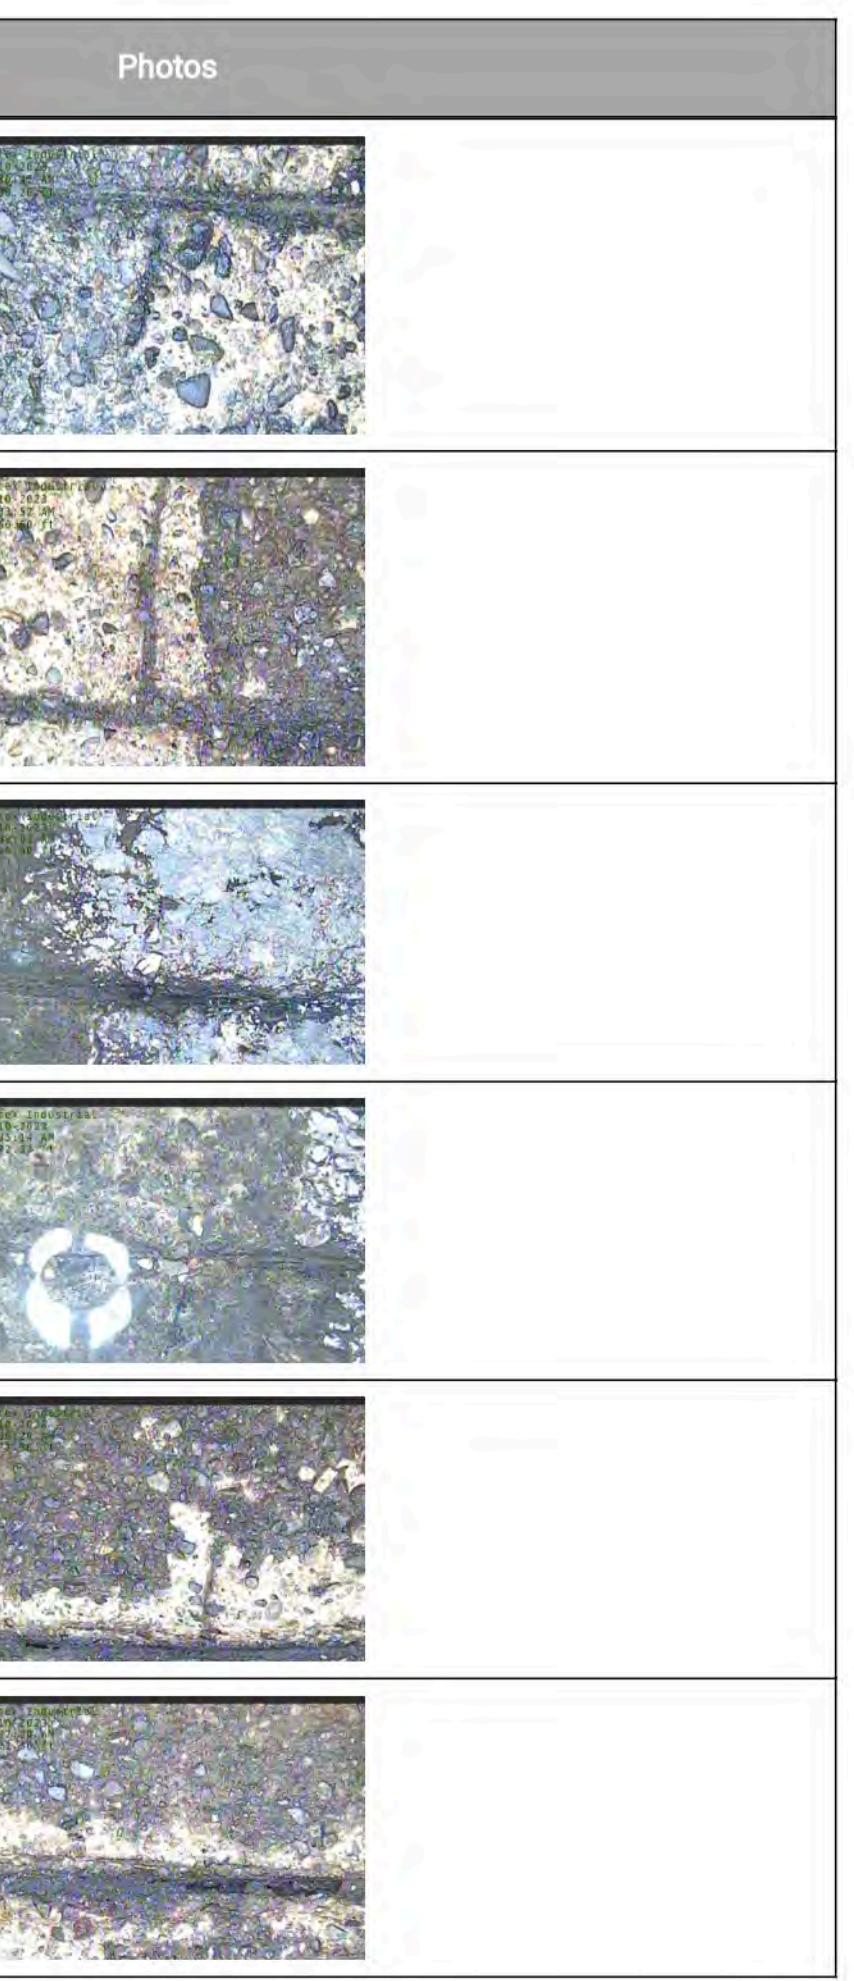
Description	Spatial Type	Distance (ft)	Туре	Percent	Clock	SR	0&M	С	PR	Remarks	
Crack Longitudinal	Point	160.2	Structural	0	4	2	0	0	1	Crack Longitudinal	
Crack Longitudinal	Point	166.6	Structural	0	3	2	0	0	1	Crack Longitudinal	
Crack Longitudinal	Point	166.6	Structural	0	5	2	0	0	1	Crack Longitudinal	
Crack Longitudinal	Point	172.3	Structural	0	6	2	0	0	1	Crack Longitudinal	
Crack Longitudinal	Point	172.3	Structural	0	10	2	0	0	1	Crack Longitudinal	
Crack Longitudinal	Point	172.3	Structural	0	12	2	0	0	1	Crack Longitudinal

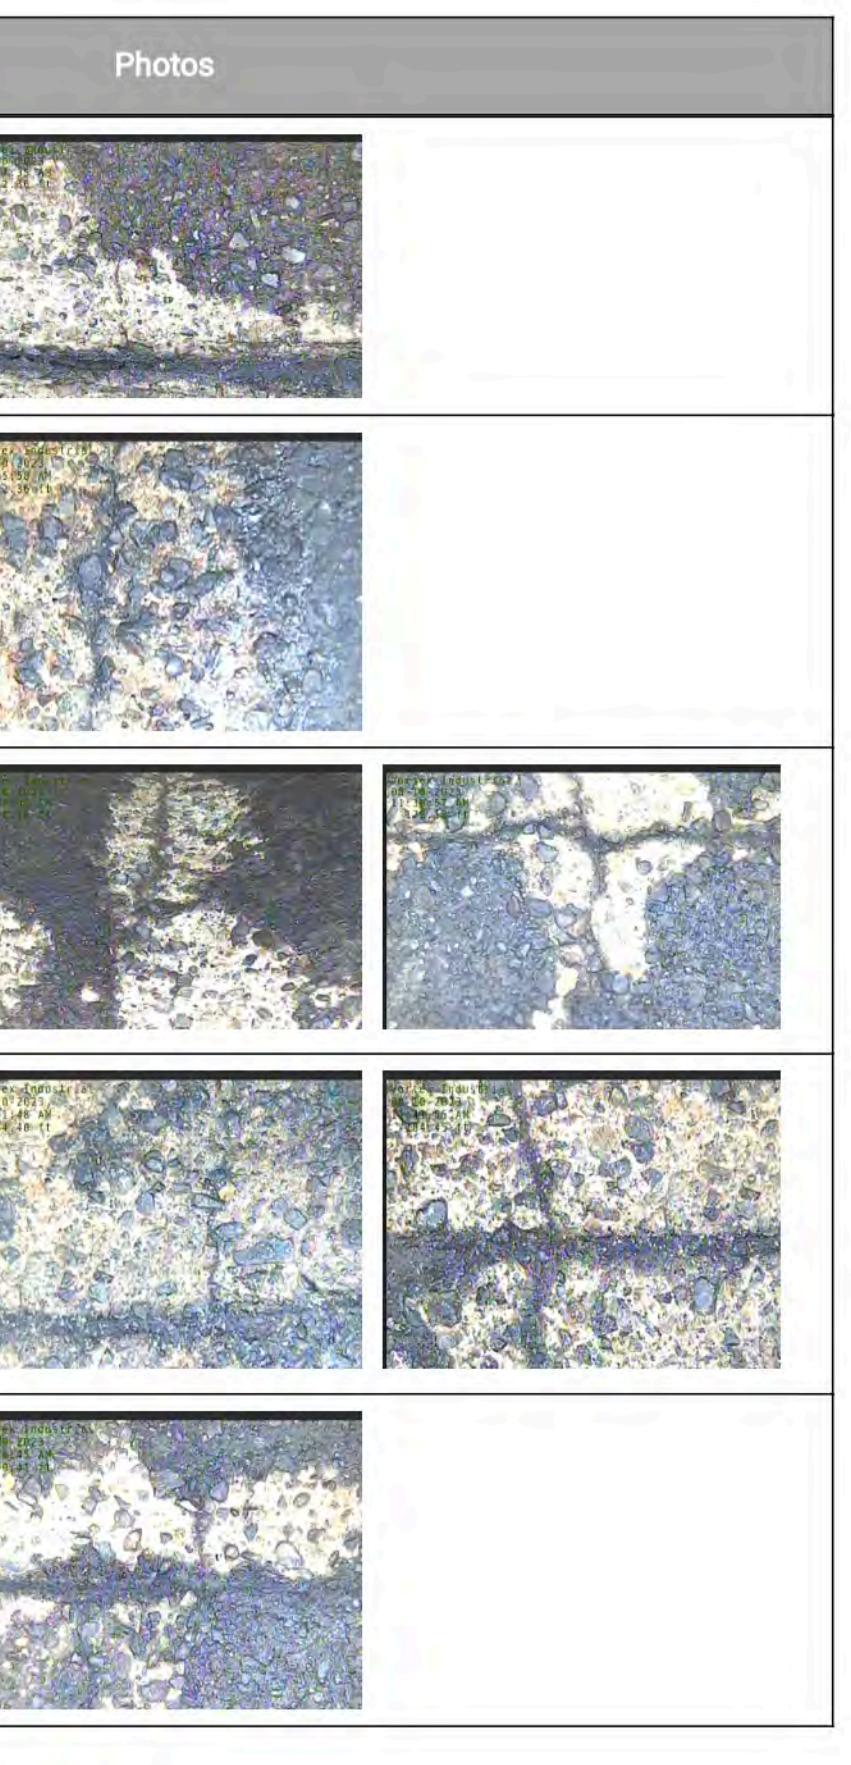
Description	Spatial Type	Distance (ft)	Туре	Percent	Clock	SR	0&M	С	PR	Remarks	
Crack Longitudinal	Point	172.3	Structural	0	1	2	0	0	1	Crack Longitudinal	
Crack Longitudinal	Point	172.3	Structural	0	8	2	0	0	1	Crack Longitudinal	
Crack Multiple	Point	178.2	Structural	0	6-11	3	0	0	1	Crack Multiple	
Crack Multiple	Point	184.5	Structural	0	8-9	2	0	0	1	Crack Multiple	
Crack Longitudinal	Point	190.4	Structural	0	9	2	0	0	1	Crack Longitudinal

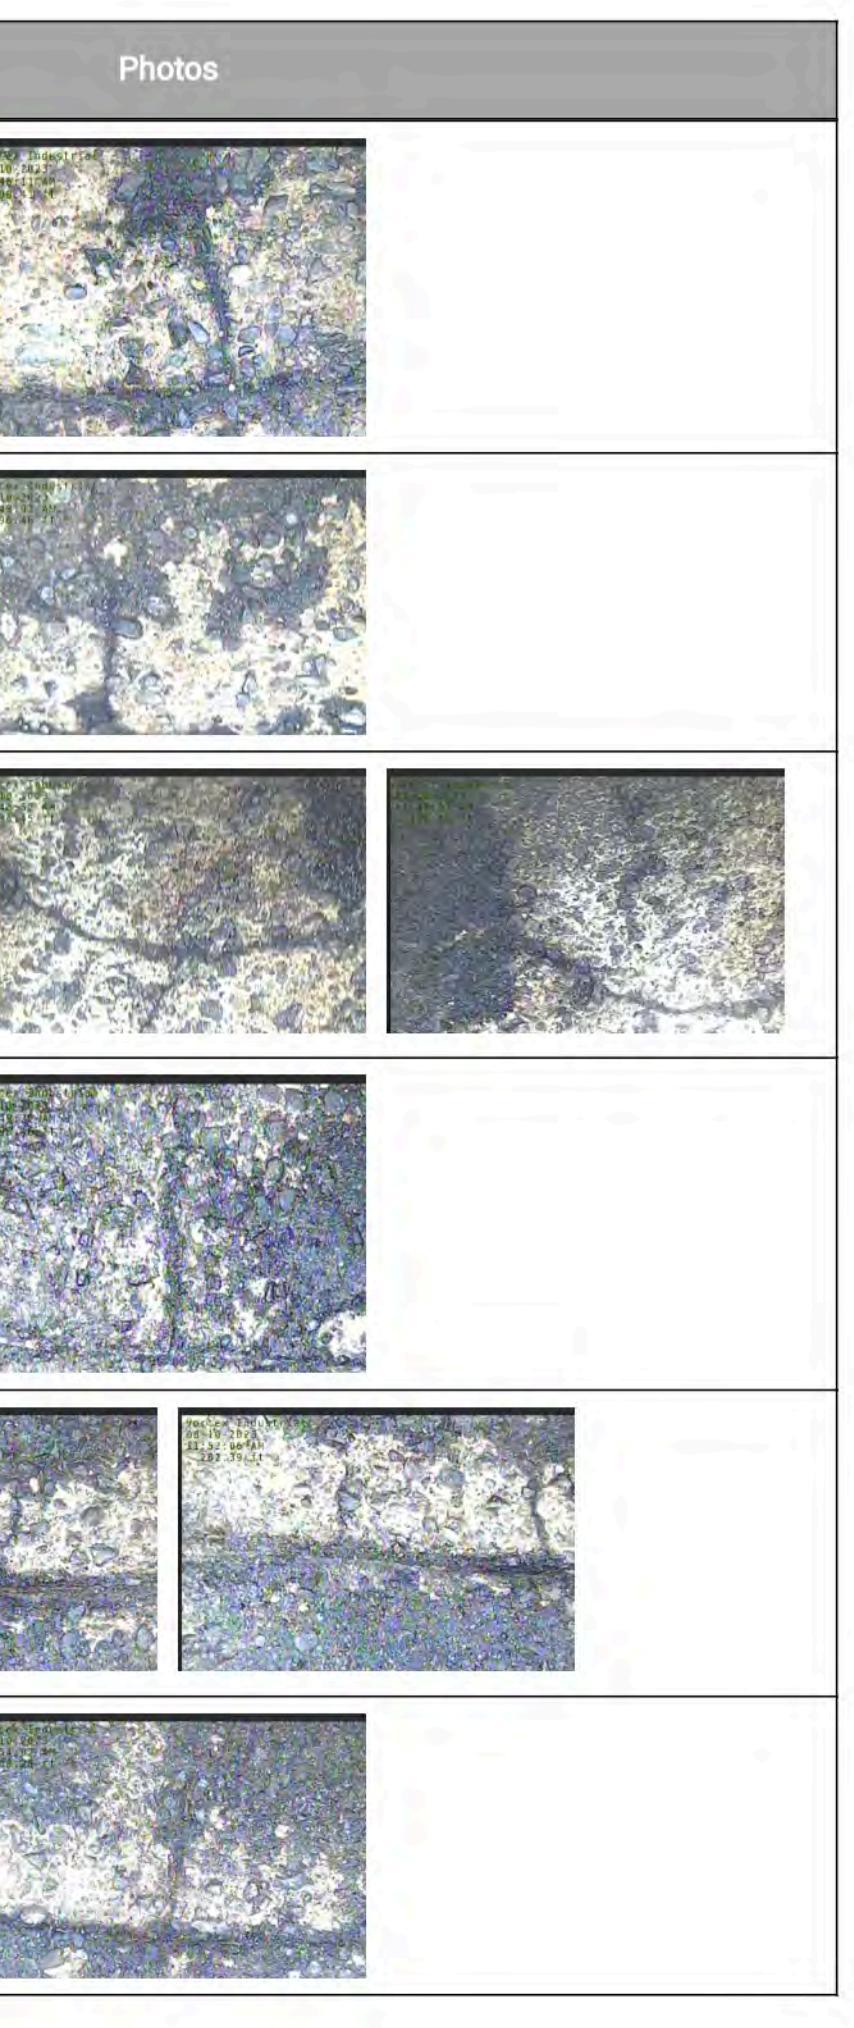
Description	Spatial Type	Distance (ft)	Туре	Percent	Clock	SR	0&M	С	PR	Remarks	
Crack Longitudinal	Point	190.4	Structural	0	8	2	0	0	1	Crack Longitudinal	
Crack Longitudinal	Point	196.4	Structural	0	1	2	0	0	1	Crack Longitudinal	
Crack Multiple	Point	196.4	Structural	0	8-10	3	0	0	1	Crack Multiple	
Crack Longitudinal	Point	196.4	Structural	0	3	2	0	0	1	Crack Longitudinal	
Crack Multiple	Point	202.4	Structural	0	1-2	3	0	0	1	Crack Multiple	
Crack Longitudinal	Point	208.2	Structural	0	1	2	0	0	1	Crack Longitudinal

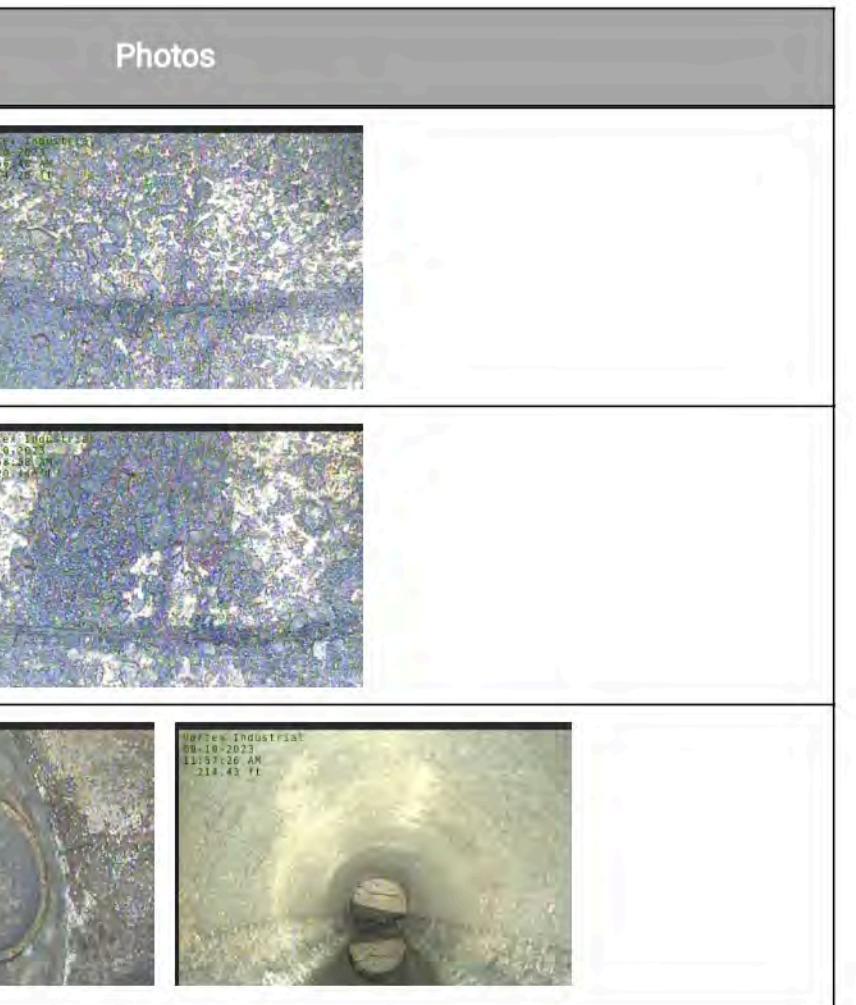
Description	Spatial Type	Distance (ft)	Туре	Percent	Clock	SR	0&M	С	PR	Remarks	
Crack Longitudinal	Point	214.3	Structural	0	11	2	0	0	1	Crack Longitudinal	
Crack Longitudinal	Point	220.4	Structural	0	12	2	0	0	1	Crack Longitudinal	
Manhole	Point	227.7	Constructional	0		0	0	0	0	D-6.1	89-10-2022 12:90-19-202 22:700-91 22:7,00-91

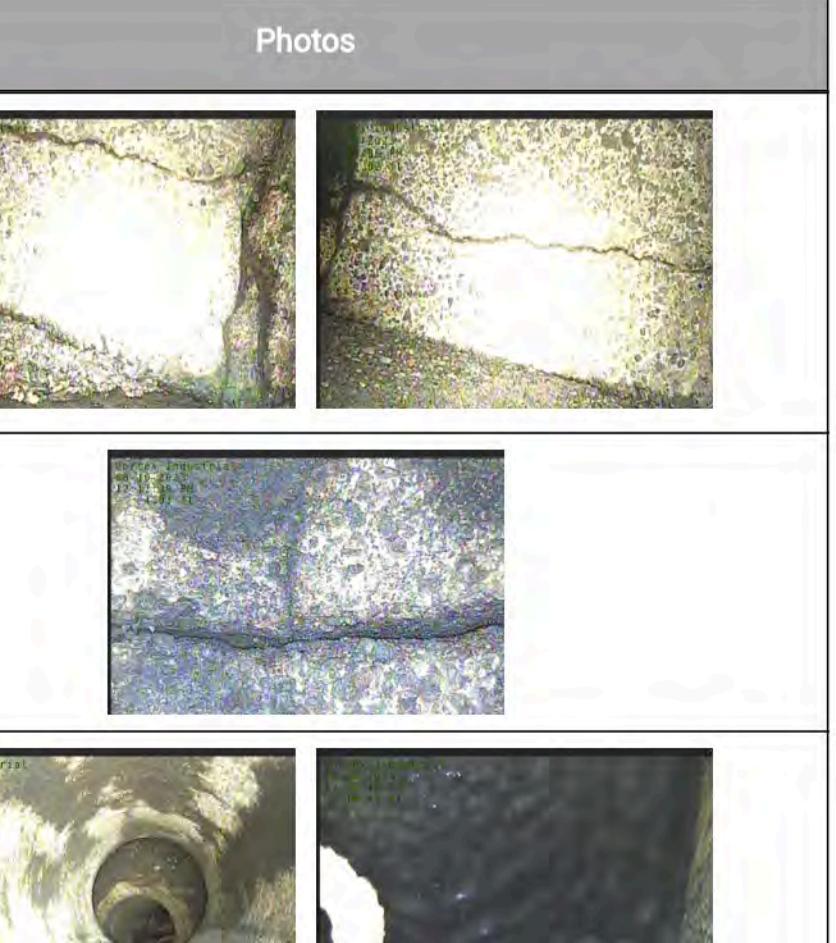
Description	Spatial Type	Distance (ft)	Туре	Percent	Clock	SR	0&M	С	PR	Remarks	
Fracture Multiple	Point	0.5	Structural	0	8-9	4	0	0	2	Fracture Multiple	
Crack Longitudinal	Point	4	Structural	0	11	2	0	0	1	Crack Longitudinal	
Manhole	Point	10.5	Constructional	0		0	0	0	0	D-6	Vortex Indus 88-10-263 12.182-37 PH 4.27 Yr 8

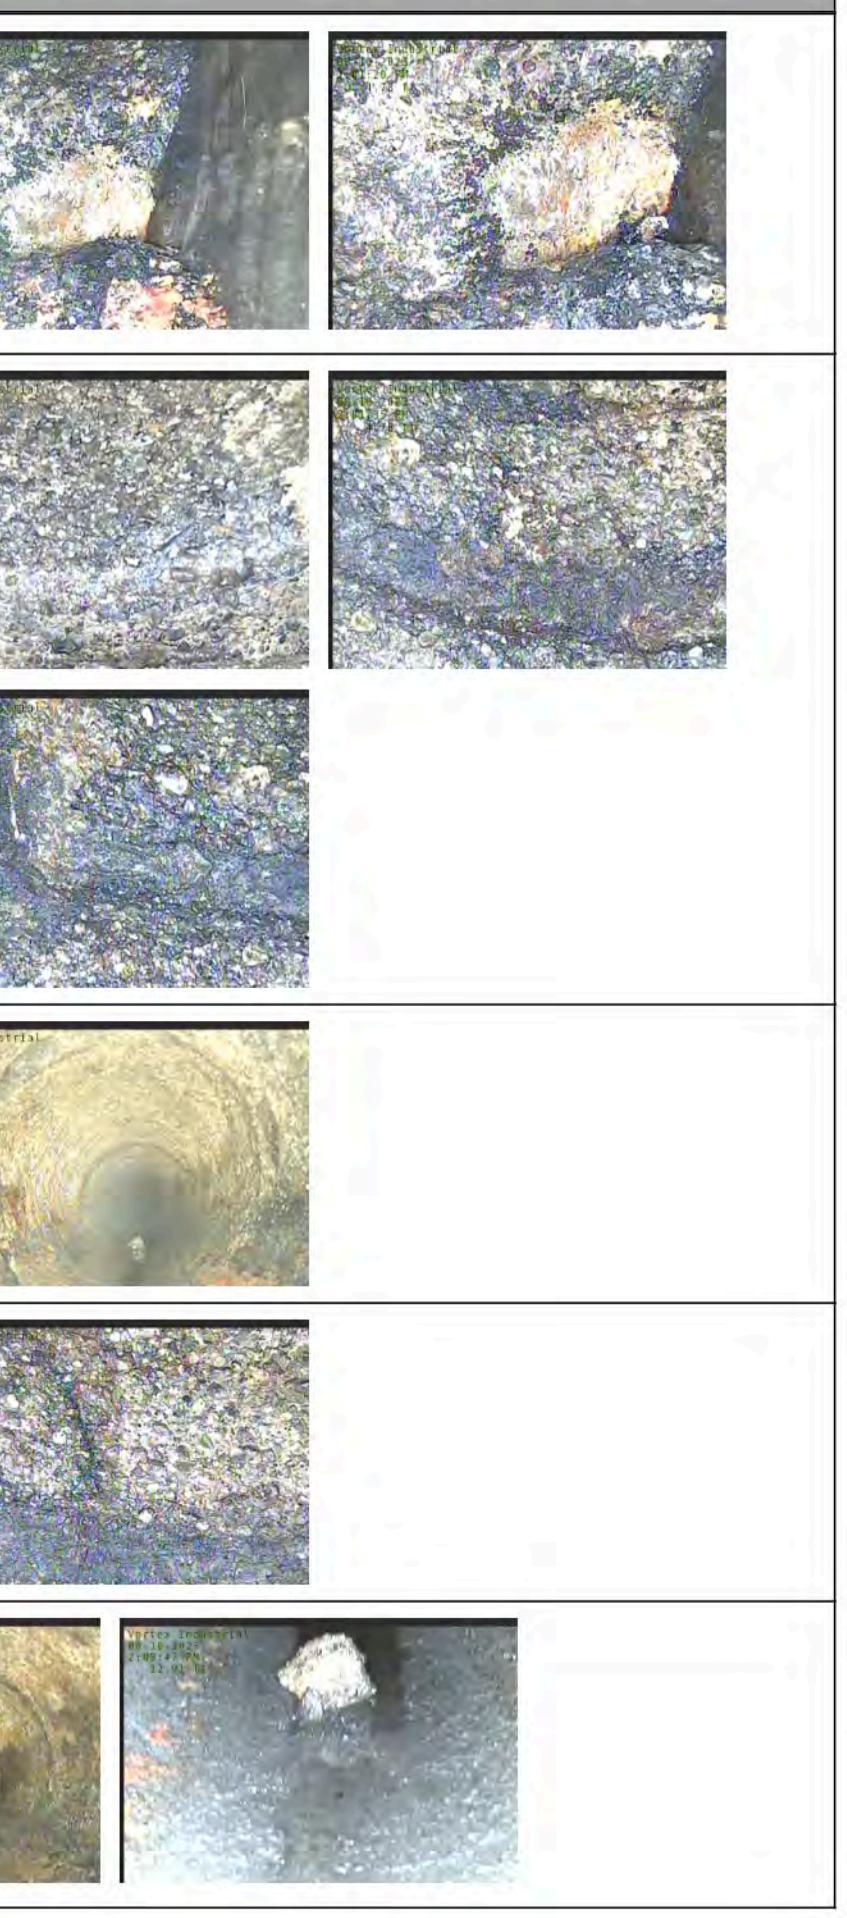
Description	Spatial Type	Distance (ft)	Туре	Percent	Clock	SR	O&M	С	PR	Remarks	
Fracture Circumferential	Point	4.8	Constructional	0	7-8	2	0	0	2	Fracture Circumferential	Process Tapostraat
Crack Circumferential	Point	4.8	Structural	0	9-7	1	0	0	1	Crack Circumferential	
Miscellaneous Water Level	Point	7	Miscellaneous	0		0	0	0	0	Miscellaneous Water Level	Vortes ing 19 10 292 2: 07:5 PX - 0:45 11 - 1: - 1: - 1: - 1: - 1: - 1: - 1: -
Crack Longitudinal	Point	13	Structural	0	4	2	0	0	1	Crack Longitudinal	
Obstruction Rocks	Point	14	O&M	10	6	0	2	0	0	Obstruction Rocks	Yonfor Industrial Basis 23 PR Program 9:05 Tr

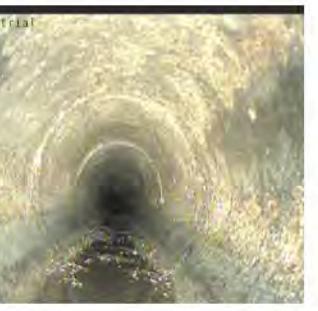
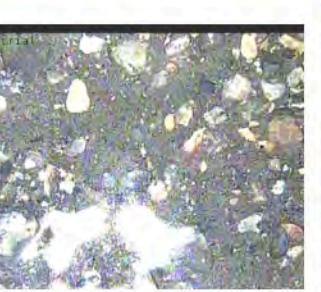
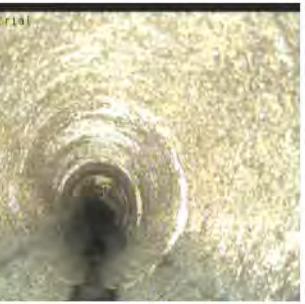
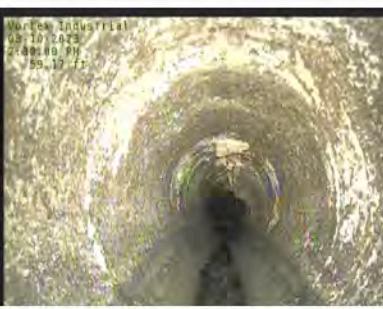
Description	Spatial Type	Distance (ft)	Туре	Percent	Clock	SR	O&M	С	PR	Remarks	
Miscellaneous Water Level	Point	33.4	Miscellaneous	10		0	0	0	0	Miscellaneous Water Level	Vortex Indo 08 10 2023 2120107 PM 33 16 FE
Deposits Settled Gravel	Continuous	37.5 - 52.8	O&M	10	6	0	2	0	0	Deposits Settled Gravel	Nortex Industrial Nortex Industrial 27.50 ft
Crack Longitudinal	Point	45.5	Structural	0	1	2	0	0	1	Crack Longitudinal	
Miscellaneous Water Level	Point	53.6	Miscellaneous	0		0	0	0	0	Miscellaneous Water Level	Vortex 1993 96 19 293 31 29 493 58 56 11
Point Repair Patch	Point	61.9	Structural	0	12	0	0	0	3	Point Repair Patch	Footness Industrial Anduard 975 Status of the the status of the stat

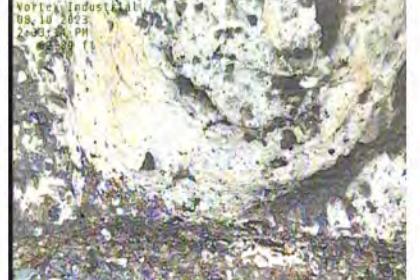
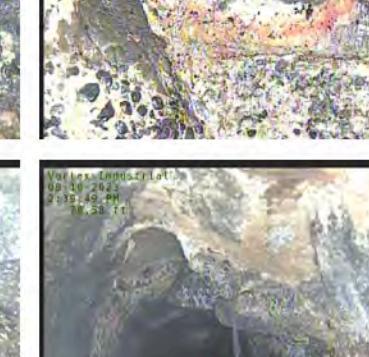
Description	Spatial Type	Distance (ft)	Туре	Percent	Clock	SR	O&M	С	PR	Remarks	
Crack Circumferential	Point	62.3	Structural	0	1-11	1	0	0	2	Crack Circumferential	Here have been set of the set of
Point Repair Patch	Continuous	66.1 - 75.1	Structural	20	12-3	0	0	0	3	Point Repair Patch	The set of th
Deposits Attached Encrustation	Point	78.5	0&M	10	12	0	2	0	0	Deposits Attached Encrustation	Vorter Industria 06530-2023 2/4/500 PN 24/50 FF

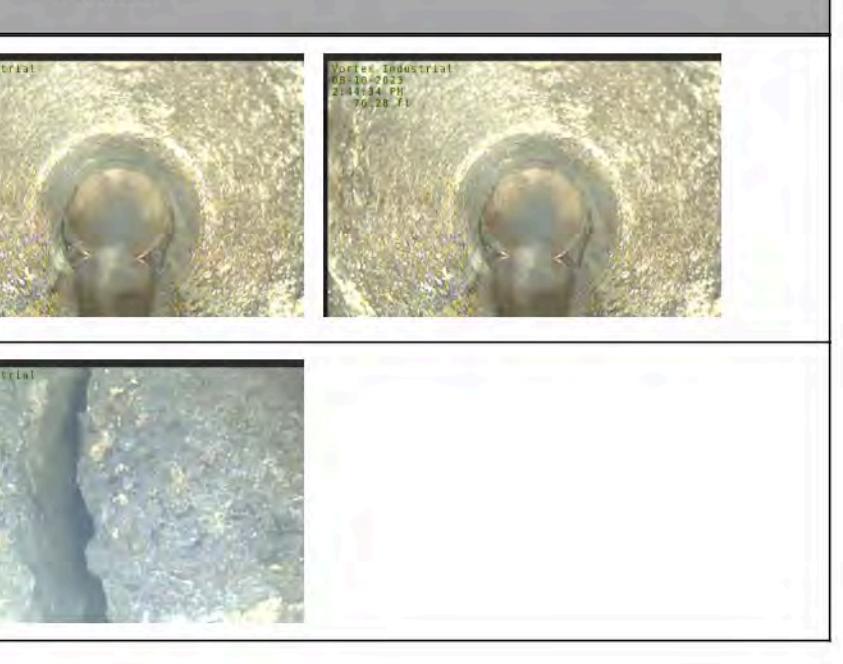
Description	Spatial Type	Distance (ft)	Туре	Percent	Clock	SR	0&M	С	PR	Remarks	The second second
Manhole	Point	82	Constructional	0		0	0	0	0	D-19	Vortes Today 10% 10 2023 10% 10% 10% 10% 10% 10% 10% 10% 10% 10% 10% 10% 10% 10% 10%
Fracture Longitudinal	Point	82	Structural	0	6	3	0	0	3	Fracture Longitudinal	Voctex Indus 08 18 2023 2147/31 PM 02/09 TF

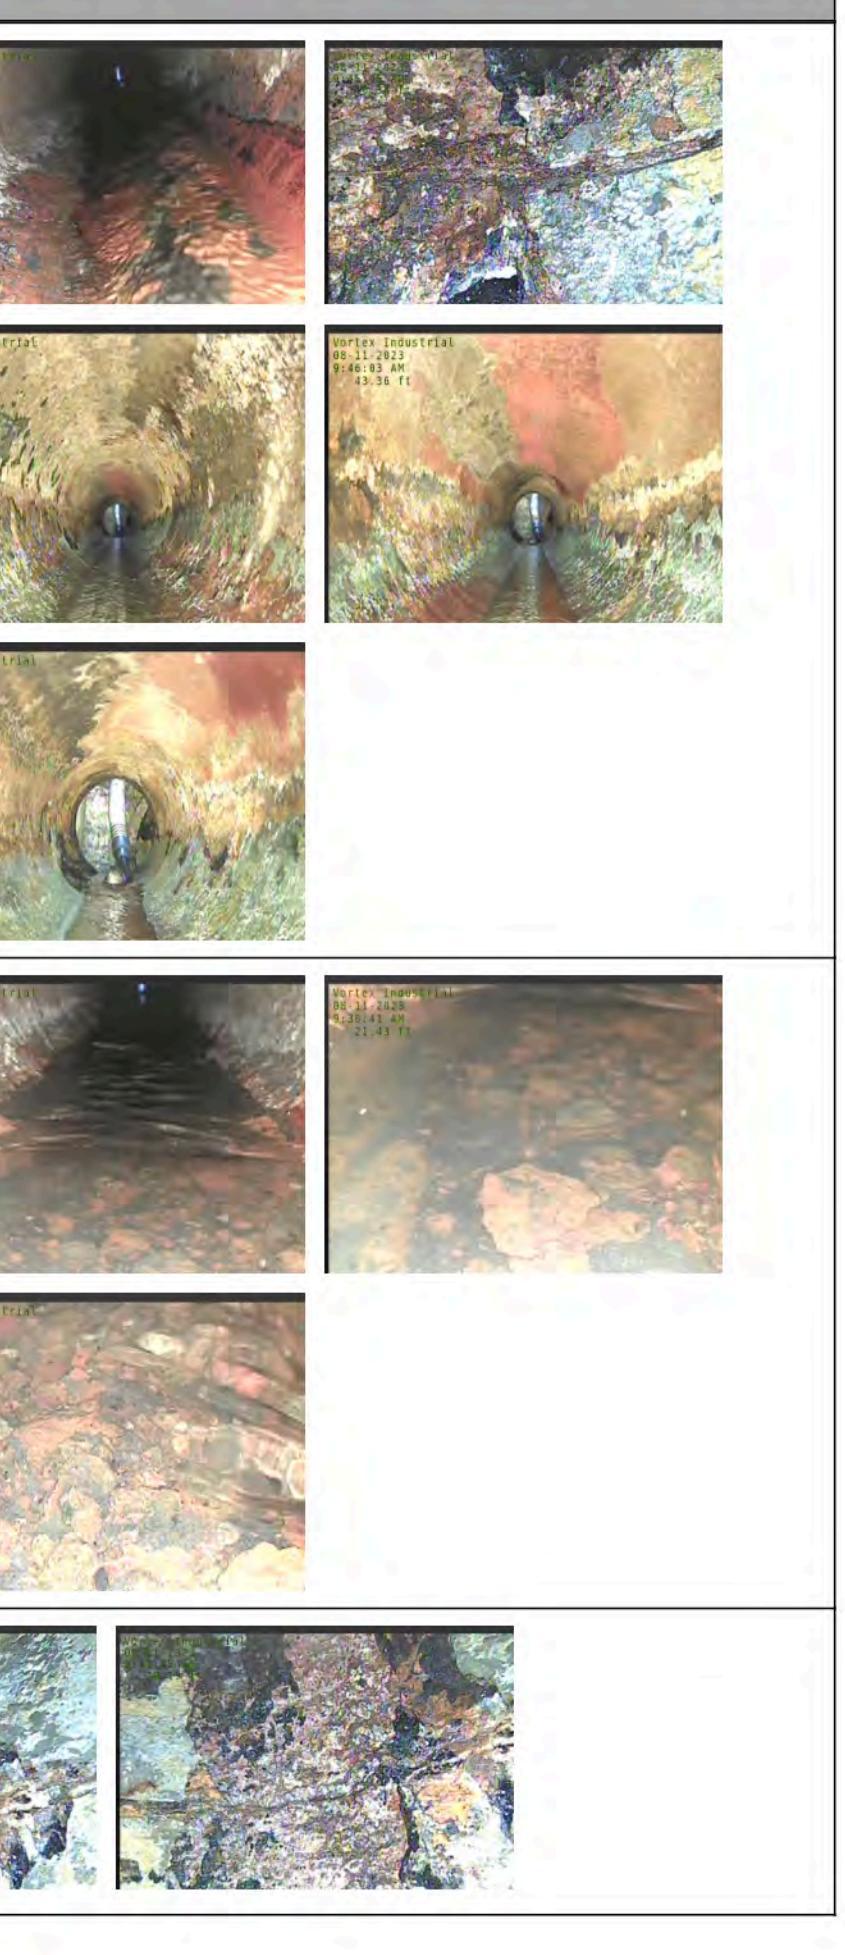
Description	Spatial Type	Distance (ft)	Туре	Percent	Clock	SR	O&M	С	PR	Remarks	22.222
Surface Damage Surface Spalling	Continuous	0 - 64.3	Structural	0	12- 12	2	0	0	1	Surface Damage Surface Spalling	Image: state in the state
Deposits Settled Gravel	Continuous	18.2 - 22.2	O&M	10		0	2	0	0	Deposits Settled Gravel	Wortex Index 1 2023 1 2023 1 2021 2 2023 1 2021 2 2027 1 2025 1 2025
Crack Longitudinal	Point	20.2	Structural	0	8	2	0	0	1	Crack Longitudinal

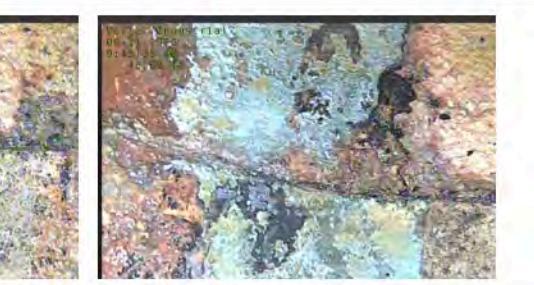
Description	Spatial Type	Distance (ft)	Туре	Percent	Clock	SR	0&M	С	PR	Remarks	
Crack Longitudinal	Point	40.4	Structural	0	4	2	0	0	1	Crack Longitudinal	Vortier Industrial TRT-1-2033 A-1-3-9 Art A-1-4-4 Art Art A-1-4-4 Art A-1-4-4 Art A-1-4-4 Art A-1-4-4 Art A-1-4-4 Art A-1-4-4 Art A-1-4-4 Art A-1-4-4 Art A-1-4-4 Art A-1-4-4 Art A-1-4-4 Art A-1-4-4 Art Art A-1-4-4 Art Art A-1-4-4 Art Art A-1-4-4
Crack Longitudinal	Point	59.1	Structural	0	7	2	0	0	1	Crack Longitudinal	
Manhole	Point	64.3	Constructional	0		0	0	0	0	D-20C	909-19- 2023 9-39/72- An 5-9-37/72- An 5-9-37/72- An

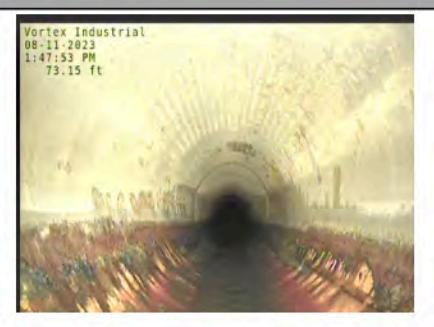
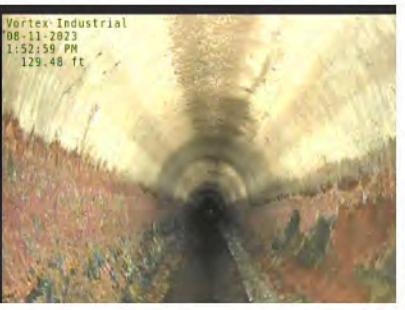
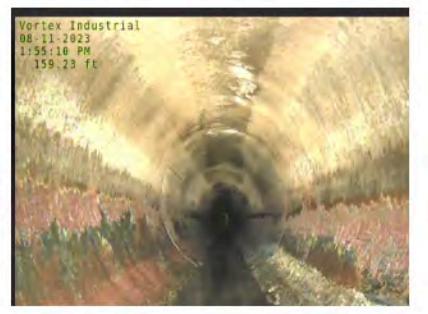
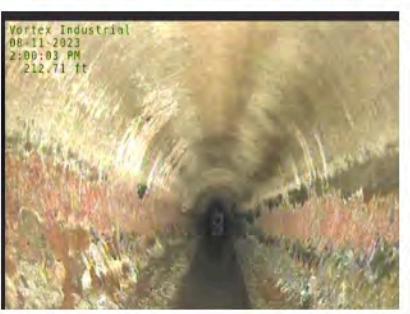
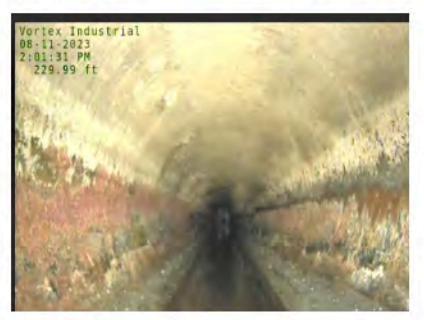
Setup ID	2023-9	Inspec	tion Date	Aug 11, 2	023	Inspe	cted Le	ength	(ft)	332	Defects Rated ≥3 0 Peak Structural Rating 3
Segment ID	D-22:D-23	Primary P	Pipe Material	SP		Pipe	e Diame	eter (ir	ר)	30	Peak Prioritization Rating 2 Peak C/O&M Rating 0
Description	Spatial Type	Distance (ft)	Туре	Percent	Clock	SR	O&M	С	PR	Remarks	Photos
Manhole	Point	0	Constructiona	1 0		0	0	0	0	D-22	
Miscellaneous Water Level	Point	0	Miscellaneous	s 10		0	0	0	0	Water Leve at Start of Survey	Vortex Industrial Vortex Indust
Surface Damage Corrosion	Continuous	0 - 332	Structural	0	3-9	3	0	0	2	Surface Damage Corrosion	Vortes Industrial Smult. Jo23 11.125 PP Pr 11.78 ft 11.78
											Vortex-Indvortiat BS-11-2023 1:41:97-99 32.29/ft

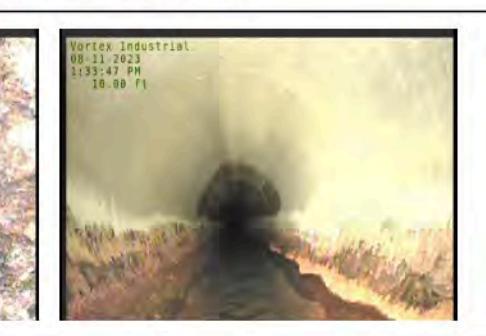
Description	Spatial Type	Distance (ft)	Туре	Percent	Clock	SR	0&M	С	PR	Remarks	
											Vortex Industrial 89-11-2023 231,01 ft 235.40 Ff 235.94 ft 235.94 ft 245.94 ft 24
Crack Longitudinal	Point	10	Structural	0	5	2	0	0	1	Crack Longitudinal	
Surface Damage Roughness Increase	Point	47.7	Structural	0	9	1	0	0	2	Surface Damage Roughness Increase	Vortex Industrial BB-11-2023 1-44:41 PM 47.17 ft
Crack Longitudinal	Point	49.8	Structural	0	4	2	0	0	1	Crack Longitudinal

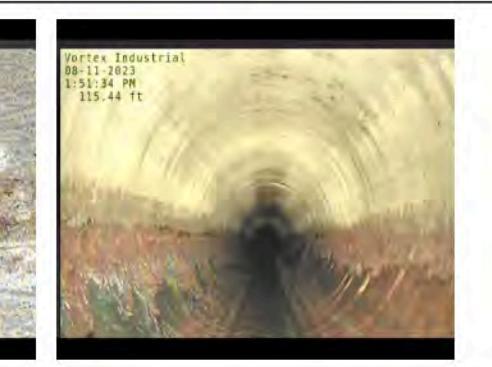
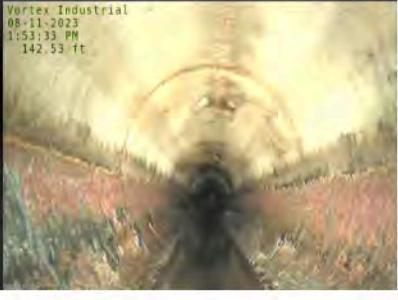
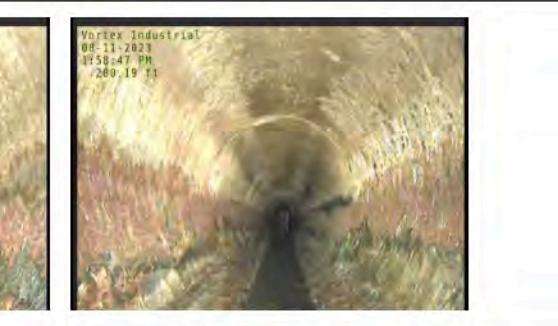
Description	Spatial Type	Distance (ft)	Туре	Percent	Clock	SR	0&M	С	PR	Remarks	
Surface Damage Roughness Increased	Continuous	55 - 61.3	Structural	0	11-1	1	0	0	1	Surface Damage Roughness Increased	Vortex Industrial 06:11:2023 11:46:07 PM 53:20 ft
Crack Longitudinal	Continuous	110.8 - 127.2	Structural	0	3	2	0	0	1	Crack Longitudinal	House's Industrial Bar 2023 E-Jacob PR 2029 E-Jacob PR 2020 E-Jacob PR 2020 E-
Crack Longitudinal	Continuous	129.2 - 147	Structural	0	1	2	0	0	2	Crack Longitudinal	Vortex Industrial BB-11-2023 IS52:00 PM IZ6.30 ft IS52:00 PM IS52:00 PM
Surface Damage Roughness Increased	Point	162	Structural	0	12	1	0	0	1	Surface Damage Roughness Increased	Vorte Tiduarial Di 31:203 Ito 66 ft
Surface Damage Roughness Increased	Continuous	189.2 - 208.9	Structural	0	9-3	1	0	0	1	Surface Damage Roughness Increased	Vortex Industrial 08-11-2013 1158:17 PM 189:00 ft W-Par

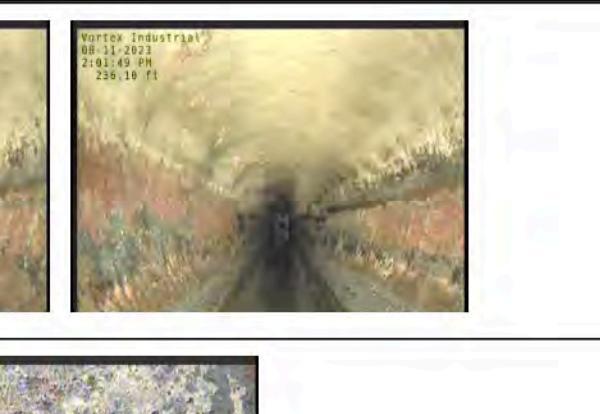
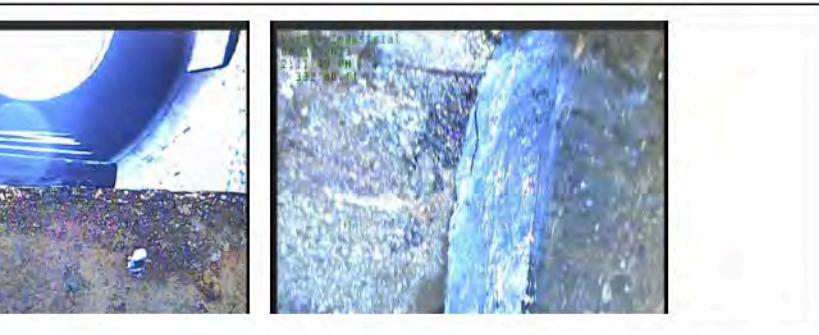
Description	Spatial Type	Distance (ft)	Туре	Percent	Clock	SR	0&M	С	PR	Remarks	
Surface Damage Roughness Increased	Continuous	237 - 247	Structural	0	11	1	0	0	1	Surface Damage Roughness Increased	Vortex Industrial 08-11-2623 27:01:45.90 234,70 ft
Crack Longitudinal	Point	309.6	Structural	0	10	2	0	0	1	Crack Longitudinal	
Manhole	Point	332	Constructional	0		0	0	0	0	D-23
