2024 ANNUAL PROGRESS REPORT SWMU-1 OILY WATER SEWER

HF SINCLAIR PUGET SOUND REFINING LLC

March 2025

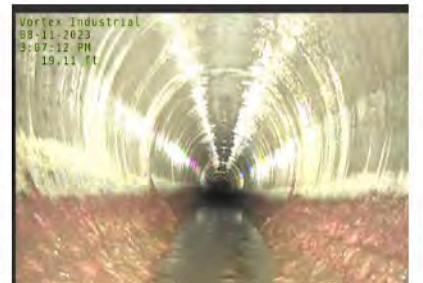
Description	Spatial Type	Distance (ft)	Туре	Percent	Clock	SR	O&M	С	PR	Remarks	
Surface Damage Corrosion	Point	17	Structural	0	4-8	3	0	0	3	Surface Damage Corrosion	Vortex Industrial 09-11-2023 3:07:08 PH 17:09 Ti
Surface Damage Corrosion	Continuous	19 - 75	Structural	0	4-8	3	0	0	2	Surface Damage Corrosion	Vorter Talustriat 30925 87 37.36 ft Vorter Tausstriat 81.32 99 Pt 18.32 ft

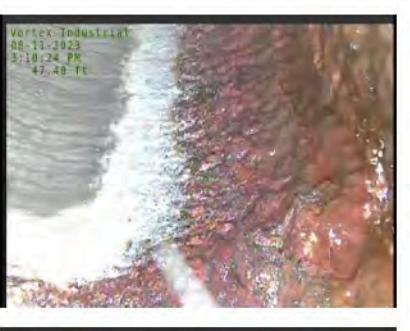
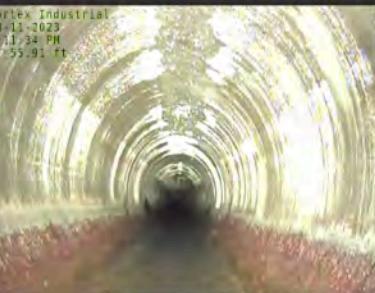
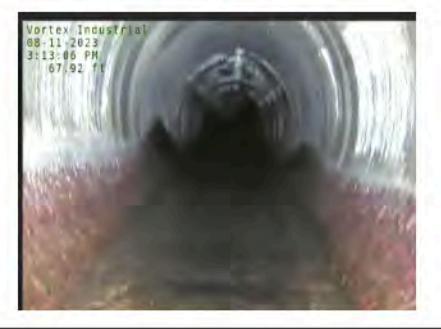
Description	Spatial Type	Distance (ft)	Туре	Percent	Clock	SR	O&M	С	PR	Remarks	
Surface Damage Corrosion	Continuous	75 - 88	Structural	0	4-8	3	0	0	3	Surface Damage Corrosion	Vortex Industriat 09-11-2023/ 3:13:7023/ 76-38 ft 76-38 ft
Surface Damage Corrosion	Continuous	88 - 120	Structural	0	4-8	3	0	0	2	Surface Damage Corrosion	Vortex Industrial 00-11-2023 3:27:10 PM 93.73 ft Vortex Industrial 00-11-2023 3:13:57 PM 124.75 ft
Surface Damage Roughness Increased	Continuous	117 - 125.4	Structural	0	9-1	1	0	0	1	Surface Damage Roughness Increased	00rtex Industrial 85-11-2023 3-20-06 PM 115-23 ft

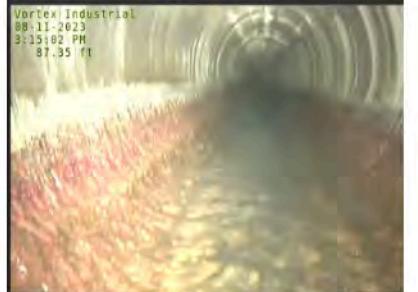
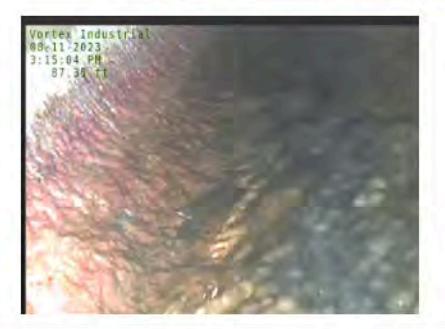
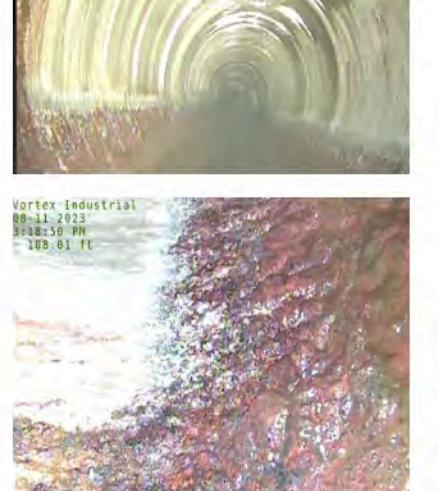
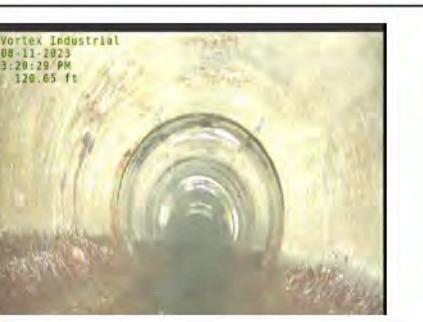
Description	Spatial Type	Distance (ft)	Туре	Percent	Clock	SR	O&M	С	PR	Remarks	
Surface Damage Corrosion	Continuous	120 - 150	Structural	0	4-8	3	0	0	3	Surface Damage Corrosion	Vortex Industrial Bize.ol ft
Surface Damage Roughness Increased	Point	135	Structural	0	11-1	1	0	0	1	Surface Damage Roughness Increased	
Surface Damage Roughness Increased	Continuous	146 - 158	Structural	0	10-2	1	0	0	1	Surface Damage Roughness Increased	Vertex Industrial 88-15-2023 3:23:56 Pr 165:93.00

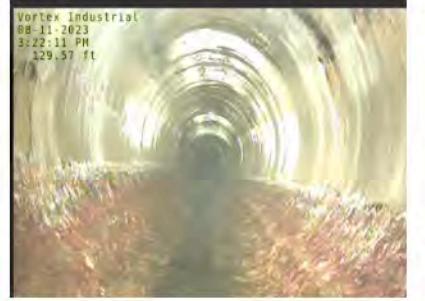
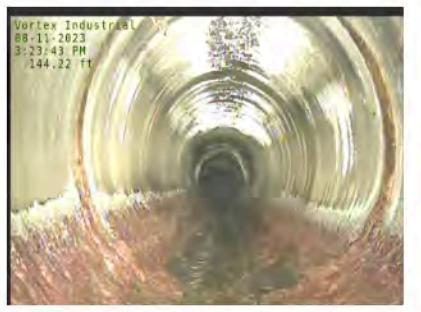
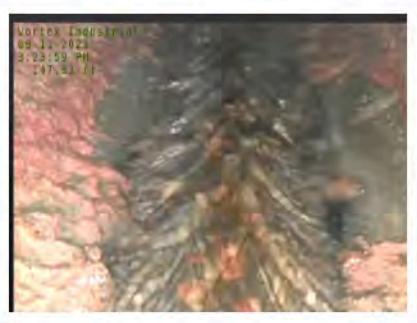
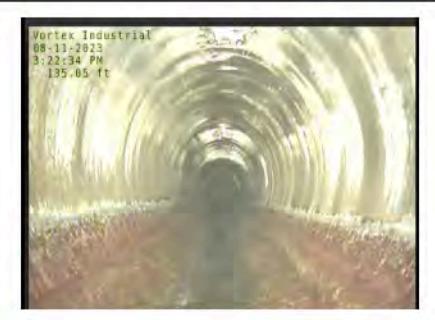
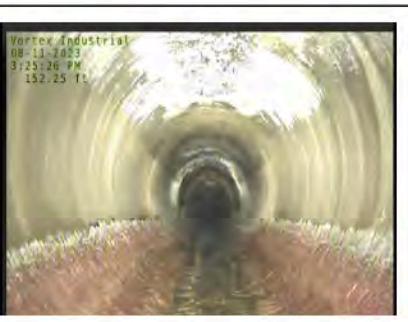
Description	Spatial Type	Distance (ft)	Туре	Percent	Clock	SR	O&M	С	PR	Remarks	
Surface Damage Corrosion	Continuous	150 - 176.1	Structural	0	4-8	3	0	0	2	Surface Damage Corrosion	139.89 Tr 139.89 Tr 139.89 Tr
Surface Damage Roughness Increased	Continuous	165 - 171.4	Structural	0	10-2	1	0	0	1	Surface Damage Roughness Increased	
Surface Damage Corrosion	Continuous	176.2 - 217.3	Structural	0	12- 12	3	0	0	2	Surface Damage Corrosion	Vortex Industrial The 14:003 V75.93, Ht V75.93, Ht V75.94, Ht V75.94, Ht V75.95, Ht

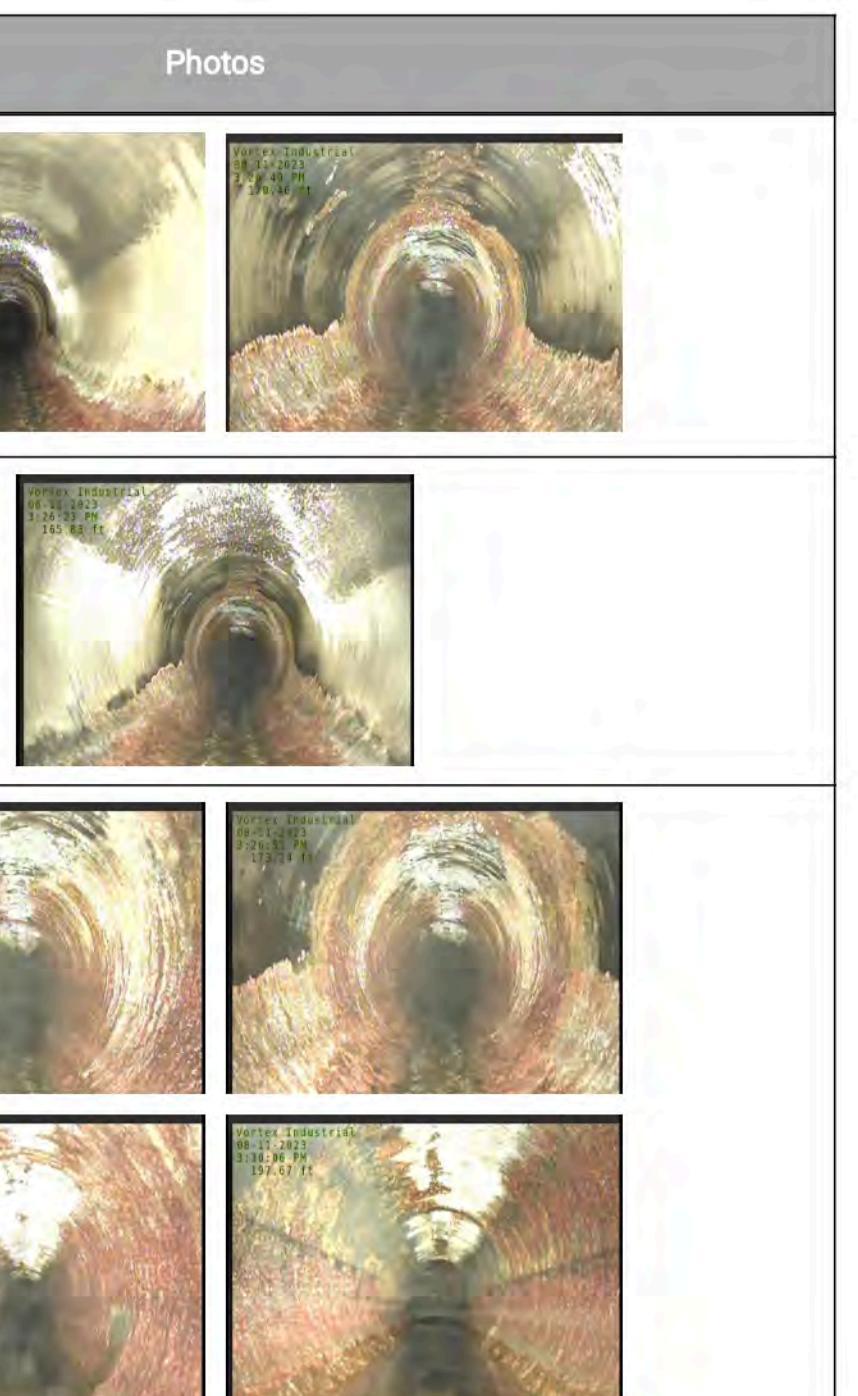
Description	Spatial Type	Distance (ft)	Туре	Percent	Clock	SR	0&M	С	PR	Remarks	
Surface Damage Spalling	Point	187.6	Structural	5	11	2	0	0	1	Surface Damage Spalling	Sortes. Industrials, Book - 2003 B27A-827 PM - 3273 B1 Tu - 2004 B27A-827 PM - 3273 B1 Tu - 2004 B27A-827 PM - 3274 B27A-827 PM - 3274 B27A-827
Miscellaneous General Observation	Point	206.5	Miscellaneous	5	10	0	0	0	0	Ring Inserted in Pipe	Warter Industrian De 11 2023 2 71 al PR 206 55 1t
Manhole	Point	217.3	Constructional	0		0	0	0	0	D-24	Vortex Industrial eg 11 2023 3:49:46 PM 214.79 Tr
Line Down	Point	217.3	Constructional	100		0	4	4	0	Line Down	Vortex Industrial Statisty Ph 236 01 ft

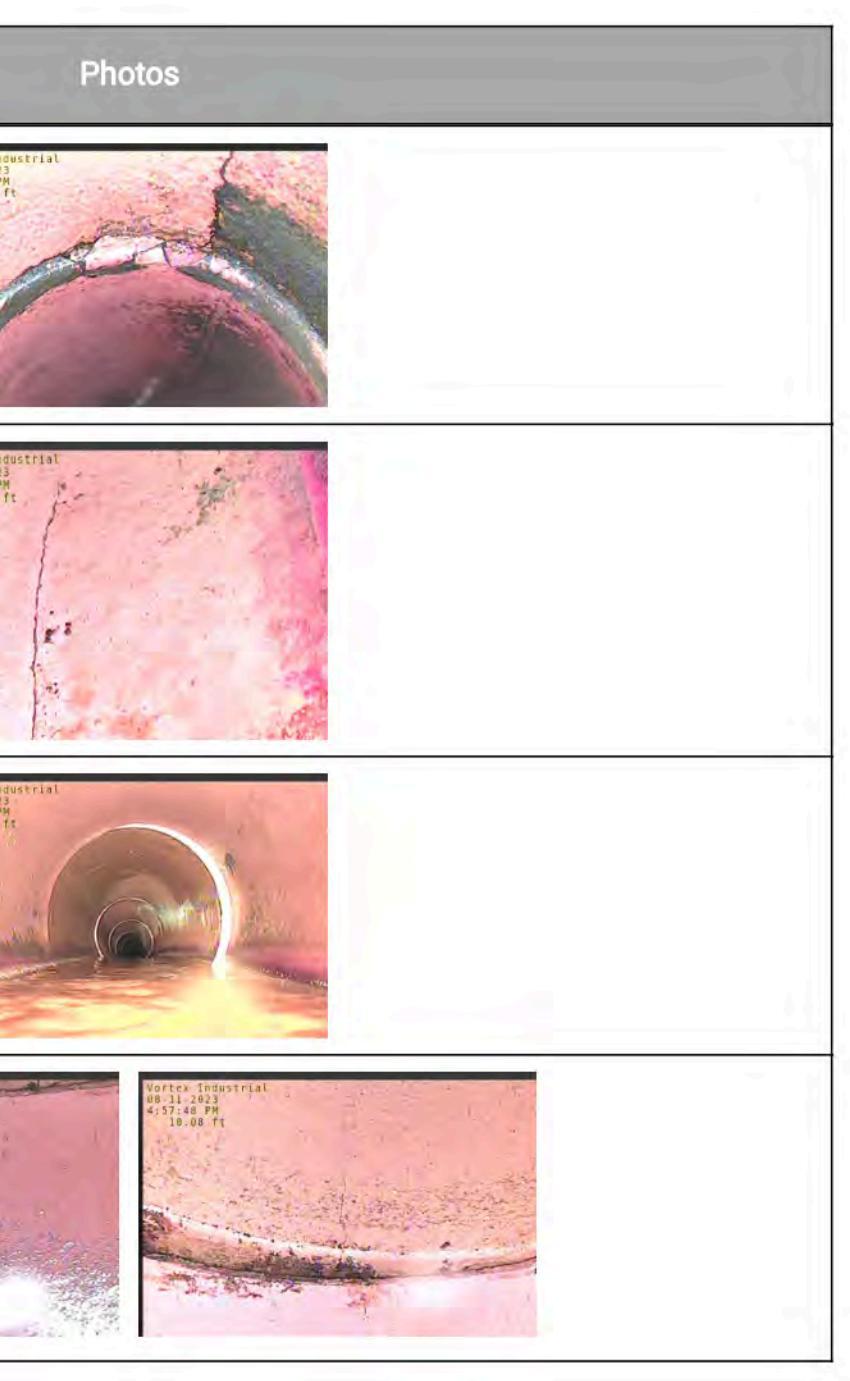
Description	Spatial Type	Distance (ft)	Туре	Percent	Clock	SR	O&M	С	PR	Remarks	
Fracture Multiple	Doint	14.2	Structural	0	12-	2	0	0	2	Fracture Multiple	Vortex 1 BB-11-20 4:59:49 13.09 1
	Foint	14.2	Structural		12	2			5		PH 44
Crack Multiple	Point	18.2	Structural	0	1-3	3	0	0	2	Crack Multiple	Vortex tedustrial DB-11-2027 S103:16-PR 18.25 Ft 18.25 Tt 18.25 Tt 18.
Crack Multiple	Point	18.2	Structural	0	5-6	3	0	0	2	Crack Multiple	5100[19]

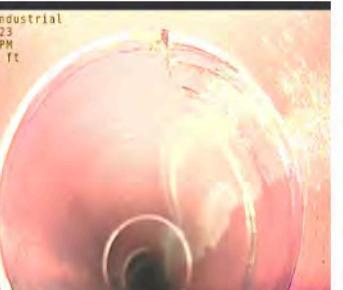
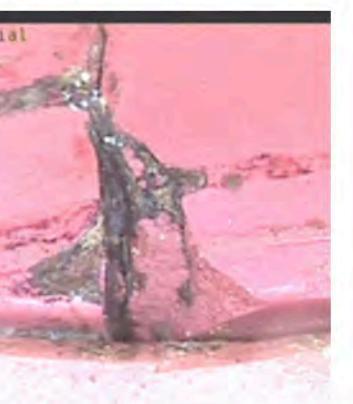
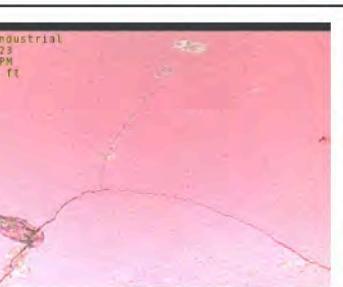
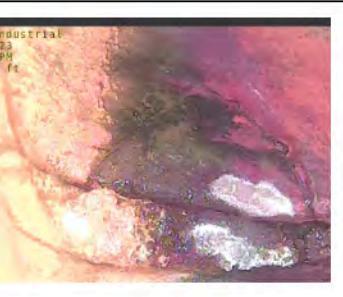
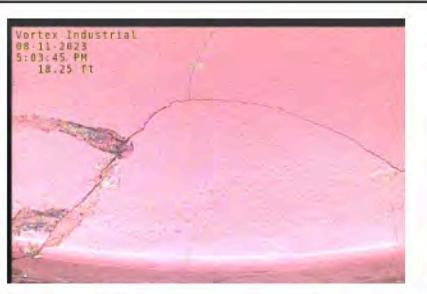
Description	Spatial Type	Distance (ft)	Туре	Percent	Clock	SR	O&M	С	PR	Remarks	E T Look and the
Crack Multiple	Point	22.2	Structural	0	12- 12	3	0	0	2	Crack Multiple	Vertex.Inductors 3:35:26 mpr 2:2:39 pr 3:35:26 mpr
Crack Spiral	Point	24.5	Structural	0	2-6	2	0	0	1	Crack Spiral	Vorter Industriet 318:12-2023 78:51-20 77:53 77:53 78:54 7 7 7 7 7 7 7 7 7 7 7 7 7 7 7 7 7 7 7
Crack Multiple	Point	26.5	Structural	0	12- 12	3	0	0	2	Crack Multiple	Vortex Industrial S1:12:023 S1:12:05 S1:12:06 S1:12:07 S1:12:07

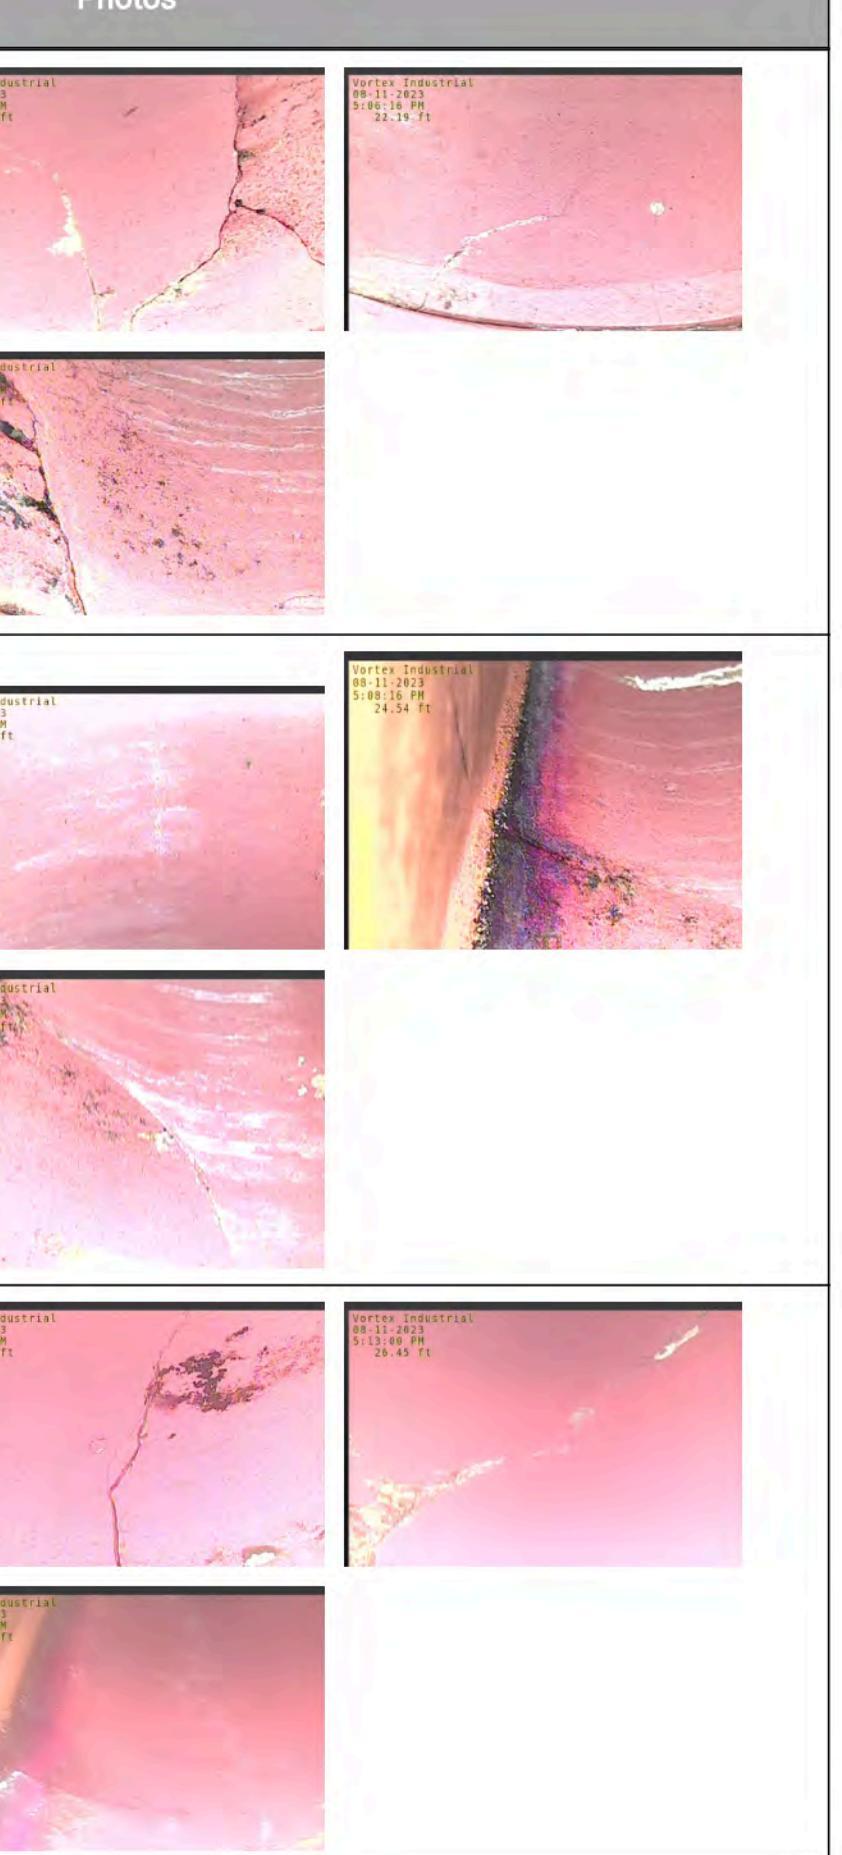
Description	Spatial Type	Distance (ft)	Туре	Percent	Clock	SR	O&M	с	PR	Remarks	
Crack Longitudinal	Point	27.2	Structural	0	6	2	0	0	1	Crack Longitudinal	
Crack Longitudinal	Point	30.4	Structural	0	2	2	0	0	1	Crack Longitudinal	Vortex In 08-11-202 5:18:04 F 38,44
Crack Longitudinal	Point	34.4	Structural	0	1	2	0	0	1	Crack Longitudinal	Vortex Industrial 08-11-2023 5:2101 PM 34.36 Tt
Crack Longitudinal	Point	34.4	Structural	0	4	2	0	0	1	Crack Longitudinal	Vortex Industrial 08-11-2023 S:21:13 PM 34.36 TC
Crack Longitudinal	Point	34.4	Structural	0	7	2	0	0	1	Crack Longitudinal	5120148 7 34 36
Crack Longitudinal	Point	34.4	Structural	0	9	2	0	0	1	Crack Longitudinal	Vin 1127 1 08-11-20 34.36

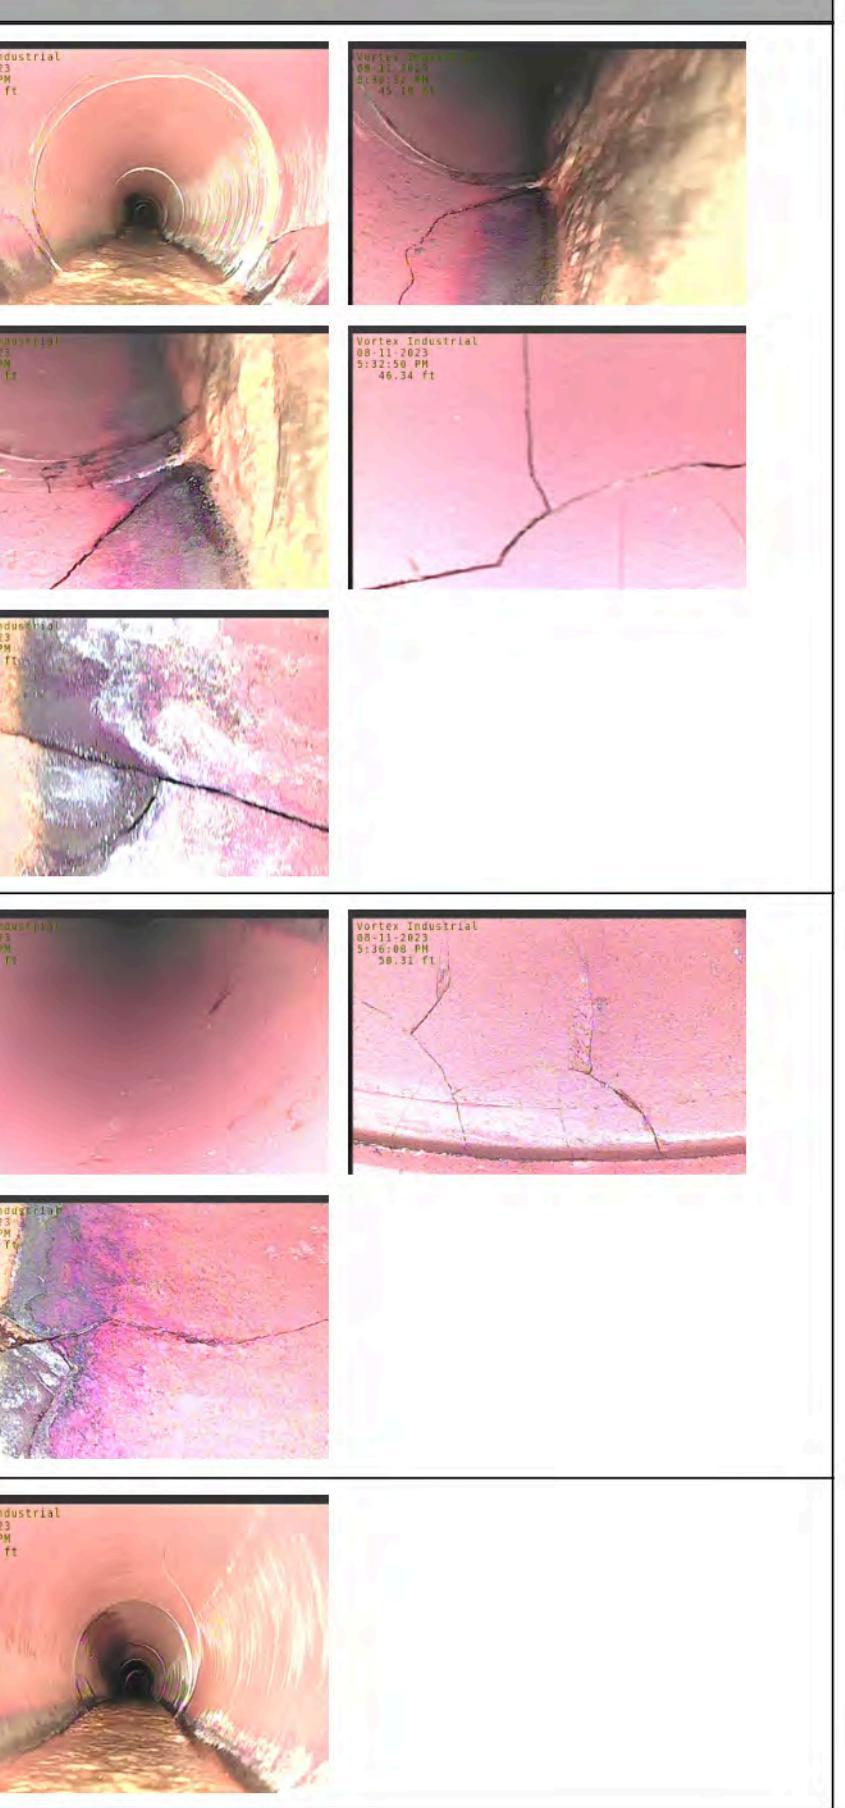
Description	Spatial Type	Distance (ft)	Туре	Percent	Clock	SR	O&M	С	PR	Remarks	
Fracture Multiple	Point	54.4	Structural	0	12- 12	3	0	0	3	Fracture Multiple	Vortex lature Industrial Stream Industrial Vortex lature Industrial Vortex lature
Crack Longitudinal	Point	58.5	Structural	0	7	2	0	0	1	Crack Longitudinal	Vortex. I 08-11-20 3148:51 38-05
Crack Spiral	Point	58.5	Structural	0	2-6	2	0	0	2	Crack Spiral	Vortex Industrial 05:11:2023 Silia M Solds Tr
Crack Longitudinal	Point	58.5	Structural	0	10	2	0	0	1	Crack Longitudinal	Sortas 1 08-11-20 5150-56 58-45

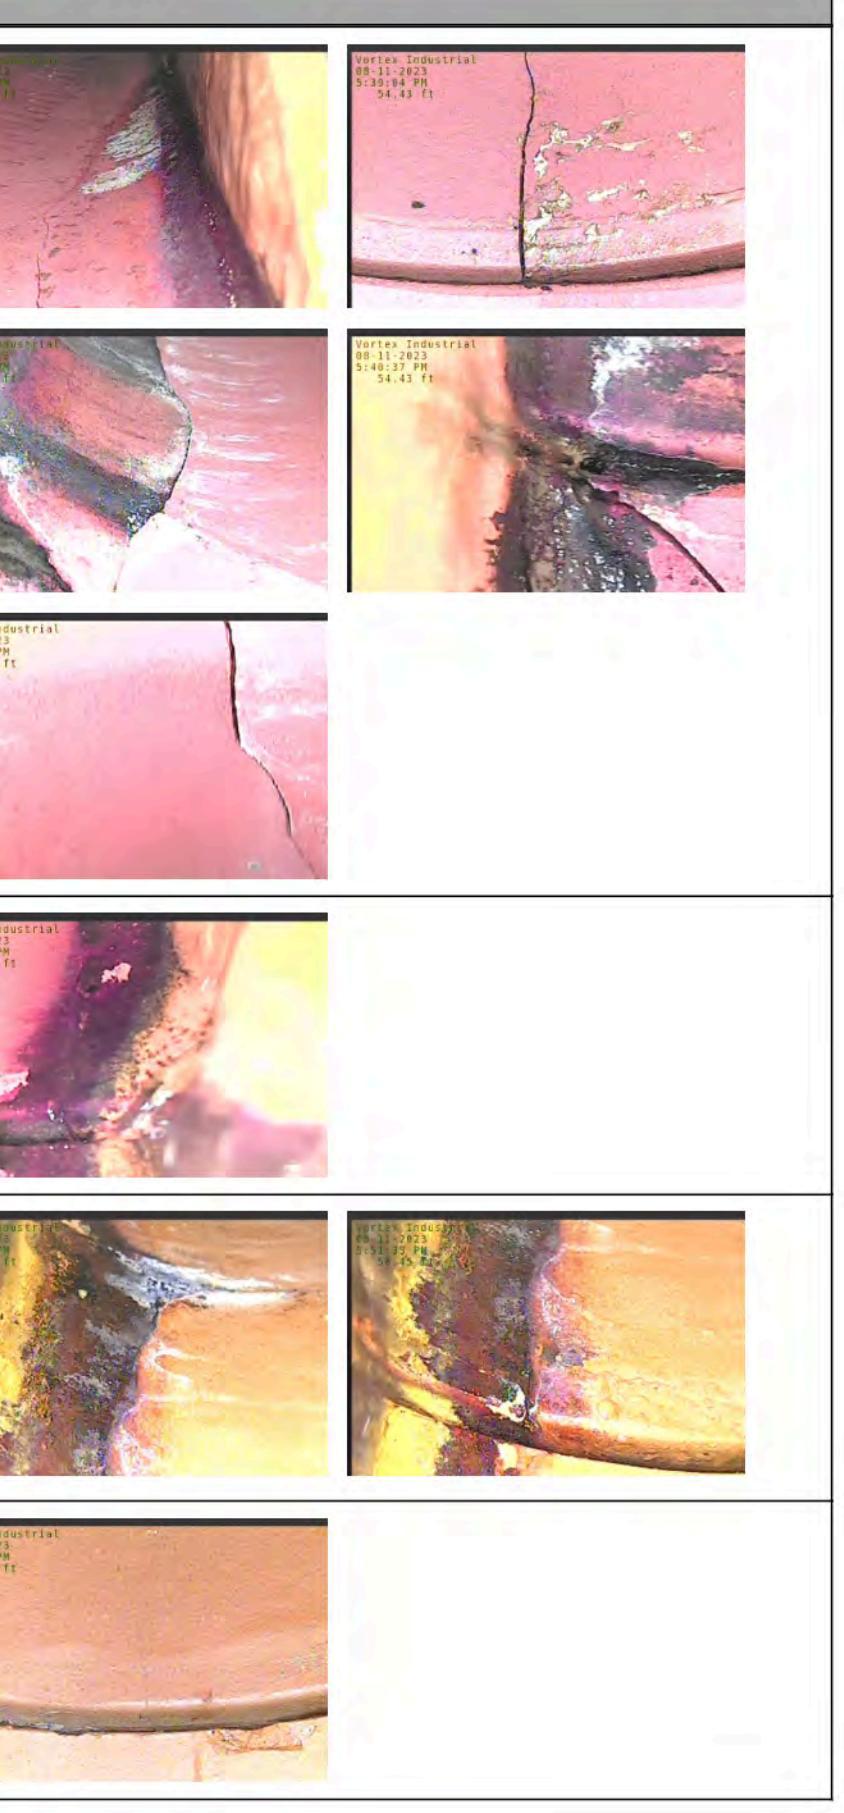
Description	Spatial Type	Distance (ft)	Туре	Percent	Clock	SR	O&M	С	PR	Remarks	
Crack Longitudinal	Point	62.8	Structural	0	7	2	0	0	2	Crack Longitudinal	Vortex Industria 08-11-2023 5153199 PM 62.61 ft
Crack Longitudinal	Point	62.8	Structural	0	6	2	0	0	2	Crack Longitudinal	
Crack Spiral	Point	62.8	Structural	0	1-6	2	0	0	2	Crack Spiral	Vortex Industrial 08-11-203 5:52:37 PM 61.00 ft 00-11-202 5:54:32 F 5:22:1 00-11-202 5:54:32 F 5:52:1 00-11-202 5:54:32 F 5:52:1 00-11-202 5:54:32 F 5:52:1 00-11-202 5:54:32 F 5:52:1 00-11-202 5:54:32 F 5:54:32 F 5:54:
Crack Spiral	Point	66.4	Structural	0	11-5	2	0	0	2	Crack Spiral	berlar Tribustrial 00-11-2023 3:537:49 PM 66.36 ft
Crack Spiral	Point	66.4	Structural	0	6-8	2	0	0	2	Crack Spiral	Vortex 1 08-11-20 5:56:53 66.36

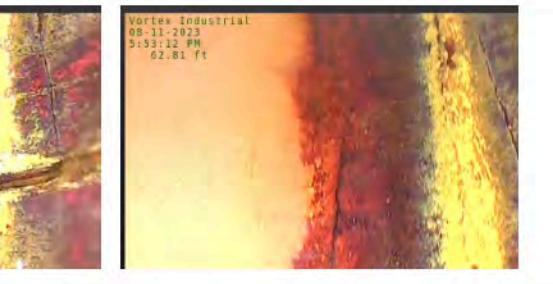
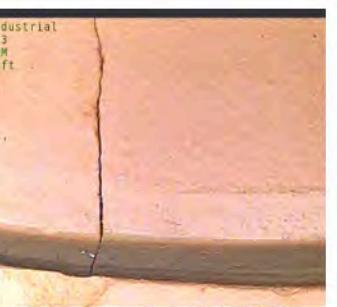
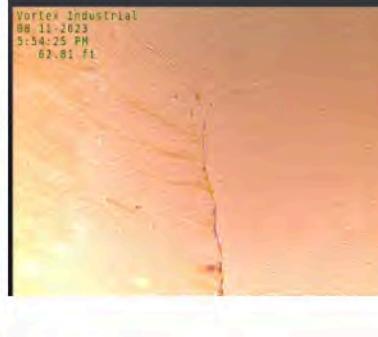
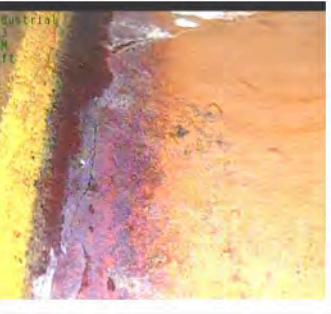
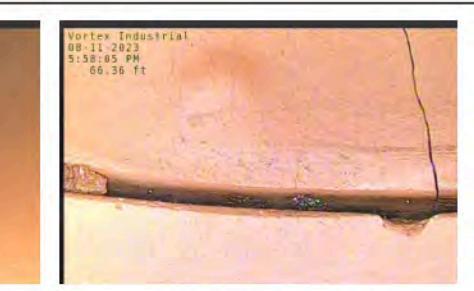
Description	Spatial Type	Distance (ft)	Туре	Percent	Clock	SR	O&M	С	PR	Remarks	
Joint Offset Medium	Point	70.3	Structural	0		3	0	0	1	Joint Offset Medium	Vortex 1 08:11:20 3:199:12 68:50
Fracture Circumferential	Point	70.5	Structural	0	10- 11	4	0	0	2	Fracture Circumferential	Vortex Industrial 08-11-2023 6:01:33 PM 70.53 ft
Fracture Spiral	Point	70.5	Structural	0	7-9	3	0	0	2	Fracture Spiral	Vortex Industrial 00:11-20 6:00:21 PM 70:55 Tt
Crack Multiple	Point	70.5	Structural	0	3-5	3	0	0	2	Crack Multiple	Vortex Industrial 09:11:20:23 61:02:53 PM 70:53 Tt 70:53 Tt 70:55

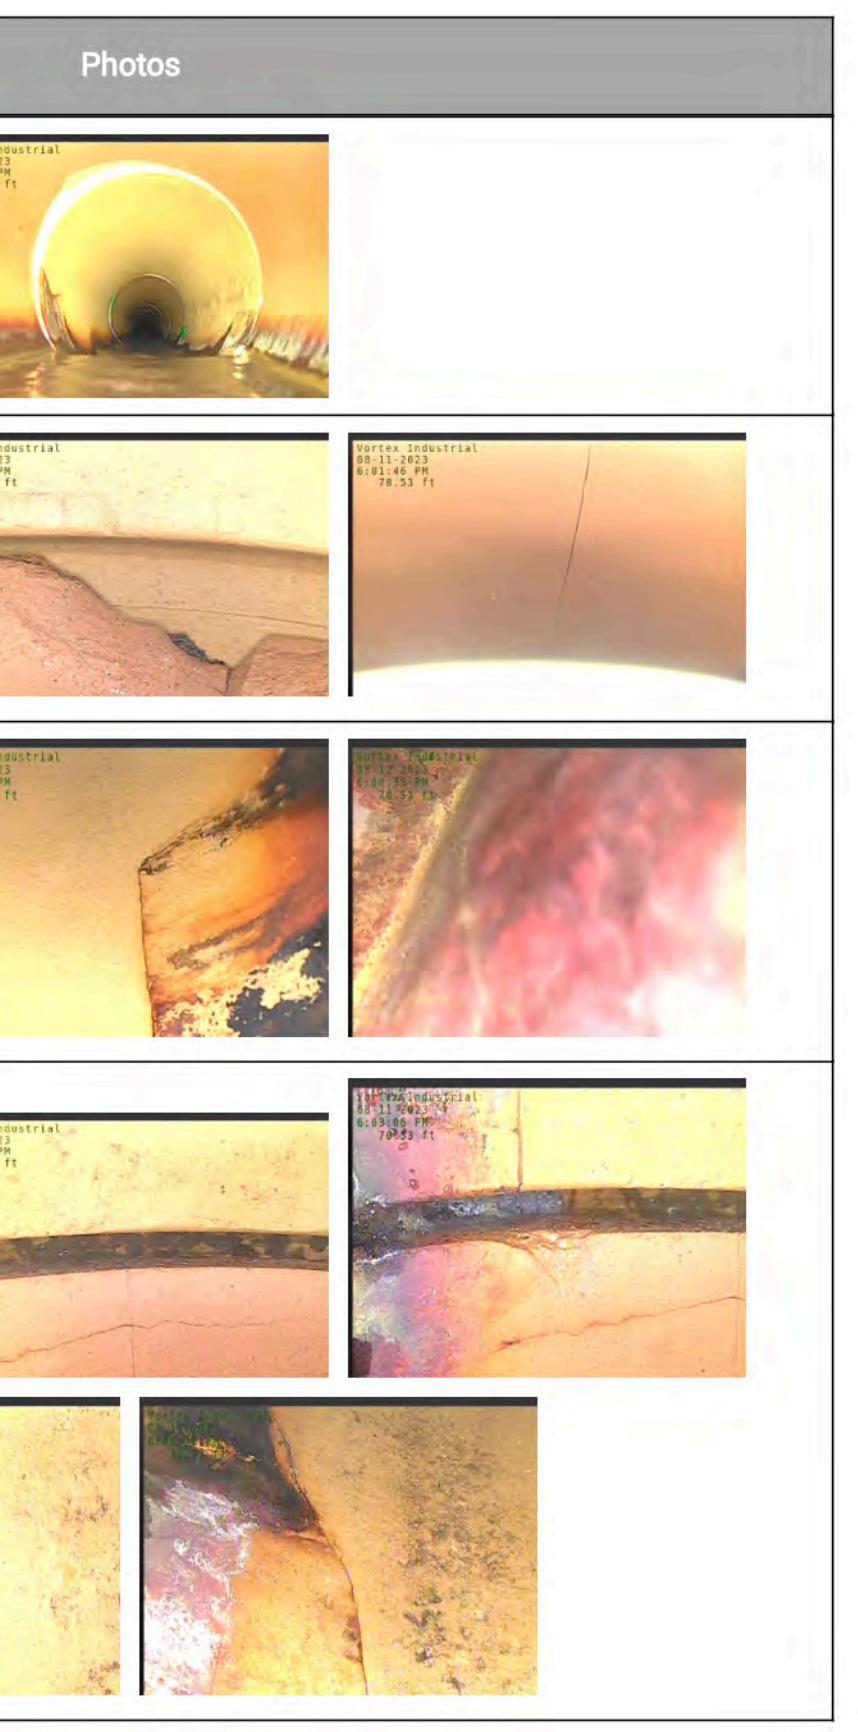
Description	Spatial Type	Distance (ft)	Туре	Percent	Clock	SR	O&M	С	PR	Remarks	
Crack Spiral	Point	74.3	Structural	0	12- 12	2	0	0	2	Crack Spiral	Vortex Industrial 08-11-2023 07-26 PM 72.34 ft 09-14 00-11-2023 0-27-12 0-27-
Crack Spiral	Point	78	Structural	0	12-8	2	0	0	2	Crack Spiral	Vortex industrial 0:93:30 PF 0:93:76 0:00 FF 0:00 FF <
Crack Spiral	Point	82.4	Structural	0	2-5	2	0	0	2	Crack Spiral	Vortex Industrial 08:11:2023 6:12:33 PM 82:38 ft
Crack Longitudinal	Point	82.4	Structural	0	7	2	0	0	2	Crack Longitudinal	Vortex Industrial 05-11-2023 0712:30 PM 82-38 ft 82-38 ft

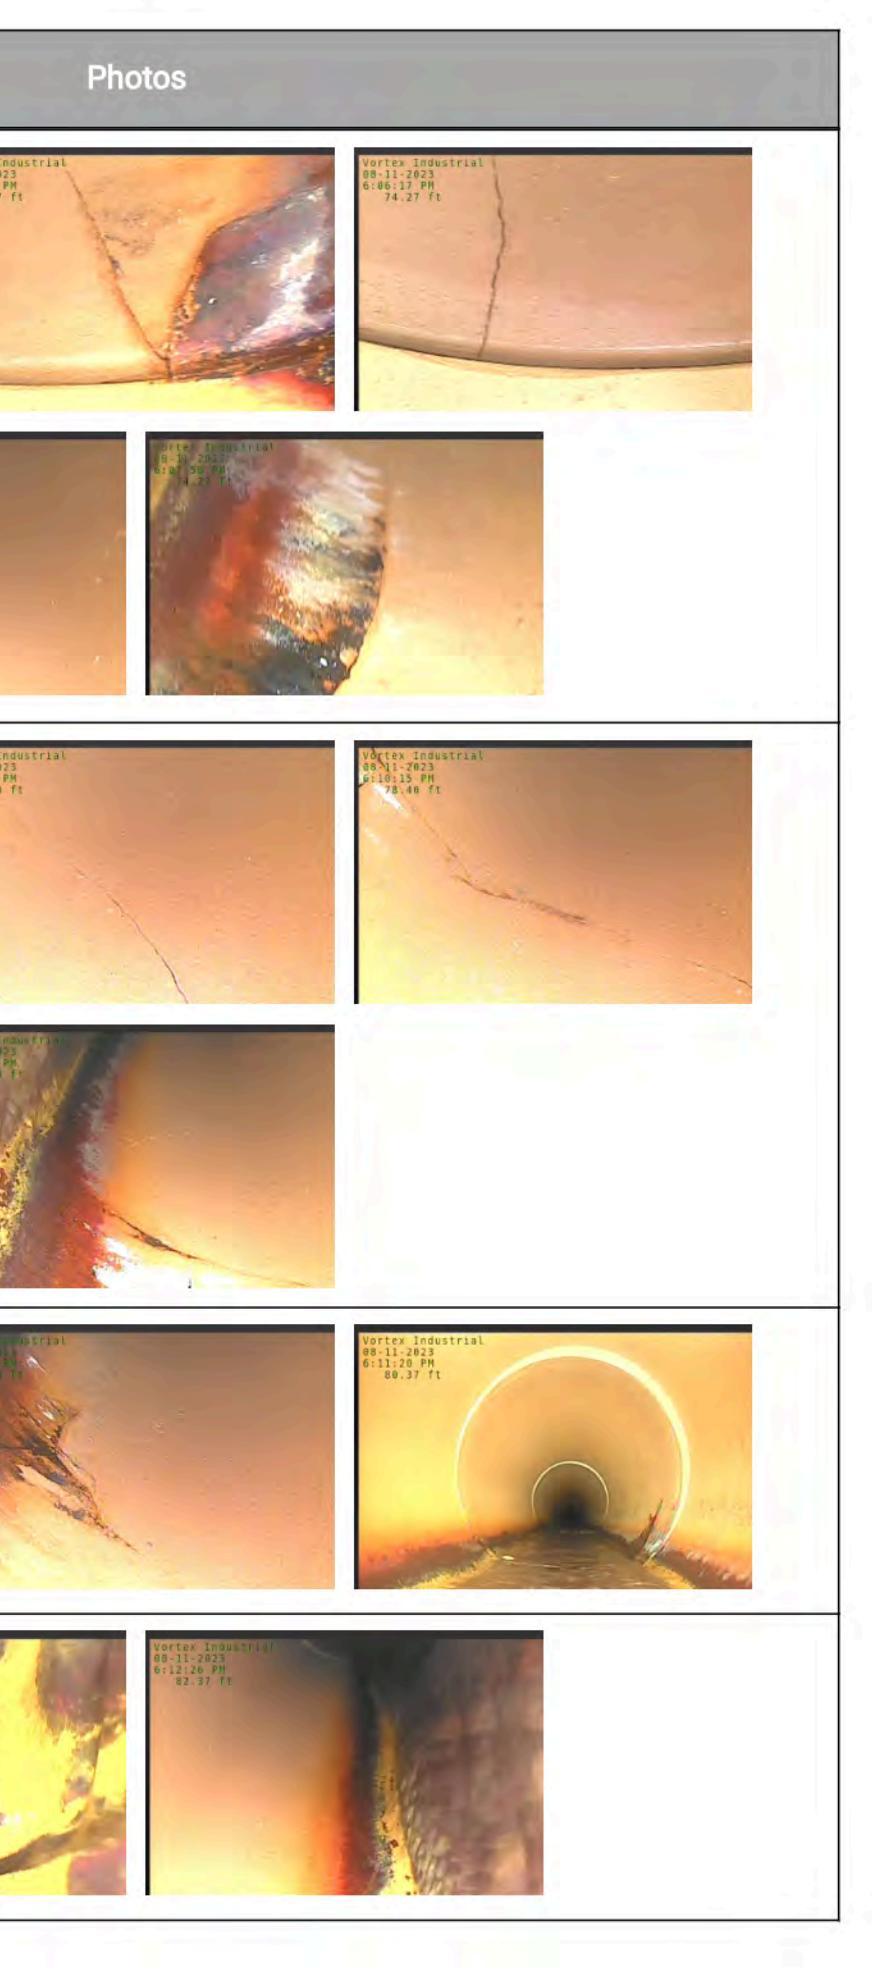
Description	Spatial Type	Distance (ft)	Туре	Percent	Clock	SR	O&M	С	PR	Remarks	
Crack Longitudinal	Point	86.3	Structural	0	5	2	0	0	1	Crack Longitudinal	Vortex 1 68-11-20 9:15:53 86-33
Crack Longitudinal	Point	86.3	Structural	0	9	2	0	0	2	Crack Longitudinal	Vortex Industrial 08-41-2023 9:14:15 PM 85.33 ft
Crack Multiple	Point	90.7	Structural	0	12- 12	3	0	0	2	Crack Multiple	Vortex Industriat 05:11:20:3 05:11:20:3 05:11:20:3 05:11:20:3 05:11:20:3 05:11:20:3 06:11:20:3 07:12:20:3 07:12:20:3 07:12:20:3 07:12:20:3 07:12:35: RN 08:11:20:30: RN 08:11:20:30: RN 09:12:35: RN 09:12:35: RN 09:12:35: RN 09:12:35: RN 09:12:35: RN 09:12:30: RN 09:12:30: RN 09:12:30: RN 100:12:12:10:10 100:12:12:10:10 100:12:10:10 100:12:10:10 100:12:10:10 100:12:10:10 100:12:10:10 100:12:10:10 100:12:10:10 100:10:10 100:10:10 100:10:10 100:10:10 100:10:10 100:10:10 100:10:10 100:10:10 100:10:10 100:10:10 100:10:10 100:10:10 <tr< td=""></tr<>

Crack Spiral	Point	94.6	Structural	0	12- 12	2	0	0	2	Crack Spiral	Yorlex Industrial 01:12073 02:2071 92:6271 91:2013 92:000

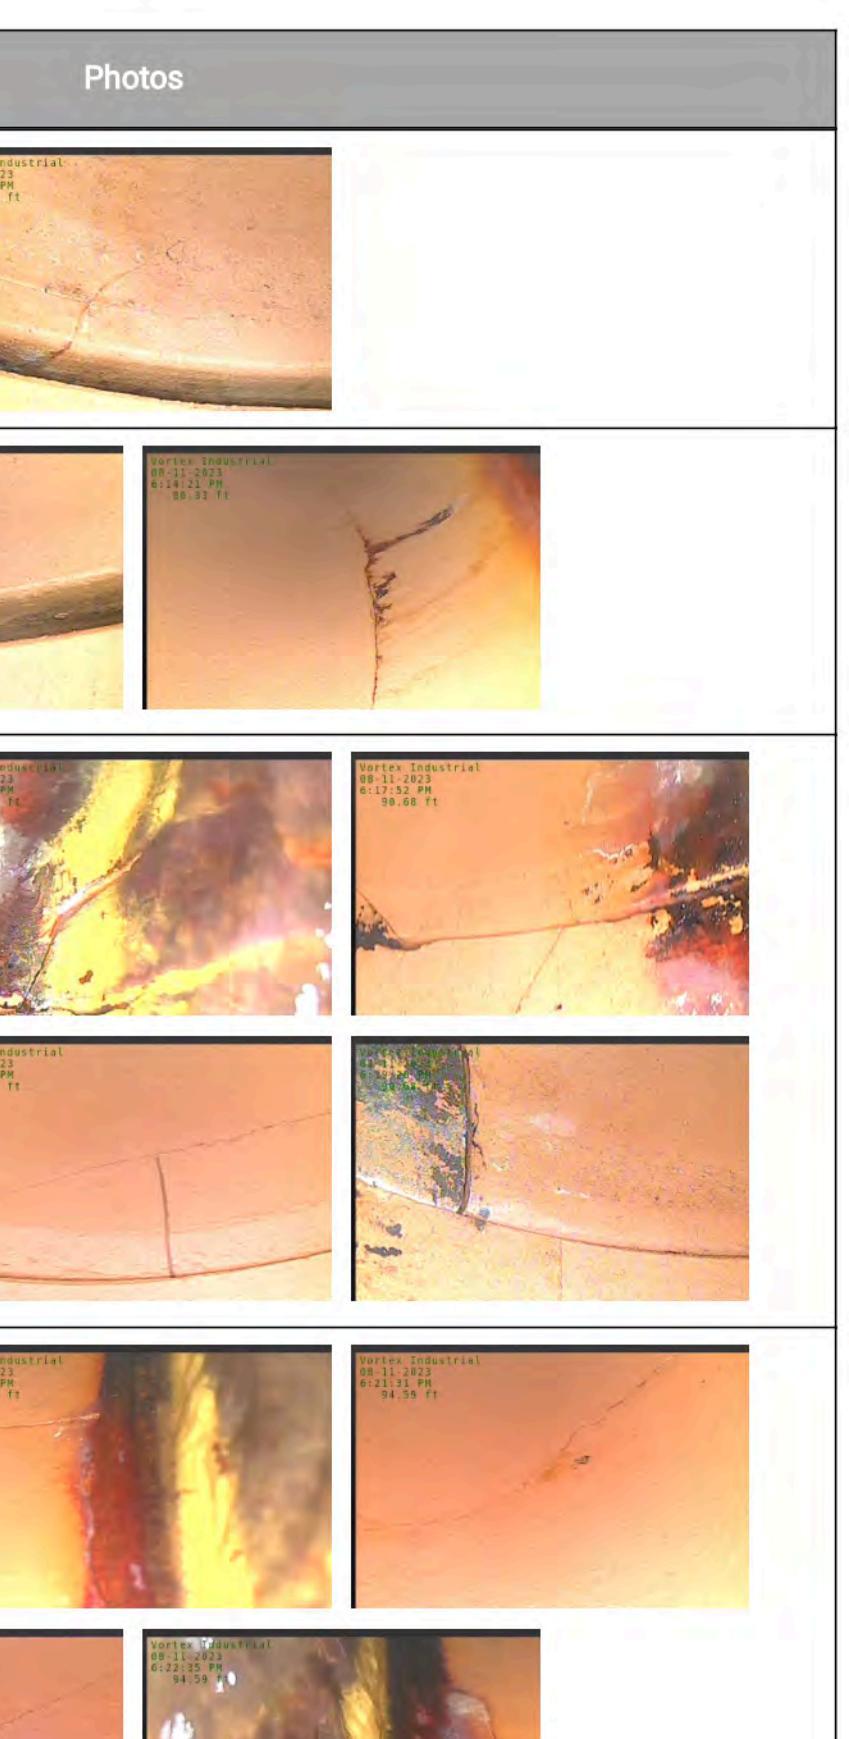
Description	Spatial Type	Distance (ft)	Туре	Percent	Clock	SR	O&M	С	PR	Remarks	
Crack Spiral	Point	98.7	Structural	0	5-1	2	0	0	2	Crack Spiral	Vortex Industrial 0F-11-2023 6:23:36 PR 96.65 It 96.65 Contemporation 96.65 Contemporation 96
Crack Spiral	Point	102.5	Structural	0	6-1	2	0	0	2	Crack Spiral	Vortex Industrial 06-11-2023 6:25:31 PR 102:38 ft 06-21:29 06:00 06:00 06:00 06:00 06:00 06:00 06:00
Crack Longitudinal	Point	102.7	Structural	0	5	2	0	0	2	Crack Longitudinal	00+13.4 09-33.4 102-26 102-10
Fracture Longitudinal	Point	106.7	Structural	0	5	2	0	0	2	Fracture Longitudinal	Vorte en 1997 e 2000 095-11-24 6-30-12 and 195-25 10-2

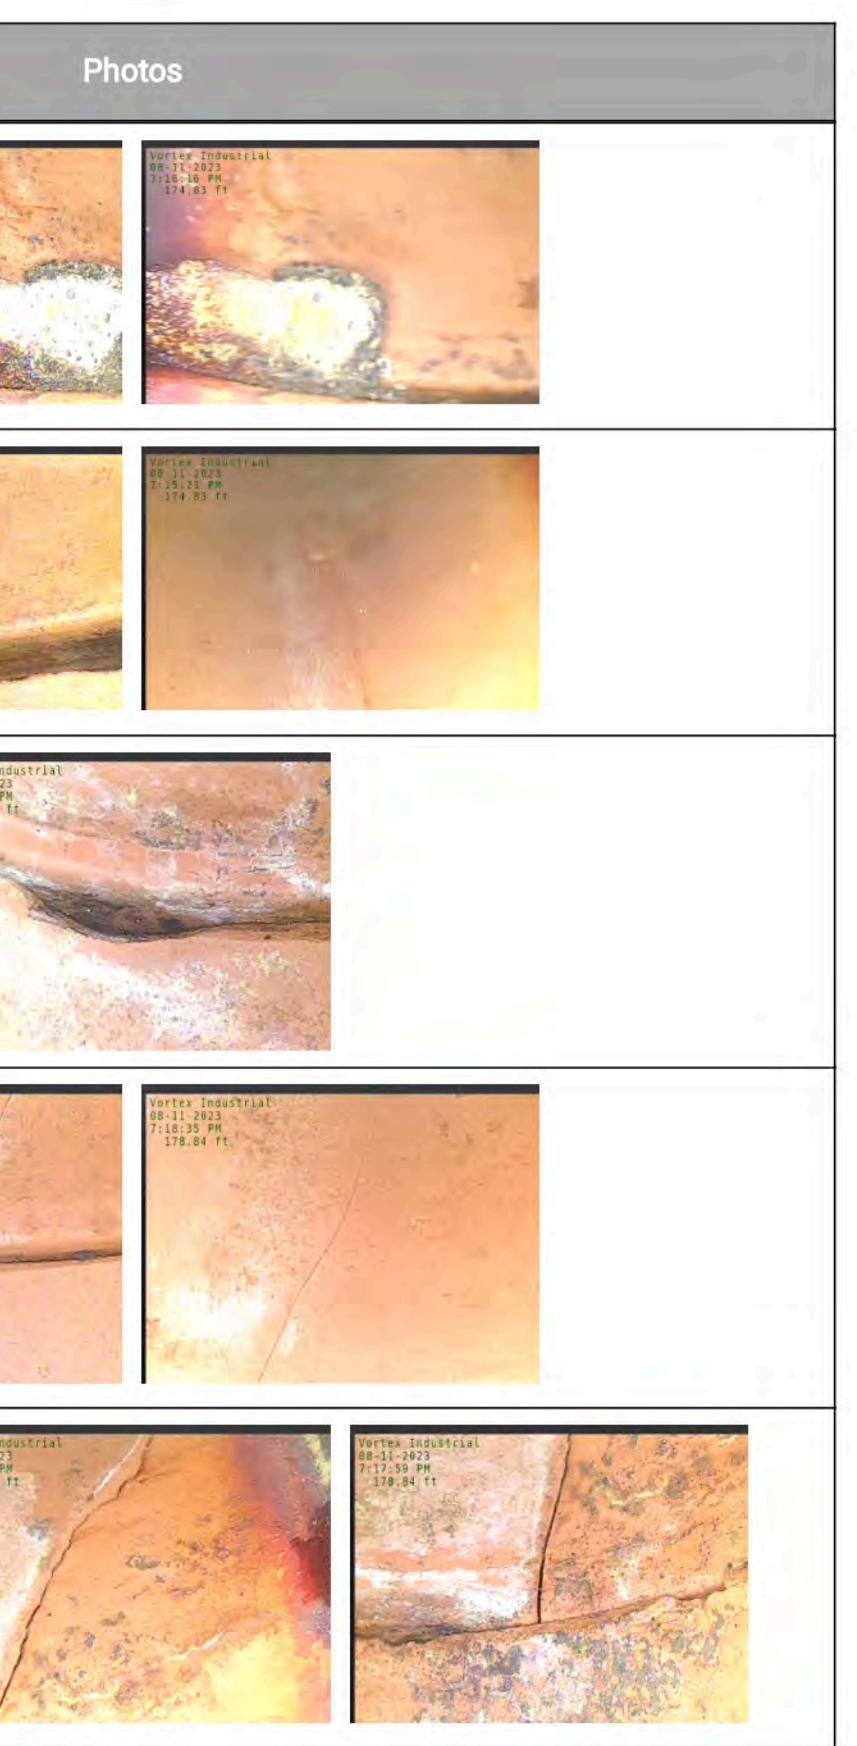
Description	Spatial Type	Distance (ft)	Туре	Percent	Clock	SR	0&M	С	PR	Remarks	
Deposits Settled Hard/Compacted	Point	174.8	O&M	10	5-6	0	2	0	0	Deposits Settled Hard/Compacted	Vortex Indestria 08-11-2023 7:16:15 Pt 1/4-03 0
Crack Longitudinal	Point	174.8	Structural	0	8	2	0	0	2	Crack Longitudinal	Voriex Industriak 06-11.2023 7:15:19 PM 174-83 Tr
Fracture Circumferential	Point	178.8	Structural	0	3-4	2	0	0	2	Fracture Circumferential	Vortex 1 98-11-20 7:18-53 178.64
Crack Longitudinal	Point	178.8	Structural	0	12	2	0	0	1	Crack Longitudinal	Vortex Industriat 00-11-2023 7718:38 FP 178:58 ft
Crack Multiple	Point	178.8	Structural	0	6-9	3	0	0	2	Crack Multiple	Vortex I dB 112-36 1732-04

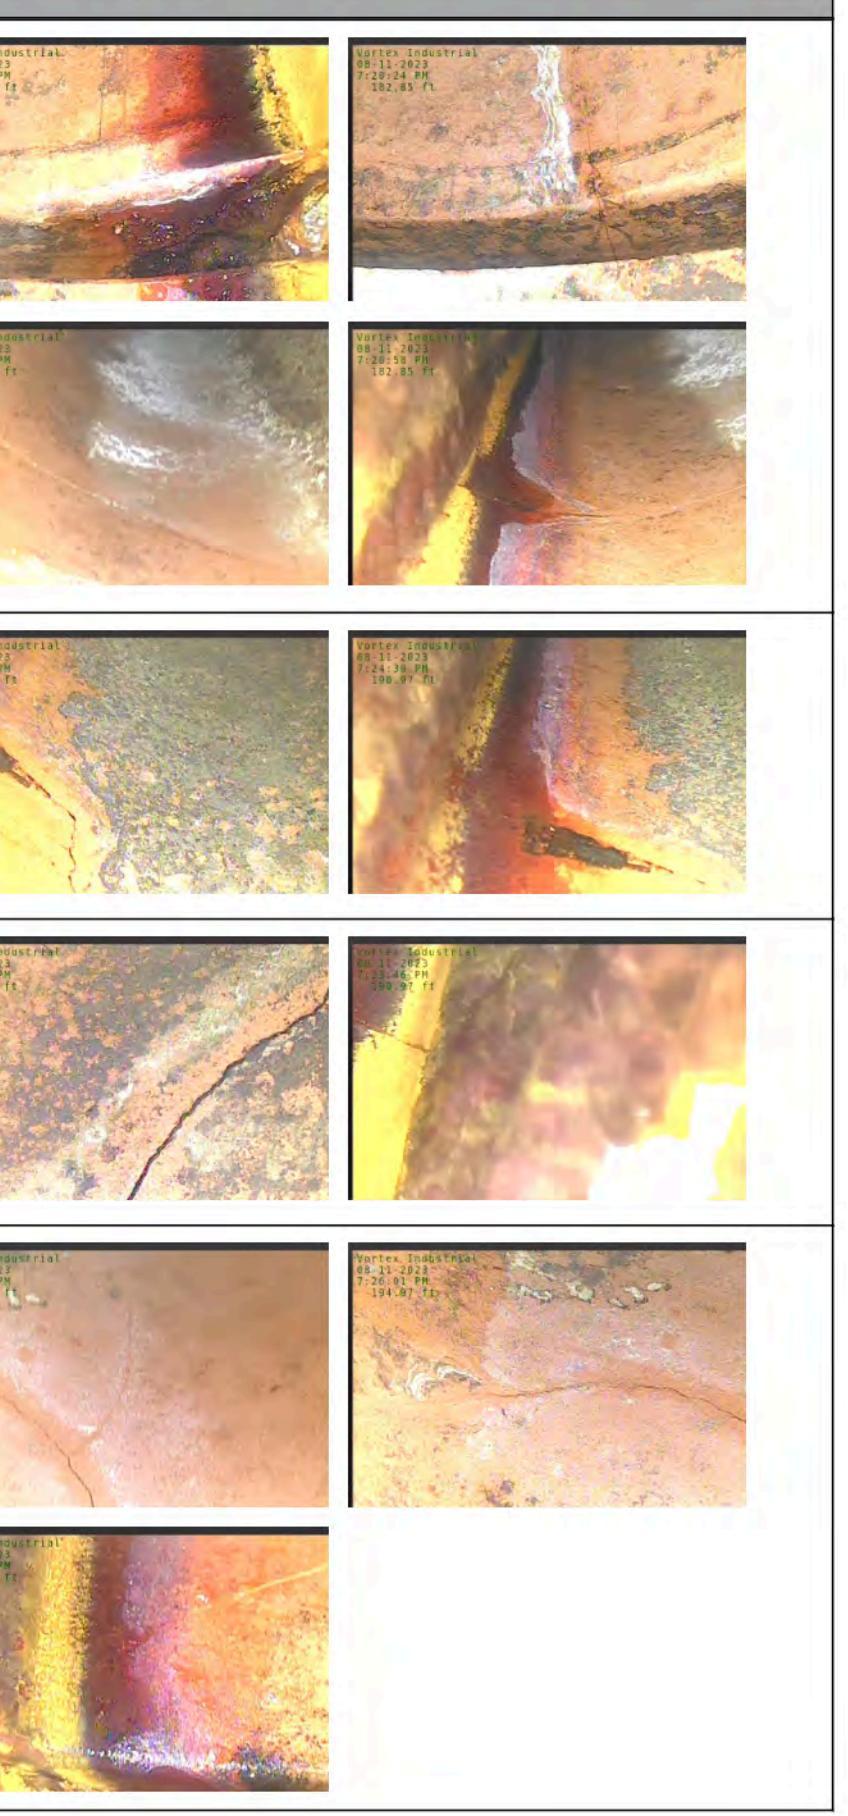
Description	Spatial Type	Distance (ft)	Туре	Percent	Clock	SR	O&M	С	PR	Remarks	
Crack Multiple	Point	182.9	Structural	0	12-9	3	0	0	2	Crack Multiple	Vortes Industrial 98:13-2023 199:13-2023 7:13:16 P 101:21 P 11:20:20 P <t< th=""></t<>
Crack Spiral	Point	190.8	Structural	0	3-5	2	0	0	2	Crack Spiral	Yortex Industrial 06-13-2022 143-20
Crack Spiral	Point	190.8	Structural	0	6-10	2	0	0	2	Crack Spiral	Vertex industriat 08-31-2023 77:22393 PM 188-79 rt
Crack Spiral	Point	195	Structural	0	1-5	2	0	0	2	Crack Spiral	Vortex Industrial Wortex Industrial 7:25:53 PR 194:97'H* 194:97'H* 194:97'H*

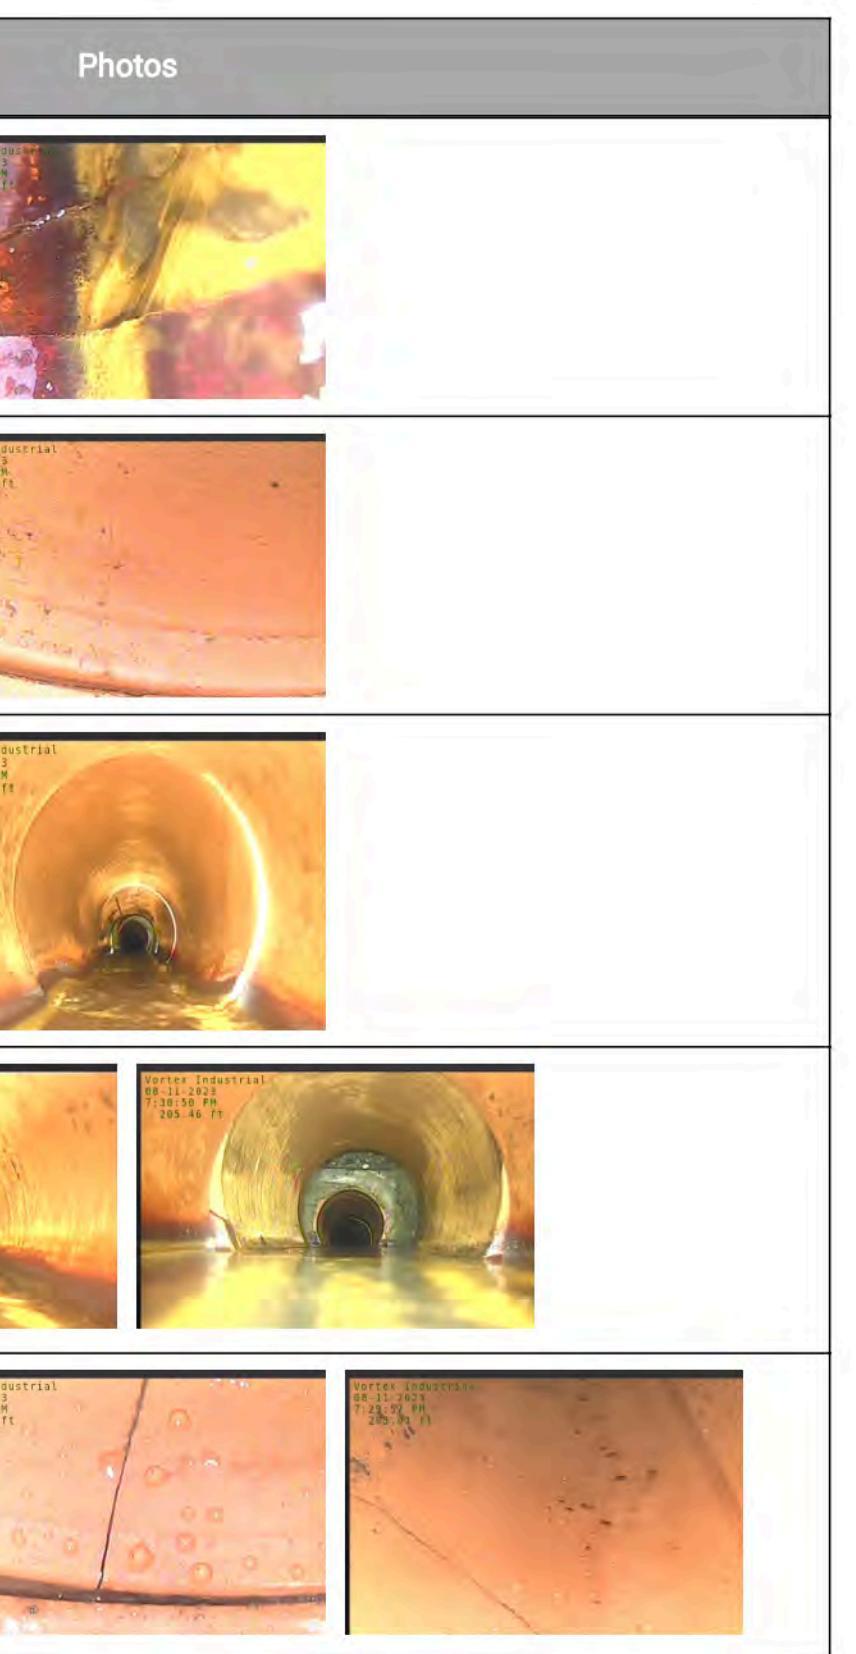
Description	Spatial Type	Distance (ft)	Туре	Percent	Clock	SR	O&M	С	PR	Remarks	
Crack Spiral	Point	198.8	Structural	0	6-7	2	0	0	2	Crack Spiral	Vortes 1 95-11-20 71-271-28 118-82
Crack Longitudinal	Point	198.8	Structural	0	3	2	0	0	1	Crack Longitudinal	Vortek 1 96-11-202 97-29-30 P - 139, 82, 149
Joint Offset Medium	Point	198.8	Structural	0		3	0	0	2	Joint Offset Medium	Vortax 1 66-11-20 7:23:09 197:96
Miscellaneous Water Level	Point	203	Miscellaneous	30		0	0	0	0	Miscellaneous Water Level	Vorter Tedustriat 905-11-2923 7-26:21 PW 202-44 tt
Crack Multiple	Point	203	Structural	0	10-5	3	0	0	2	Crack Multiple	Vortex Industria) 05 11 - 2023 7:29:46 PR _203.03 TL _203.03 TL _203.03
