2024 ANNUAL PROGRESS REPORT SWMU-1 OILY WATER SEWER

HF SINCLAIR PUGET SOUND REFINING LLC

March 2025

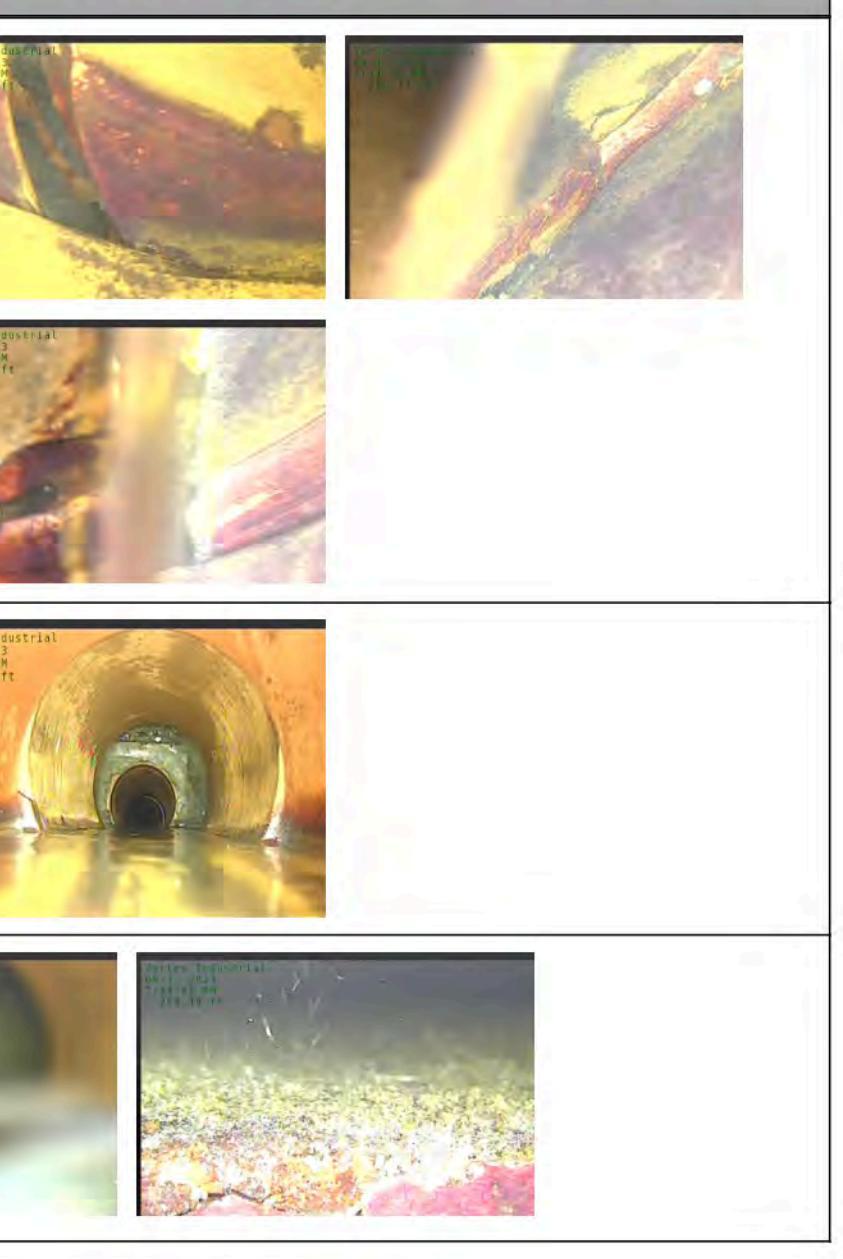
Description	Spatial Type	Distance (ft)	Туре	Percent	Clock	SR	O&M	С	PR	Remarks	
Broken	Point	206.8	Structural	0	5-8	4	0	0	4	Broken	Varies 10 Varies 10 1 give 10 2 to 11 to 2 t
											266.77
Joint Offset Medium	Point	206.8	Structural	0		3	0	0	2	Joint Offset Medium	Vorta, 202 08-11-202 7;30:49 P 205-21
Manhole	Point	209.4	Constructional	0		0	0	0	0	B-3	Vortes Industria 03-11-2027 7:32:09 PM 207,09 Tt

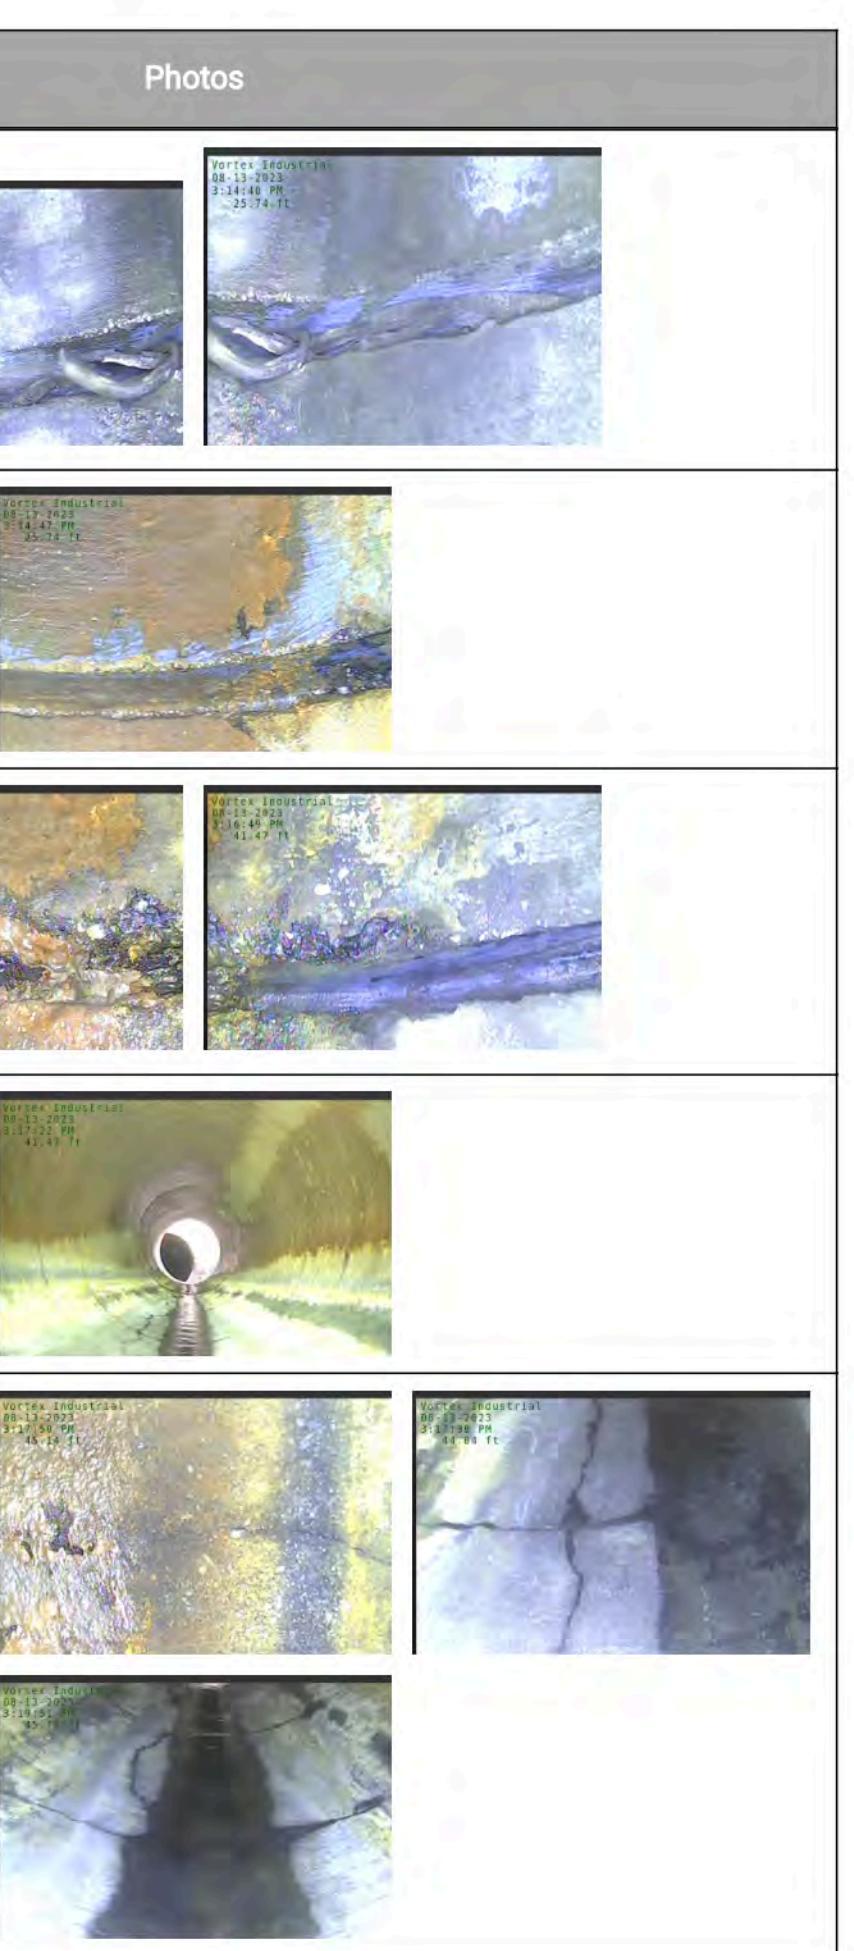
Description	Spatial Type	Distance (ft)	Туре	Percent	Clock	SR	O&M	С	PR	Remarks	
Intruding Sealing Material Grout	Point	25.7	O&M	10	7-8	0	2	0	0	Intruding Sealing Material Grout	Vorites Tadustrist UB-14-2028 3-13-32 PR 2-33-4 TT
Crack Longitudinal	Point	25.7	Structural	0	9	2	0	0	1	Crack Longitudinal	
Surface Aggregate Visible	Point	41.5	Structural	0	8-9	2	0	0	2	Surface Aggregate Visible	Vortex Endustrial RK-13-2623 R-16-354 PP 31:17-11 Vortex Endustrial RK-15-2623 R-16-354 PP 31:17-11 Vortex Endustrial RK-15-2623 RK-15-2623 R-16-354 PP 31:17-11 Vortex Endustrial RK-15-2623 RK-15
Miscellaneous Water Level	Point	41.7	Miscellaneous	0		0	0	0	0	Miscellaneous Water Level	
Crack Multiple	Continuous	44 - 47.1	Structural	0	5-10	3	0	0	2	Crack Multiple	Vertes Indu-trua 9:13:2029 3:14:1 0:10

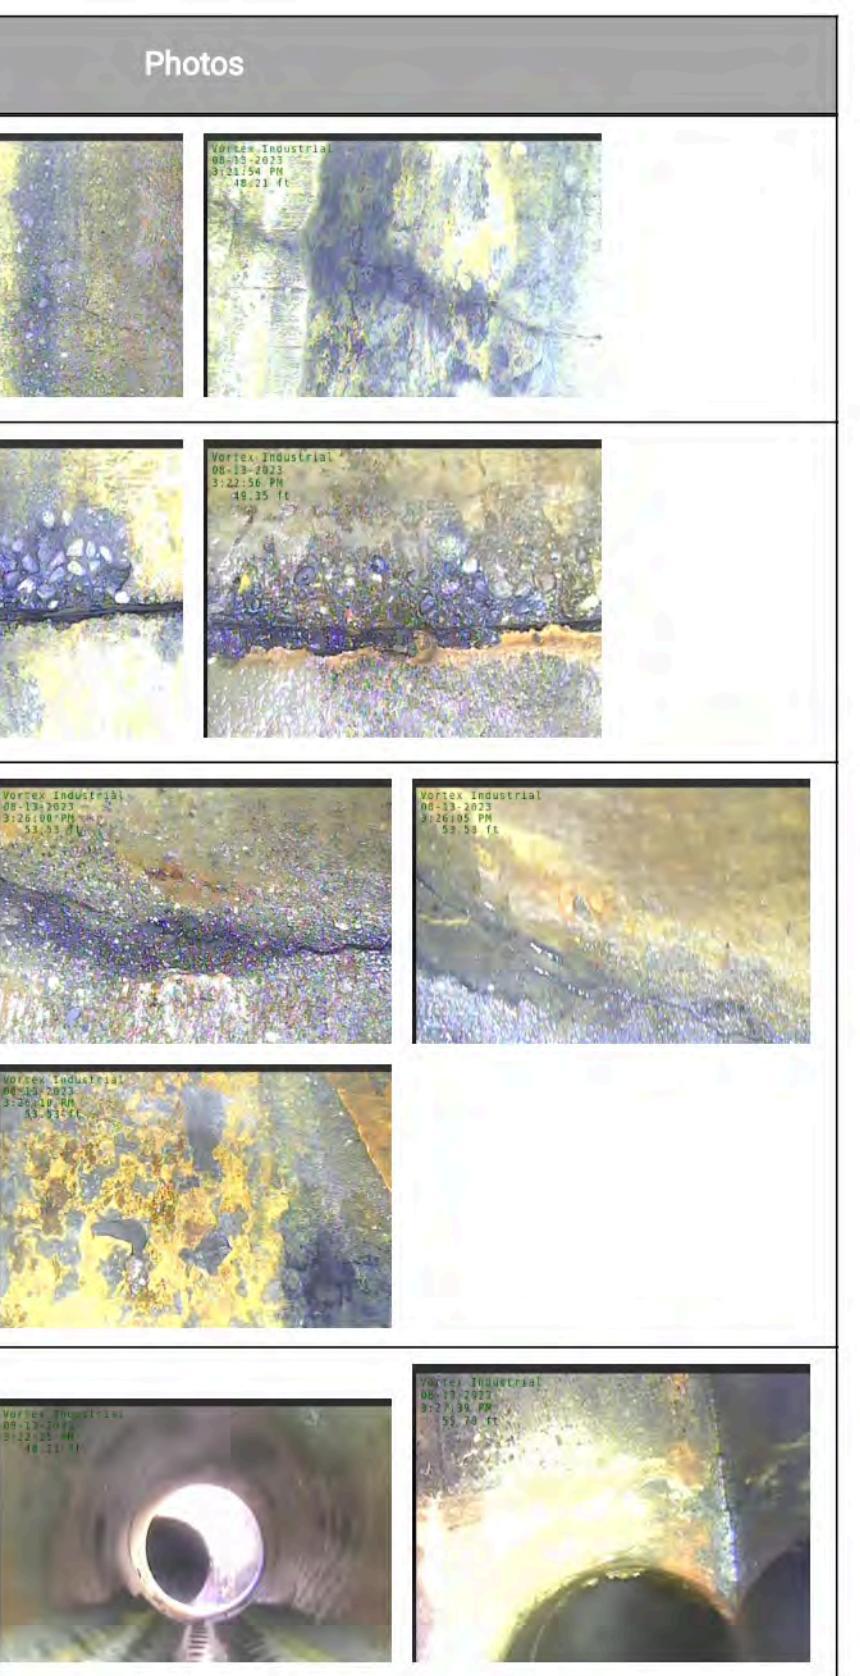
Description	Spatial Type	Distance (ft)	Туре	Percent	Clock	SR	O&M	С	PR	Remarks	
Crack Circumferential	Point	48.2	Structural	0	3-7	1	0	0	2	Crack Circumferential	Vories Industriat Valid 2023 # 21:37 PH 44.22 ft
Surface Damage Aggregate Missing	Point	49.3	Structural	0	7-9	4	0	0	2	Surface Damage Aggregate Missing	The second secon
Crack Circumferential	Point	53.5	Structural	0	12- 12	1	0	0	2	Crack Circumferential	por teer Induserial SE-13 - 7023 PI25-55 PR - PIAL 3 - 70 - 70 - 70 - 70 - 70 - 70 - 70 - 70
Manhole	Point	55.7	Constructional	0		0	0	0	0	5-P	100-131-7073 100-131-7073 102-132-70 102-120-120-120 102-120-120 102-120-120 102-120-120 102-120-120 102-120 102-120-120 102-120-120 102-120-120 102-120 102-120-120 102-120-120 102-120-120 102-120-120 102-120 102-120-120 102

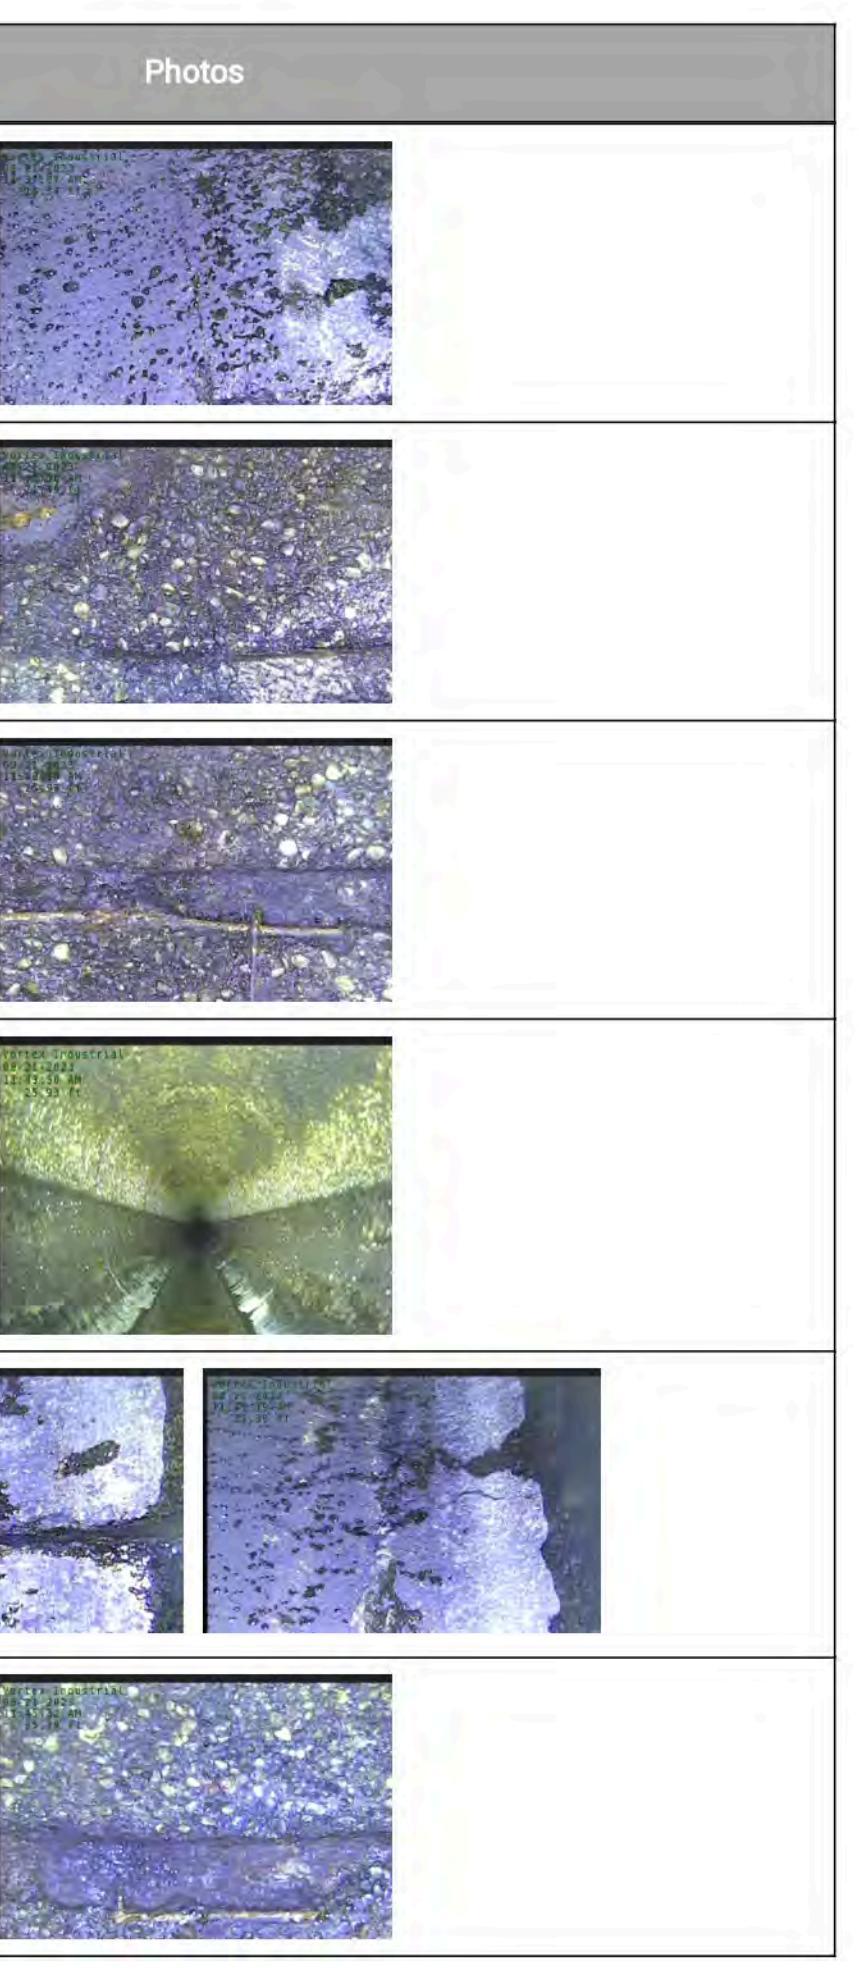
Description	Spatial Type	Distance (ft)	Туре	Percent	Clock	SR	0&M	с	PR	Remarks	
Crack Longitudinal	Point	18.3	Structural	0	8	2	0	0	1	Crack Longitudinal	
Crack Longitudinal	Point	21.5	Structural	0	11	2	0	0	1	Crack Longitudinal	
Surface Damage Reinforcement Visible	Point	25.9	Structural	0	12	4	0	0	2	Surface Damage Reinforcement Visible	
Miscellaneous Water Level	Point	26	Miscellaneous	10		0	0	0	0	Miscellaneous Water Level	
Crack Spiral	Point	35.3	Structural	0	6-7	2	0	0	2	Crack Spiral	
Surface Damage Reinforcement Visible	Point	35.4	Structural	0	10	4	0	0	2	Surface Damage Reinforcement Visible

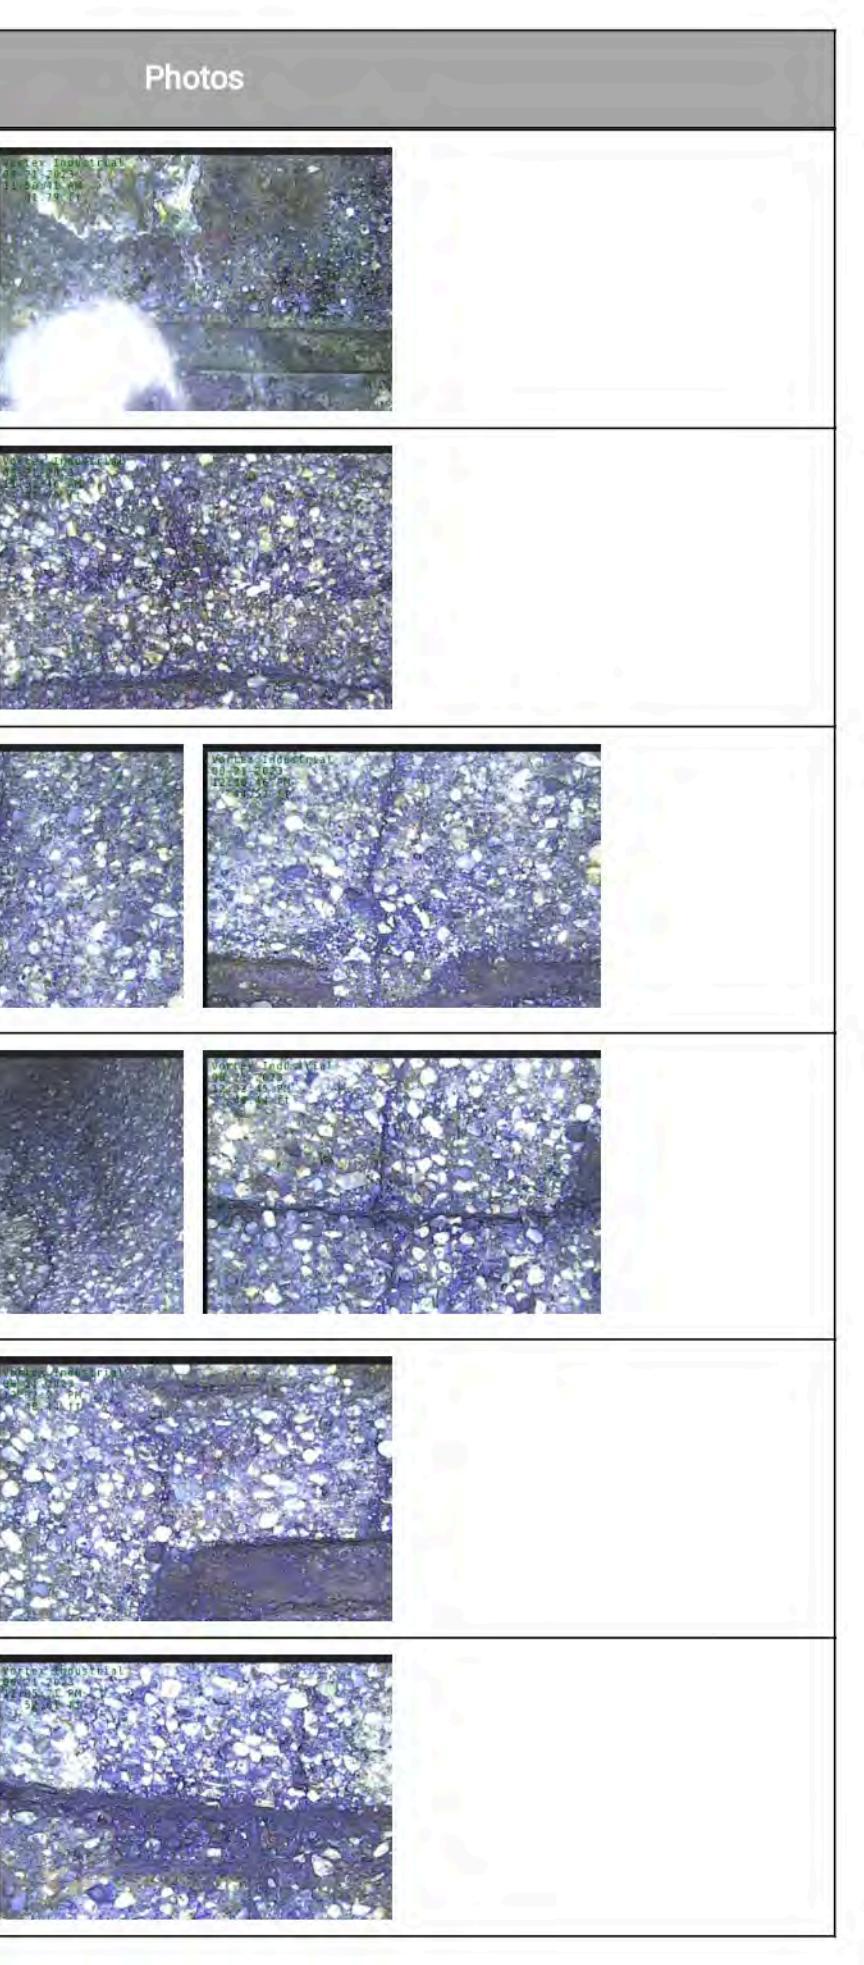
Description	Spatial Type	Distance (ft)	Туре	Percent	Clock	SR	0&M	С	PR	Remarks	
Crack Longitudinal	Point	41.8	Structural	0	6	2	0	0	1	Crack Longitudinal	
Crack Multiple	Point	41.8	Structural	0	12-1	3	0	0	1	Crack Multiple	
Crack Longitudinal	Point	45.2	Structural	0	4	2	0	0	2	Crack Longitudinal	
Crack Longitudinal	Point	48.4	Structural	0	2	2	0	0	1	Crack Longitudinal	
Crack Longitudinal	Point	48.4	Structural	0	1	2	0	0	1	Crack Longitudinal	
Crack Longitudinal	Point	52.6	Structural	0	3	2	0	0	1	Crack Longitudinal

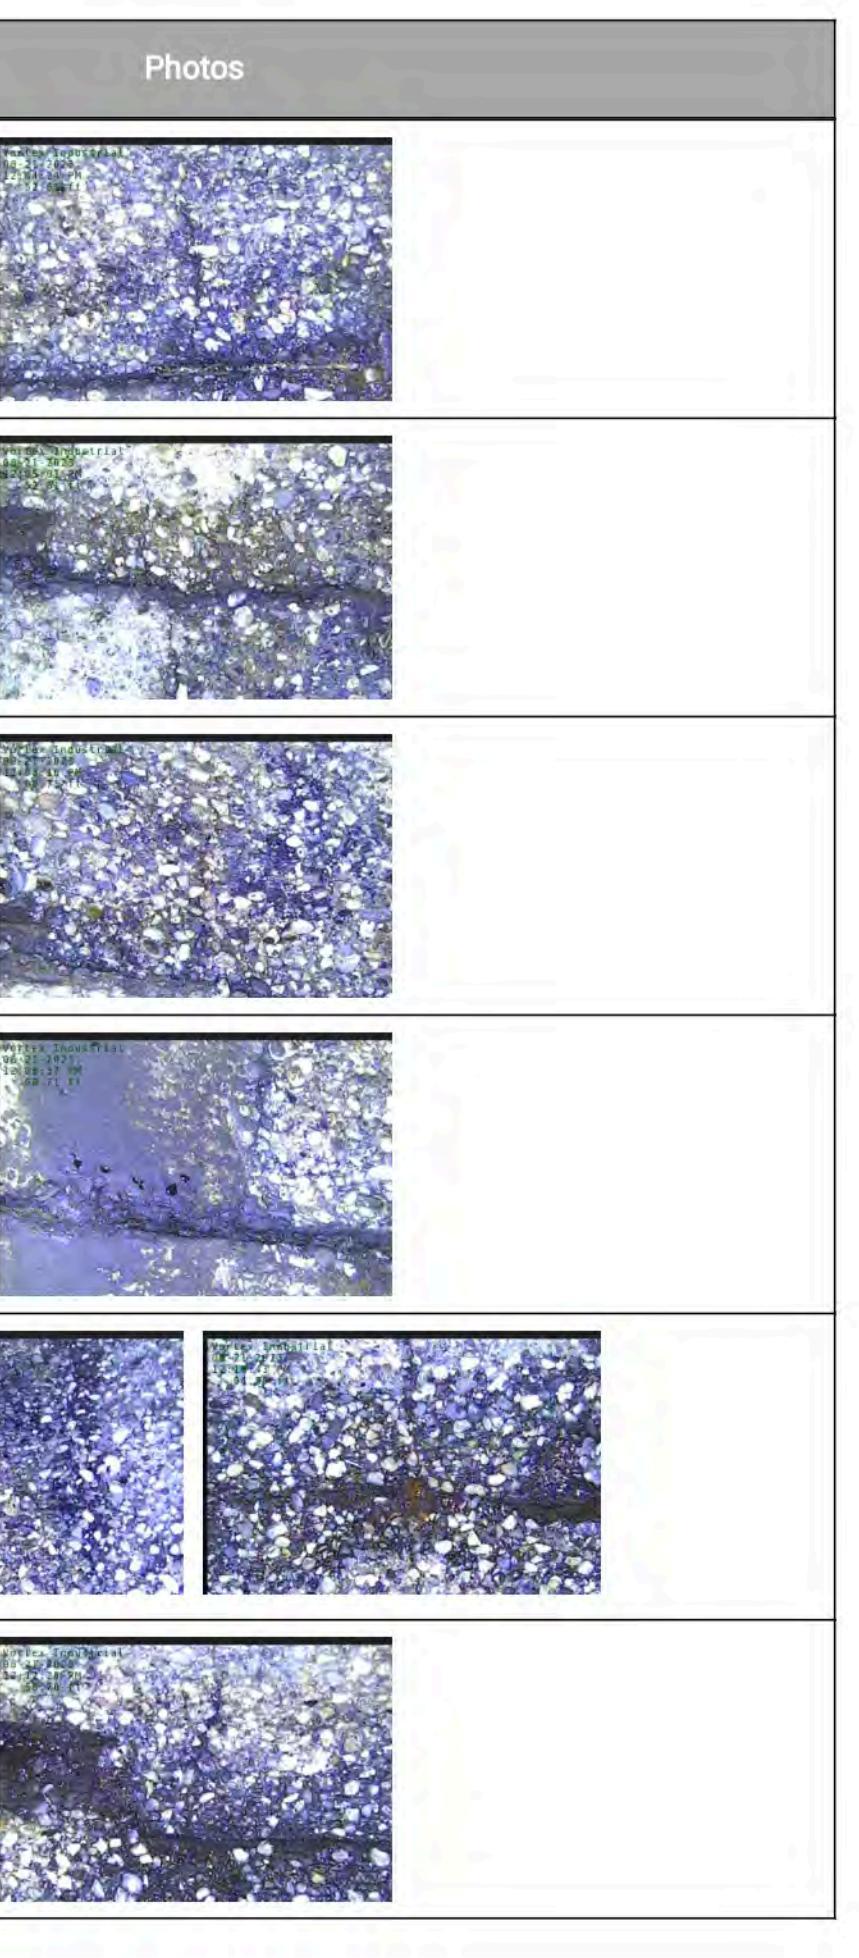
Description	Spatial Type	Distance (ft)	Туре	Percent	Clock	SR	0&M	С	PR	Remarks	
Crack Longitudinal	Point	52.6	Structural	0	11	2	0	0	1	Crack Longitudinal	
Crack Longitudinal	Point	52.6	Structural	0	1	2	0	0	1	Crack Longitudinal	
Crack Longitudinal	Point	60.7	Structural	0	1	2	0	0	1	Crack Longitudinal	
Crack Longitudinal	Point	60.7	Structural	0	3	2	0	0	1	Crack Longitudinal	
Crack Longitudinal	Point	64.9	Structural	0	10	2	0	0	1	Crack Longitudinal	
Crack Longitudinal	Point	68.7	Structural	0	12	2	0	0	1	Crack Longitudinal

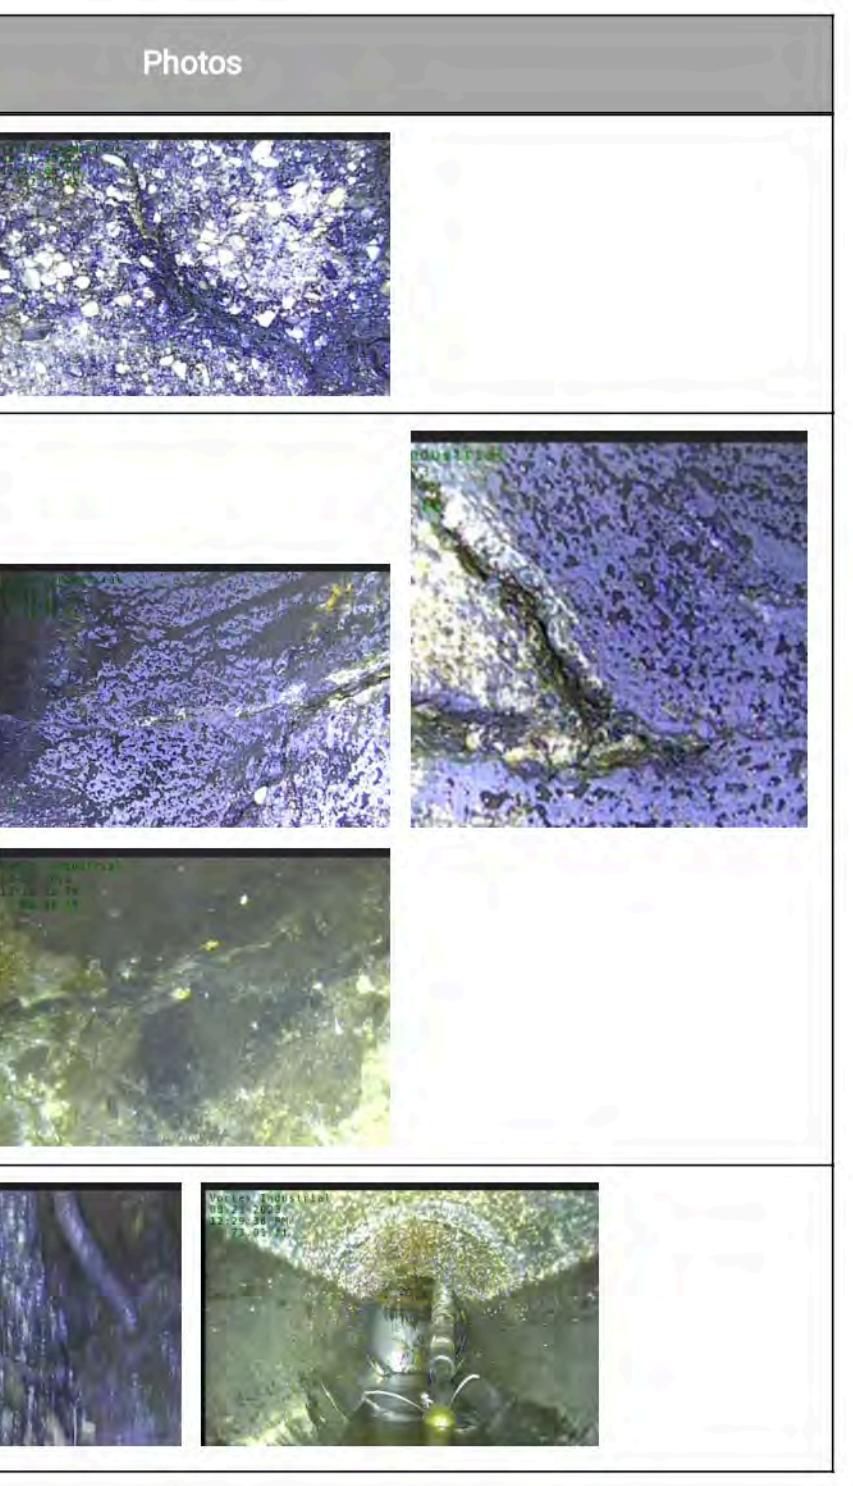
Description	Spatial Type	Distance (ft)	Туре	Percent	Clock	SR	O&M	С	PR	Remarks	
Crack Longitudinal	Point	72.8	Structural	0	11	2	0	0	1	Crack Longitudinal	
Fracture Spiral	Point	80.9	Structural	0	5-8	2	0	0	3	Fracture Spiral	
Manhole	Point	82	Constructional	0		0	0	0	0	5-C	Vor tes Tentas i r Ann de se deze 22: se deze deze 80 deze nitioner (Ann de se deze deze deze deze deze deze deze

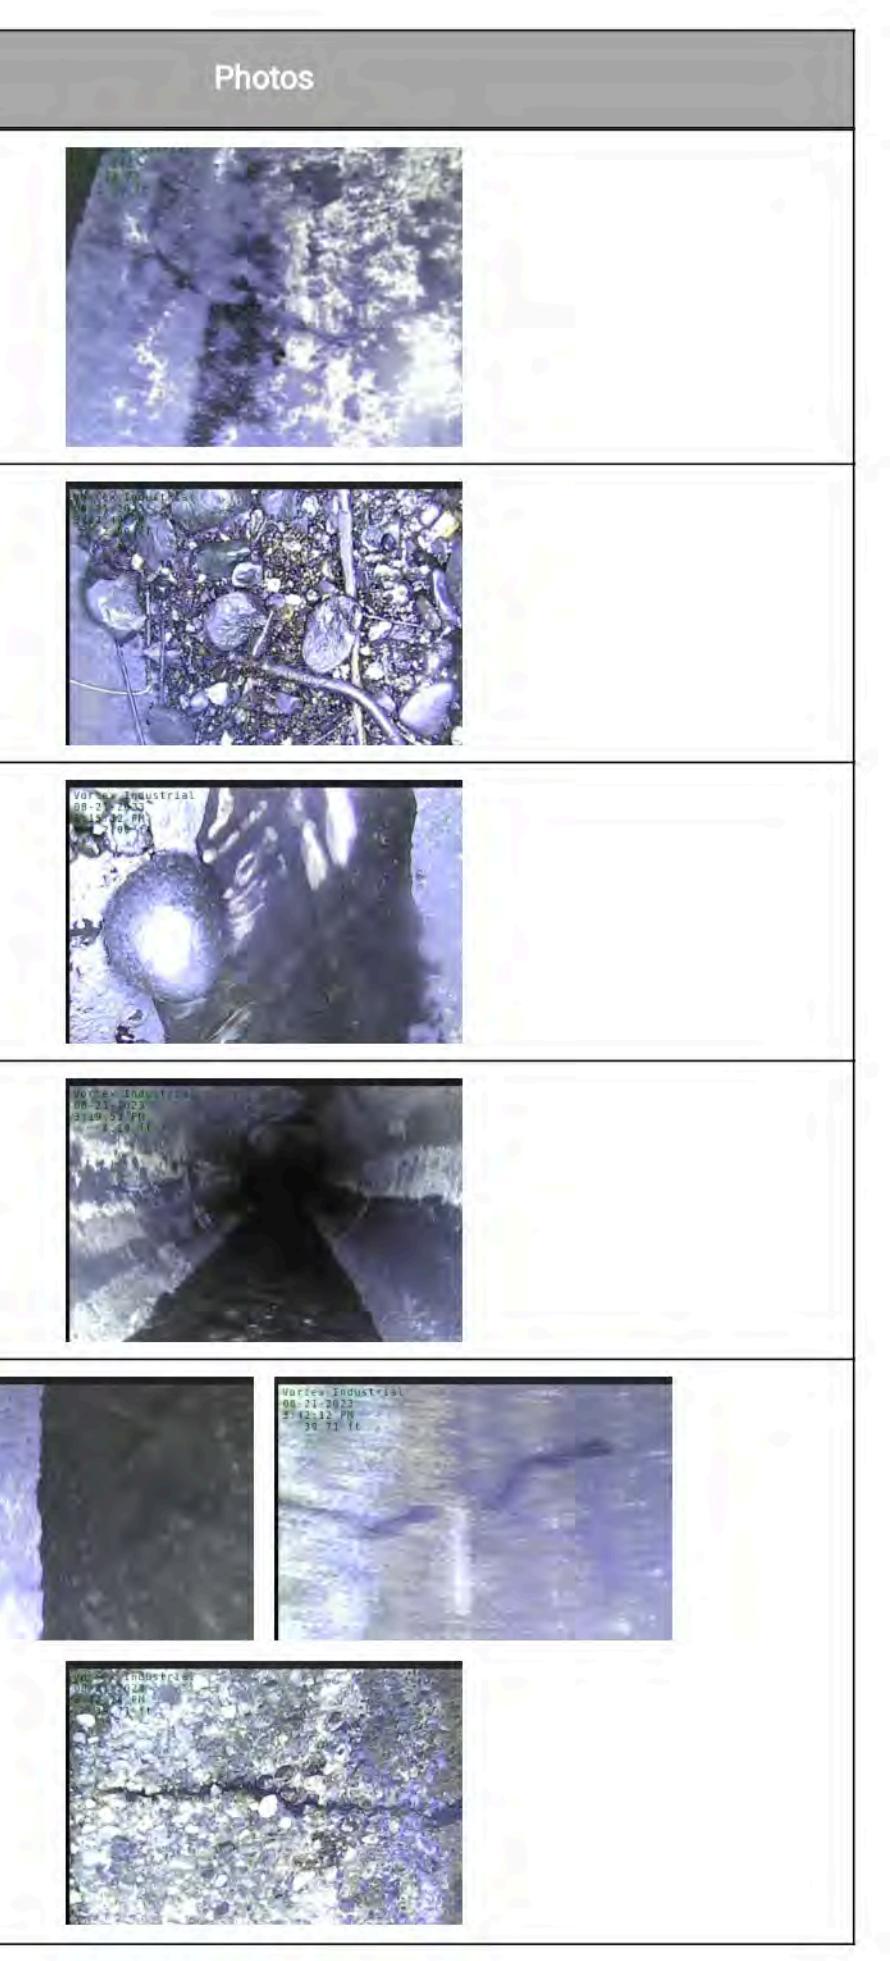
Description	Spatial Type	Distance (ft)	Туре	Percent	Clock	SR	O&M	С	PR	Remarks	
Crack Longitudinal	Point	2	Structural	0	7	2	0	0	2	Crack Longitudinal	
Deposits Settled Gravel	Point	2	O&M	10	6	0	2	0	1	Deposits Settled Gravel	
Crack Longitudinal	Point	2	Structural	0	6	2	0	0	2	Crack Longitudinal	
Miscellaneous Water Level	Point	4.2	Miscellaneous	10)))	0	0	0	0	Miscellaneous Water Level	
Crack Circumferential	Point	39.5	Structural	0	6-8	1	0	0	2	Crack Circumferential	Vorben Industruat die 24 28 23 24 42 (54 5 1) 29 45 1)

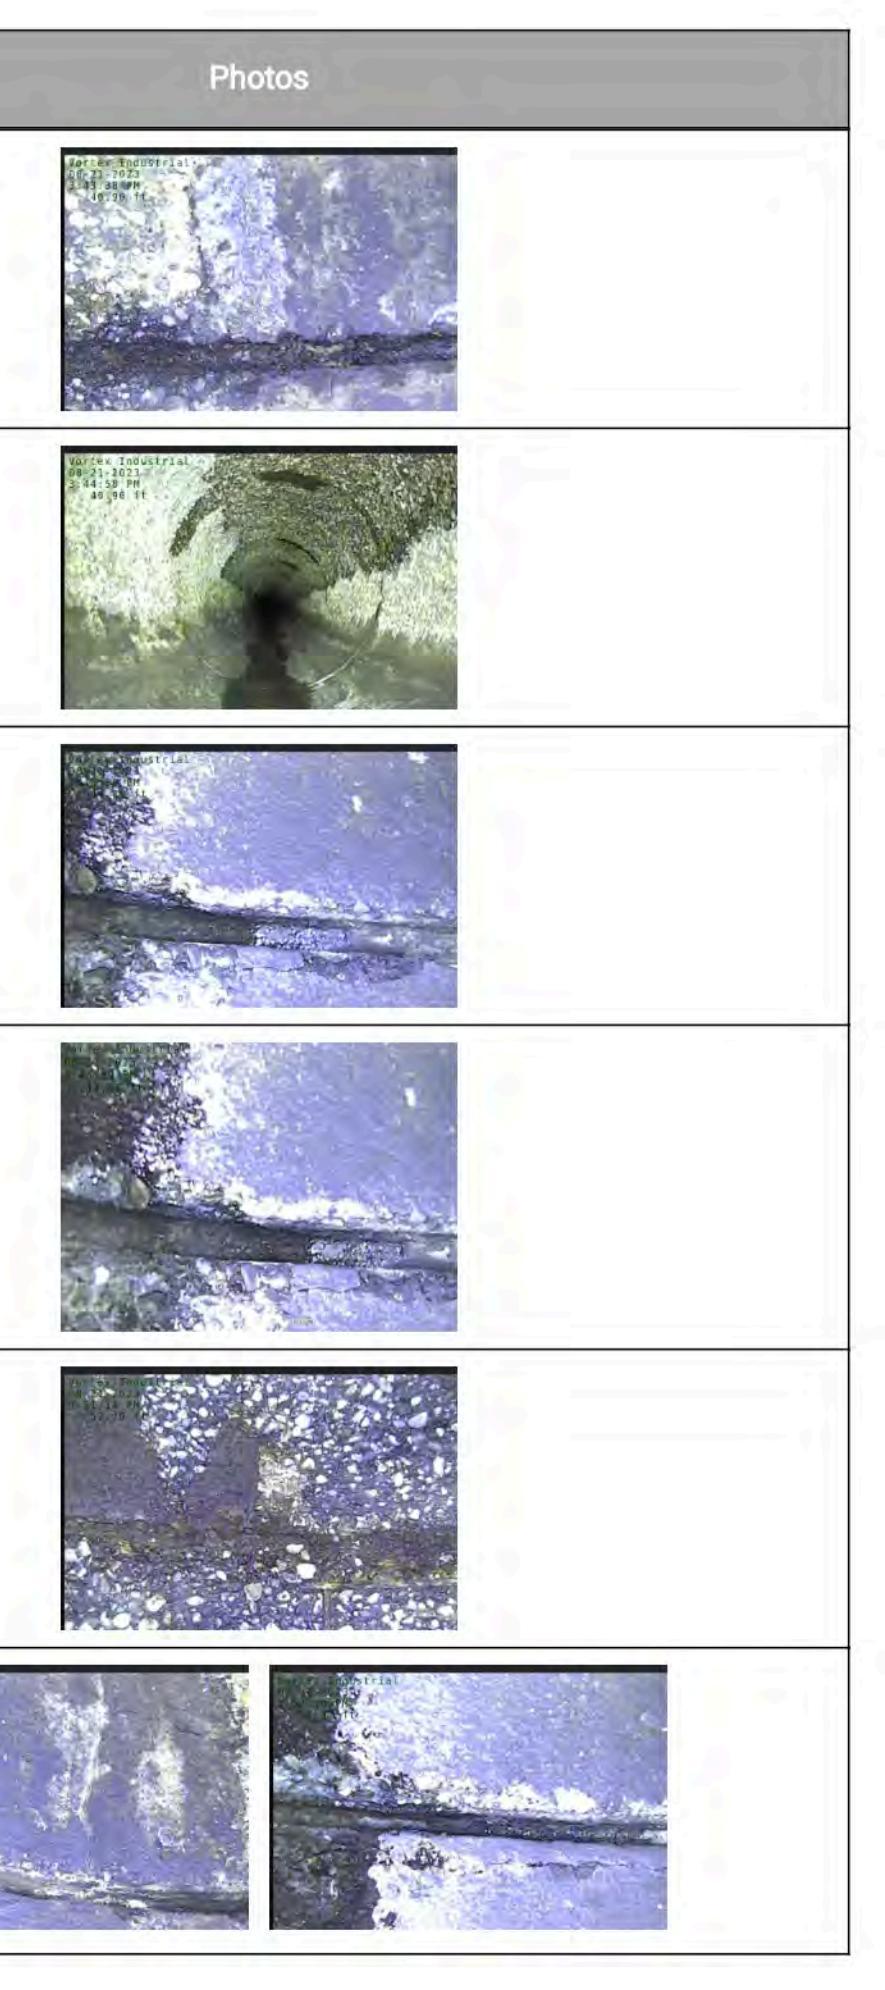
Description	Spatial Type	Distance (ft)	Туре	Percent	Clock	SR	0&M	С	PR	Remarks	
Crack Longitudinal	Point	40.9	Structural	0	8	2	0	0	1	Crack Longitudinal	
Miscellaneous Water Level	Point	40.9	Miscellaneous	0		0	0	0	0	Miscellaneous Water Level	
Crack Circumferential	Point	41.9	Structural	0	5-6	1	0	0	1	Crack Circumferential	
Crack Longitudinal	Point	44.9	Structural	0	4	2	0	0	1	Crack Longitudinal	
Crack Longitudinal	Point	52.7	Structural	0	11	2	0	0	2	Crack Longitudinal	
Crack Circumferential	Point	52.7	Structural	0	4-5	1	0	0	1	Crack Circumferential	dustrial R T

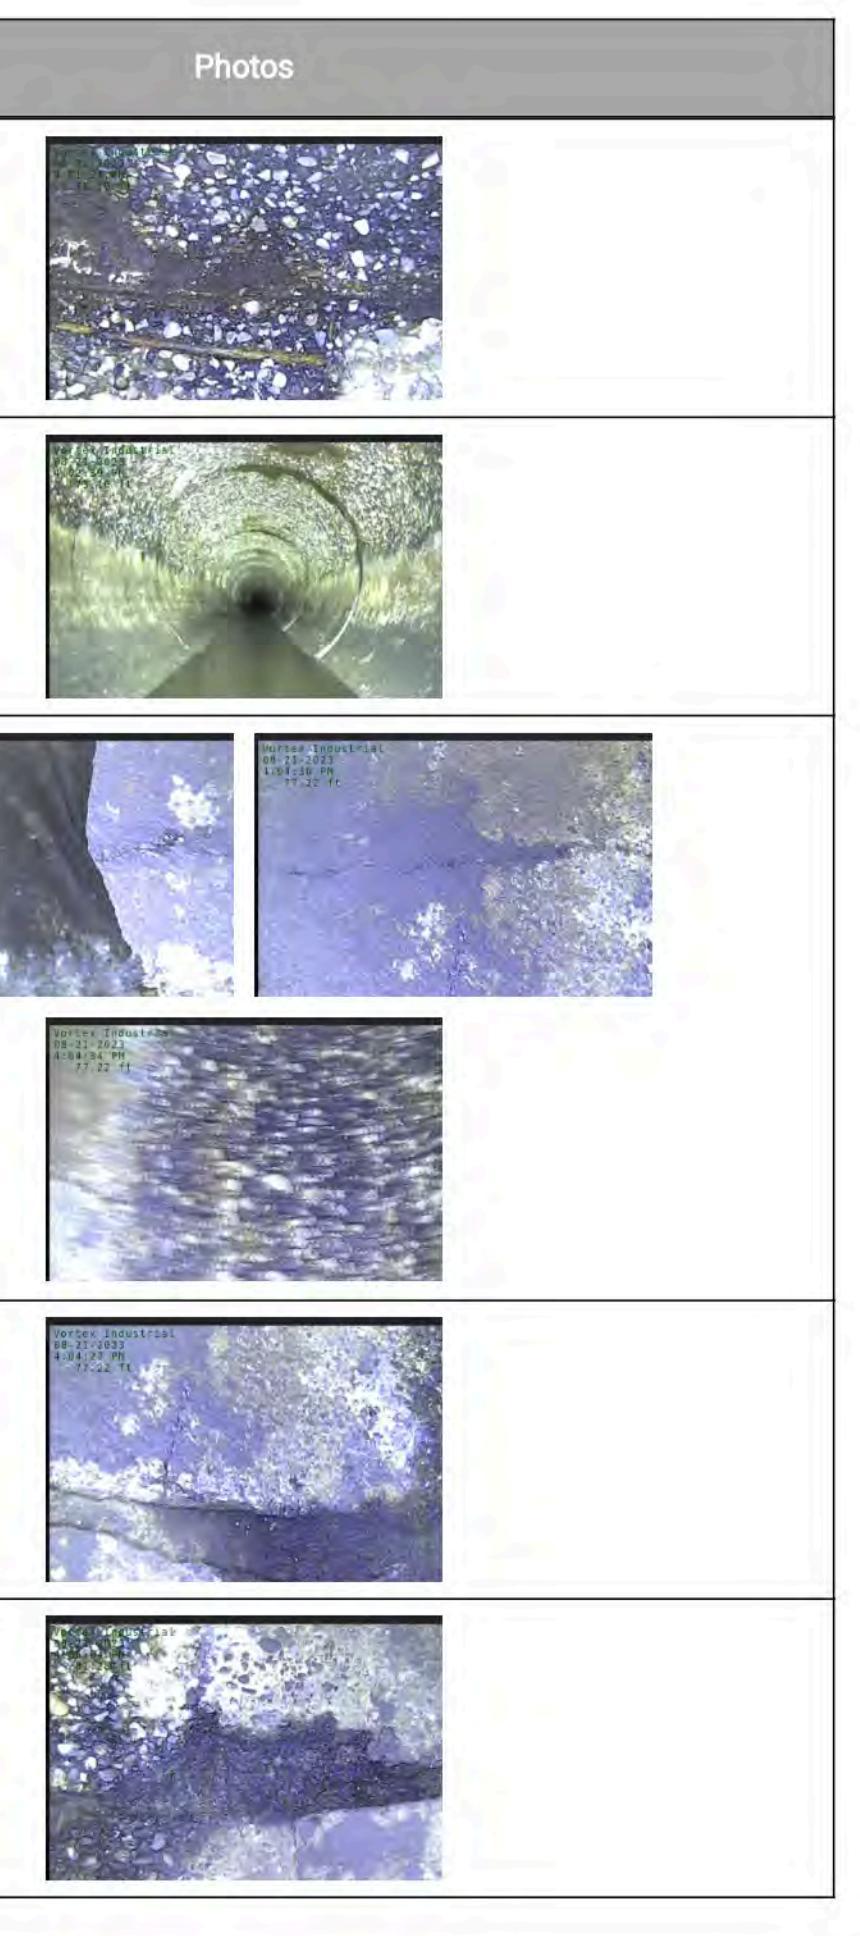
Description	Spatial Type	Distance (ft)	Туре	Percent	Clock	SR	0&M	С	PR	Remarks	
Surface Damage Reinforcement Visible	Point	73.1	Structural	0	10	4	0	0	2	Surface Damage Reinforcement Visible	
Miscellaneous Water Level	Point	73.1	Miscellaneous	10		0	0	0	0	Miscellaneous Water Level	
Crack Circumferential	Point	77.3	Structural	0	5-6	1	0	0	2	Crack Circumferential	947144 204021-13. 88.83742023 87.84.85 90 27.22 **
Crack Longitudinal	Point	77.3	Structural	0	4	2	0	0	1	Crack Longitudinal	
Crack Longitudinal	Point	81.3	Structural	0	8	2	0	0	1	Crack Longitudinal

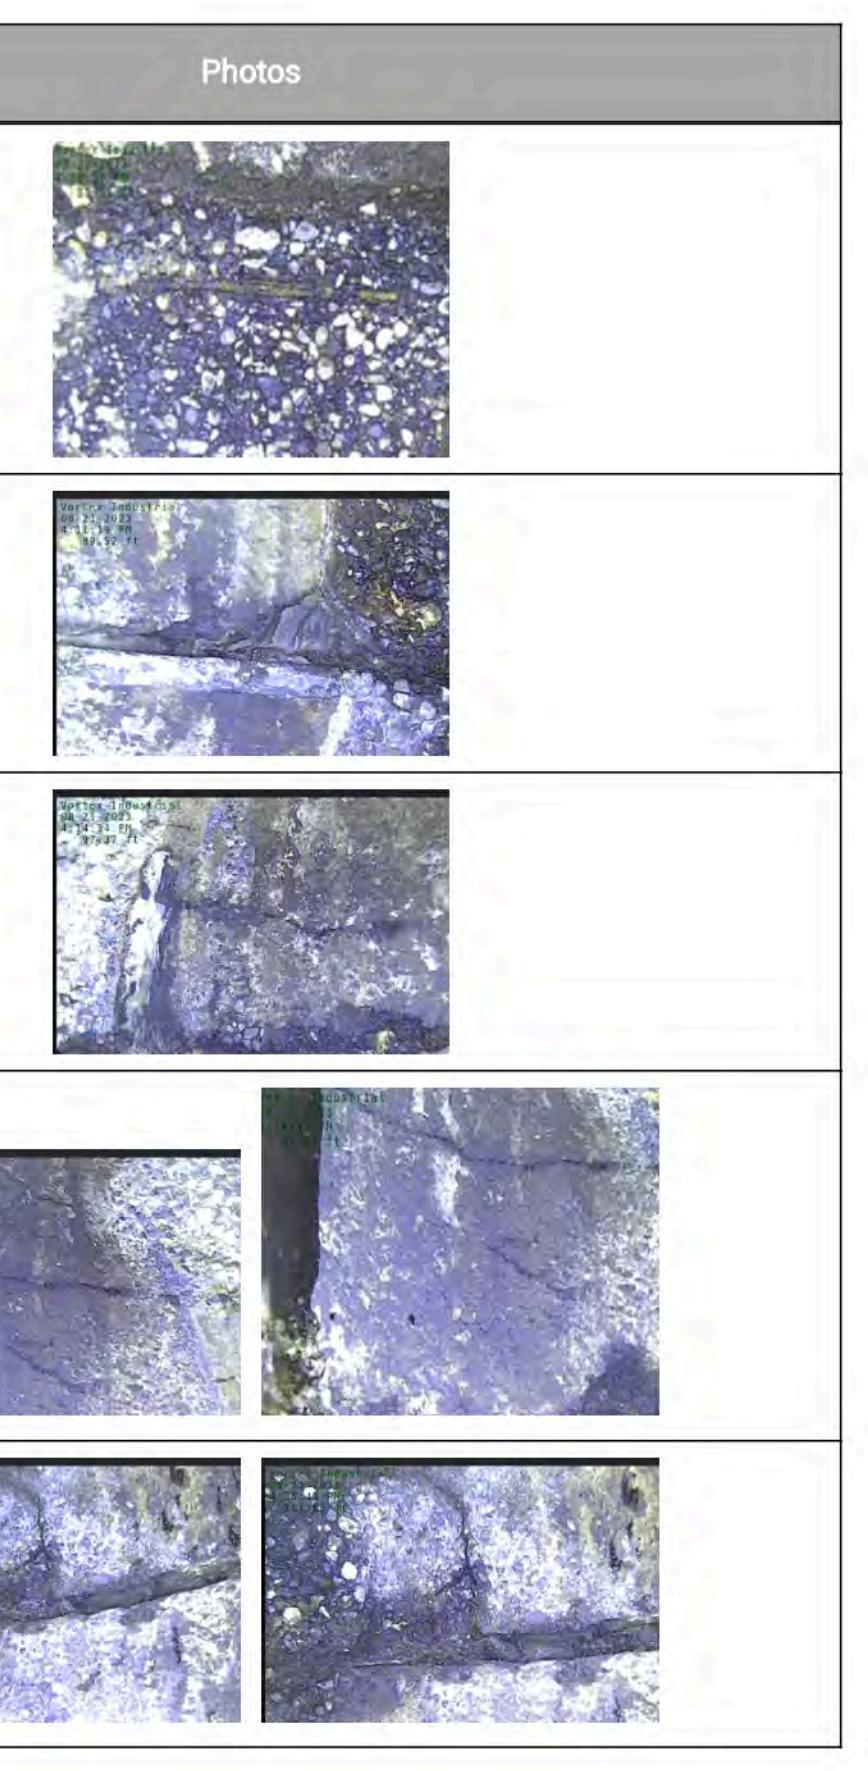
Description	Spatial Type	Distance (ft)	Туре	Percent	Clock	SR	O&M	С	PR	Remarks	12
Surface Damage Reinforcement Visible	Point	85.5	Structural	0	4	4	0	0	2	Surface Damage Reinforcement Visible	
Crack Multiple	Point	89.5	Structural	0	3-4	3	0	0	2	Crack Multiple	
Crack Circumferential	Point	97.4	Structural	0	6-7	1	0	0	2	Crack Circumferential	
Crack Circumferential	Point	97.4	Structural	0	4-5	1	0	0	2	Crack Circumferential	Per de la constante de la constant
Crack Longitudinal	Point	101.7	Structural	0	8	2	0	0	2	Crack Longitudinal

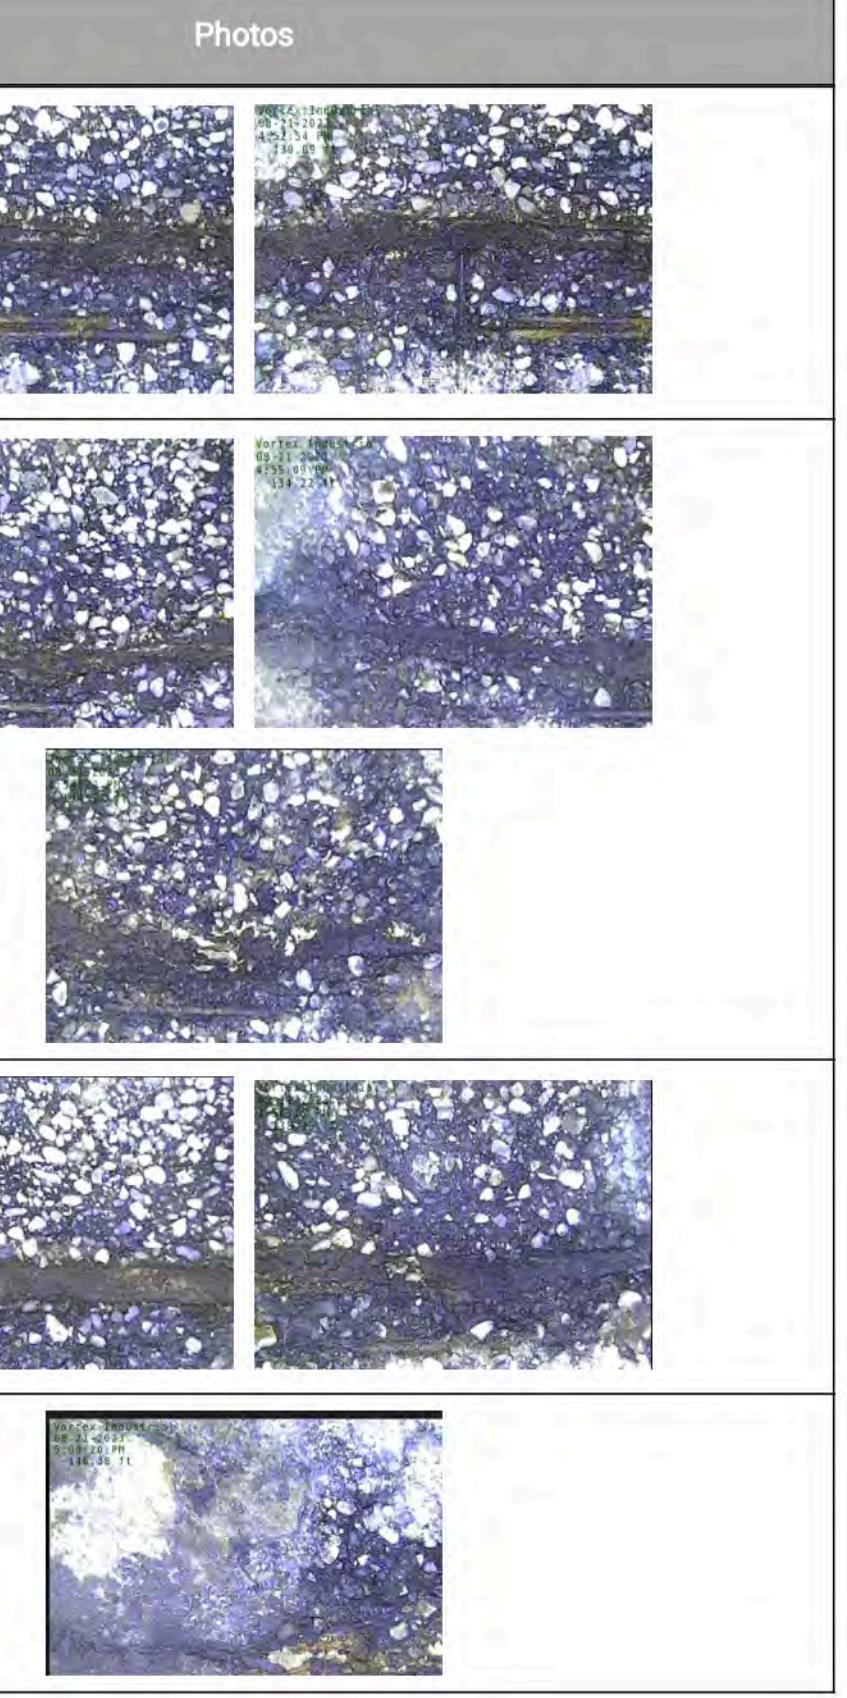
Description	Spatial Type	Distance (ft)	Туре	Percent	Clock	SR	O&M	С	PR	Remarks	Saa
Surface Damage Reinforcement Visible	Point	130.1	Structural	0	5-7	4	0	0	2	Surface Damage Reinforcement Visible	
Surface Damage Reinforcement Visible	Point	134.2	Structural	0	1-4	4	0	0	2	Surface Damage Reinforcement Visible	
Surface Damage Reinforcement Visible	Point	138.3	Structural	0	2-4	4	0	0	2	Surface Damage Reinforcement Visible	
Crack Longitudinal	Point	146.4	Structural	0	2	2	0	0	2	Crack Longitudinal

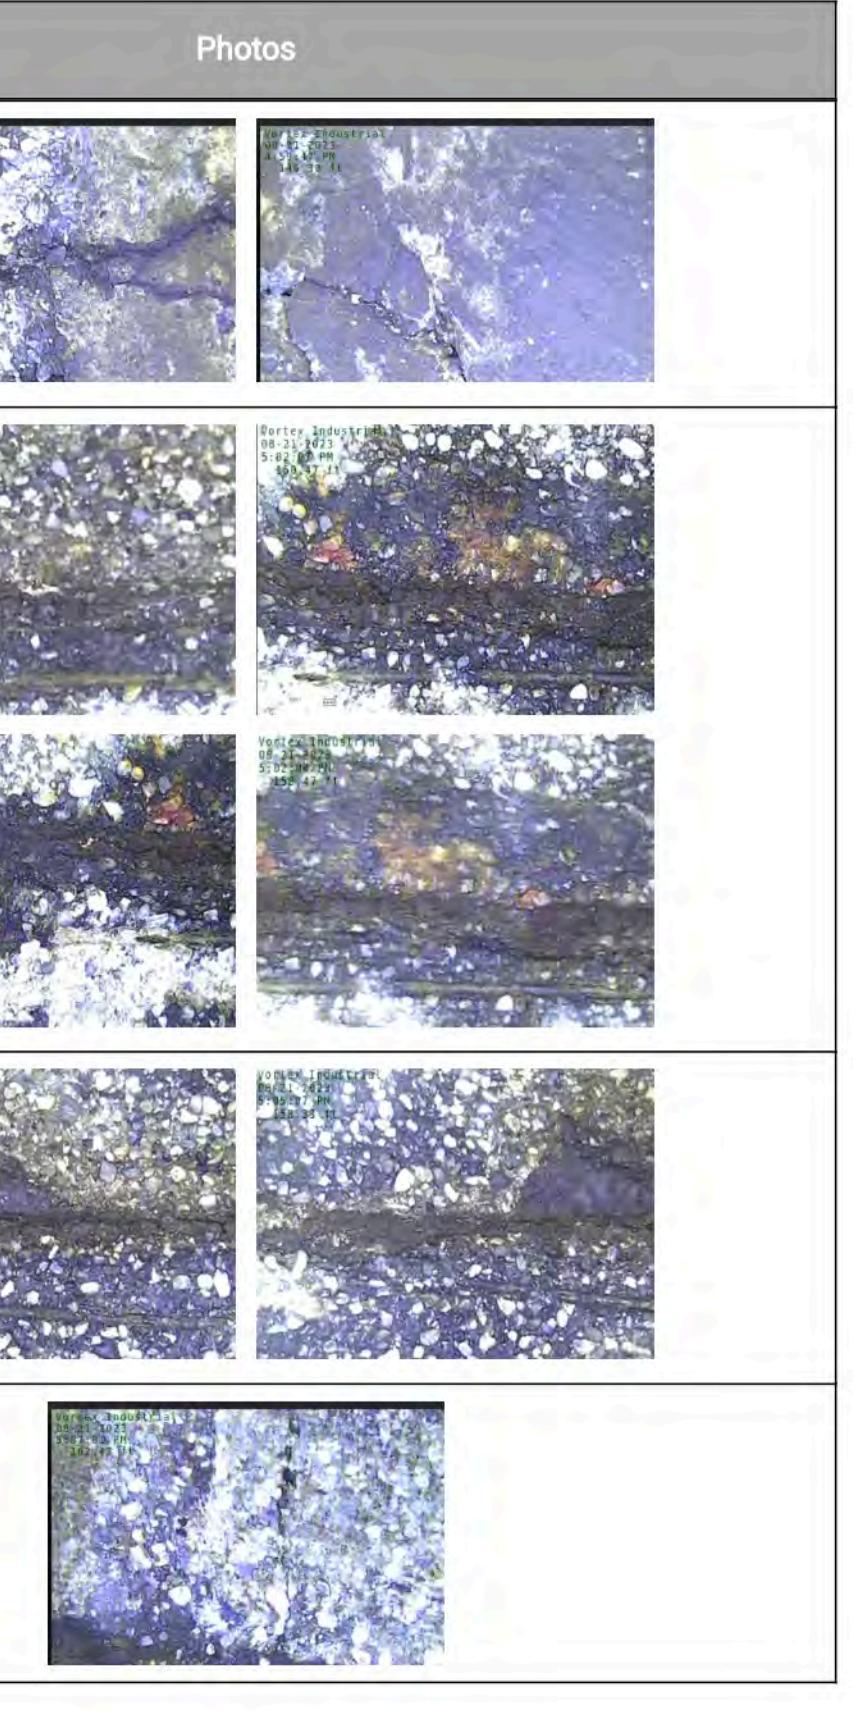
Description	Spatial Type	Distance (ft)	Туре	Percent	Clock	SR	O&M	С	PR	Remarks	Kenner
Crack Multiple	Point	146.4	Structural	0	8-9	3	0	0	2	Crack Multiple	
Surface Damage Reinforcement Visible	Point	150.5	Structural	0	50- 10	4	0	0	2	Surface Damage Reinforcement Visible	
Surface Damage Reinforcement Visible	Point	158.5	Structural	0	5-10	4	0	0	2	Surface Damage Reinforcement Visible	
Crack Longitudinal	Point	162.4	Structural	0	3	2	0	0	1	Crack Longitudinal
