2024 ANNUAL PROGRESS REPORT SWMU-1 OILY WATER SEWER

HF SINCLAIR PUGET SOUND REFINING LLC

March 2025

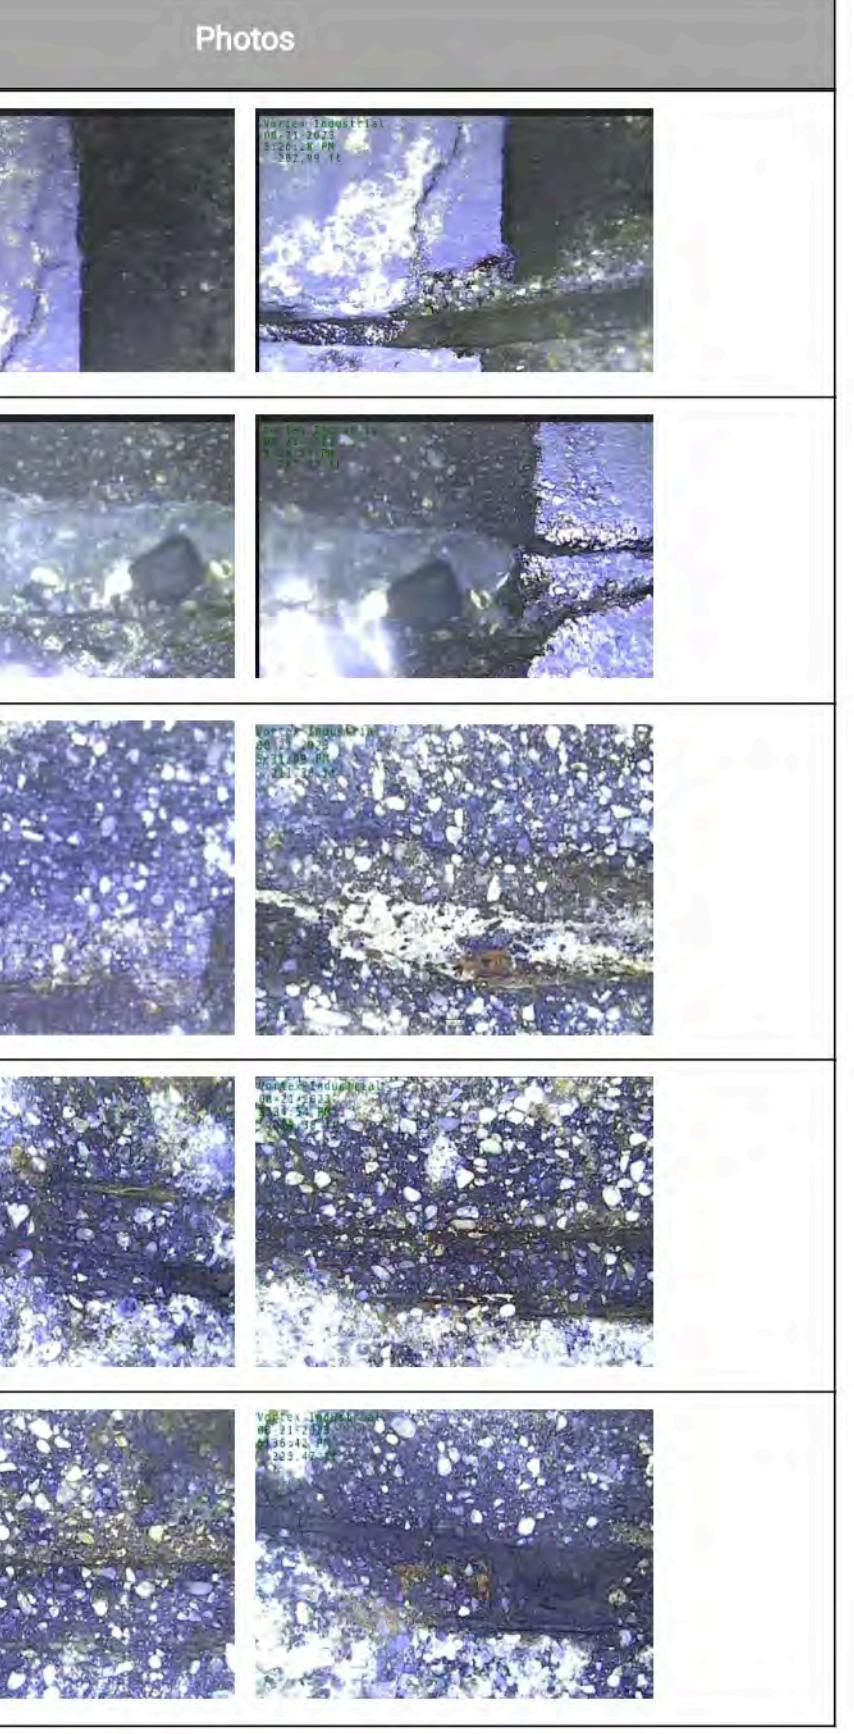
Description	Spatial Type	Distance (ft)	Туре	Percent	Clock	SR	O&M	С	PR	Remarks	
Crack Longitudinal	Point	203	Structural	0	7	2	0	0	2	Crack Longitudinal	Deriver 2 types (* 1916) 1912 - 7403 1913 - 22 - 4403 1913 - 22 - 444 1917 - 22 - 444 1917 - 22 - 444 1917 - 2017 - 2017 1917 - 2017 - 2017 - 2017 1917 - 2017
Fracture Circumferential	Point	207	Structural	0	5-6	2	0	0	2	Fracture Circumferential	2024 - 2020 9123 - 2020 9123 - 30 - 90 205,
Surface Damage Reinforcement Visible	Point	215.3	Structural	0	5-10	4	0	0	2	Surface Damage Reinforcement Visible	Wartson Doministration in the constraints of the constraints of the co
Surface Damage Reinforcement Visible	Point	219.4	Structural	0	1-4	4	0	0	2	Surface Damage Reinforcement Visible	Viniting Studient (45.1) 00 a 22 d 0 2 d 3 3 3 4 3 5 Pri 2 3 3 4 3 5 Pri 2 3 5 4 7 d 4 4 4 4 4 4 4 4 4 4 4 4 4 4 4 4 4 4 4
Surface Damage Reinforcement Visible	Point	223.5	Structural	0	6-10	4	0	0	2	Surface Damage Reinforcement Visible

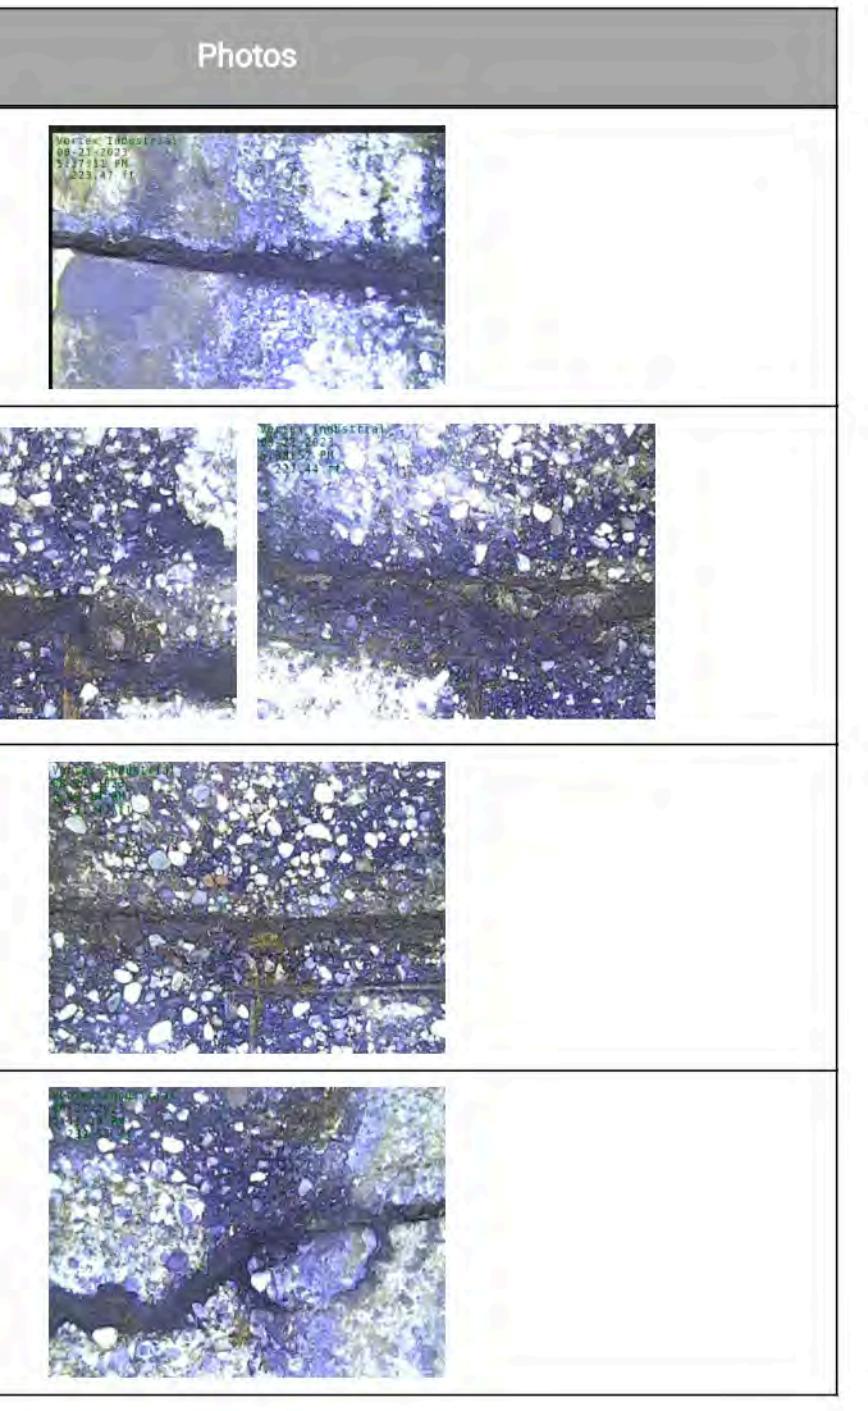
Description	Spatial Type	Distance (ft)	Туре	Percent	Clock	SR	O&M	С	PR	Remarks	
Crack Longitudinal	Point	223.5	Structural	0	3	2	0	0	1	Crack Longitudinal	
Surface Damage Reinforcement Visible	Point	227.4	Structural	0	6-10	4	0	0	2	Surface Damage Reinforcement Visible	
Surface Damage Reinforcement Visible	Point	231.4	Structural	0	2-4	4	0	0	2	Surface Damage Reinforcement Visible	
Crack Circumferential	Point	239.5	Structural	0	7-8	1	0	0	2	Crack Circumferential

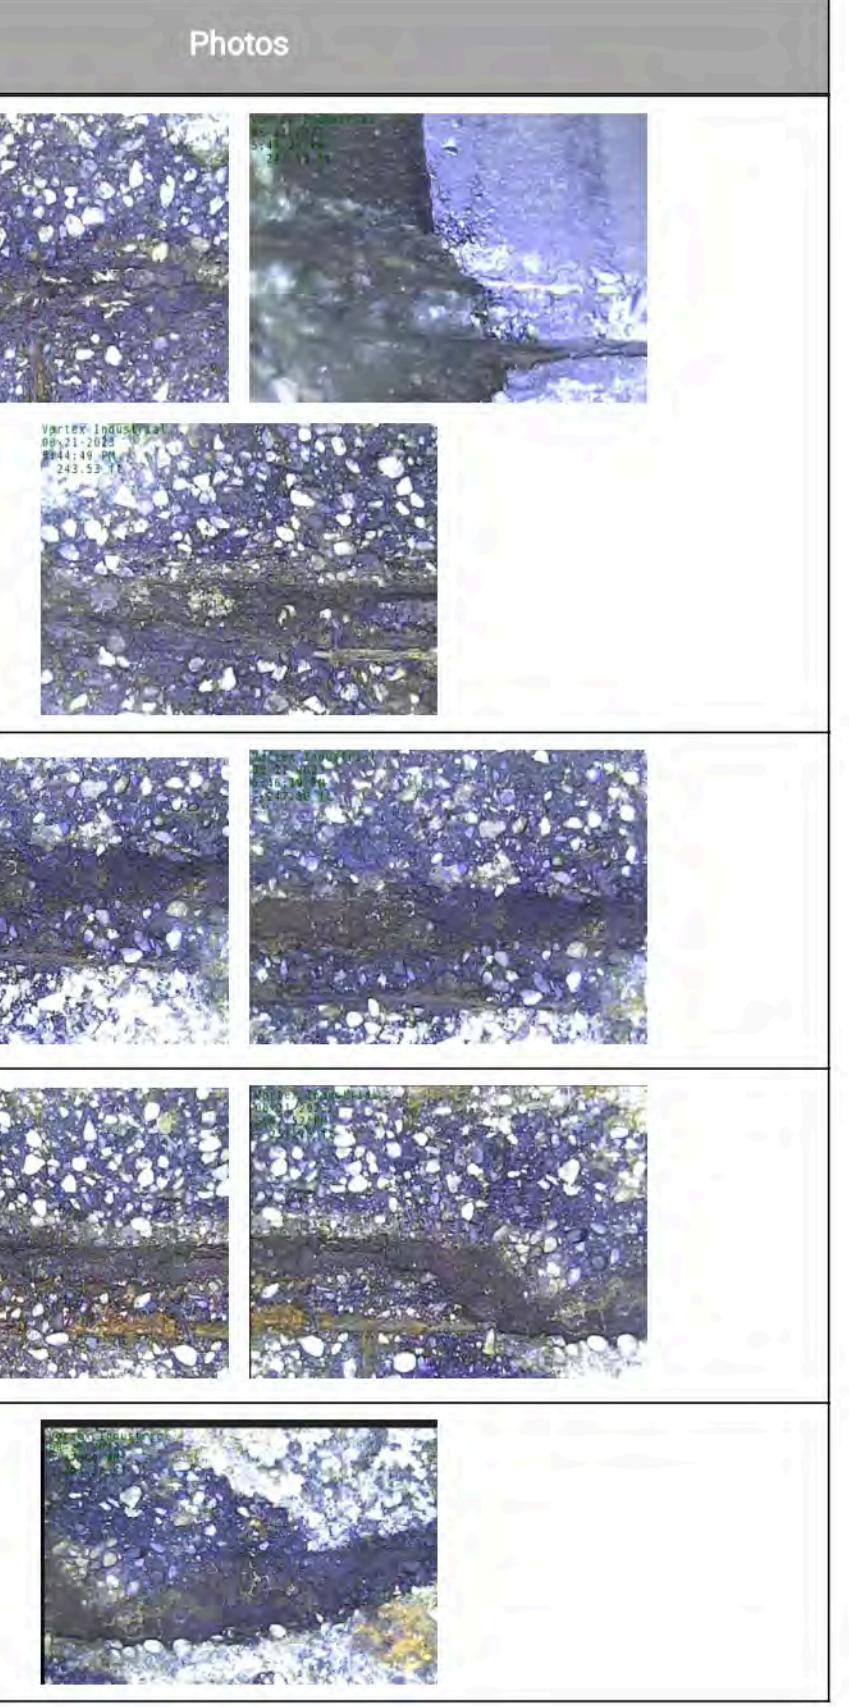
Description	Spatial Type	Distance (ft)	Туре	Percent	Clock	SR	O&M	С	PR	Remarks	
Surface Damage Reinforcement Visible	Point	243.5	Structural	0	12- 12	4	0	0	2	Surface Damage Reinforcement Visible	
Surface Damage Reinforcement Visible	Point	247.8	Structural	0	2-4	4	0	0	2	Surface Damage Reinforcement Visible	
Surface Damage Reinforcement Visible	Point	251.8	Structural	0	6-8	4	0	0	2	Surface Damage Reinforcement Visible	
Fracture Circumferential	Point	251.8	Structural	0	10- 11	2	0	0	2	Fracture Circumferential

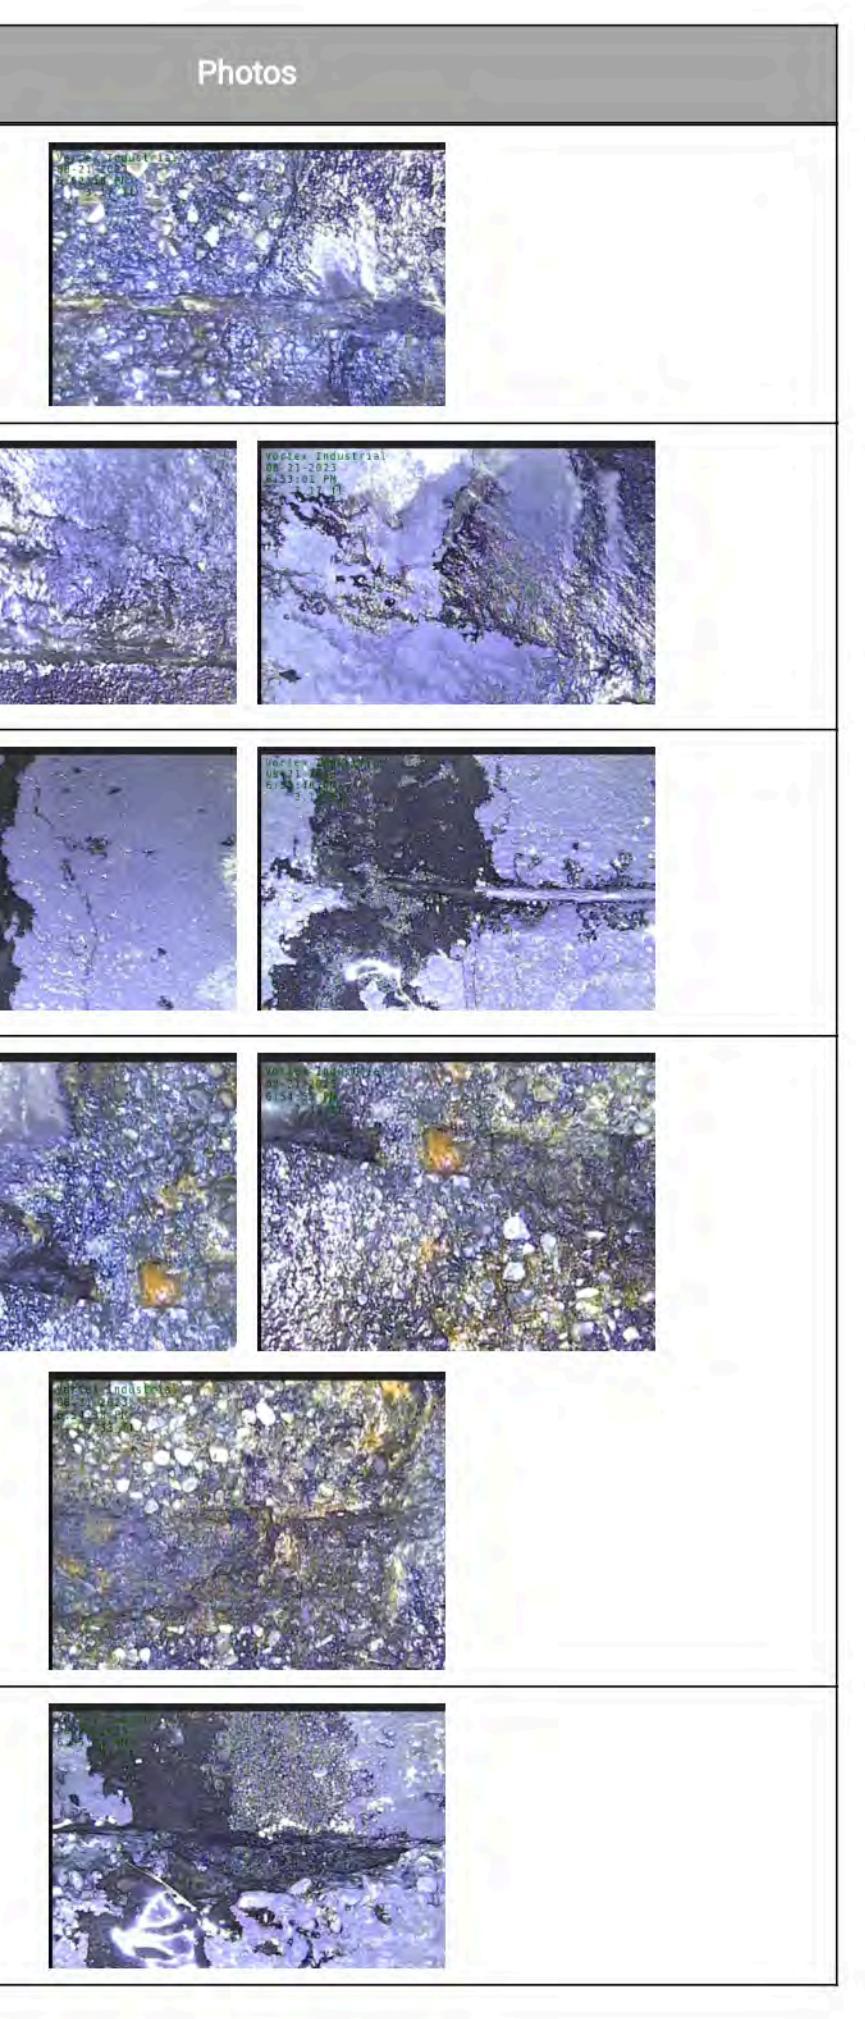
Description	Spatial Type	Distance (ft)	Туре	Percent	Clock	SR	0&M	С	PR	Remarks	
Crack Longitudinal	Point	3.2	Structural	0	10	2	0	0	1	Crack Longitudinal	
Crack Spiral	Point	3.2	Structural	0	3-4	2	0	0	1	Crack Spiral	2) conservation to 24 76 - 21 - 2403 61 - 21 - 21 - 21 1 - 21 - 1 1 - 21 - 1 1 - 21 - 2
Crack Longitudinal	Point	3.2	Structural	0	6	2	0	0	1	Crack Longitudinal	Vurier Junus (m) 05721-2623 6:53138.94 3:11/11 3:11/11
Surface Damage Reinforcement Visible	Point	7.3	Structural	0	2-4	4	0	0	2	Surface Damage Reinforcement Visible	in rice. Tradus final in the to area in the to area in the to area in the total in totali in total in totali in totalin totali in to
Fracture Circumferential	Point	7.3	Structural	0	5-6	2	0	0	2	Fracture Circumferential

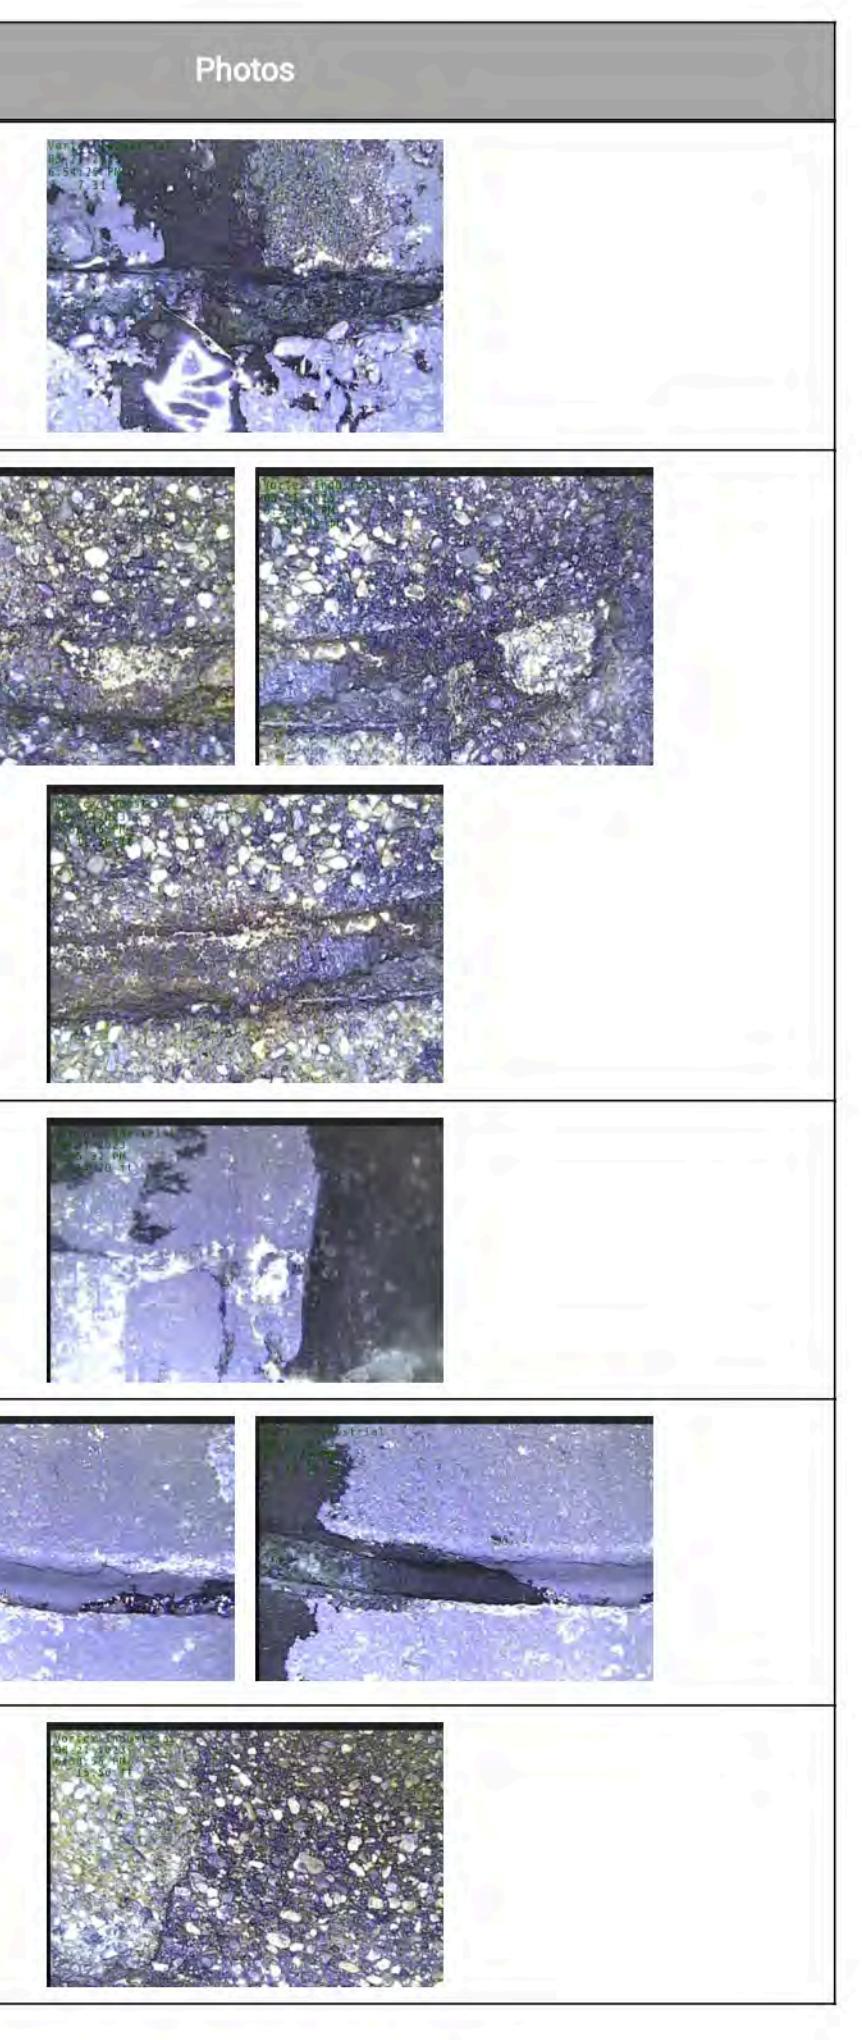
Description	Spatial Type	Distance (ft)	Туре	Percent	Clock	SR	0&M	С	PR	Remarks	
Surface Aggregate Visible	Point	7.3	Structural	0	5-6	2	0	0	1	Surface Aggregate Visible	
Surface Damage Reinforcement Visible	Point	11.2	Structural	0	2-4	4	0	0	2	Surface Damage Reinforcement Visible	Vactor Louisian Alter Other Ot
Crack Longitudinal	Point	11.2	Structural	0	7	2	0	0	2	Crack Longitudinal	
Crack Circumferential	Point	15.6	Structural	0	4-5	1	0	0	1	Crack Circumferential	tar (ex 3 ndsafras) 65 32 5023 65 327 6 PR 35 36 Fr
Crack Longitudinal	Point	15.6	Structural	0	2	2	0	0	2	Crack Longitudinal

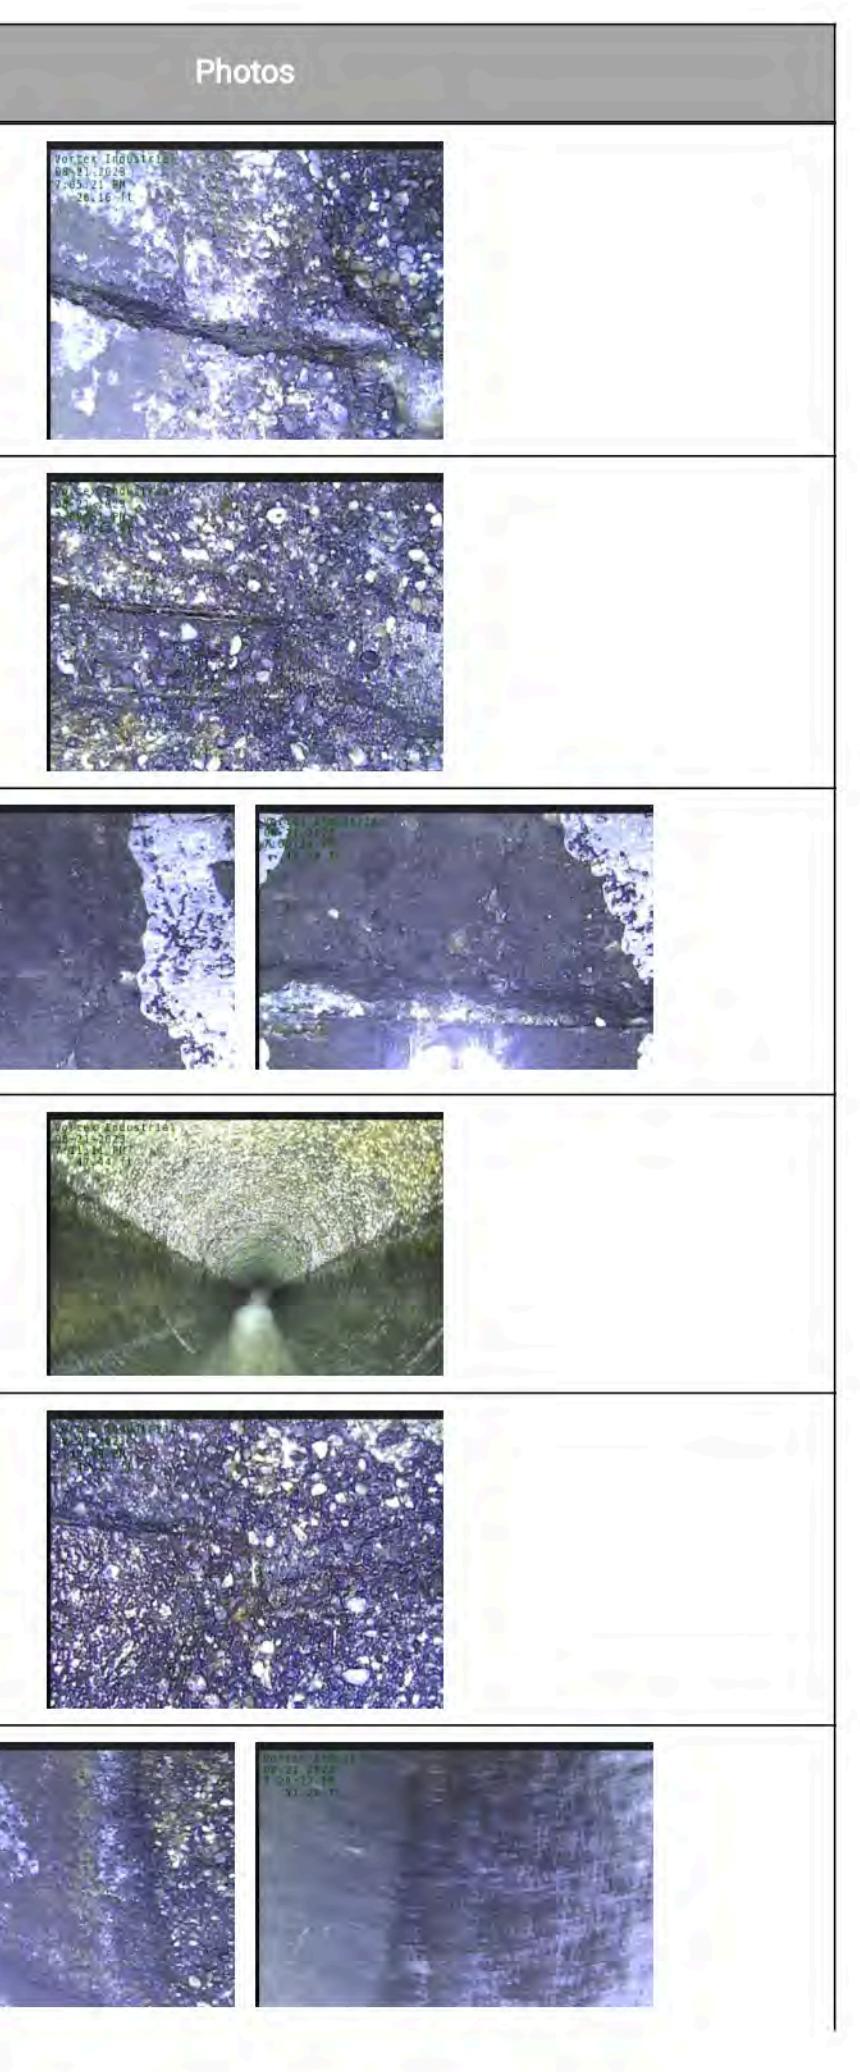
Description	Spatial Type	Distance (ft)	Туре	Percent	Clock	SR	O&M	С	PR	Remarks	
Fracture Circumferential	Point	26.2	Structural	0	2-3	2	0	0	2	Fracture Circumferential	
Surface Damage Reinforcement Visible	Point	38.4	Structural	0	8	4	0	0	2	Surface Damage Reinforcement Visible	
Crack Longitudinal	Point	43.2	Structural	0	6	2	0	0	2	Crack Longitudinal	
Miscellaneous Water Level	Point	47.5	Miscellaneous	10		0	0	0	0	Miscellaneous Water Level	
Surface Damage Reinforcement Visible	Point	48.2	Structural	0	4	4	0	0	2	Surface Damage Reinforcement Visible	
Crack Circumferential	Point	51.3	Structural	0	3-5	1	0	0	1	Crack Circumferential	100-00 1000/0010 99-00-00 97-014-00 51-20-50

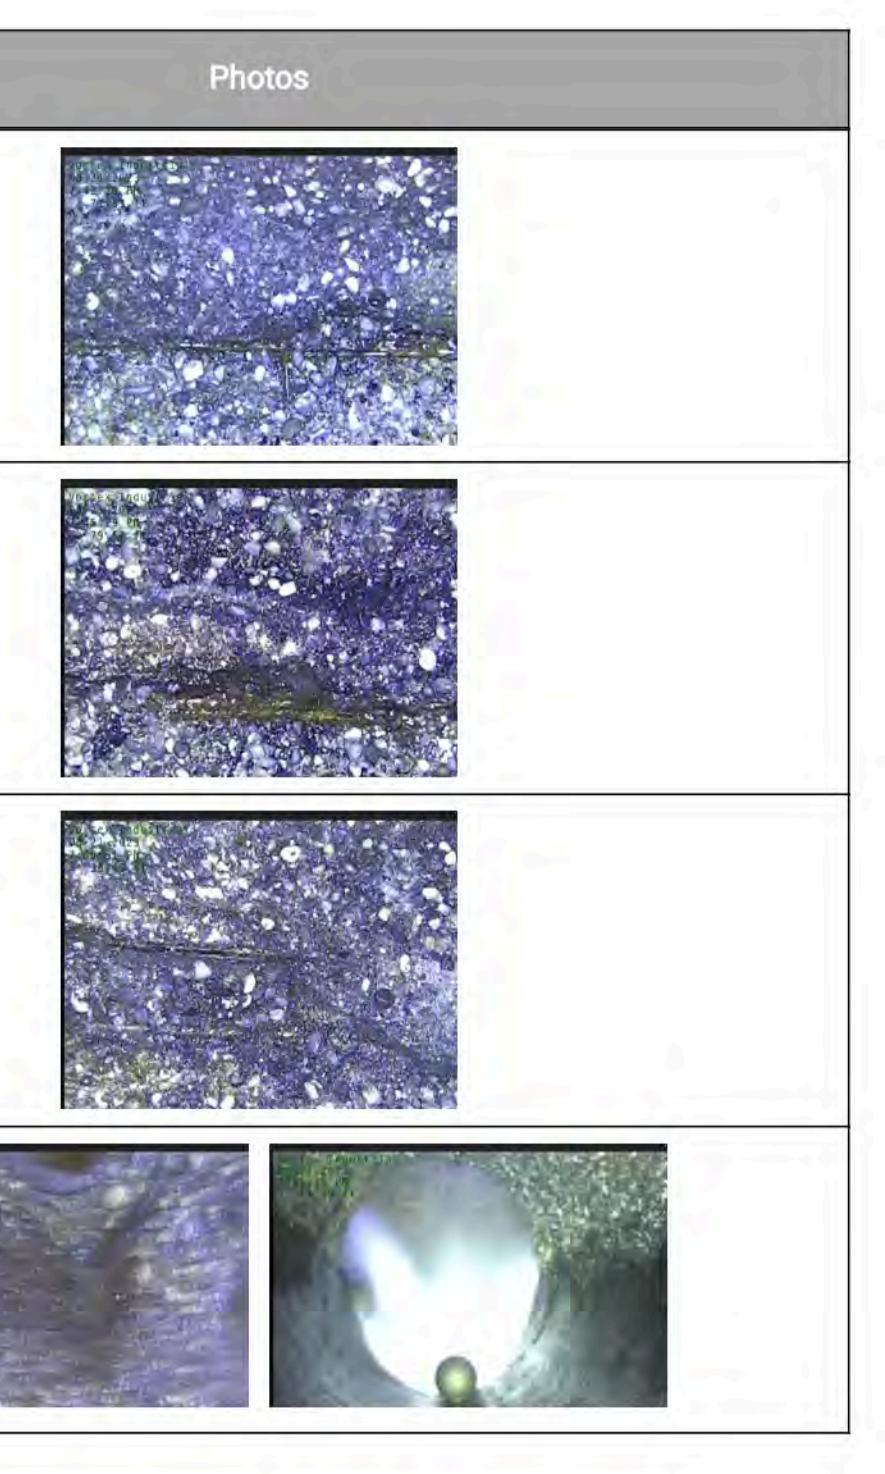
Description	Spatial Type	Distance (ft)	Туре	Percent	Clock	SR	O&M	С	PR	Remarks	
Surface Damage Reinforcement Visible	Point	71.8	Structural	0	3	4	0	0	2	Surface Damage Reinforcement Visible	
Surface Damage Reinforcement Visible	Point	79.5	Structural	0	2-4	4	0	0	2	Surface Damage Reinforcement Visible	
Surface Damage Reinforcement Visible	Point	87.9	Structural	0	10	4	0	0	2	Surface Damage Reinforcement Visible	
Manhole	Point	89.5	Constructional	0		0	0	0	0	5-E

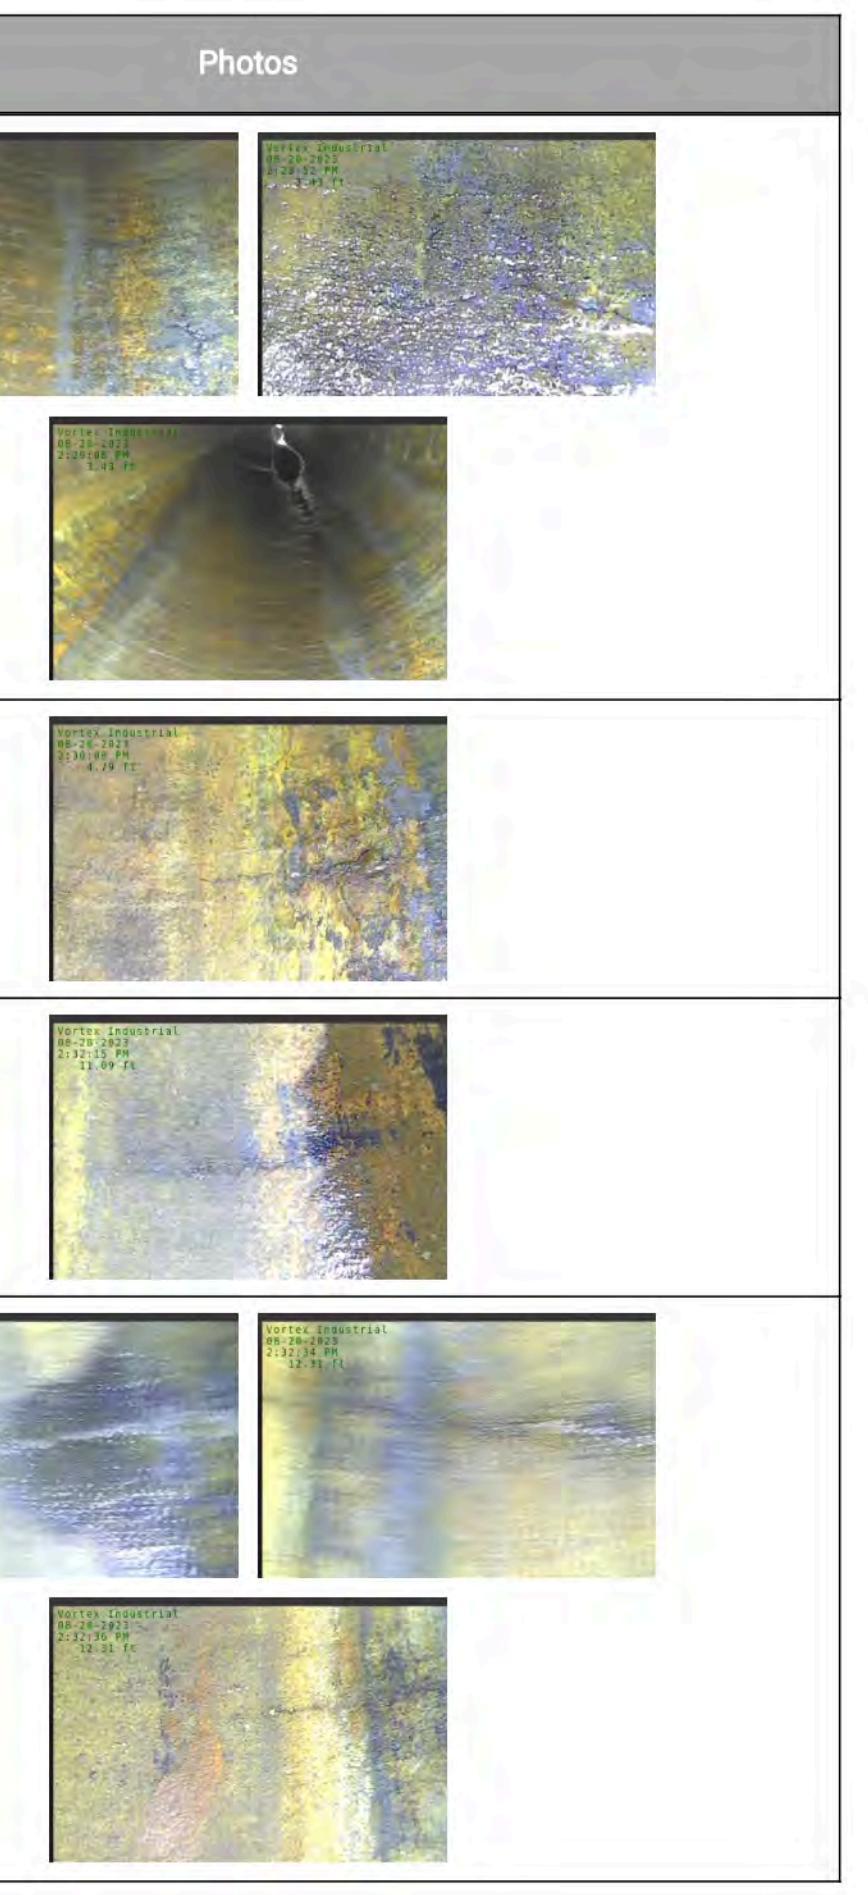
Description	Spatial Type	Distance (ft)	Туре	Percent	Clock	SR	O&M	С	PR	Remarks	
Crack Spiral	Point	3.4	Structural	0	5-7	2	0	0	2	Crack Spiral	
Crack Circumferential	Point	4.8	Structural	0	6-7	1	0	0	2	Crack Circumferential	
Crack Circumferential	Point	11.1	Structural	0	6-7	1	0	0	2	Crack Circumferential	
Crack Circumferential	Point	12.3	Structural	0	6-9	1	0	0	2	Crack Circumferential	Vortex Industrial 105-20-2023 2132:33 PM 12:31 T 12:31 T

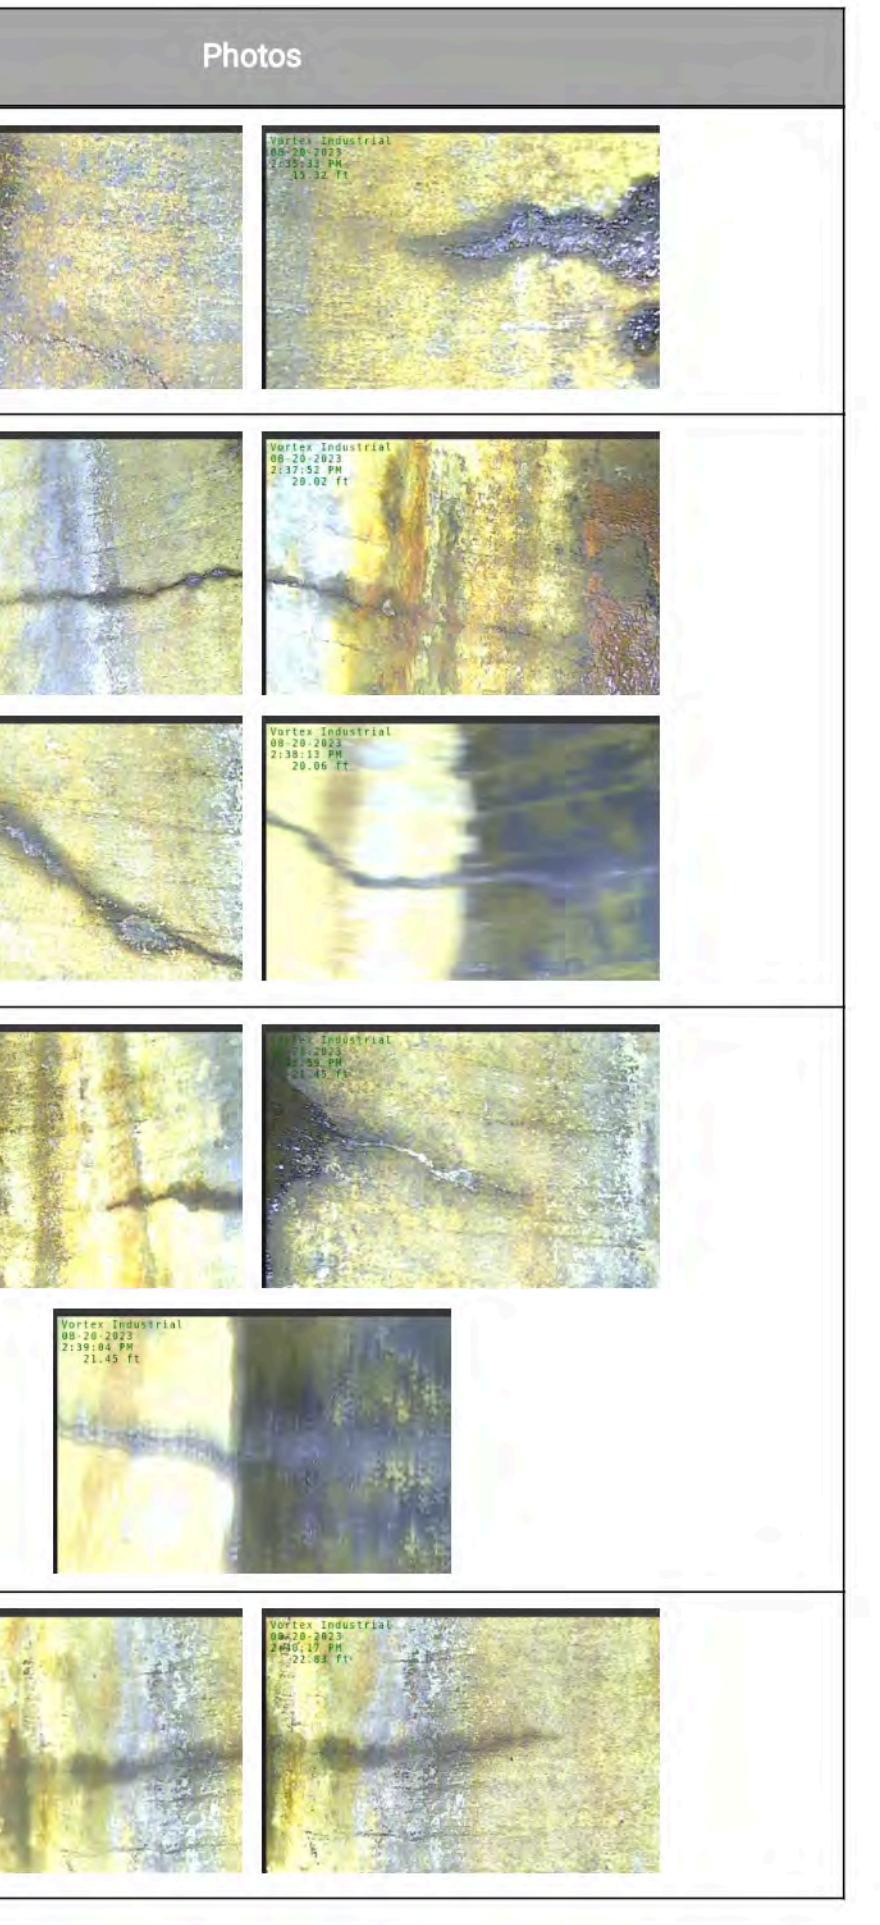
Description	Spatial Type	Distance (ft)	Туре	Percent	Clock	SR	0&M	С	PR	Remarks	
Crack Circumferential	Point	15.3	Structural	0	5-7	1	0	0	2	Crack Circumferential	
Crack Circumferential	Point	20.1	Structural	0	3-9	1	0	0	2	Crack Circumferential	
Crack Circumferential	Point	21.5	Structural	0	5-9	1	0	0	2	Crack Circumferential	And the Engender of the second
Crack Circumferential	Point	22.8	Structural	0	8-9	1	0	0	2	Crack Circumferential	Vortex Industriat 08:20:2023 2:4000 ff 22:20 ff 2:200 ff

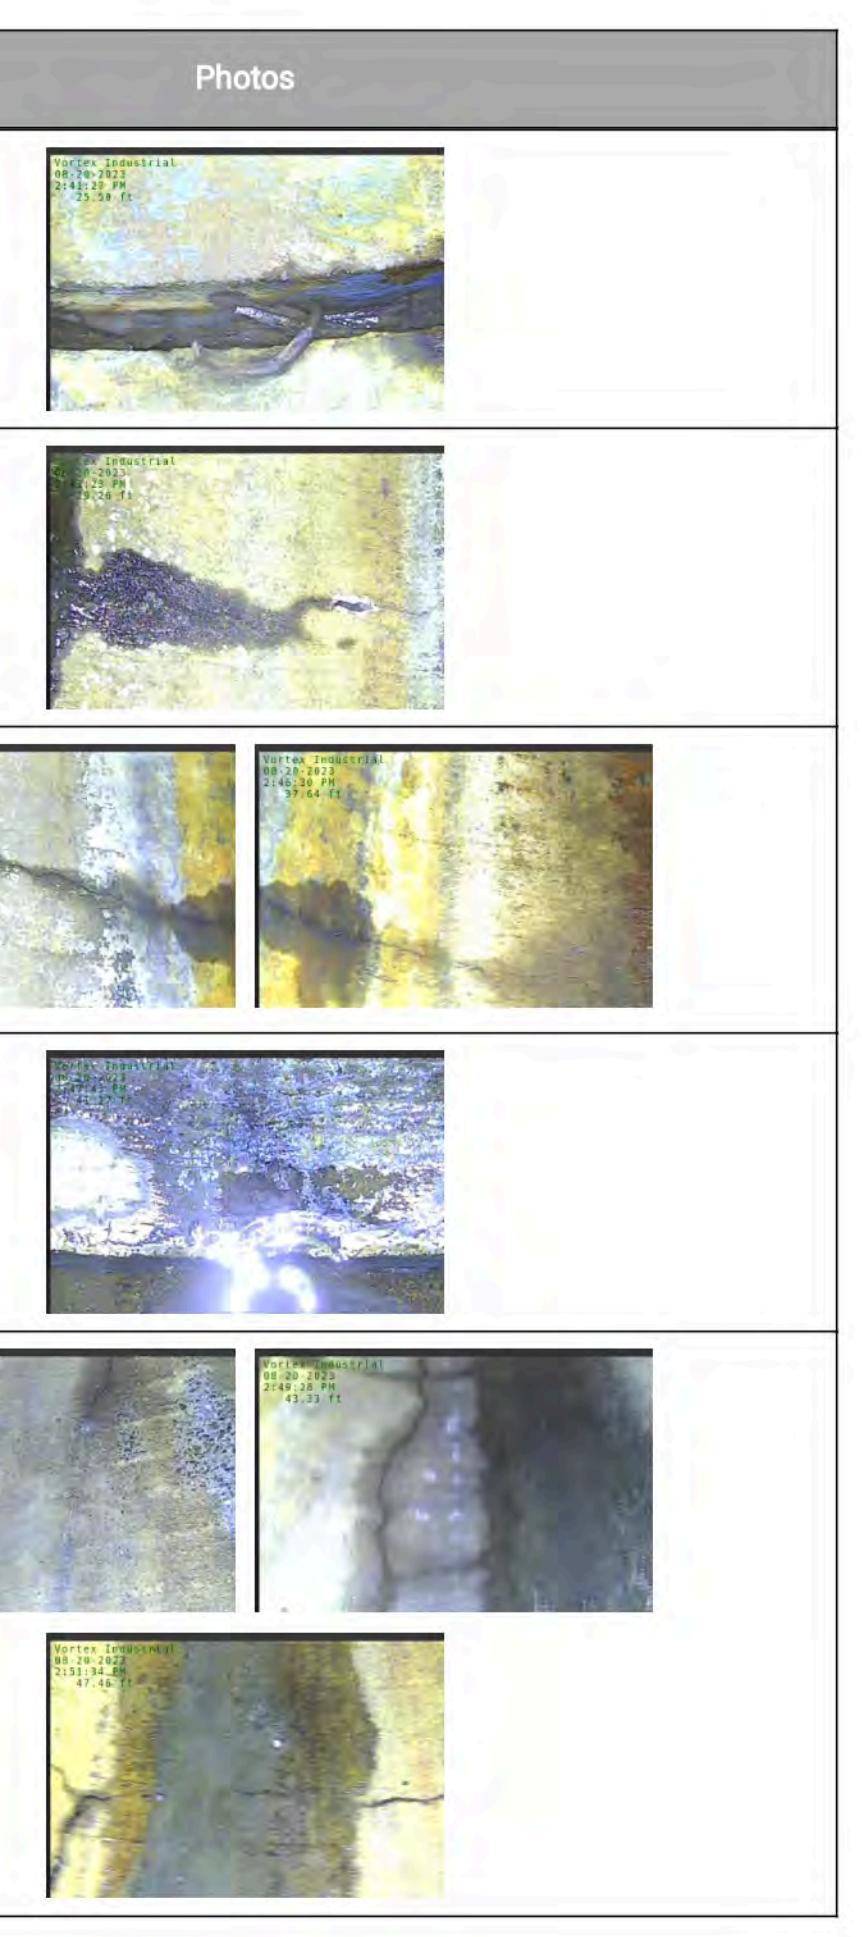
Description	Spatial Type	Distance (ft)	Туре	Percent	Clock	SR	0&M	С	PR	Remarks	
Intruding Sealing Material Grout	Point	25.6	O&M	10	7	0	2	0	0	Intruding Sealing Material Grout	
Crack Circumferential	Point	29.3	Structural	0	5-6	1	0	0	2	Crack Circumferential	
Crack Circumferential	Point	37.6	Structural	0	2-6	1	0	0	2	Crack Circumferential	00 r184 Industrial 00 00 - 07.3 24 56:27 PM 32.02 ft
Crack Longitudinal	Point	41.2	Structural	0	6	2	0	0	2	Crack Longitudinal	
Crack Multiple	Continuous	43 - 47.3	Structural	0	5-7	3	0	0	2	Crack Multiple	Varies, Industrial DE-20-2023 201000-2023 2020-002 2020-000 2020-000 20200-000 2020-000 2020-000 2020-000 2020-000 2020-000 2020-000 2020-000 2020-000 2020-000 2020-000 2020-000 2000-000 2020-000 2020-000 2020-000 2020-000 2020-000 2020-000 2020-000 2020-000 2020-000 2020-000 2020-000 2020-000 2020-000 2020-000 2020-000 2020-000 2020-000 2020-000 2000-000 2000-000 2000-0000 2000-0000 2000-0000 2000-0000 2000-0000 2000-0000 2000-0000 2000-0000 2000-0000 2000-00000000

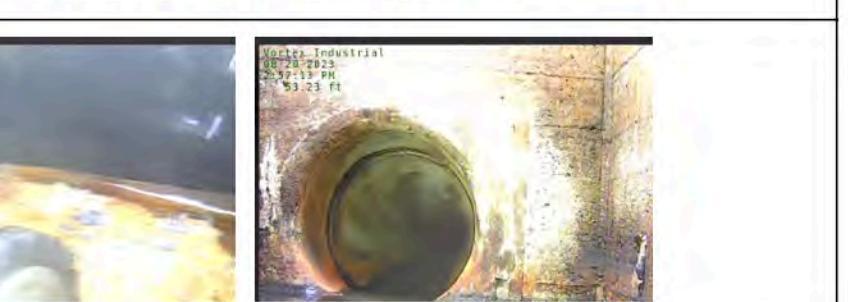
Description	Spatial Type	Distance (ft)	Туре	Percent	Clock	SR	O&M	с	PR	Remarks	12 5 7 7 8 3
Surface Damage Aggregate Missing	Point	48.7	Structural	0	12- 12	4	0	0	2	Surface Damage Aggregate Missing	Ser The DOUSLERAL 44 and 123 45 state 7% 13 state 7%
Crack Circumferential	Point	49.3	Structural	0	6-8	1	0	0	2	Crack Circumferential	Vortex Indostretal 08-26-22 2154:10 20 45:11.17
Crack Circumferential	Point	53.2	Structural	0	8-5	1	0	0	2	Crack Circumferential	Verter fremitrin 219314294 55933 Tr 55933 Tr 55935 2195551 PB 32235551 PB 3223716
Manhole	Point	55.2	Constructional	0		0	0	0	0	5-P	Verisi Industria) NS 24 2823 SS 28 Ft

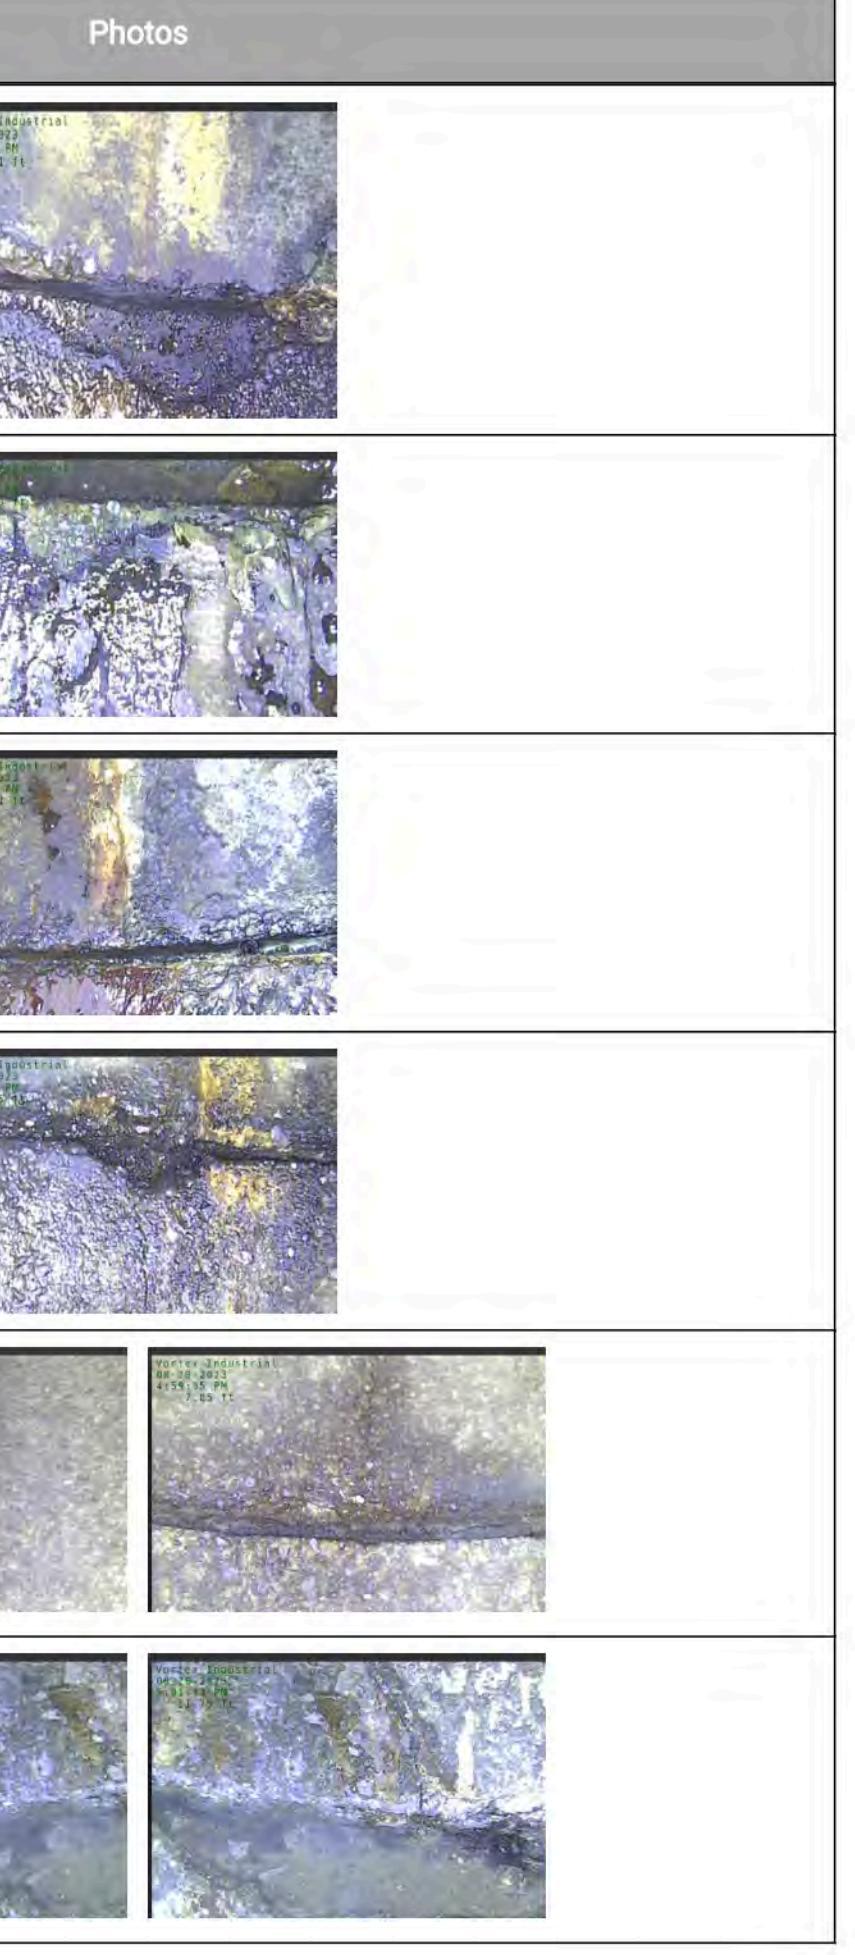
Description	Spatial Type	Distance (ft)	Туре	Percent	Clock	SR	0&M	С	PR	Remarks	
Fracture Circumferential	Point	3.9	Structural	0	9	2	0	0	2	Fracture Circumferential	
Crack Longitudinal	Point	3.9	Structural	0	6	2	0	0	2	Crack Longitudinal	
Crack Longitudinal	Point	3.9	Structural	0	7	2	0	0	2	Crack Longitudinal	
Crack Longitudinal	Point	7.9	Structural	0	3	2	0	0	1	Crack Longitudinal	a the second
Crack Longitudinal	Point	7.9	Structural	0	11	2	0	0	1	Crack Longitudinal	Vortre Industra i Ba. 14-2633 4-38-71 PM 1:45-71
Fracture Circumferential	Point	11.8	Structural	0	5-6	2	0	0	2	Fracture Circumferential	Vorface - Industrial Mill 20130 235 Staff 1,51 PM 11,15 Tt 12

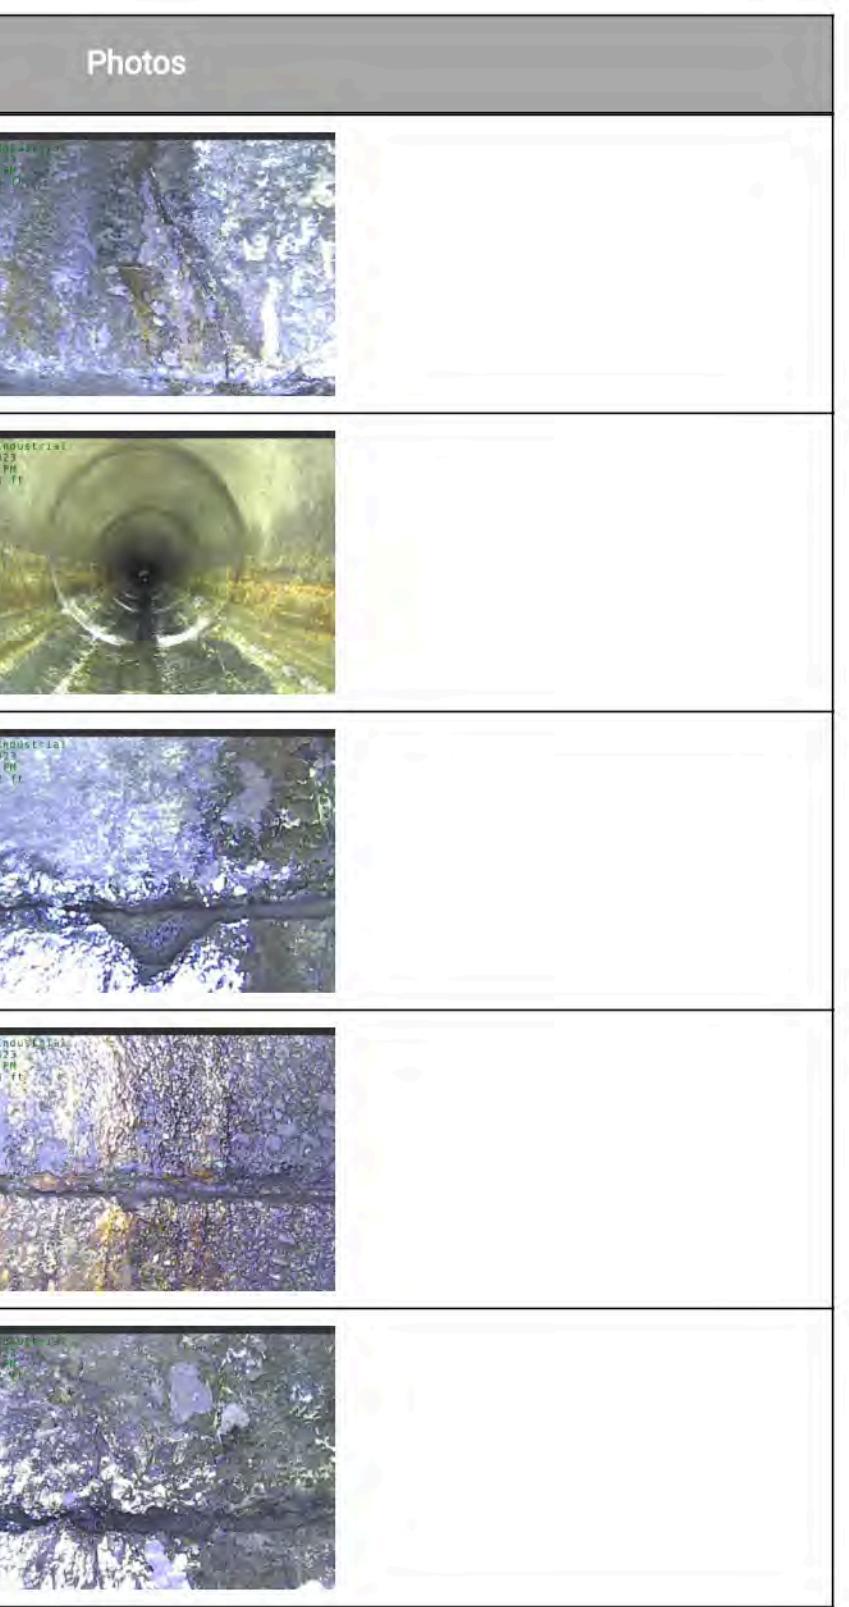
Description	Spatial Type	Distance (ft)	Туре	Percent	Clock	SR	O&M	С	PR	Remarks	
Crack Longitudinal	Point	11.8	Structural	0	6	2	0	0	2	Crack Longitudinal	Va. 175 - 2 3 - 21 - 2 7 - 7 7 - 7 7 7 - 7 7 - 7 7 7 - 7 7 7 - 7 7 7 - 7 7 7 7 - 7 7 7 7
Crack Longitudinal	Point	15.5	Structural	0	5	2	0	0	2	Crack Longitudinal	90/76-5 60/20-21 51/92/30 73/77
Fracture Circumferential	Point	21.1	Structural	0	6-7	2	0	0	2	Fracture Circumferential	
Crack Longitudinal	Point	24.4	Structural	0	3	2	0	0	2	Crack Longitudinal	00-20-21 5109-37 28-31
Crack Longitudinal	Point	28.1	Structural	0	6	2	0	0	2	Crack Longitudinal
