2024 ANNUAL PROGRESS REPORT SWMU-1 OILY WATER SEWER

HF SINCLAIR PUGET SOUND REFINING LLC

March 2025

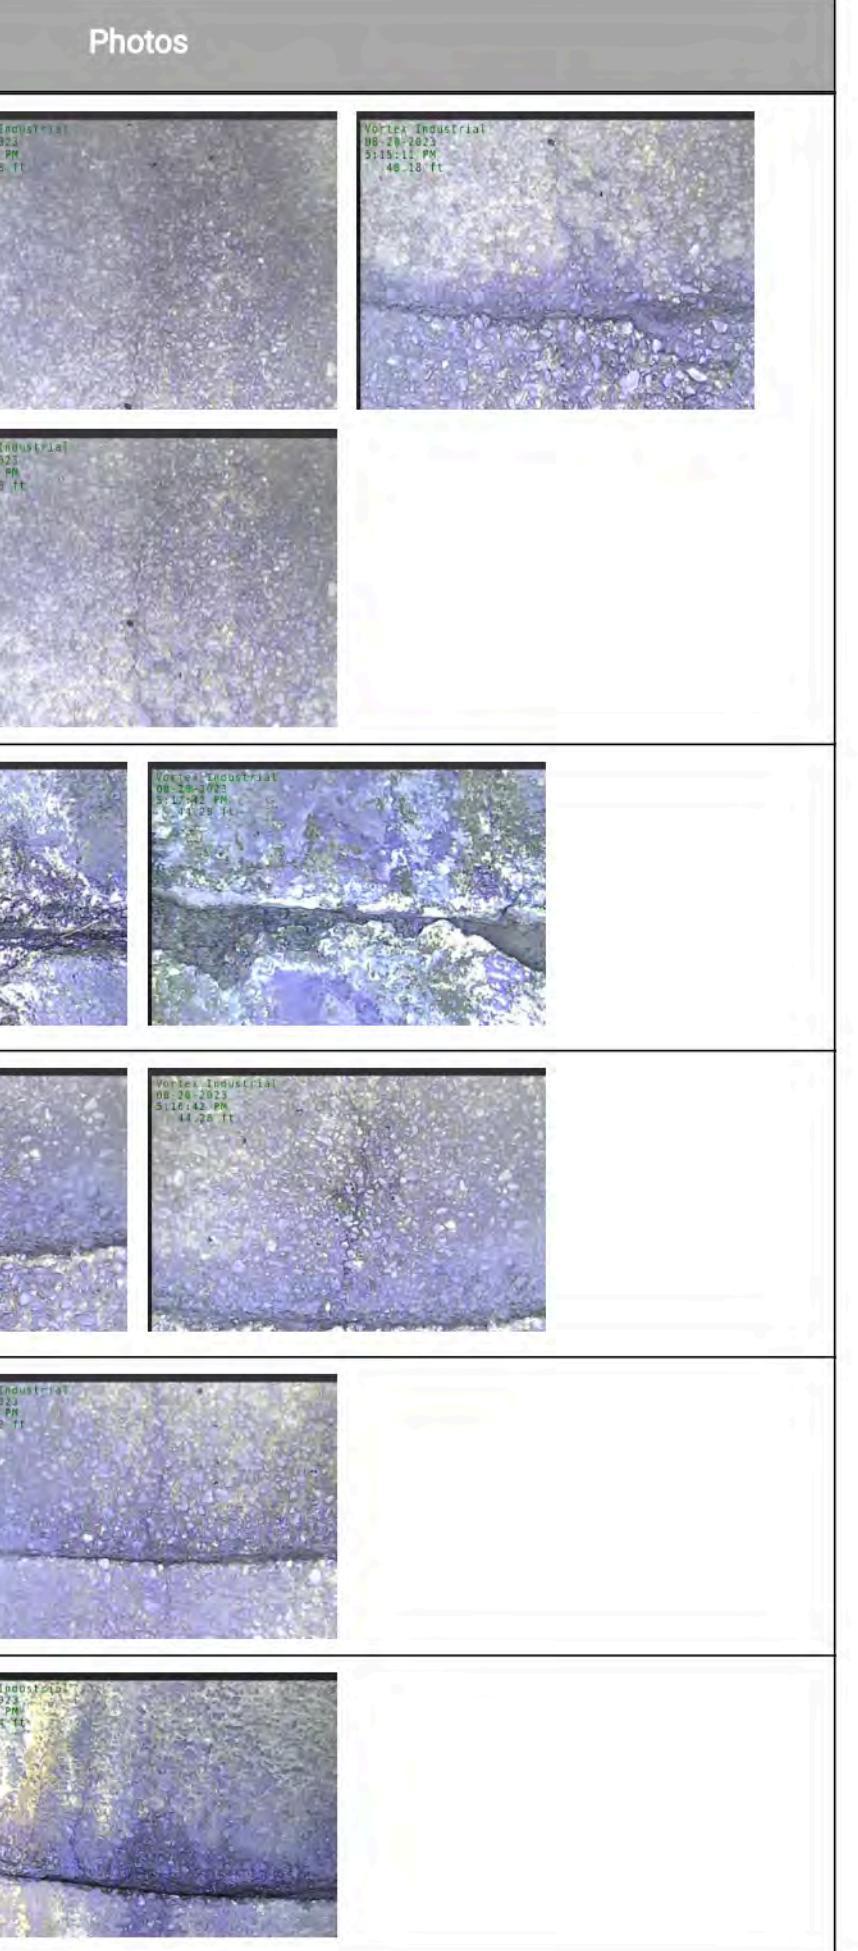
Description	Spatial Type	Distance (ft)	Туре	Percent	Clock	SR	0&M	С	PR	Remarks	
Crack Longitudinal	Point	40.2	Structural	0	8	2	0	0	1	Crack Longitudinal	Vorter Industrie 88 20 - 2023 5:15:19 PR 40.18 1 40.18 1 40.1
Fracture Circumferential	Point	44.3	Structural	0	5-6	2	0	0	2	Fracture Circumferential	
Crack Longitudinal	Point	44.3	Structural	0	11	2	0	0	2	Crack Longitudinal	Vories-Edustria de:20:203 3:14:30 PT 44:20 TT Solution
Crack Longitudinal	Point	48.3	Structural	0	12	2	0	0	1	Crack Longitudinal	Vorser 88 28 - 2 5 - 18:53 83 - 3
Crack Longitudinal	Point	56.4	Structural	0	4	2	0	0	1	Crack Longitudinal	9051 c5 88 - 20 - 20 55 - 23 - 45 - 56 - 4

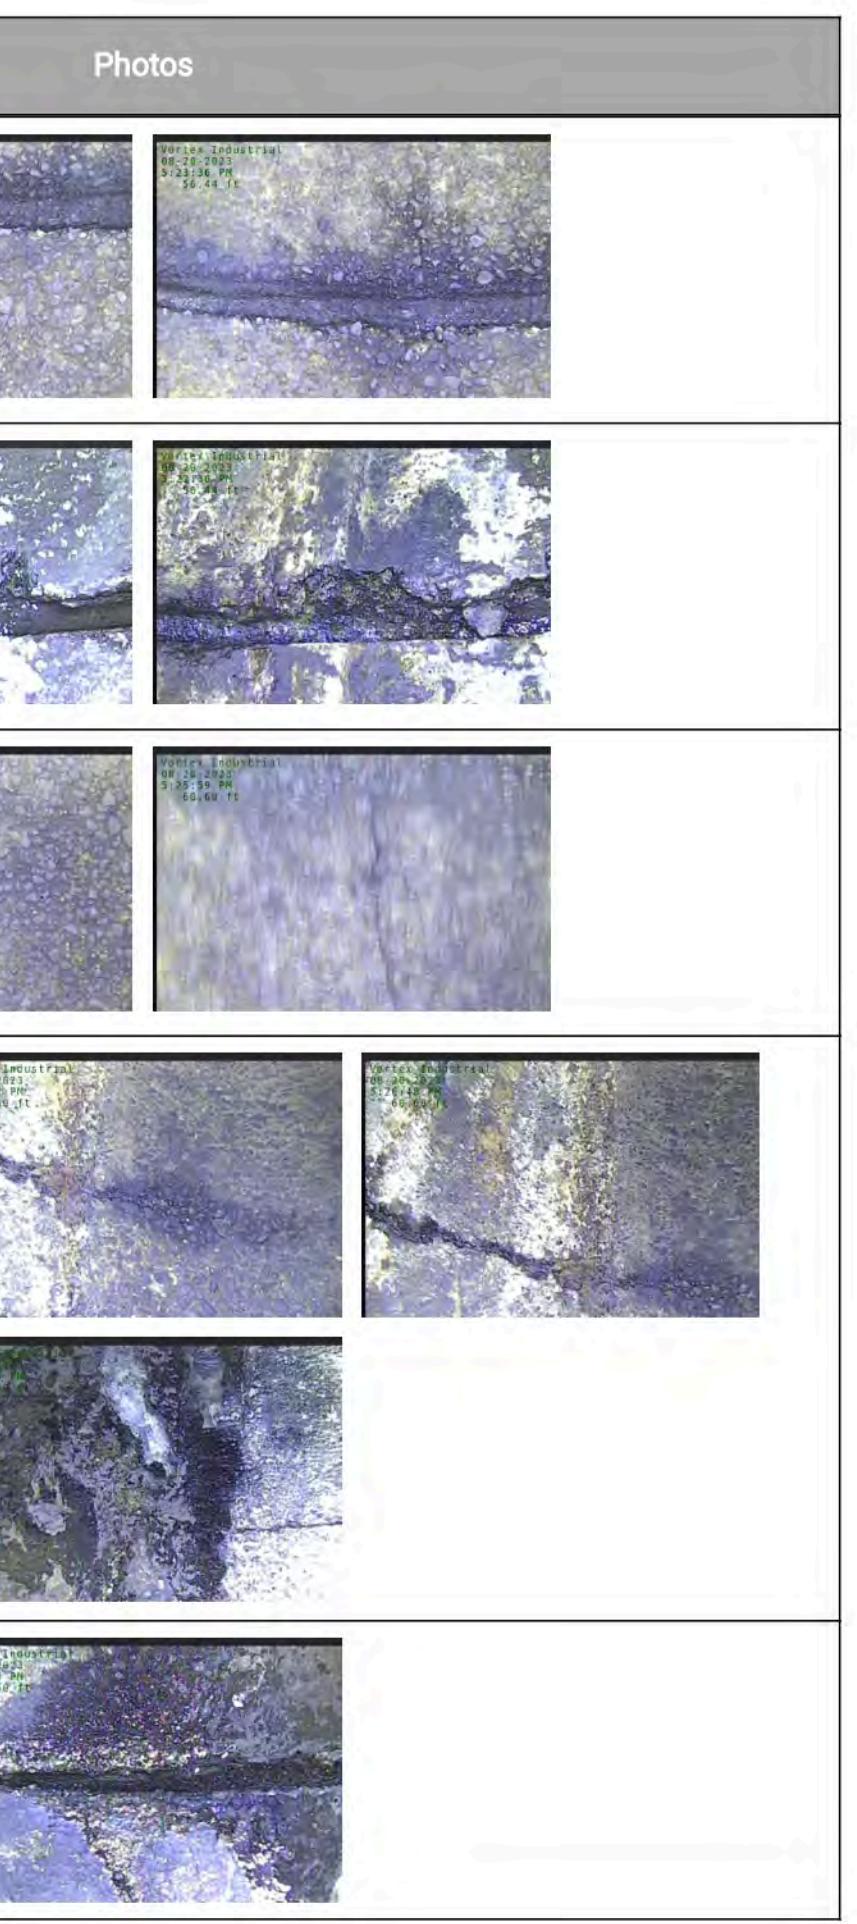
Description	Spatial Type	Distance (ft)	Туре	Percent	Clock	SR	0&M	С	PR	Remarks	
Crack Longitudinal	Point	56.4	Structural	0	2	2	0	0	1	Crack Longitudinal	Varies Industrias 00-26-23 3-22-16 Ph 37-46-71
Fracture Circumferential	Point	56.4	Structural	0	7-8	2	0	0	2	Fracture Circumferential	
Crack Longitudinal	Point	60.6	Structural	0	1	2	0	0	1	Crack Longitudinal	Voriek Industraal 98 40 30 30 93 24 30 30 93 30 94 30
Crack Circumferential	Point	60.6	Structural	0	2-5	1	0	0	2	Crack Circumferential	
Crack Longitudinal	Point	60.6	Structural	0	6	2	0	0	2	Crack Longitudinal

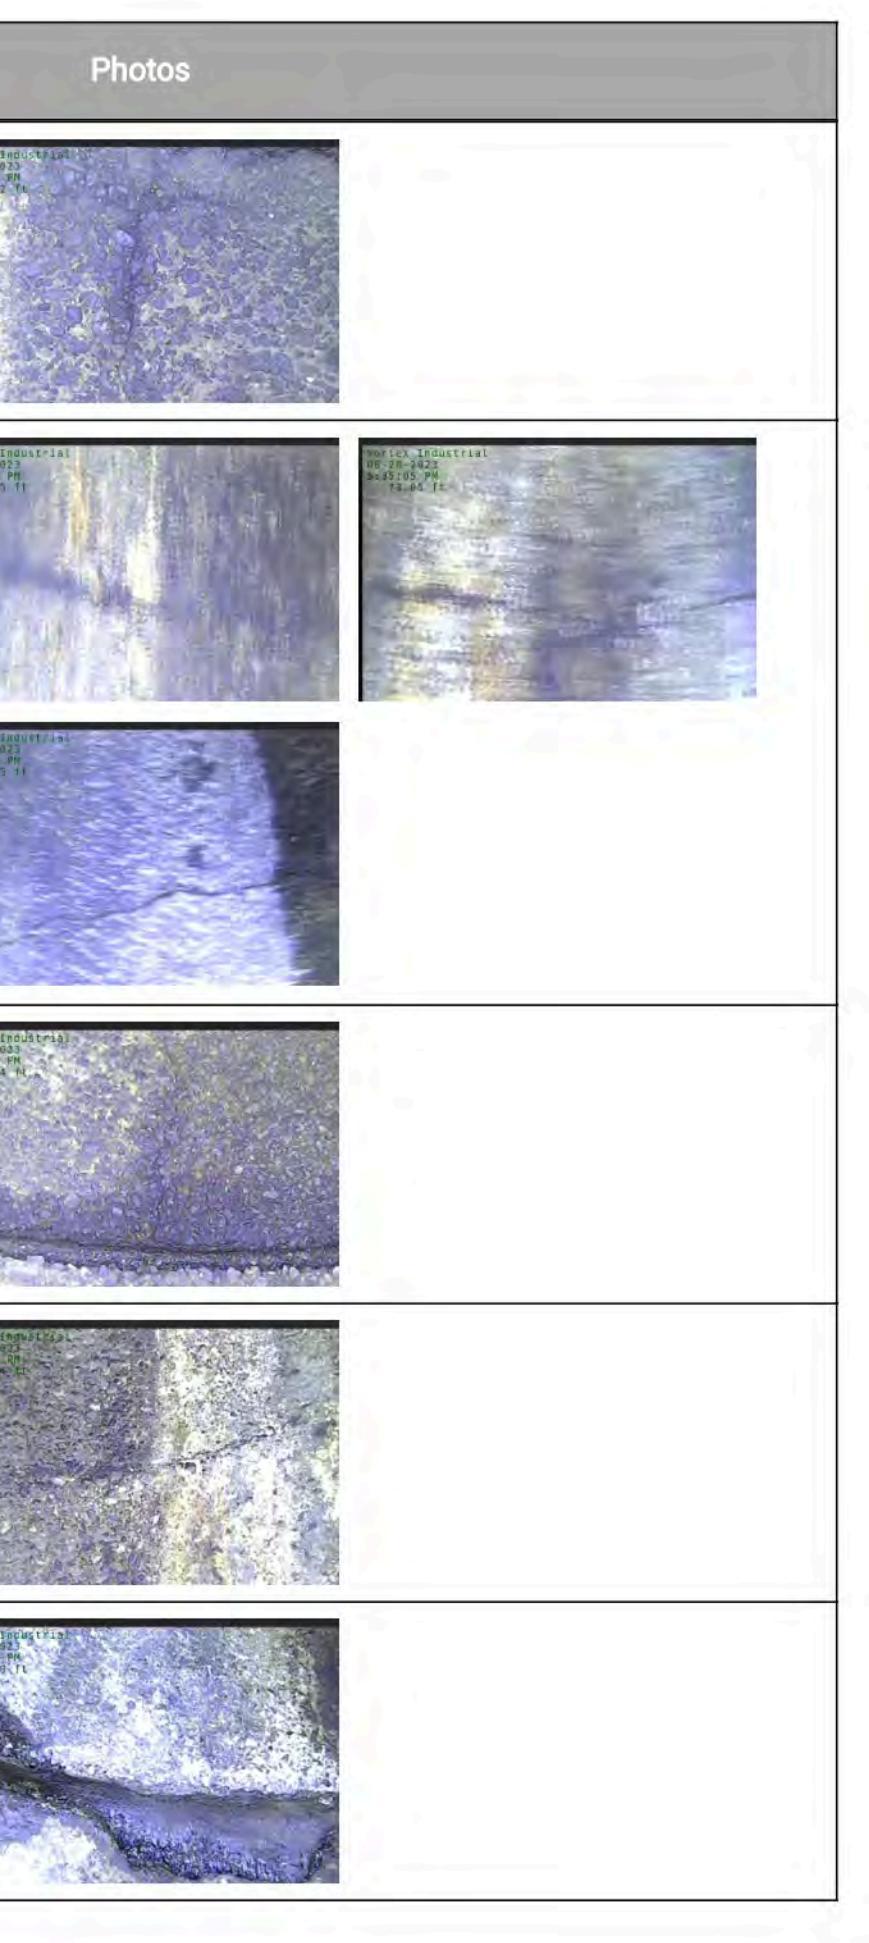
Description	Spatial Type	Distance (ft)	Туре	Percent	Clock	SR	O&M	С	PR	Remarks	
Crack Longitudinal	Point	72.6	Structural	0	2	2	0	0	2	Crack Longitudinal	
Crack Circumferential	Point	73	Structural	0	3-9	1	0	0	2	Crack Circumferential	
Crack Longitudinal	Point	76.7	Structural	0	12	2	0	0	1	Crack Longitudinal	00-fte 4 08-34: 3-7 76- 3-7 76
Crack Circumferential	Point	76.7	Structural	0	6-9	1	0	0	2	Crack Circumferential	
Fracture Circumferential	Point	80.7	Structural	0	4-5	2	0	0	2	Fracture Circumferential

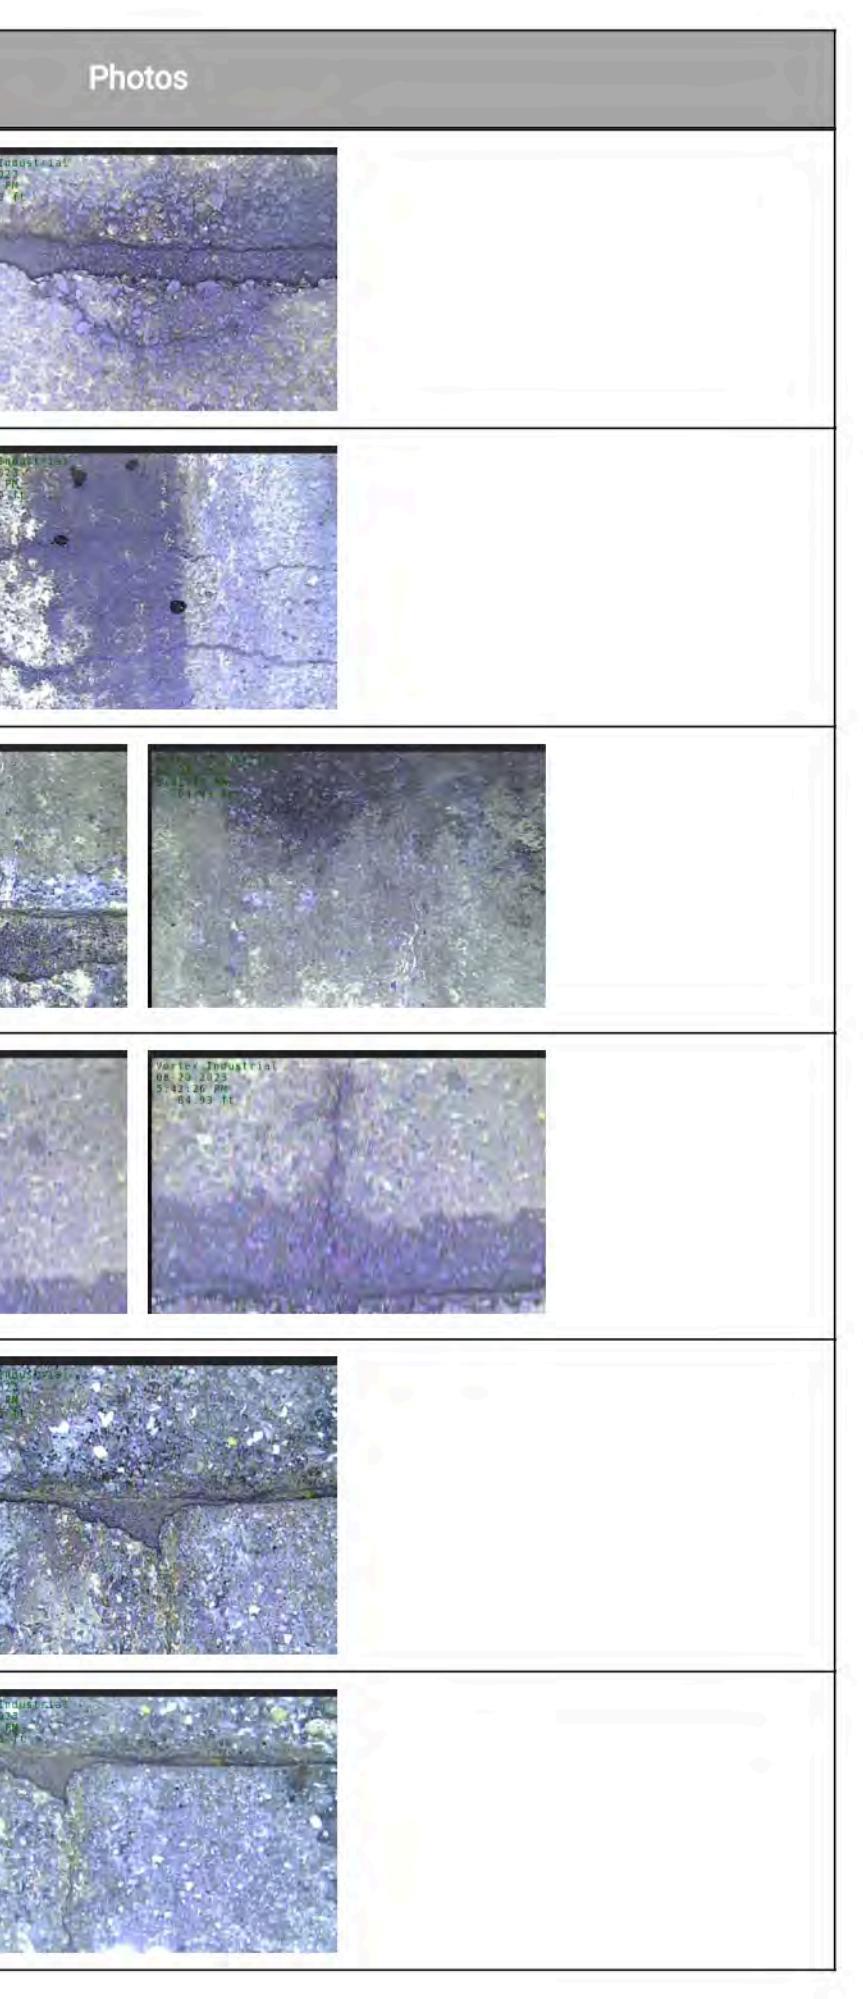
Description	Spatial Type	Distance (ft)	Туре	Percent	Clock	SR	0&M	С	PR	Remarks	
Crack Circumferential	Point	80.7	Structural	0	1-2	1	0	0	2	Crack Circumferential	V07tm 08-20-3 5-33148 20-3
Crack Circumferential	Point	84.2	Structural	0	7-9	1	0	0	1	Crack Circumferential	
Crack Longitudinal	Point	84.9	Structural	0	6	2	0	0	1	Crack Longitudinal	Horsey - Except Anal. State 22, 2025 State 23, 2025 State 24, 2025 State 2
Crack Longitudinal	Point	84.9	Structural	0	12	2	0	0	1	Crack Longitudinal	Voree Thomerian 96 - 20 - 2233 5 - 42 - 35 FM - 94 - 33 TM - 94 - 33 TM
Surface Damage Aggregate Missing	Point	88.5	Structural	0	7	4	0	0	1	Surface Damage Aggregate Missing	
Crack Longitudinal	Point	88.5	Structural	0	6	2	0	0	1	Crack Longitudinal

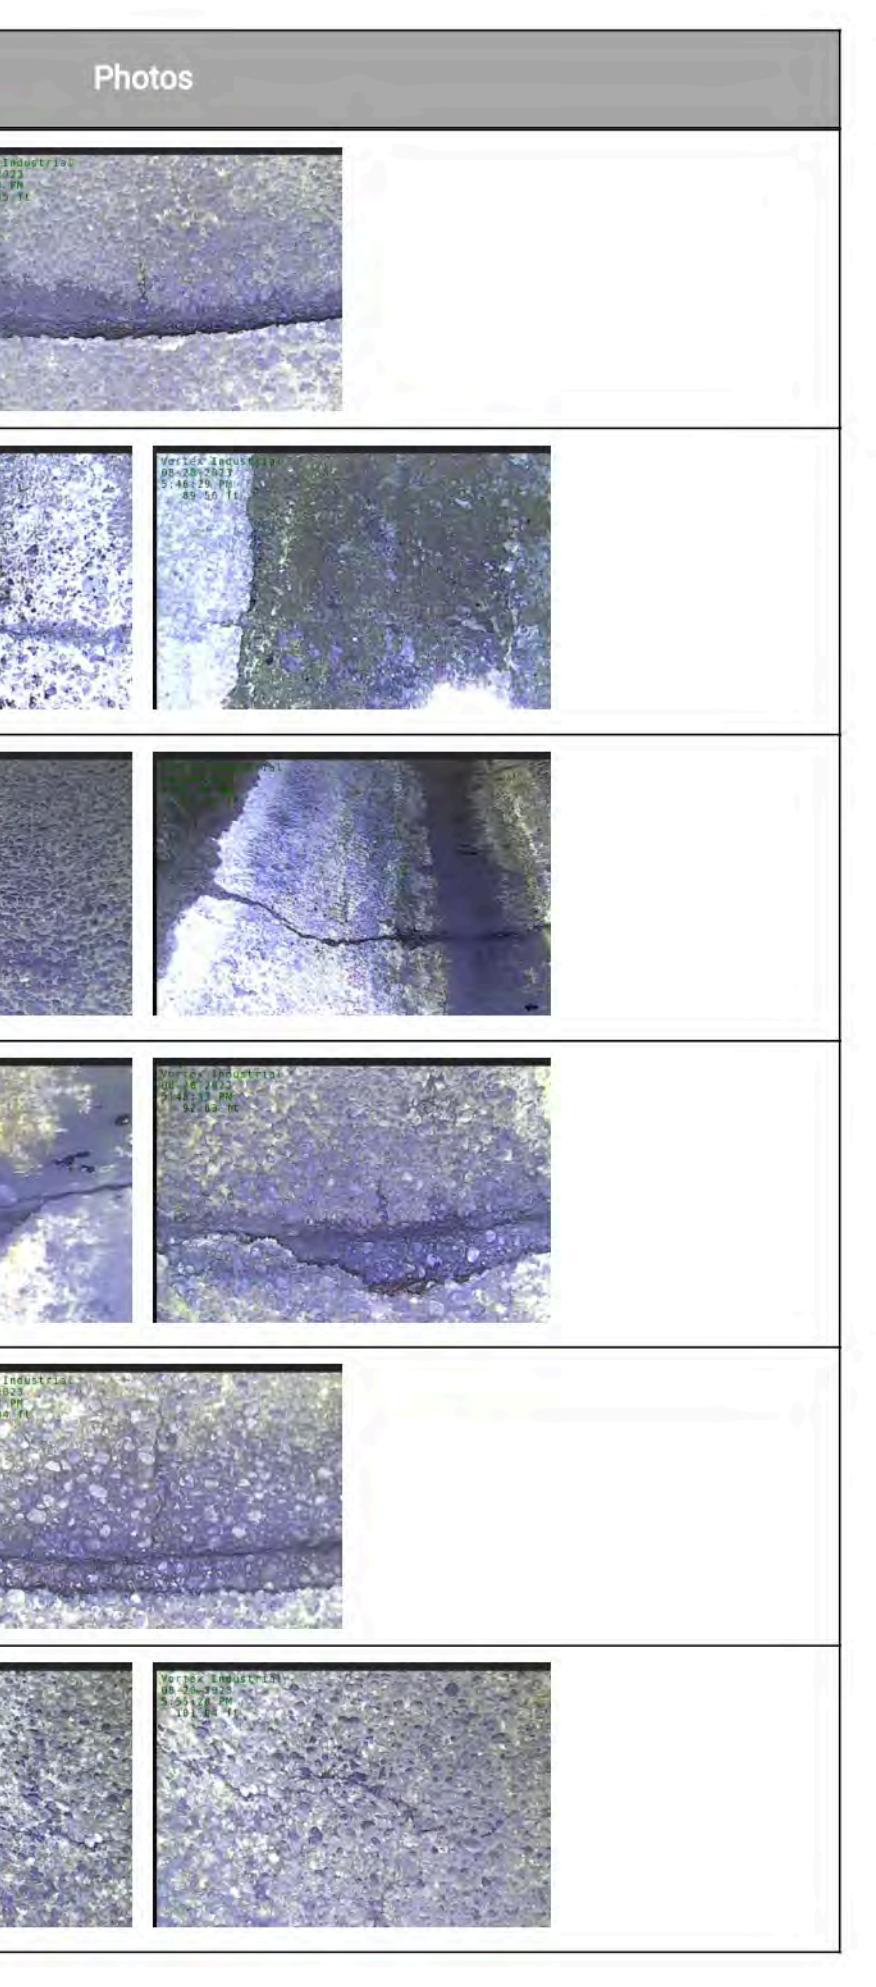
Description	Spatial Type	Distance (ft)	Туре	Percent	Clock	SR	0&M	С	PR	Remarks	
Crack Longitudinal	Point	88.5	Structural	0	11	2	0	0	1	Crack Longitudinal	
Crack Circumferential	Point	89.6	Structural	0	6-10	1	0	0	2	Crack Circumferential	
Fracture Circumferential	Point	92.8	Structural	0	3-5	1	0	0	2	Fracture Circumferential	Vestion There exists a second se
Fracture Circumferential	Point	92.8	Structural	0	9-10	2	0	0	2	Fracture Circumferential	1971 The Jonus (1981) at 1982 at 1983 at 1984 at 1984 at 1985
Crack Longitudinal	Point	101	Structural	0	10	2	0	0	1	Crack Longitudinal	
Crack Circumferential	Point	101.1	Structural	0	3-5	1	0	0	2	Crack Circumferential

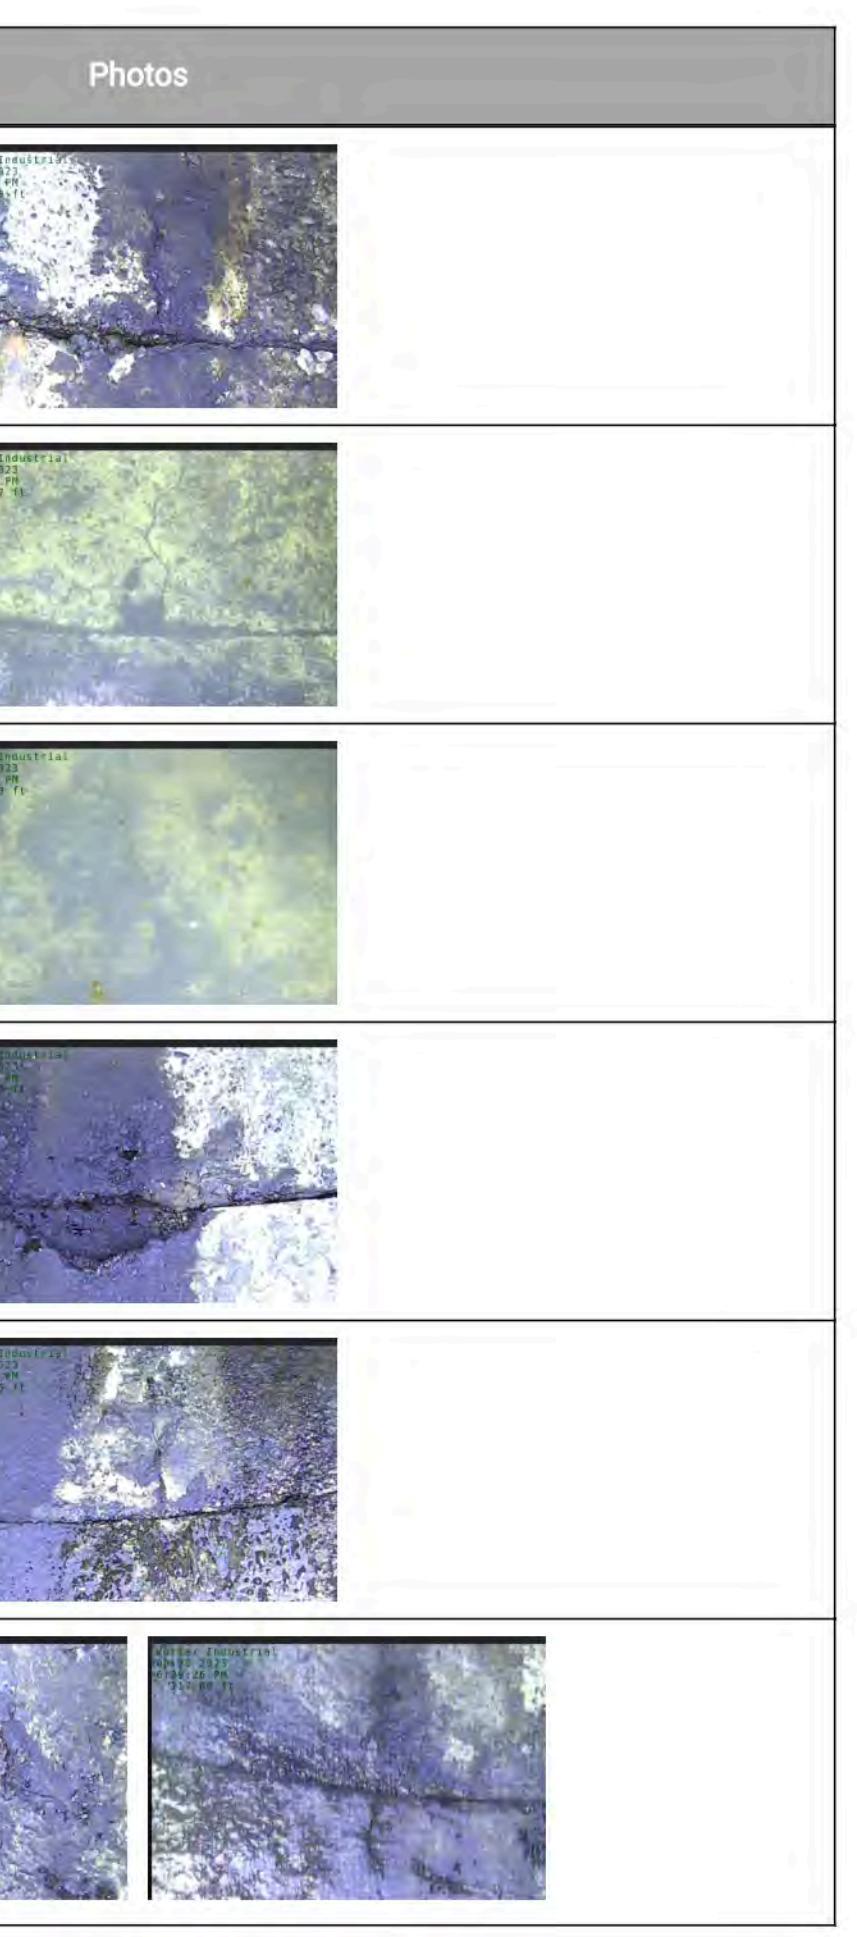
Description	Spatial Type	Distance (ft)	Туре	Percent	Clock	SR	0&M	С	PR	Remarks	
Crack Longitudinal	Point	105	Structural	0	4	2	0	0	2	Crack Longitudinal	
Crack Longitudinal	Point	109	Structural	0	6	2	0	0	2	Crack Longitudinal	307 15 5 1 5 1 1 9 4 5 1 7 1 9 4 5 2
Crack Longitudinal	Point	113.1	Structural	0	6	2	0	0	2	Crack Longitudinal	907 147 1 06 20 20 119 20 119 20
Fracture Circumferential	Point	113.1	Structural	0	8-9	2	0	0	2	Fracture Circumferential	
Crack Longitudinal	Point	117	Structural	0	8	2	0	0	2	Crack Longitudinal	001 20 - 20 61 21 - 20 61 21 - 20 7 - 127 - 10 7 - 127 - 127 - 127 7 - 127
Crack Longitudinal	Point	117	Structural	0	5	2	0	0	1	Crack Longitudinal

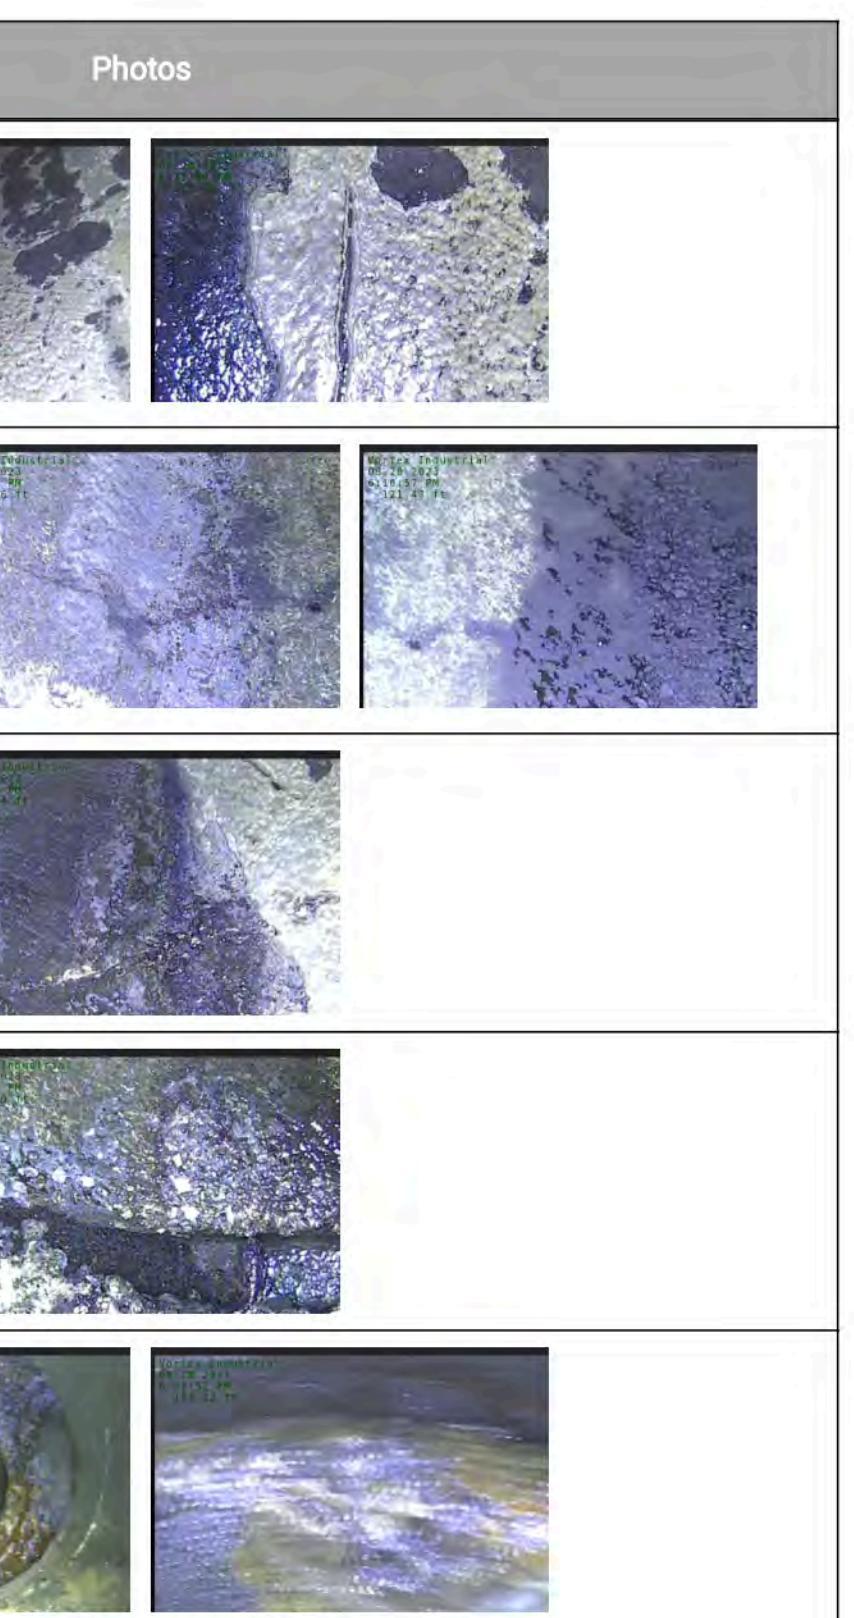
Description	Spatial Type	Distance (ft)	Туре	Percent	Clock	SR	0&M	С	PR	Remarks	
Crack Longitudinal	Point	120.4	Structural	0	7	2	0	0	2	Crack Longitudinal	
Crack Circumferential	Point	121.5	Structural	0	4-5	1	0	0	1	Crack Circumferential	Version Provide Provid
Crack Longitudinal	Point	127.4	Structural	0	7	2	0	0	2	Crack Longitudinal	
Fracture Circumferential	Point	129	Structural	0	5-6	2	0	0	2	Fracture Circumferential	
Manhole	Point	133.2	Constructional	0		0	0	0	0	5-B	tore are a real to the second se

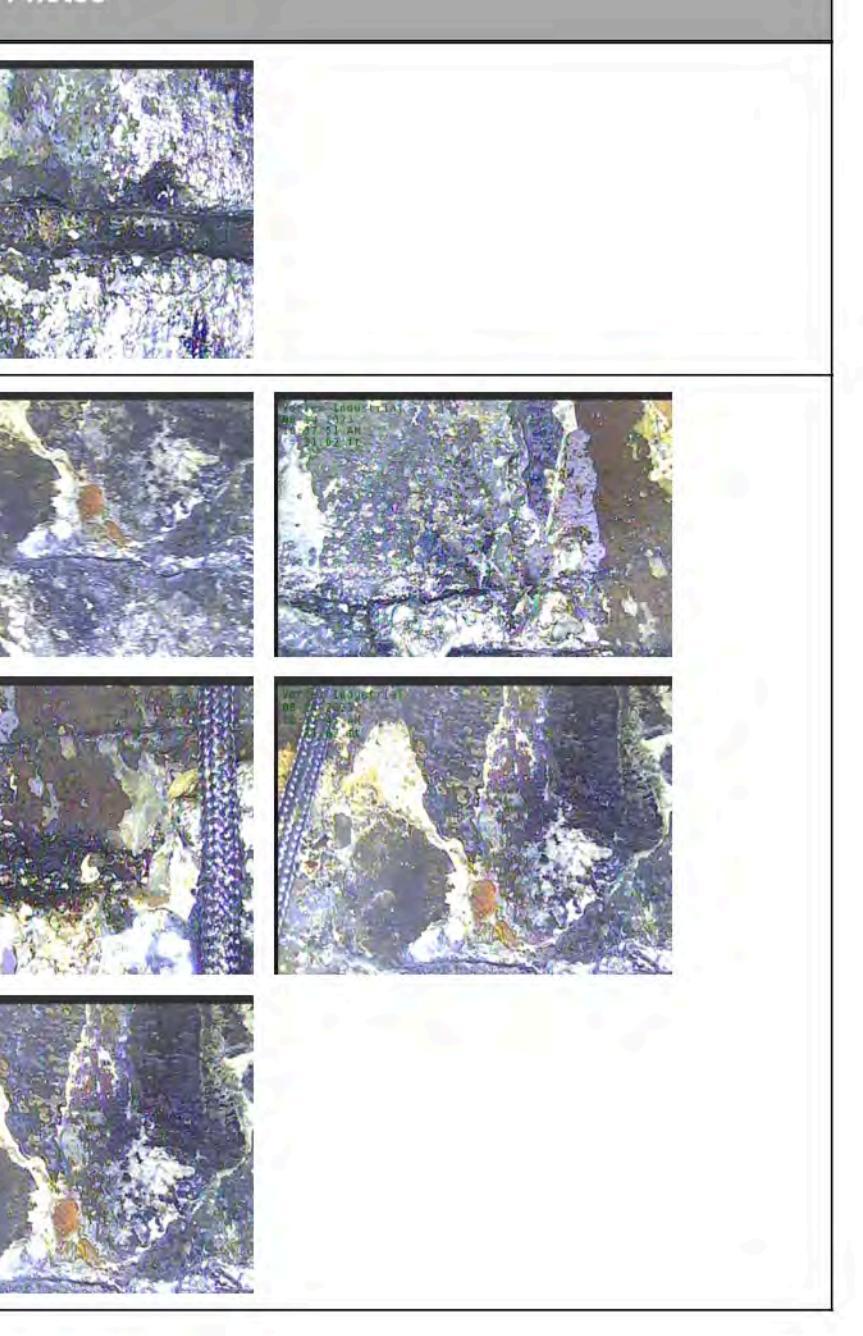
Description	Spatial Type	Distance (ft)	Туре	Percent	Clock	SR	0&M	С	PR	Remarks	
Crack Longitudinal	Point	23.1	Structural	0	4	2	0	0	1	Crack Longitudinal	er industrial de la 223 au 386 At 17 92 At
Crack Circumferential	Point	31	Structural	0	6-8	1	0	0	2	Crack Circumferential	
					1	1	12.14

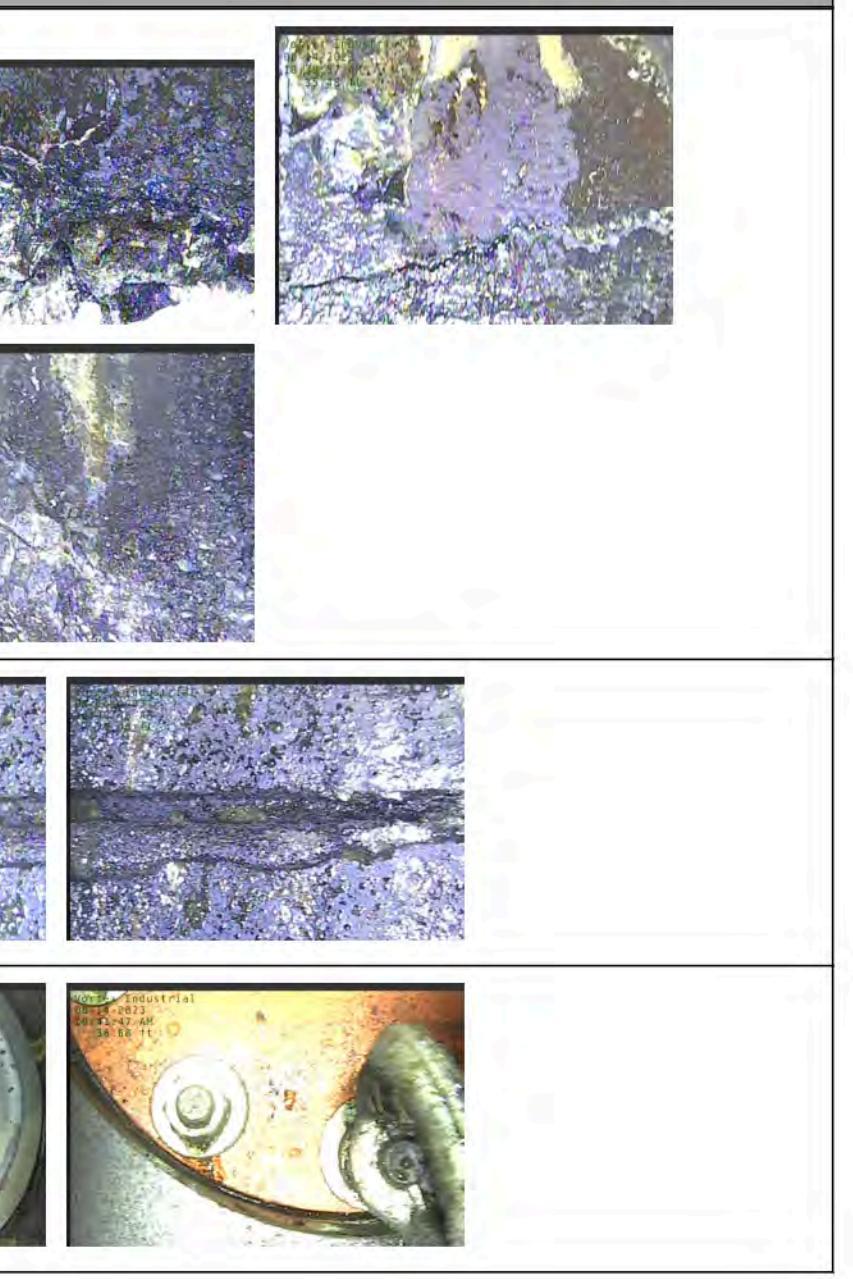
Description	Spatial Type	Distance (ft)	Туре	Percent	Clock	SR	0&M	С	PR	Remarks	
Crack Multiple	Point	35.5	Structural	0	4-6	3	0	0	2	Crack Multiple	<image/>
Fracture Circumferential	Point	35.5	Structural	0	7-8	2	0	0	2	Fracture Circumferential	
Miscellaneous Survey Abandoned	Point	38.7	Miscellaneous	0		0	0	0	0	Plugged

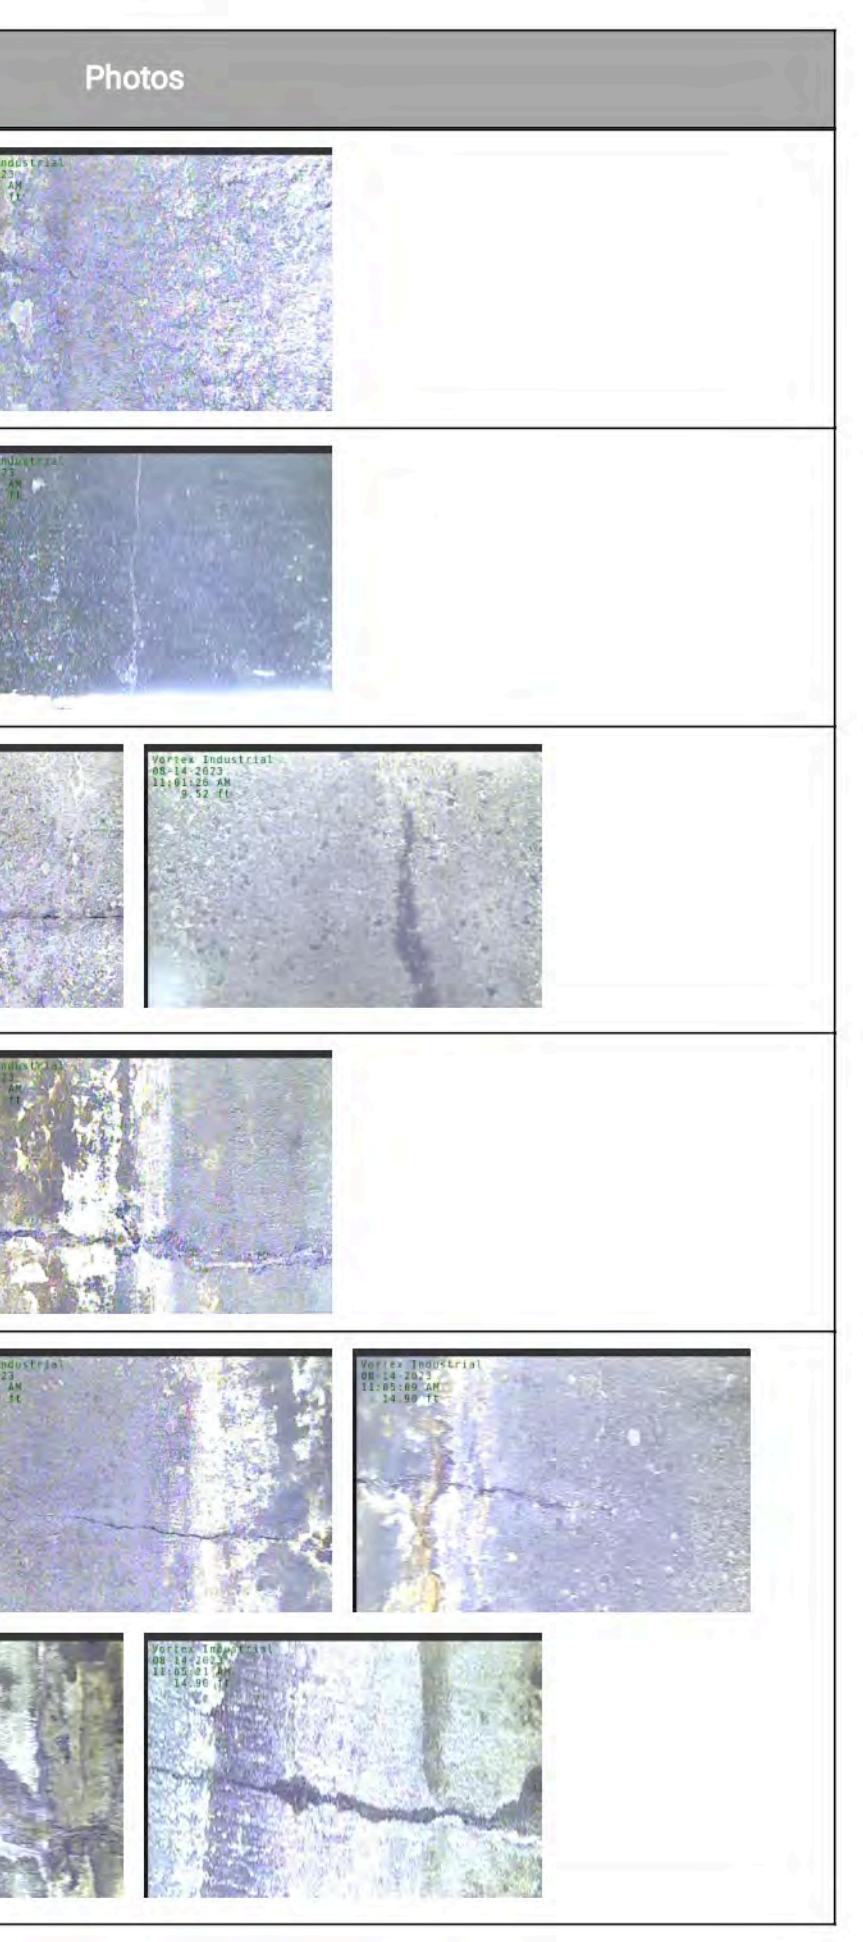
Description	Spatial Type	Distance (ft)	Туре	Percent	Clock	SR	O&M	с	PR	Remarks	
Crack Circumferential	Point	8	Structural	0	8-9	1	0	0	1	Crack Circumferential	Vur tex 1 195 14 - 20 195 54 78 8 00
Crack Longitudinal	Point	9.5	Structural	0	9	2	0	0	1	Crack Longitudinal	
Crack Longitudinal	Point	9.5	Structural	0	6	2	0	0	1	Crack Longitudinal	Workes Industrial Brissississi Tilssis 201 432 11 432 11
Crack Circumferential	Point	12.2	Structural	0	6-9	1	0	0	2	Crack Circumferential	
Crack Circumferential	Point	14.9	Structural	0	7-5	1	0	0	1	Crack Circumferential	Verter reported to the second

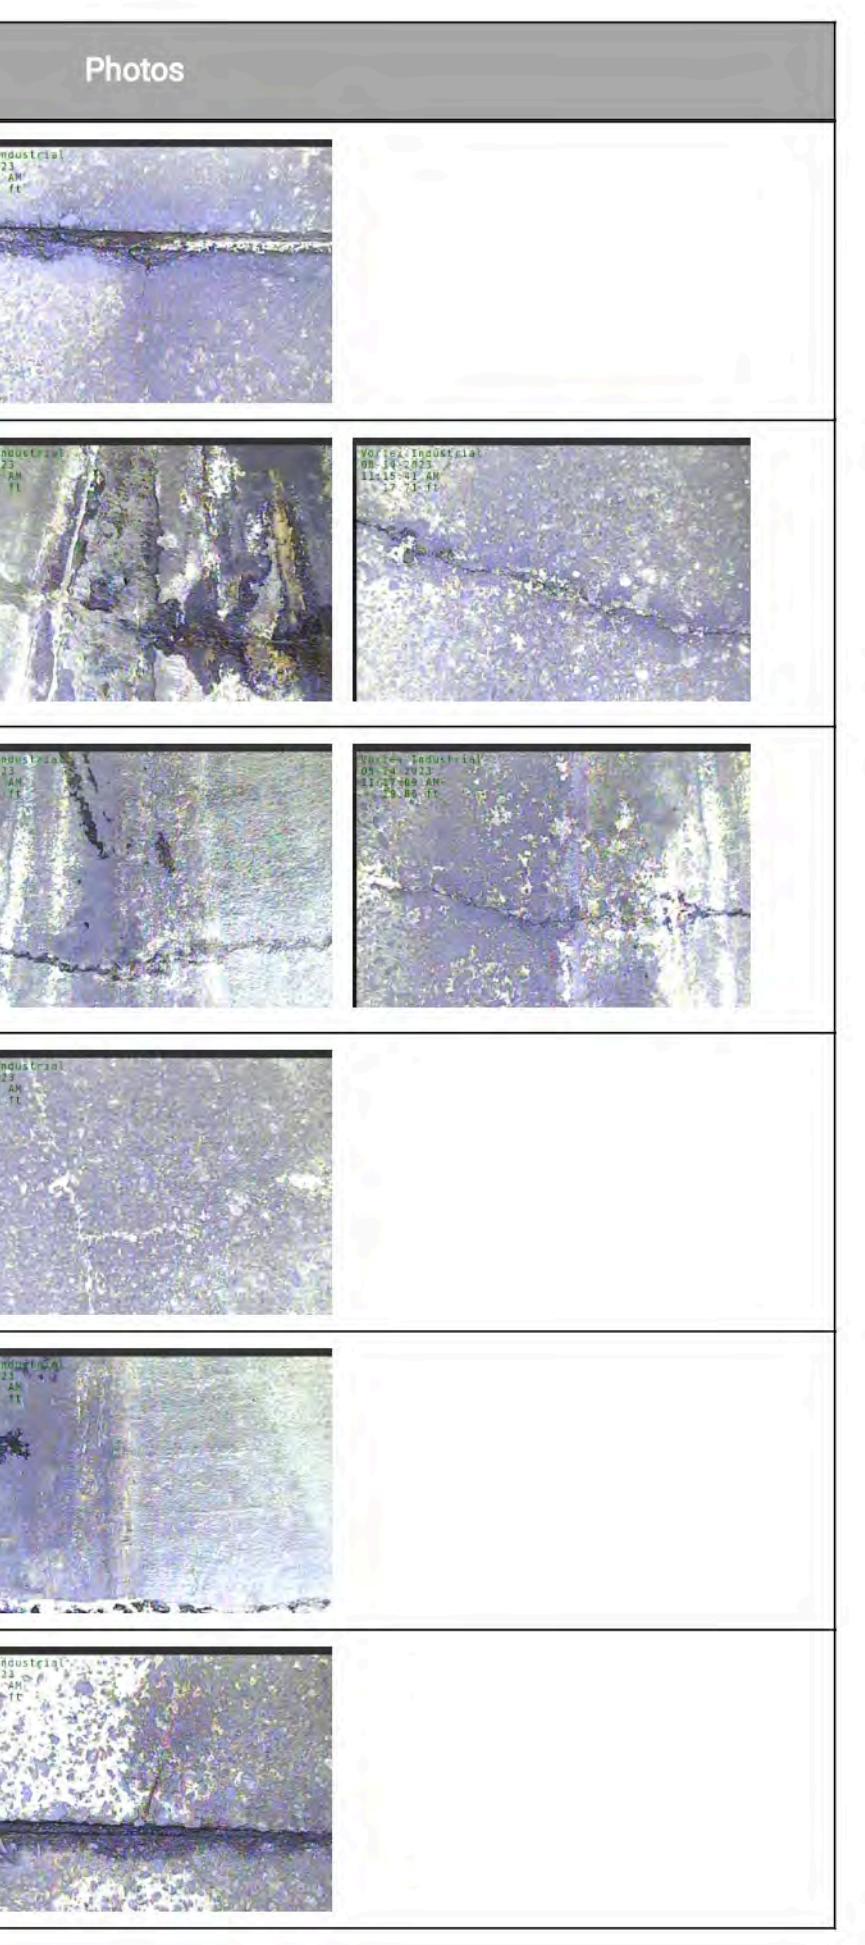
Description	Spatial Type	Distance (ft)	Туре	Percent	Clock	SR	O&M	С	PR	Remarks	
Crack Longitudinal	Point	14.9	Structural	0	11	2	0	0	2	Crack Longitudinal	Vor.42/ 08.14-2 11:13-2 2.5
Crack Circumferential	Point	17.7	Structural	0	6-5	1	0	0	2	Crack Circumferential	Here a construction of the
Crack Circumferential	Point	19.9	Structural	0	7-11	1	0	0	2	Crack Circumferential	Horizon Findia Hella J Barde - Zia Za - La Maria - Maria - Mari Maria - Maria - Ma Maria - Maria - Mar
Crack Longitudinal	Point	19.9	Structural	0	11	2	0	0	1	Crack Longitudinal	Vor ee 00 14 2 13 (7 4 19 3
Crack Longitudinal	Point	22.7	Structural	0	8	2	0	0	1	Crack Longitudinal	
Crack Longitudinal	Point	22.7	Structural	0	10	2	0	0	1	Crack Longitudinal

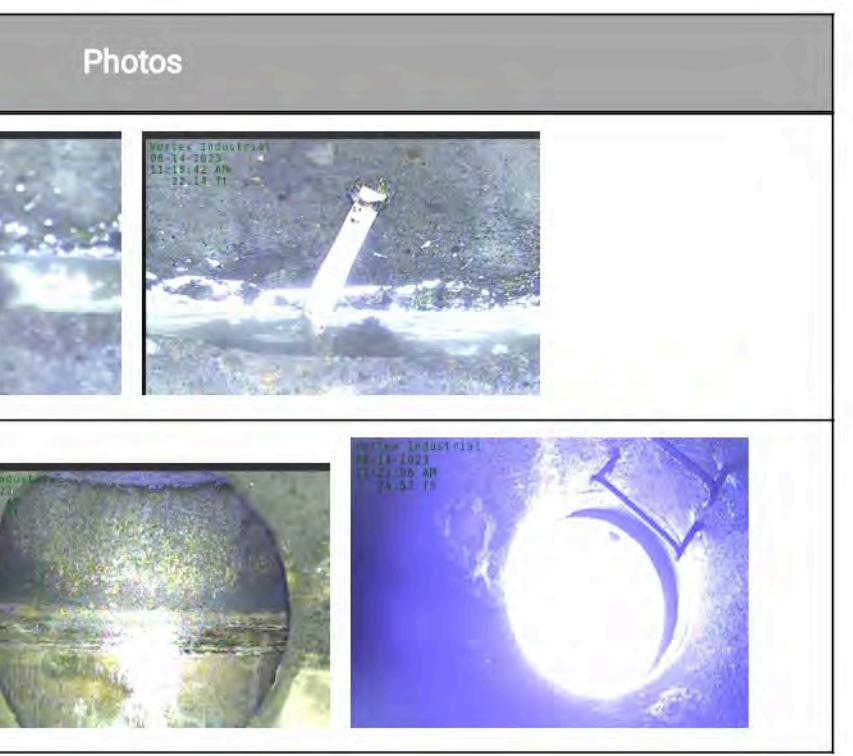
Description	Spatial Type	Distance (ft)	Туре	Percent	Clock	SR	O&M	С	PR	Remarks	
Miscellaneous General Photograph	Point	22.7	Miscellaneous	0	6	0	0	0	0	Object in Joint	Voriev Industrial BB-14-2023 Ilrib:20 AM 22272 (1
Manhole	Point	26.6	Constructional	0		0	0	0	0	23-2	11.10 0 0 0 0 0 0 0 0 0 0 0 0 0 0 0 0 0

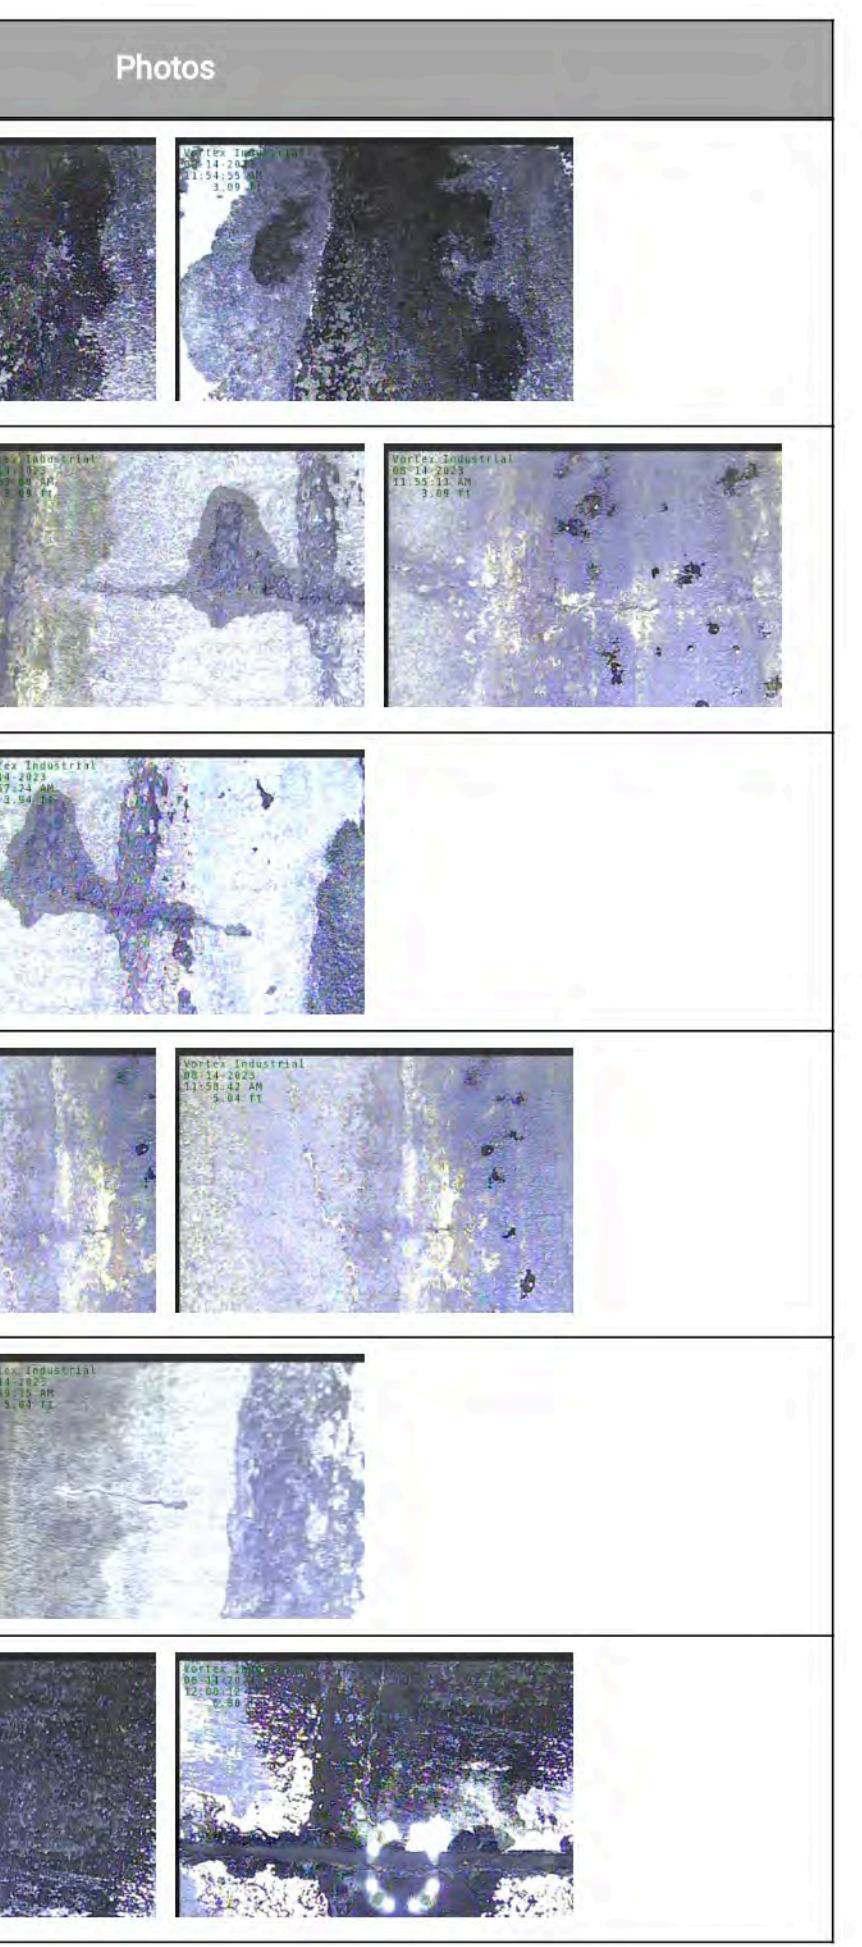
Description	Spatial Type	Distance (ft)	Туре	Percent	Clock	SR	0&M	С	PR	Remarks	
Crack Longitudinal	Point	3.1	Structural	0	6	2	0	0	1	Crack Longitudinal	
Crack Circumferential	Point	3.1	Structural	0	7-9	1	0	0	1	Crack Circumferential	The decay thread the decay of t
Crack Circumferential	Point	3.9	Structural	0	7-8	1	0	0	1	Crack Circumferential	
Crack Spiral	Point	5	Structural	0	6-8	2	0	0	1	Crack Spiral	Vortes (news)rtsi 08-14-2023 11-50-53-20 5-00-74 5-00-74
Crack Circumferential	Point	5	Structural	0	7-8	1	0	0	1	Crack Circumferential	
Crack Longitudinal	Point	6.8	Structural	0	6	2	0	0	1	Crack Longitudinal	Vortes Ind 06-14-277 12:05-31:05 20:07
